Structural Engineering Reconnaissance of the August 17, 1999, Kocaeli (Izmit), Turkey, Earthquake

Structural Engineering Reconnaissance of the August 17, 1999 Earthquake: Kocaeli (Izmit), Turkey

PEER Report 2000/09
Pacific Earthquake Engineering Research Center
College of Engineering
University of California, Berkeley
December 2000

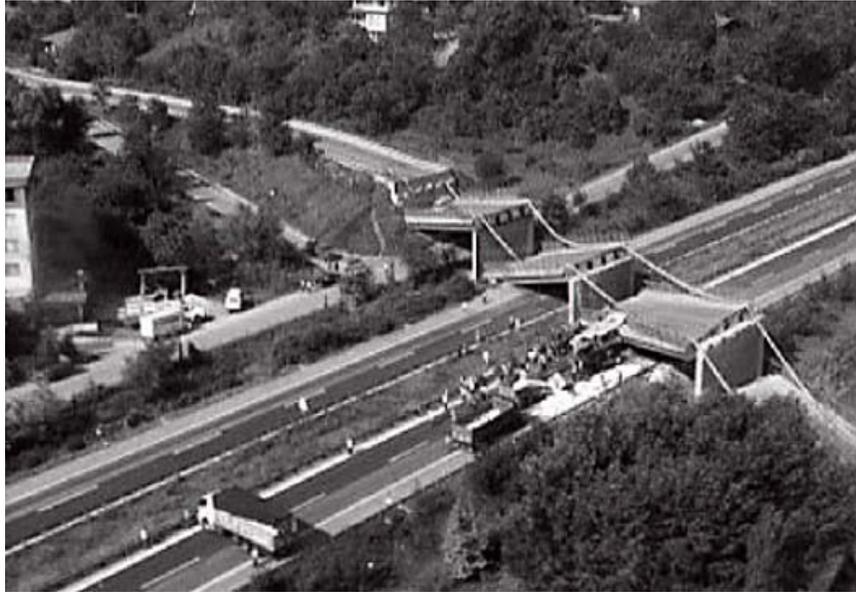
The reconnaissance team documented the collapse of two bridges. Each collapse was a result of fault rupture beneath the piers. Figure 1-5 shows the collapse of the bridge over the Trans-European Motorway. This bridge was composed of four 26-m-long simply supported spans. Each of the spans was positioned on elastomeric bridge bearings. Each span lost the support of at least one end. Figure 1-6 is a view of the bearings and an unseated span from one abutment. Another bridge near Akyazi collapsed (see Figure 1-7), reportedly due to movement of the supporting piers; much of the bridge is submerged in the photograph.

Figure 1-5 Failure of a bridge over the Trans-European Motorway

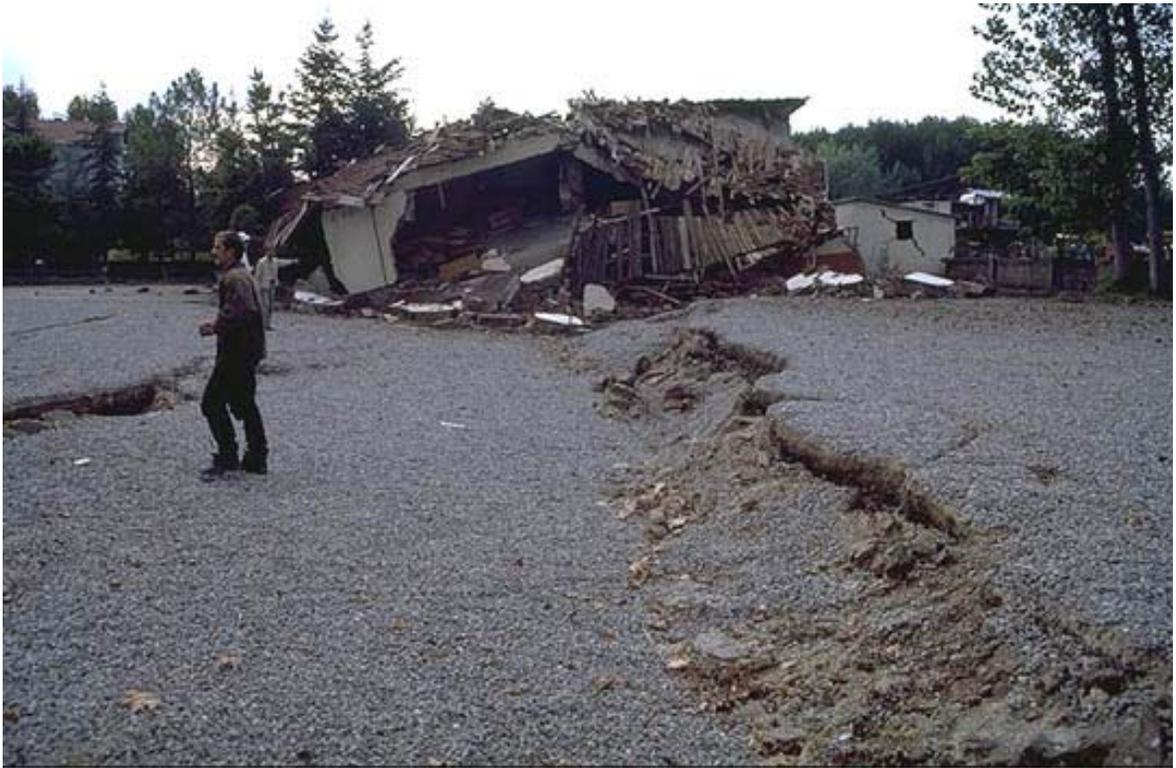
Figure 3-14 Collapsed school building that straddled the line of rupture

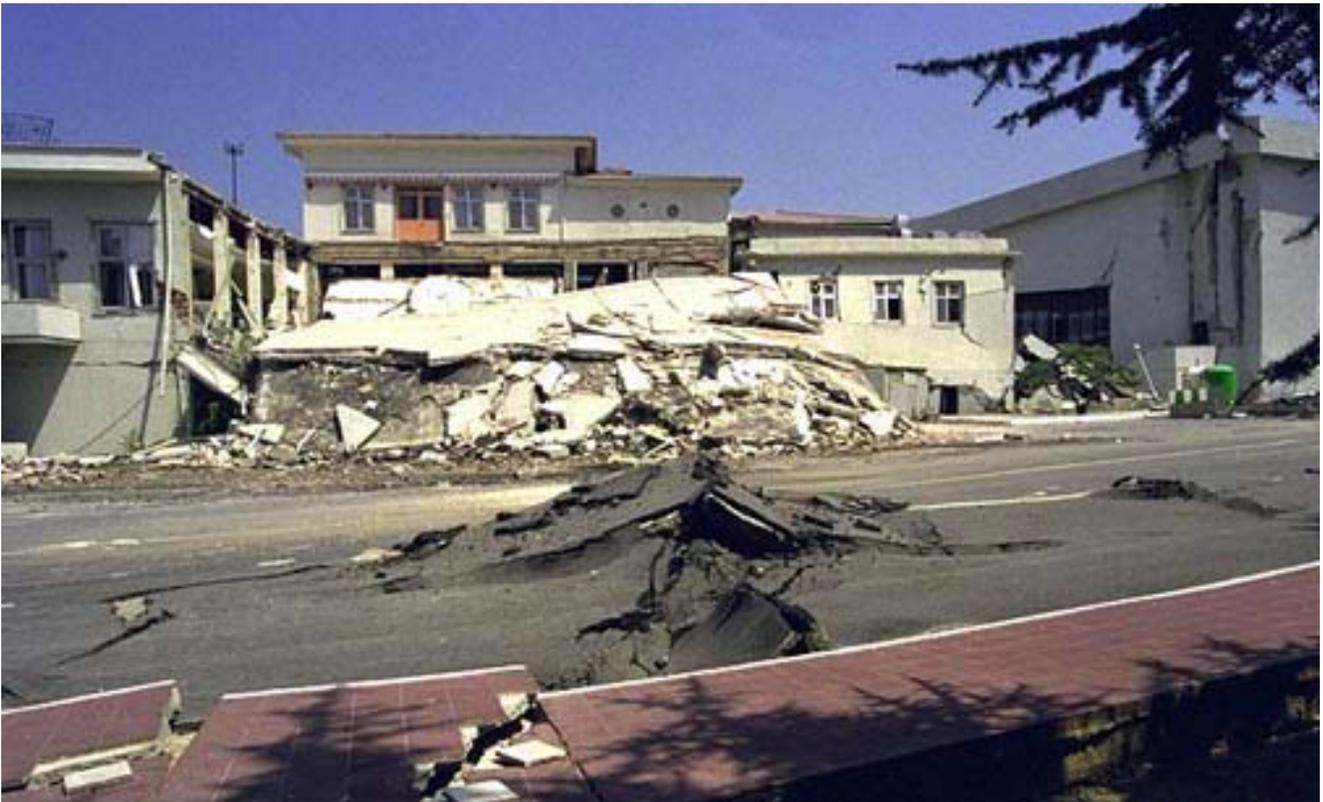
Figure 3-15 Collapsed and damaged moment-frame buildings on the Gölcük navy base

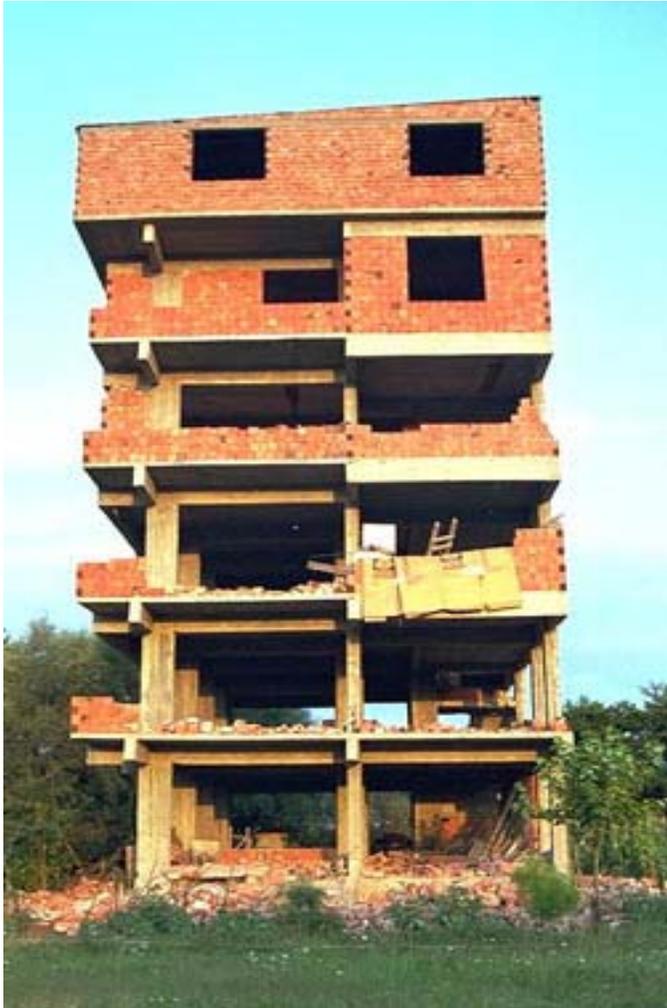
Damage to infill masonry walls was concentrated in the lower stories of buildings because of higher demands on the strength of the moment-frame-infill wall system. Figure 3-20 illustrates the distribution of damage to infill walls in two buildings, one near Gölcük, and one in Degirmendere. In these buildings, the lateral stiffness of the masonry infill walls is likely of the same order or greater than that of the moment-frames. For these buildings not to collapse following the failure of the infill walls the moment-frames must have possessed significant strength and some limited ductility.

a. infill wall damage in Gölcük

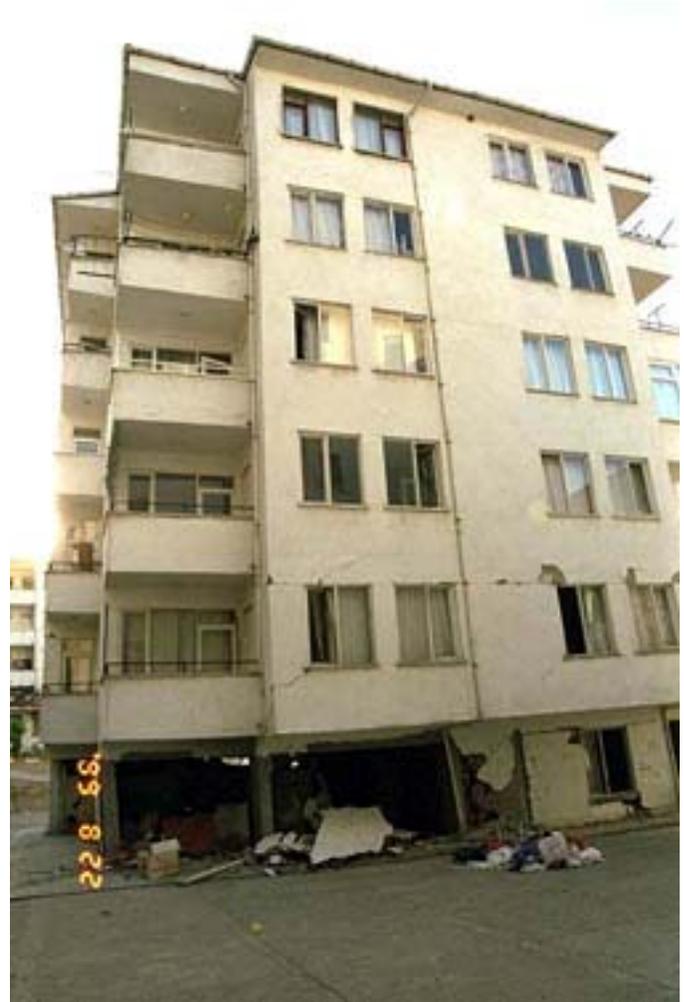
b. infill wall damage in Degirmendere

Figure 3-20 Damage to infill masonry walls

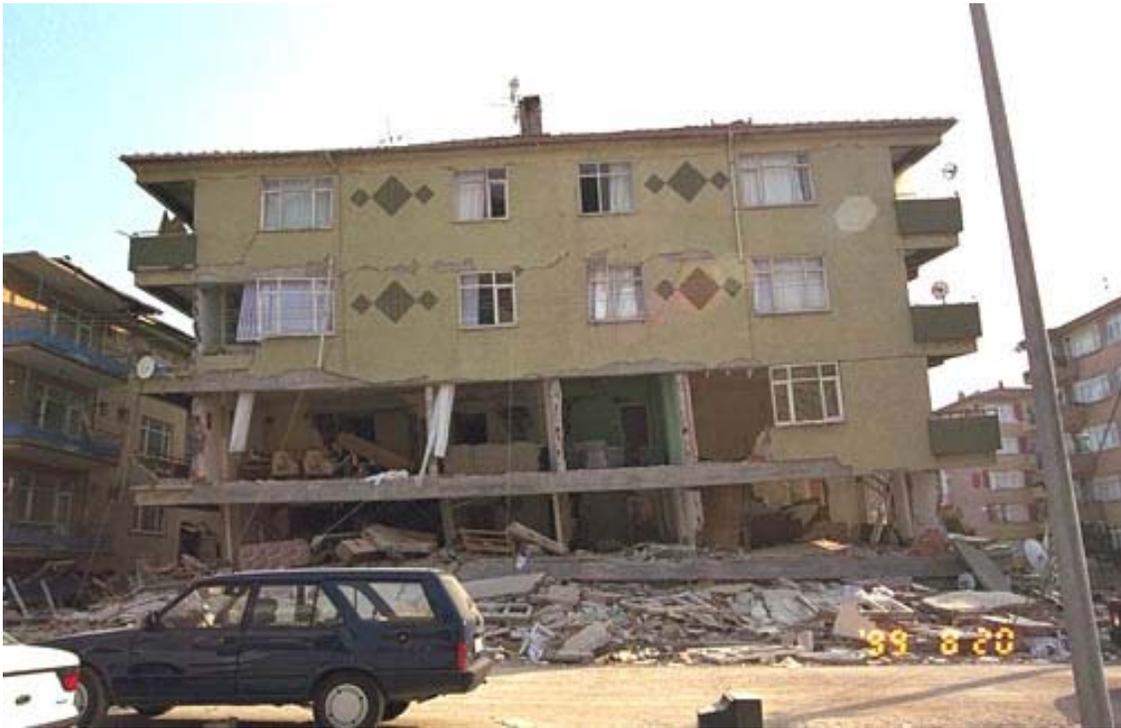
Figure 3-22 Failure of two stories of moment-frame building with infill masonry

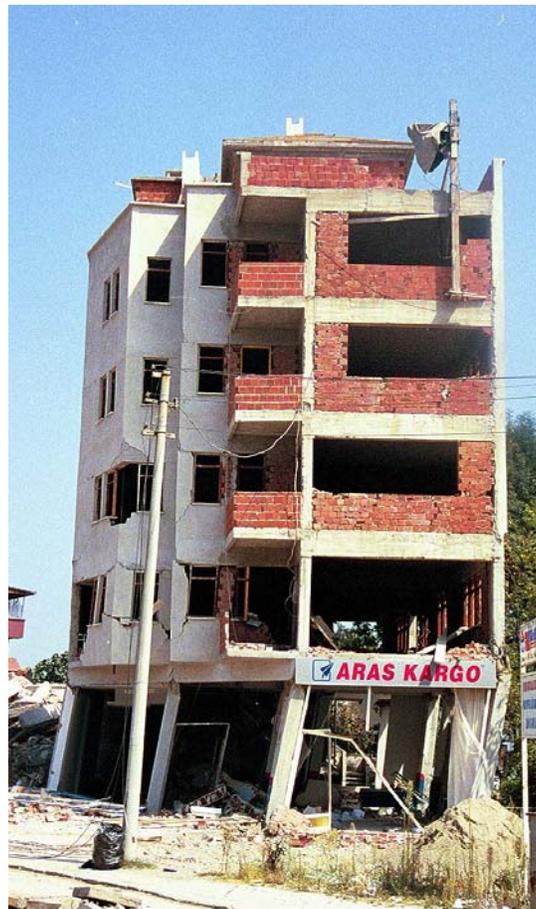
Figure 3-23 Formation of a soft and weak story

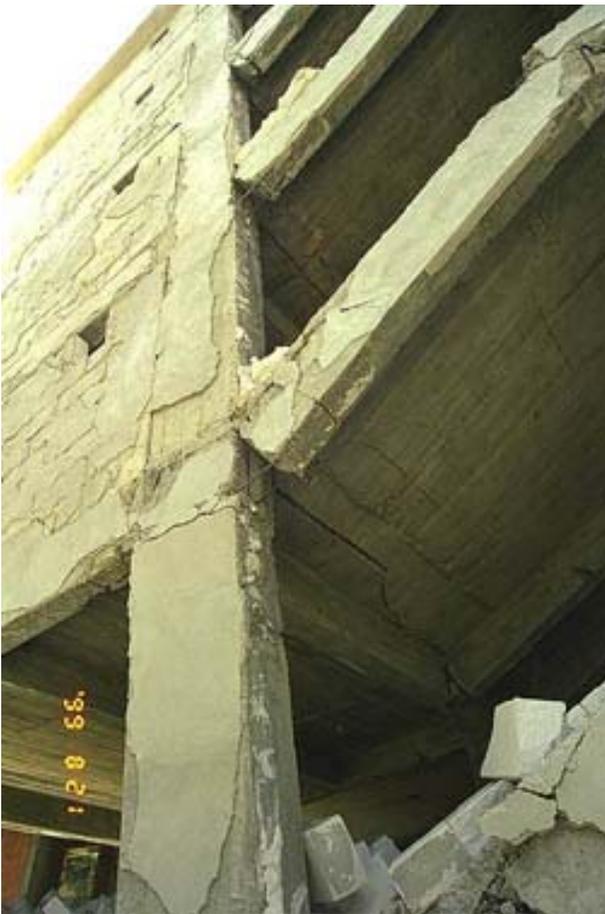
The reconnaissance team observed little damage to interior moment-frame beams because columns were generally weaker than beams. One type of beam damage is shown in Figure 3-24. The building in this figure suffered a partial story collapse because the fault ruptured beneath the building. The beams shown in the frame elevation were forced to accommodate the partial collapse and were badly damaged at the beam-column connection due to slip of the smooth longitudinal beam rebar. In many cases, beam bottom rebar was inadequately anchored in and through beam-column joints.

Figure 3-24 Damage to a nonductile reinforced concrete beam

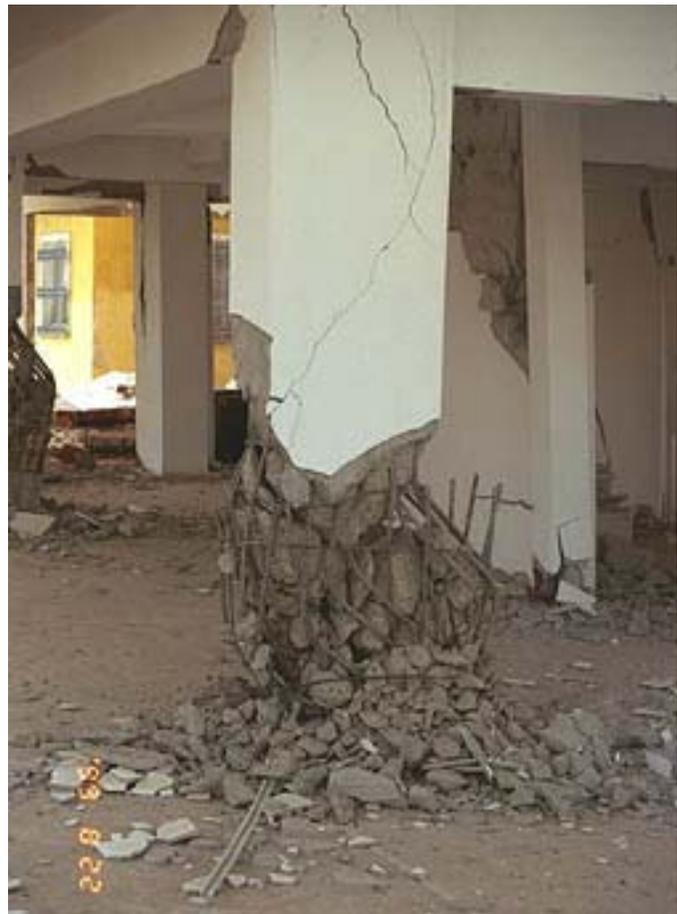
Figure 3-25 Failure of lap splices in a moment frame connection

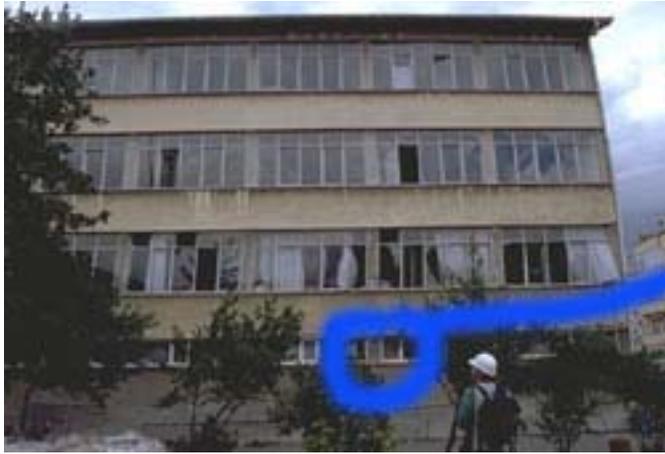
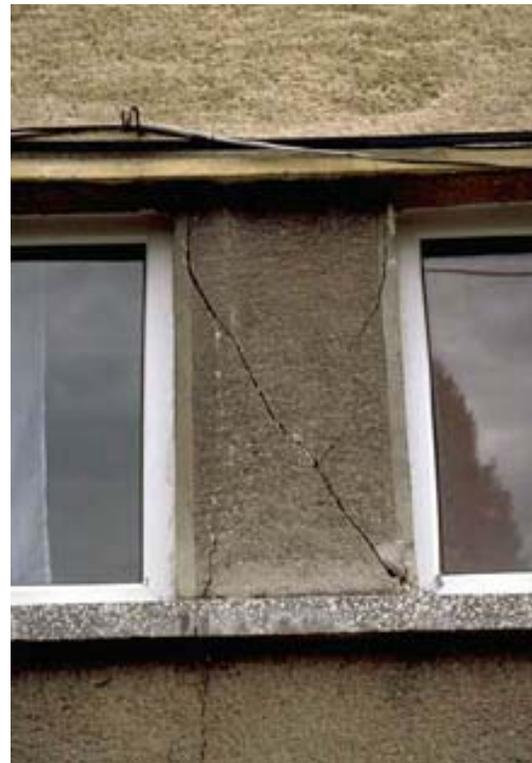
Shear failures in short columns were common. A typical example of such a failure is a school building in Adapazari, shown in Figure 3-29. The damaged column of Figure 3-29b is shown in Figure 3-29a in a blue circle.

Figure 3-29 Shear cracking in short columns

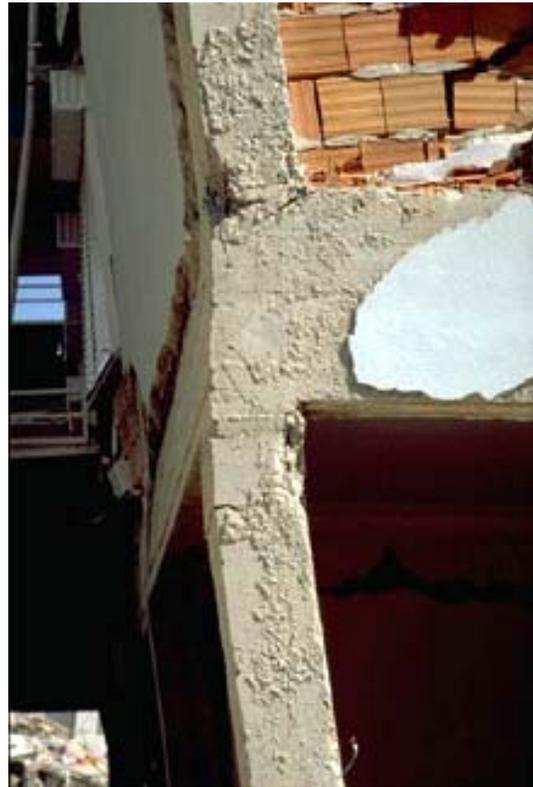
Concentrated damage at the ends of moment-frame columns was observed throughout the epicentral region. Examples of such damage are presented in Figures 3-31, 3-32, and 3-33. Large rotations at the ends of the columns (Figure 3-31) produced severe cracking and loss of concrete. (Note the relative proportions of the columns and the beam in this figure.) Out-of-plane deformations in the column of Figure 3-32a led to loss of cover concrete in the hinging zone. The transverse ties in this column were widely spaced (200 mm) and composed of

Figure 3-31 Concentrated damage at ends of moment-frame columns due to excessive drift

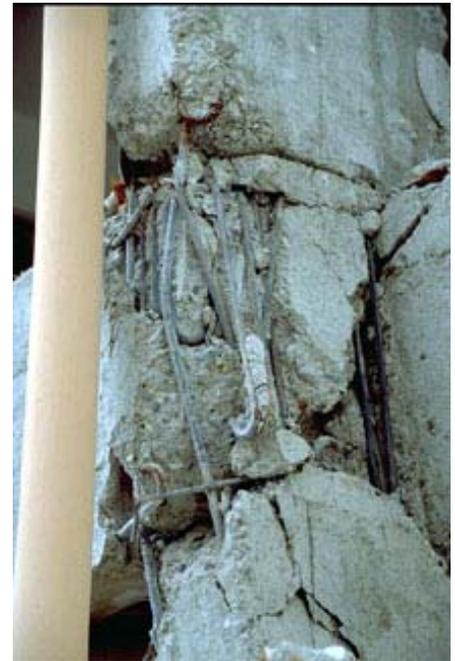
Figure 3-34 b. Damage to moment-frame beam-column joints, reinforcement in joint

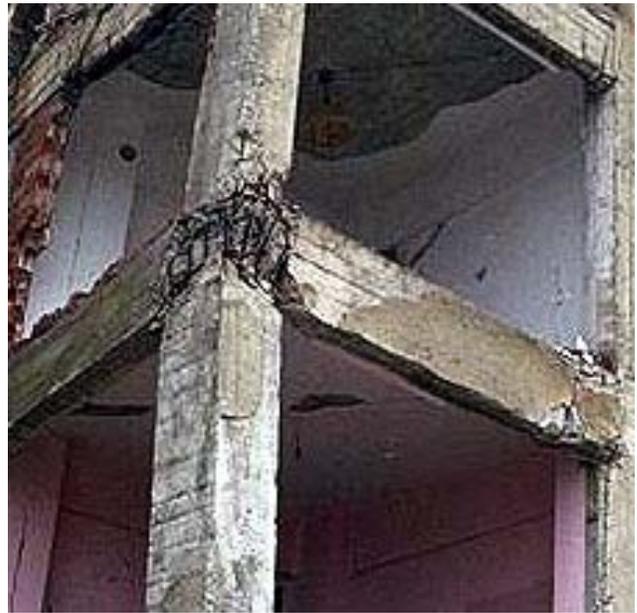
Figure 3-35 b. Damage to one beam column joint

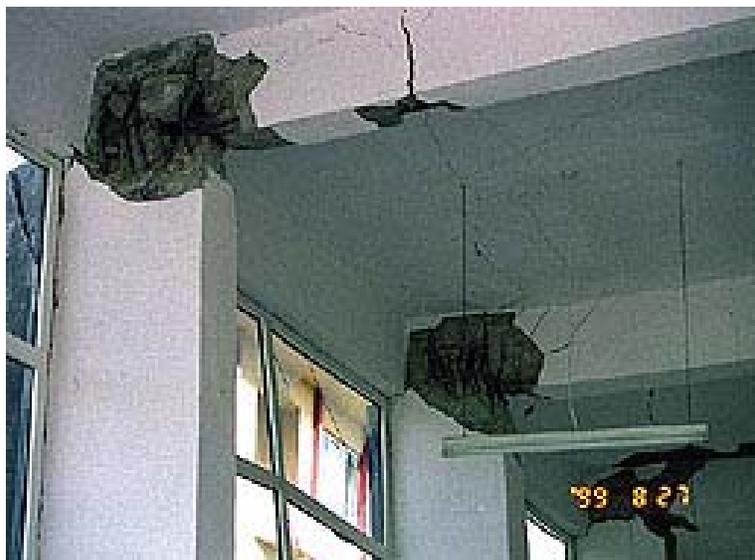
Figure 3-36 is a photograph taken in a building under construction in Adapazari at the time of the earthquake. Severe damage in the beam-column joints is evident, but horizontal transverse ties in the joints maintained the integrity of the joints. (See Section 3.7.3 for a more complete description of this building.)

Figure 3-36 Damage to a new moment-frame beam-column joint

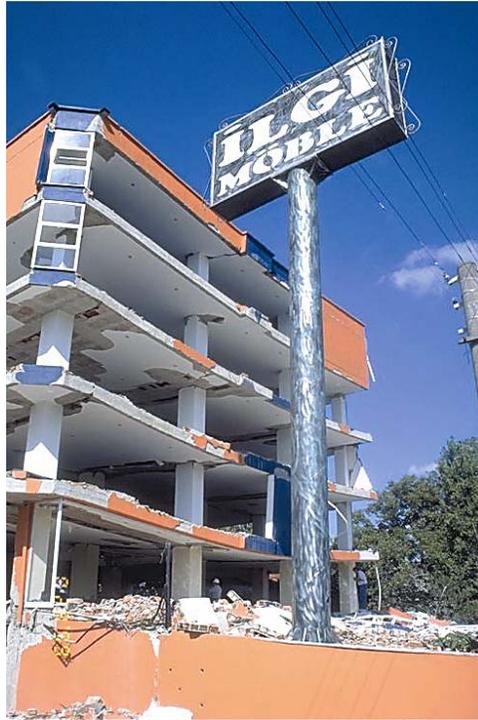
The asmolen slab floor system, described in Section 3.3.2, is commonly used in the epicentral region. In this type of construction, the hollow clay tile, which is used as permanent formwork, is not positively attached to the slab or the joist-beam framing.

Figure 3-37 Typical damage to asmolen floor systems

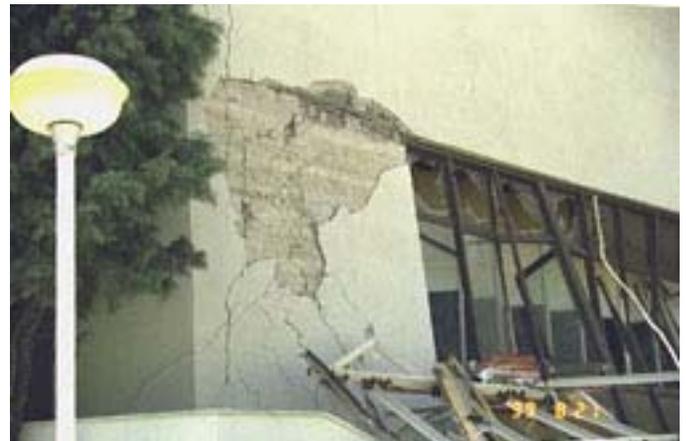
Figure 3-40 b. Close up of damage to a shear wall

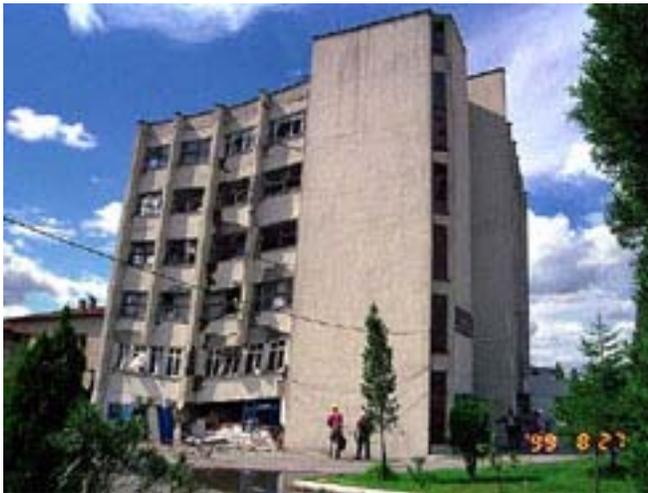
Figure 3-42 a. Damaged wall-frame building due to ground failure and wall rotation

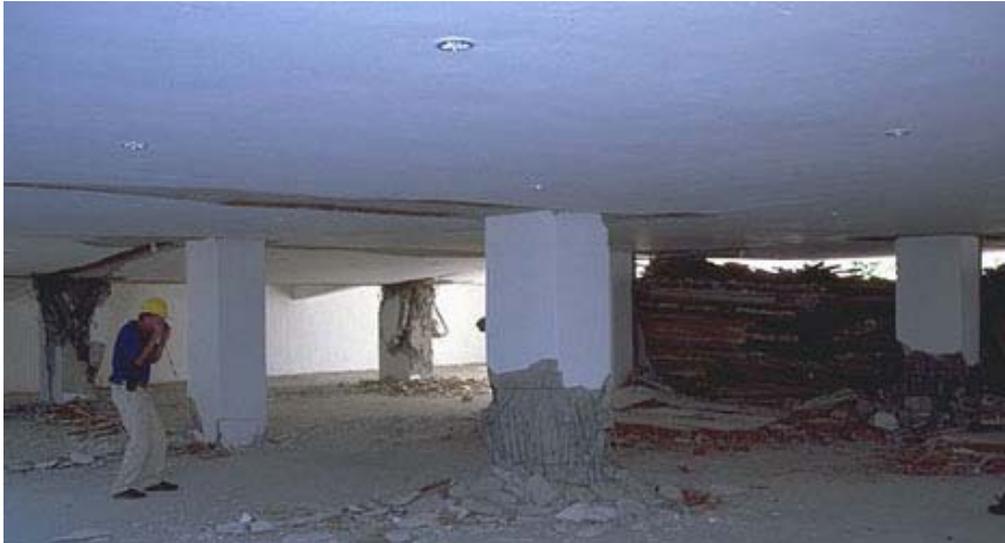
Structural damage was concentrated in the first-story columns at the front of the building (Figure 3-47) and around the stairwell at the rear of the building (Figure 3-48). Nonductile detailing was evident in each damaged component viewed by the reconnaissance team.

Figure 3-47 Damage to first story columns

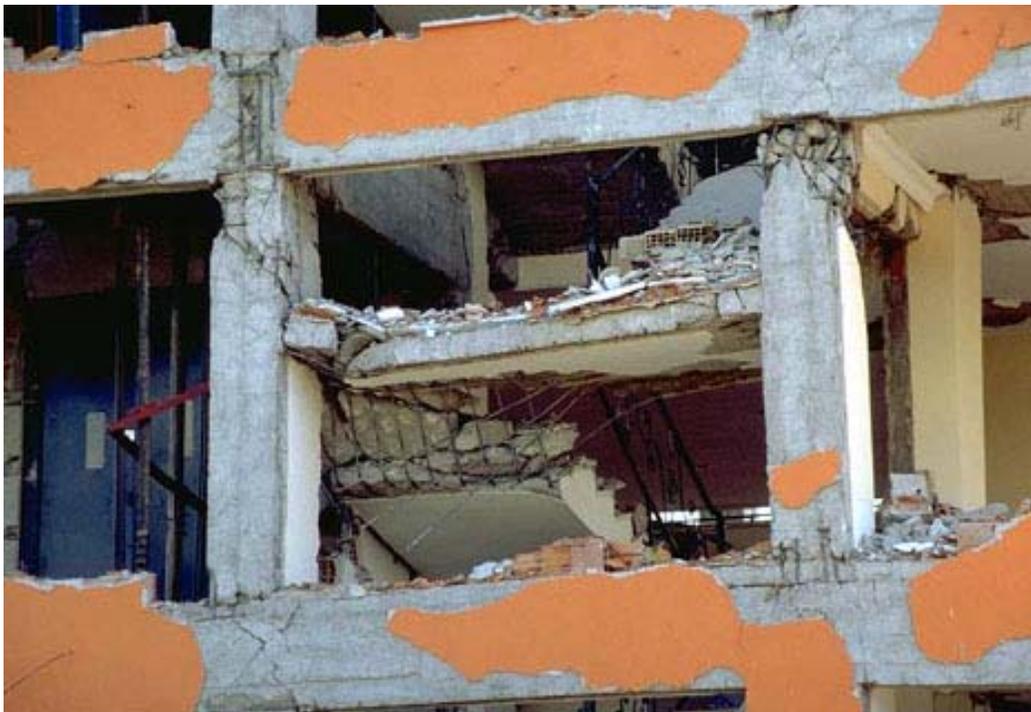
Figure 3-48 Damage at the rear stairwell

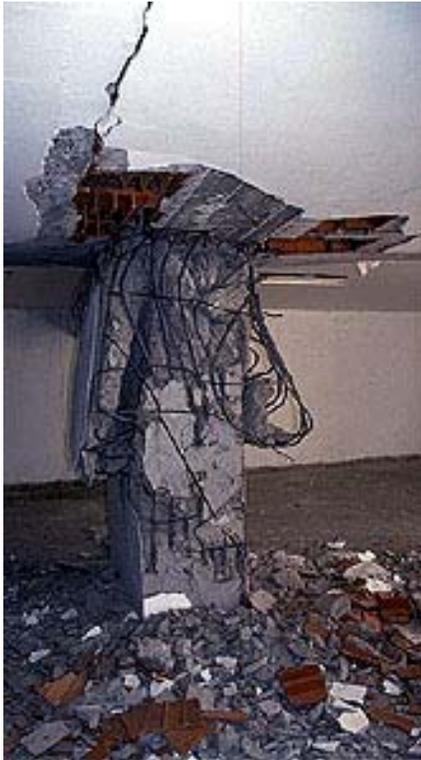
The distribution of damage to columns in the first story is shown in Figure 3-46. Figures 3-49, 3-50, and 3-51 show column failures. Nonductile detailing is evident, including widely spaced perimeter transverse ties with 90° hooks and no cross ties, and lap splices located at the floor level with no confining transverse reinforcement.

Figure 3-49 Shear failure of Column A (See Figure 3-46)

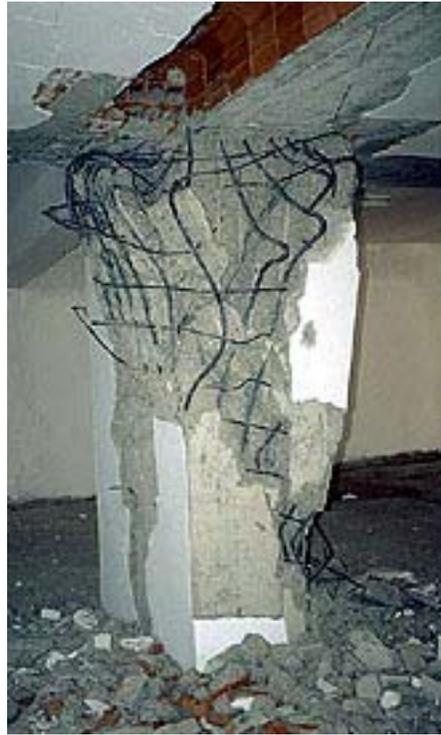
Figure 3-50 Axial failure of column B (See Figure 3-46)

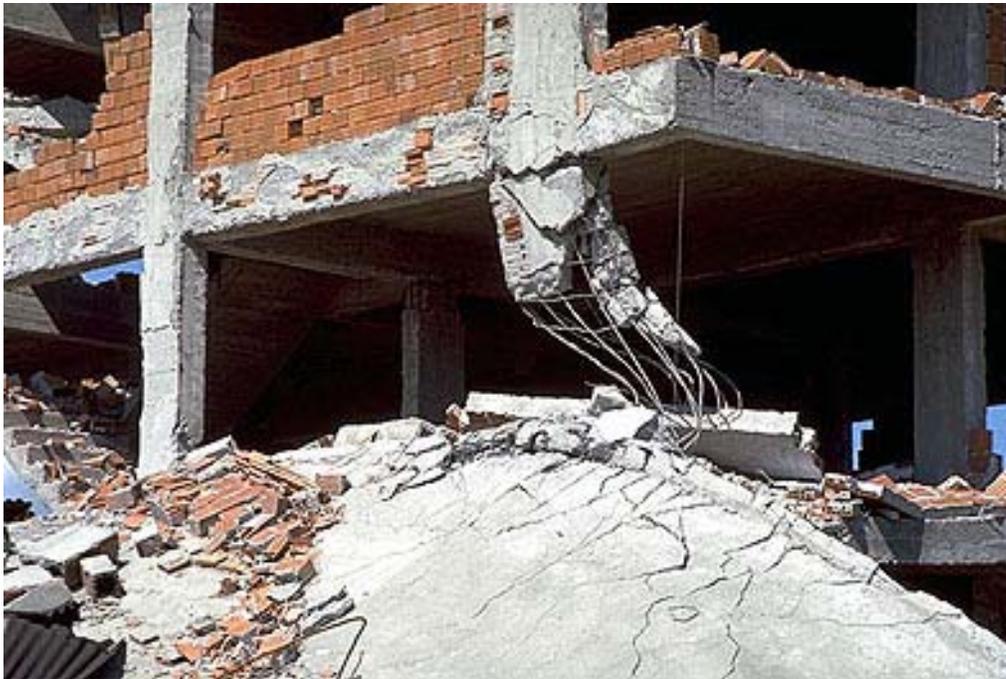
A corner column in the third story of Building B failed during the earthquake, as seen in Figure 3-52. Part of the roof framing of the adjacent building can be seen immediately below the failed column, indicating that the third-story column failed due to the impact of the adjacent building. Figure 3-53 shows more details of the failed column and the roof slab of the adjacent building.

Figure 3-53 Details of damage to third-story column of Building B

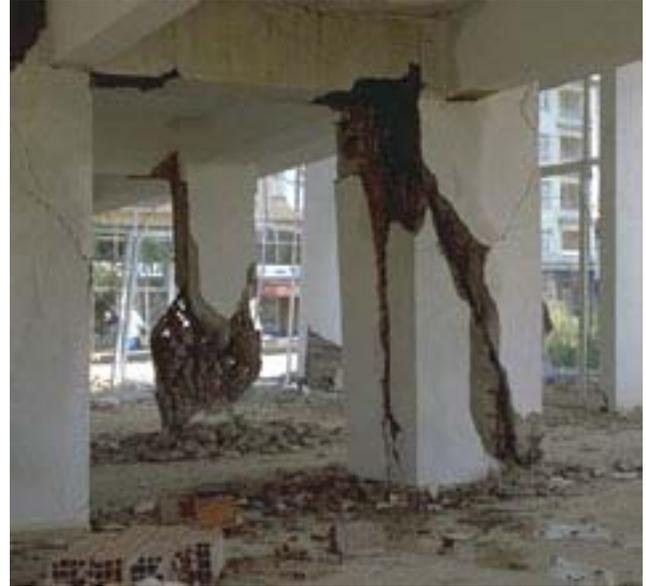
One of the failed columns at the rear of the building had a very steep shear crack (Figure 3-56) that suggested that the column was carrying high axial loads. Following a more detailed inspection of the building, the reconnaissance team concluded that the column was part of a two-story addition, which was separated from the five-story building by an expansion joint. No plausible explanation for the steep shear crack is proposed. The beam-column joints at the top of the first-story columns on the eastern façade were damaged but did not fail because transverse reinforcement was provided in the joint region; see Figure 3-57. The beam-column joint at the north-east corner of the first story was heavily damaged, as shown in Figure 3-58, but continued to carry gravity loads.

Figure 3-56 Shear crack in the first story column in the rear of Building C

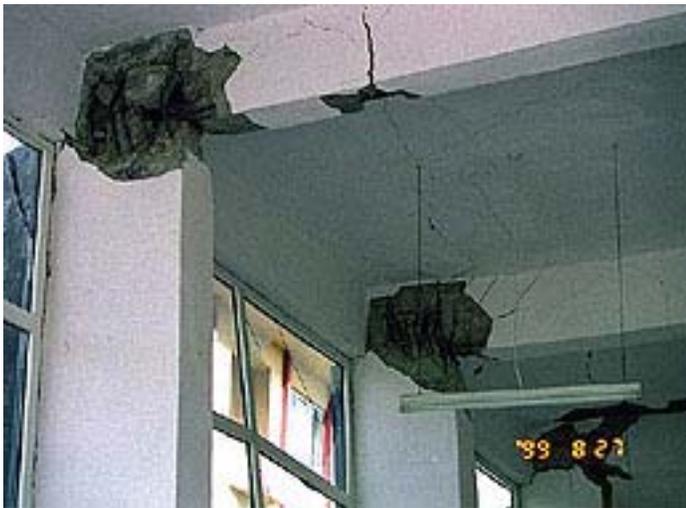
Figure 3-57 Damaged beam-column joints at top of first story columns, Building C

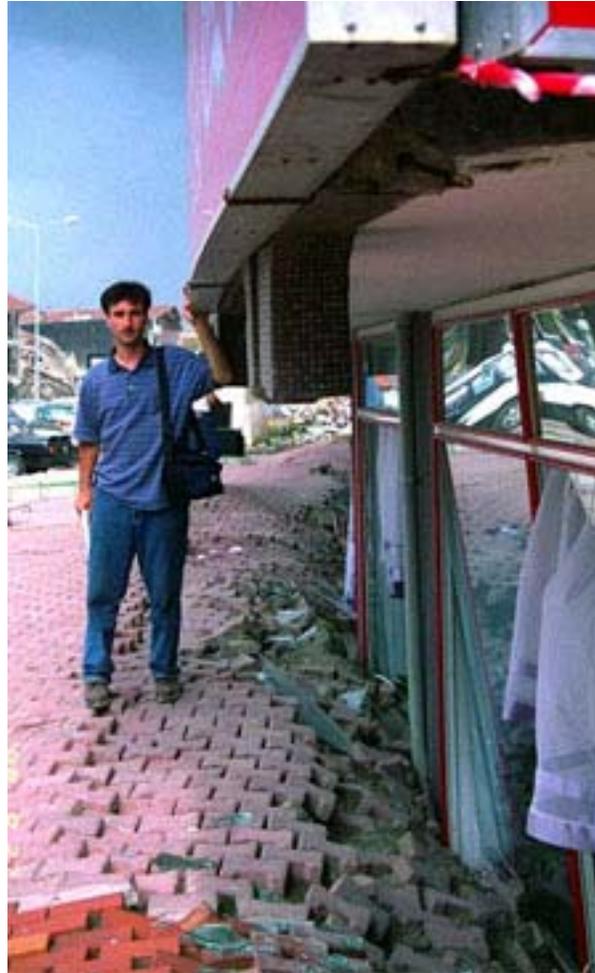
explicitly account for soil and foundation behavior in performance-based earthquake engineering. Although the building would have satisfied the performance level of collapse prevention (as defined in FEMA 273 [FEMA 1997] and Vision 2000 [SEAOC 1995]), it would not have satisfied the egress requirements of the life-safety performance level. To achieve performance beyond collapse prevention, site improvements to avoid liquefaction would have been required.

Figure 3-60 Settlement of Building D due to liquefaction and soil-bearing failure

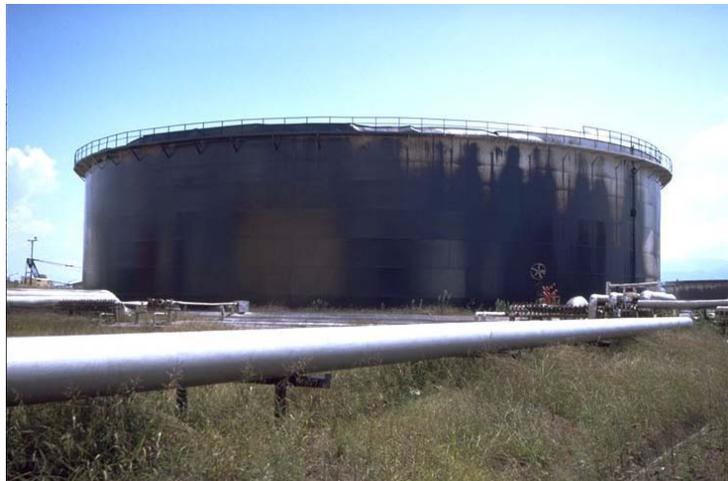
Figure 4-19. Overtopping of tank wall due to sloshing and failure of perimeter seals

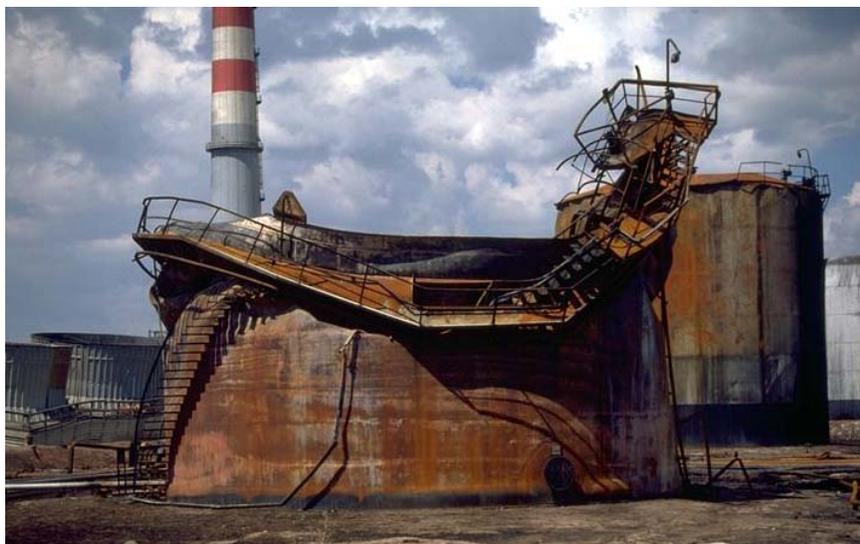
Figure 4-23. Tank destroyed by fire in burn zone

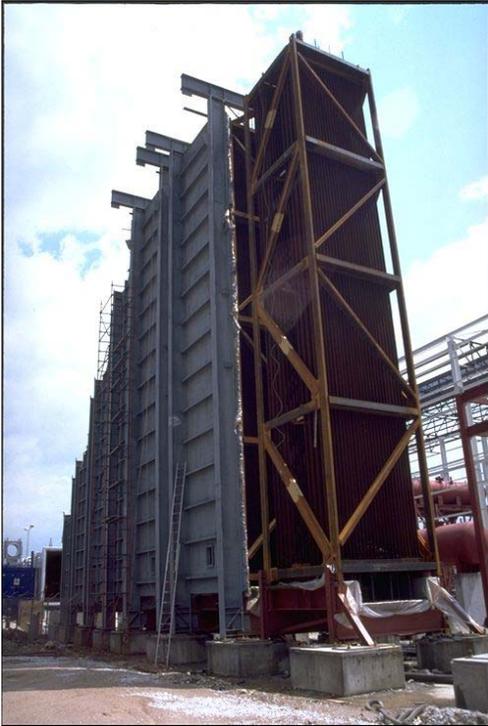
Figure 4-48a. Damaged framing to new steam generator, EnerjiSA

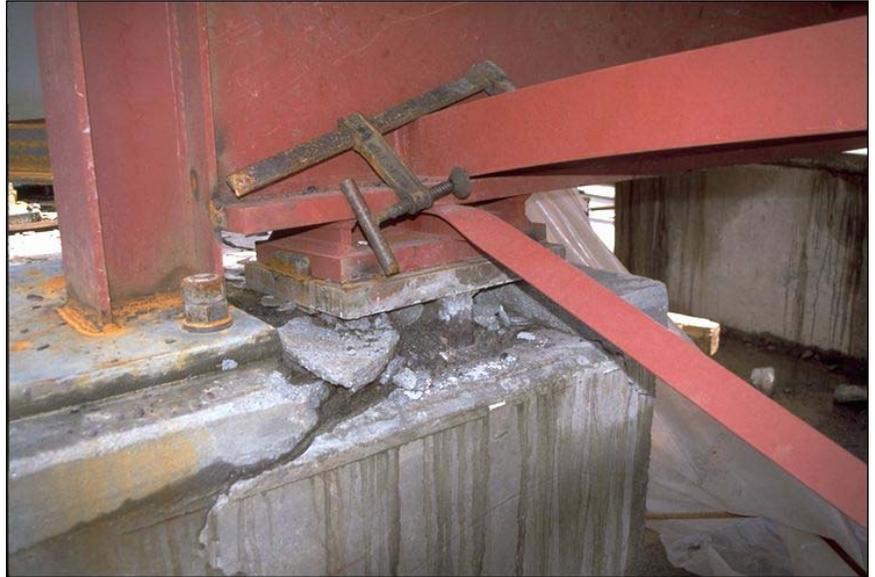
Figure 4-48b. Failed fillet weld connection of new boiler framing to baseplate, EnerjiSA

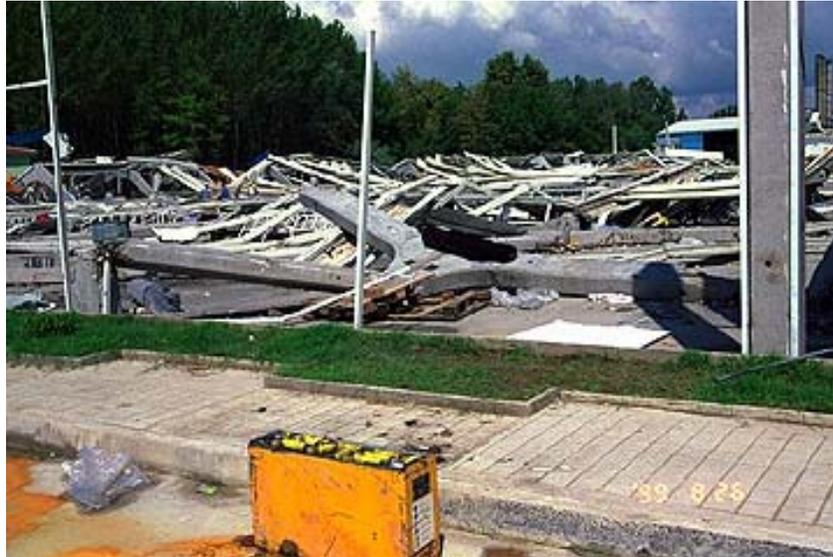
Figure 4-54 Collapsed precast reinforced concrete building, Cap textile plant.
