PACIFIC EARTHQUAKE ENGINEERING RESEARCH CENTER

Damage to Bridges during the 2001 Nisqually Earthquake

PEER Report 2001/15

November 2001

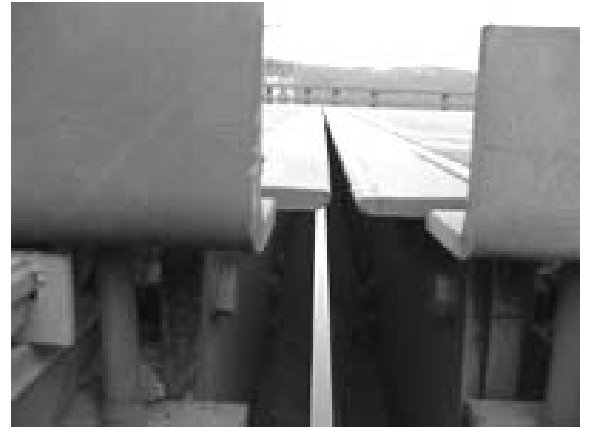
Of the 78 bridges that were damaged by the earthquake, six were classified by the WSBI as movable bridges. Typical types of damage that were reported for these bridges include: damage to the leafs, dislodging of the counterweights, damage to the centerlock, and lateral shifting to the bascule towers. An example of damage to a movable bridge is shown in Fig. 2-2.

Fig. 2-2: Damage to a movable bridge (099/530w)

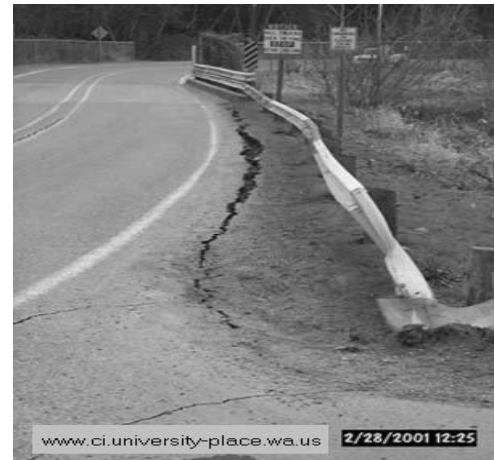
Fig. 2-3: Damage due to settlement of approach (Chambers Creek Bridge)

ranged from minor differential settlement to a reported movement of 100 yards of the approach. An example of approach settlement can be seen in Fig. 2-3.

54	Chambers Creek Bridge	University Place	29202A	08395200	47.1917	-122.5717	11.97	7.76	32.79	12.75	4.02	1946	No damage to actual bridge. Damage to approach on University Place side.	4752				1	1	2	1	
55	South Park Bridge	King County	3179	08433700	47.5298	-122.3141	51.73	30.04	74.25	36.72	2.82	1931	Spalling, shear cracking to South and North approach. Lateral Shifting on Baxcule Towers	25000	\$750,000			3	5	4	16

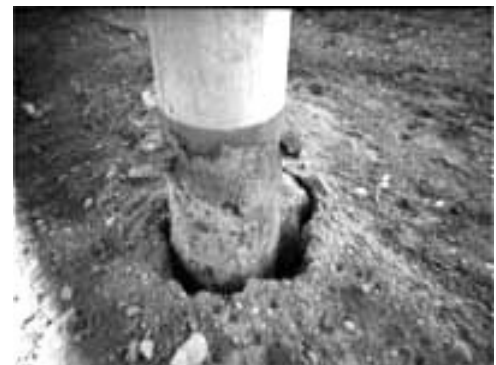
Fig. 2-4: Damage due to liquefaction on bridge 002/6s-w (WSDOT)

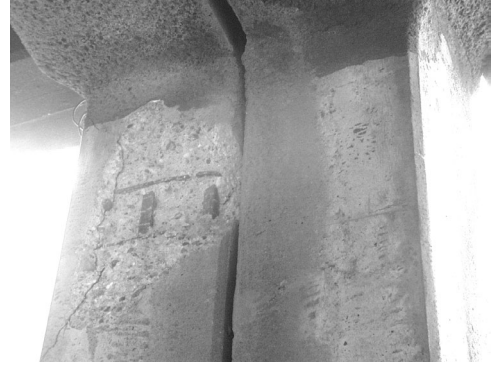
Of the 72 fixed (not movable) bridges that were damaged, 48 had damage to a concrete element. The types of damage included spalling and cracking of columns, diaphragms, and abutments. An example of concrete damage is shown in Fig. 2-5.

Fig. 2-5: Damage to concrete on Spokane St. Viaduct (WSDOT)

67	Spokane St Viaduct	SEATTLE	90	08526200	47.5722 -122.3190	55.39	22.53	53.13	37.25	3.65	1941	Cracks & spalling at expansion joints	69500	\$70,000	2	2	2	2

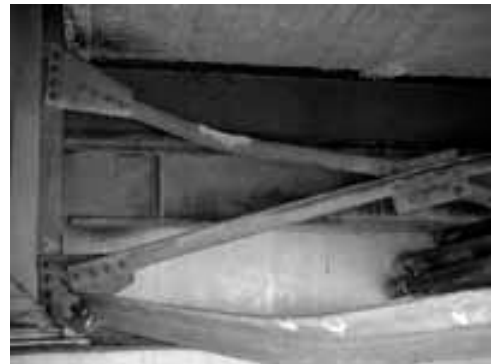
Only six fixed bridges sustained damage to the steel superstructure. Such damage usually consisted of bent and broken cross frames and bearing stiffeners. An example of steel damage is shown in Fig. 2-6.

Fig. 2-6: Damage to steel on bridge 005/322 (WSDOT)

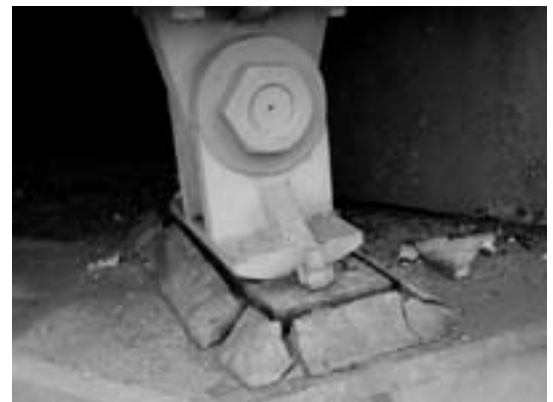
Damage to the restrainers, joints, or bearings included elongated or broken restrainers, damage to movement joints, and excessive tipping of rocker bearings. Eleven of the damaged bridges sustained one of these types of damage. An example of a damaged bearing is displayed in Fig. 2-7.

Fig. 2-7: Damage to bearing on bridge 005/221 in Chehalis (WSDOT)
