Structures and Data Collection

Andre R. Barbosa
PEER and Oregon State University

Nepal RAPID Reconnaissance Team

PEER – EERI – GEER Reconnaissance Briefing on the April 2015 Gorkha (Nepal) Earthquake

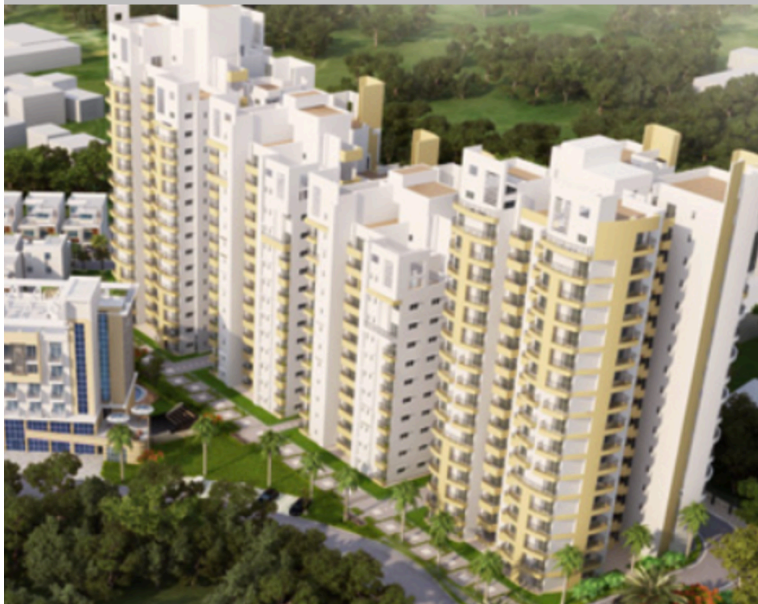
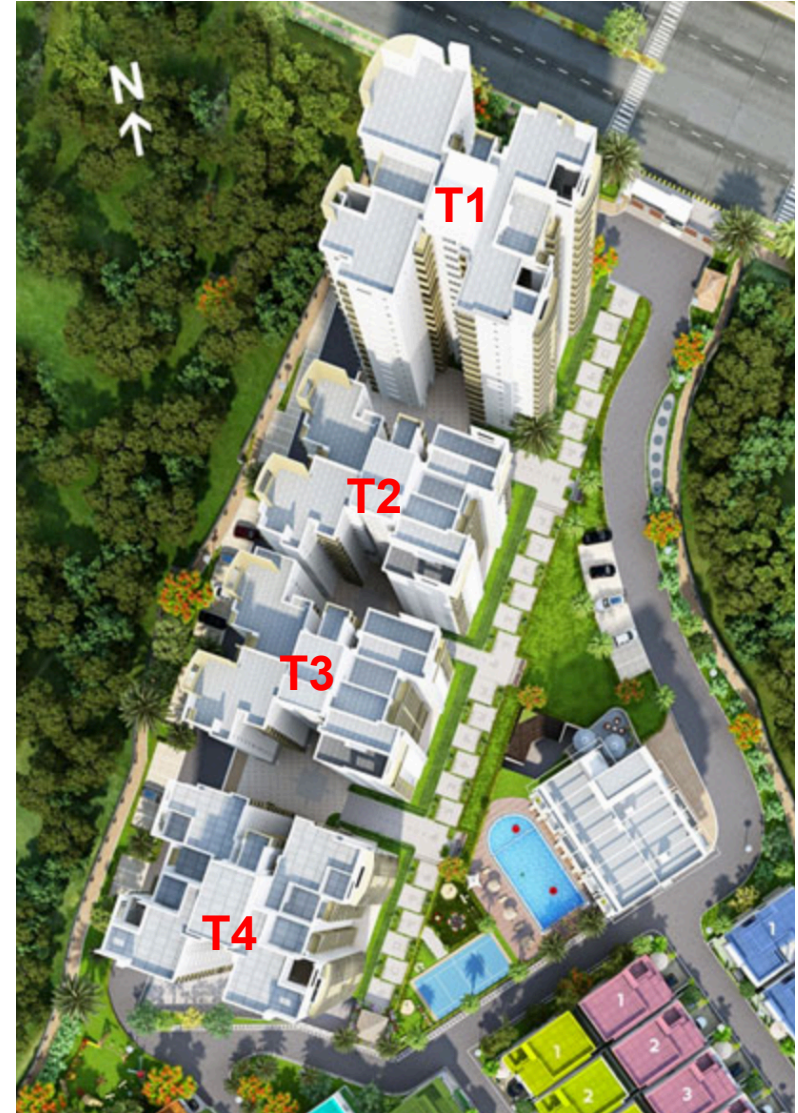
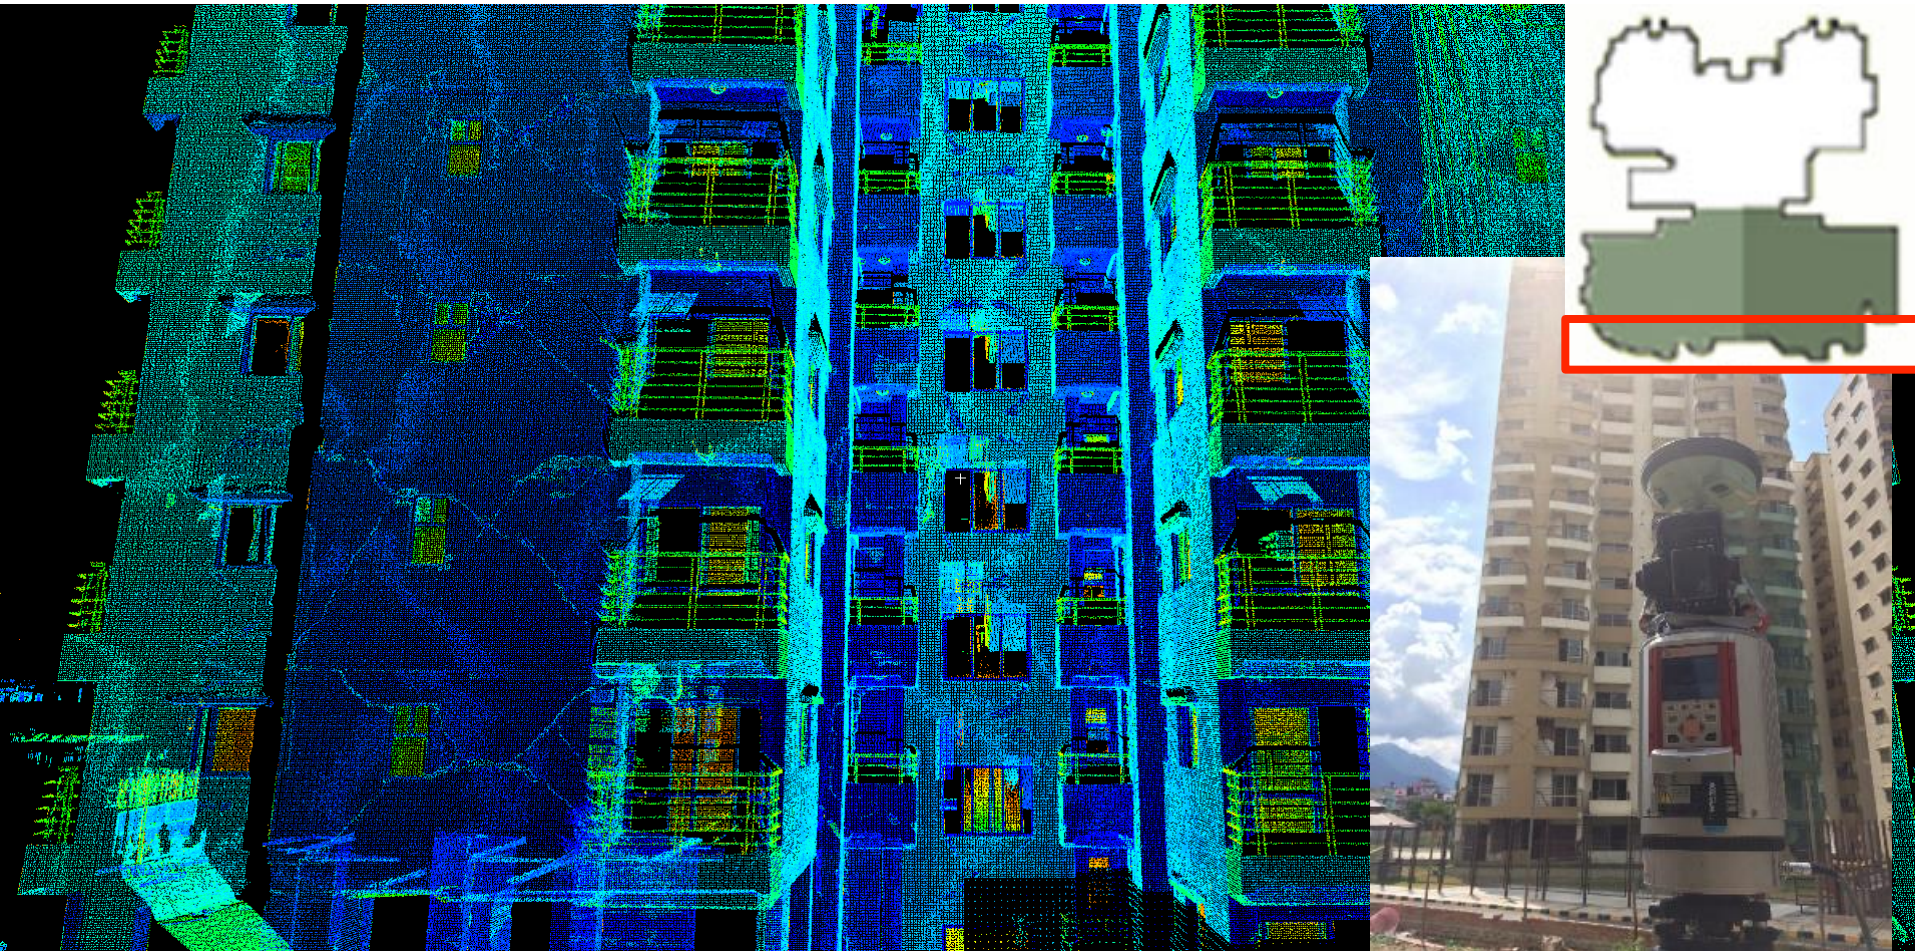
Performance of Tall Buildings

- ◆ Hatiban, Kathmandu
- ◆ 4 Towers (T1 – T4) on the same site
- ◆ T1 and T4 are 18 story towers
- ◆ T2 and T3 are 12 story towers
- ◆ Slight non-structural damage on T2/T3.
- ◆ Extensive non-structural and moderate structural damage on T1/ T4

- ◆ Buildings were designed for shaking intensities larger than experienced
- ◆ In general, buildings performed “well” (life-safety)
- ◆ Buildings are repairable, but significant losses, mostly to be covered by insurance
- ◆ Misinformation by media

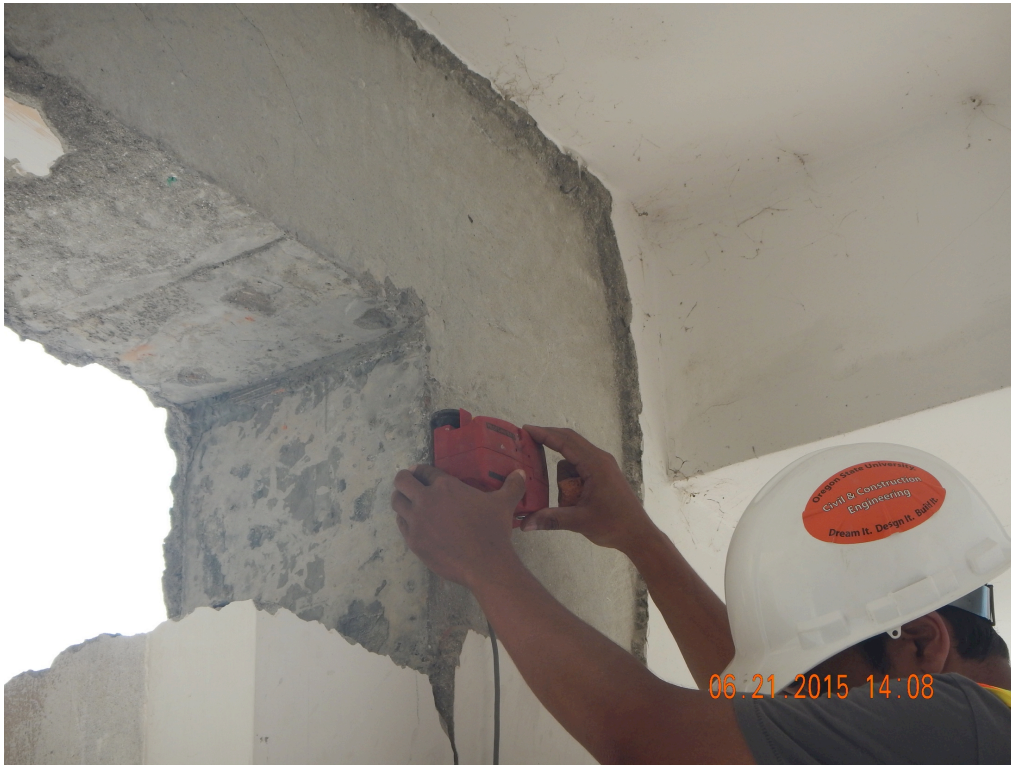
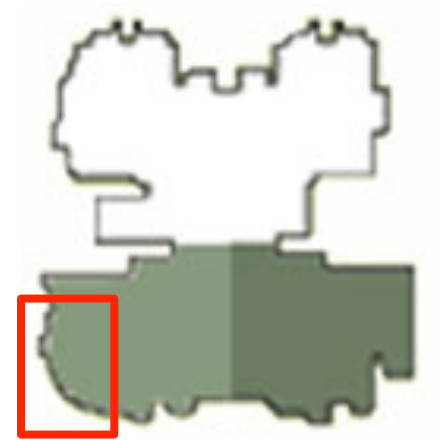
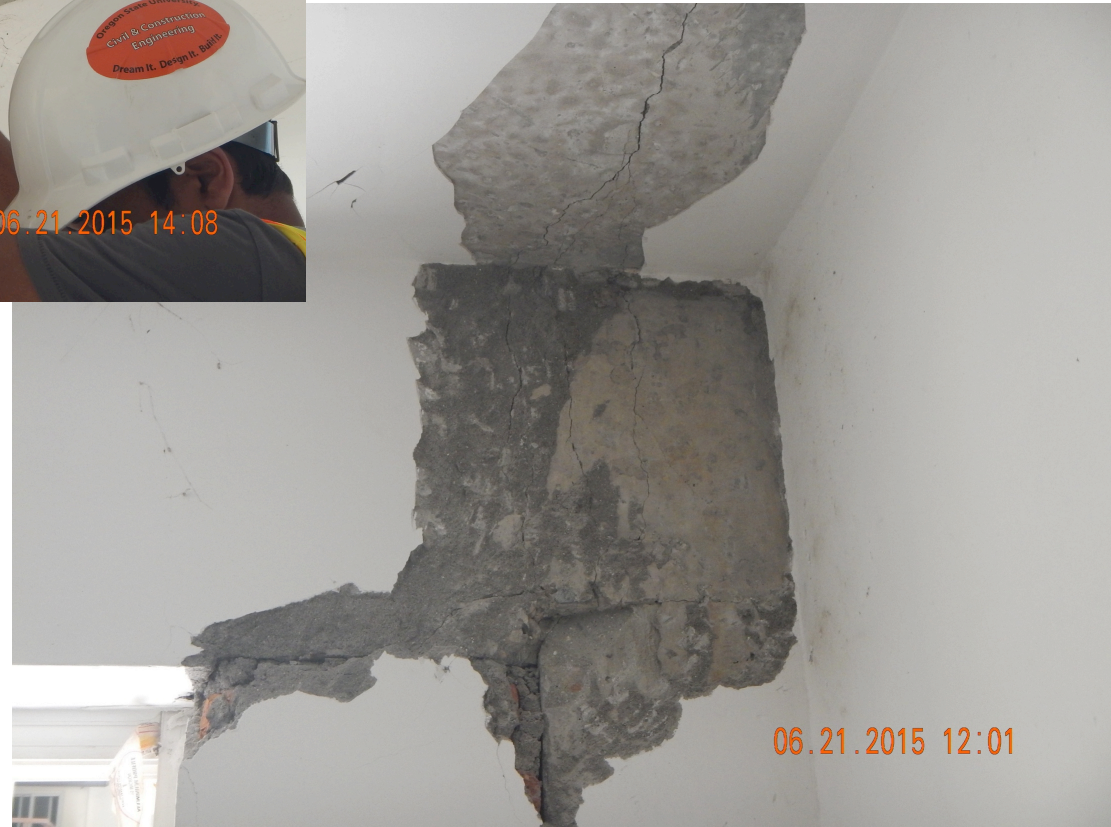
- ♦ Vertical irregularity (stiffness)

- ♦ Good construction practice
- ♦ Beam-column joint cracks and shear cracks visible in coupling beam and short beams
- ♦ Flexural cracks on beams propagated to the 6" slabs

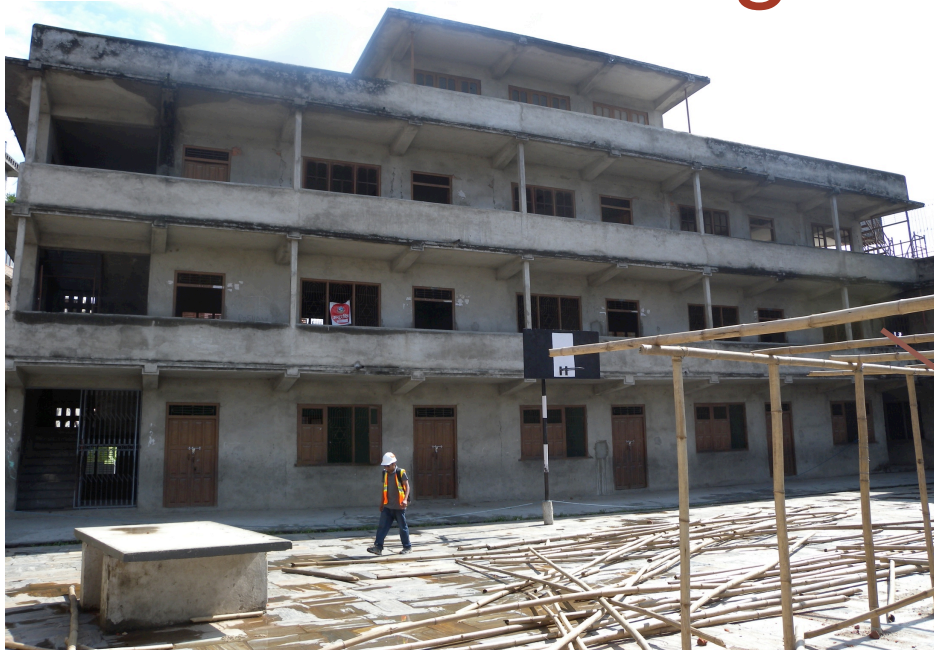
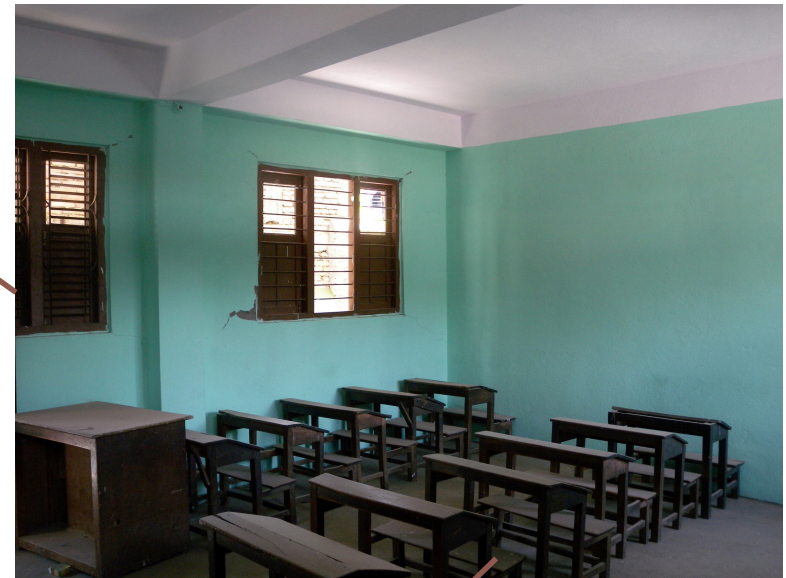
◆ Tarun ma vi (Balaju, Kathmandu)

- Torsional irregularity (stair case)
- Vertical irregularity (infill walls and column size)

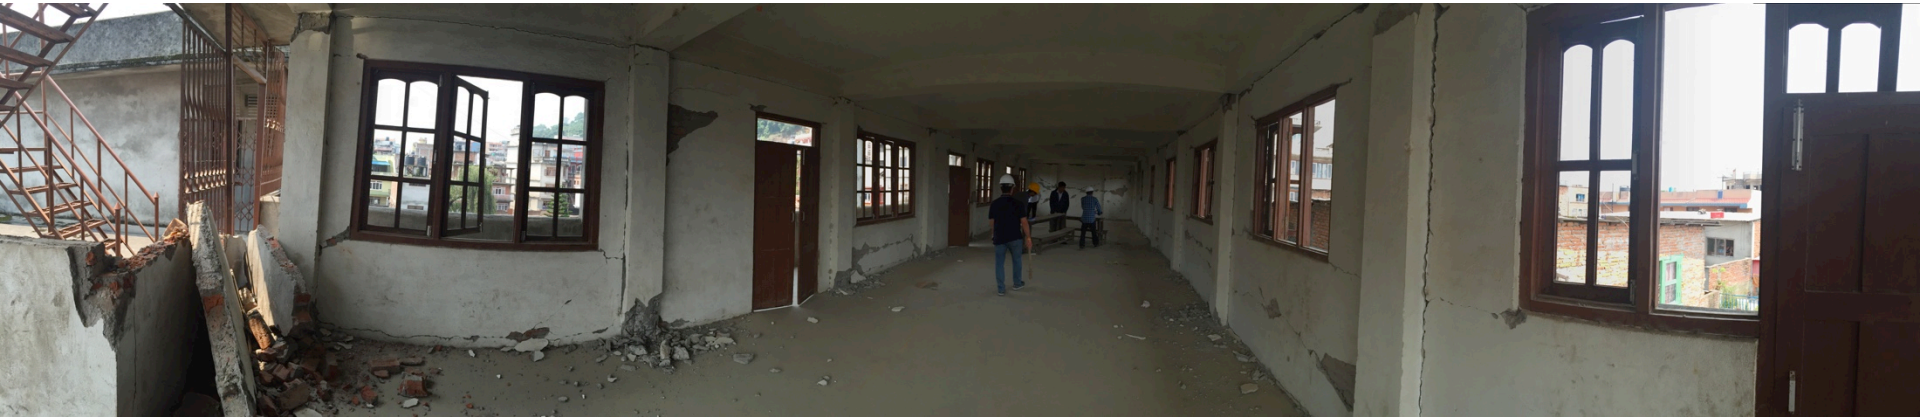
- ◆ **Level 3 – reduction of the number of infill walls and section of columns**

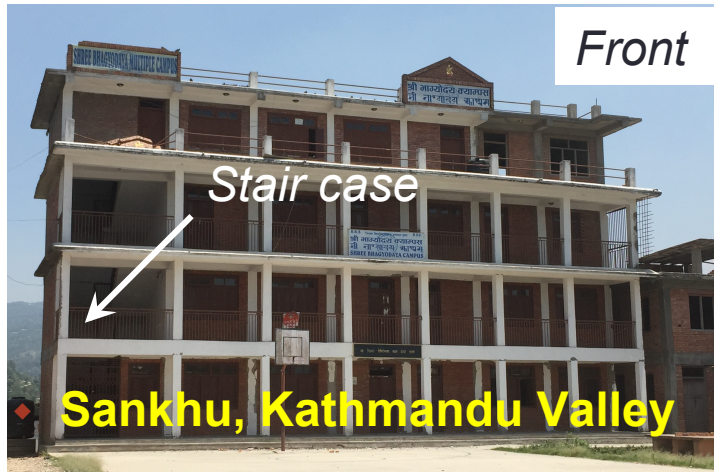
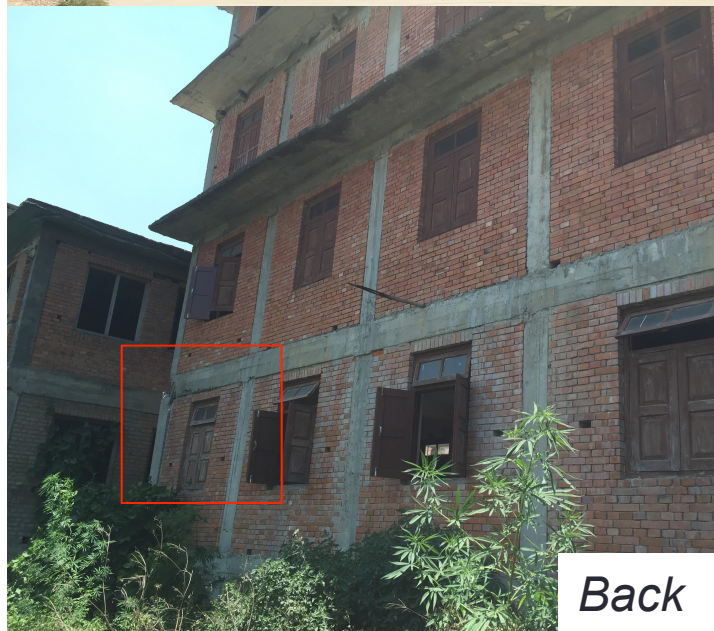
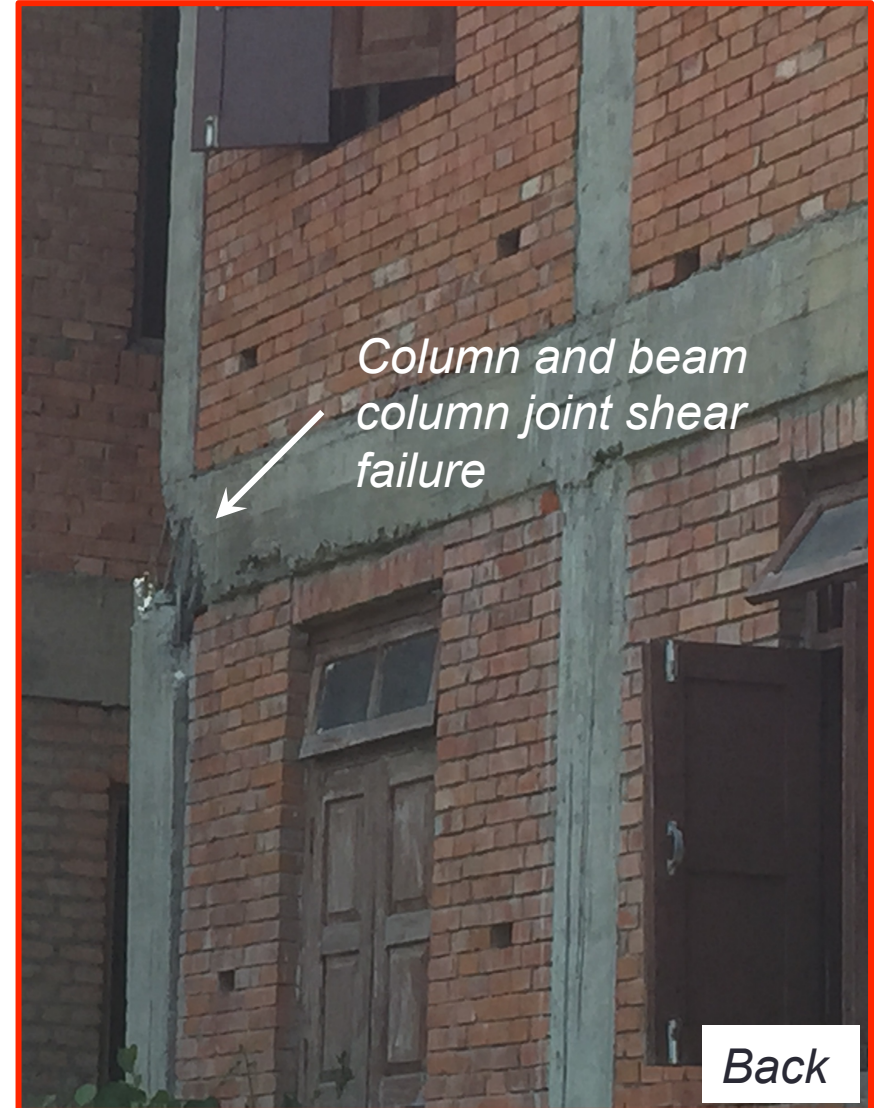
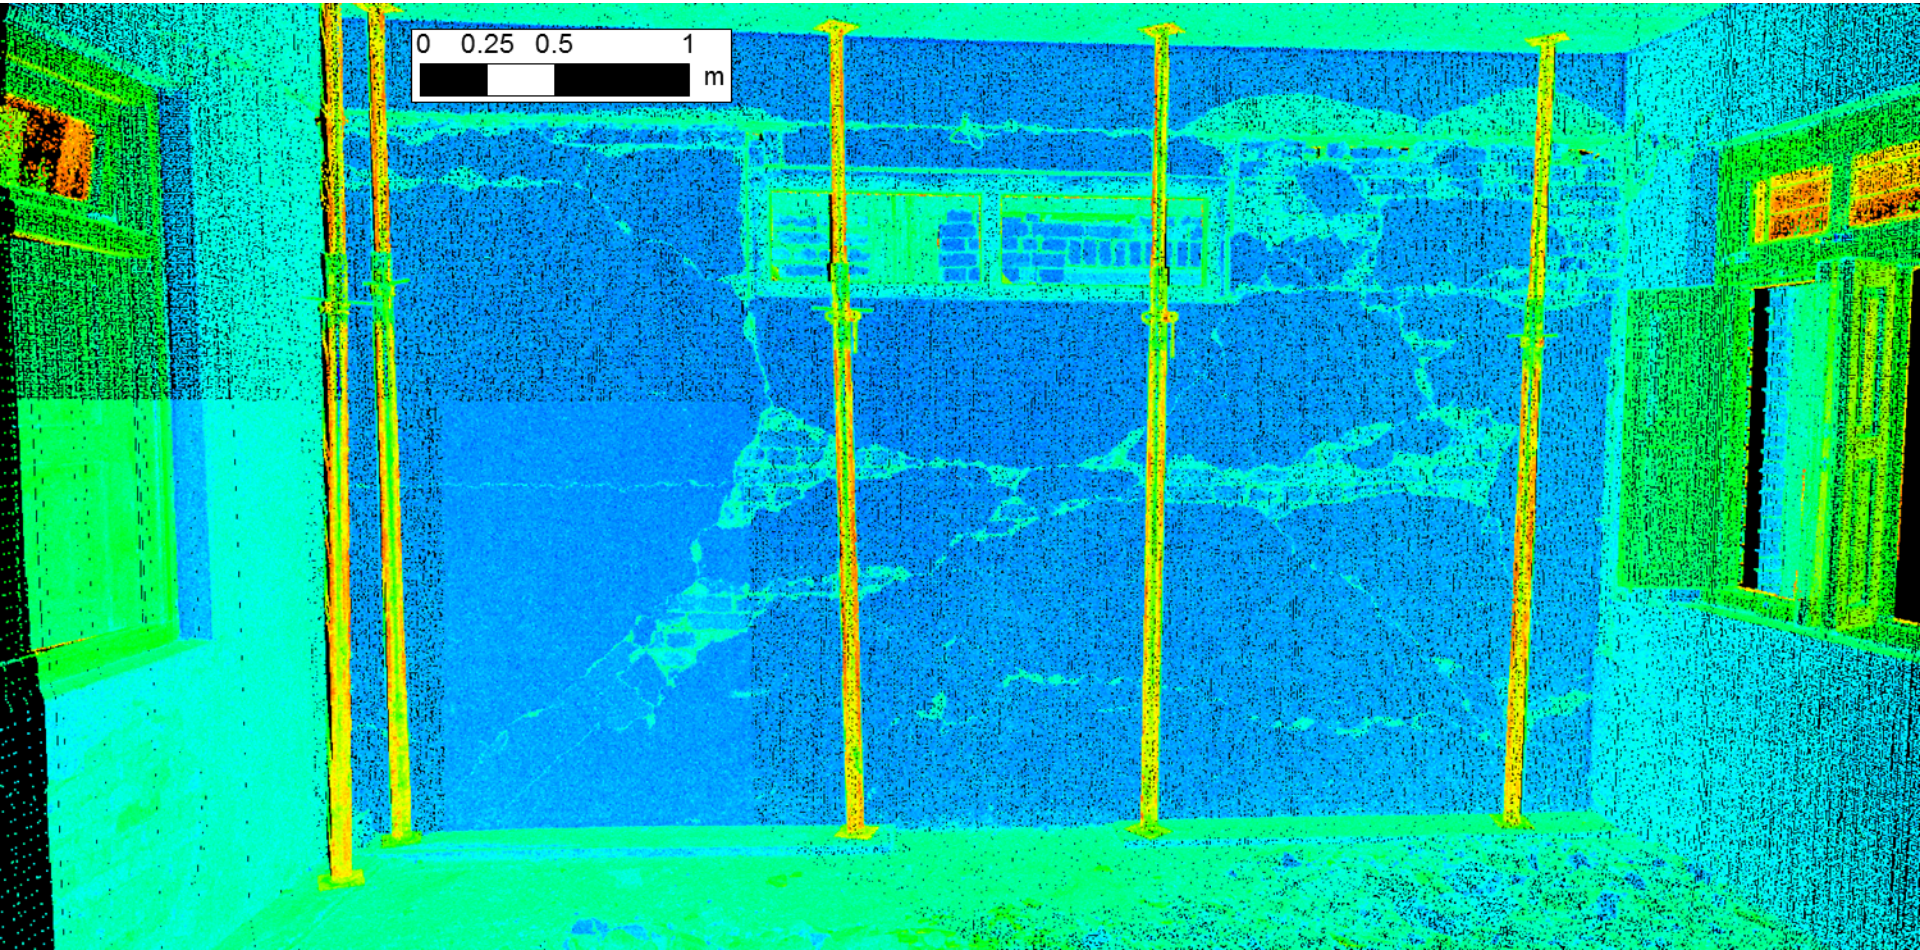
School Buildings (2)

- Reinforced concrete (RC) frame plan irregular/asymmetric building

- ♦ **Damage in Story 1**
