2007 Niigata Chuetsu-oki Earthquake, Field Reconnaissance Report

- **Visiting Date:** 20th-21st, July, 2007.
- **Participators:** Gakuho WATANABE , Kahori Iiyama , Naoya Kawano
- **Surveyed Locations:** Niigata Prefecture Ojiya City, Nagaoka City (visited in 7/20)
Kashiwazaki City, Kariwa City (visited in 7/21)

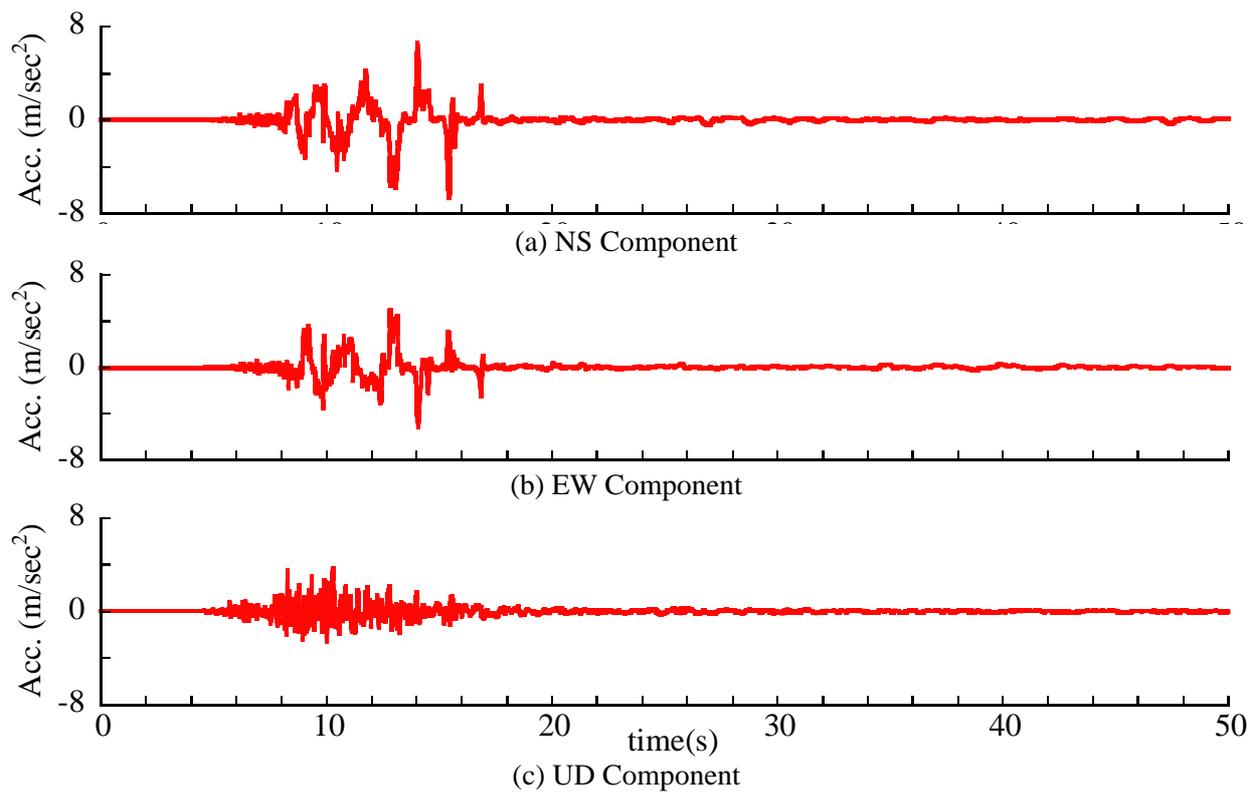
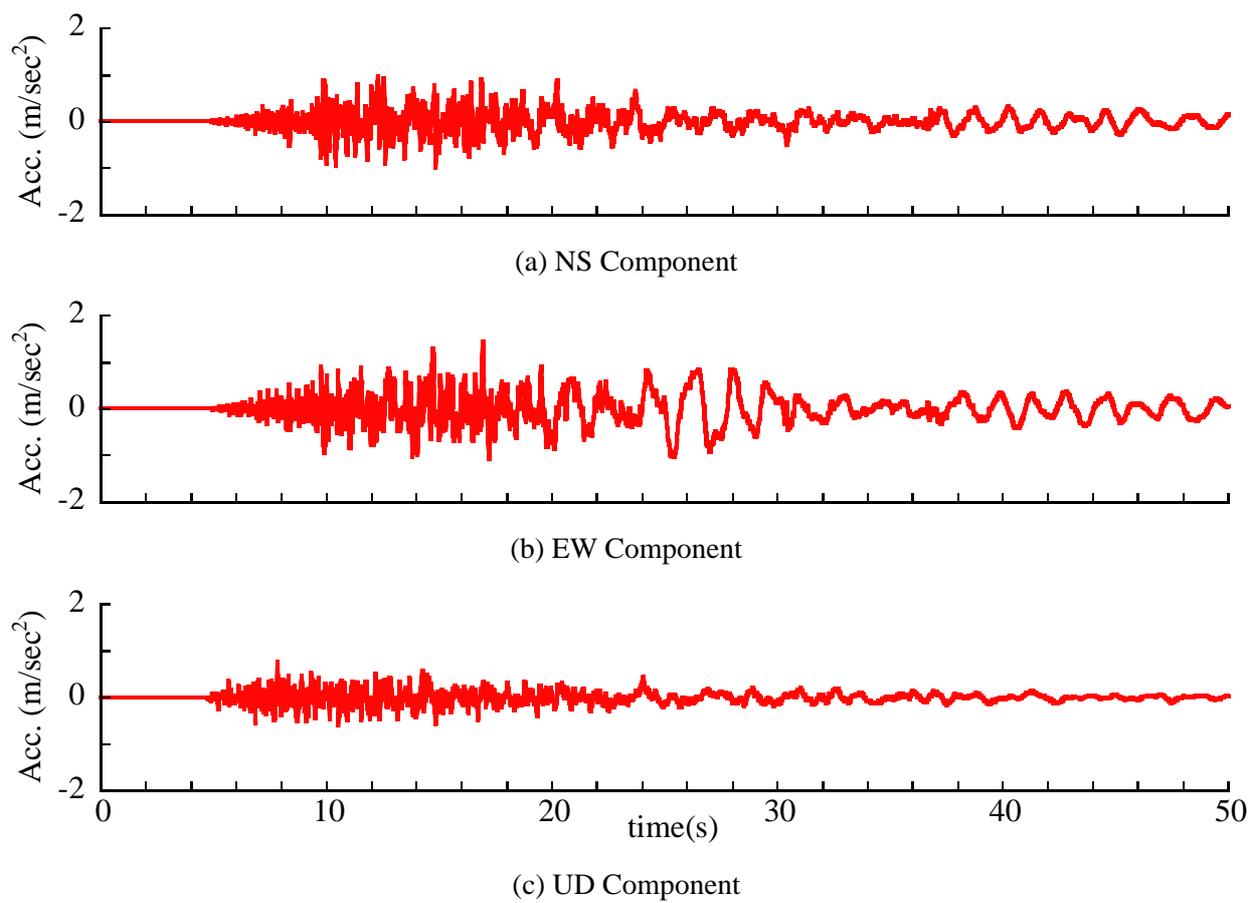
Figure 2 Ground Motion Records at Kashiwazaki City (K-net: NIG018)

Figure 2 (a) shows the time histories of ground accelerations measured at Kashiwazaki city, K-net: NIG018, (refer to Figure 1 for the location). K-net is the name of system which sends the ground accelerations measured with accelerometer offered by National Research Institute for Earth Science and Disaster Prevention, NIED. For the reference, the ground accelerations measured during 2004 Niigata Chuetsu Earthquake at Kashiwazaki K-net are also illustrated in Figure 2 (b). The maximum ground accelerations during 2007 Niigata earthquake in NS, EW, and UD was 6.67 m/sec^2 , 5.14 m/sec^2 , 3.69 m/sec^2 , respectively, where as 2004 Niigata earthquake was 0.98 m/sec^2 , 1.44 m/sec^2 , and 0.76 m/sec^2 , respectively. From the preliminary investigation of the ground motion, it is found that there is a long pulse components included in the acceleration, like JR Takatori record during 1995 Kobe Earthquake.

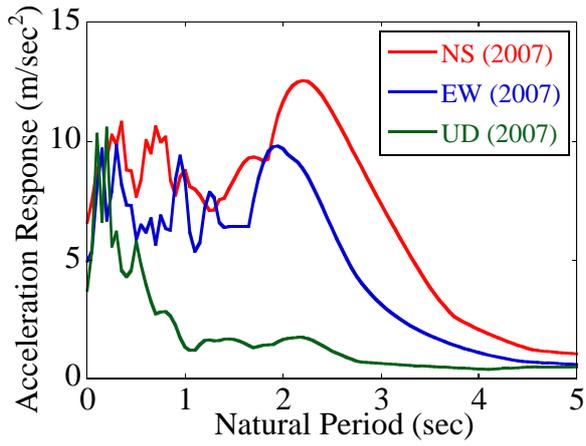
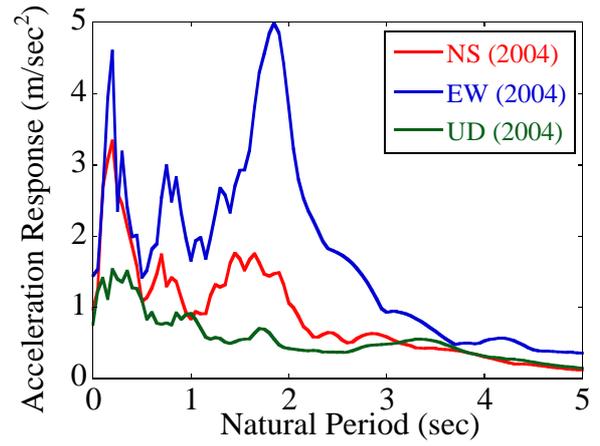
Figure 3 Acceleration Response Spectra of Kashiwazaki Record (K-net: NIG018)

Figure 3 shows the acceleration response spectra of NIG018 assuming damping ratio as 5 %. Predominant period of horizontal component is about 2.2 seconds. Figure 4 shows the comparison of acceleration response spectra for Kashiwazaki records during 2004 and 2007 Niigata Earthquake. This acceleration response spectrum is normalized by peak ground acceleration.

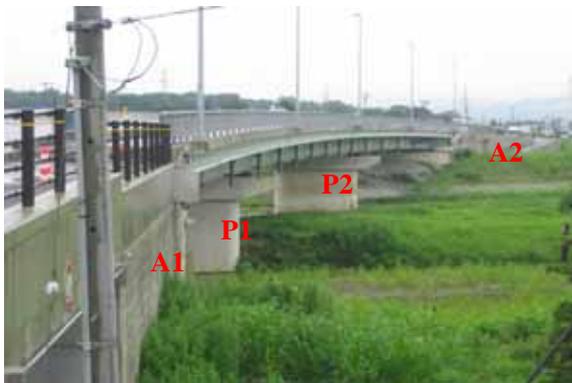
(a) Toyota Bridge

Photo 1 shows the damage on bridge called ‘Toyota Bridge’ along the National Highway, Route 8 (refer to Figure 1 for the location). Toyota Bridge is 3-span continuous curved bridge and deck is supported by elastomeric bearings, having dimension of 700 mm x 700 mm x 250 mm (=27.6' x 27.6' x 9.8'). It is consisted of a rubber and steel plate, and the ratio between those is one. The total length and width of the deck is 160 m and 12 m, respectively.

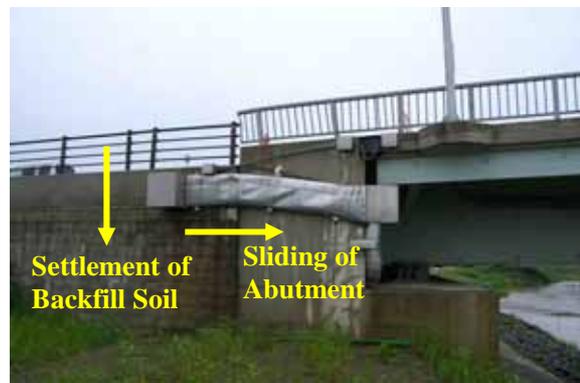
From the observation, the backfill soil has settled approximately 400 mm (=15.7'), and the abutment has moved toward the river side, approximately 200 mm (=7.9'). Since the abutment has moved toward the river, the gap of expansion joint between the abutment and the deck has completely closed. The elastomeric bearing has permanent deformation of 200 mm (=7.9') which corresponds to the shear strain of 160 %.

(b) Side View of Abutment A1

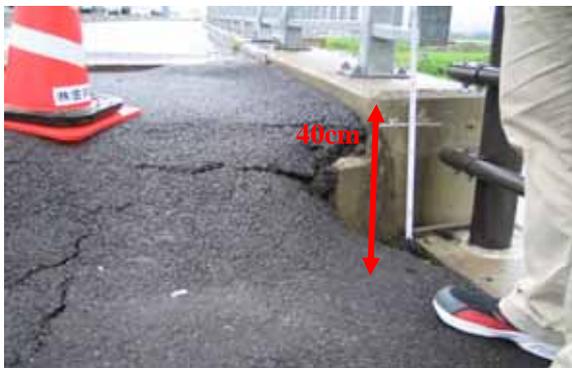
(c) Settlement of Backfill Soil

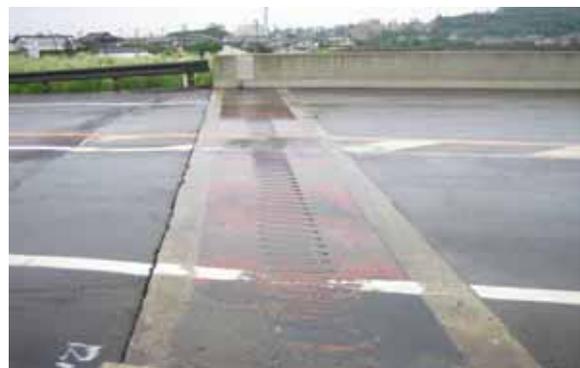
(d) Closure of Expansion Joint

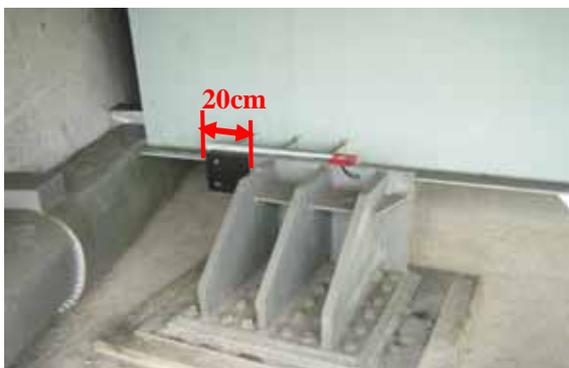
(e) Sliding of Abutment

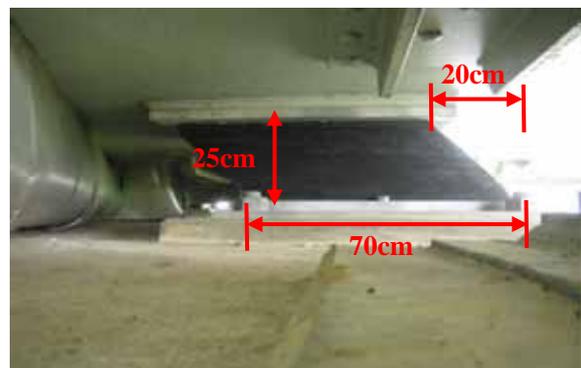
(f) Permanent Deformation of Elastomeric Bearing

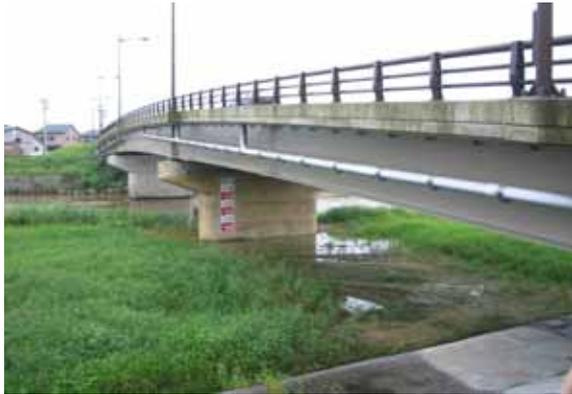
(a) Nagomi Bridge

Photo 2 shows the damage on bridge called ‘Nagomi Bridge’ which is located parallel to the Toyota Bridge (refer to **Figure 1** for the location). This is straight bridge, where deck is 100 m long and 10 m wide. This bridge also supported by elastomeric bearing, however the dimension is not measured.

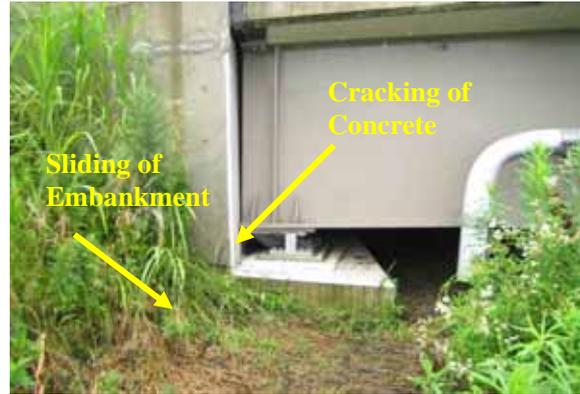
The damages were similar to the Toyota Bridge, that the backfill soil has settled and this results the permanent deformation of elastomeric bearing, and closure of the expansion joint gap. The rubber installed among the expansion joint has squeezed out. In the base of abutment, cracking of concrete is observed which can be estimated that this has progressed during the event.

(b) Sliding of Embankment

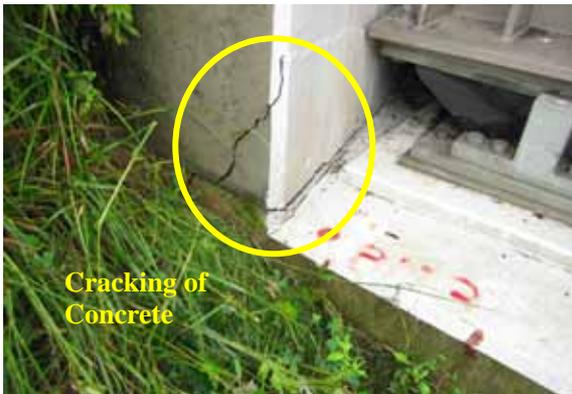
(c) Cracking of Concrete, Abutment (close up)

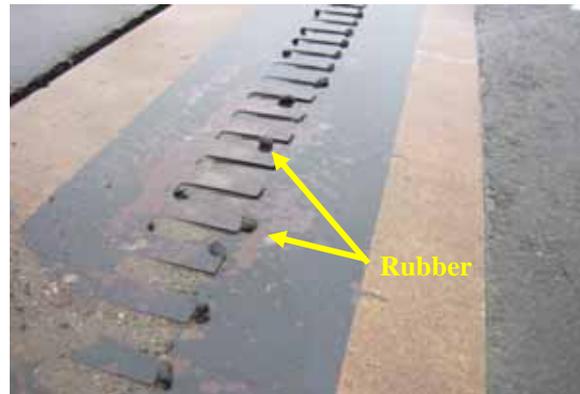
(d) Squeeze out of Rubber among Expansion Joint

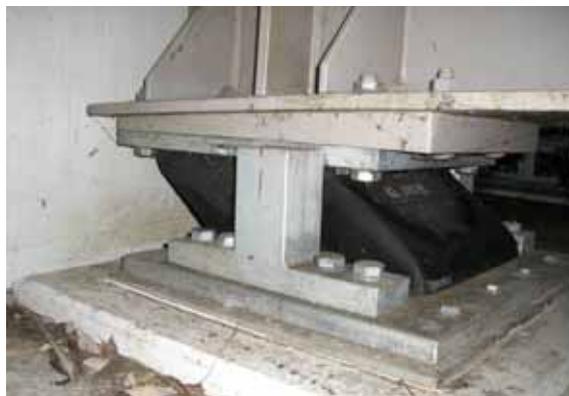
(e) Permanent Deformation of Elastomeric Bearing

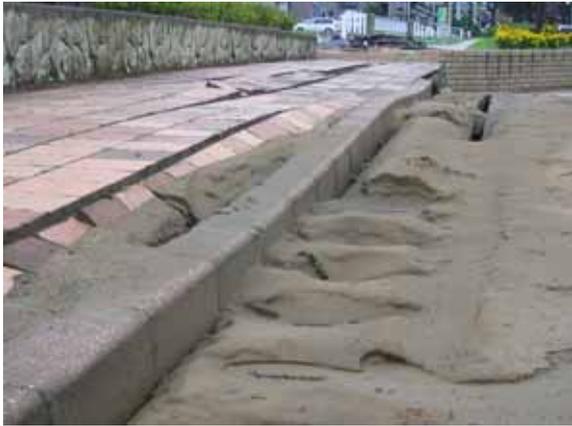
Photo 3 shows the damage at the ‘Sabaishi River Memorial Park’ which is located at the small land near to Kashiwazaki City (refer to Figure 1). Since it was located near to the river, liquefaction and soil boiling is observed around this area. The settlement and sliding of embankment is observed at the bridge and the revetment seems had slide toward the river. In addition, on the side of slided revetment, the electric pole has tilted toward river due to the settlement of revetment.

(a) Soil Boiling near the Pavement

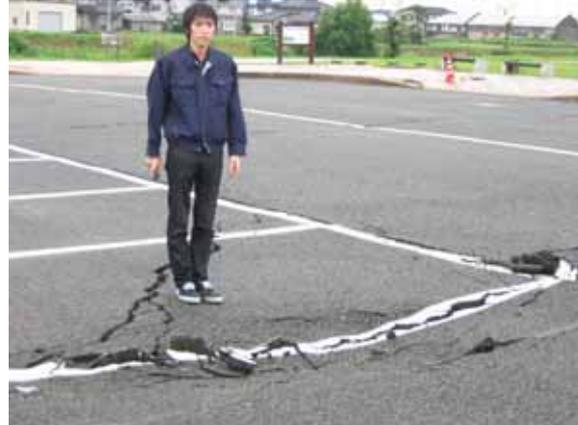
(b) Liquefaction of Parking Area

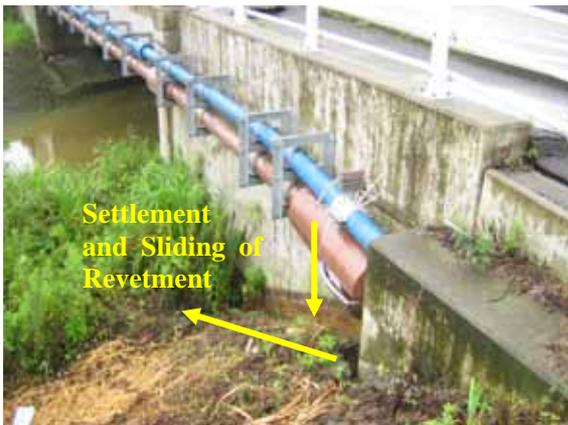
(c) Revetment

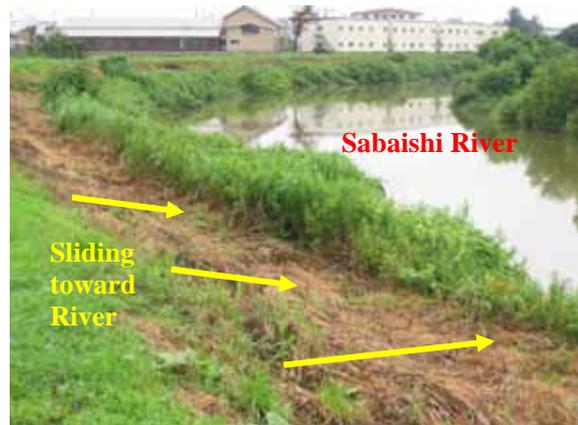
(d) Sliding of Revetment

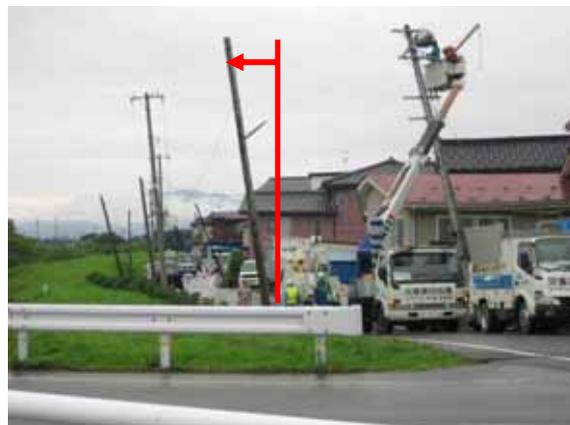
(e) Tilting of Electric Pole

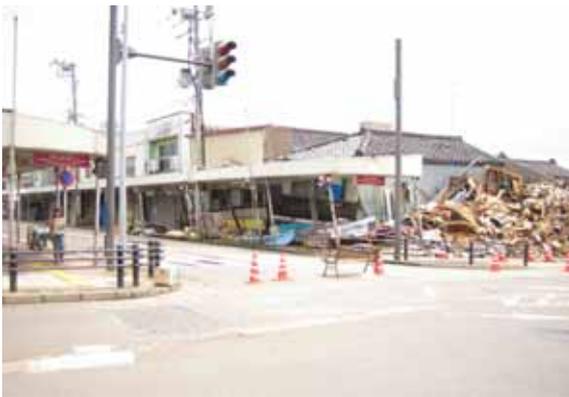
In the Kashiwazaki city, a large number of Japanese traditional wooden type houses are totally or partially collapsed, as shown in **Photo 4**. Most of the Japanese wooden houses are designed with have heavy roof in order to protect against the typhoon. However this produces the long fundamental period of houses, having period around 2-3 seconds. Referring to the response acceleration spectra in **Figure 3**, it should be noticed that the acceleration measured in the Kashiwazaki city (NIG018) have peak acceleration at around $T= 2$ seconds. The damage may be caused due to the resonance of structural and ground motion and this brought tragedy. The settlement of the ground is observed in the city center. There was no visible damage is observed for the structure even the ground has settled nearly 300 mm (=11.8').

(a) Complete Collapse of House along the Street Market

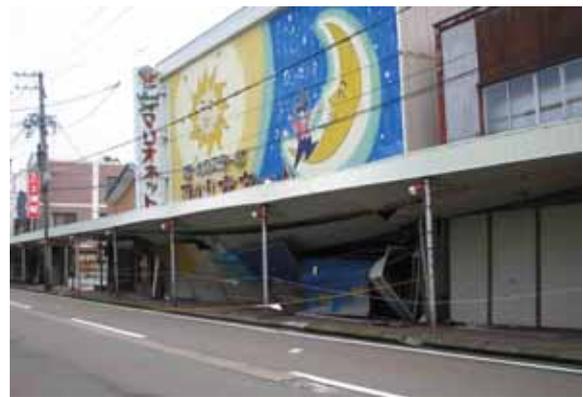
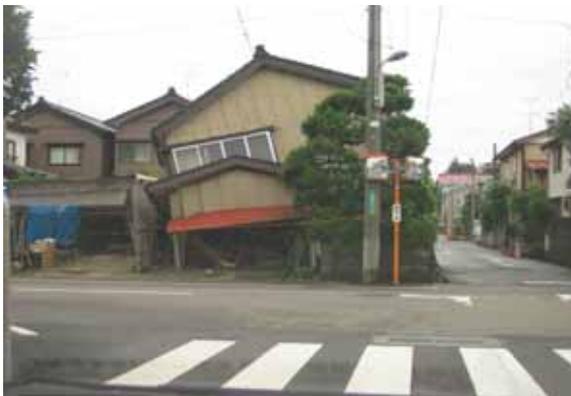
(b) Partial Collapse of House

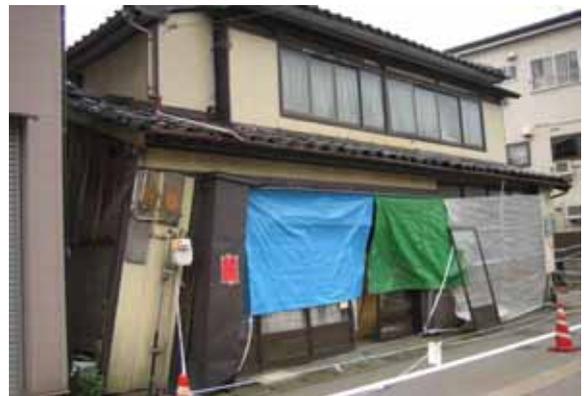
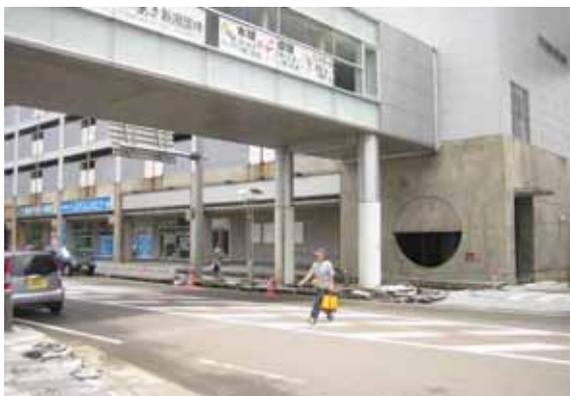
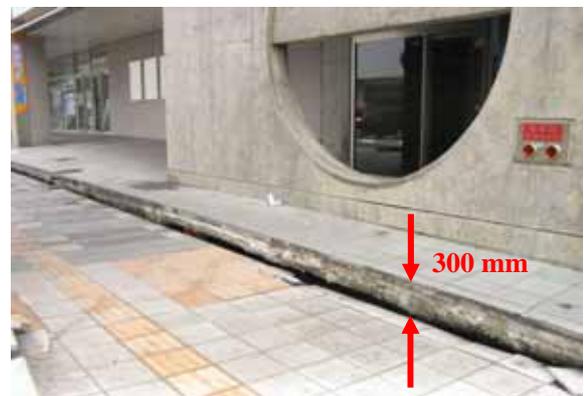
(c) Settlement of Ground
