PACIFIC EARTHQUAKE ENGINEERING RESEARCH CENTER

Fire-Induced Structural Collapse on Pier 45 at Fisherman's Wharf, San Francisco, California, May 23, 2020

PEER Report No. 2021/01

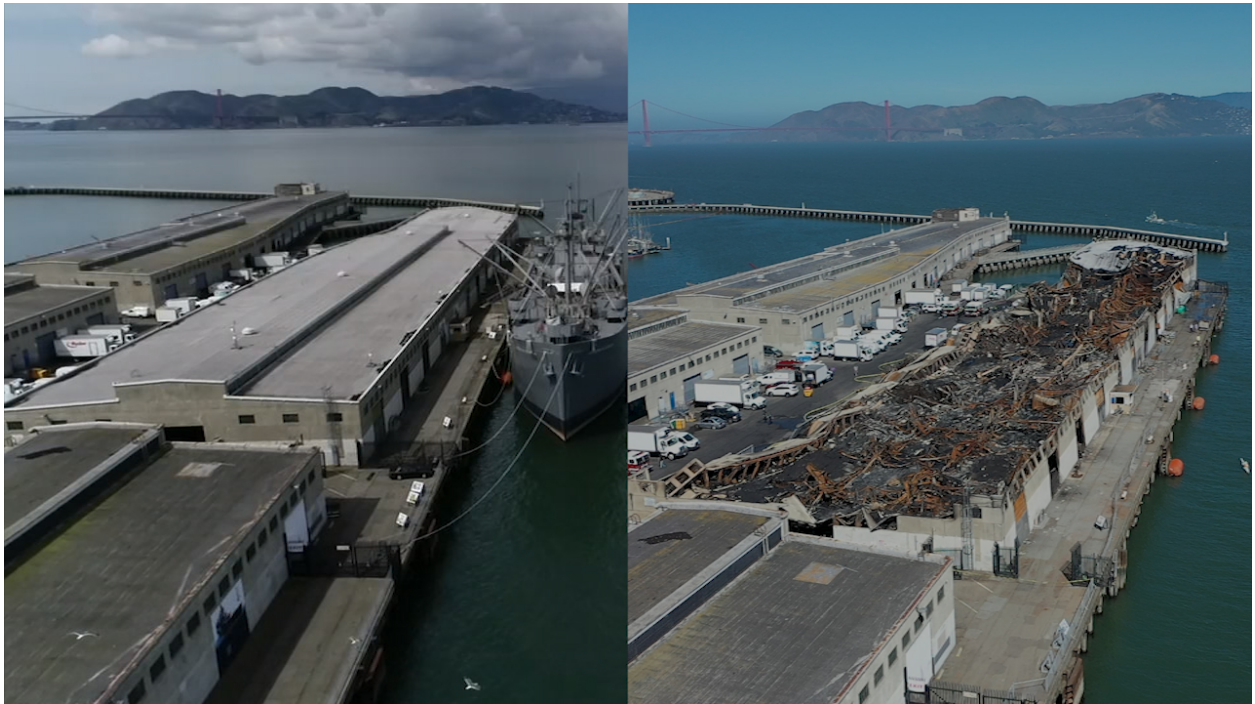
**Figure 2.4: Aerial view of side-by-side comparison before and after fire exposure of Pier 45.
(Credit: by ABC 7 News)**

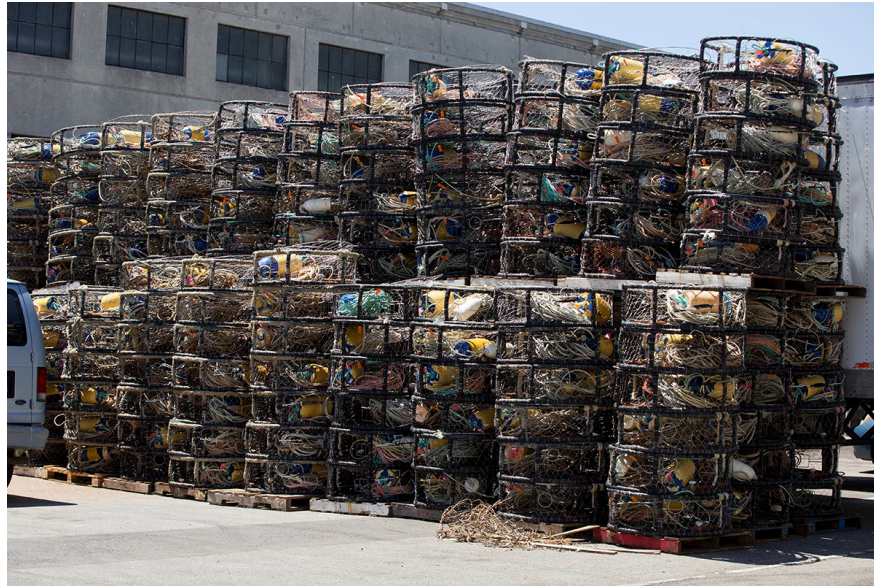
Figure 2.5 shows fishing equipment piled outside of Shed C. Note: large amounts of fishing equipment similar to what is shown in Figure 2.5 may have served as fuel for the fire. Figure 2.6 shows the type of equipment being housed in Shed A, which is identical equipment that had been stored in Shed C. The historic SS Jeremiah O'Brien ship was spared from the fire, and it was towed to Pier 35 the Tuesday afternoon after the fire.

Figure 2.5: Large amounts of fishing equipment in front of Shed C.

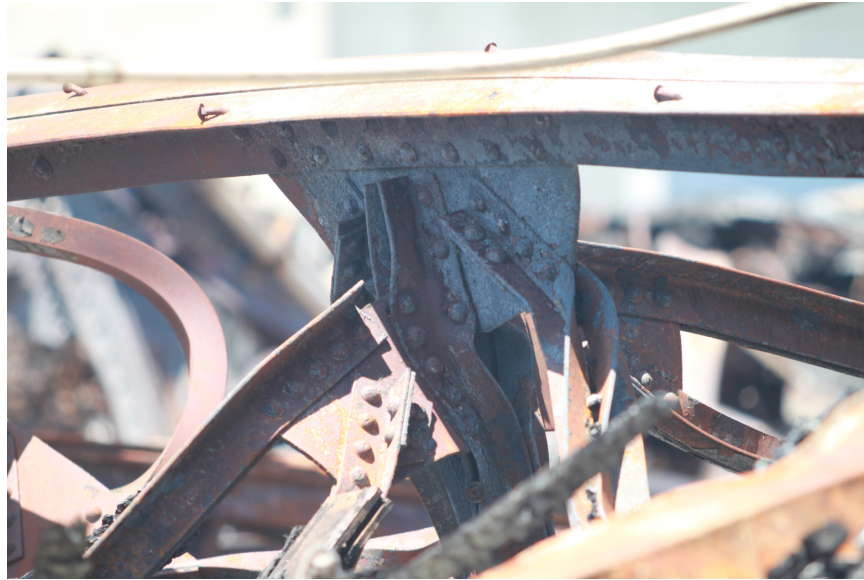
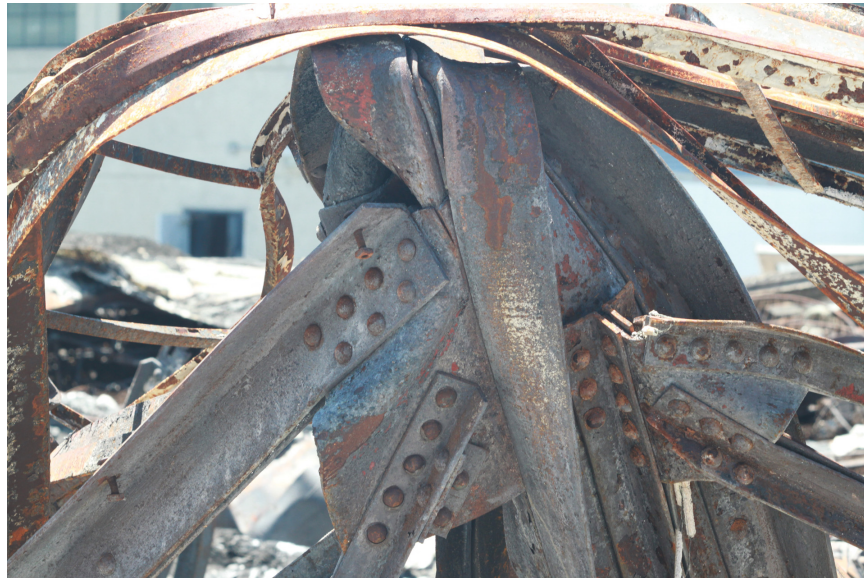
As noted in Section 4.3, the steel column to concrete base connection on the west side of the building failed in numerous ways . This section focuses on the truss-to-column connections. While the top chord, bottom chord, and web members suffered significant fire-induced damage, the connections were found to be relatively intact during the site visit, suggesting adequate performance during fire exposure. There were no records of gusset plate rupture, rivet failure, or block shear failure. This confirms the design concept that the connection may fail after the full capacity of the connecting members is achieved. Figure 4.12 shows samples of damage to truss connections. While excessive deformation of gusset plates can be seen in Figure 4.12, there was no evidence of block shear or rivet failure in the connecting members.

Figure 4.12: Damage to truss connection: (a) excessive deformation in truss members with no failure in rivet or gusset plate; and (b) typical truss connection exhibiting severe deformation and collapsed connection members.

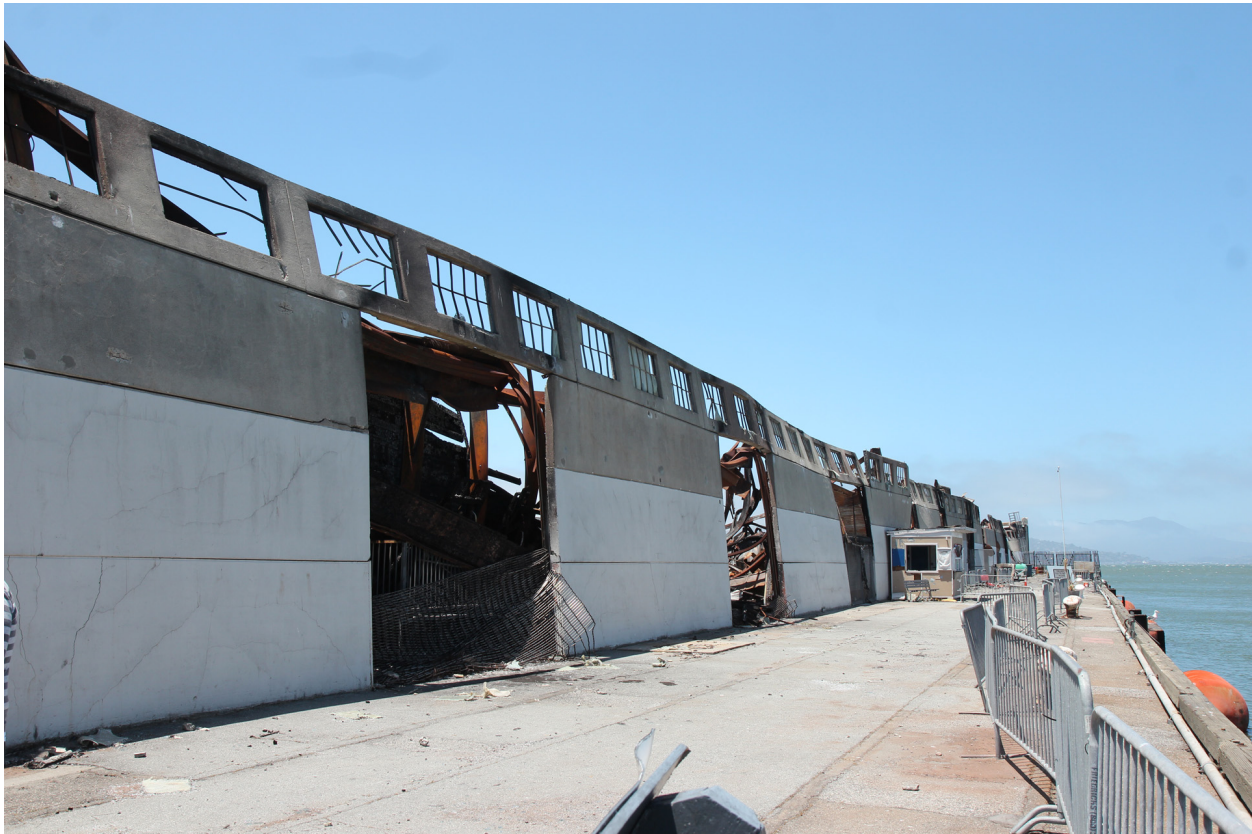
Figure 4.17: Damage to window and glass in east-side perimeter wall.

Damage to glass can be seen in the Figures 4.17 to 4.22. It is recommended to conduct furnace tests on samples of undamaged glass of Shed C. Obtaining the melting temperature of glass can significantly help in estimating the actual temperature of the structure. In fact, glass can be used as evidence to evaluate the actual temperature of the Shed C fire [Lentini [1992]].

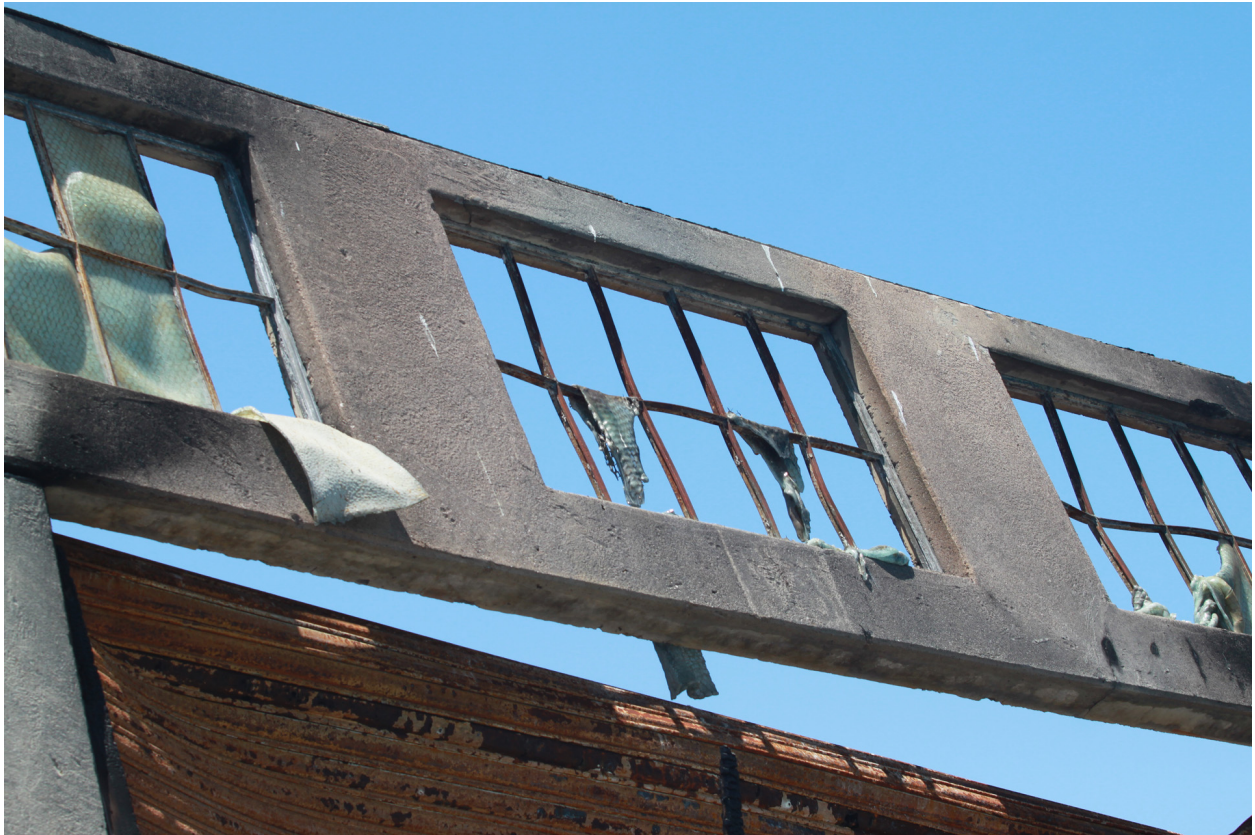
Figure 4.19: Damage to window frame and molten glass in the east wall.

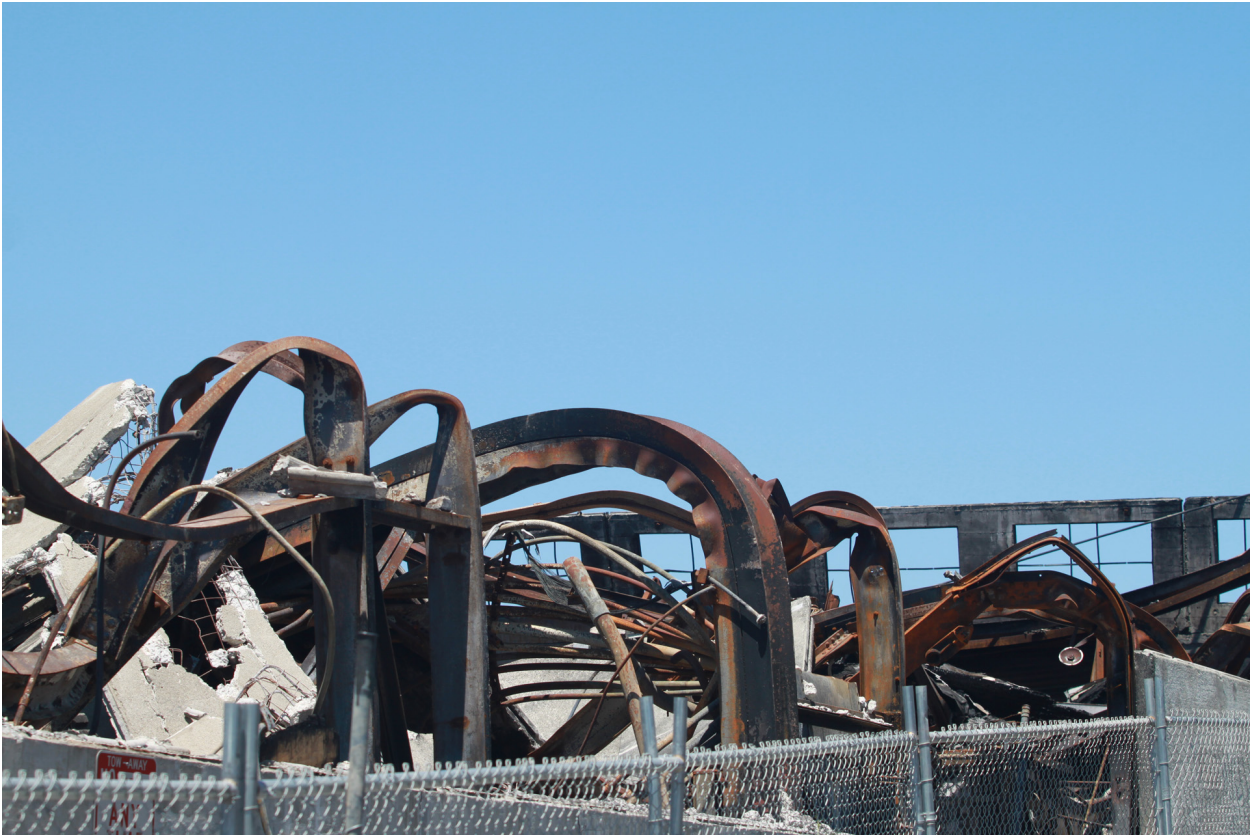
Figure A.20: Bending of column in the weak axis direction, with local buckling in flanges.

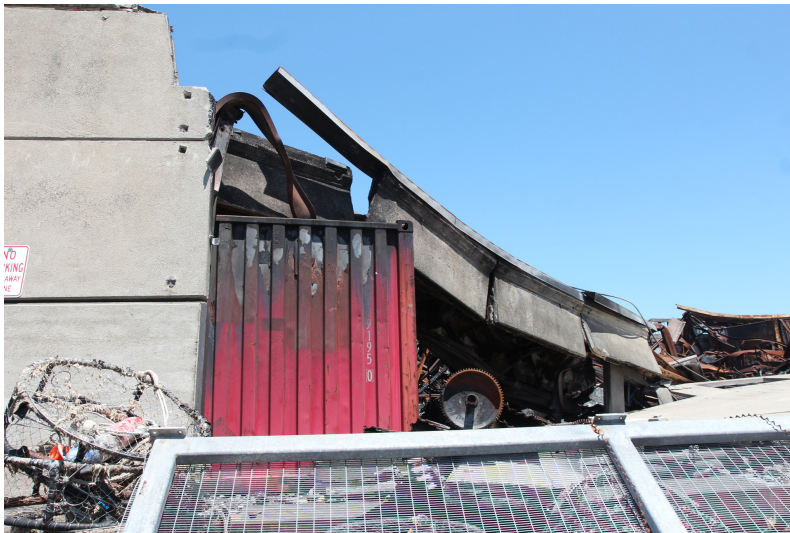
Figure A.31: Wall collapse and column buckling observations on the western side of the structure: (a) prevention of wall inward collapse because of a container; and (b) buckling of the column at mid-height can be seen.
