OBSERVATIONS AFTER 5/12/2008 WENCHUAN EARTHQUAKE BASED ON FIELD RECONNAISSANCE FROM 7/4/2008 TO 7/7/2008

Khalid M. Mosalam, PhD, PE mosalam@ce.berkeley.edu

Nicholas Sitar, PhD, PEng sitar@ce.berkeley.edu

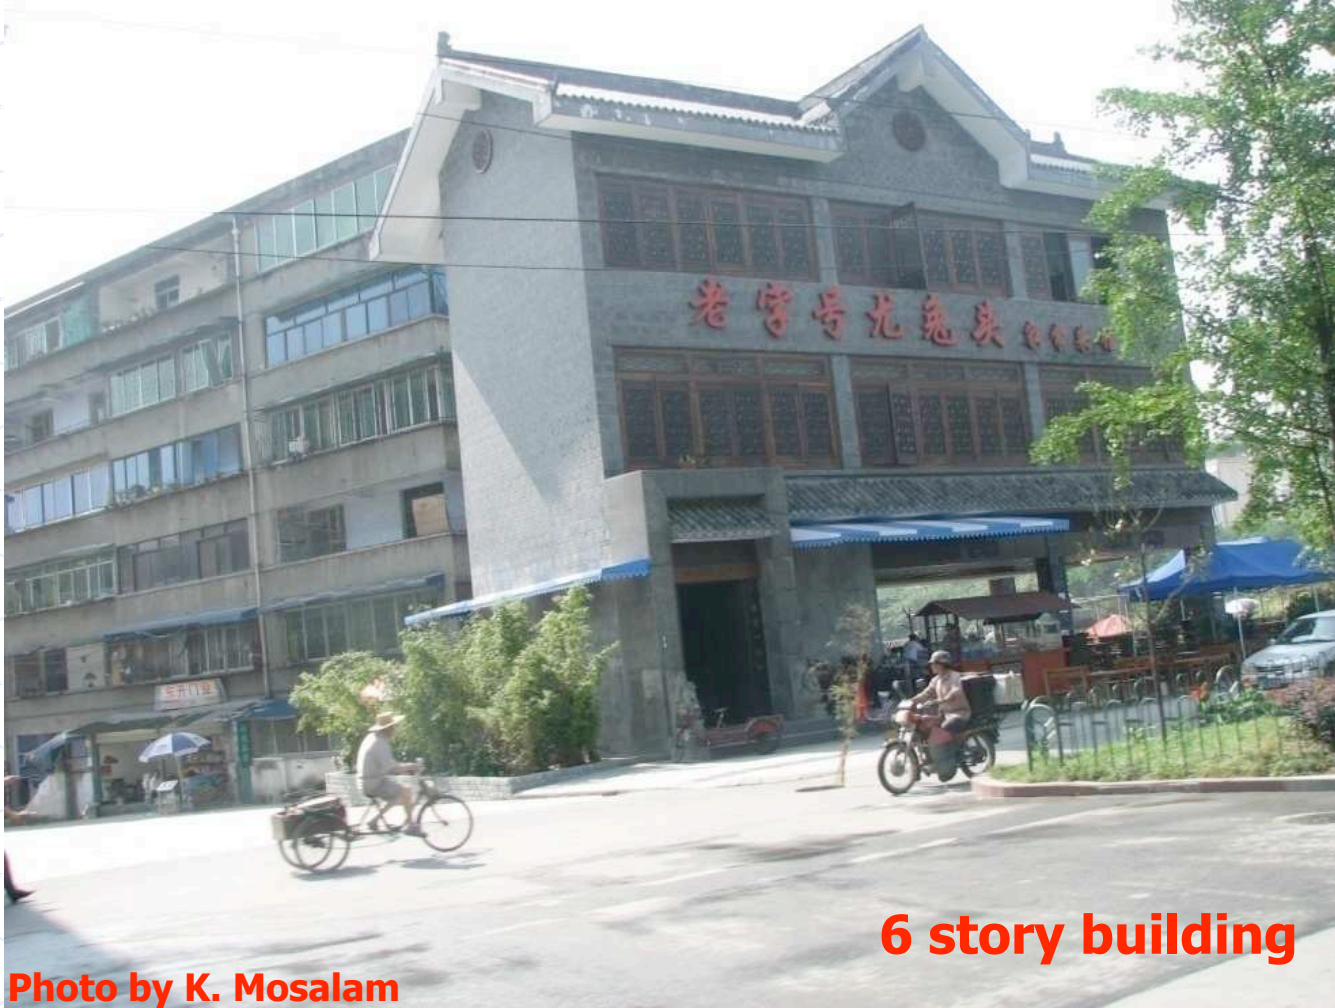
6 story building

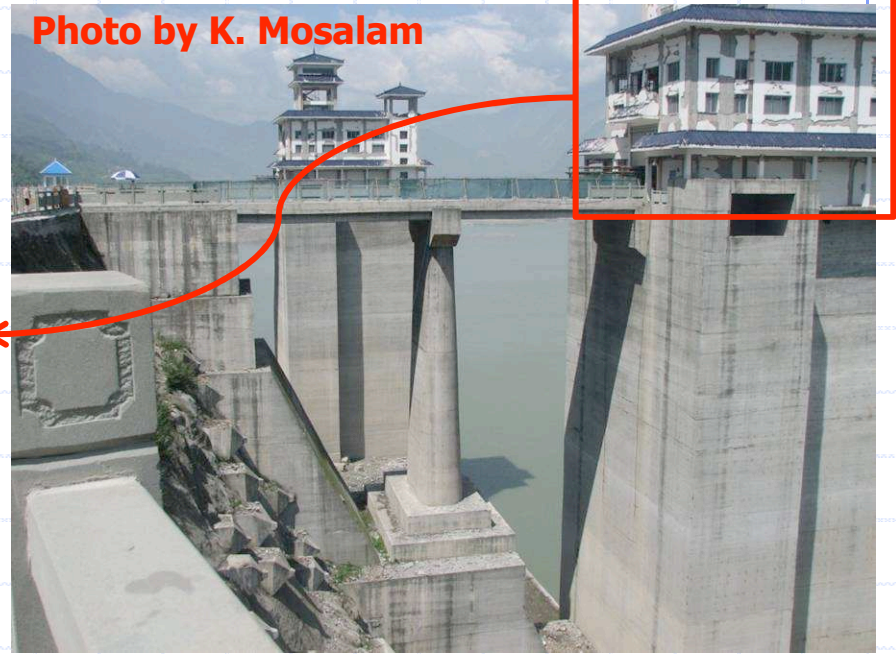
Fault orientation

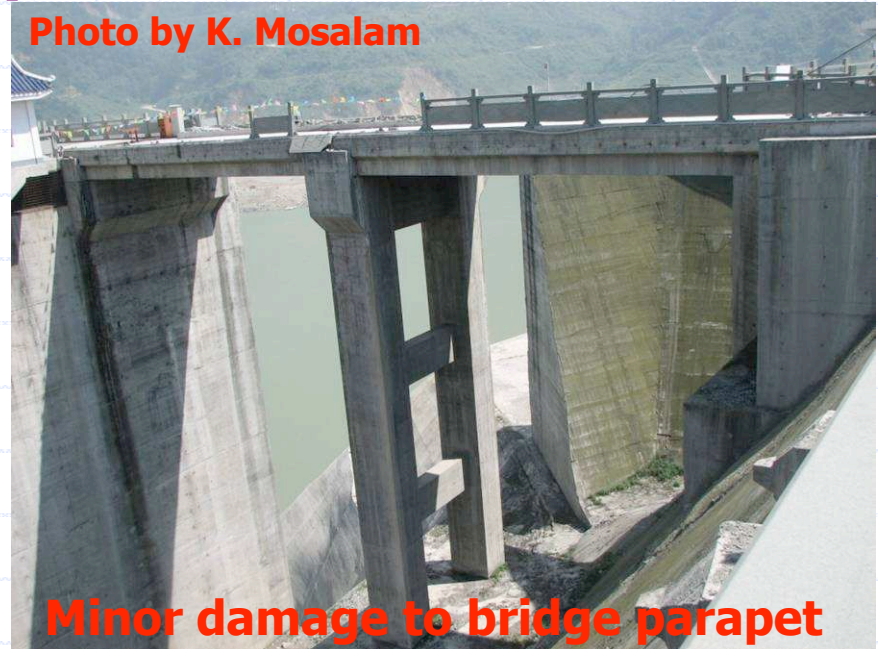
Minor damage to bridge parapet

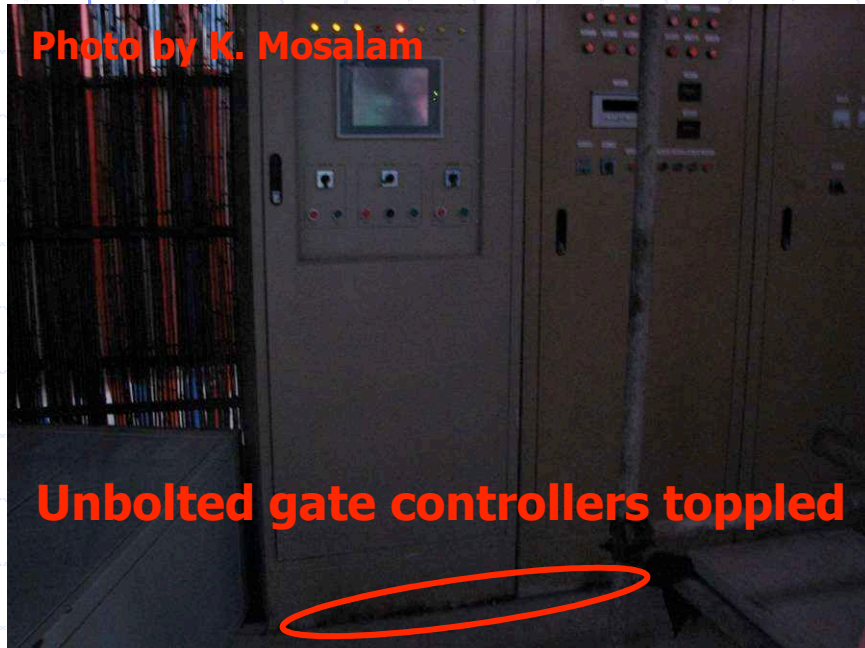
Unbolted gate controllers toppled

Bolting equipment after earthquake

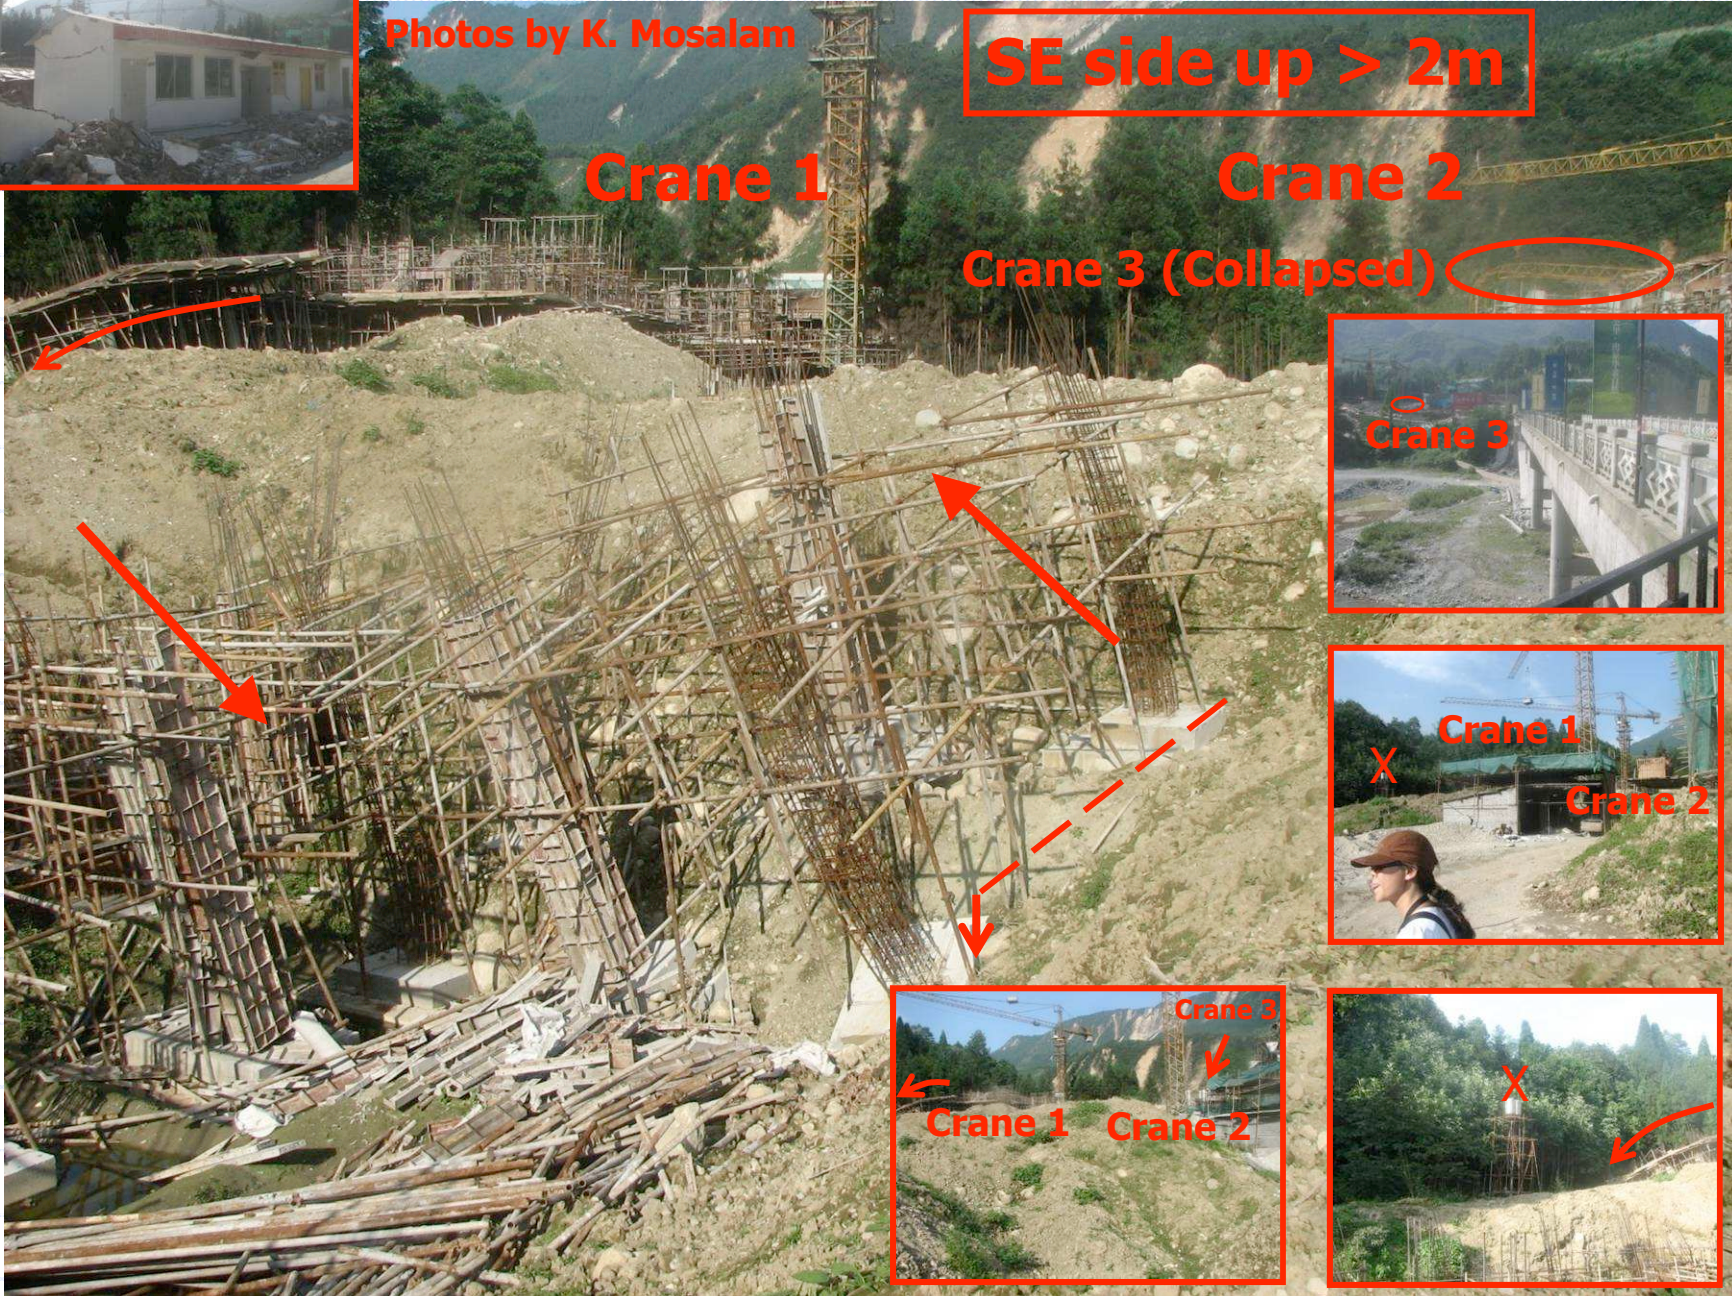
SE side up > 2m

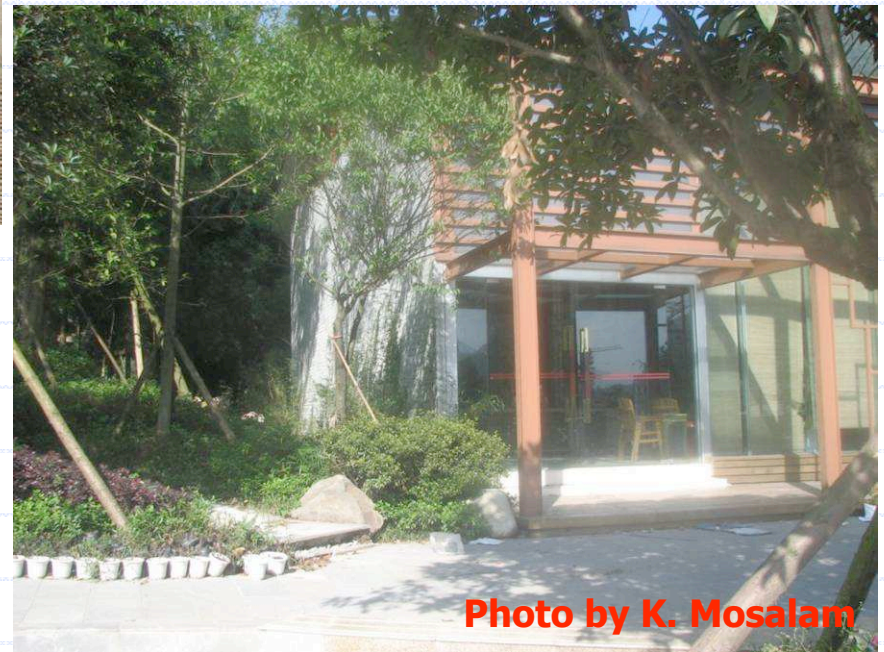
Good performance – within
the fault zone

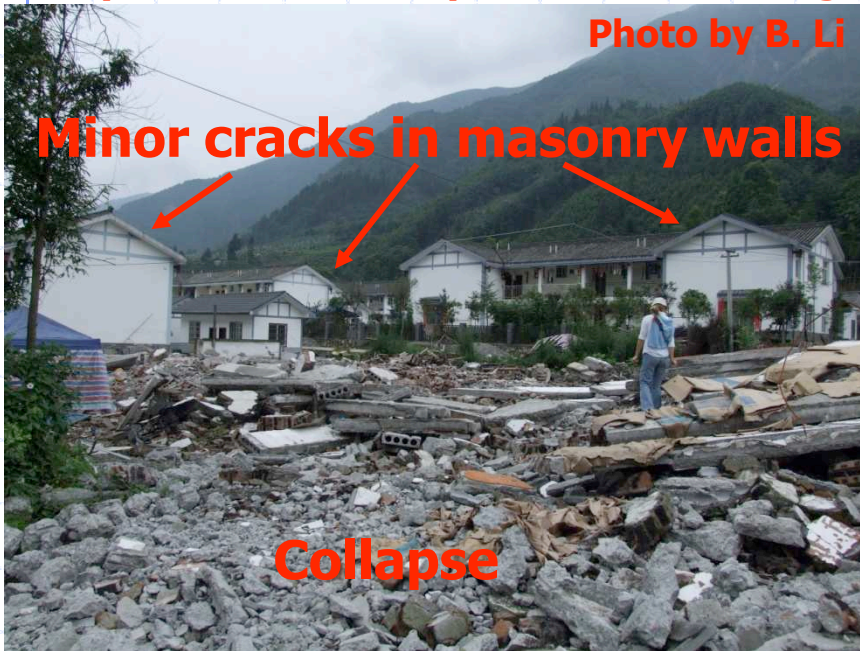
Minor cracks in masonry walls
