PEER Preliminary Notes and Observations on the August 24, 2014, South Napa Earthquake

2014 South Napa Field Notes
Oregon State University Team

Report No. 2014/13

A 2014 South Napa Field Notes—Oregon State University Team⁺

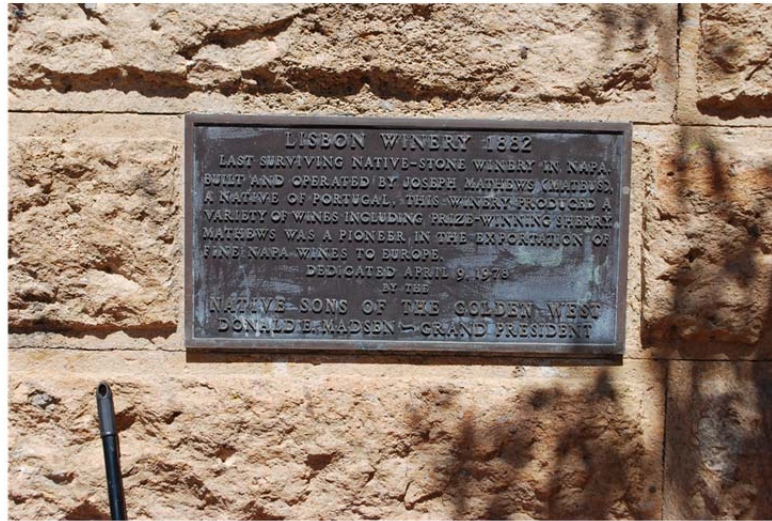
Figure 3 Evaluated Structure No. 1.

No.	Address	Building Name	Photo Comments
1	1762 Brown St.	Lisbon Winery	Minor exterior damage, major interior damage due to water leak

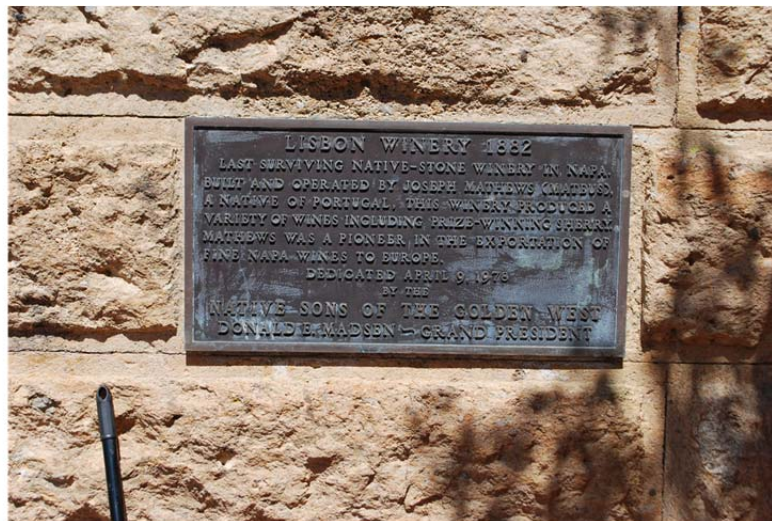
Figure 4 Evaluated Structure No. 1.

No.	Address	Building Name	Photo Comments
1	1762 Brown St.	Lisbon Winery	Minor exterior damage, major interior damage due to water leak

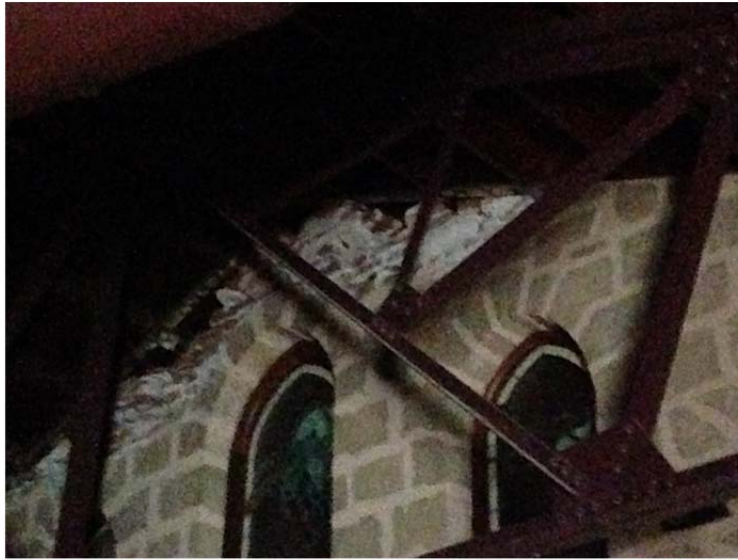
Figure 5 Evaluated Structure No. 1.

No.	Address	Building Name	Photo Comments
1	1762 Brown St.	Lisbon Winery	Interior damage in a old bearing wall that is not supporting load.

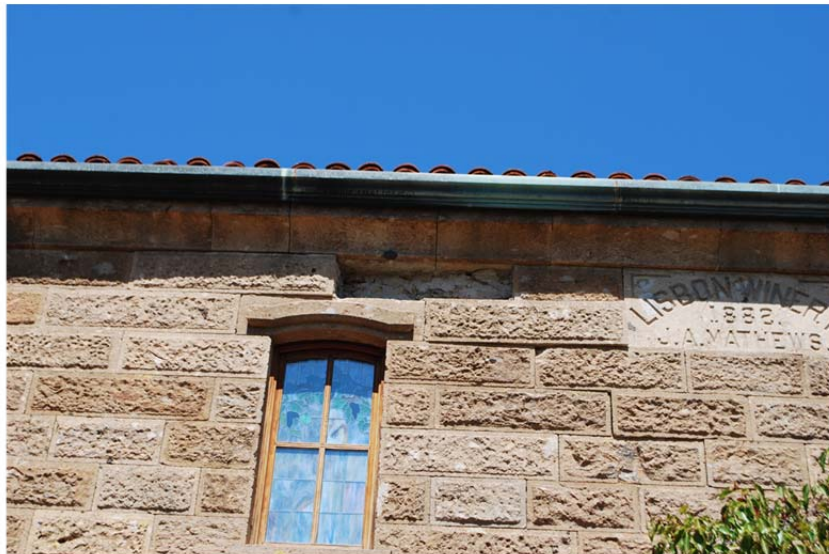
Figure 6 Evaluated Structure No. 1.

No.	Address	Building Name	Photo Comments
1	1762 Brown St.	Lisbon Winery	Fallen stone and displaced stones adjacent to it.

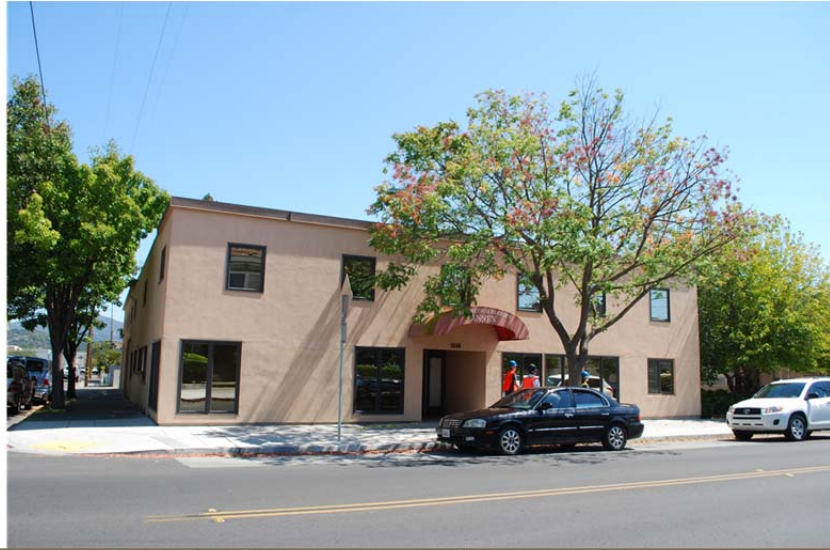
Figure 7 Evaluated Structure No. 2.

No.	Address	Building Name	Photo Comments
2	1660 Main St.	Jarvis Conservatory Annex	Wood-frame warehouse/auditorium. Stucco exterior walls extensively damaged and detaching from main structure. No interior damage.

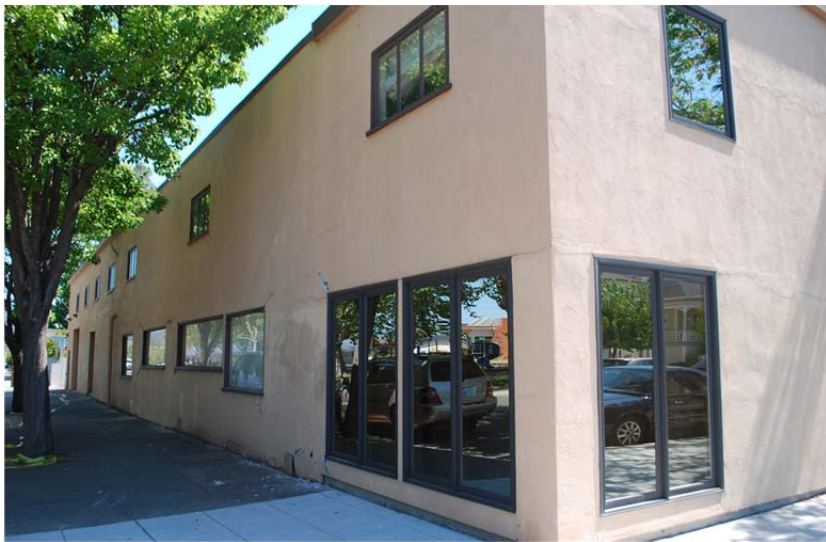
Figure 8 - Evaluated Structure No. 2.

No.	Address	Building Name	Photo Comments
2	1660 Main St.	Jarvis Conservatory Annex	Visible exterior wall damage in stucco walls.

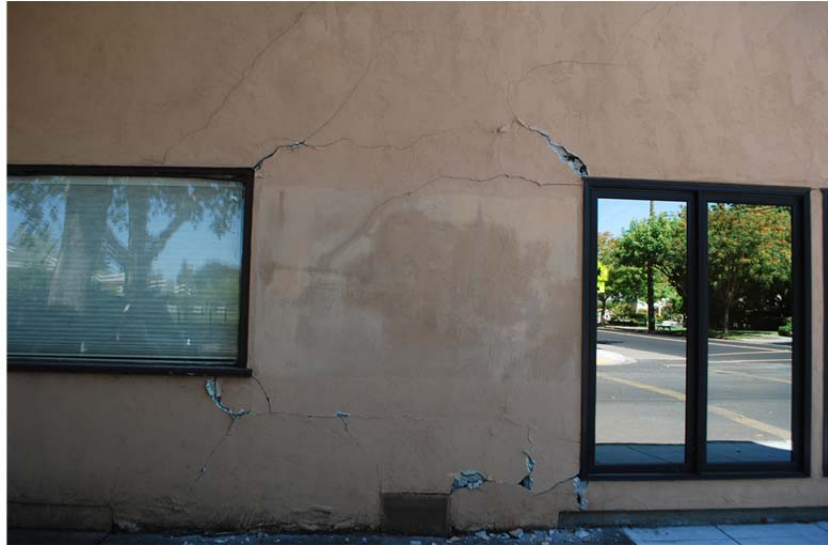
Figure 9 Evaluated Structure No. 2.

No.	Address	Building Name	Photo Comments
2	1660 Main St.	Jarvis Conservatory Annex	Visible exterior wall damage in stucco walls.

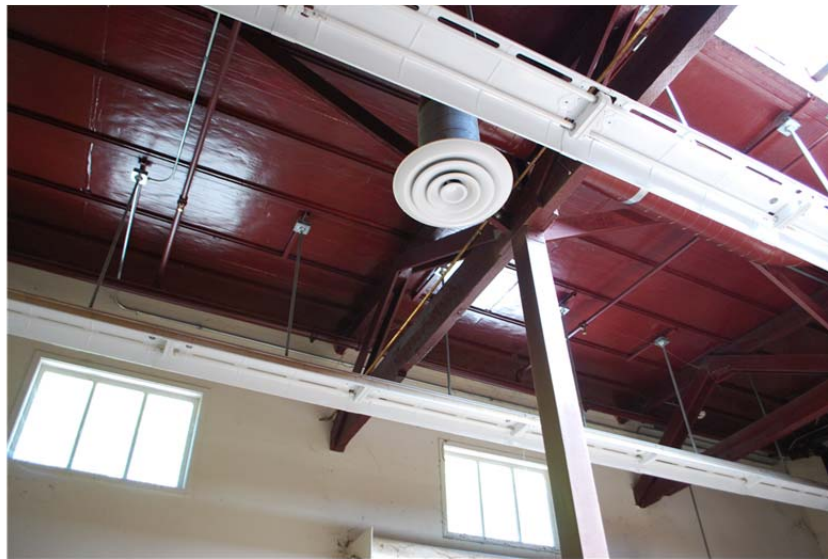
Figure 10 Evaluated Structure No. 2.

No.	Address	Building Name	Photo Comments
2	1660 Main St.	Jarvis Conservatory Annex	No interior damage observed.

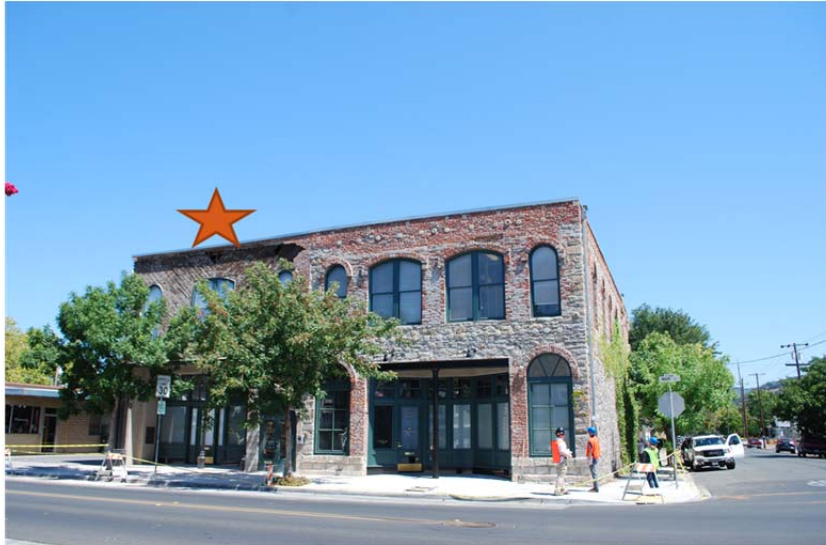
No.	Address	Building Name	Photo Comments
3	1606/1610 Main St.	Law Offices	1610 Main St. has a first story URM and a extension (wood shear wall) with masonry veneer on second floor. Veneer collapsed out-of-plane.

Figure 11 Evaluated Structure No. 3: Star indicates 1610 Main St.

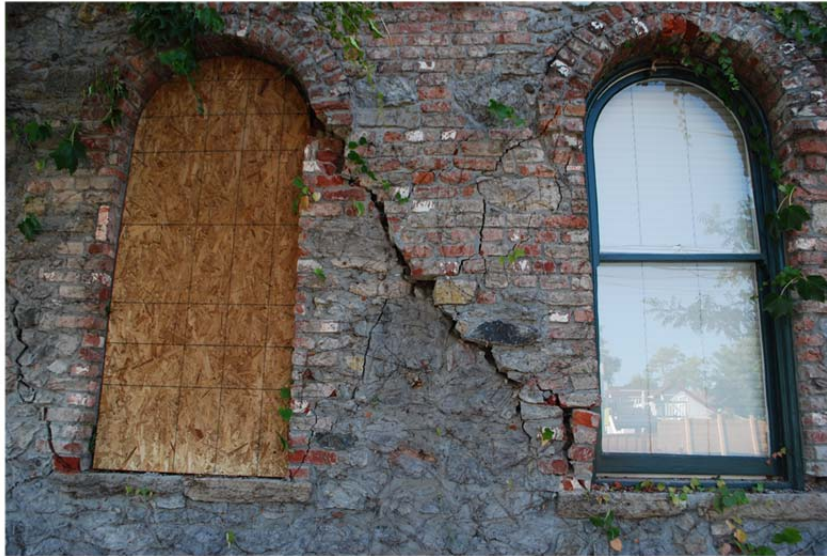
Figure 13 Evaluated Structure No. 3.

No.	Address	Building Name	Photo Comments
3	1606/1610 Main St.	Law Offices	Different masonry type construction visible on both floor levels. In-plane cracks, and out-of-plane cracks visible.

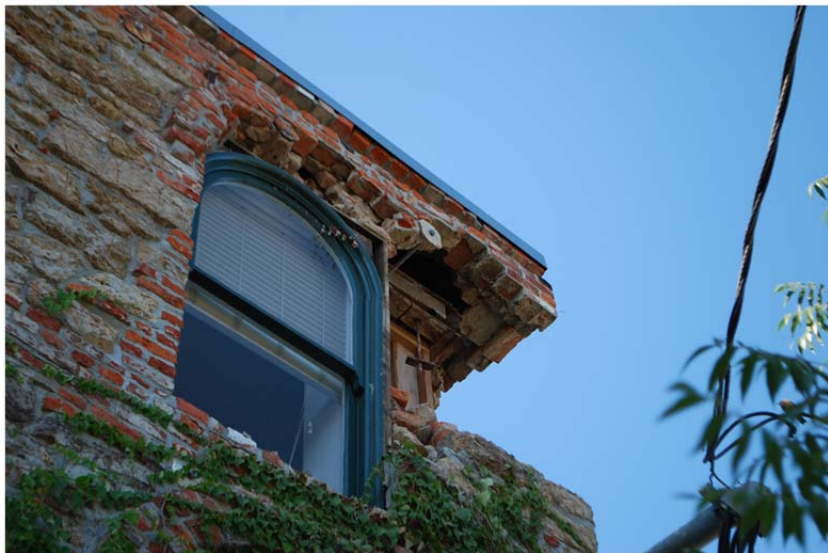
Figure 14 Evaluated Structure No. 3.

No.	Address	Building Name	Photo Comments
3	1606/1610 Main St.	Law Offices	Significant damage to the masonry walls.

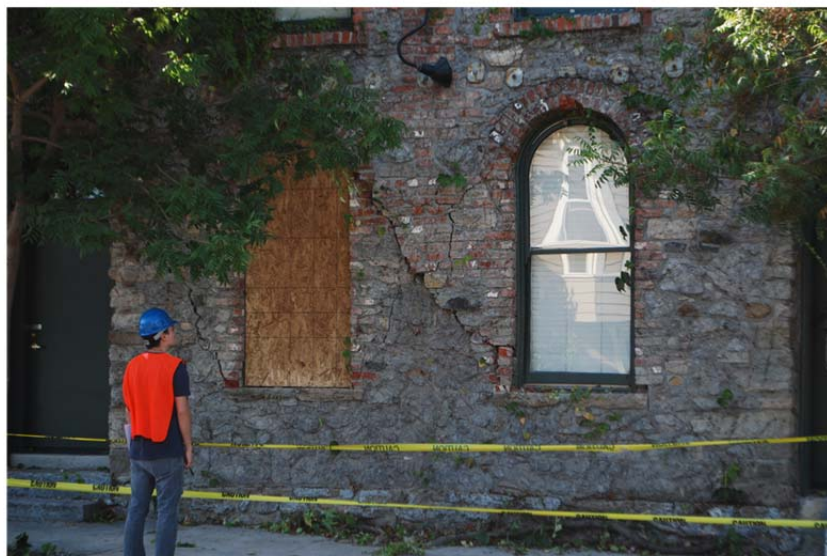
Figure 15 Evaluated Structure No. 3.

No.	Address	Building Name	Photo Comments
3	1606/1610 Main St.	Law Offices	Wall-to-floor ties performed well. Out-of-plane movements between floors.

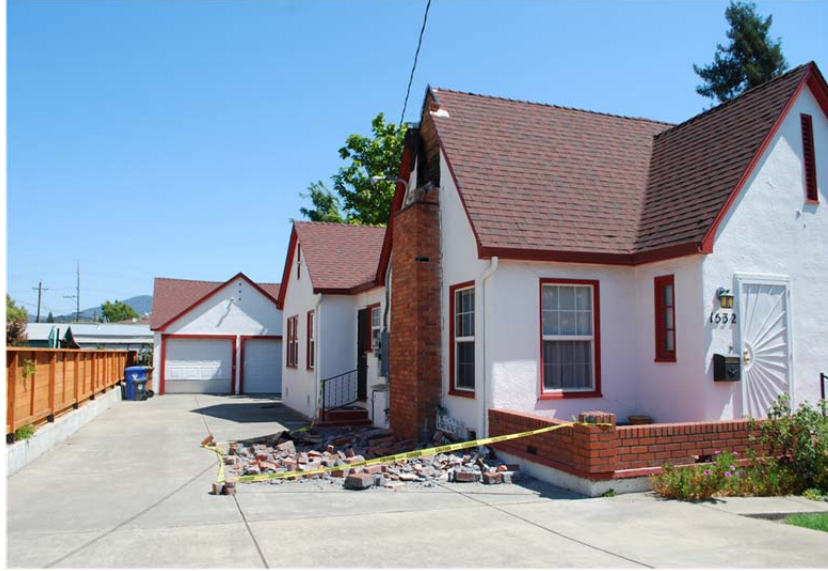
Figure 17 Evaluated Structure No. 4.

No.	Address	Building Name	Photos Comments
4	1530/32 Main St.	Duplex Residence	Two chimneys damaged and collapsed. Garage shifted off foundation. Stucco cracks in exterior walls.

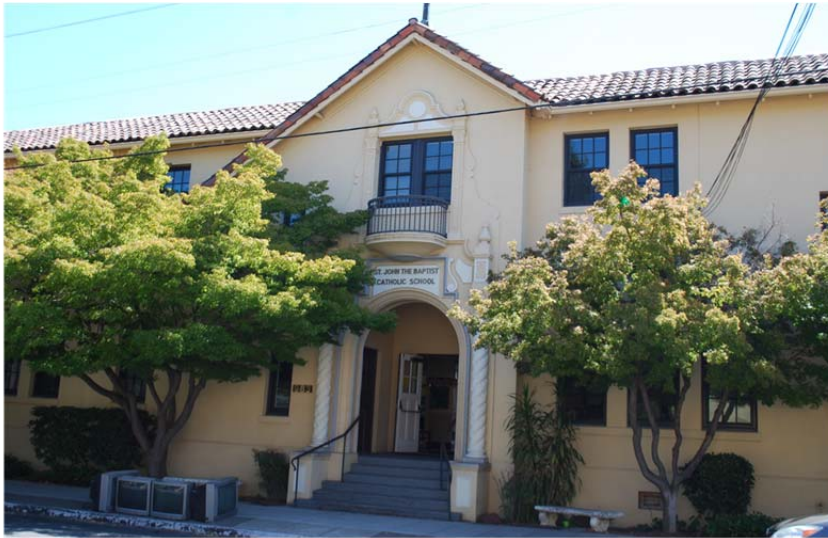
Figure 18 Evaluated Structure No. 5.

No.	Address	Building Name	Photo Comments
5	980 Napa St.	St. John the Baptist Catholic School	Private School. Some cracking on exterior facades. Interior tabique partition walls damaged. Fallen ceiling tiles and content. Broken glass debris.

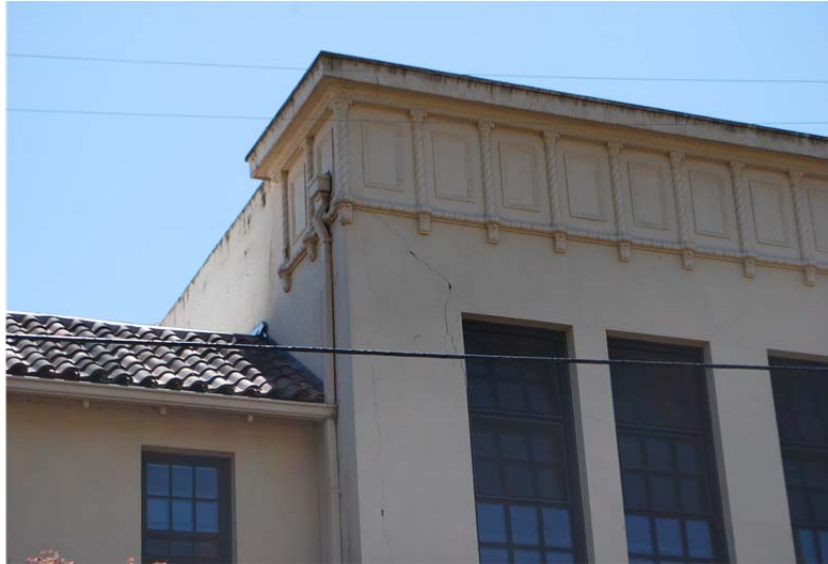
Figure 19 Evaluated Structure No. 5.

No.	Address	Building Name	Photo Comments
5	980 Napa St.	St. John the Baptist Catholic School	Some cracking on exterior facades.

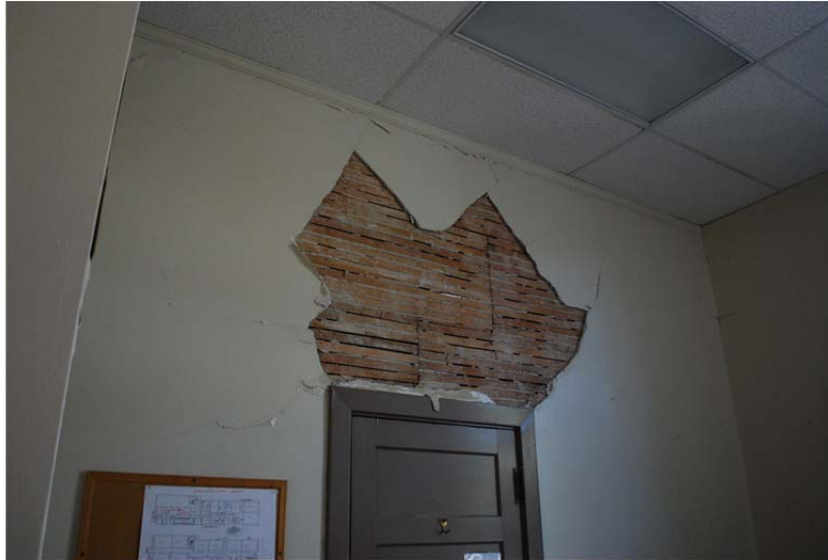
Figure 20 Evaluated Structure No. 5.

No.	Address	Building Name	Photo Comments
5	980 Napa St.	St. John the Baptist Catholic School	Some cracking on exterior facades. Interior tabique partition walls damaged.

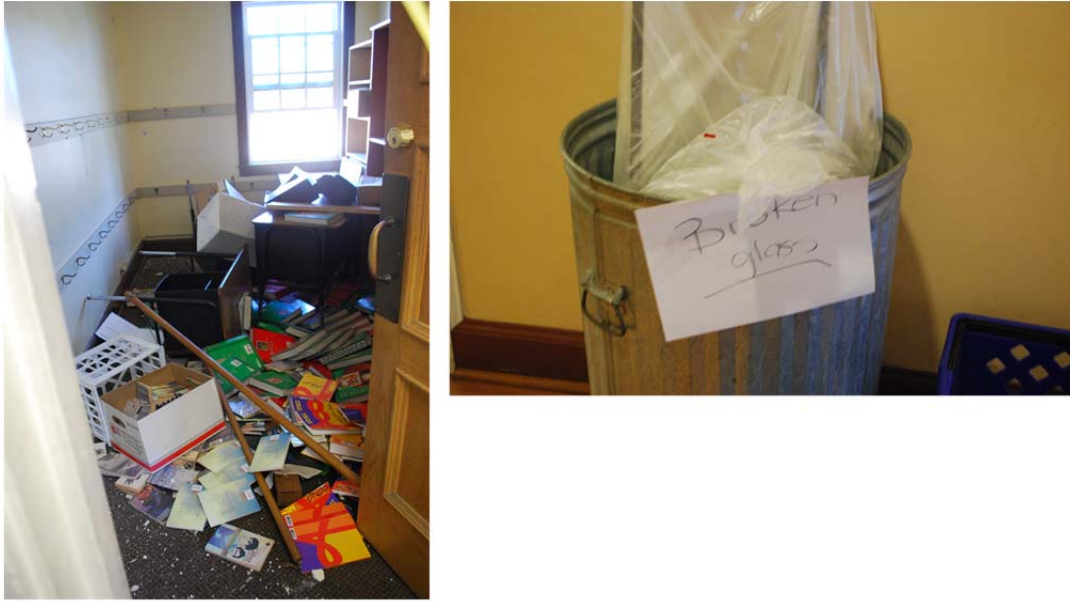
Figure 21 Evaluated Structure No. 5.

No.	Address	Building Name	Photo Comments
5	980 Napa St.	St. John the Baptist Catholic School	Fallen ceiling tiles and content. Broken glass debris.

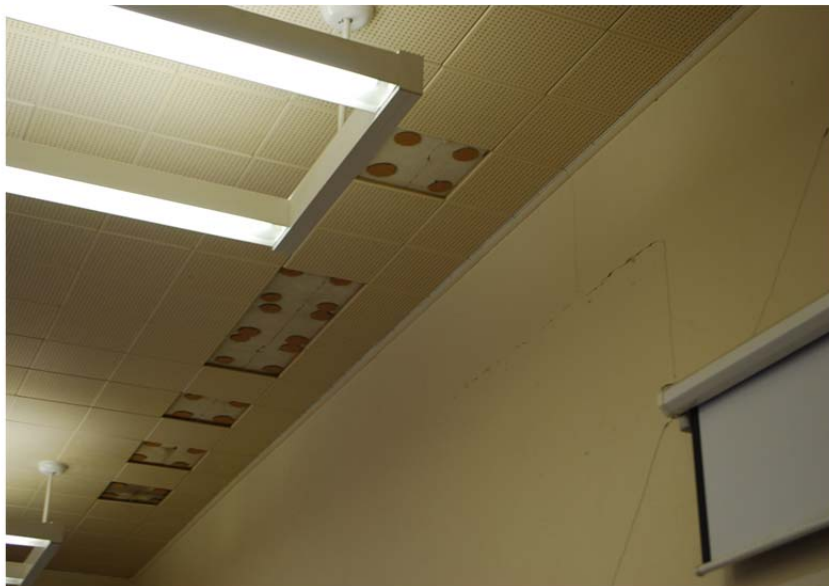
Figure 22 Evaluated Structure No. 5.

No.	Address	Building Name	Photo Comments
5	980 Napa St.	St. John the Baptist Catholic School	Fallen ceiling tiles. Cracked plaster.

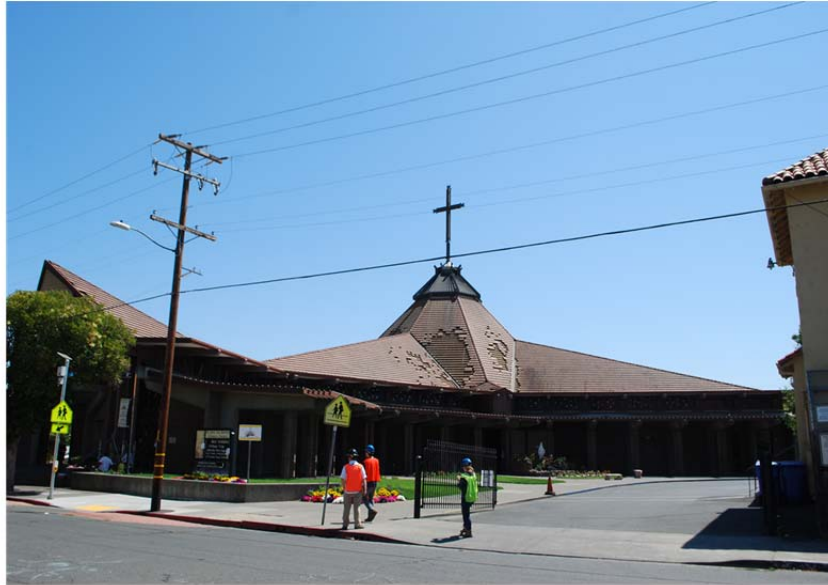
Figure 23 Evaluated Structure No. 6.

No.	Address	Building Name	Photo Comments
6	981 Caymus St.	St. John the Baptist Catholic Church	Roof tile damage.

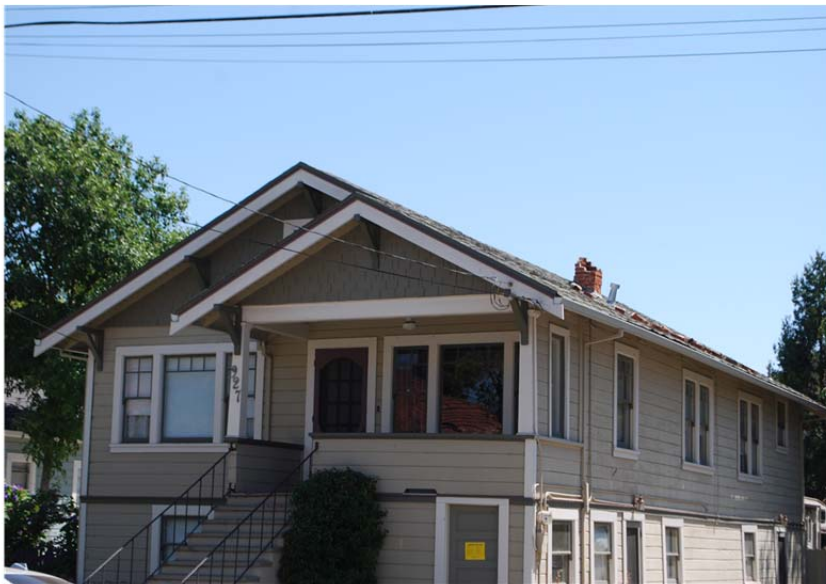
Figure 24 Evaluated Structure No. 7.

No.	Address	Building Name	Photo Comments
7	927 Caymus St.	Residence	Wood frame housing, with no visible damage. Chimney collapse.

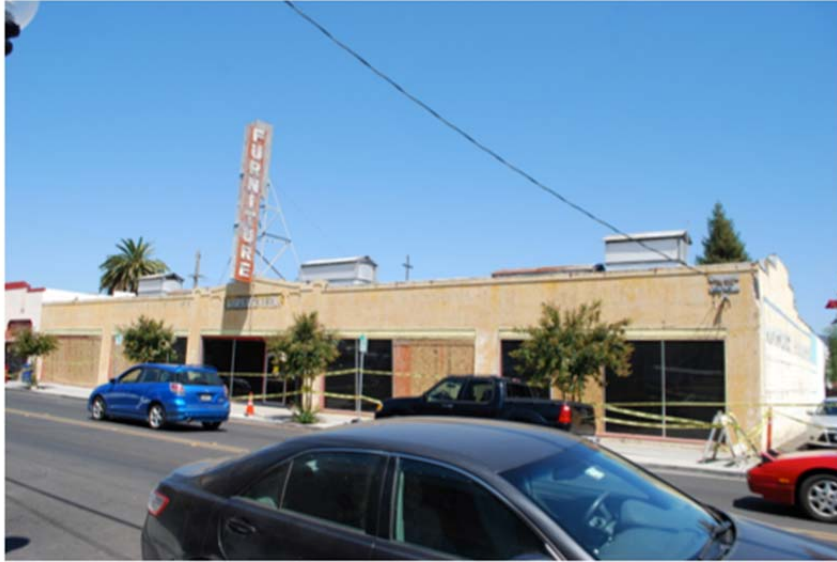
Figure 25 Evaluated Structure No. 8.

No.	Address	Building Name	Photo Comments
8	1326 Main St.	Abandoned commercial building	Reinforced concrete building. Glazing and corner wall/wall damage.

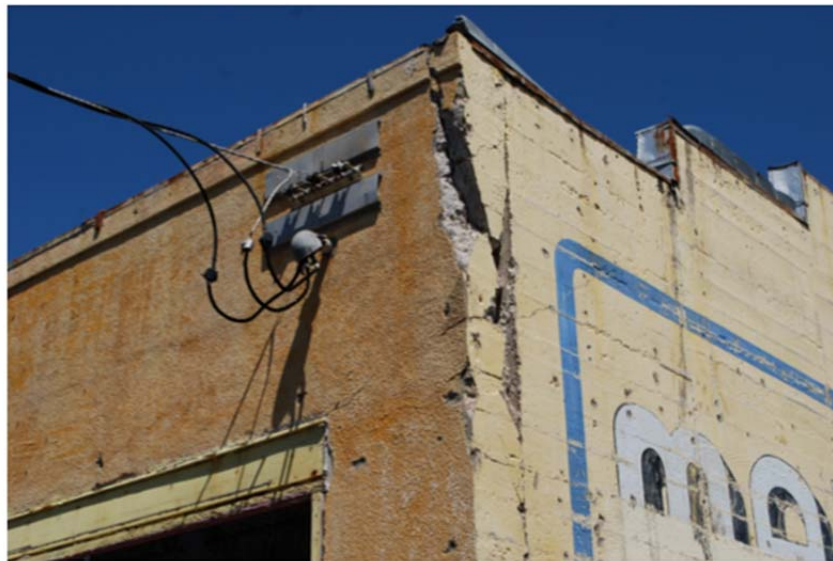
Figure 26 Evaluated Structure No. 8.

No.	Address	Building Name	Photo Comments
8	1326 Main St.	Abandoned commercial building	Corner wall damage.

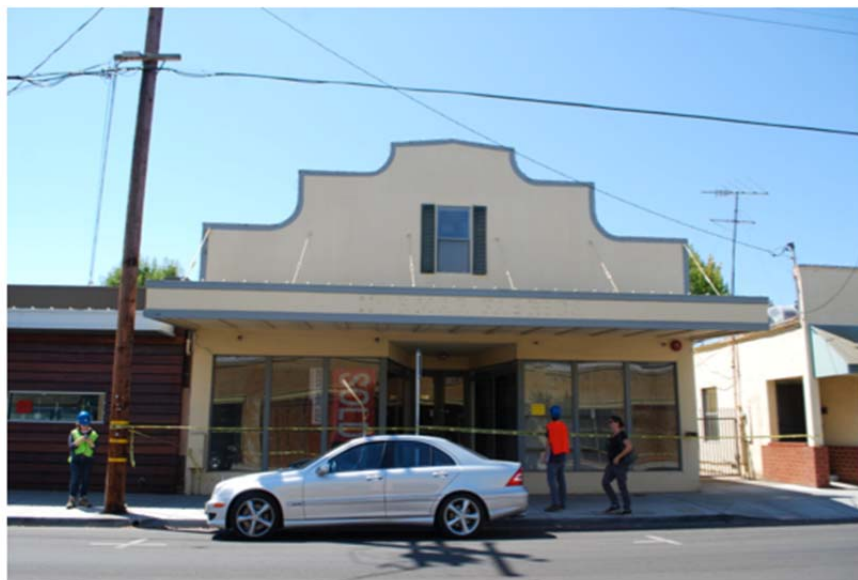
Figure 27 Evaluated Structure No. 9.

No.	Address	Building Name	Photo Comments
9	1327 Main St.	Normar Fabrics	Glazing damage; visible crack in beam-column joint. It looks like the building is RC.

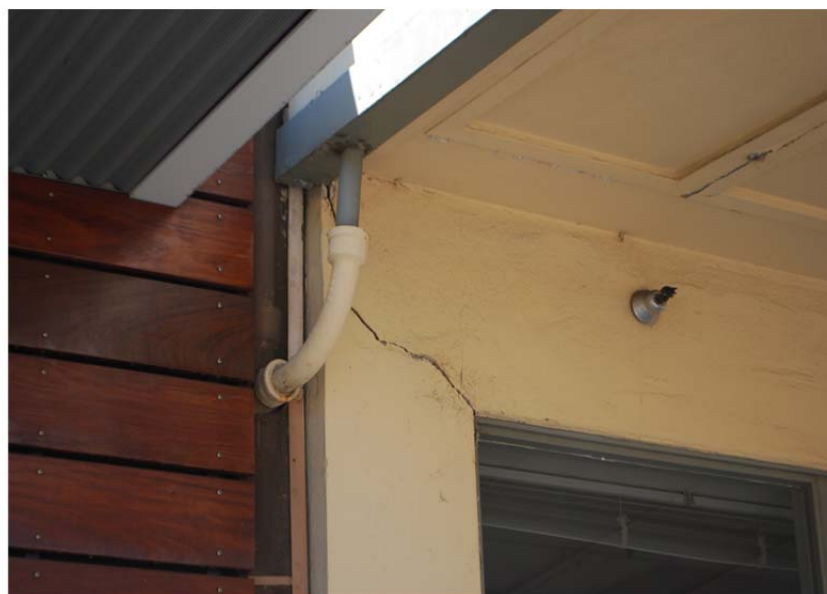
Figure 28 Evaluated Structure No. 9.

No.	Address	Building Name	Photo Comments
9	1327 Main St.	Normar Fabrics	Visible crack in beam-column joint.

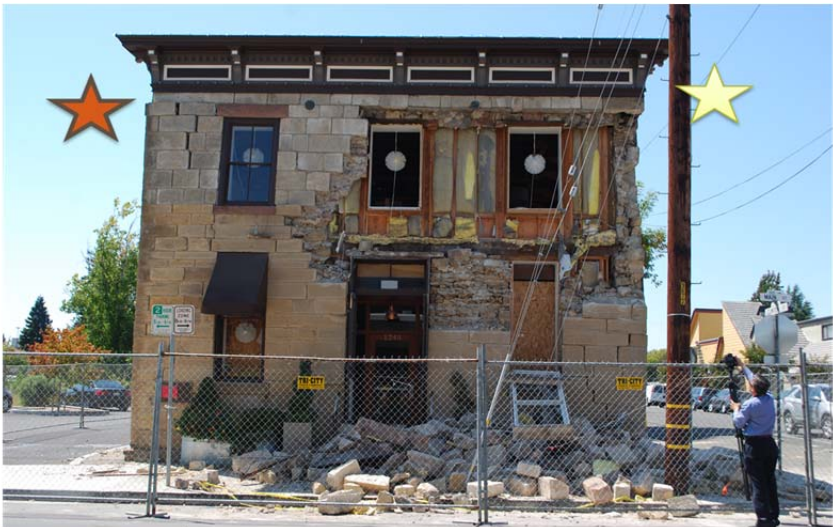
Figure 29 Evaluated Structure No. 10.

No.	Address	Building Name	Photo Comments
10	1245 Main St.	Vintner's Collection	Retrofitted URM building (stone masonry). Significant exterior damage, with stone blocks falling from wall and falling hazard from adjacent stones. In-plane shear cracking visible.

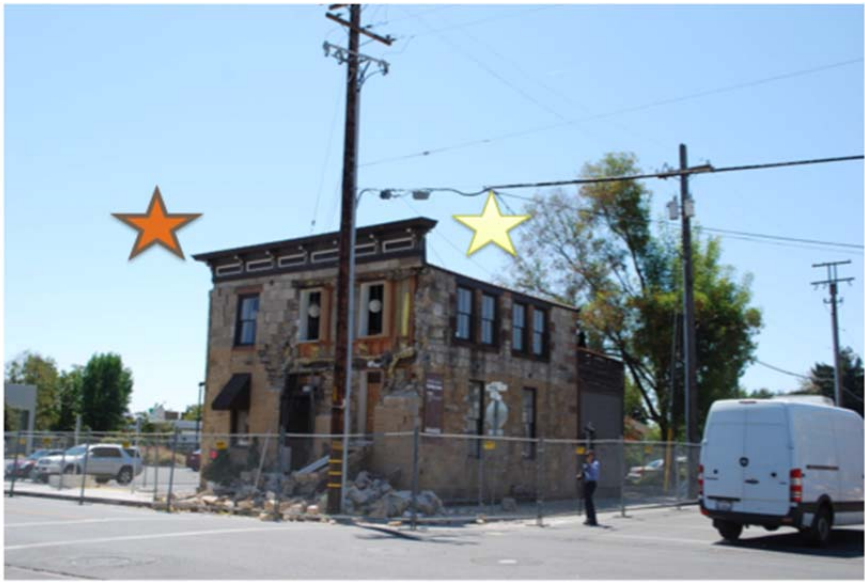
Figure 30 Evaluated Structure No. 10.

No.	Address	Building Name	Photo Comments
10	1245 Main St.	Vintner's Collection	Significant exterior damage, with stone blocks falling from wall and falling hazard from adjacent stones.

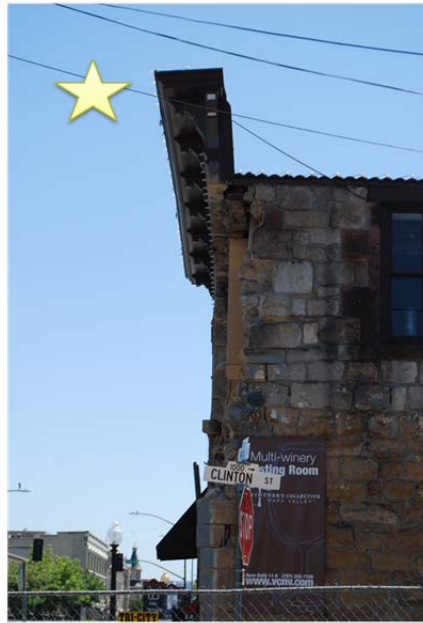
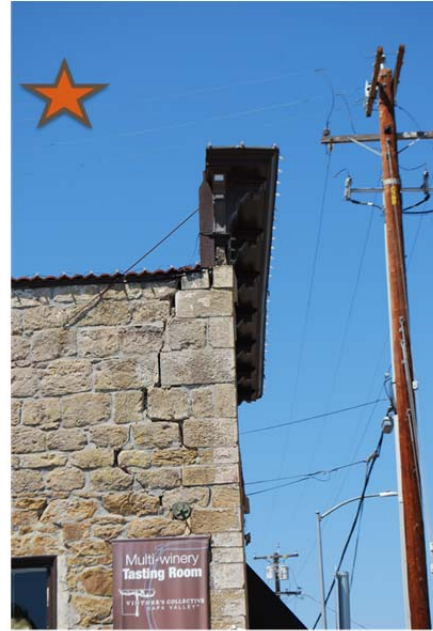
Figure 31 Evaluated Structure No. 10.

No.	Address	Building Name	Photo Comments
10	1245 Main St.	Vintner's Collection	In-plane shear cracking visible.

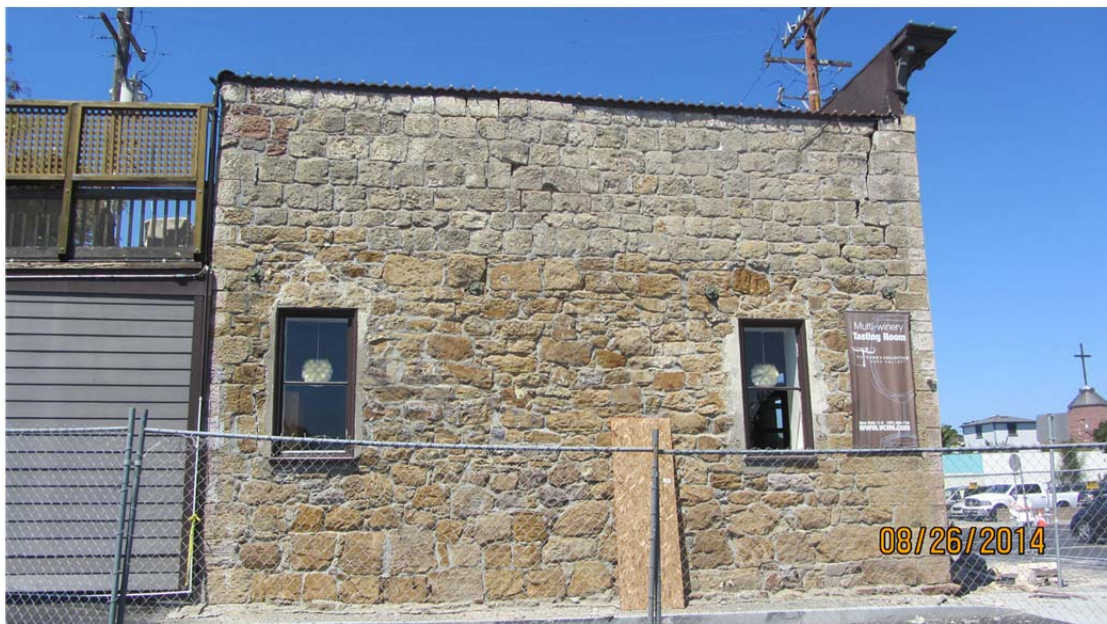
Figure 32 Evaluated Structure No. 10.

No.	Address	Building Name	Photo Comments
10	1245 Main St.	Vintner's Collection	In-plane shear cracking visible.

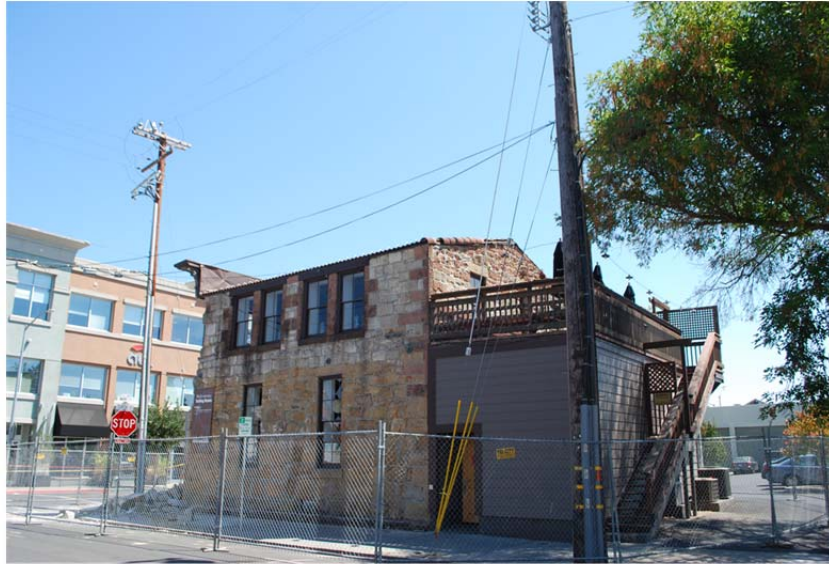
Figure 33 Evaluated Structure No. 10.

No.	Address	Building Name	Photo Comments
10	1245 Main St.	Vintner's Collection	Significant exterior damage, with stone blocks falling from wall and falling hazard from adjacent stones.

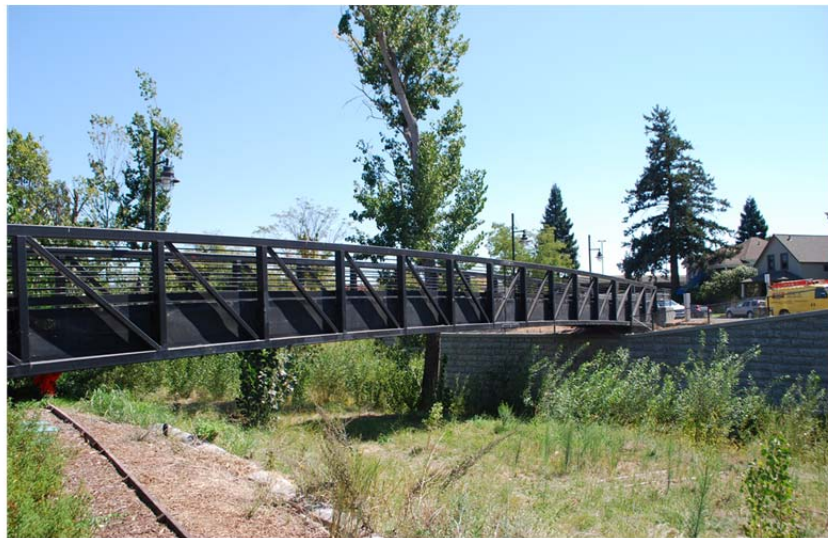
Figure 34 Evaluated Structure No. 11.

No.	Address	Building Name	Photo Comments
11	Clinton St. and Coombs St. over Napa Creek	Pedestrian Bridge	Bridge structural elements sustained no apparent damage. In the bearings, bolts had yielded and had residual deformations.

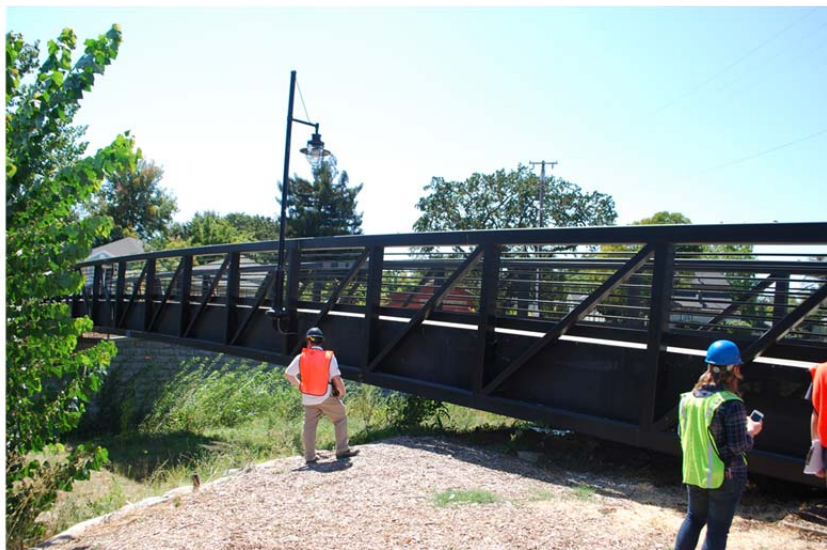
Figure 35 Evaluated Structure No. 11.

No.	Address	Building Name	Photo Comments
11	Clinton St. and Coombs St. over Napa Creek	Pedestrian Bridge	Bridge structural elements sustained no apparent damage.

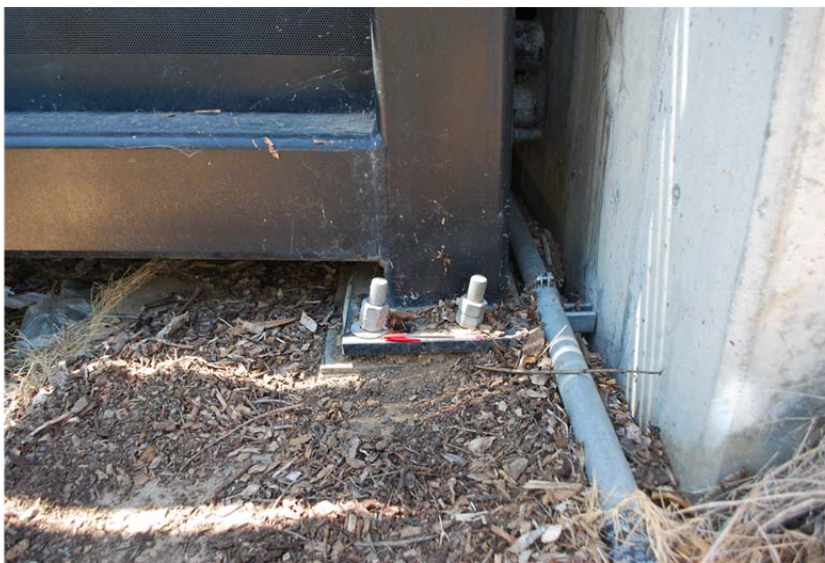
Figure 36 Evaluated Structure No. 11.

No.	Address	Building Name	Photo Comments
11	Clinton St. and Coombs St. over Napa Creek	Pedestrian Bridge	In the bearings, bolts had yielded and had residual deformations.

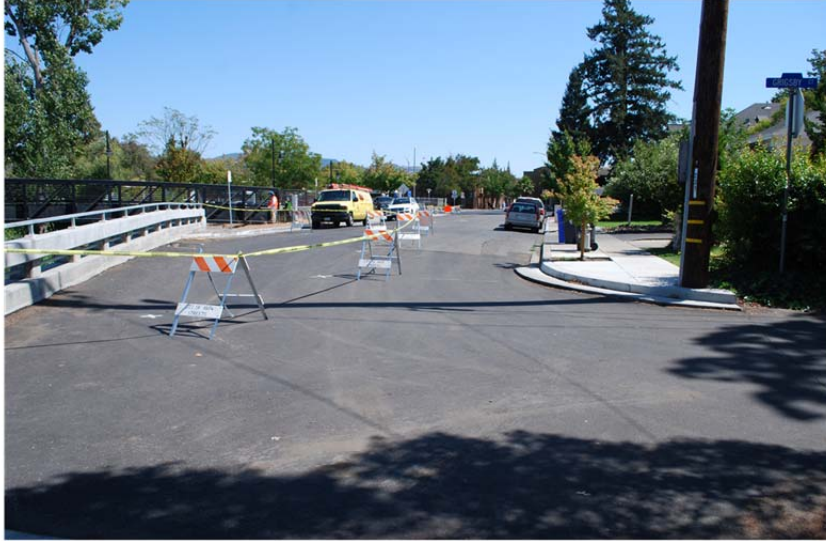
Figure 37 Evaluated Structure No. 12.

No.	Address	Building Name	Photo Comments
12	Coombs St. Retaining Wall (Napa Creek)	Retaining wall	Deformation of backfill visible. Settlement of adjacent roadway. No notable rotations of the wall were observed.

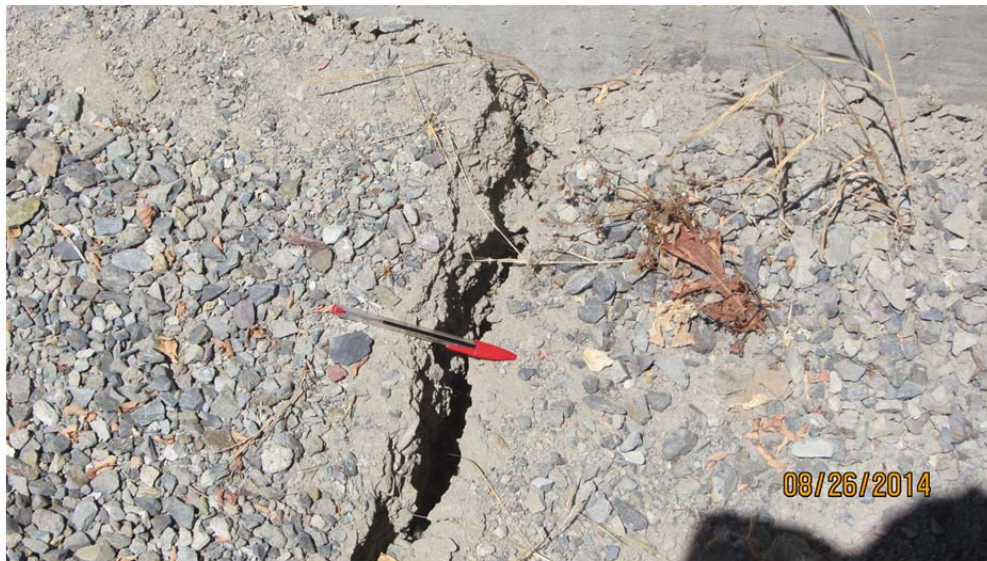
Figure 38 Evaluated Structure No. 12.

No.	Address	Building Name	Photo Comments
12	Coombs St. Retaining Wall (Napa Creek)	Retaining wall	Deformation of backfill notable.

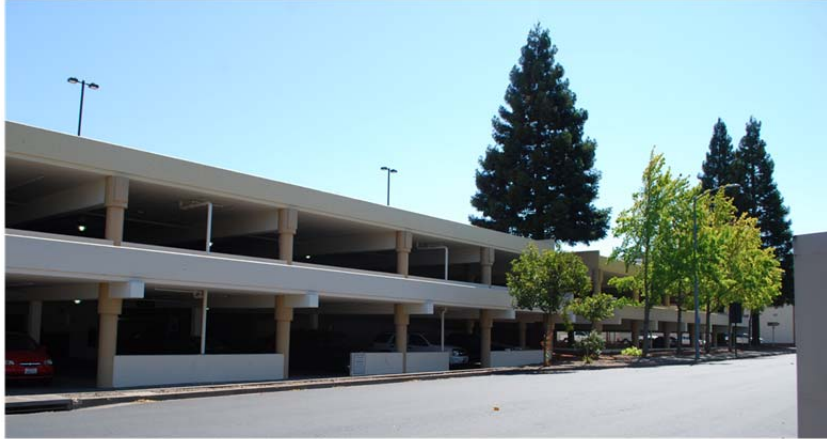
Figure 39 Evaluated Structure No. 13.

No.	Address	Building Name	Photo Comments
13	Pearl St. Garage	Parking garage	Overall structure did not show signs of distress. However, flexural/shear cracks were visible in short columns. Minor cracks had been painted over, larger cracks seemed to be recent and a cause of the earthquake ground motion. Pending confirmation.

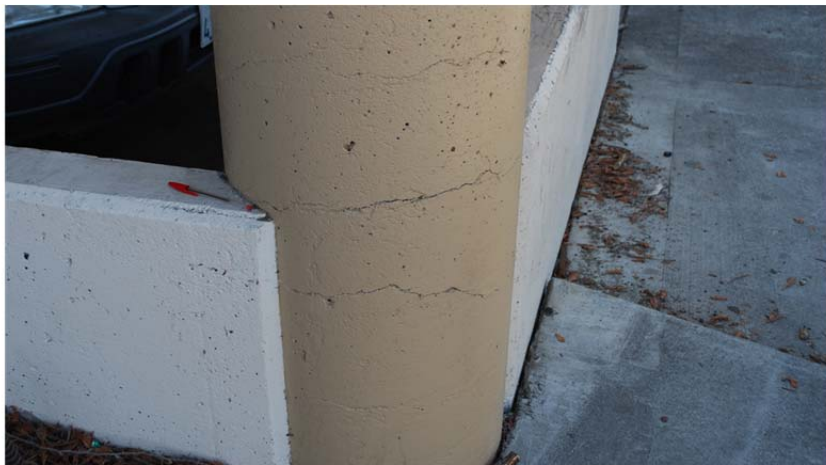
Figure 40 Evaluated Structure No. 13.

No.	Address	Building Name	Photo Comments
13	Pearl St. Garage	Parking garage	Flexural cracks were visible in short columns. Minor cracks were painted over indicating that these were not due to the earthquake. However, larger cracks seemed to be recent and maybe due to earthquake motion. Pending confirmation.

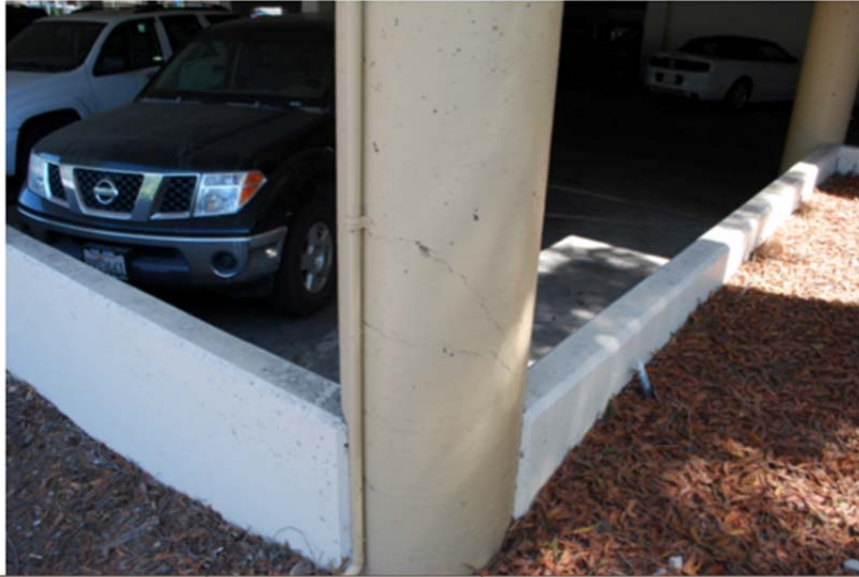
Figure 41 Evaluated Structure No. 13.

No.	Address	Building Name	Photo Comments
13	Pearl St. Garage	Parking garage	Shear cracks were visible in this short column. Large cracks seemed to be recent and caused by ground motion. Pending confirmation.

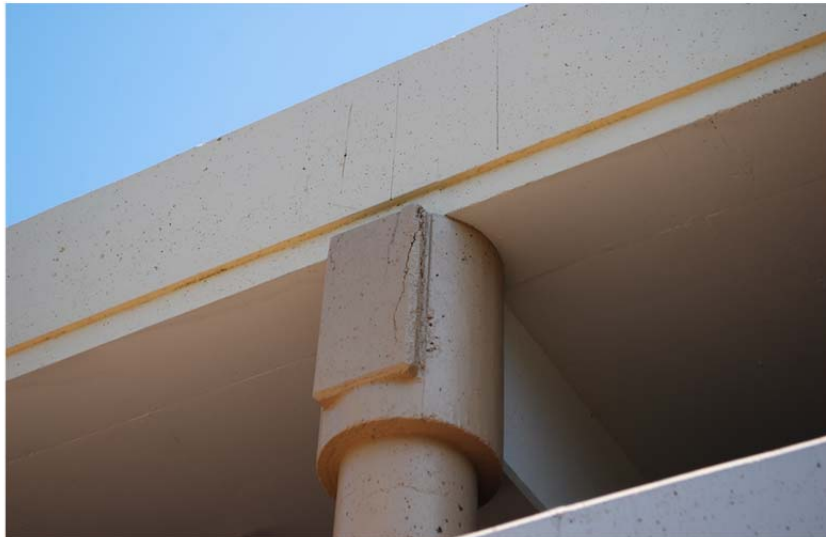
Figure 42 Evaluated Structure No. 13.

No.	Address	Building Name	Photo Comments
13	Pearl St. Garage	Parking garage	Visible cracks in beam end. It is unlikely that the damage is due to the earthquakes. However, this is pending confirmation.

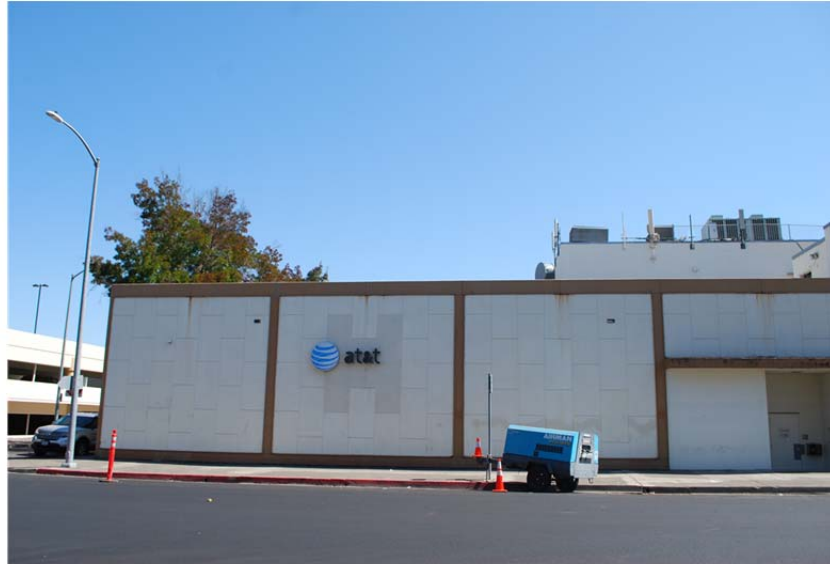
Figure 43 Evaluated Structure No. 14.

No.	Address	Building Name	Photo Comments
14	1300 Clay St.	AT&T Building	RC concrete building. Non-structural pre-fabricated concrete wall panel sheared off from supporting angles.

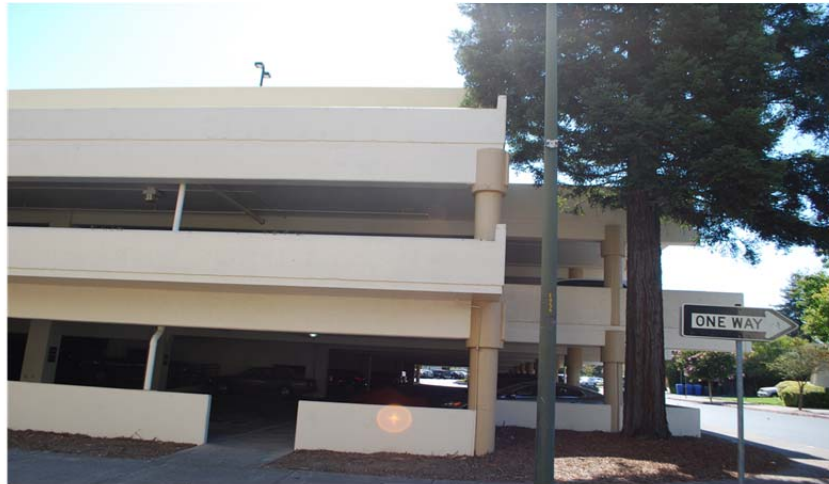
Figure 46 Evaluated Structure No. 15.

No.	Address	Building Name	Photo Comments
15	Clay St. Garage	Parking garage	Overall structure did not show signs of distress. However, flexural/shear cracks were visible in short columns. Minor cracks had been painted over, larger cracks seemed to be recent and a cause of the earthquake ground motion. Pending confirmation.

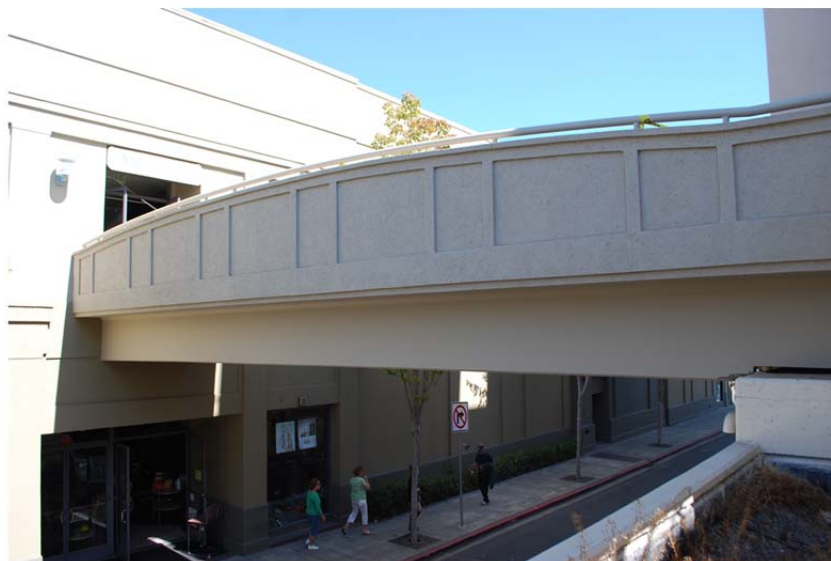
Figure 47 Evaluated Structure No. 16.

No.	Address	Building Name	Photo Comments
16	Clay St.	Skyway over Franklin St.	Pounding between skyway and parking garage. Damage on precast double-t girder.

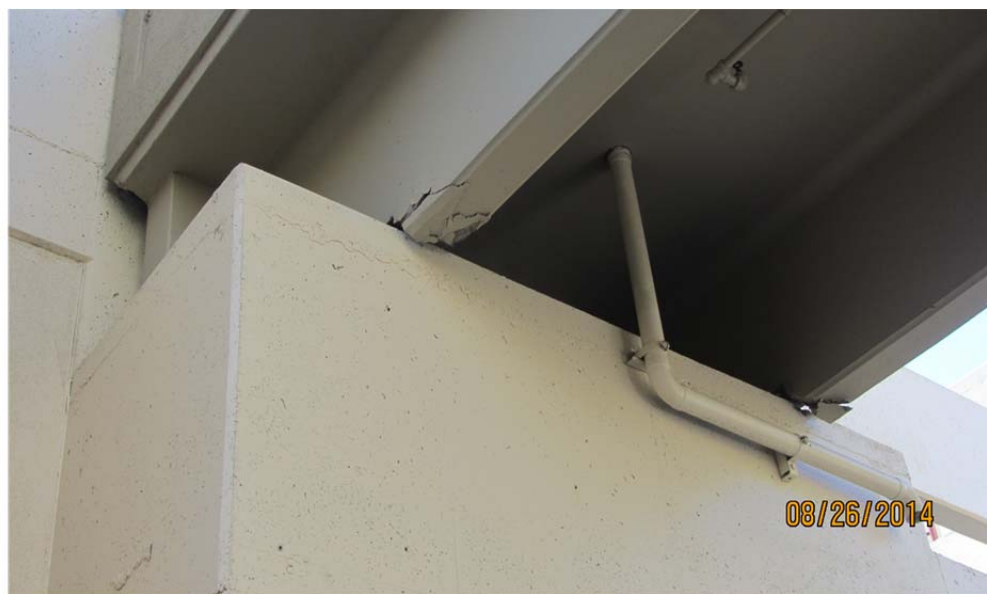
Figure 48 Evaluated Structure No. 16.

No.	Address	Building Name	Photo Comments
16	Clay St.	Skyway over Franklin St.	Damage on precast double-t girder.

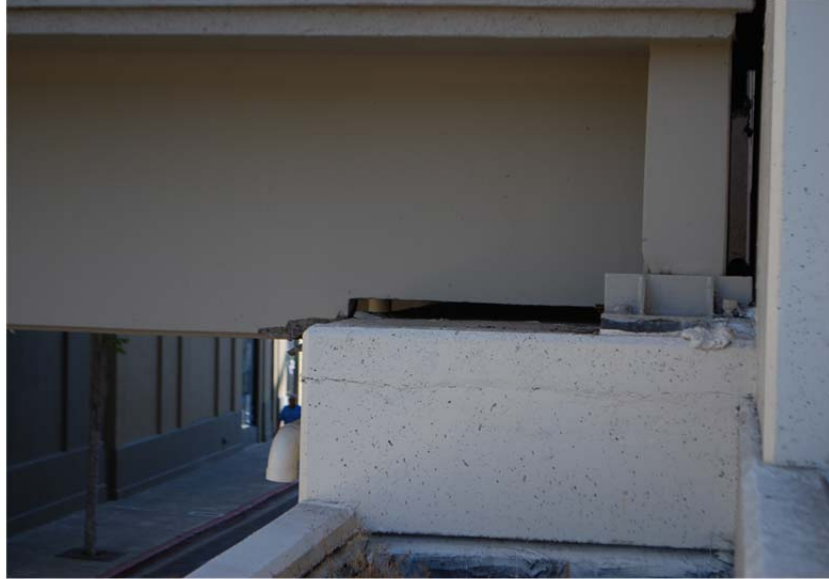
Figure 49 Evaluated Structure No. 16.

No.	Address	Building Name	Photo Comments
16	Clay St.	Skyway over Franklin St.	Damage on precast double-t girder.
