PEER Preliminary Notes and Observations on the August 24, 2014, South Napa Earthquake

2014 South Napa Field Notes
Oregon State University Team

Report No. 2014/13

A 2014 South Napa Field Notes—Oregon State University Team⁺

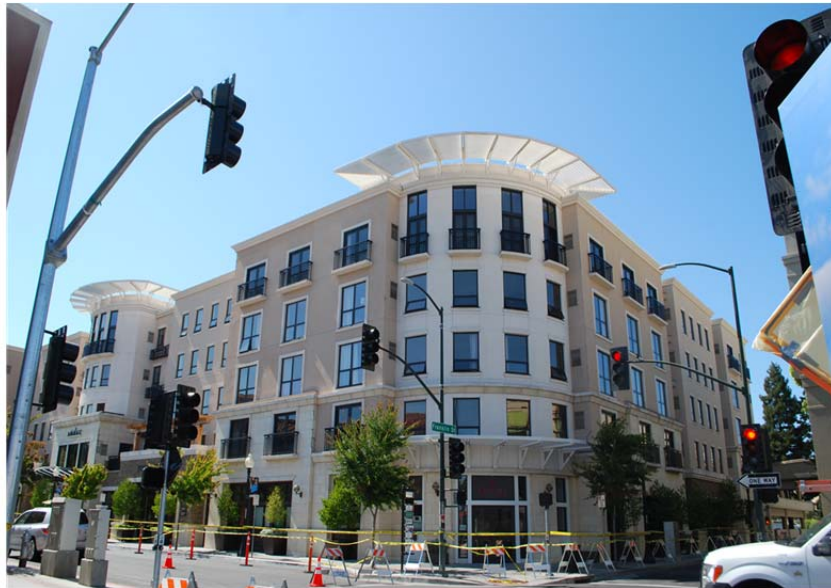
Figure 50 Evaluated Structure No. 17.

No.	Address	Building Name	Photo Comments
17	1450 1st St.	Andaz Napa Hotel	Cracking of exterior wall cladding and falling hazard from ornamental fixtures.

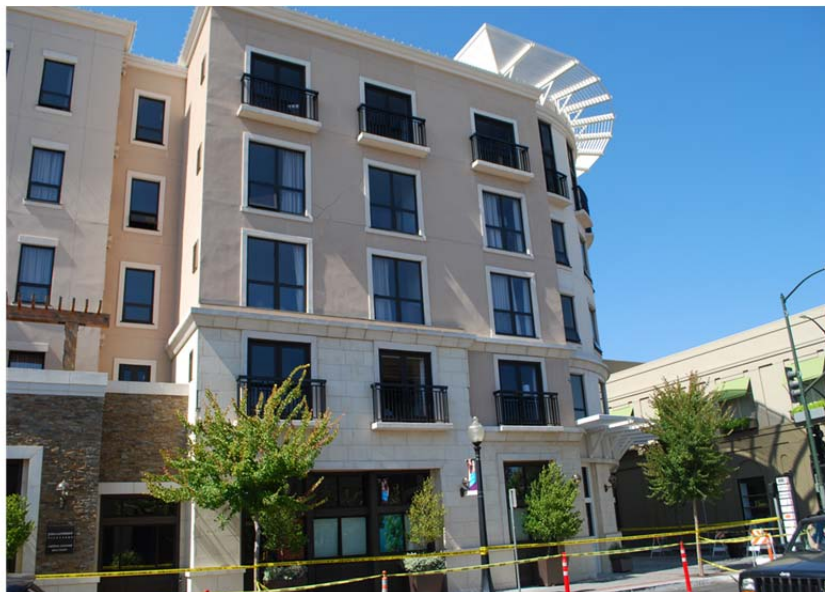
Figure 51 Evaluated Structure No. 17.

No.	Address	Building Name	Photo Comments
17	1450 1st St.	Andaz Napa Hotel	Cracking of exterior wall cladding and falling hazard from ornamental fixtures.

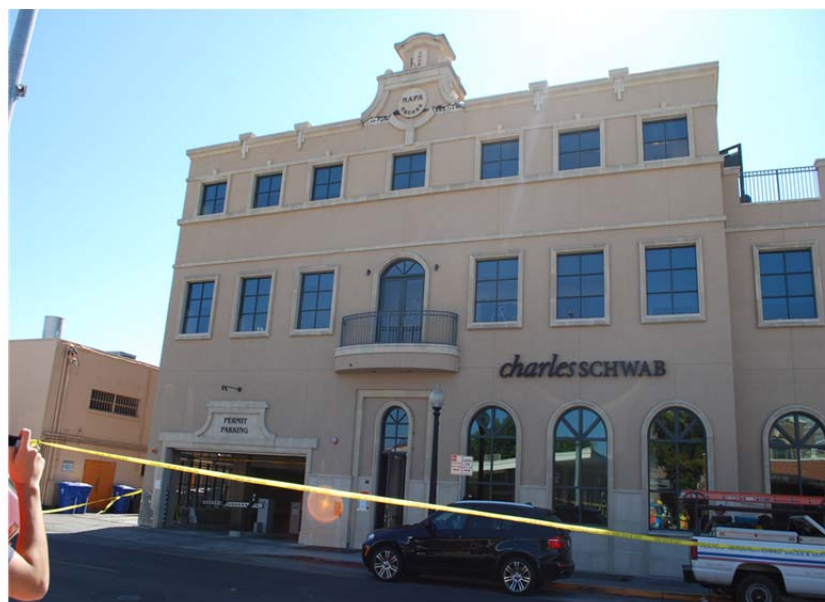
Figure 52 Evaluated Structure No. 18.

No.	Address	Building Name	Photo Comments
18	935 Franklin St.	Charles Schwab Building	Failed wall-to-diaphragm connections. Cornice cracked.

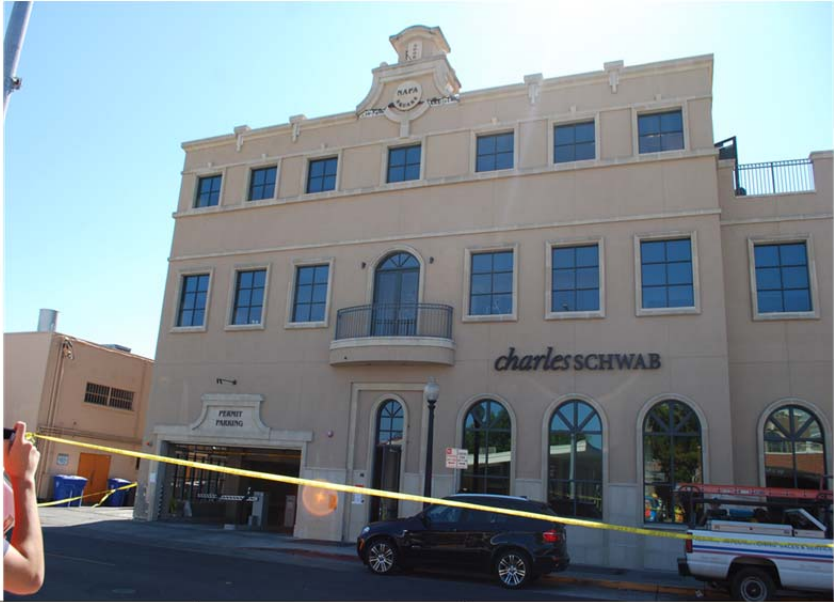
Figure 53 Evaluated Structure No. 18.

No.	Address	Building Name	Photo Comments
18	935 Franklin St.	Charles Schwab Building	Failed wall-to-diaphragm connections. Cornice cracked.

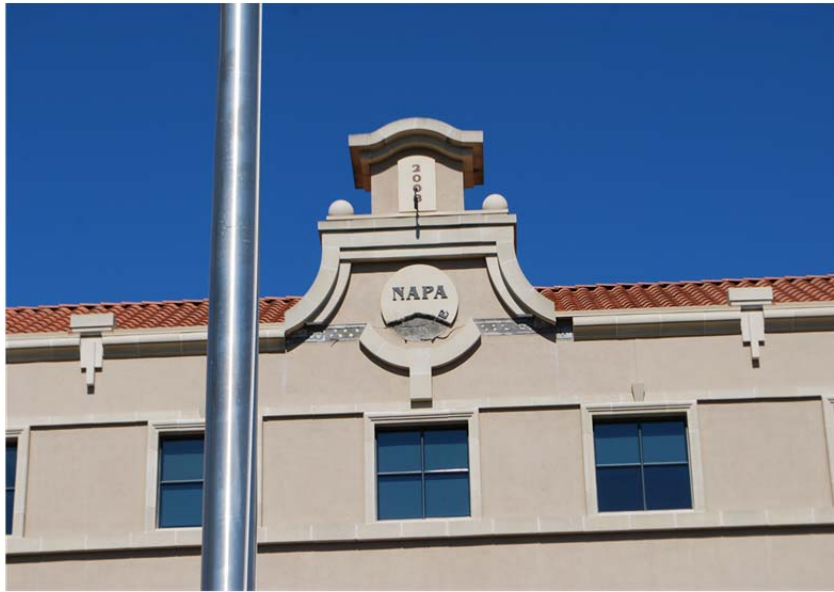
Figure 54 Evaluated Structure No. 18.

No.	Address	Building Name	Photo Comments
18	935 Franklin St.	Charles Schwab Building	Cornice cracked.

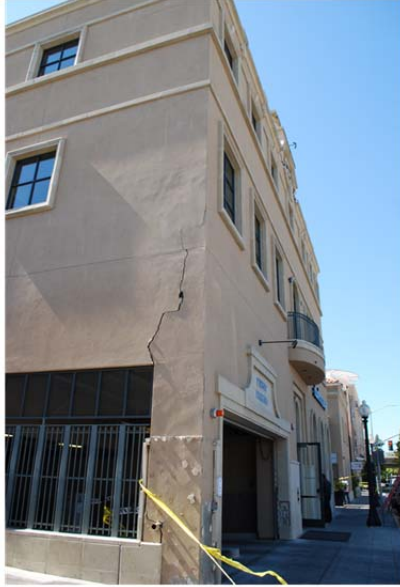
Figure 55 Evaluated Structure No. 18.

No.	Address	Building Name	Photo Comments
18	935 Franklin St.	Charles Schwab Building	Failed wall-to-diaphragm connections.

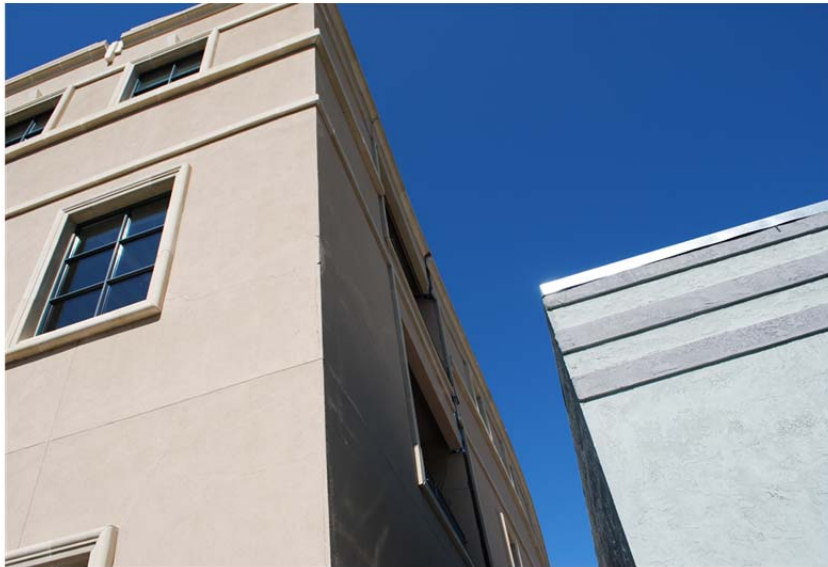
Figure 56 Evaluated Structure No. 18.

No.	Address	Building Name	Photo Comments
18	935 Franklin St.	Charles Schwab Building	Failed wall-to-diaphragm connections.

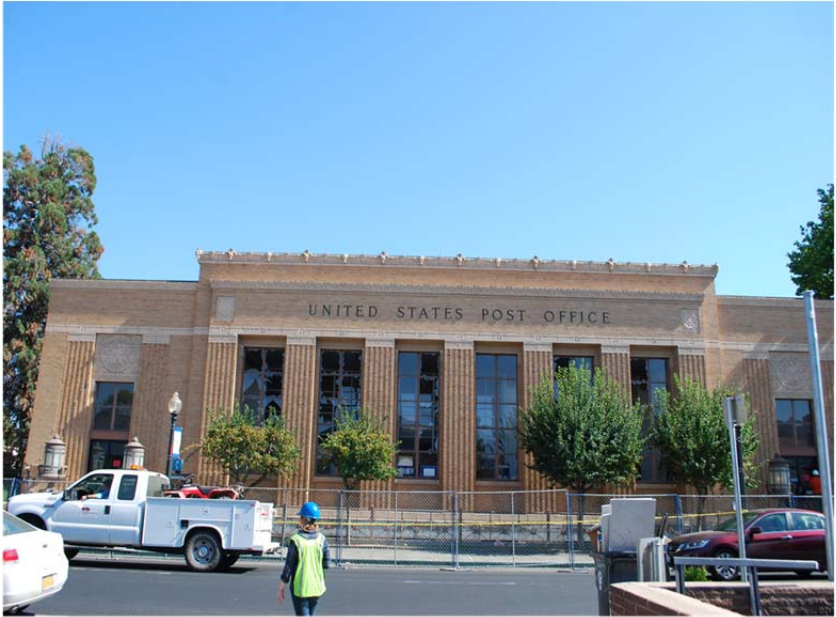
Figure 57 Evaluated Structure No. 19.

No.	Address	Building Name	Photo Comments
19	820 Randolph St.	Post Office	Steel framing with infills.

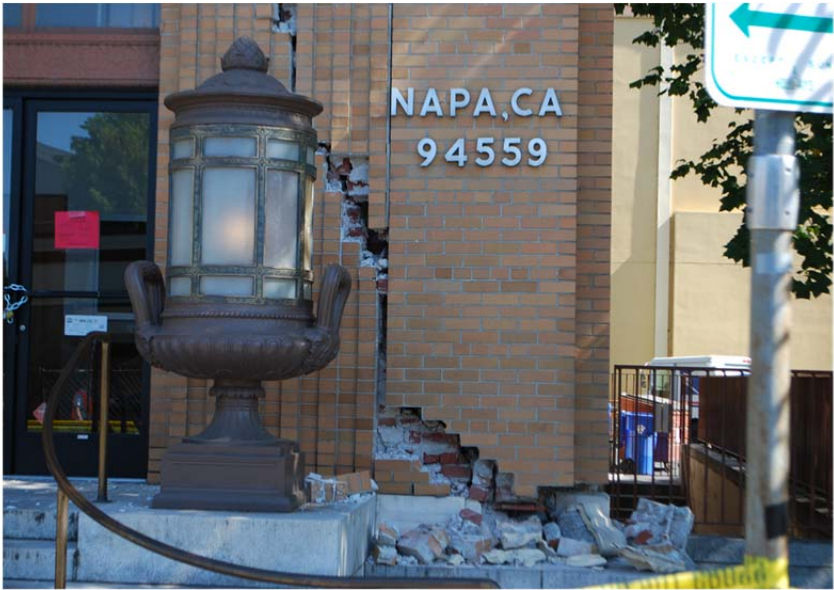
Figure 58 Evaluated Structure No. 19.

No.	Address	Building Name	Photo Comments
19	820 Randolph St.	Post Office	Steel framing with masonry infill. Shear cracking.

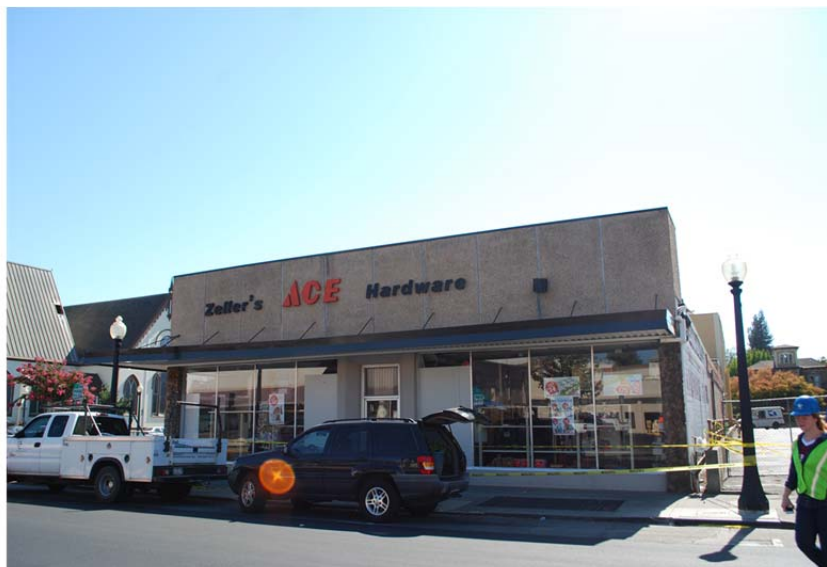
Figure 60 Evaluated Structure No. 20.

No.	Address	Building Name	Photo Comments
20	819 Randolph St.	Ace Hardware	Parapet ties yielded and stepped cracking in masonry walls.

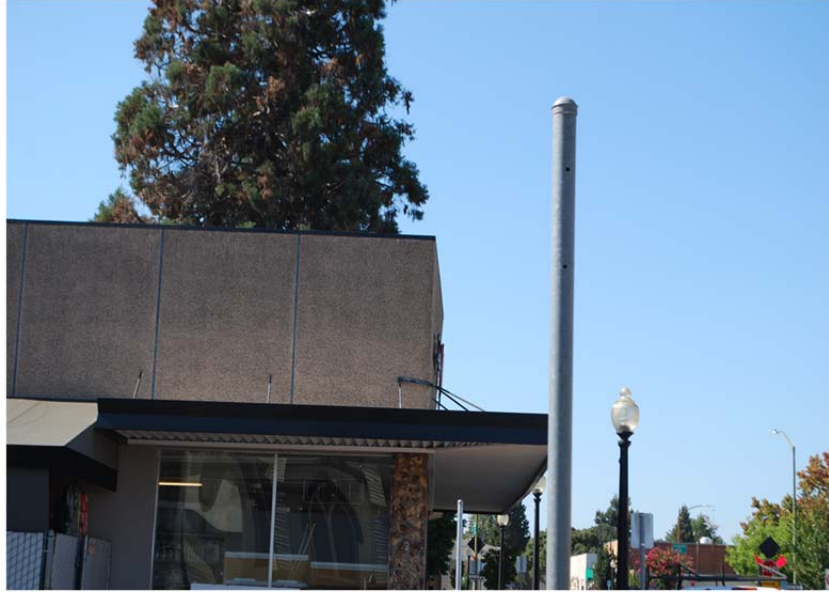
Figure 61 Evaluated Structure No. 20.

No.	Address	Building Name	Photo Comments
20	819 Randolph St.	Ace Hardware	Parapet ties yielded and parapet is bowing out.

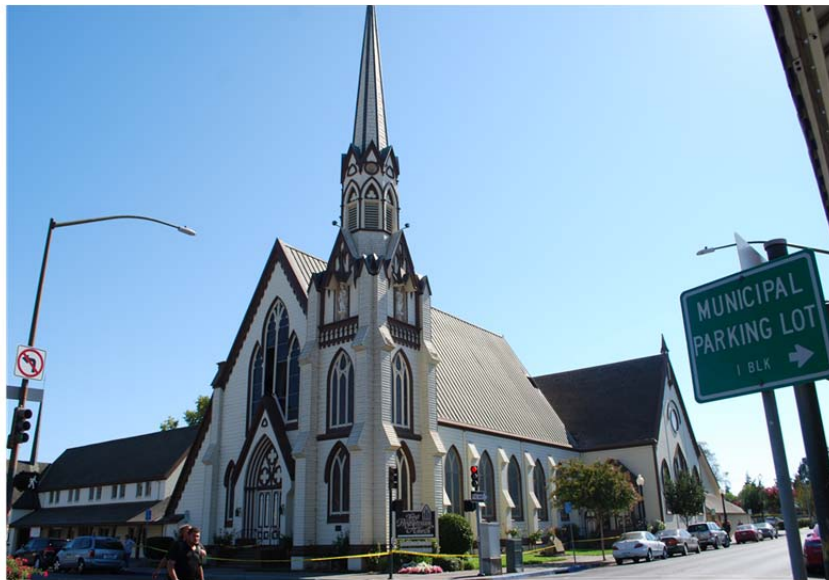
Figure 62 Evaluated Structure No. 21.

No.	Address	Building Name	Photo Comments
21	1333 3 rd St.	First Presbyterian Church	Chimney damage.

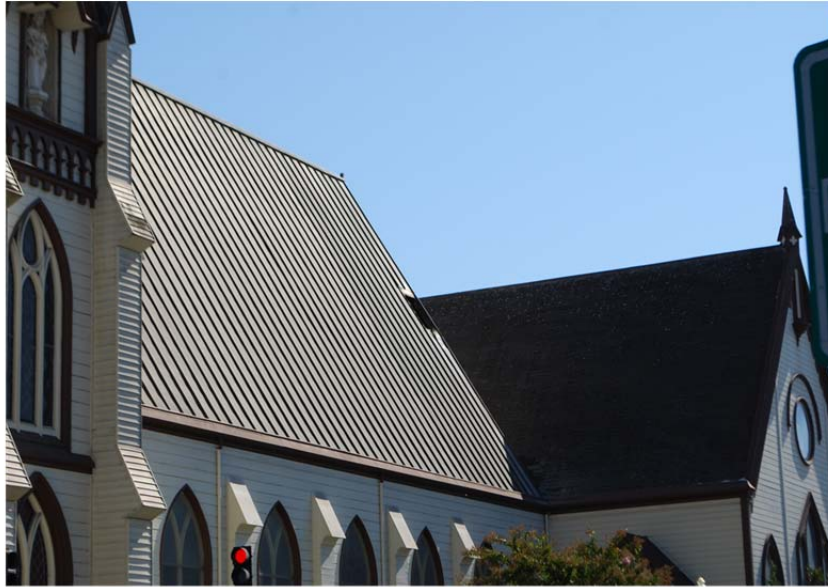
Figure 63 Evaluated Structure No. 21.

No.	Address	Building Name	Photo Comments
21	1333 3 rd St.	First Presbyterian Church	Chimney damage.

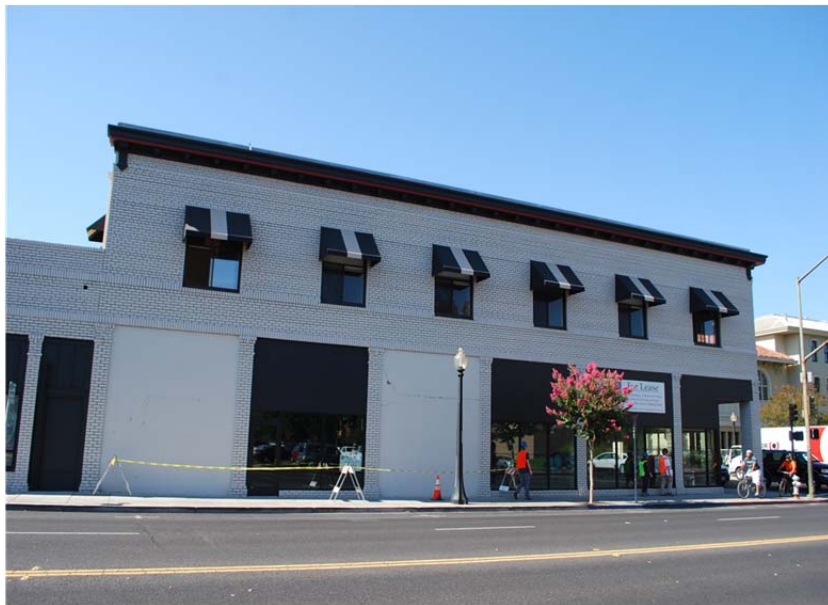
Figure 64 Evaluated Structure No. 22.

No.	Address	Building Name	Photo Comments
22	801 Coombs St.	--	Plaster and glazing damage.

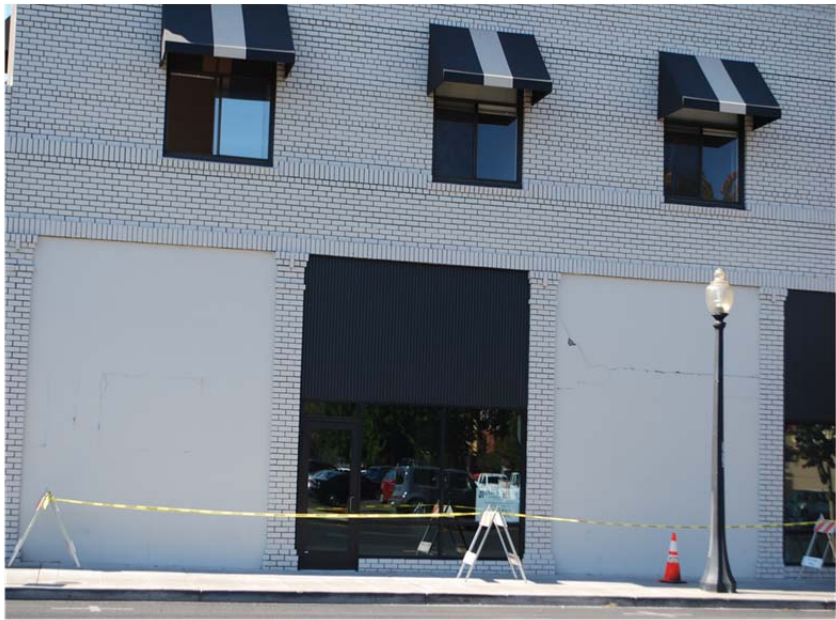
Figure 65 Evaluated Structure No. 22.

No.	Address	Building Name	Photo Comments
22	801 Coombs St.		Plaster and glazing damage.

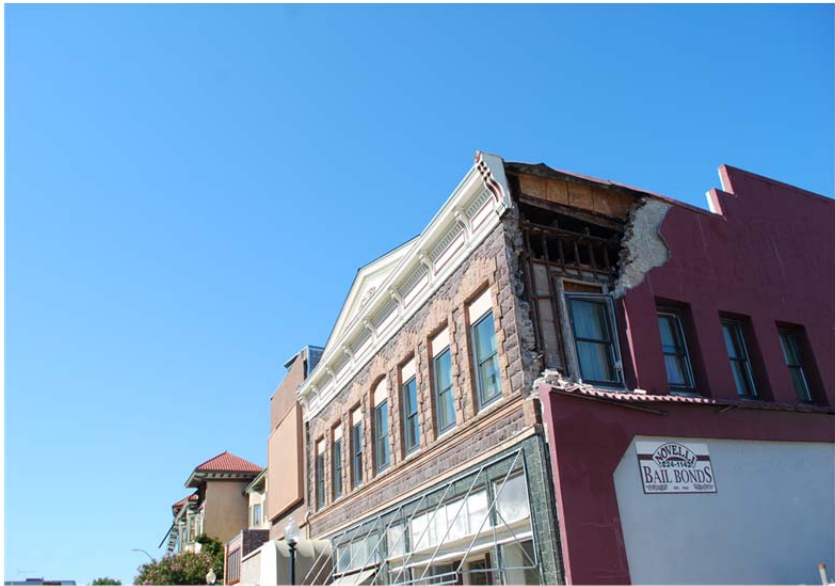
Figure 66 Evaluated Structure No. 23.

No.	Address	Building Name	Photo Comments
23	810-816 Brown St.	--	Unretrofitted URM building. Out-of-plane failure.

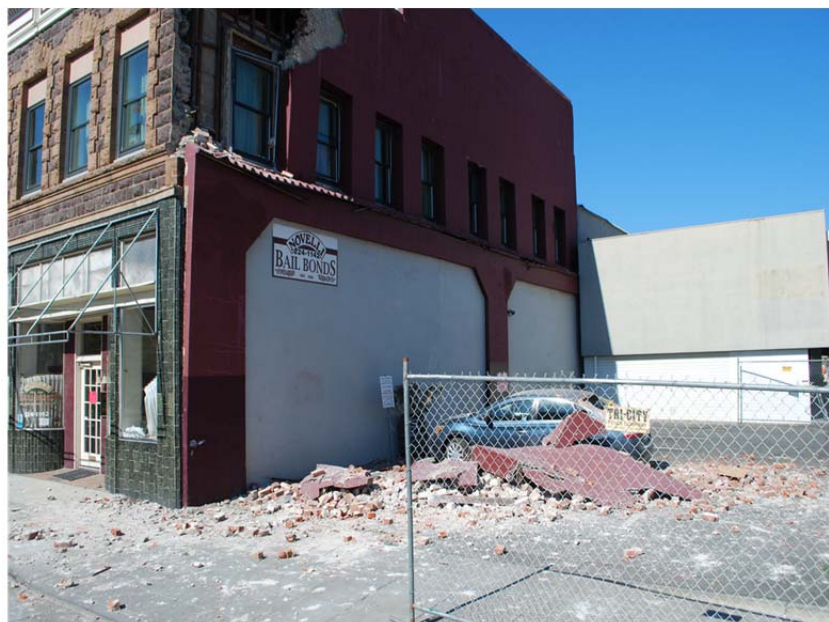
Figure 67 Evaluated Structure No. 23.

No.	Address	Building Name	Photo Comments
23	810-816 Brown St.	--	Out-of-plane failure.

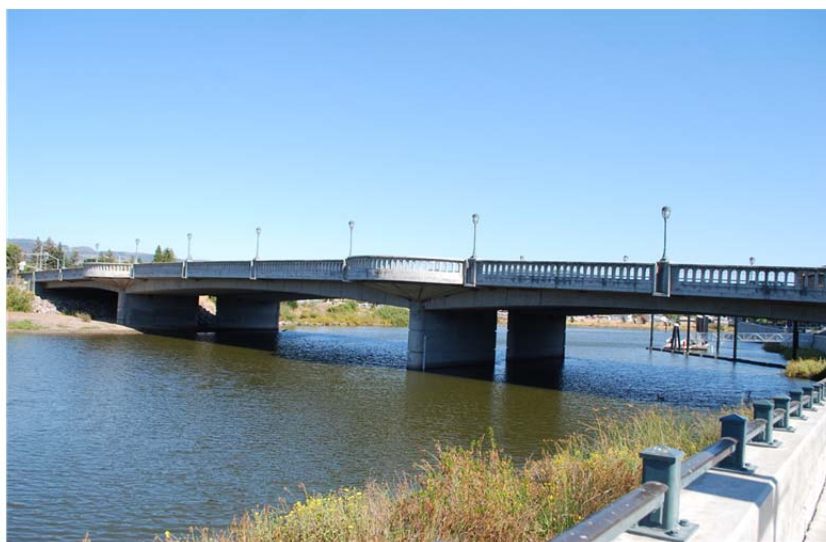
Figure 68 Evaluated Structure No. 24.

No.	Address	Building Name	Photo Comments
24	3 rd St. Bridge	--	Increased gap between abutment and bridge. No signs of pounding. Retaining wall under bridge with 1/2 to 1 inch (?) permanent gap. Confirmation needed.

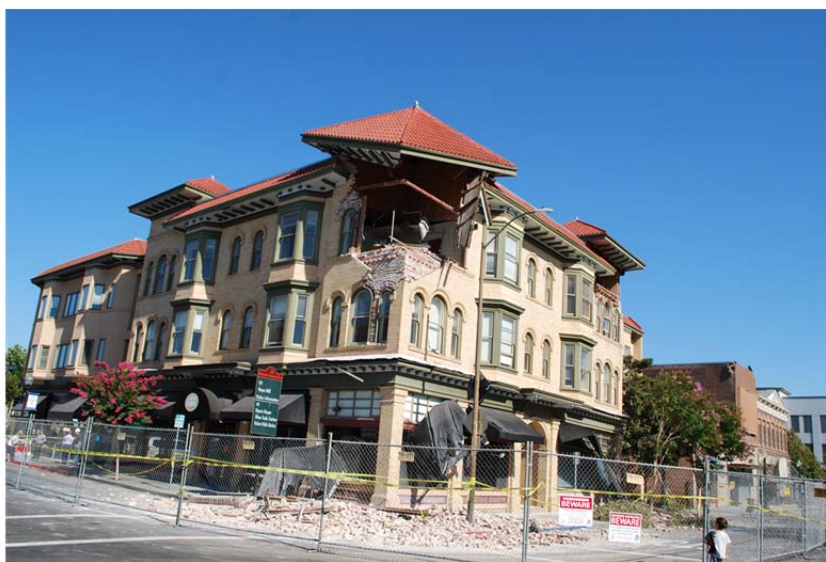
Figure 72 Evaluated Structure No. 26.

No.	Address	Building Name	Photo Comments
26	840 Brown St.	Alexandria Building	Significant damage to signature URM retrofitted building. Smooth, straight dowels are visible.

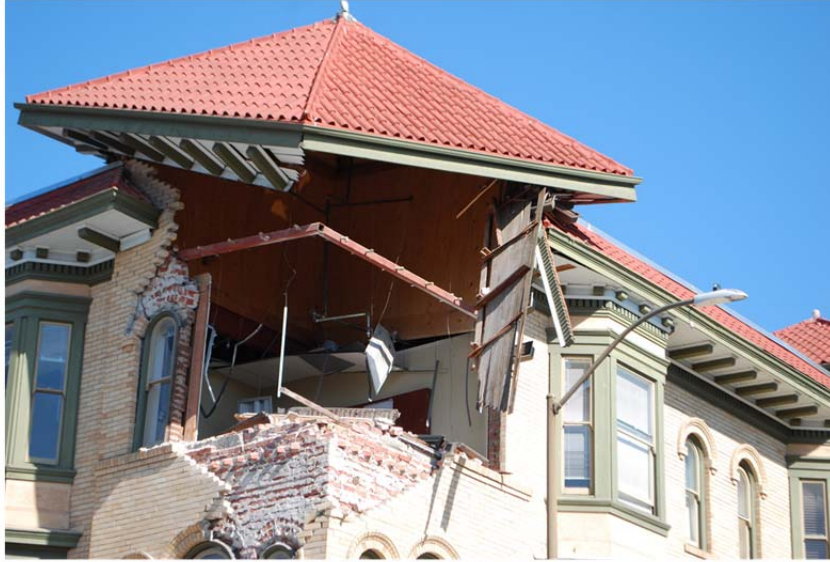
Figure 73 Evaluated Structure No. 26.

No.	Address	Building Name	Photo Comments
26	840 Brown St.	Alexandria Building	Smooth, straight dowels are visible. Two-wythe wall with brick veneer on the outside.

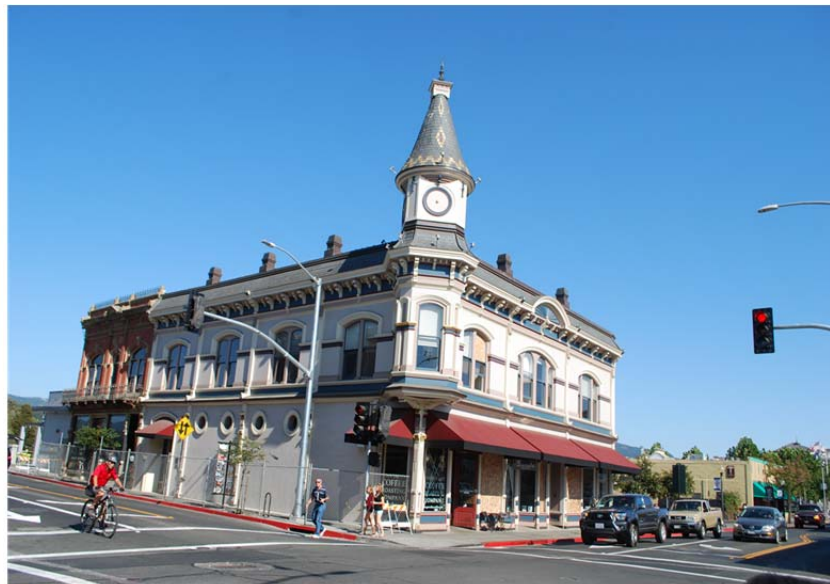
Figure 74 Evaluated Structure No. 27.

No.	Address	Building Name	Photo Comments
27	942 Main St.	--	Storefront glazing damage and cornice damage.

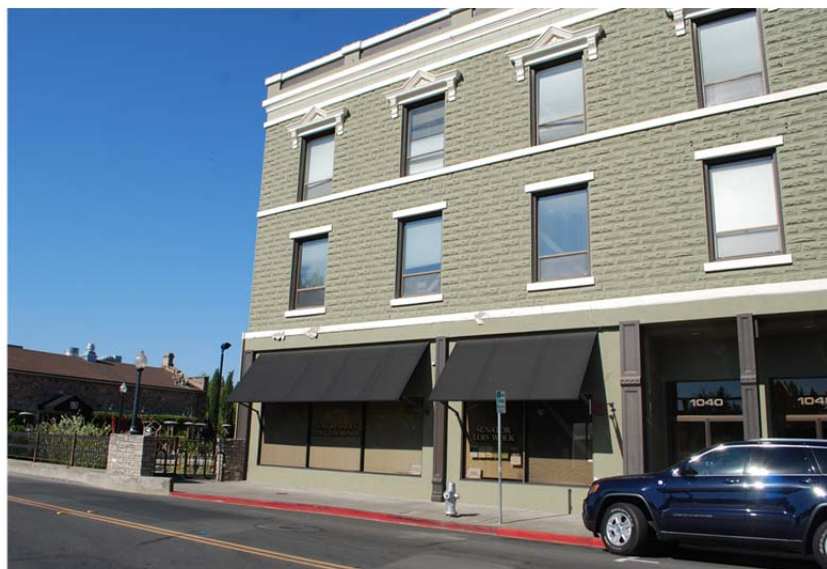
Figure 75 Evaluated Structure No. 28.

No.	Address	Building Name	Photo Comments
28	1040 Main St.	--	Retrofitted URM building with interior braced frames.

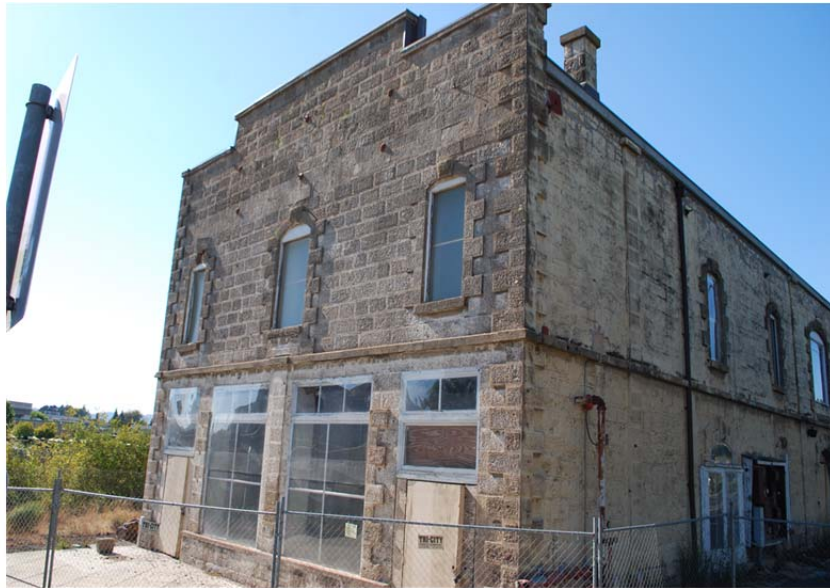
Figure 78 Evaluated Structure No. 29.

No.	Address	Building Name	Photo Comments
29	963 3 rd St.	--	Stone masonry URM building. Stone had fallen off. No other visible damage.

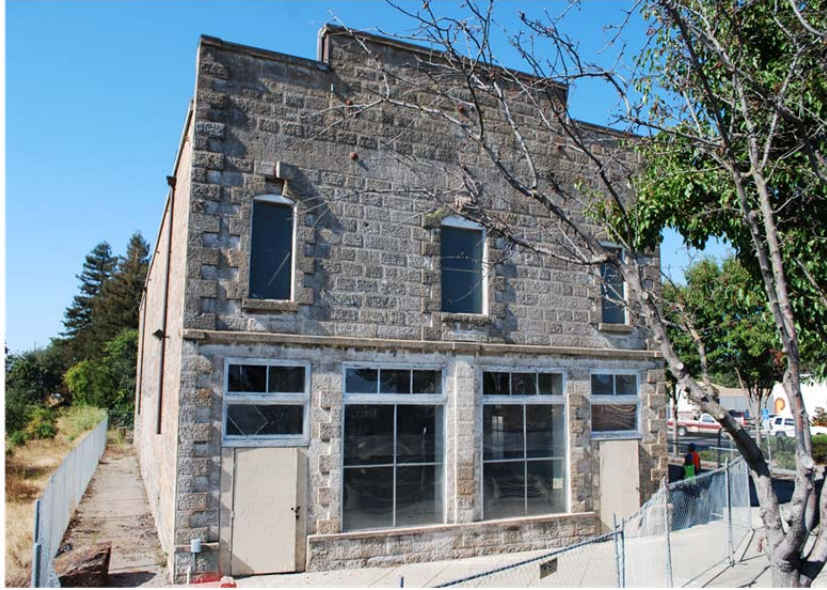
Figure 79 Evaluated Structure No. 29.

No.	Address	Building Name	Photo Comments
29	963 3 rd St.	--	Stone masonry URM building. Stone had fallen off. No other visible damage.

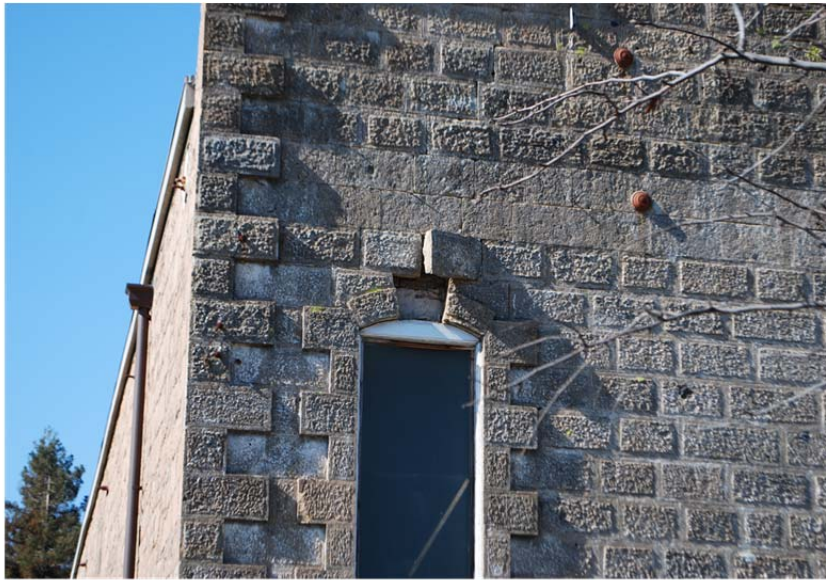
Figure 80 Evaluated Structure No. 29.

No.	Address	Building Name	Photo Comments
29	963 3 rd St.	--	Stone masonry URM building. Stone had fallen off. No other visible damage.

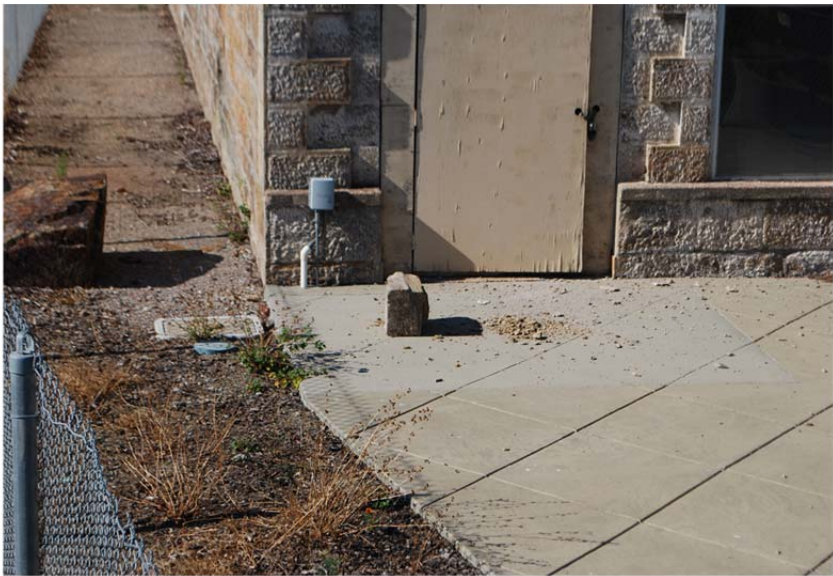
Figure 81 Evaluated Structure No. 29.

No.	Address	Building Name	Photo Comments
29	963 3 rd St.	--	Stone masonry URM building. Stone had fallen off. No other visible damage.
