Damage of Transportation Facility due to 2010 Chile Earthquake

April 5, 2010

Kawashima, K., Unjoh, S.,
Hoshikuma, J. and Kosa, K.

Bridge Team Dispatched by
Japan Society of Civil Engineers

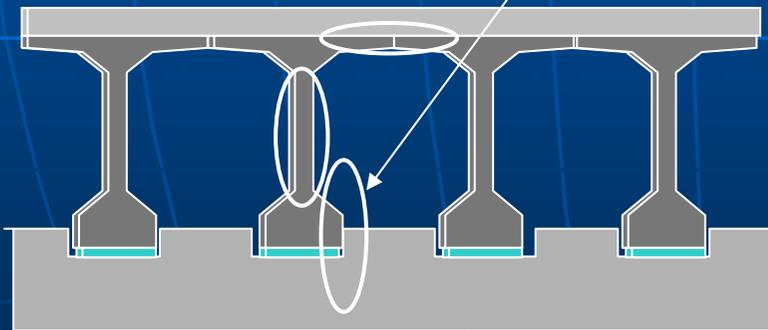
Contact of a PC girder to stopper results in failure of lower flange, shear failure of web plate, rupture of deck slabs and connection between deck slab and upper flange

Seismic force in the TR direction

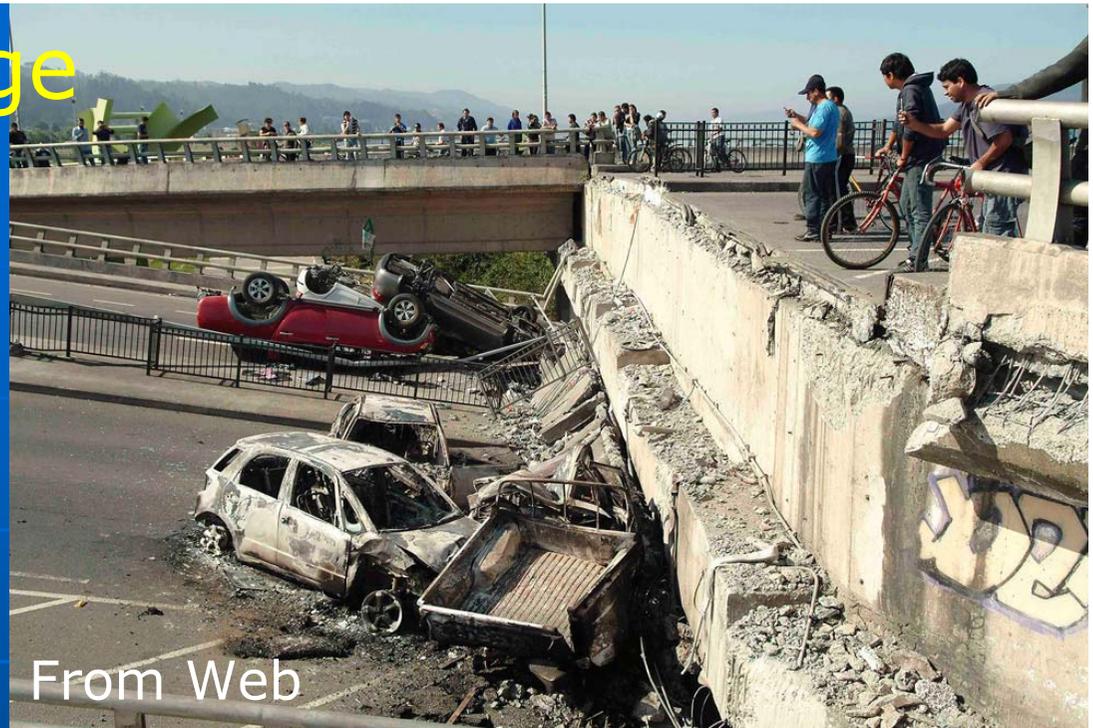
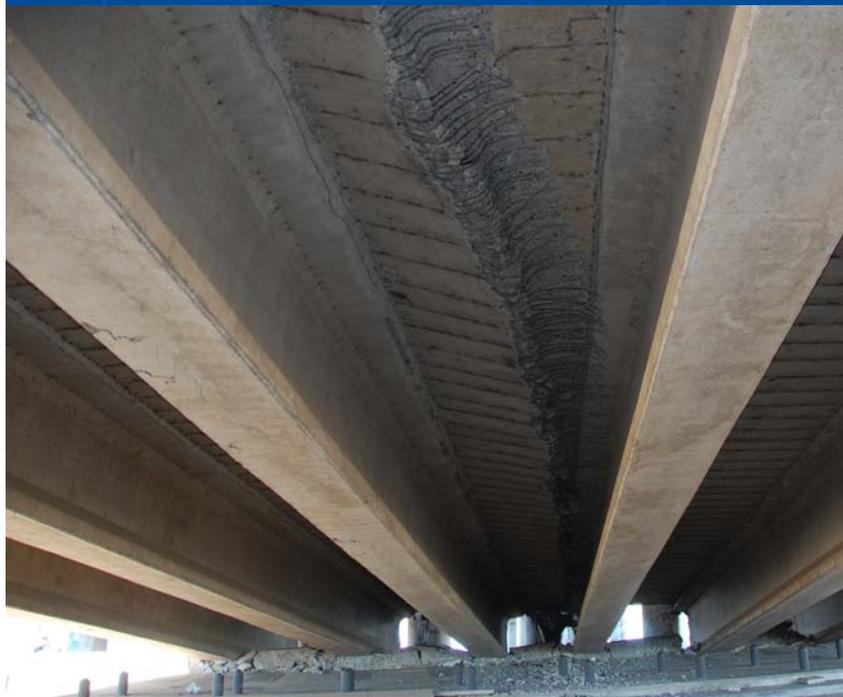
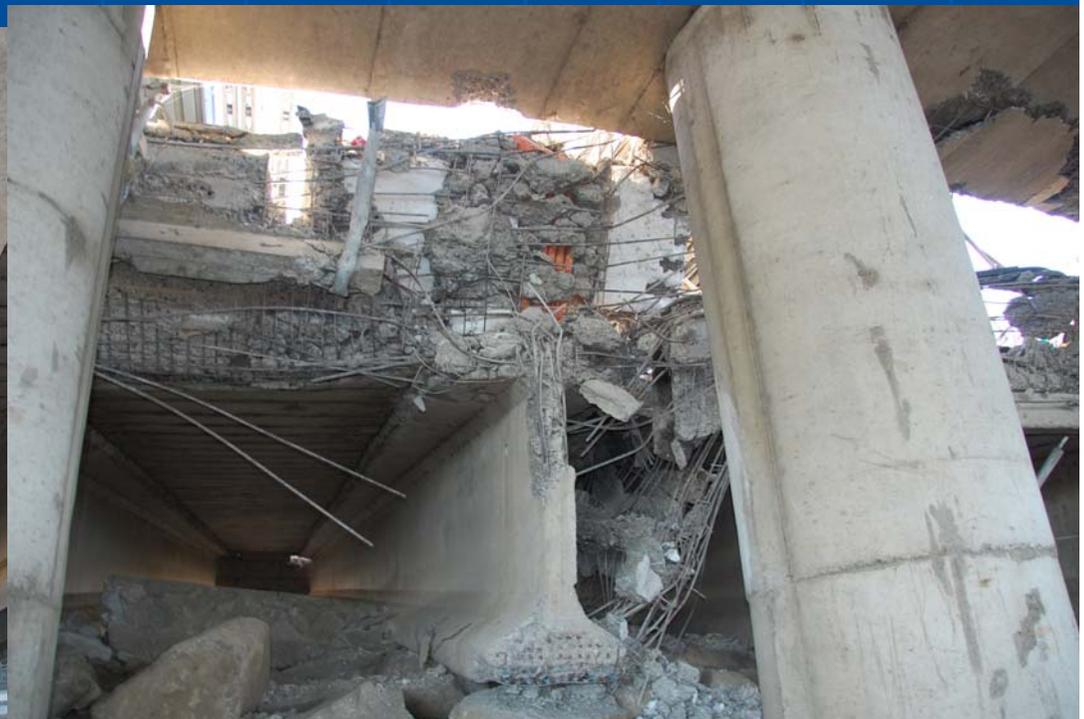
Llacolén Bridge
Conception

Example of damage
due to lack of
diaphragms

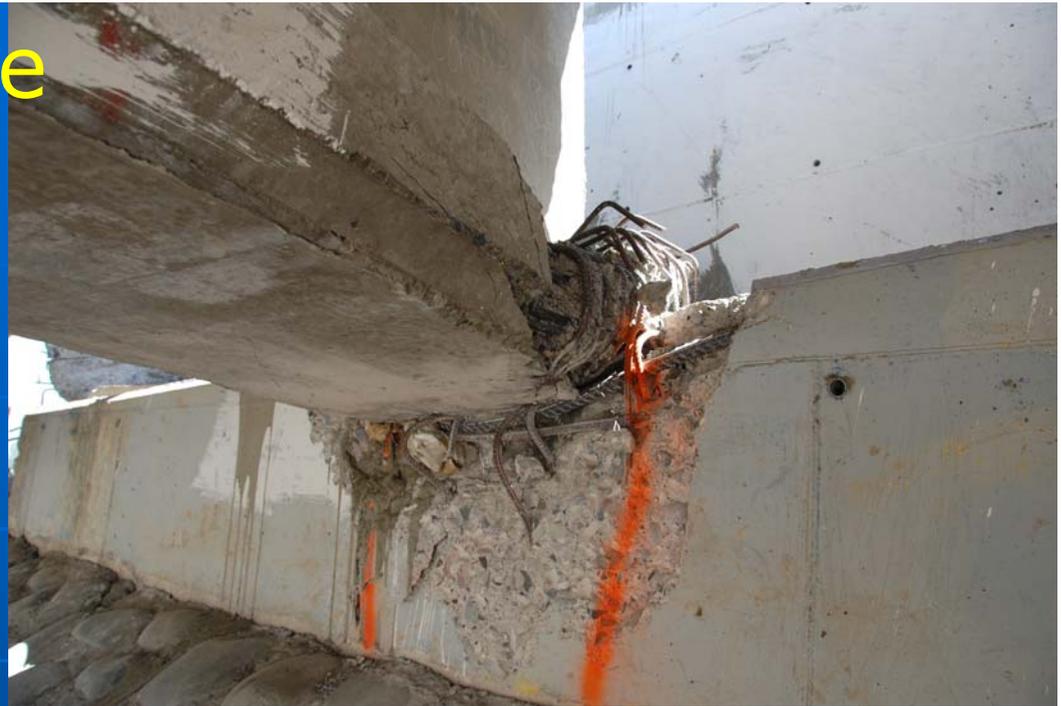
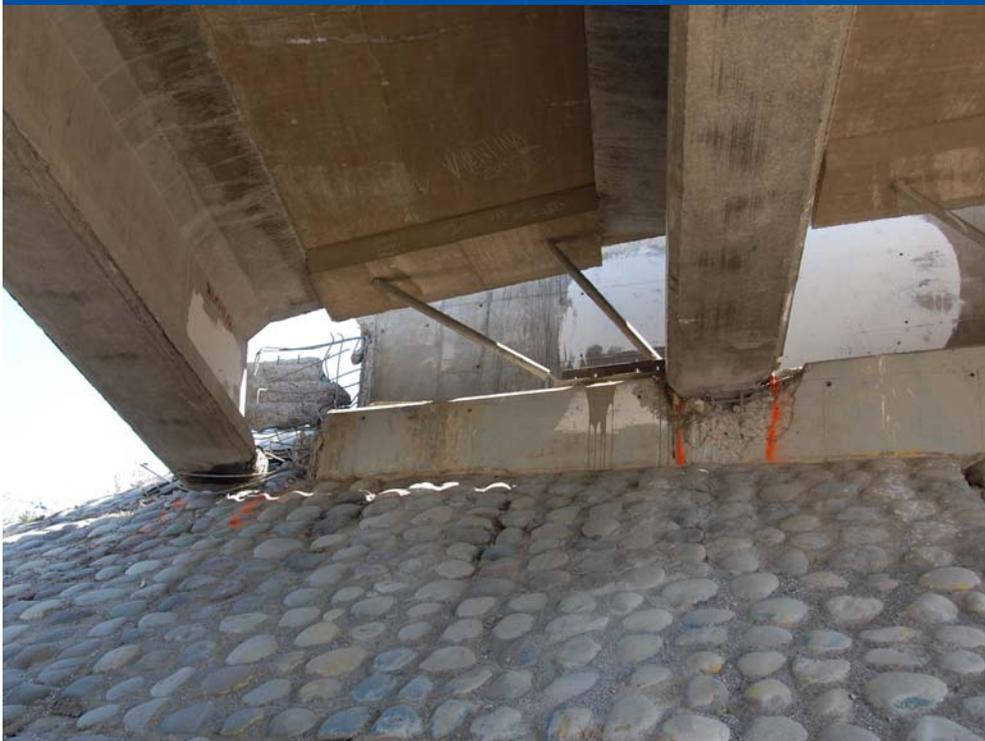
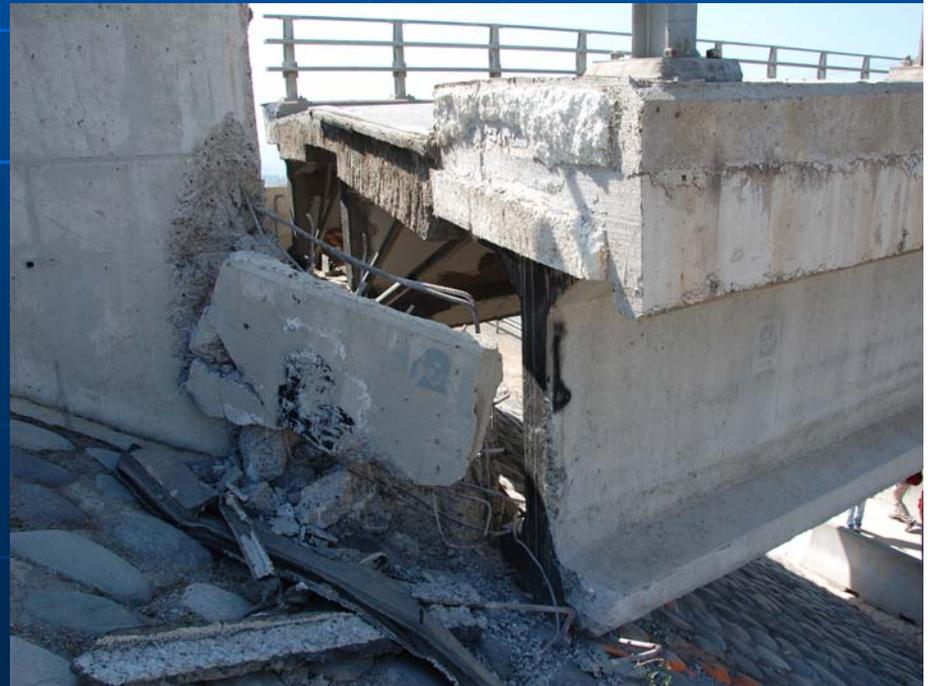
Las Mercedes Bridge
Route 5

Example of damage
due to lack of side
stoppers and
diaphragms

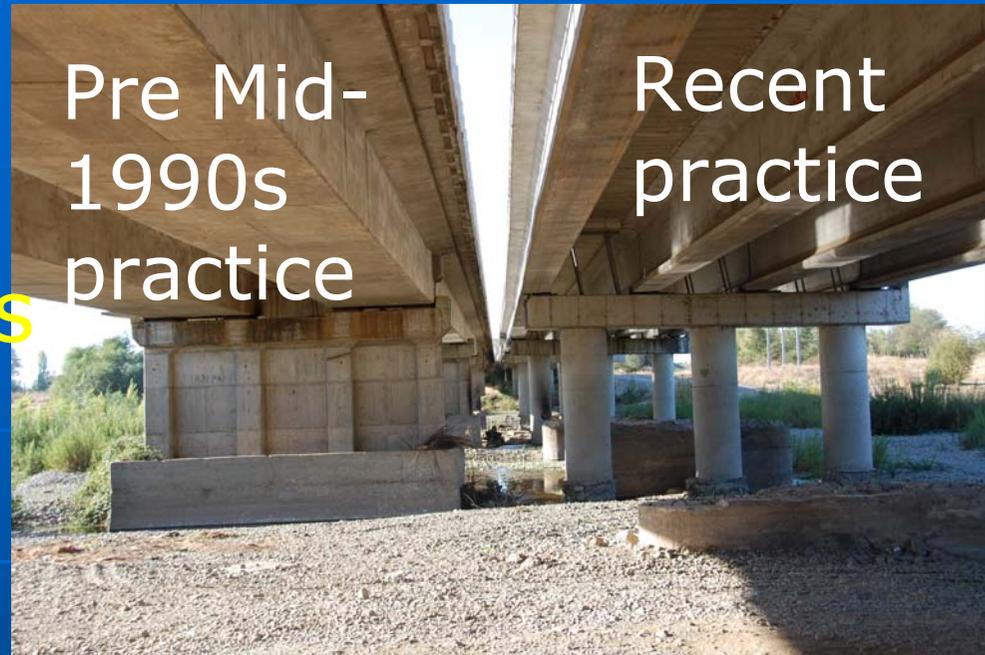
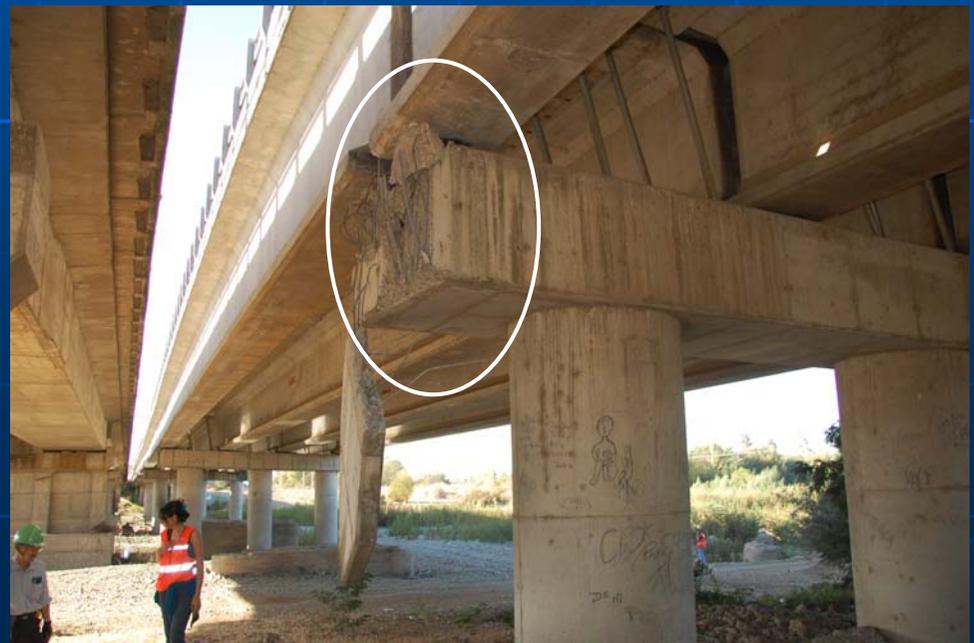
Perqui Lauquen Bridge
Route 5

Bridges based on recent practice suffered more damage than bridges based on pre mid-1990s practice

Very lucky!
About to collapse

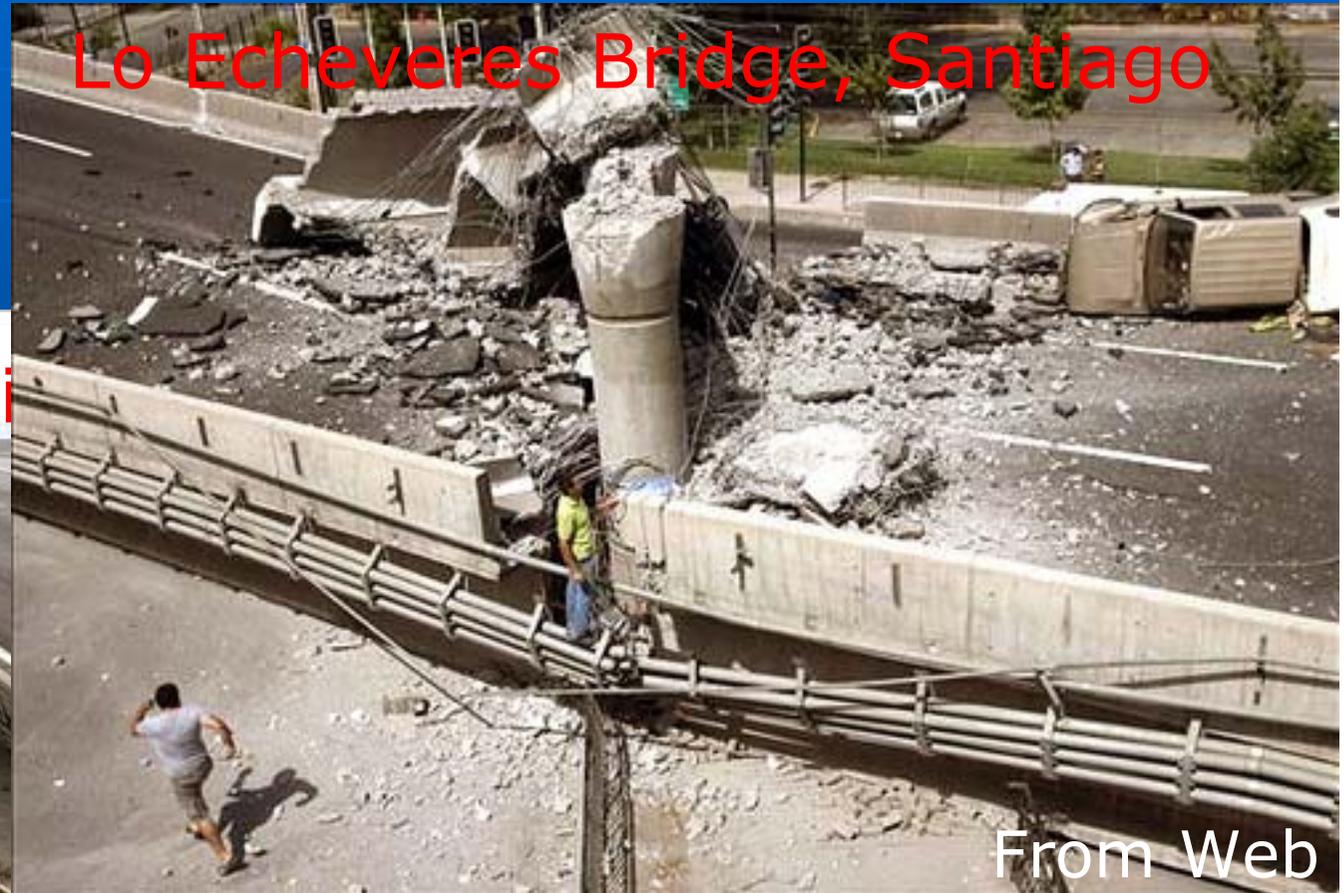
Lo Echeveres Bridge, Santiago

Skewed bridges which lacked diaphragms and effective side stoppers suffered extensive damage

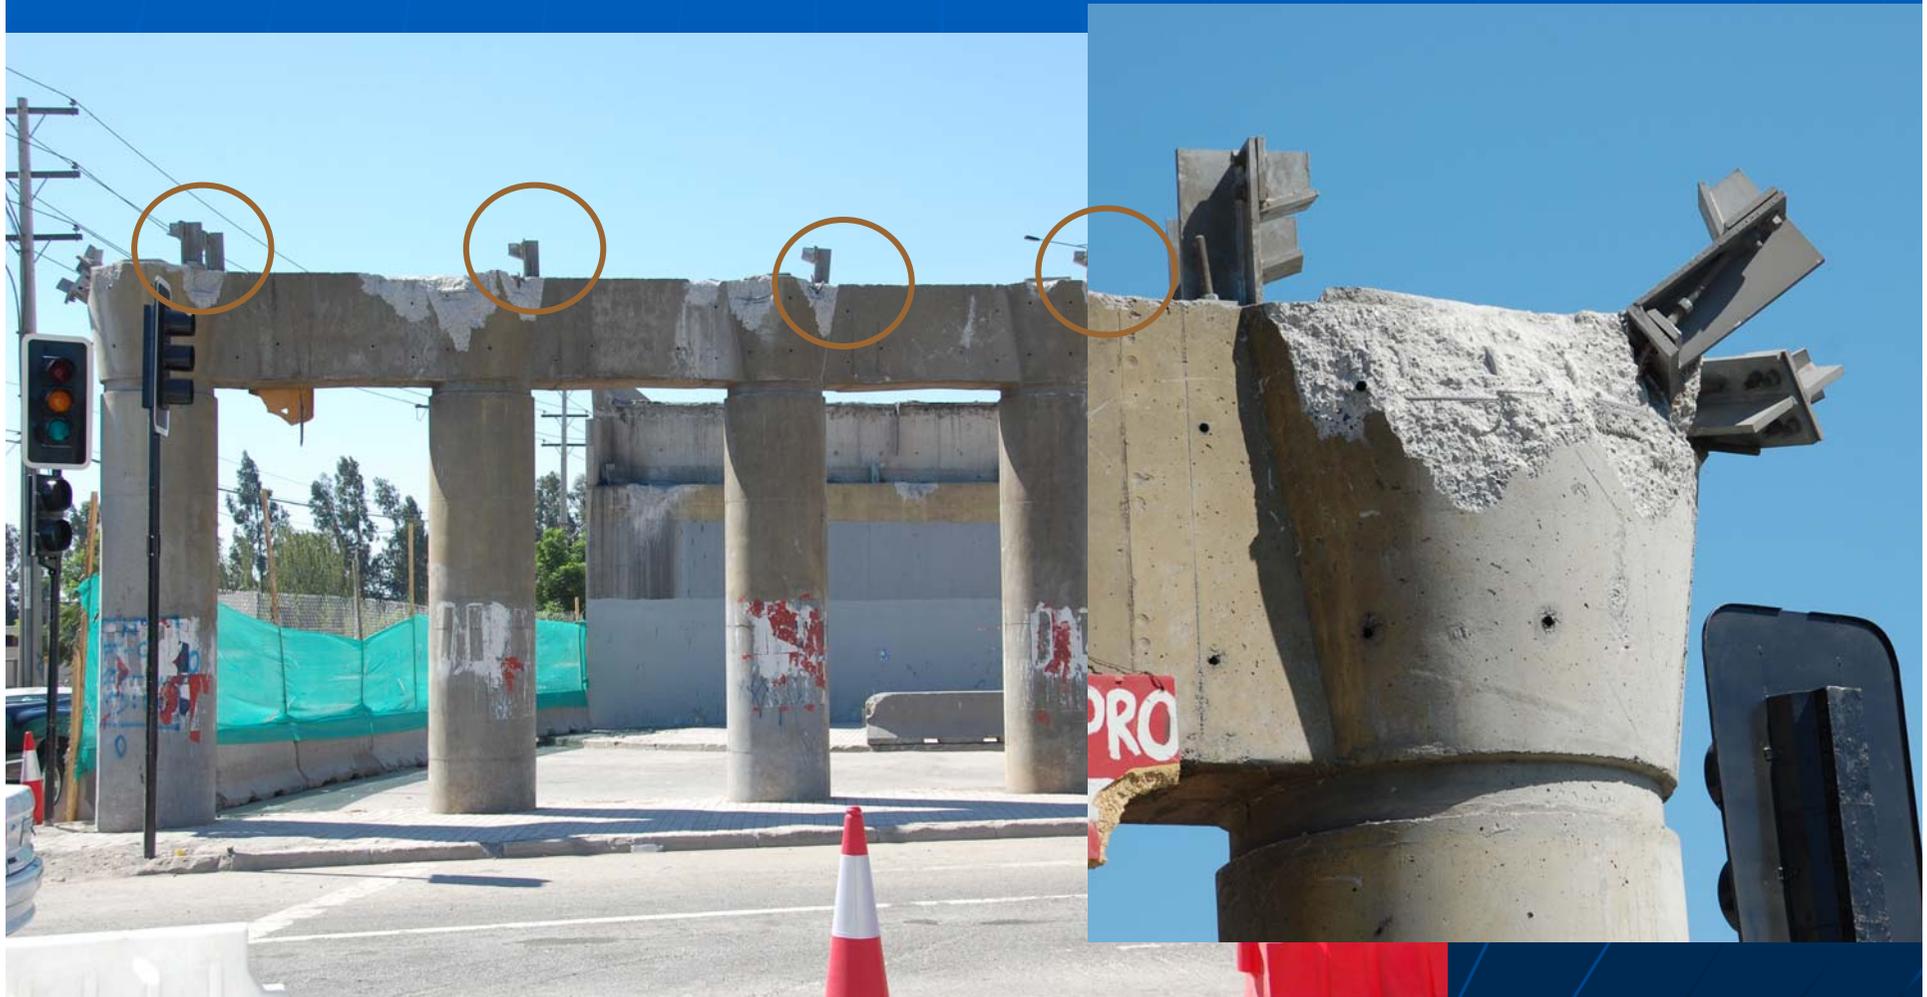
Mira Flores Bridge, Santiago

No mechanism to prevent TR and LG offset of bridges

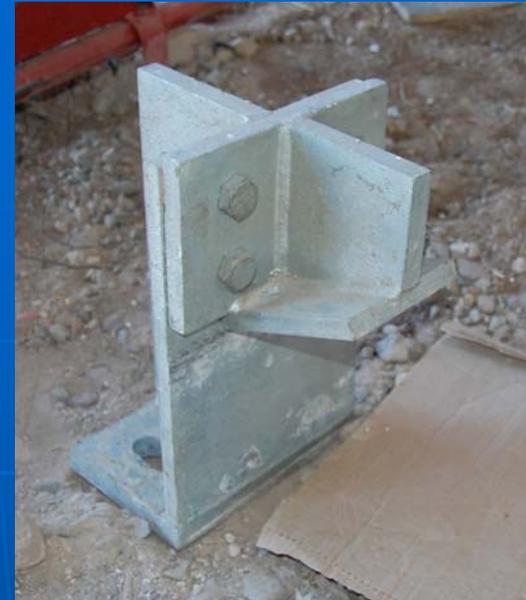
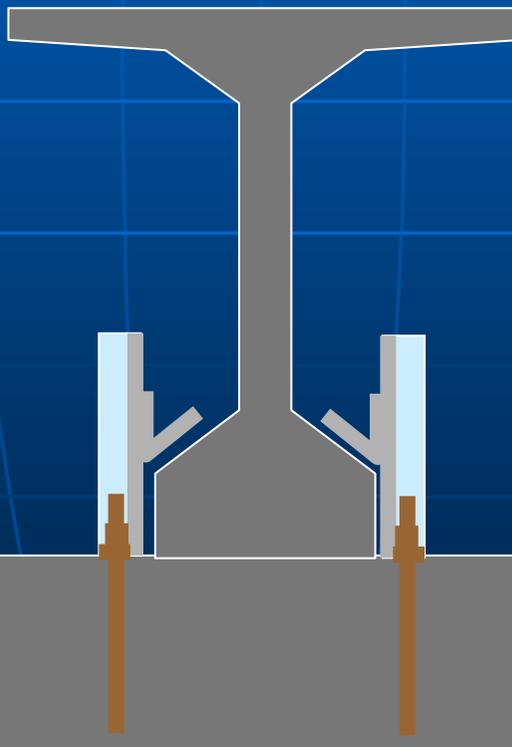
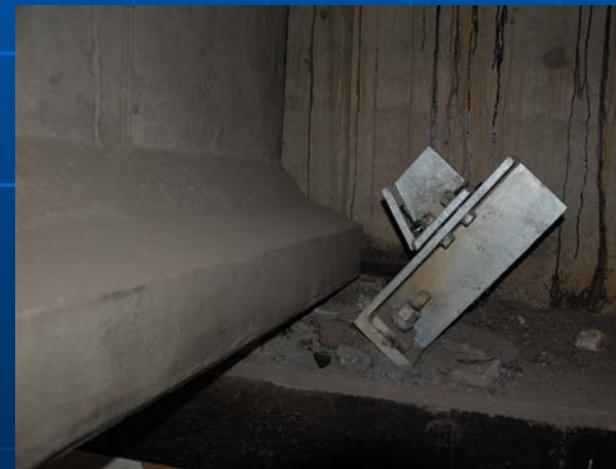
Stoppers for uplift?

- They were set not for preventing TR offset of bridges but for uplift prevention
- They were too weak

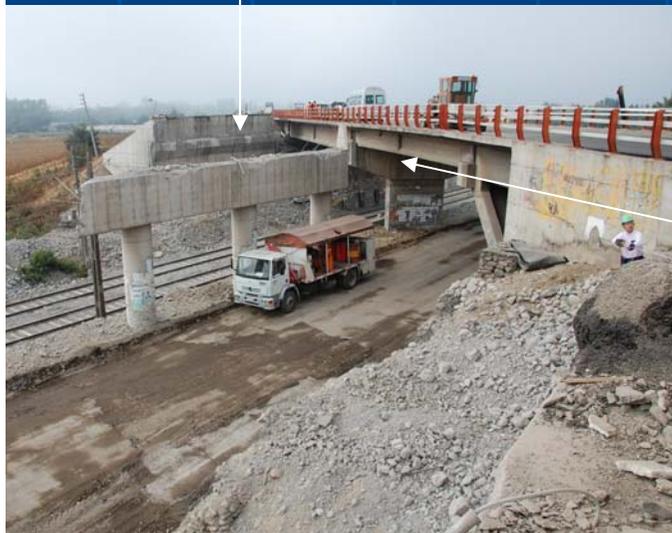
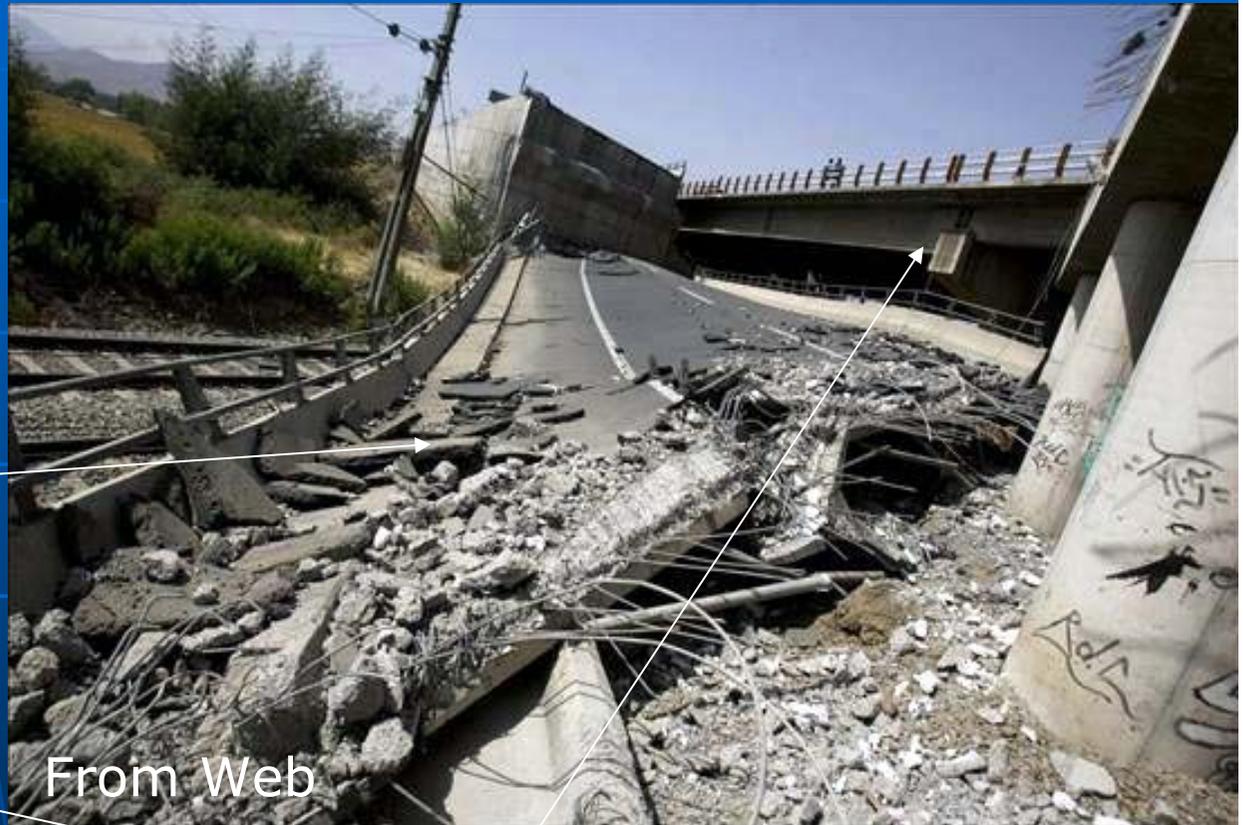
Hospital Bridge
Route 5

Skewed PC girder bridges recently built without diaphragms and effective side stoppers suffered extensive damage

Recent practice

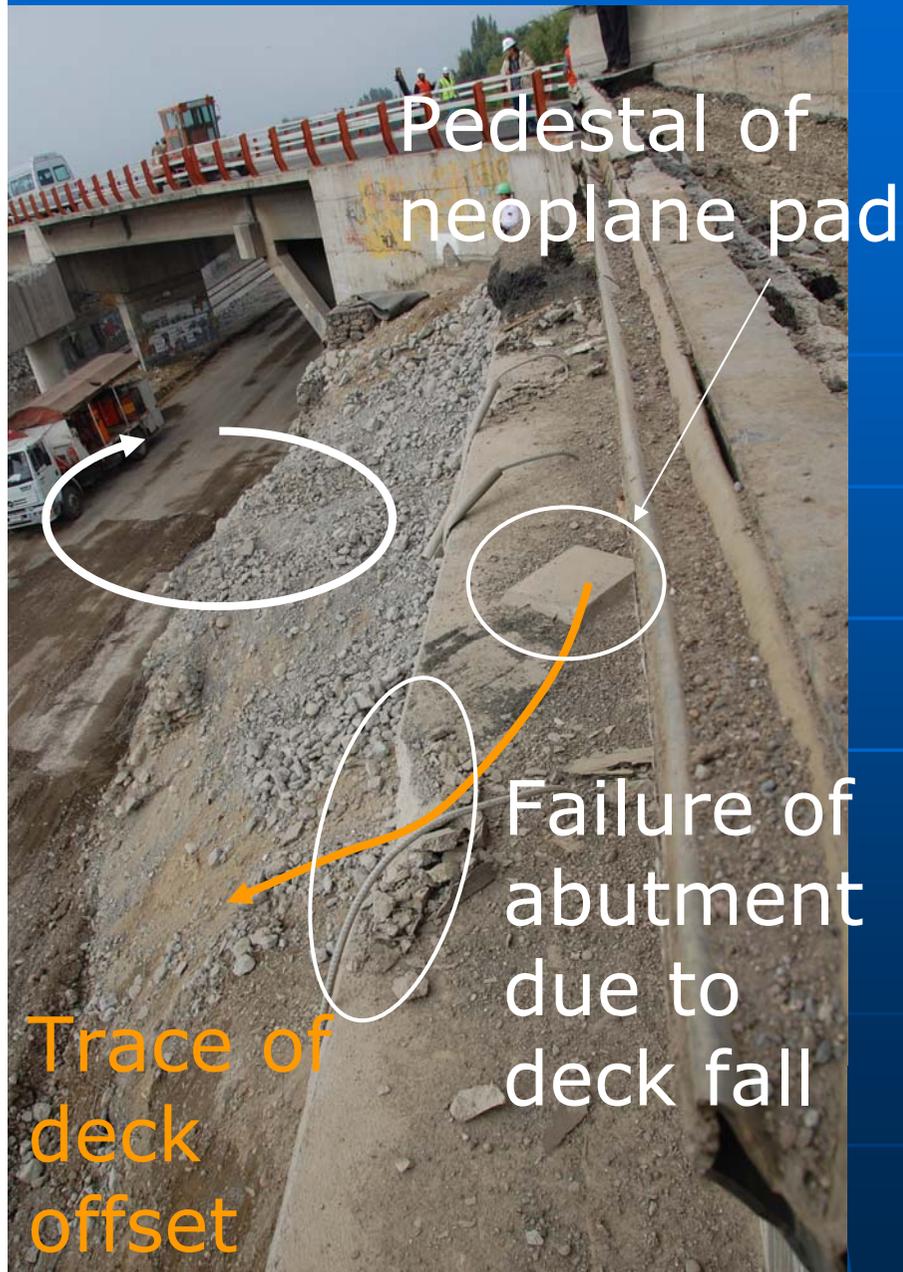
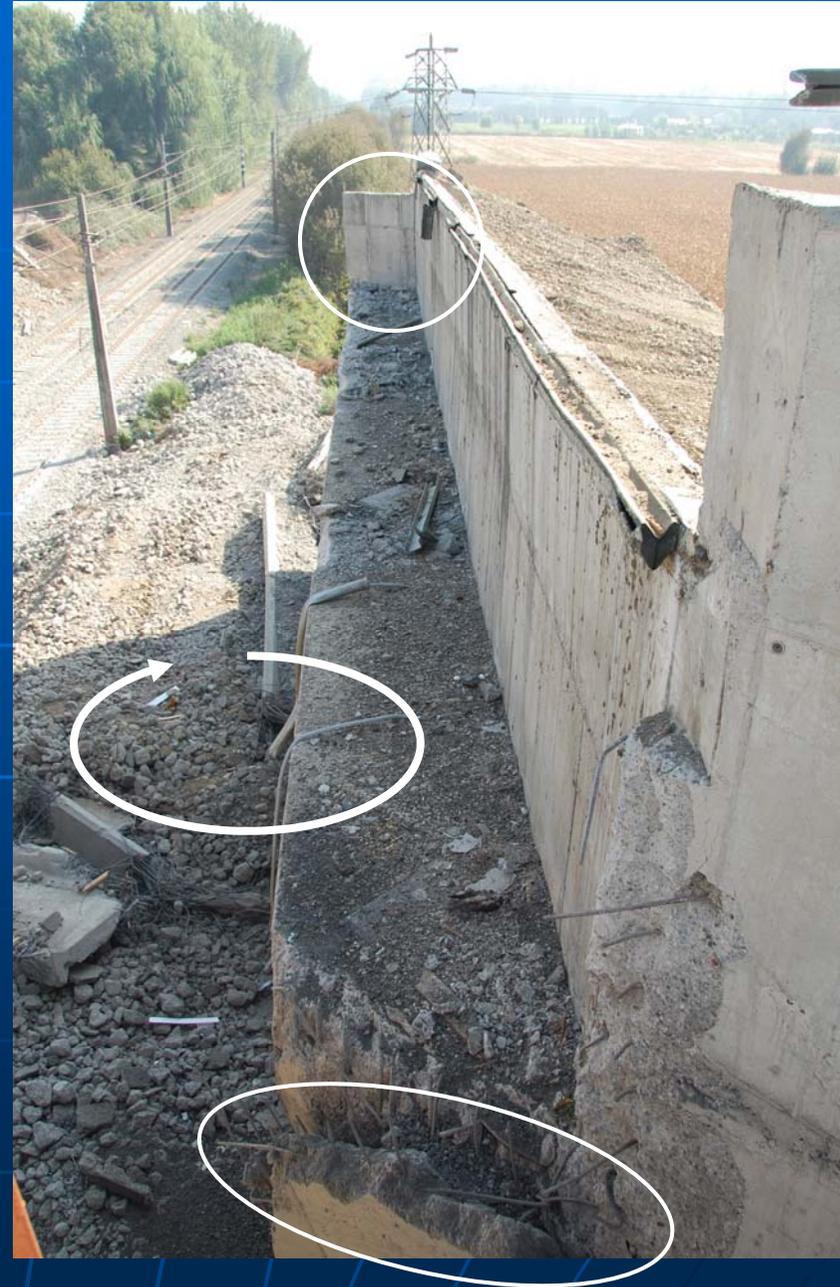
Collapse due to rotation of a skew bridge

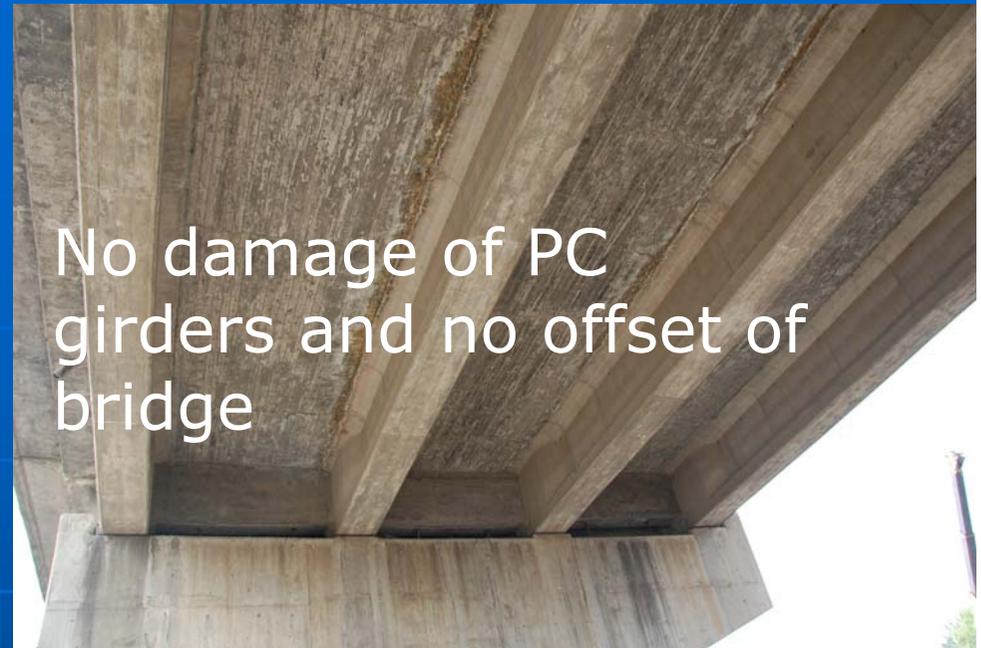
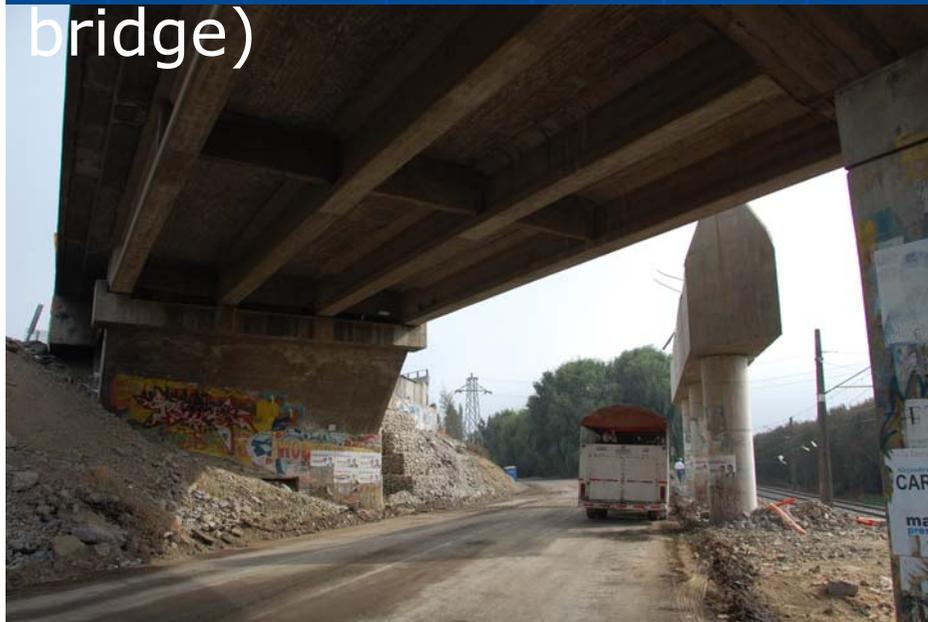
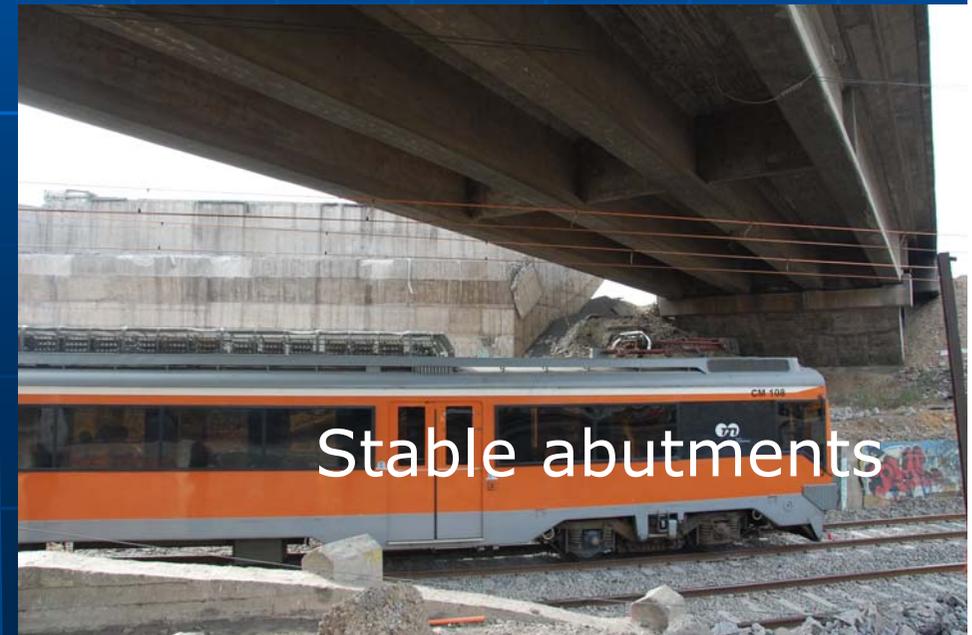
Older bridge based
on Pre Mid-1990s
Chile Design Practice
performed well

Abutments and piers
were built perpendicular
to bridge axis (straight
bridge)

No damage of PC
girders and no offset of
bridge

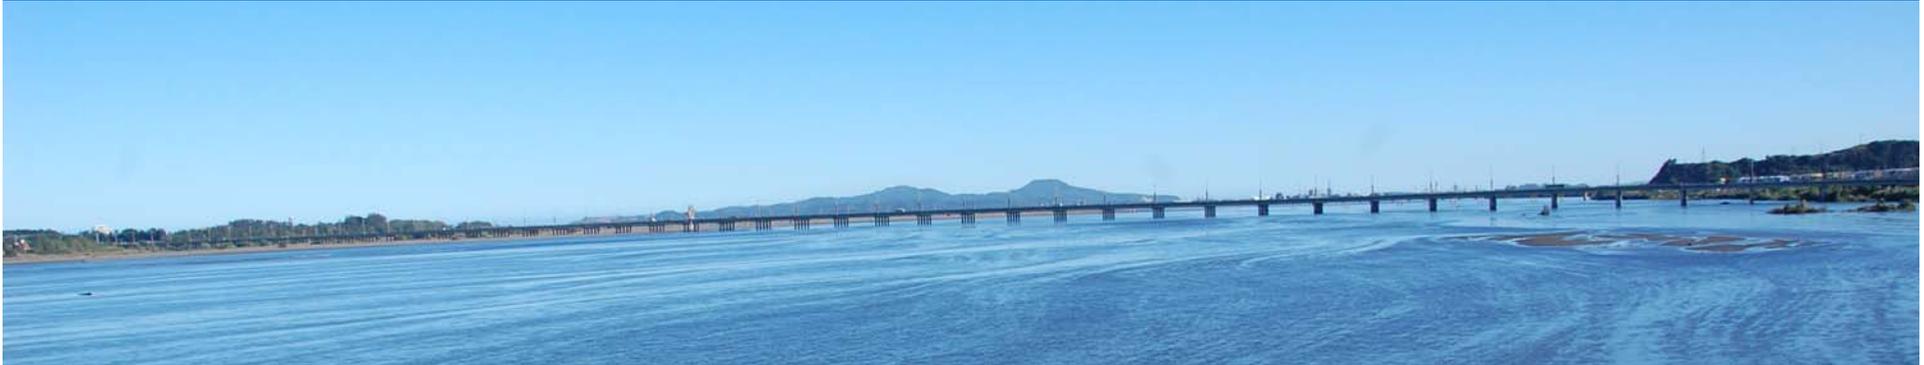
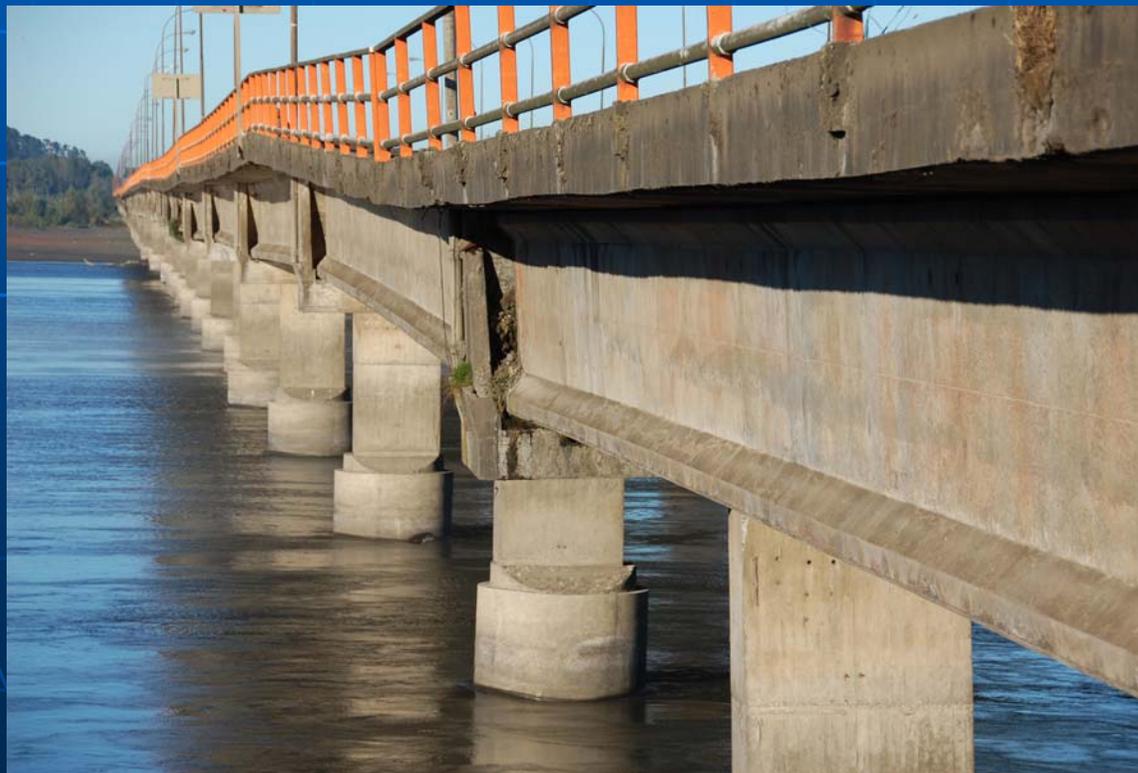
Jan Pablo II Bridge

Stable abutments

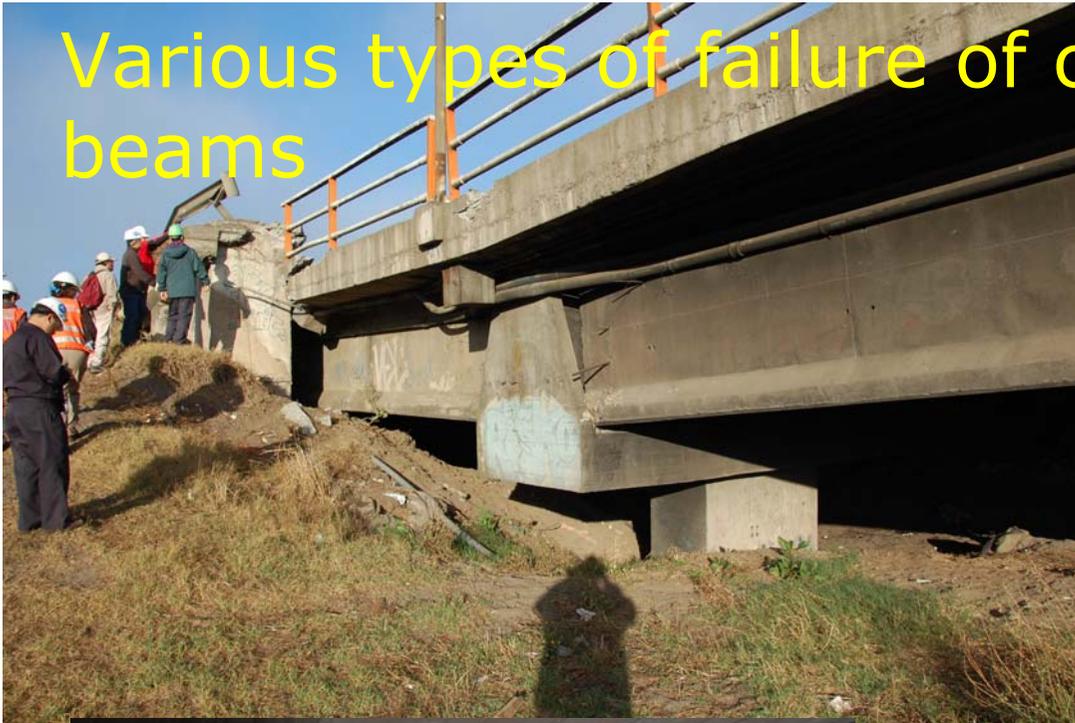
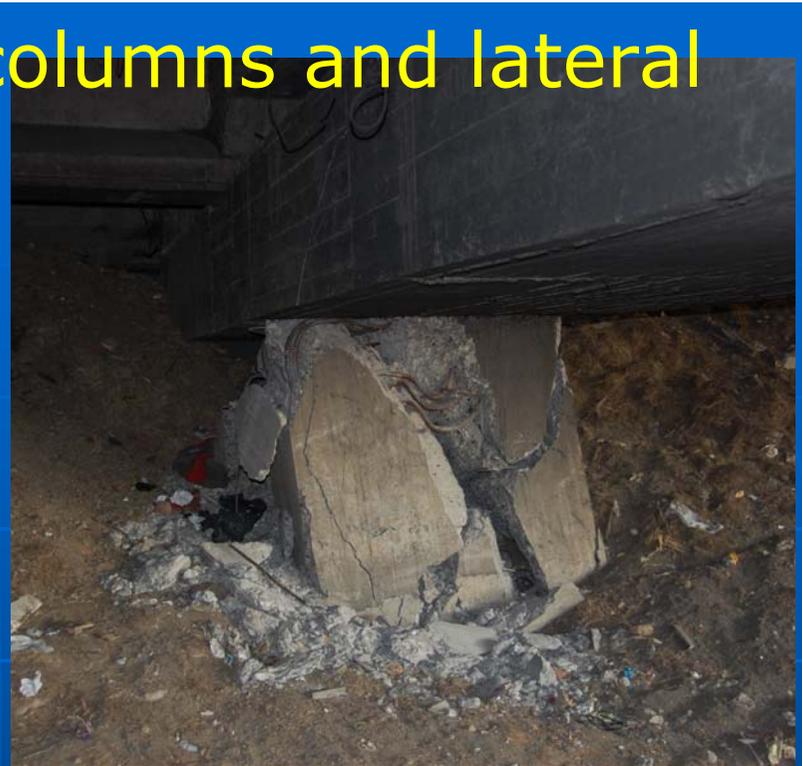
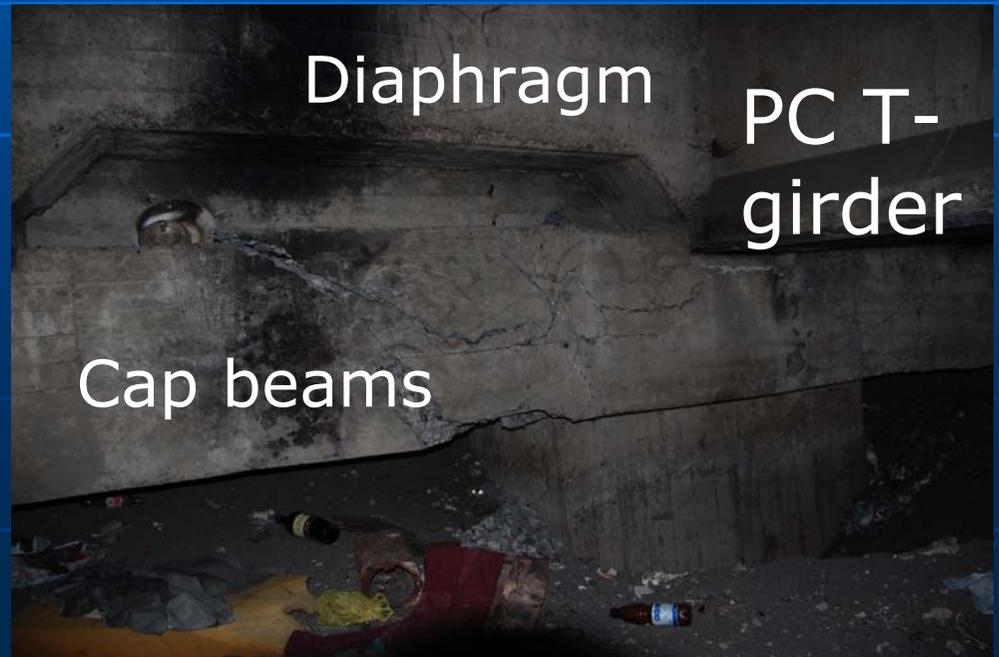
Various types of failure of columns and lateral beams

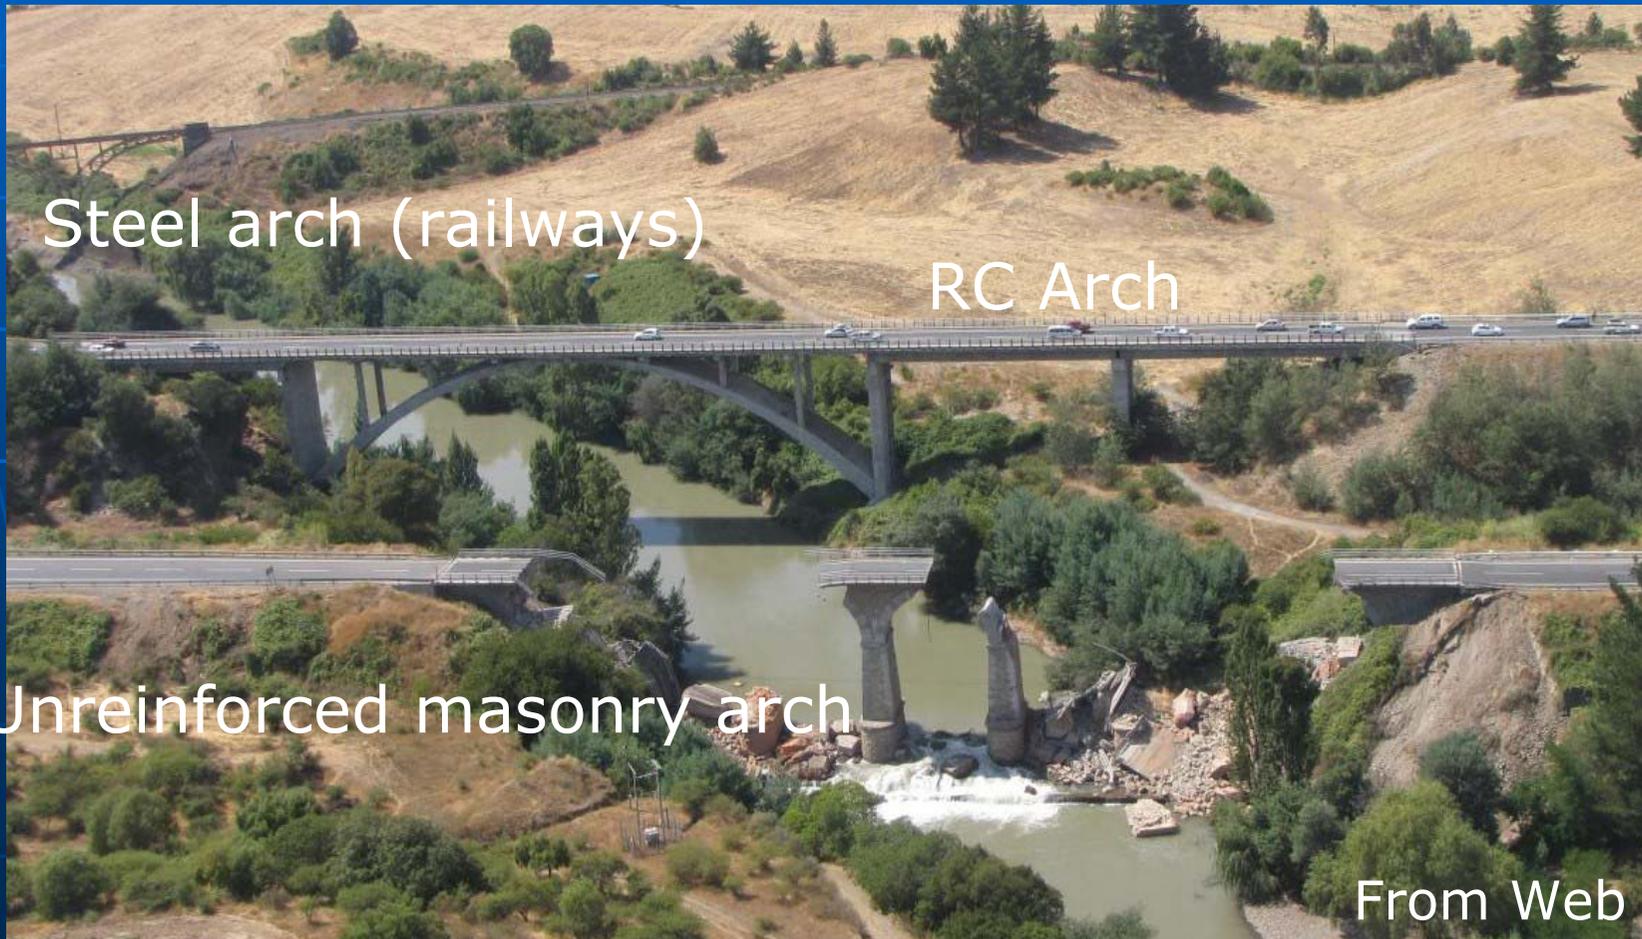
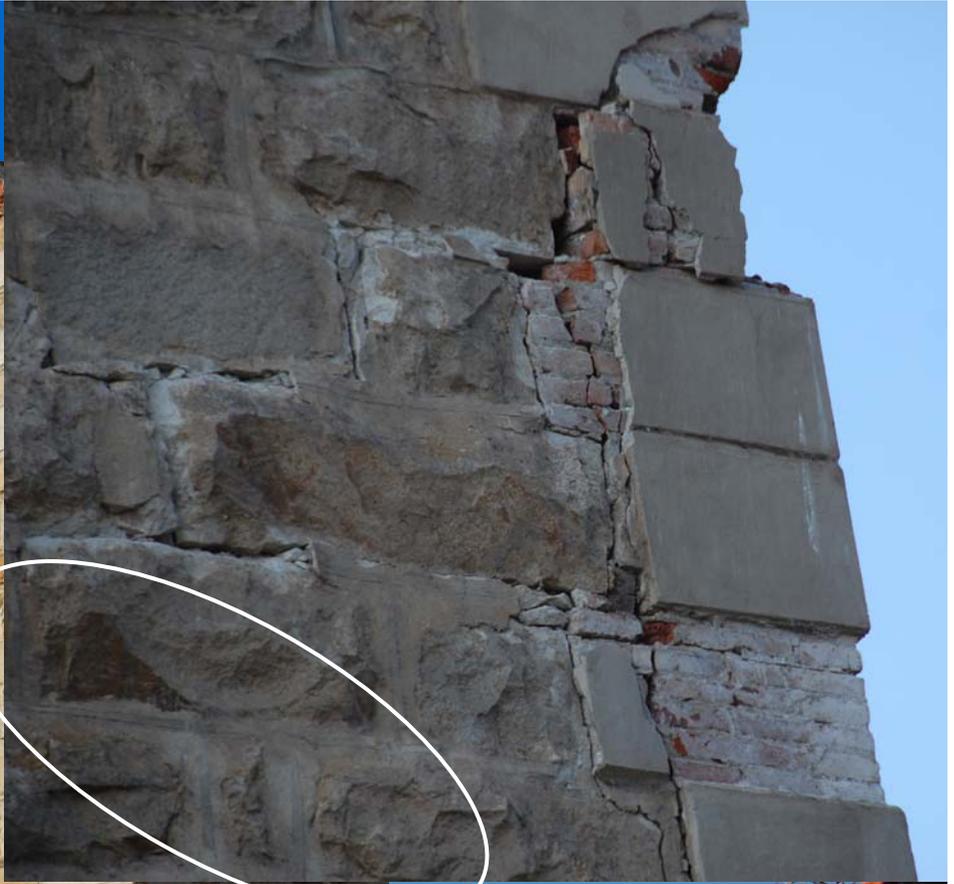
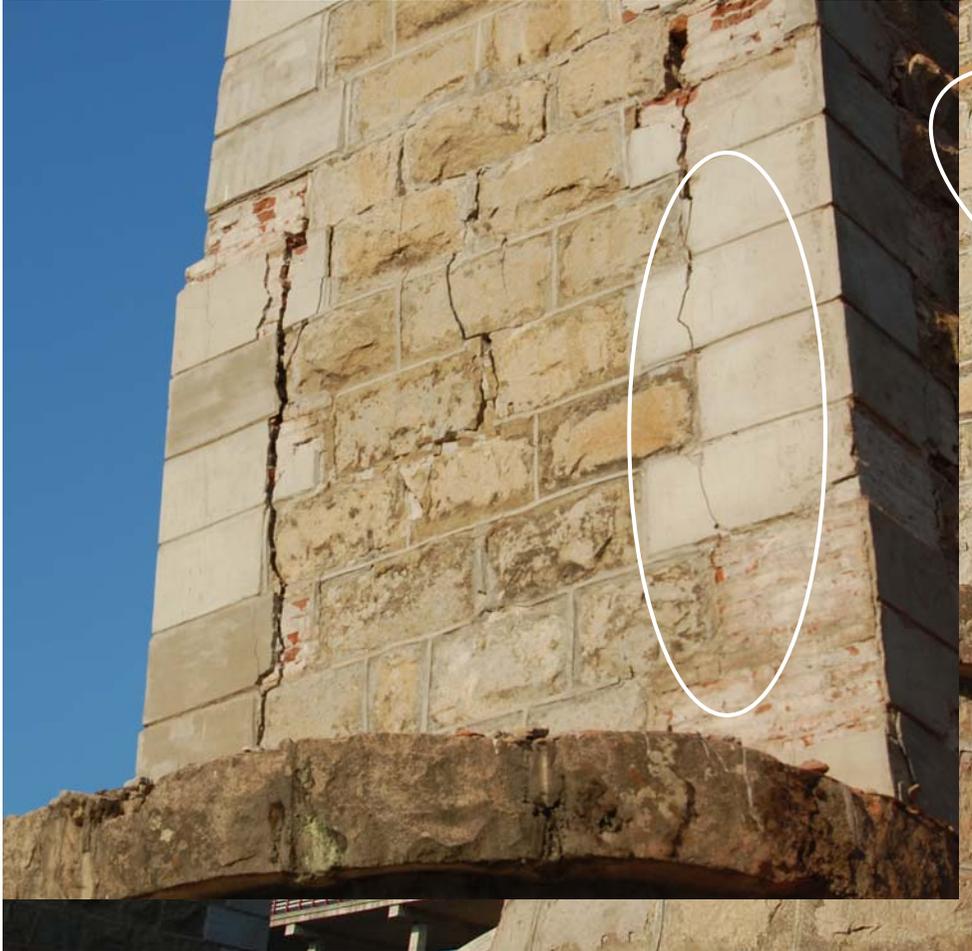
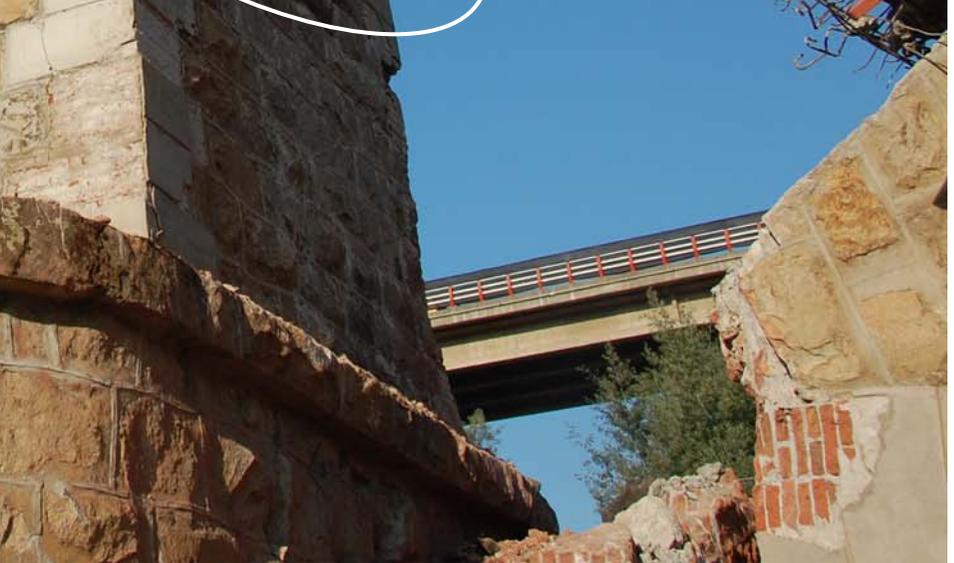
Rio Claro Bridge

A 140 years old unreinforced masonry bridge built in 1870
