Damage of Transportation Facility due to 2010 Chile Earthquake

April 5, 2010

Kawashima, K., Unjoh, S.,
Hoshikuma, J. and Kosa, K.

Bridge Team Dispatched by
Japan Society of Civil Engineers

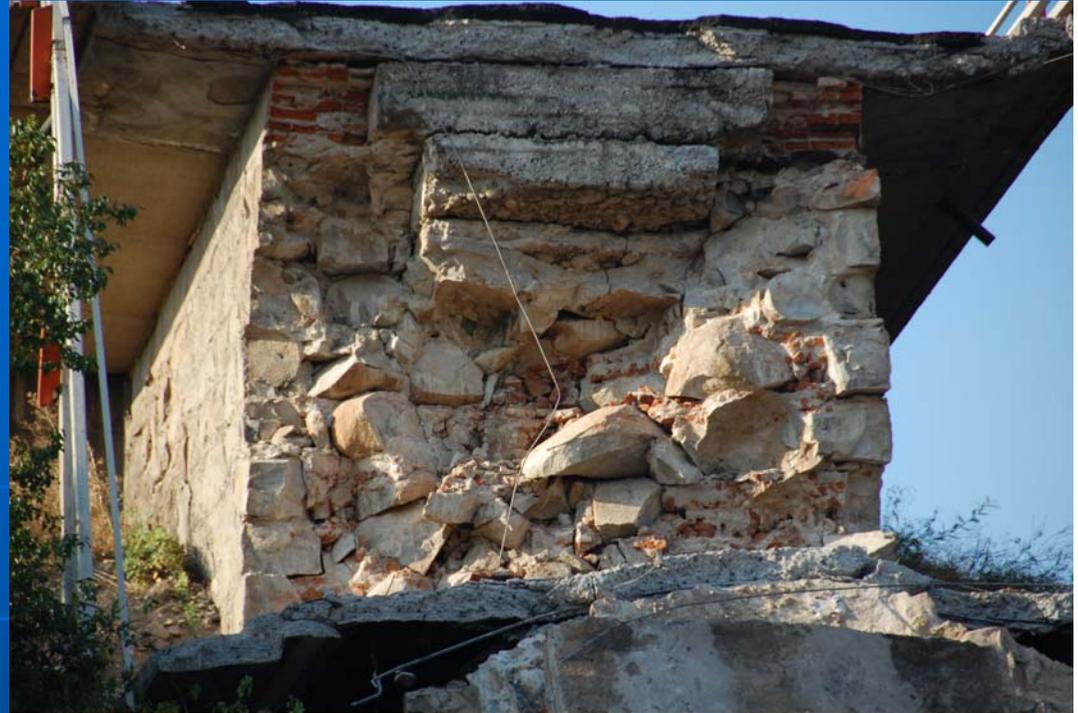
Claro Bridge
survived heavy
duty for long time

Brittle masonry
easy to remove
clay soil

- Arch crown was only 3m thick
- It must be very tuff to survive heavy traffic

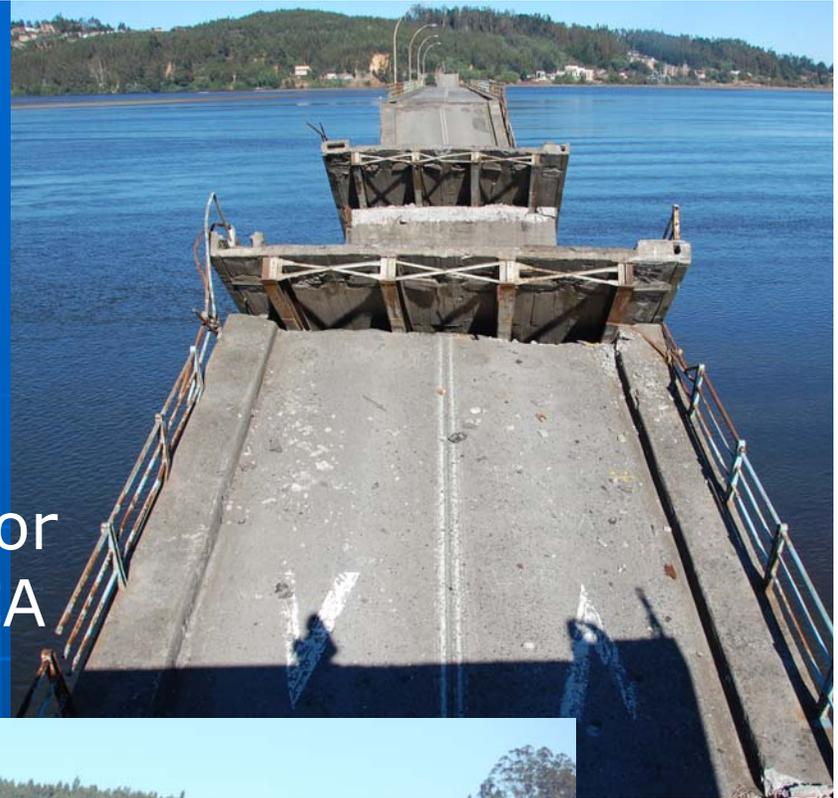
Bio Bio Bridge

- Built in 1930s
- Recognized to be insufficient for traffic since 1990s based on JICA evaluation

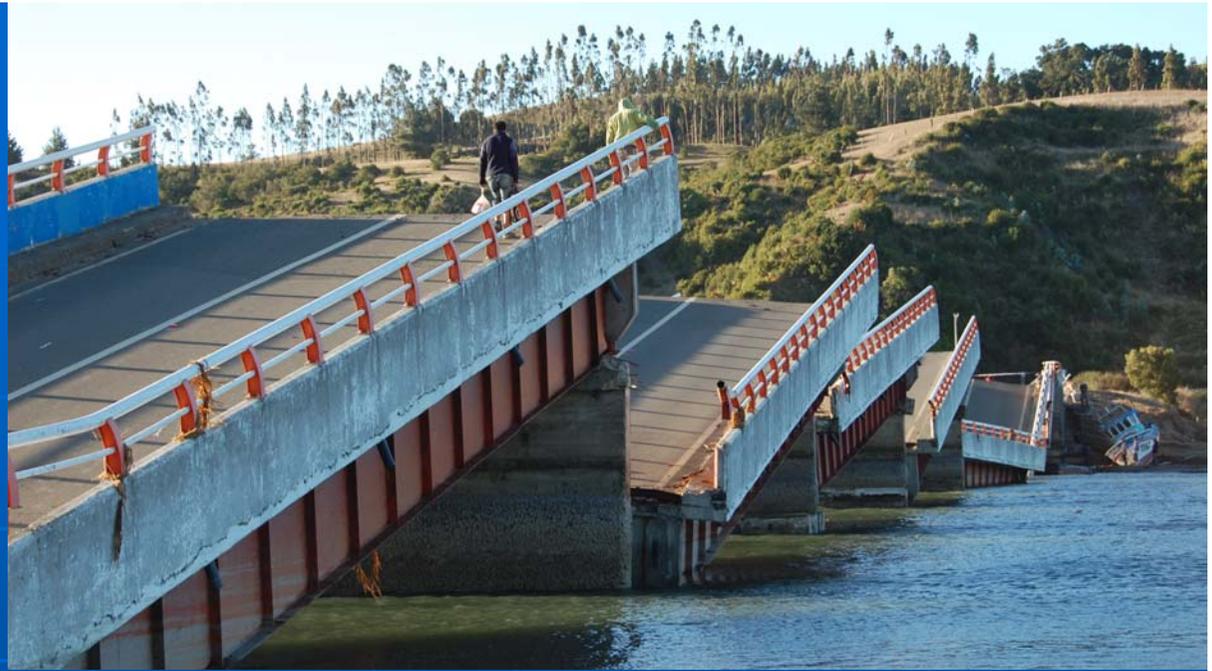
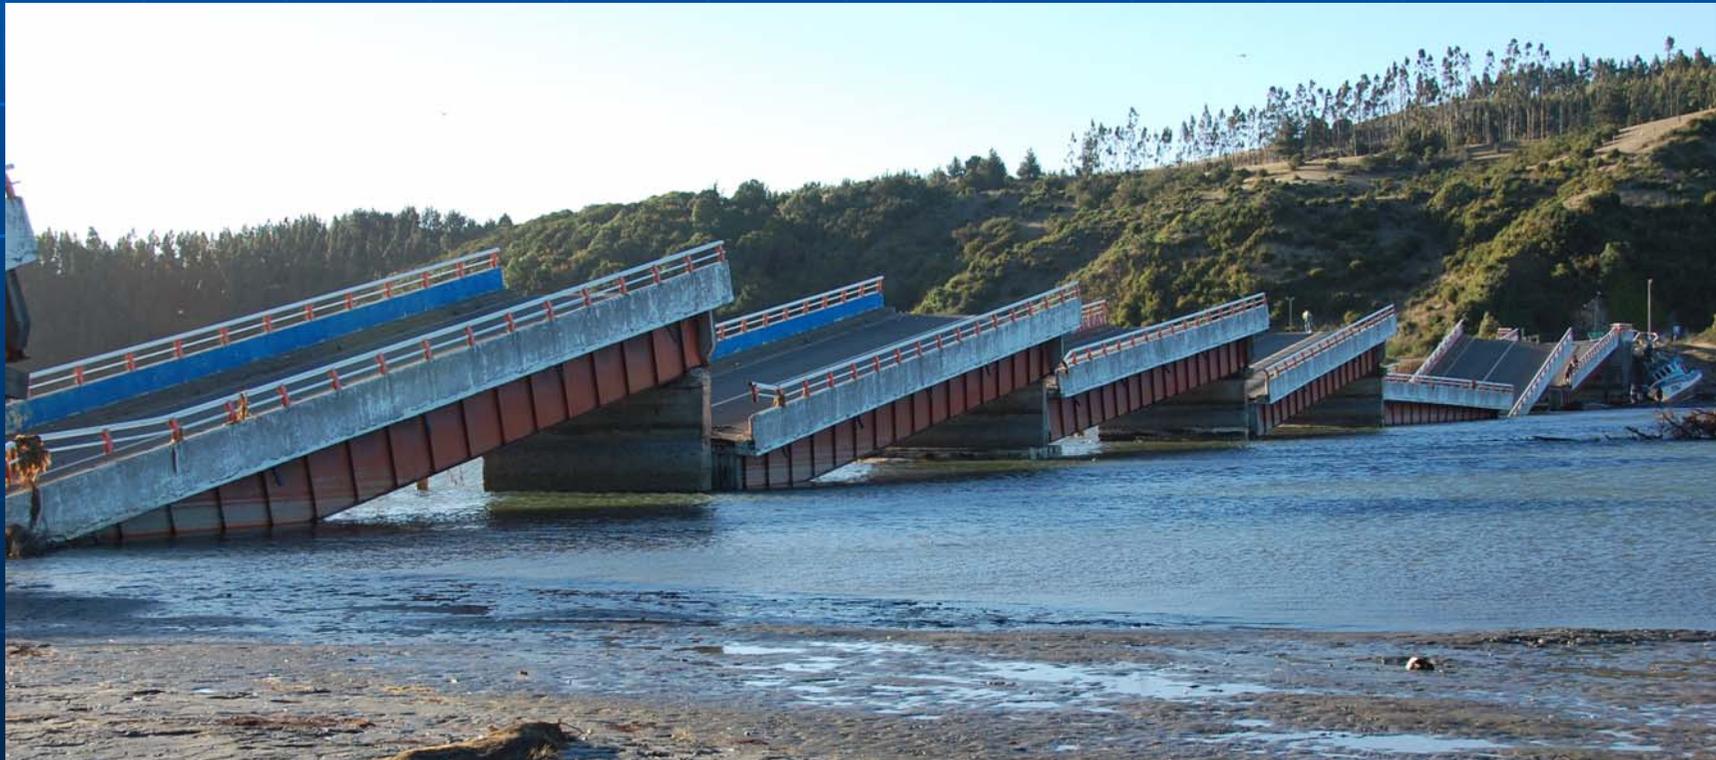
Tubul Bridge Apauco

Insufficient
performance
of foundations

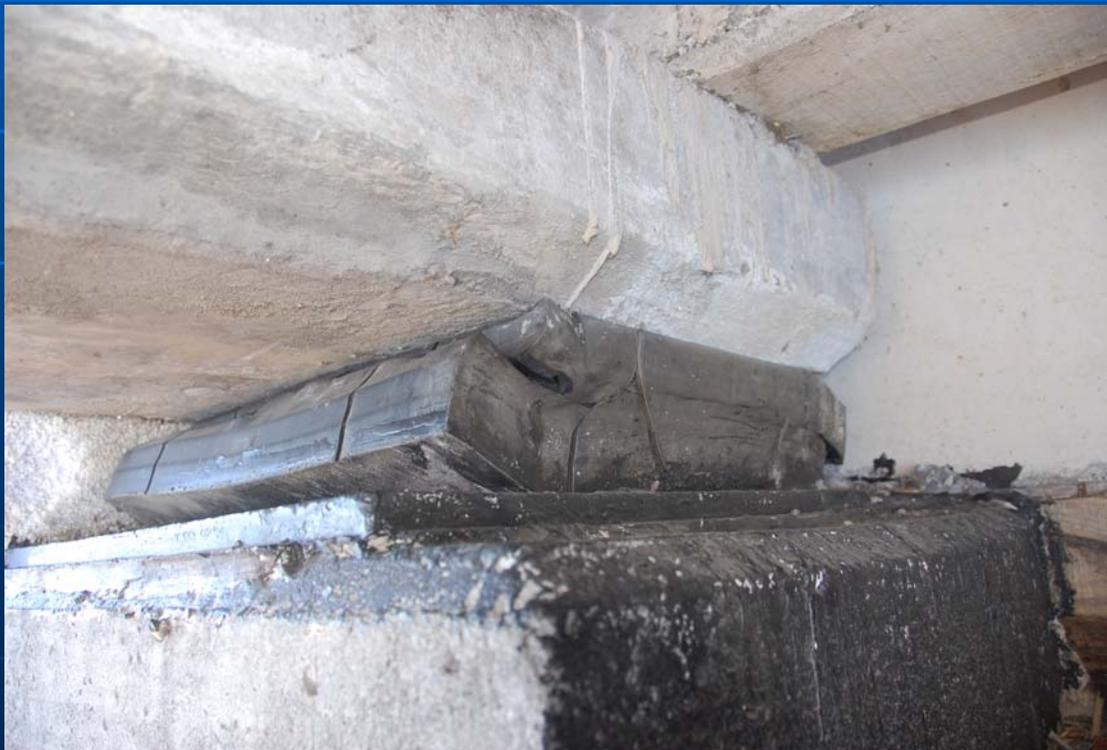
Las Balenas Bridge
Local Road, Suburbs of
Conseption

Rupture of Elastomeric Bearing

A 15 cm tall
60cm by 60cm
elastomeric
bearing ruptures
due to shear at
shear strain of
about 70%

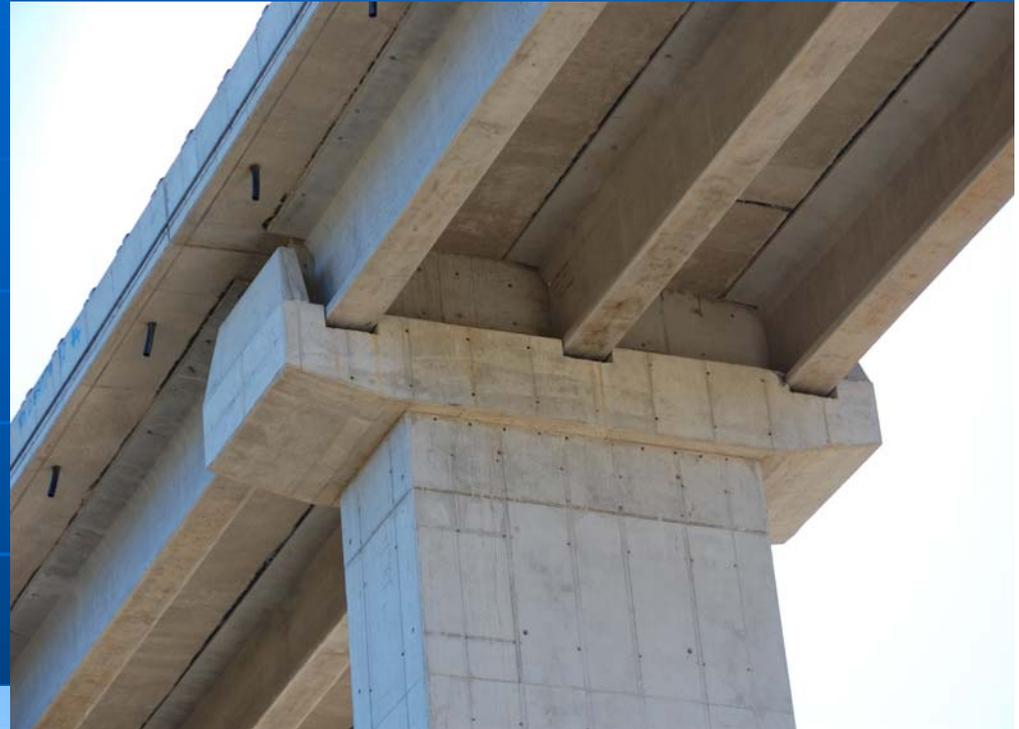
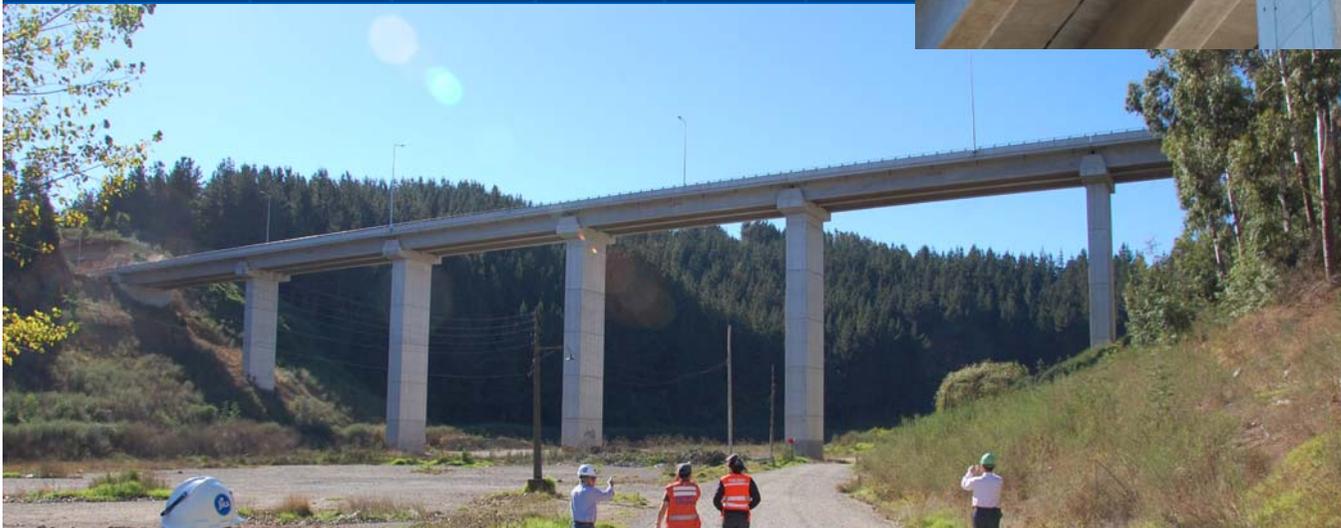
A new bridge constructed based on the existing Chile design survived with only very minor damage

- Side stoppers
- Diaphragms
