February 2023 Earthquakes in Türkiye and Syria: Observations from the Field and the Structural Engineering Office

Ayşe Hortaçsu
Applied Technology Council

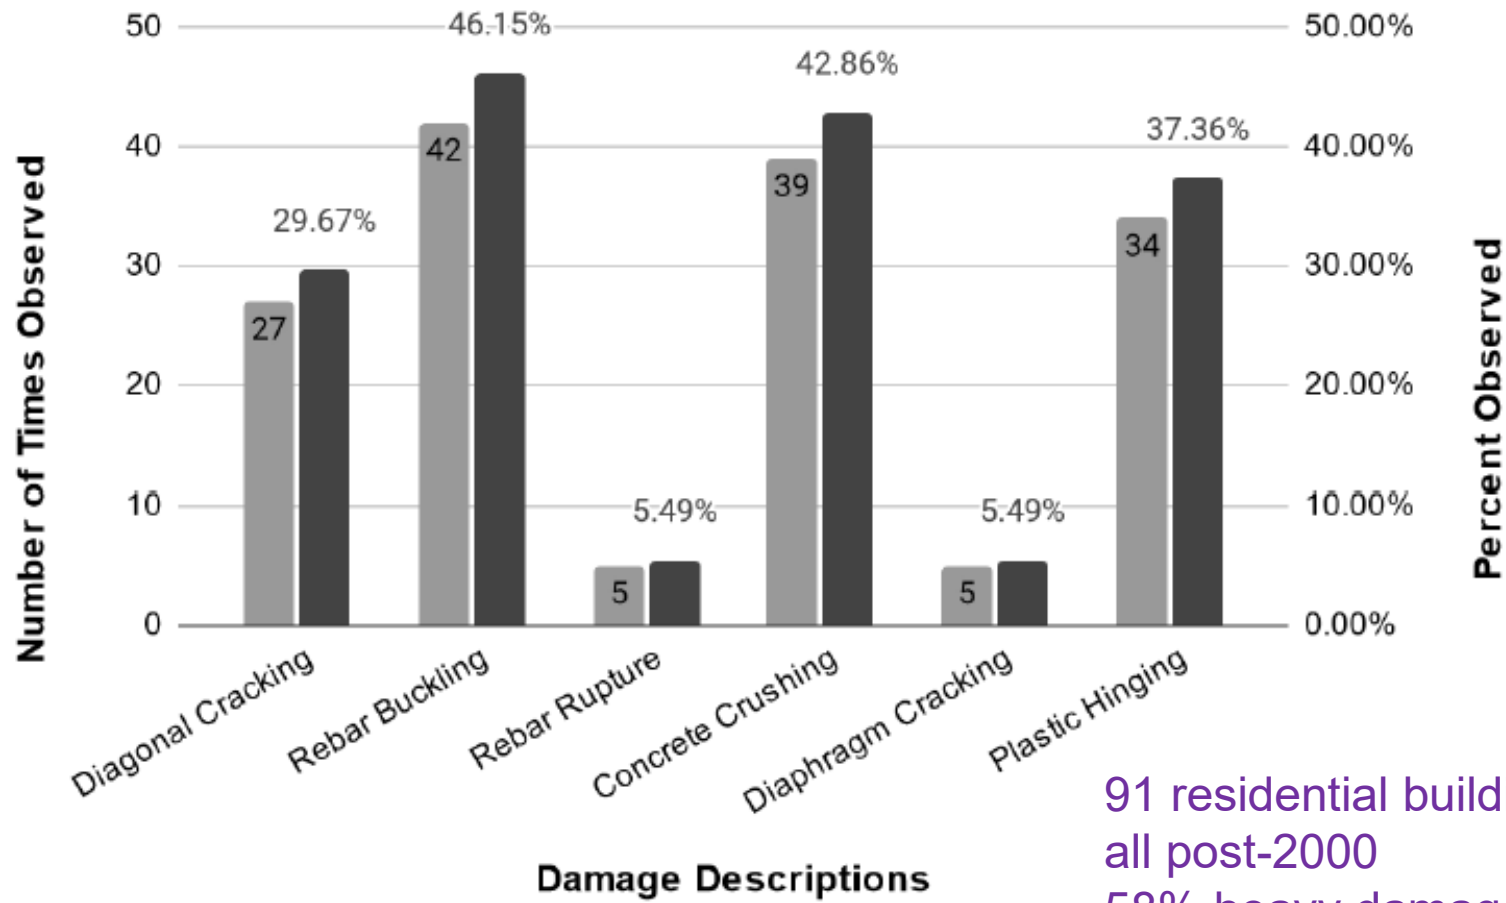
Figure 5.10. Types of damage observed in the residential buildings visited by the EERI Buildings team.

91 residential buildings
all post-2000
58% heavy damage

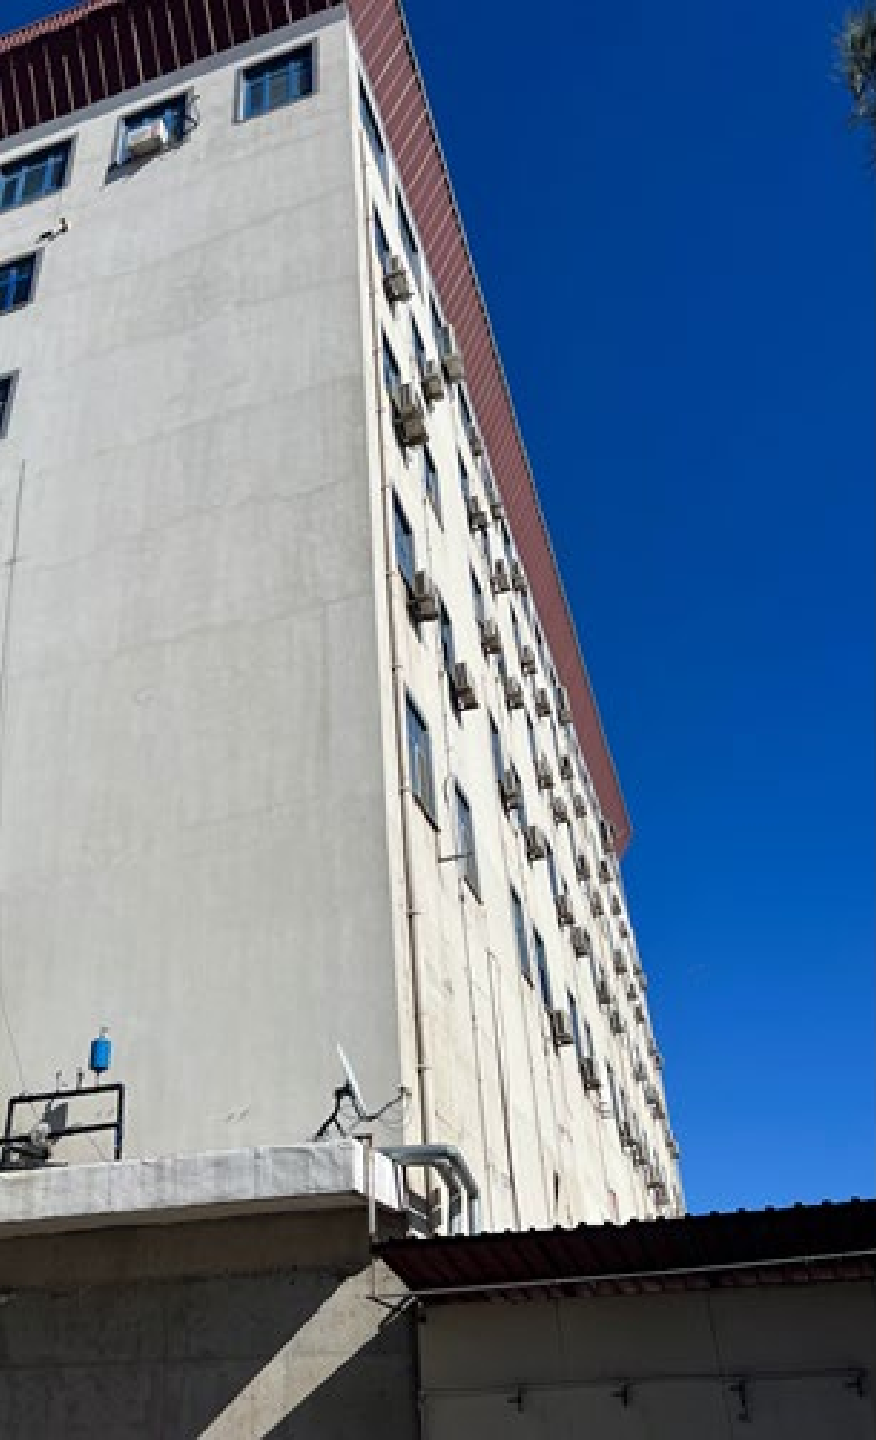
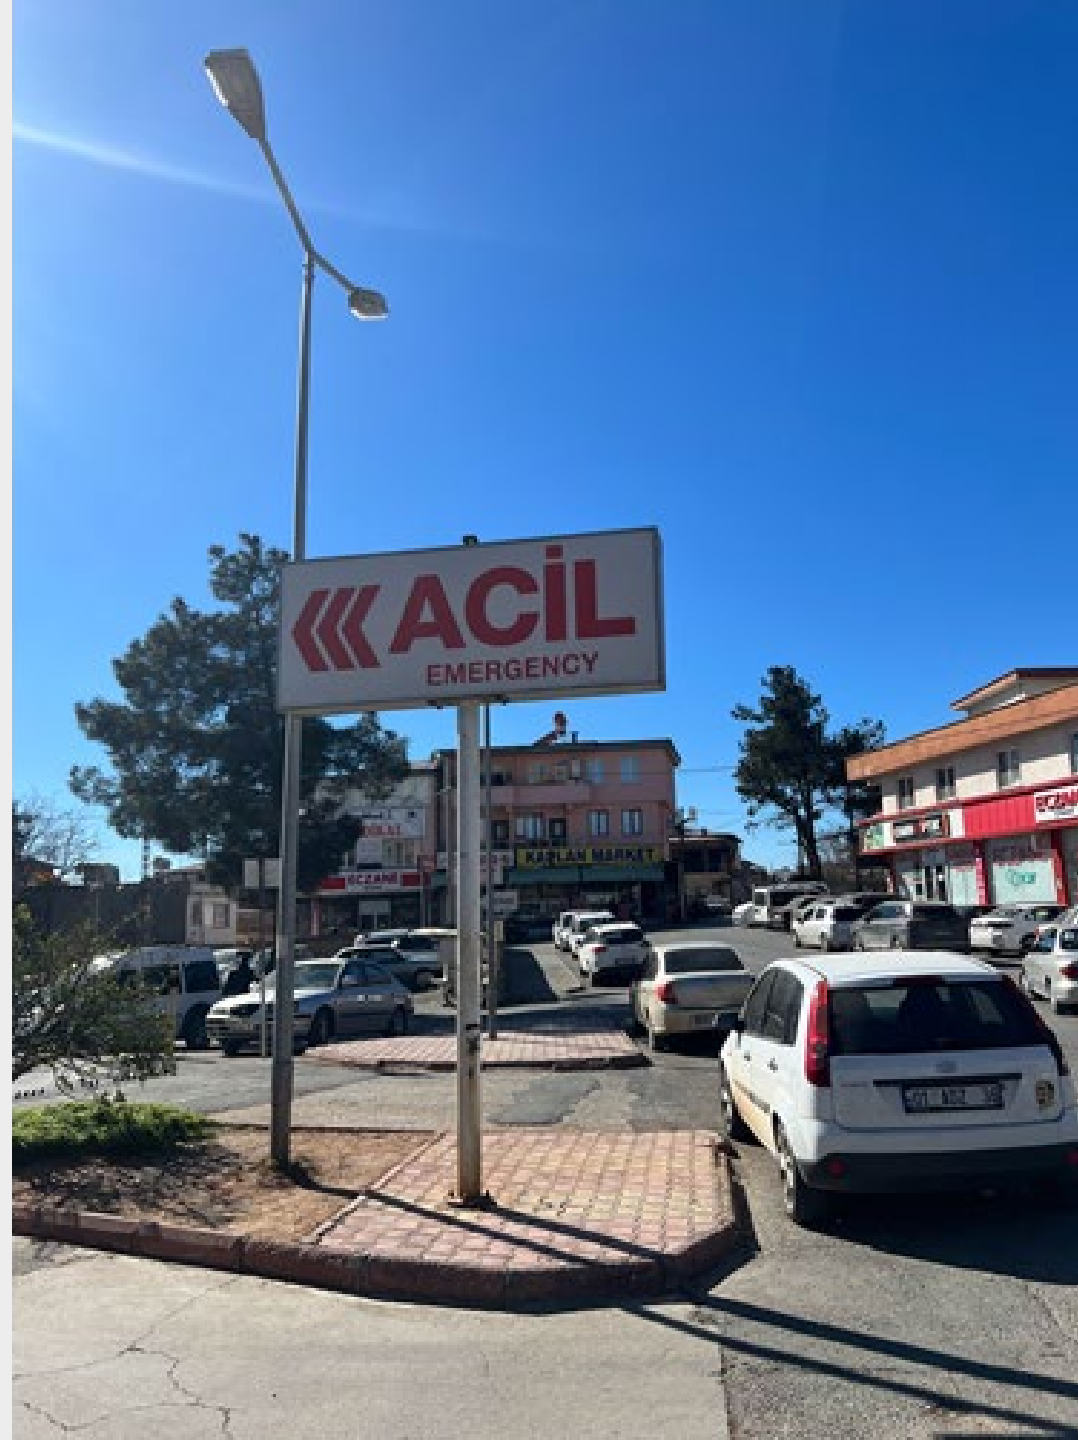
City Hospital

- Back-up systems operational
- Continued operations after 1st shock
- Paused operations for one day
- Serving 300 patients

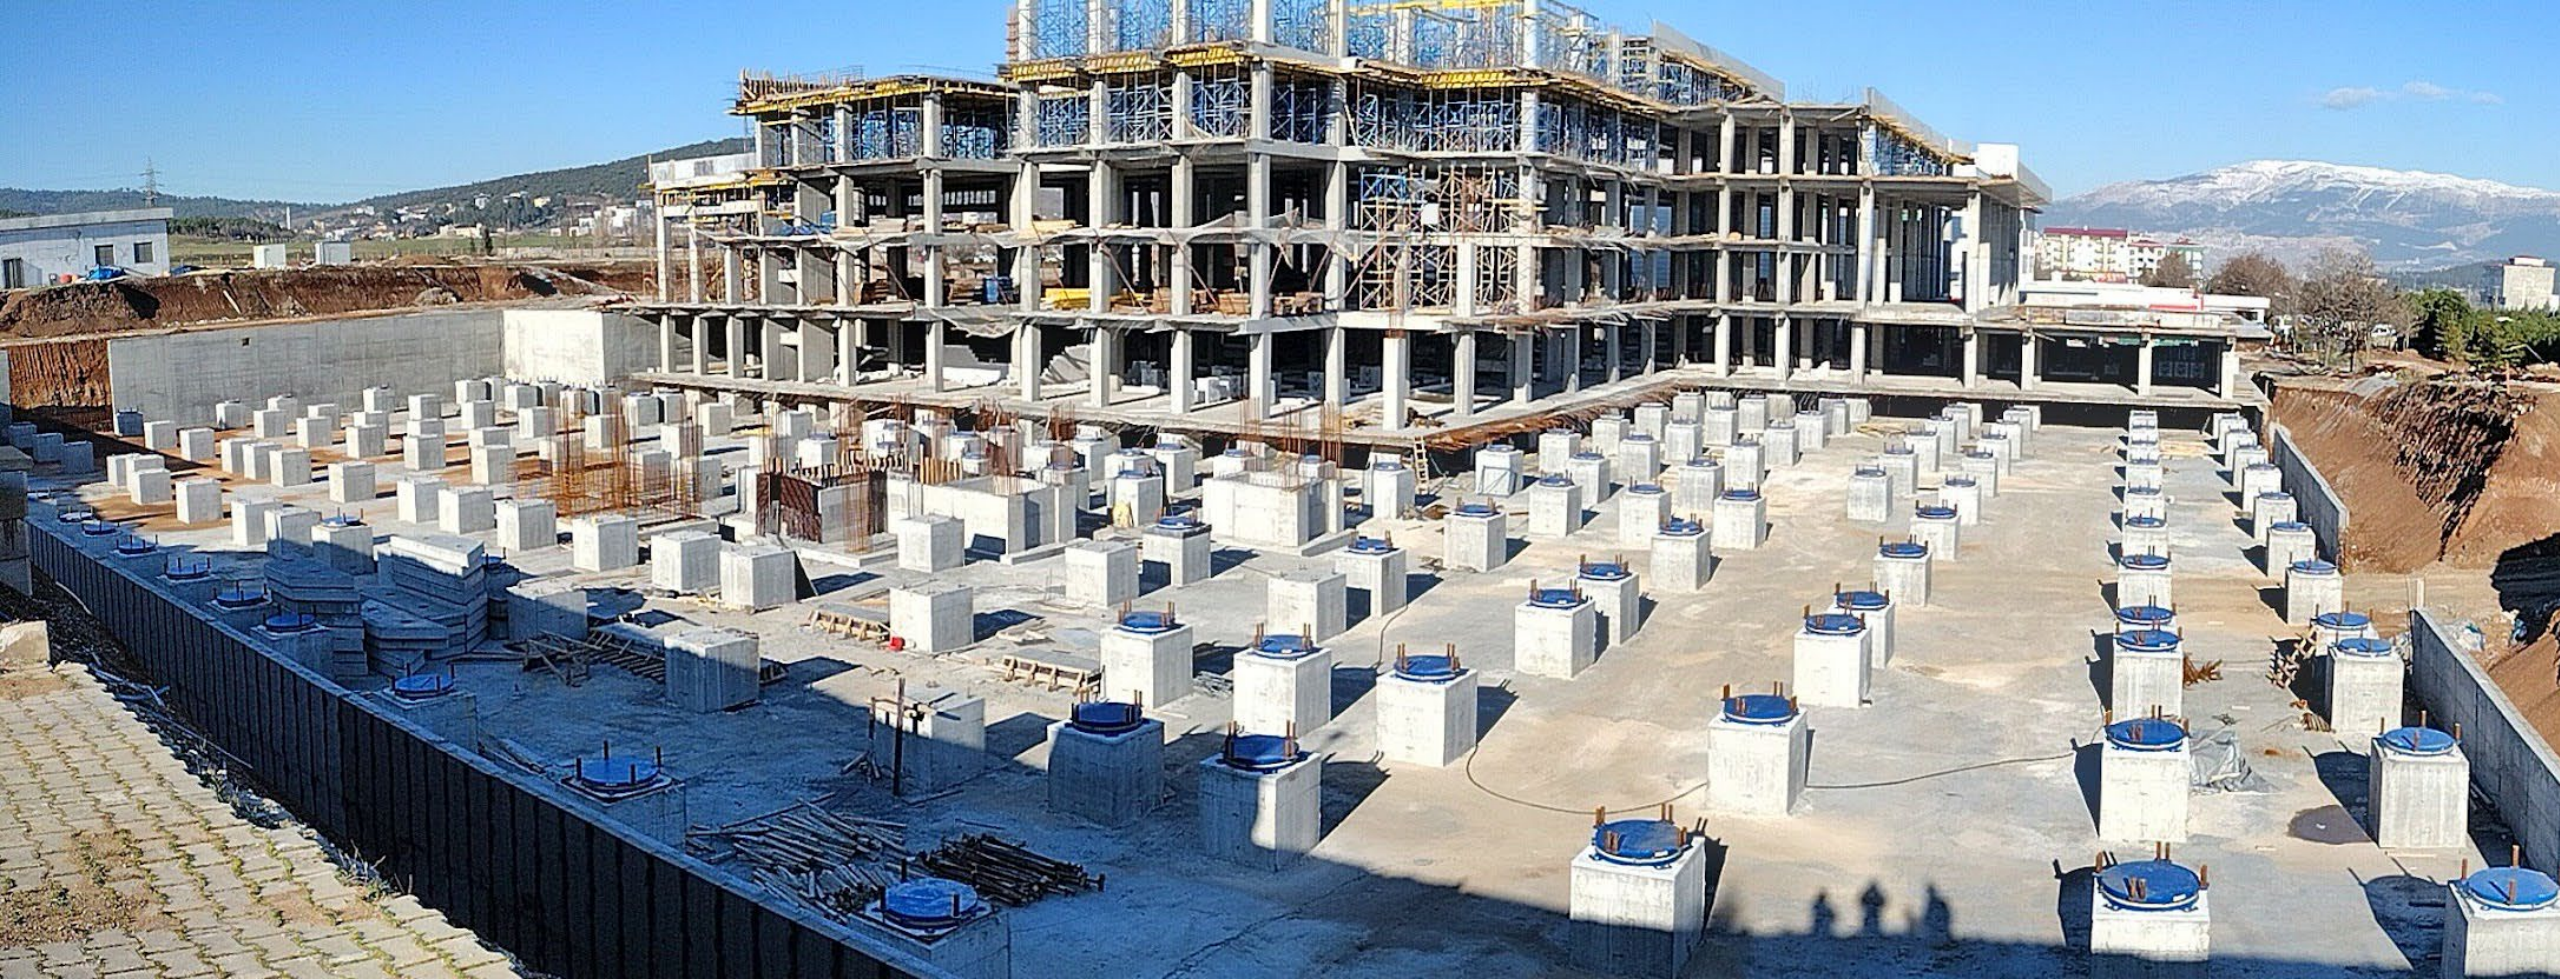
New Hospital (under construction)

- 361 base isolators
- 9-story wing to be added
- 18cm movement

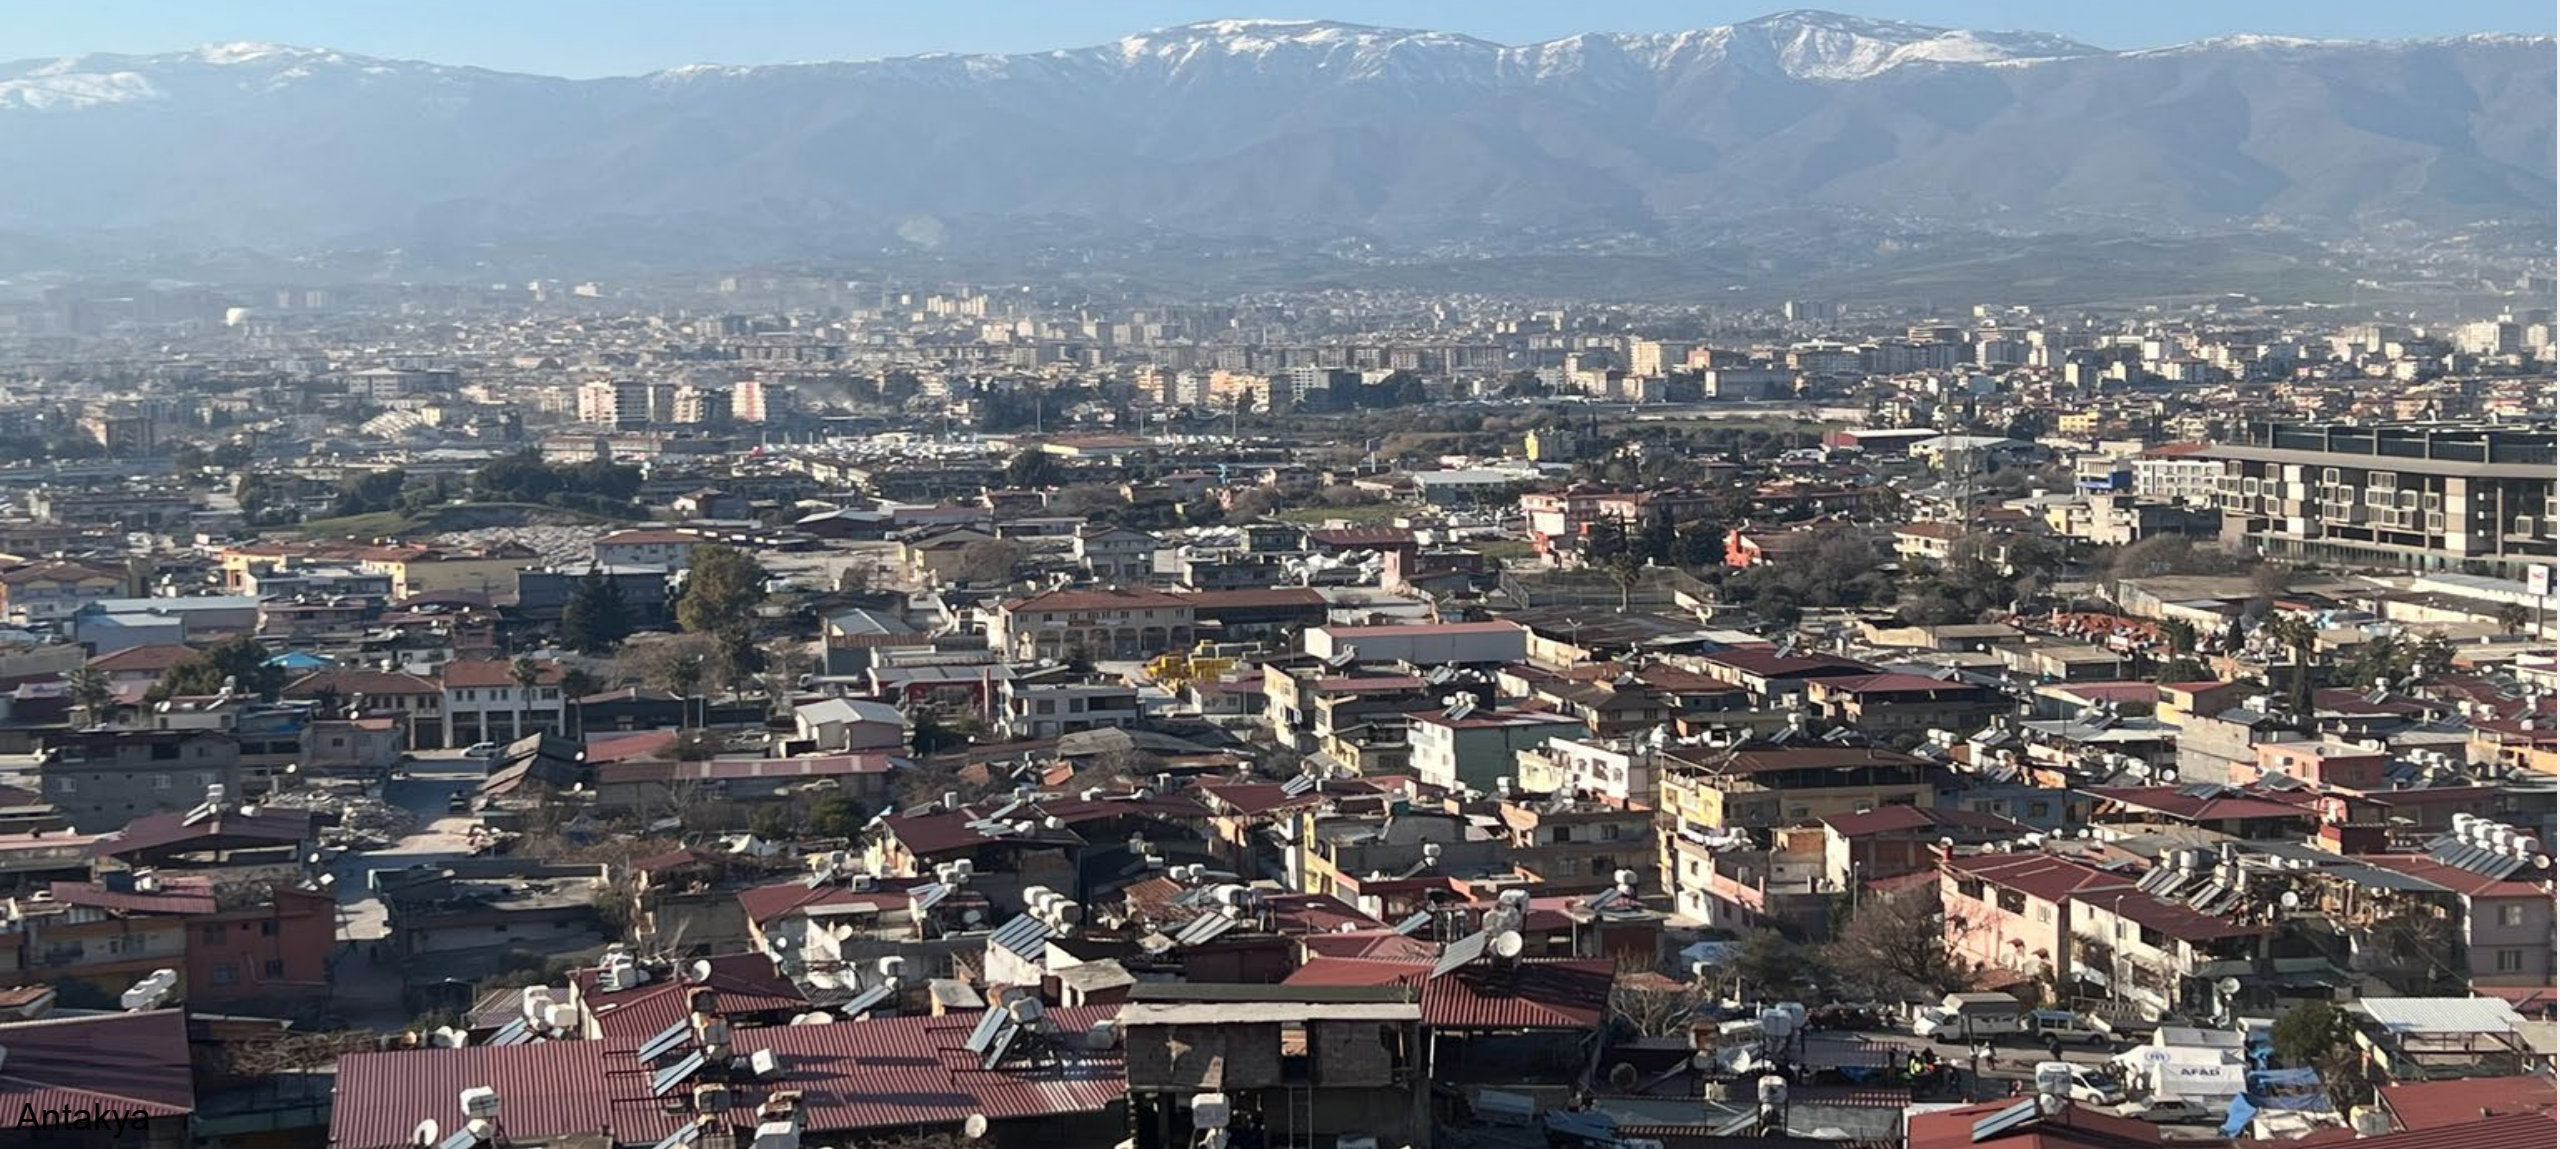
Fire Station in Antakya

“The main fire station in Antakya collapsed on top of three fire engines and one Search&Rescue vehicle. Fortunately all of it's 25 strong shift miraculously survived as the trucks below stopped the failing slab. The crew didn't have any time to recover from the shock as they needed to immediately start suppressing numerous earthquake induced fires in addition to Search&Rescue operations.” – Anton Andonov (EEFIT Team)
