OBSERVATIONS AFTER 5/12/2008 WENCHUAN EARTHQUAKE BASED ON FIELD RECONNAISSANCE FROM 7/4/2008 TO 7/7/2008

Khalid M. Mosalam, PhD, PE mosalam@ce.berkeley.edu
Professor and Vice Chair for Research and Technical Services
Structural Engineering, Mechanics and Materials
Department of Civil and Environmental Engineering

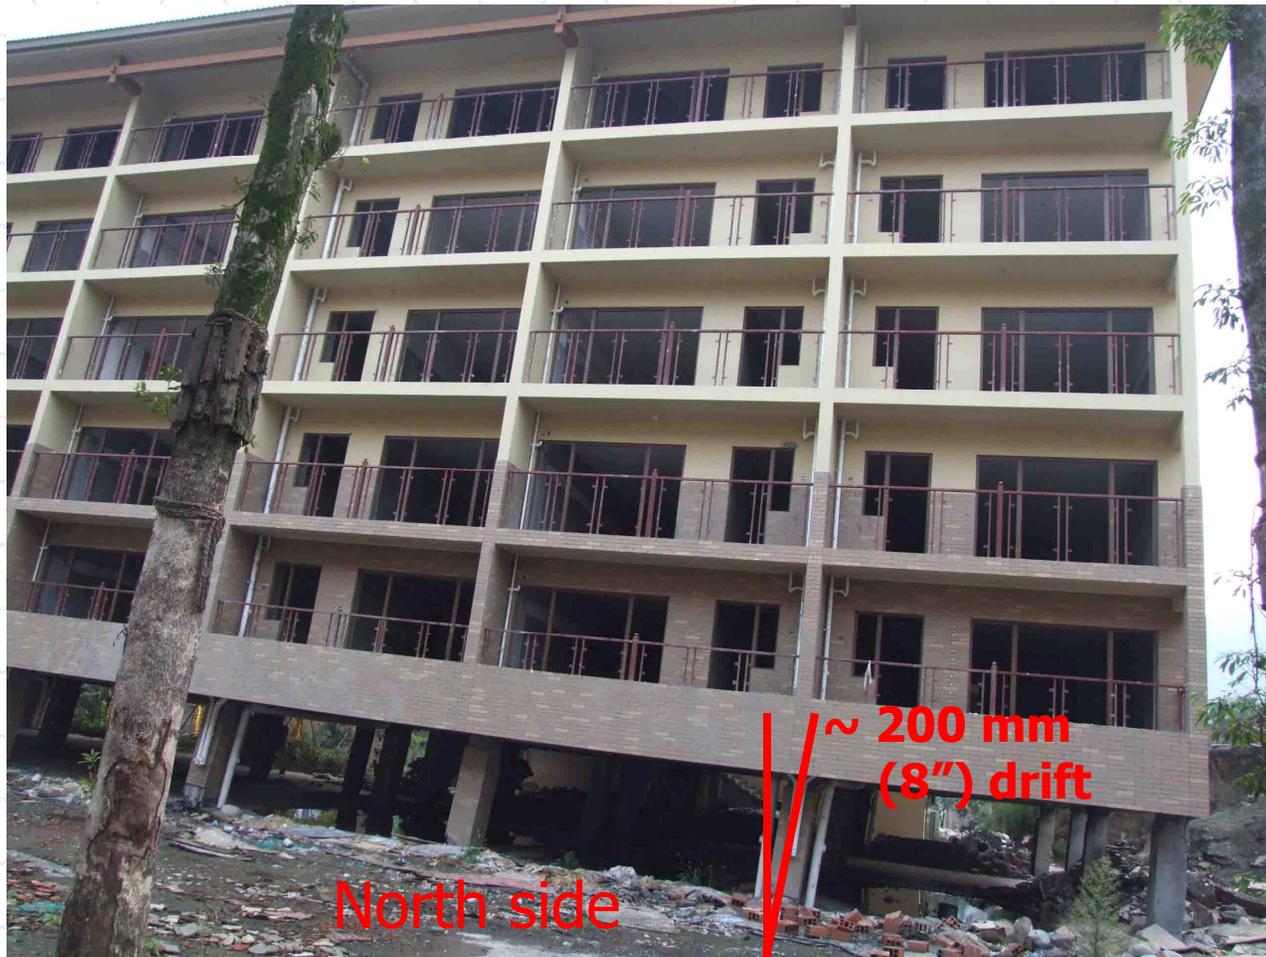
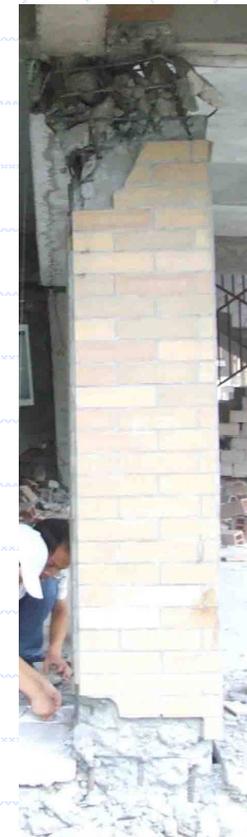
Building 1 (6 story with "open" parking in first story)

Column hinging

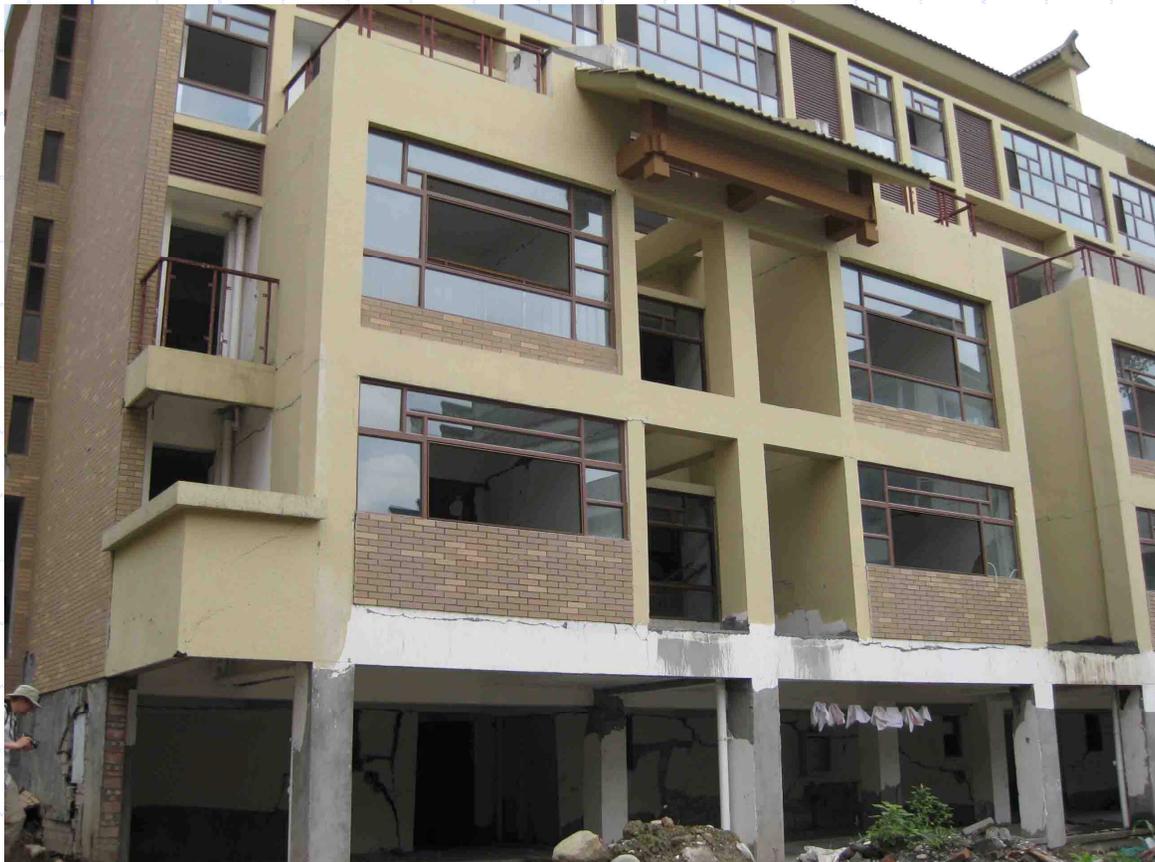
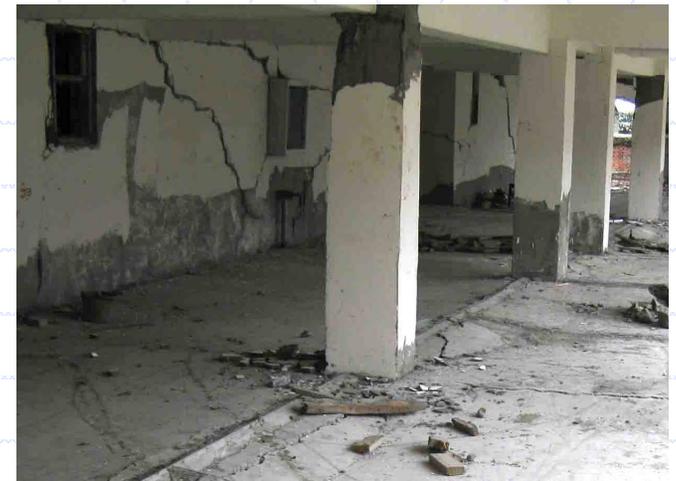
Building 2 (5 story some infill walls in first story)

First story infill cracking
