Reconnaissance Report on the China Wenchuan Earthquake May 12, 2008

*Chu-Chieh J. Lin, Associate Research Fellow of NCREE
Juin-Fu Chai, Research Fellow of NCREE*

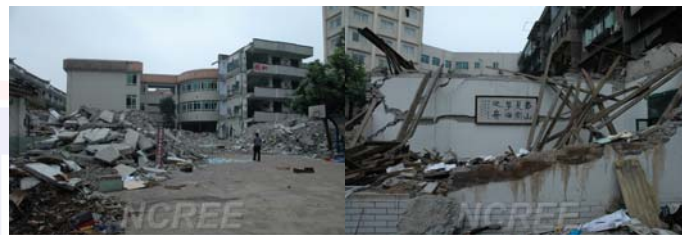
A significant number of casualties and injures in the rural areas were associated with the total collapse of the HRM and URM buildings. Figures 1 and 2 show the collapsed buildings of an elementary school at

Dujiangyan and figures show some commercial and residential buildings at Dujiangyan (3-8), Yingshow (9-10), and Mianzhu (11-12). Since there are no ductile elements to resist the lateral force caused by earthquake in the HRM and URM buildings, it usually caused total building collapses and made human losses and injuries.

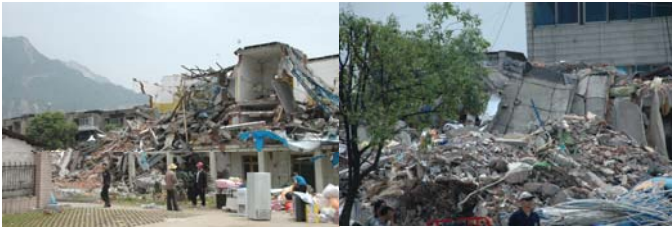
Figures 13-14 show the collapsed buildings of the 3rd People's Hospital at Hanwang township of Mianzhu. These four story HRM buildings collapsed during the earthquake when they supposed to be operated with

normal function to help people and save lives after this catastrophe.

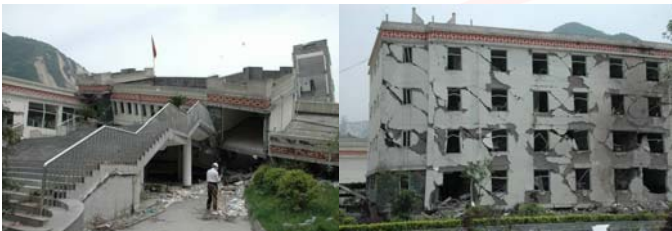
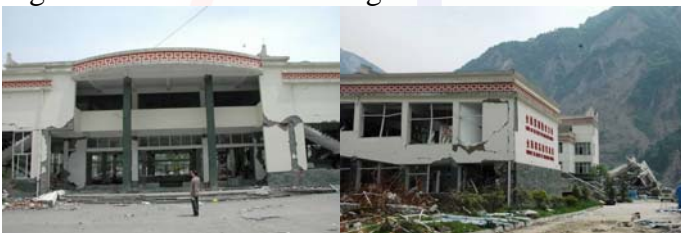
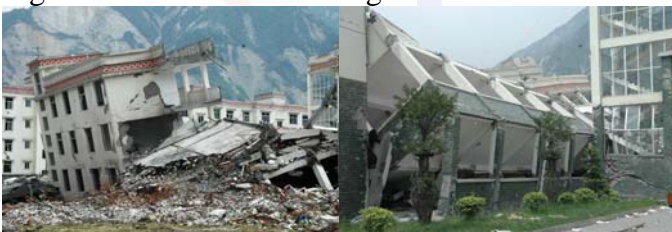
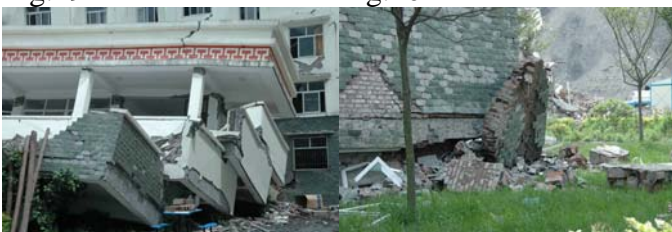
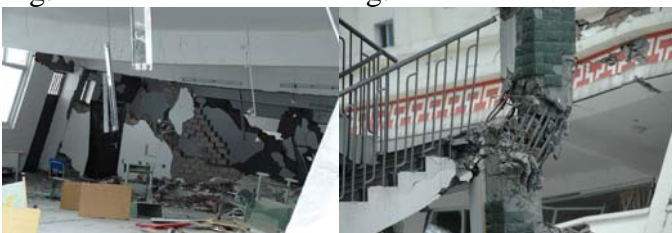
There are some engineered RC buildings suffered severe damages or collapsed, such as buildings of Hsuanko High School (HKHS) at Yingshow Township (Wenchuan county) near epicenter. Figures 15-24 show the damages of HKHS including the details of some RC members.

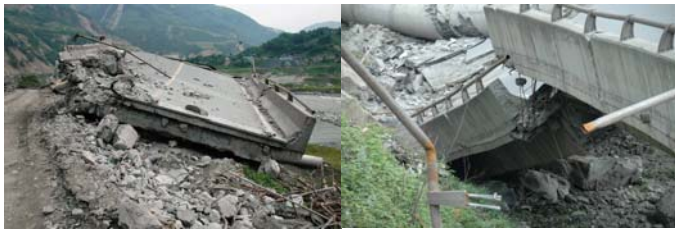
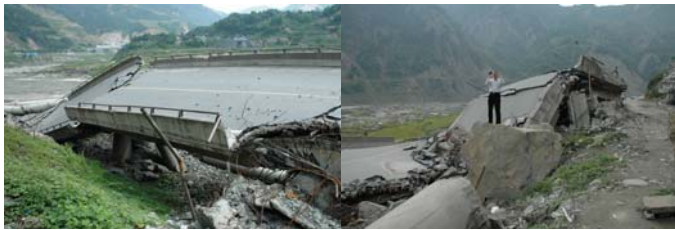
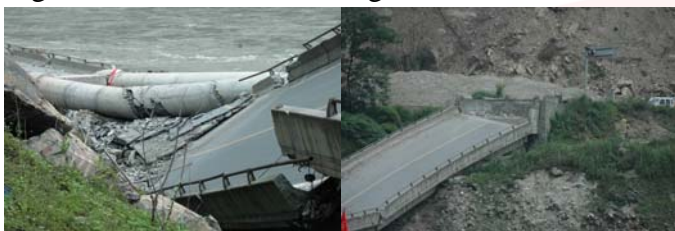
Baihwa Bridge is a 500 m long viaduct with 30 m height, and plays a critical role on the route from Dujiangyan to Wenchuan. Construction finished in 2004, Baihwa Bridge is a RC slab beam continuous bridge supported by twin column pier with cap beam on expansion joint and twin column without cap beam at other places. As shown in figures 33-38, there are about 50 m long bridge slab collapsed on the location of the turning section after earthquake. Due to the safety reason, the un-collapsed part of Baihwa Bridge is exploded to reduce the threat to the emergency path underneath the bridge.

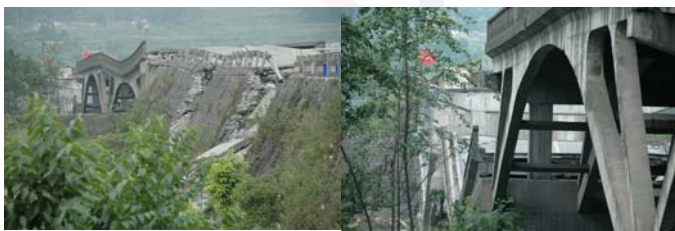
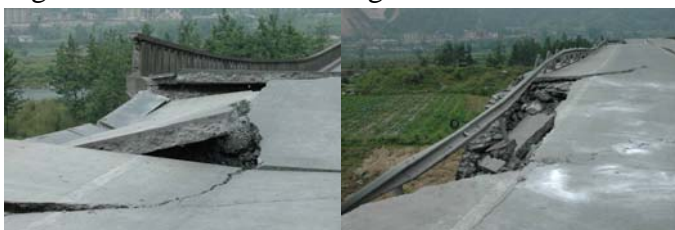
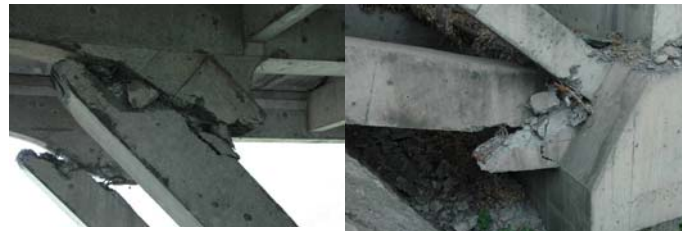
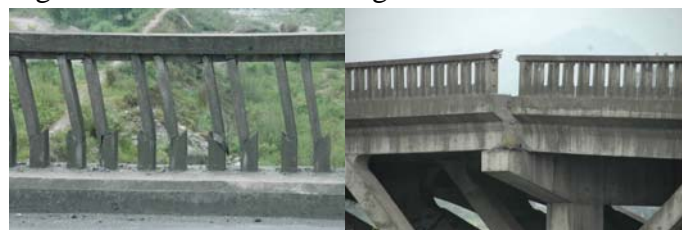
As shown in figures 39-46, Hsiaoyudong Bridge was a four-span RC arch bridge. The strong motion of the earthquake caused two spans of Hsiaoyudong Bridge collapsed and severely damaged the rest of the spans. The destruction of the embankment, abutment and the barrier, the buckling of the arch, as well as the shifting of the road surface are also observed to witness the enormous pressure of the strong earthquake motion.

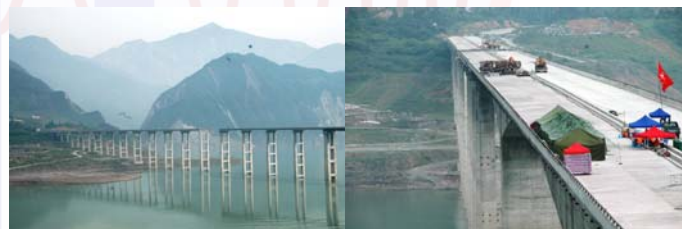
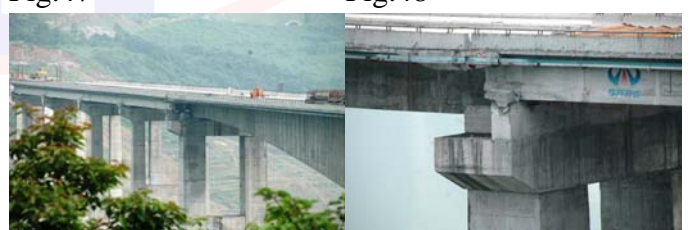
Miaotzuping Bridge is located at the water reservoir area (Zipingdu dam) near Dujiangyan, as shown in figures 47-50. This beautiful bridge is 1436 m long with 100 m height composed of main bridge (long span box girder bridge) and 19 approaches (T-girder bridge). The construction of the bridge is completed but not opened to traffic yet. There are shifting on both longitudinal and horizontal directions causing the damages of side stoppers. Besides, the earthquake caused one of the T-girder approaches collapsed due to possible insufficient support length of cap beam for falling prevention.
