ASCE-41 Evaluation of a Reinforced-Concrete Building Damaged in the 2016 Meinong Earthquake

Andrew D. Sen, Jakob Sumearll, Dawn E. Lehman, and Laura N. Lowes

University of Washington – ATC-134 Project

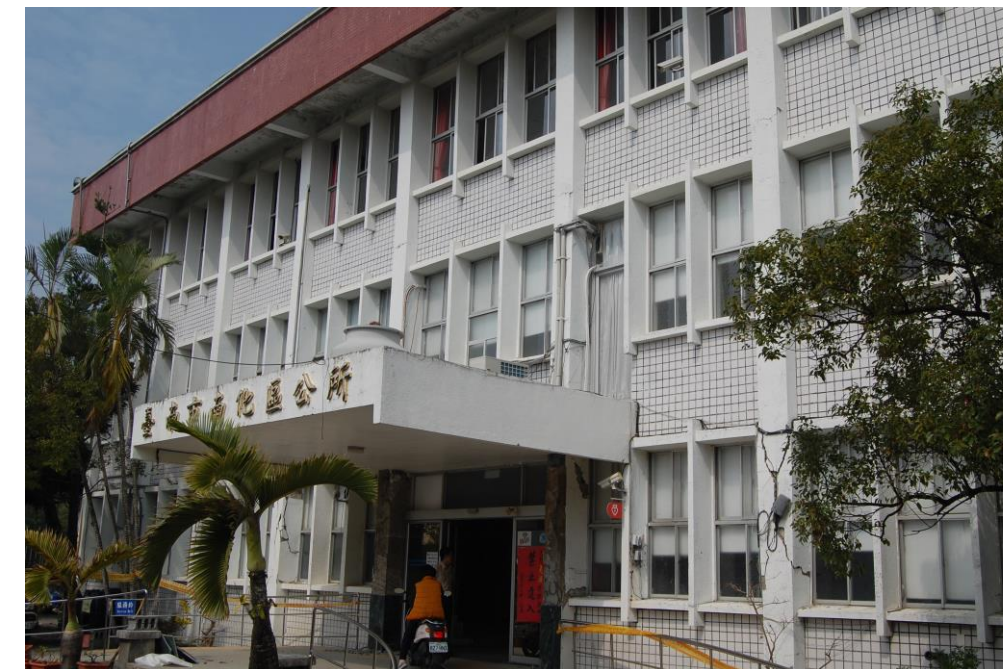
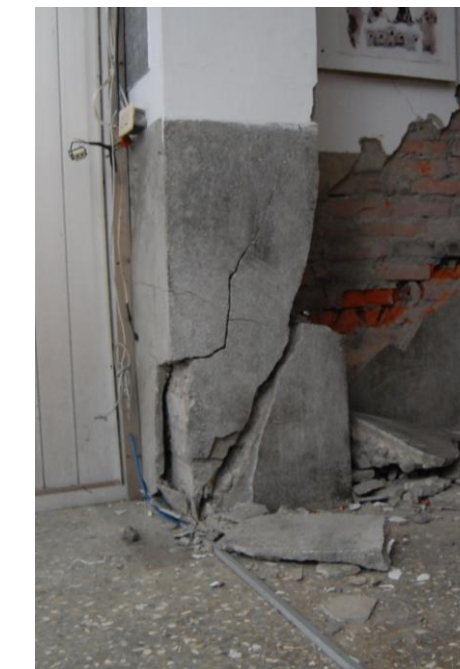
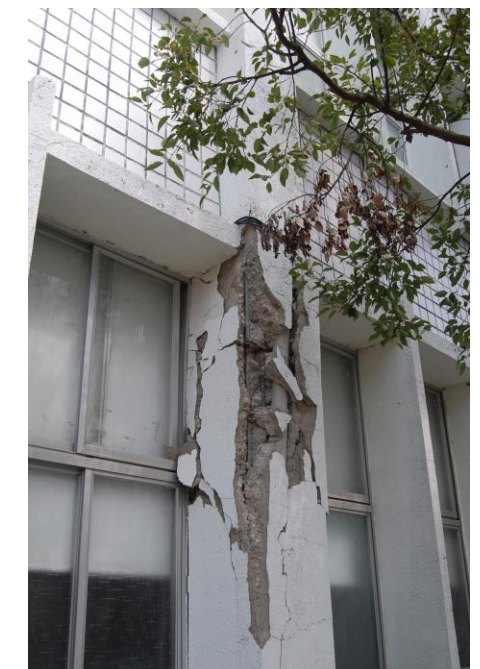
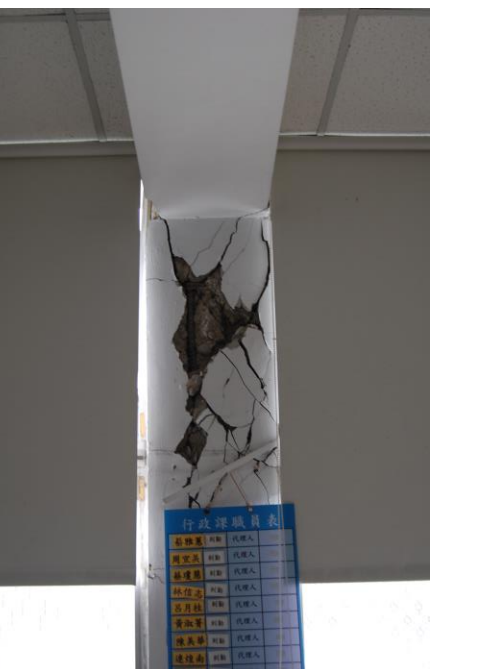
- > M6.4 earthquake occurred in southern Taiwan near the city of Tainan on February 6, 2016
- > Significant damage to reinforced-concrete buildings, particularly moment-resisting frames with masonry infill
 - > Several major collapses
 - > 3 district offices damaged, including Nanhua District Office (1967):

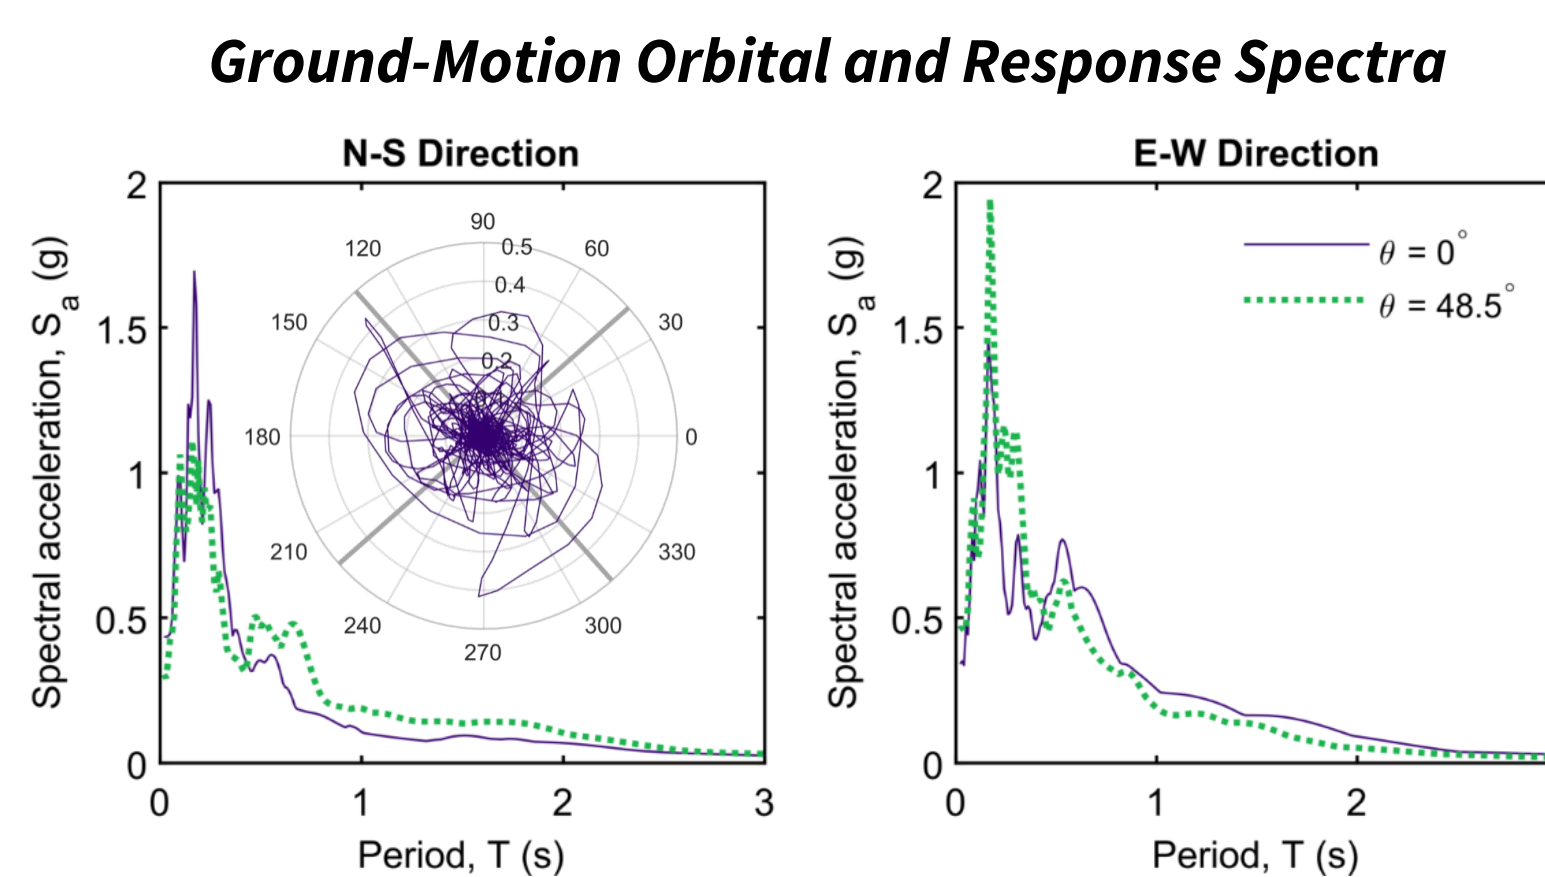
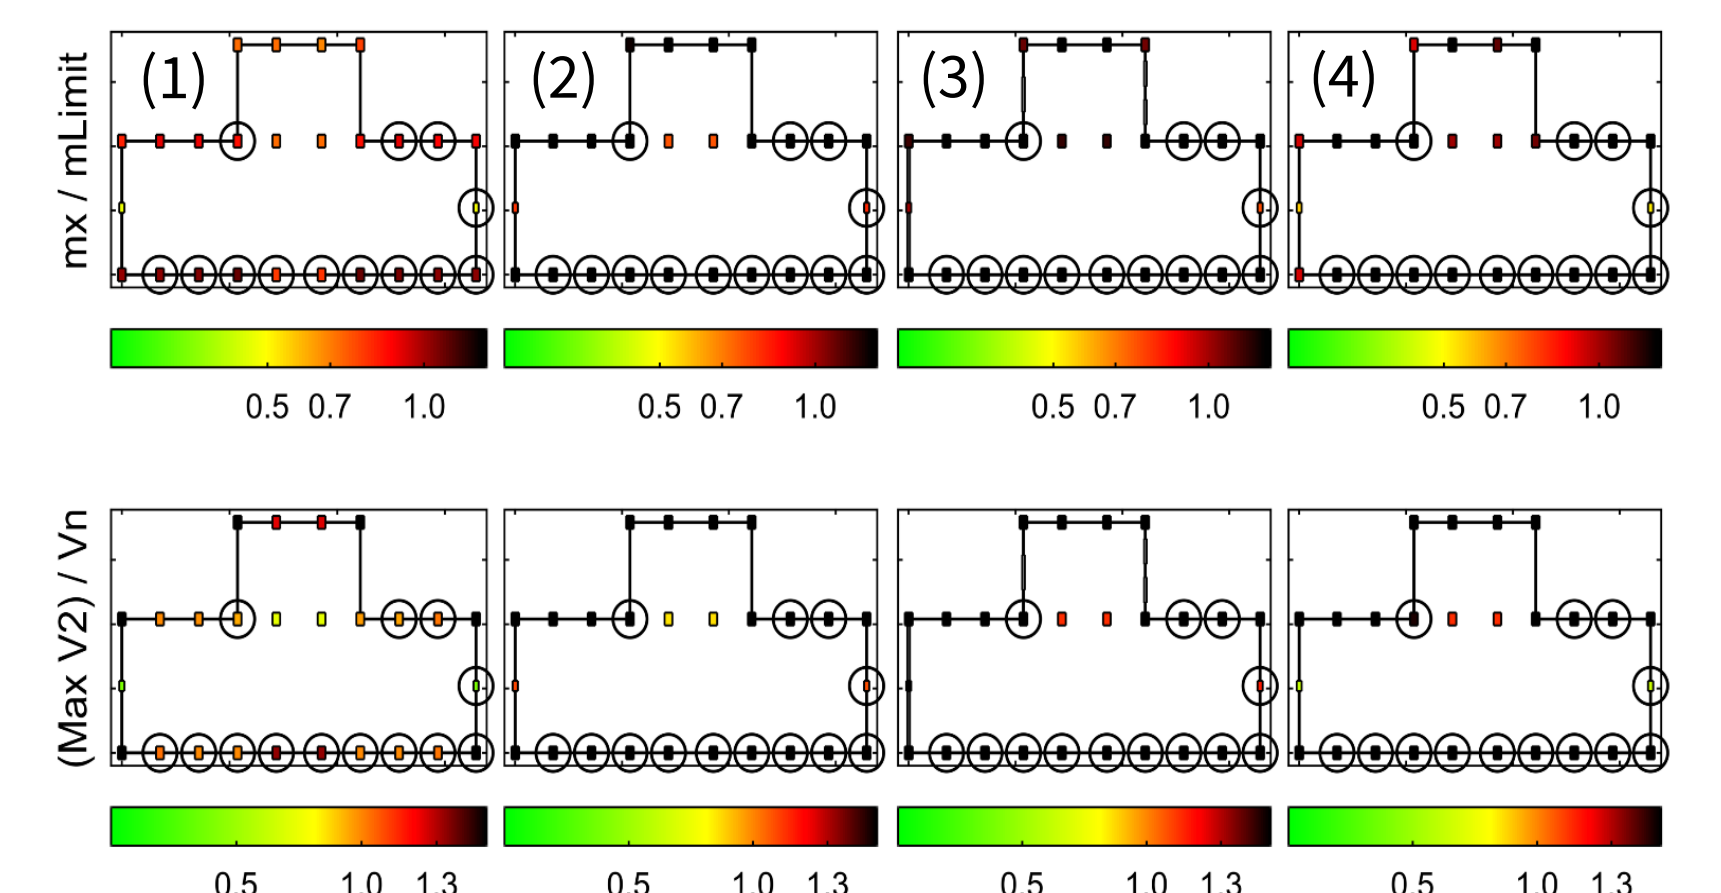
- > Analyses performed in SAP2000 using four model variations
- > Ground motion is closest to building and captures forward-directivity effects
- > Results:
 - > Variation in response of models is not significant
 - > Predicted damage modes inconsistent with observations

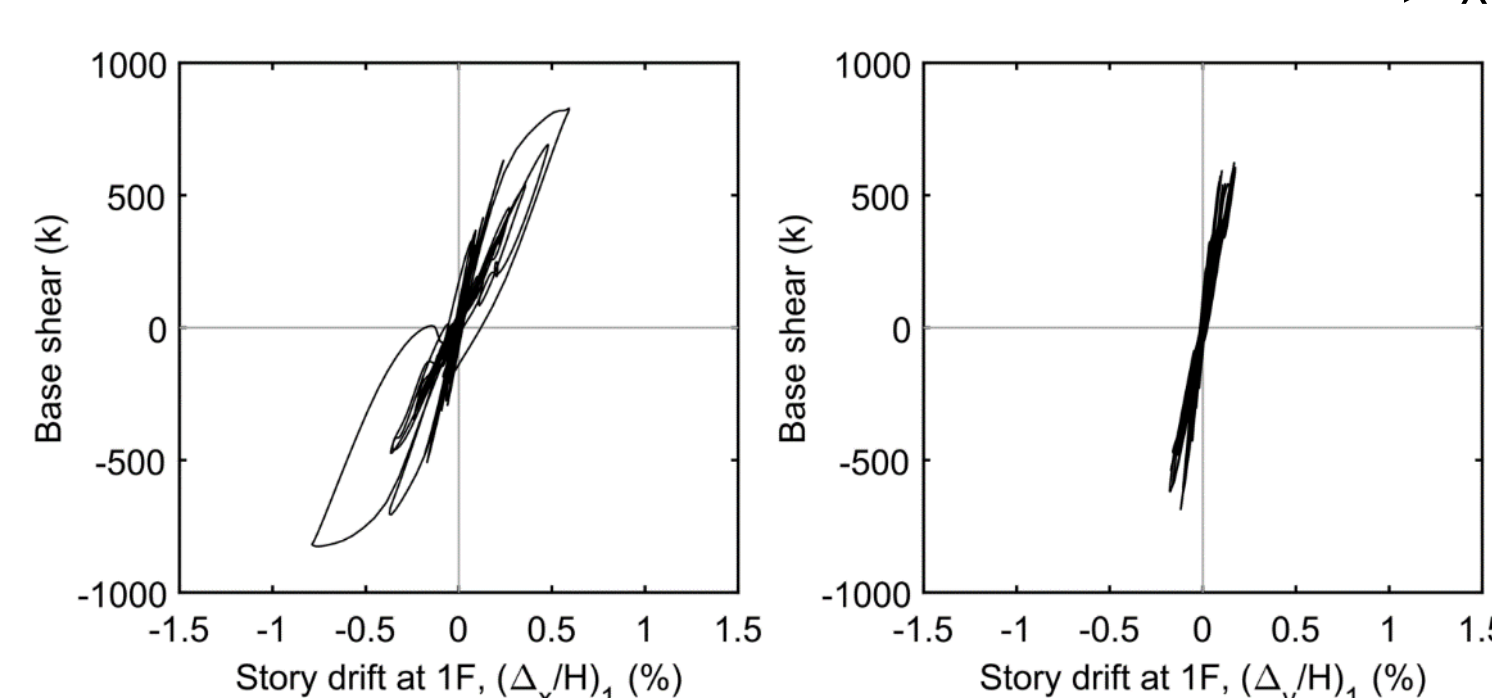
First-Story Hysteretic Response

- > Columns yield but do not sustain shear or flexure-shear degradation
- > Acceptance criteria for life safety exceeded in several cases
- > In contrast to linear analysis but in concert with post-earthquake reconnaissance, predicted damage only in longitudinal (X) direction of building
