Experimental Seismic Test of Drywall Partition Walls with Improved Detailing for Damage Reduction

NHERI TallWood

Student Investigators: Hamed Hasani, University of Nevada Reno
Principal Investigator: Keri Ryan, University of Nevada Reno
Natural Hazard Engineering Research Infrastructure, Lehigh Equipment Facility

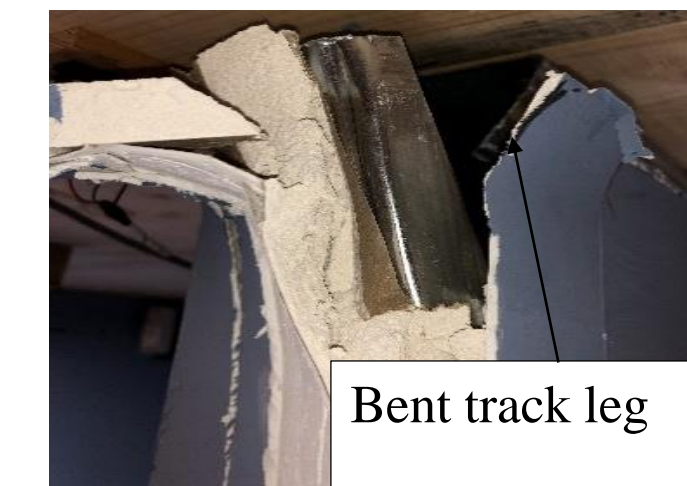
3.2% drift

Slip-track detailing:

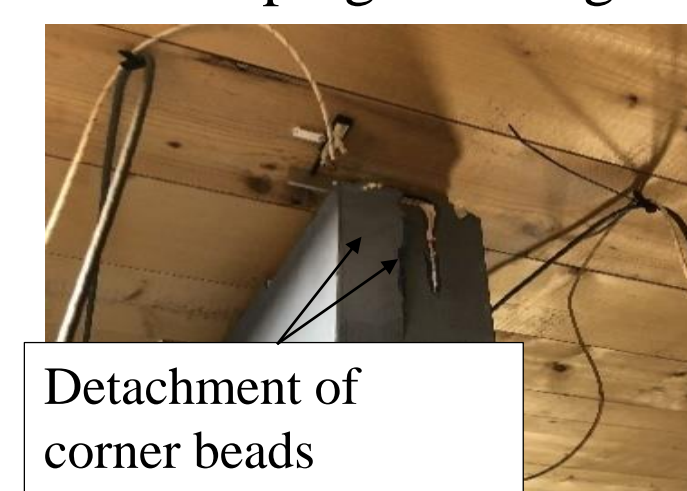
1.64% drift

Telescoping detailing:

Telescoping detailing can eliminate damage to the framing of the drywall partition walls, and out of plane drift did not affect the in-plane resistance considerably.

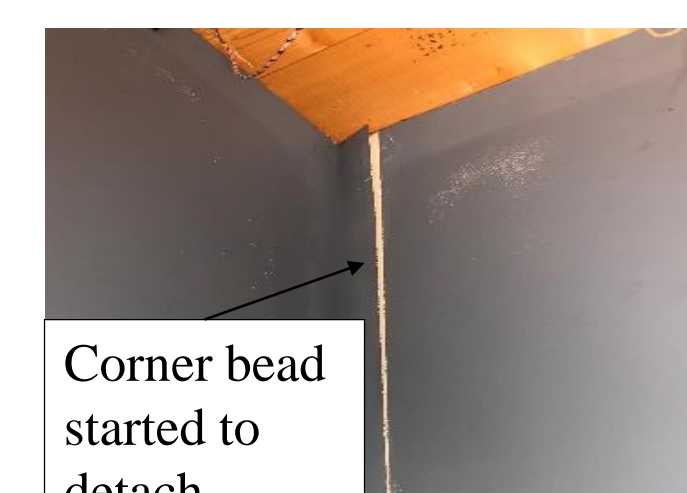
0.43% drift

Corner gap detailing:

In corner gap detailing, although the sacrificial corner beads detached at low drifts, wall itself was damage free until high drifts.

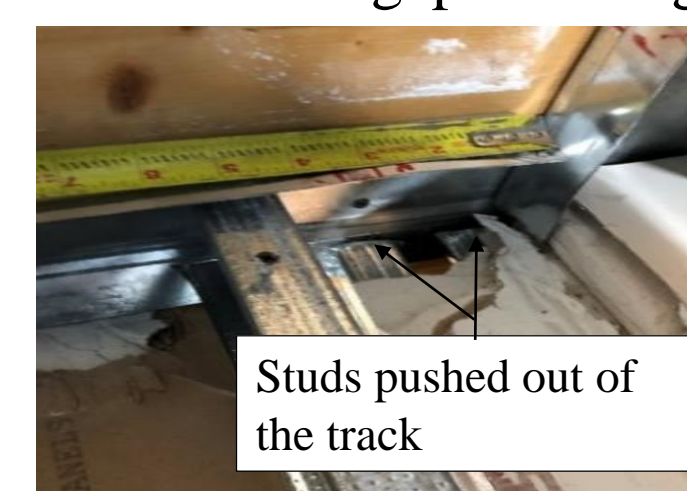
After test fire-rated

In distributed gap detailing, only the expansion joints adjacent to the wall intersections were effective, and delayed the damage to about 1% drift.

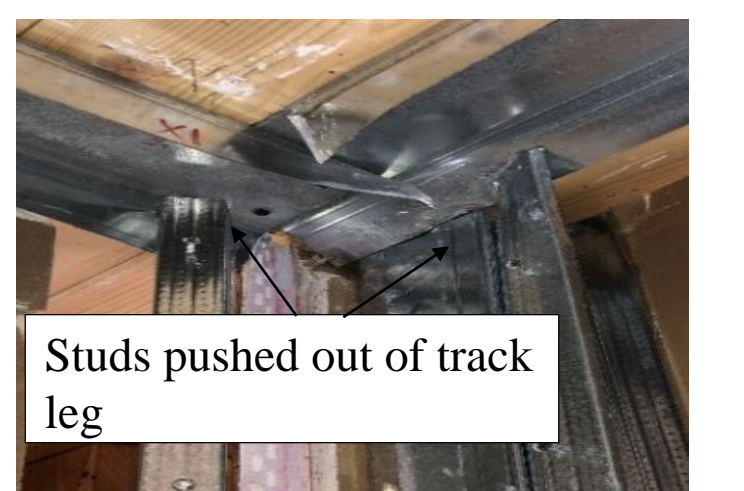
After test non-fire-rated
