Reconnaissance Report

2016/02/06 Meinong Earthquake, Kaohsiung, Taiwan
Main damage area: Tainan

Prepared by **Yi-Hsuan Tu**
Associate Prof., Dept. of Architecture,
National Cheng Kung University, Taiwan
2016/02/07

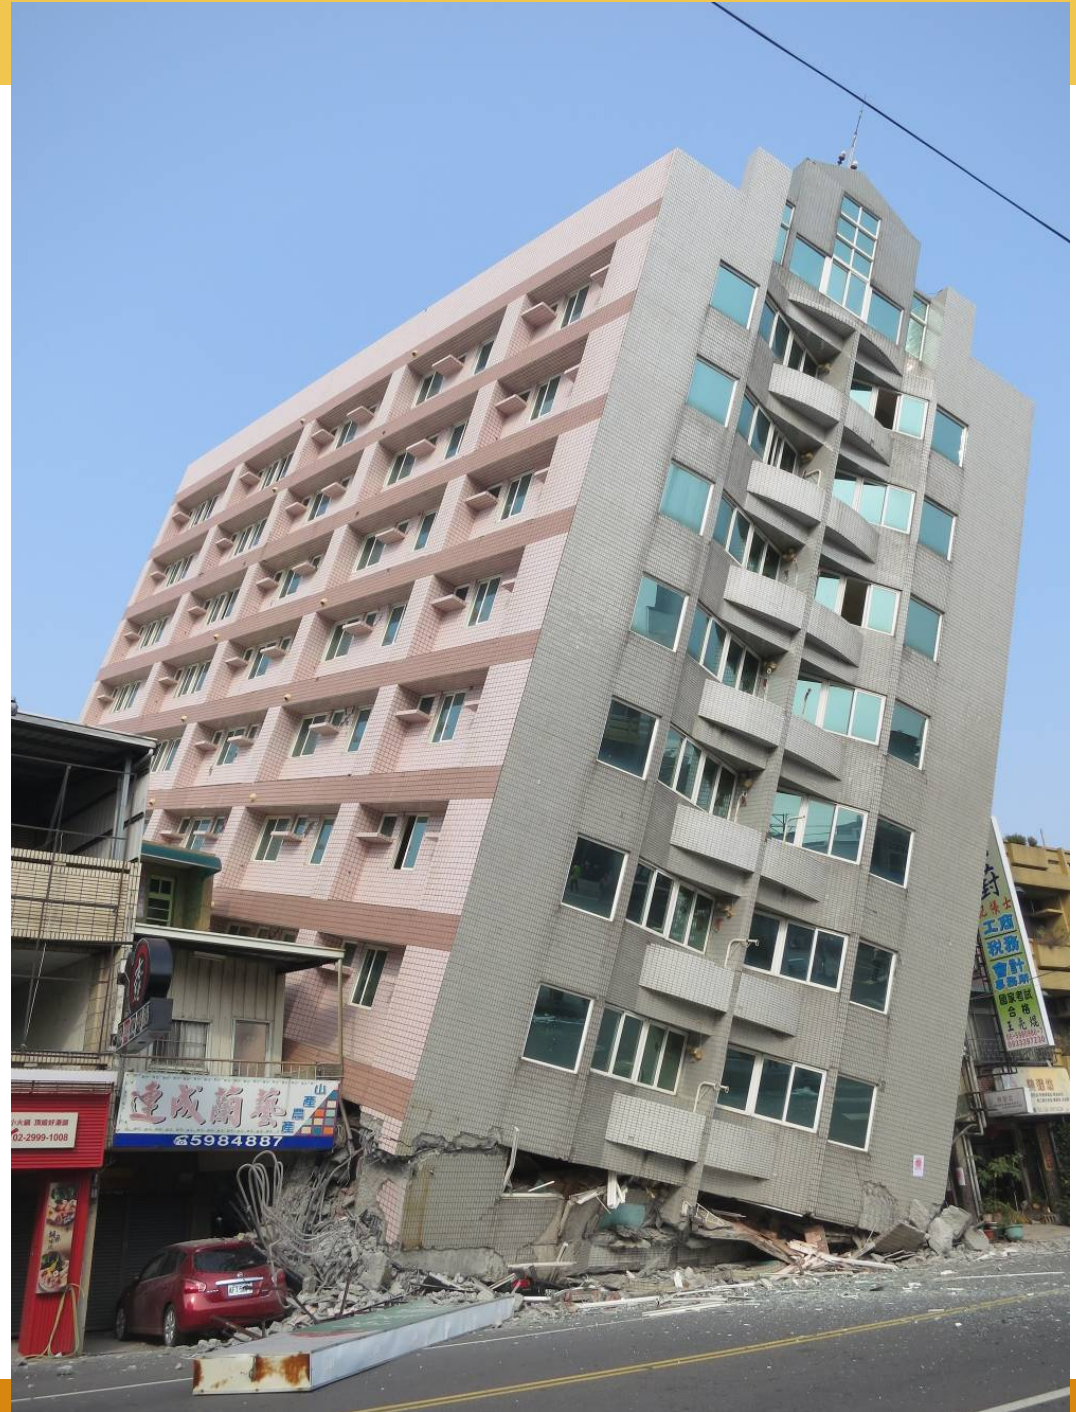
■ King's Town Bank

10 stories with 1-story
basement

About 20 years old

1F-3F collapsed and
inclined to the street side

1F-3F: Bank and office

Above 4F: rental suites

(not occupied so no
casualties reported)

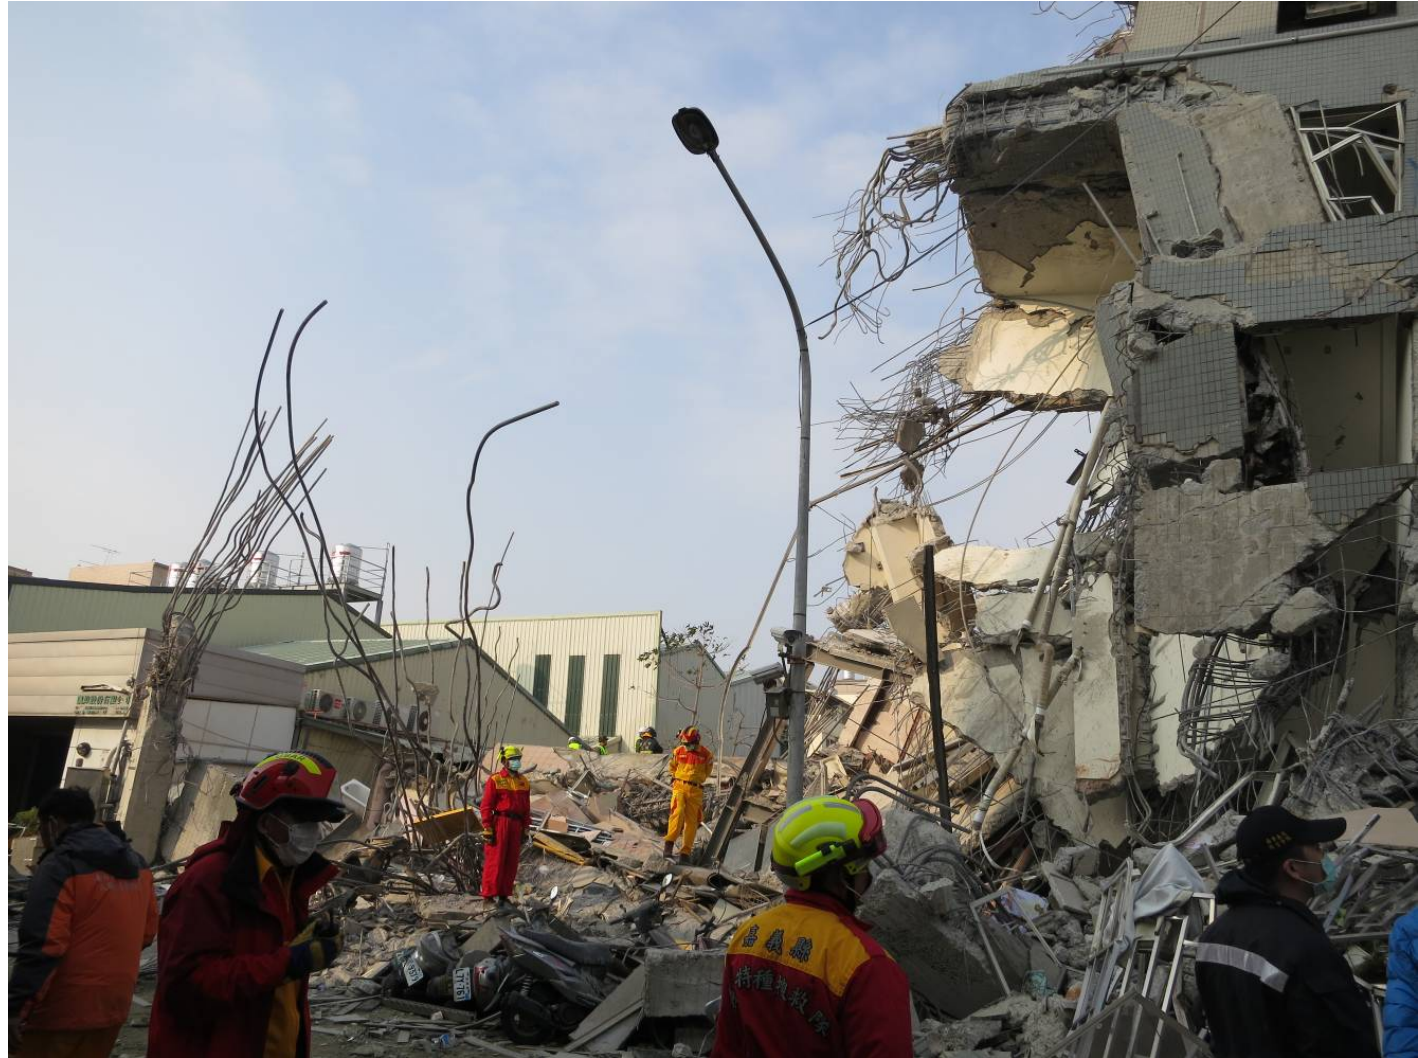
■ Weiguan building

16 stories with 1-story basement

About 16 years old

Collapsed and overturned to the street side

1F-2F: commercial
(big electronic store)

Above 3F: residential

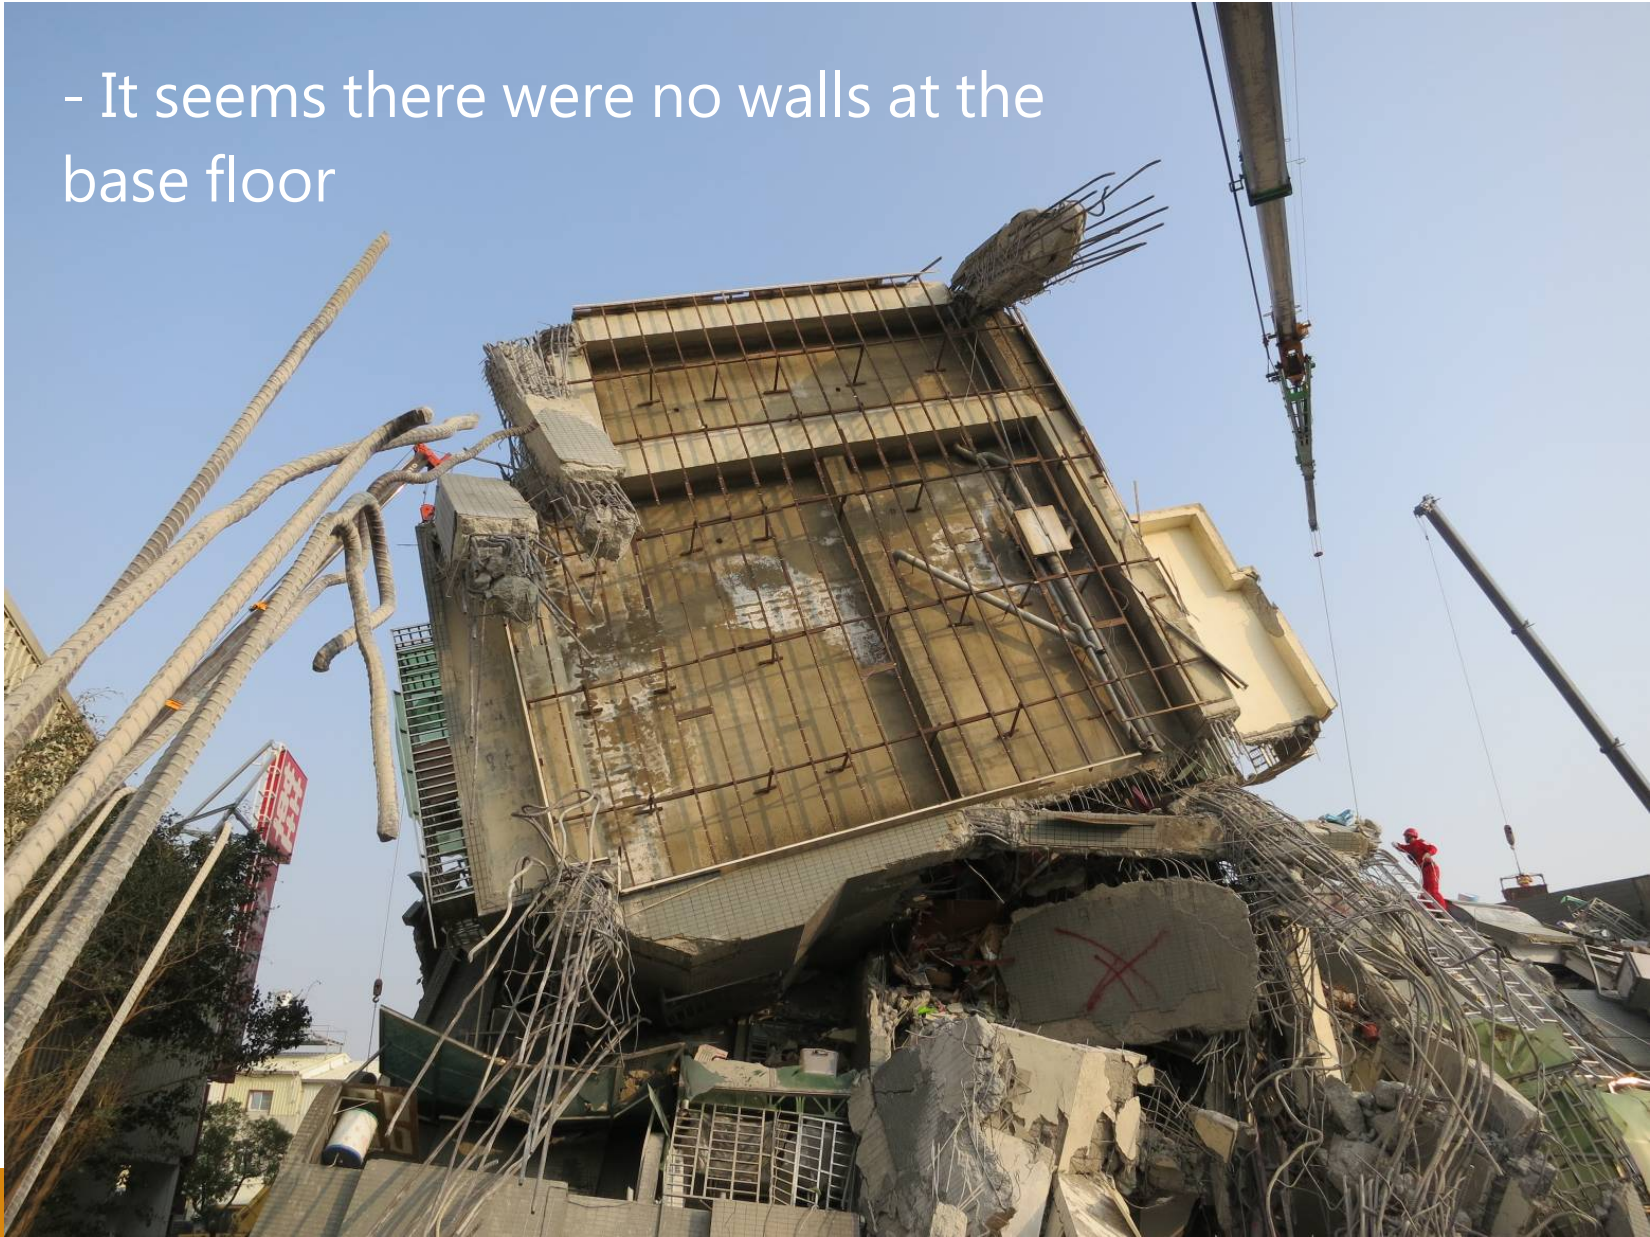
■ Weiguan building

- It seems there were no walls at the base floor

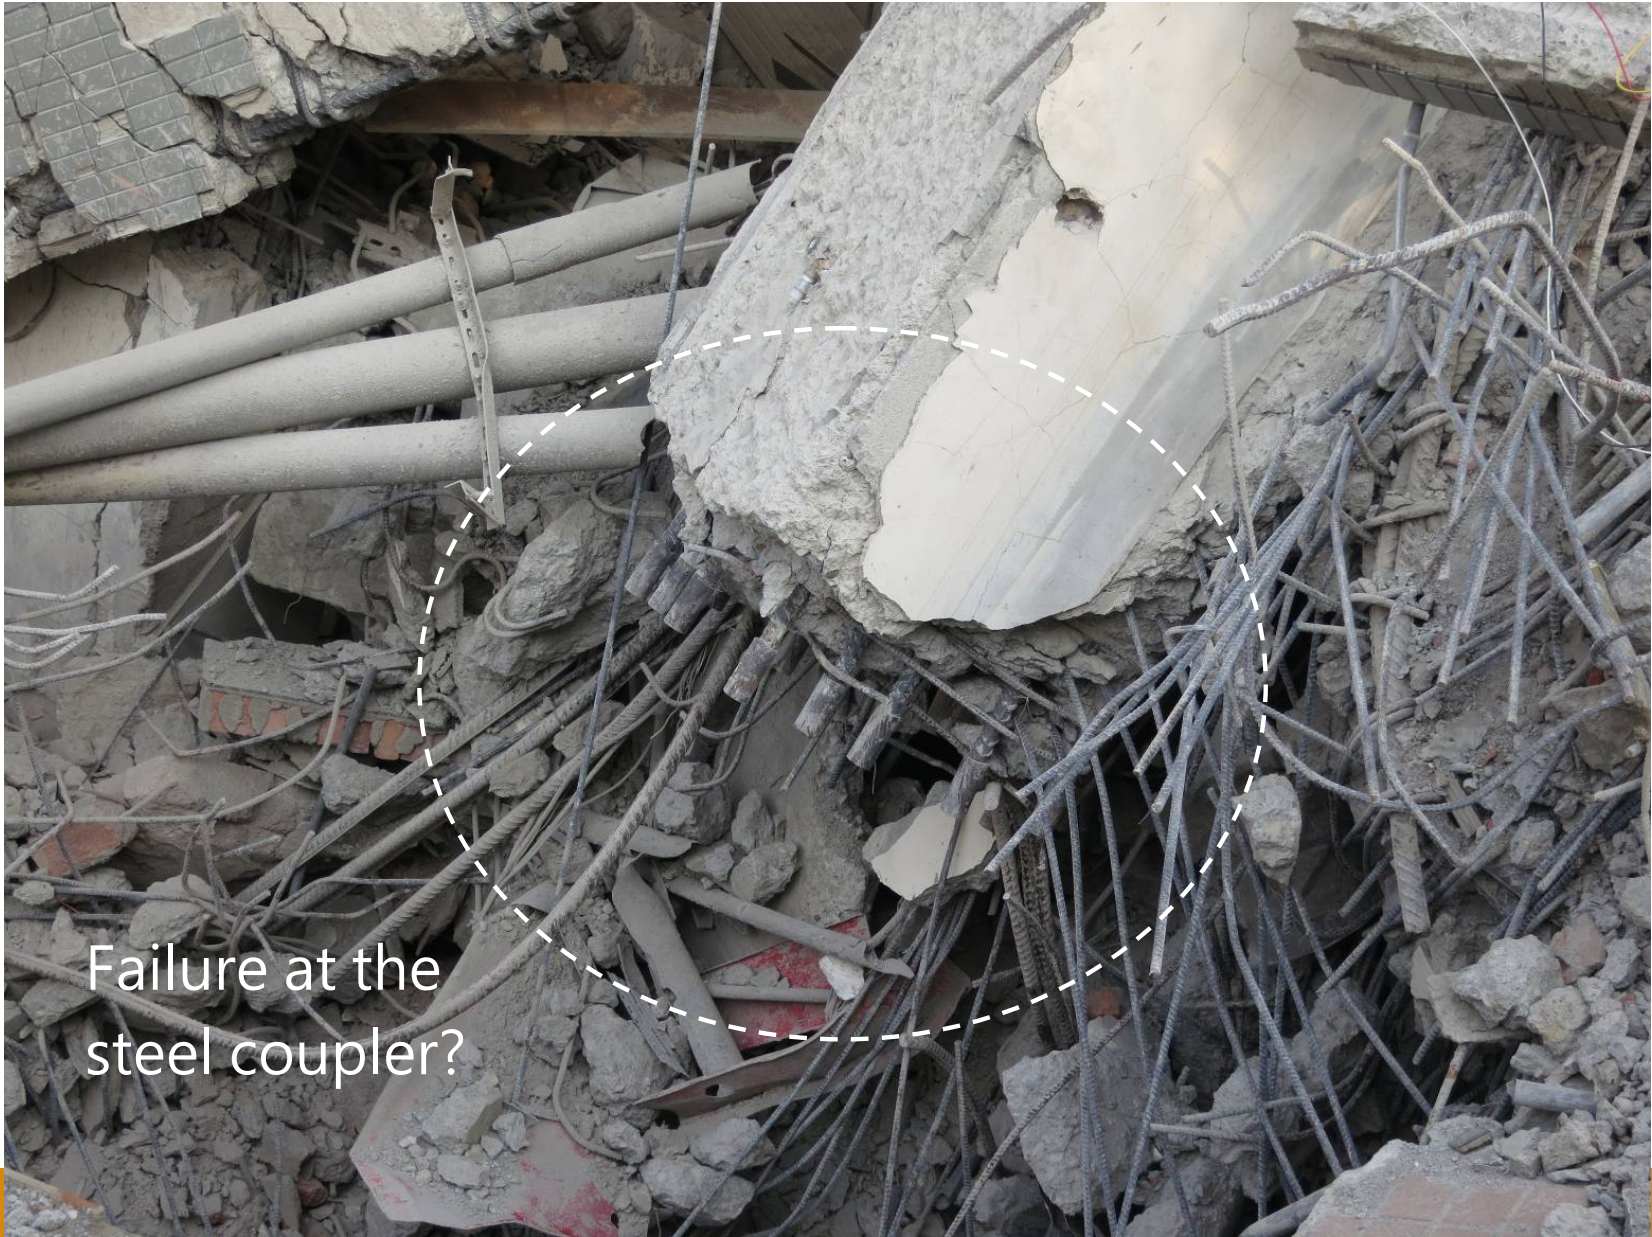
■ Weiguan building

Failure at the
steel coupler?

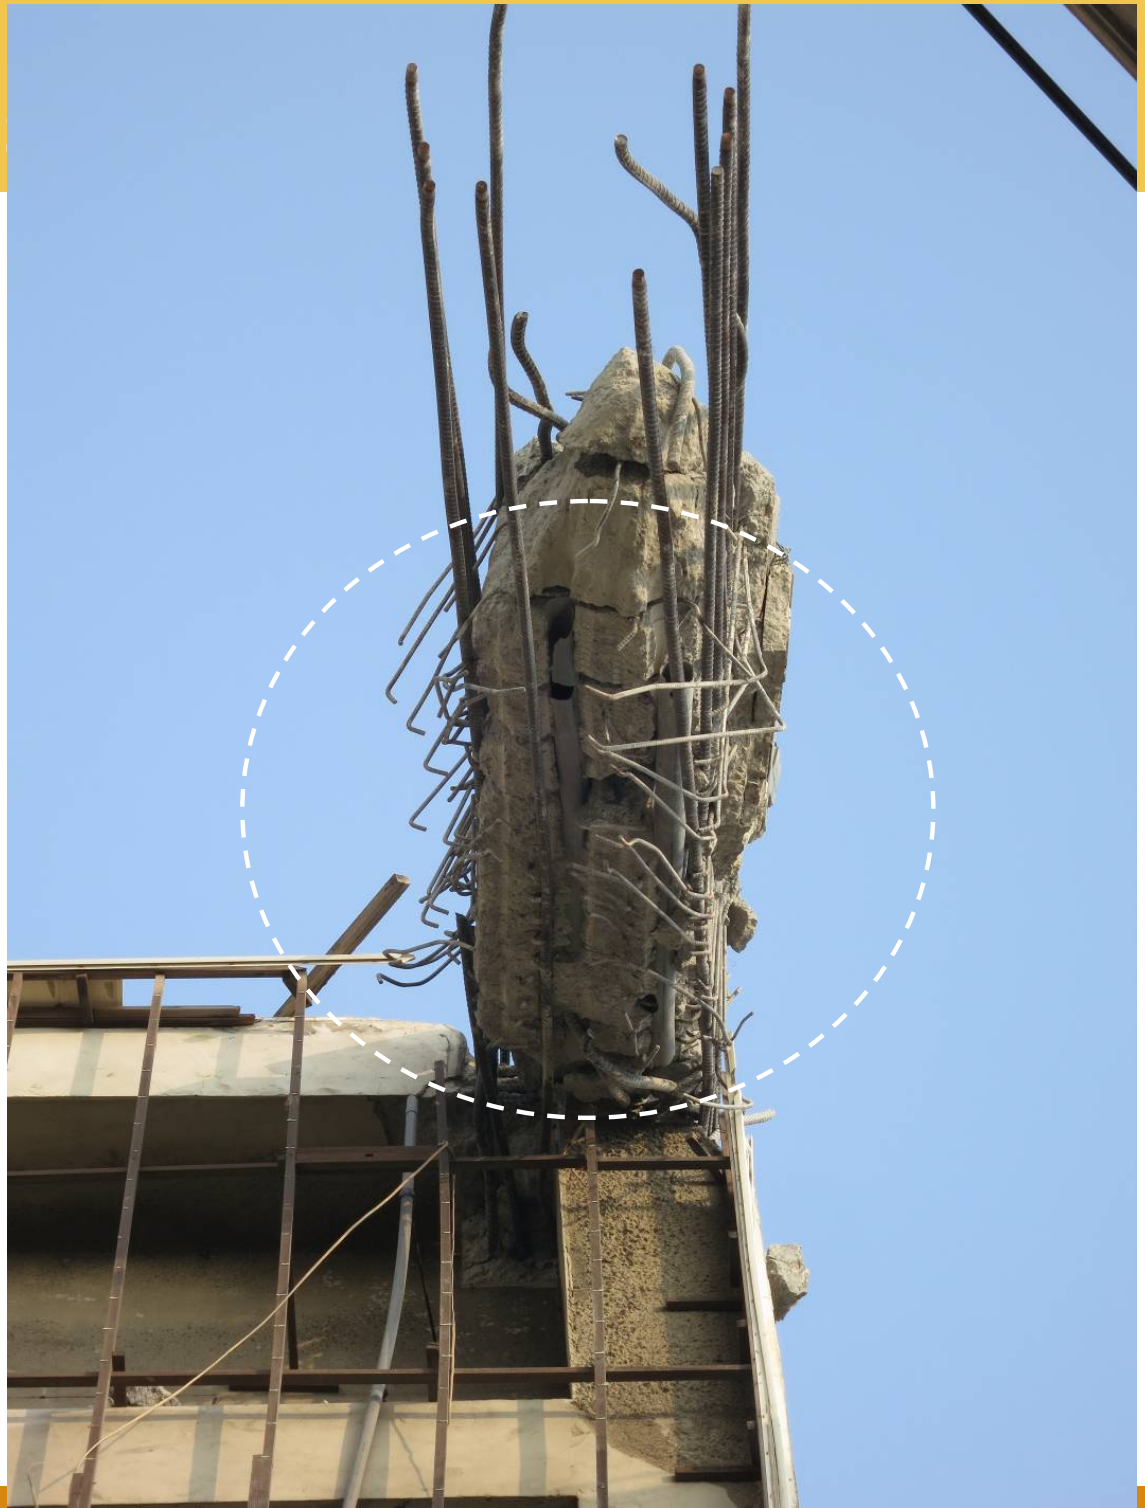
■ Weiguan building

90-degree bend hooks were allowed to use before Chi-Chi earthquake. However the hooks drew the attention of the public opinion and is blamed for the collapse.

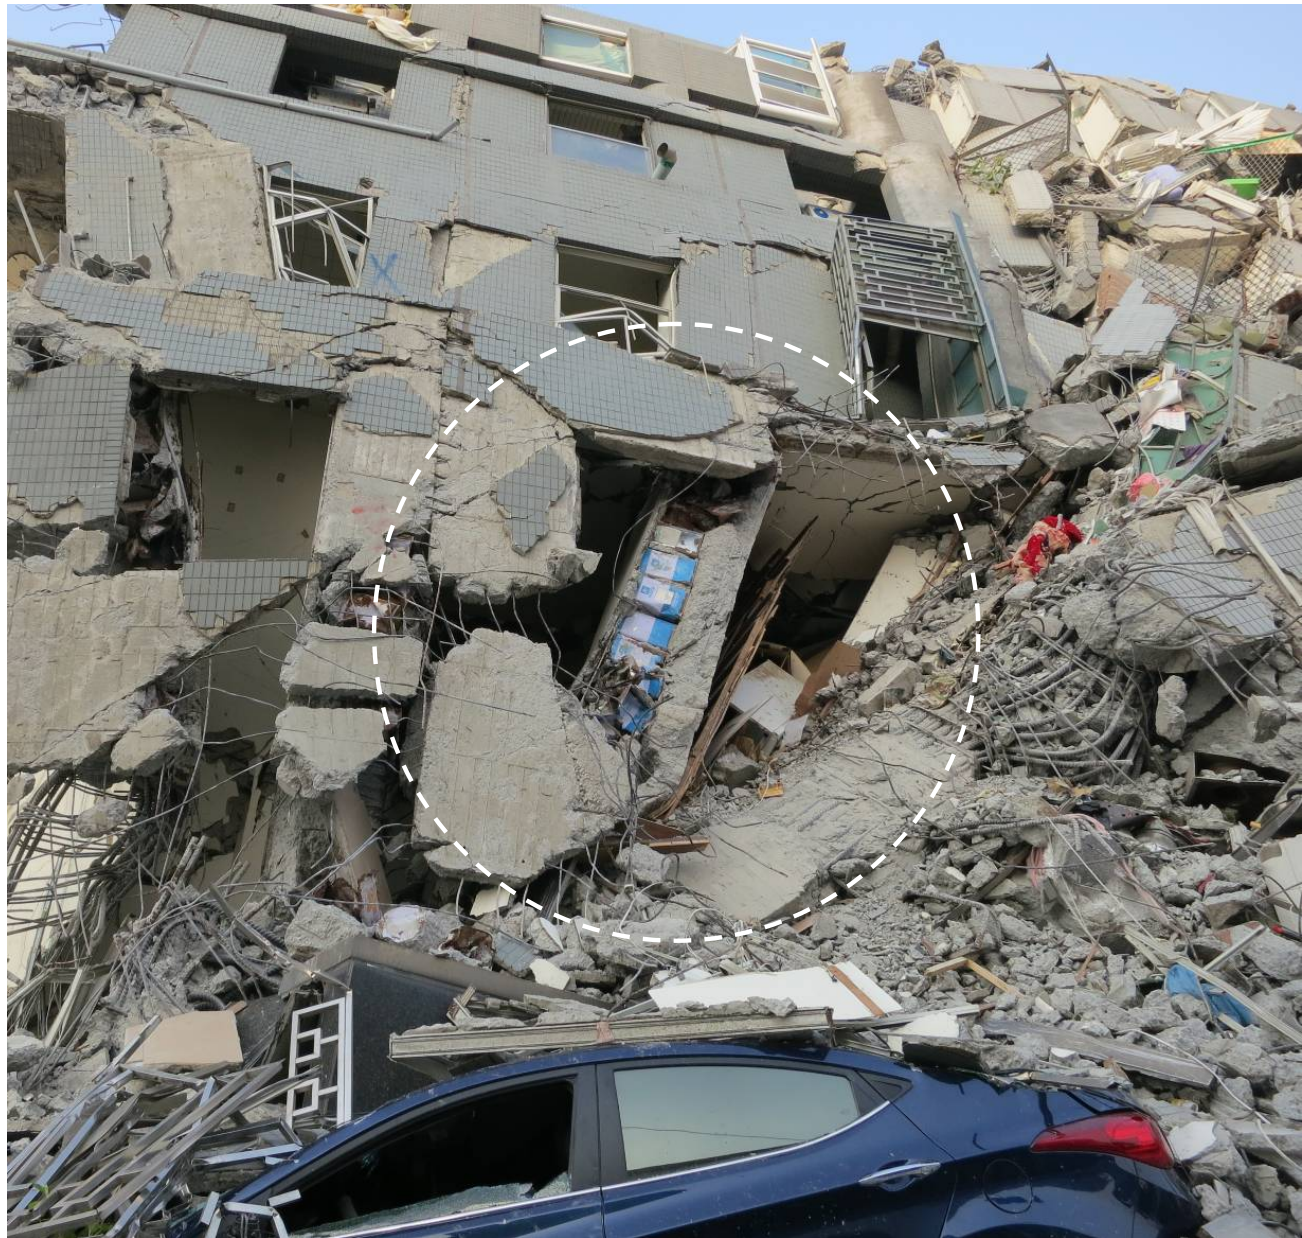
■ Weiguan building

Used oil tanks cast in the concrete were used as inside formwork of non-structural façade to reduce the weight. Some local media mistook this for jerry-building.

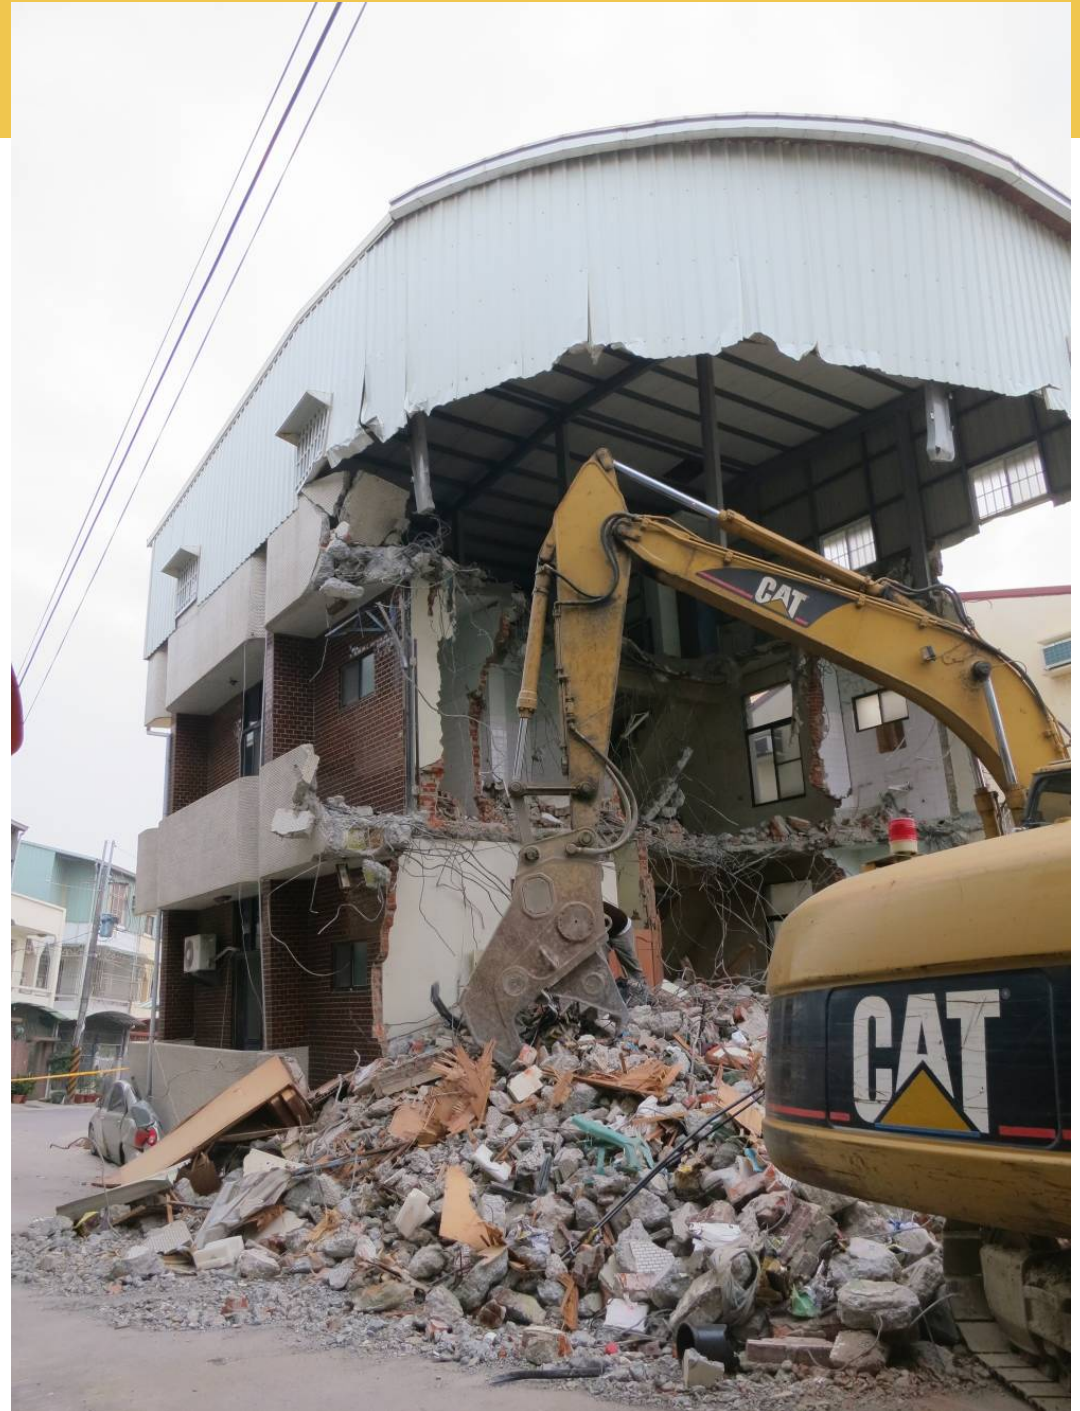
■ Street Building

3 stories + 1-story rooftop
additions

37 years old

Collapse at the ground
floor

The upper stories were
intact. It was demolished
for safety reason.

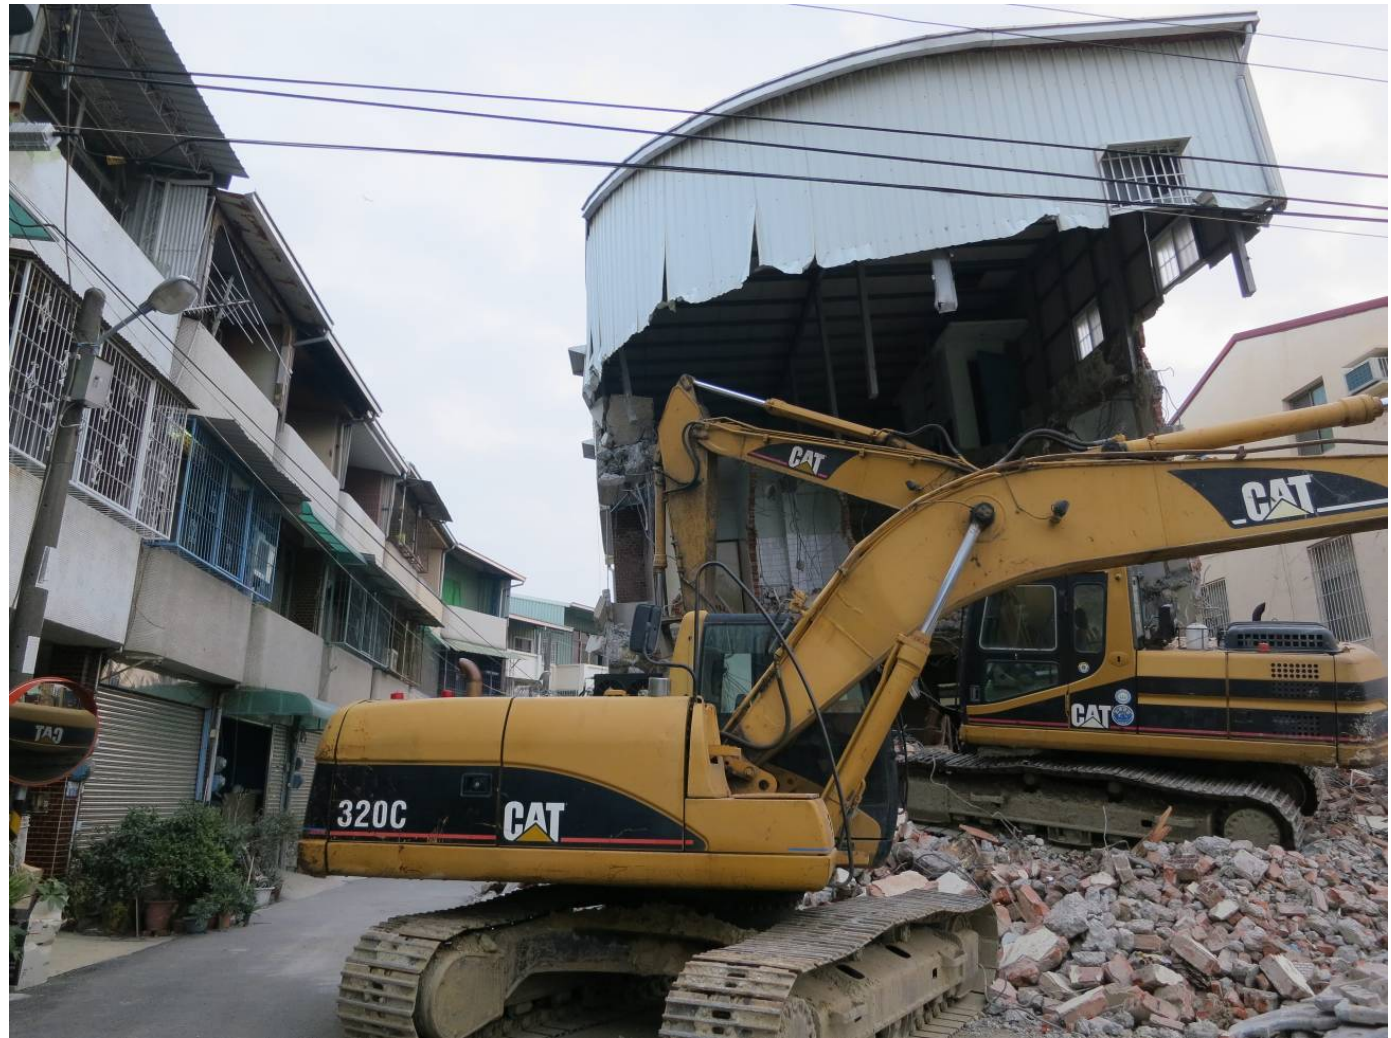
■ Street Building

The 2+1F buildings at the left side were built at the same time and they are intact.

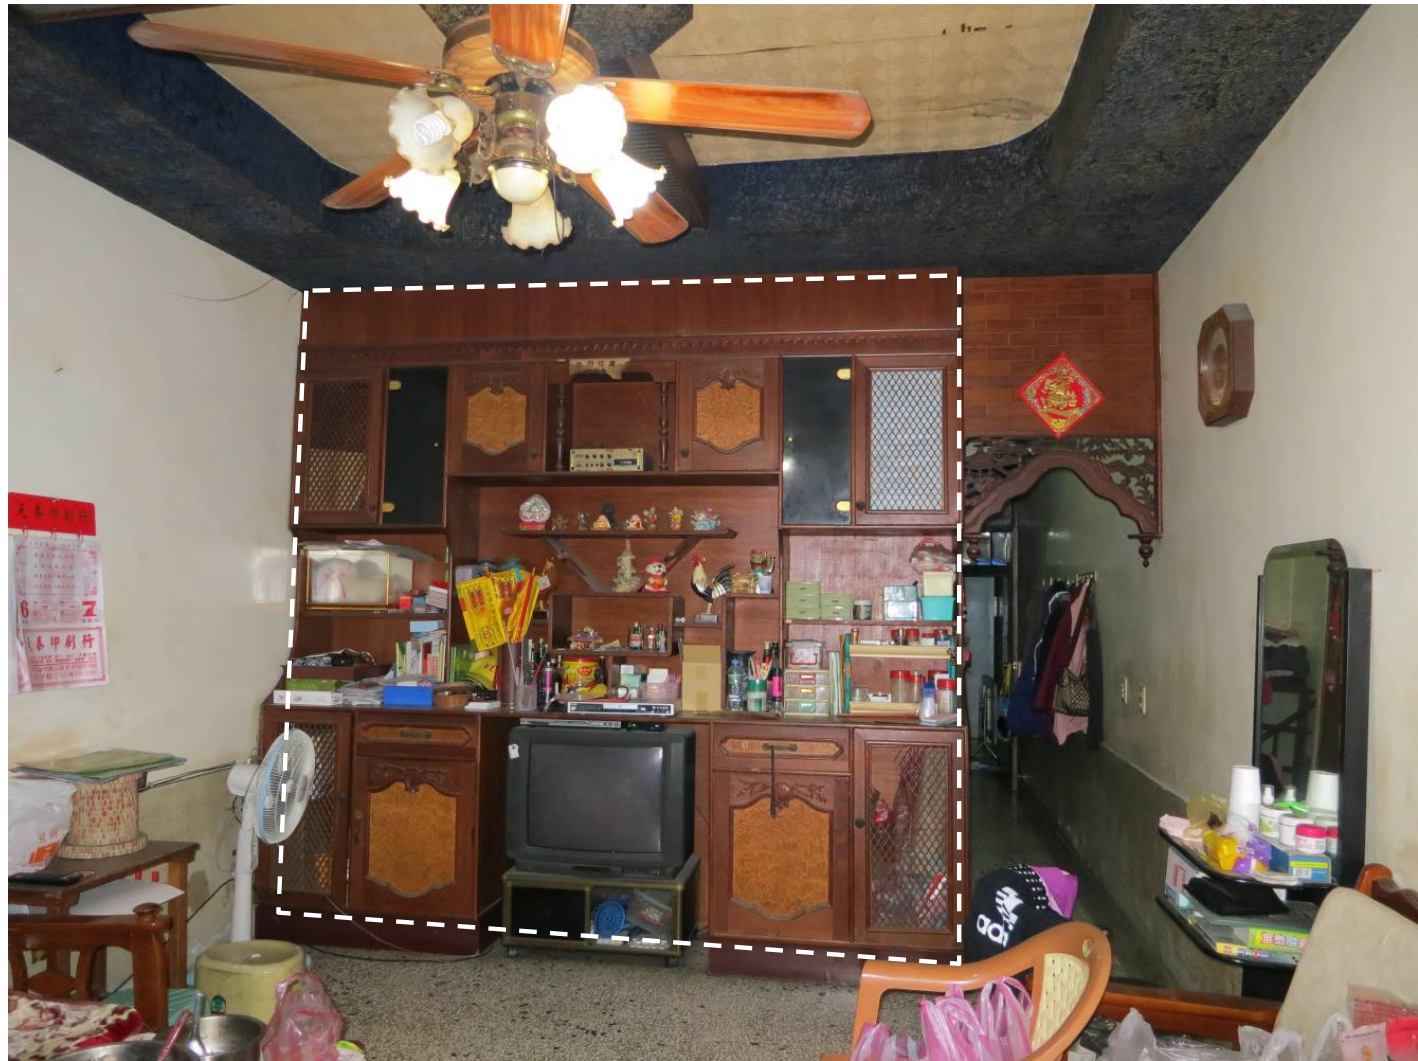
■ Street Building

The intact neighbor buildings are lower and have partially confined masonry panels (behind the closet and adjacent to the stairs) at the base floor.

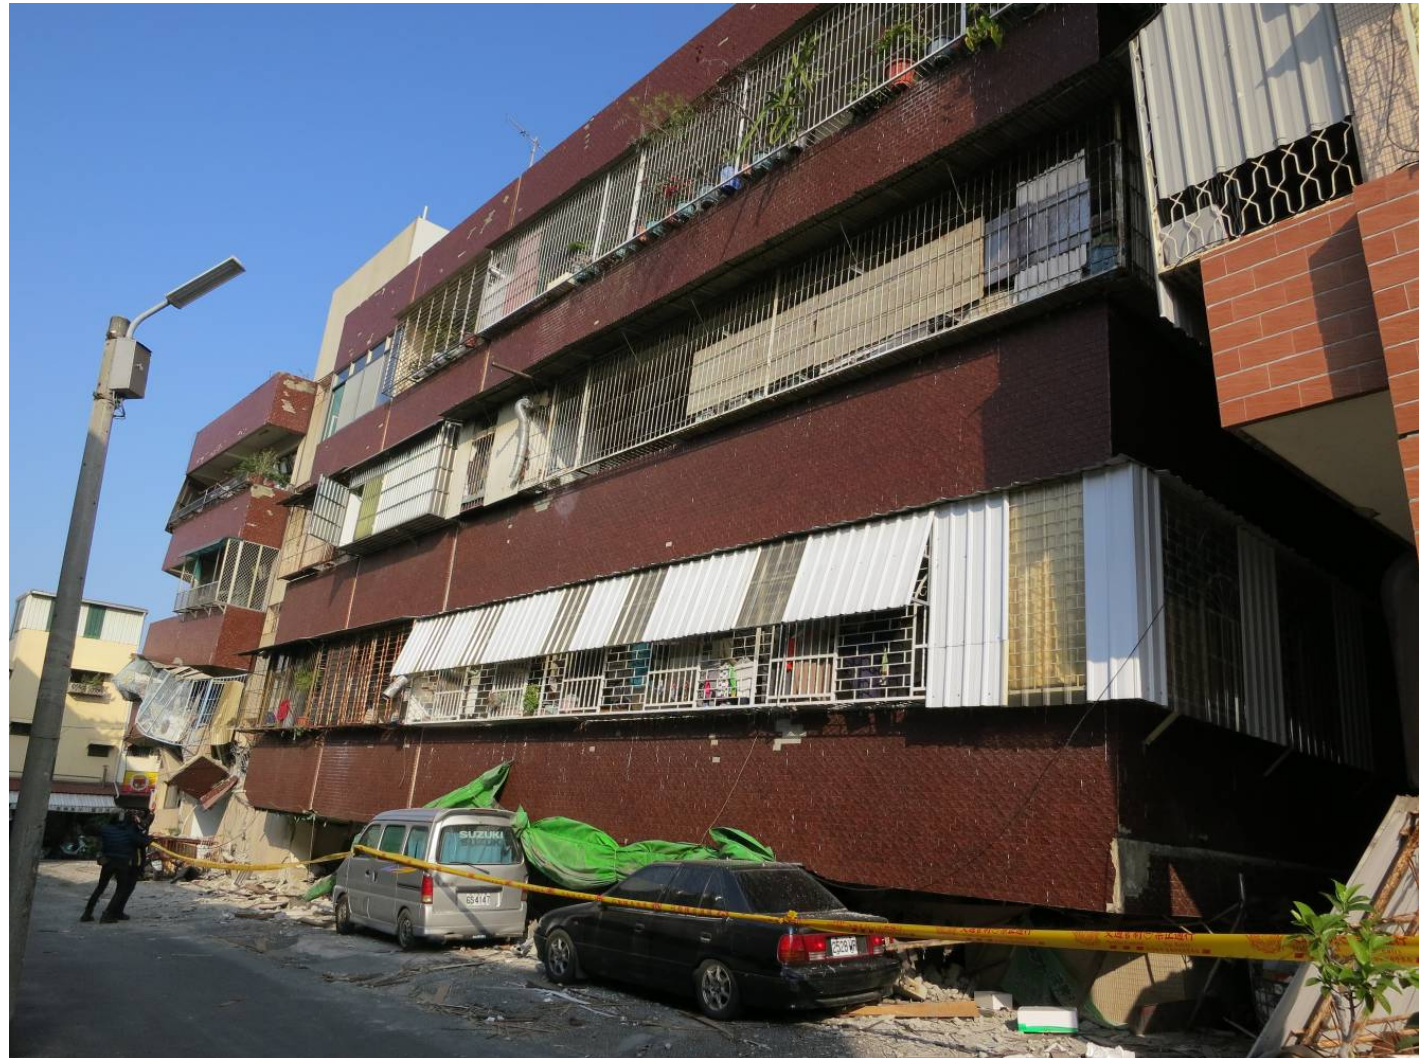
■ Tachi Market

4 stories

About 31 years old

Collapse at the
ground floor

1F: market

Above 2F: residence

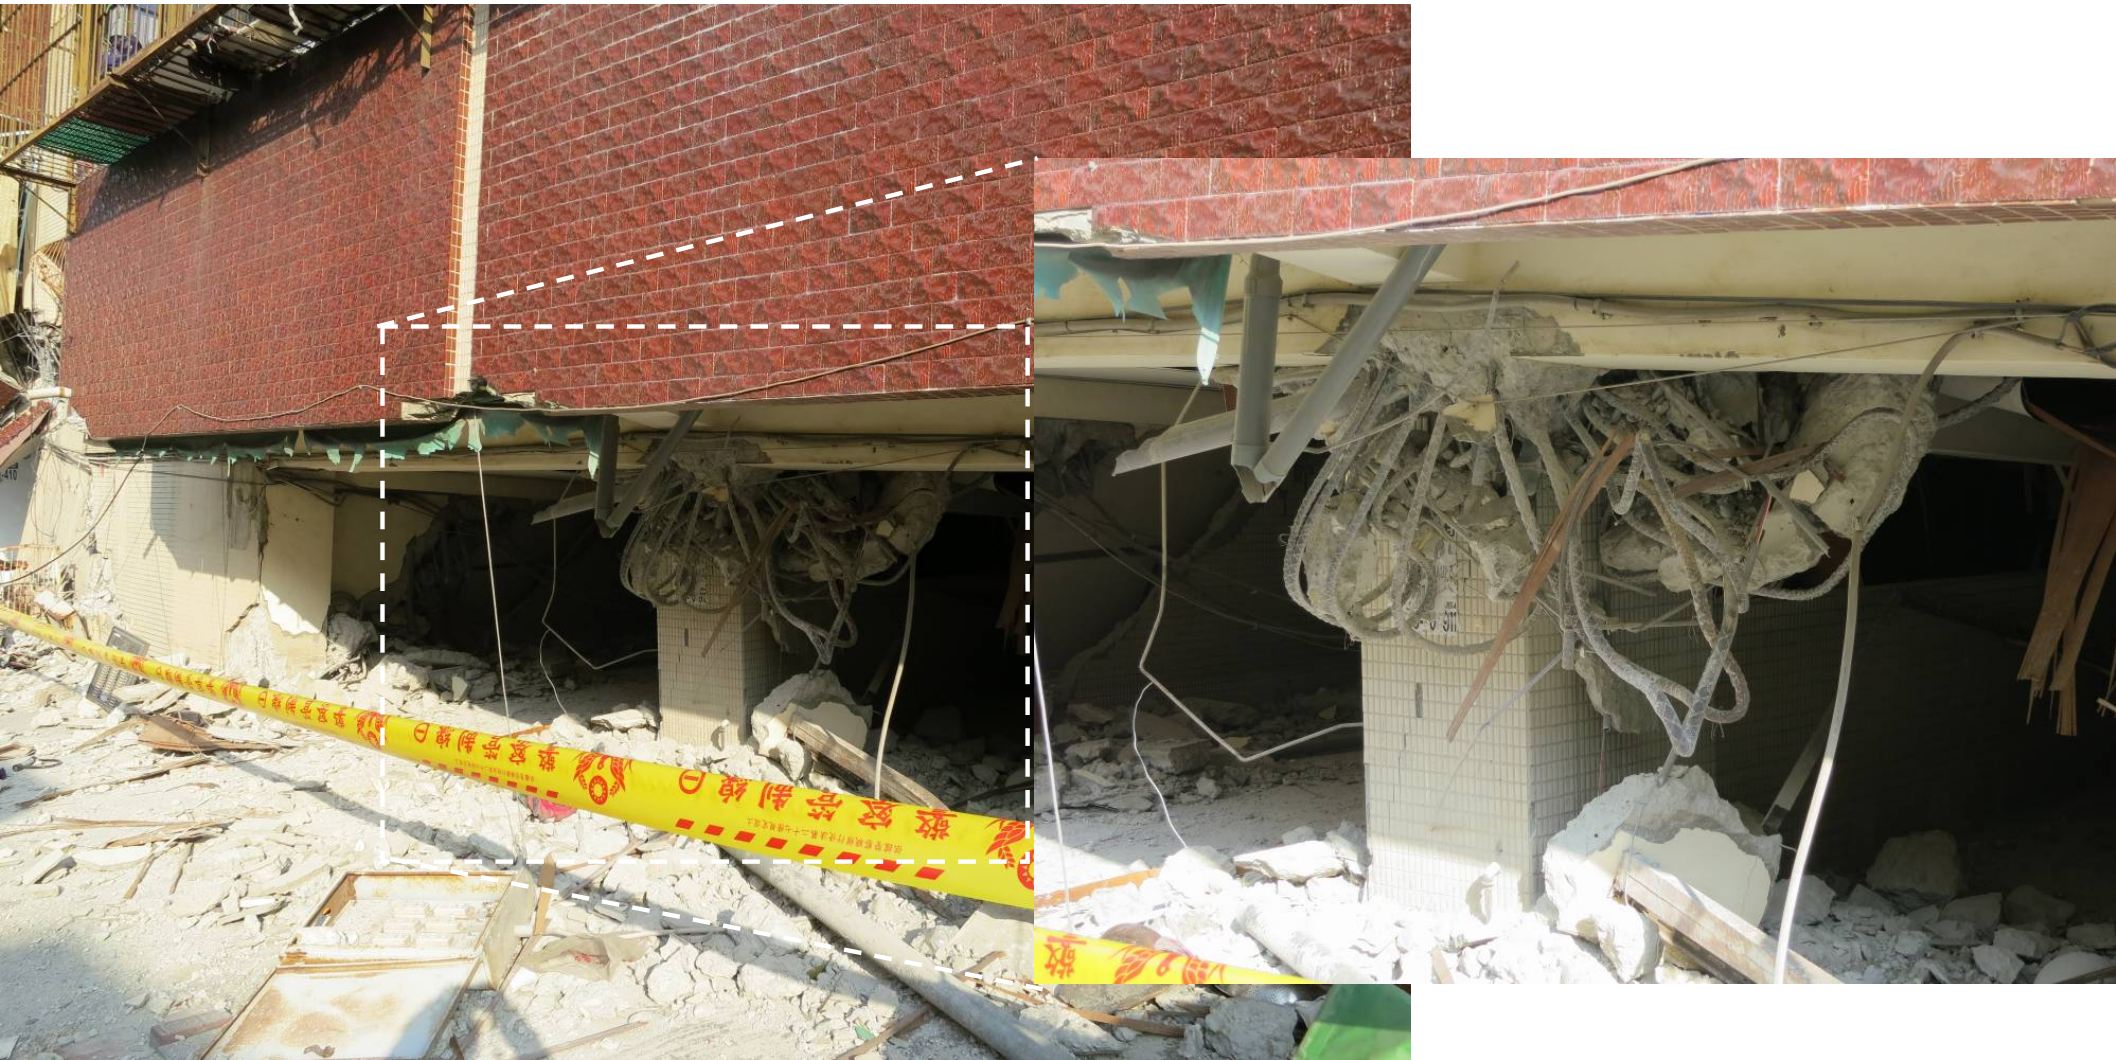
■ Tachi Market - Soft ground floor

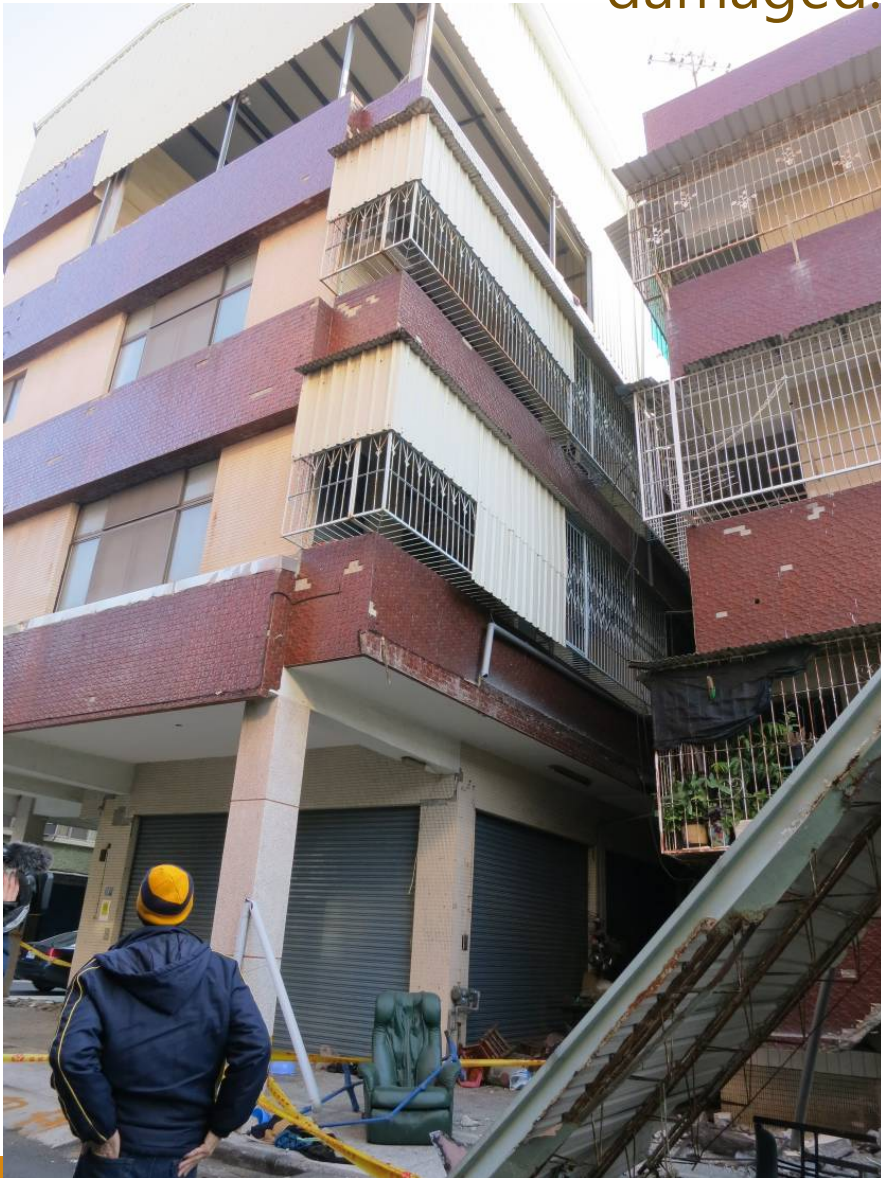
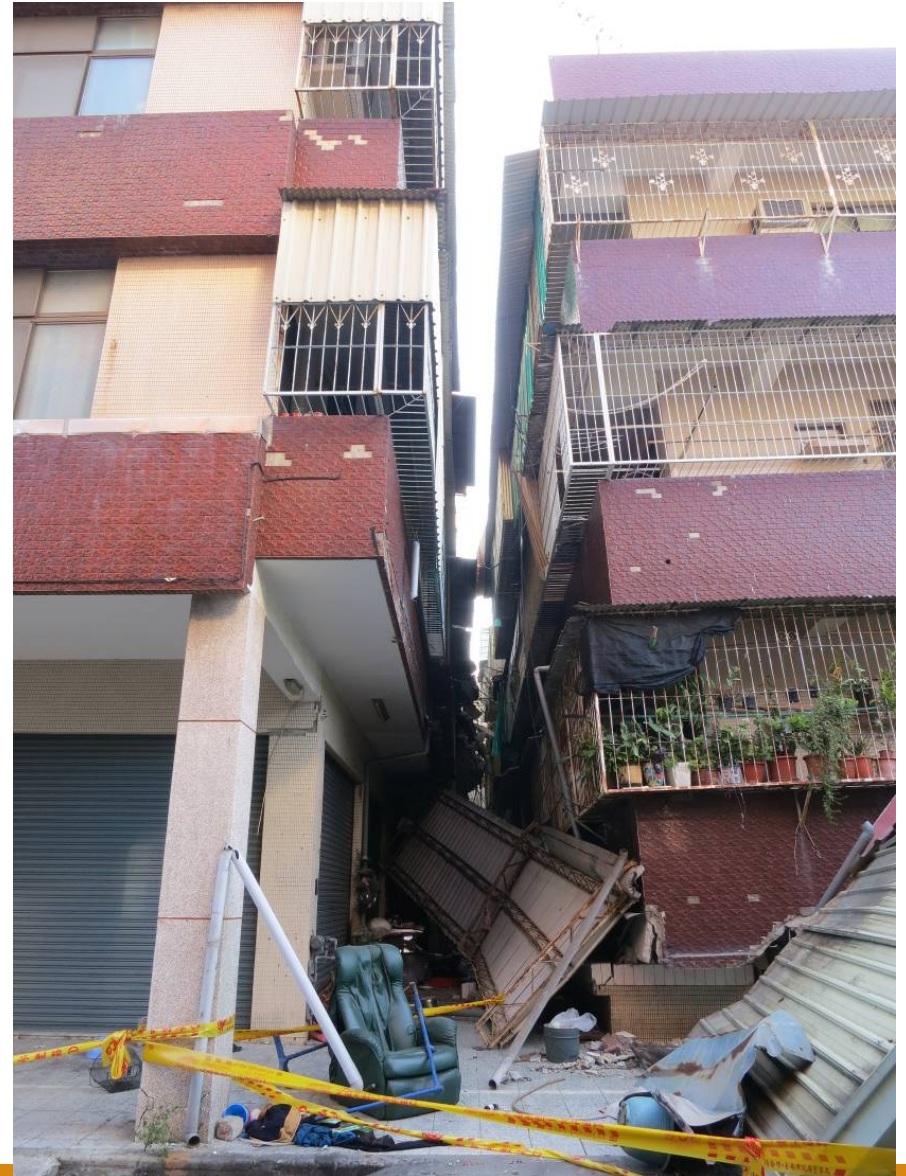
■ Tachi Market

- The building (left) next to the market was mildly damaged.

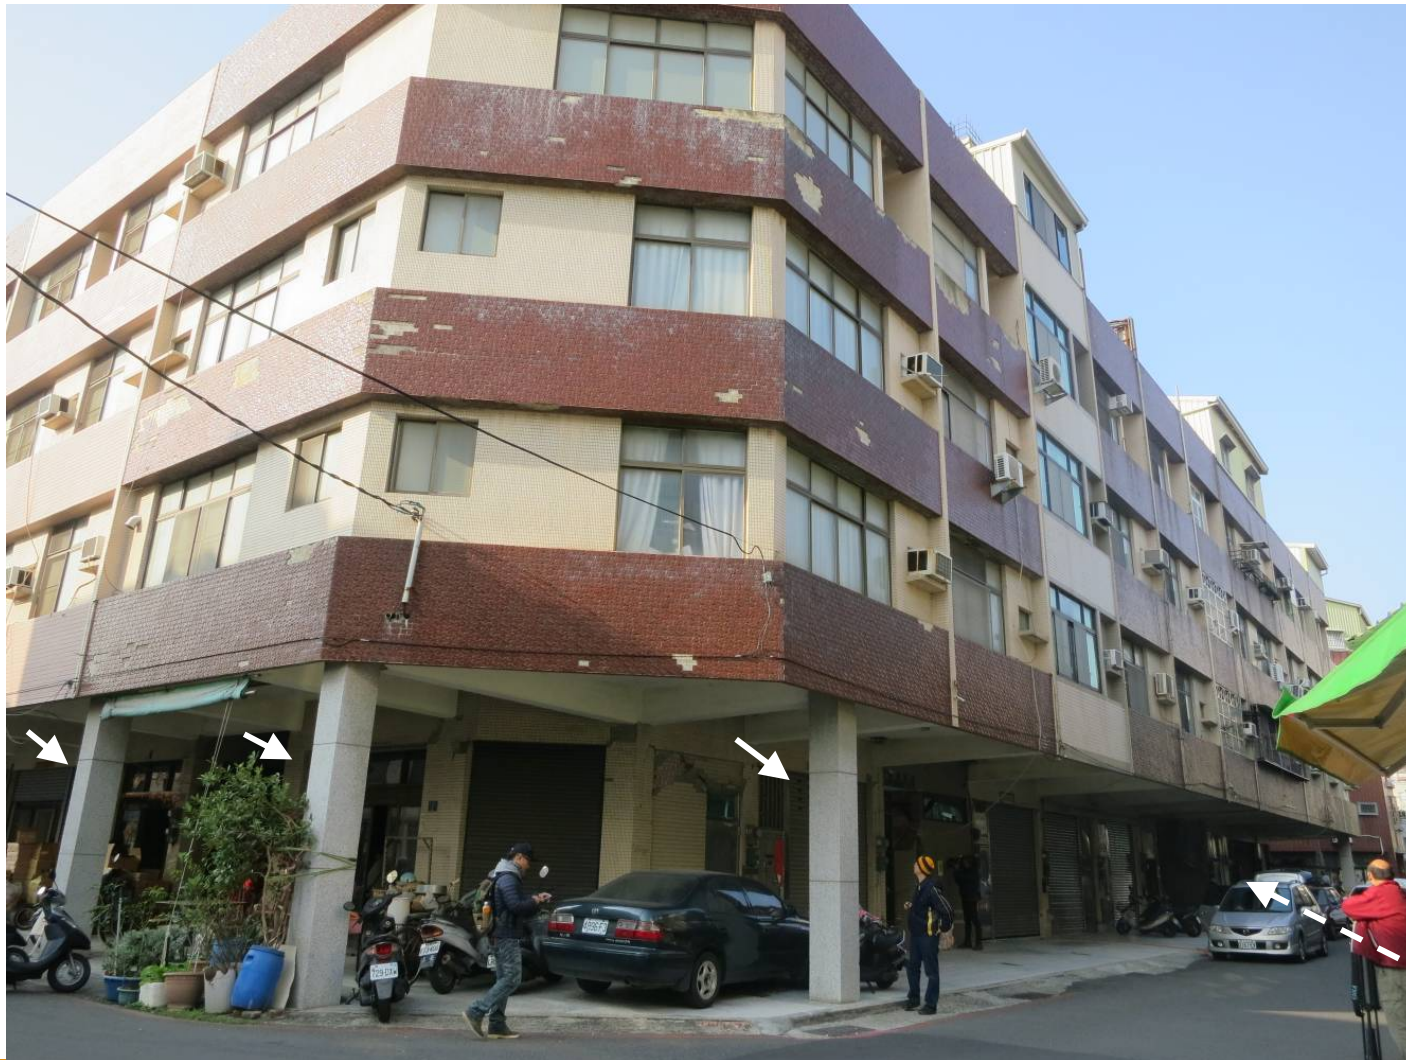
- Tachi Market - The building arcade was originally cantilevered. Columns were added at the corner at 2013.

Cantilever
arcade
