Reconnaissance Report

2016/02/06 Meinong Earthquake, Kaohsiung, Taiwan
Main damage area: Tainan

Prepared by **Yi-Hsuan Tu**
Associate Prof., Dept. of Architecture,
National Cheng Kung University, Taiwan
2016/02/07

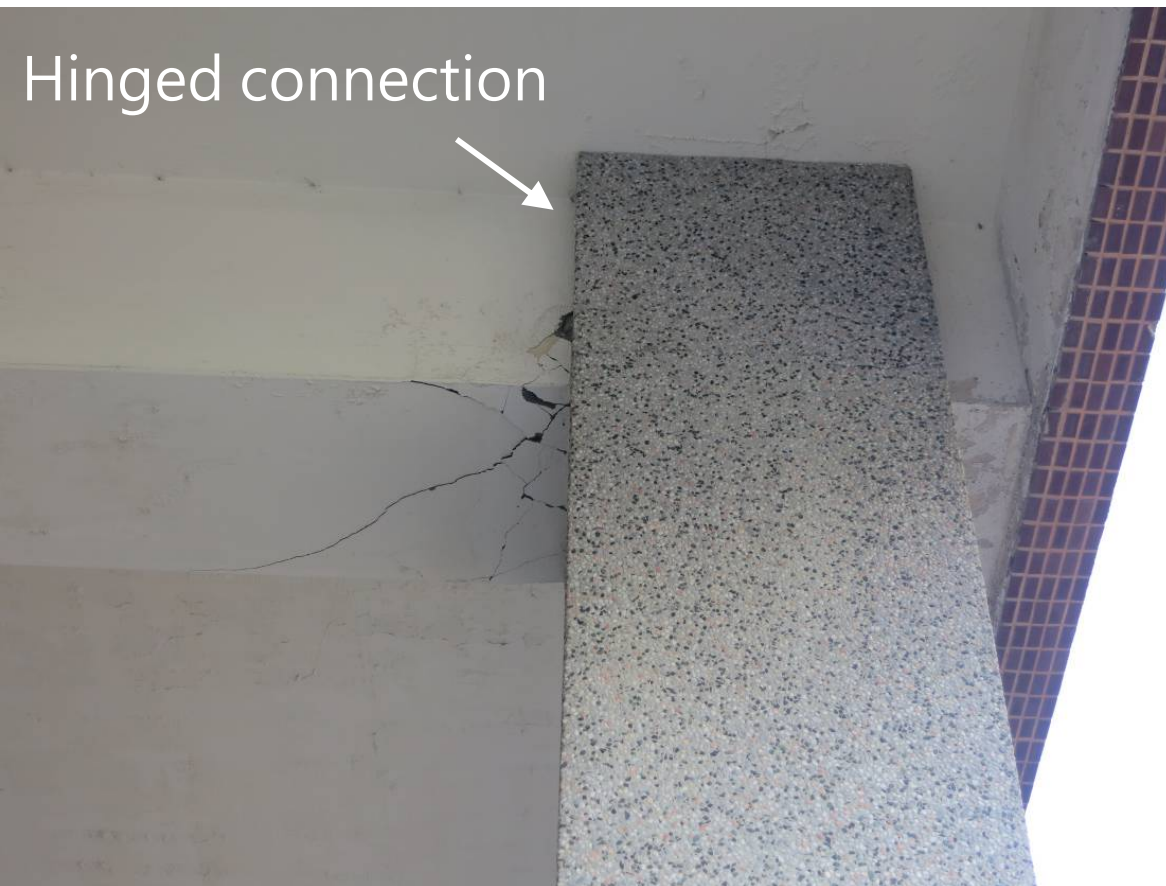
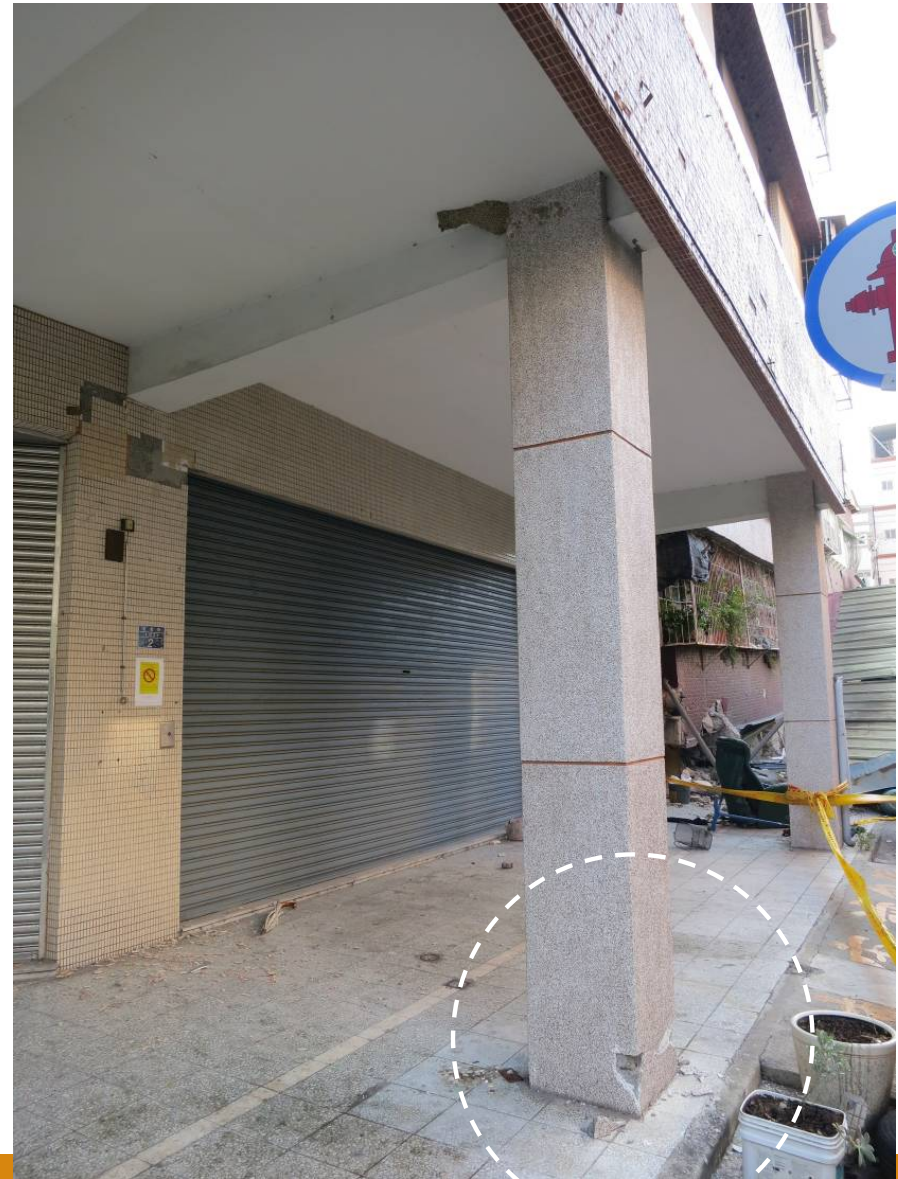
■ Tachi Market

- The column bases and the original cantilever beam ends were damaged.

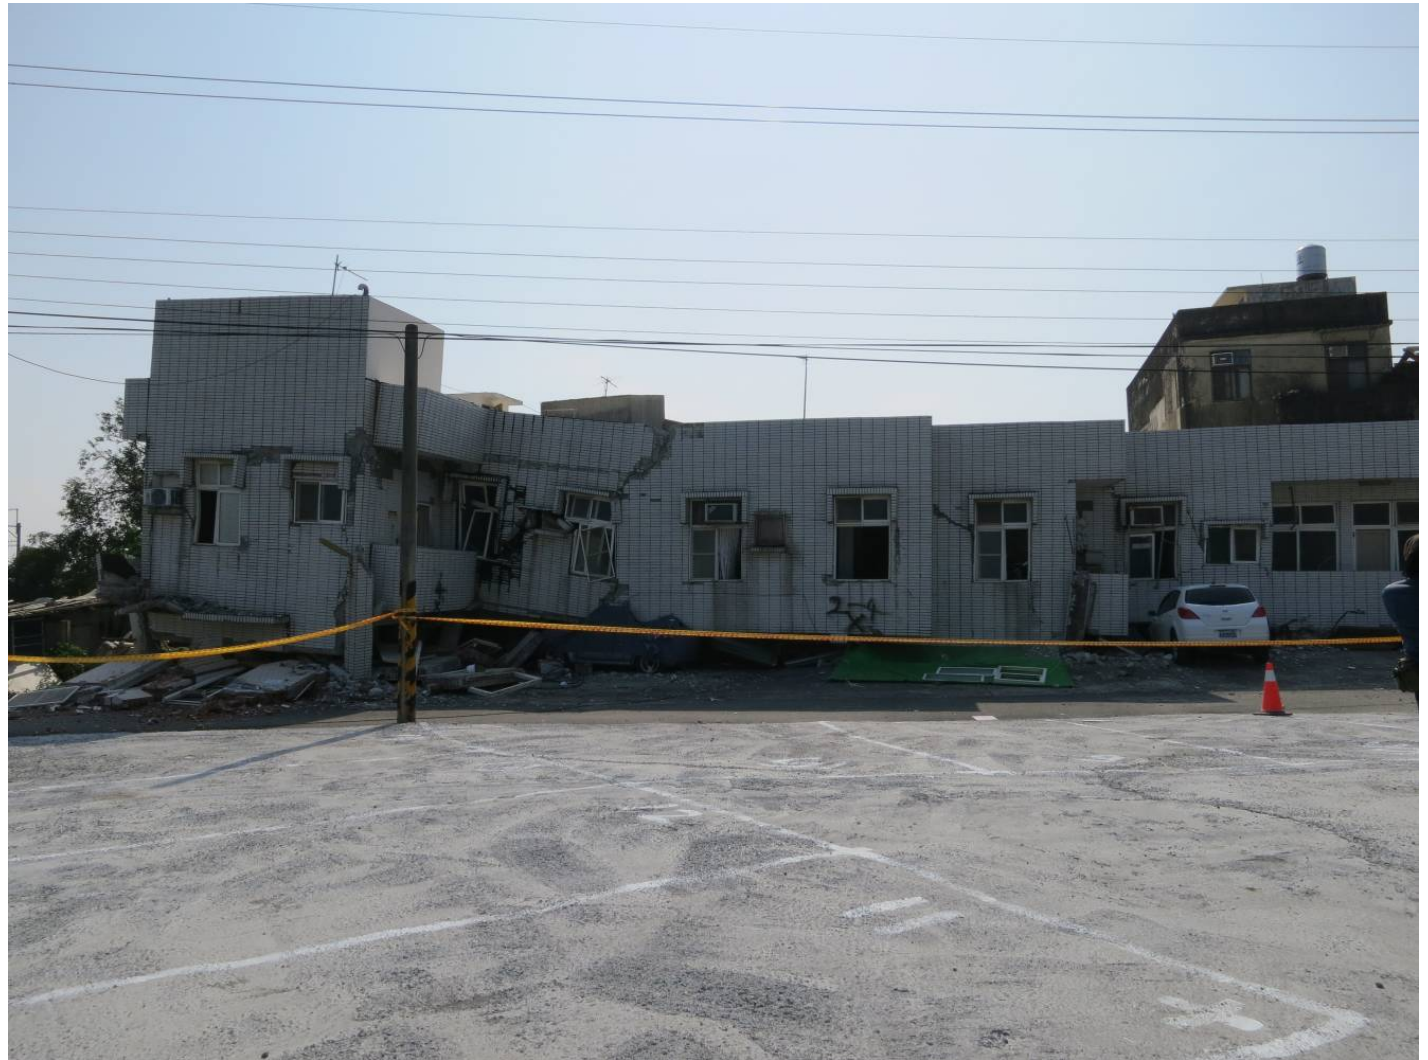
■ Shanshang Market

2 stories

About 30 years old

Collapse at the
ground floor

1F: market

2F: residence

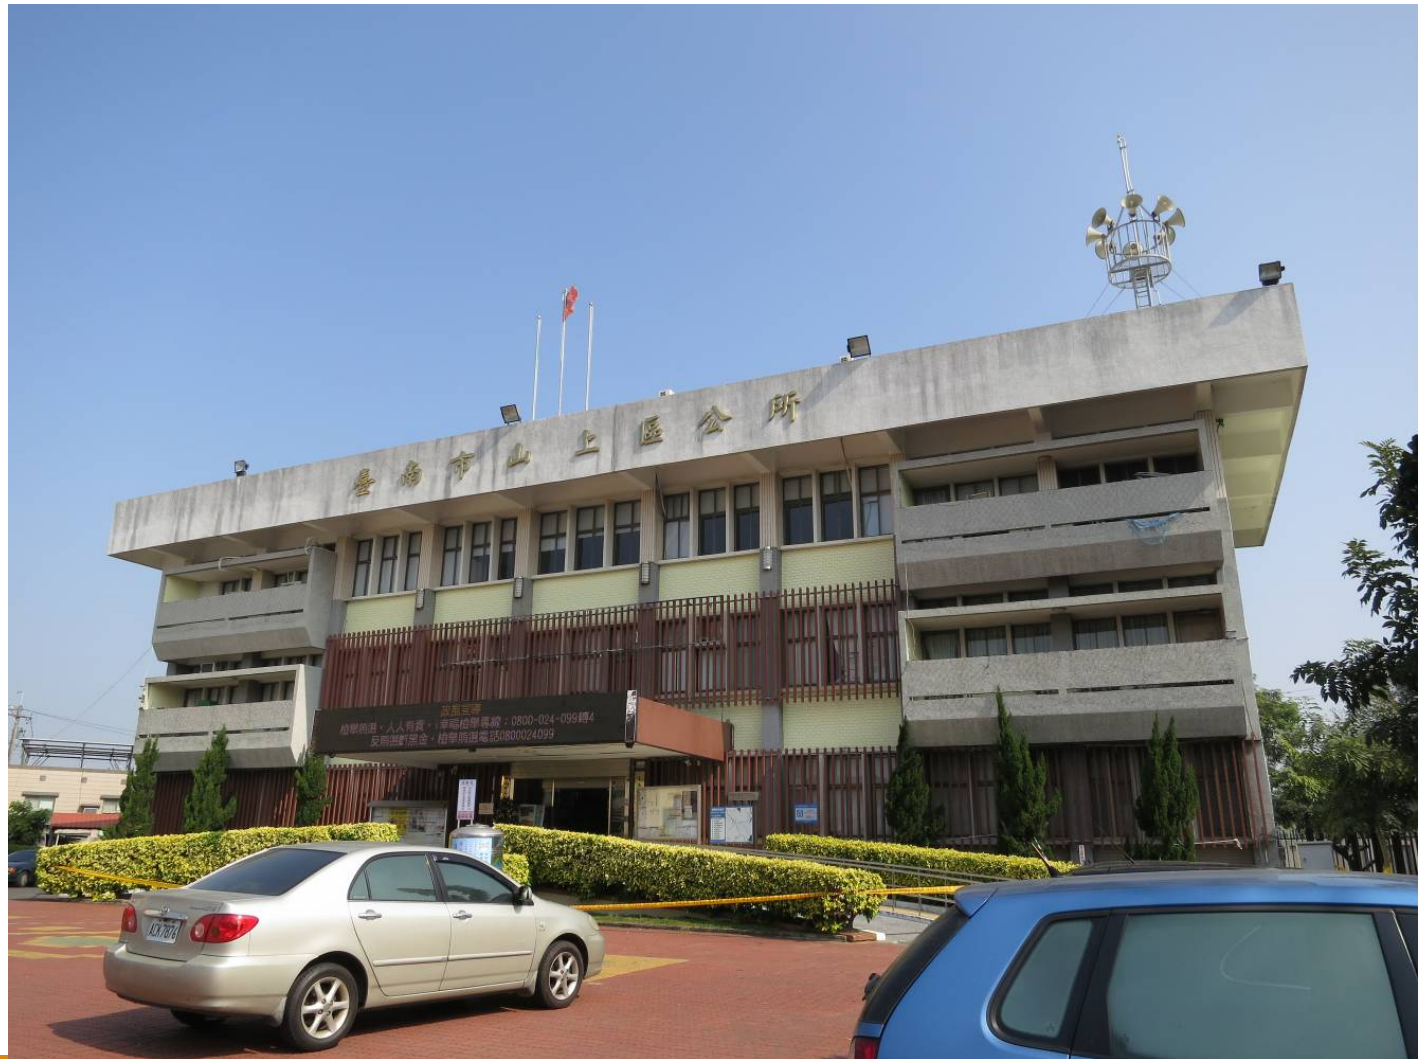
■ Shanshang District Office

3 stories

About 30 years old

Moderate damage

- Shear cracks appeared on almost every column at 1F and some at 2F
- Ceilings and shelves damaged

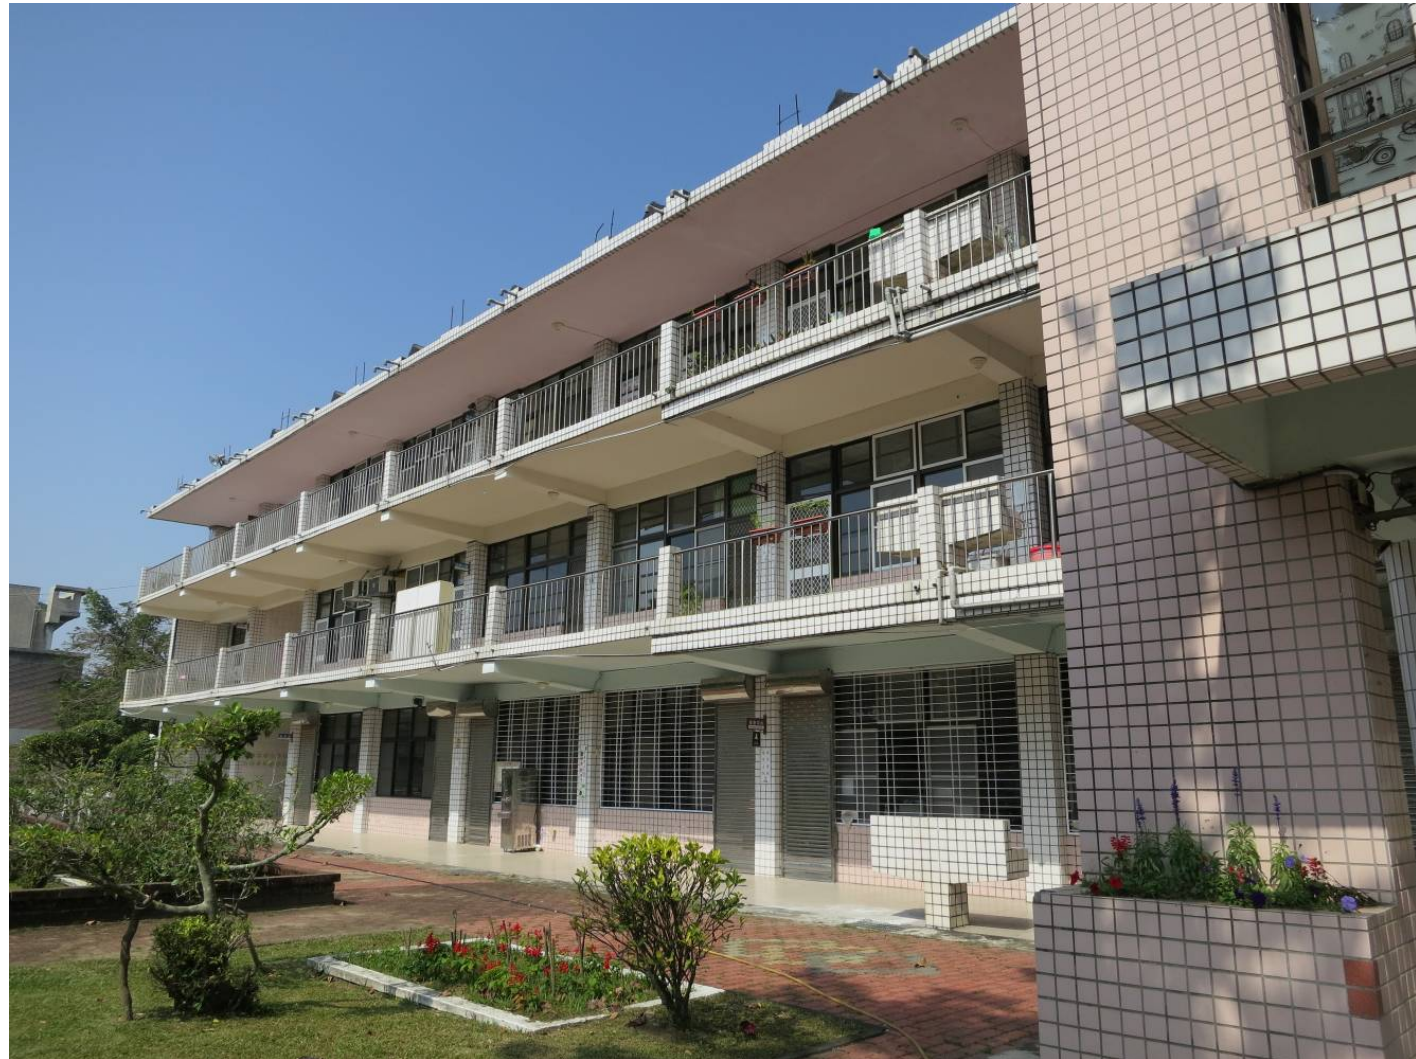
■ Shanshang Junior High School

Standard plan with cantilever corridor and larger span. Similar buildings have been found severely damaged or collapsed in Chi-Chi earthquake, but....

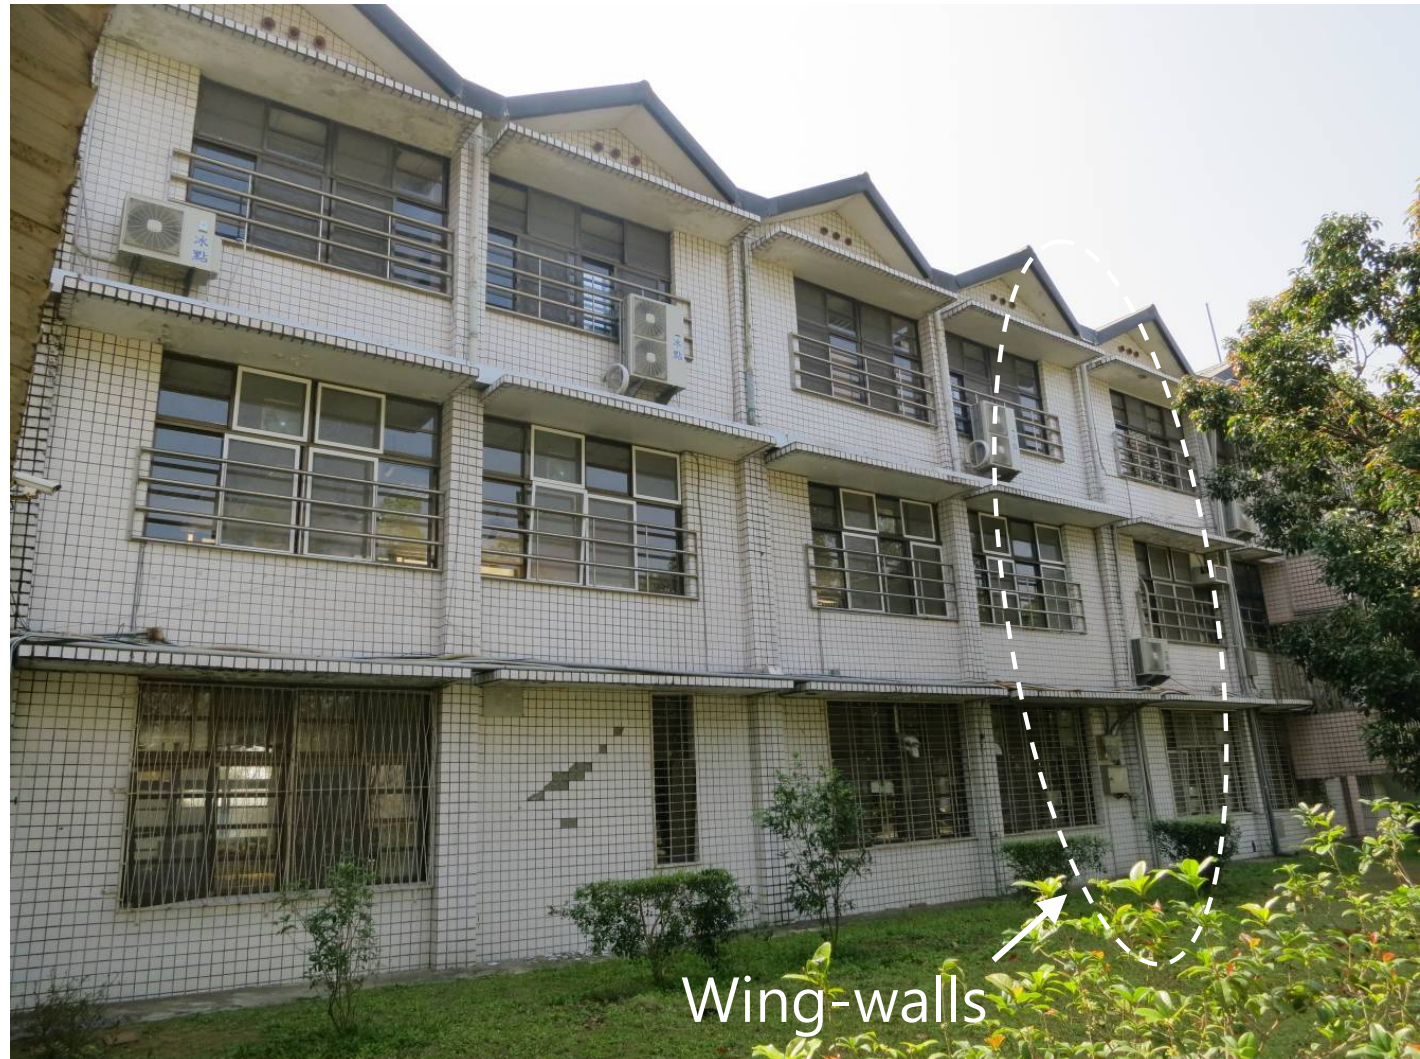
■ Shanshang Junior High School

The building has partially confined masonry wing-walls in the back frame. This is also the reason that it rated a high score in the preliminary seismic evaluation and has not been put in the waiting list for retrofit.
