24 August 2014 South Napa M_w 6 Earthquake Reconnaissance Report

26 September 2014

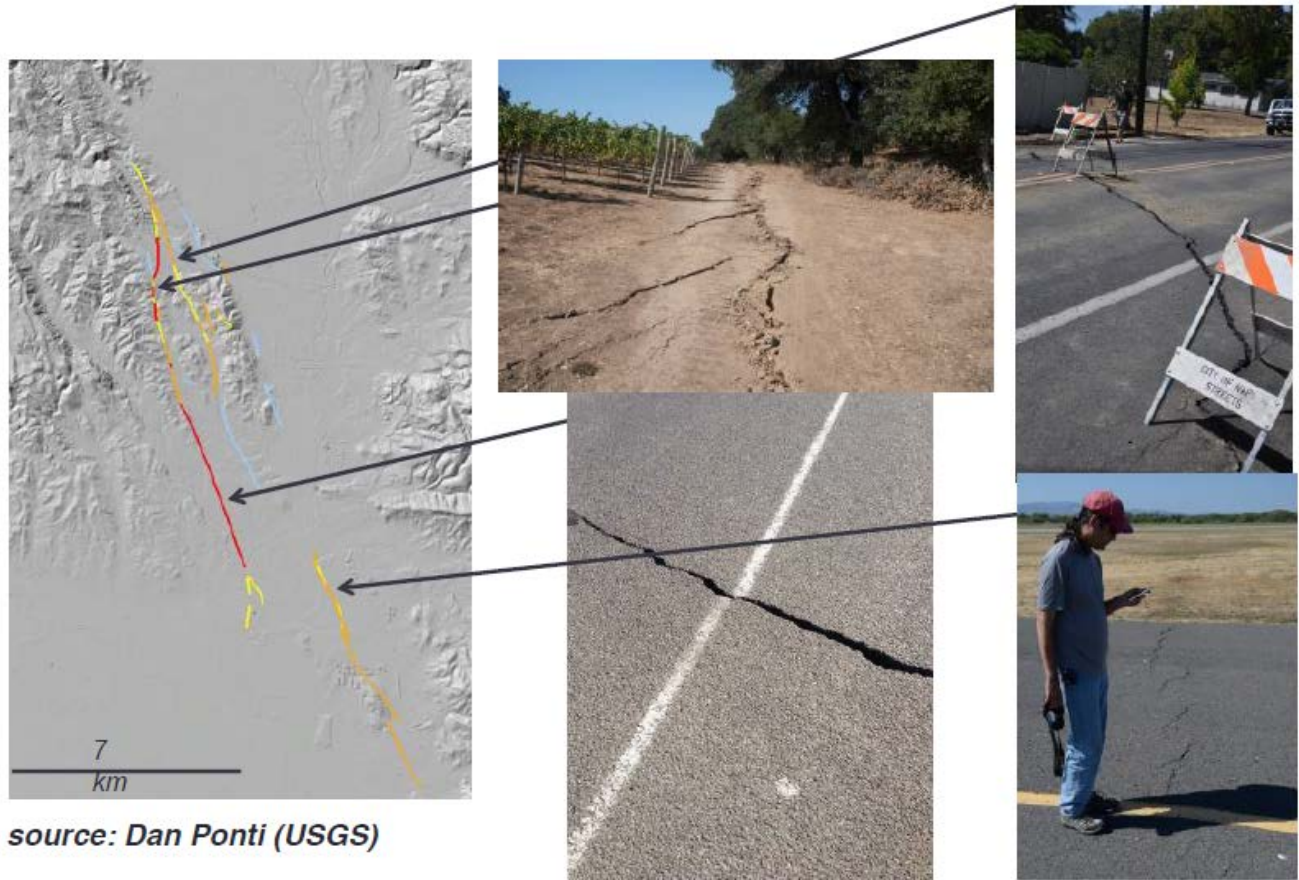
Figure 8 Observed surface faulting

Ground rupture and geotechnical effects are covered extensively in (Bray et al. 2014), who concluded “The rupture mechanism was primarily strike-slip and surface fault rupture and was expressed along much of the ruptured fault plane trending NNW and extending for a distance of 12-14 km from the hypocenter.... Surface faulting damaged homes, underground utilities, and other infrastructure when it traversed developed areas, such as the Browns Valley area in western Napa.... There was a lack of liquefaction and liquefaction-induced ground failure in this event, even in areas previously identified as being susceptible to liquefaction hazard.” Observed traces of the fault are shown in Figure 8, taken from a presentation by T. Dawson.

Source: from T. Dawson presentation at PEER-EERI S. Napa Earthquake briefing, 15 Sept. 2014
(lower right is runway cracking at Napa County airport)

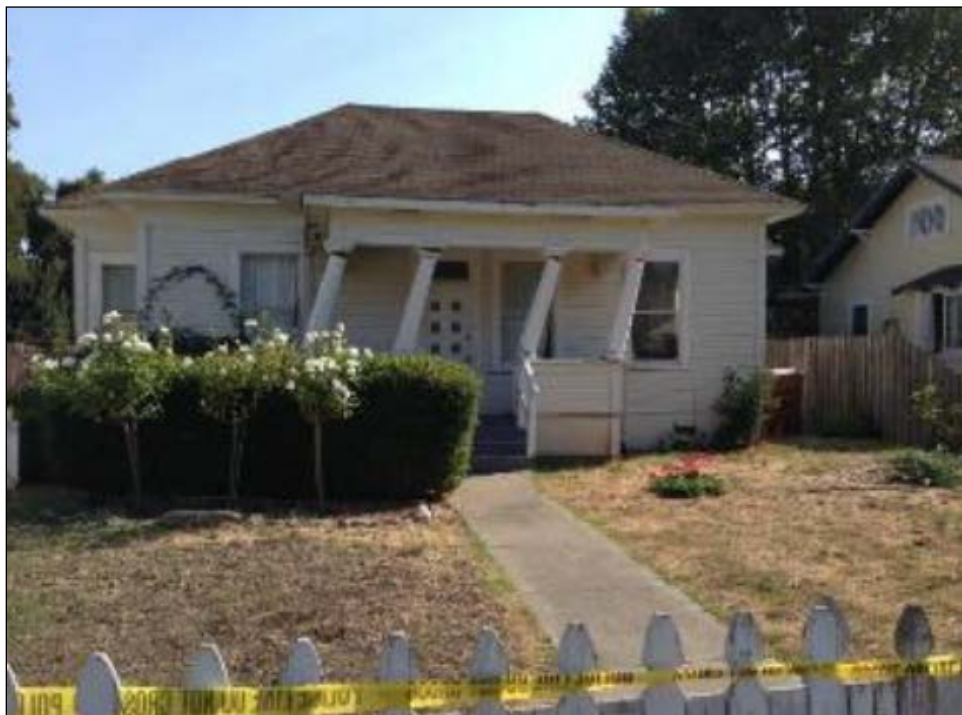
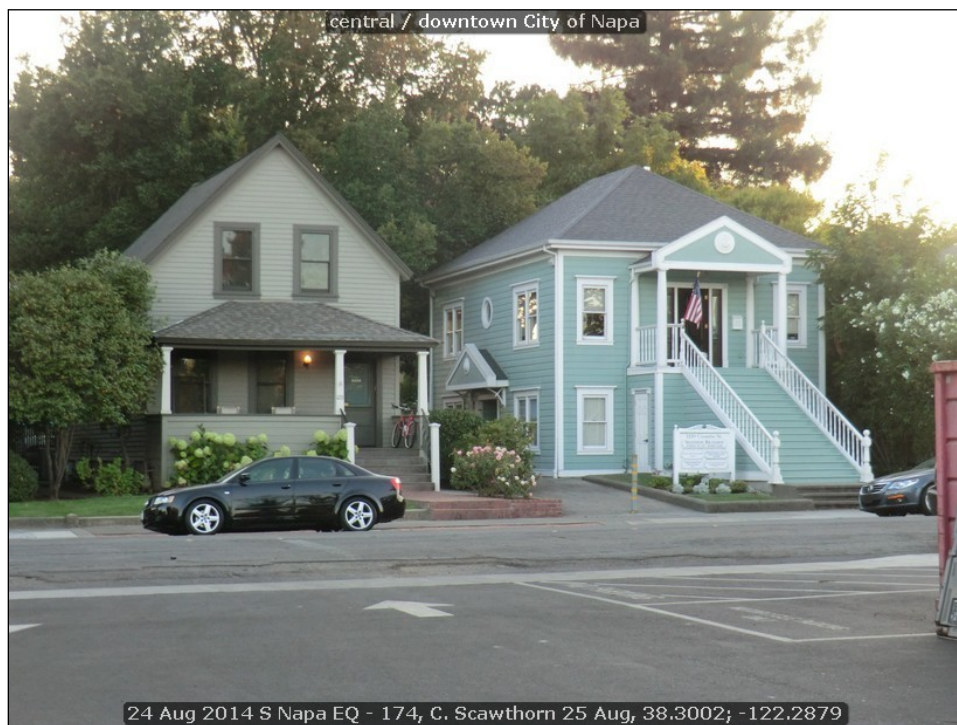
- Wood-framed single family dwellings performed relatively well, except in the areas of highest intensity, where significant damage was observed among some but not all such buildings, Figure 10. The kind of damage shown in Figure 10 is fairly common, predictable, and straightforward to mitigate. Chimney damage was more widespread, Figure 11, and is also very common.

Figure 10 Single family wood framed dwellings – (t) damaged, photo by J. Maffei; (b) undamaged, central Napa (photo by author)

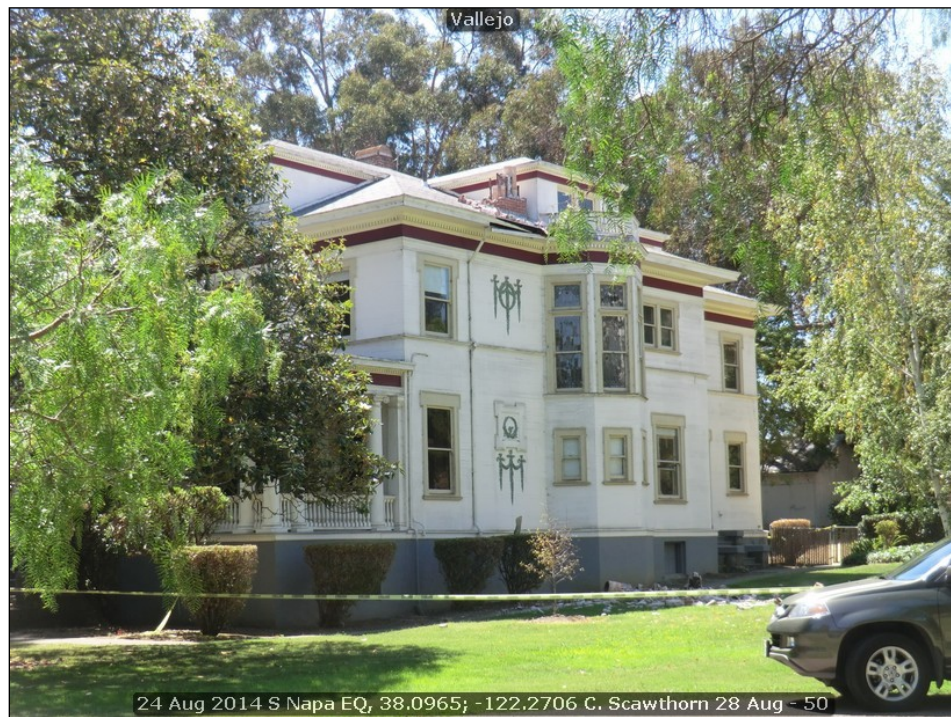
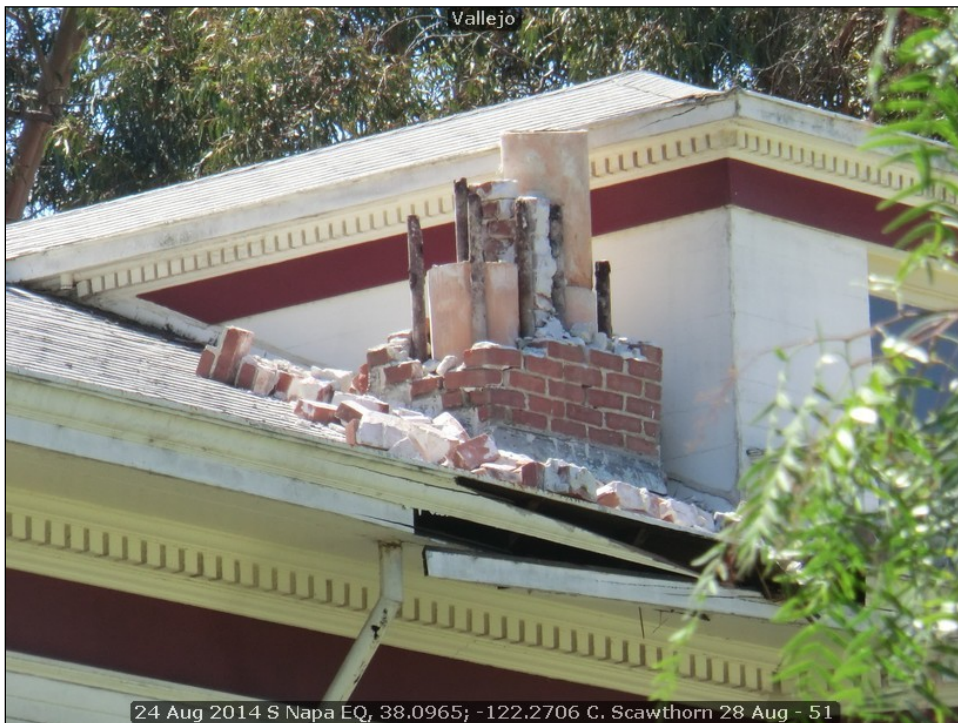
Figure 11 Approximately 1900 era house with chimney damage, Mare Island

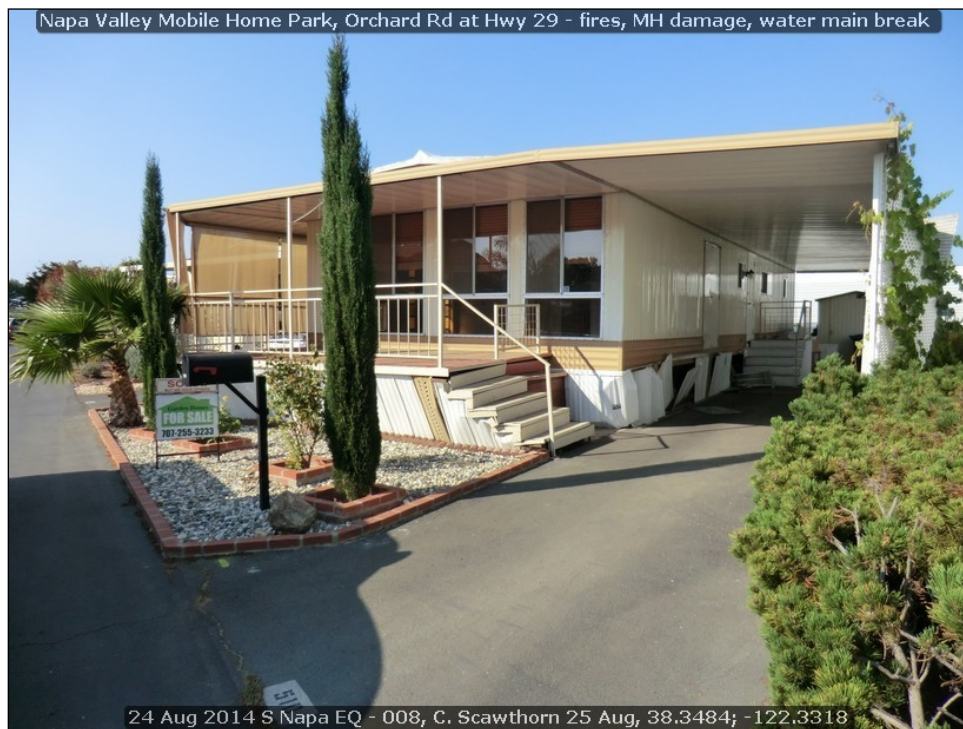
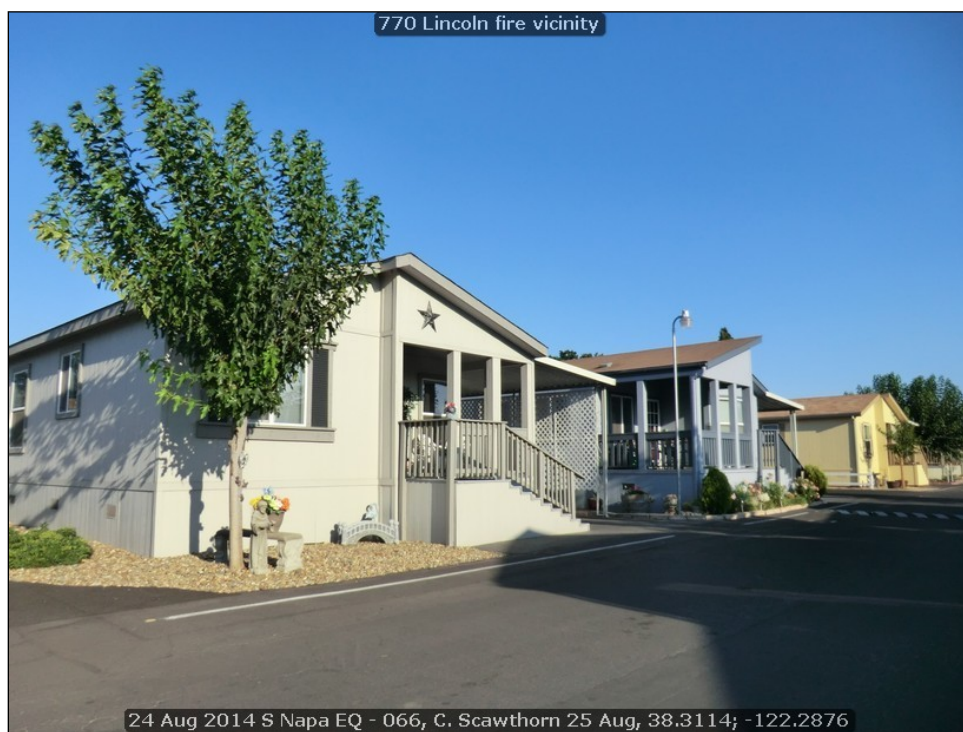
- Manufactured homes are of at least two kinds in the affected area – older “trailers” no longer on wheels but rather on blocks of some sort, and newer actual manufactured homes. Performance of both kinds was observed on a limited basis at the relatively large Napa Valley Mobile Home Park on Orchard Road in northern City of Napa, and at a smaller group of such buildings on Lincoln Road in more central City of Napa. The older type of home generally did much more poorly, with a number of instances of what is probably total loss. The newer type of home generally did well, with few observations of significant structural damage, Figure 12. This kind of damage has been repeatedly observed in California earthquakes. Mobile homes and other manufactured buildings such as temporary buildings at schools commonly suffer damage like this at low levels of shaking if they are not properly secured. Earthquake resistant bracing systems and engineered tie-down systems are fairly inexpensive methods to prevent this kind of damage. For more information, see <http://www.sparisk.com/pubs/SPA-2014-Mobile-Homes-in-Earthquakes.pdf>.

Figure 12 Manufactured home (t) racking of substructure; (b) undamaged

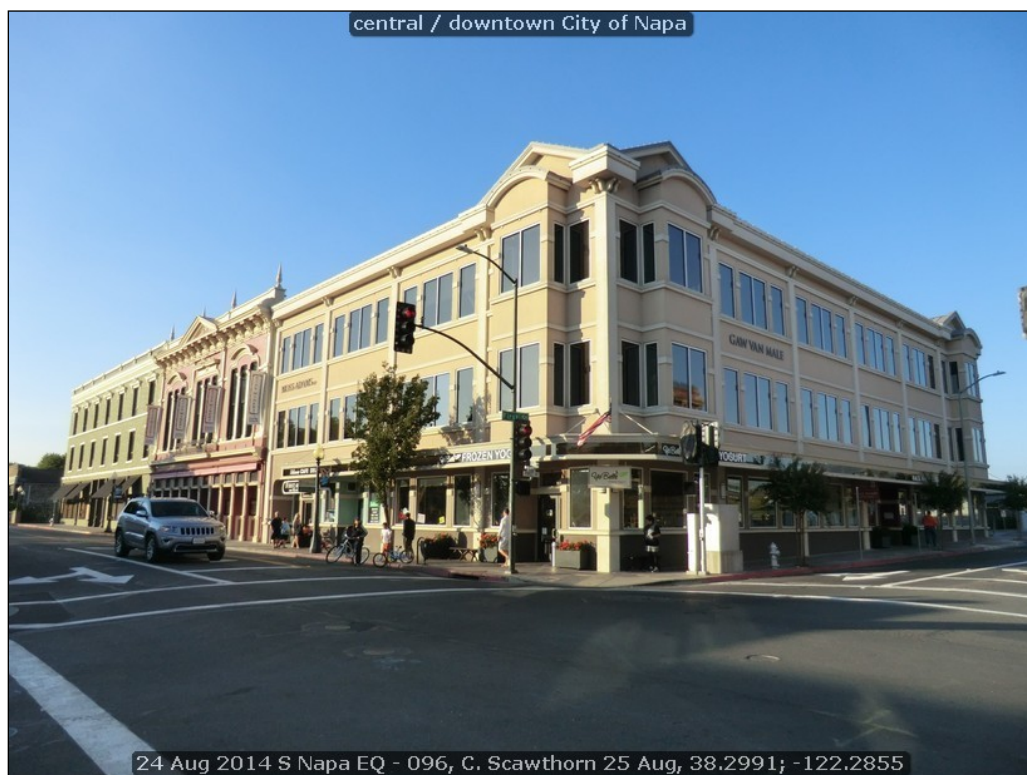
- Extensively and probably more recently retrofitted, which appear to have done very well in this event, Figure 13 to Figure 16;
 - Less, perhaps marginally, and perhaps older retrofits, which appear to have, at least some instances, sustained major damage, Figure 17;

Figure 13 Napa Valley Opera House and adjoining buildings, East side of 1000 block of Main Street, City of Napa: (t) entire block, photo looking NE; (b) north end of block

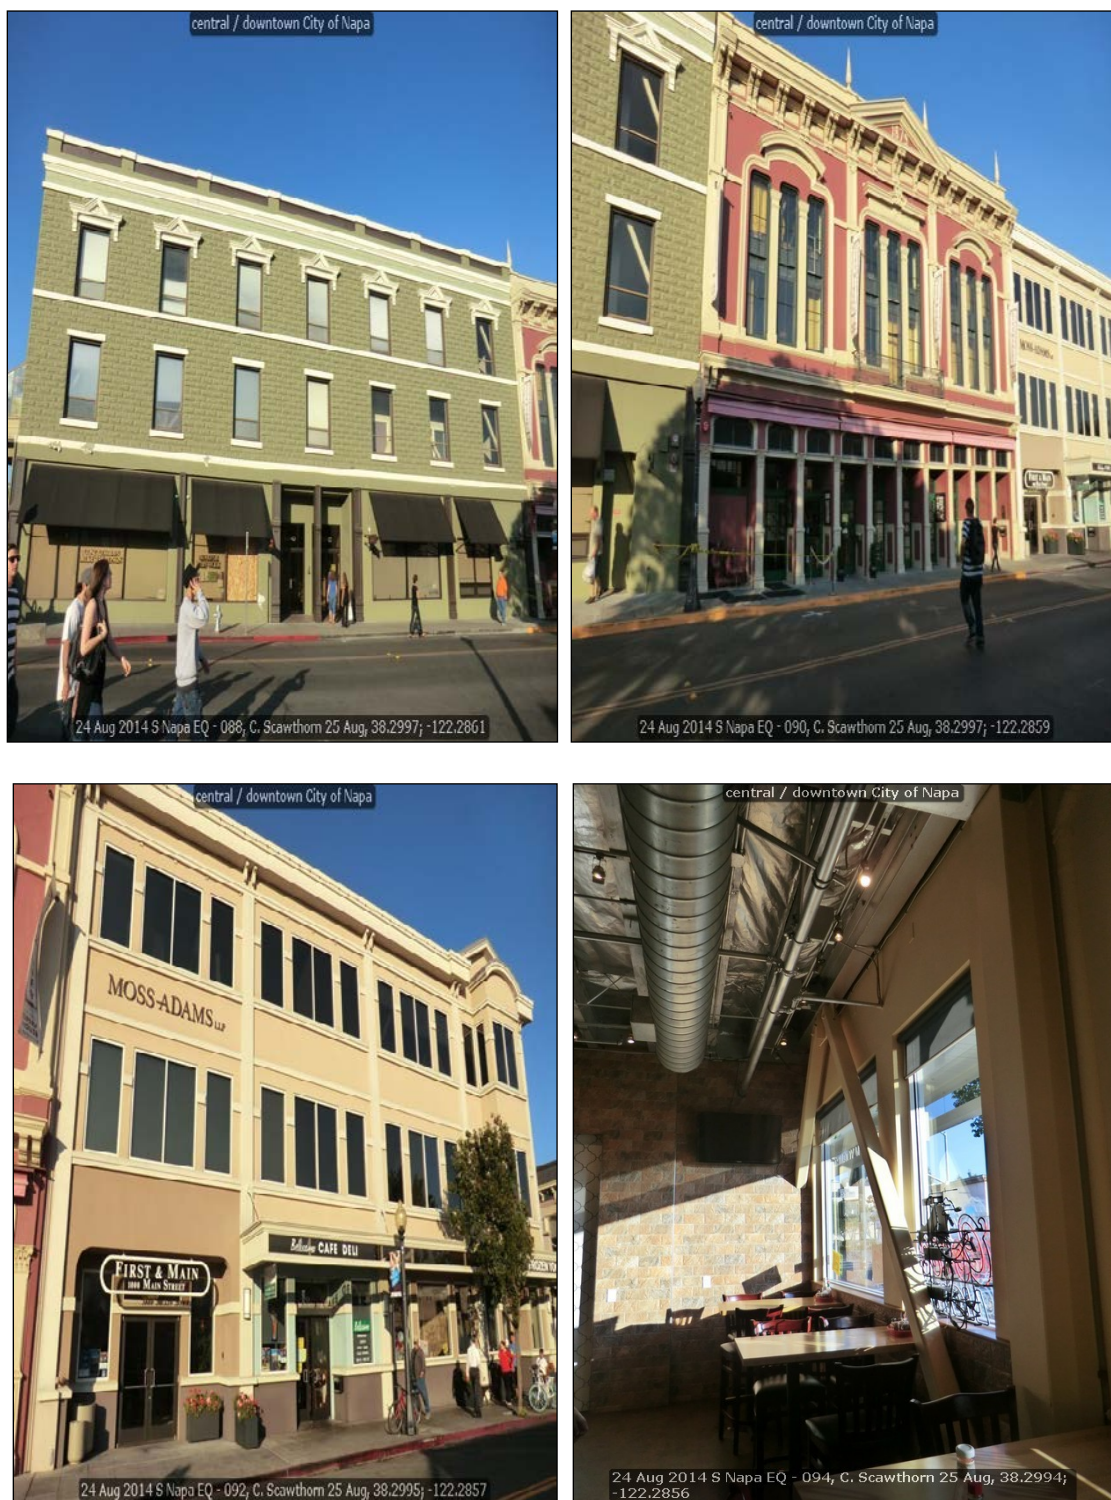
Figure 14 Napa Valley Opera House and adjoining buildings Main Street Napa (cont.): (top) north building and Opera House facades; (b) south building façade and bracing (interior of café).

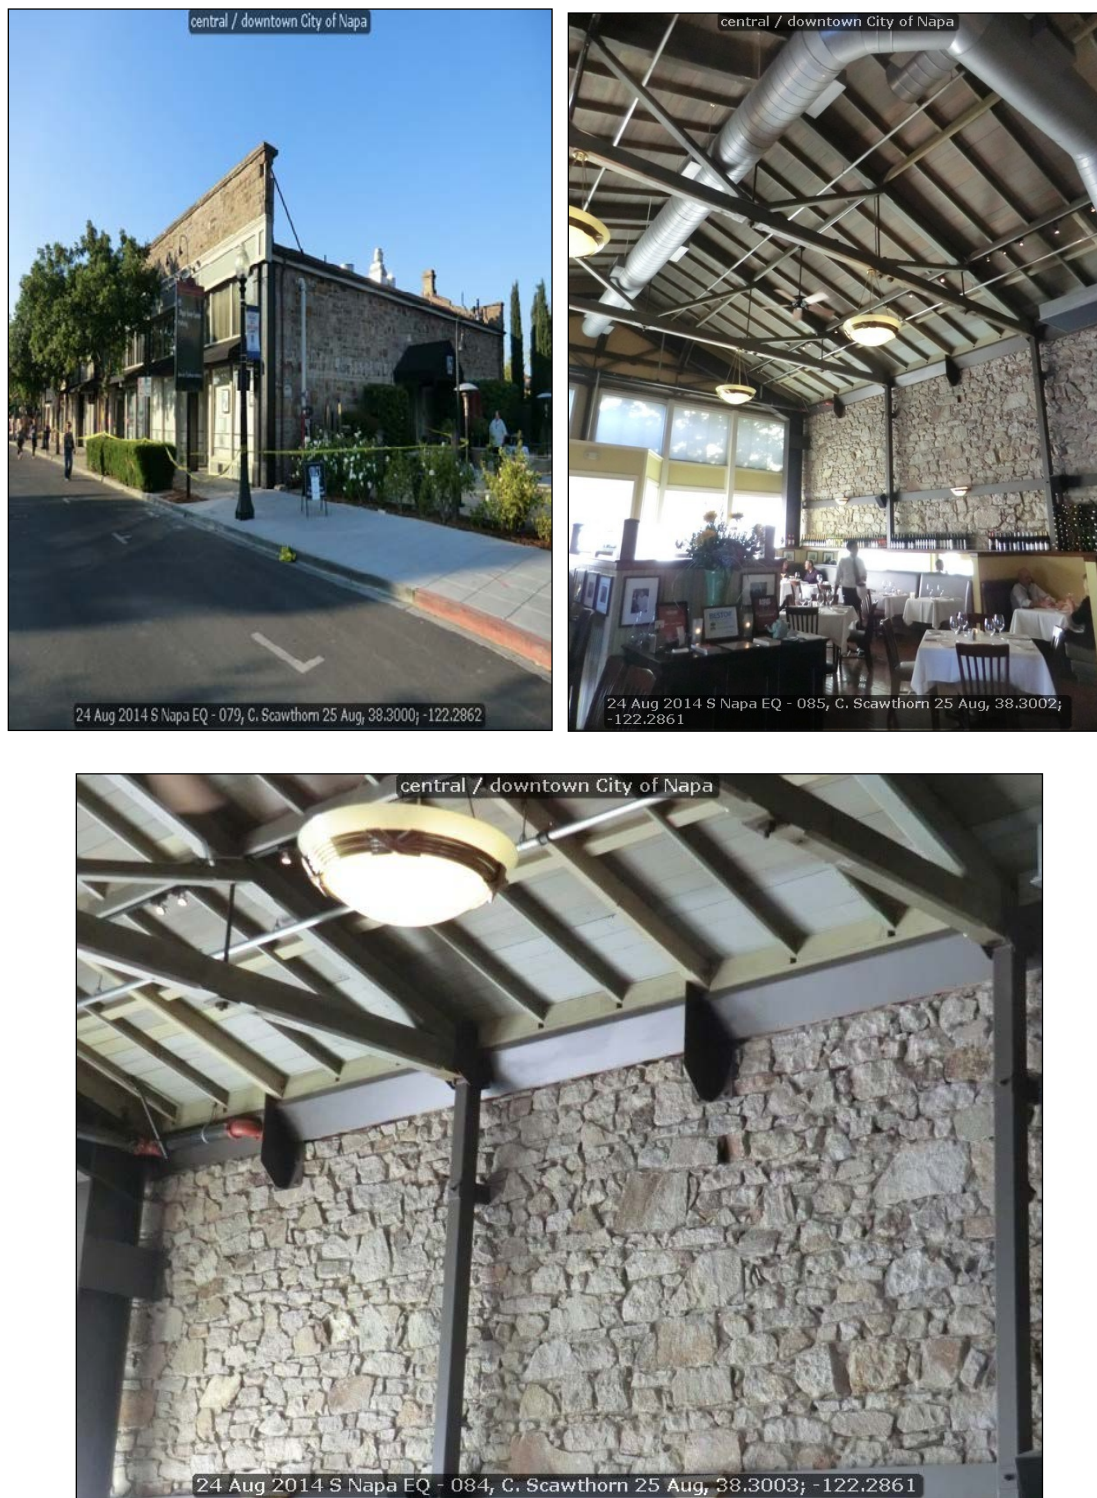
Figure 15 Restaurant building Main Street Napa, field stone URM retrofitted, with only minor damage – building was yellow tagged with notation “Guests allowed.”

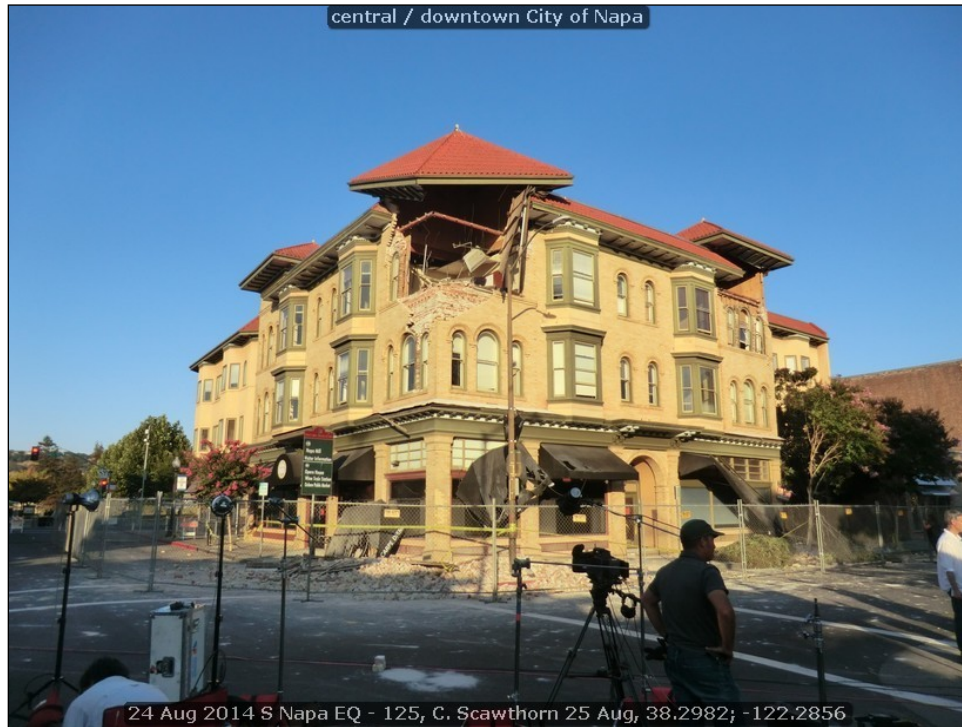
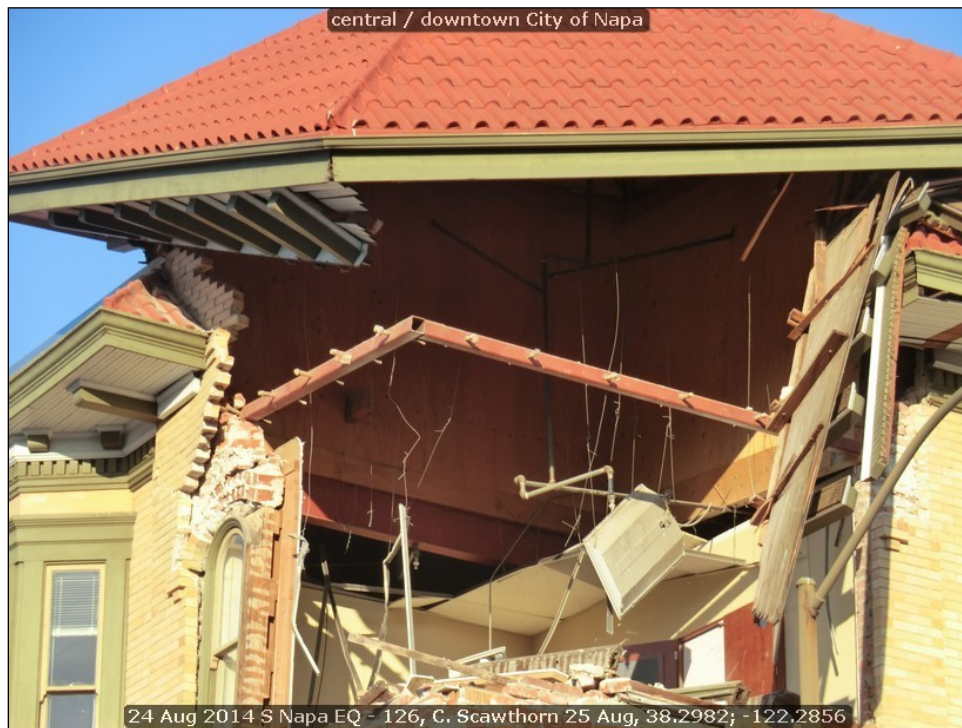
Figure 17 Heavily damaged URM building, Main Street Napa – note light horizontal member used in retrofitting, with clean pull out of masonry anchors.

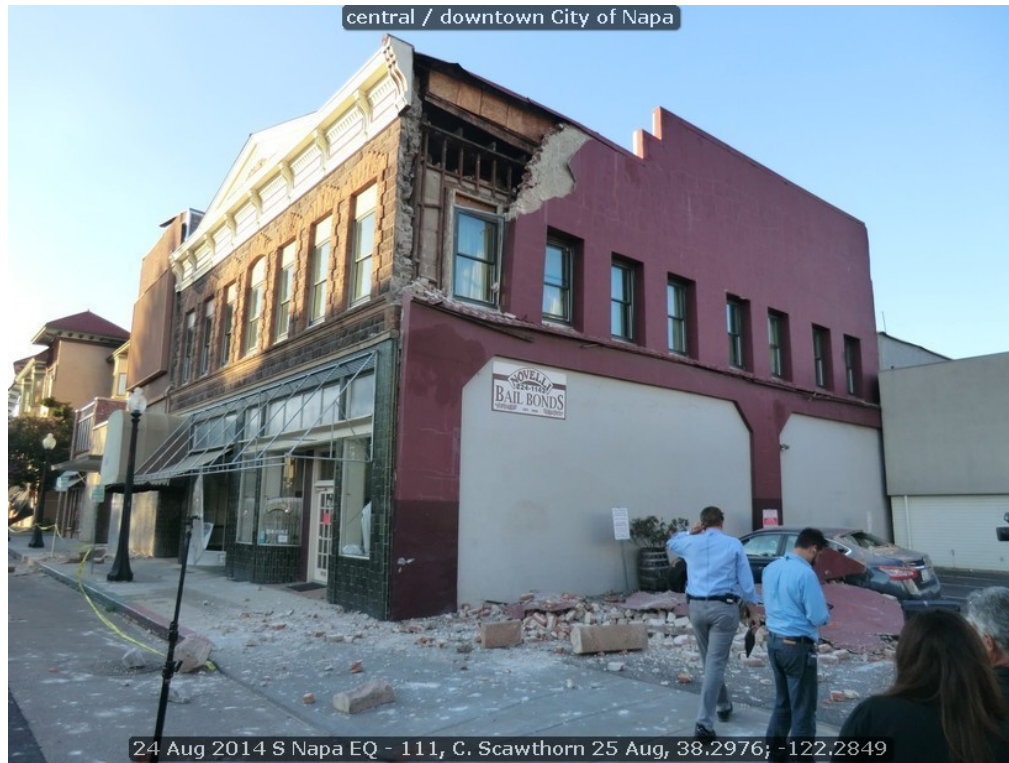
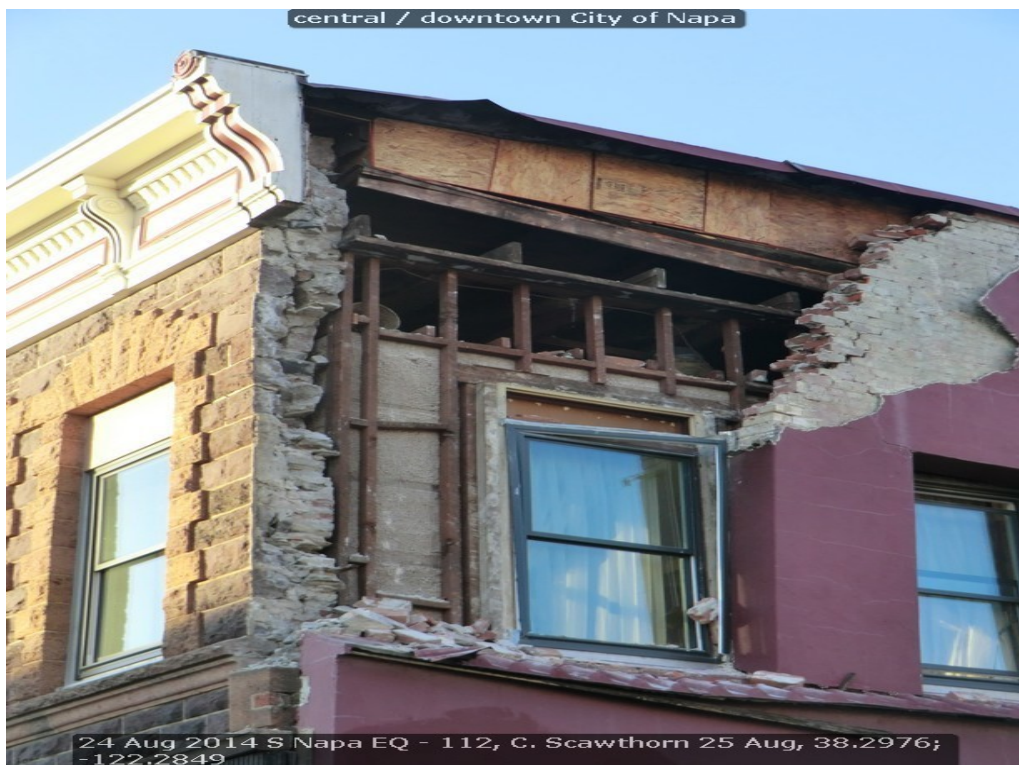
Figure 18 Building directly across Main Street from buildings in Figure 16 with no apparent retrofitting and partial loss of second story wall.

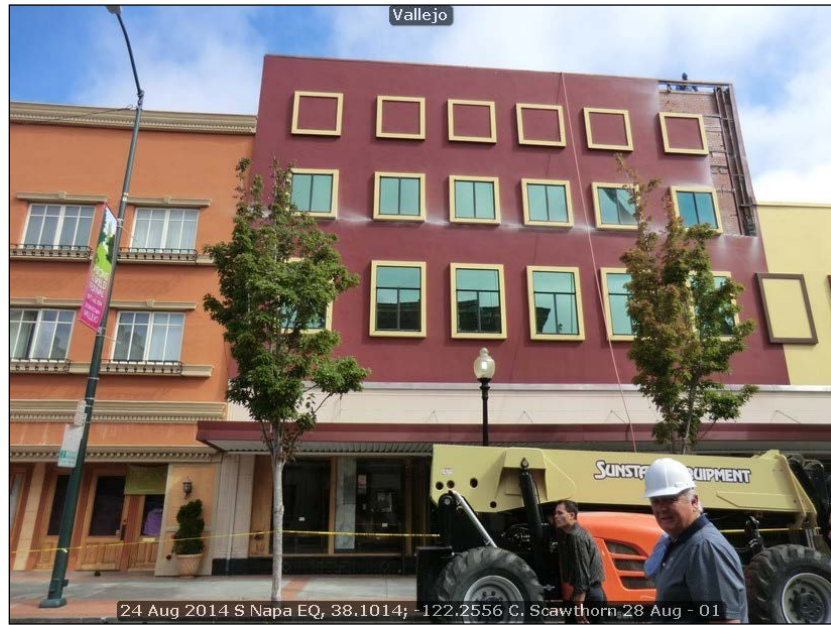
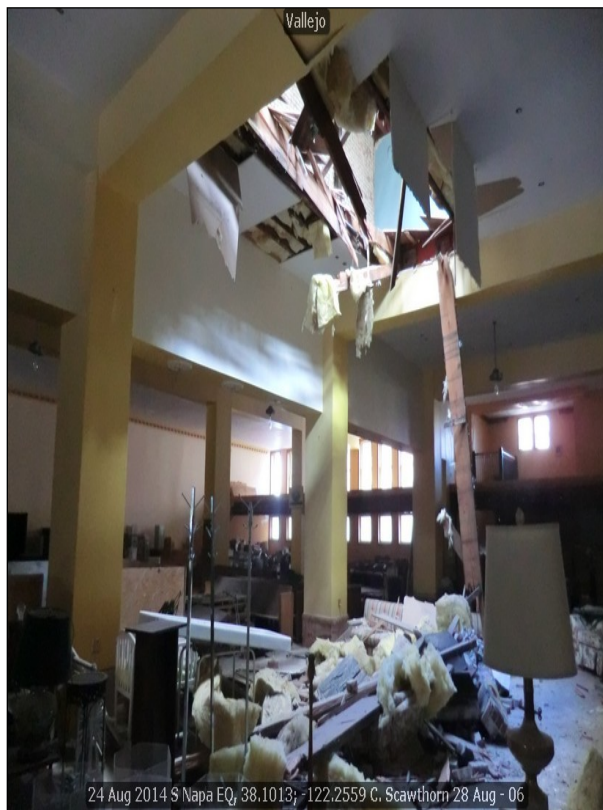
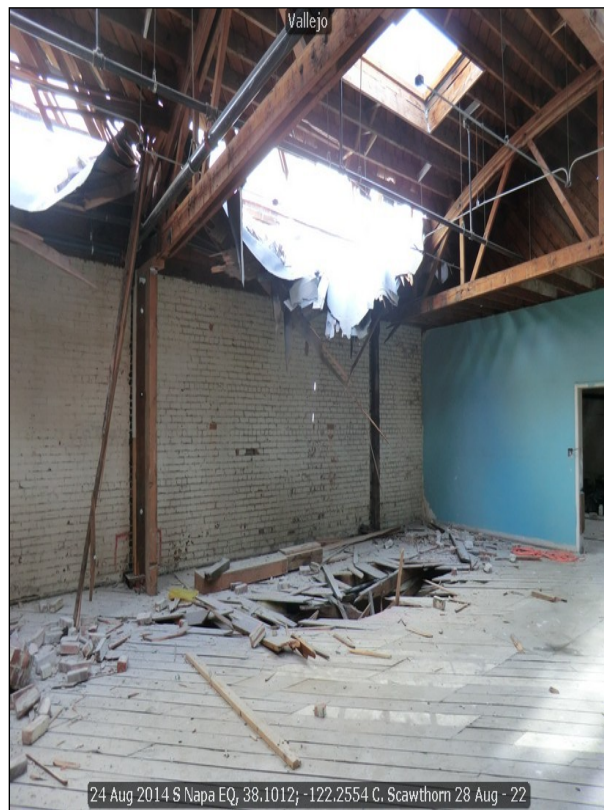
Figure 19 highlights the fact that a fragile building next door can imperil a modern, well designed building and can potentially kill or injure building occupants and cause business interruption.

Figure 19 URM building, Georgia Street, Vallejo, (t) façade, with little apparent damage, note unbroken windows; (b) interior, showing ground floor on left and second floor on right, where parapet fell through to ground floor.

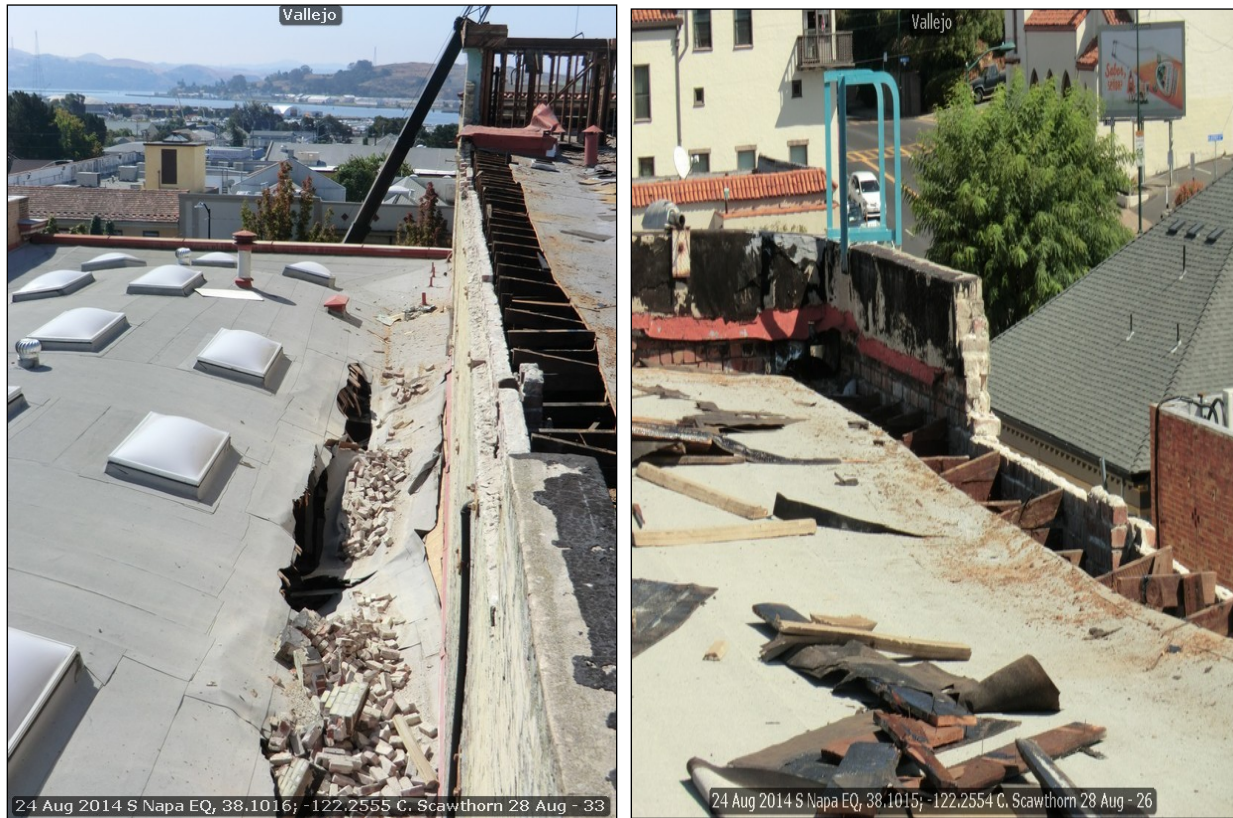
Figure 20 Roof of URM building shown in Figure 19, showing approximately 3 ft. by 40 ft. long section of parapet, which fell approximately 15 ft. onto and through neighboring building roof.

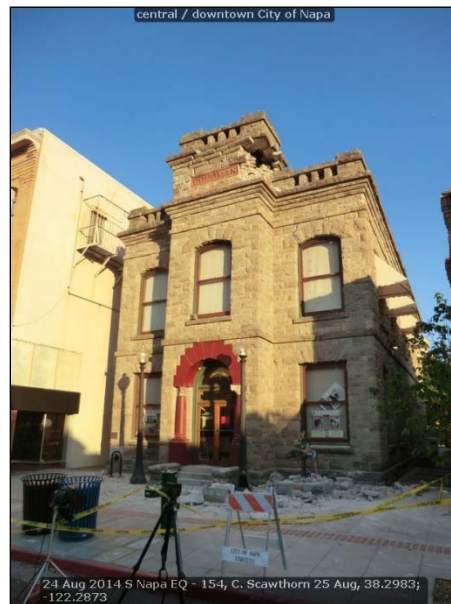
Figure 21 Goodman library – URM built 1901, longest continuously operating library in California, National Register #74000539, retrofit unclear, damaged.

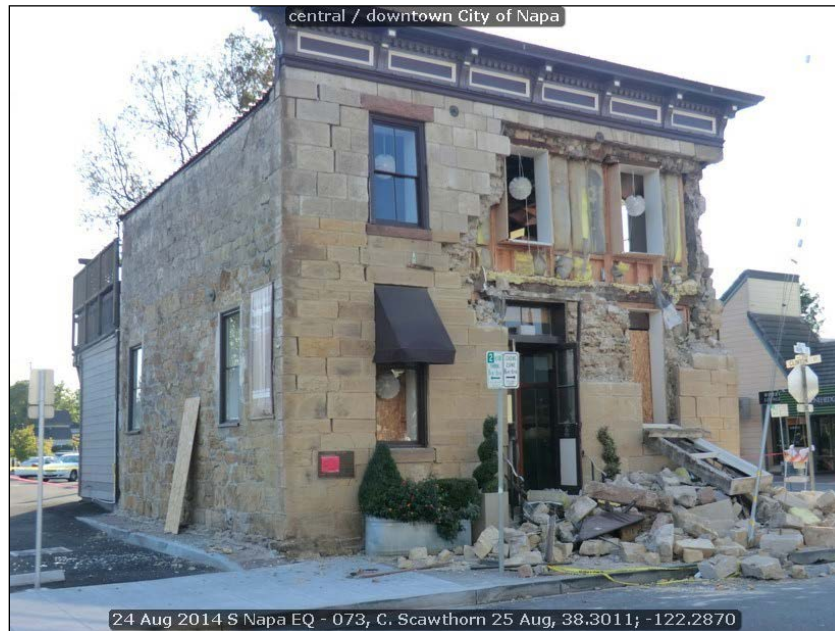
Figure 22 Sam Kee Laundry Building, also known as the Pfeiffer Building, 1245 Main St. Napa, built 1875, is the oldest stone building and commercial building in Napa, National Register #74000540, unretrofitted and damaged.

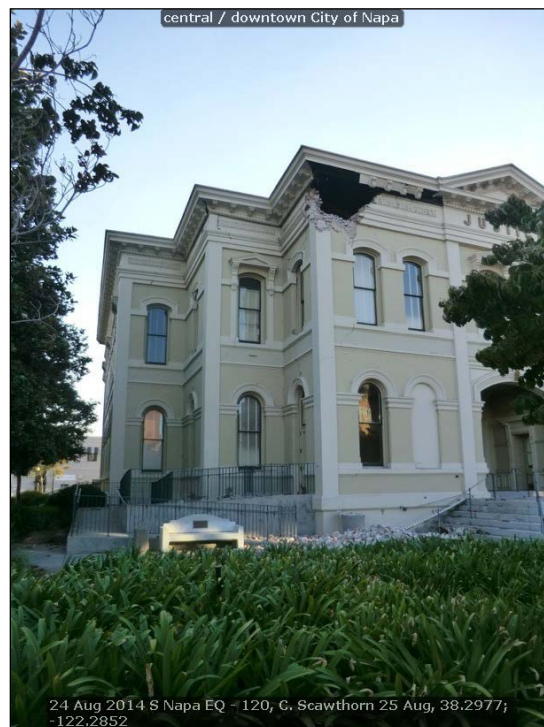
Other damaged buildings including the Old Courthouse, Figure 23, and a modern (built 1984) three story 40,000 sq. ft. office building, Figure 24. Several of these buildings were historic structures, listed on the National Register of Historic Places.

Figure 23 Napa County Courthouse, built 1870

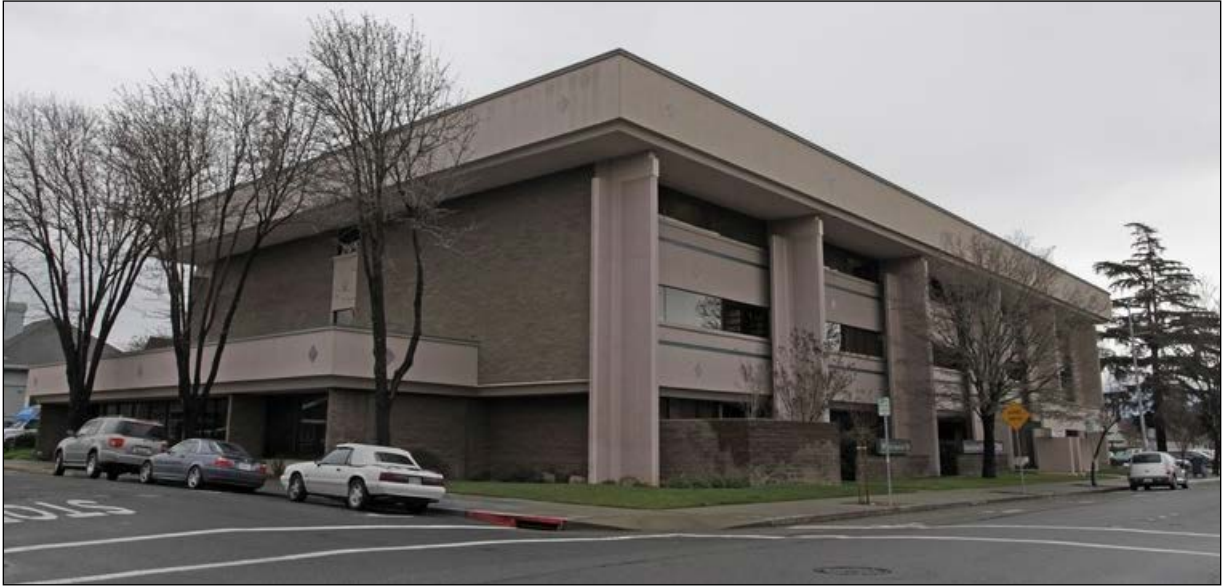
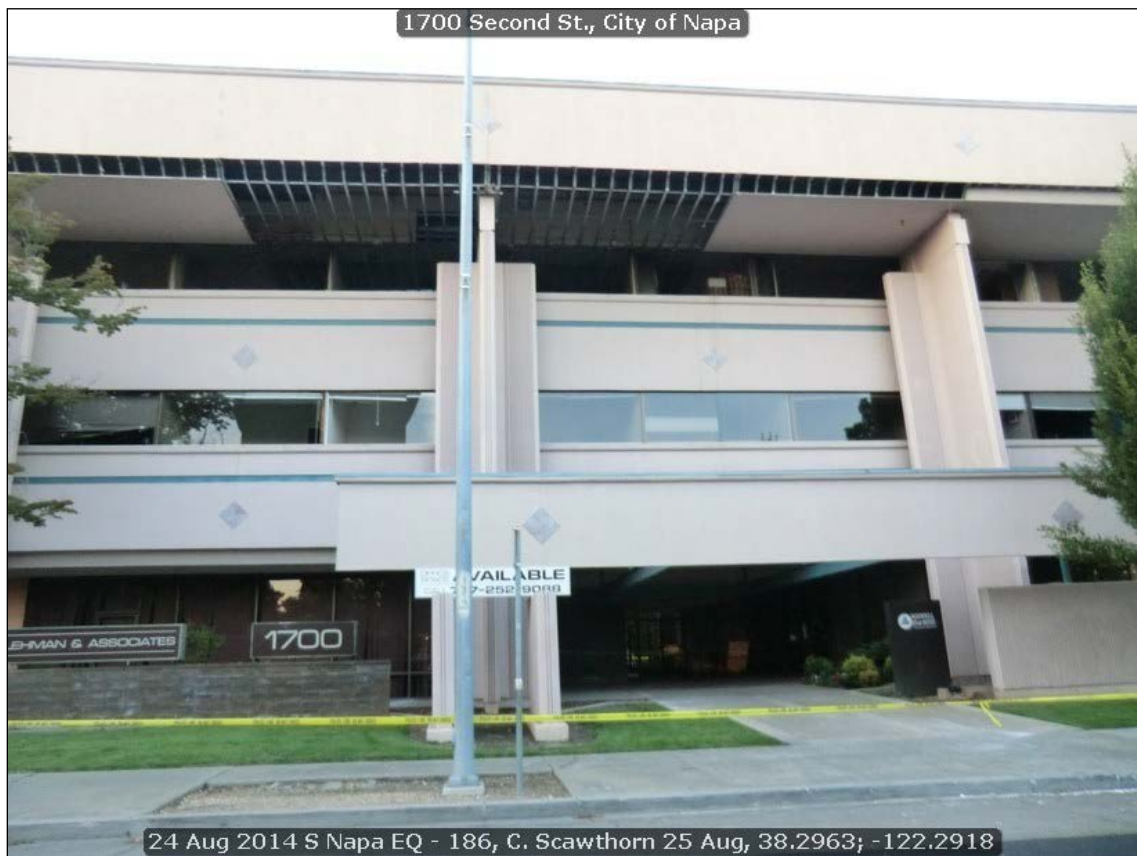
Figure 24 Office building 1700 Second Street, built 1984, damage to third floor exterior soffit

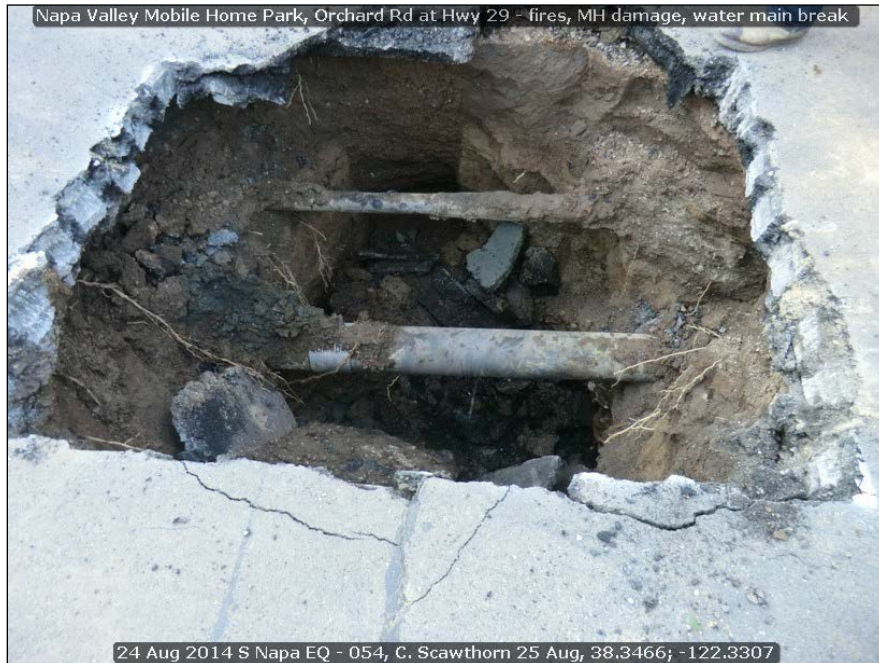
Figure 27 Water main break, Orchard Road.

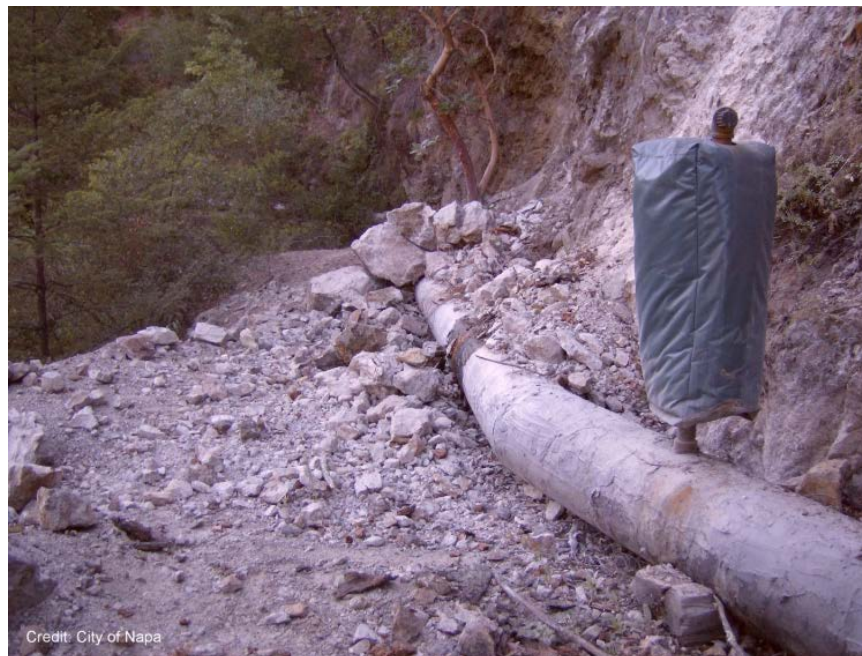
In some ways, the most significant break was in the main transmission pipe from the Milliken source, which was broken by a rock slide, Figure 28.

Figure 28 Milliken line, broken by rock slide.

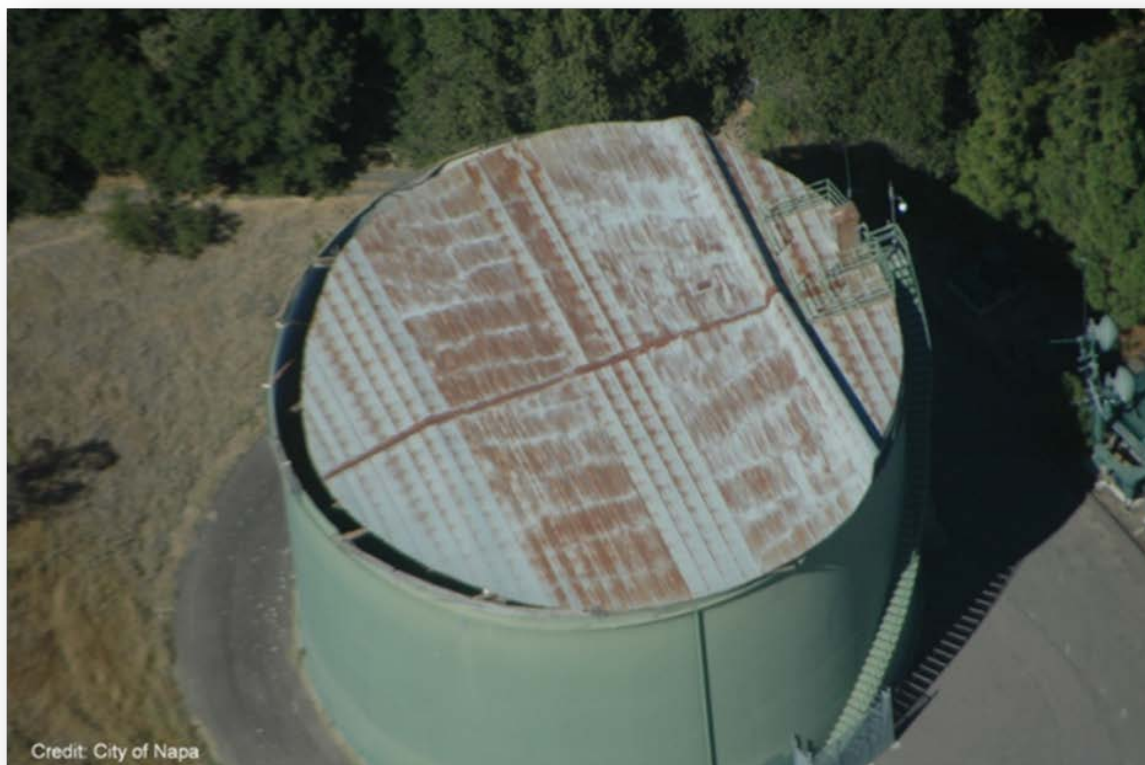
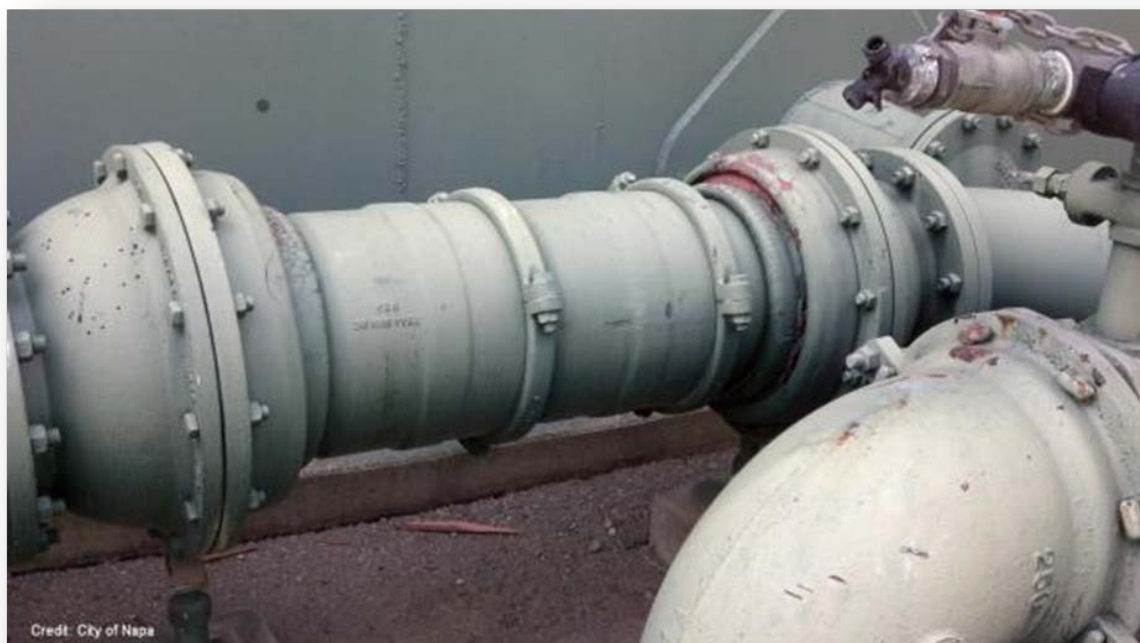
Of the 12 tanks in the system, one (termed Montana "B") sustained significant damage, Figure 29. The tank is an unanchored 67-foot diameter, 37-ft high circular welded steel tank with corrugated iron (CGI) roof supported by redwood beams on steel columns. The water sloshed with approximately 6 ft amplitude, damaging the roof. No buckling of the walls occurred, but some rocking occurred as evidenced by motion at the outtake slip joint. The tank drained immediately following the event due to a nearby pipe break.

Figure 29 Montana “B” tank – roof damaged by sloshing and outtake exhibiting evidence of motion at slip joint.

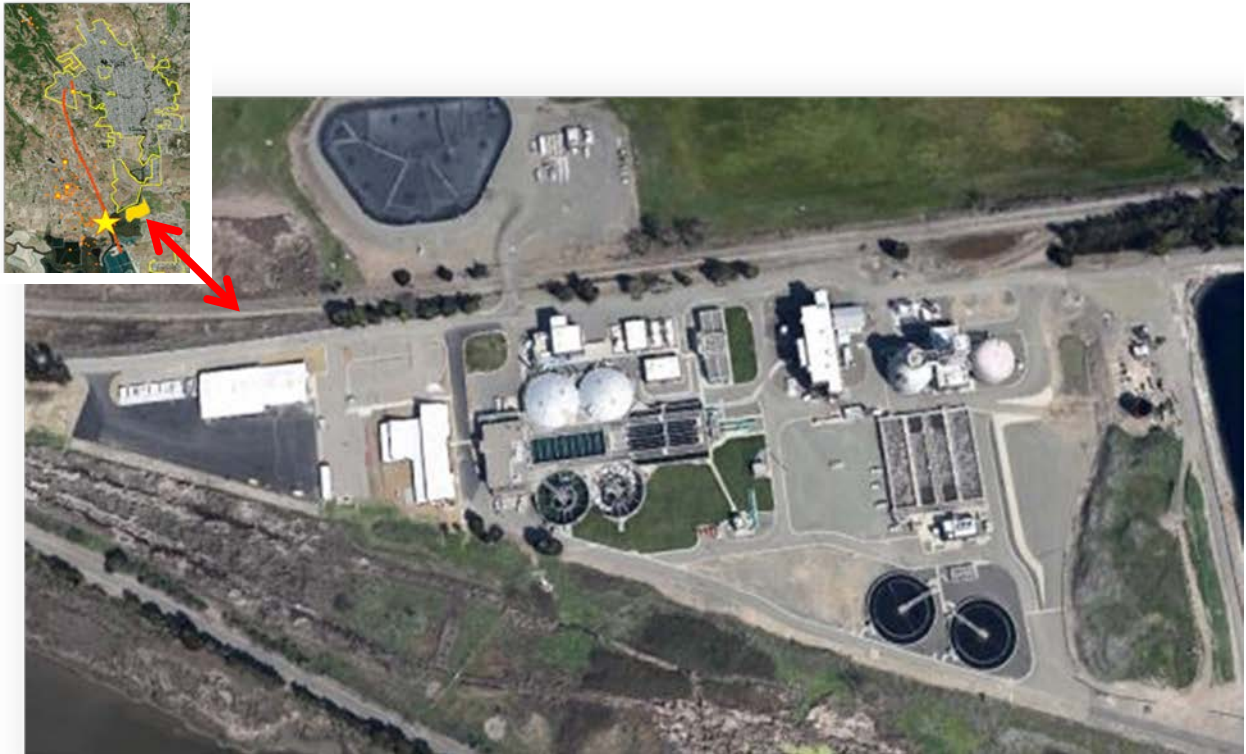
Figure 31 Napa Sanitation District (NSD) Soscol Water Recycling Facility (SWRF)

Napa's wastewater is treated at the 7 mgd (dry weather) Soscov Water Recycling Facility (SWRF), Figure 31. SWRF experienced sloshing and spillage at the sand filters. Additionally, minor cracking was observed in the several reinforced concrete structures at the plant.
