24 August 2014 South Napa M_w 6 Earthquake Reconnaissance Report

26 September 2014

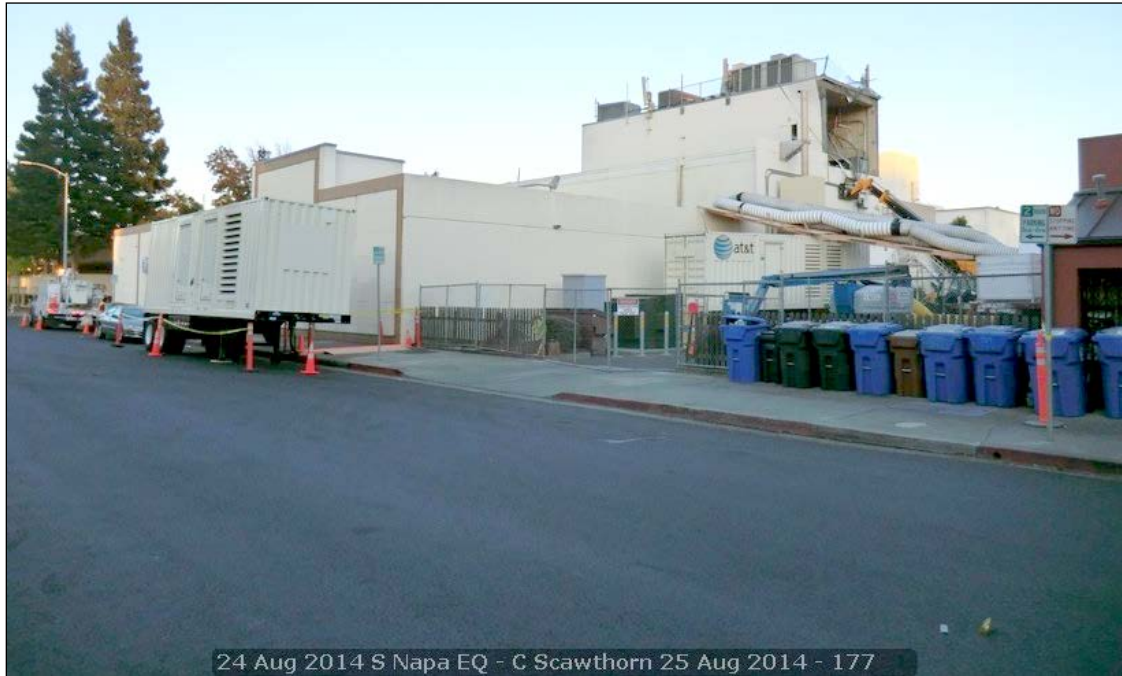
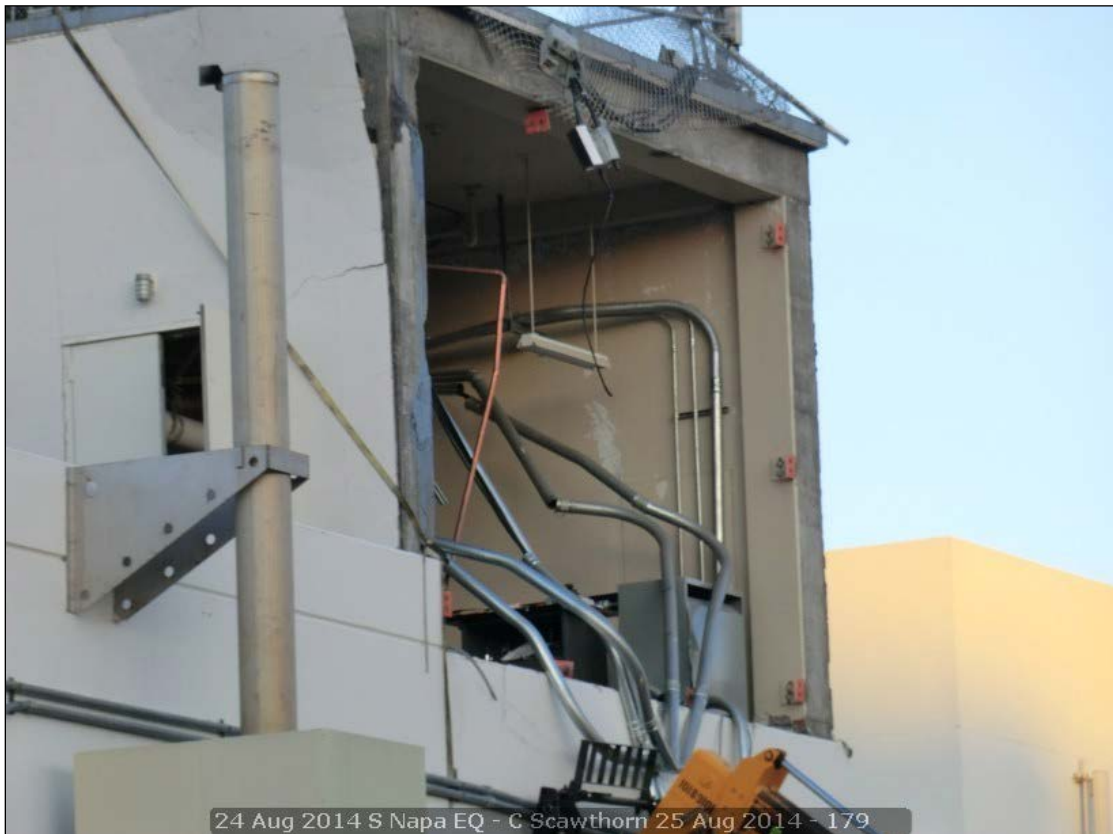
Figure 36 Damage to AT&T building, Napa

Telecommunications generally performed well in this event. The AT&T building in downtown Napa sustained damage to a concrete wall panel, attached to the building using 8 bolted angles and which fell due to connection failure during the earthquake and disrupted PG&E supply to the building, Figure 36. Emergency generators did not work, but the equipment and operations were sustained by battery systems. It is not unusual for emergency generators to fail to start, especially if they are not regularly tested, or if they or any of their ancillary equipment such as day tanks, starter batteries, fuel lines, and fuel tanks, are not seismically secured.

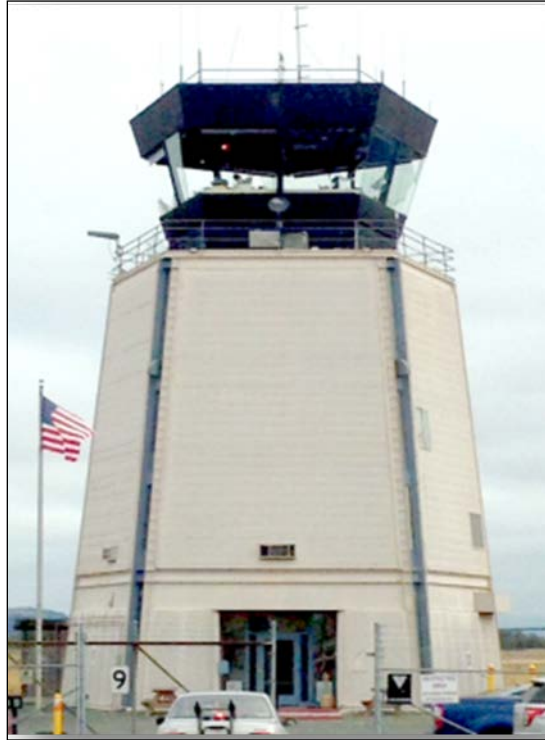
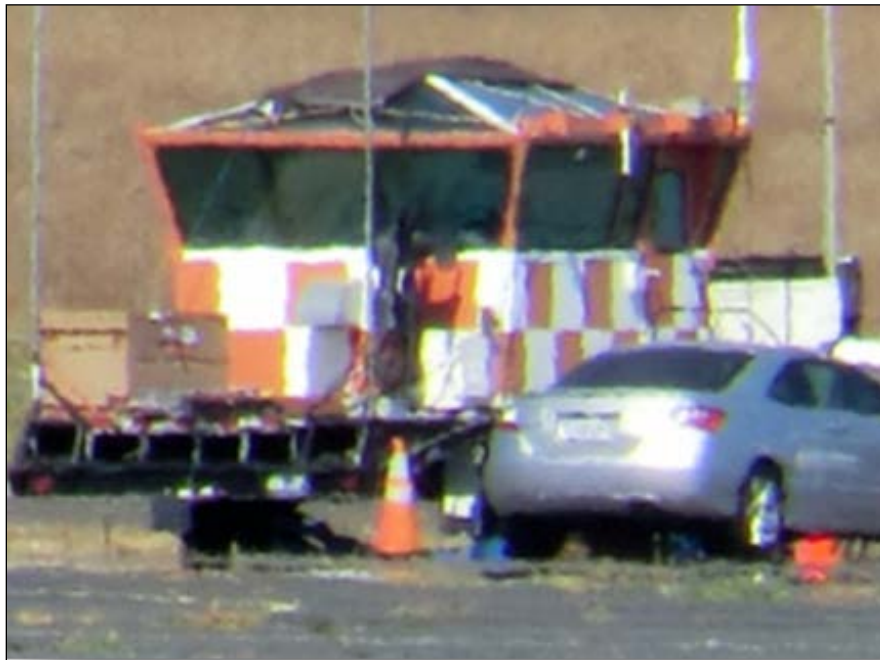
The ATC tower at Napa airport is owned and operated by the FAA, and sustained no structural damage but did sustain glass breakage of its main control room windows. Local ATC was not available for four days until a temporary tower was brought in, Figure 39. The temporary tower is anticipated to be required for several weeks, pending delivery of replacement glass. Operations continued without ATC, based on pilots communicating directly via radio, which is the normal procedure at airports that normally do not have ATC.

Figure 39 Napa airport ATC tower with broken glass (above) and temporary tower (below)

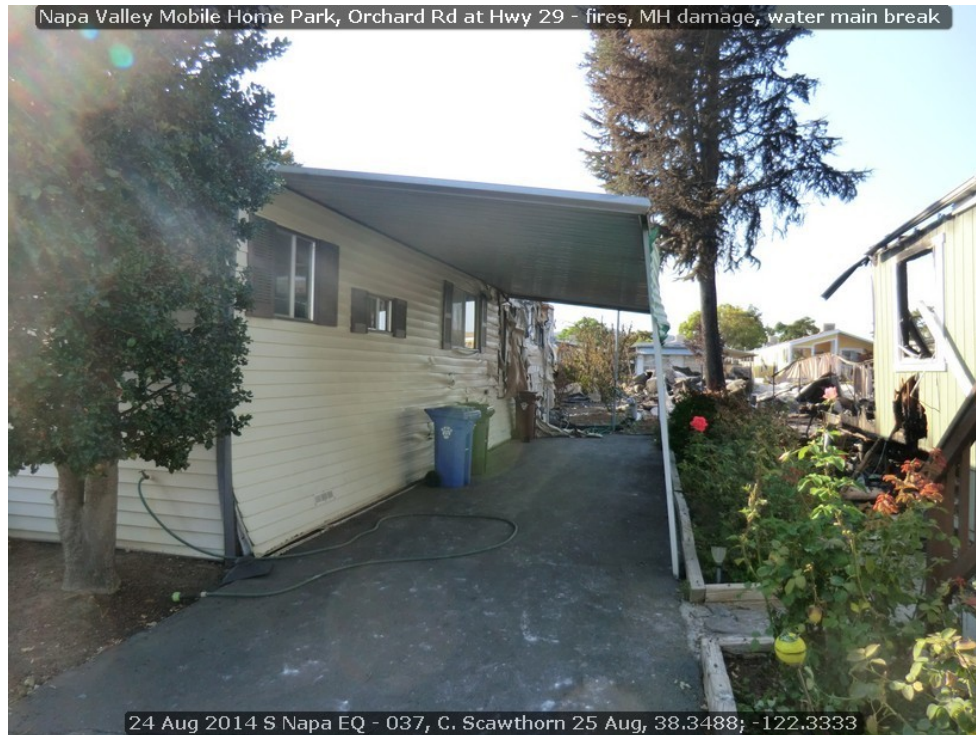
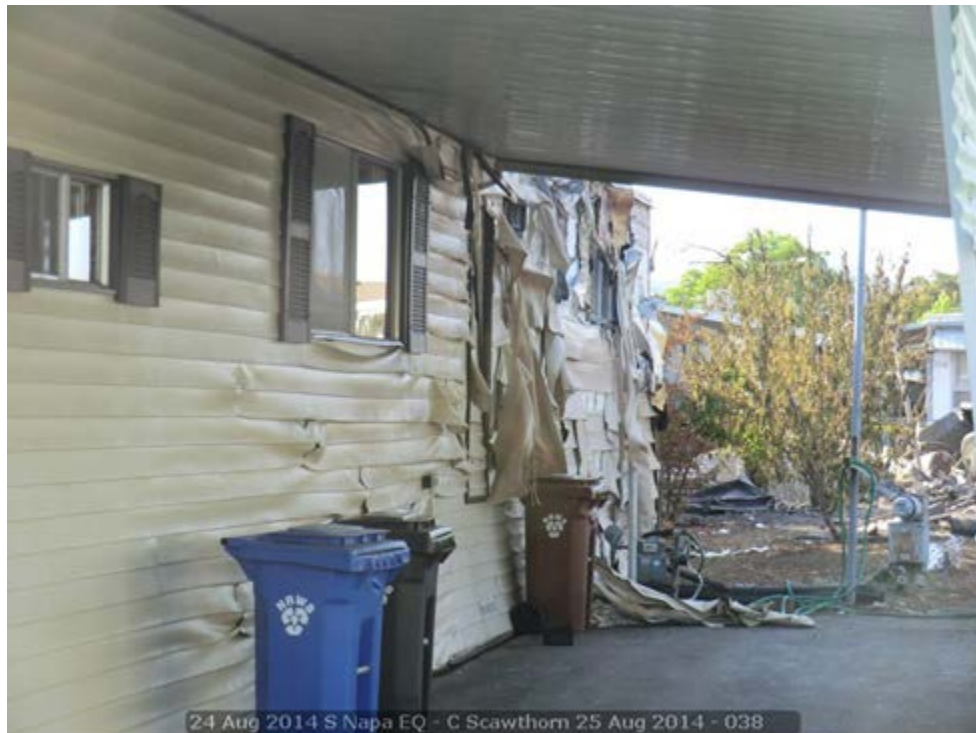
Figure 51 Damage to exposure structures, 317 Patty Way, NVMHP Park, 24 Aug 2014 S. Napa M_w 6.0 Earthquake, structure to south of fireground
