# Strong Motion, Damage, and Loss of Wenchuan Earthquake

Zifa Wang

Institute of Engineering Mechanics, China Earthquake Administration

August 18, 2008

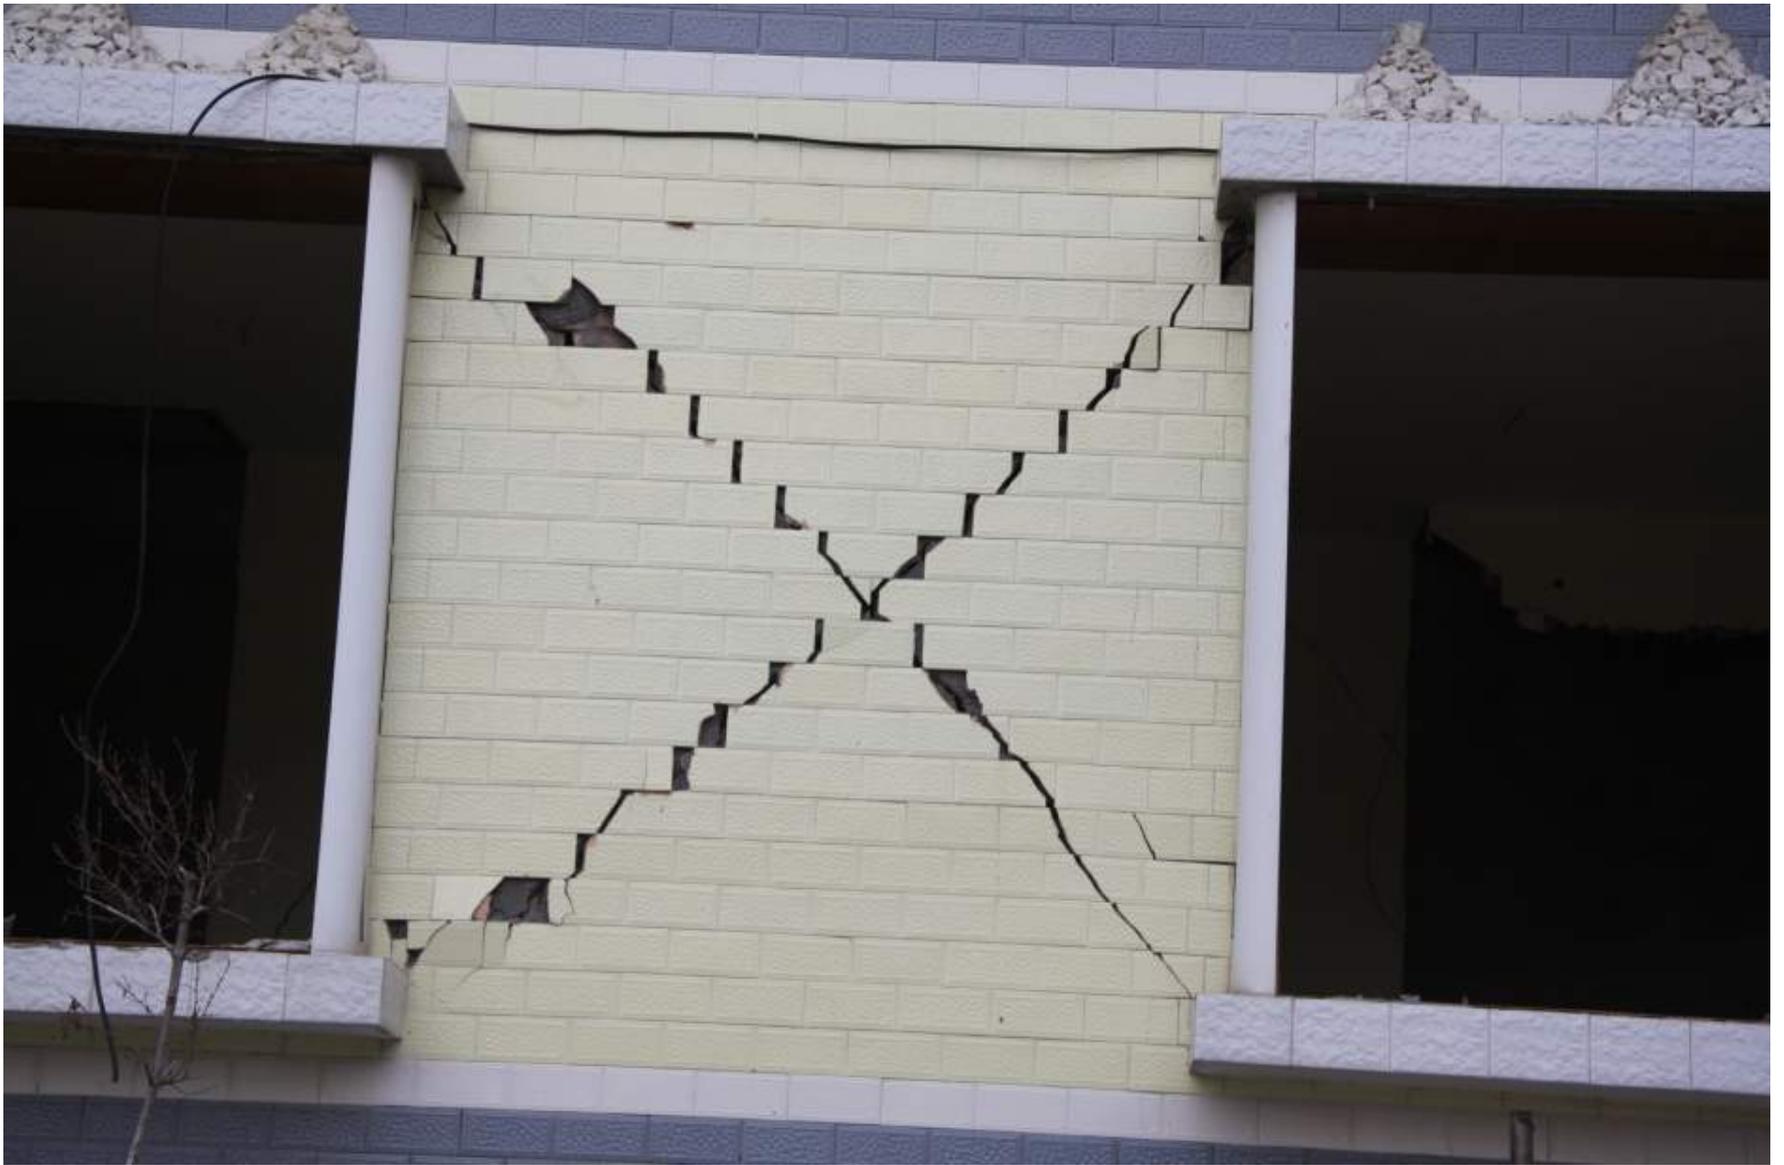
Typical damage for a brick structure

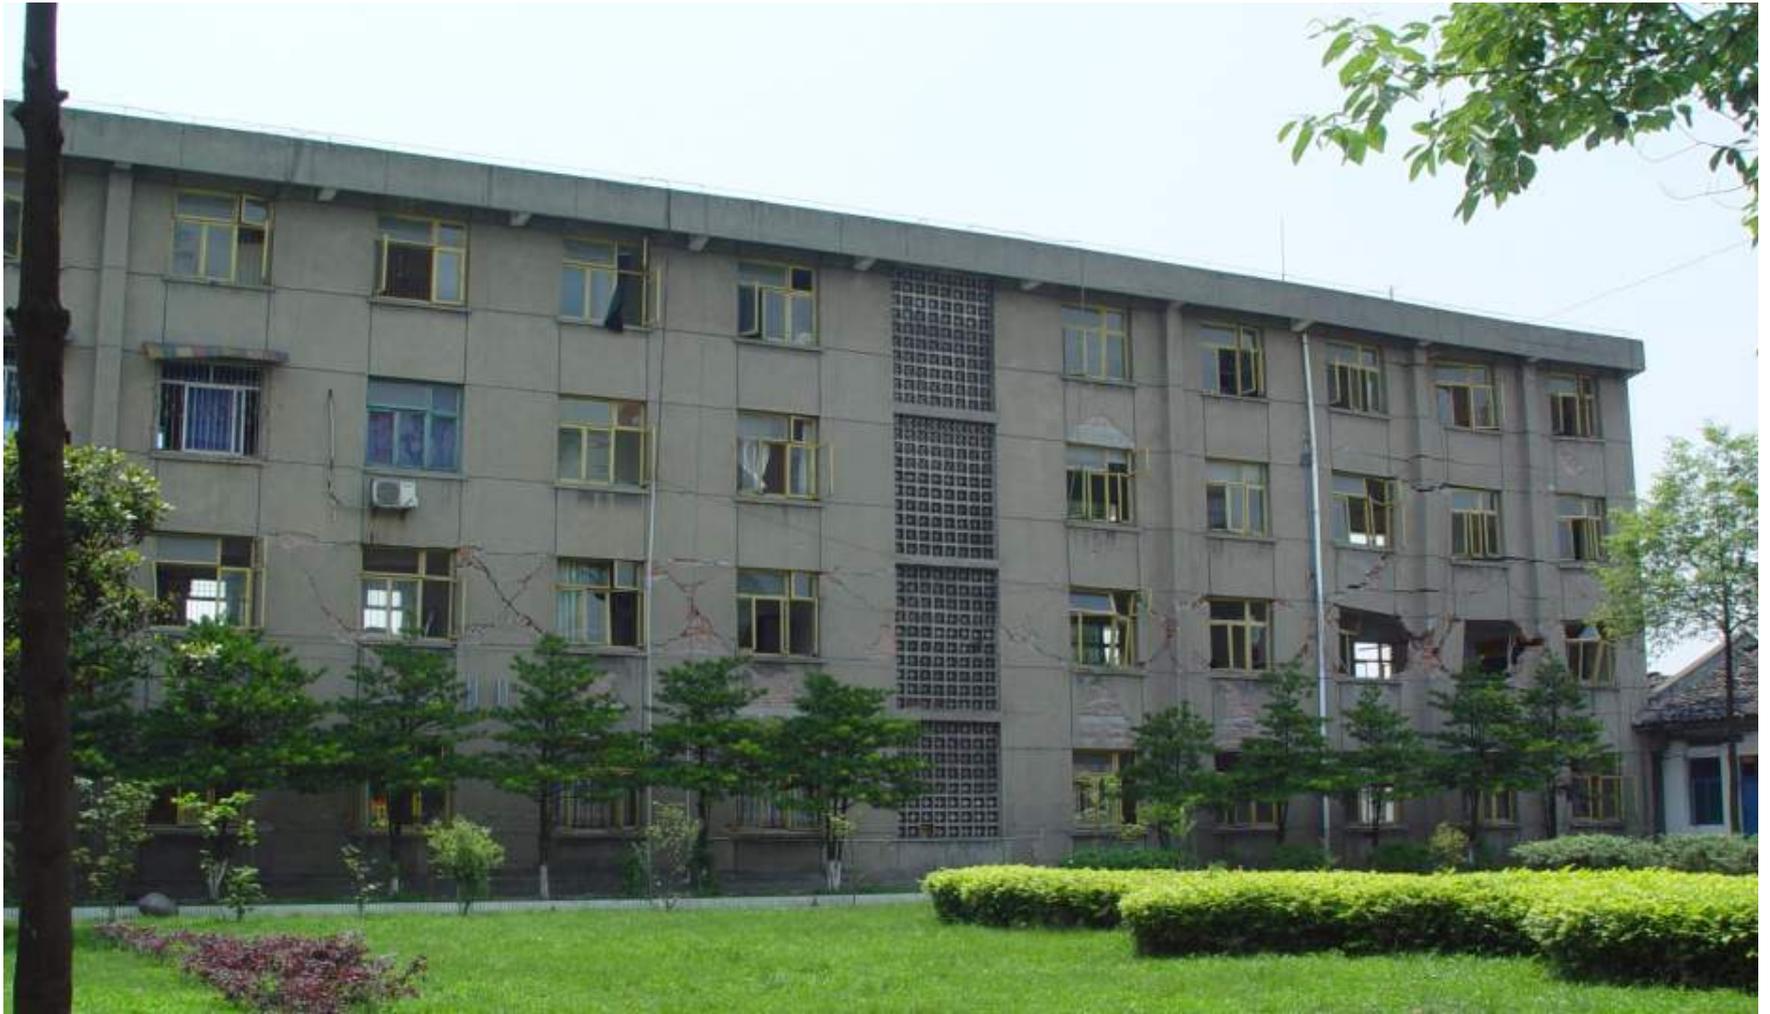
Damage to a dorm in Tumen Middle School in Mianzhu City

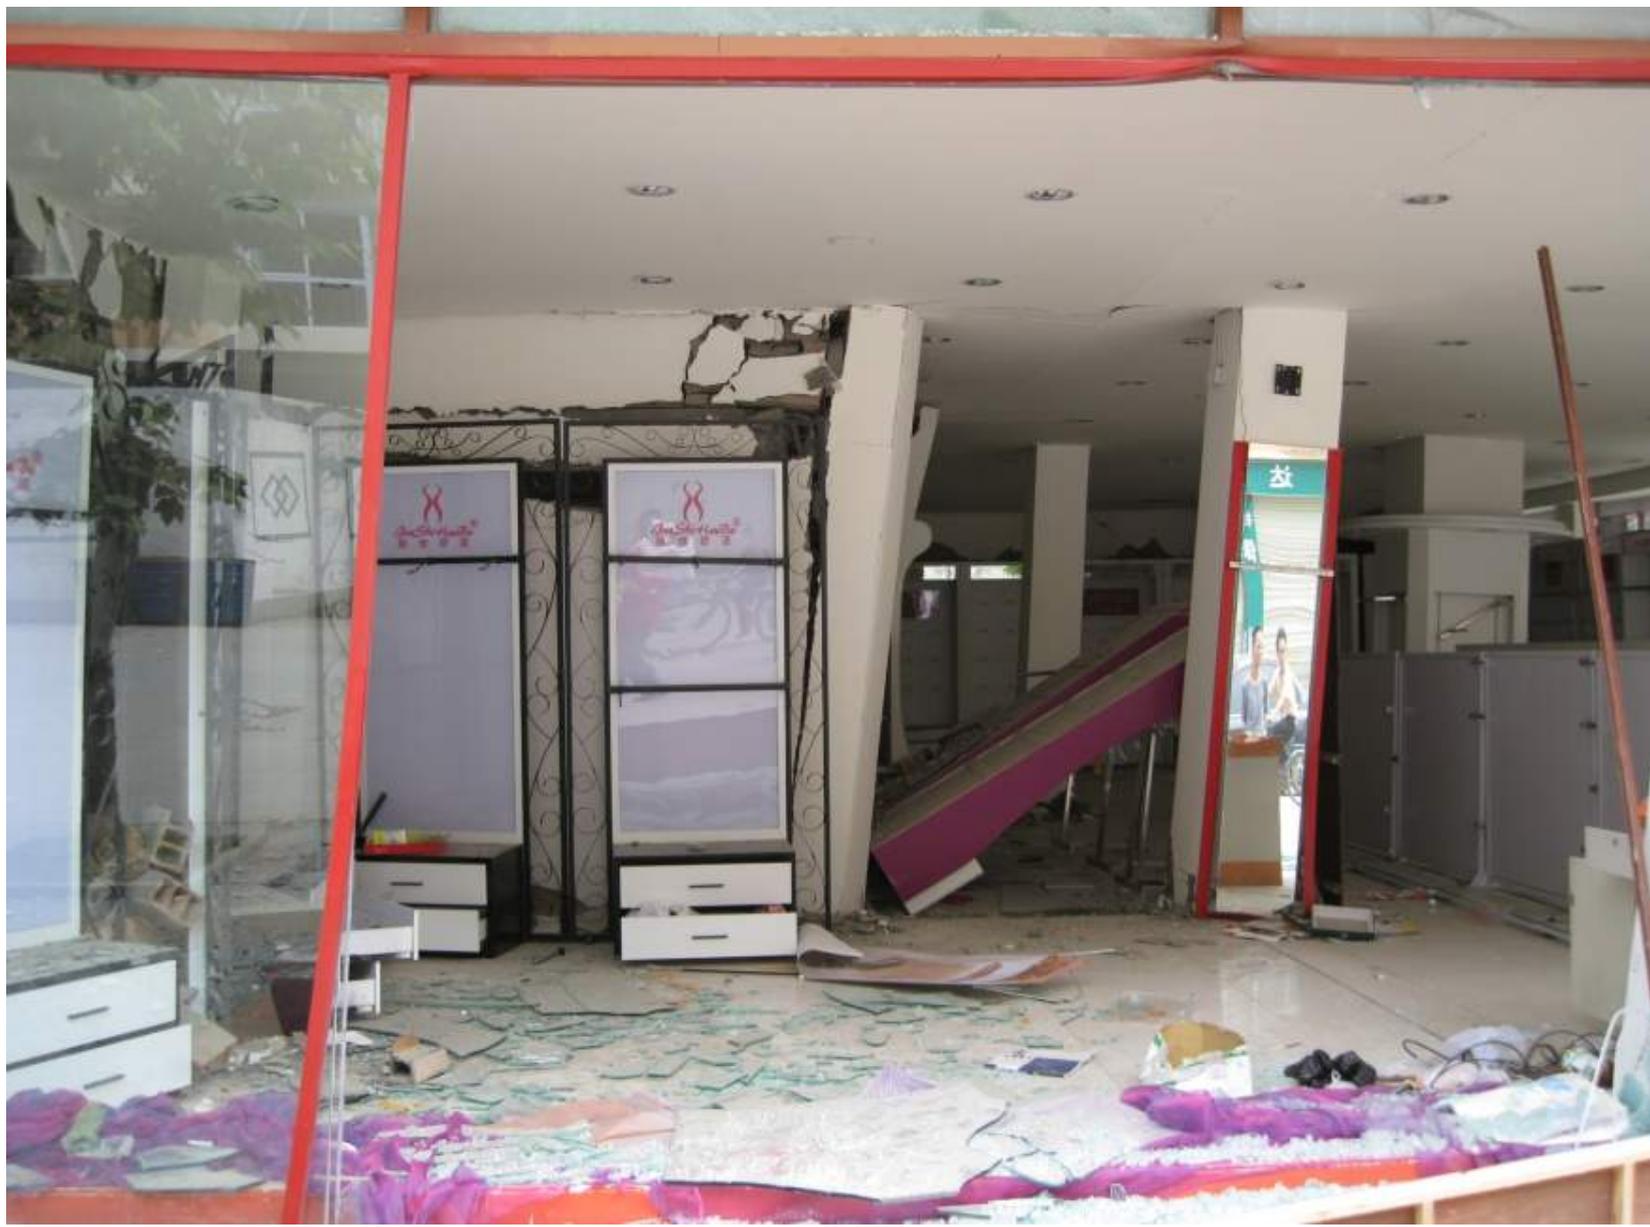
Tilted building toward right

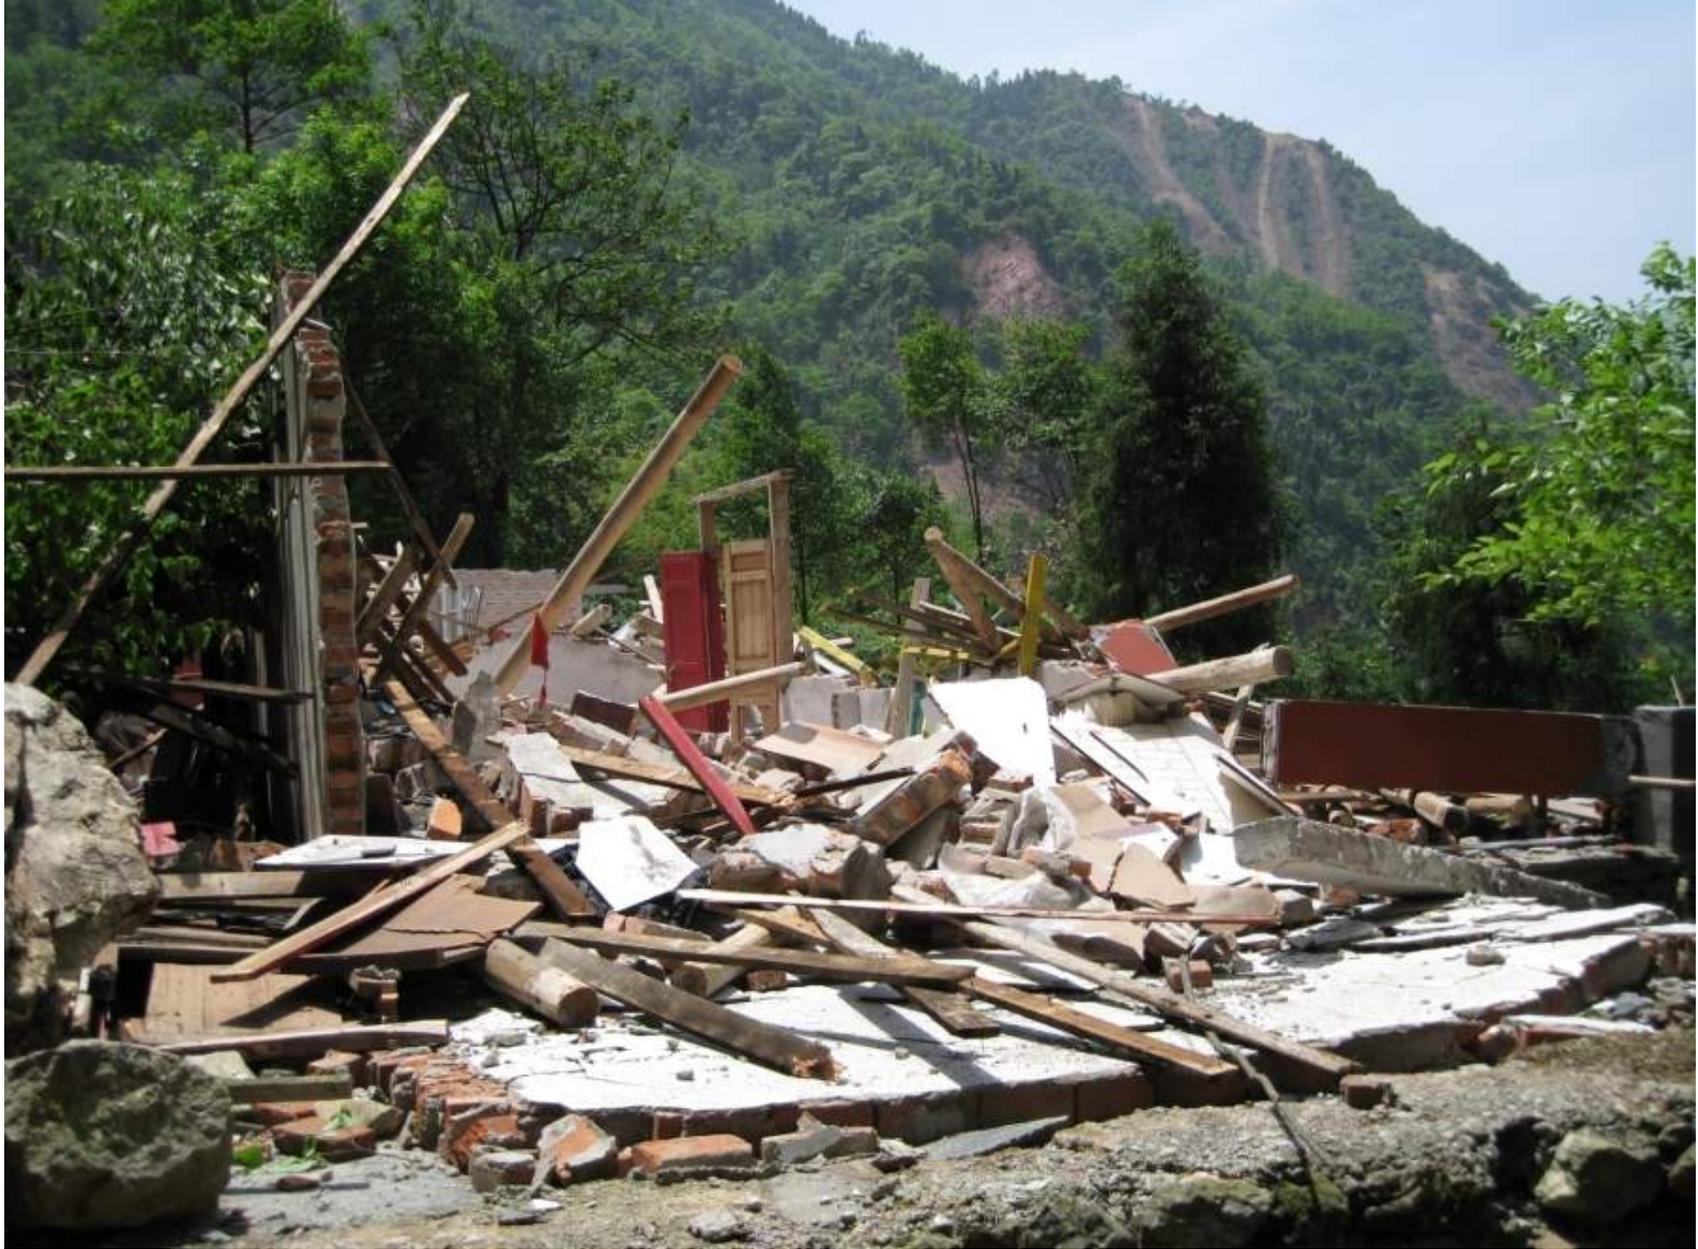
Complete destruction to buildings in the remote villages

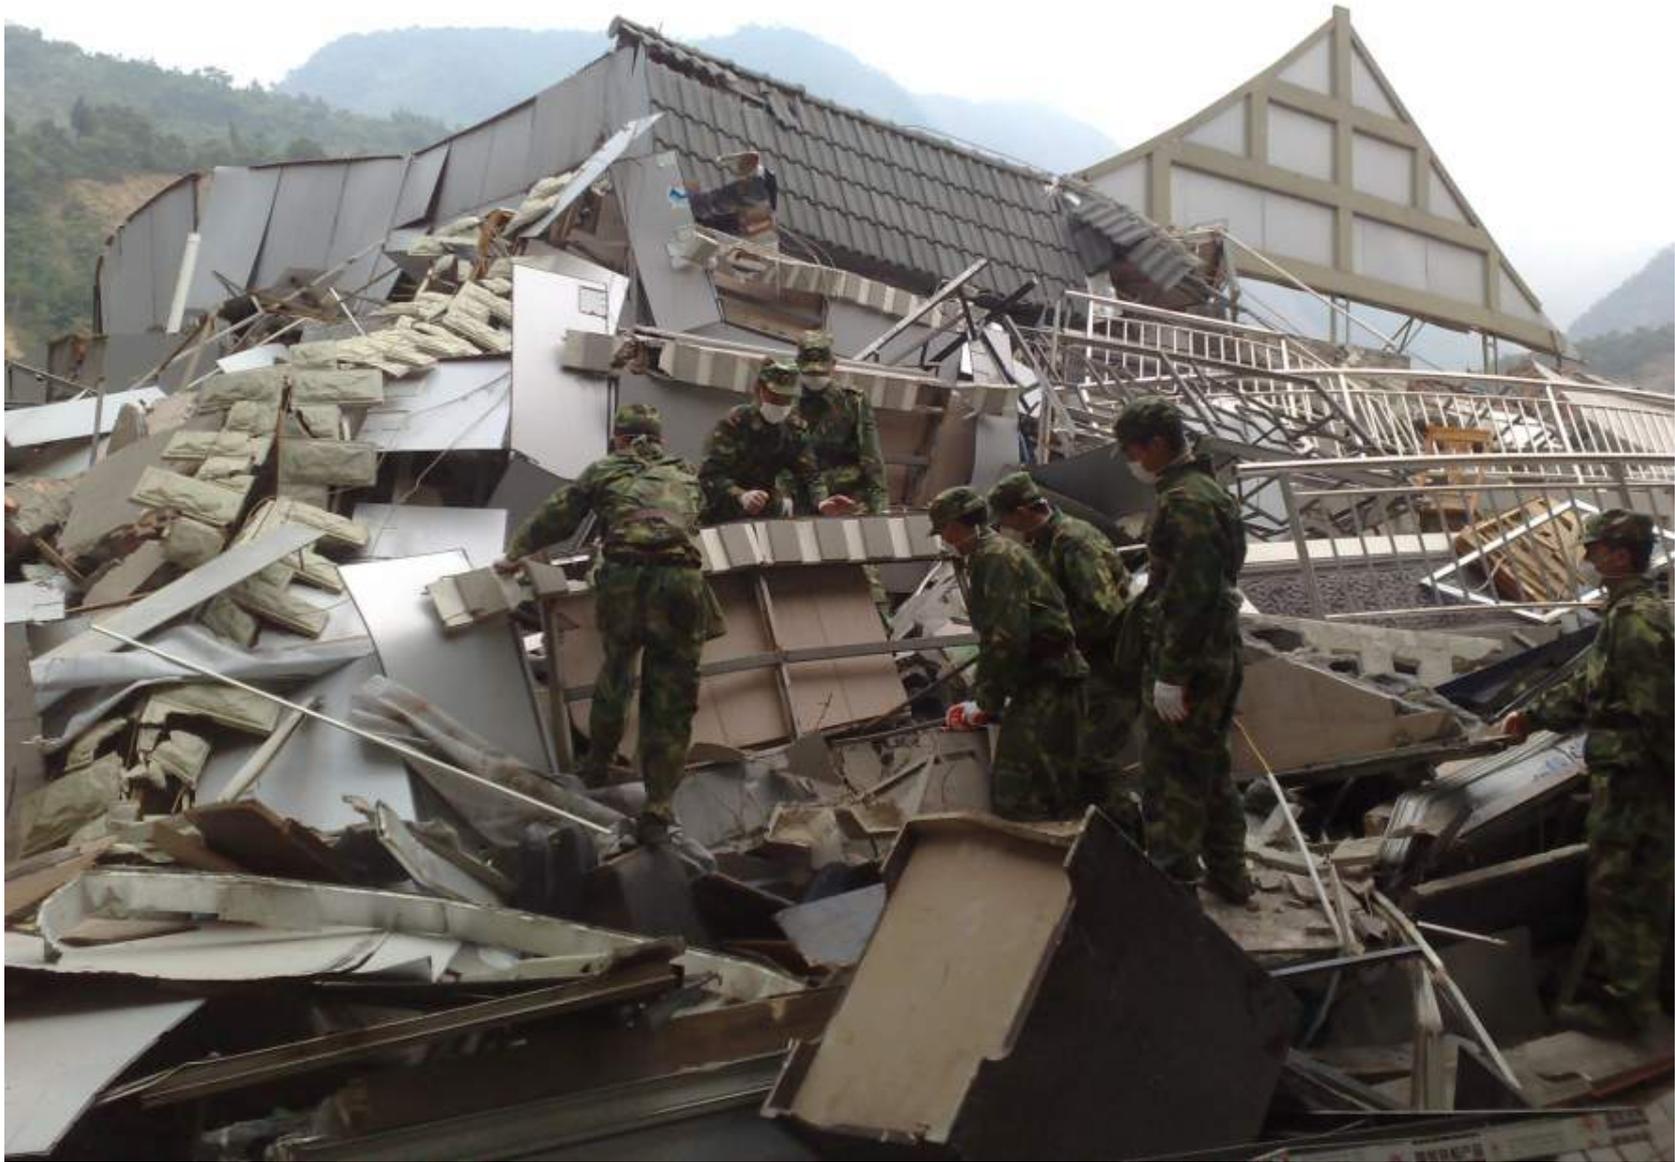
Collapse of an 8-story building in Beichuan County

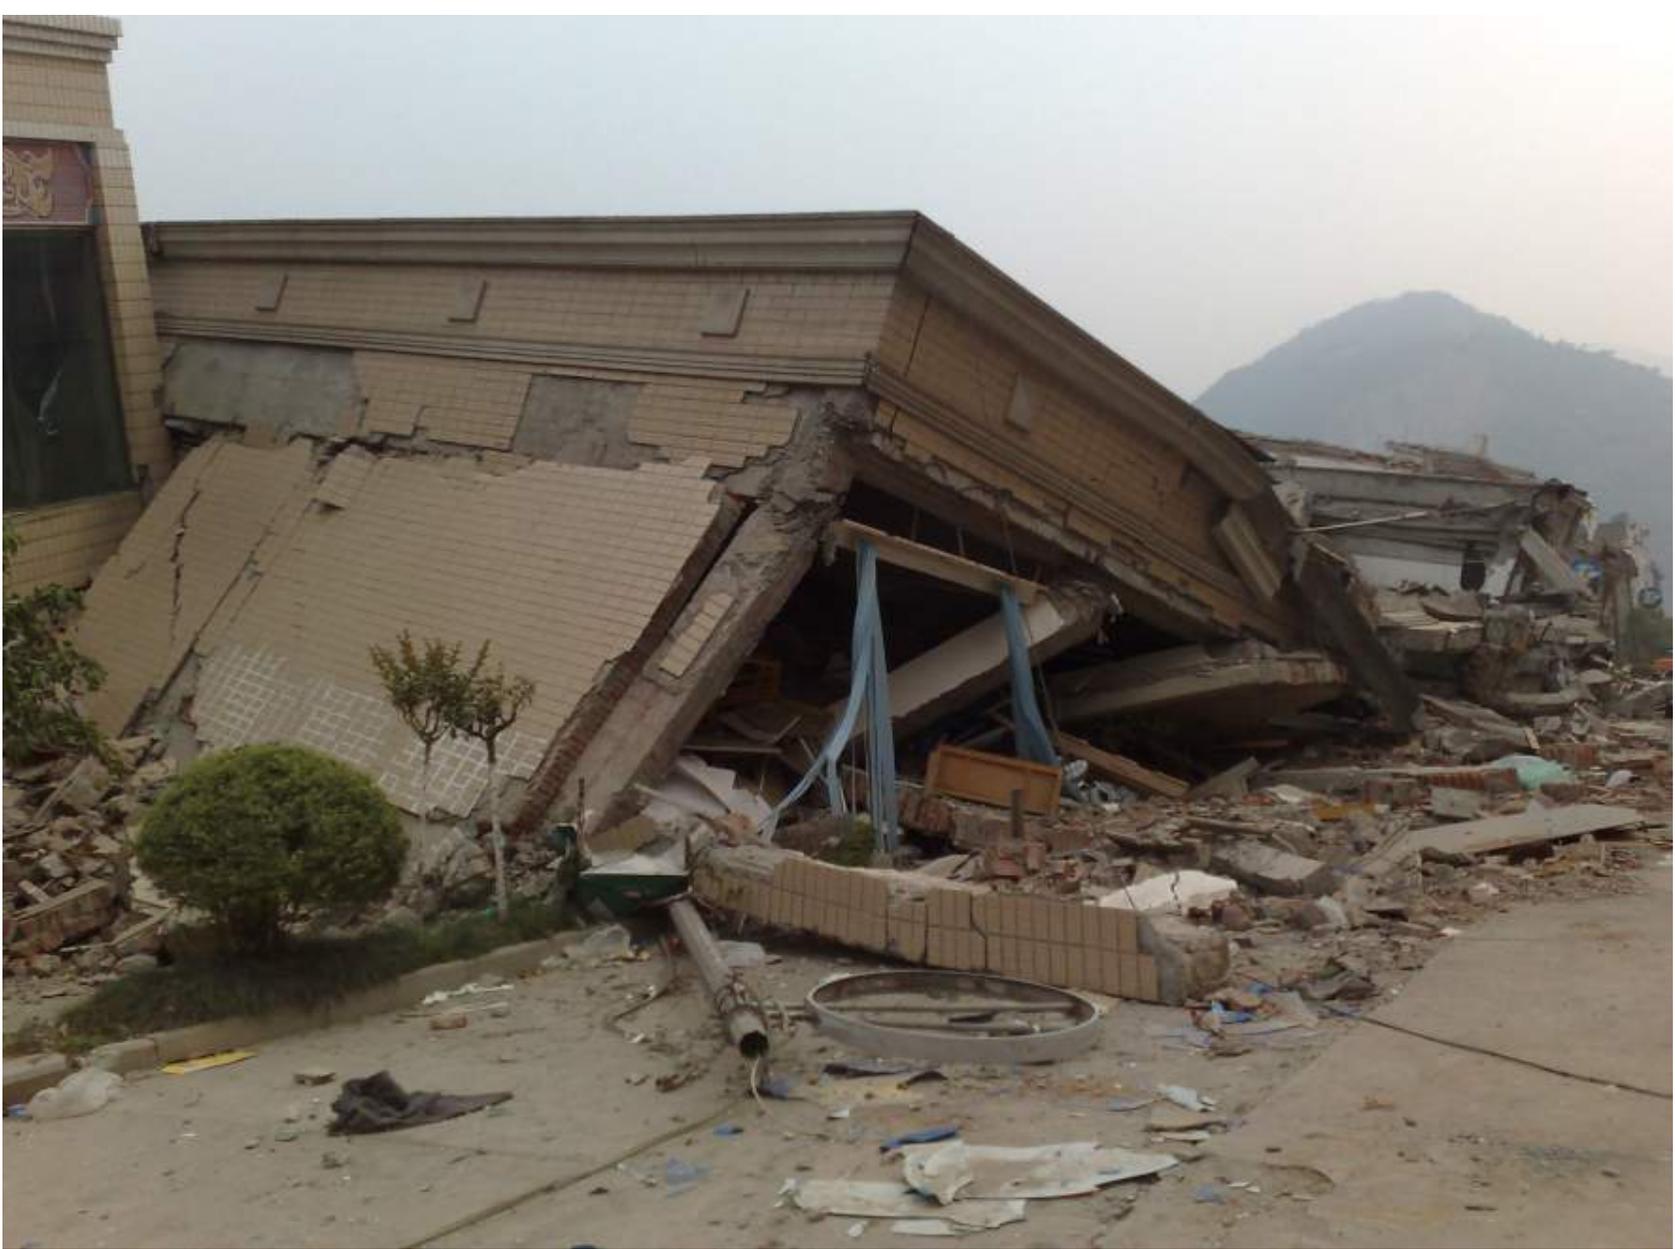
Damage to a 2-story building in Beichuan County

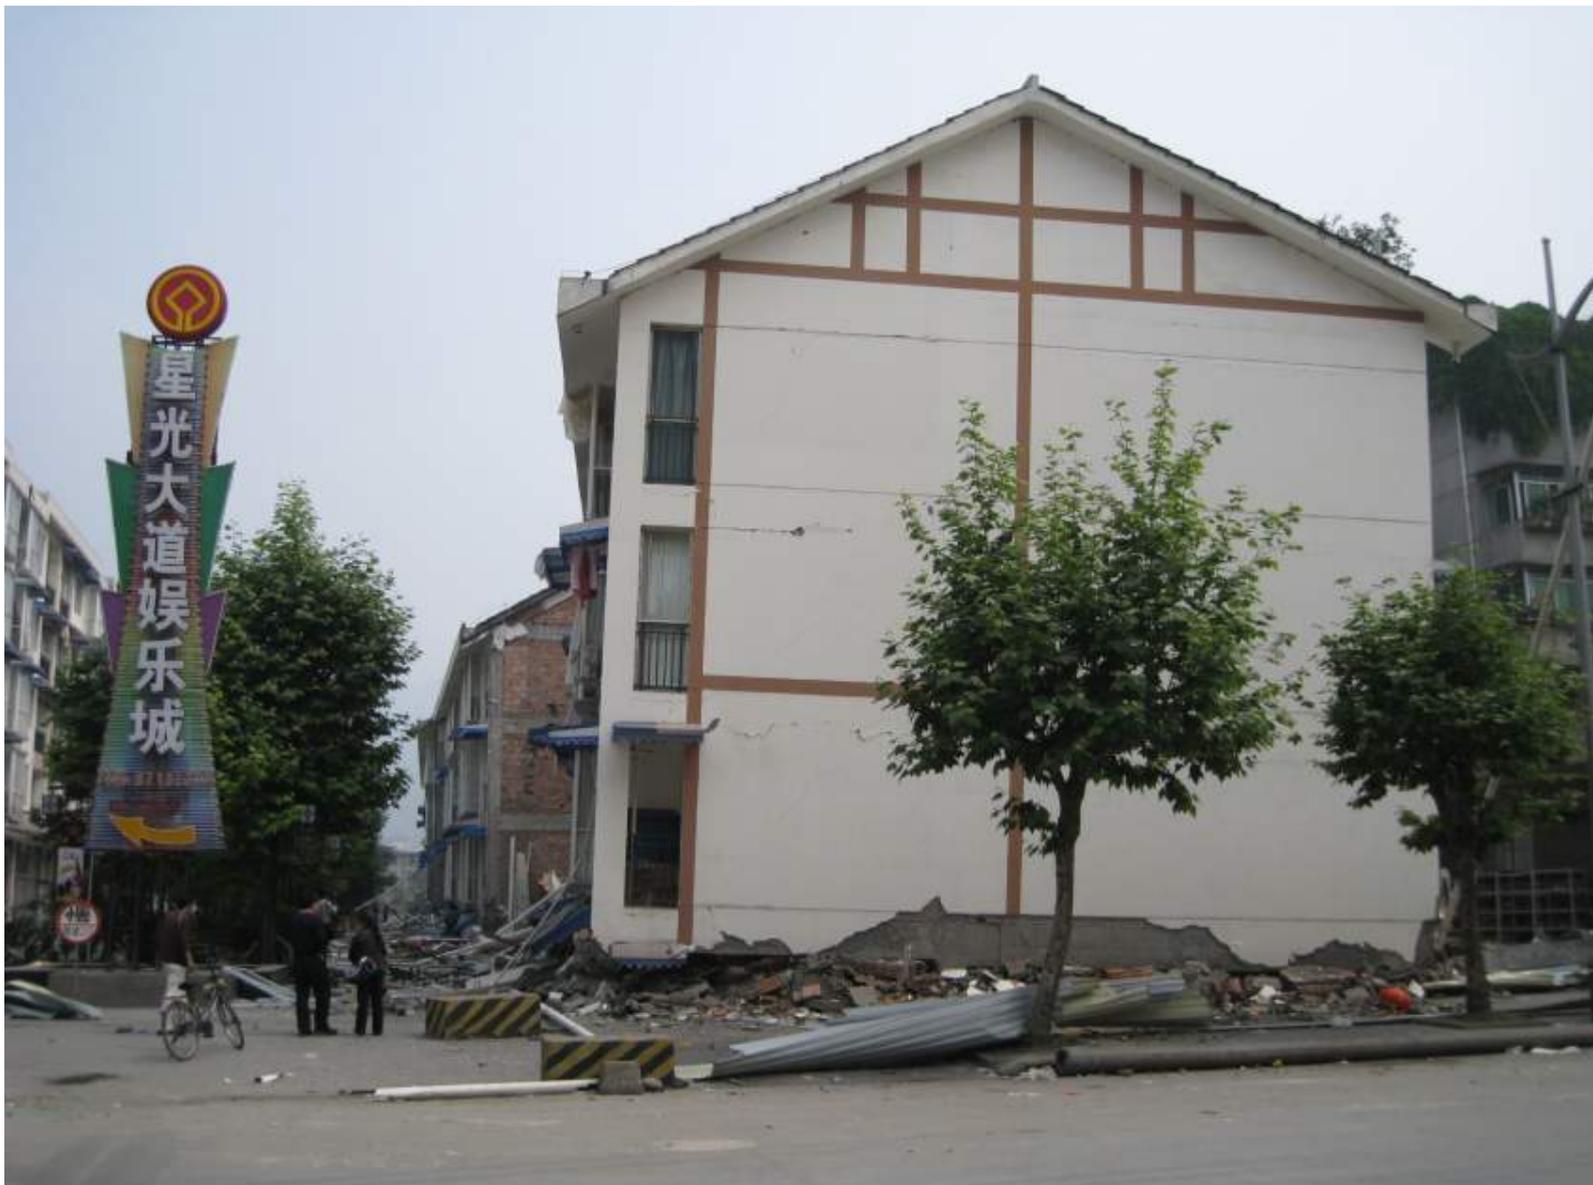
Crushed bottom 2 stories and rotation of the building in Dujiangyan City

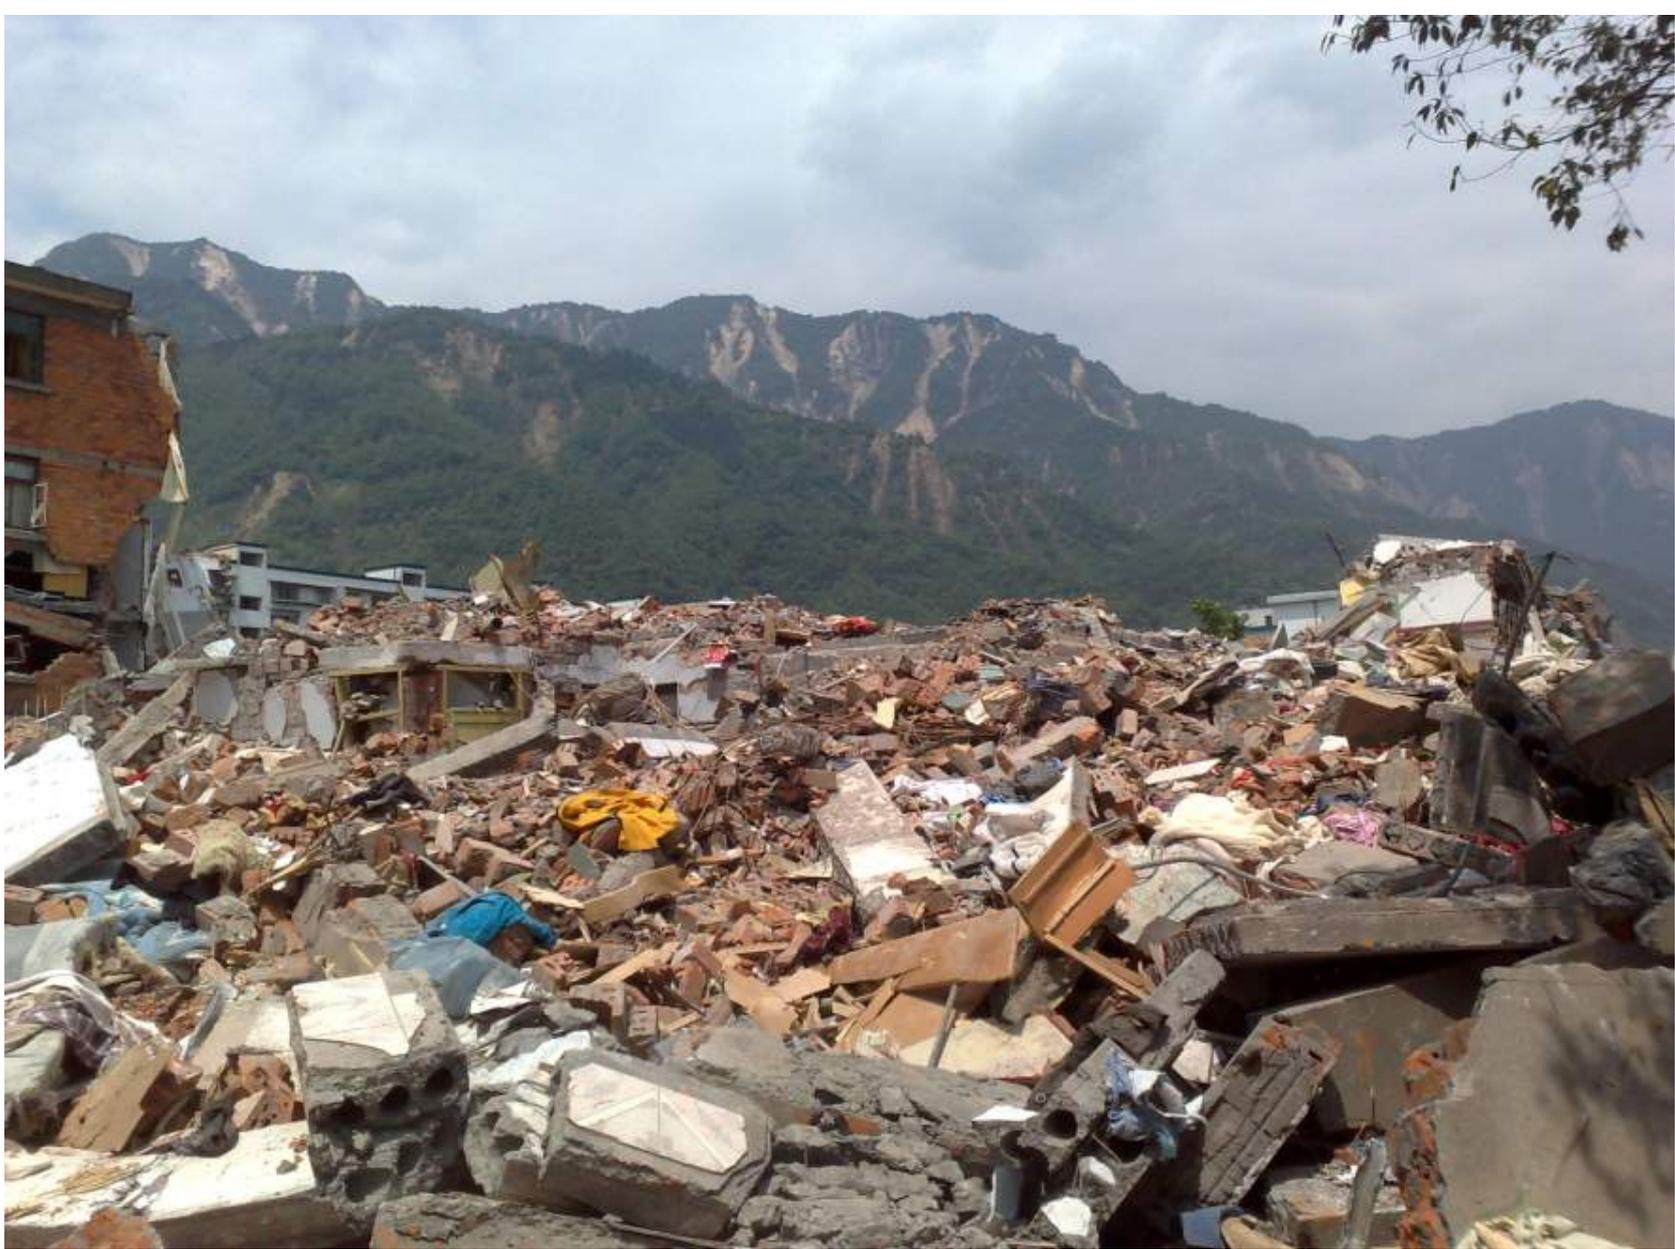
Complete destruction to school buildings in Hanwang town in Mianzhu

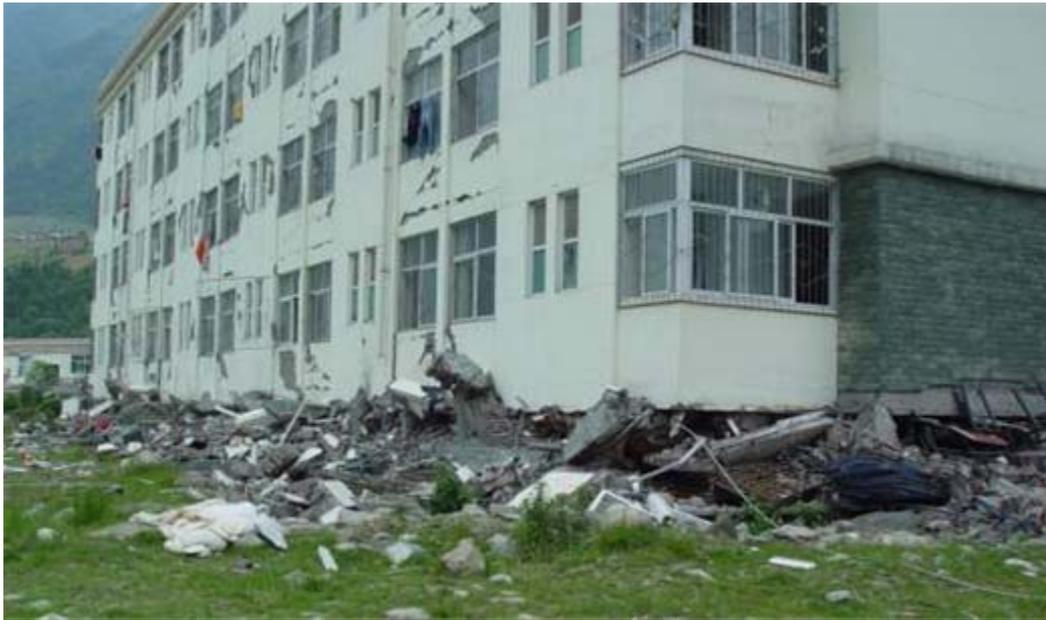
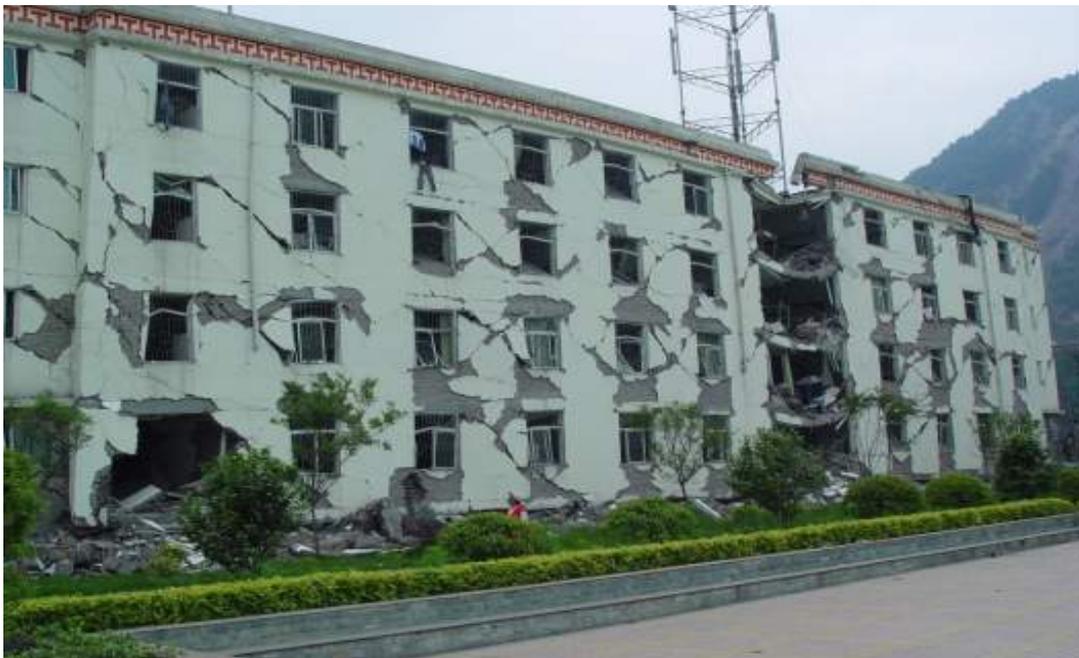
Collapse of the 1<sup>st</sup>  
story in a dorm  
building of Xuankou  
Middle School at  
Yingxiu town of  
Wenchuan County

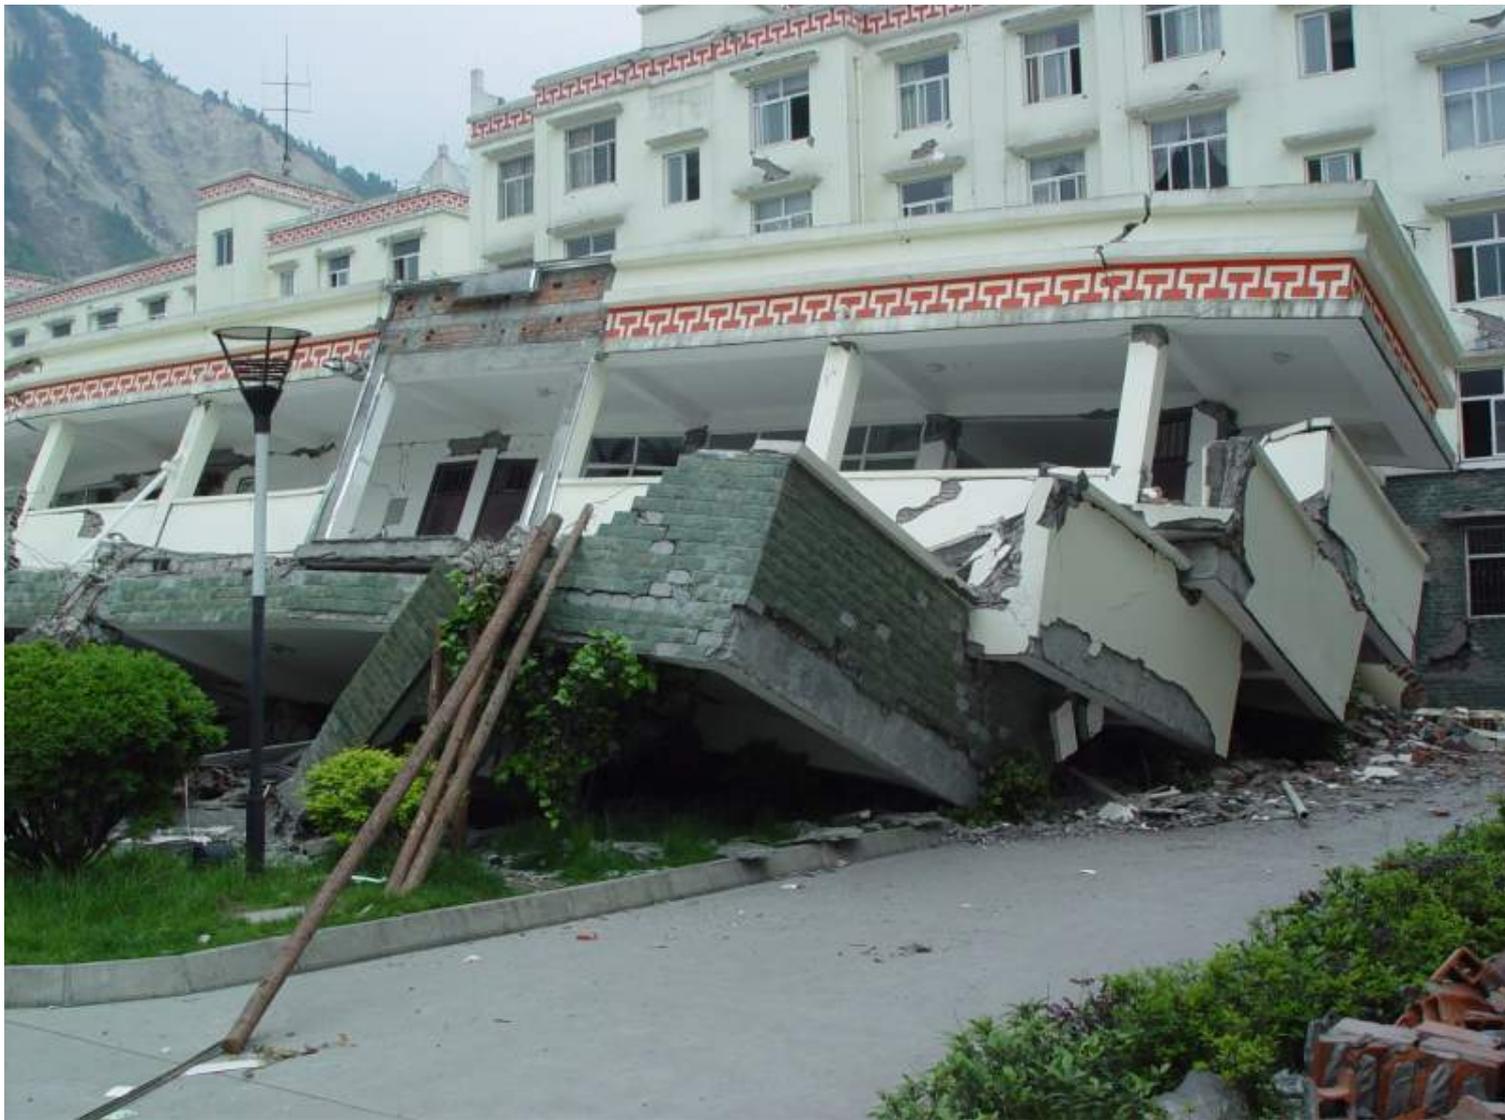
Collapse of classroom building in Xuankou Middle School of Yingxiu Town in Wenchuan County

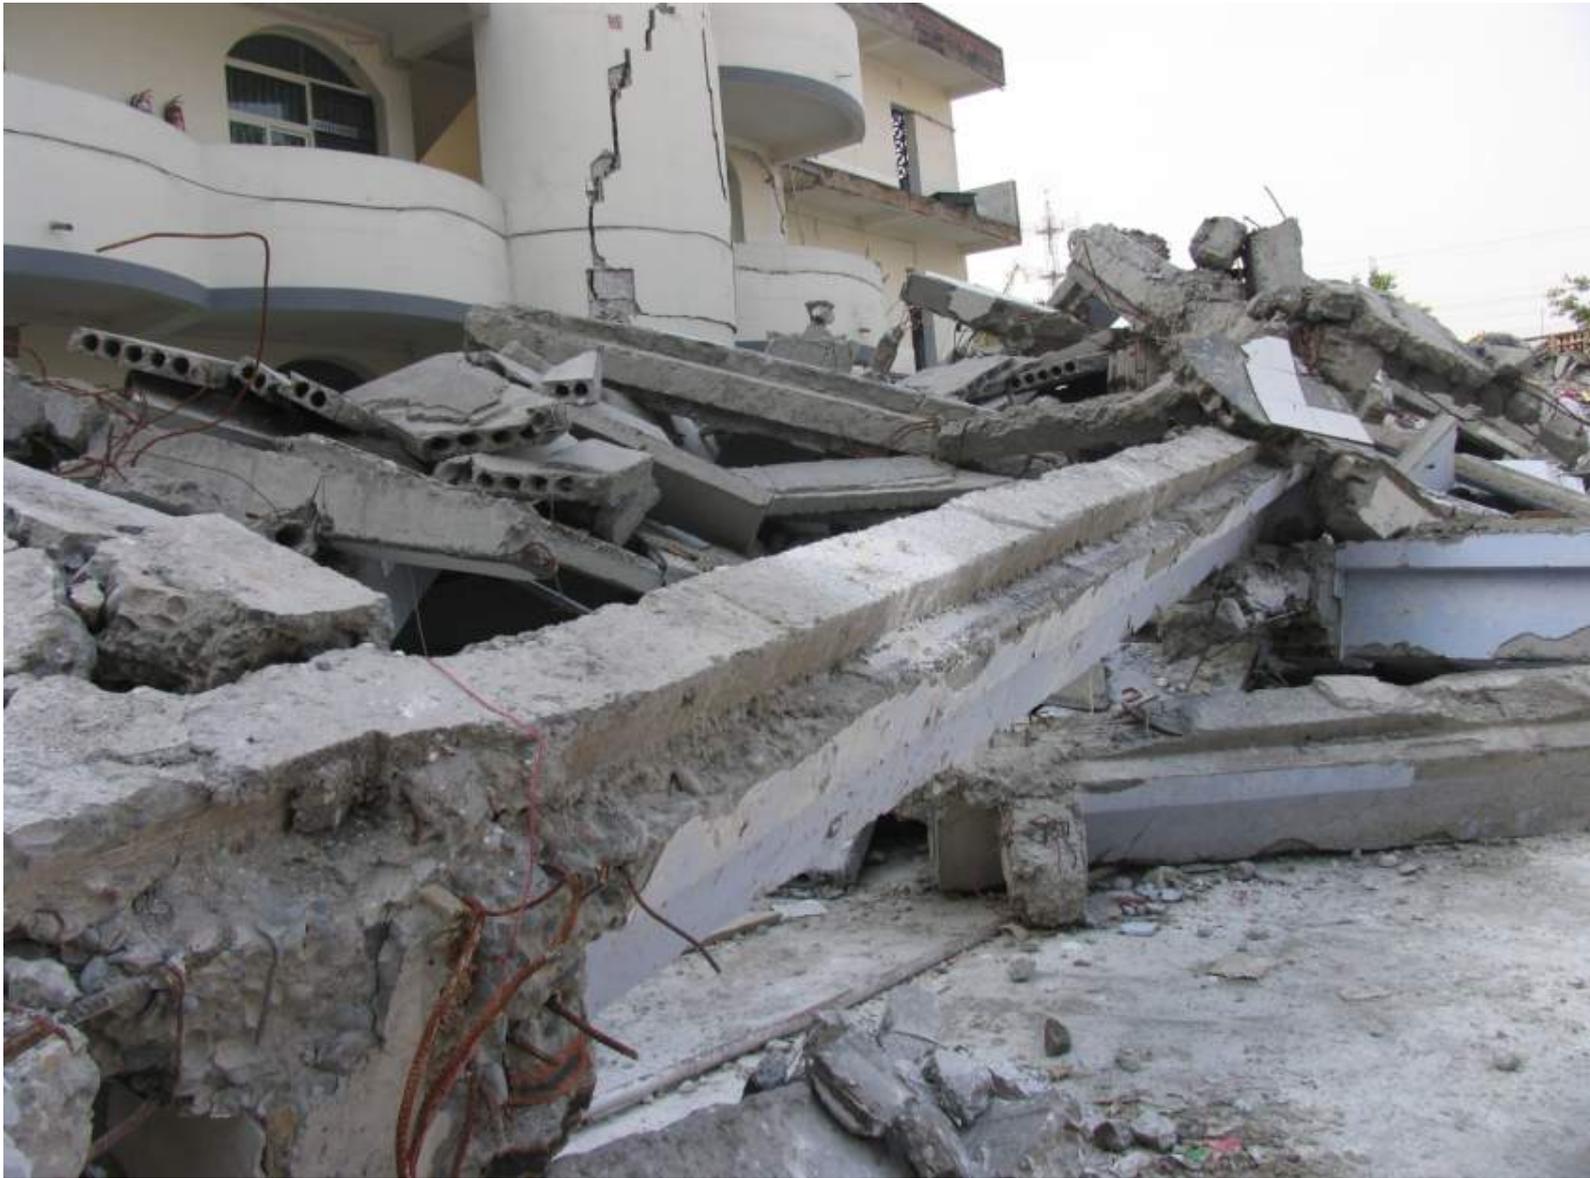
Damage to a classroom building at  
Jiuyuan Middle School in Dujiangyan City

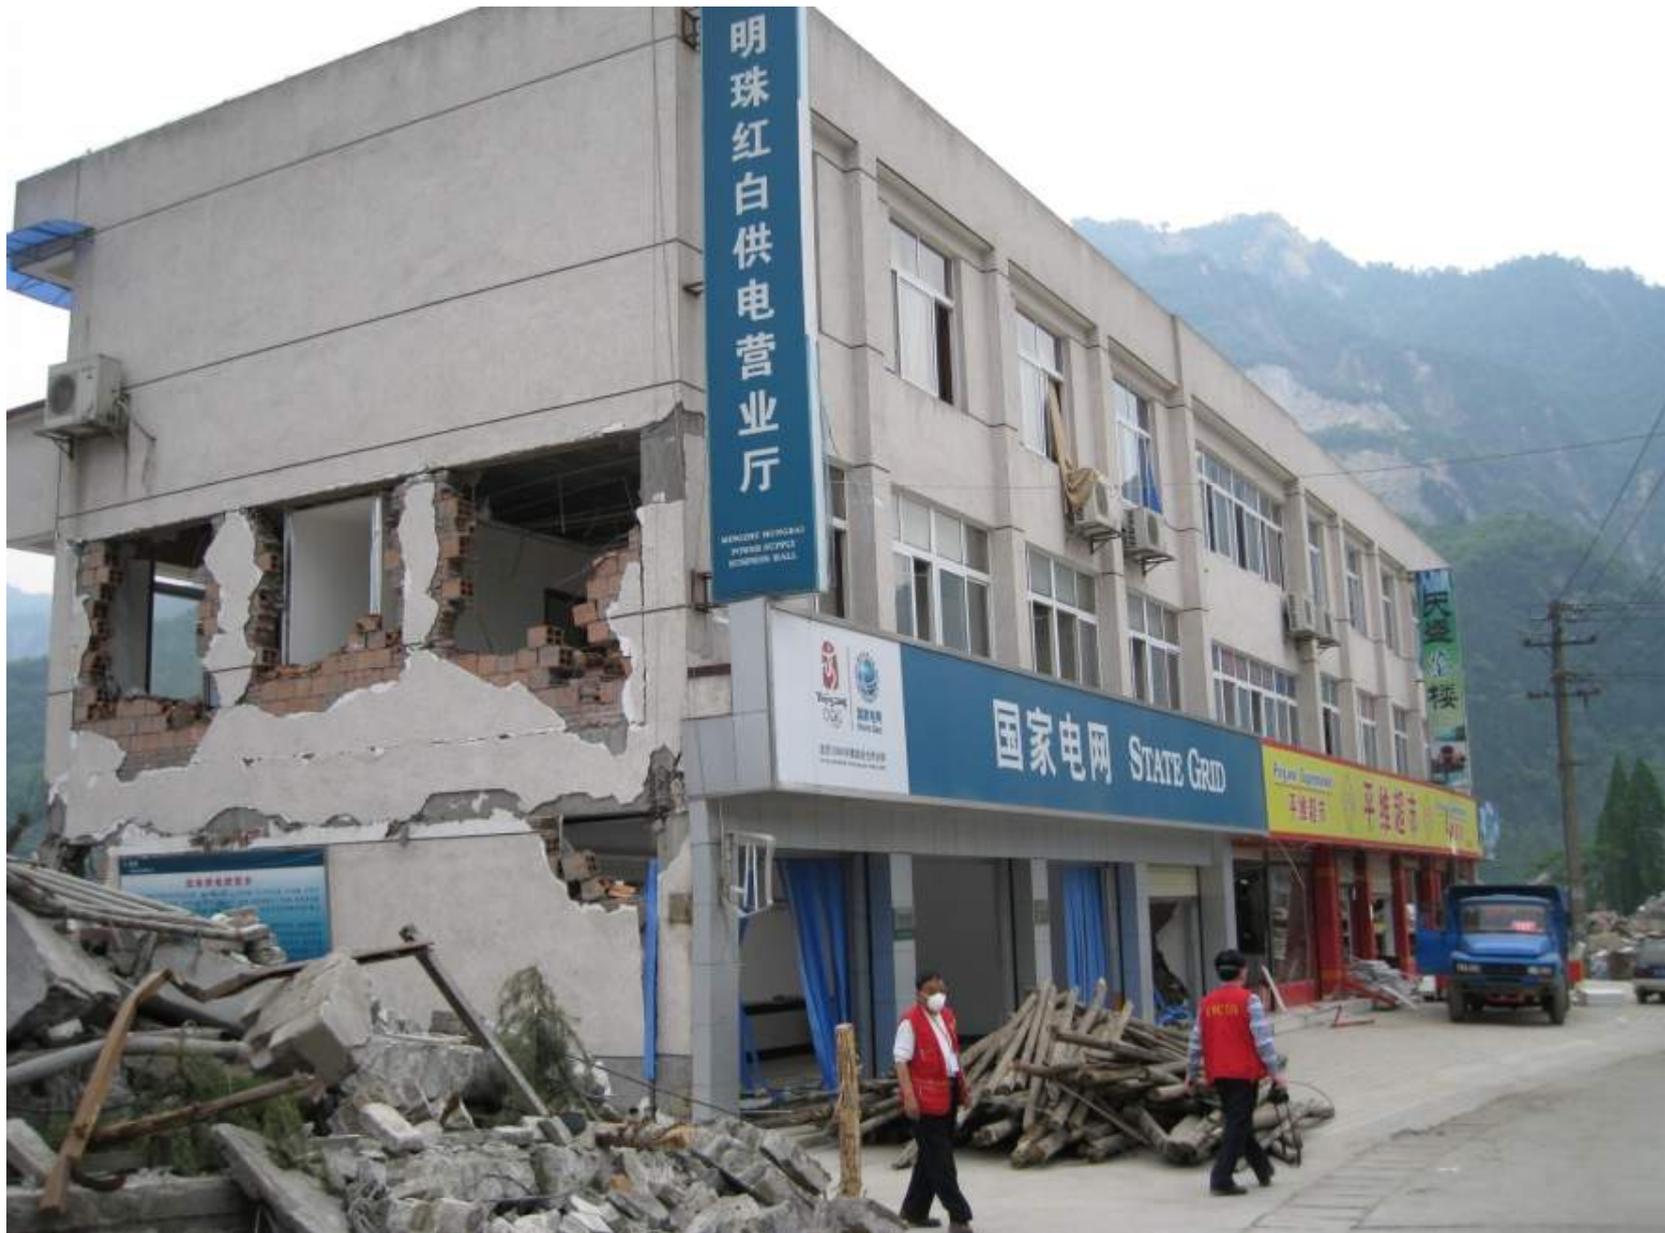
A Standing structure in Hongbai town of Shifang City
