# Strong Motion, Damage, and Loss of Wenchuan Earthquake

Zifa Wang

Institute of Engineering Mechanics, China Earthquake Administration

August 18, 2008

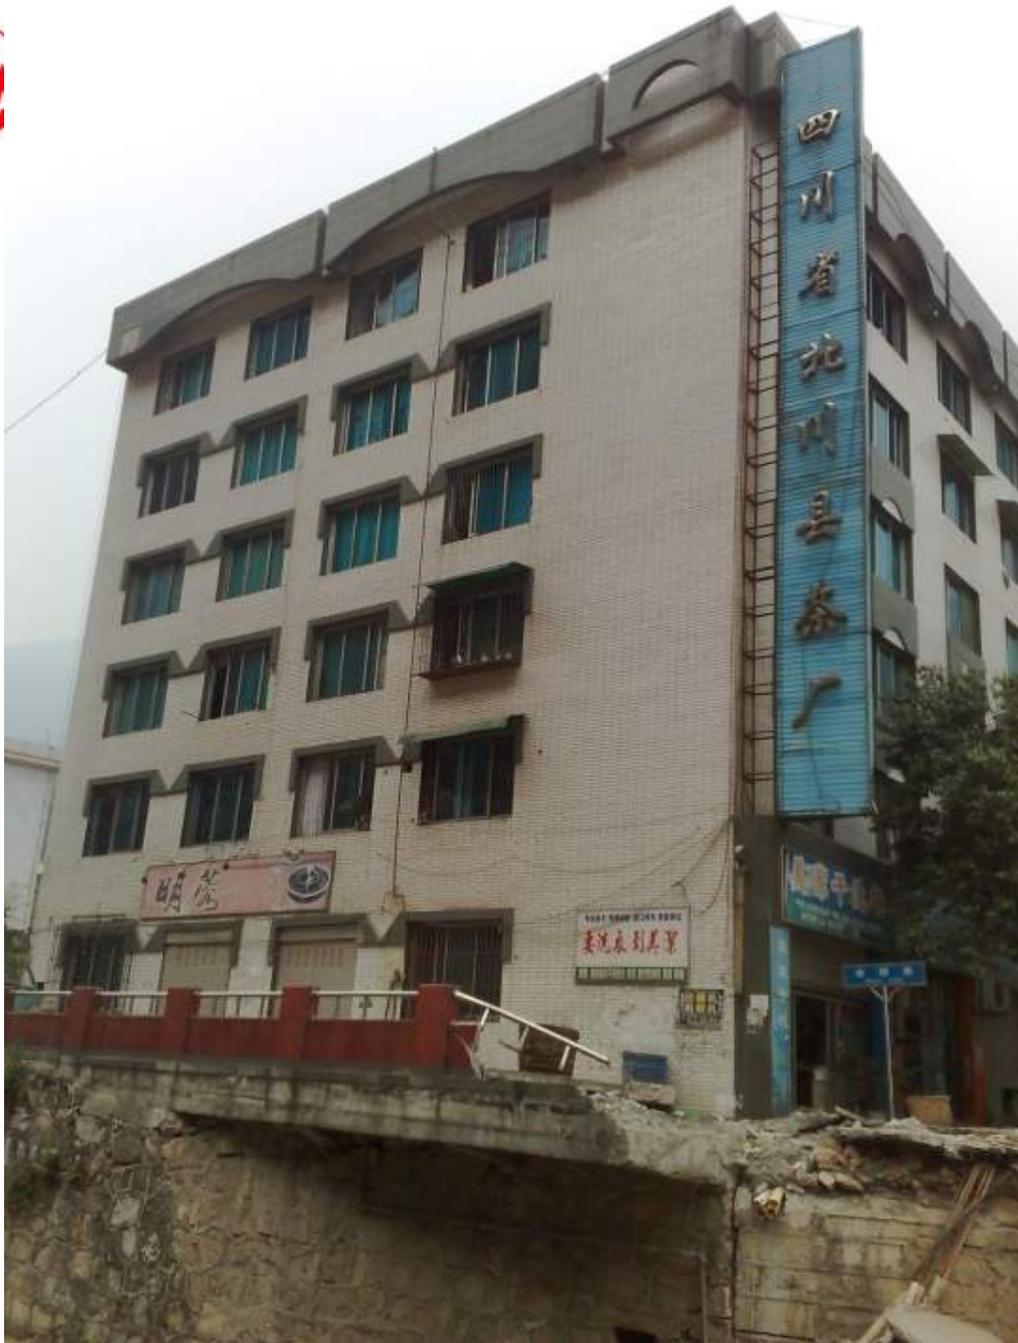
Minor damage  
to an office  
building for  
Beichuan Tea  
Manufacturer in  
Beichuan  
County

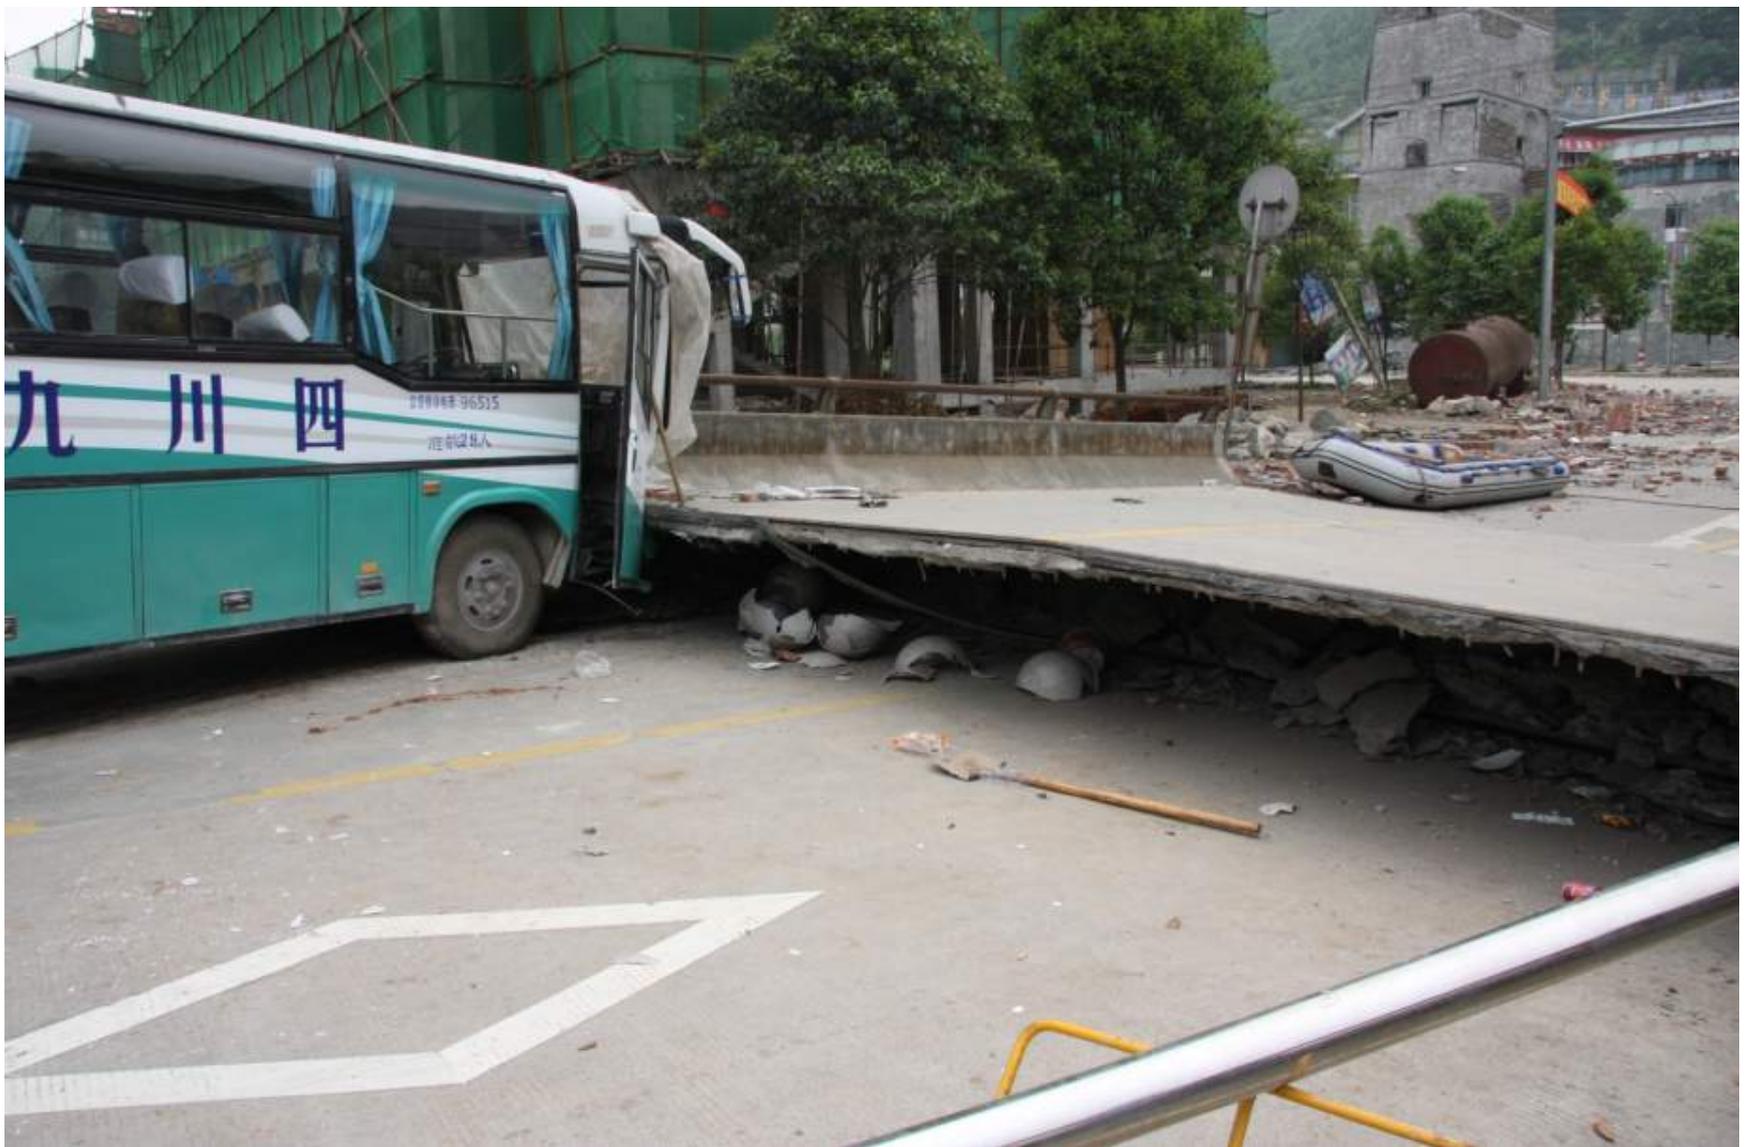
Damage to a bridge in Beichuan County

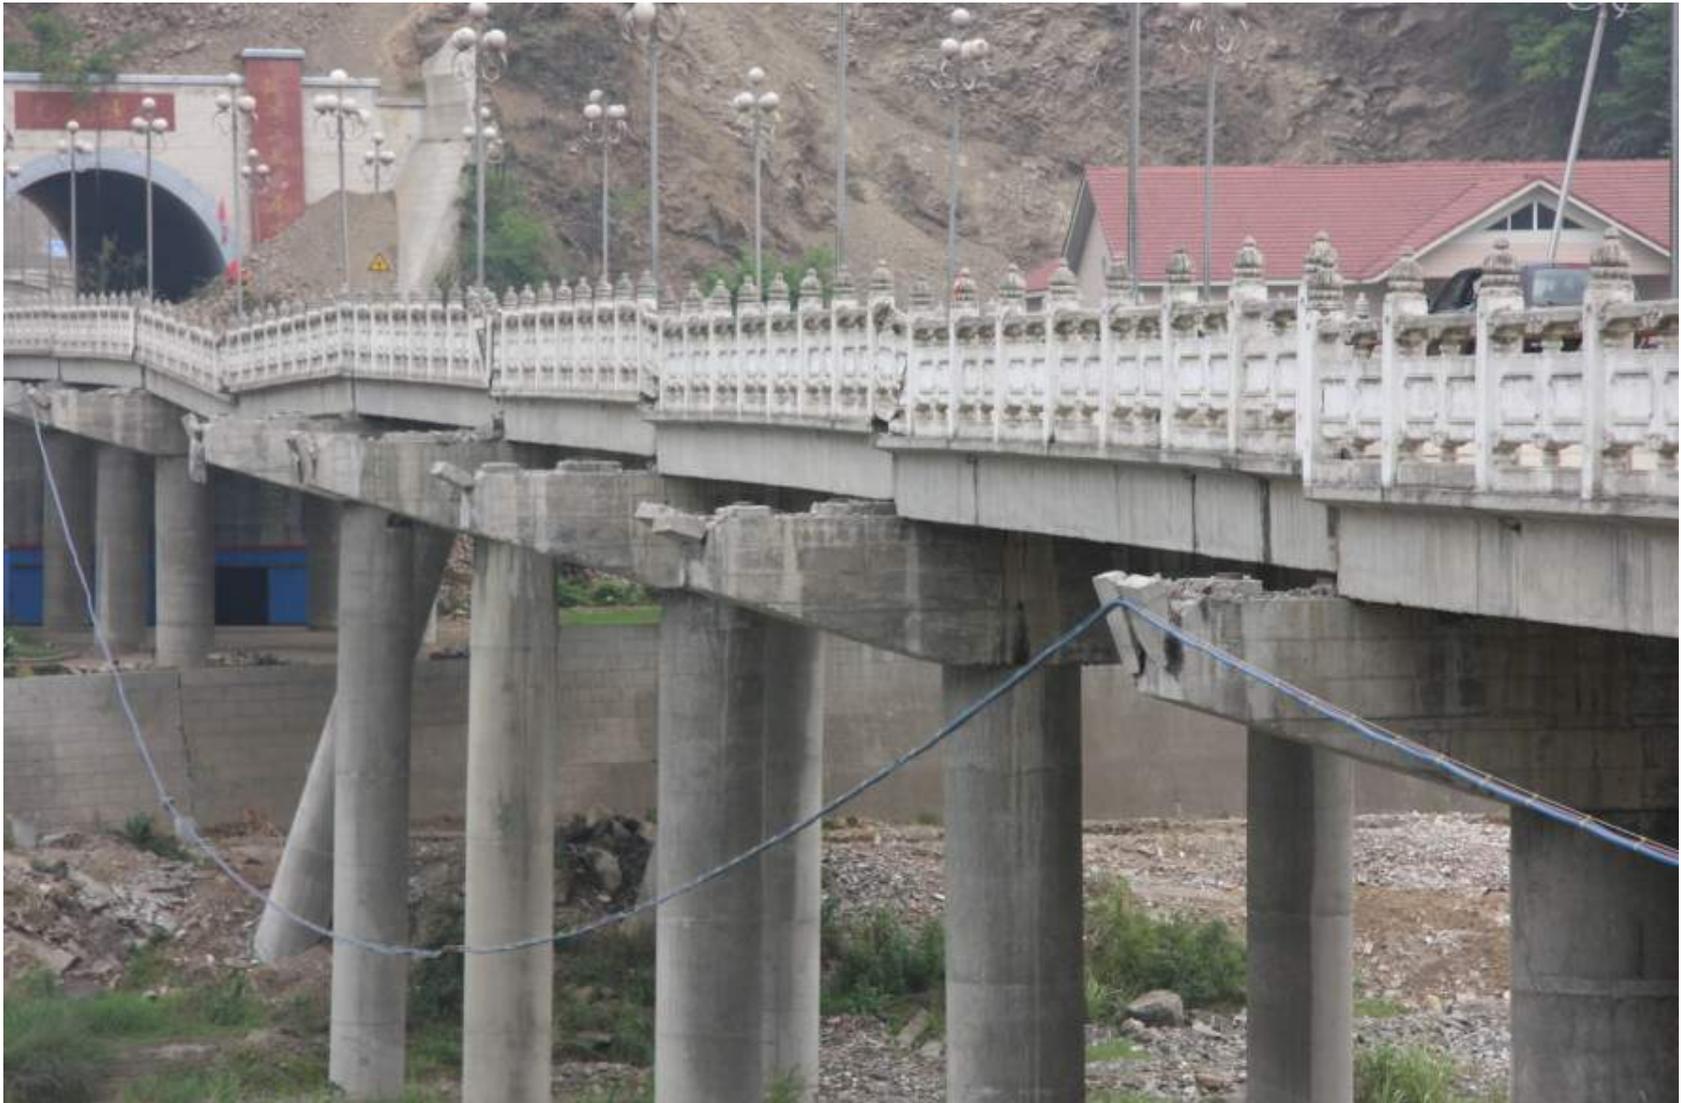
Sliding of the bridge decks in Beichuan County

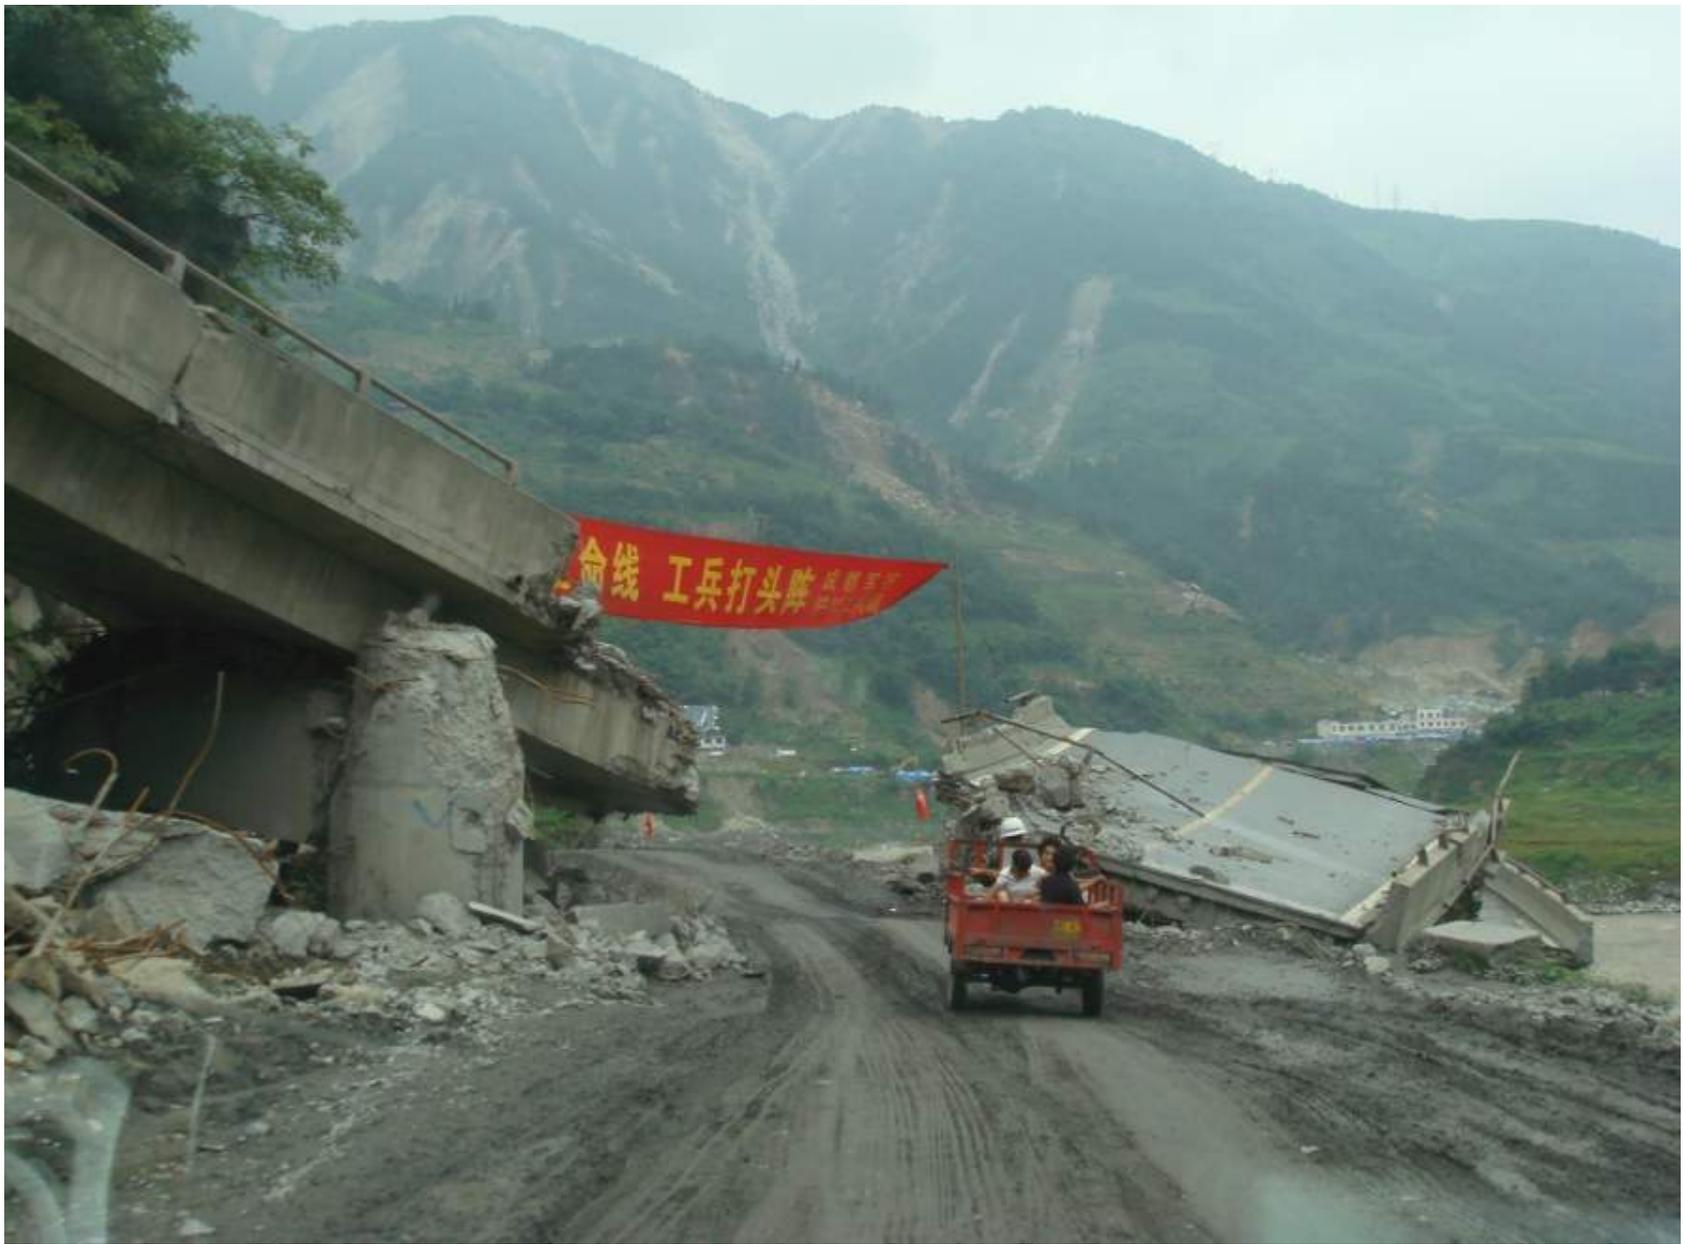
Collapse of Baihua Bridge toward Yingxiu

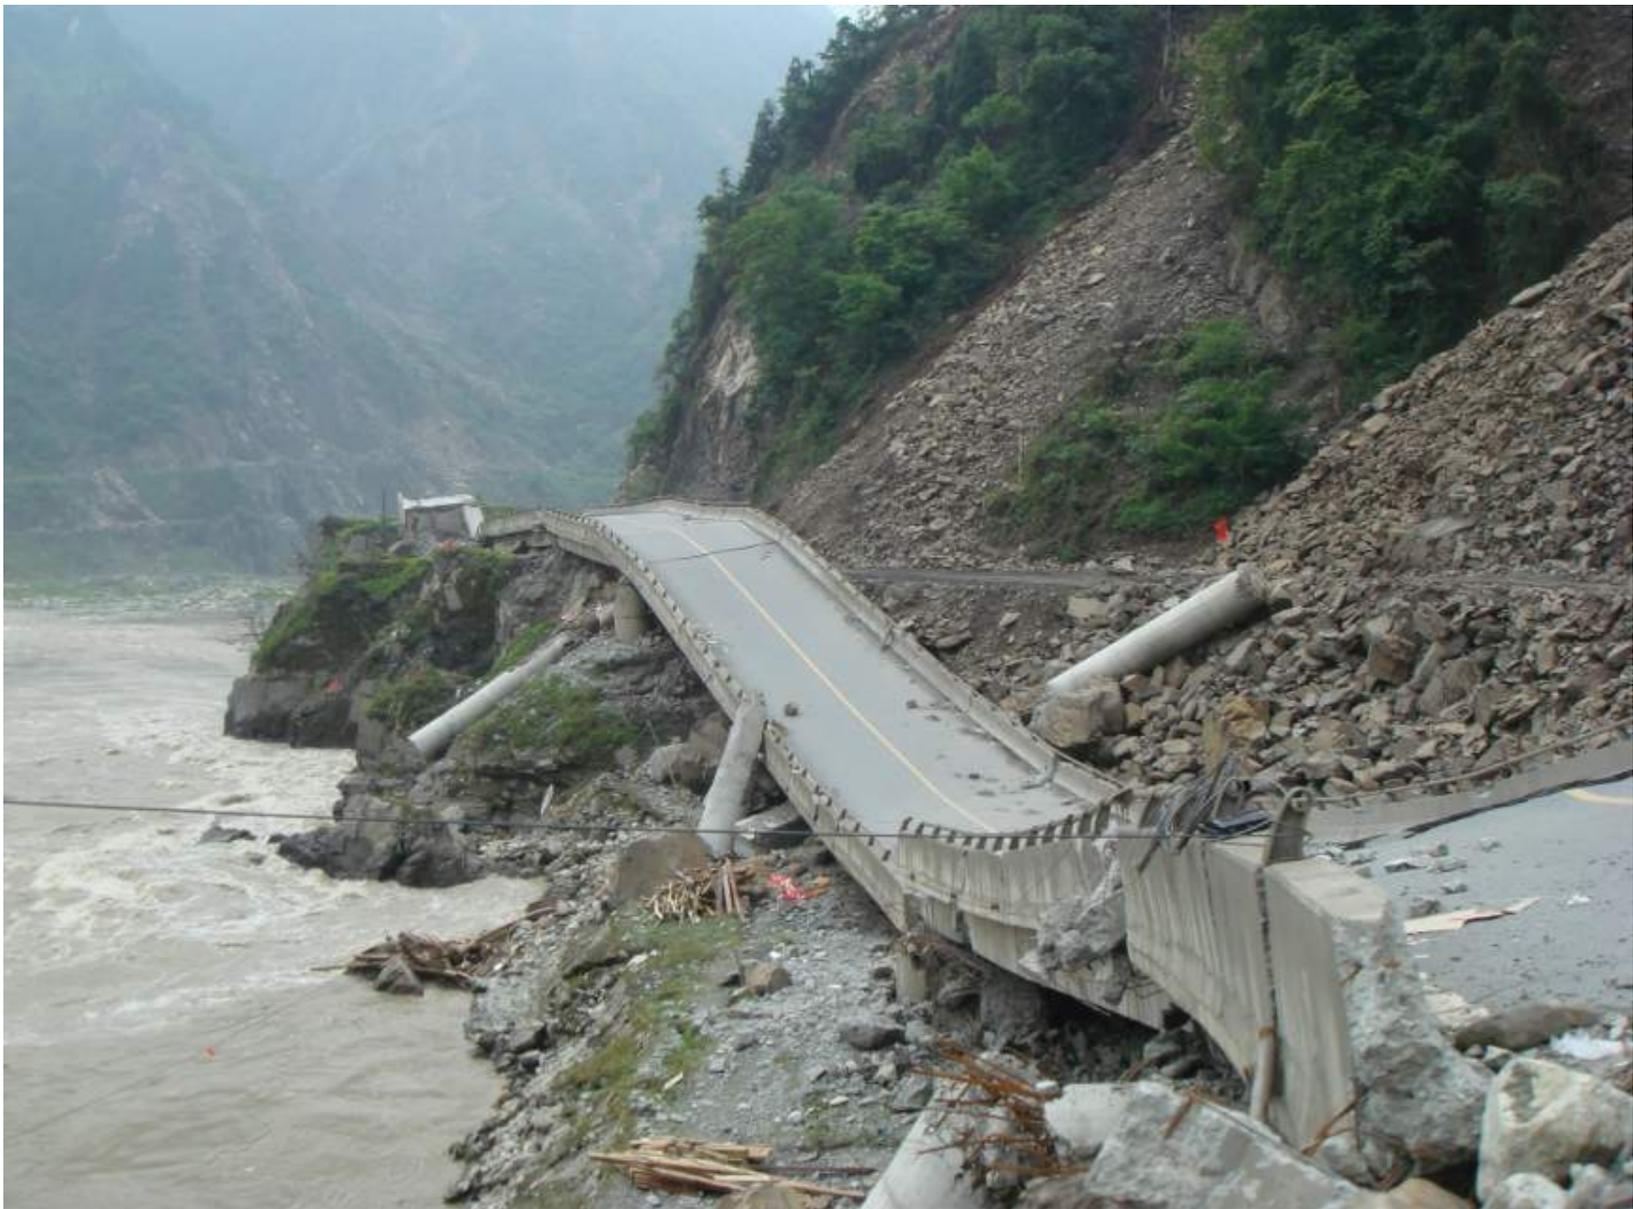
Damage to the roads to Yingxiu

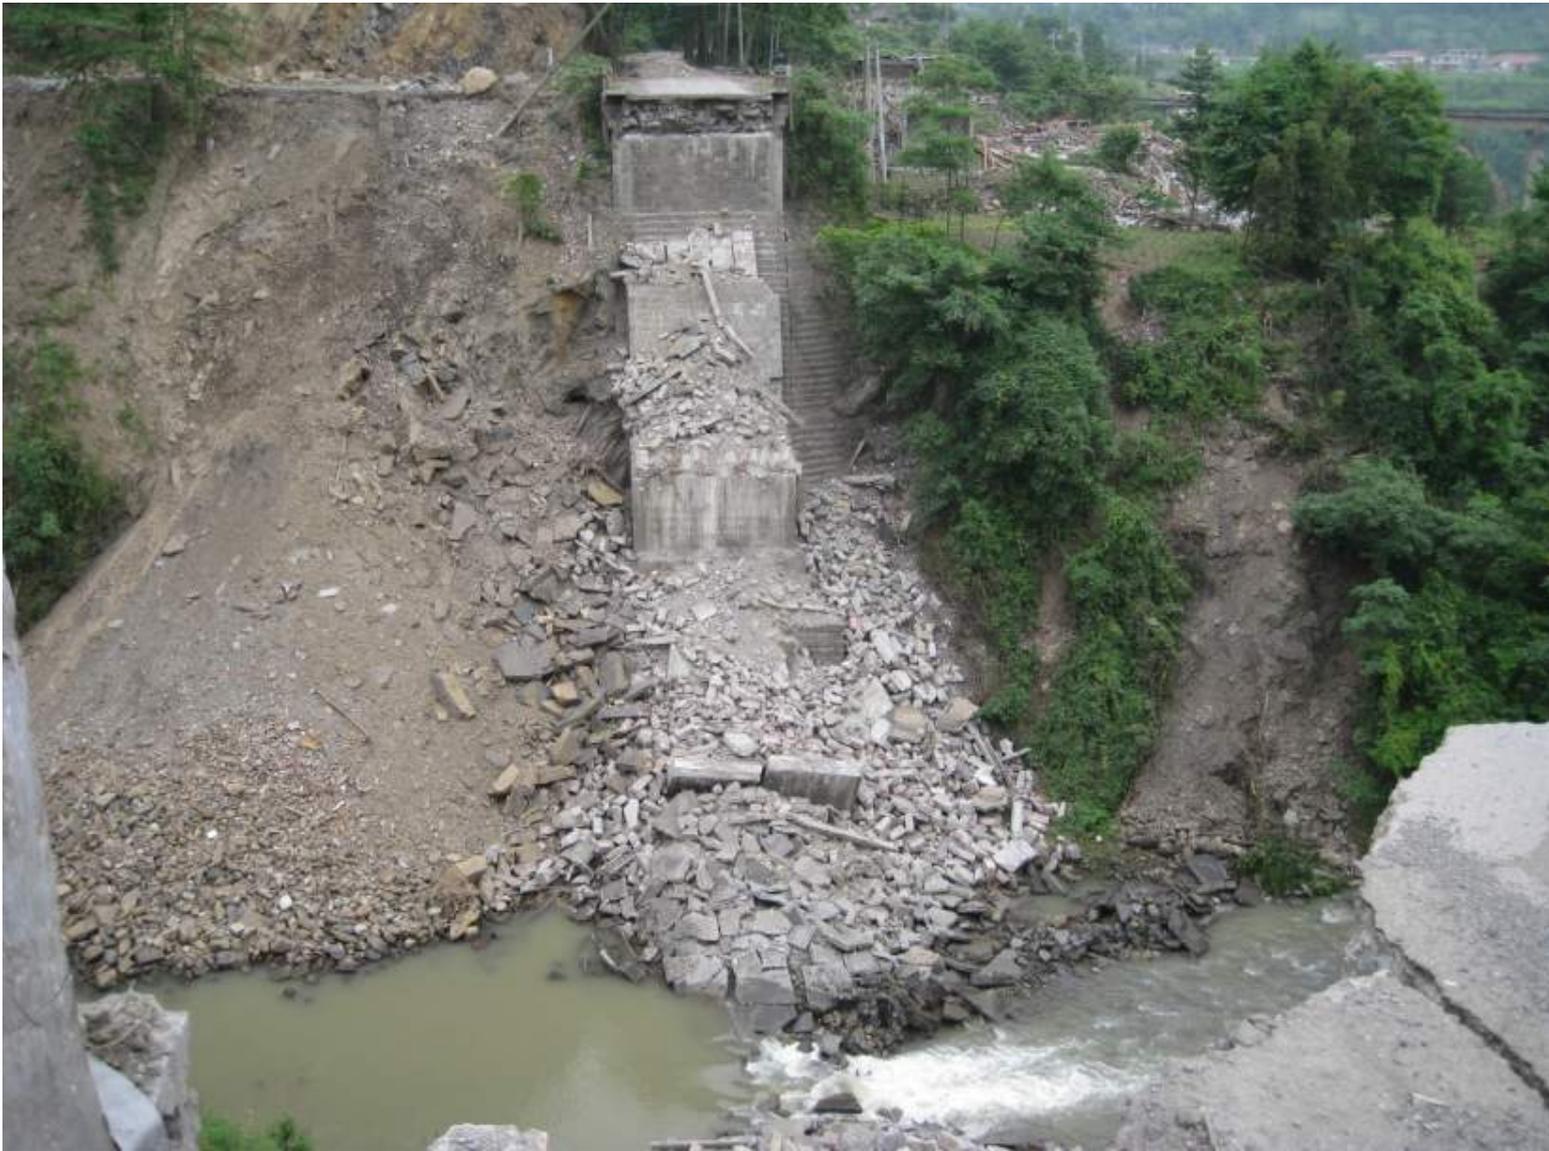
Collapse of small bridges deep in the mountains near Hongbai town

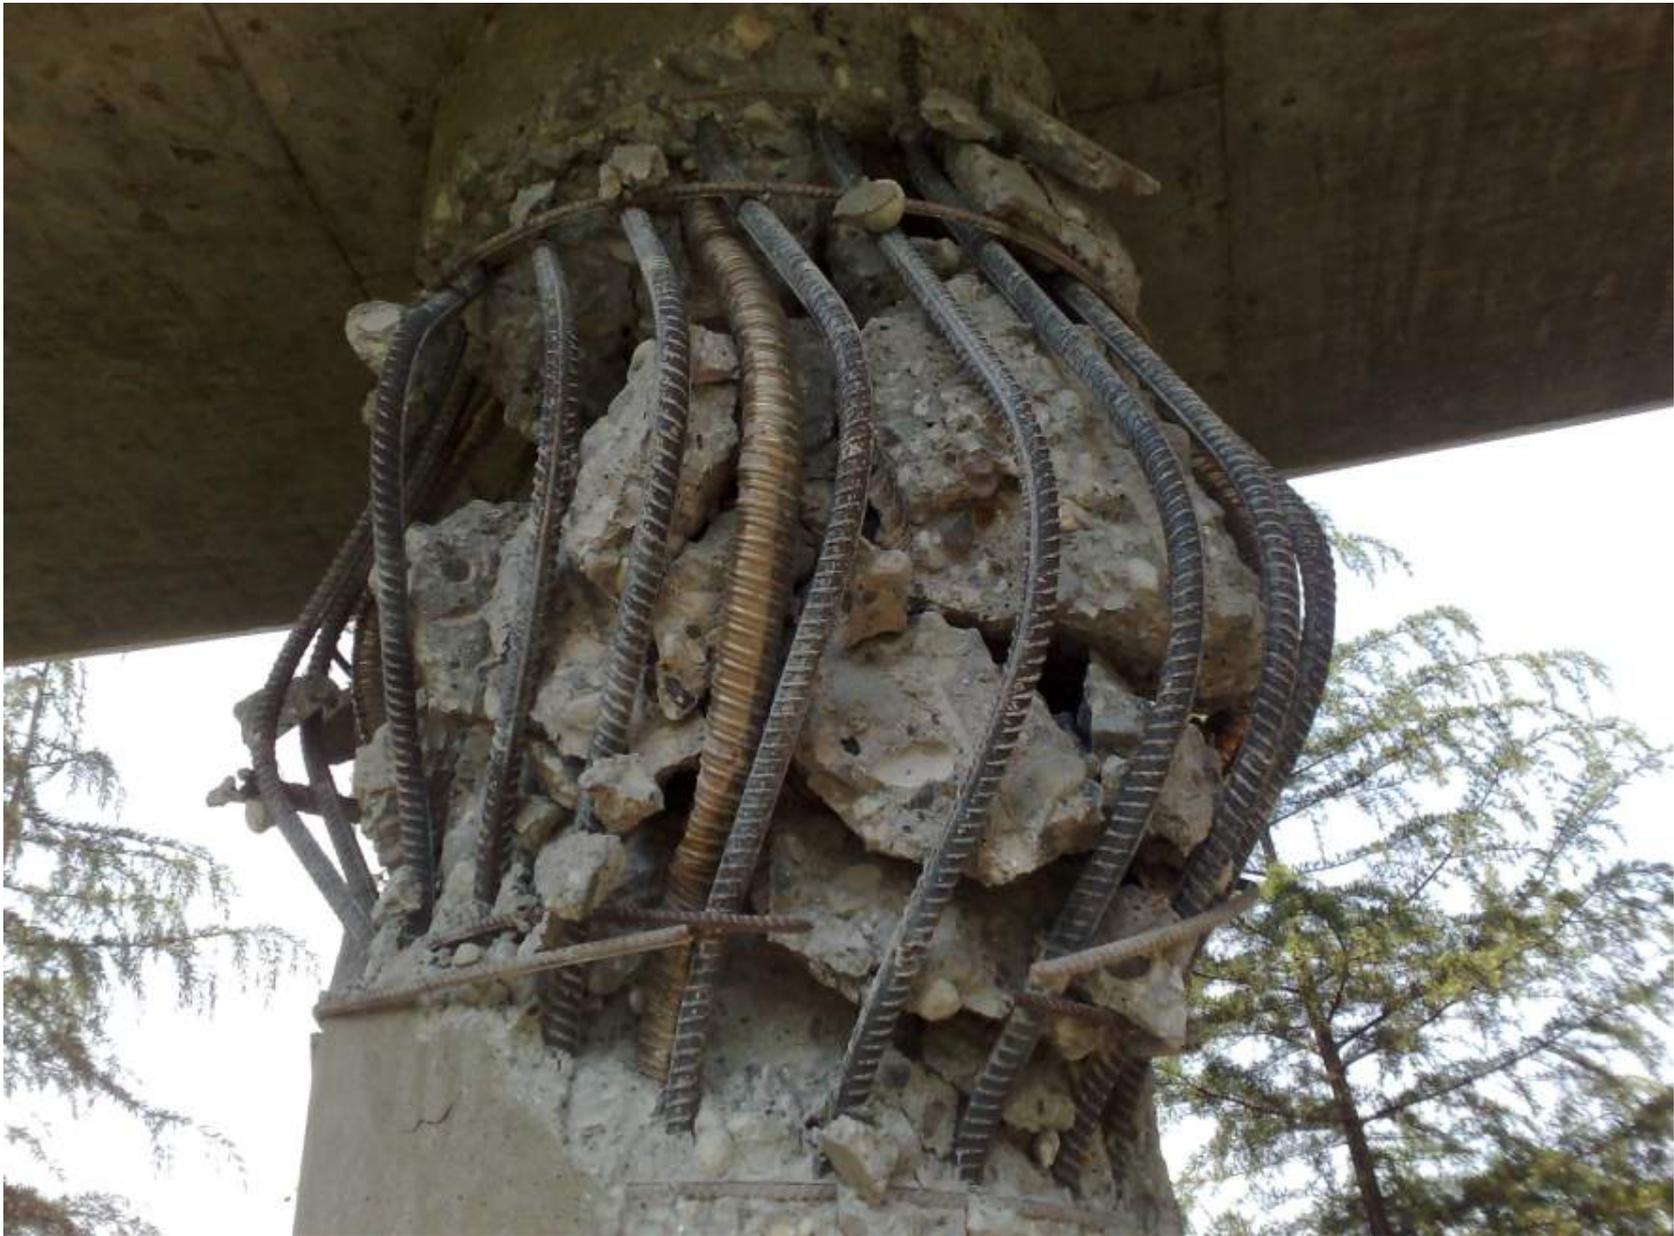
Damage to the pillar of Huilan Bridge in Mianzhu City

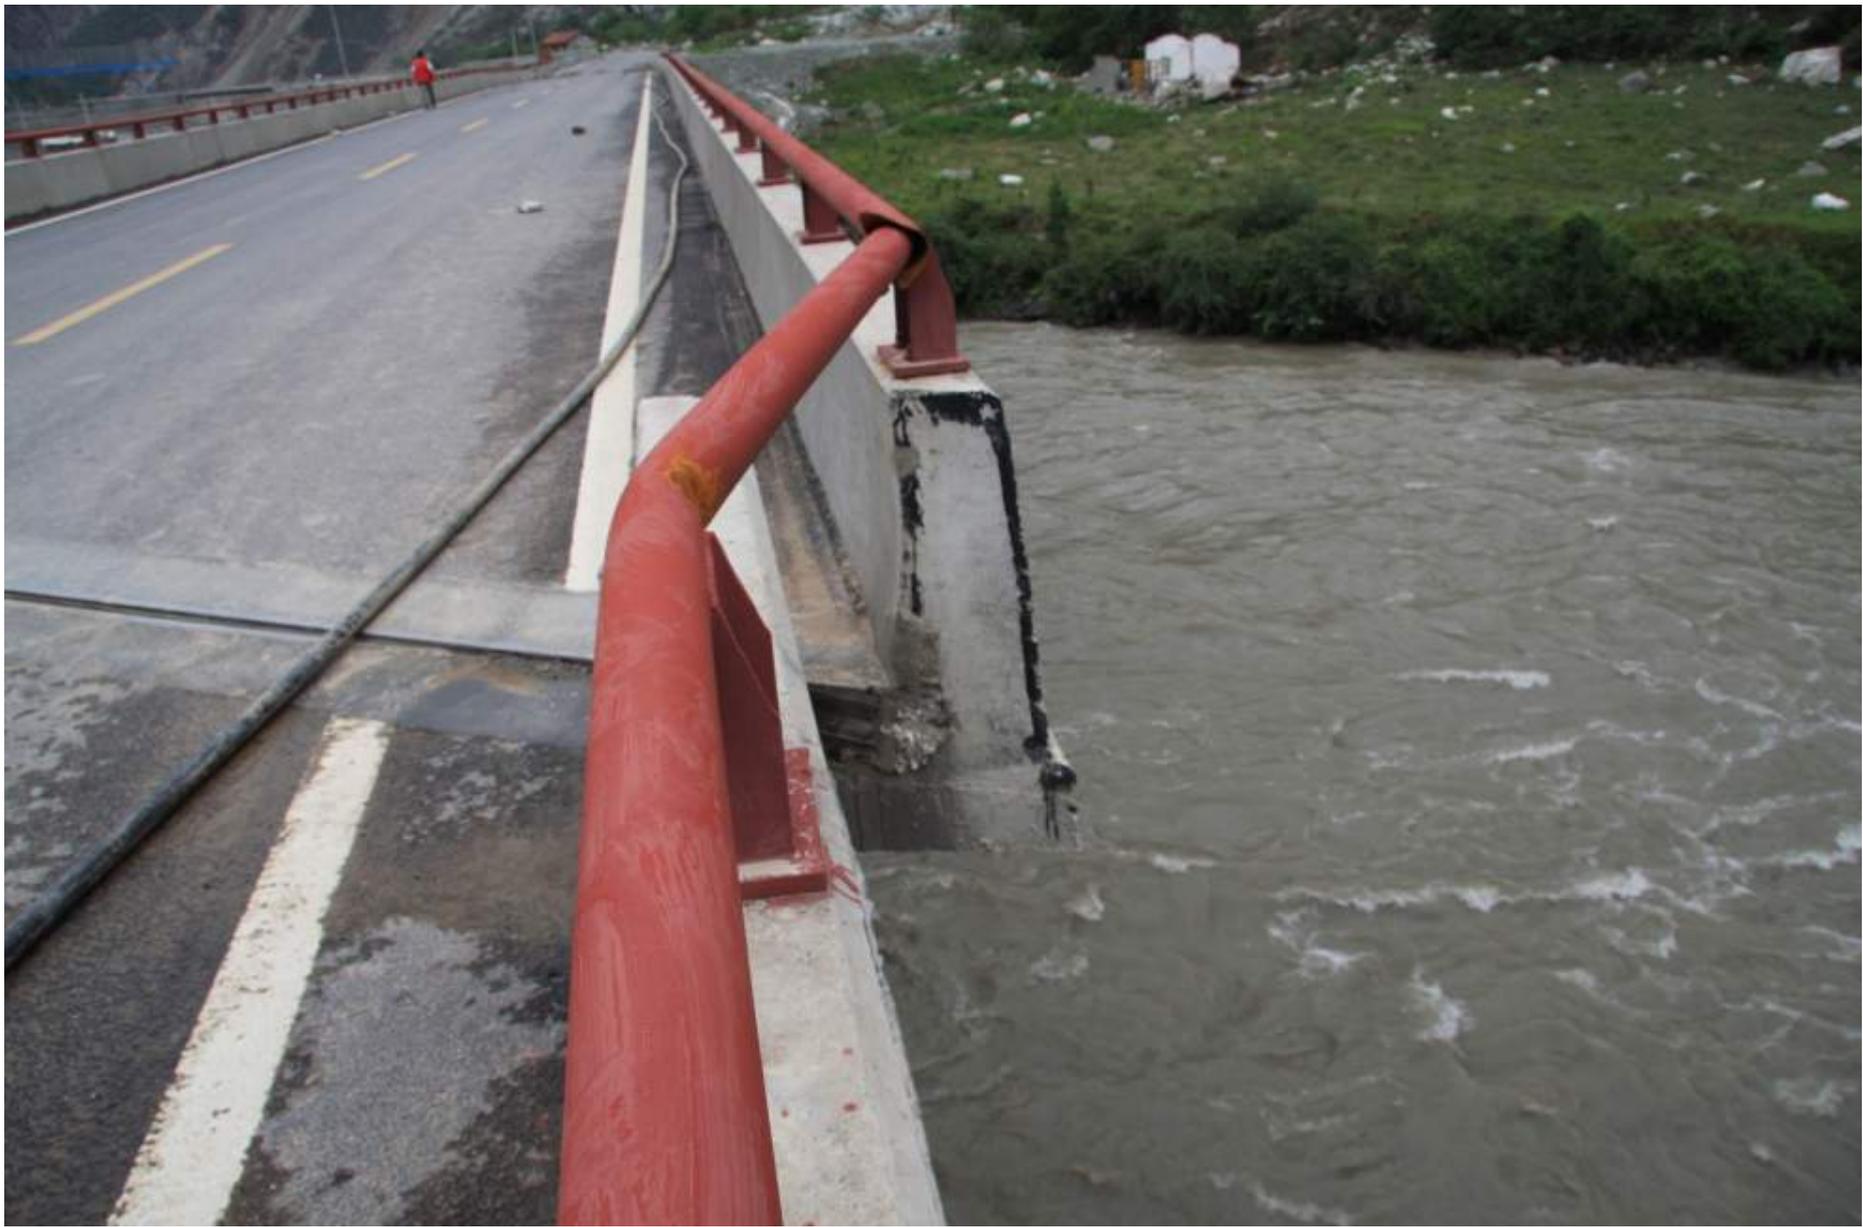
Damage to a bridge in Mianchi Town

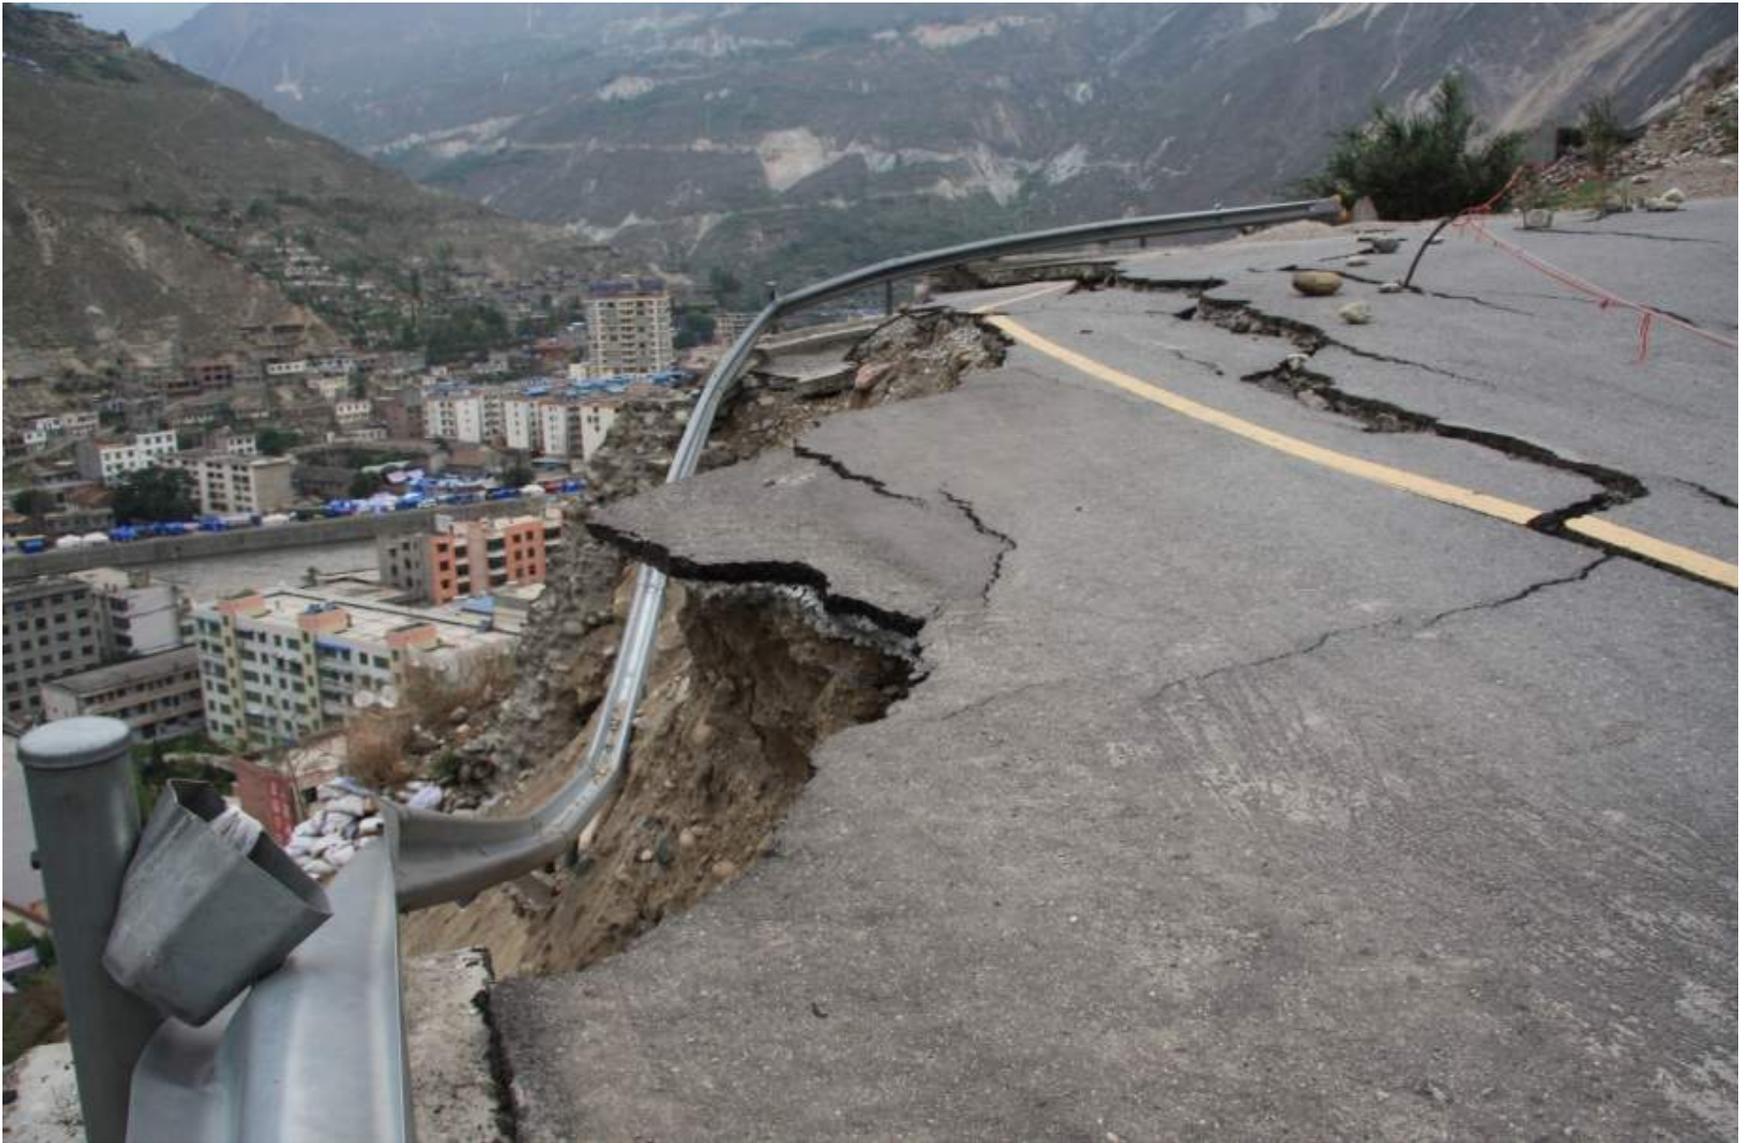
Road damage due to landslide near Yingxiu

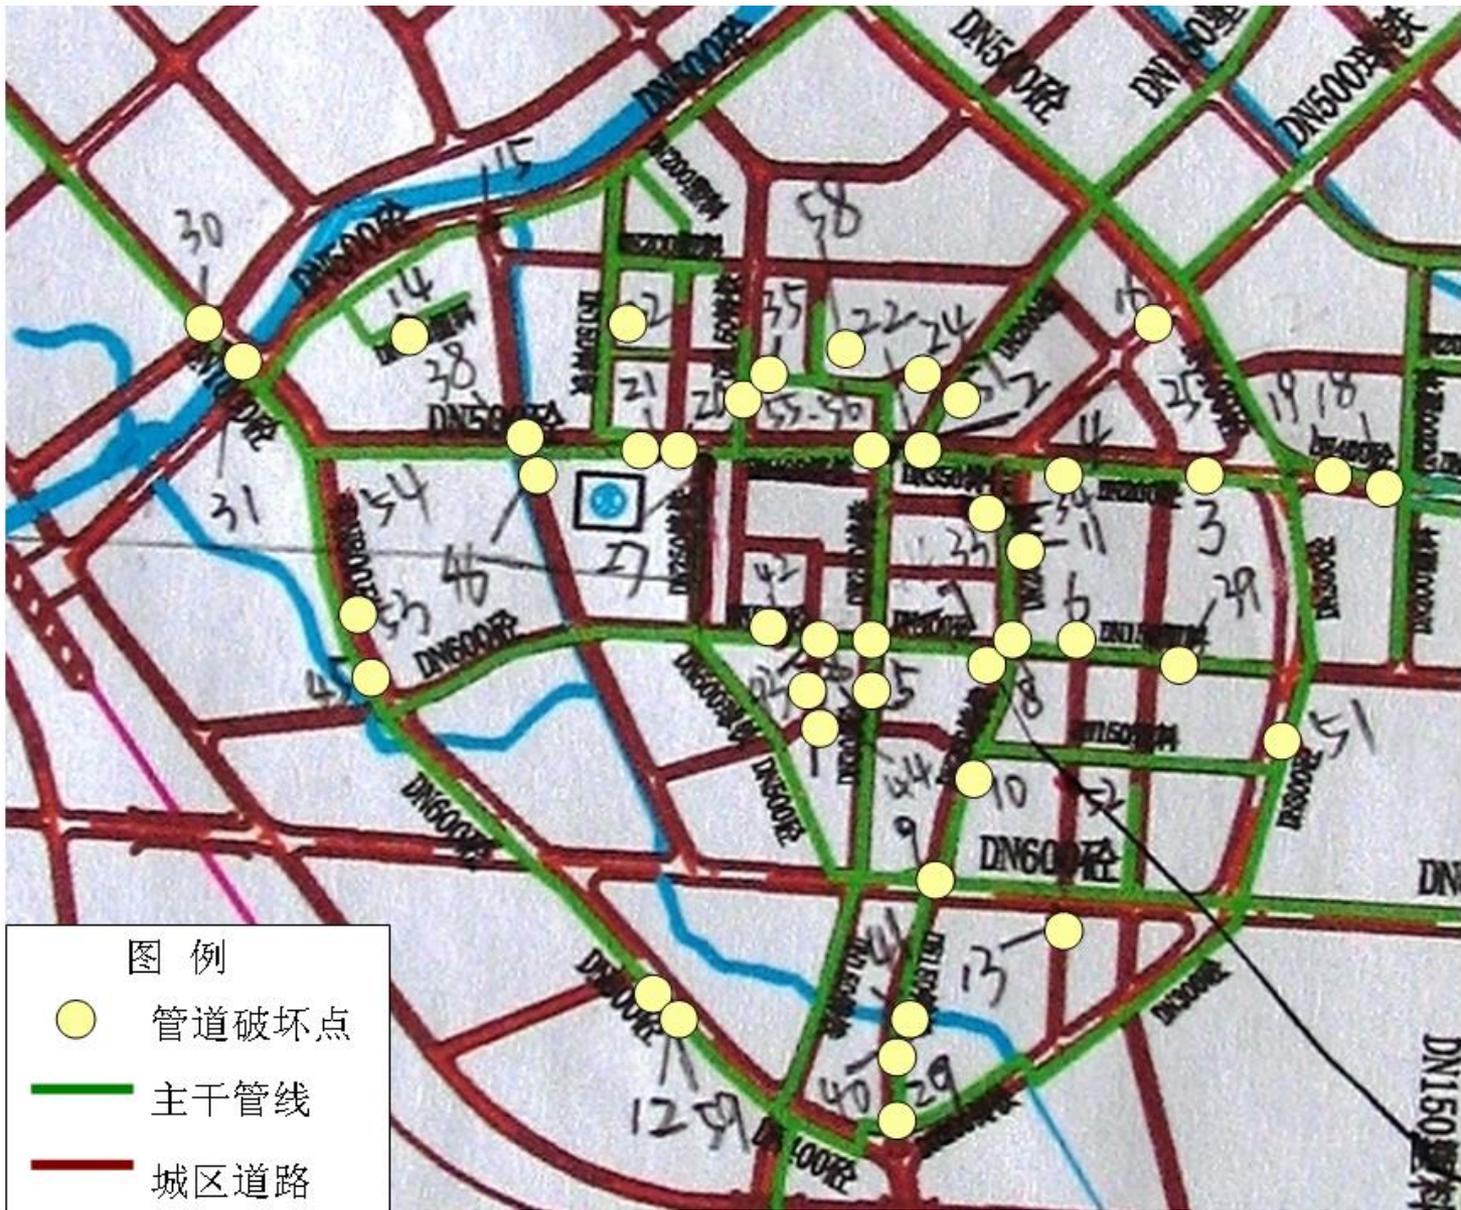
Damage to water system in Pengzhou city

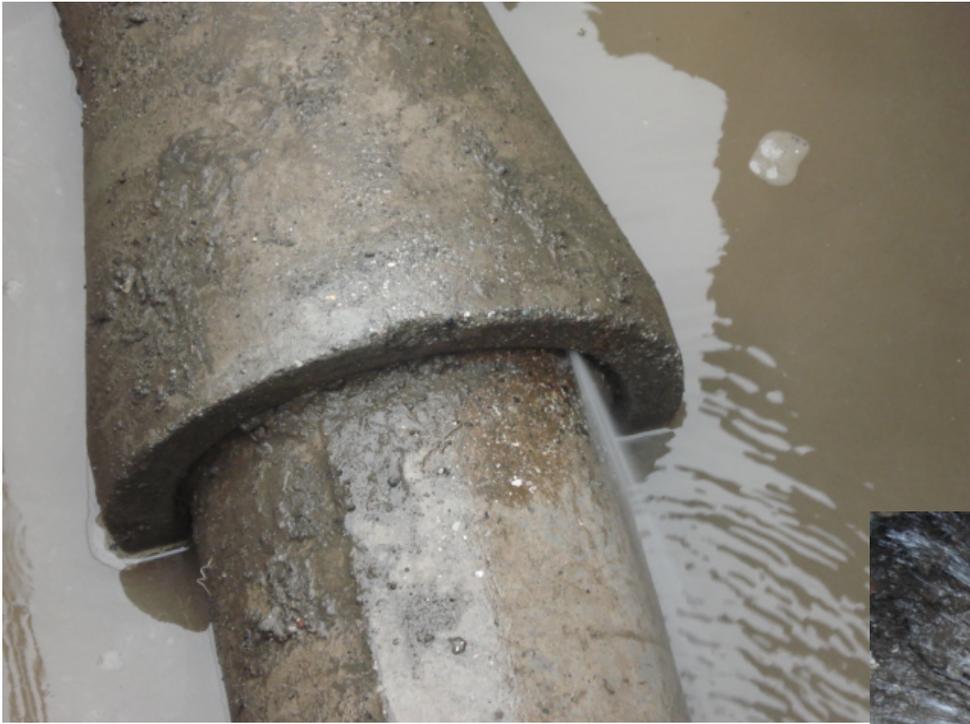
Damage to Pipe Joint

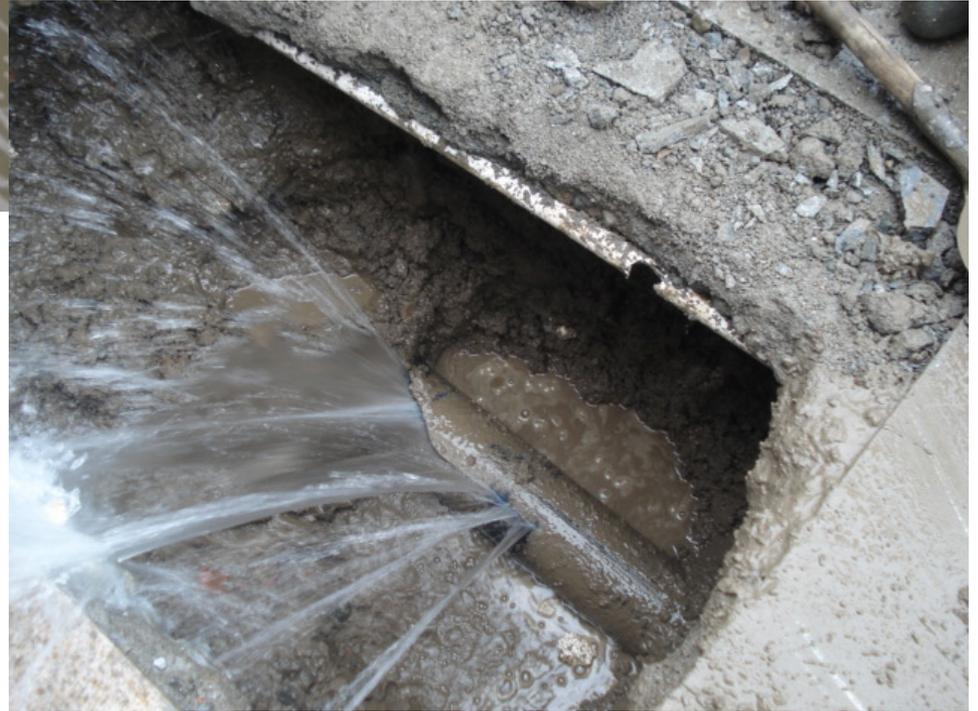
Damage to PVC pipeline

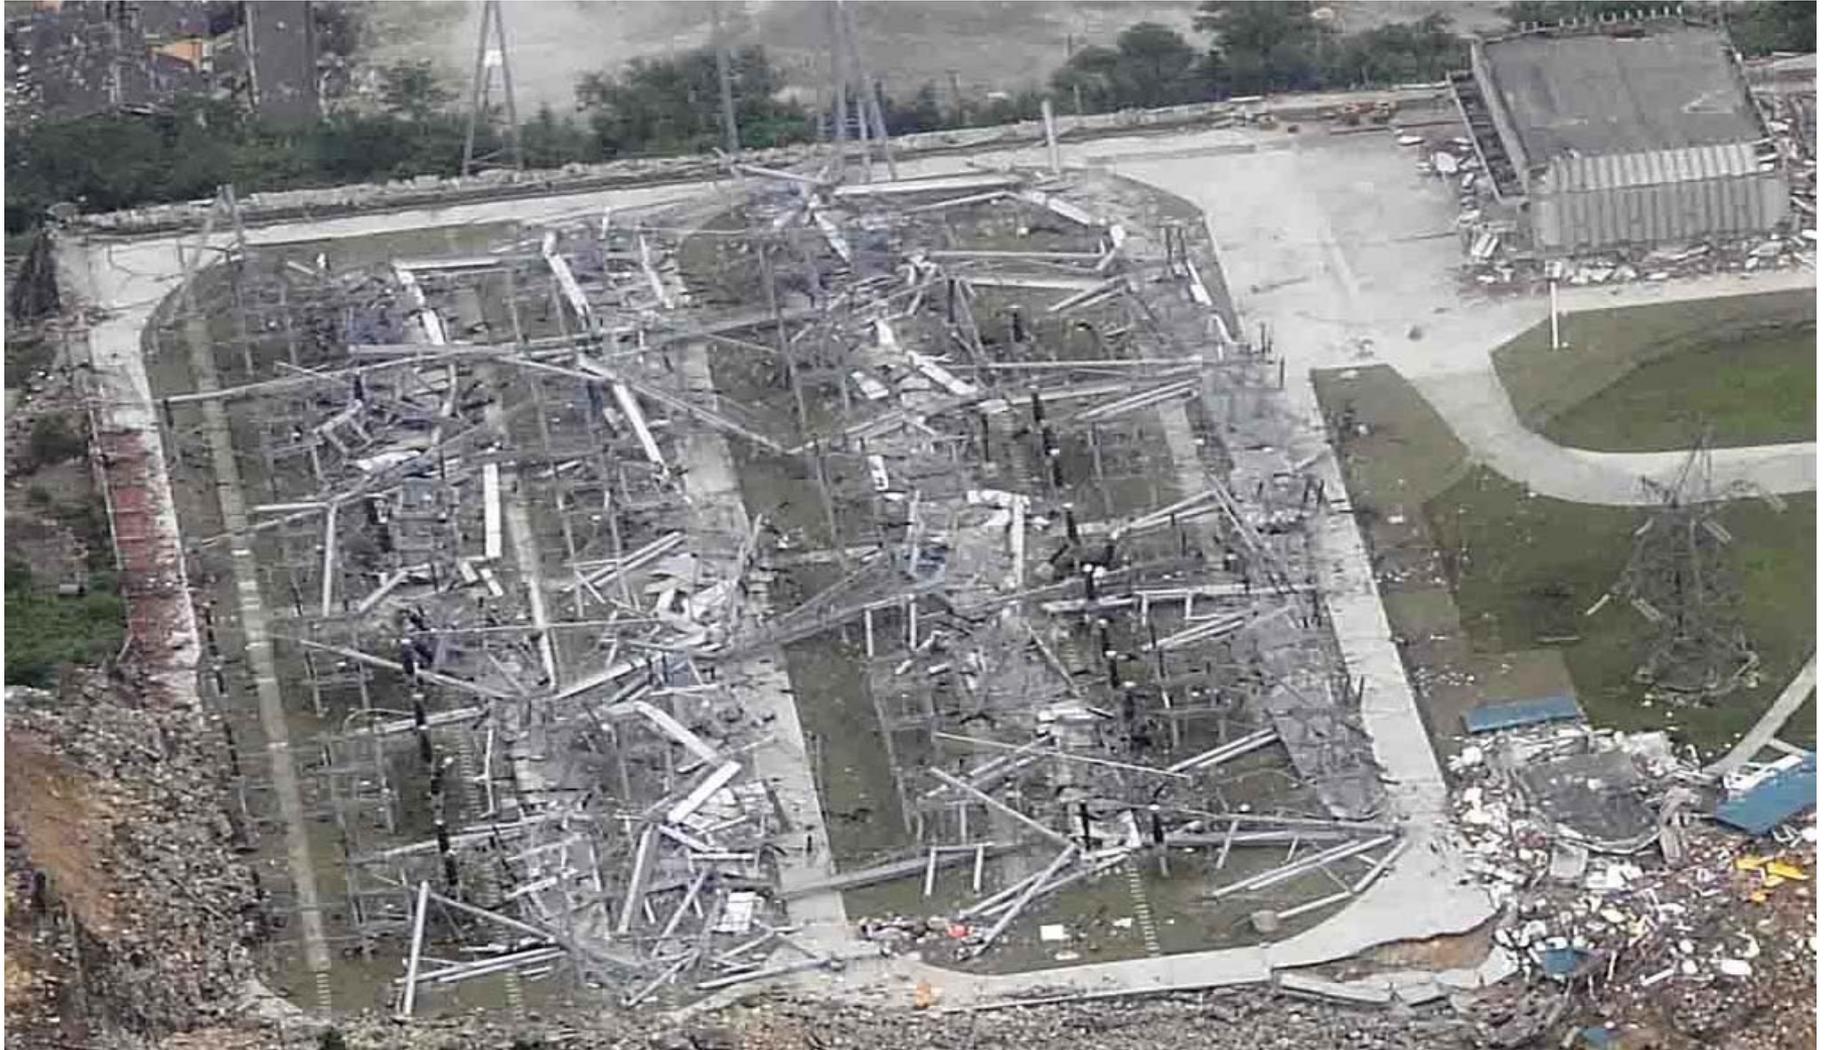
# Destruction to Ertaihan Station (220kV, near epicenter)
