# Strong Motion, Damage, and Loss of Wenchuan Earthquake

Zifa Wang

Institute of Engineering Mechanics, China Earthquake Administration

August 18, 2008

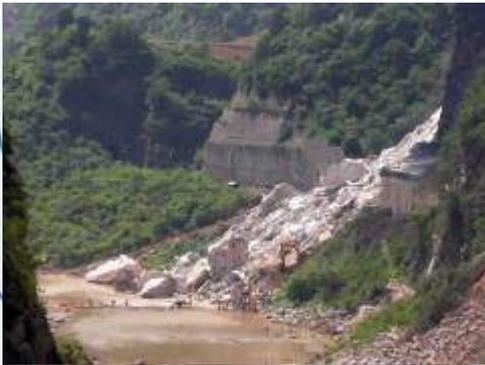
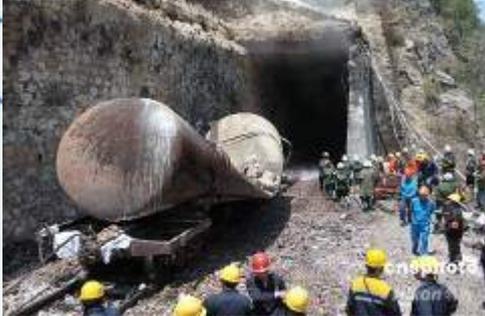
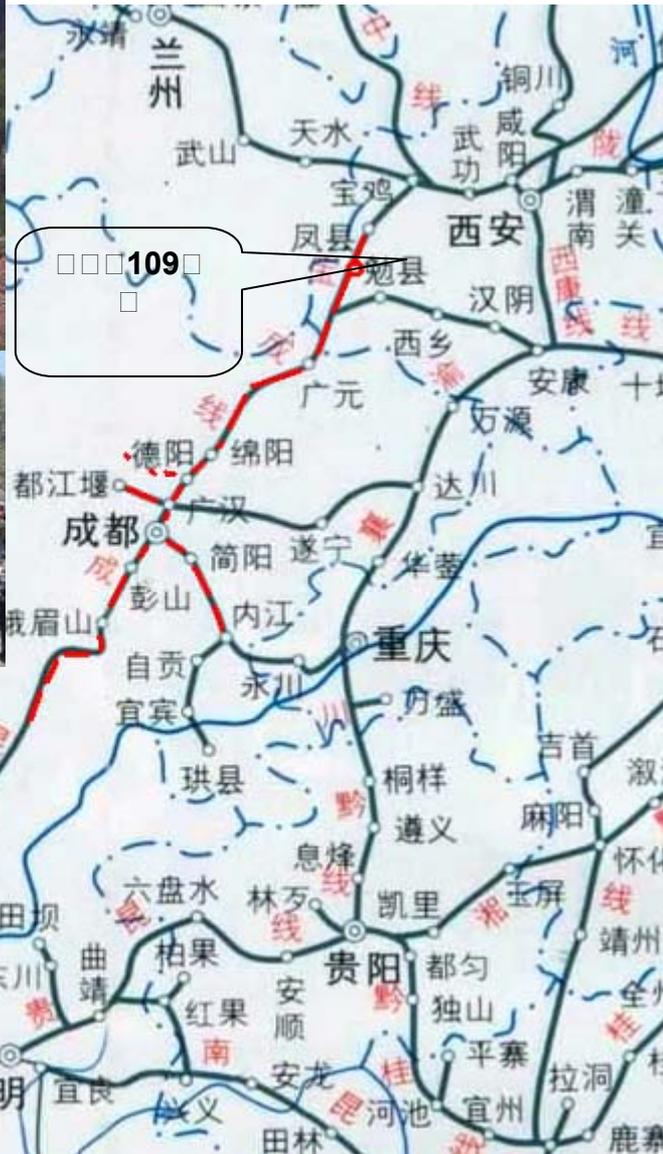
- Damage to rails
  - Baoji-Chengdu line 4 locations, Chengde-Kunming line 4 locations, and Chengde-Chongqing 7 locations
- Damage to Stations
  - May 24, all major lines were repaired and service was restored

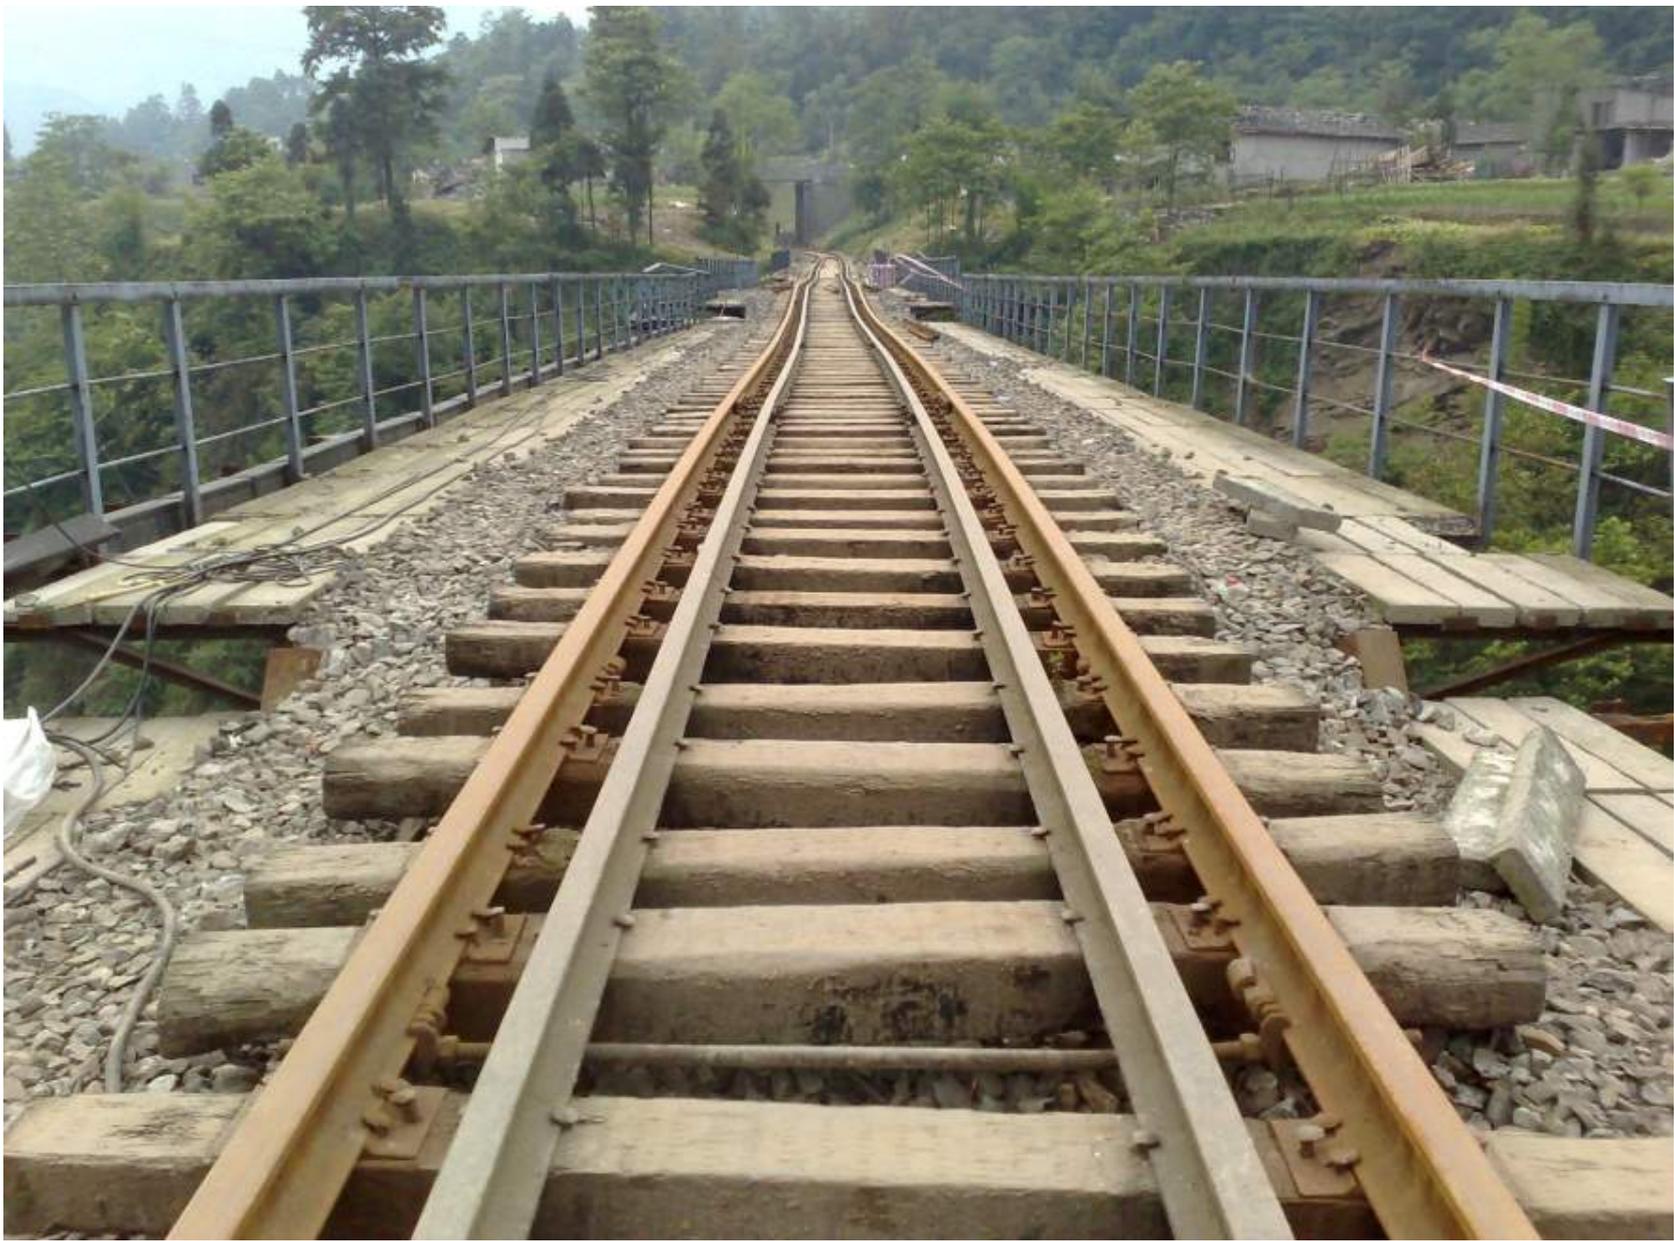
Damage to train tracks on a bridge near Yinghua town

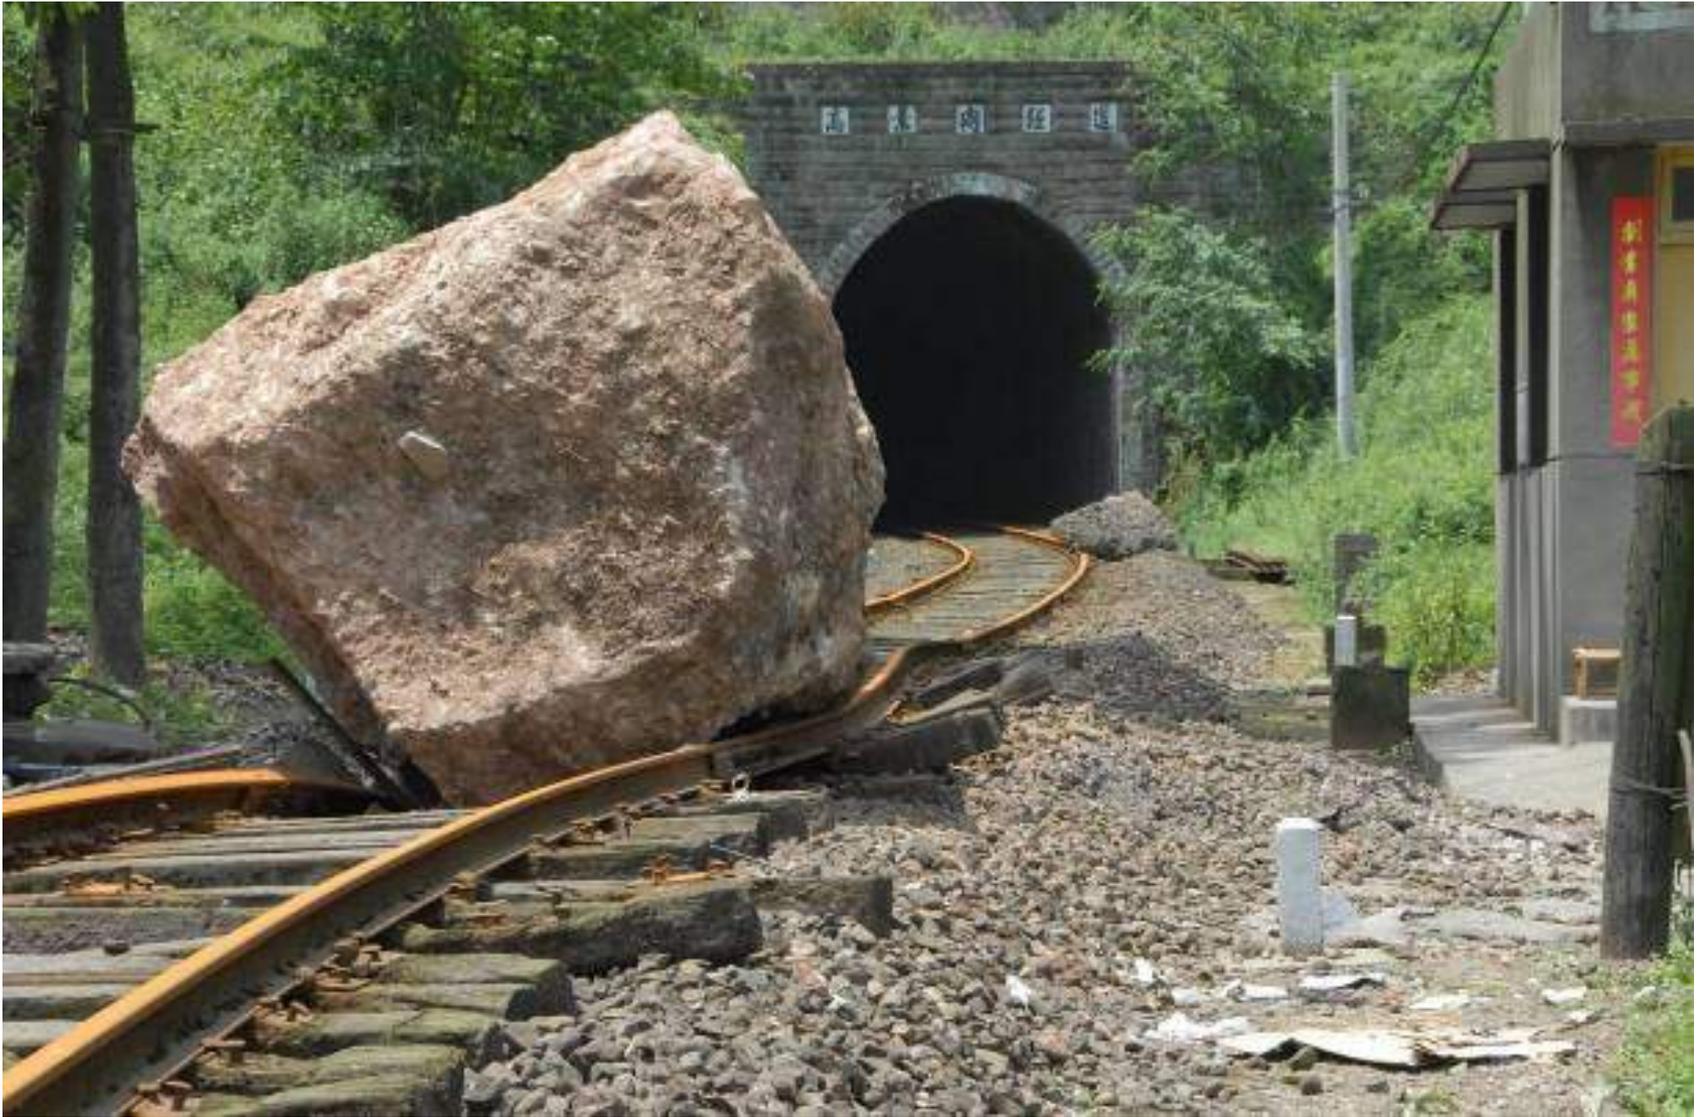
Damage due to rolling stones (Shifang City)

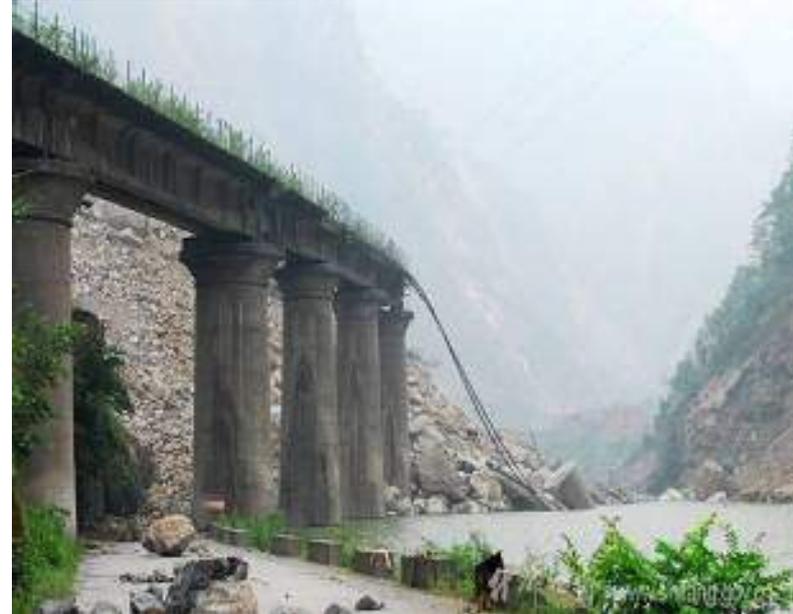
Damage to Macaotan railway bridge near Hongbai town

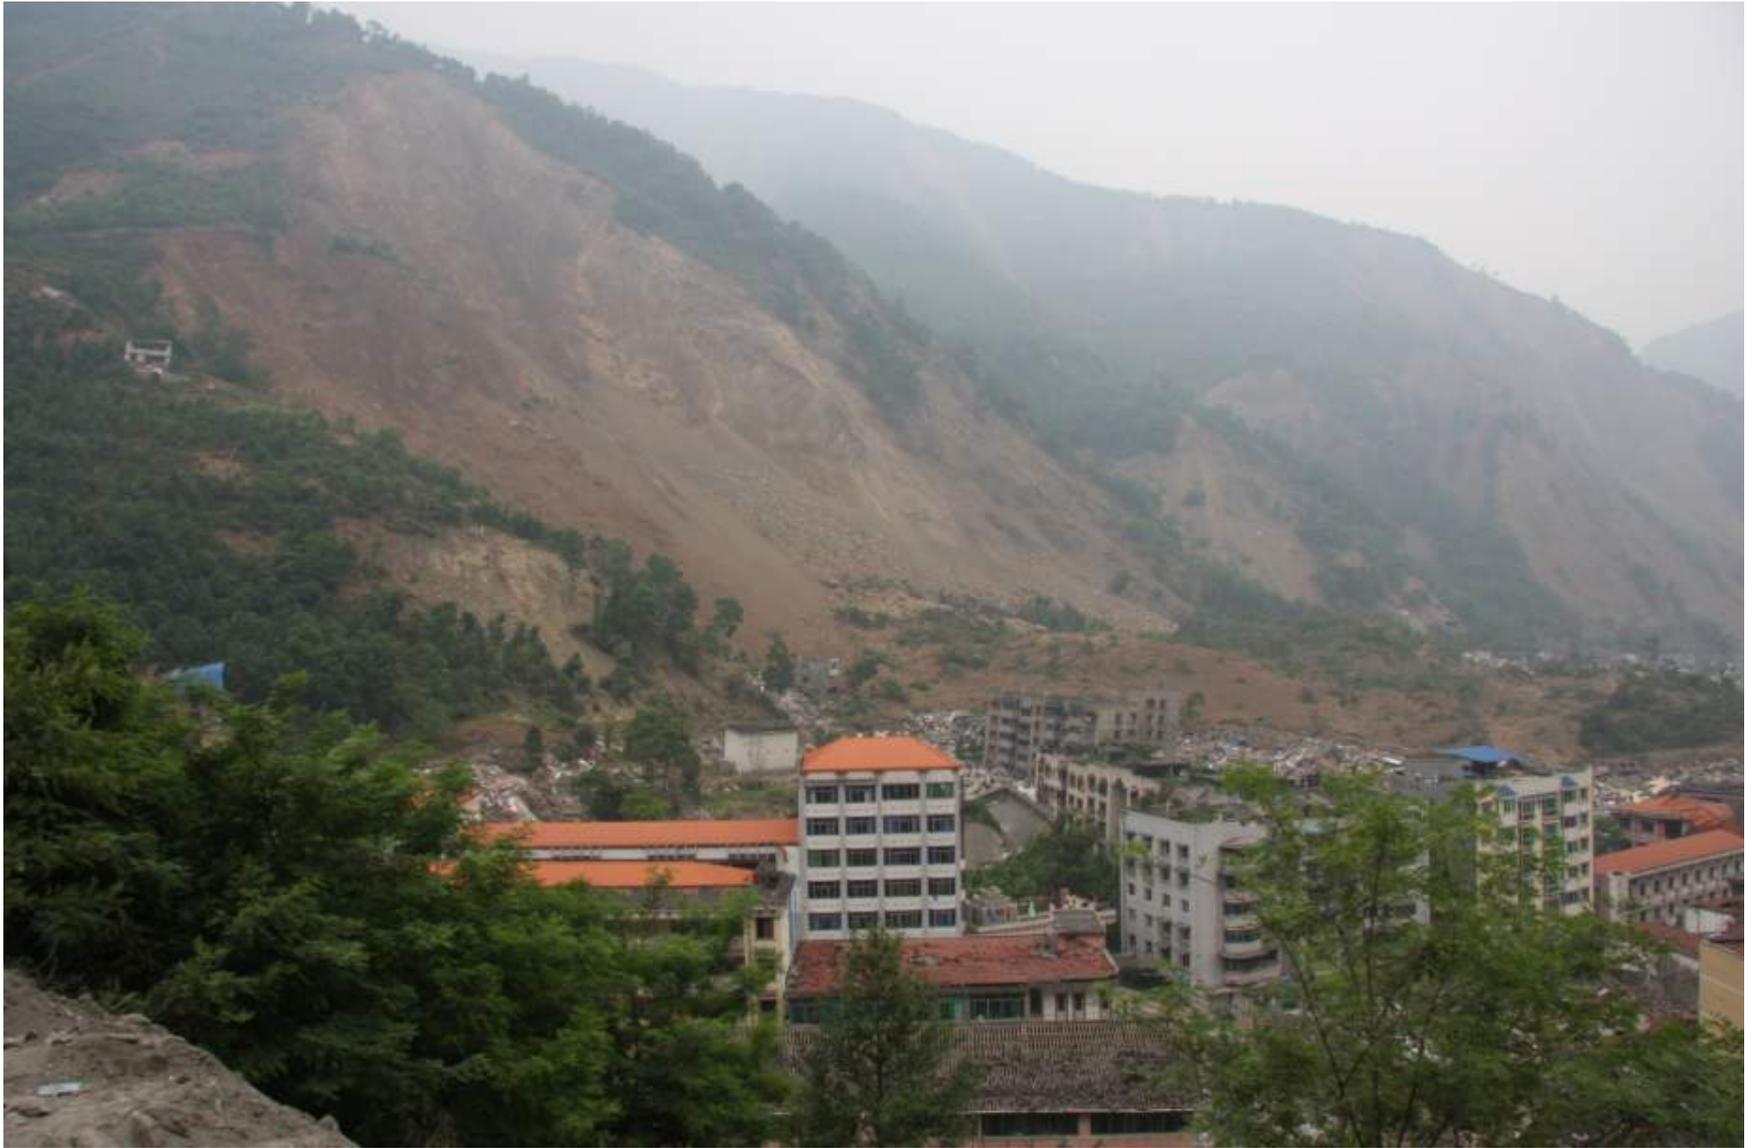
Landslide on the left side of  
Beichuan County

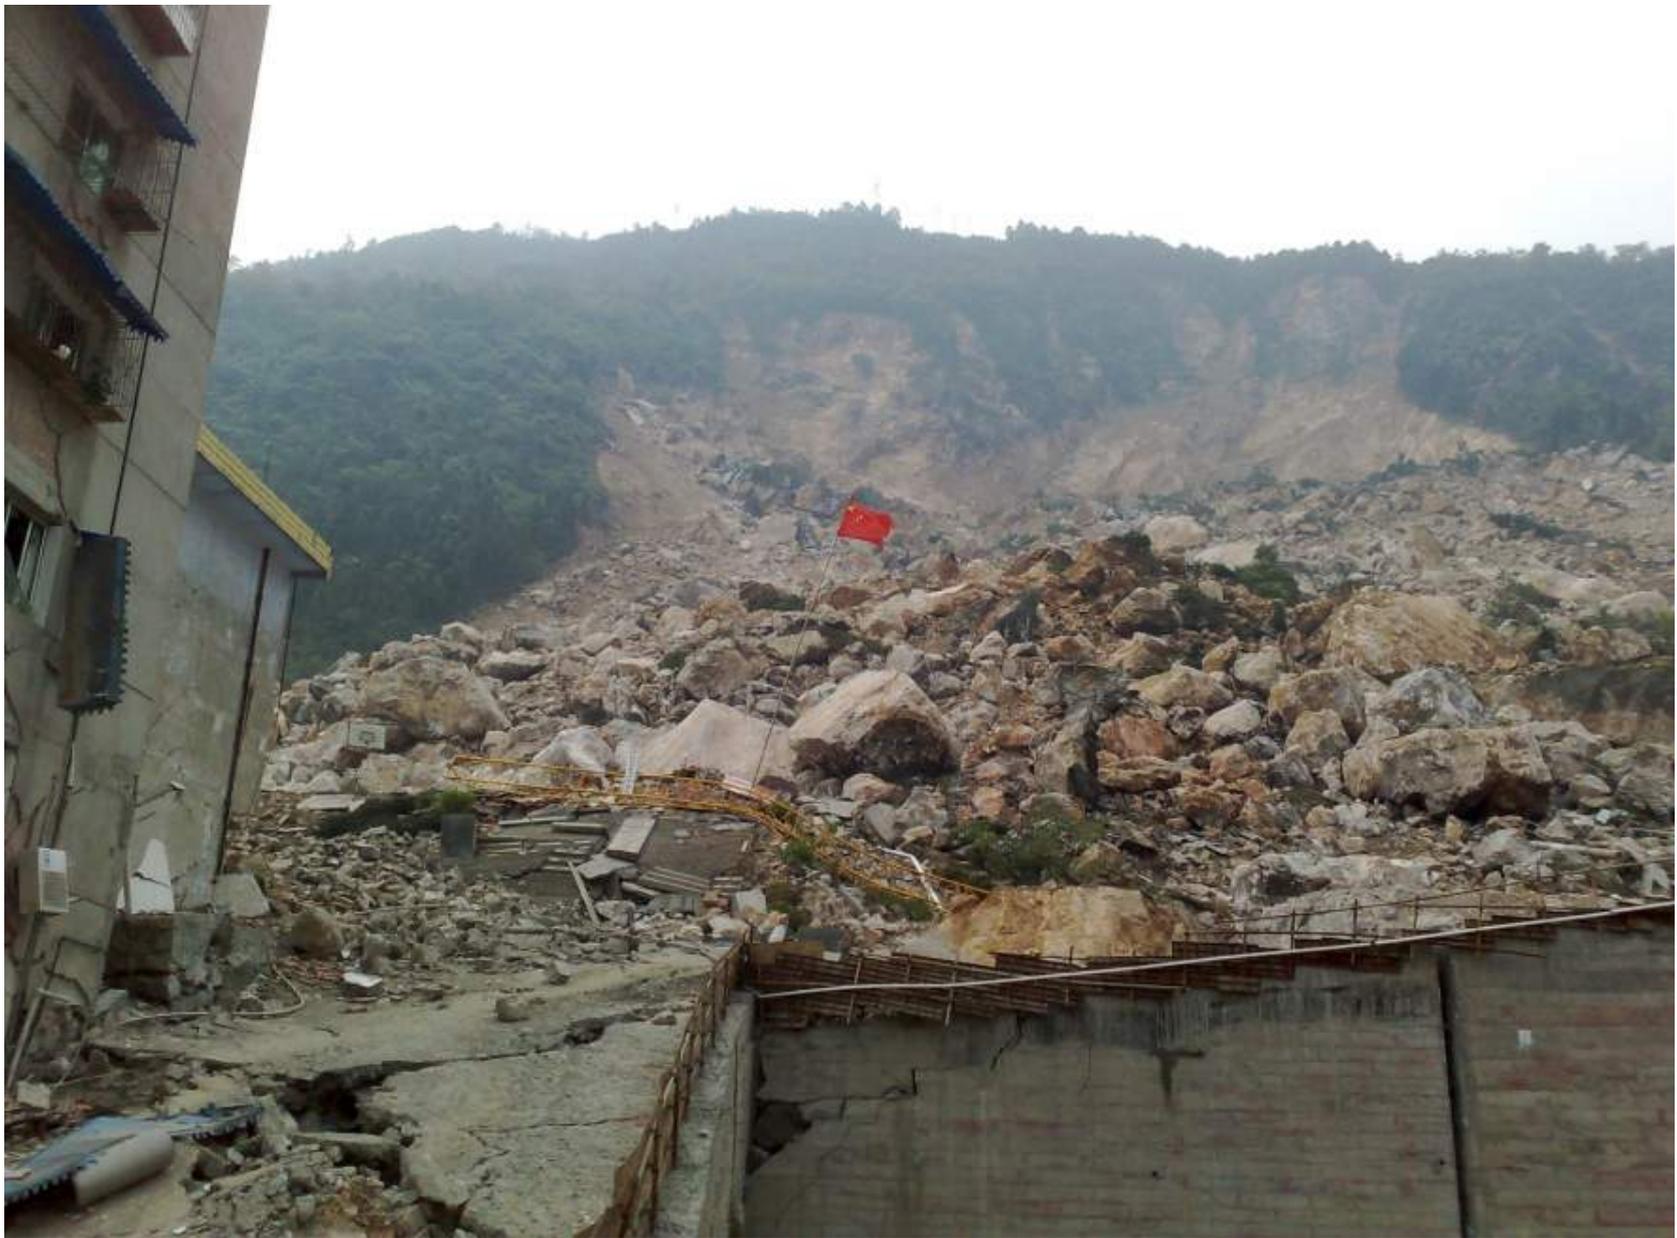
Rolling stones on the right side in Beichuan County ( Beichuan Middle School new site) □

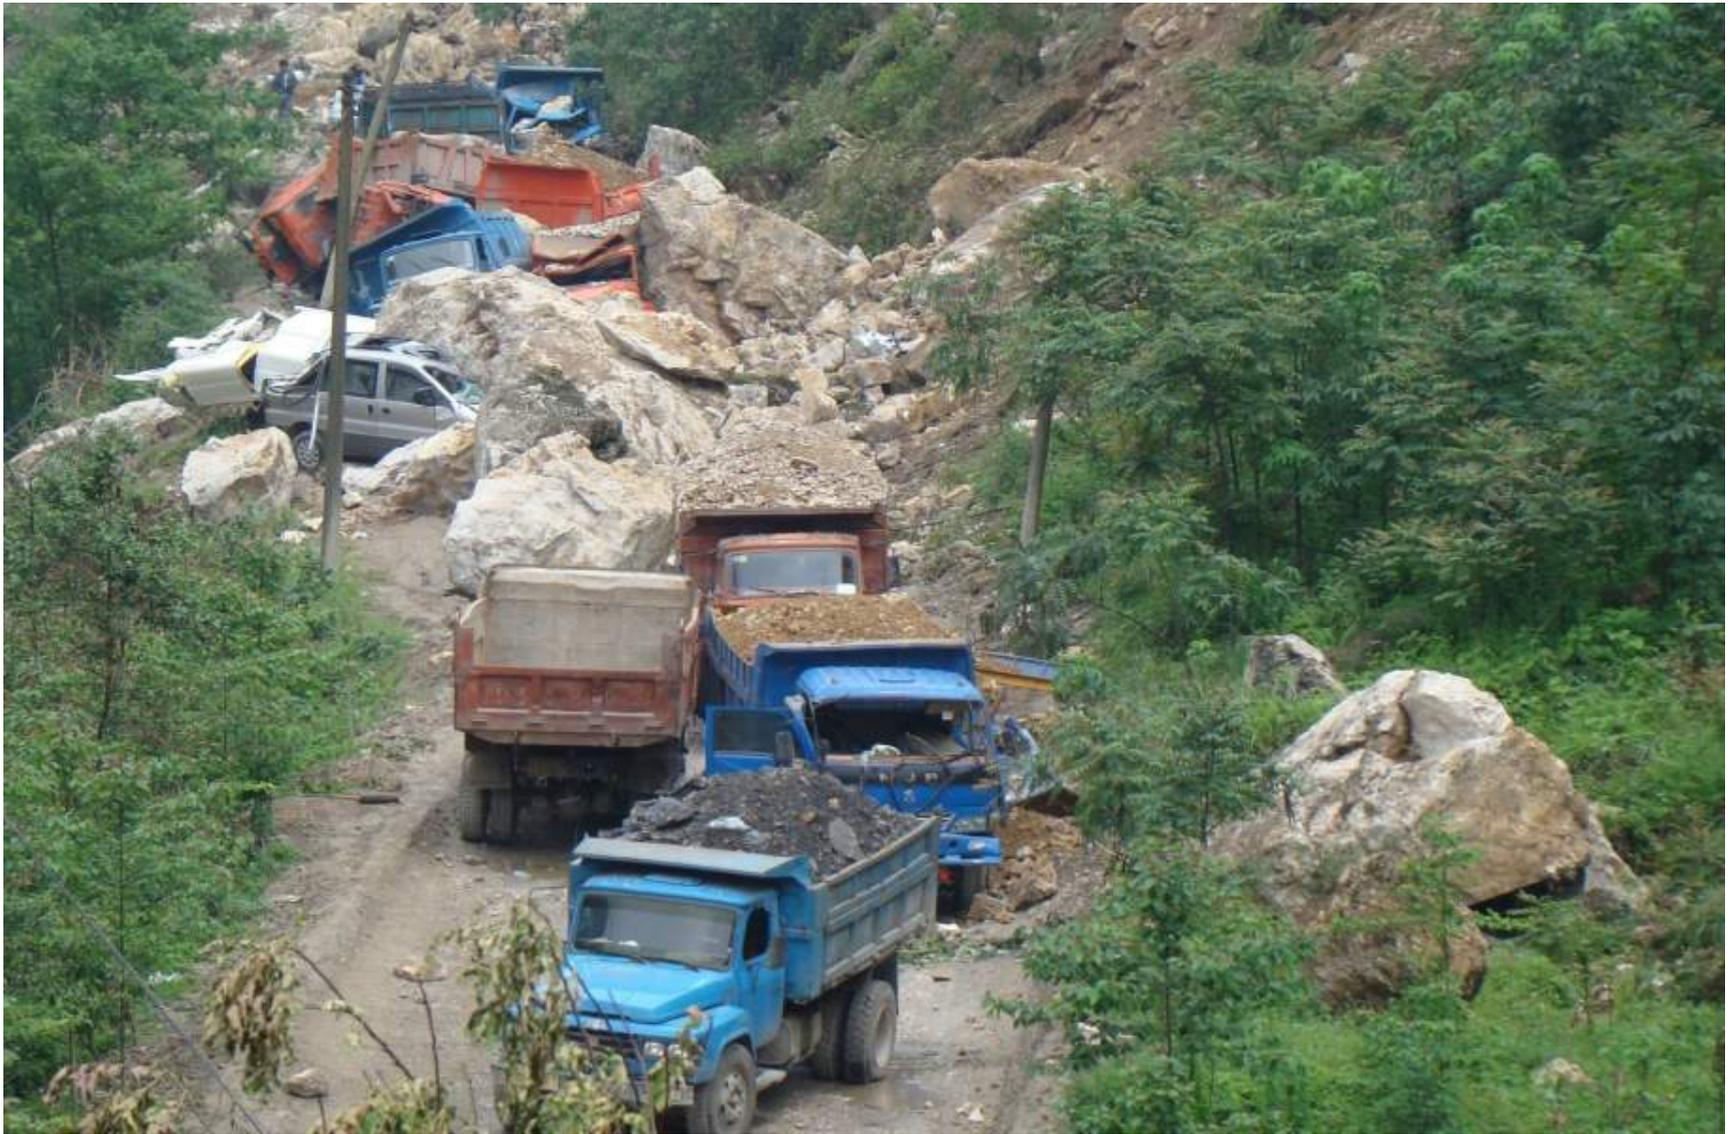
Rolling stones in Gaochuan, Anxian County

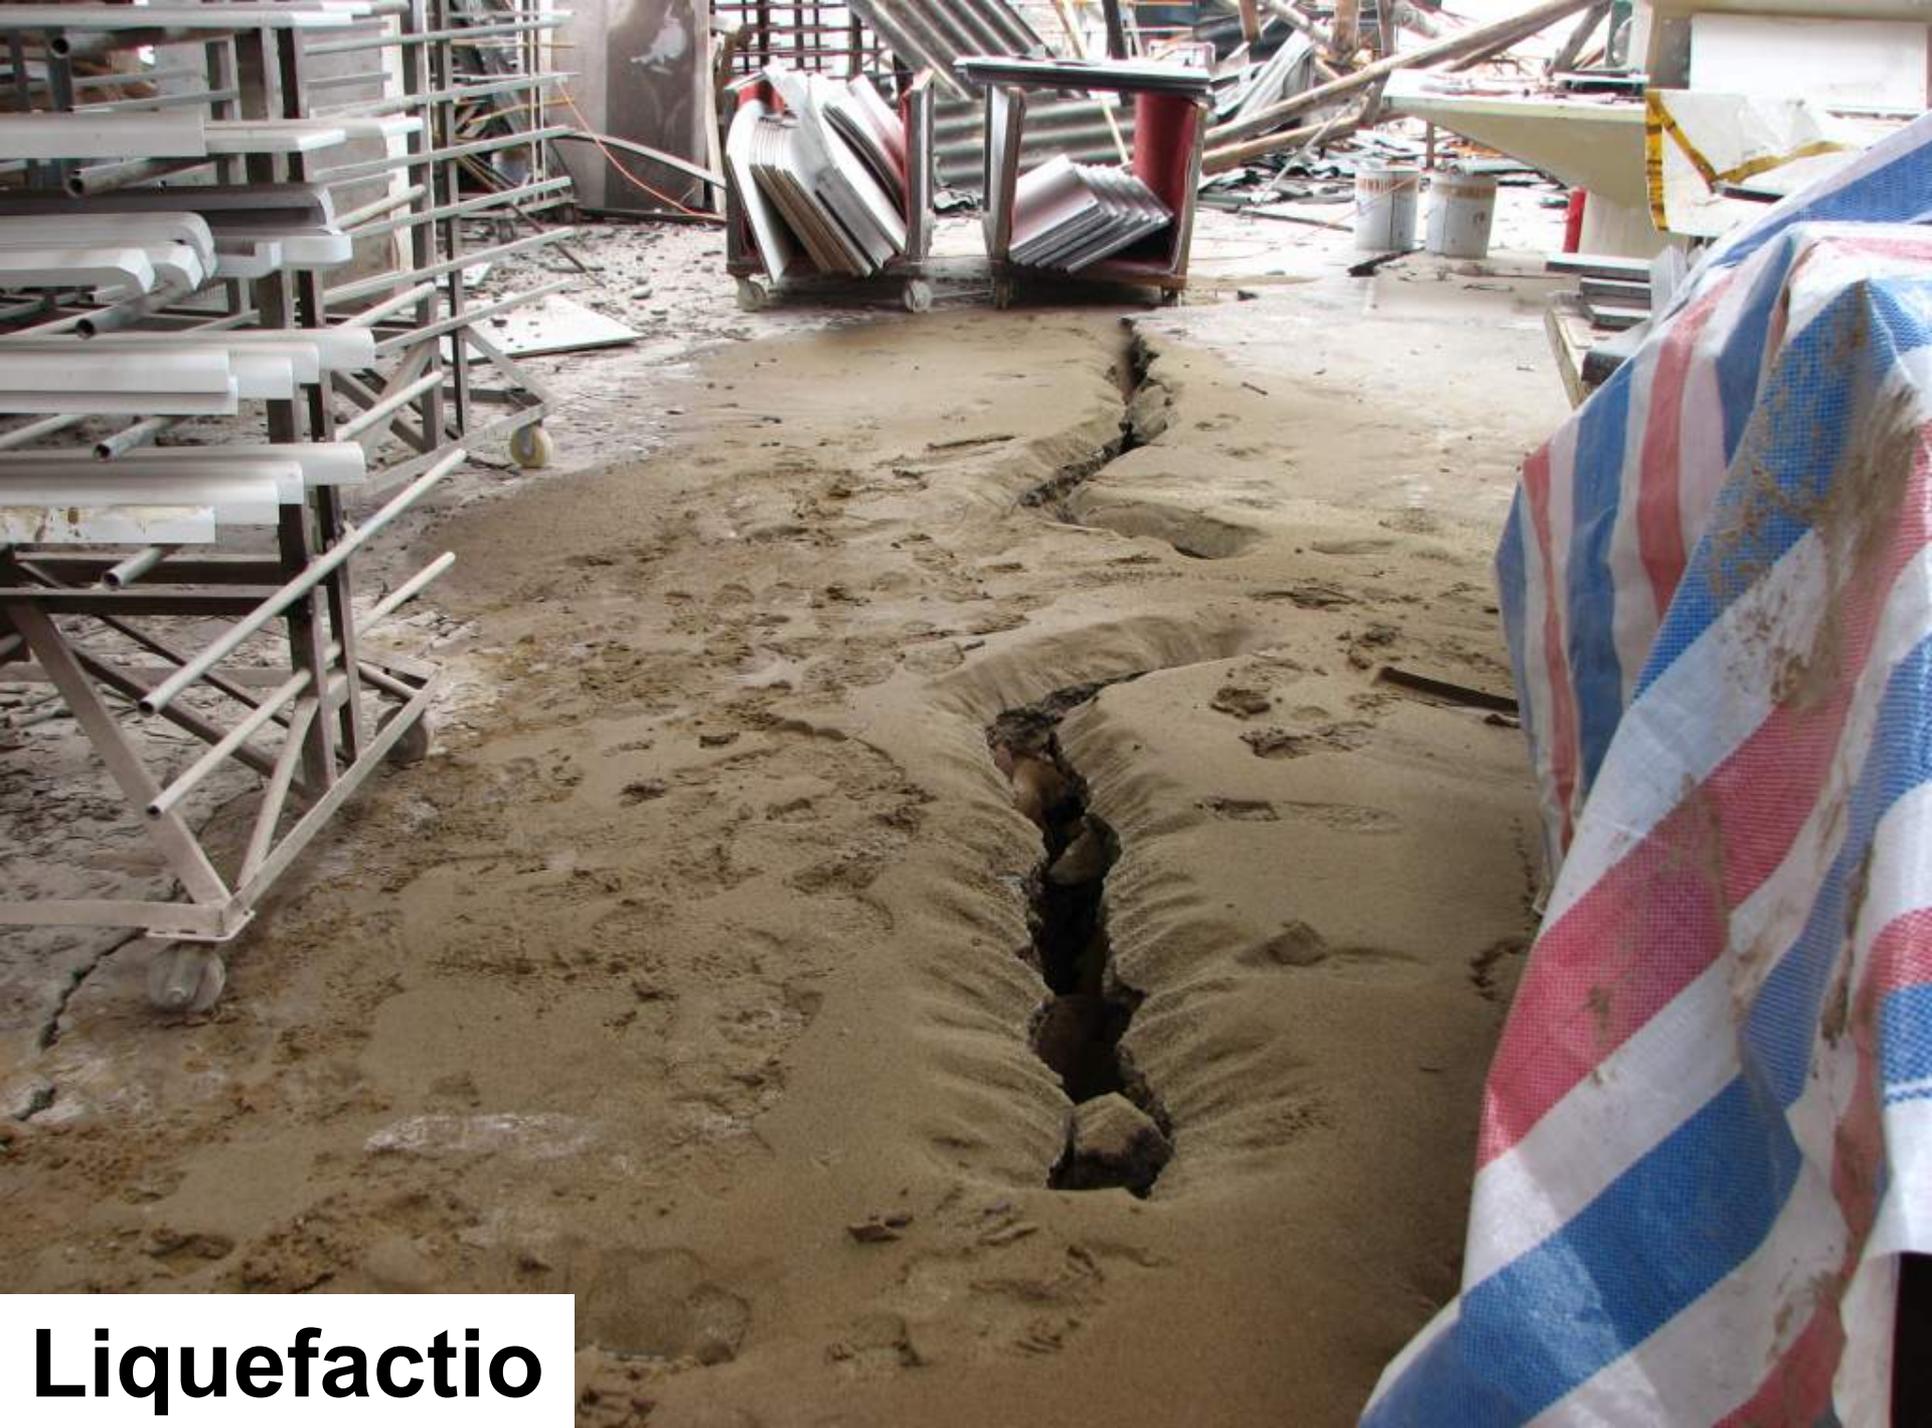
**Liquefactio**

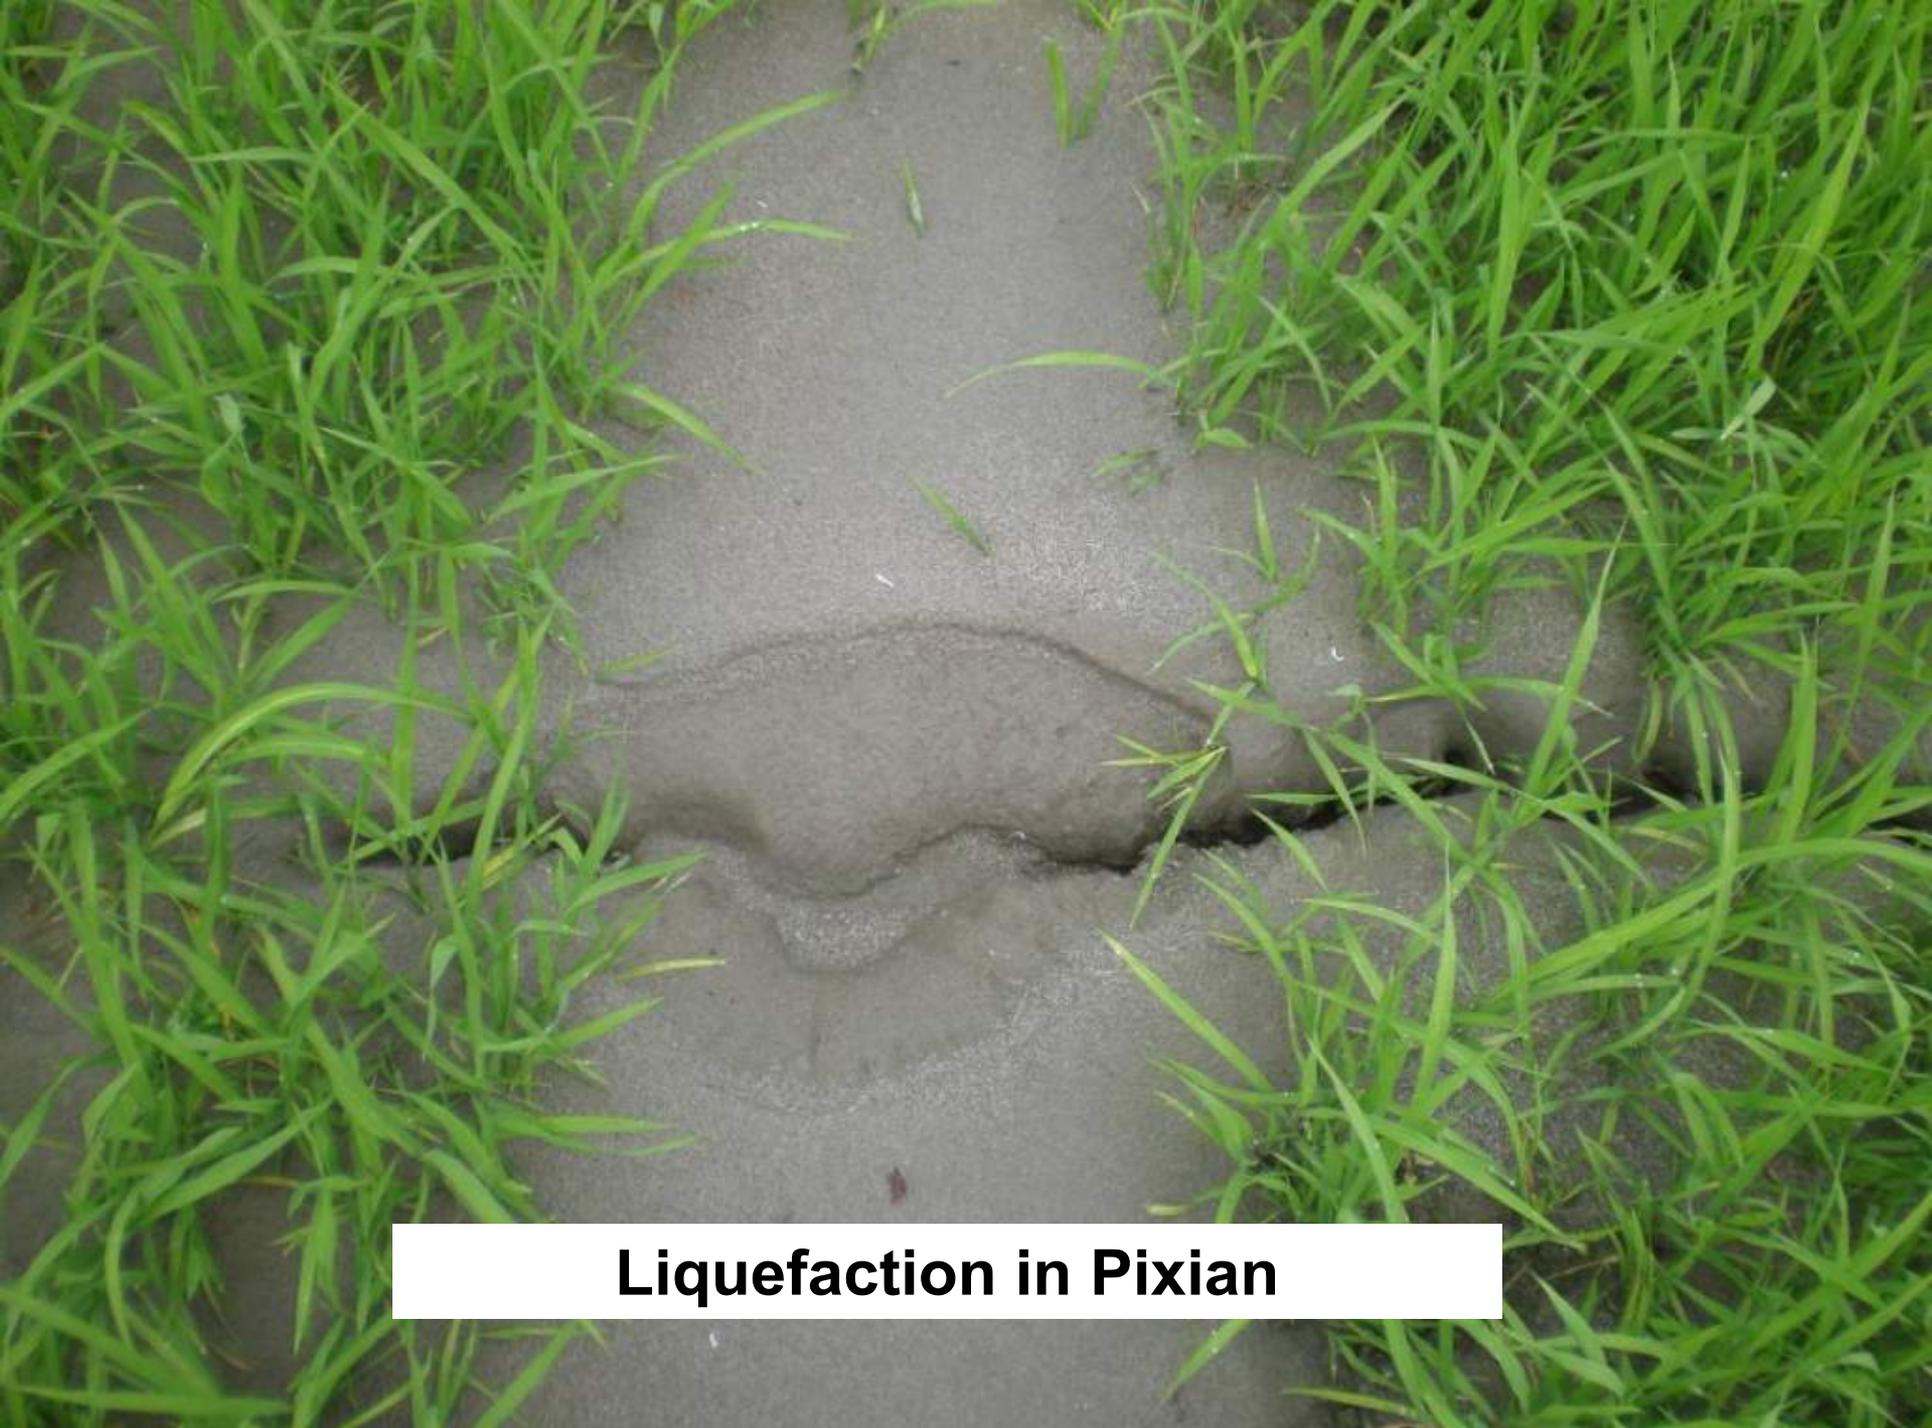
**Liquefaction in Pixian**

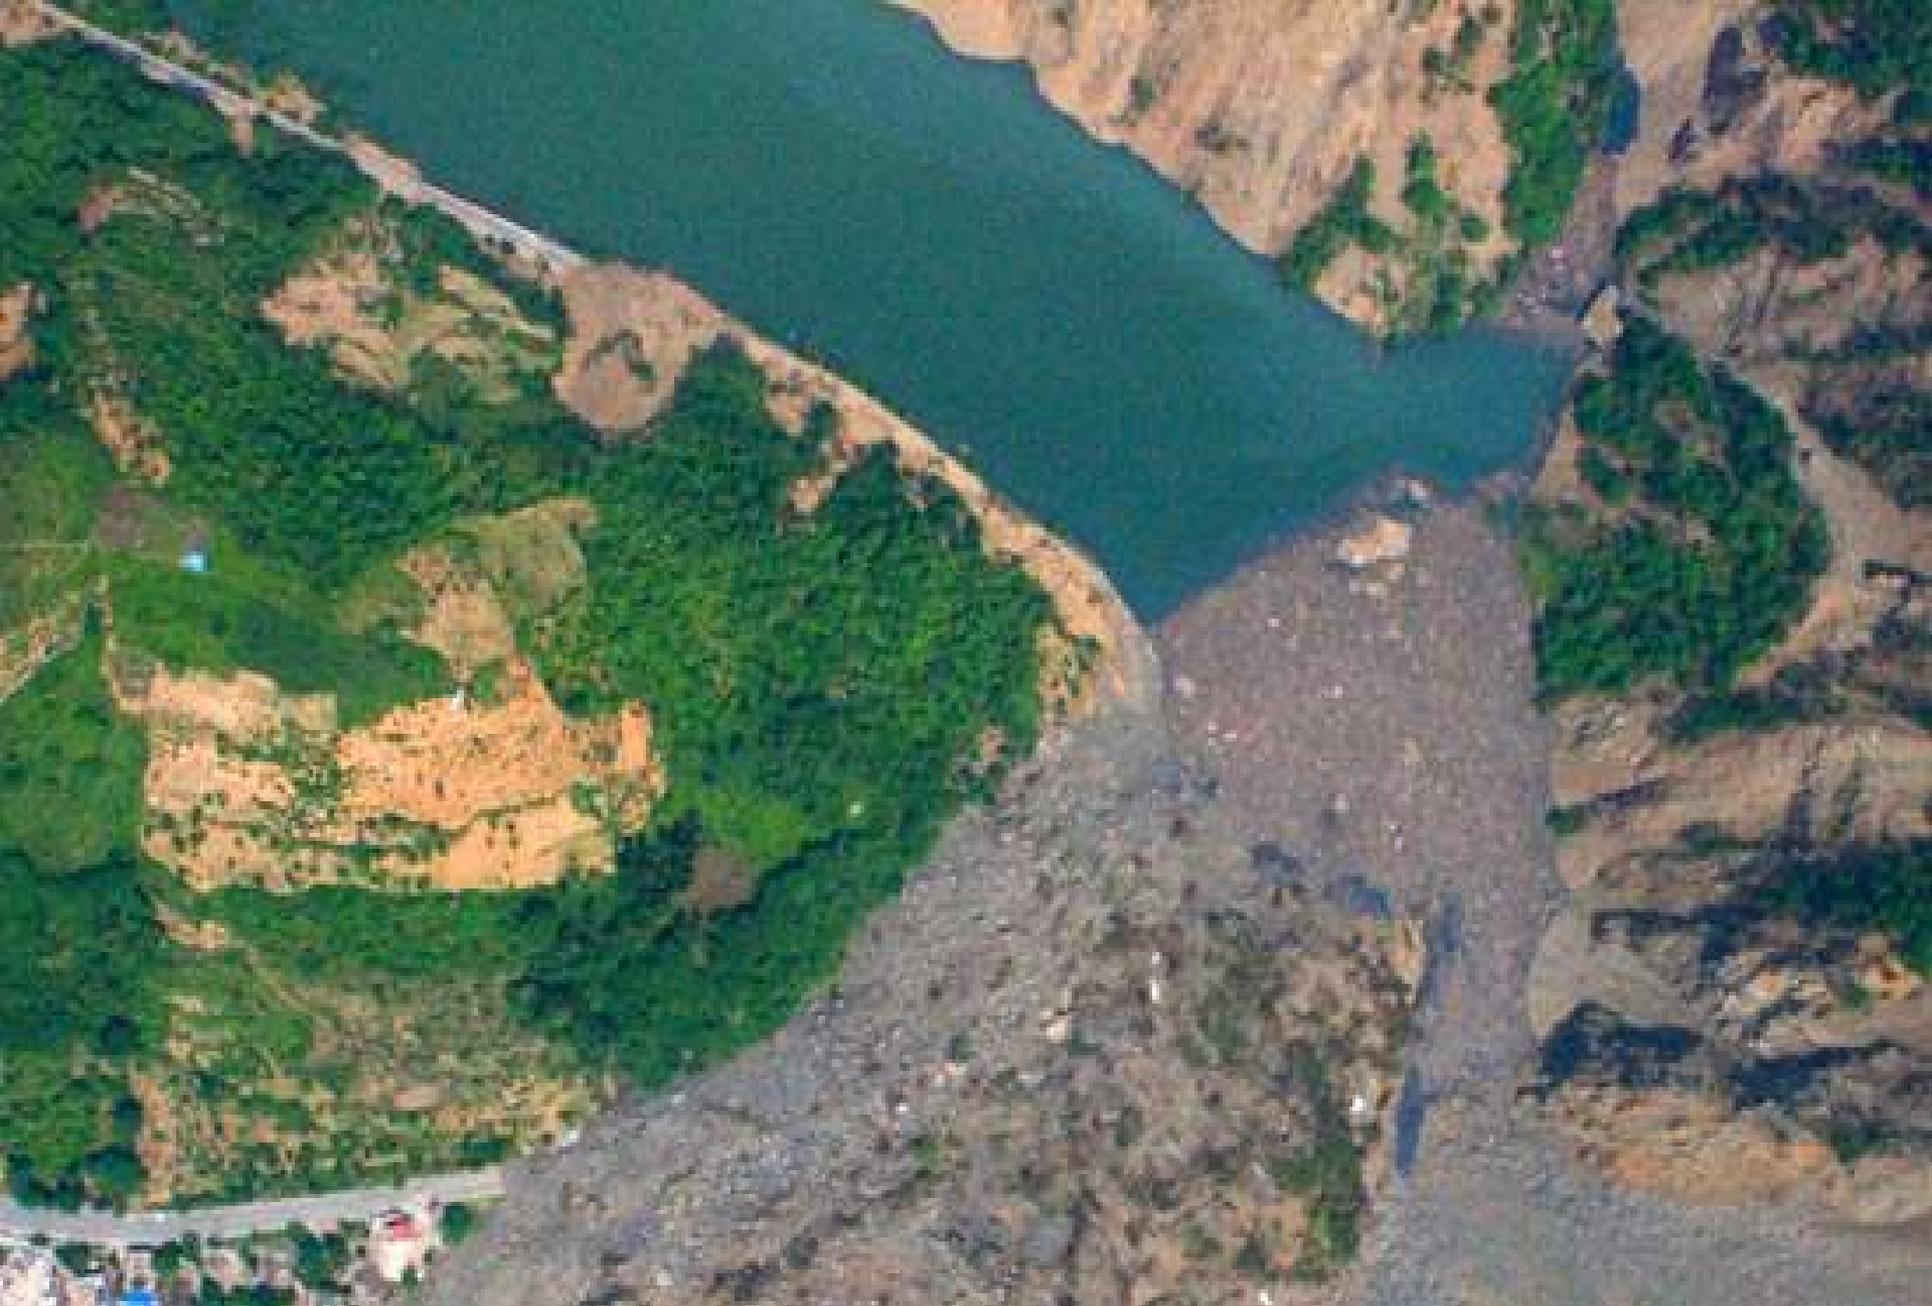
**Quake Lake at Tangjiashan**

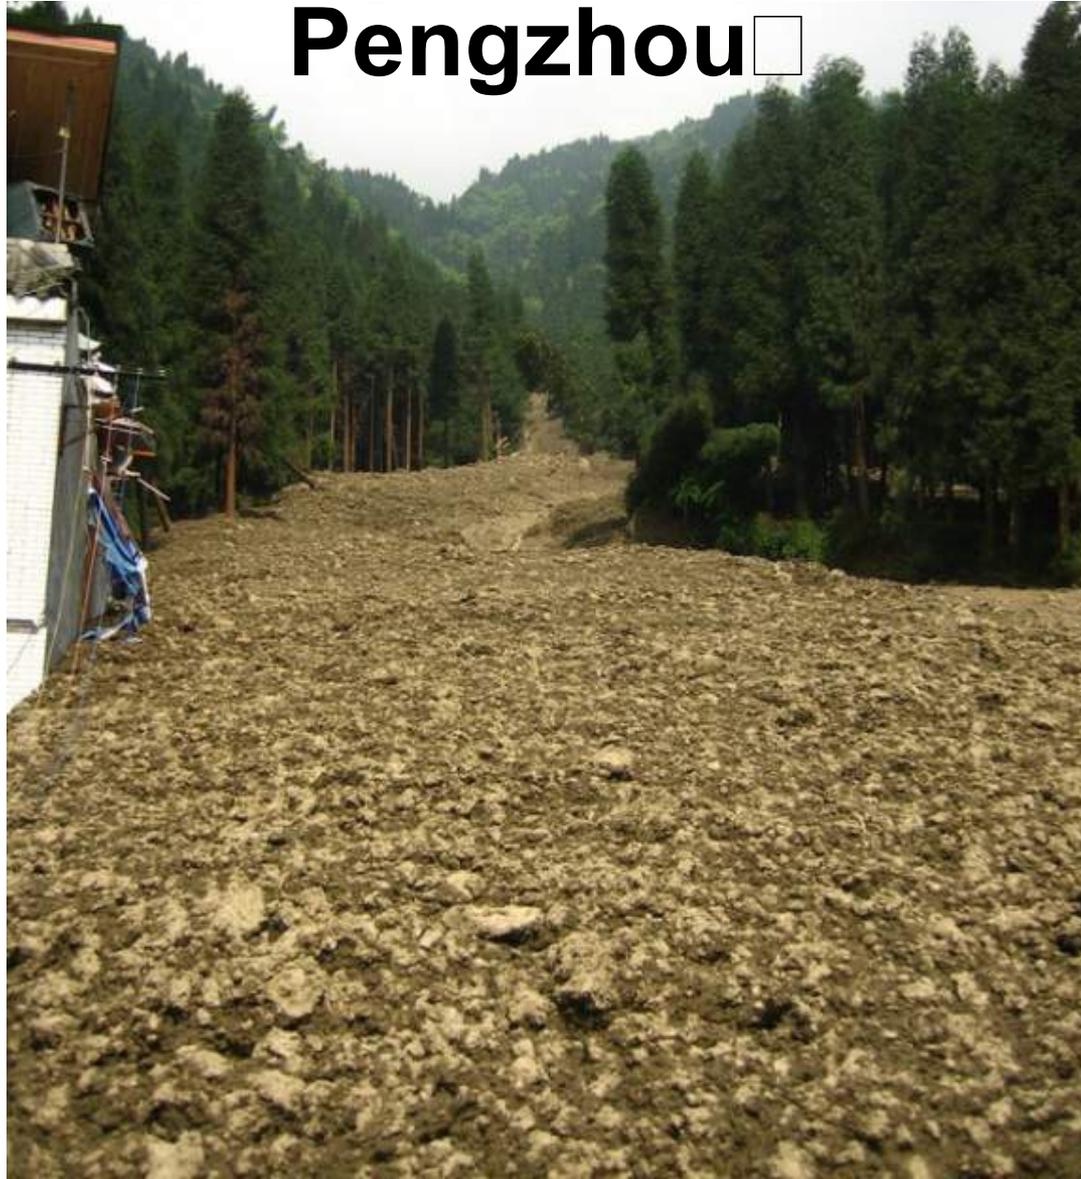
# Mudslide

## □ Jiufengshan, Penzhou □

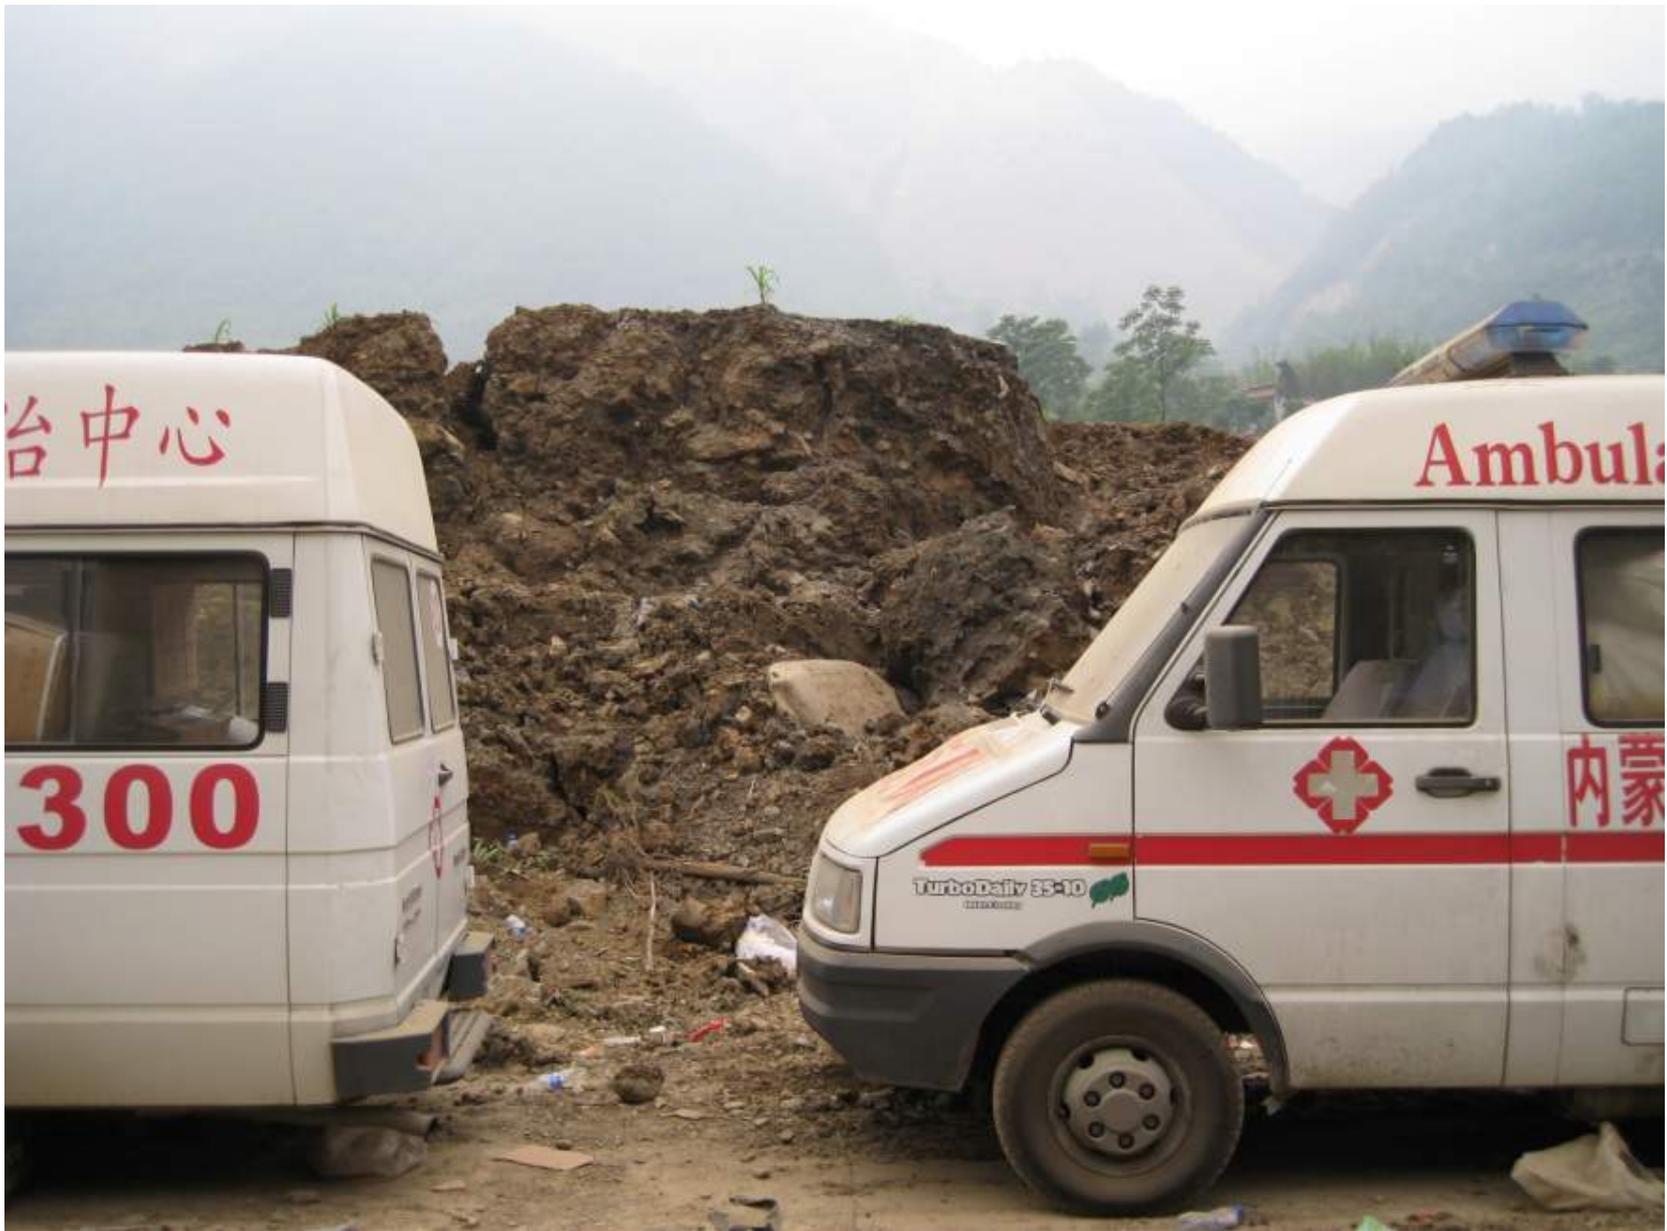
Fault Rupture near Beichuan  
County
