# Strong Motion, Damage, and Loss of Wenchuan Earthquake

Zifa Wang

Institute of Engineering Mechanics, China Earthquake Administration

August 18, 2008

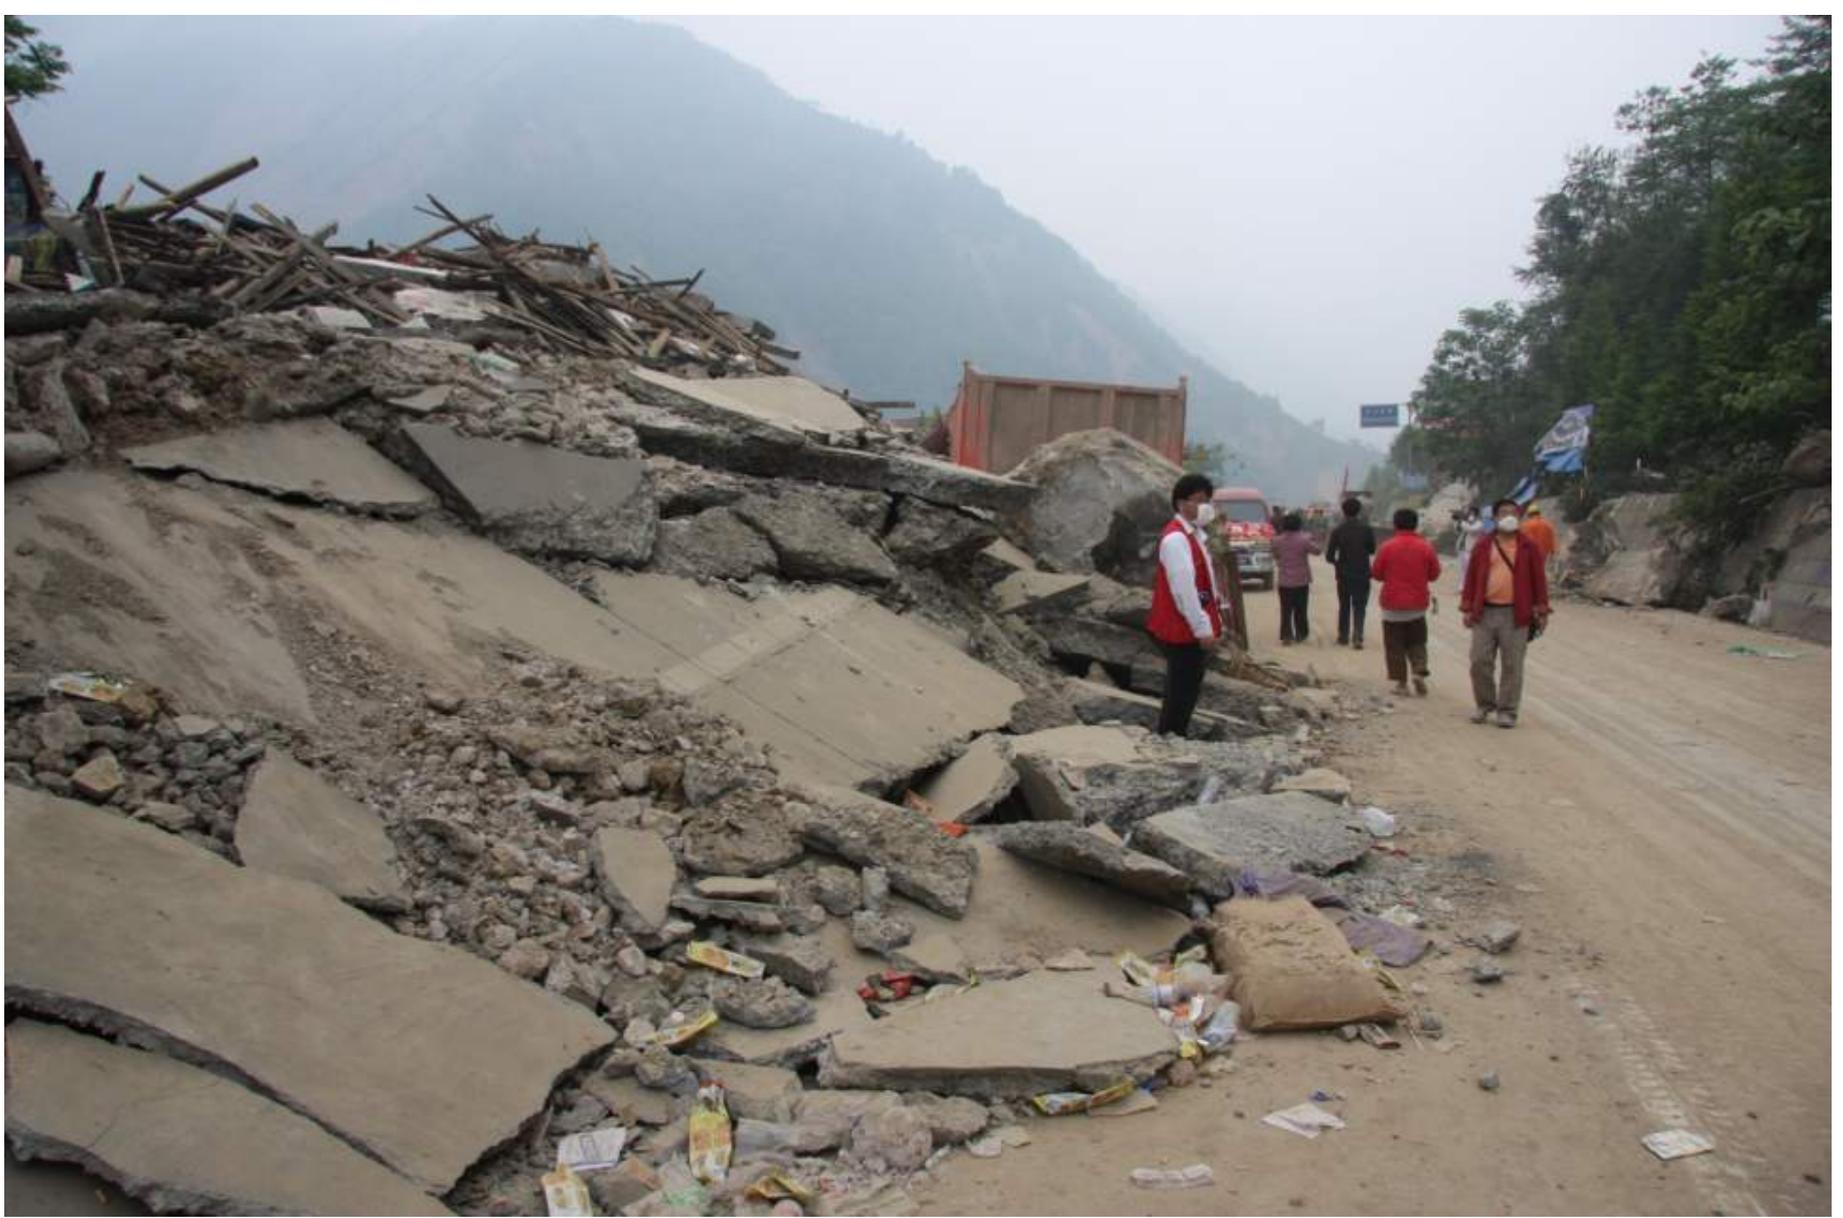
Rupture along a road to Beichuan County

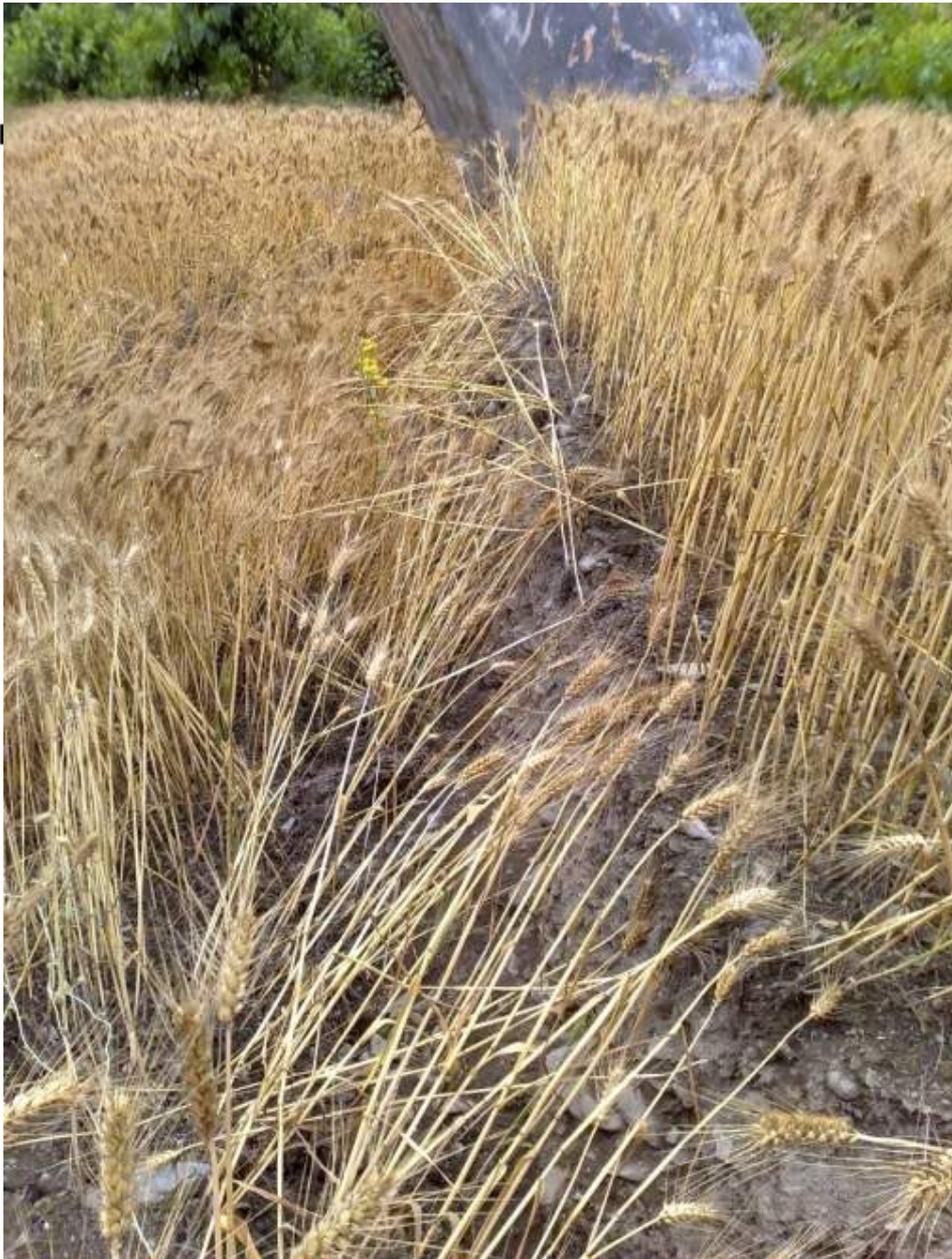
Fault Rupture in  
Pingtong town in  
Pingwu County
