Cripple Wall Small-Component Test Program: Wet Specimens I

**A Report for the “Quantifying the Performance of
Retrofit of Cripple Walls and Sill Anchorage in Single-
Family Wood-Frame Buildings” Project**

PEER Report 2020/16

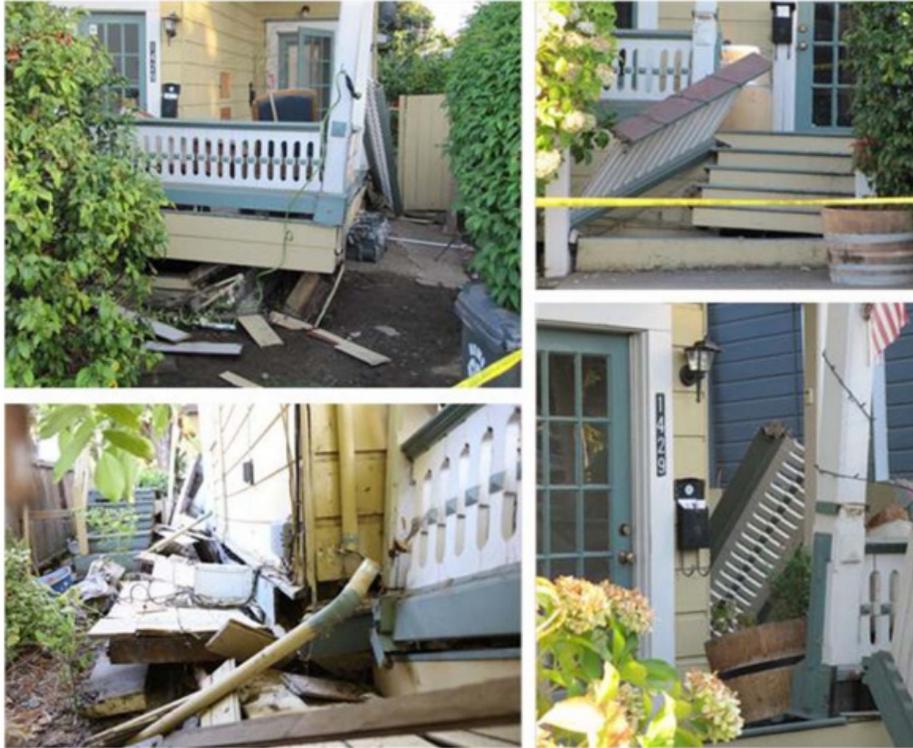
Figure 1.3 A view of a cripple wall collapse on an as-built house (top left), damage to the utility lines and gutter pipe (bottom left), and displacement as well as elevation change of the homes entrance stairs (top right) and patio railing (bottom right), 2014 Napa earthquake, Napa, California (image courtesy of Kang and Mahin [2014]).

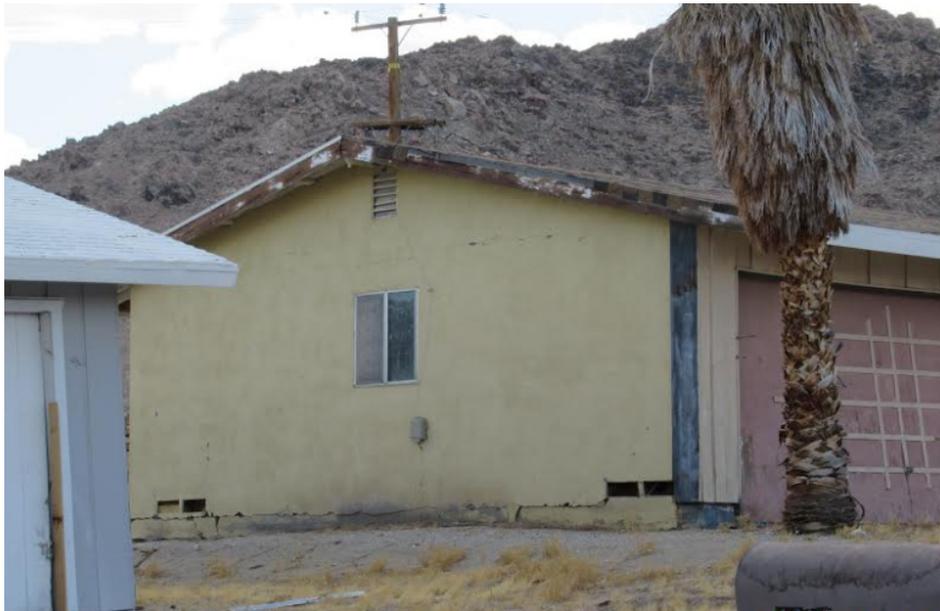
Figure 1.4 Partial foundation anchorage failure at the cripple wall of a stucco house in Trona, California (image courtesy of Cobeen [2019]), 2019 Ridgecrest earthquake, Ridgecrest, California.

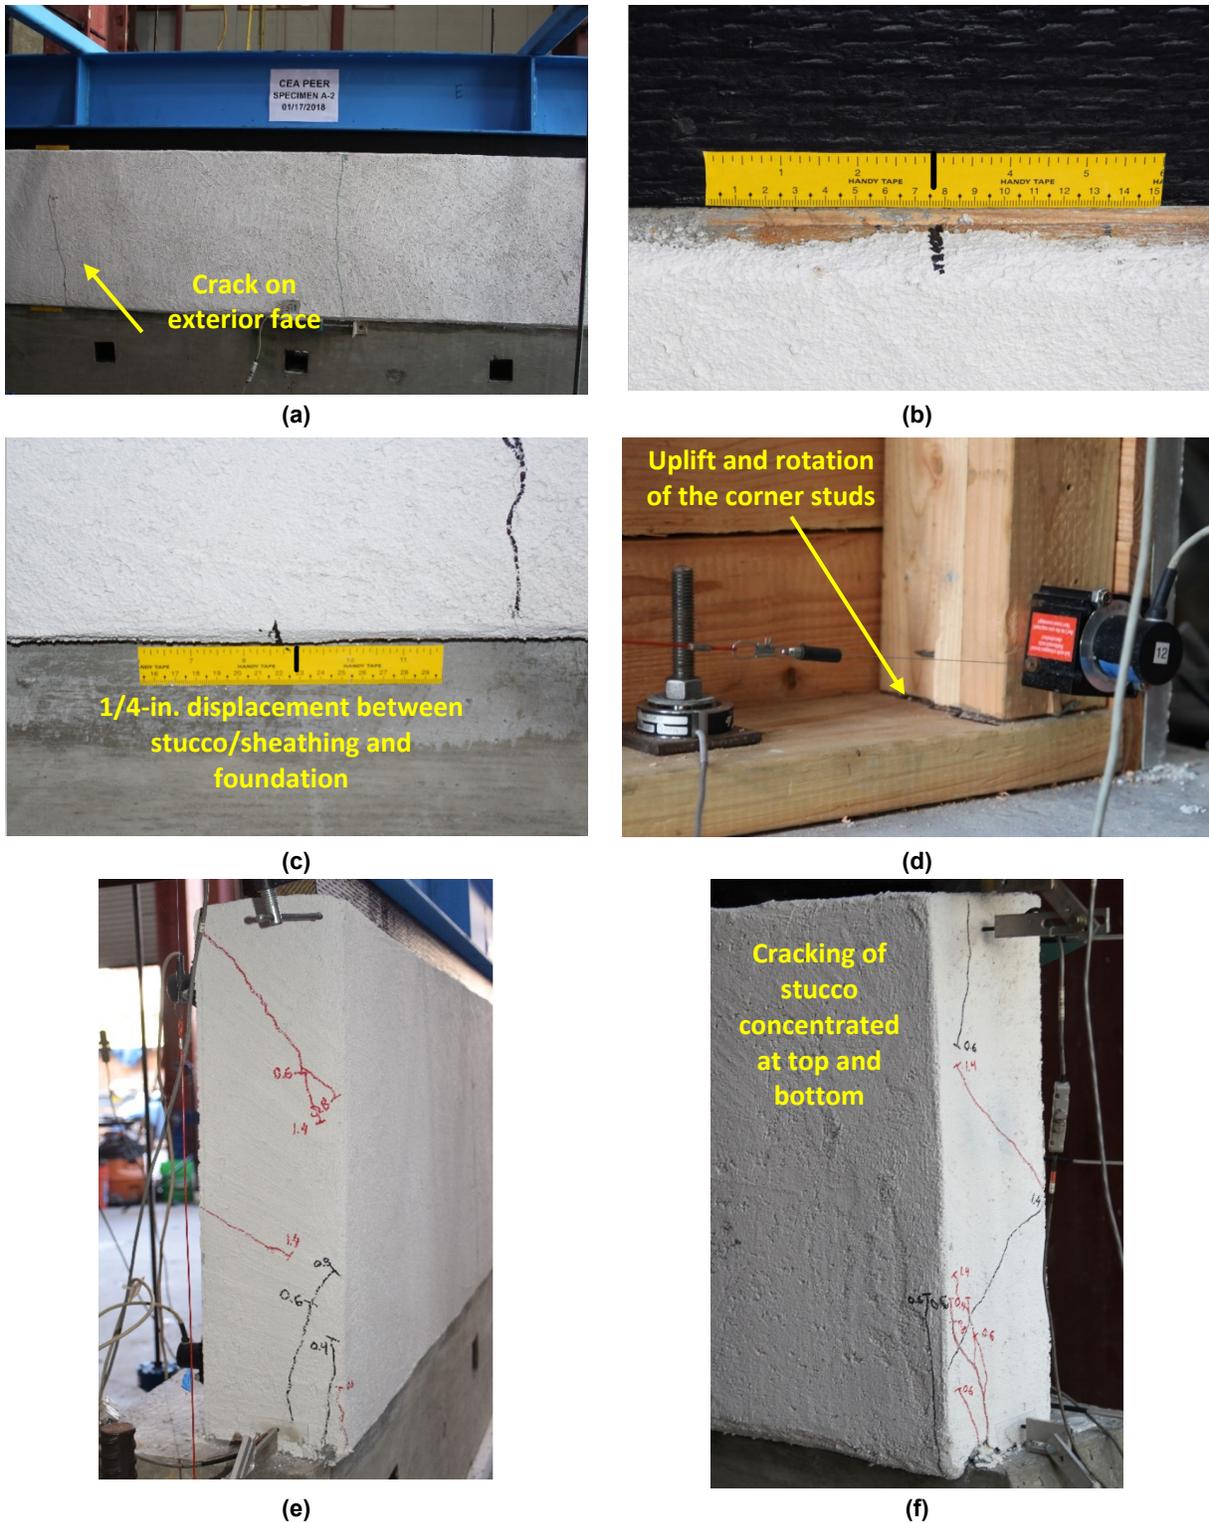
Figure 5.4 Specimen A-2 damage state at -1.4% drift @ $\Delta = -0.336$ in.: (a) exterior elevation; (b) top of exterior wall; (c) bottom of exterior wall; (d) bottom corner of south-end interior; (e) north-end exterior corner view; and (f) north-end interior corner view.

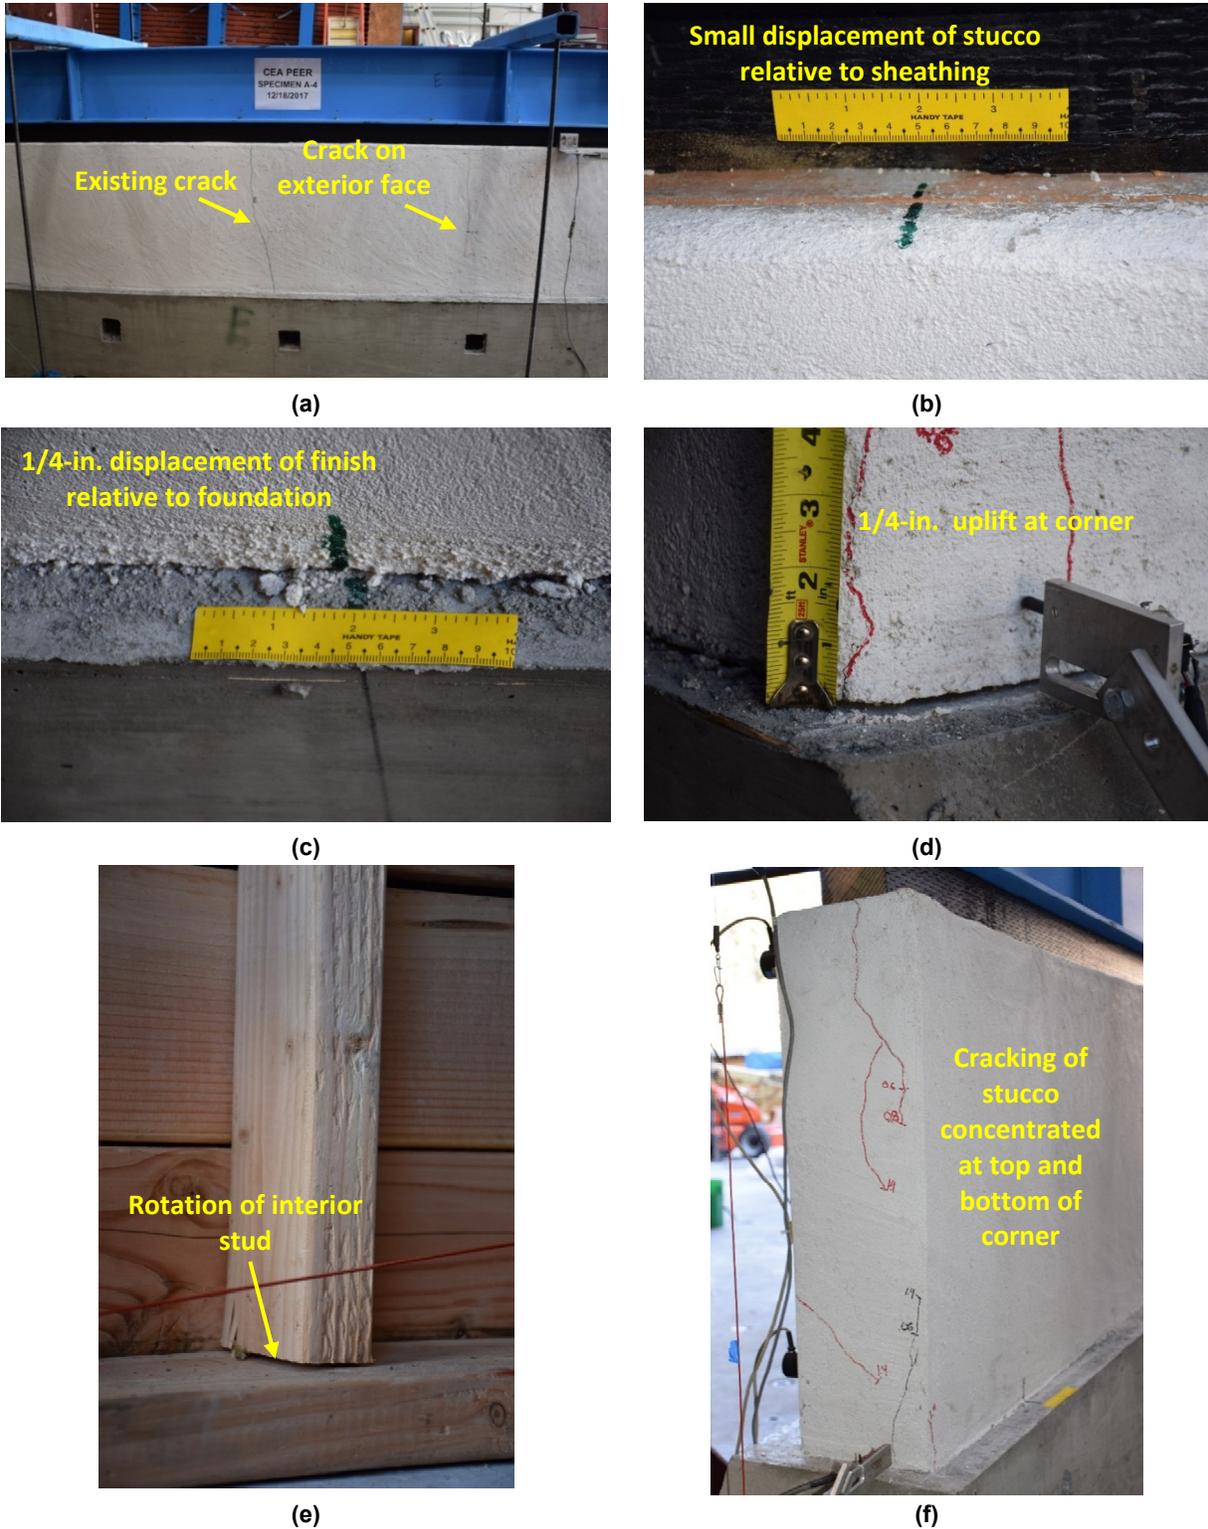
Figure 5.8 Specimen A-4 damage state at -1.4% drift ($\Delta = -0.336$ in.): (a) exterior elevation; (b) top of exterior wall; (c) bottom of exterior wall; (d) bottom of north-end exterior corner; (e) bottom of interior wall; and (f) north-end of exterior corner.

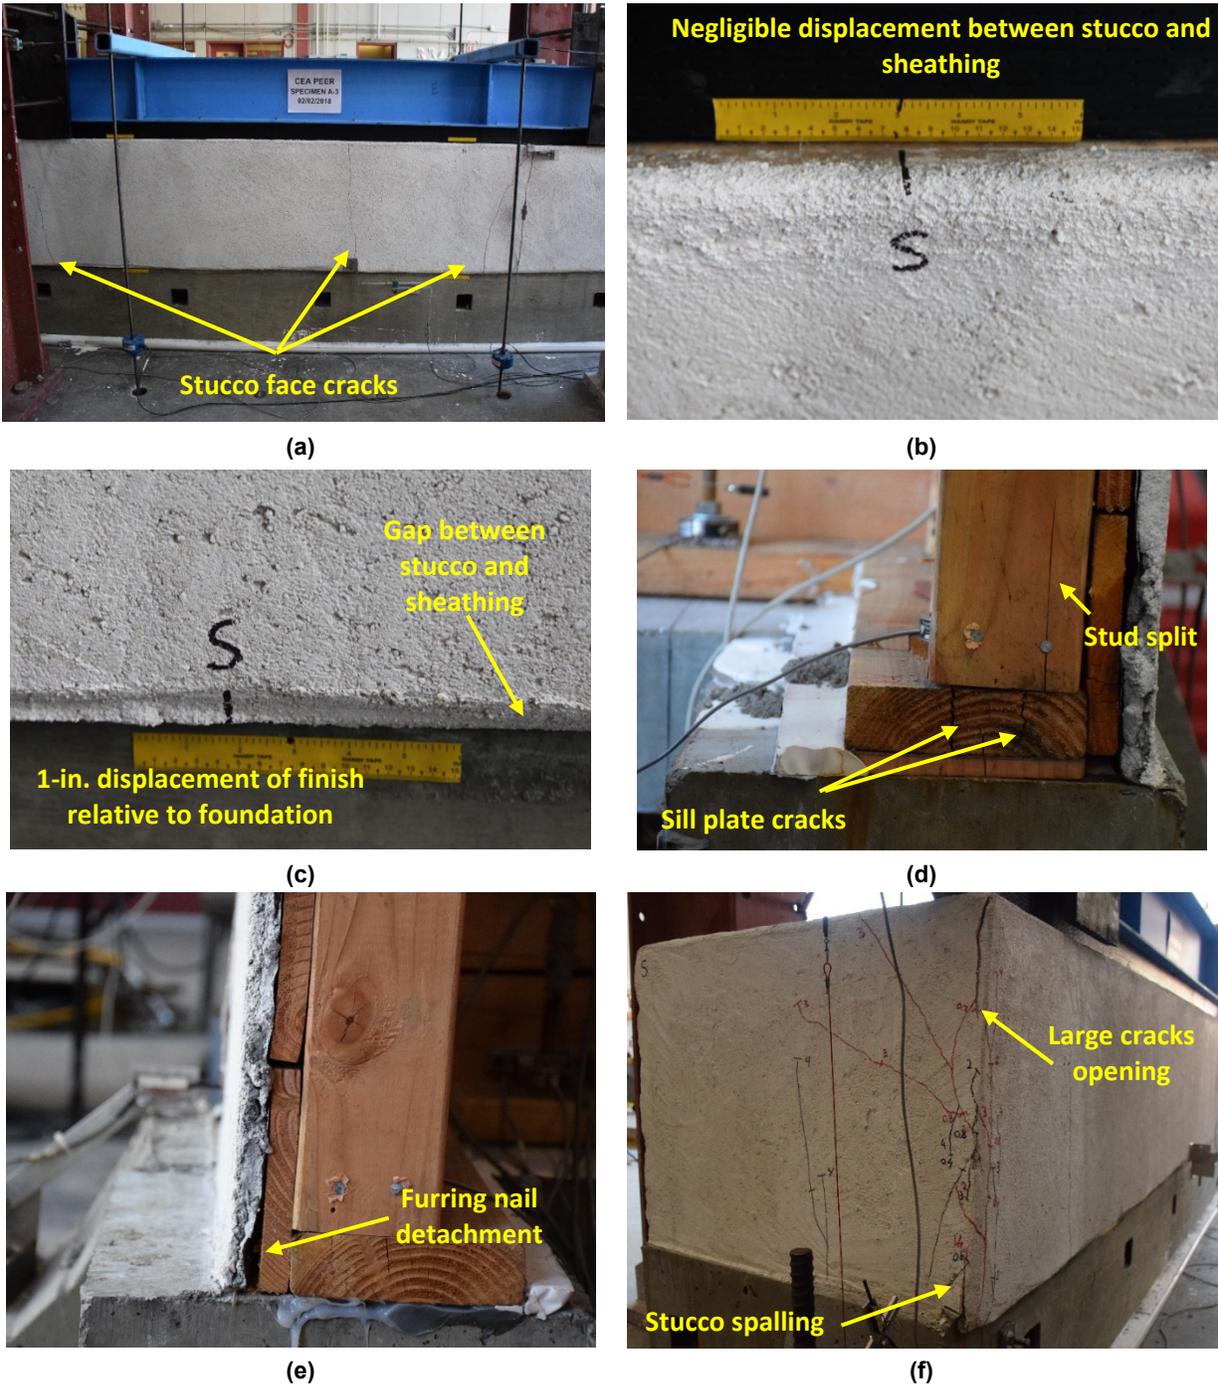
Figure 5.15 Specimen A-3 damage state at lateral strength @ +4% drift, $\Delta = +0.96$: (a) exterior elevation; (b) top of exterior wall (c) bottom of exterior wall; (d) close-up of south-end wall; (e) close-up of north-end corner of wall; and (f) north-end exterior corner.

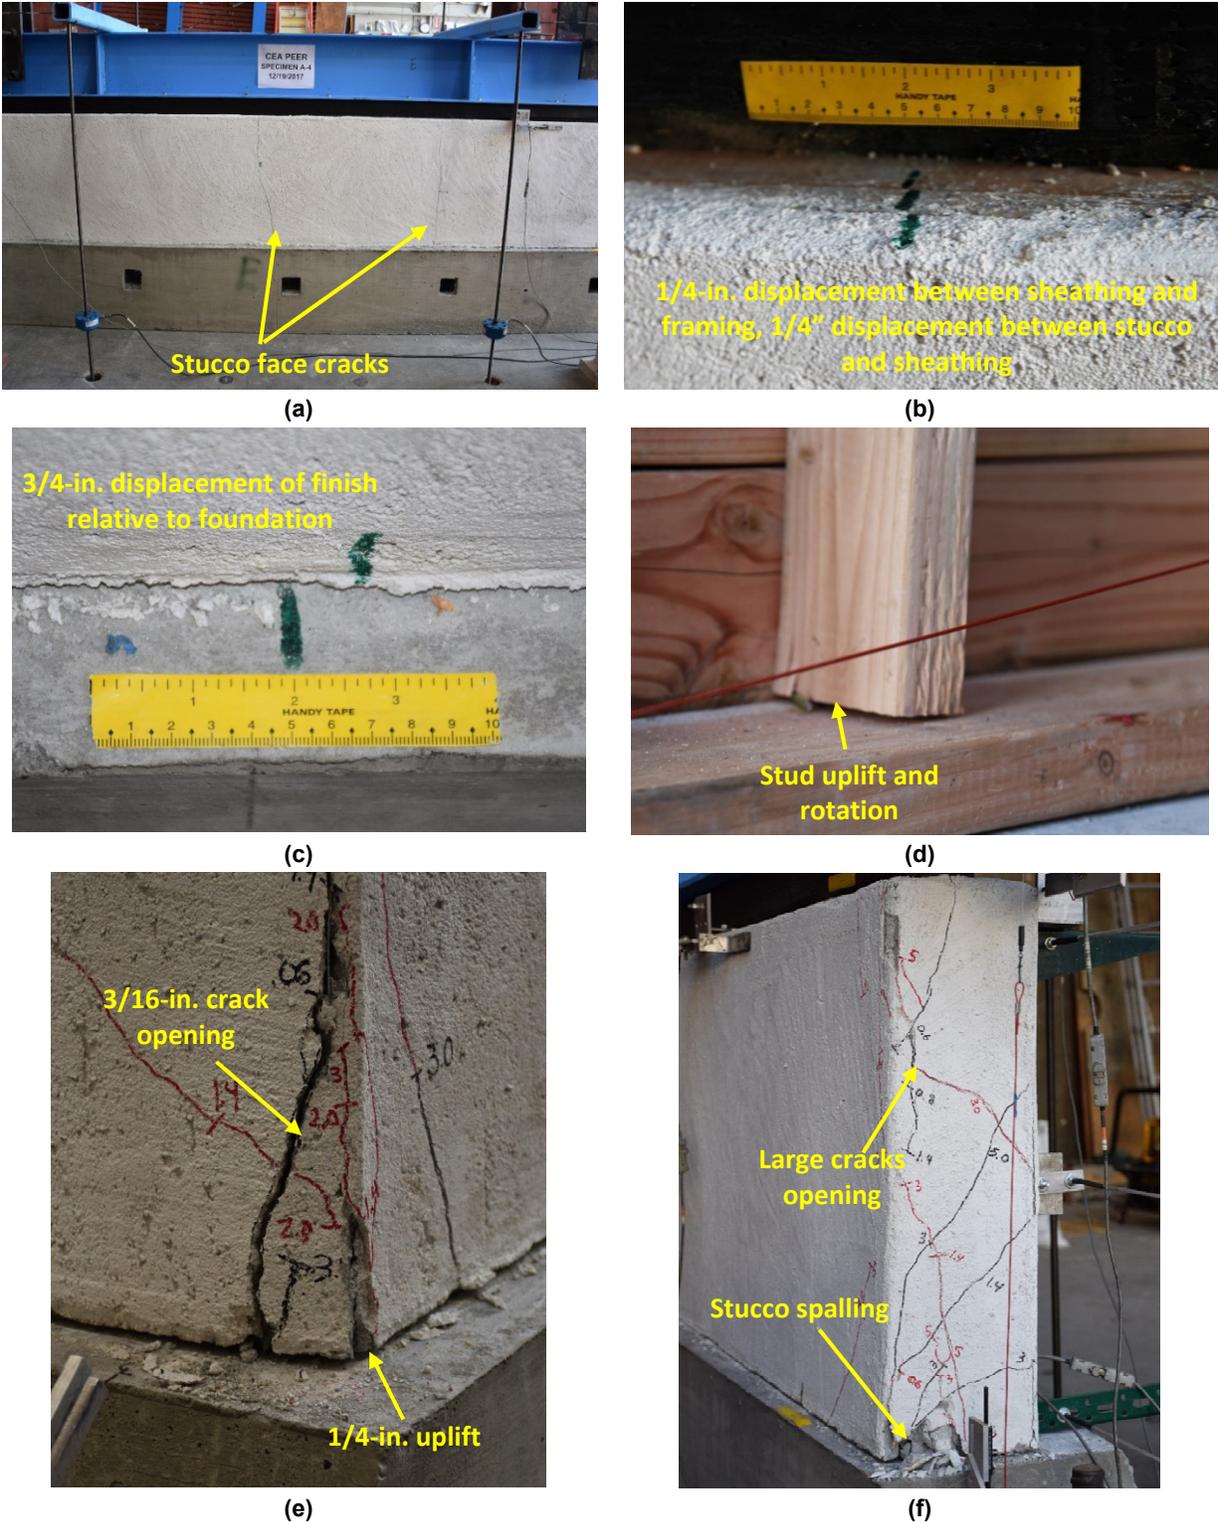
Figure 5.16 Specimen A-4 damage state at lateral strength @-5% drift, $\Delta = -1.20$ in.: (a) exterior elevation; (b) top of exterior wall; (c) bottom of exterior wall; (d) close-up of stud; (e) close-up of exterior south-end corner; and (f) north-end exterior corner.

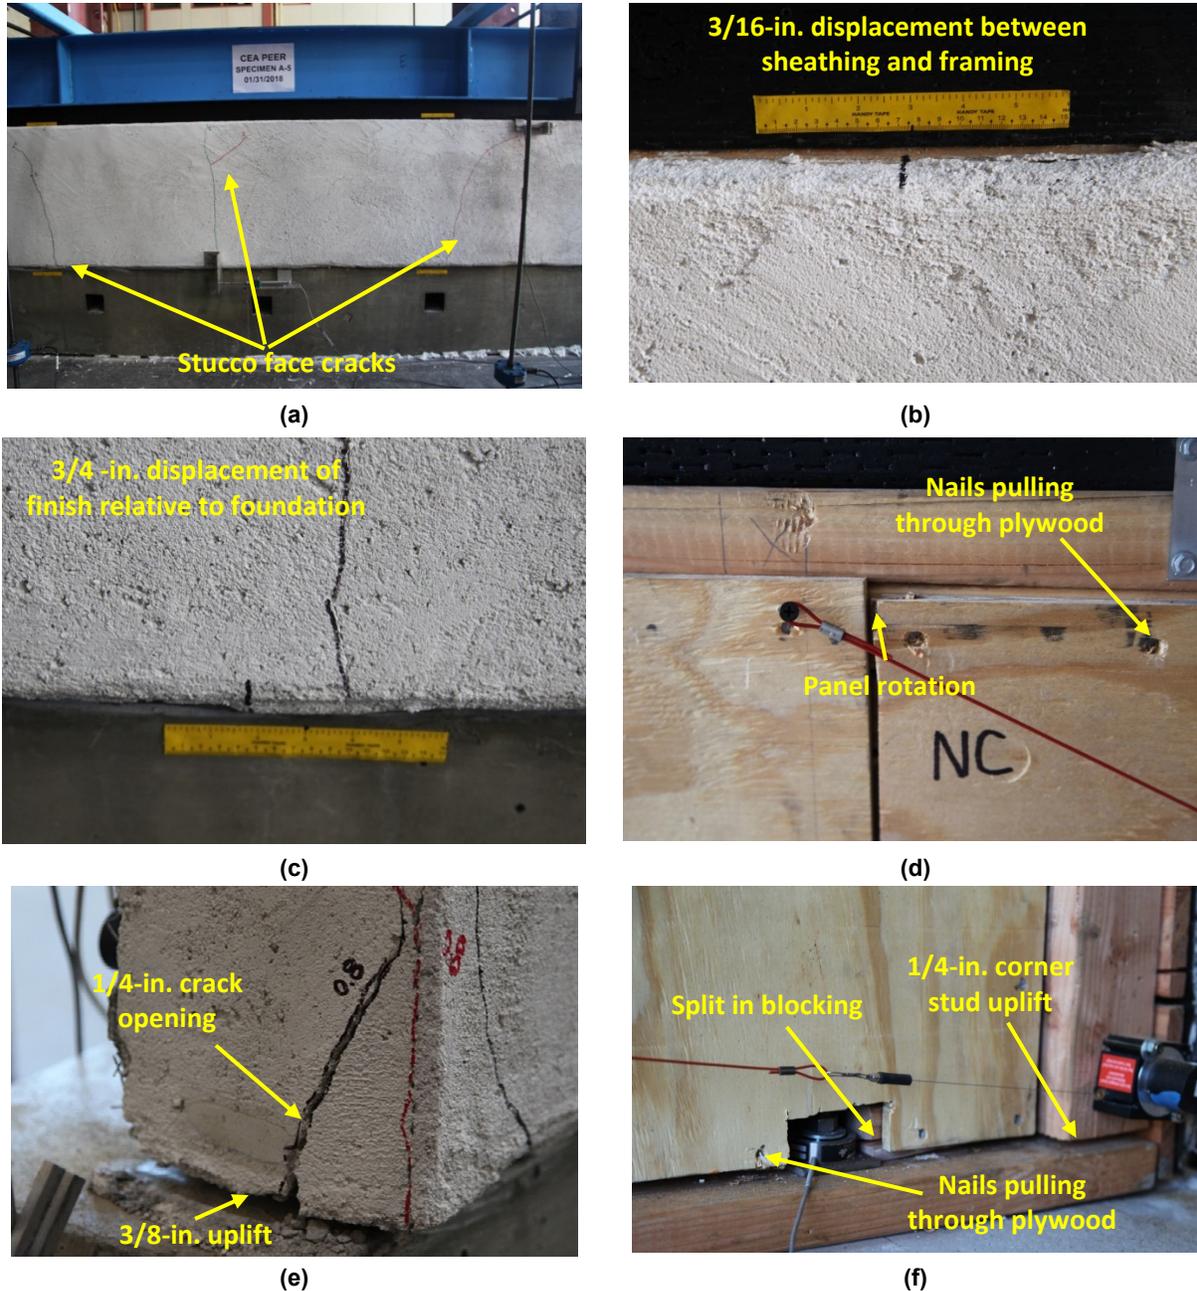
Figure 5.17 Specimen A-5 damage state at lateral strength @ +5% drift, $\Delta = +1.20$ in.: (a) exterior elevation; (b) top of exterior wall; (c) bottom of exterior wall; (d) close-up of plywood panel joint; (e) close-up of south-end exterior corner; and (f) bottom of south-end interior wall corner.

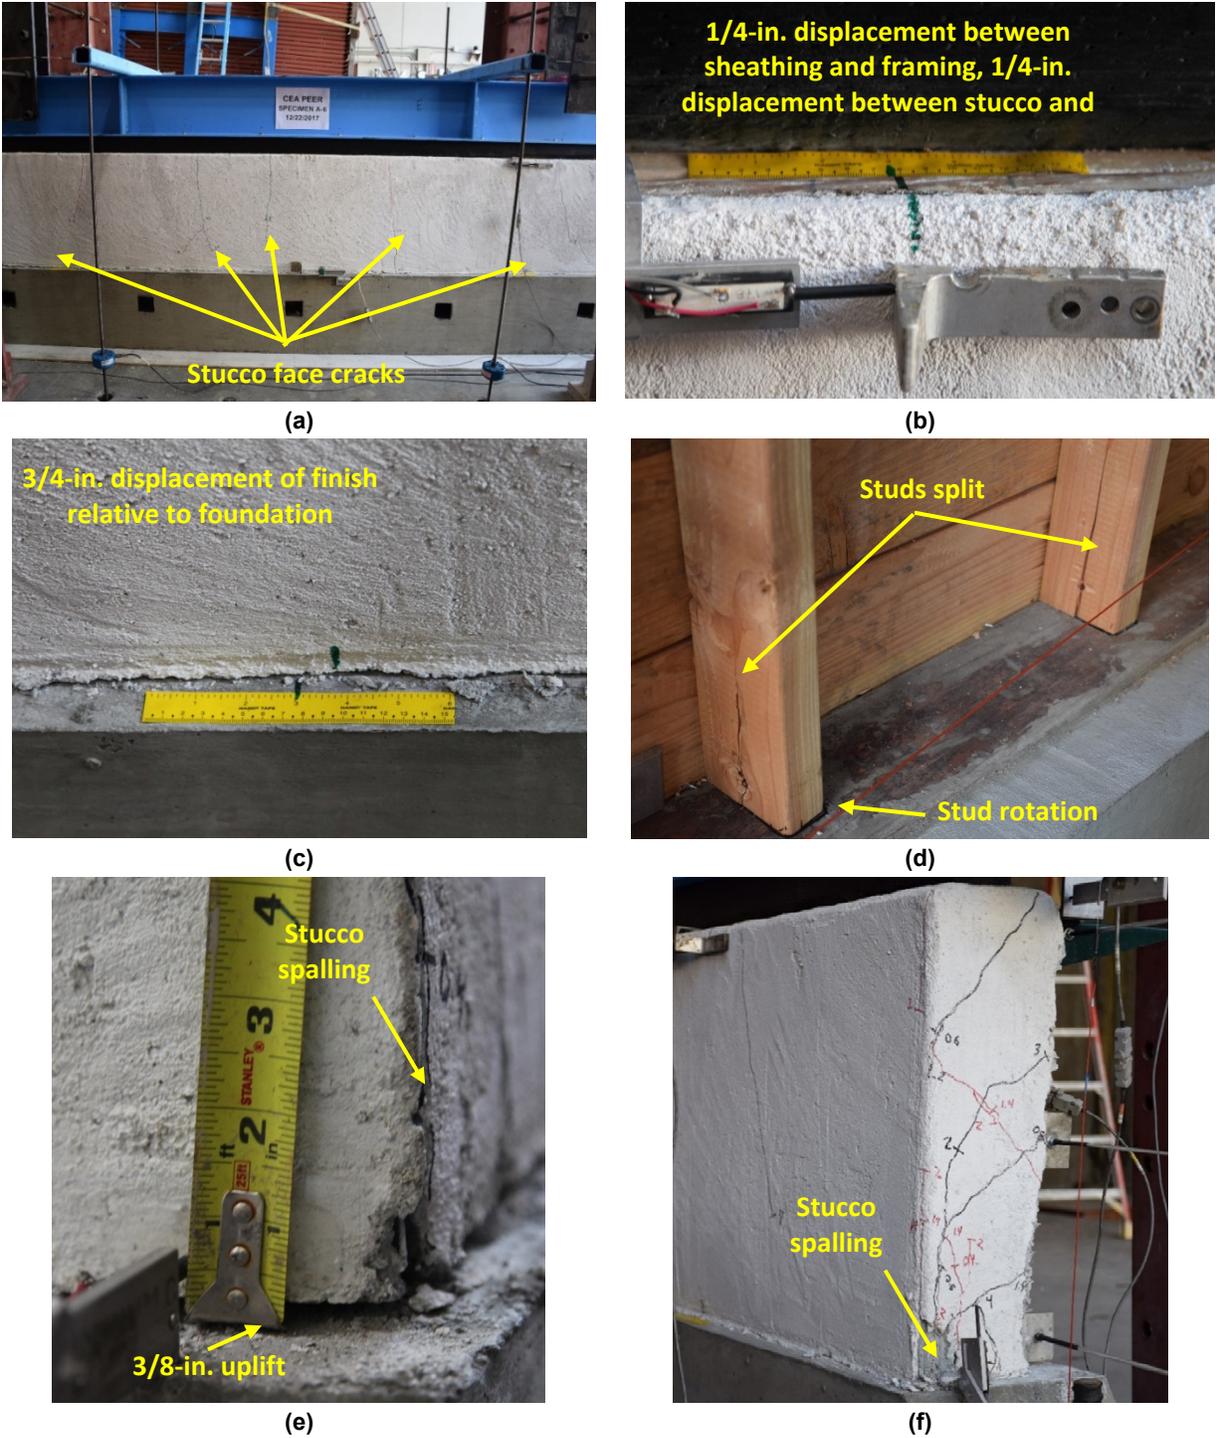
Figure 5.18 Specimen A-6 damage state at lateral strength @ +3% drift, $\Delta = +0.72$ in.: (a) exterior elevation; (b) top of exterior wall; (c) bottom of exterior wall; (d) close-up of studs and sill plate; (e) close-up of south-end of exterior corner; and (f) north-end exterior corner.

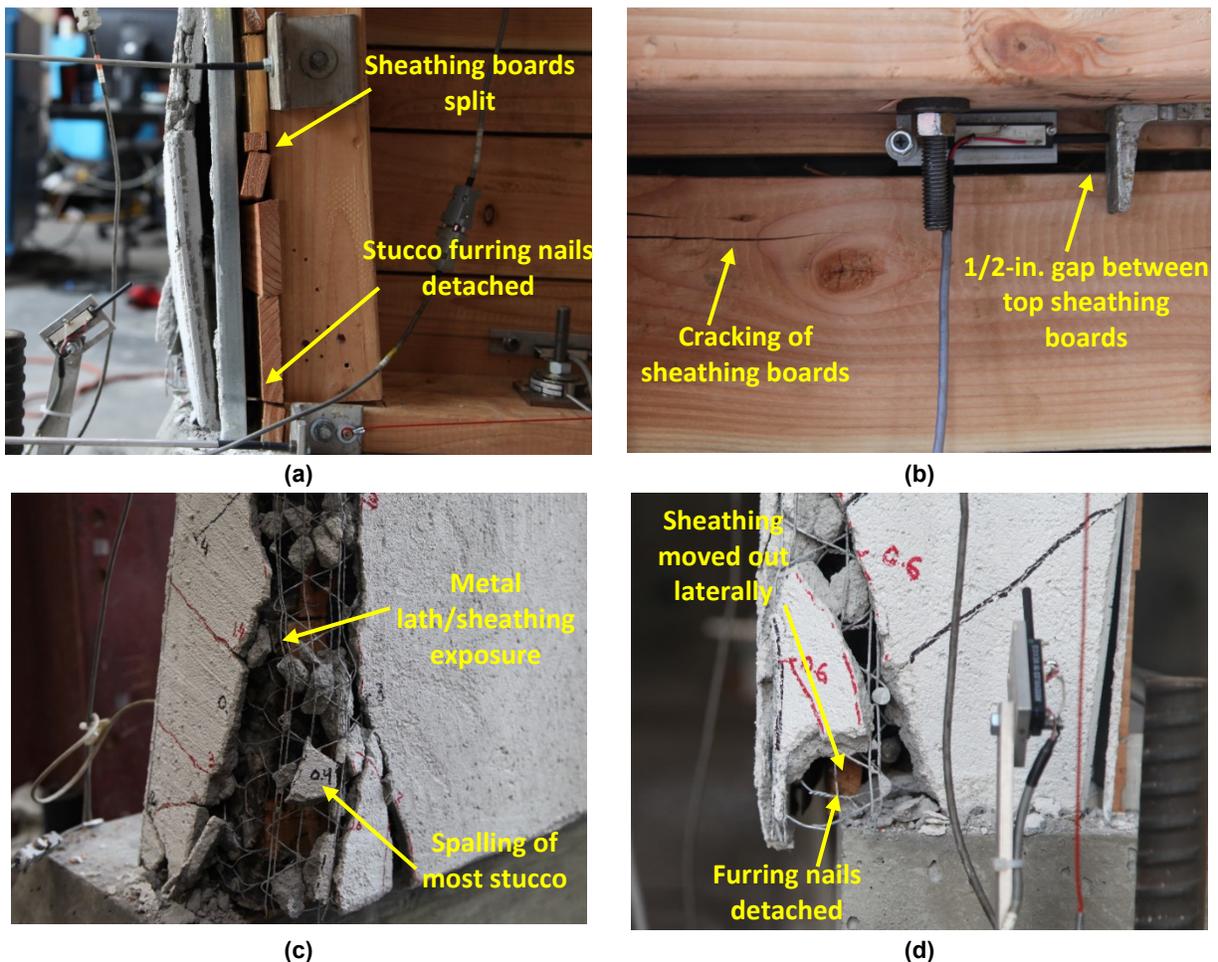
Figure 5.21 Specimen A-2 damage state at 70% post-peak reduction of lateral strength @ +12% drift, $\Delta = +2.88$ in.: (a) north-end of interior corner bottom; (b) close-up of top of interior wall; (c) south-end of exterior bottom corner; and (d) north-end of bottom corner.

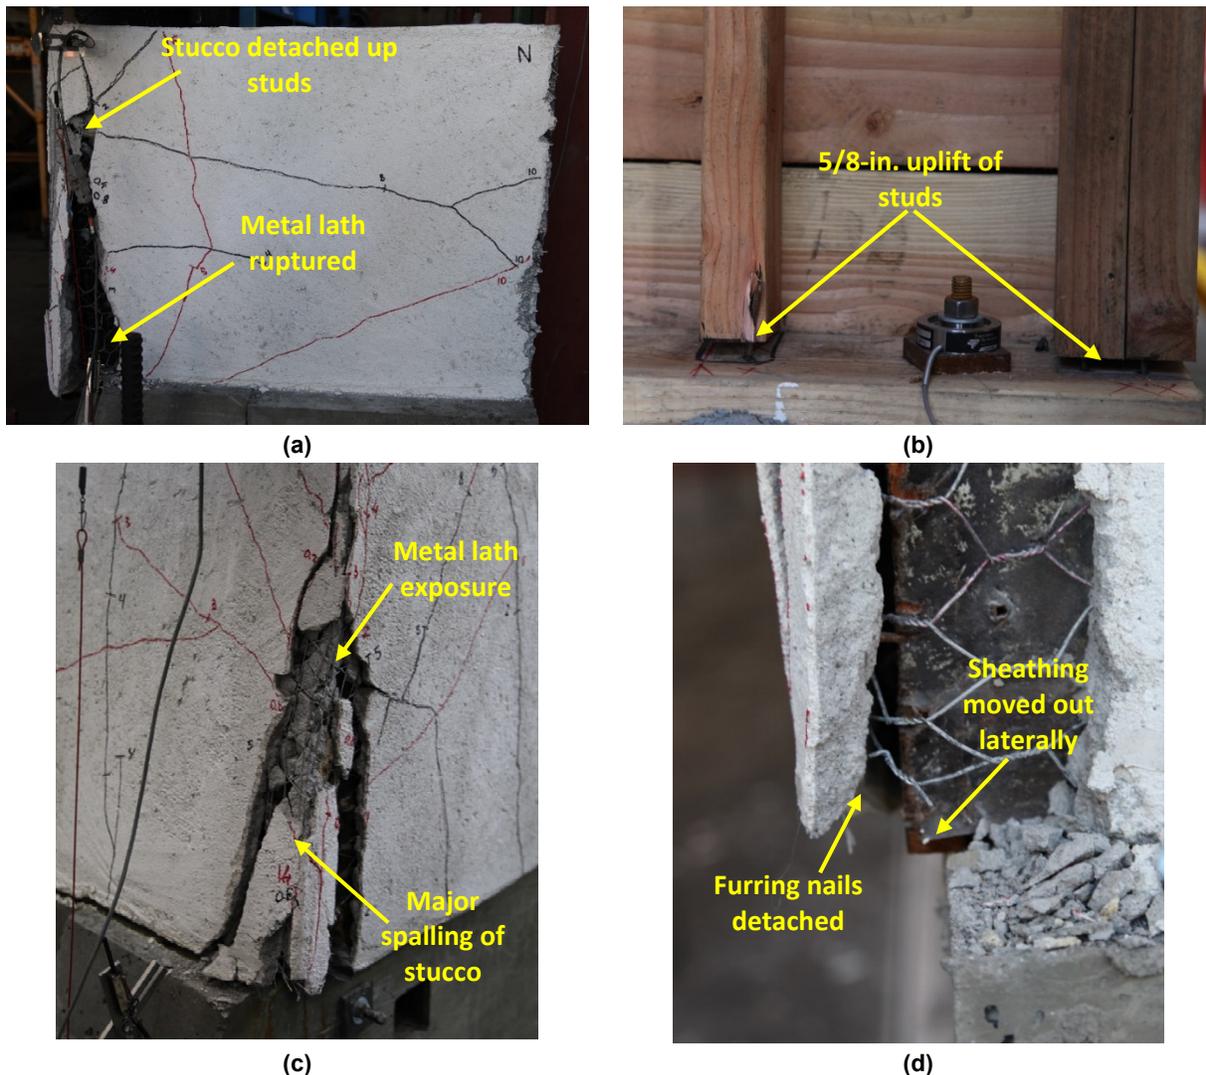
Figure 5.23 Specimen A-3 damage state at 60% post-peak reduction of lateral strength @ -12% drift, $\Delta = -2.88$ in.: (a) exterior view of north-end return wall; (b) interior of bottom of south-end return wall; (c) bottom of south-end exterior corner; and (d) bottom of north-end corner.

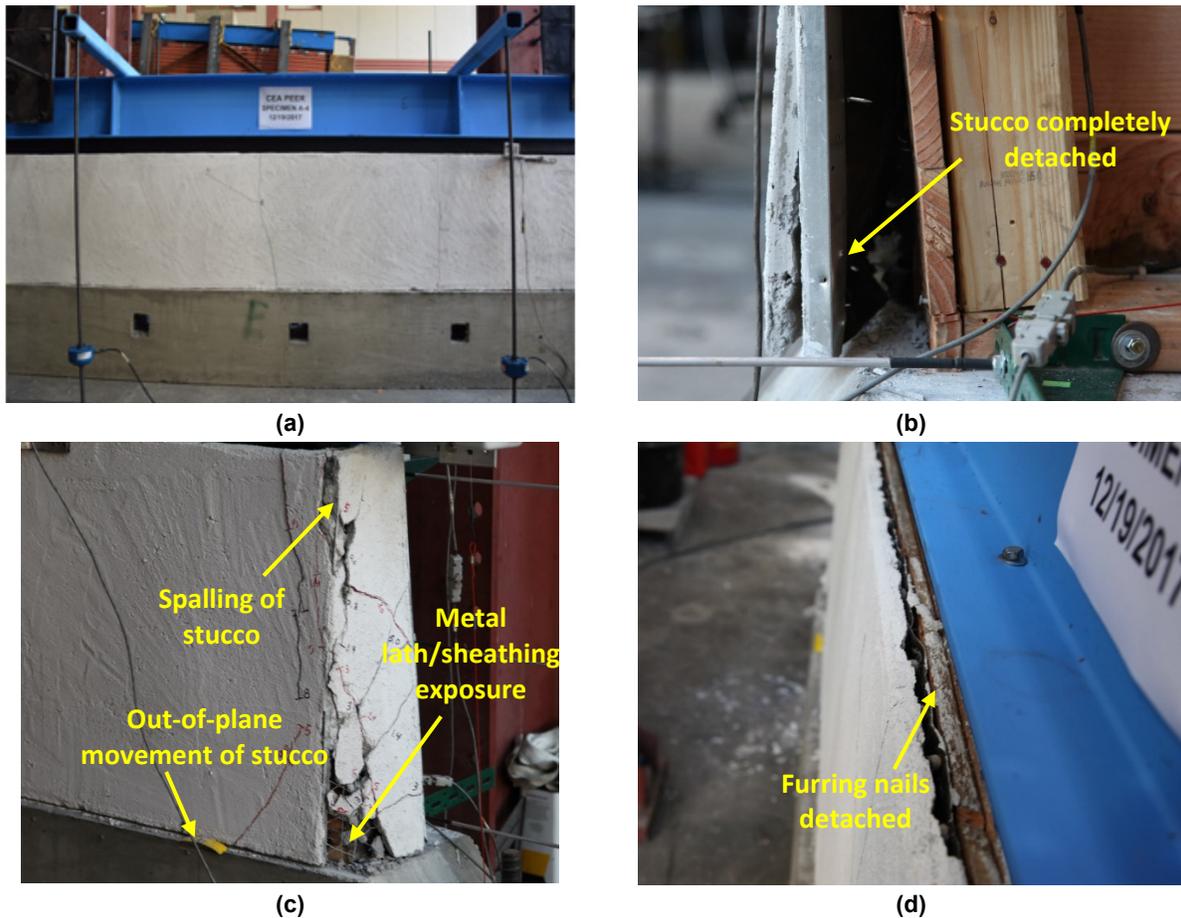
Figure 5.25 Specimen A-4 damage state at 80% post-peak reduction of lateral strength @ -12% drift, $\Delta = -2.88$ in.: (a) exterior elevation; (b) bottom of north-end interior corner; (c) north-end exterior corner; and (d) bottom of north-end corner.

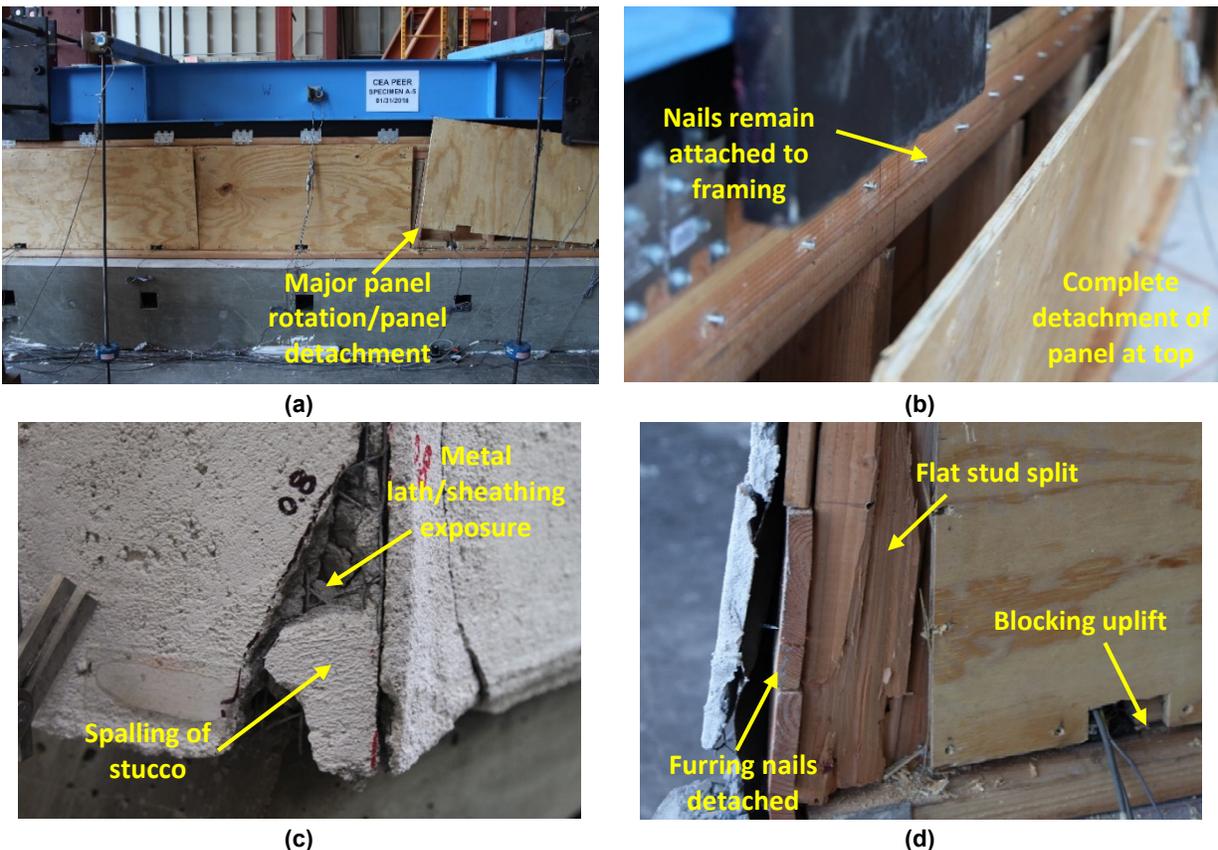
Figure 5.27 Specimen A-5 damage state at 80% post-peak reduction of lateral strength @ -11% drift, $\Delta = -2.64$ in.: (a) interior elevation; (b) top-down view of interior; (c) close-up of exterior south-end corner; and (d) close-up of interior north-end corner.

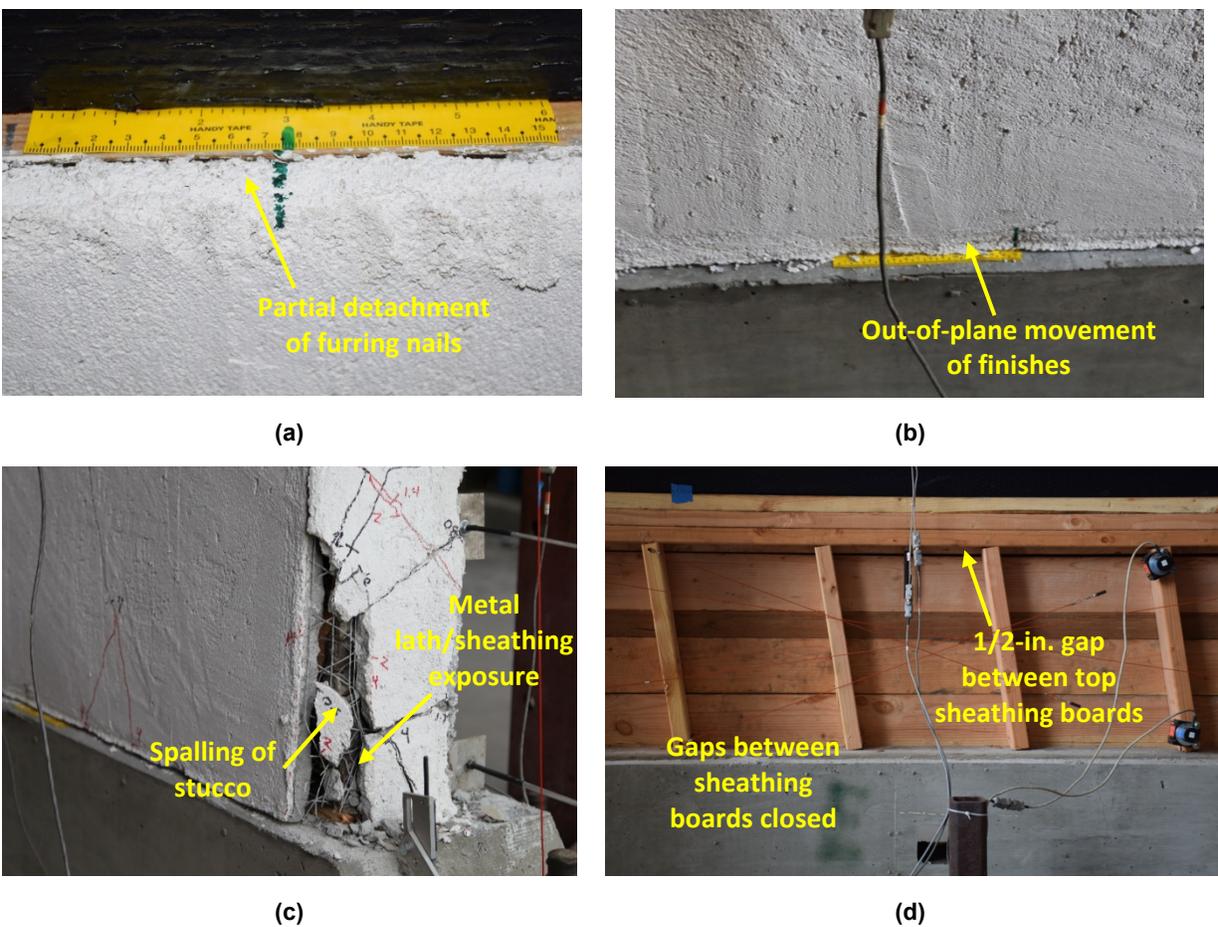
Figure 5.29 Specimen A-6 damage state at 40% post-peak reduction of lateral strength @ +13% drift, $\Delta = +3.12$ in.: (a) close-up of top of exterior wall; (b) close-up of the bottom of the exterior wall; (c) the north-end bottom of the exterior corner; and (d) the interior of the wall.
