Damage of Bridges Resulted from March 11, 2011 East-Japan Earthquake

April 15, 2011

Kazuhiko Kawashima Department of Civil Engineering Tokyo Institute of Technology

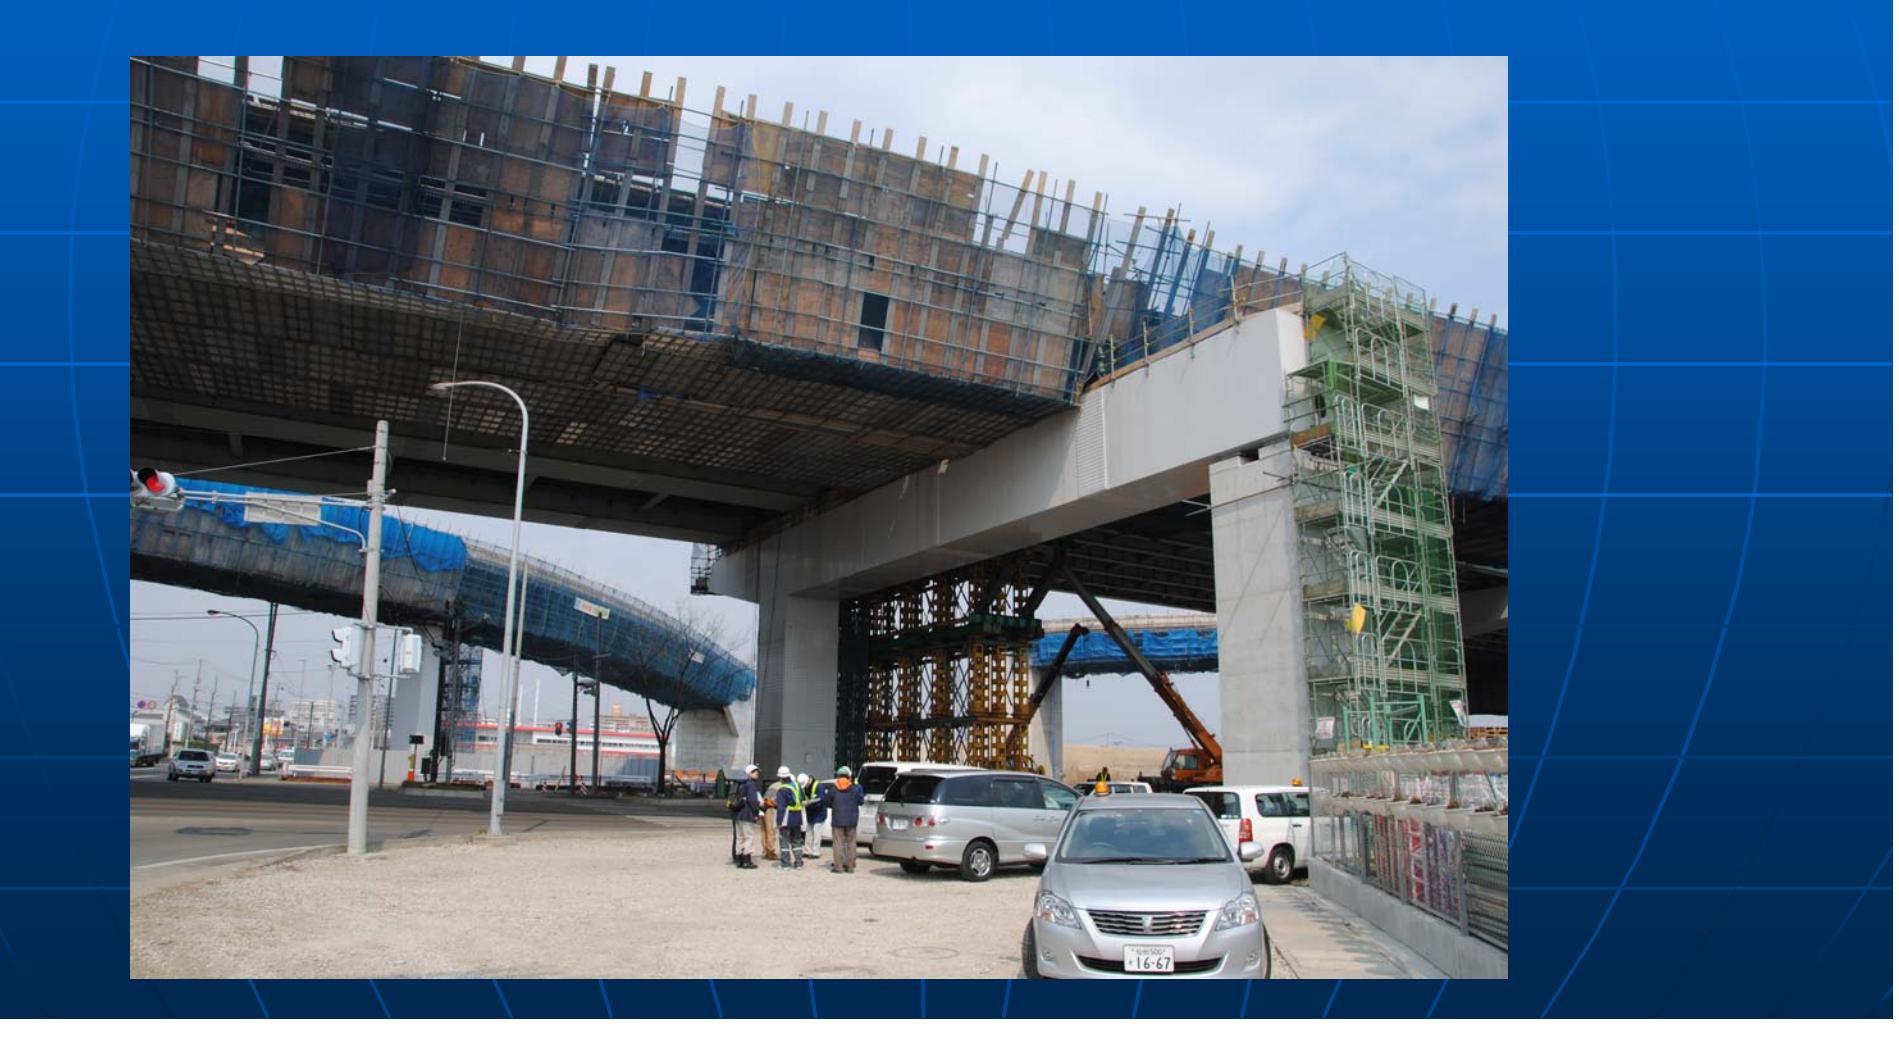
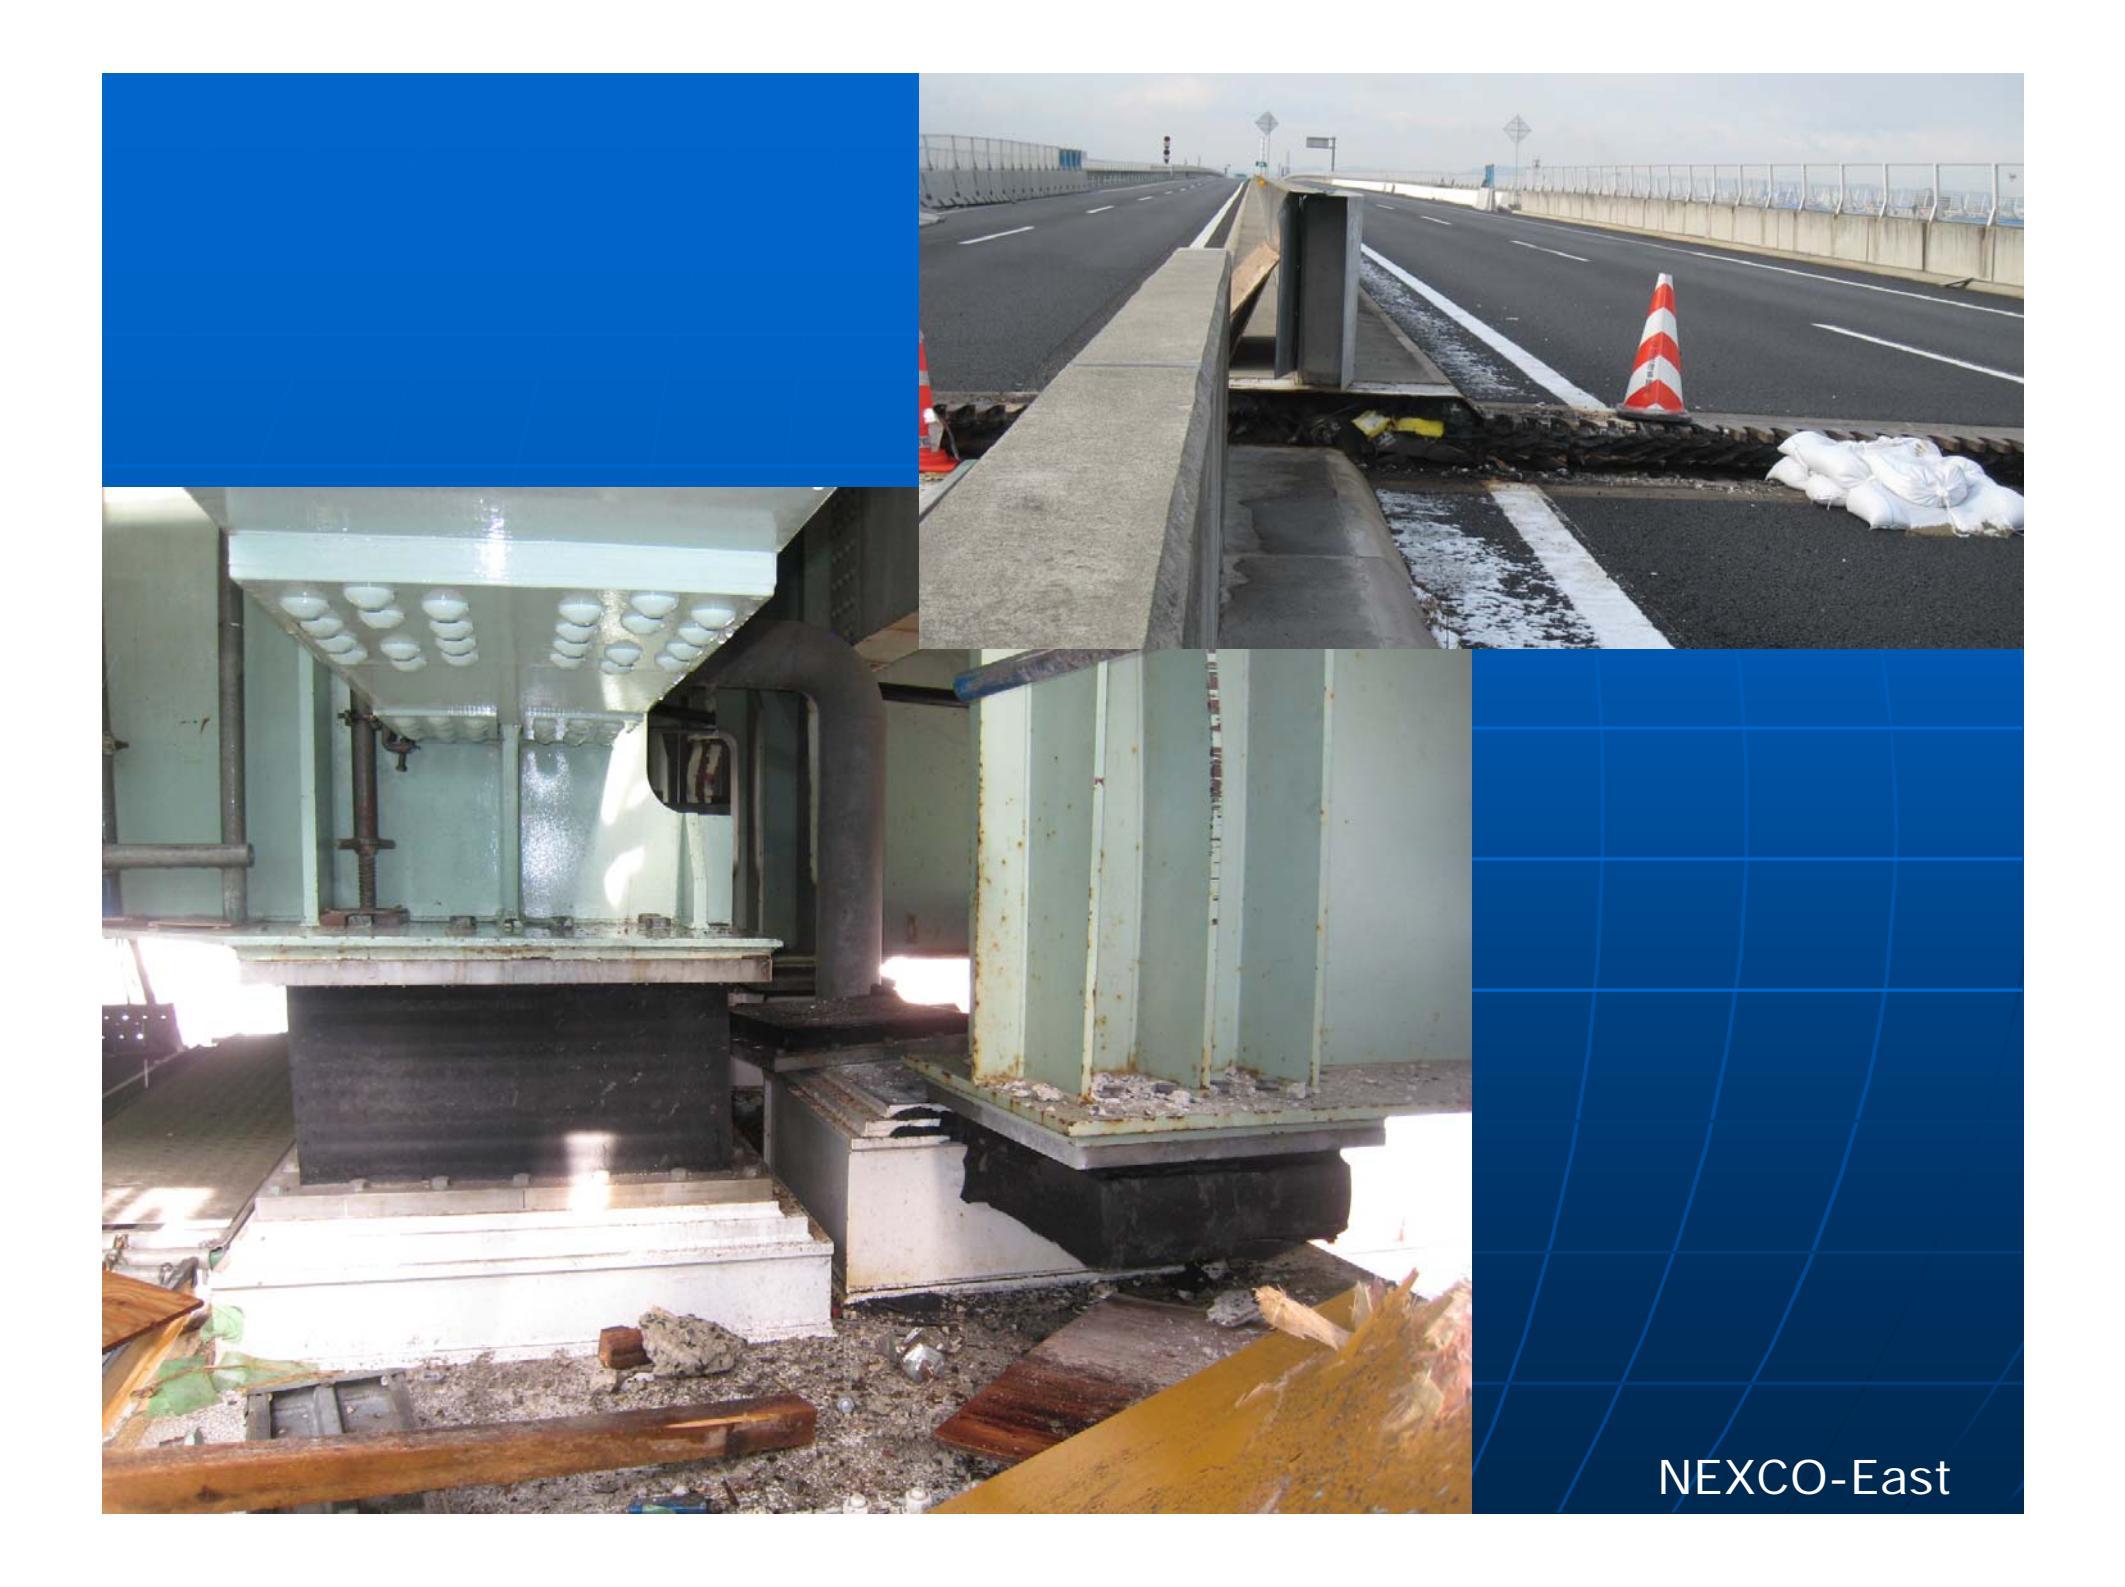
East Sendai Road, NEXCO-East

Rupture of Elastomeric Bearings Occurred at Two Locations Close Each Other

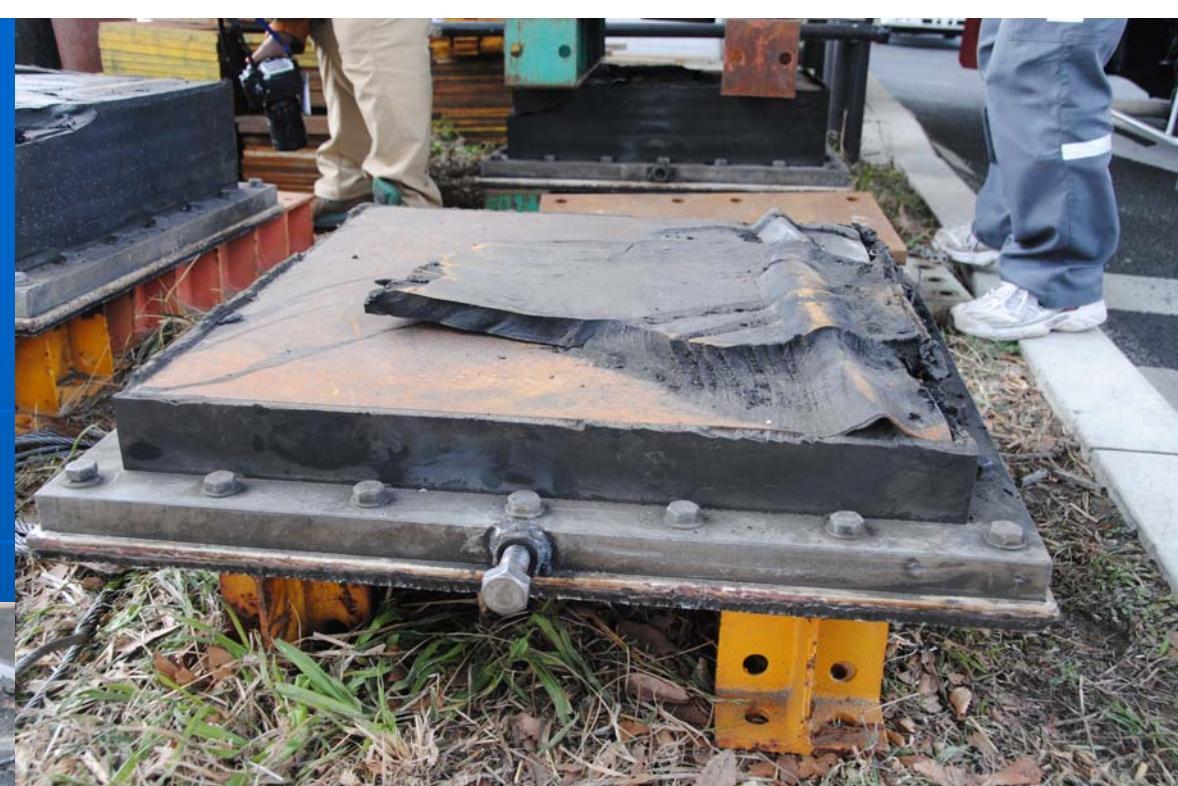
Bearings Damaged

Separation of a subber layer and a steel p

The steel plate bent in double in a complex manner

Separation of rubber layers from steel plates did not occur in the past

How large shear strain was induced in the rubber layers?
Was the bearing properly fabricated?

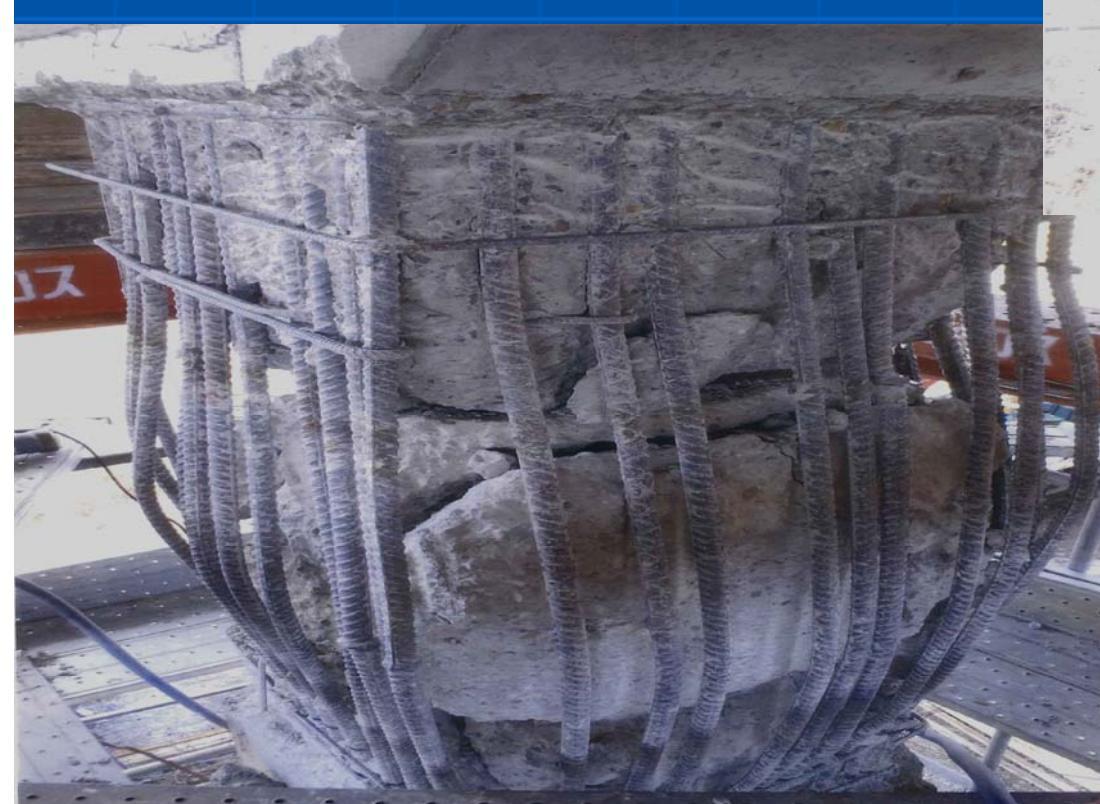
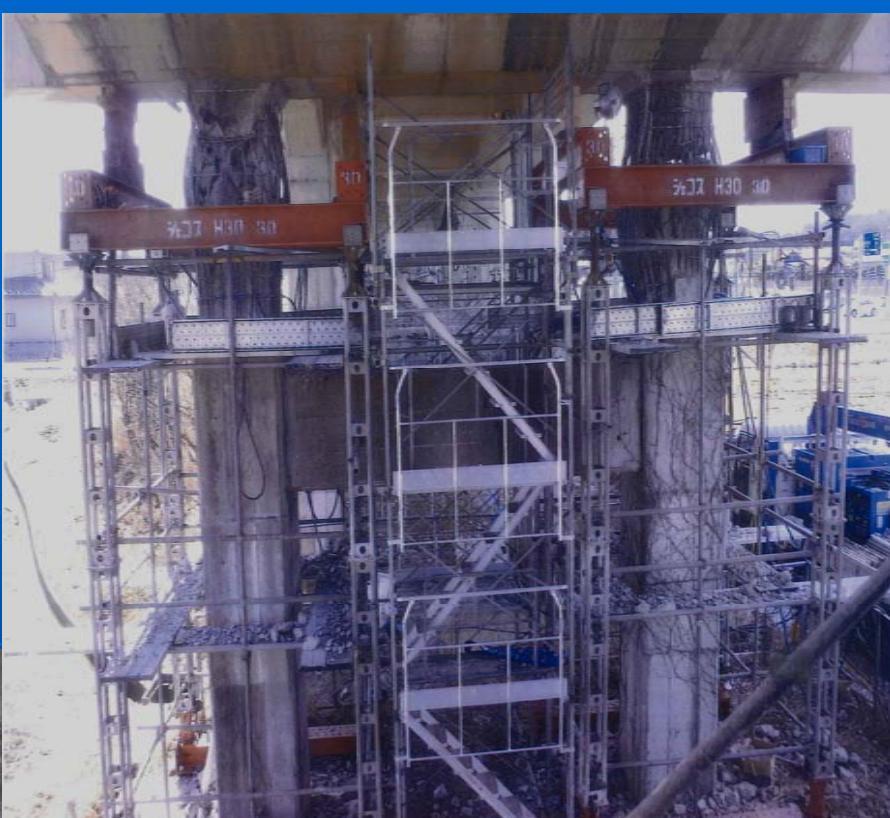
Unretrofitted Shinkansen columns suffered extensive damage

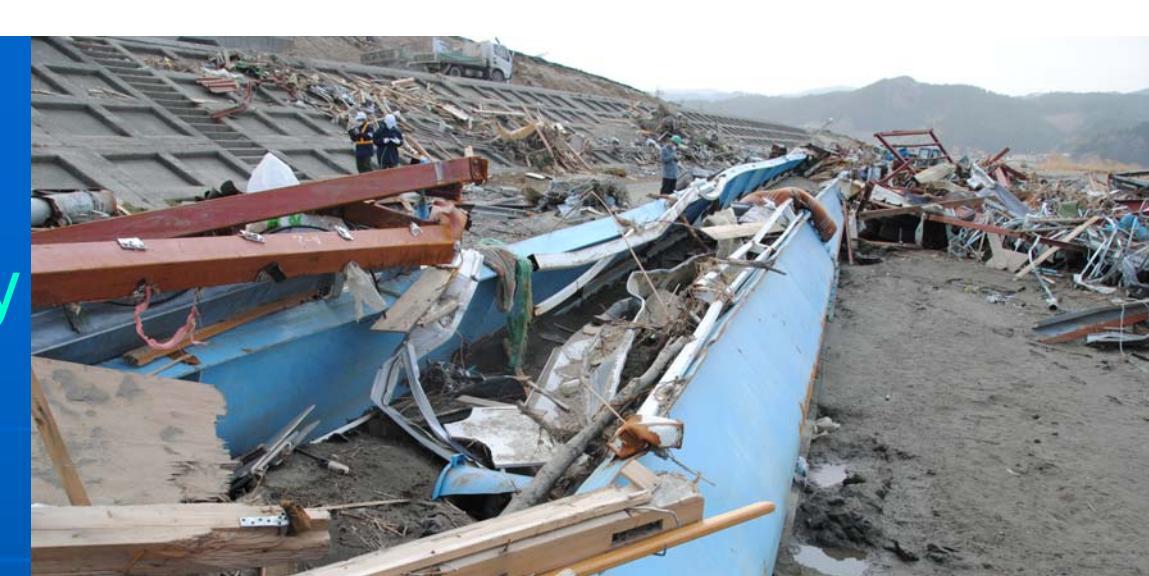
Kesen Bridge Route 45 Rikuzen-Takada City

The superstructure was washed away 310 m upstream

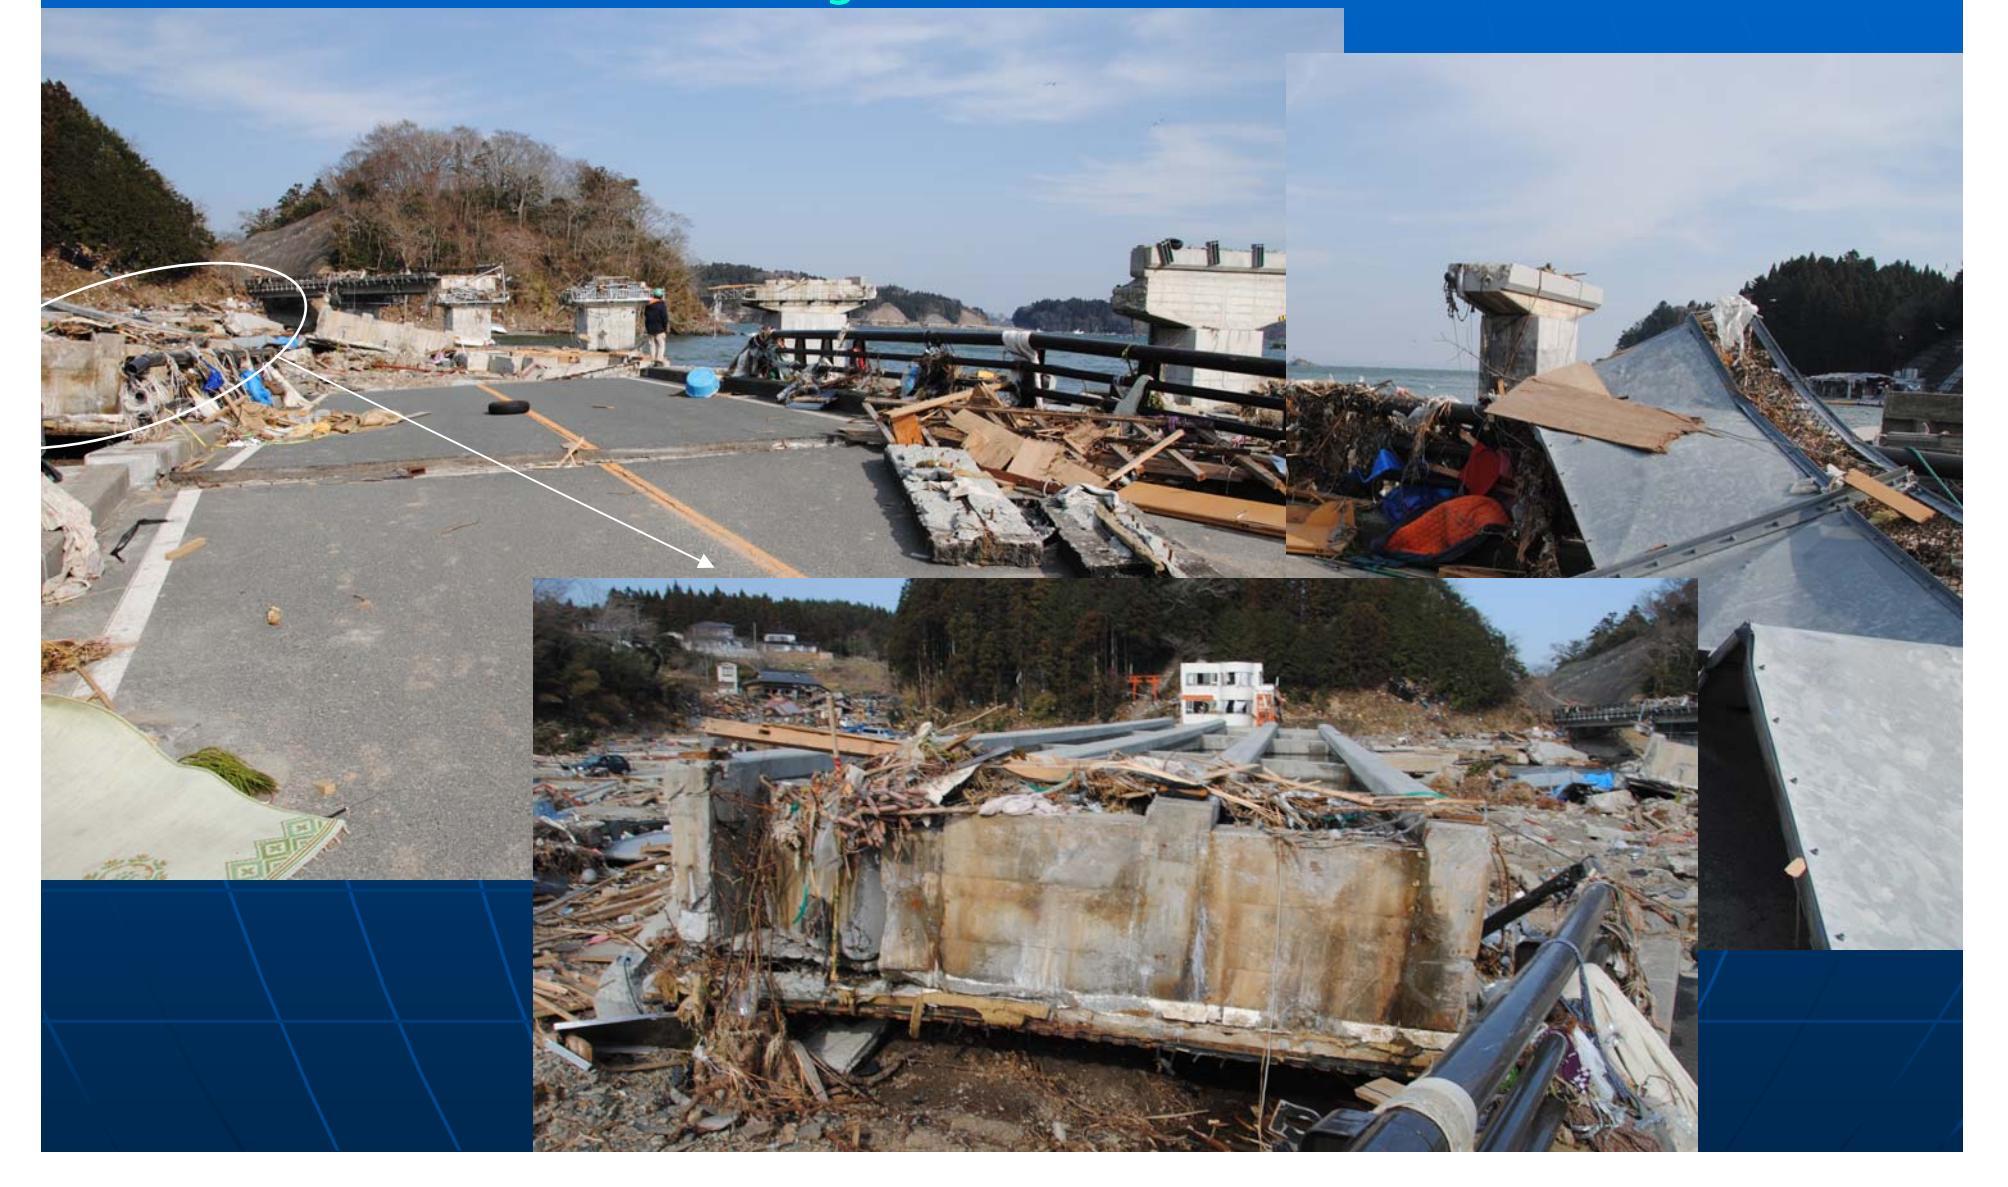
Utazu Bridge Route 45 Rikuzen-Takada City

Some cable restrainers were still alive

Installed in 2005 for seismic retrofit

Steel stoppers were provided, but they were ineffective for preventing transverse deck movement & uplift by tsubamine

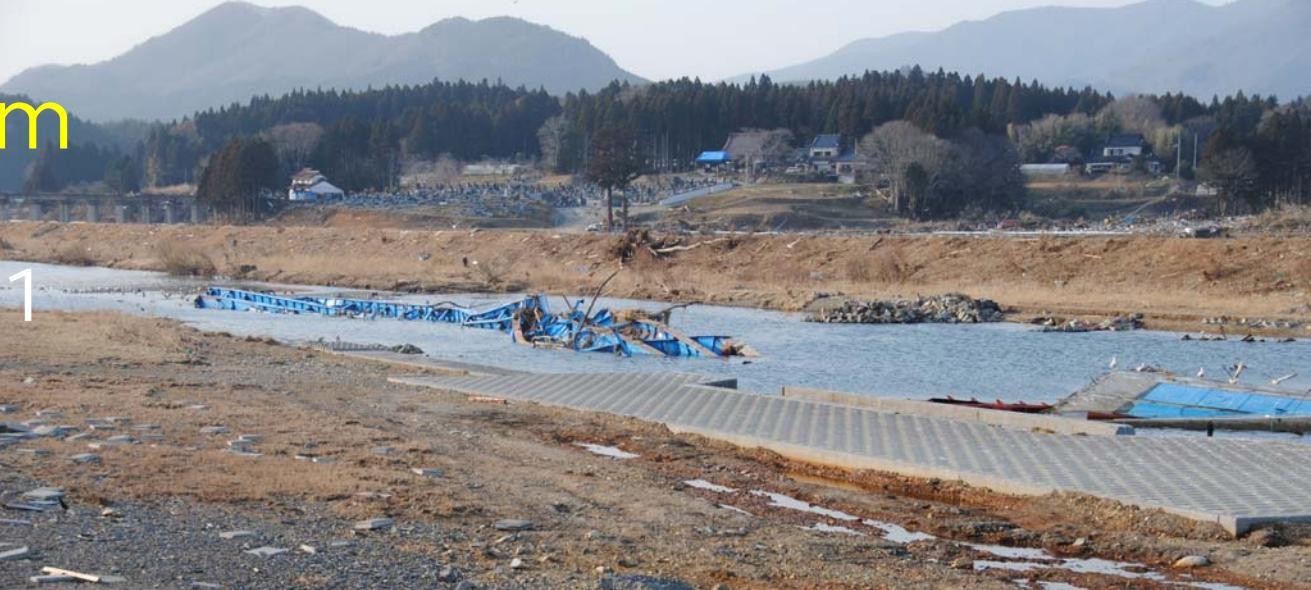
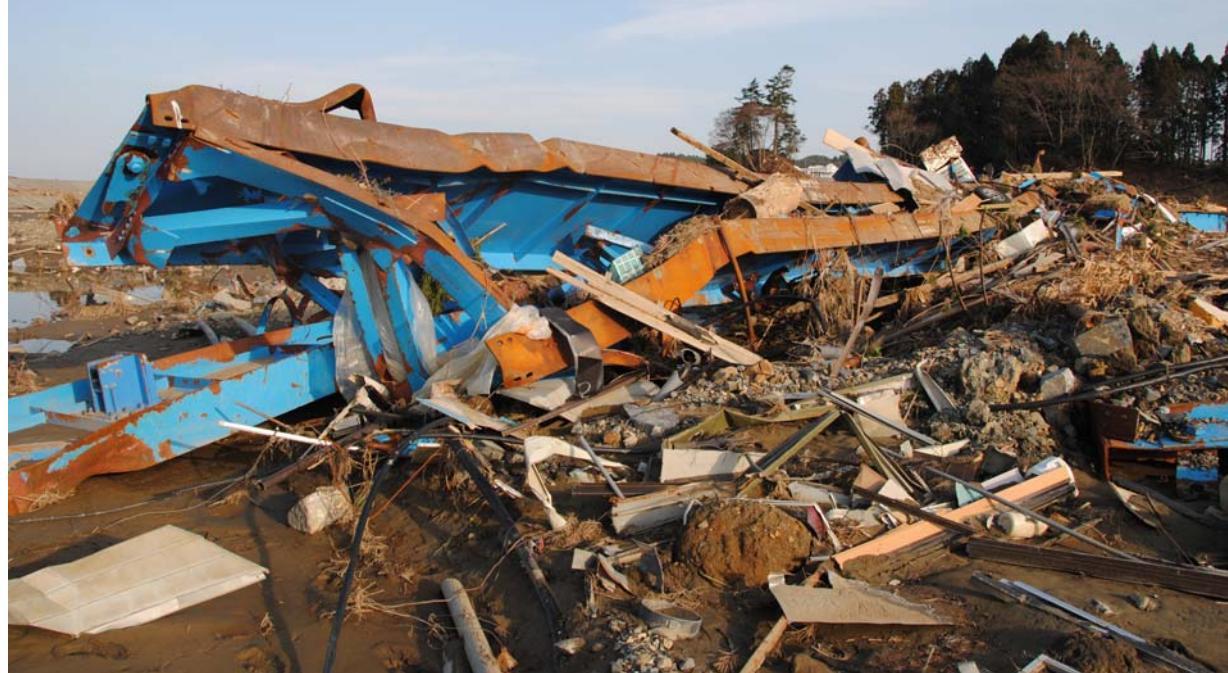
Two 3-span continuous superstructures were washed away upstream

350 m upstream

Another superstructure was washed away 450m upstream at the left side bank

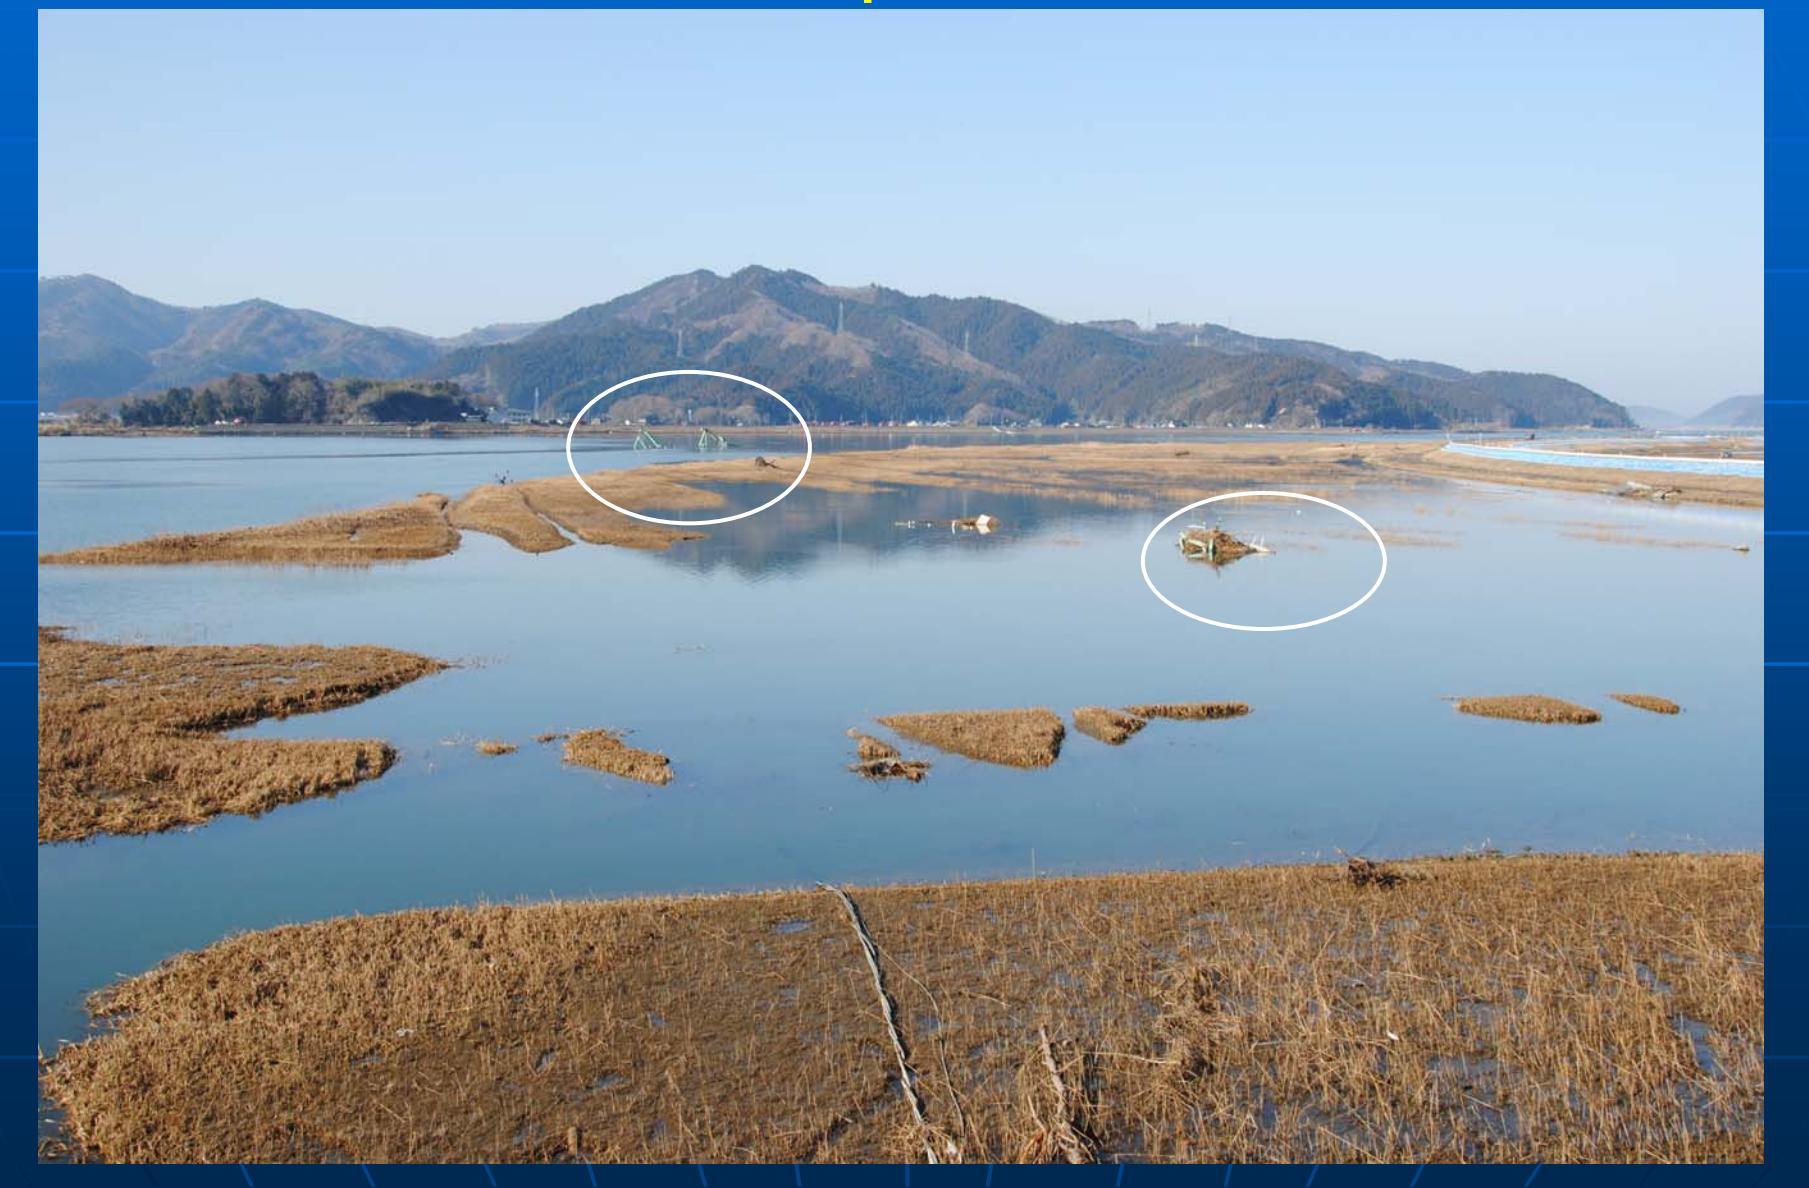
Shin-Kitakami Bridge Regional Road over Kitakami River

Two spans were washed away several hundreds meters upstream

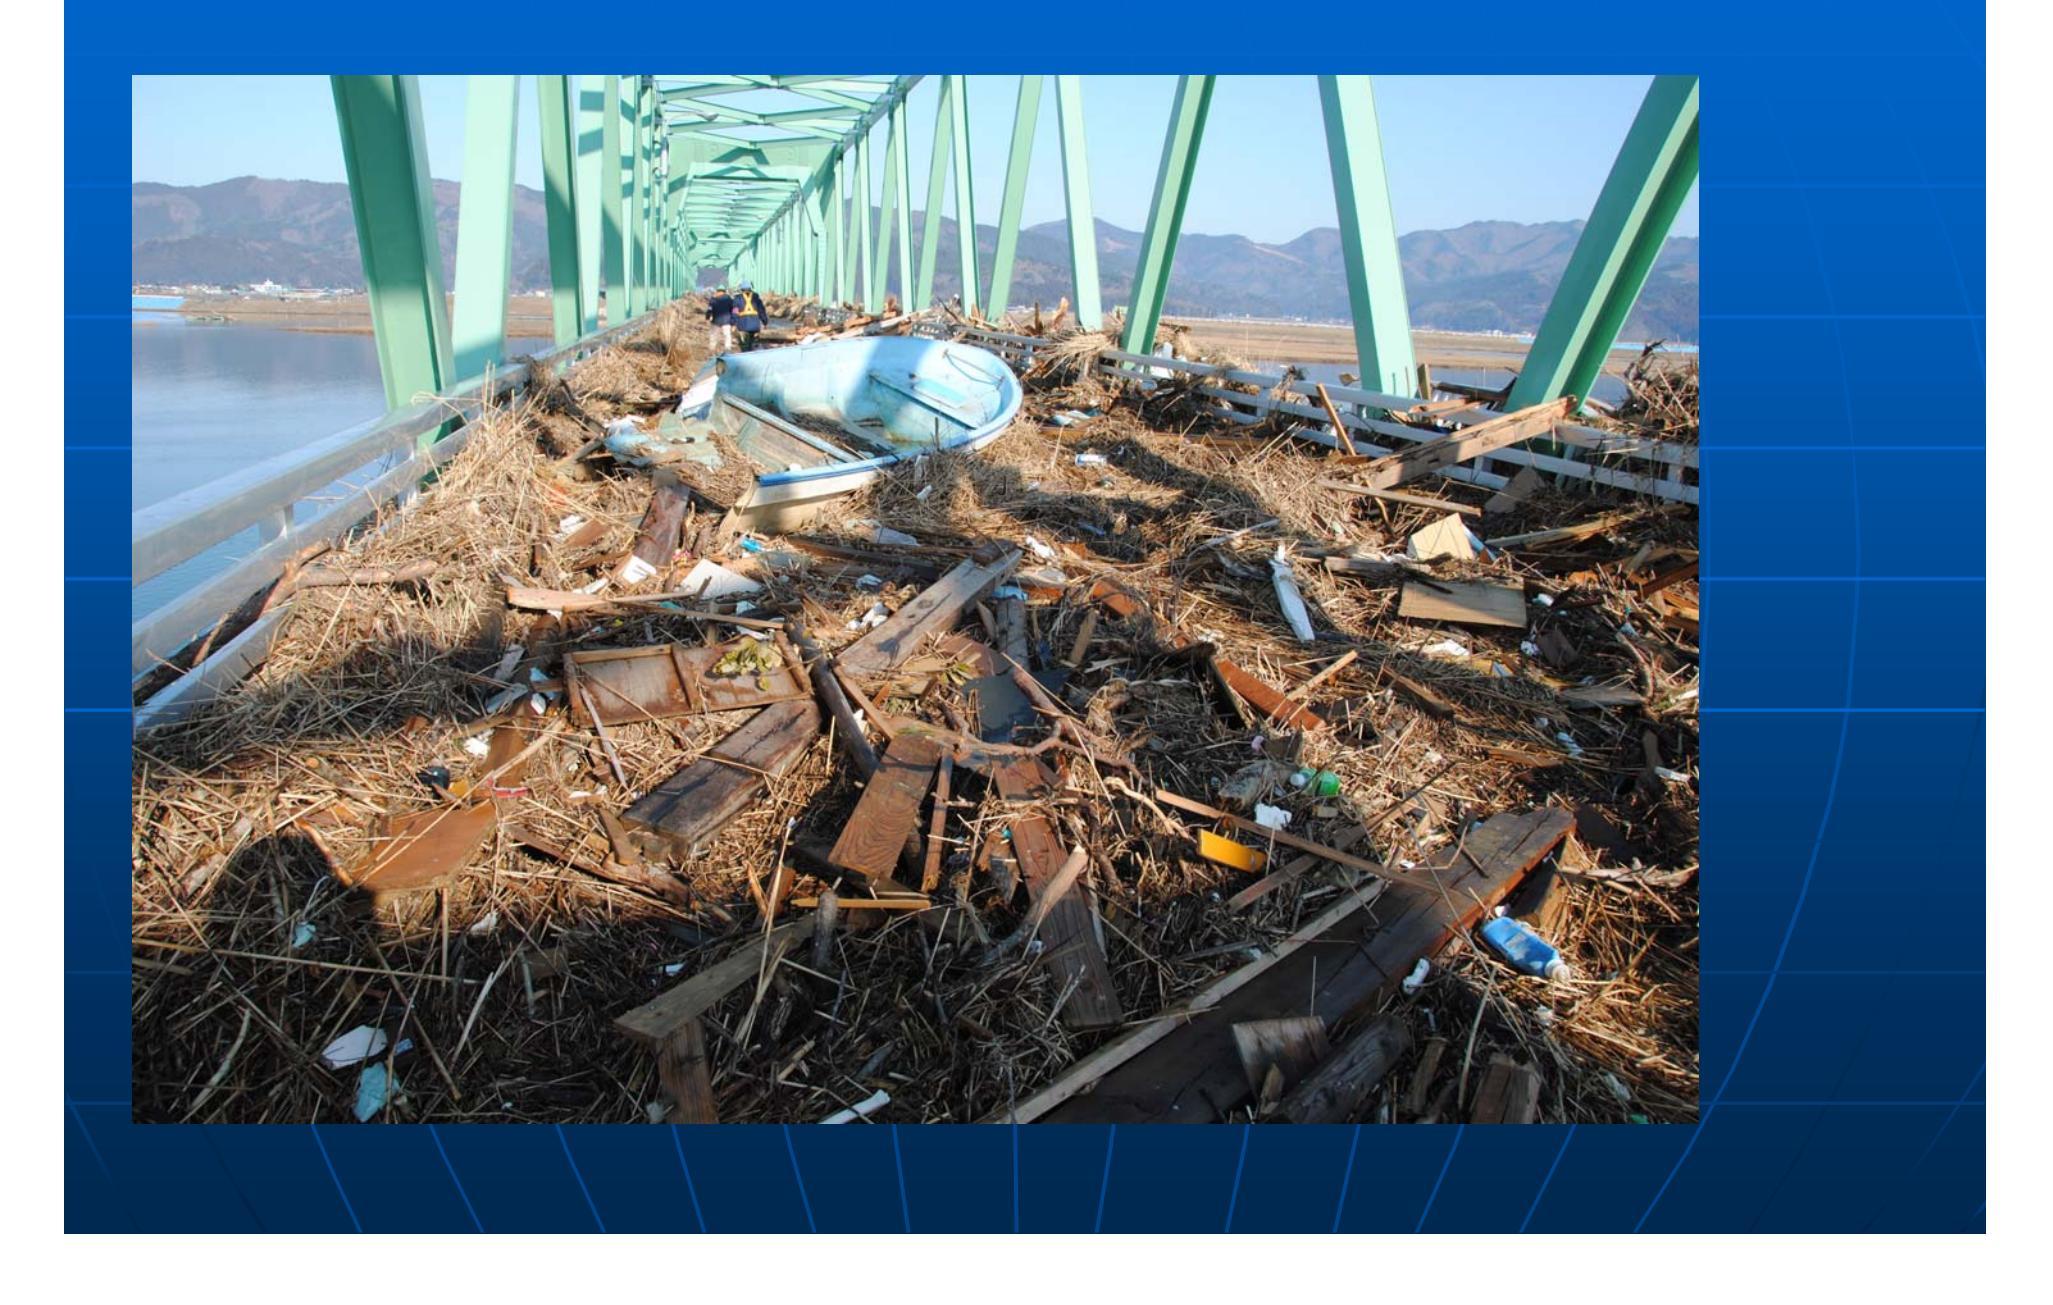
Full of Debris on the Deck

Deck floors of a side pedestrian bridge (upstream side) uplifted to rotate by 90 degree from the ginders of the side of the si

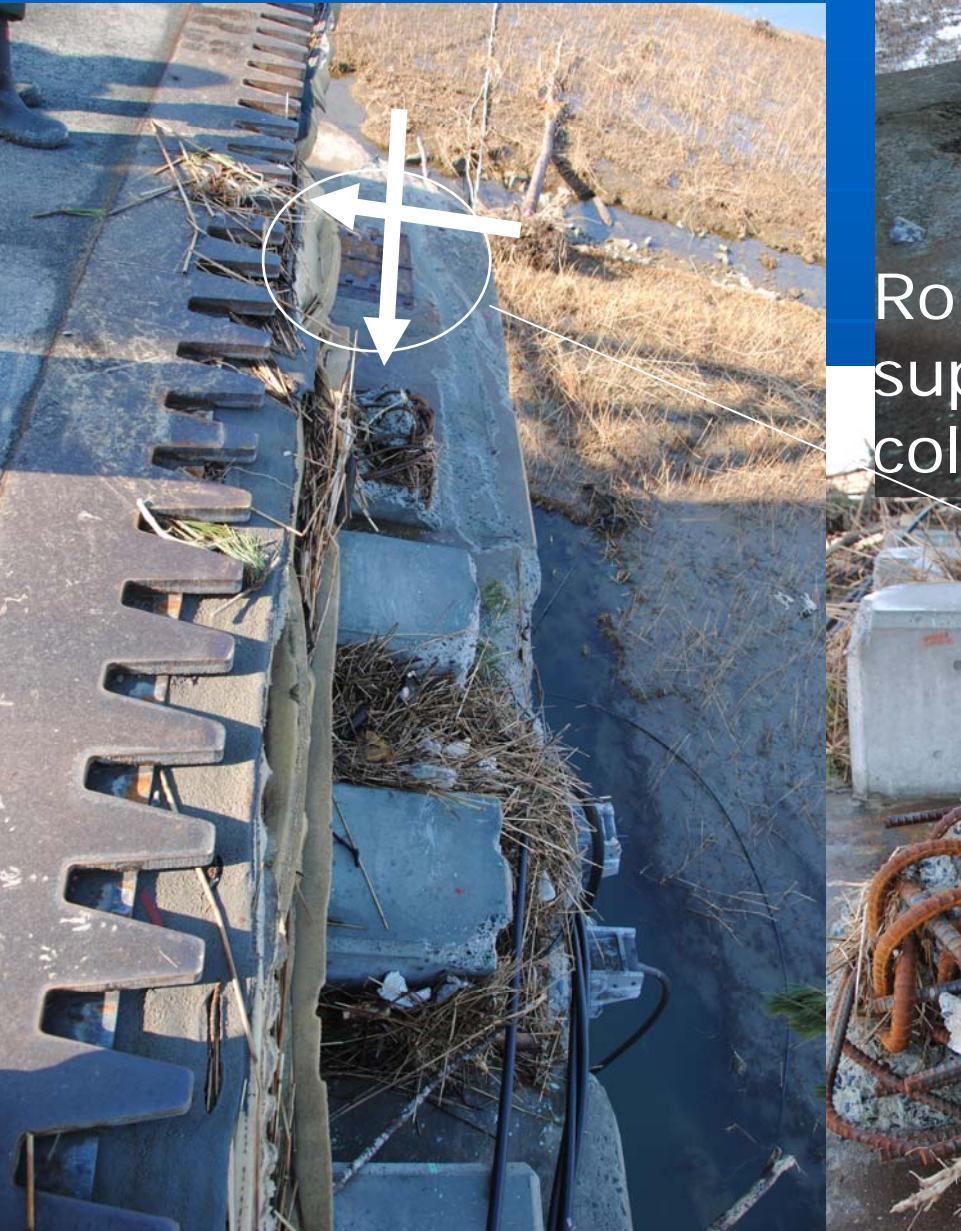
Abutment seat from where the span fel

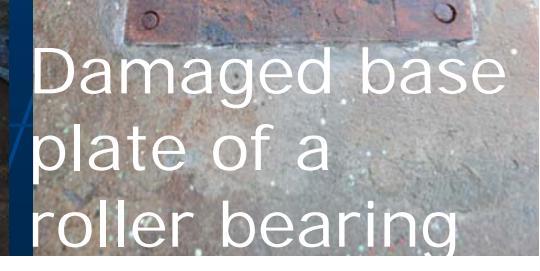
Roller bearing which supported the uncollapsed bridge

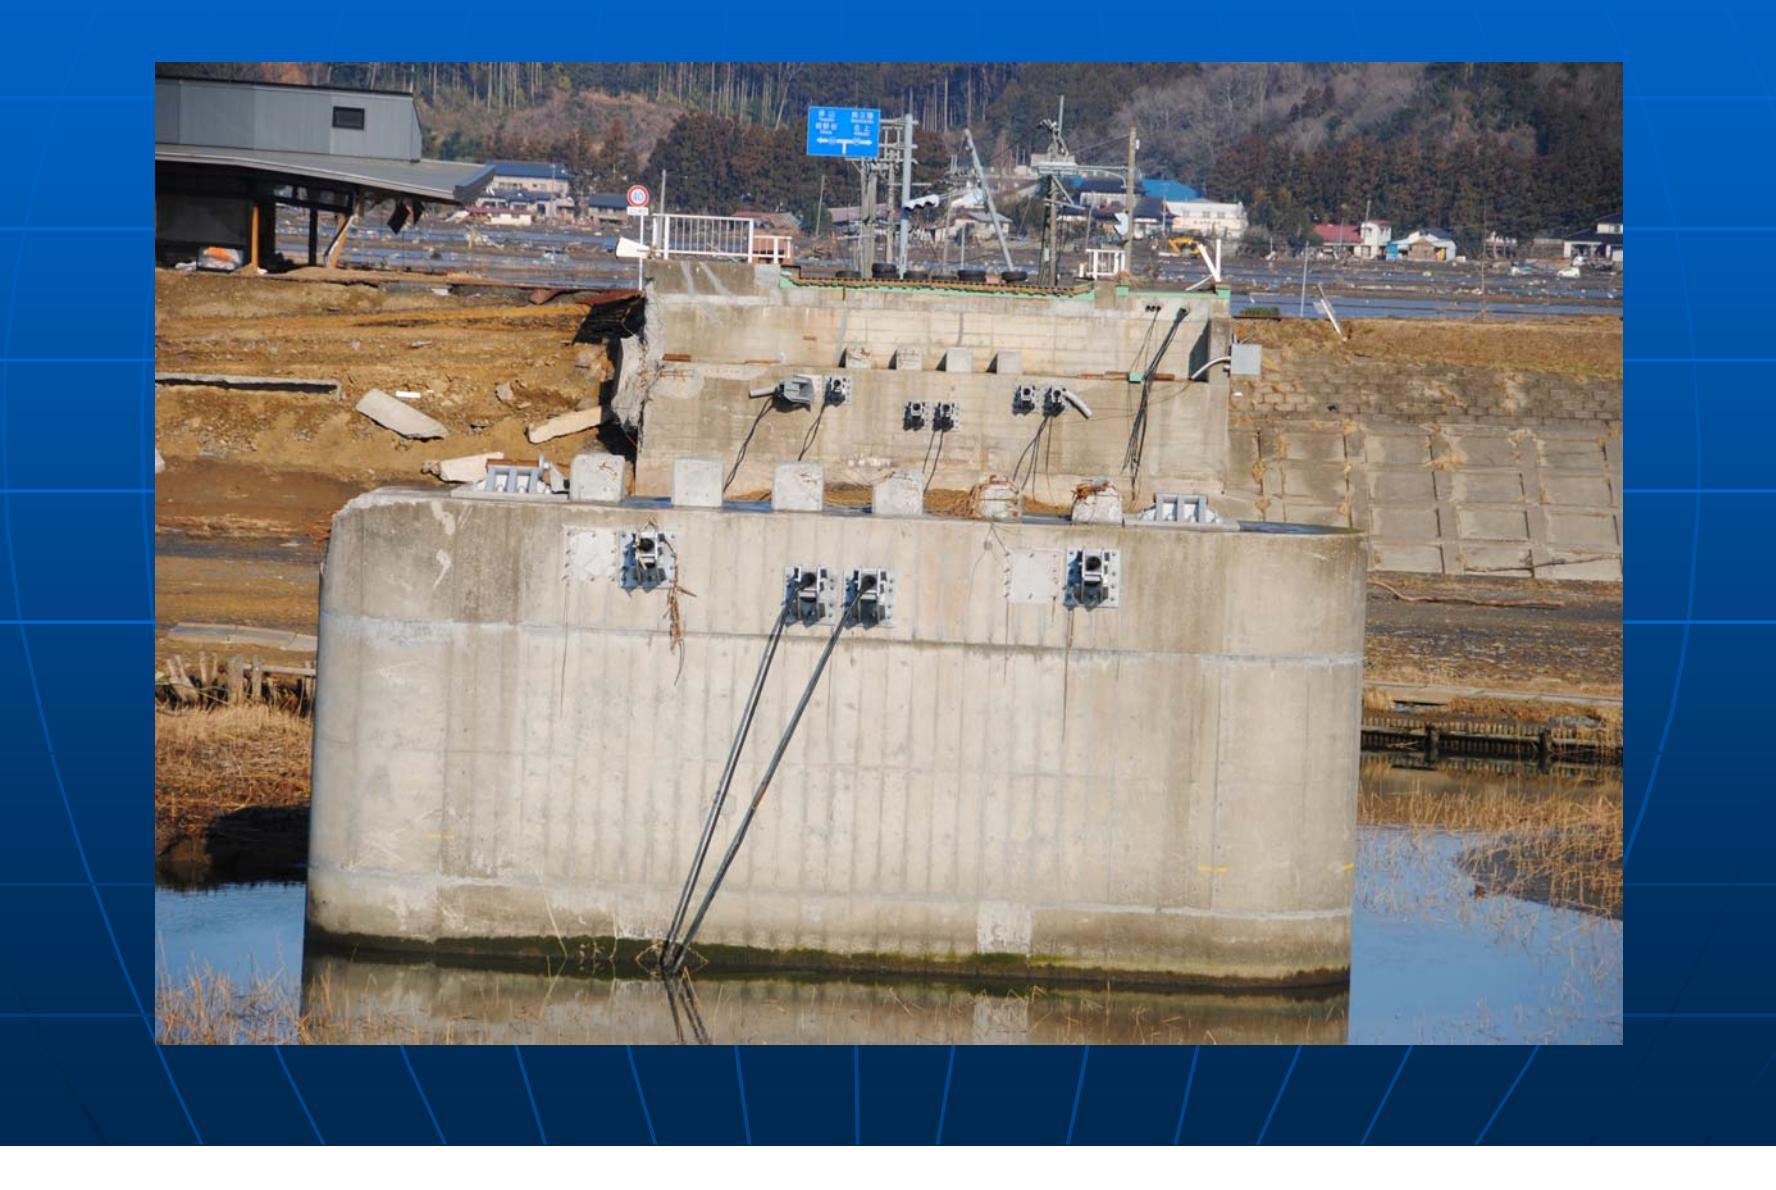
Two piers and the left side abutment did not suffered damage

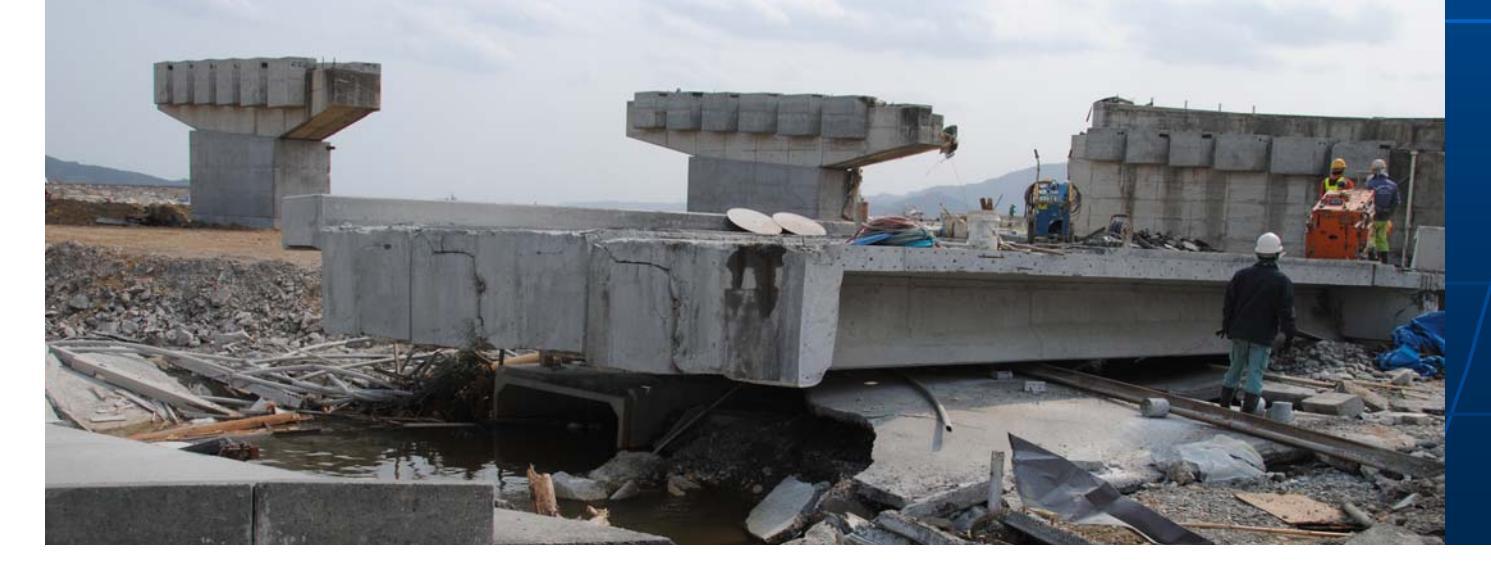
Numata Over Bridge Ropute 45 Rikuzen-Takada City

Six longitudinal stoppers were provided. They must be effective to prevent transverse movement of the deck.
Unless the decks were uplifted by tsunami, this failure could not happen.
