Damage of Bridges Resulted from March 11, 2011 East-Japan Earthquake

April 15, 2011

Kazuhiko Kawashima Department of Civil Engineering Tokyo Institute of Technology

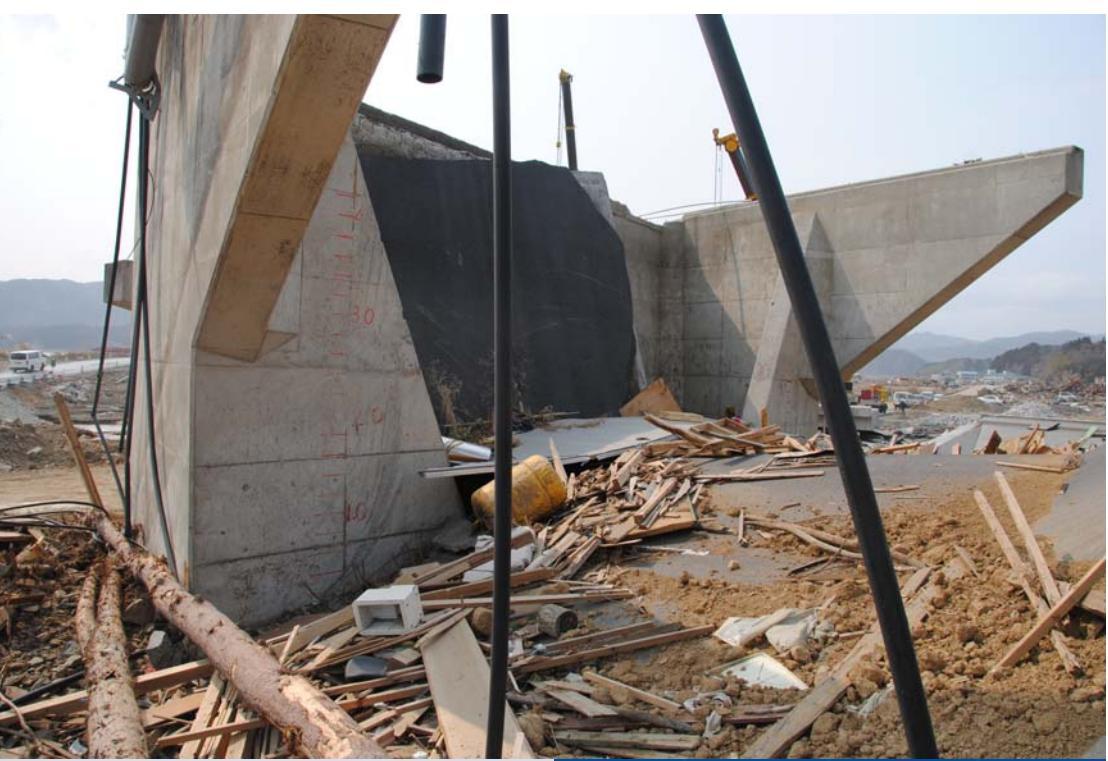
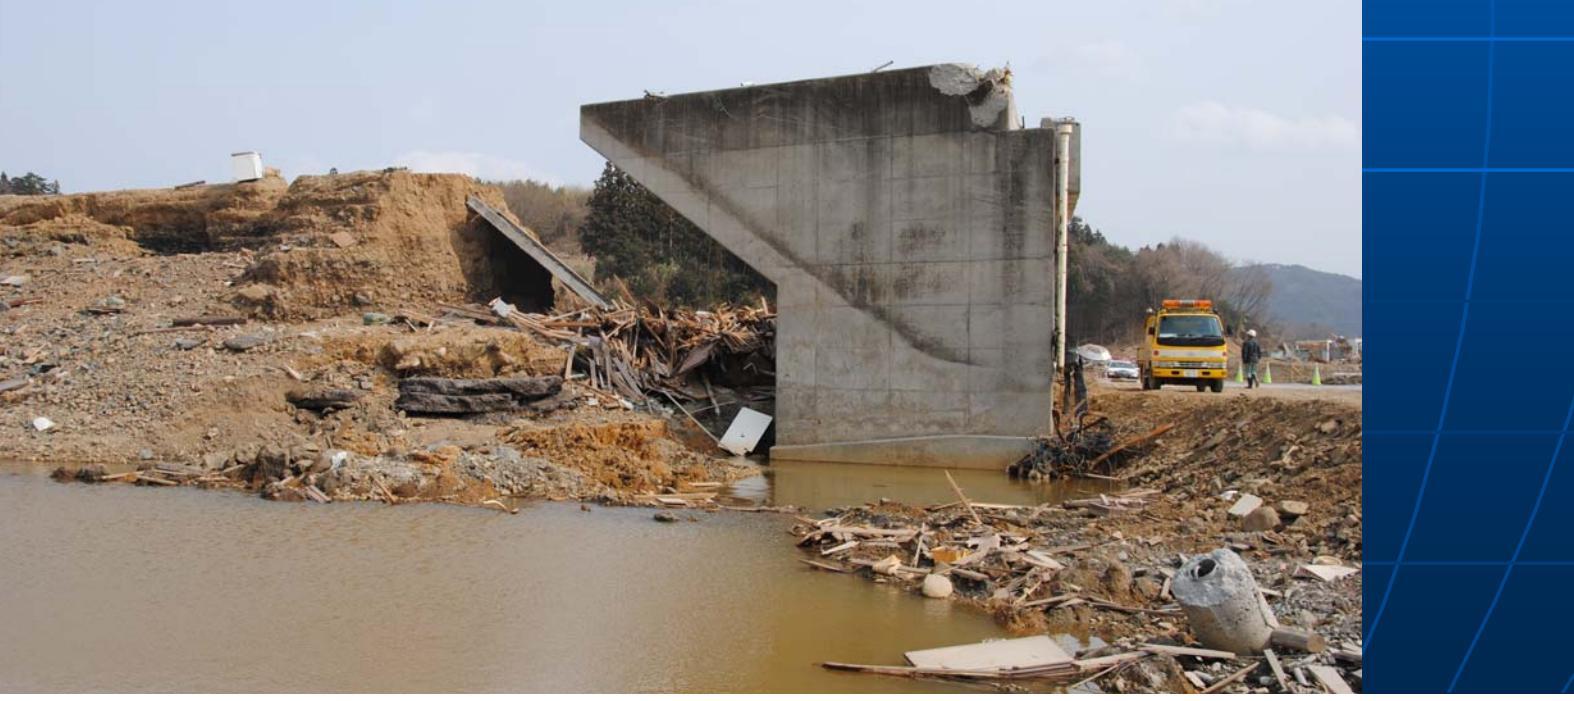
Embankment was completely washed away, and an abutment was left alone

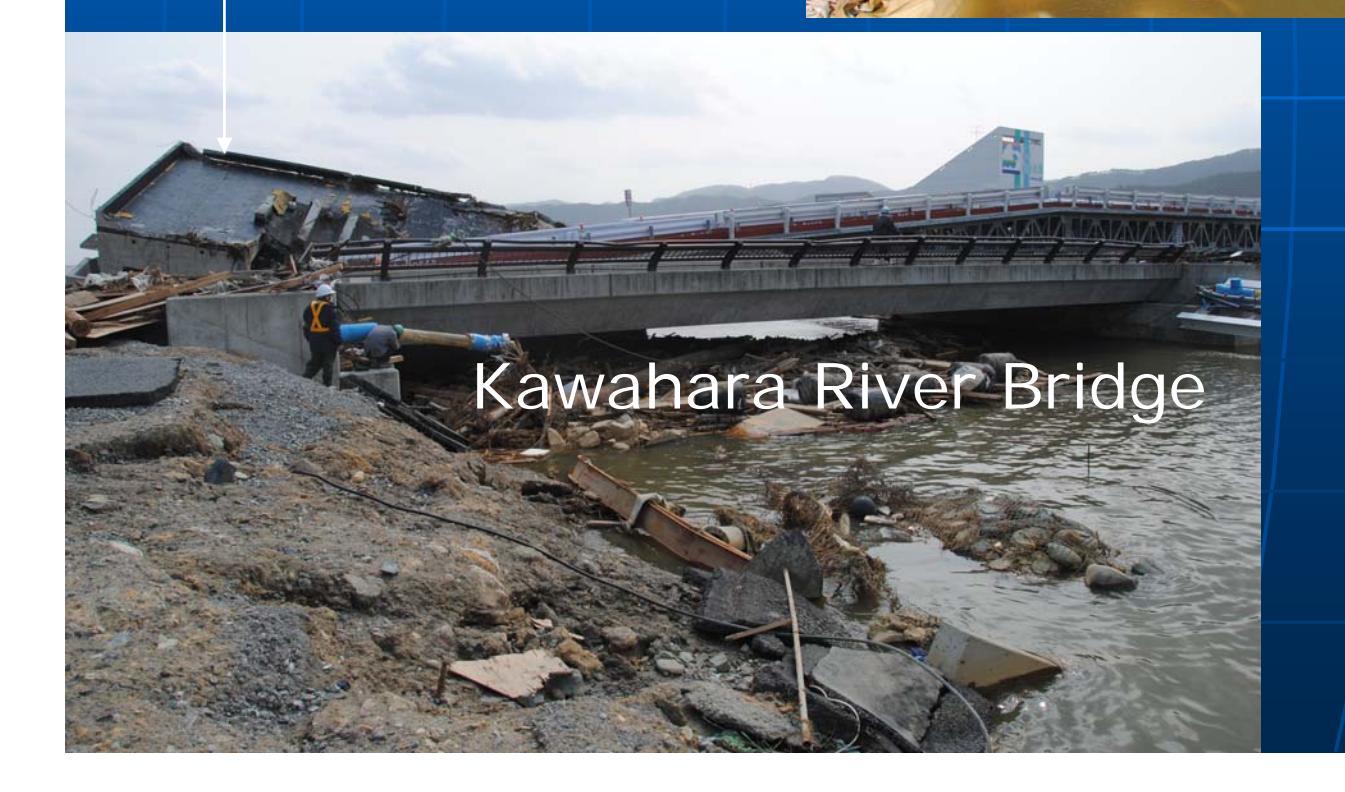
There were a number of bridges which did not suffer damage by tsunami, but back soils & embankment were washed away Kawahara River Bridge Route 45 Rikuzen-Takada City The two story building hit the bridge, but the bridge survived

Embankment was completely washed away

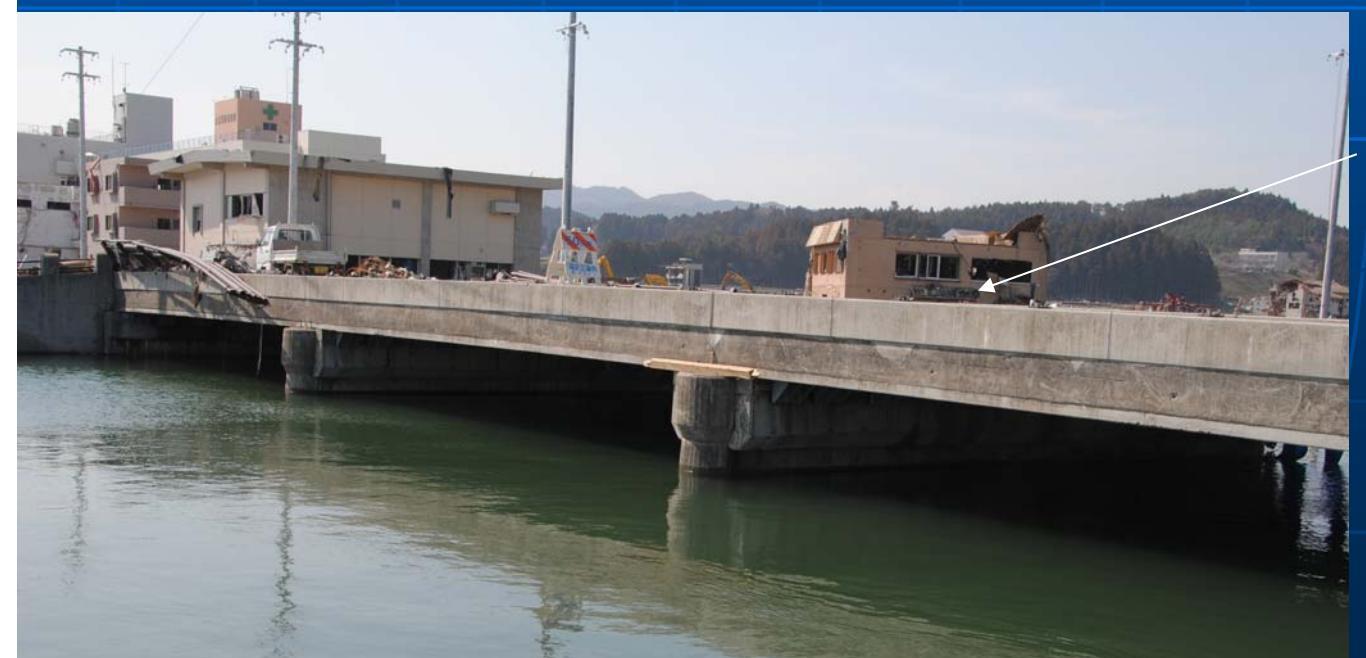
Damage of the town around the bridge

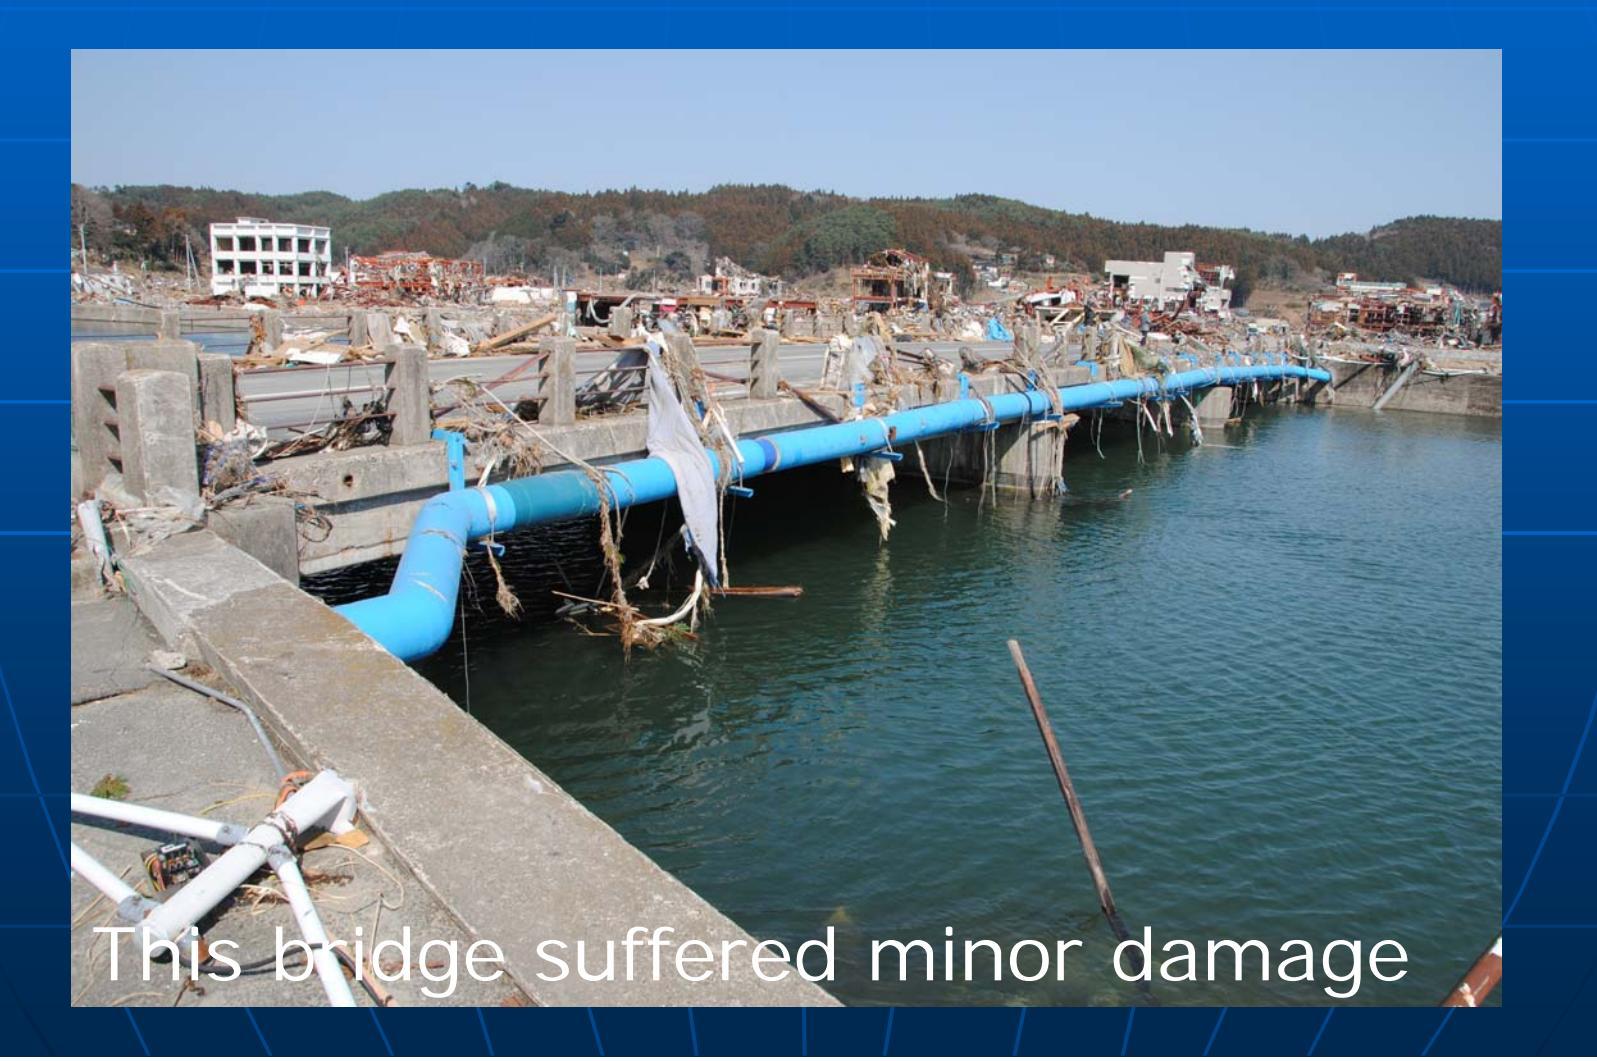
Minato Bridge 150 m downstream of the bridge in the previous slide Shizu-gawa town

Guard Rails were washed away

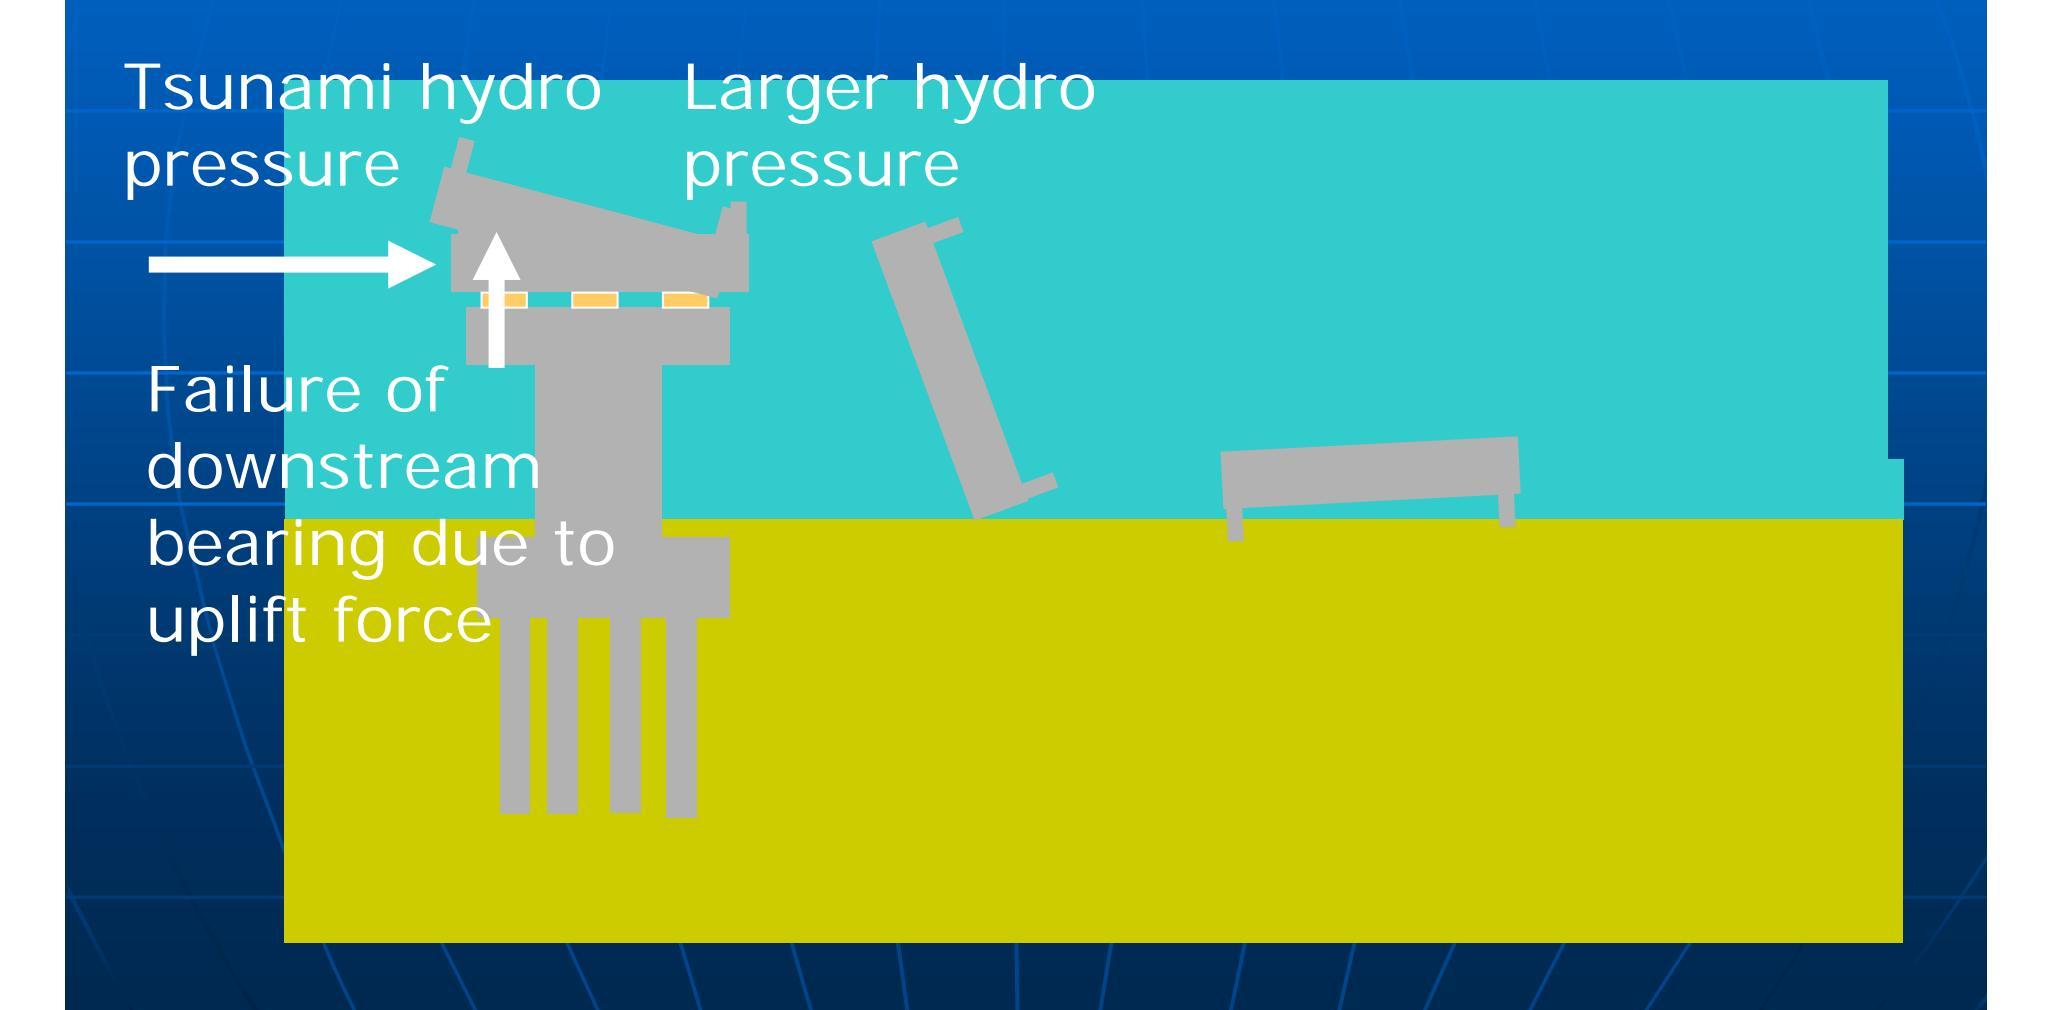
Most Probable Failure Mechanism of Bridges due to Tsunami

•A number of bridges suffered damage by tsunami. Damage was possibly developed by deck rotation toward upstream side, resulted from uplifting force. If failure of bearings (particularly downstream side bearings) due to uplifting force can be prevented, damage of tsunami may be mitigated.

It is recommended to install "unseating prevention device for tsunami." Restrainers which are widely used for unseating prevention device for earthquake may be effective if they are set in the vertical direction.
