5 	Steer STRUCTURAL EXTREME EVENTS RECONNAISSANCE	EVENT BRIEFING	
			Event:	26 November, 2019 Albania, Mw 6.4 Earthquake
		Region:	Europe	
Authors:	Alicia Tsai, Fan Hu, Selim Günay and Khalid M. Mosalam University of California, Berkeley			
Editors:	Ian Robertson, University of Hawaii at Manoa David O. Prevatt, University of Florida Tracy Kijewski-Correa, University of Notre Dame			
DesignSafe Project # PRJ-2654		Release Date:	December 14, 2019

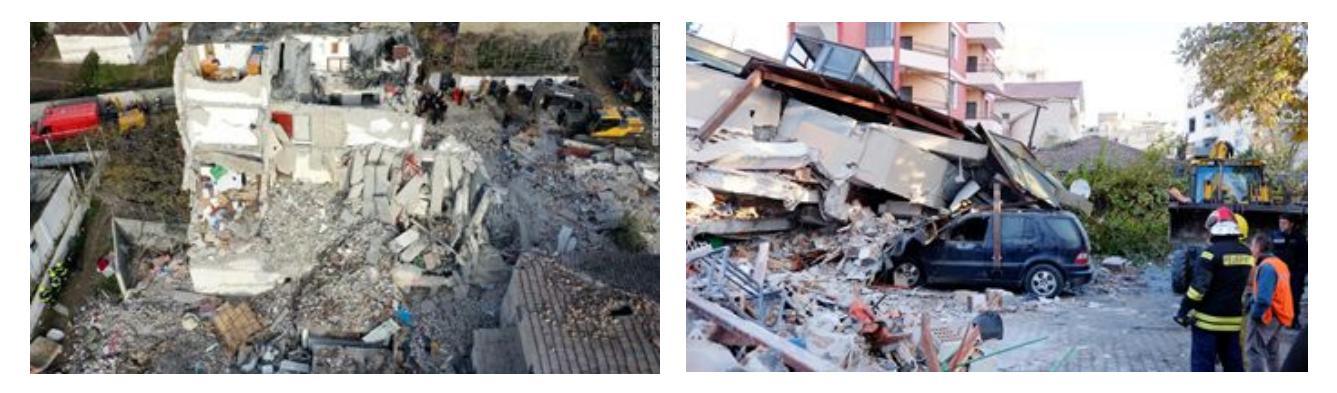
Albanian Prime Minister Edi Rama indicated that more than 1,465 buildings in Tirana and about 900 in the nearby city Durres had been seriously damaged (Deutsche Welle, 2019). Many reinforced concrete (RC) and masonry buildings experienced collapse and severe damage (Figs. 3-5). Two hotels and two apartment blocks collapsed in Durres. Four buildings, including a five-story apartment block, collapsed in Thumane. At the time this briefing was authored, many people were still trapped

Figure 3. Collapsed reinforced concrete buildings (CNN, 2019)

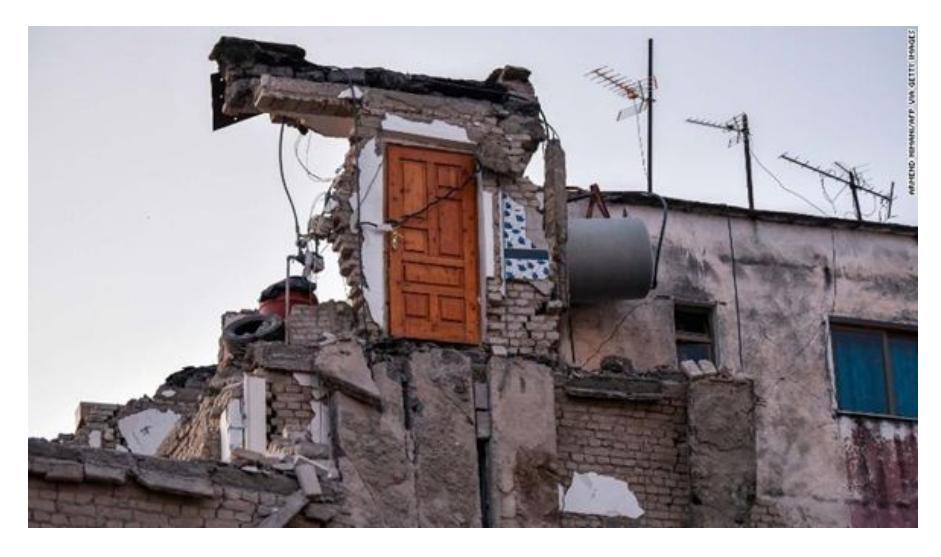
Figure 4. Collapsed masonry building in Thumane with the doorframe standing (CNN, 2019)

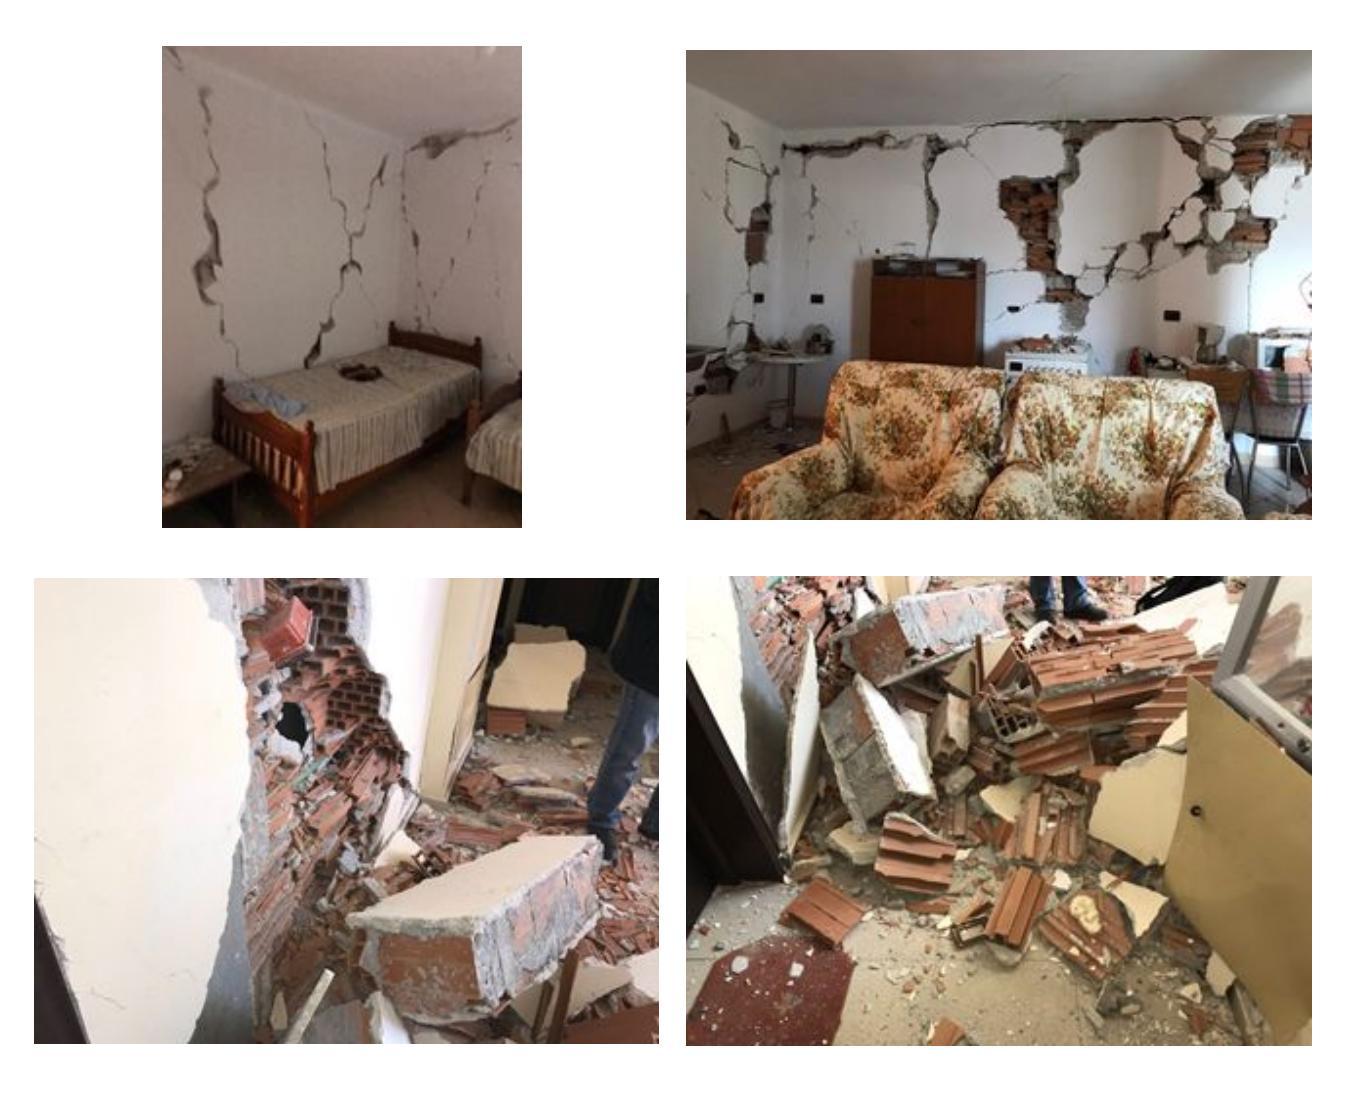
Event Briefing Building Resilience through Reconnaissance 11.26.2019 Mw 6.4 Earthquake in Albania | Released December 14, 2019 Related to the damage in masonry buildings, photos in Figure 5 show the presence of multicell clay blocks. These blocks are not only very brittle but they afford no options for reinforcing or grouting the cells to increase the wall strength and ductility. The use of such brittle material should be outlawed in all earthquake-prone areas, including Albania and other countries around the region.

Figure 5. Heavily damaged multicell clay blocks in masonry buildings and infill walls in RC buildings (Twitter, 2019)

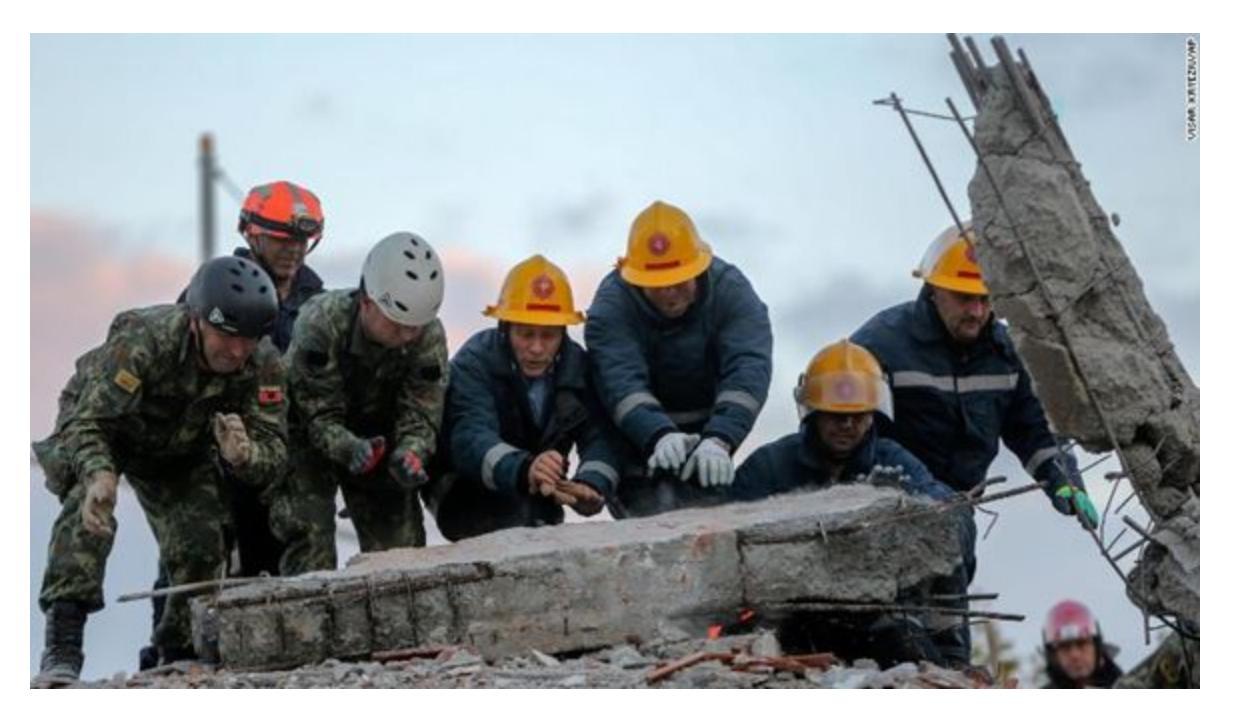
in the remains of the ruined buildings (Wikipedia, 2019). An illustration of insufficient detailing from a collapsed RC building is provided by Figure 6: the exposed vertical element shows a lack of transverse reinforcement and failure in a diagonal plane associated with shear damage; the horizontal element in this figure is observed to have adequately anchored transverse reinforcement with only 90-degree hooks in place of the 135-degree seismic hooks necessary for confinement. These and other non-ductile features such as the presence of strong-beam/weak-column proportions, lack of confinement at member ends and connections and weak/soft stories (Fig. 7) potentially contributed to the observed collapses. One of the commonly observed damage types of RC buildings in this earthquake is the In-Plane (IP)/Out-of-Plane (OOP) failures of infill walls (Fig. 8). Fortunately, the damage in these photos was limited to the infill failures and did not result in the formation of weak and soft stories and consequent story collapses. However, infill wall failures may have contributed to other building collapses, similar to those observed during previous earthquakes in Europe (Mosalam and Günay, 2015). Infill wall failures also present a high risk of injury or death due to falling masonry rubble.

Figure 6. Lack of transverse reinforcement and failure in a diagonal plane associated with shear damage of the vertical element and lack of adequately anchored confining reinforcement in the horizontal element (CNN, 2019)

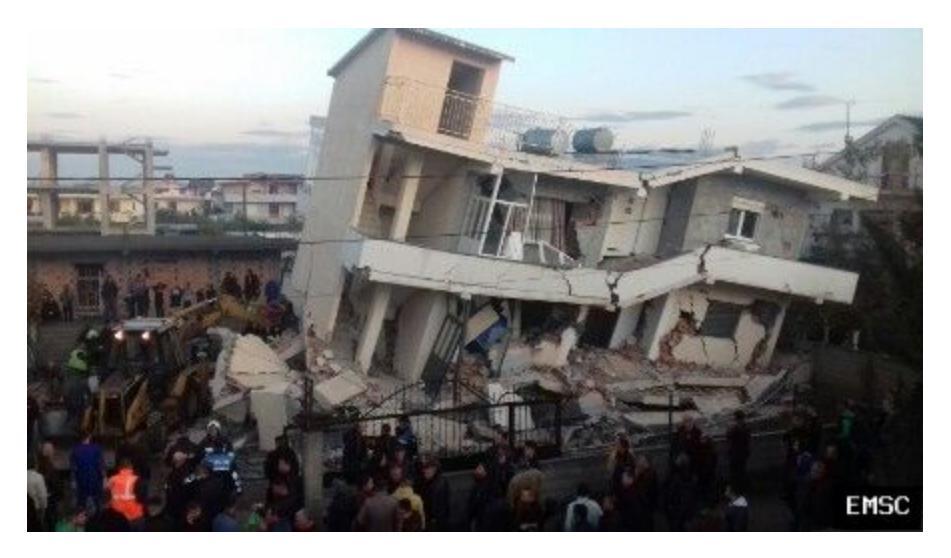
Figure 7. A soft/weak story collapse observed in Durres (CSEM, 2019)

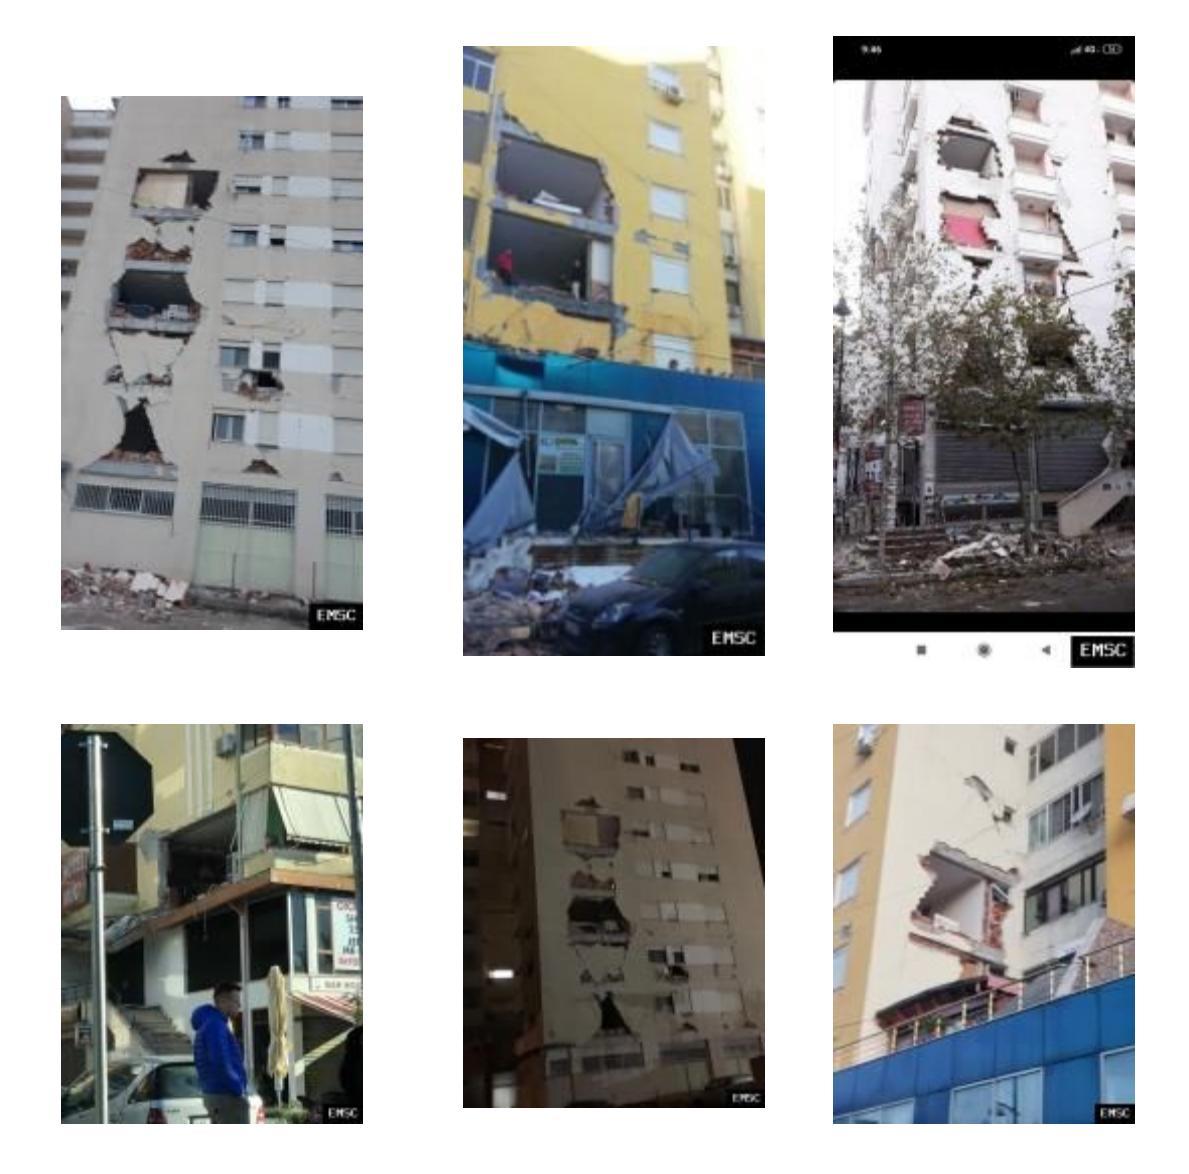
Figure 8. In-plane (IP) / Out-of-Plane (OOP) failures of infill walls (CSEM, 2019)

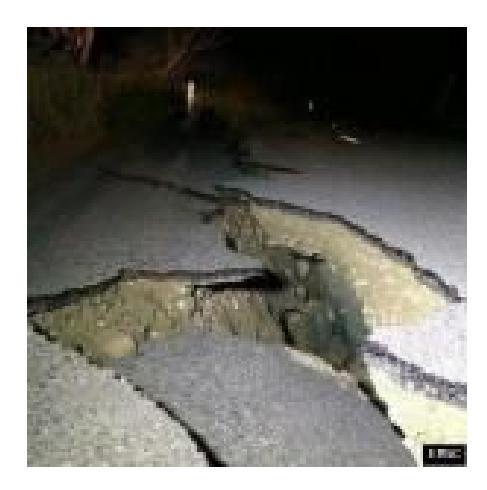
Because the earthquake caused significant building damage, collapses and consequent fatalities, almost all of the preliminary information is on buildings. At the time this briefing was authored, there was not much information available related to the damage of other infrastructure, though the photo in Figure 9 shows significant road damage in the capital city Tirana.

Figure 9. Significant road damage in Tirana (CSEM, 2019)
