# Shaking table model test of a super high-rise building with setbacks in elevation

Ningfen SU, Xilin LU, Ying ZHOU, Kun DING, Wensheng LU  
 State Key Laboratory of Disaster Reduction in Civil Engineering of Tongji University

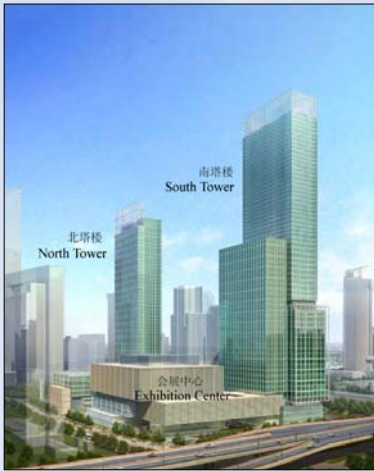
Storey: 58 above the ground and a 4-storey basement  
 Height: 244.8m (top of roof)  
 260.0m (top of steel frame)  
 Function: office building and hotel  
 Structural system: SRC frame and RC core  
 Characteristics: setbacks  
 inclined columns  
 belt truss storey  
 transfer bracing  
 Seismic design intensity: 7 (0.1g)  
 Code: Chinese code for seismic design of buildings (GB 50011-2001)  
 Technical specification for concrete structures of tall building (JGJ 3-2002)

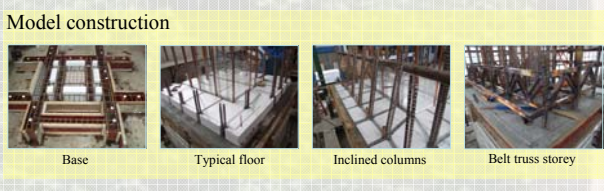
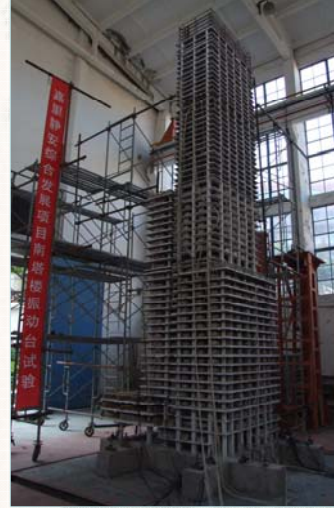
Parameters	Relationships	Model/prototype
Length	$S_L$	1/35
Elastic modulus	$S_E$	0.30
Stress	$S_\sigma$	0.30
Strain	$S_\epsilon/S_{\epsilon E}$	1.00
Density	$S_\rho$	3.50
Force	$S_F$	2.45E-04
Frequency	$S_f$	10.25
Acceleration	$S_a$	3.00
