PACIFIC EARTHQUAKE ENGINEERING RESEARCH CENTER

Experimental and Analytical Studies on the Seismic Behavior of Conventional and Hybrid Braced Frames

PEER Report 2013/20
Pacific Earthquake Engineering Research Center
Headquarters, University of California, Berkeley

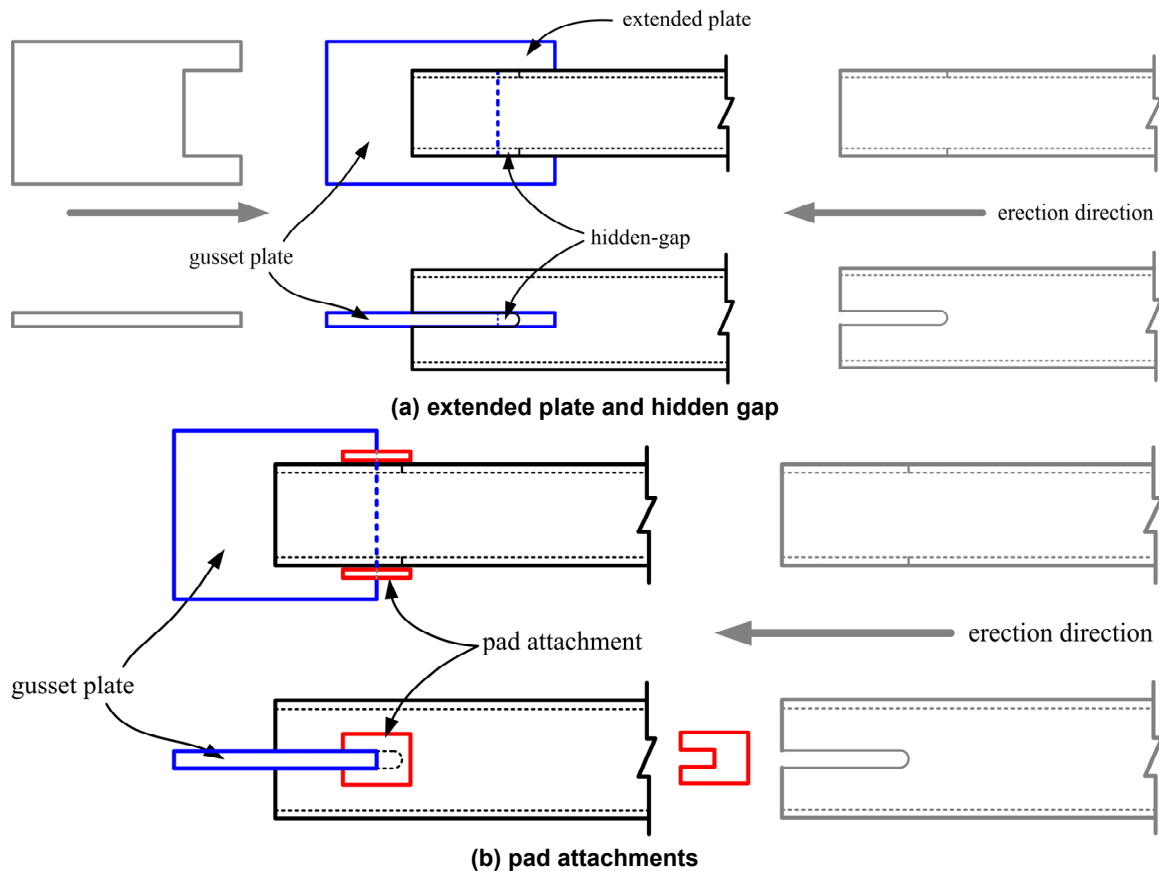
Figure 2.2 Other possible net section reinforcing schemes.

maximum force that will develop in the brace. Reinforcing cover plates were mentioned as one scheme to overcome strength deficiencies at the net reduced section. In some instances, welds were wrapped around the gusset plate edges as reinforcement. These were not recommended by many in the United States because of possible poor fit up of the leading edge of the gusset plate and the end of the slot on the brace (making the weld effectiveness difficult to judge), and the potential for high stresses in this area (due to applied loads or weld shrinkage) that could lead to ductility reduction [Cheng et al. 1998] or crack initiation. Other possible reinforcing schemes (Figure 2.2), while not prohibited by AISC, were not mentioned, including extended gusset plate details [Mitsui and Kurobane 1981], pad attachments [Mitsui and Maeda 1986], and modified hidden gap detailing [Packer 2006; Martinez-Saucedo et al. 2008a, 2008b]. The most recent version of the AISC Seismic Provisions [AISC 2010a] retains the basic requirements from the 2005 edition. As the specific issues of the behavior of the net reduced section region and detailing to mitigate the effects of strength deficiencies are not the subject of this work, simple approaches (i.e., cover plates) will be used herein to avoid premature brittle failures in these regions.

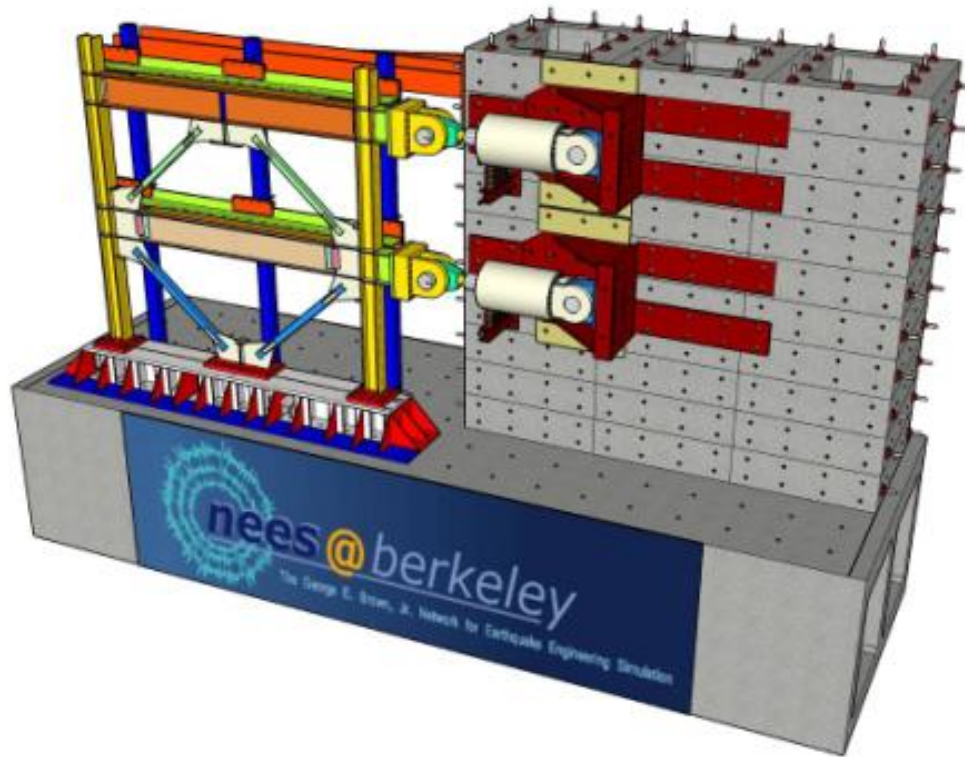
Figure 3.9 Overview of the final test set up.

Several different systems were considered to provide lateral restraint for the test specimen (Figure 3.8). To improve access to the specimen during erection and repair, and to facilitate observation during testing, the lateral stability system shown in Figures 3.9 and 3.15 was used. Detail design calculations for the lateral support frame are described in Appendix A. Shop drawings of the frame are provided in Appendix B.

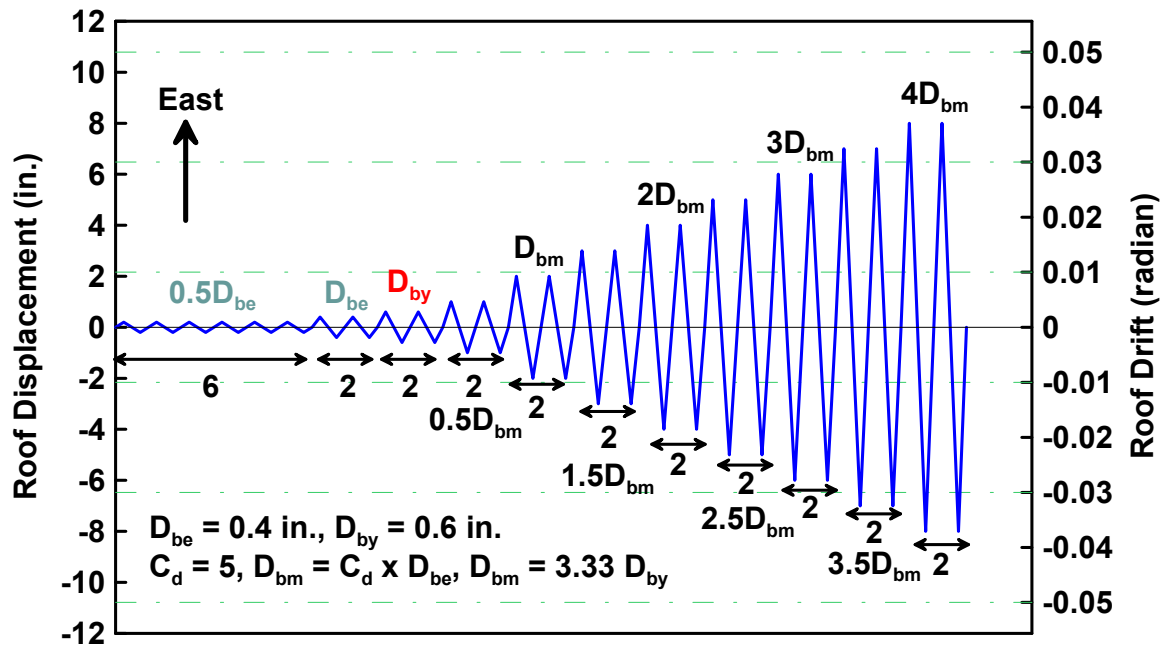
Figure 3.28 Specimens TCBF-B-1, TCBF-B-2, and TCBF-B-3: cyclic loading protocol.

Figure 3.28 shows the cyclic loading protocol for the first three specimens in terms of roof displacement and roof drift ratio. The sign convention for imposed displacements and forces are that positive displacements and forces correspond to the actuator pushing the specimen to the east side of laboratory (Figure 3.16), while negative values correspond to the actuator pulling the specimen to the west side of laboratory.

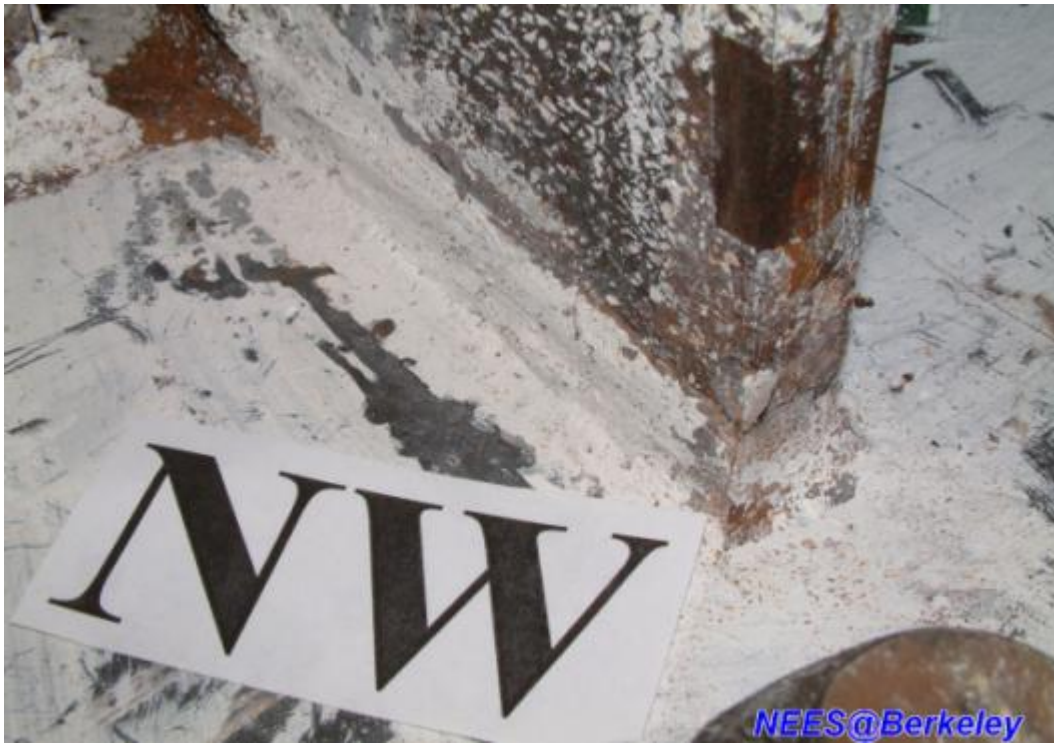
Figure 3.48(a) Crack in the CJP weld at west column base (north-west corner).

Several small weld fractures were found at both column bases during the final surface inspection (Figure 3.48) before whitewash painting. The three-step dye penetrant (cleaner/remover, penetrant and developer; see Figure 3.49) crack-detecting method was used to help determine the length of cracks (Figures 3.50). Inferior welds and cracks were gouged using air-carbon arc equipment. Two additional inches of gouging measured from the crack tips was done along the course of cracks or welds, as illustrated in Figure 3.51. Preheating before repair welding was also included in the repair weld procedure. The two column bases after weld repairs are shown in Figures 3.52 and 3.53. The side view of entire Specimen TCBF-B-2 after whitewash painting is shown in Figure 3.54.

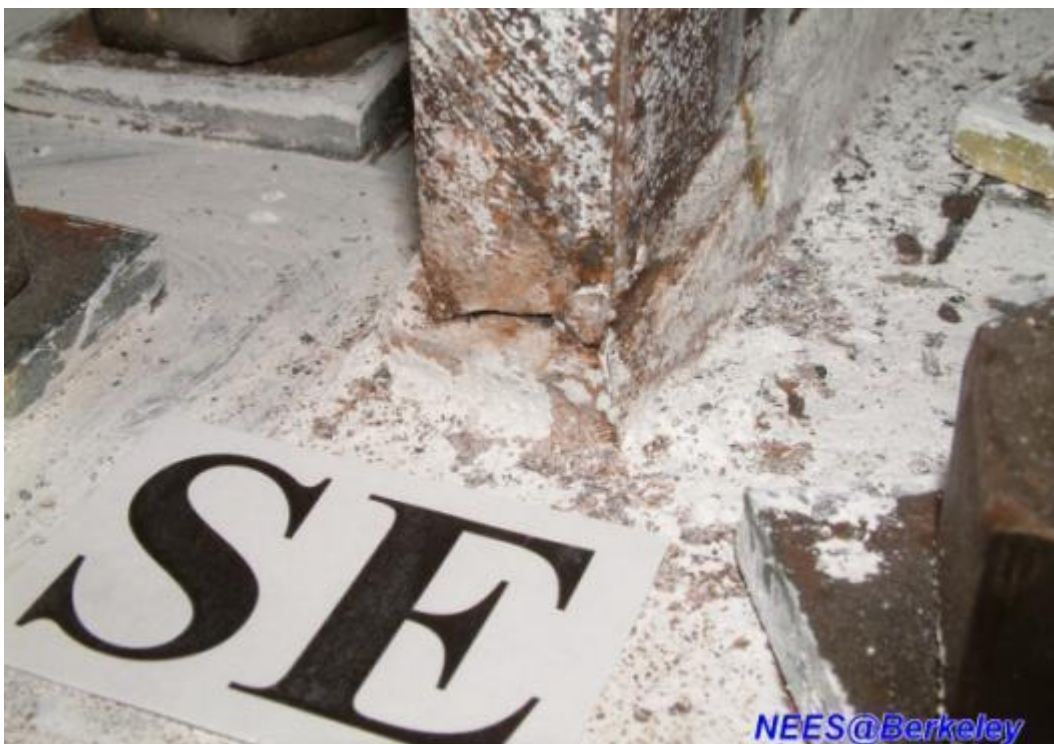
Figure 3.48(b) Crack in the CJP weld at east column base (south-east corner).

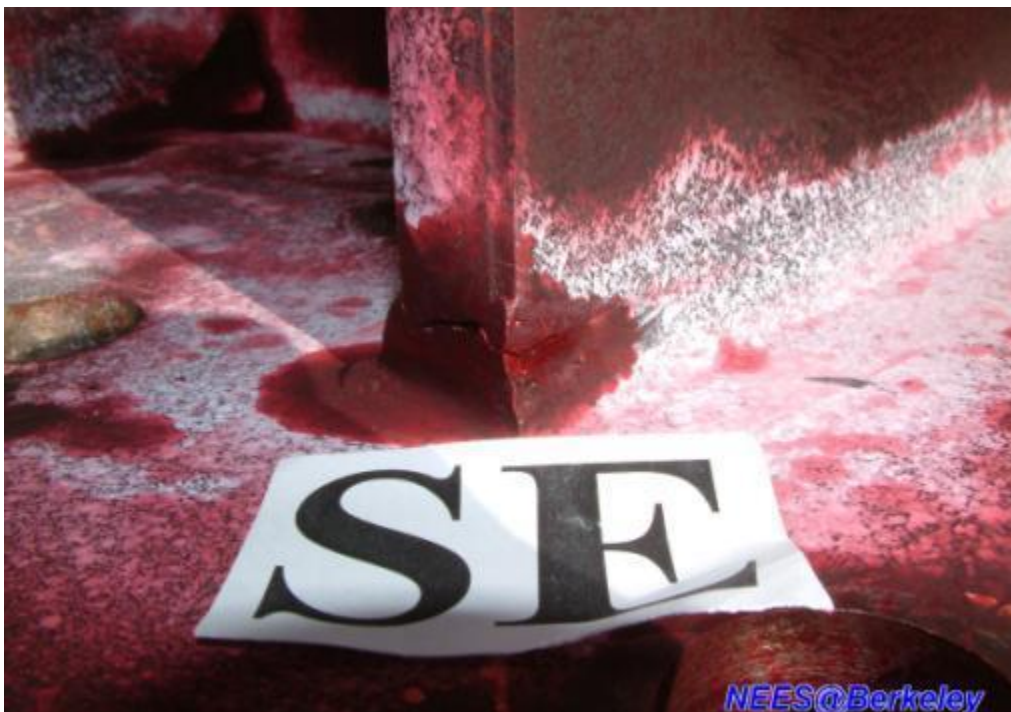
Figure 3.50 Crack detecting spray applied in the CJP weld at east column base (south-east corner).

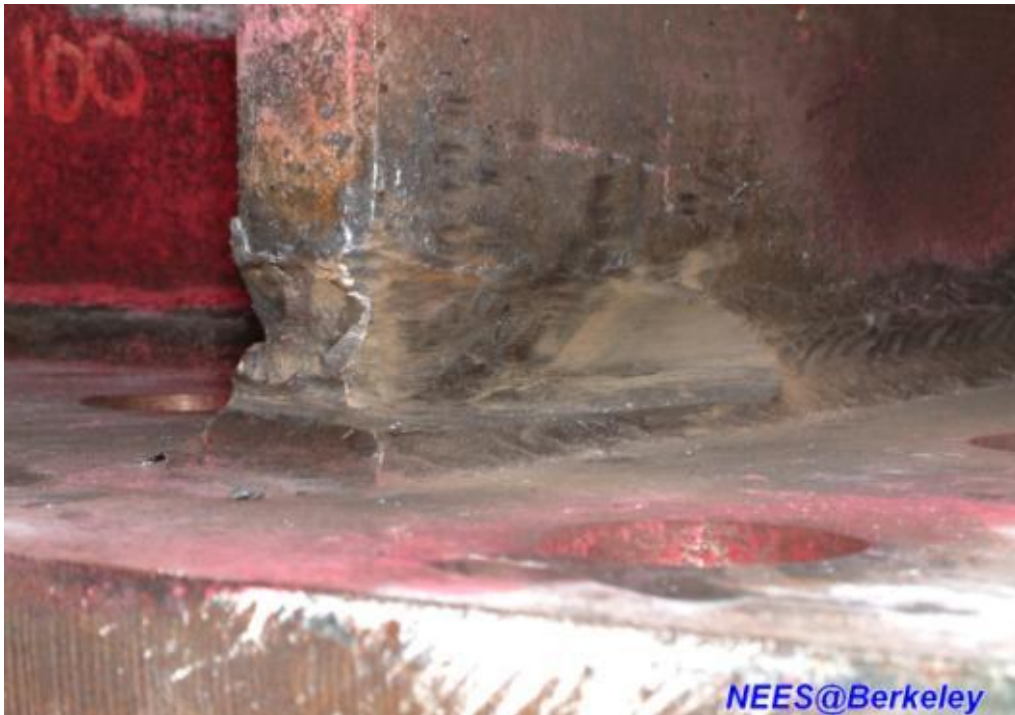
Figure 3.51 The east column base (south-east corner) after gouging the cracked welds.

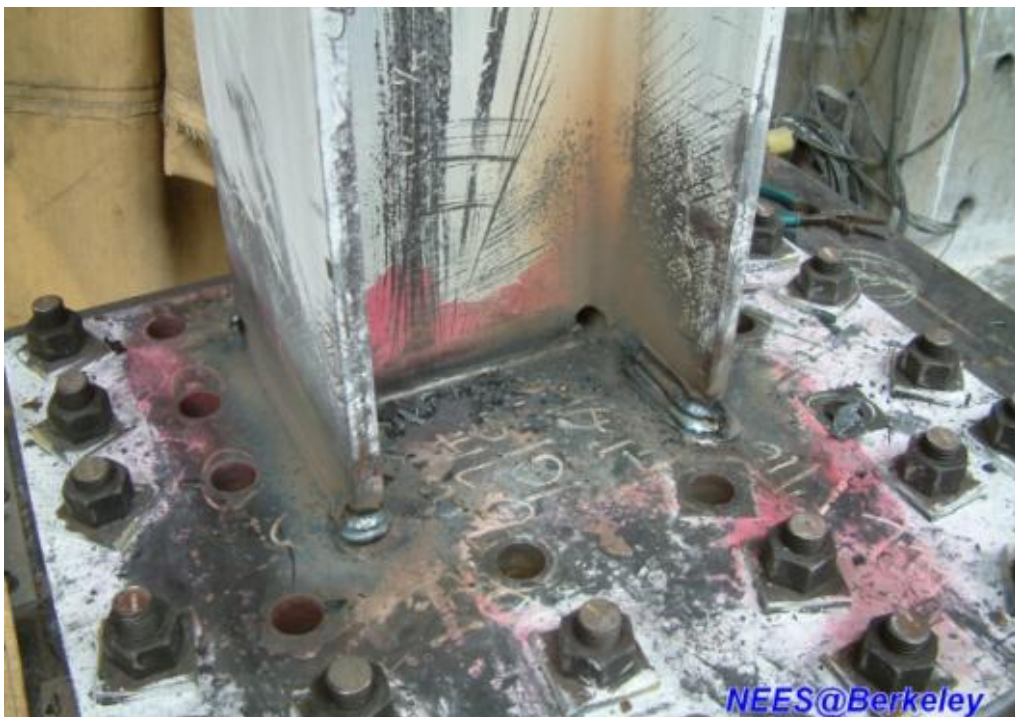
Figure 3.52 The west column base after weld repairs.

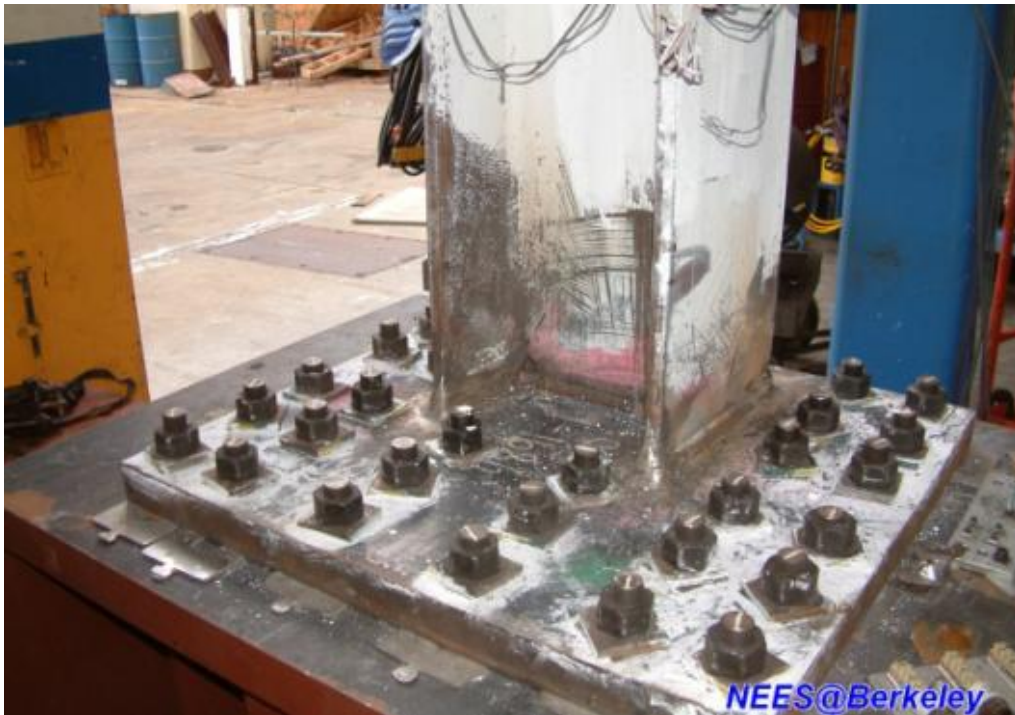
Figure 3.53 The east column base after weld repairs.

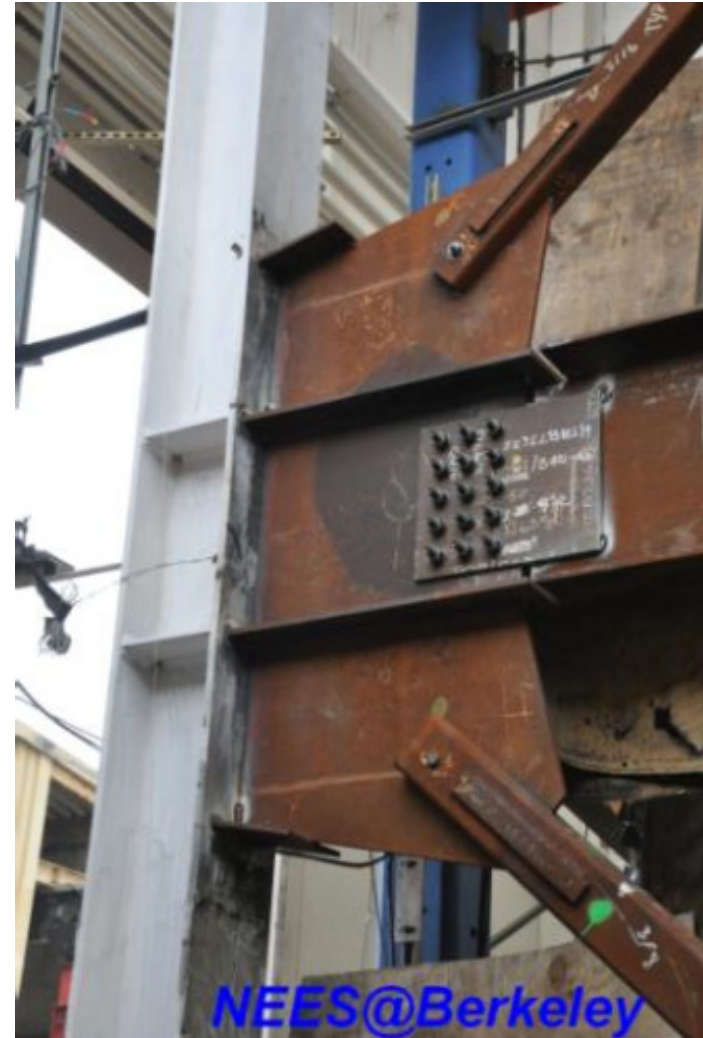
Figure 3.60 Specimen TCBF-B-4: connection detail of the lower beam to one-piece gusset plates.

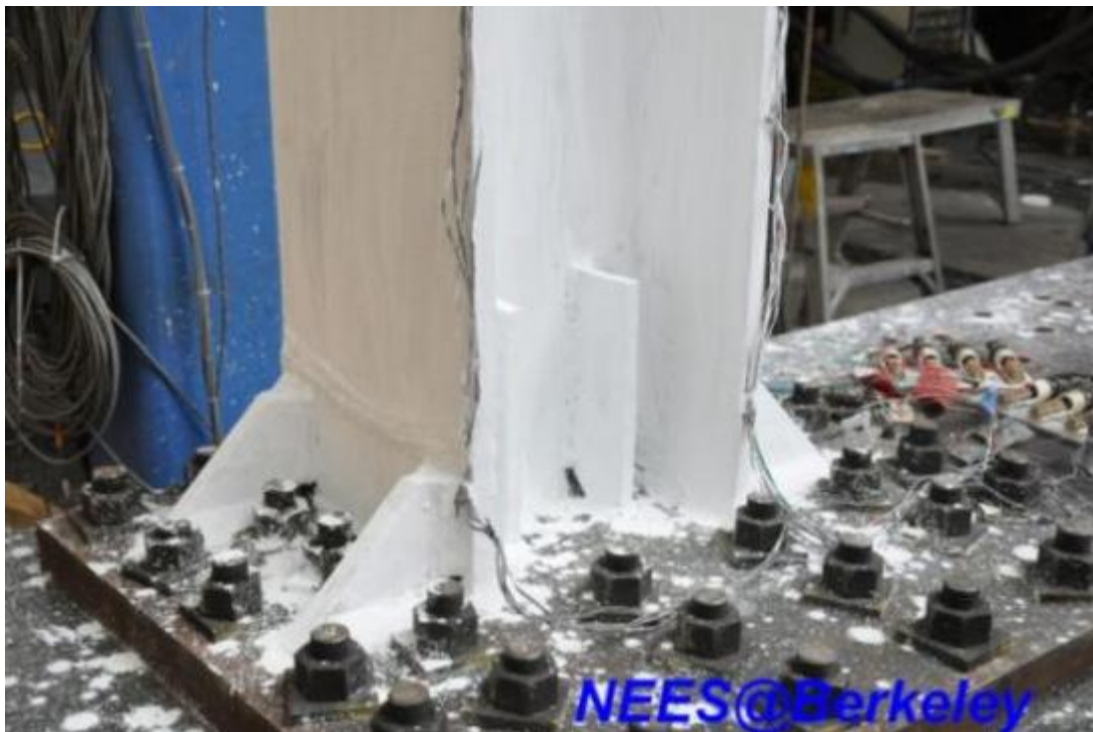
Figure 3.64 The east-side column base detail after repair and whitewash painting.

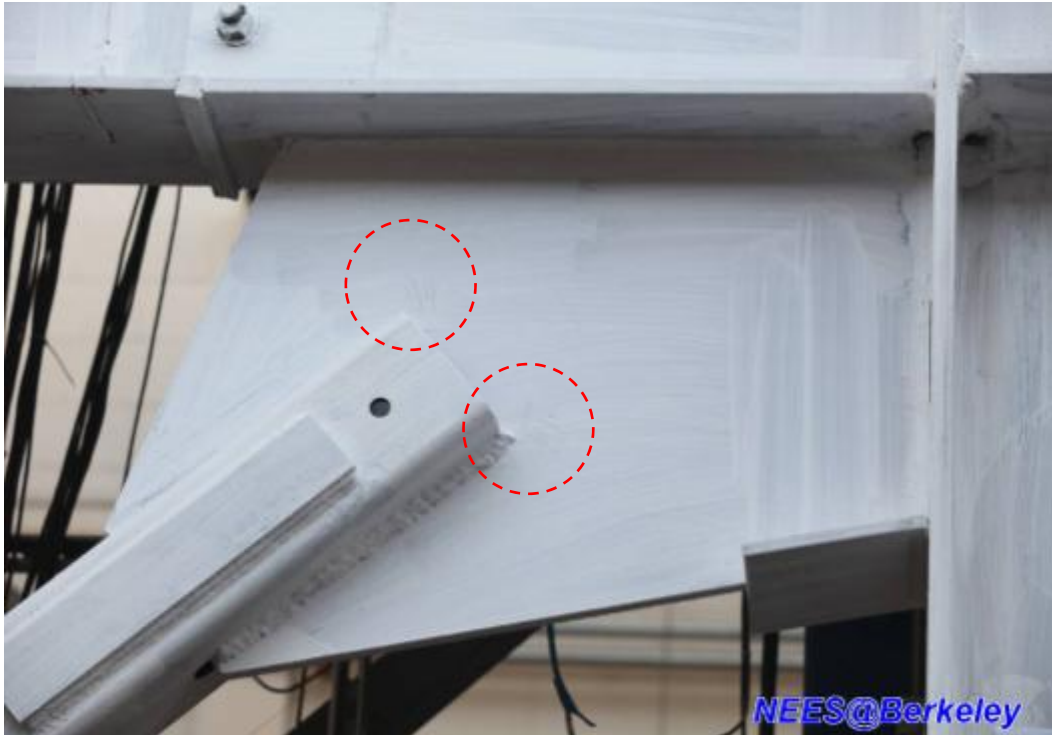
Figure 4.2 Specimen TCBF-B-1: western side of the first-story upper gusset plate.

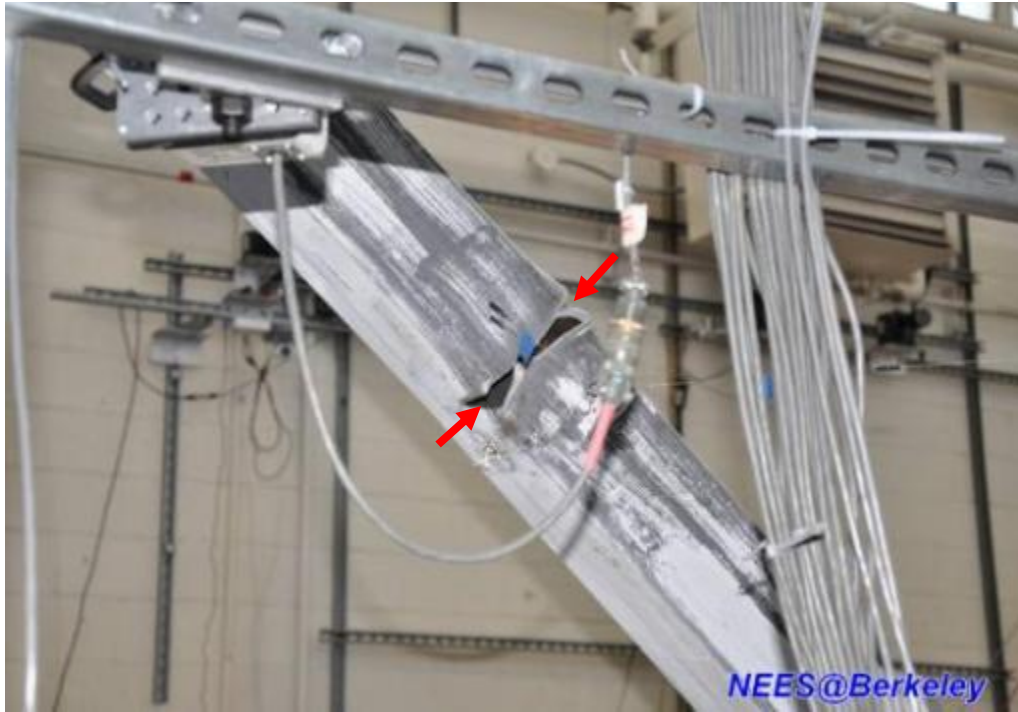
Figure 4.14 Specimen TCBF-B-1: crack propagation in the first-story western-side square HSS brace.

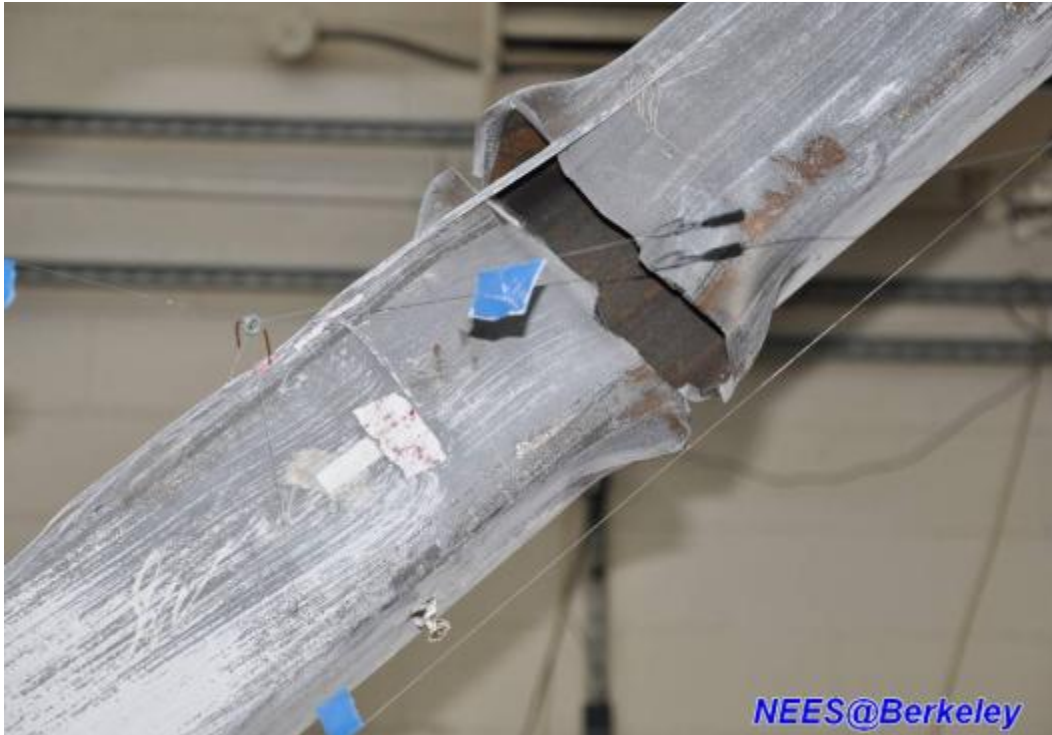
Figure 4.18 Specimen TCBF-B-1: complete fracture of first-story eastern-side square HSS brace.

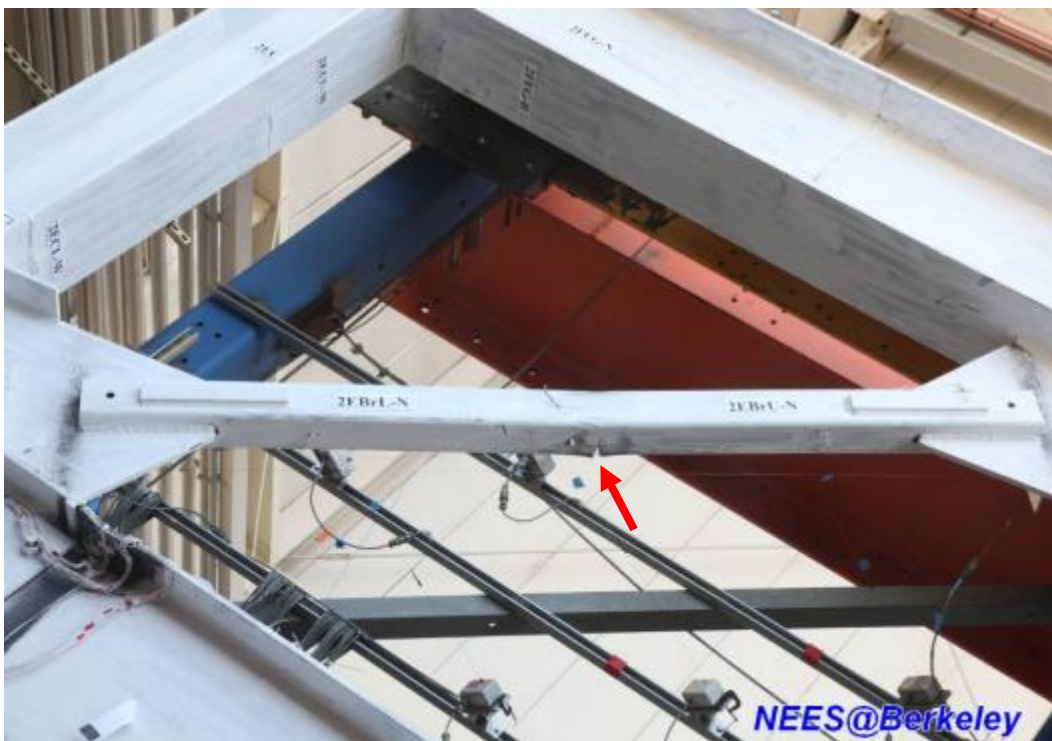
Figure 4.19 Specimen TCBF-B-1: crack propagation in the second-story eastern side square HSS brace.

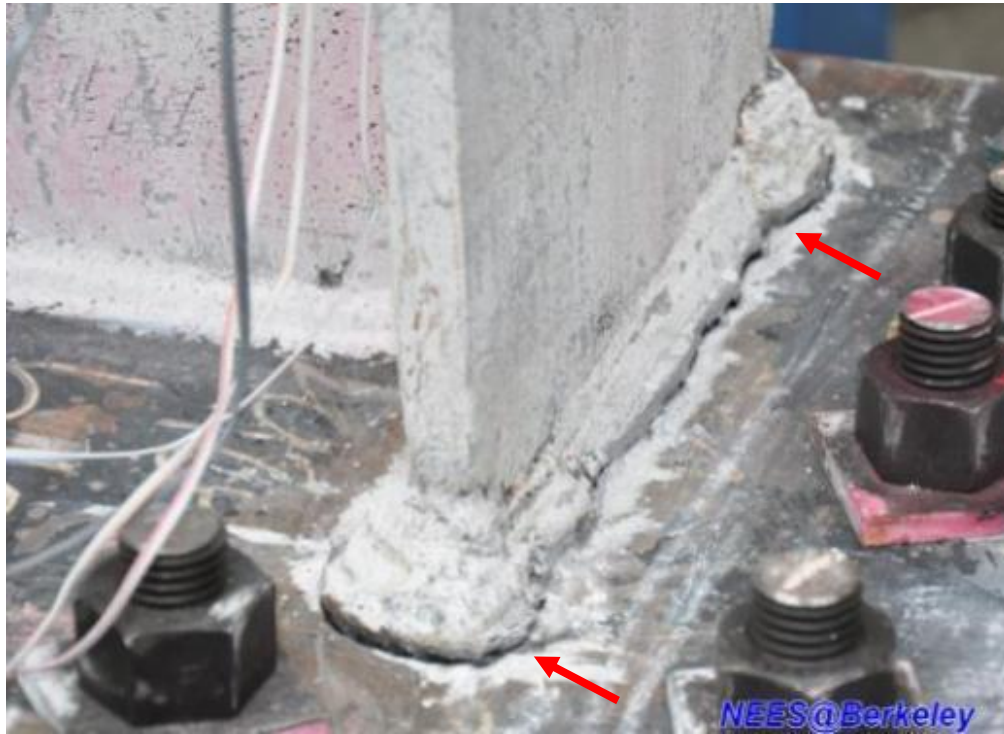
Figure 4.99 Specimen TCBF-B-2: fracture of west-side column base flange CJP welds.

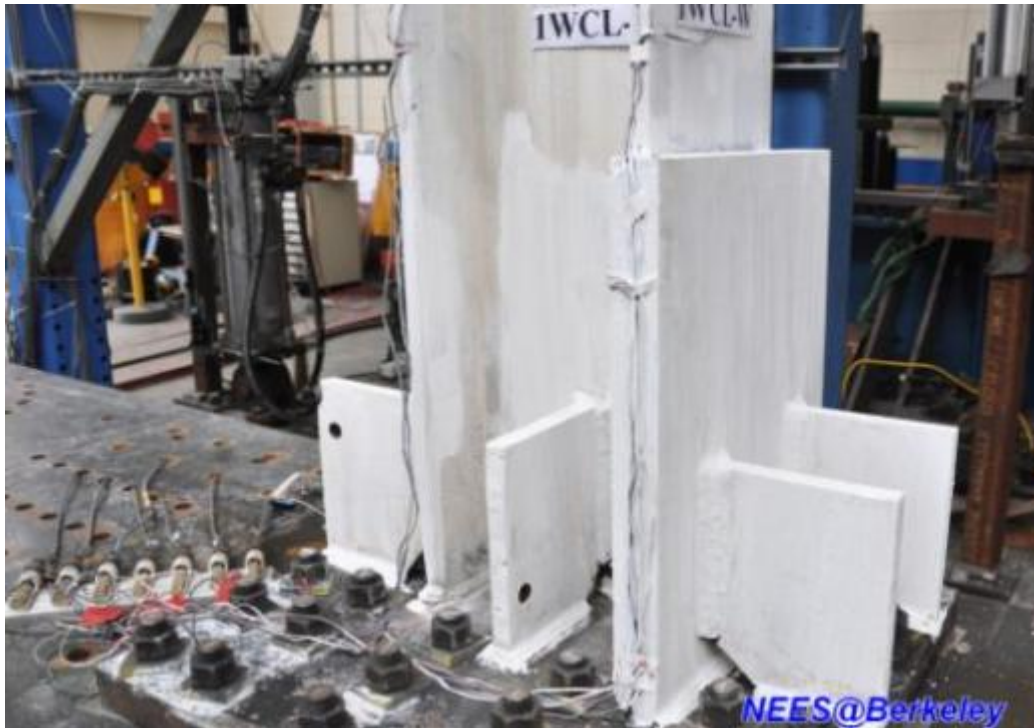
Figure 4.101 Specimen TCBF-B-2: west-side column base after repair with 1-in. thick stiffener plates and a 2-in. thick flange cover plate.

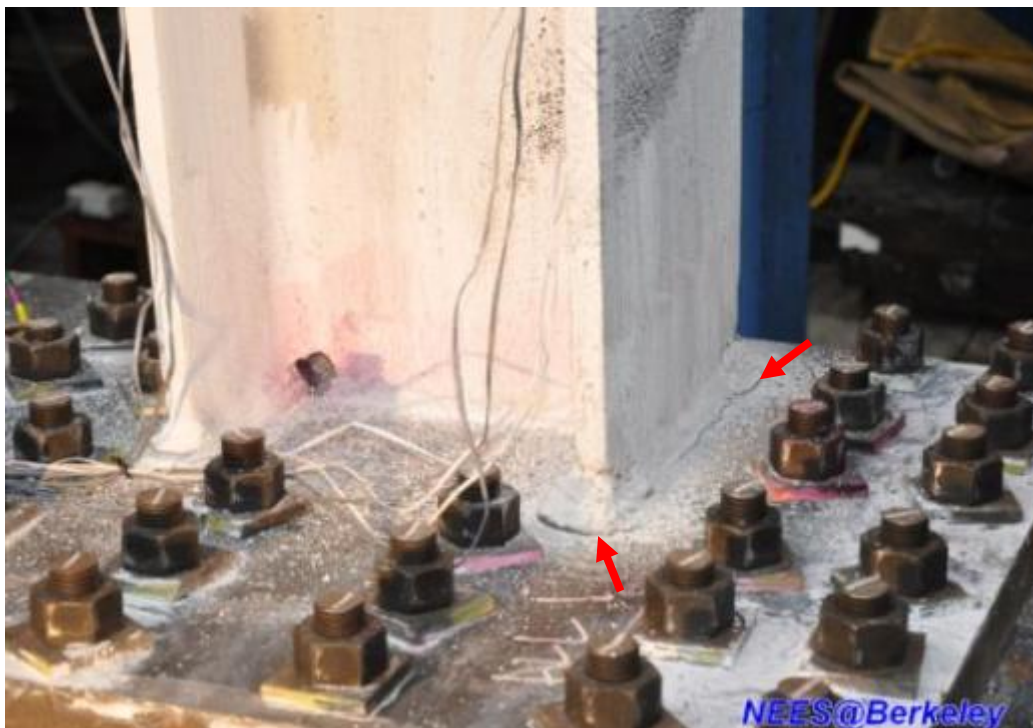
Figure 4.115 Specimen TCBF-B-2: crack near the flange CJP welds at west-side column base.

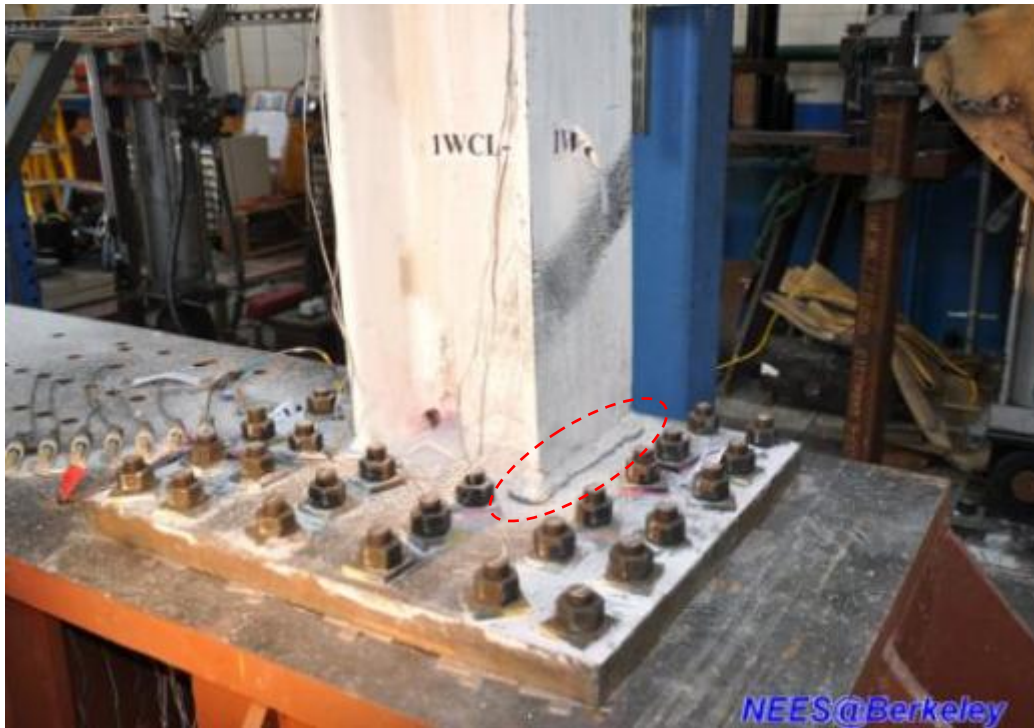
Figure 4.116 Specimen TCBF-B-2: complete fracture near the flange CJP welds at west-side column base.

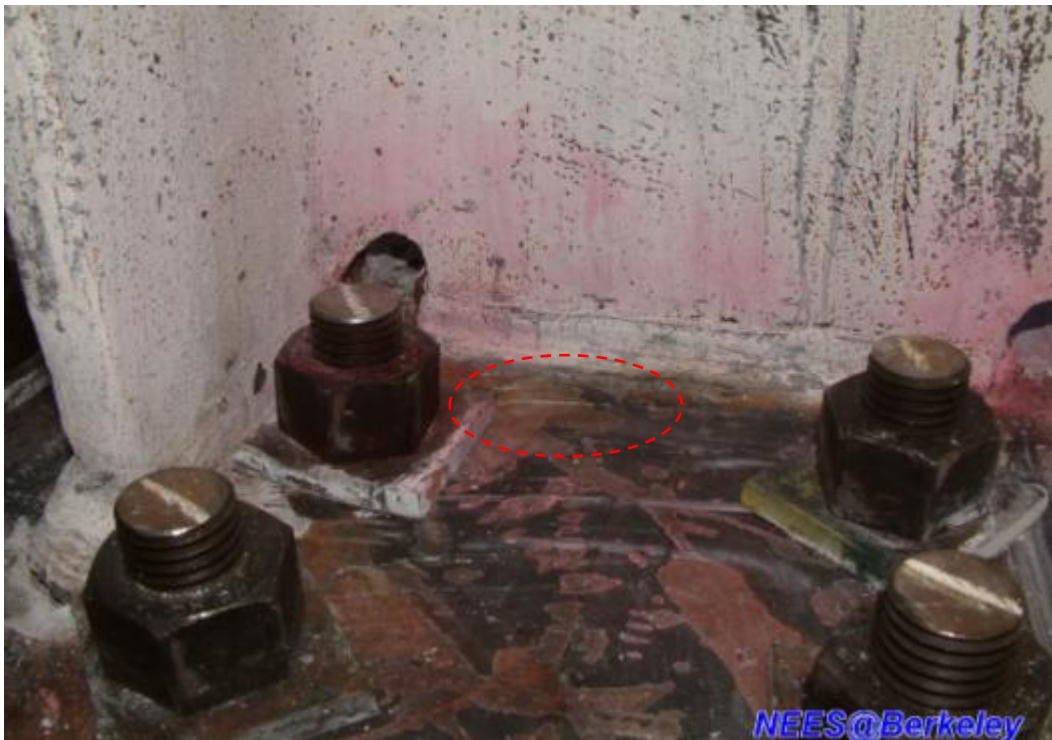
Figure 4.117 Specimen TCBF-B-2: crack near the web CJP welds at west-side column base.

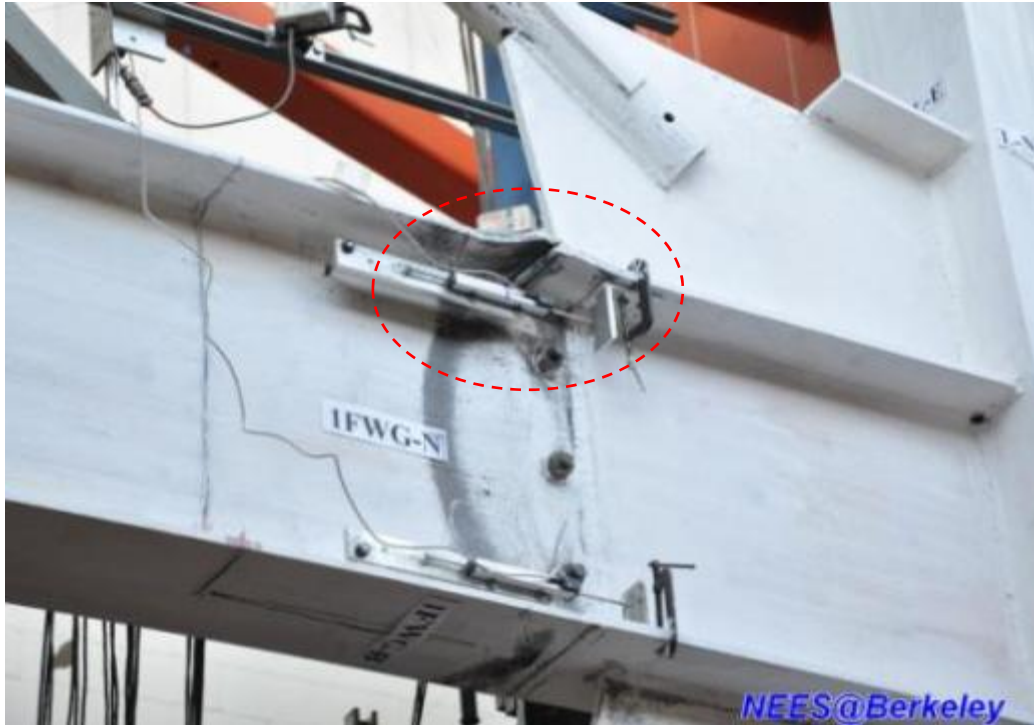
Figure 4.122 Specimen TCBF-B-2: fracture of west-side lower beam top flange.

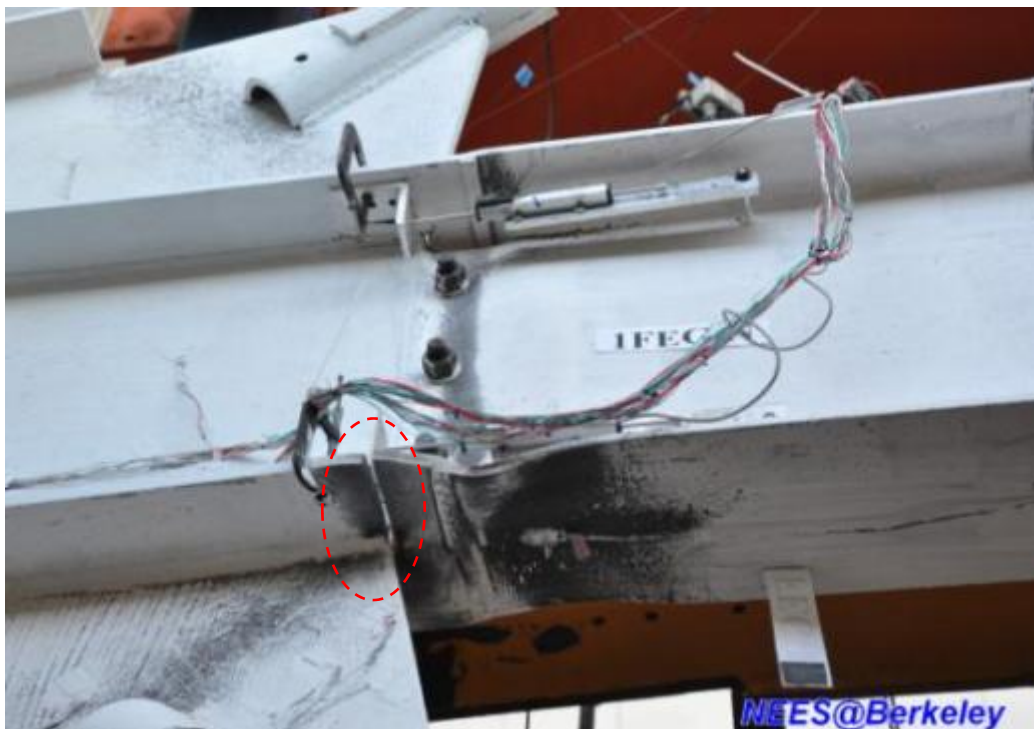
Figure 4.123 Specimen TCBF-B-2: partial fracture of east-side lower beam bottom flange finger plate.

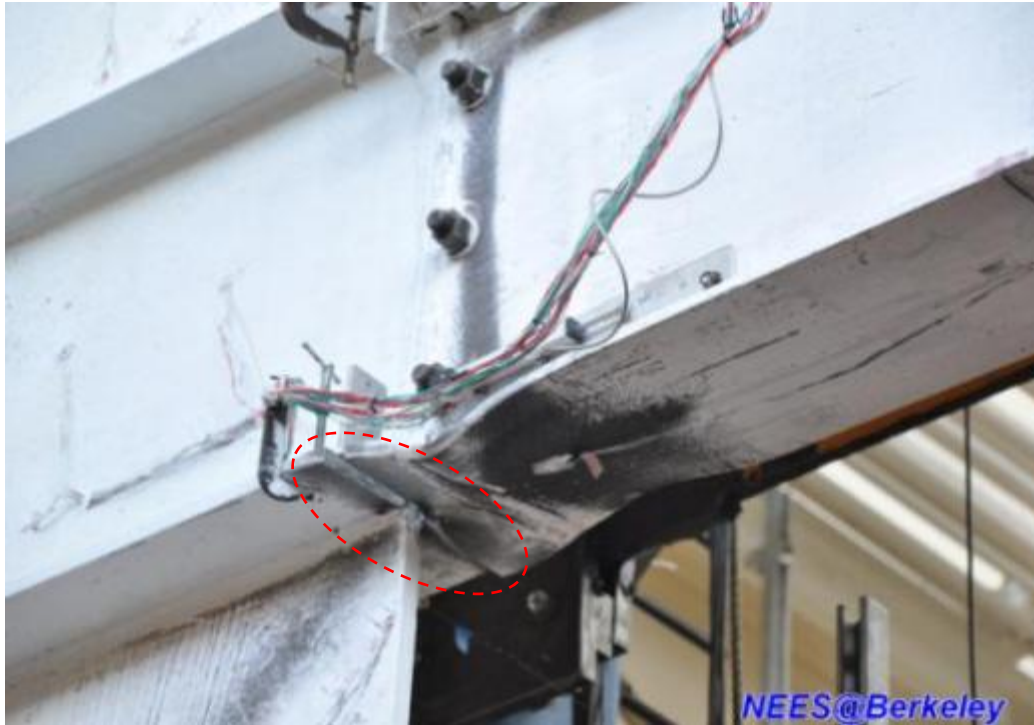
Figure 4.124 Specimen TCBF-B-2: complete fracture of east-side lower beam bottom flange finger plate.

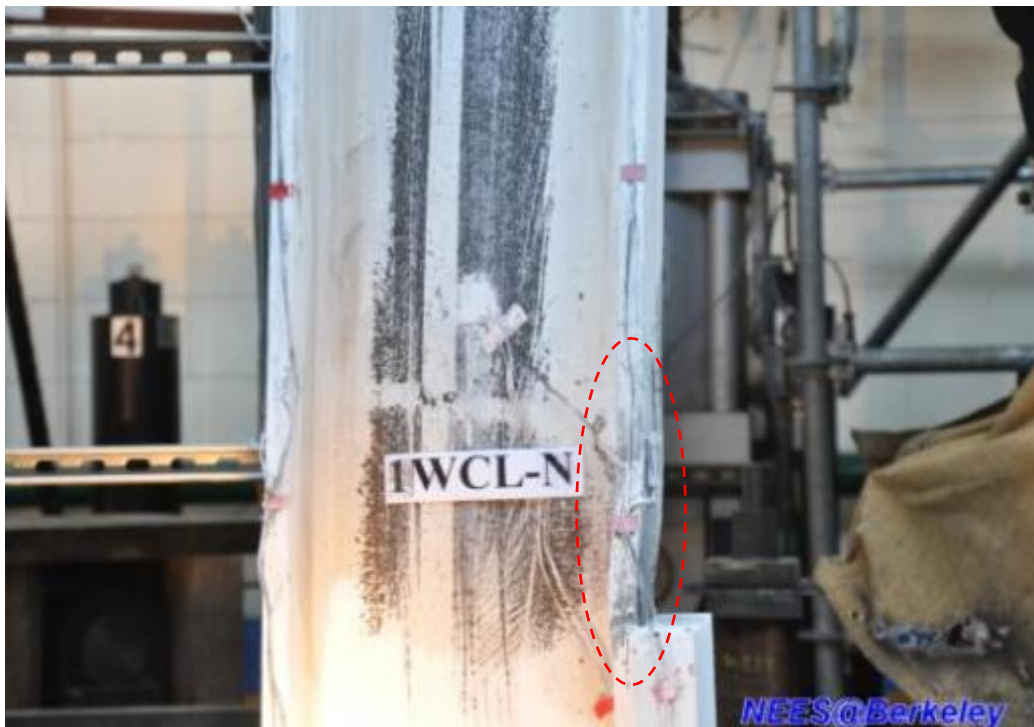
Figure 4.125 Specimen TCBF-B-2: local buckling of column flange near 2-in.-thick cover plate.

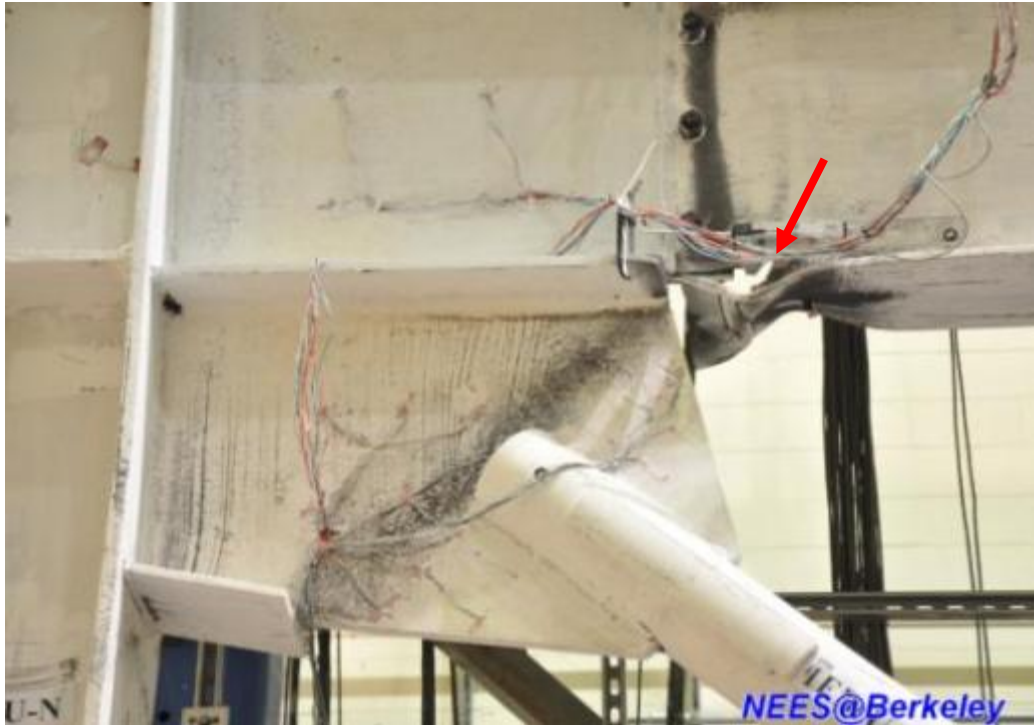
Figure 4.130 Specimen TCBF-B-2: crack propagation into web at east-side lower beam.

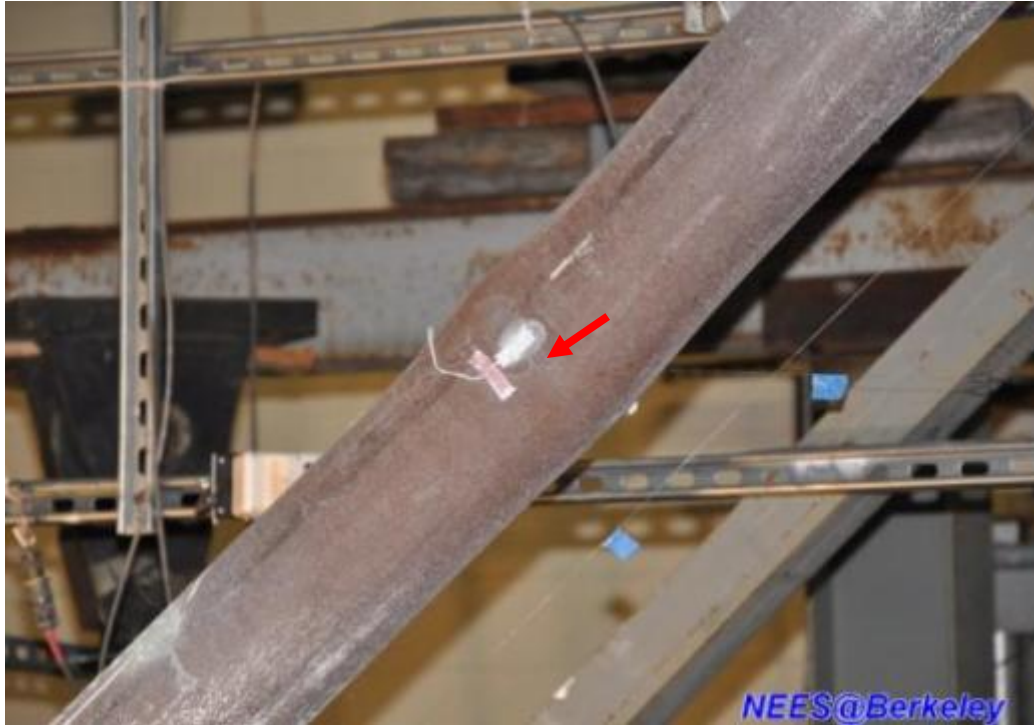
Figure 4.131 Specimen TCBF-B-2: crack initiation in first-story west-side round HSS brace.

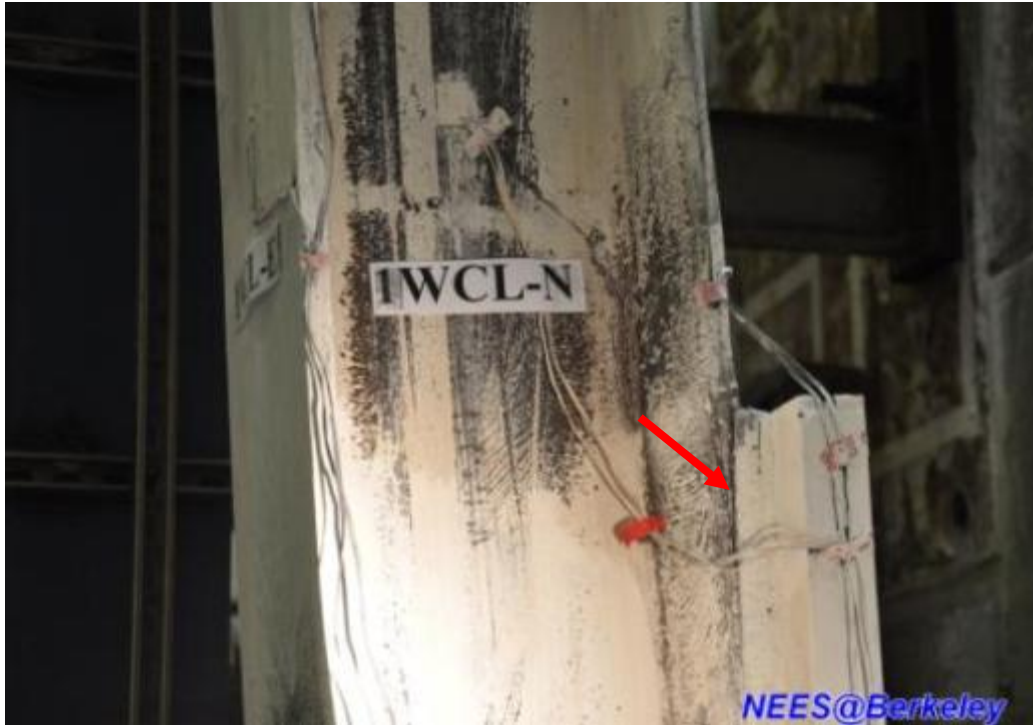
Figure 4.132 Specimen TCBF-B-2: additional tearing of fillet welds between cover plate and column flange.

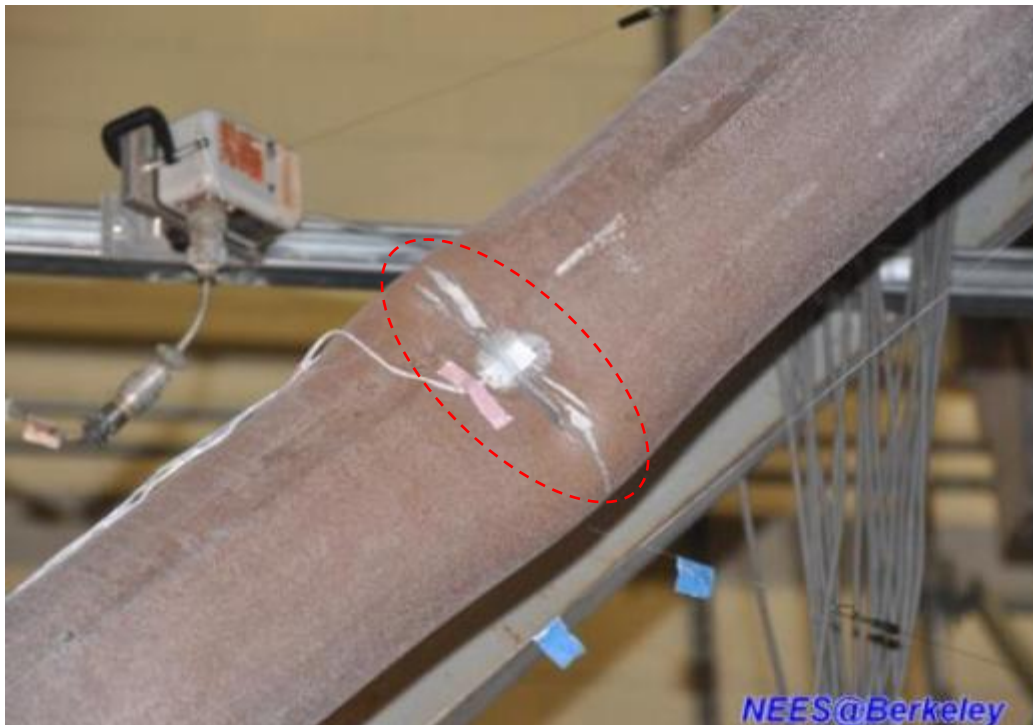
Figure 4.133 Specimen TCBF-B-2: partial fracture of first-story west-side brace.
