PACIFIC EARTHQUAKE ENGINEERING RESEARCH CENTER

Experimental and Analytical Studies on the Seismic Behavior of Conventional and Hybrid Braced Frames

PEER Report 2013/20
Pacific Earthquake Engineering Research Center
Headquarters, University of California, Berkeley

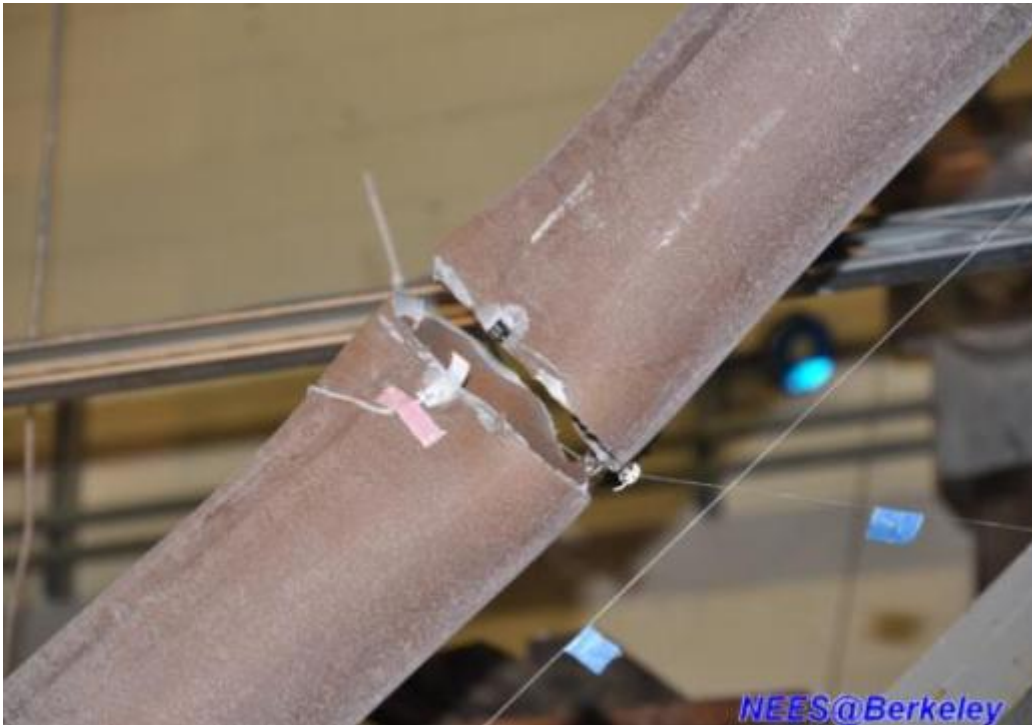
Figure 4.134 Specimen TCBF-B-2: complete fracture of first-story west-side brace.

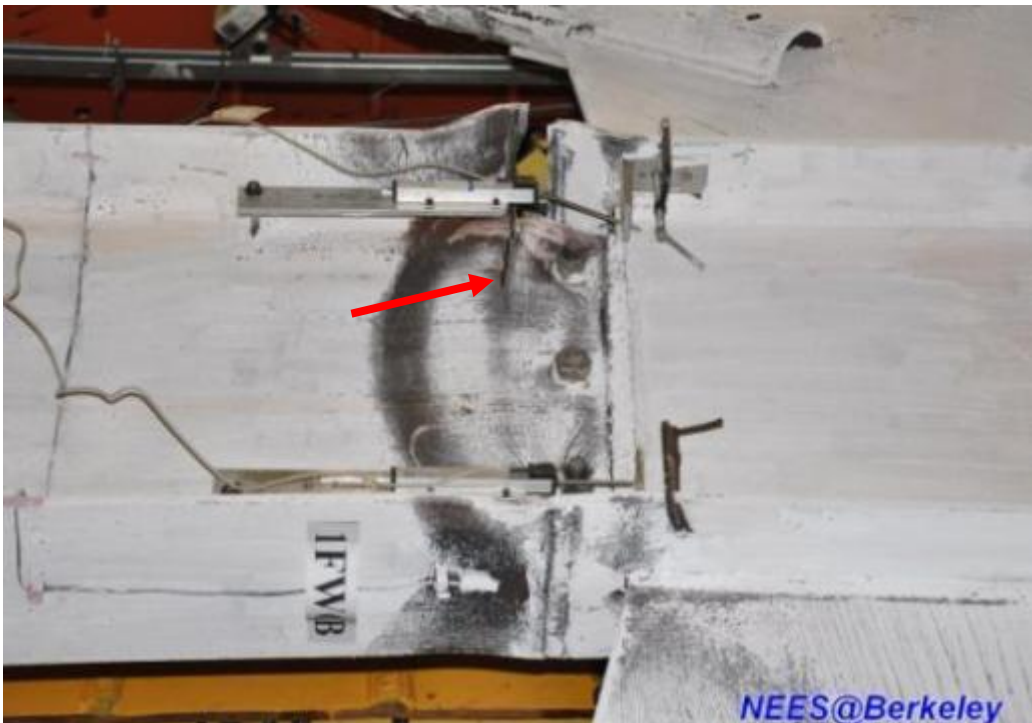
Figure 4.135 Specimen TCBF-B-2: crack in lower beam web at west-side near top flange.

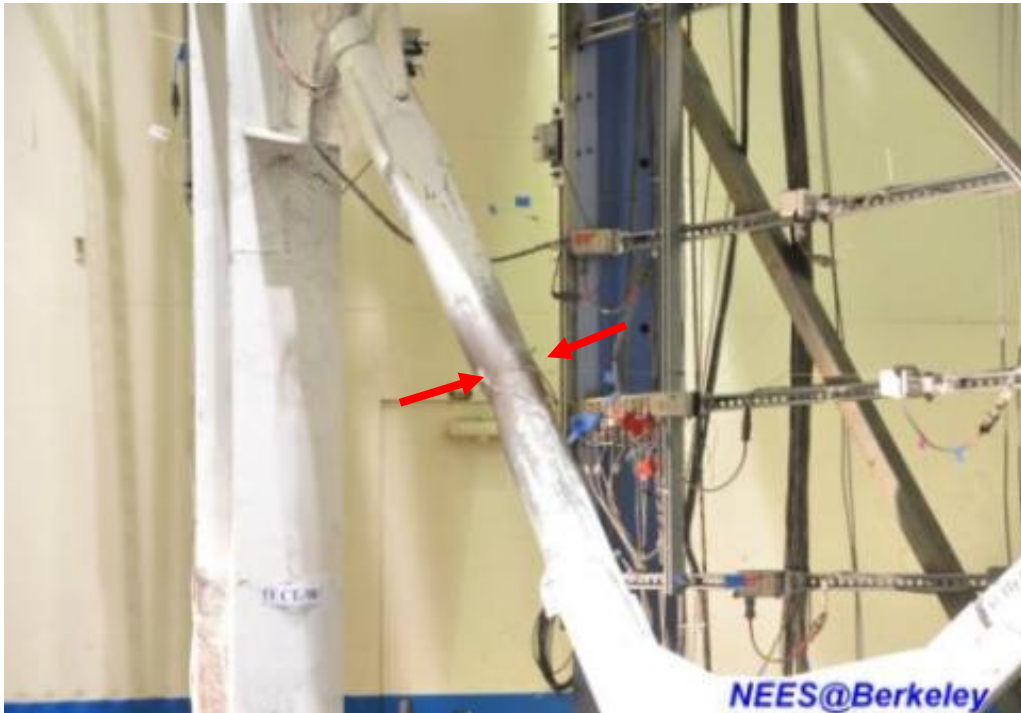
Figure 4.138 Specimen TCBF-B-2: necking of first-story east-side round HSS brace before fracture.

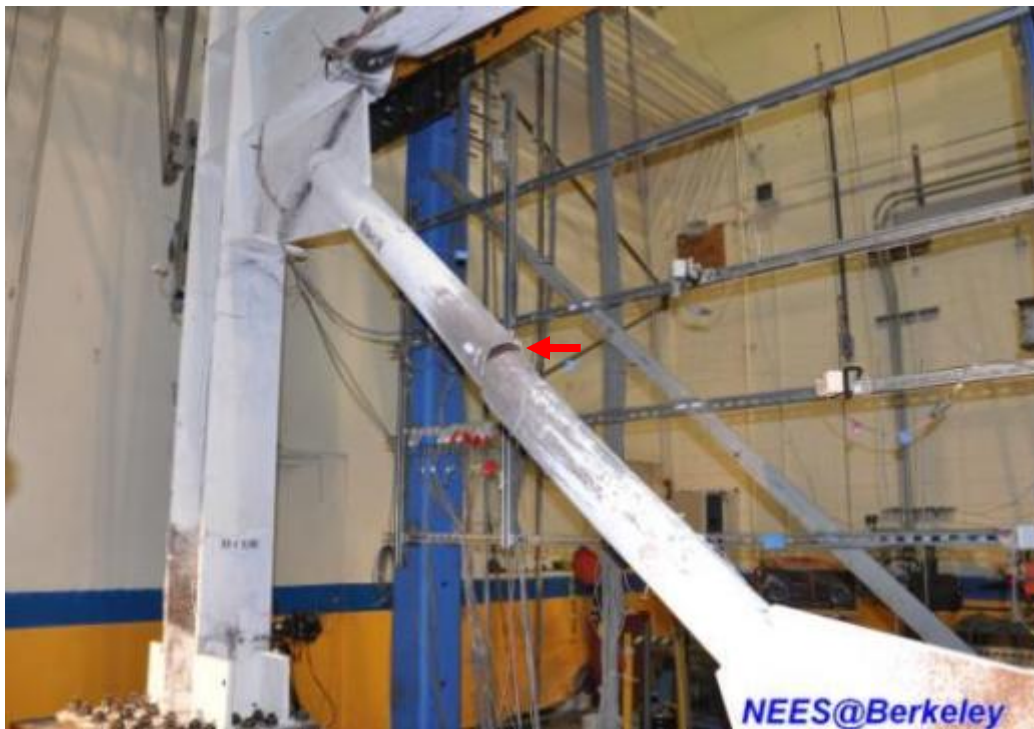
Figure 4.139 Specimen TCBF-B-2: complete fracture of first-story east-side brace.

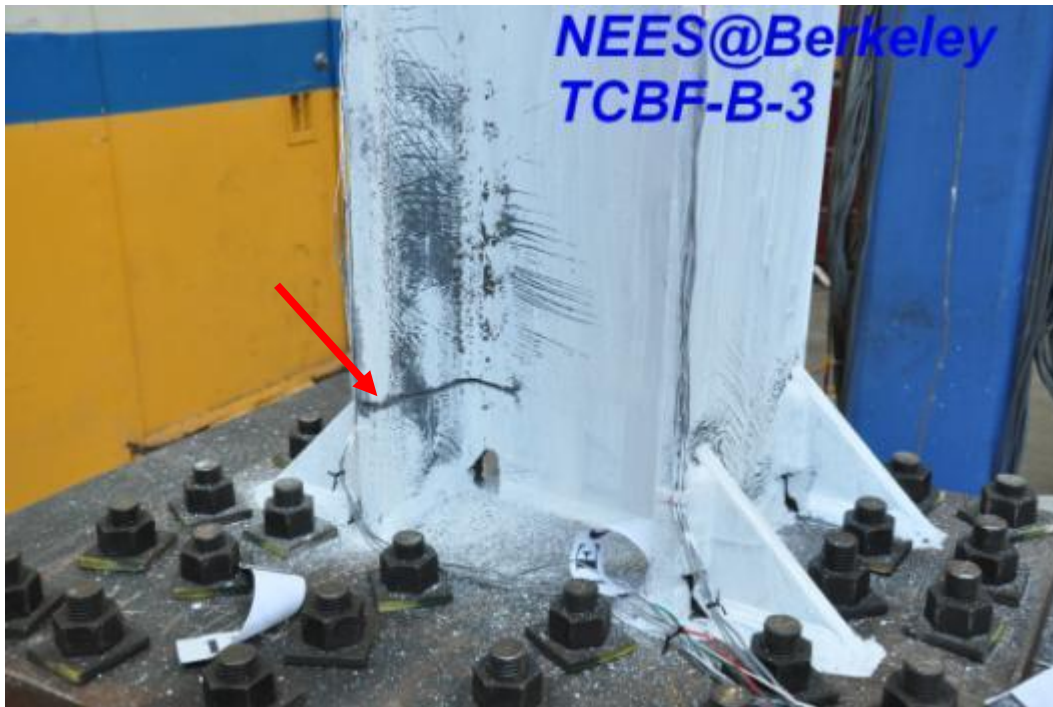
Figure 4.236 Specimen TCBF-B-3: east column flange fractured near base plate stiffeners (view from north-west side).

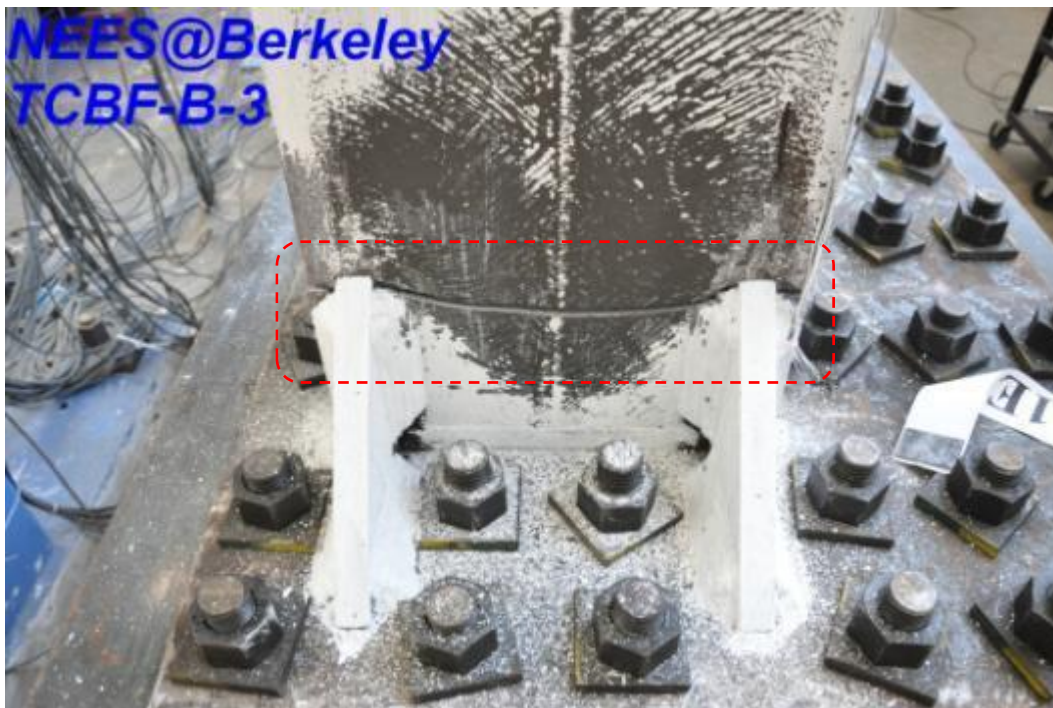
Figure 4.237 Specimen TCBF-B-3: east column flange fractured near base plate stiffeners (view from east side).

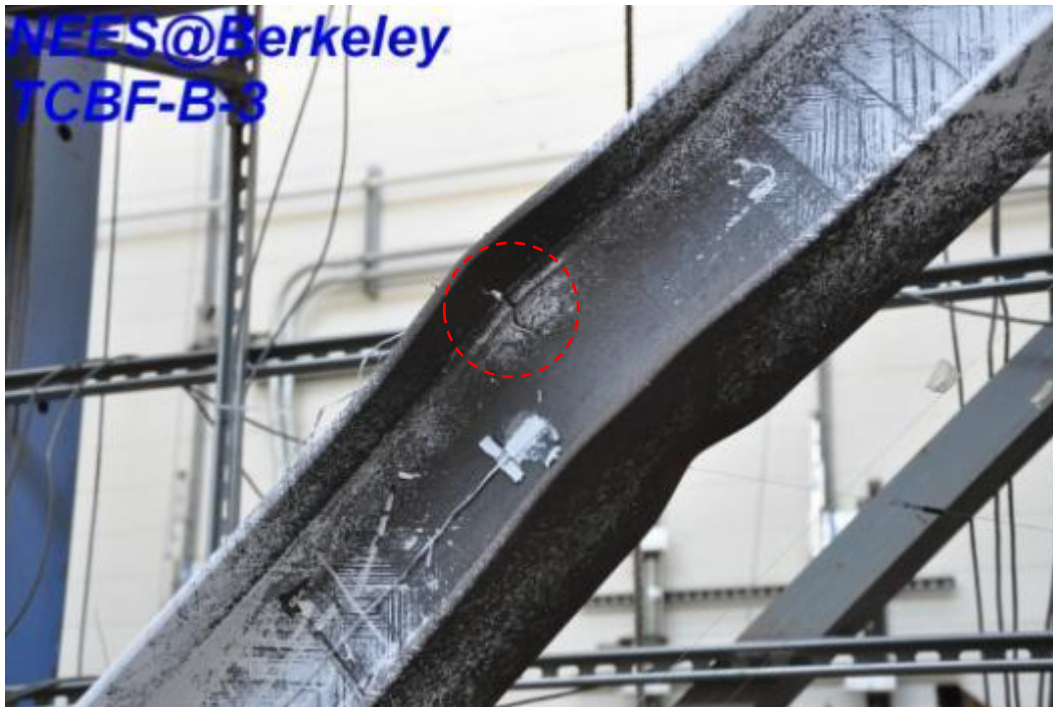
Figure 4.238 Specimen TCBF-B-3: west wide flange brace partially fractured near middle of the brace (view from north-west side).

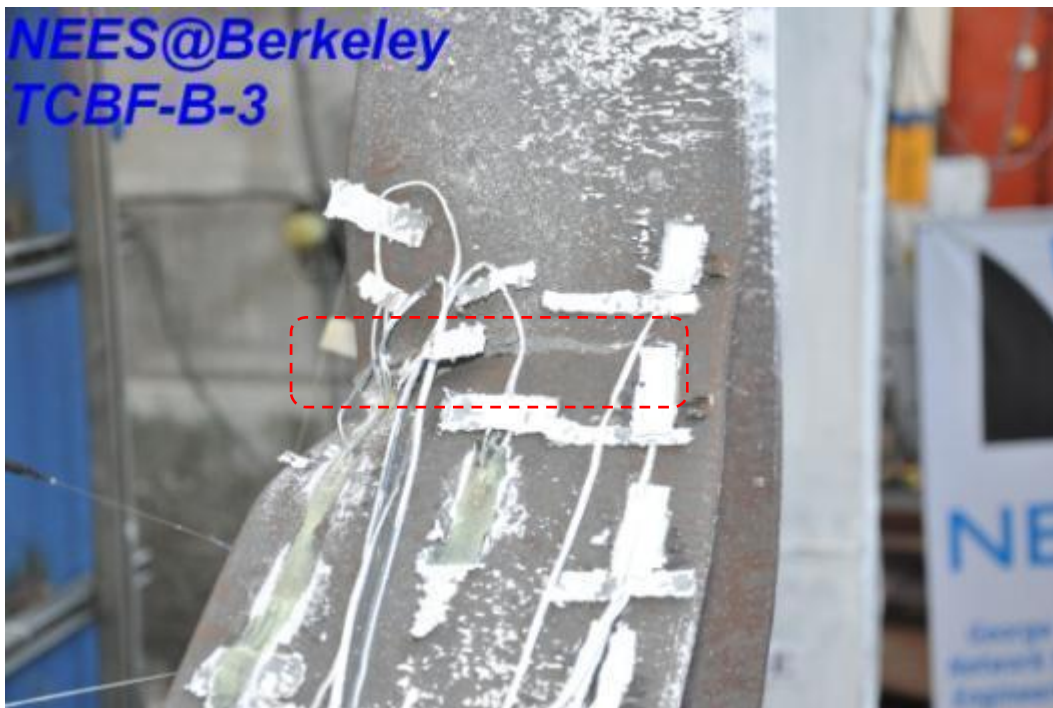
Figure 4.239 Specimen TCBF-B-3: west wide flange brace partially fractured near middle of the brace (view from east side).

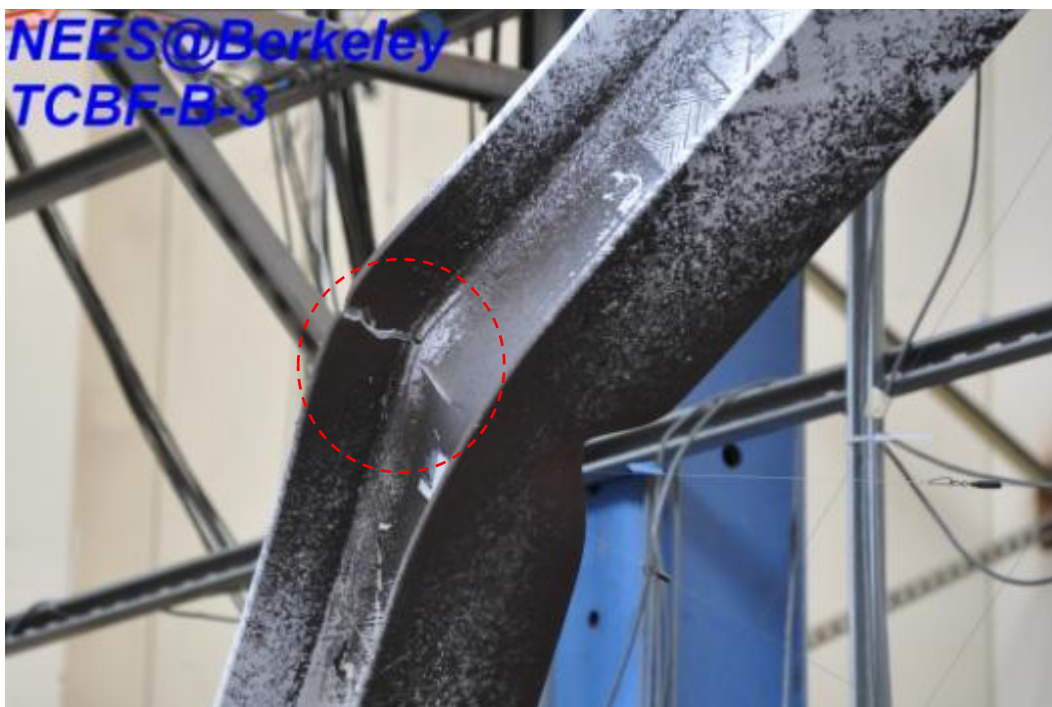
Figure 4.240 Specimen TCBF-B-3: top flange of the west wide flange brace completely fractured near the middle of brace (view from north-west side).

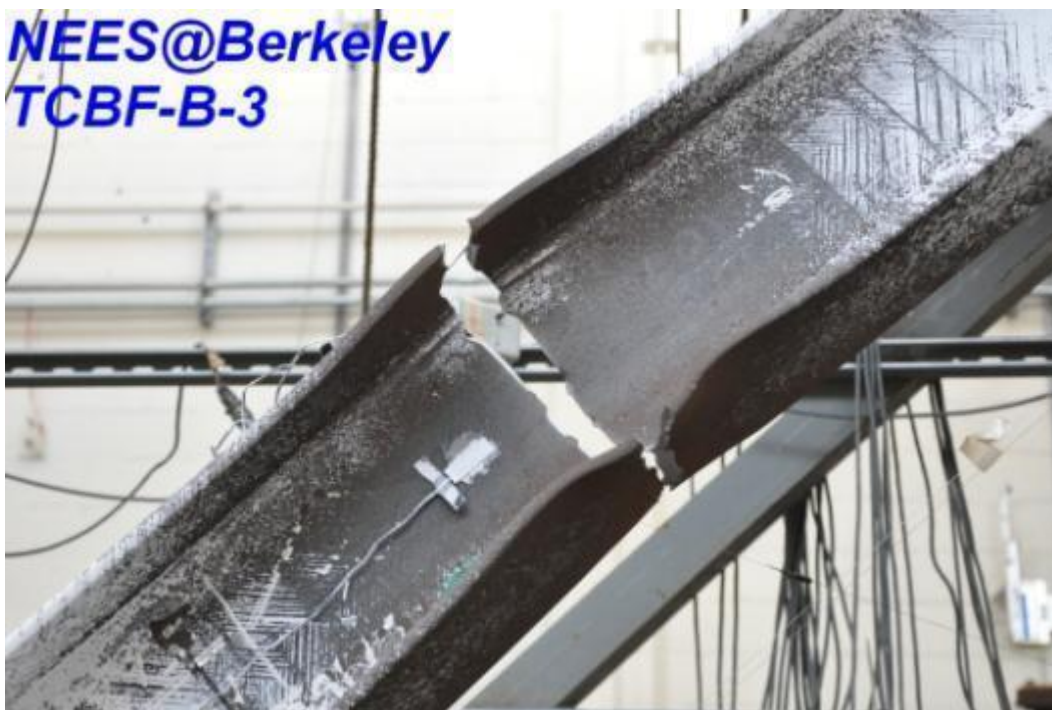
Figure 4.241 West wide flange brace completely fractured near the middle of the brace (view from north side) of Specimen TCBF-B-3.

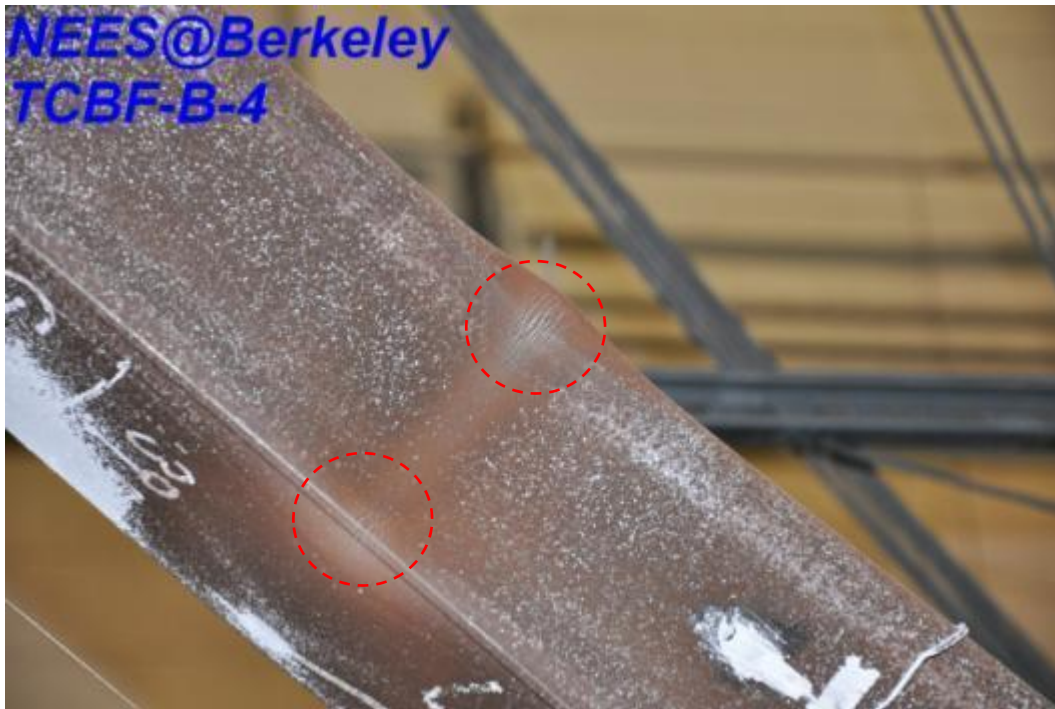
Figure 4.334 Cracks in the first-story eastern-side brace.

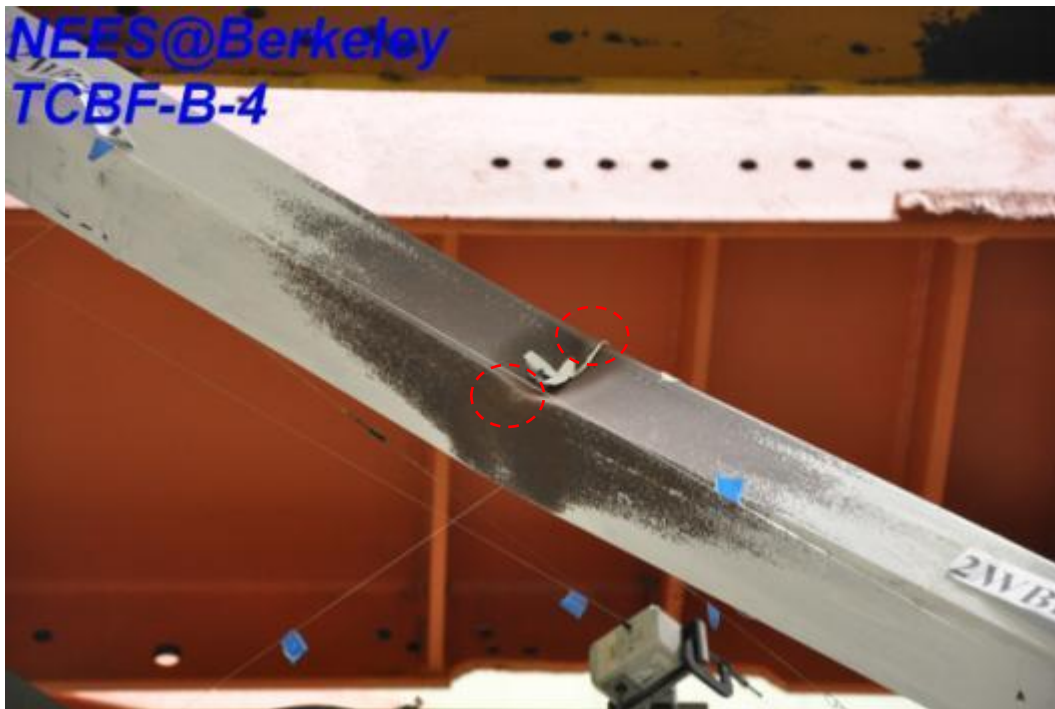
Figure 4.335 Cracks in the second-story western-side brace.

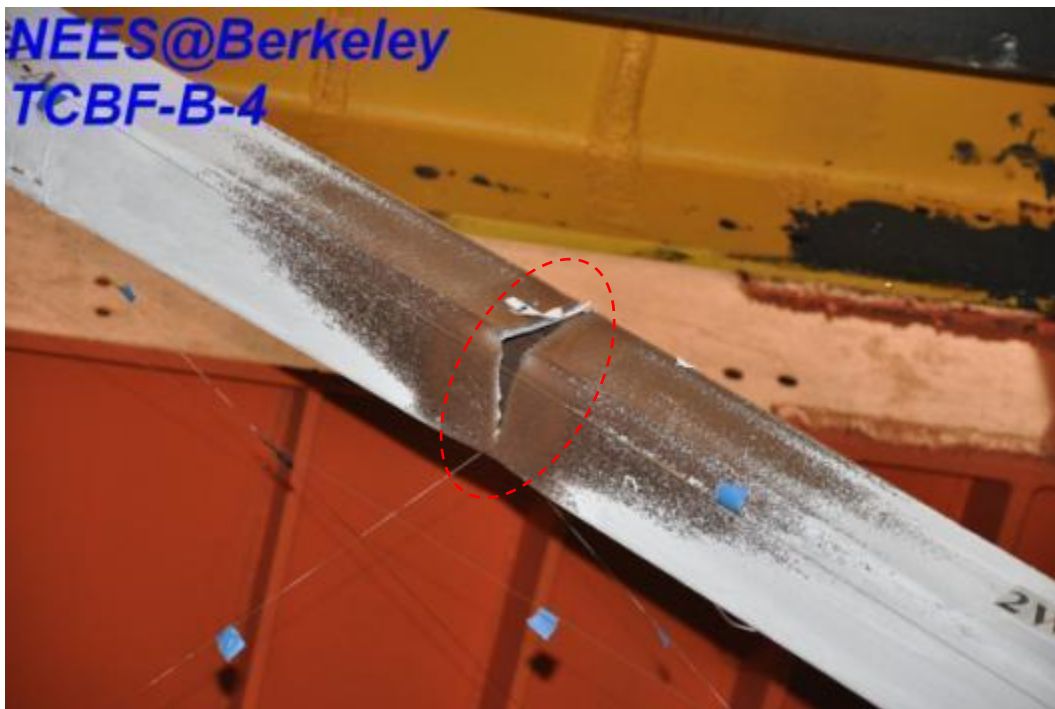
Figure 4.336 Crack propagation in the second-story western-side brace.

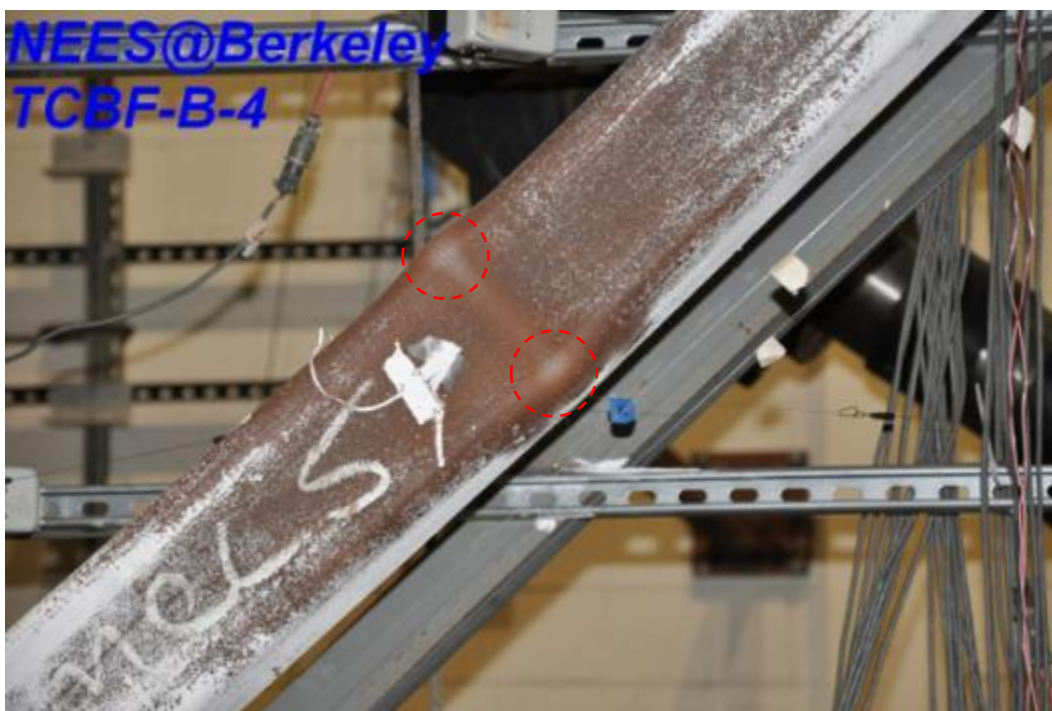
Figure 4.337 Cracks in the first-story western-side brace.

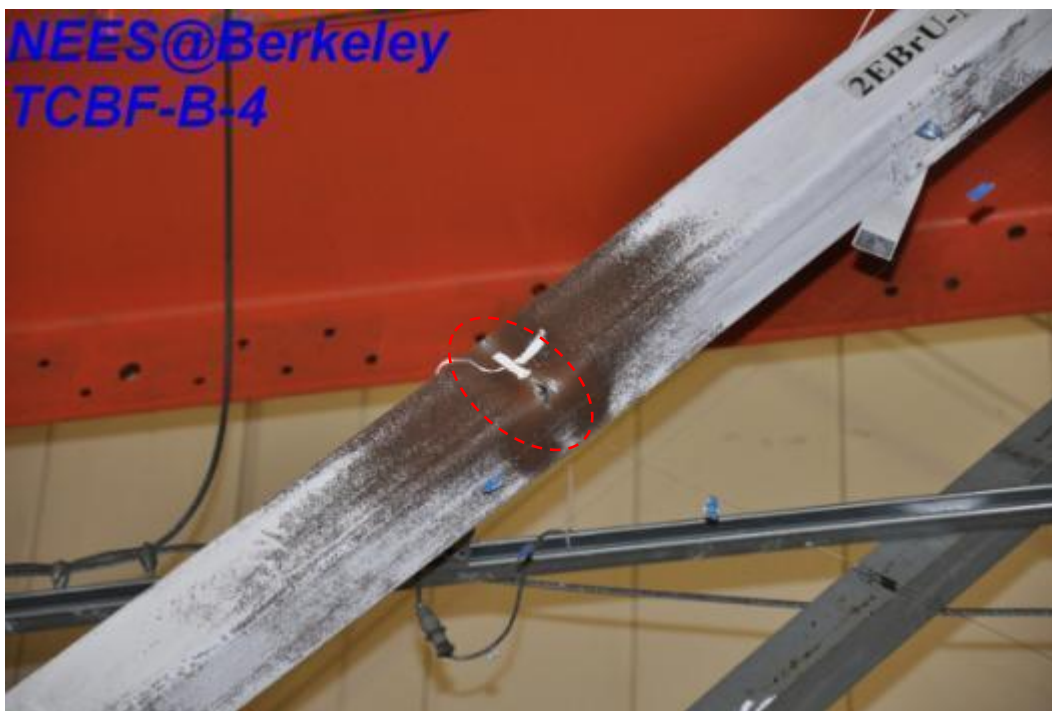
Figure 4.338 Cracks opening in the second-story eastern-side brace.

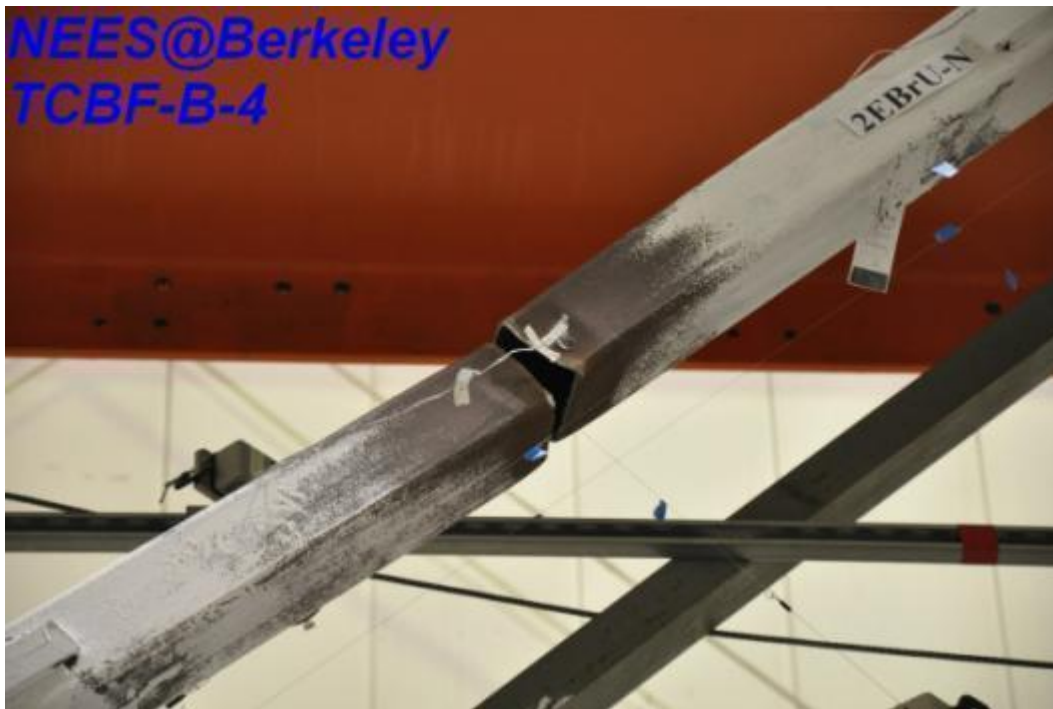
Figure 4.339 Complete fracture of the second-story eastern-side brace.

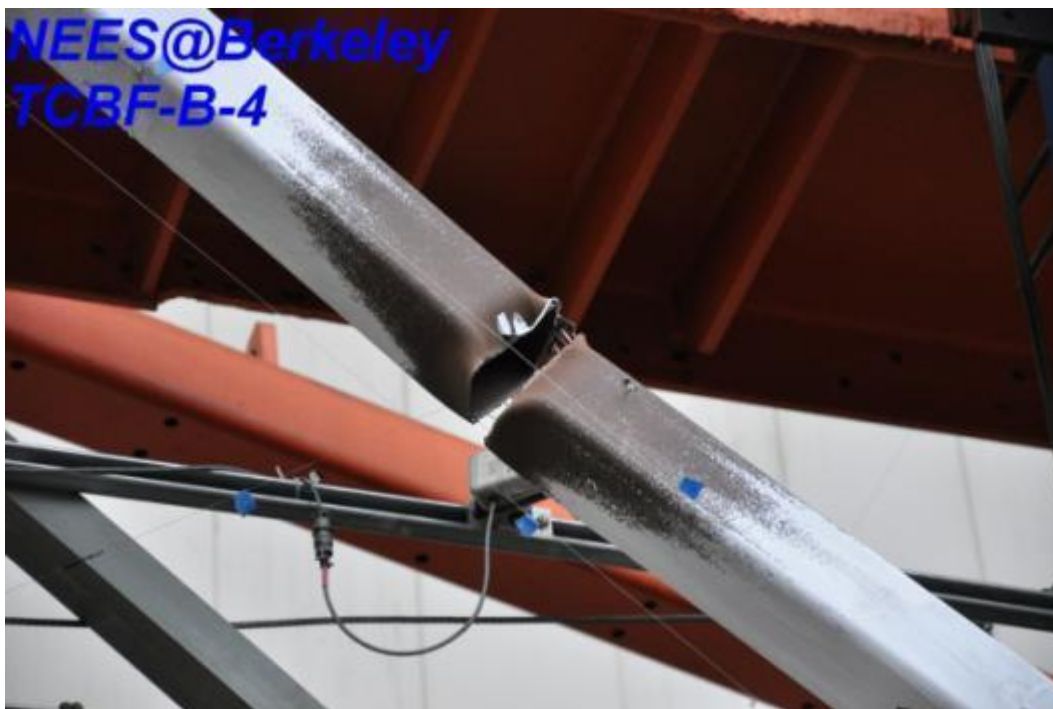
Figure 4.340 Complete fracture of the second-story western-side brace.

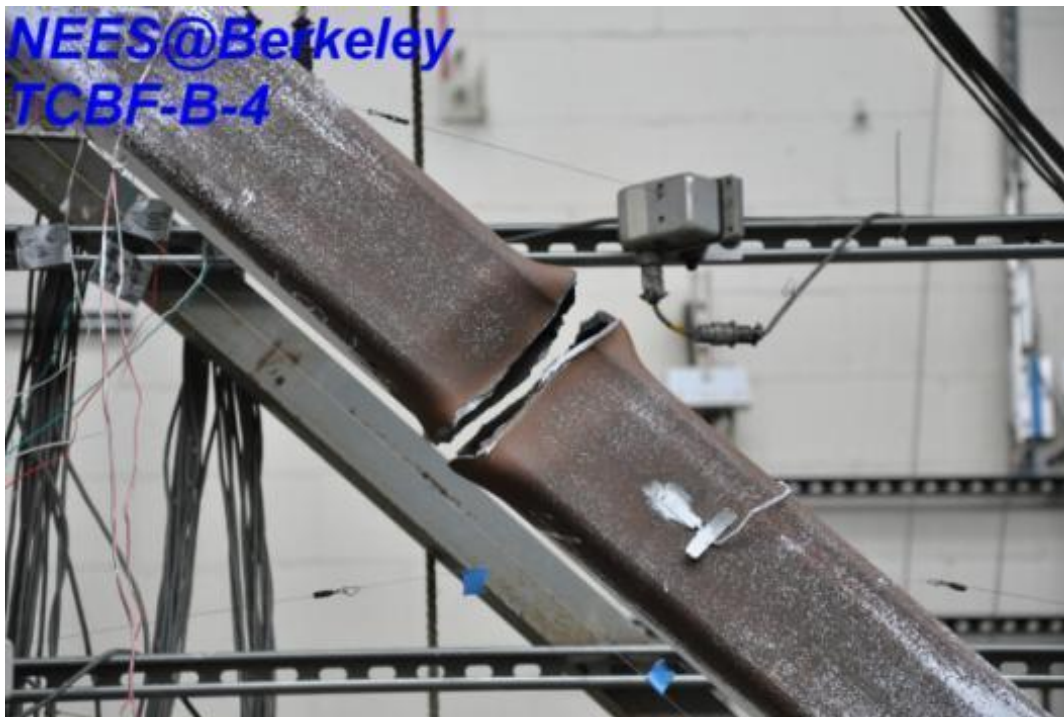
Figure 4.341 Complete fracture of the first-story eastern-side brace.

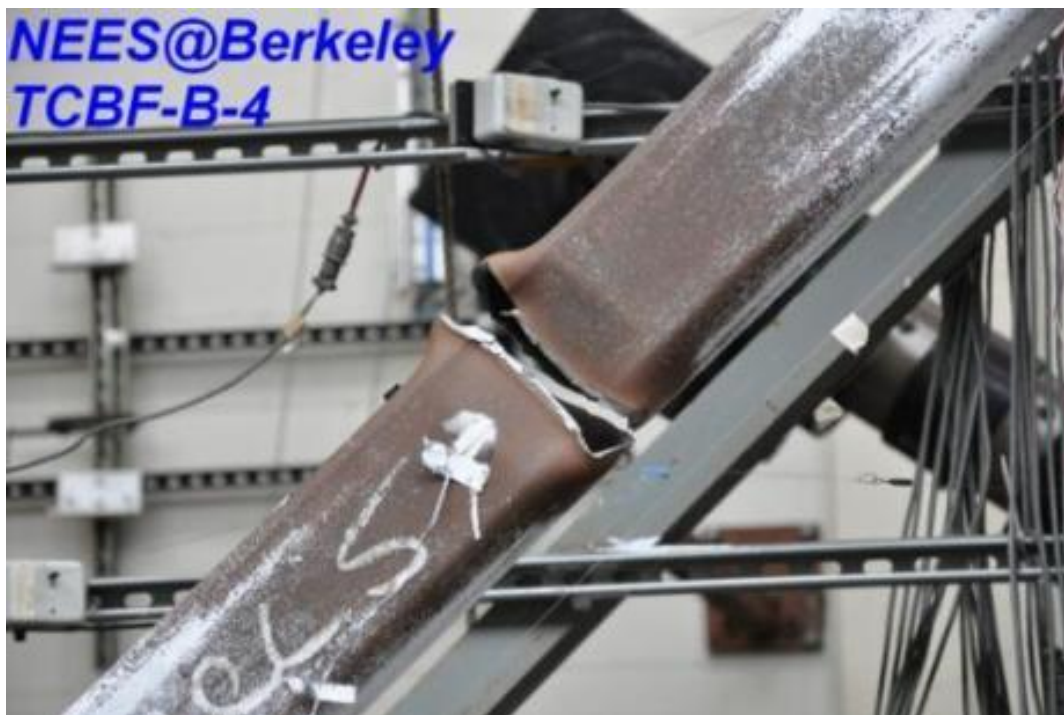
Figure 4.342 Complete fracture of the first-story western-side brace.

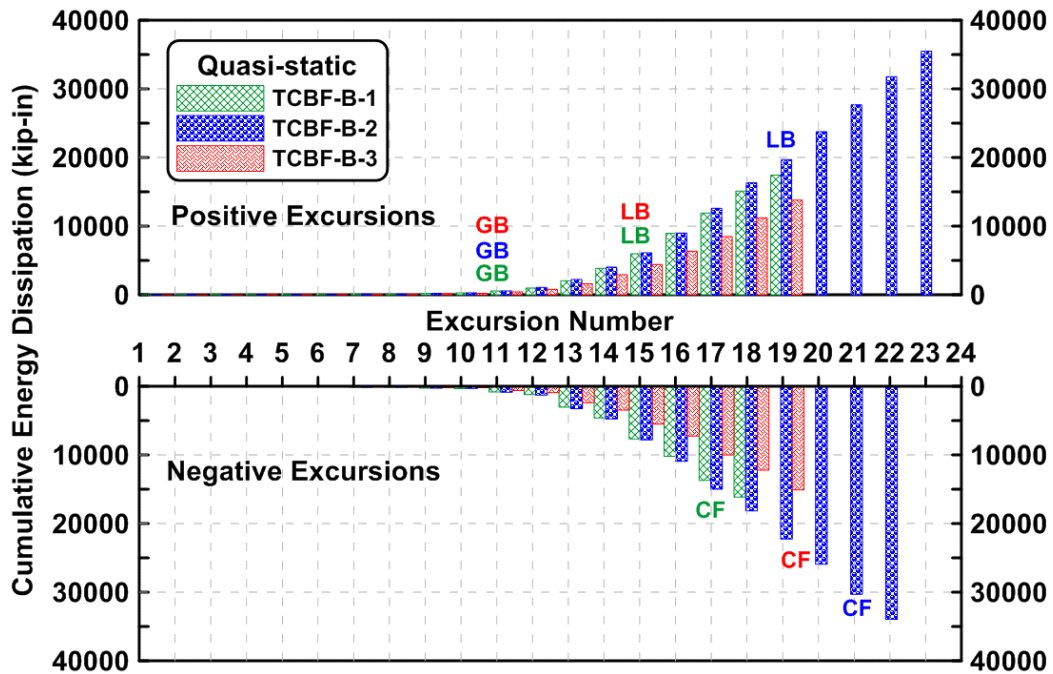
Figure 5.2 Total cumulative energy dissipation of each specimen (GB: global buckling, LB: local buckling, CF: first brace completely fracture).

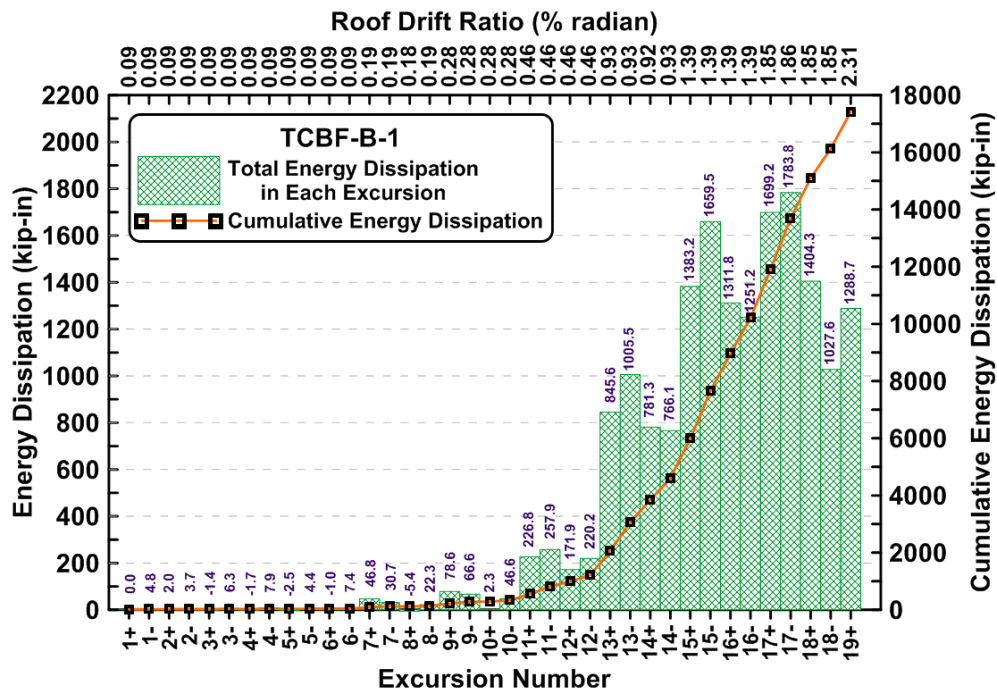
Figure 5.3 Specimen TCBF-B-1: total energy dissipation in each excursion and total cumulative energy dissipation.

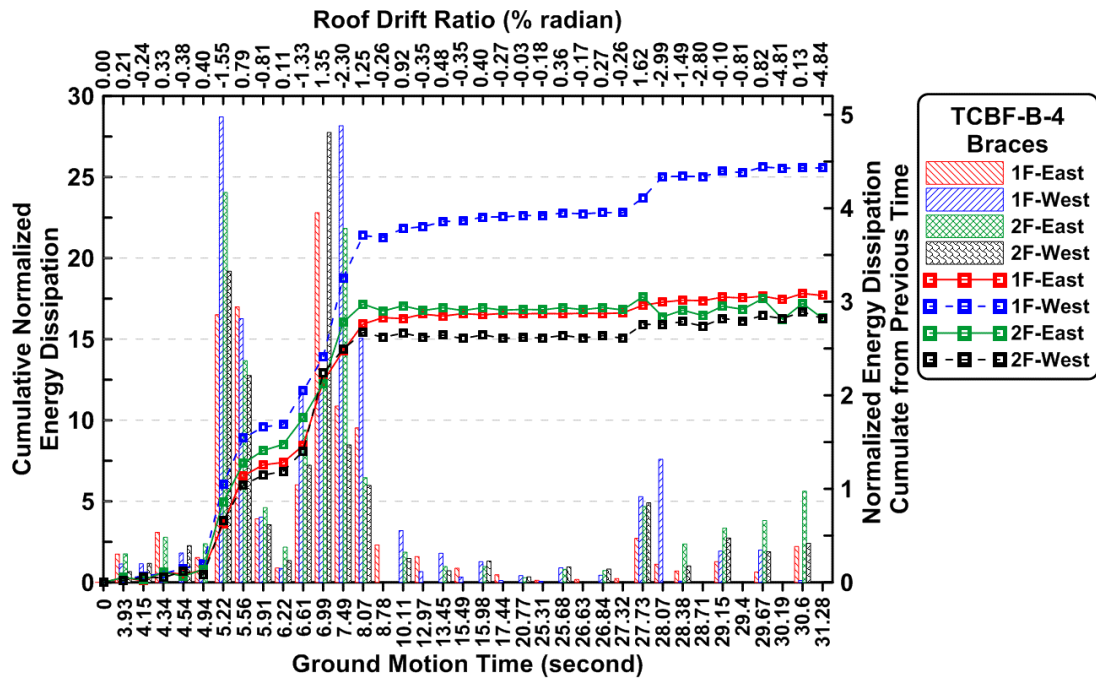
Figure 5.45 Specimen TCBF-B-4: brace cumulative normalized energy dissipation and normalized energy dissipation in each time segment.

Specimen Name	TCBF-B-4			
	1 st	2 nd	3 rd	4 th
Fracture Sequence				
Location	2F-East	2F-West	1F-East	1F-West
Ground Motion Time (sec.)	7.49	27.72	27.73	28.07
Roof Displacement at Fracture (in.)	-4.96	3.49	3.50	-6.45
Roof Drift Ratio at Fracture (% radian)	-2.30	1.62	1.62	-2.99
Brace Cumulative Plastic Deformation at Fracture (in.)	3.2	3.1	3.7	5.4
Brace Cumulative Normalized Energy Dissipation at Fracture	14.4	15.9	17.1	25.0

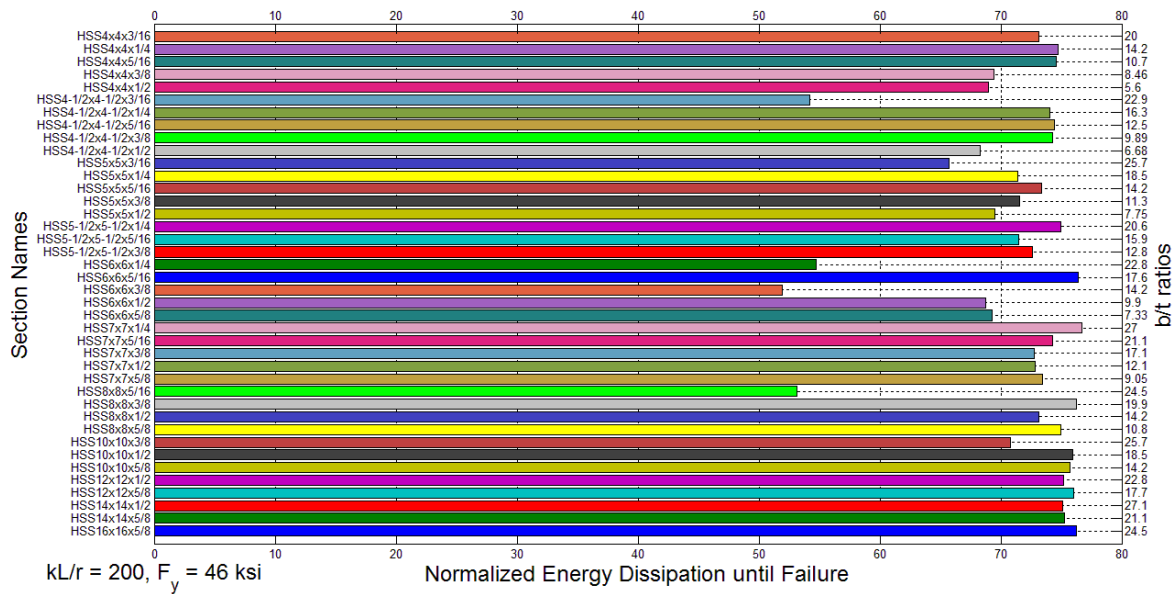
Figure 6.37 Normalized energy dissipation of selected square hollow structural sections until brace failure ($kL/r = 200$),

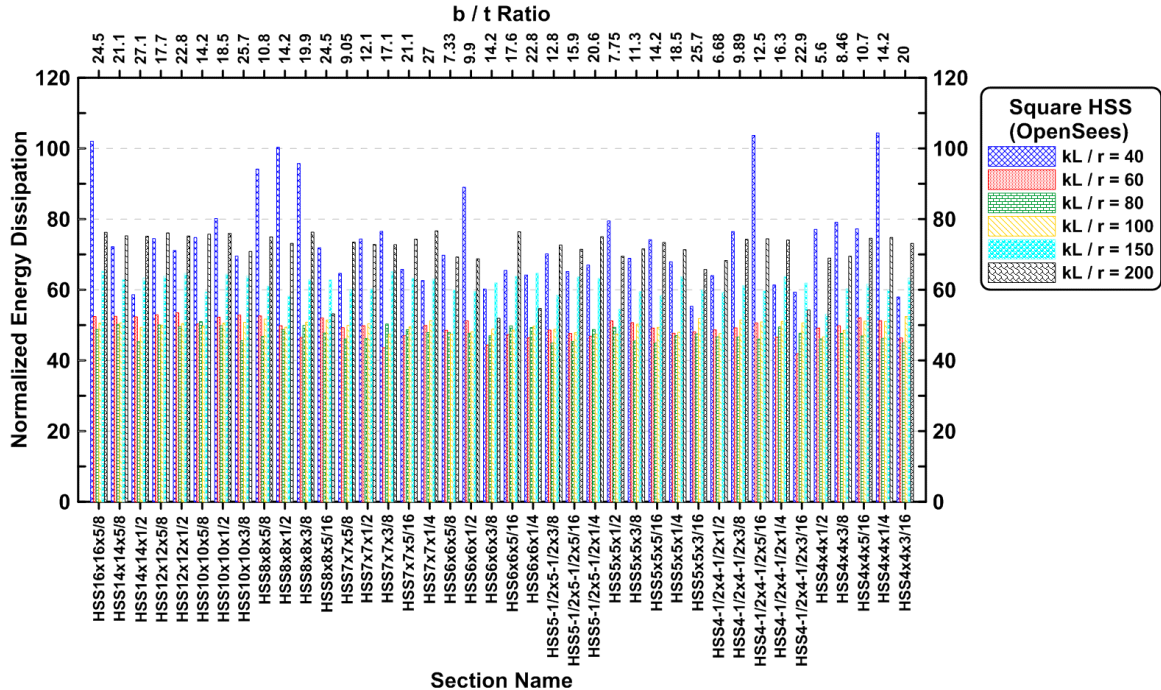
Figure 6.38 Normalized energy dissipation until brace failure of selected square hollow structural sections with different kL/r ratios.

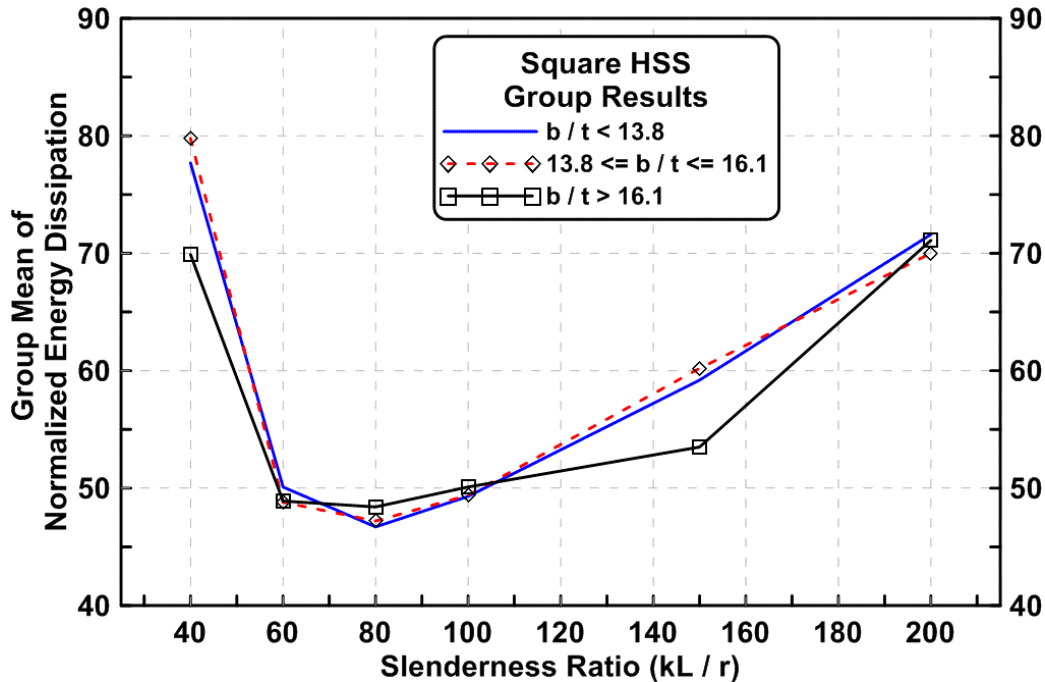
Figure 6.39 Group comparisons of normalized energy dissipation of selected square hollow structural sections with different kL/r ratios.

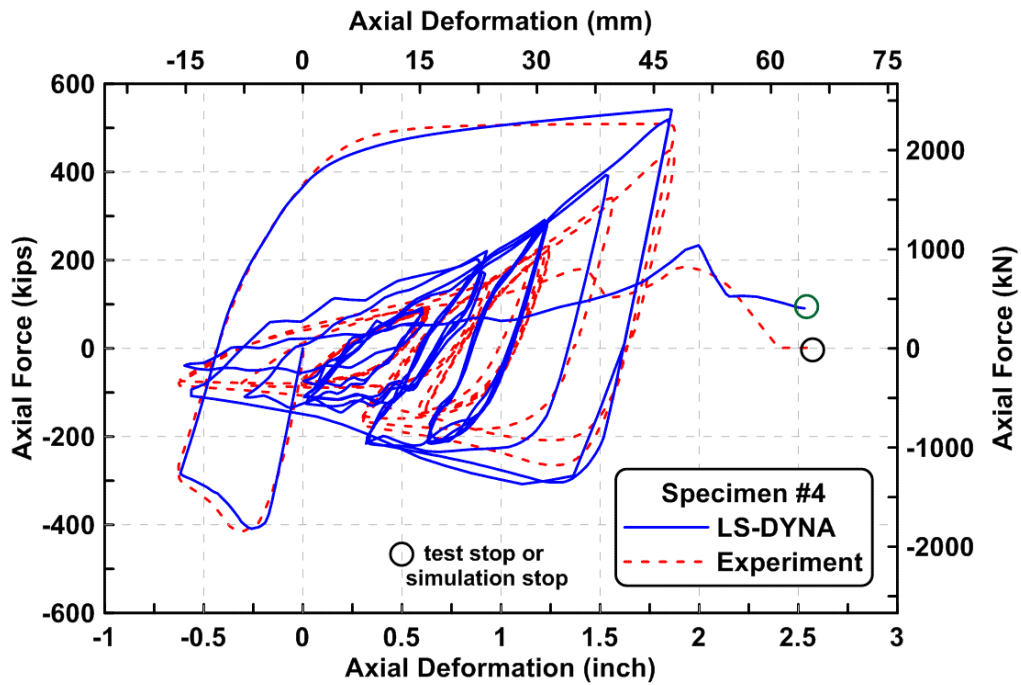
Figure 6.47 Axial force versus axial deformation relationship of Specimen #4 from experiment and LS-DYNA simulation.
