Experimental Study of Large Seismic Steel Beam-to-Column Connections

Egor P. Popov Shakhzod M. Takhirov

PEER 2001/01 NOVEMBER 2002

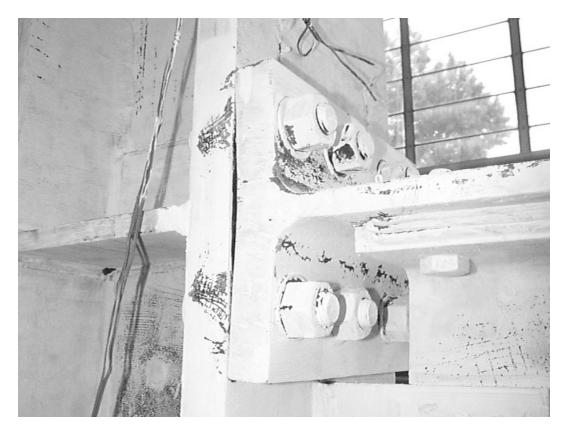
Figure 2-26. Specimen 2: residual gap opening in top T-section

At the end of the test a light buckle in the beam web and flanges was observed. The residual buckling in the beam flanges is shown in Figures 2-26 and 2-27.

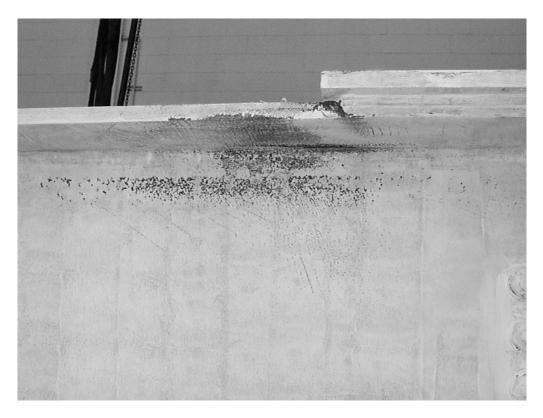
Figure 2-27. Specimen 2: top beam flange buckling
