EERI Reconnaissance Overview and Findings

Bret Lizundia, S.E.
EERI and Rutherford + Chekene, San Francisco

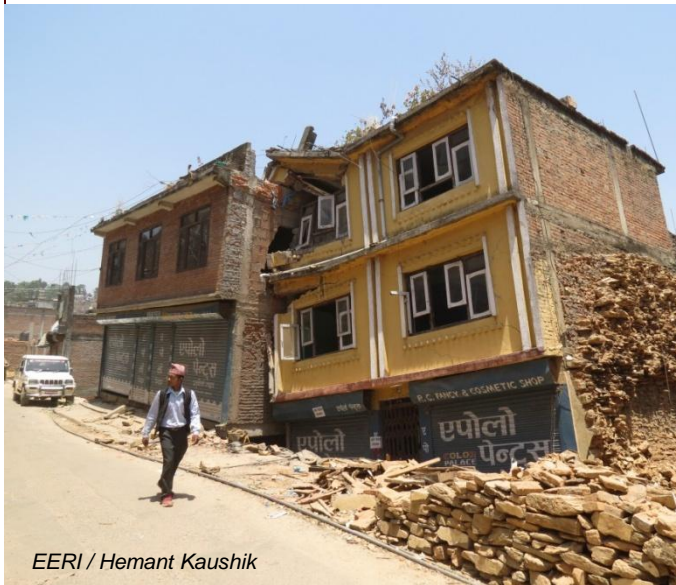
Chautara: 3-story

More damage to buildings on ridge tops - likely ridge top shatter/amplification effects

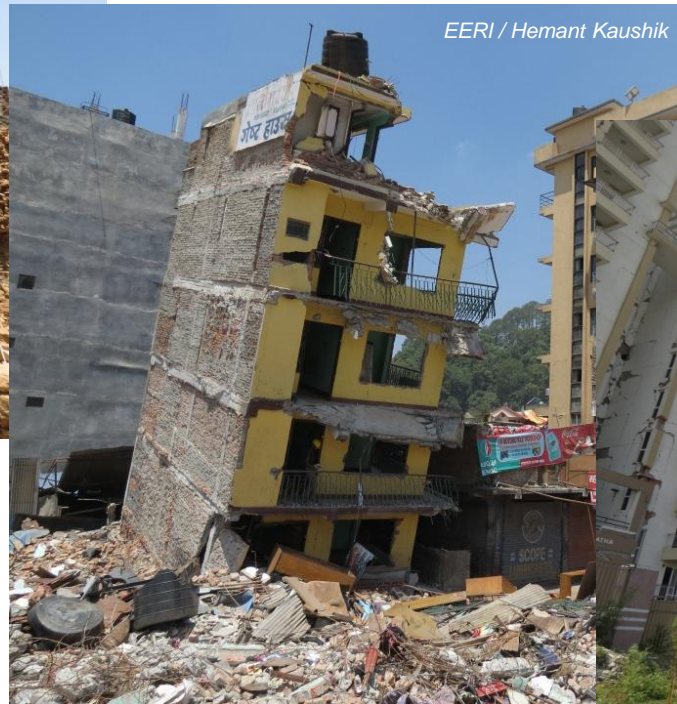
Balaju: 6-story

Less damage to infill walls in tilted buildings - walls completely intact in many cases

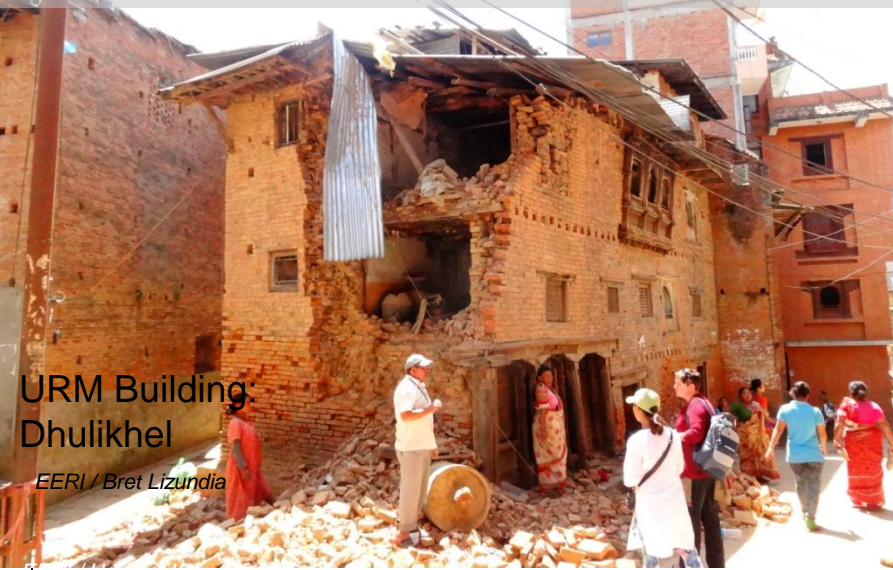
URM Building:
Dhulikhel
EERI / Bret Lizundia

- **URM Bearing Wall Buildings**
 - URM buildings performed worse than RC frame with masonry infill.
 - Poor quality construction and mud mortar performed noticeably worse.

- Typical damage includes wythe delamination, out-of-plane/in-plane/corner wall damage, roof/attic damage, and partial/total collapse.
 - Significant rebuilding of housing and repair/strengthening standards needed.

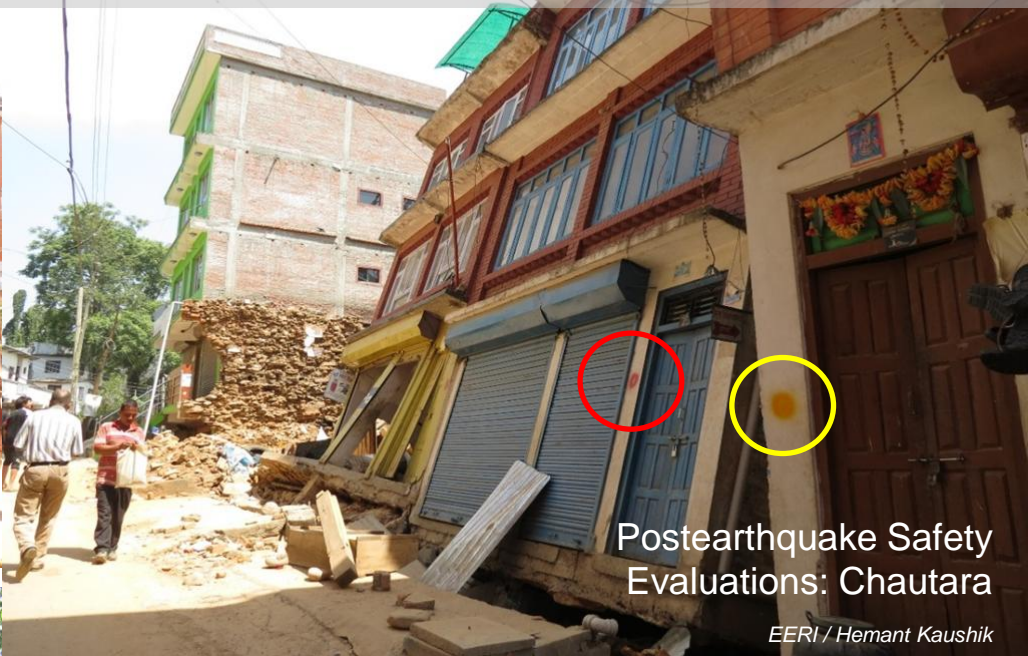
Postearthquake Safety
Evaluations: Chautara
EERI / Hemant Kaushik

- **Postearthquake Safety Evaluations**
 - Coordination between different organizations and quality assurance will be challenging.
 - Is the understanding of red and yellow tags clear to evaluators and public?

- Increase specificity and range of examples in guidelines.
- **Barricades/Shoring:** Realistic guidelines and effective implementation needed.
- **School Retrofits**

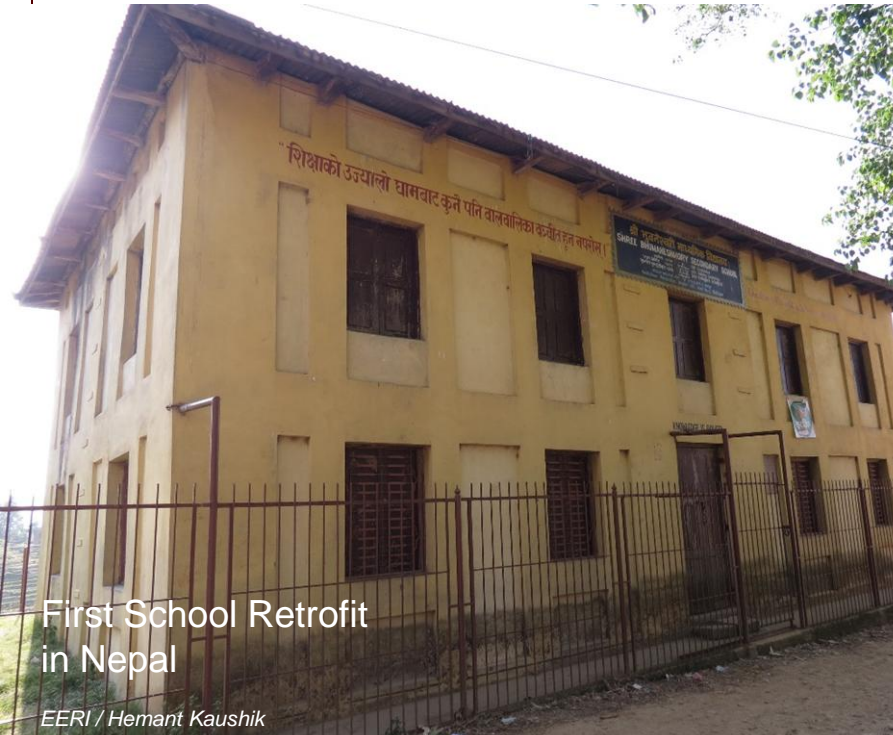
First School Retrofit
in Nepal
EERI / Hemant Kaushik

- The program should grow. There are many schools left to retrofit.
 - EERI would like more information to understand technical basis of approach.
 - Publish the design guidelines.

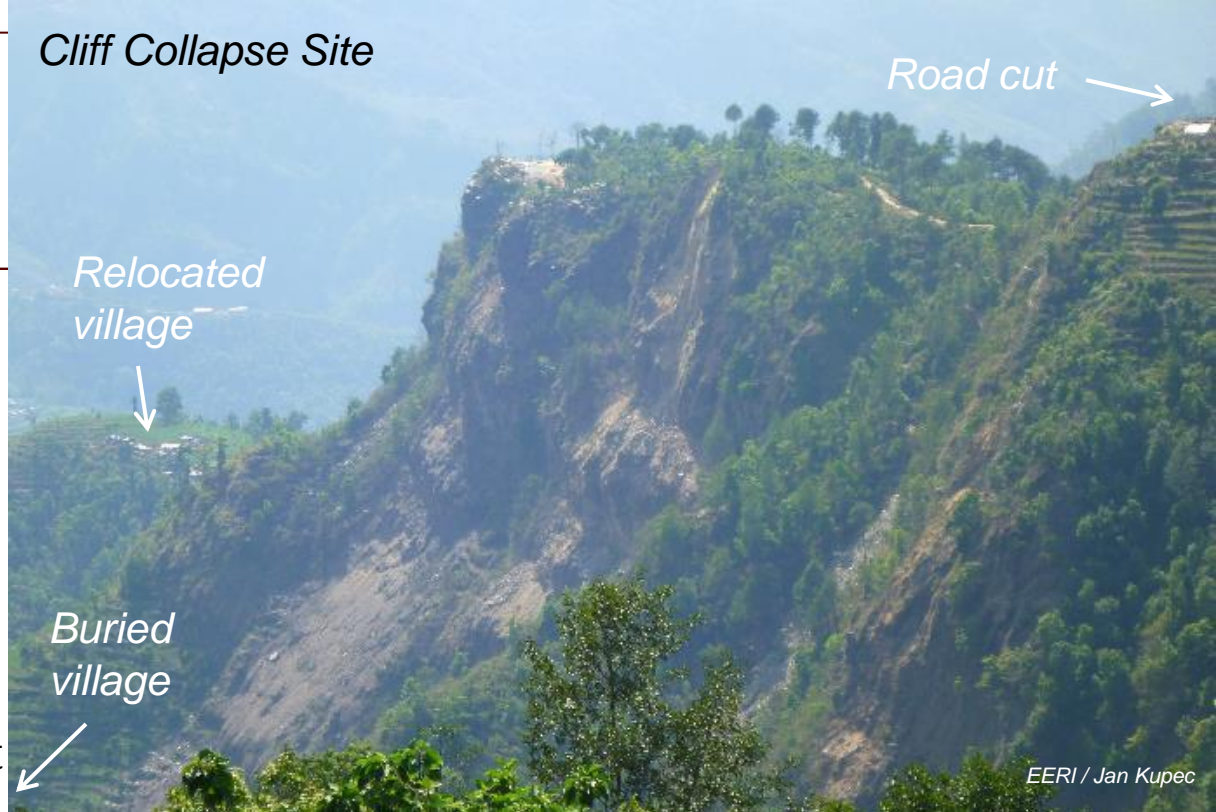
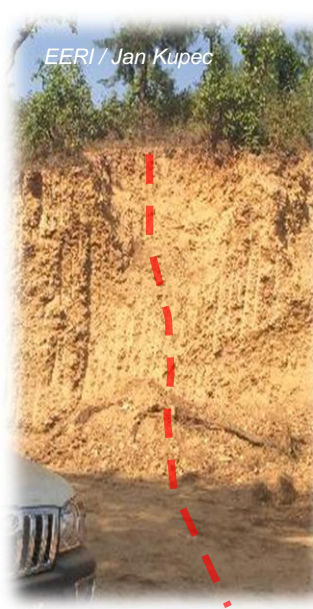
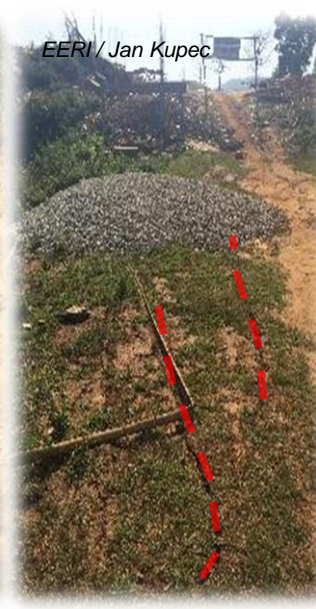
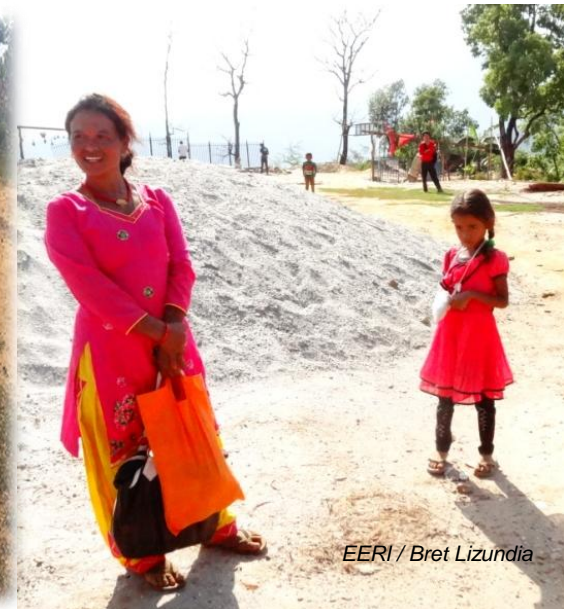
- Nepal has extensive landslides due to steep terrain.
- This cliff collapse buried a village.
- Village was relocated to a ridge spur.
- Cracking in recent road cut at top along ridge 15-25m back from cliff edge observed—potential future cliff collapse.
- EERI seeks to develop improved advice for postearthquake safety evaluation from landslide threats.

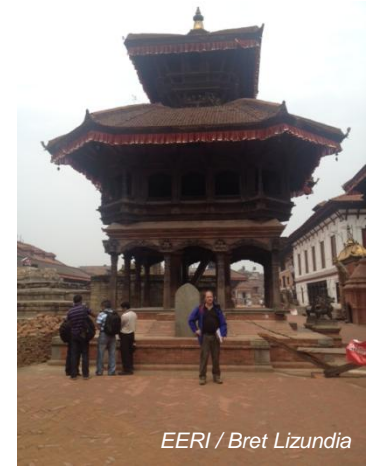
Chyasilin Mandap in Bhaktapur DS- seismically strengthened and undamaged

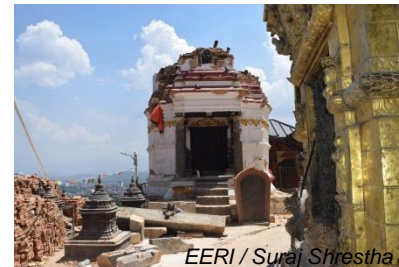
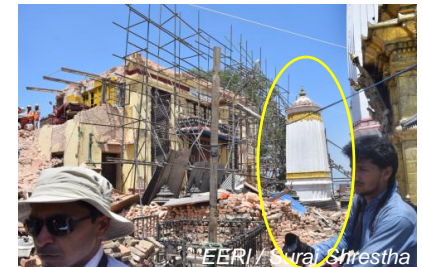
Similar Temples- Anantapur Temple (Superstructure collapsed) and Pratappur Temple (Plinth damage) of Swayambhu

- Pilot study vs. large program
- Repair guidelines (Norms/ Standards) needed
- Material testing warranted
- Strong motion instruments would help improve understanding of behavior
- Analytical modeling recommended
- Shake table testing of repair, retrofit solutions
- Quality assurance and peer review
- Research studies on underlying reasons of good and bad performance needed to verify effectiveness of local traditional technology and materials

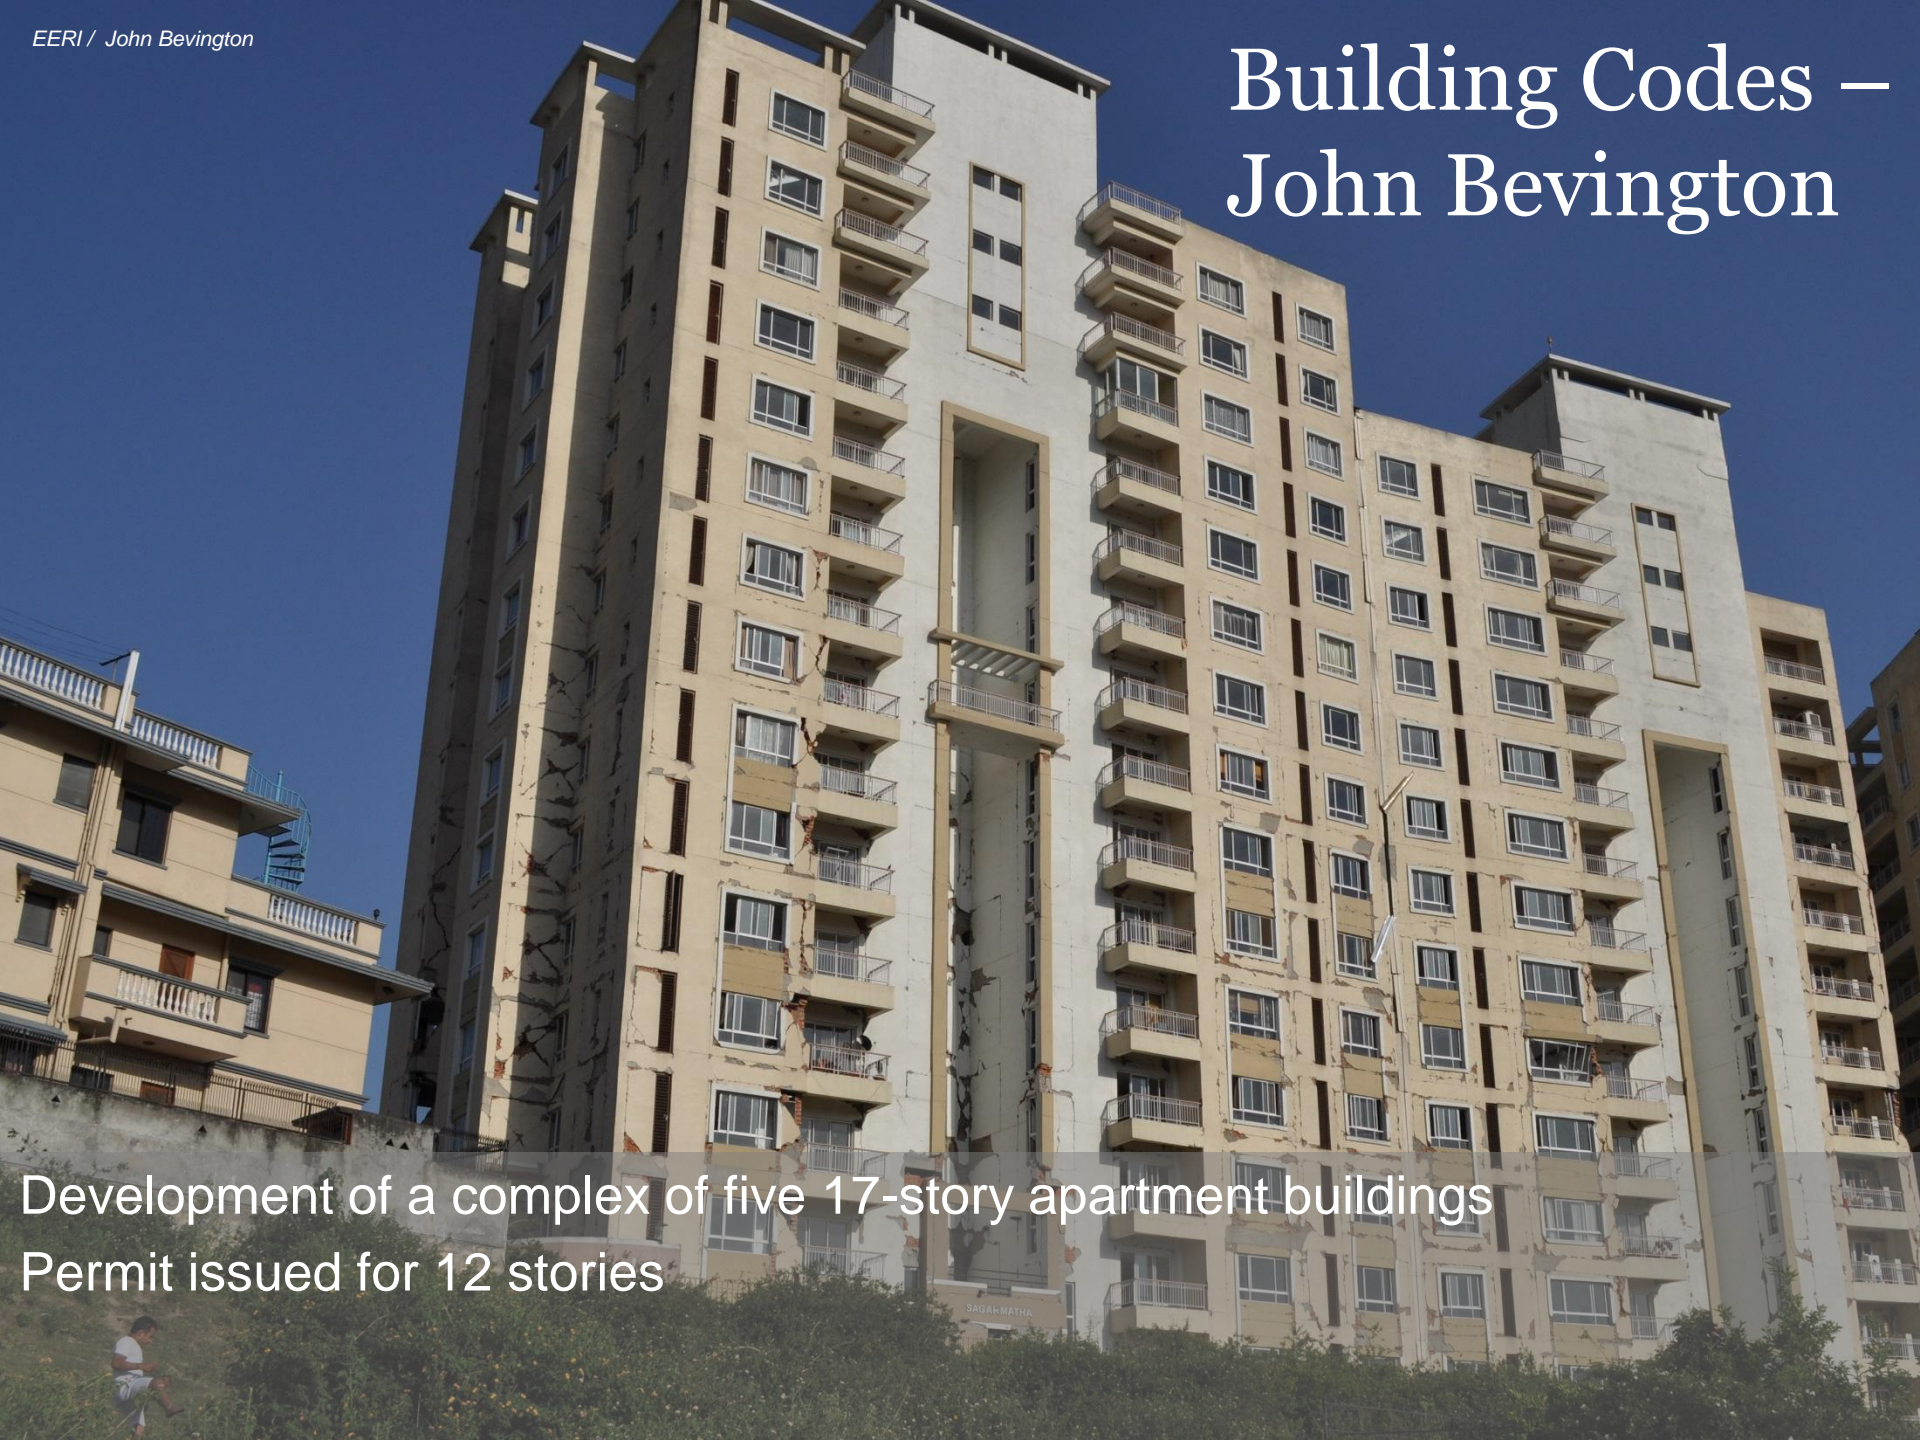
Development of a complex of five 17-story apartment buildings
Permit issued for 12 stories

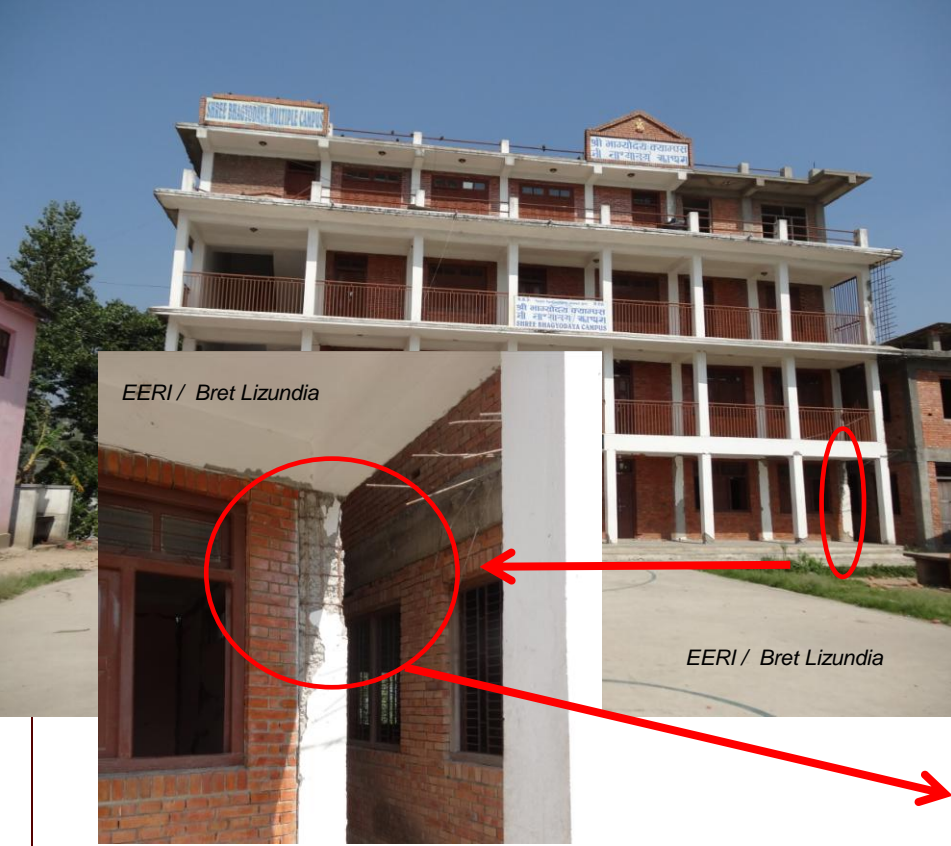
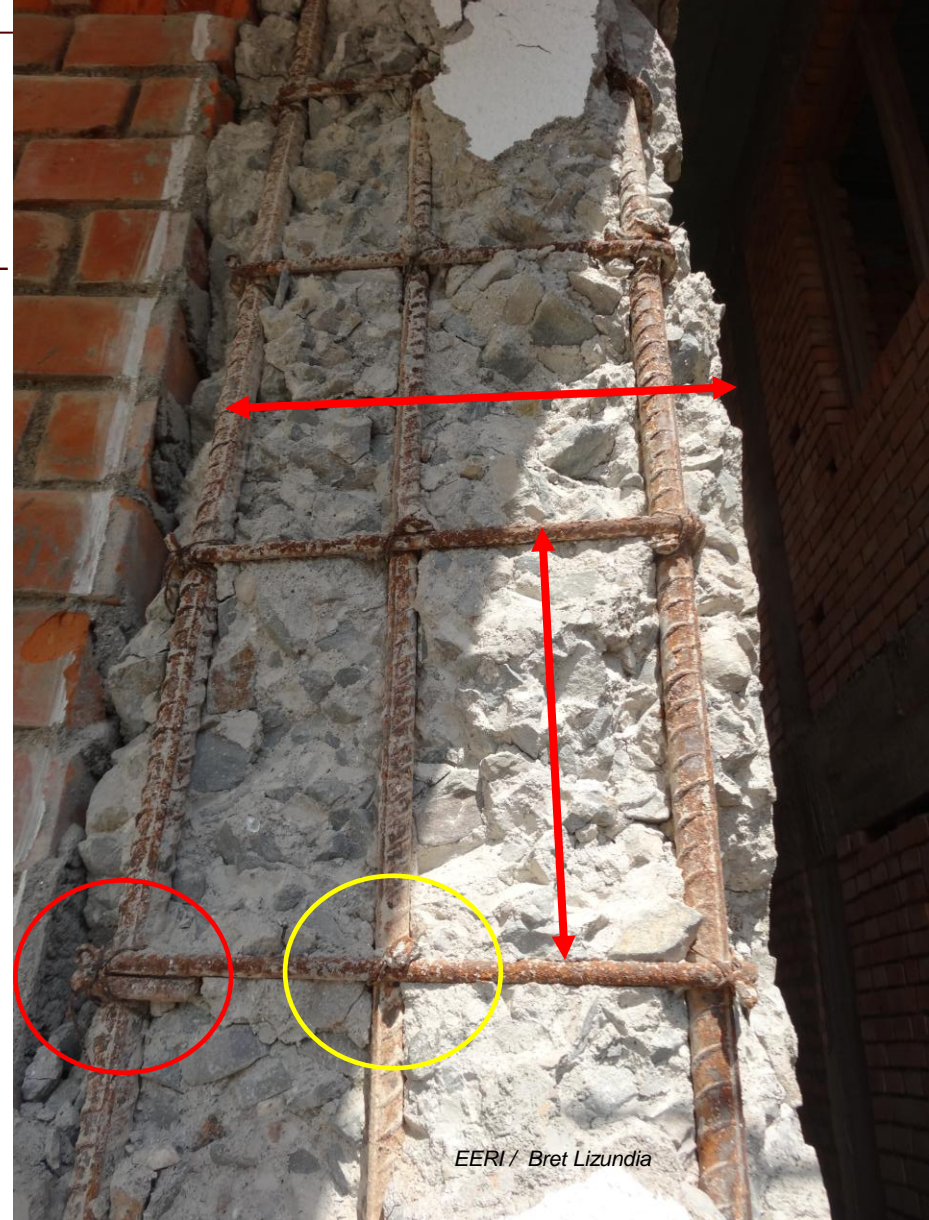
Inappropriate detailing of concrete reinforcement
Nonductile concrete with 90 degree hooks, wide tie spacing and no cross-ties on middle vertical longitudinal bar

- Building codes exist, yet adequacy, adoption and compliance are key issues.
- There are a number of potential areas for improvement and an update to the code is planned
- Evidence of code compliance is very low throughout country, especially outside of Kathmandu.
- There is heightened awareness since the earthquakes of the need to adopt the Nepal National Building Code.
 - Need to act quickly to capitalize on this.
- Awareness was increasing, even before the earthquakes, thanks to activities by organizations such as NSET.
 - Public policy needs to increase in tandem.
- Several international initiatives have been established to increase adoption and monitor compliance of codes.
 - Many initiatives are ongoing – a positive sign.
- Lessons learned from LFE reconnaissance mission have enhanced the ongoing EERI Housner Fellows Program investigation into code compliance issues in Nepal.
