PACIFIC EARTHQUAKE ENGINEERING RESEARCH CENTER

Performance of Beam to Column Bridge Joints Subjected to a Large Velocity Pulse

PEER Report 2002/24
Pacific Earthquake Engineering Research Center
College of Engineering
University of California, Berkeley
April 2002

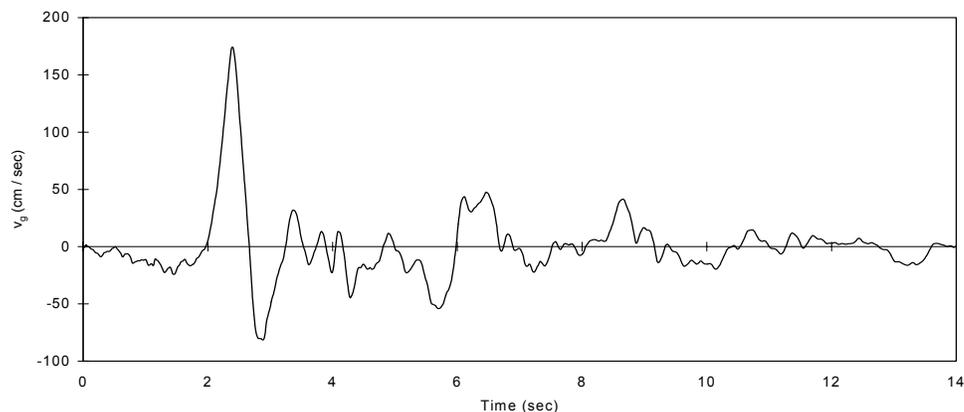
Fig. 2.1 Velocity Pulse — Rinaldi Recording Station, 1994 Northridge earthquake

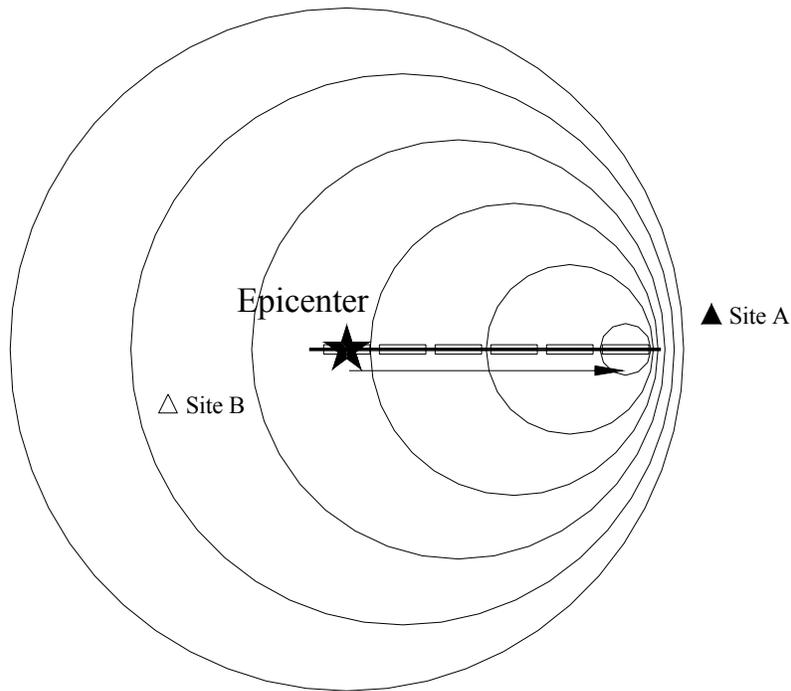
Fig. 2.2 Directivity pulse accumulates as rupture propagates to right

A main issue of concern for structures in the near field of an earthquake is the directivity effects of the slipping fault. Somerville (1997), Hall (1998) and others have studied and quantified the characteristics of near-fault ground motions. When a fault rupture propagates toward a site at a velocity close to that of the shear wave velocity, an accumulation of most of the energy of the seismic radiation of the fault can arrive at the site as a single long-period pulse. This is called a directivity pulse. The directivity pulse can be explained using a model first suggested by Abrahamson (1998) shown in Figure 2.2. The rupture is broken into subfaults; beginning at the epicenter, the rupture propagates along the fault in the direction of the arrow toward Site A. Because the velocity of the shear waves is close to the rupture velocity, the energy of the forward direction arrives within a short time period. Forward directivity effects only occur when the rupture propagates toward the site, and the direction of slip on the fault is aligned with the site. Not all near-fault locations will experience forward rupture directivity effects in a given event. It can be seen by the model that the Site B will experience a lengthening of the time between the arrival of the waves; thus the record at Site B will have a long duration but not a velocity pulse.

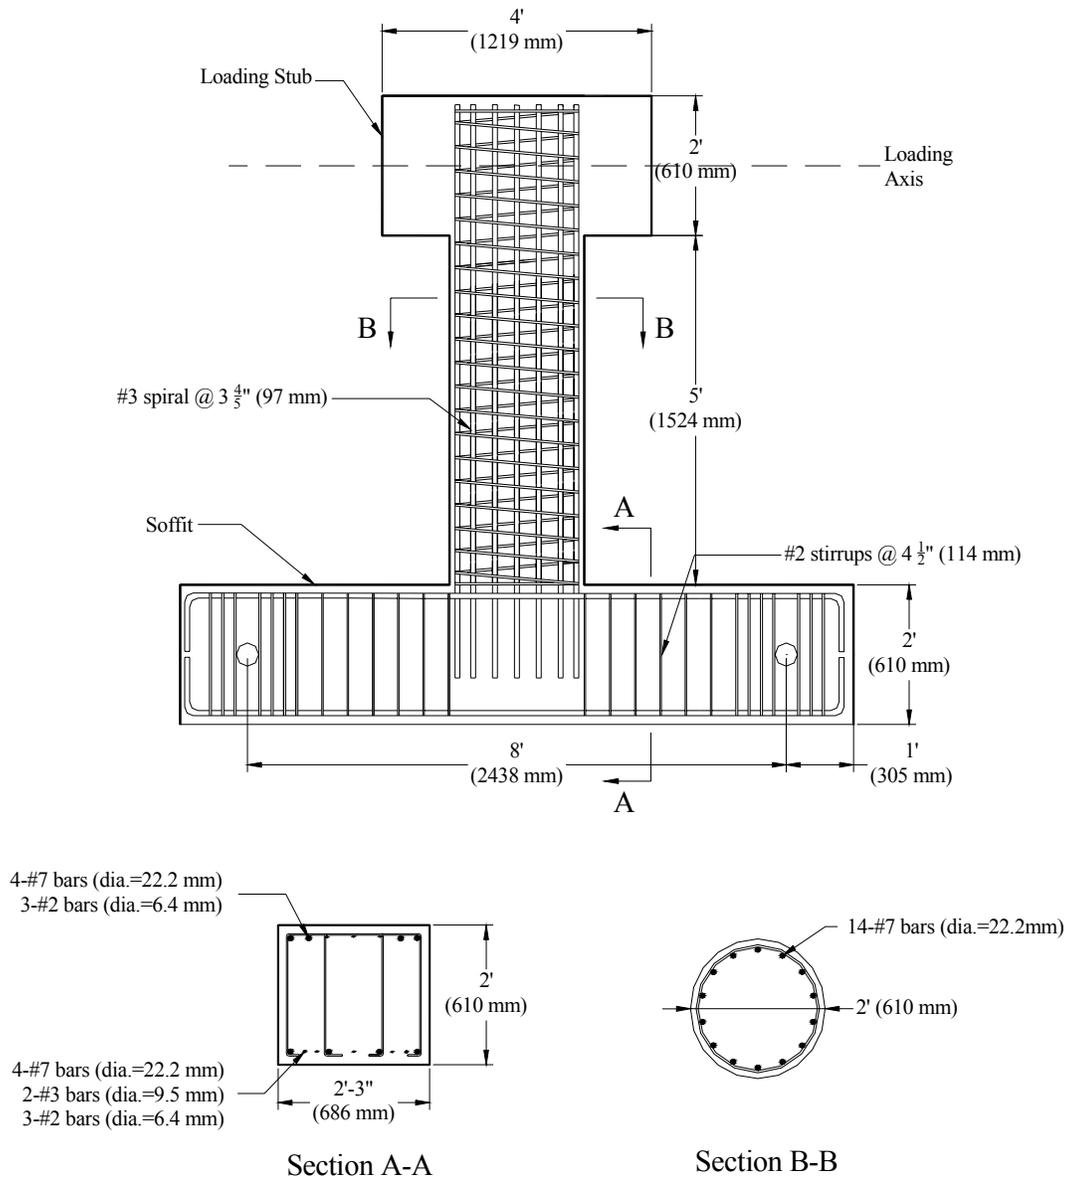
Fig. 3.1 Pre-1971 design reinforcement details (units 3, 4)

stirrups were provided at a spacing of 114 mm (4-½ in.). Similar to the prototype, no joint reinforcement was provided. The column spiral ended at the soffit face, and the transverse stirrups in the beam ended at the column face.

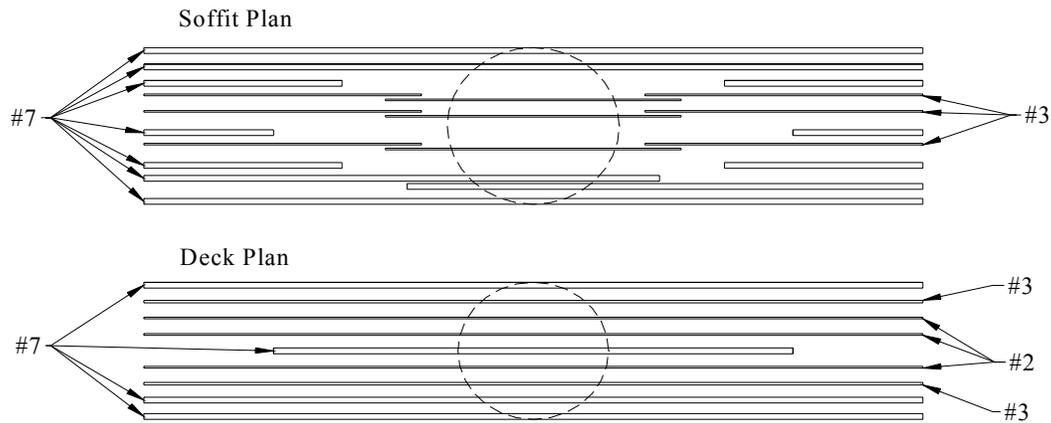
Fig. 3.2 Pre-1971 beam longitudinal bar splice layout

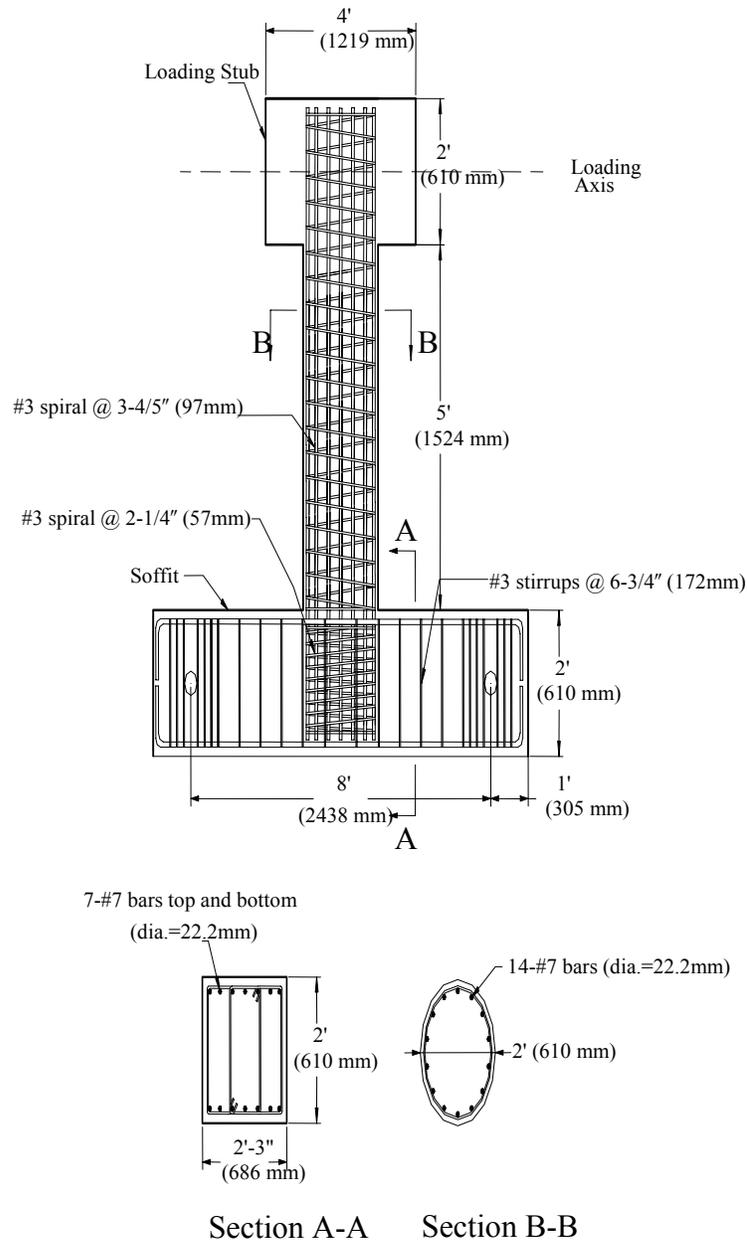
Fig. 3.3 Current design reinforcement details (units 1, 2)

The test units were built in an inverted position, similar to those of the pre-1971 design. The outside dimensions of the four test units are identical. The reinforcement details of the current design test specimens (units 1 and 2) are shown in Figure 3.3. The reinforcing is Grade 60 steel. The column is reinforced with 14 #7 bars ($d_b=22.2$ mm) that extend fully into the joint (533 mm, 21 in.) to meet the cap beam deck steel. A #3 spiral spaced at 97 mm (3.8 in.) was placed over the entire height of the column. The column longitudinal bars within the joint are restrained transversely by a #3 ($d_b=9.5$ mm) spiral spaced at 57 mm (2- $\frac{1}{4}$ in.).

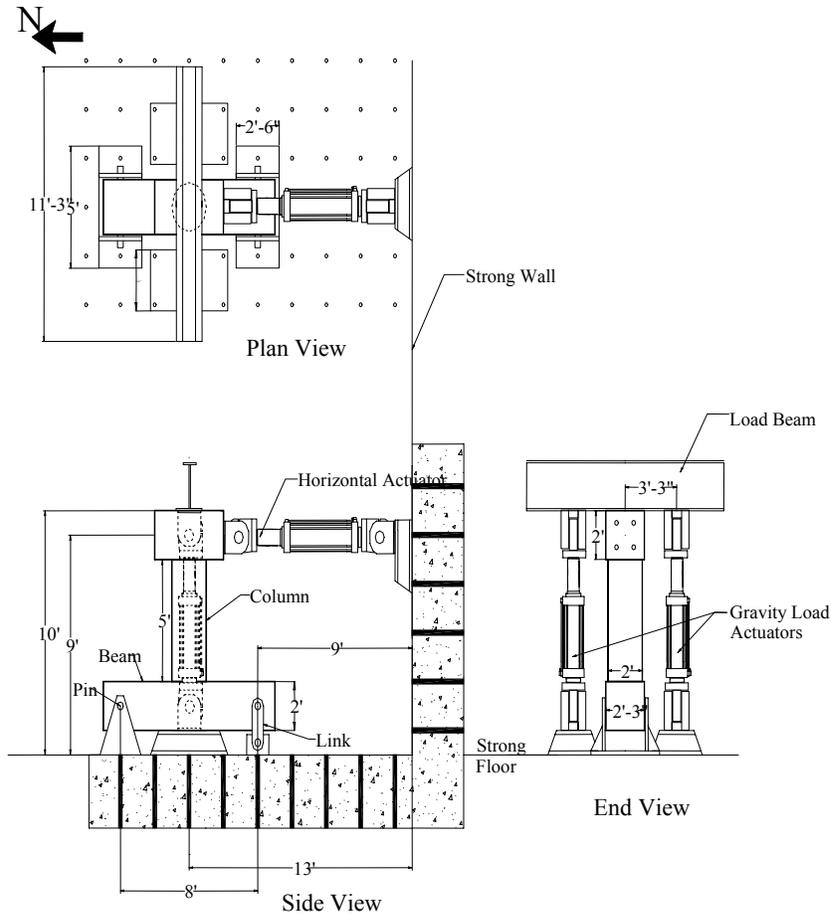
Fig. 4.1 Experimental test setup

A simulated gravity load was applied to the column and joint through a steel load beam that was attached to the top of the column. Two actuators were connected to the load beam and then to the strong floor to apply the vertical gravity load. The vertical actuators had a 734 kN (165 kip) capacity and a +/- 152 mm (6 in.) stroke. A constant load of 200 kN (45 kips) was applied by each actuator and maintained for the entire test. The horizontal cyclic load was applied by an actuator mounted to the strong wall and attached at the load stub at the top of the column. The horizontal actuator had a 980 kN (220 kip) capacity and a +/- 228 mm (9 in.) stroke, with a servo capacity of 15.8 liters per second (250 gallons per minute [GPM]). The horizontal actuator was controlled in displacement.

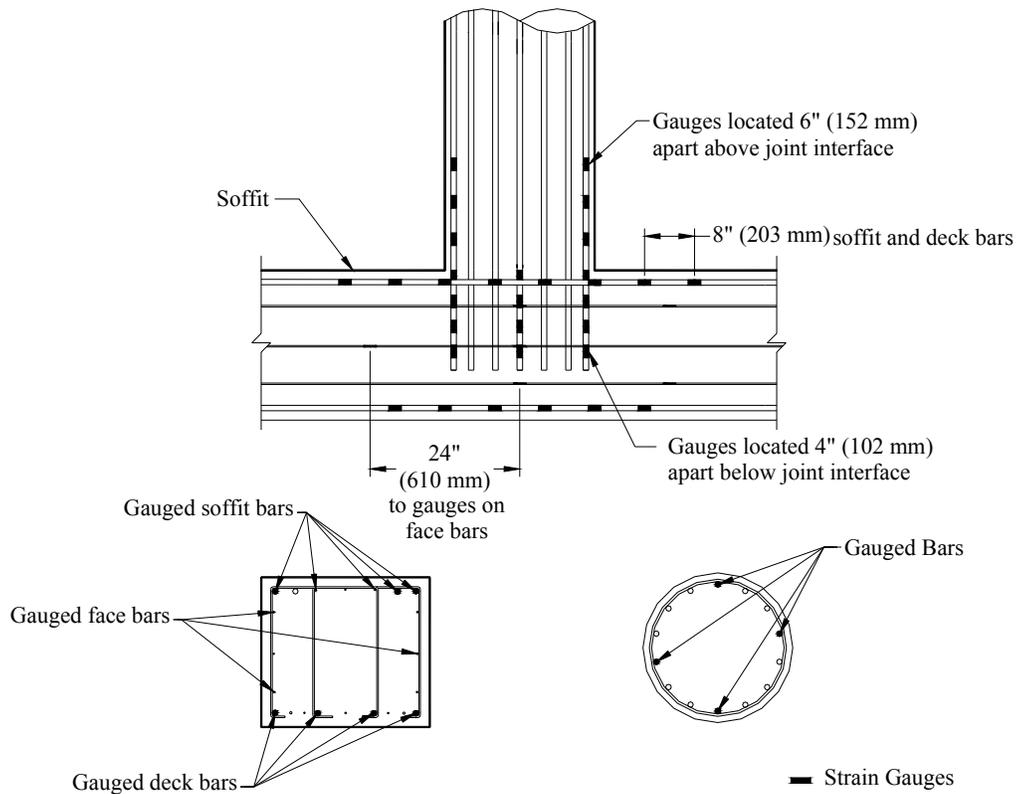
Fig. 4.3 Pre-1971 test units: location of strain gauges on longitudinal reinforcement

gauged the same way except for the fact that the gauges extend only 508 mm (20 in.) in each direction from the centerline of the column.

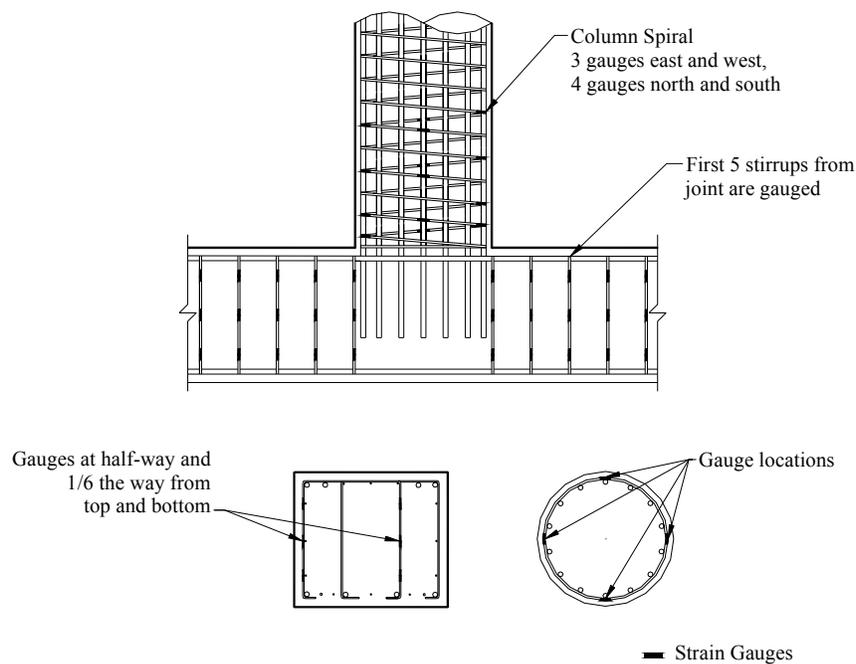
Fig. 4.5 Pre-1971 test units: location of strain gauges on transverse reinforcement

The hairpin-reinforcing bar in the joint of the current design was also gauged in the same way. The pre-1971 units were also provided with three #2 bars evenly spaced up the east and west faces of the beam. These bars were gauged at the centerline and at 24 in. north and south of the joint centerline in order to help quantify the behavior of the joint in shear. The gauges used were 5 mm high-yield gauges with a gauge factor of 2.12.

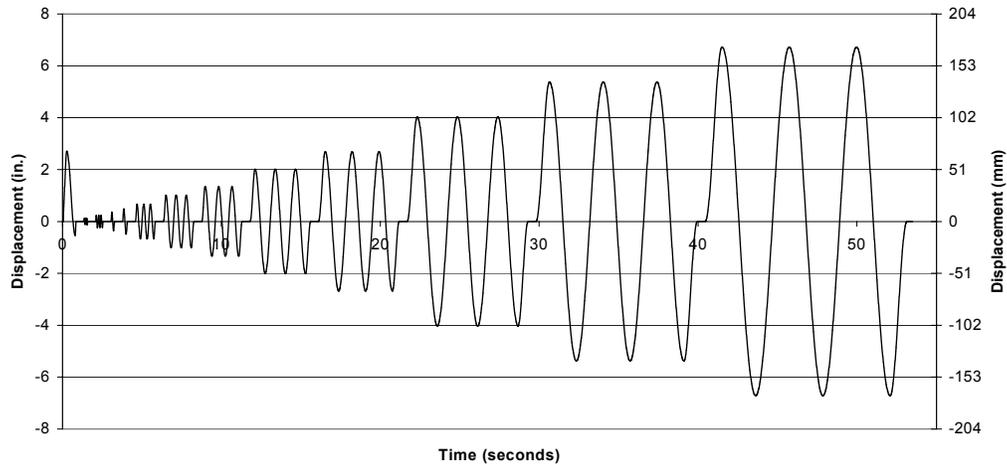
Fig. 4.7 Displacement loading history for test units

The typical cyclic loading sequence following the pulse was taken from the displacements used in the test performed by Sritharan (1996). As seen in Figure 4.7 the positive peak of the pulse is at a displacement of 6.9 cm (2.71 in.) and the negative peak of the pulse is 1.4 cm (0.55 in.).

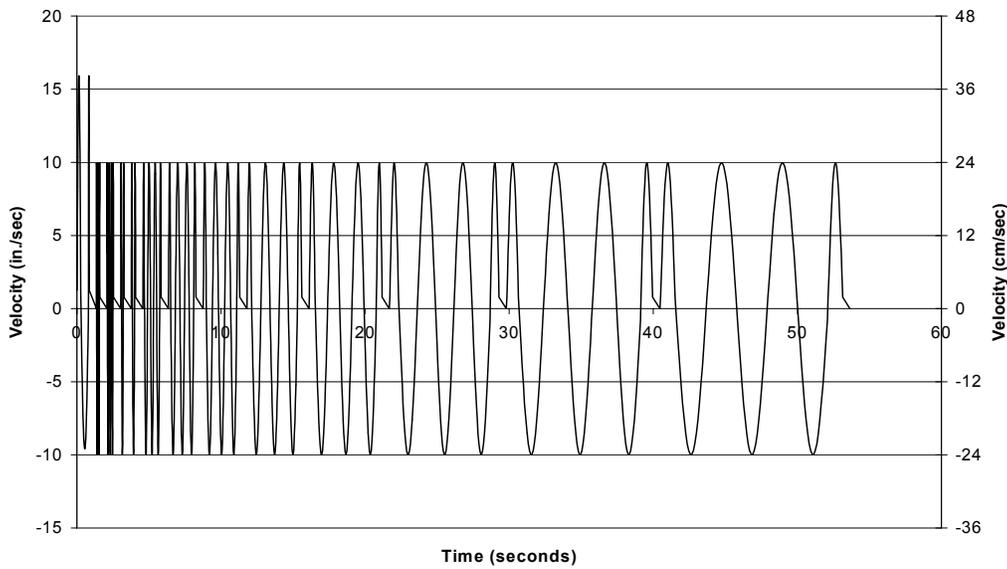
Fig. 4.8 Velocity loading history for test units

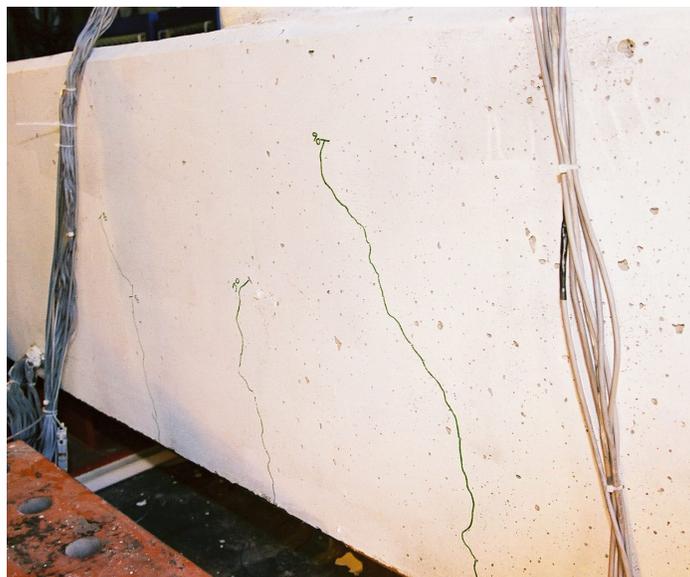
Fig. 5.1 Cracking in beam joint from gravity load

The dead load was applied to each test unit by increments of 133 kN (30 kips) until a target dead load of 400 kN (90 kips) was reached. This dead load was maintained for the rest of the test. For all specimens, the first cracks formed vertically in the beam starting at the deck and moving up the east and west sides of the joint when the gravity load reached 267 kN (60 kips). The cracks extended about halfway up the joint as seen in Figure 5.1. The beams first cracked at the same load level for all of the tests and the crack pattern was similar. Figures 5.2–5.5 present the history of the gravity load verses the horizontal displacement of the column for each specimen. It can be observed that for the quasi-static tests, as shown in Figures 5.2 and 5.3, there was very little change in the vertical load. The variation was a maximum of 9 kN (2 kips). The vertical actuators were able to respond to the movement of the horizontal actuator and maintain the vertical load. This was not the case for the dynamic tests, as shown in Figures 5.4 and 5.5. The vertical actuators were not able to keep up with the speed of the horizontal actuator and the load varied greatly from approximately 225 kN (50 kips) to 580 kN (130 kips). The change in vertical load for the higher ductility levels was much lower. By the time that a ductility of four was reached ($\mu=4$), the variation was only 110 kN (25 kips), and by $\mu=8$, the variation was less than 45 kN (10 kips).

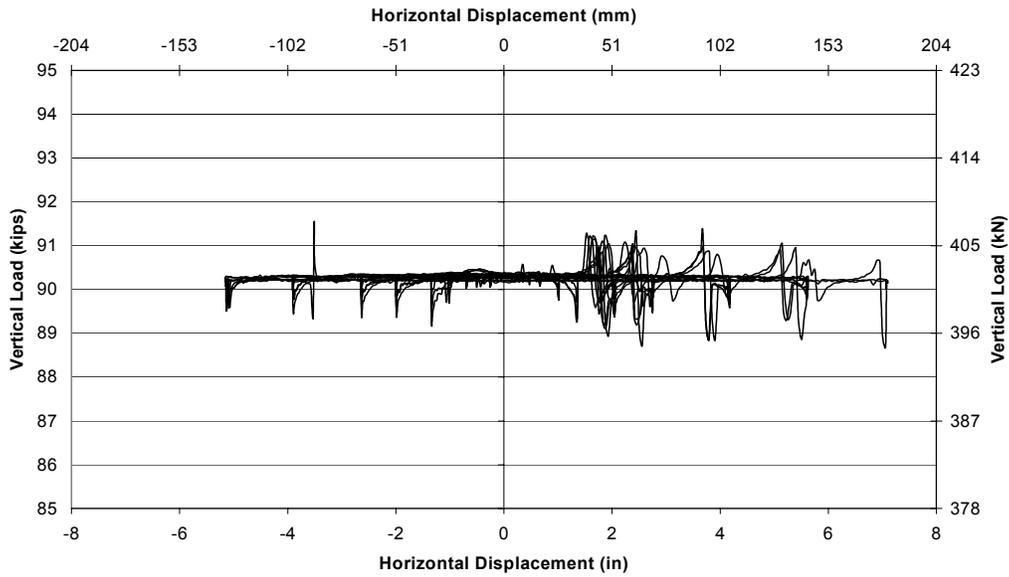
Fig. 5.2 Vertical load history: current design, quasi-static test

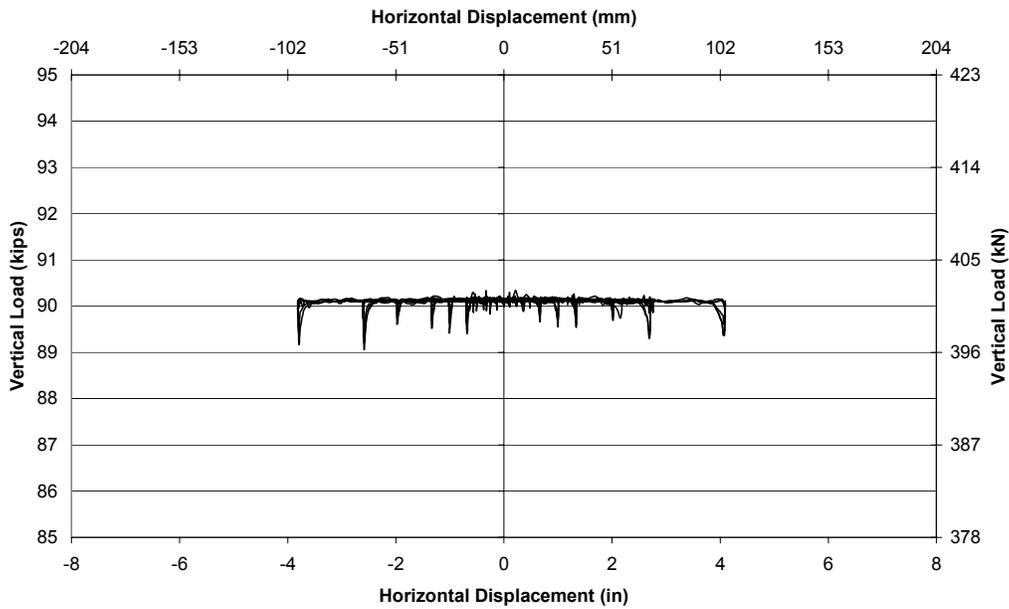
Fig. 5.3 Vertical load history: pre-1971 design, quasi-static test

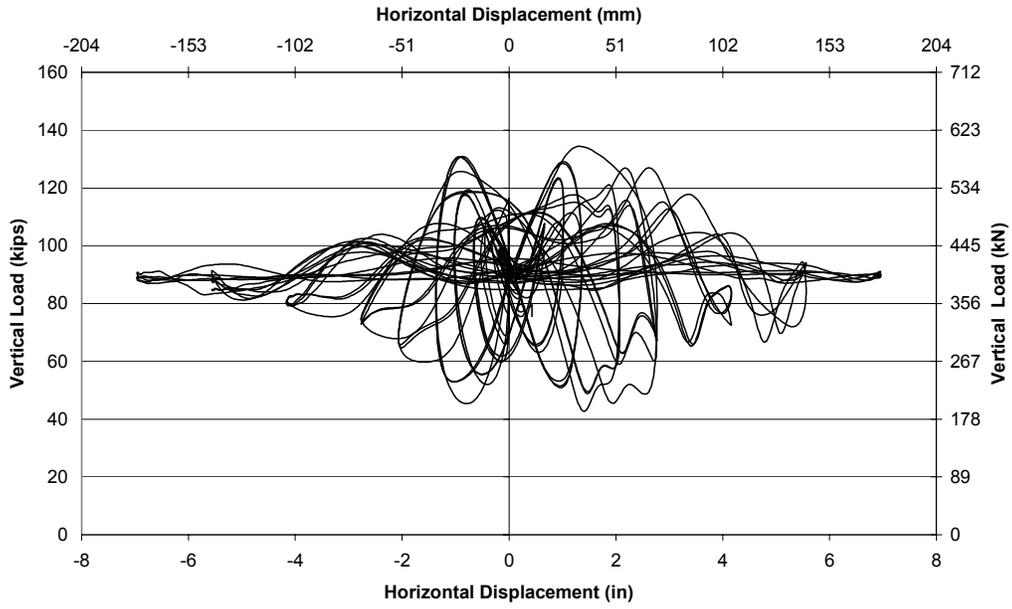
Fig. 5.4 Vertical load history: current design, dynamic test

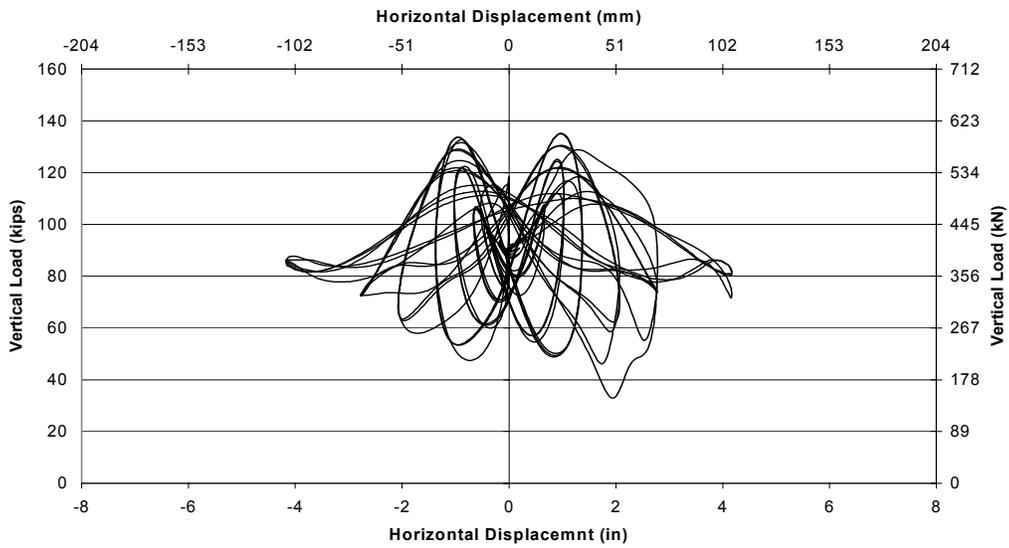
Fig. 5.5 Vertical load history: pre-1971 design, dynamic test

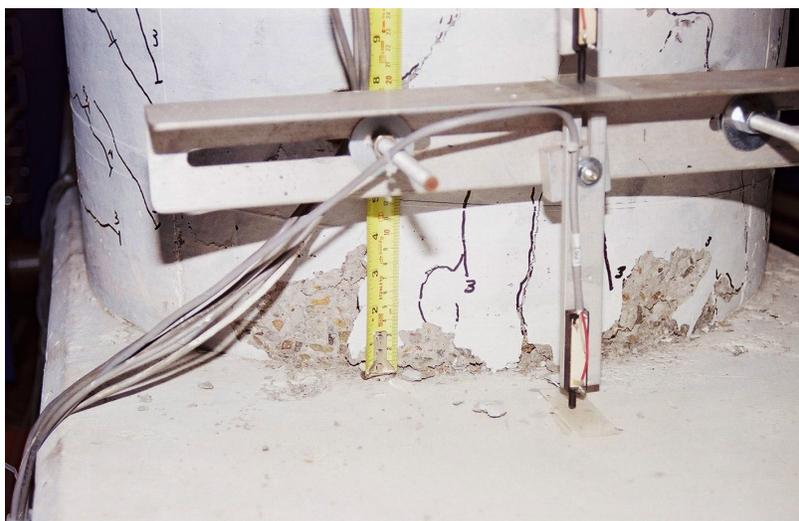
Fig. 5.6 Peak of positive pulse: current design, quasi-static test

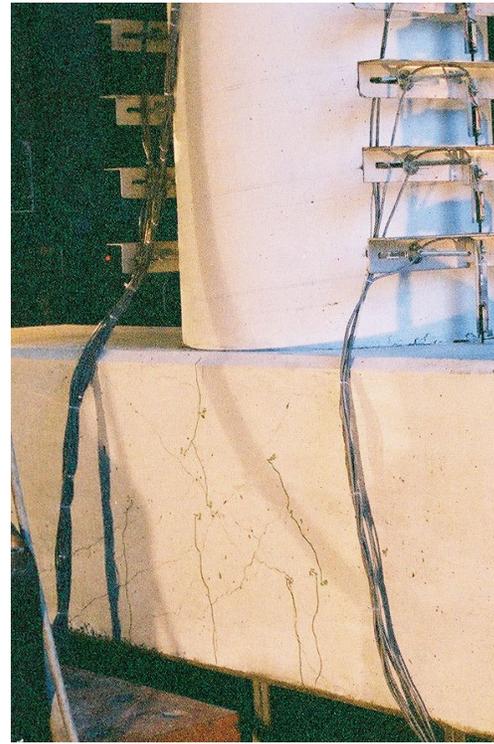
Fig. 5.8 Peak of pulse: pre-1971 design, dynamic test

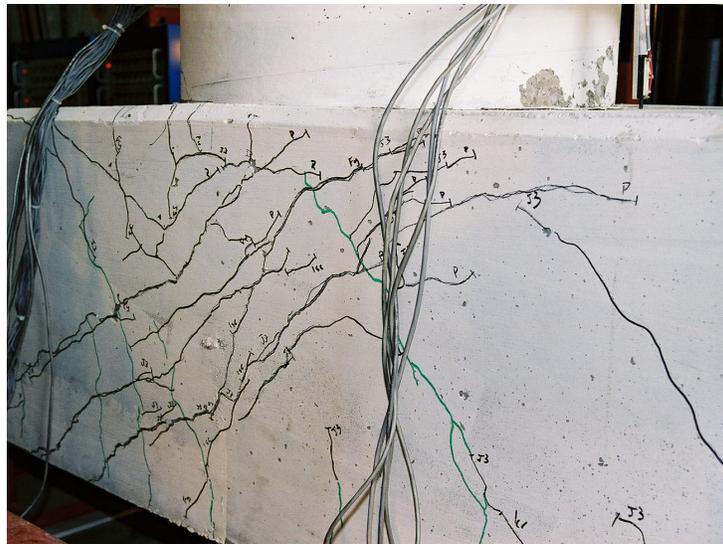
Fig. 5.9 Peak of positive pulse: pre-1971 design, quasi-static test

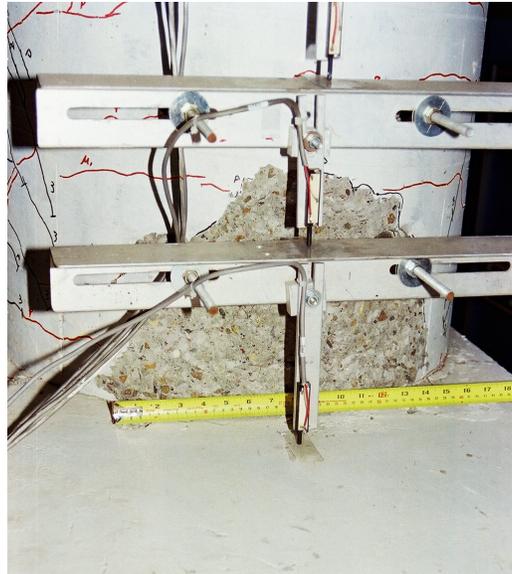
Fig. 5.10 North plastic hinge: $\mu=3$ current design, quasi-static test

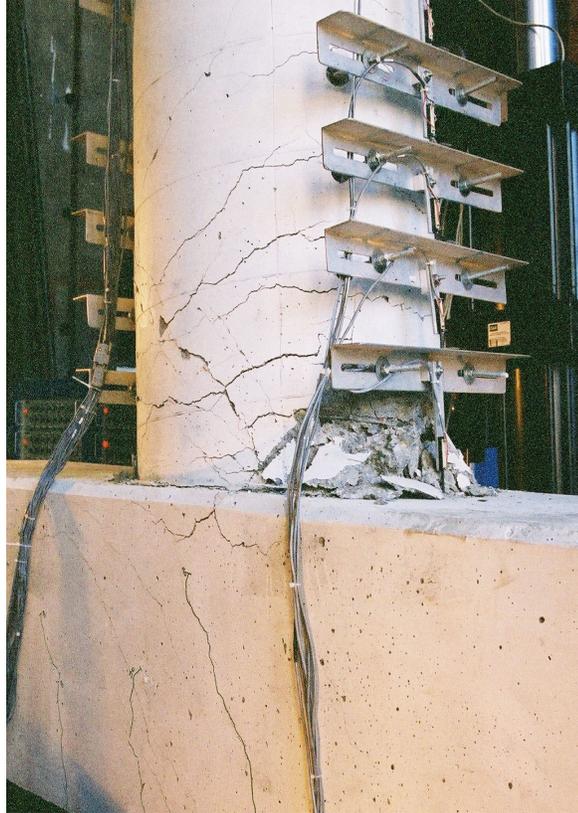
Fig. 5.12 North plastic hinge: $\mu=6$ dynamic test

$\mu=4$, the spalling in the north plastic hinge region, extended 178 mm (7 in.) from the beam. Flaking of the concrete, and large flexural cracks in the column were seen over a height about 483 mm (19 in.) from the beam, as shown in Figure 5.12.

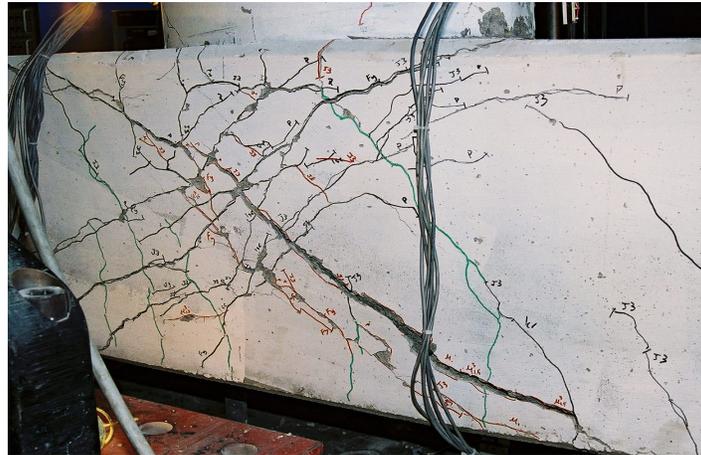
Fig. 5.13 Cracking in joint: $\mu=4$, pre-1971 design, quasi-static test

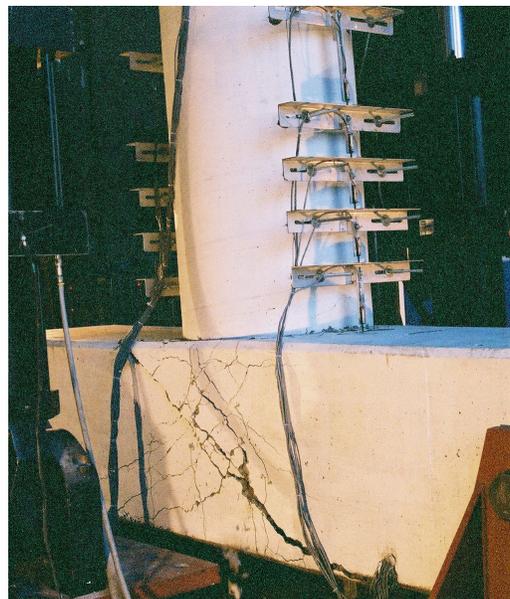
Fig. 5.14 Joint around $\mu=4$: pre-1971 design, dynamic test

The dynamic test progressed similarly to the quasi-static test. After the pulse very few new shear cracks formed. The cracks that formed during the pulse widened with each ductility level, and spalling began around $\mu=2$ with small concrete pieces falling out of the cracks. At $\mu=4$, the face concrete in the joint began to break up into chunks, and the shear plane extended through the joint and the top of the beam (Fig. 5.14).

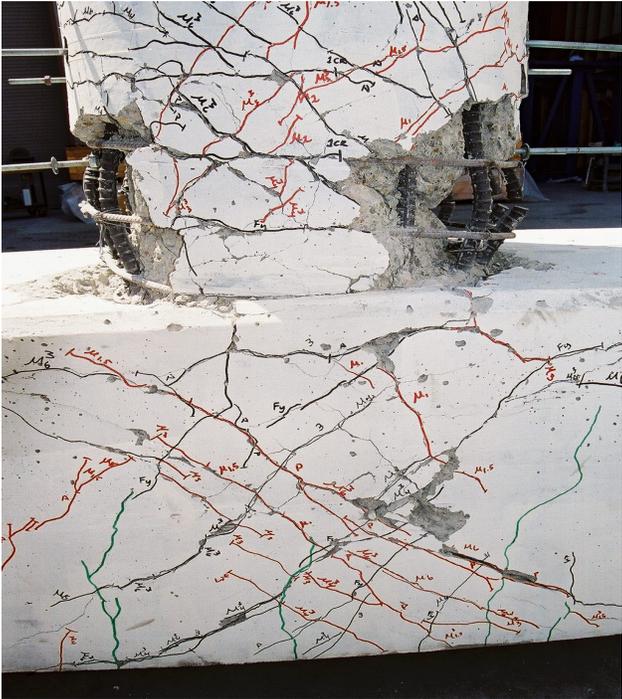
Fig. 5.15 Current design after quasi-static test (north is right)

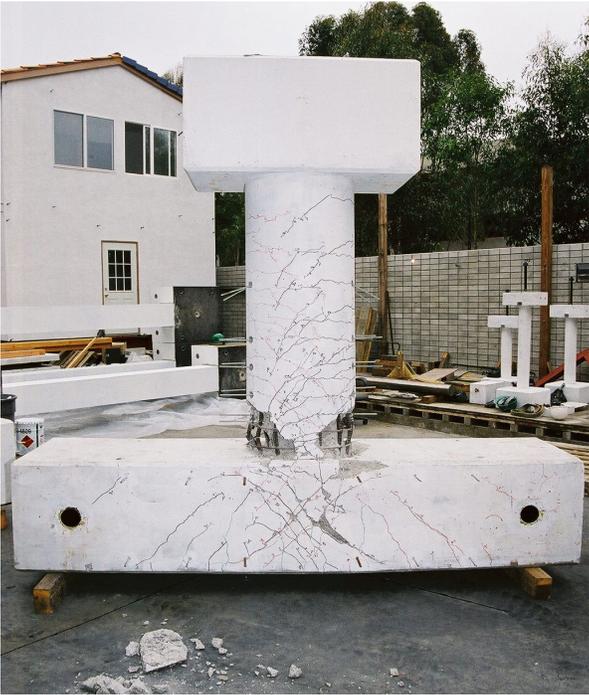
Fig. 5.16 Current design after quasi-static test (north is left)

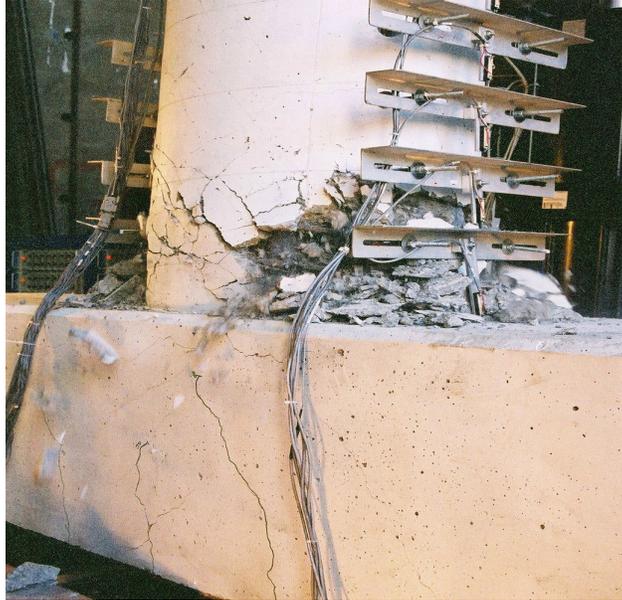
Fig. 5.17 Failure of dynamic current design (view from north)

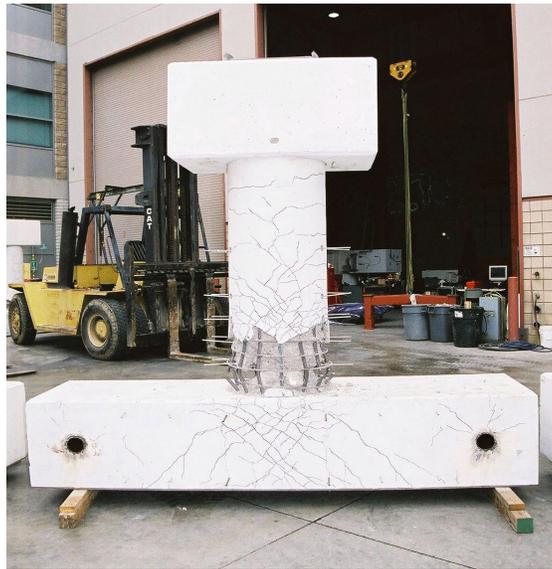
Fig. 5.18 Current design after dynamic test (north is left)

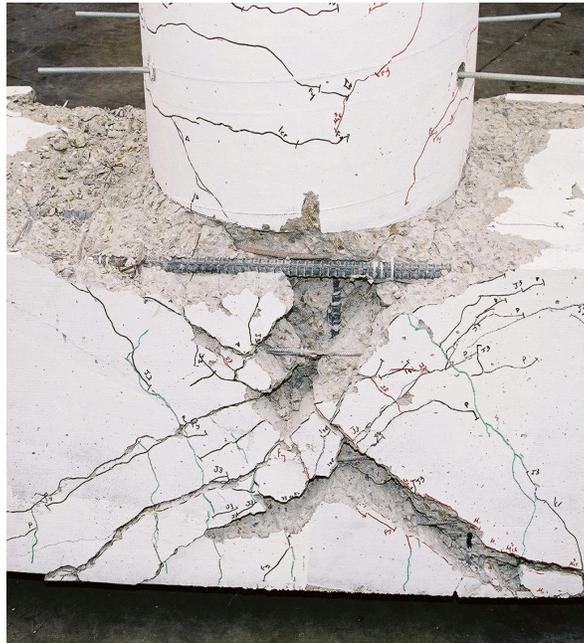
Fig. 5.19 Pre-1971 joint after quasi-static test (east view of joint)

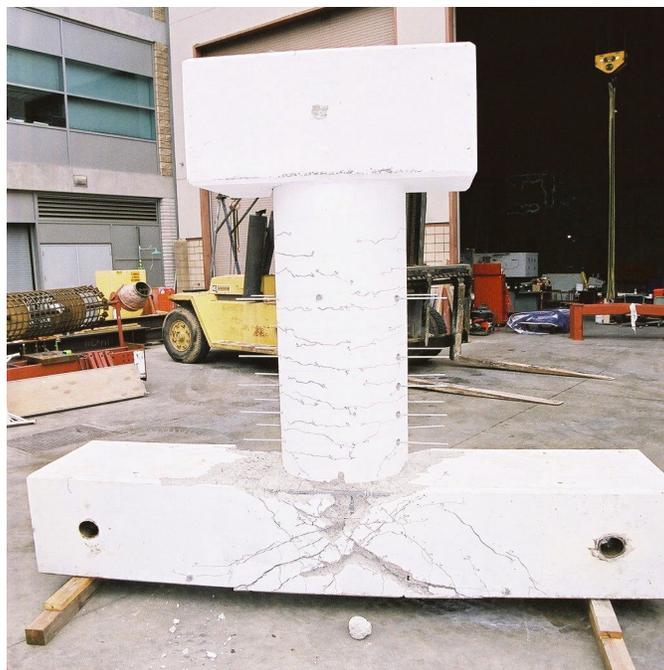
Fig. 5.20 Pre-1971 specimen after quasi-static test (north is right)

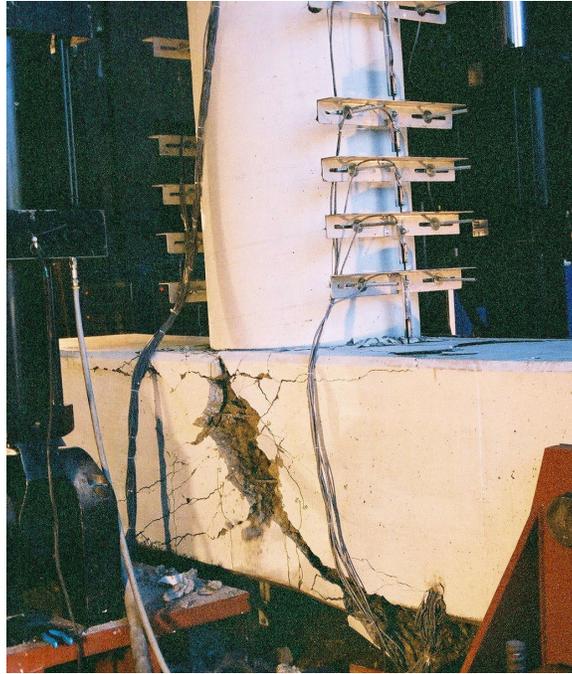
Fig. 5.21 Pre-1971 joint at failure of dynamic test (view from north)

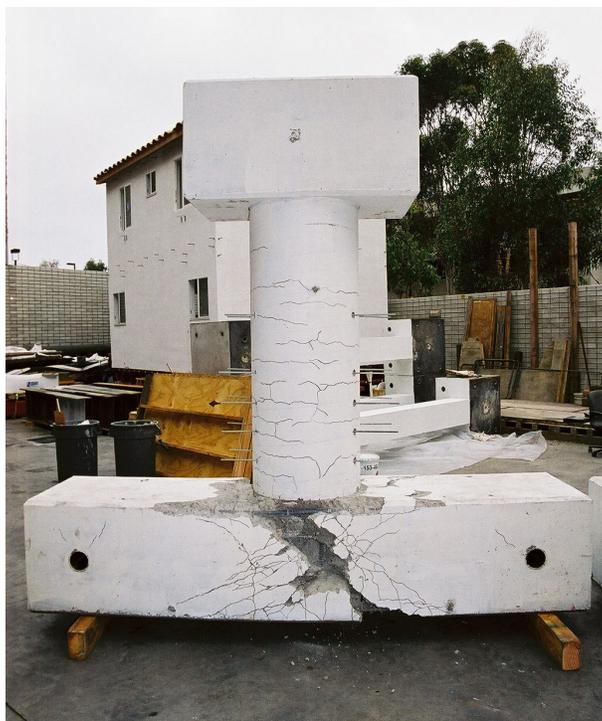
Fig. 5.22 Pre-1971 specimen after dynamic test (north is right)

The dynamic test exhibited much more concrete spalling in the joint than in the quasi-static test. At $\mu=4$ the concrete in the joint began to visibly break up, and at $\mu=6$ the core concrete began to pour out of the joint, as shown in Figure 5.21. The joint shifted along the main shear plane and then jutted out at the deck side of the beam. The soffit concrete flaked and broke apart at the base of the column. The test was stopped at the third cycle of $\mu=6$ to match the loading of the quasi-static test, as shown in Figure 5.22.

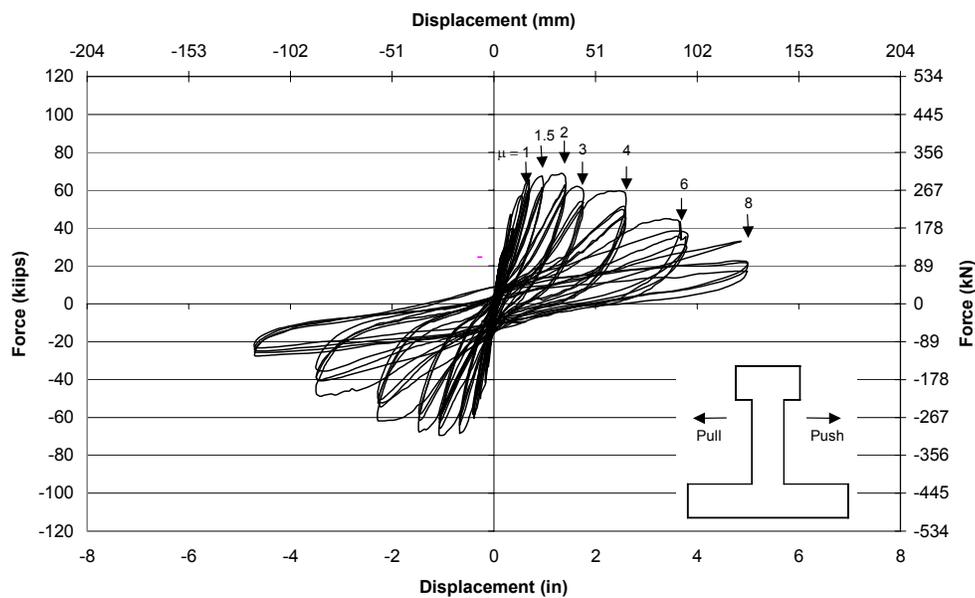
Fig. 5.23 Force-displacement history: non-pulse test, pre-1971 specimen (MacRae 1994)

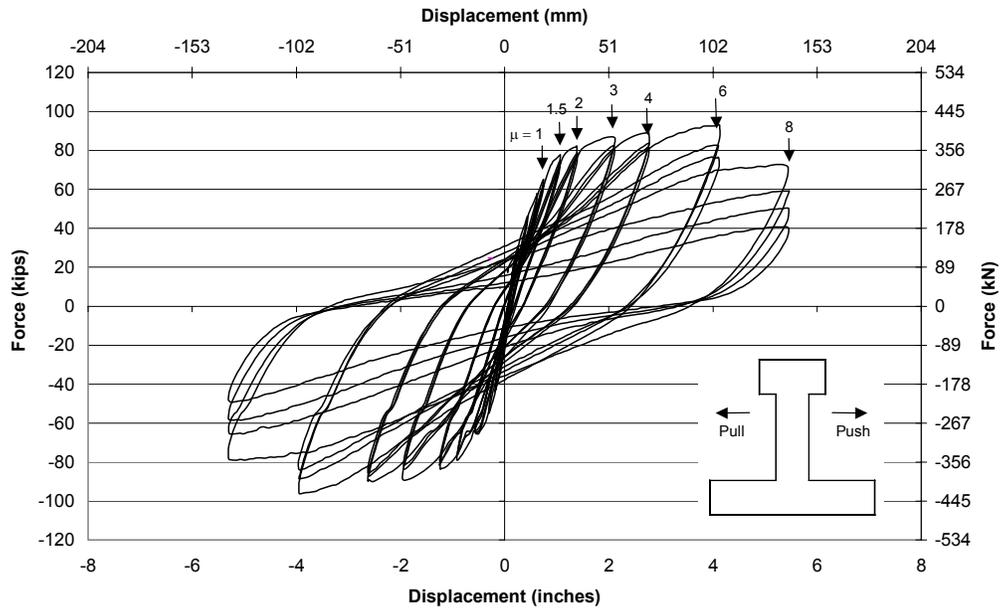
Fig. 5.24 Force-displacement history: non-pulse test, current design specimen (Sritharan 1996)

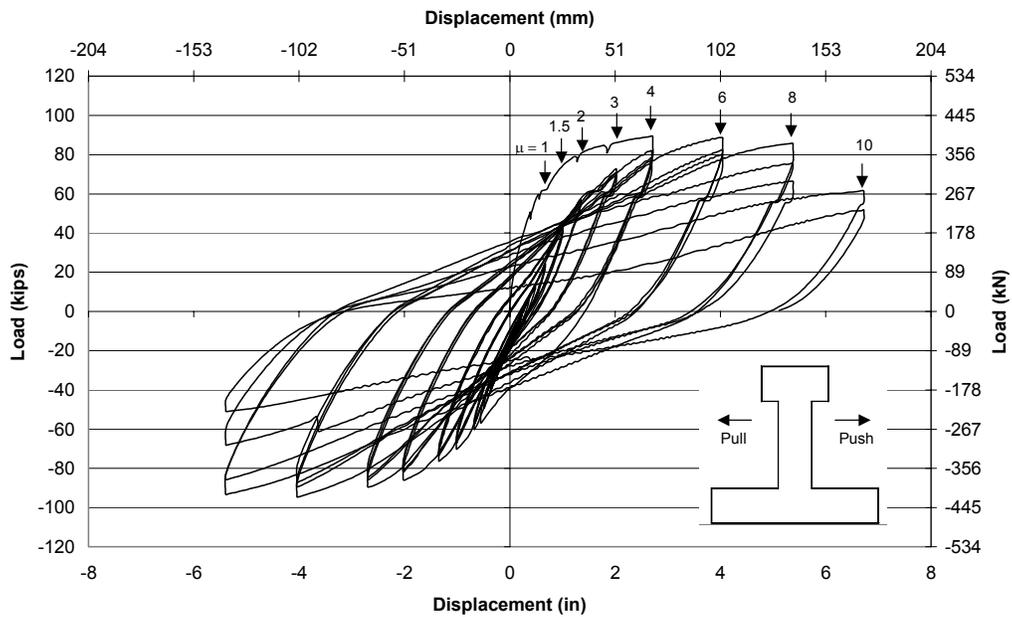
Fig. 5.25 Force-displacement history: current design specimen, quasi-static test

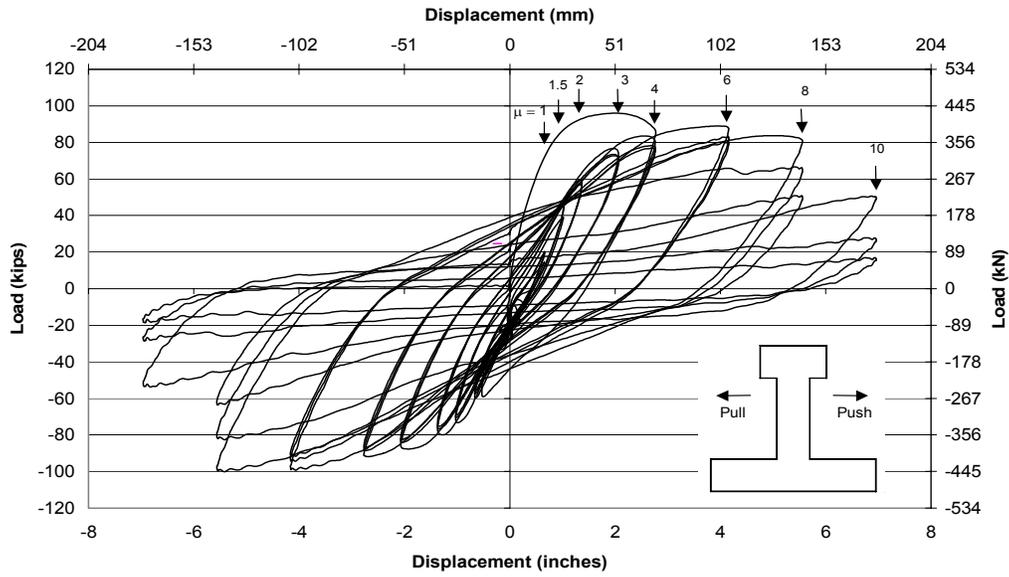
Fig. 5.26 Force-displacement history: current design specimen, dynamic test

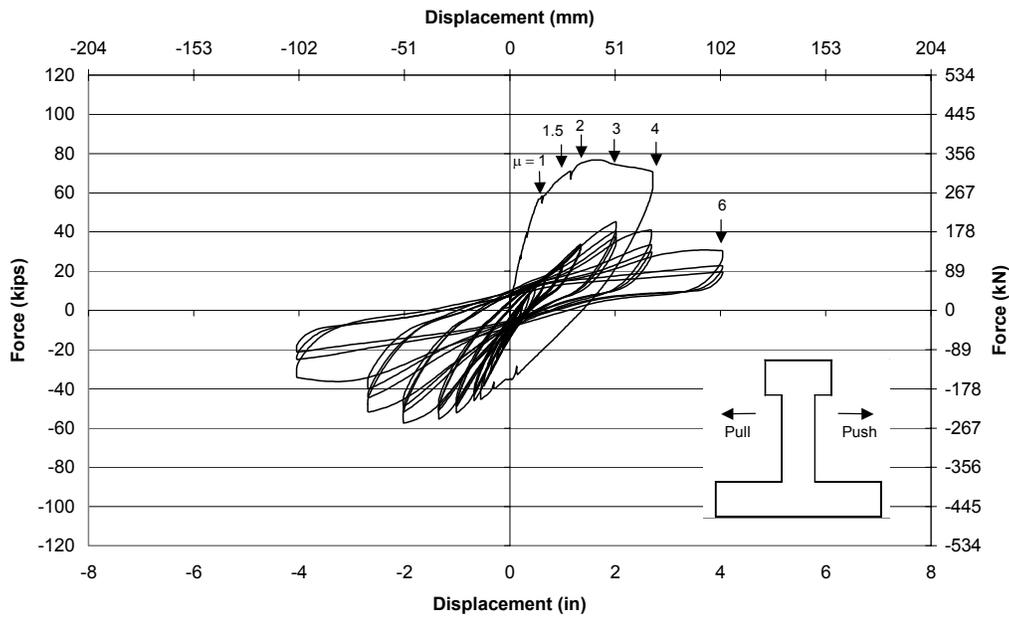
Fig. 5.27 Force-displacement history: pre-1971 specimen, quasi-static test

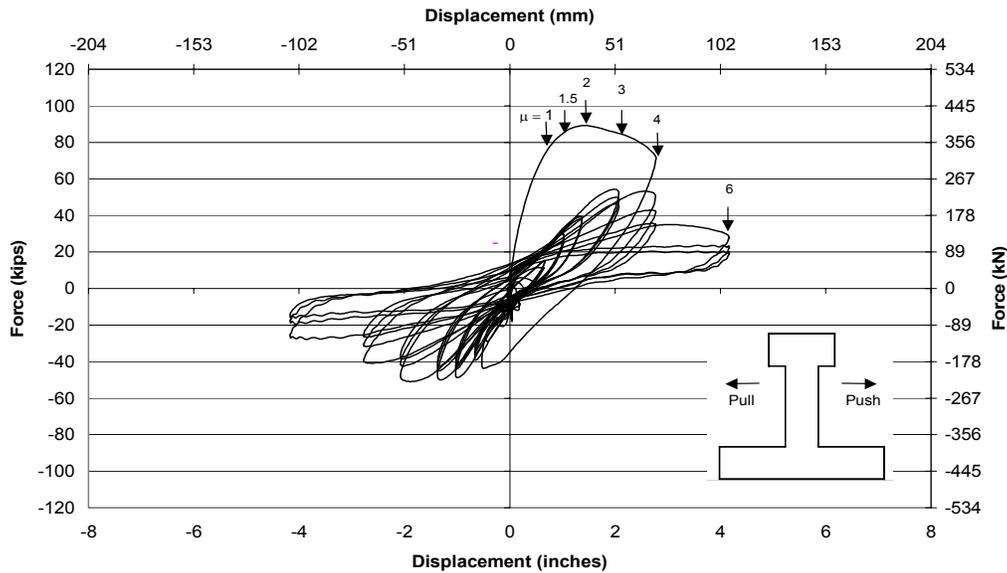
Fig. 5.28 Force-displacement history: pre-1971 specimen, dynamic test

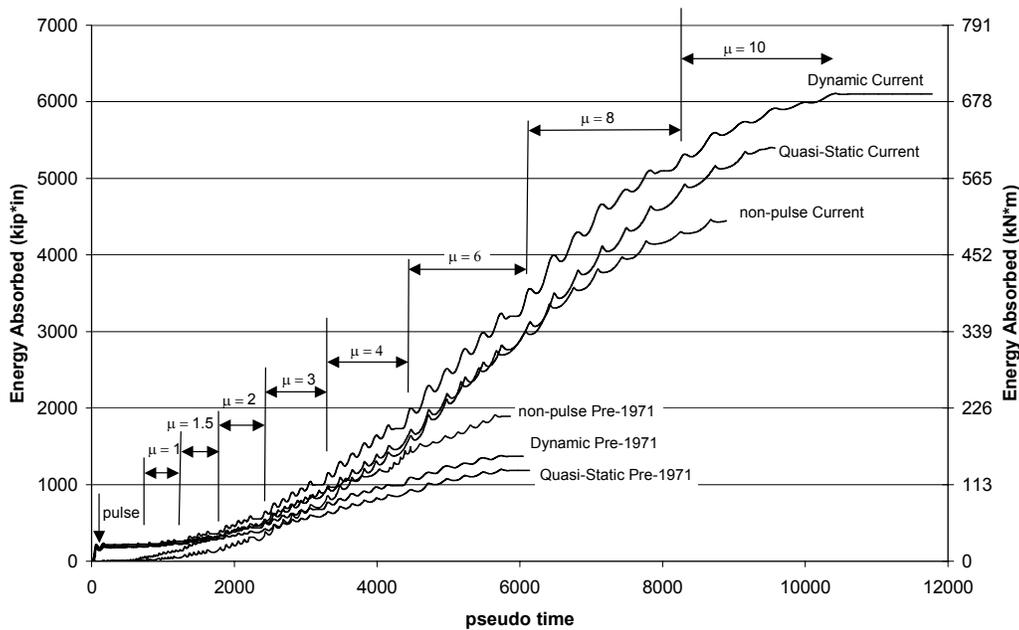
Fig. 5.29 Energy absorbed by test specimens

The current design specimens absorbed much more energy than the pre-1971 specimens. This was expected after viewing the difference in the shape of the force-displacement hysteresis loops. Both designs absorbed more energy during the dynamic tests than in the quasi-static tests. The current design non-pulse test was similar to the pulse test until $\mu=8$ when the non-pulse test began to absorb less energy. During the non-pulse cycling at $\mu=8$, recordings indicated that large joint shear deformation occurred that was consistent with an observed drop in horizontal force resistance. Much more concrete degradation and spalling was seen in the joint region during the non-pulse test than during the pulse tests of the current design specimen. Since more energy was absorbed overall during the pulse tests than during the non-pulse tests, it can be inferred that the pulse loading was not overly detrimental to the final behavior of the specimen.

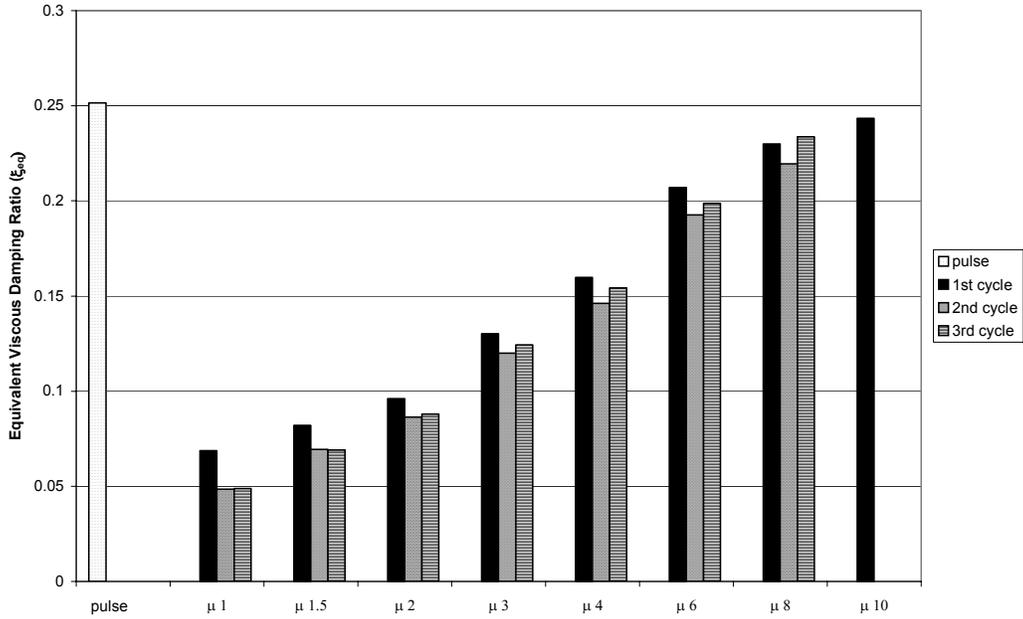
Fig. 5.30 Equivalent viscous damping ratios: current design specimen, quasi-static test
