PACIFIC EARTHQUAKE ENGINEERING RESEARCH CENTER

Performance of Beam to Column Bridge Joints Subjected to a Large Velocity Pulse

PEER Report 2002/24
Pacific Earthquake Engineering Research Center
College of Engineering
University of California, Berkeley
April 2002

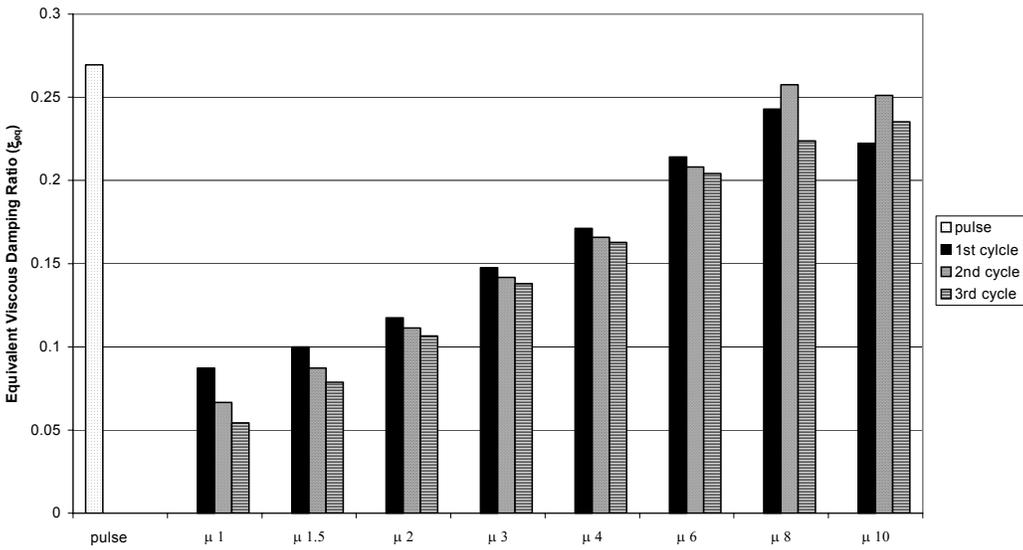
Fig. 5.31 Equivalent viscous damping ratios: current design specimen, dynamic test

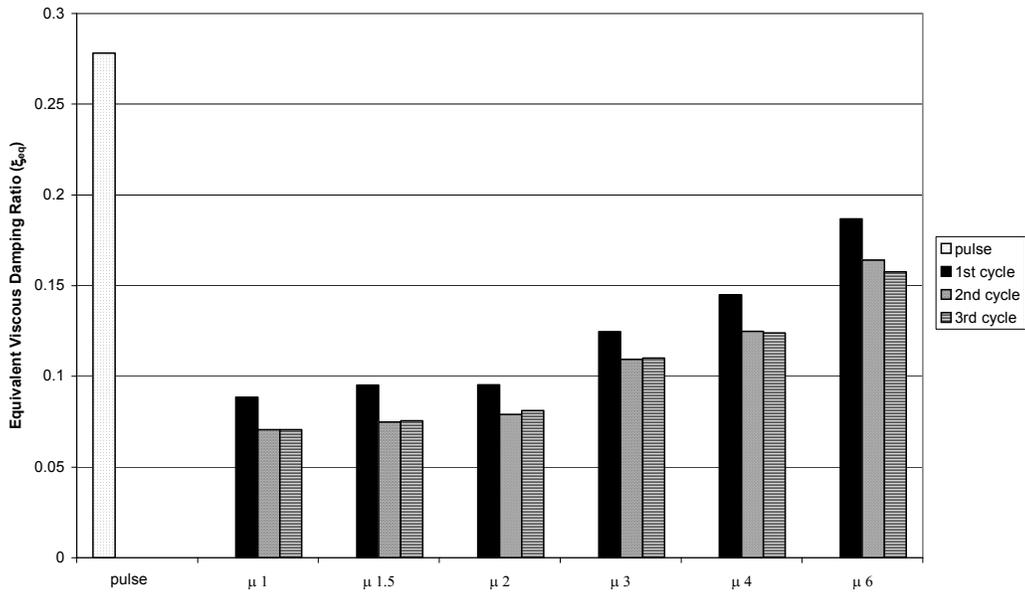
Fig. 5.32 Equivalent viscous damping ratios: pre-1971 specimen, quasi-static test

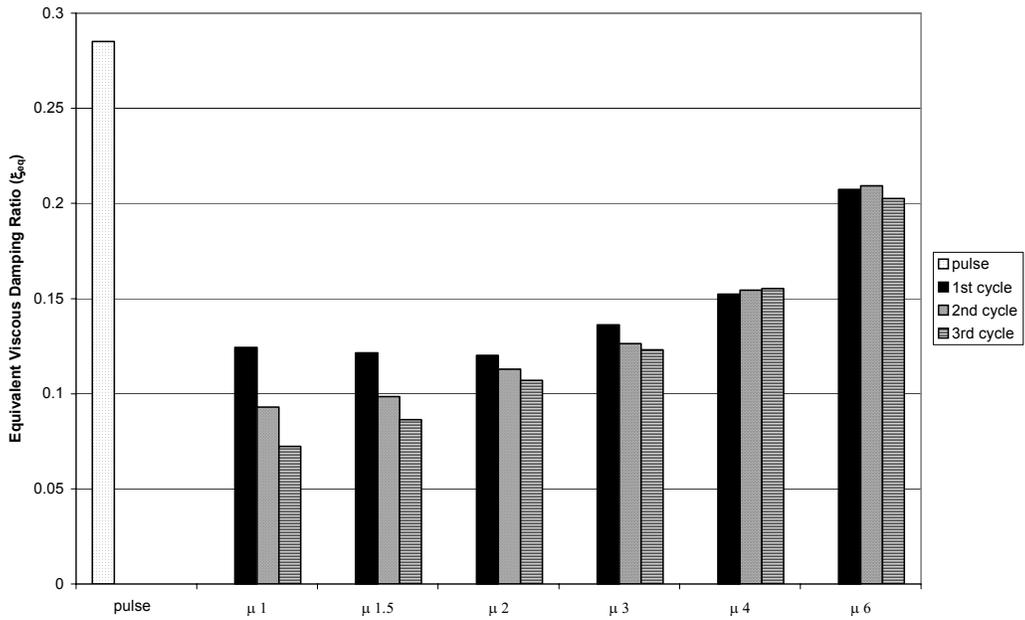
Fig. 5.33 Equivalent viscous damping ratios: pre-1971 specimen, dynamic test

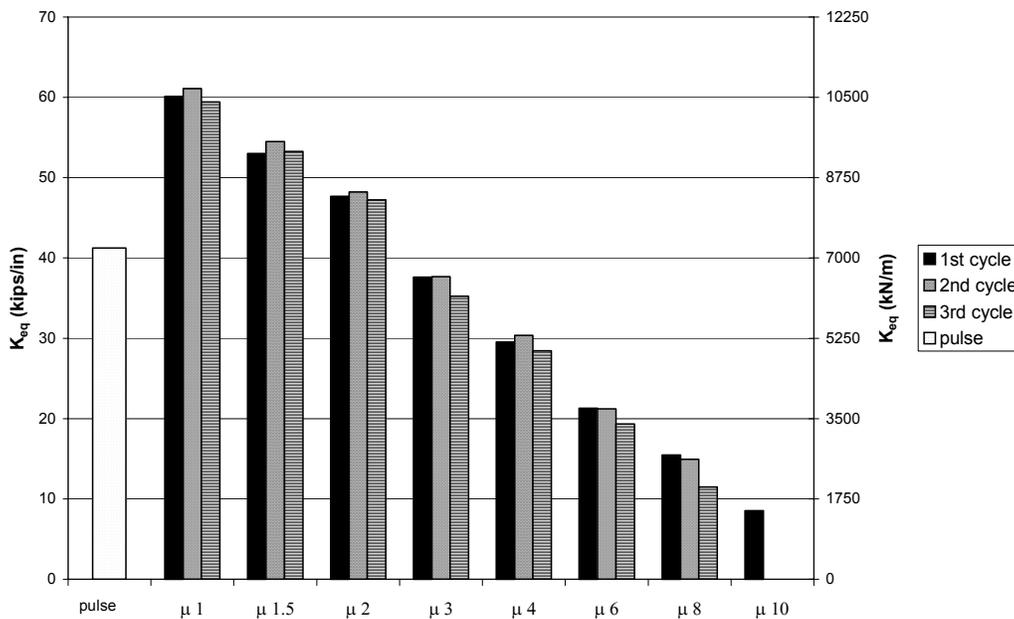
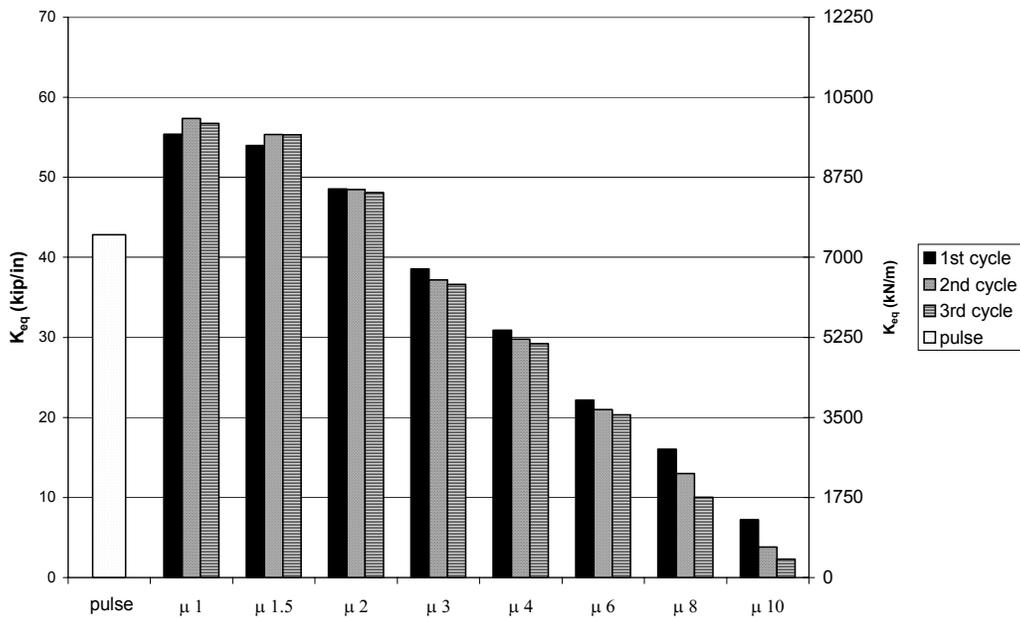
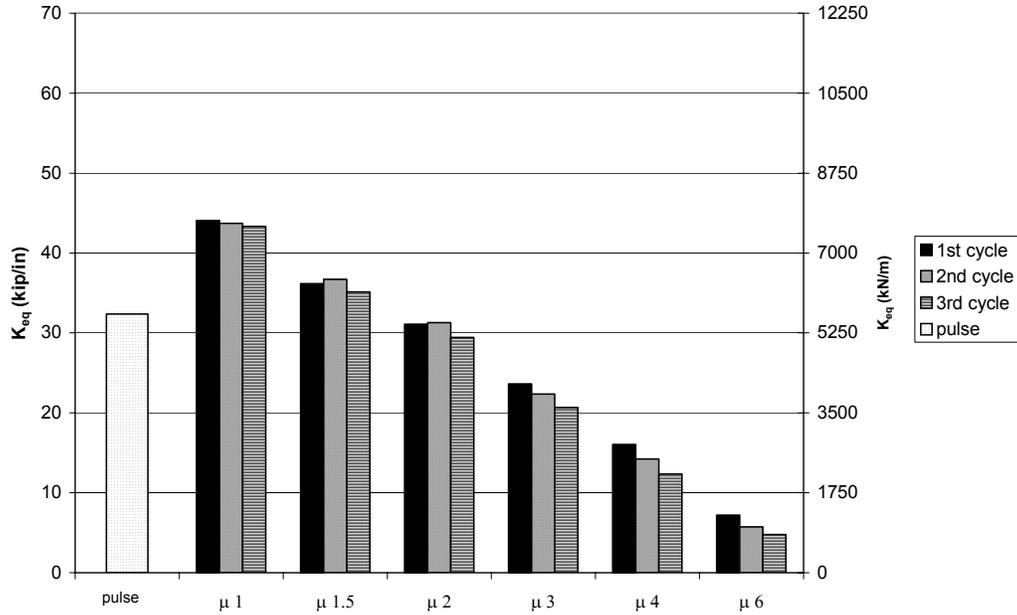
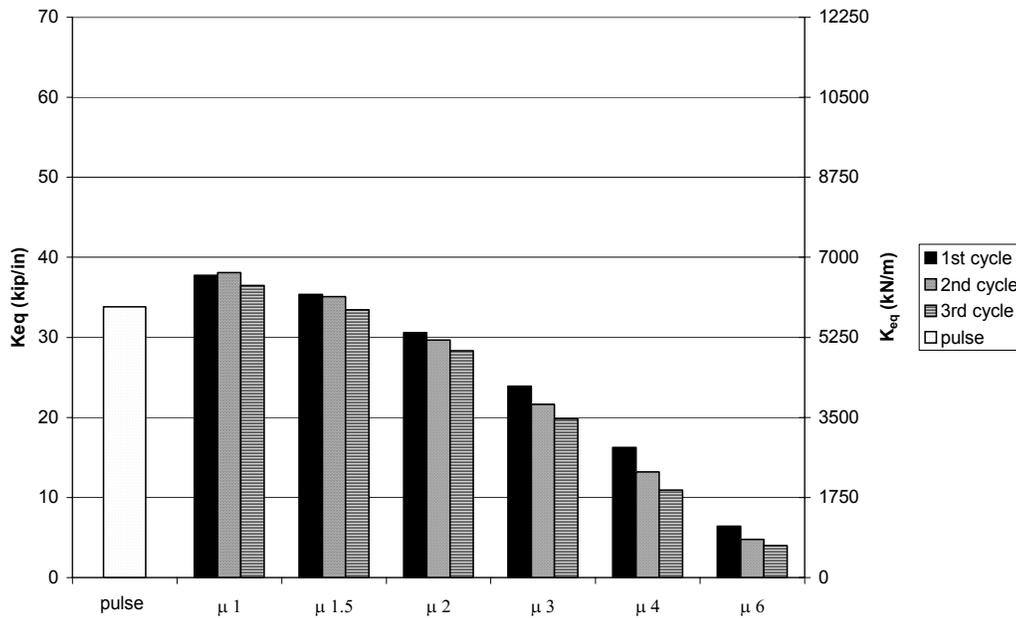
Fig. 5.34 Secant stiffness: current design specimen, quasi-static test

Fig. 5.35 Secant stiffness: current design specimen, dynamic test

Fig. 5.36 Secant stiffness: pre-1971 specimen, quasi-static test

Fig. 5.37 Secant stiffness: pre-1971 specimen, dynamic test

The stiffness for each cycle was graphed against the ductility level for each test, as shown in Figures 5.34–5.37. The stiffness visibly degraded throughout the tests. The dynamic tests were less stiff overall than the quasi-static tests; this could be due to the greater damage seen earlier on in the dynamic tests. The stiffness during the pulse was the same for the quasi-static and dynamic tests, but the current design units were stiffer than for the pre-1971 units. This is a result of the increased deformations in the joints of the pre-1971 specimens.

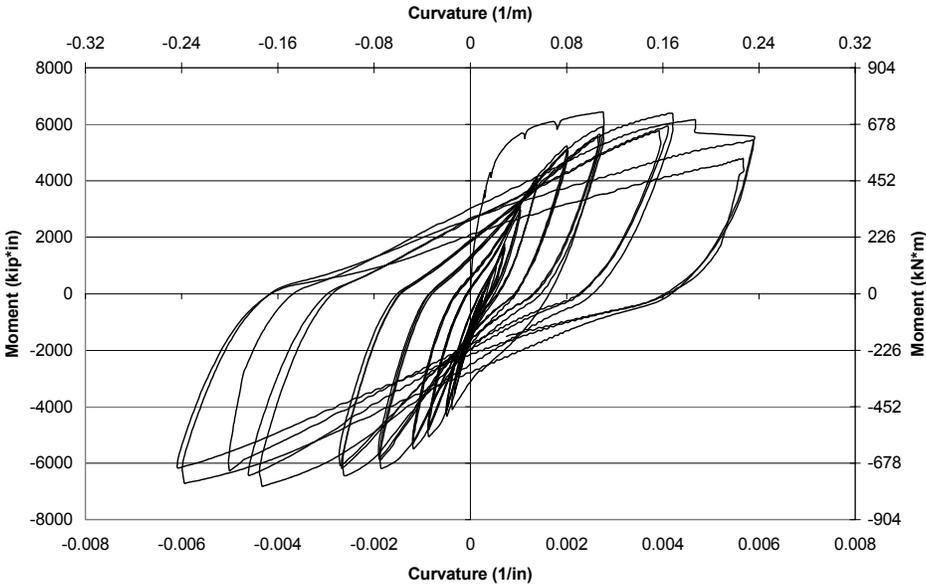
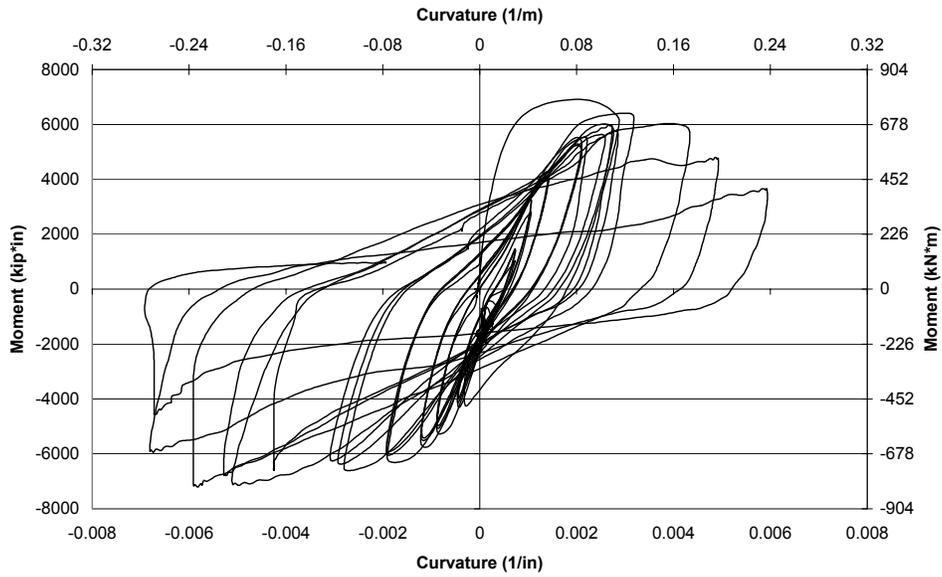
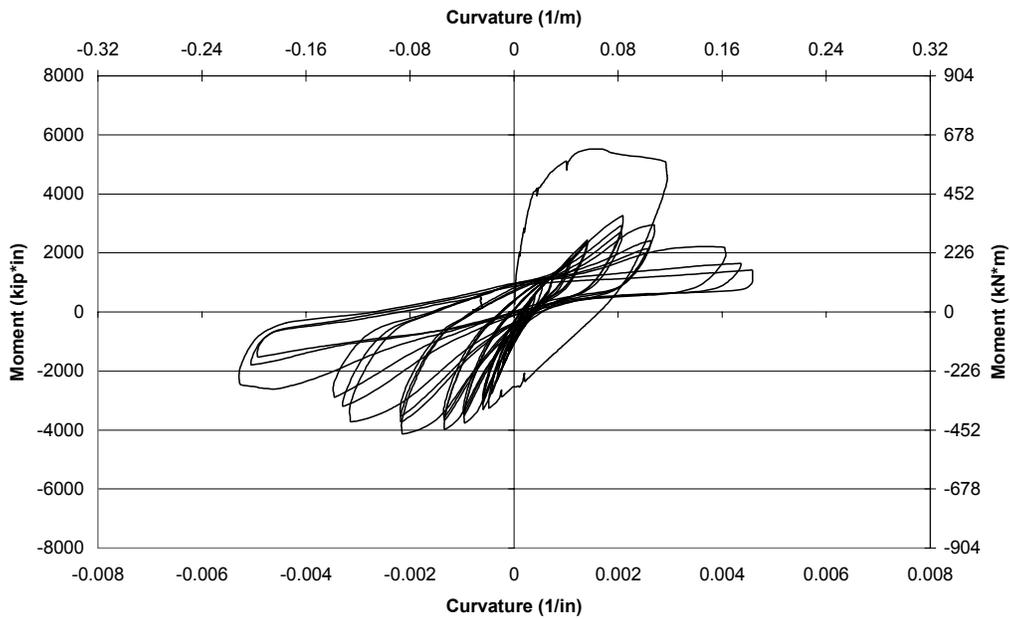
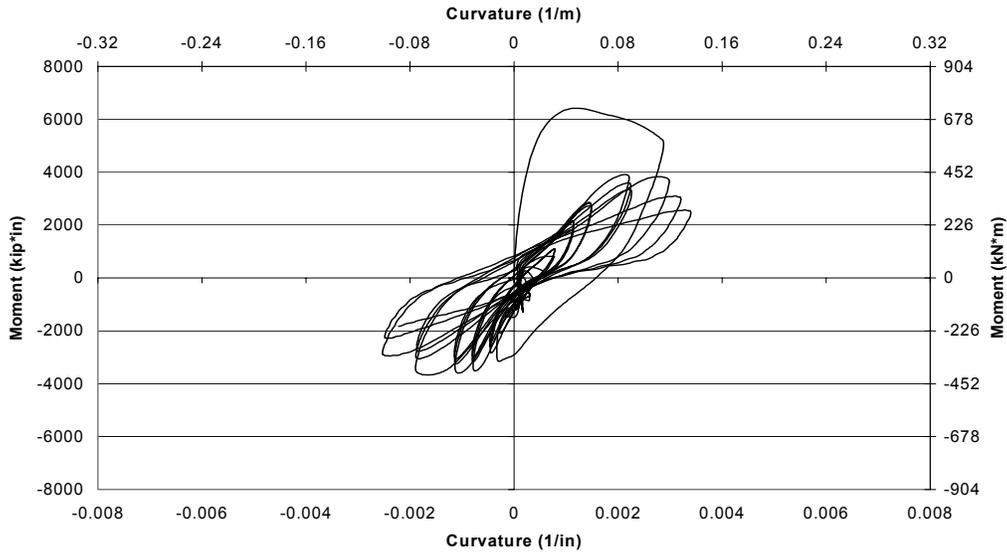
Fig. 5.38 Moment-curvature history: current design specimen, quasi-static test

Fig. 5.39 Moment-curvature history: current design specimen, dynamic test

Fig. 5.40 Moment-curvature history: pre-1971 specimen quasi-static test

Fig. 5.41 Moment-curvature history: pre-1971 specimen, dynamic test

presented in Figures 5.38–5.41. The current design specimens dissipated much more energy in flexure than the pre-1971 specimens. The curvature values are greater and the loops of the moment-curvature graphs are larger. The pre-1971 units conversely have very thin hysteresis loops. The maximum curvature for the pre-1971 units was about 65% of the curvature seen in the current design units. The dynamic test for the pre-1971 unit exhibited very little curvature in the column. The pulse portion of the load caused similar responses for all specimens. After the pulse, the pre-1971 units show little flexural behavior, whereas the current design specimens showed greater flexural behavior.

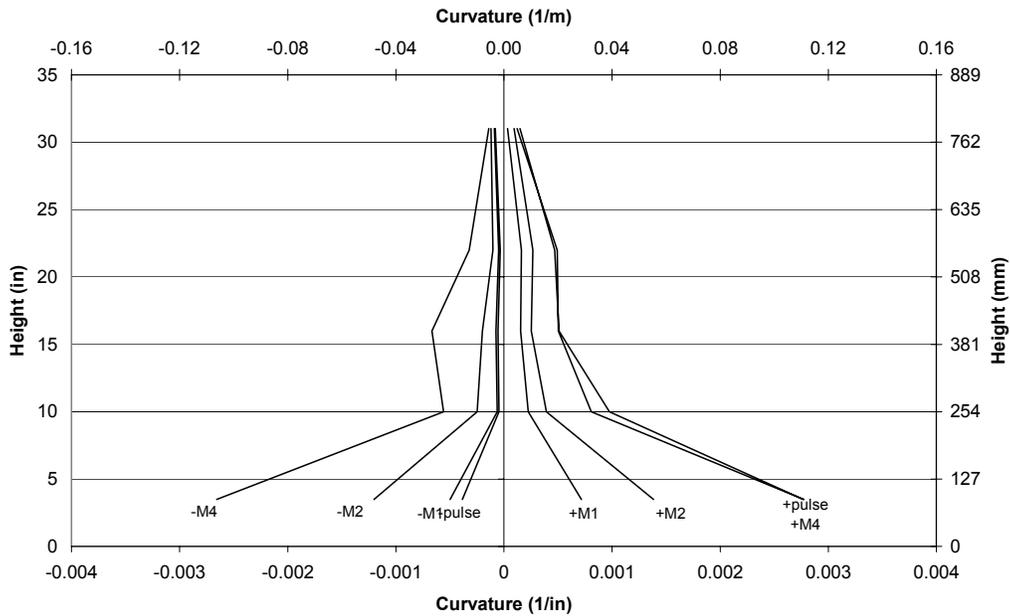
Fig. 5.42 Curvature distribution in column: current design specimen, quasi-static test

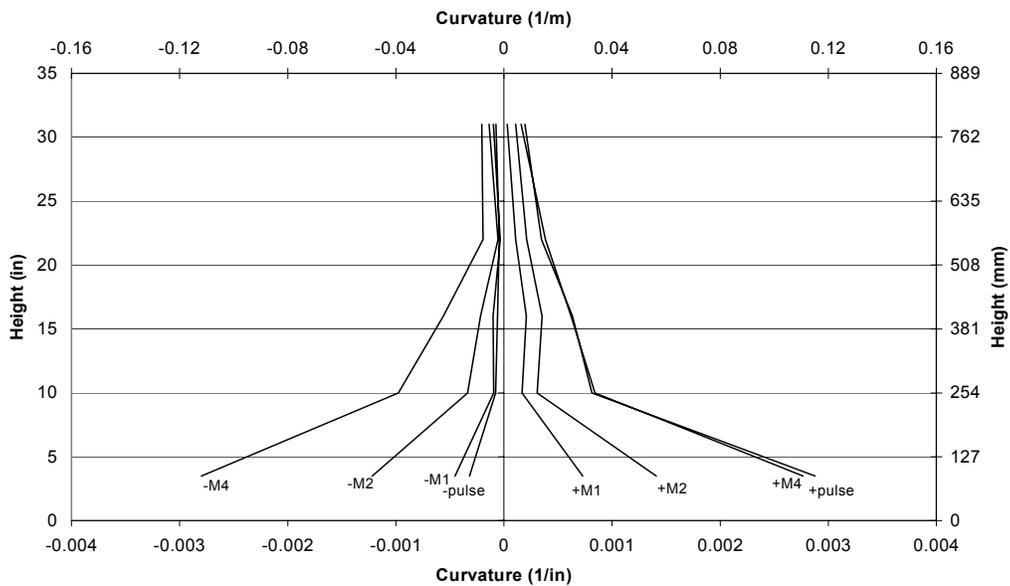
Fig. 5.43 Curvature distribution: current design specimen, dynamic test

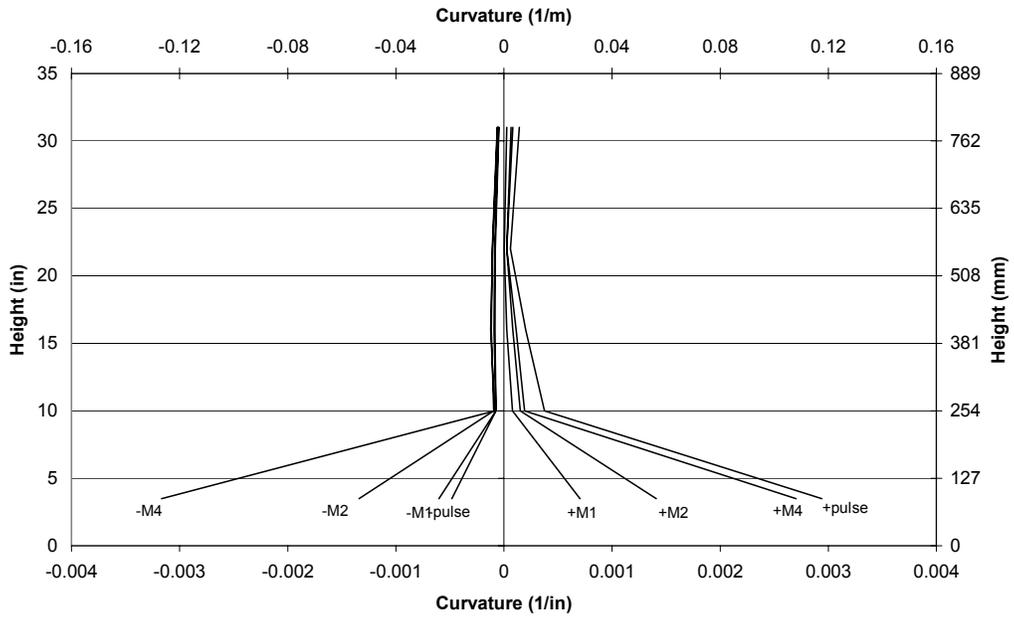
Fig. 5.44 Curvature distribution: pre-1971 specimen, quasi-static test

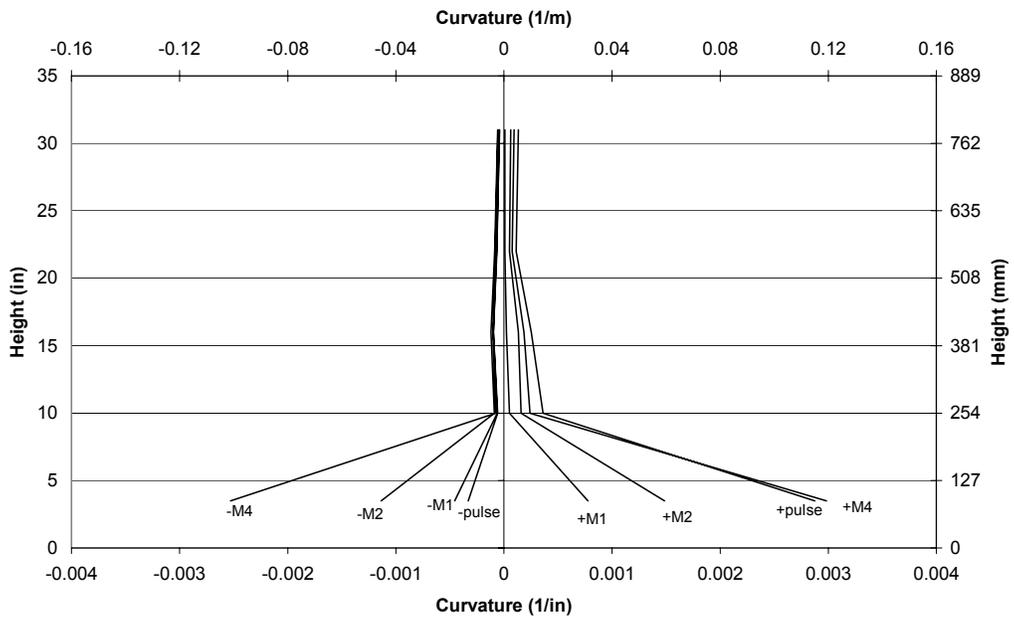
Fig. 5.45 Curvature distribution: pre-1971 specimen, dynamic test

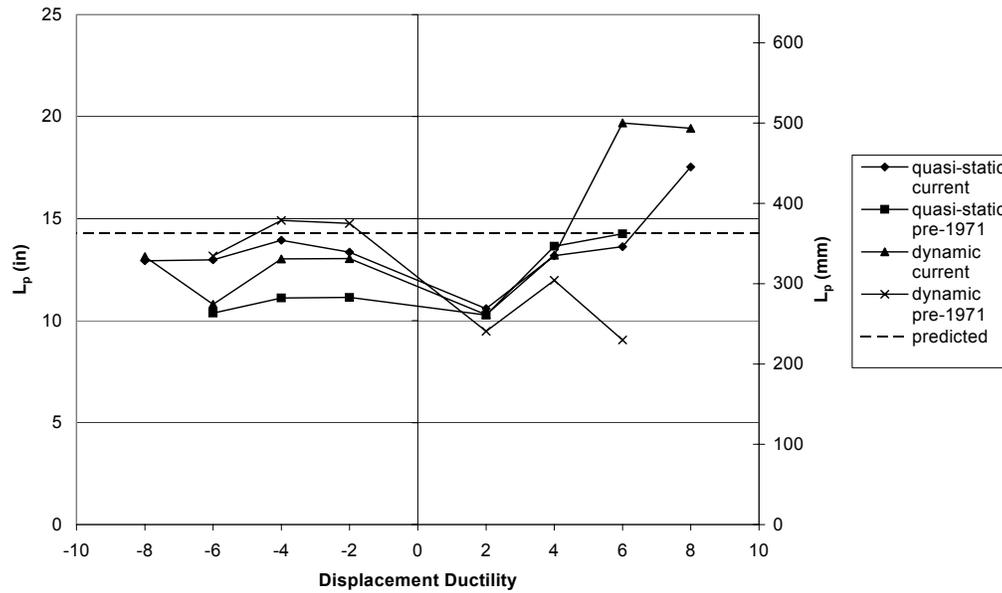
Fig. 5.46 Evolution of plastic hinge length with displacement ductility

Before testing, the plastic hinge length was predicted by Equation 5.5 (Priestley 1996). The predicted value of 363 mm (14.3 in.) is close to the actual values that were calculated from the test data. The first values that were computed were for $\mu=2$ because it was assumed that before that level, a plastic hinge has not fully formed. The values for the higher ductilities of 8 and 10 are not likely to be accurate, as the concrete in the plastic hinge regions began to spall and could have displaced the linear plots mounted on the edges of the column. The plastic hinge length is fairly constant for all of the tests, as can be seen in Figure 5.46.

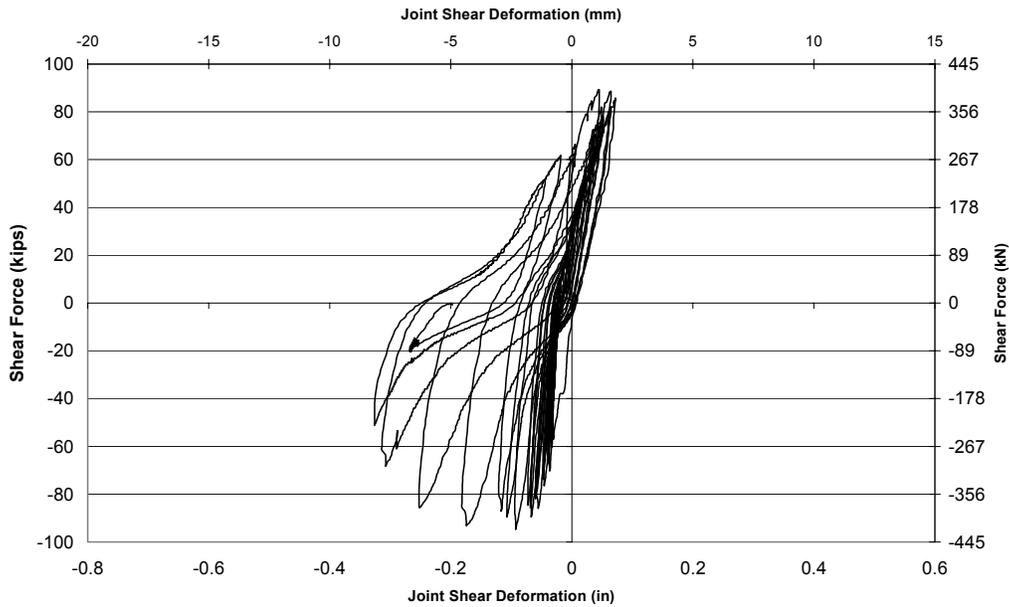
Fig. 5.48 Joint shear deformation history: current design specimen, quasi-static test

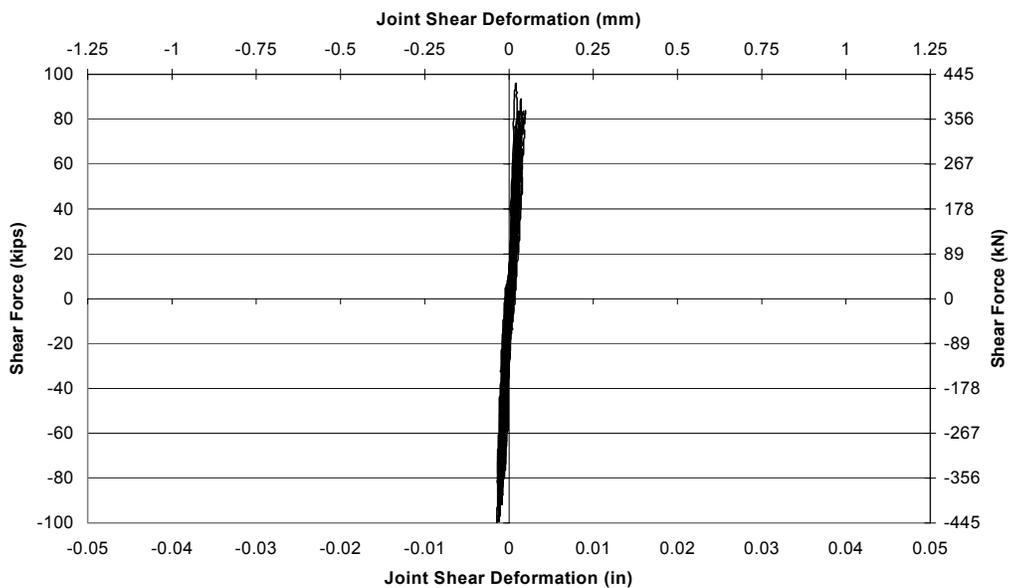
Fig. 5.49 Joint shear deformation history: current design specimen, dynamic test

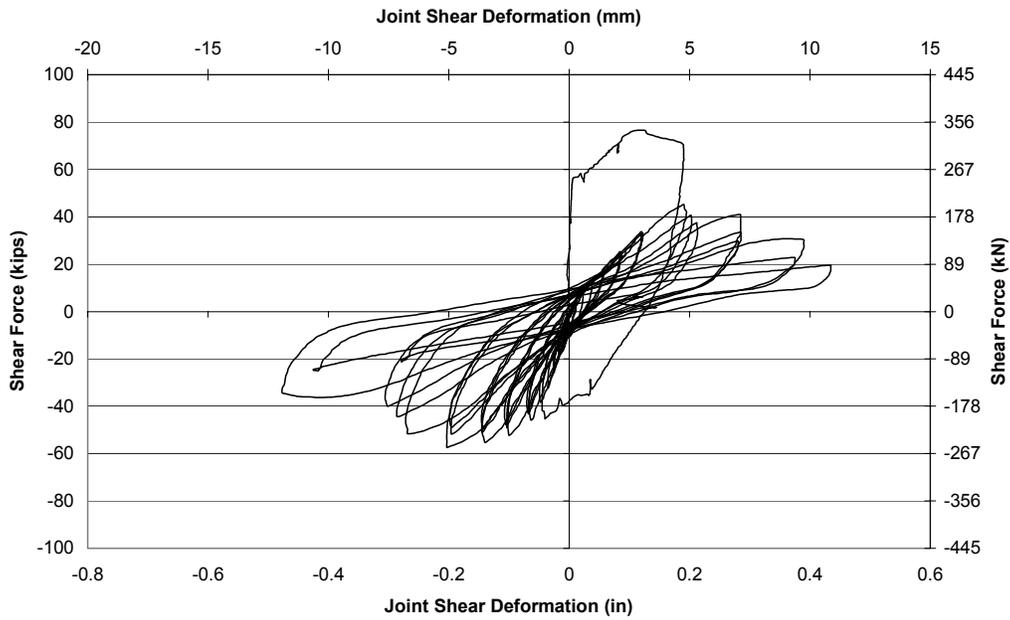
Fig. 5.50 Joint shear deformation history: pre-1971 specimen, quasi-static test

load level. The quasi-static pre-1971 test degraded slowly, with large amounts of energy dissipation in shear as seen by the large loops of Figure 5.50. The dynamic test of the pre-1971 dissipated more shear energy during the pulse than in the quasi-static test, but then during the cyclic loading the loops were very pinched and flattened out quickly, as shown in Figure 5.51.

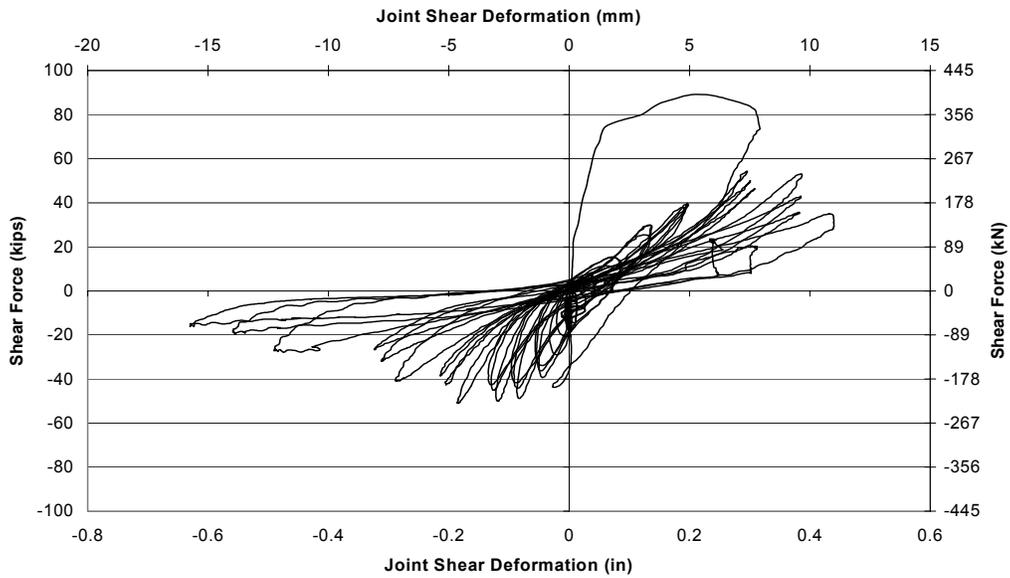
Fig. 5.51 Joint shear deformation history: pre-1971 specimen, dynamic test

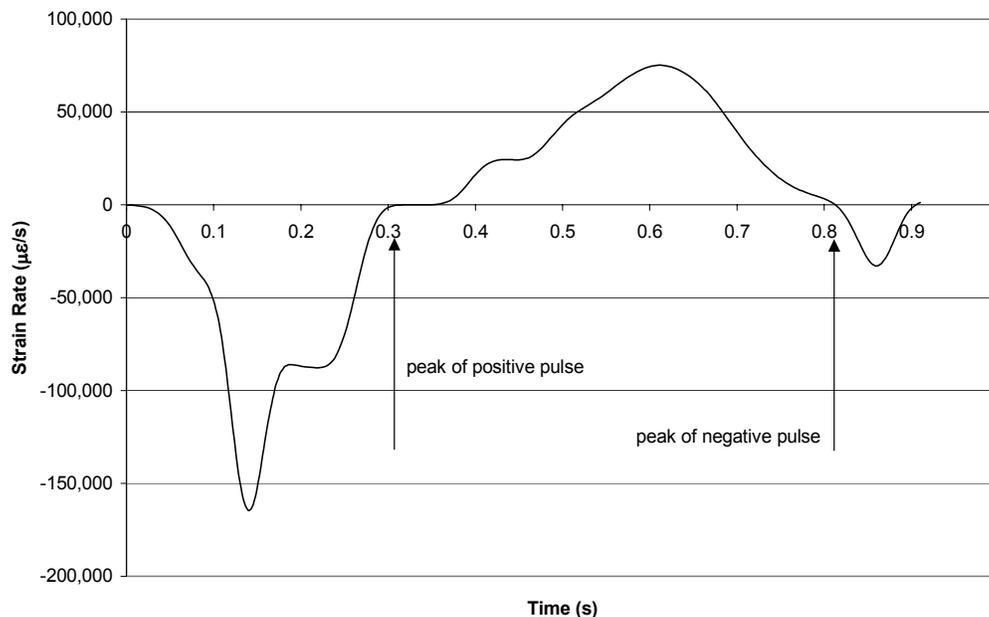
Fig. 5.52 Strain-rate time-history: south column longitudinal bar, pulse of current design specimen, dynamic test

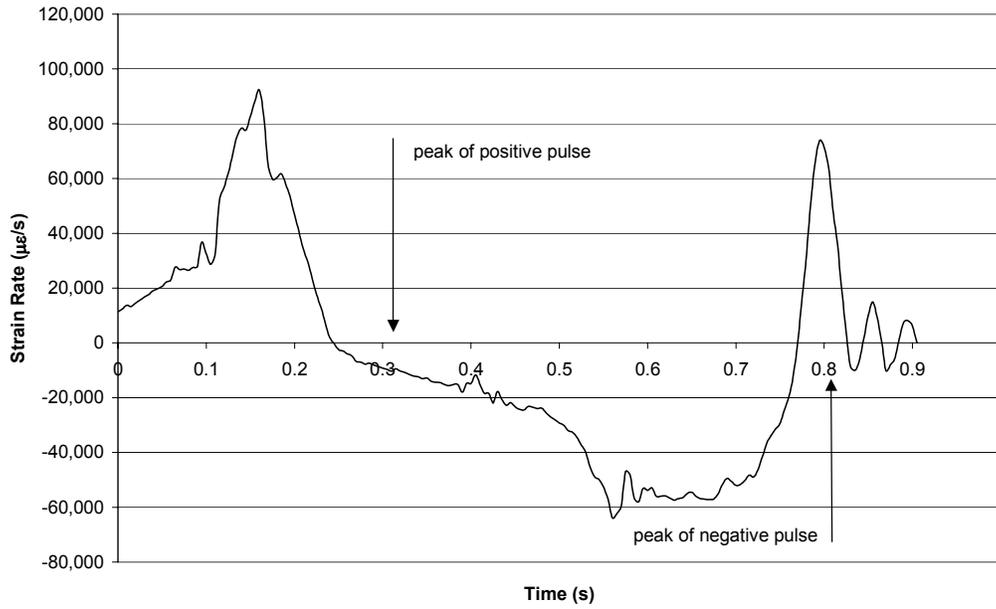
Fig. 5.53 Strain-rate time history: north column longitudinal bar, pulse of current design specimen, dynamic test

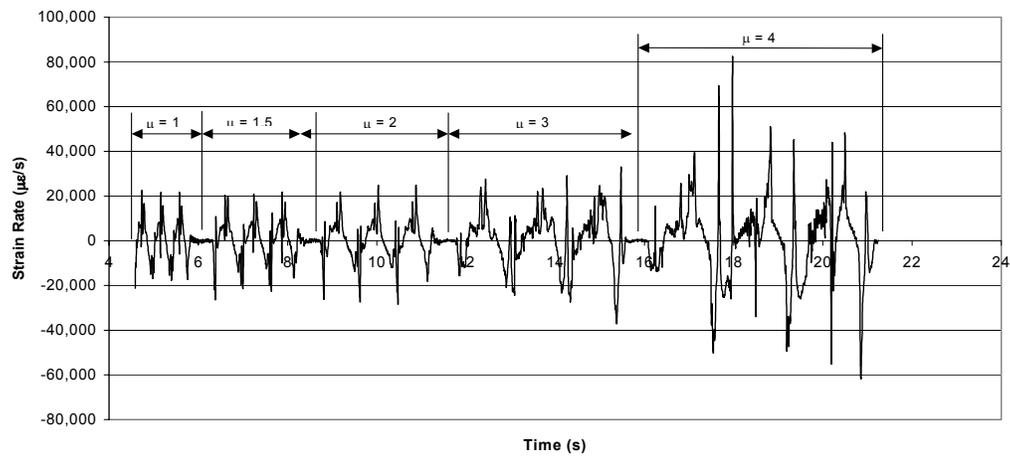
Fig. 5.54 Strain-rate time history: south column longitudinal bar during cyclic loading of current design dynamic test

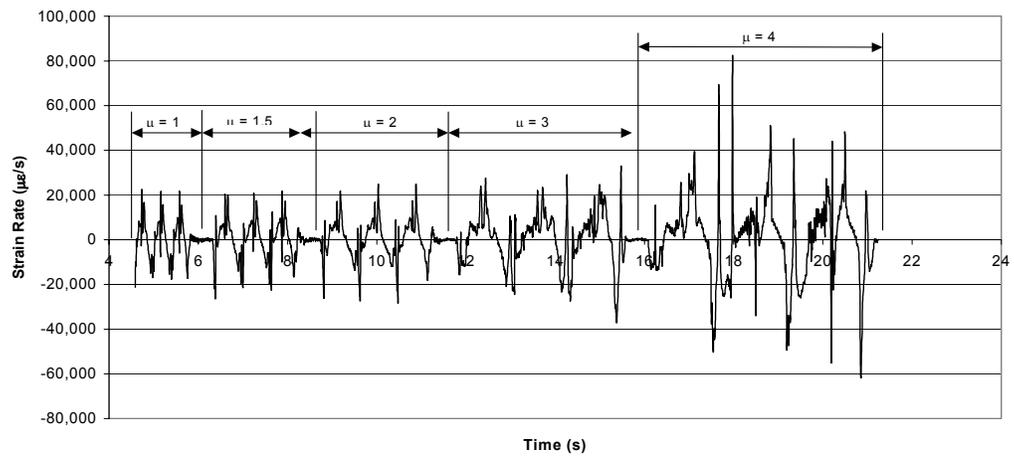
Fig. 5.55 Strain-rate time history: south column longitudinal bar during cyclic loading of current design dynamic test

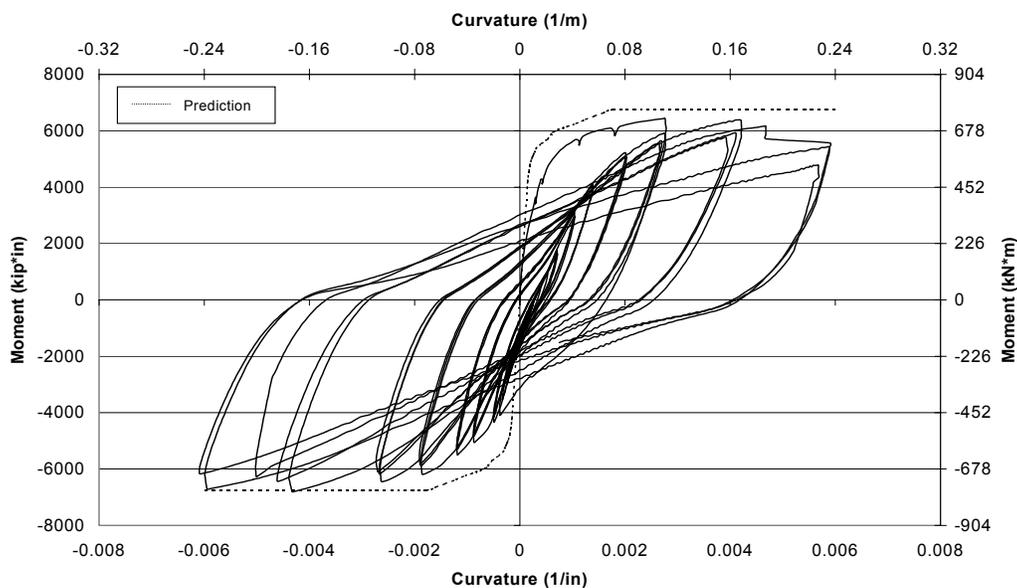
Fig. 6.1 Moment-curvature history: current design specimen quasi-static test

The response of the quasi-static tests was generally less than for the predicted model. In the negative direction of the current design specimen test, as shown in Figure 6.1, the prediction traced an envelope for the behavior of the specimen, but in the positive direction, the behavior during the pulse displacement never reached the levels predicted. The pre-1971 specimen never reached the expected strength of the column in either direction, as shown in Figure 6.2. When looking at both of the dynamic tests, as shown in Figures 6.3 and 6.4, the stiffness seen in the test results during the pulse loading is less than the prediction, and the strength of the specimens is higher than predicted by the model. The difference in stiffness could be due to the method used for calculating the curvature at the base of the column from the potentiometer readings. The difference in strength could be due to the strain-rate effects of the dynamic material response. A modification of the curvature calculation and the material properties to account for strain rate is presented in the next section.

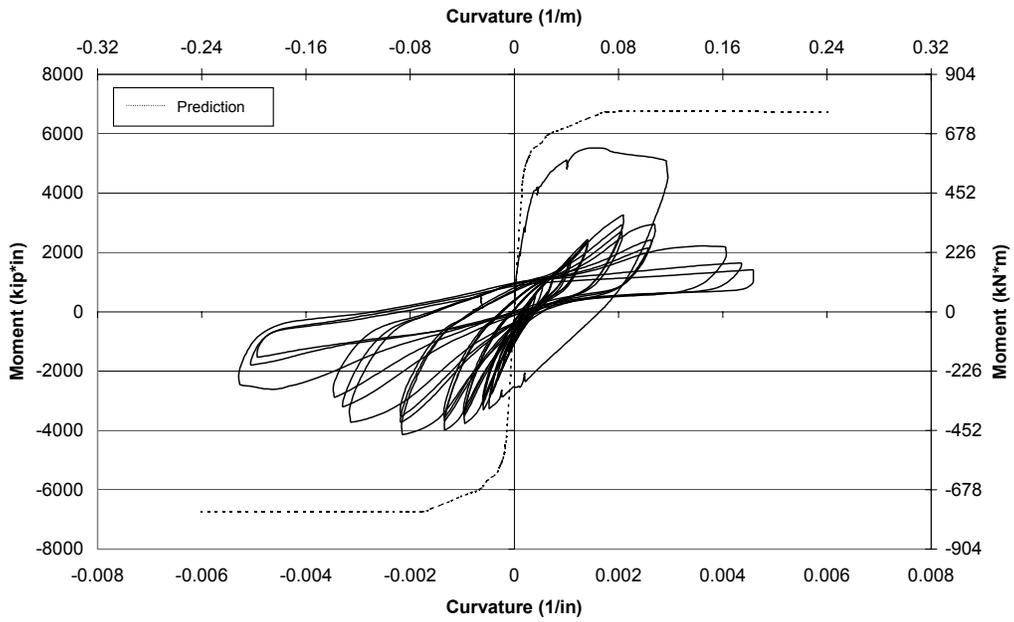
Fig. 6.2 Moment-curvature history: pre-1971 specimen quasi-static test

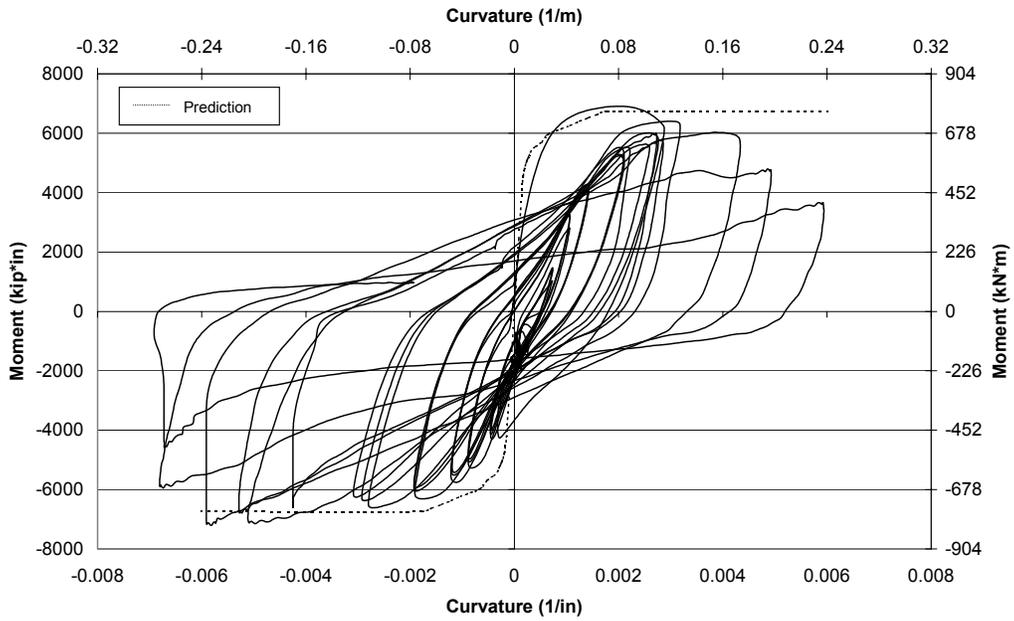
Fig. 6.3 Moment-curvature history: current design specimen dynamic test

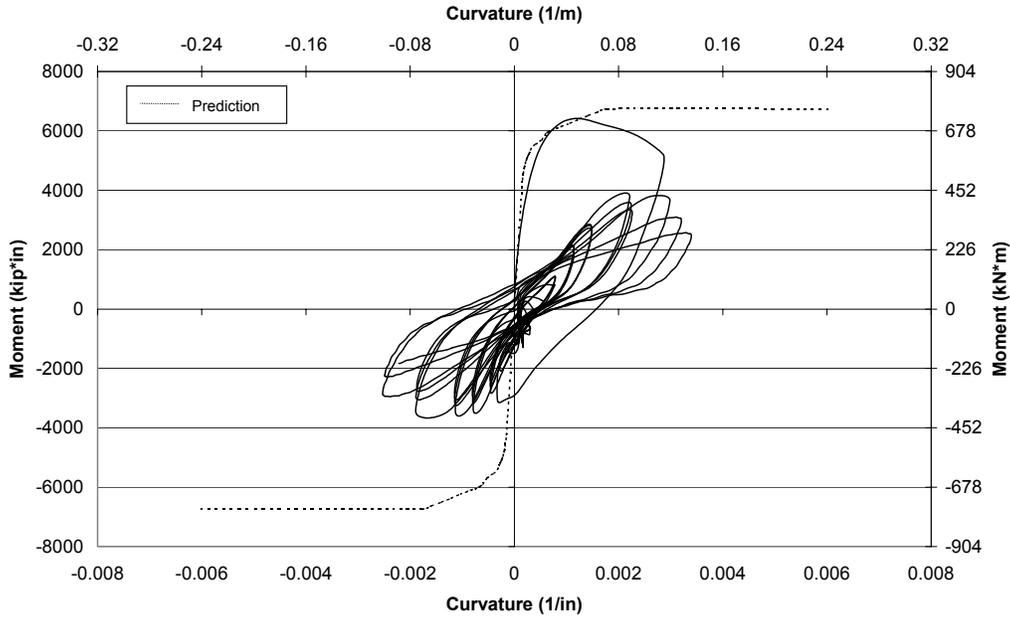
Fig. 6.4 Moment-curvature history: pre-1971 specimen dynamic test

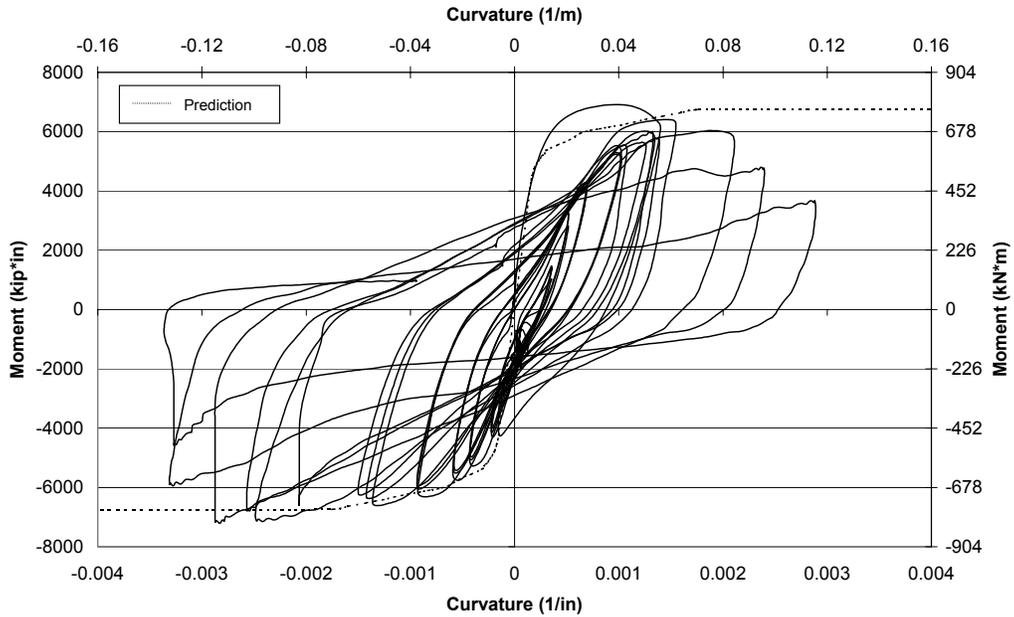
Fig. 6.5 Moment-curvature history: current design specimen with revised gauge length for curvature calculation

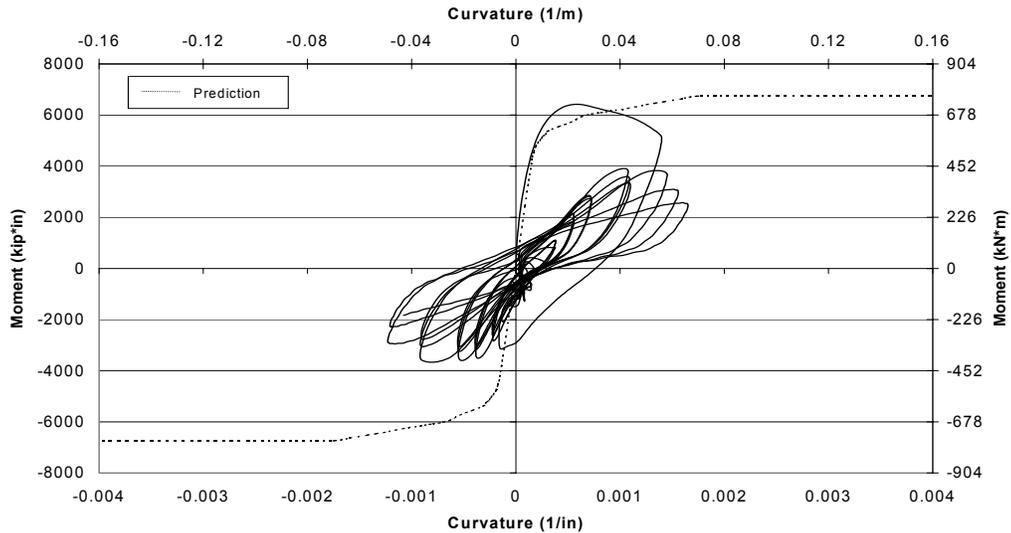
Fig. 6.6 Moment-curvature history: pre-1971 specimen with revised gauge length for curvature calculation

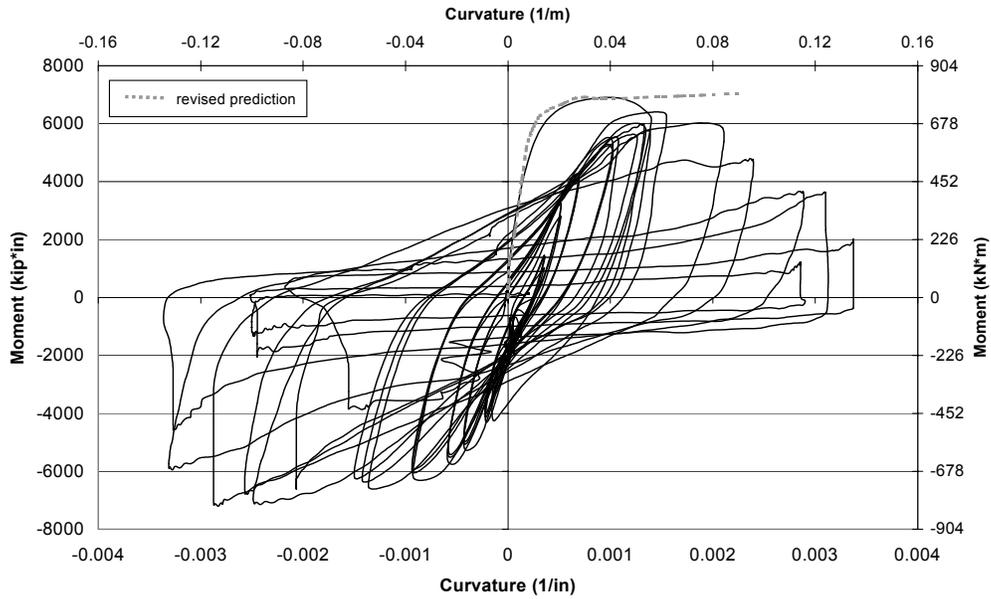
Fig. 6.7 Moment-curvature history: current design dynamic test with prediction revised for dynamic material properties

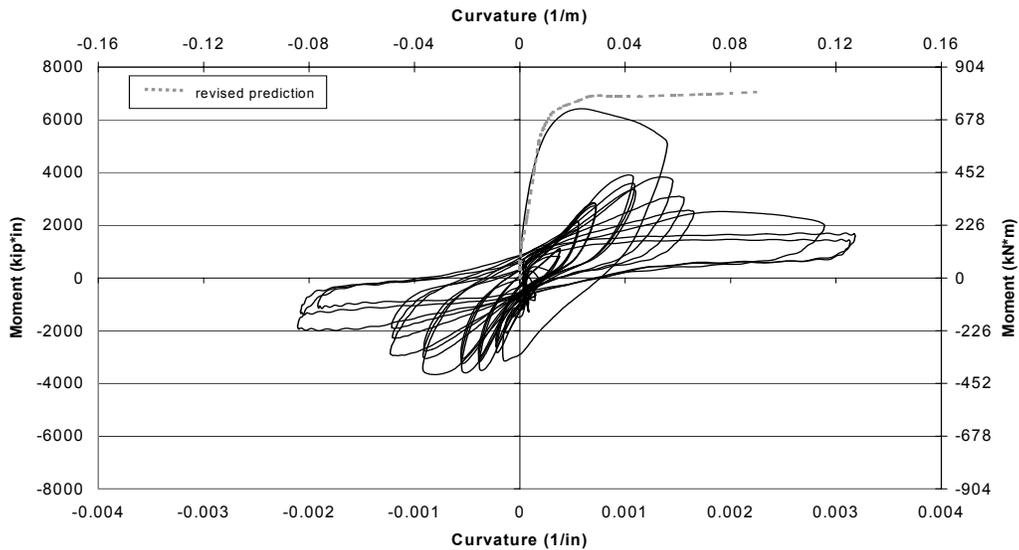
Fig. 6.8 Moment-curvature history: pre-1971 dynamic test with prediction revised for dynamic material properties

loading of the positive pulse but due to the concentration of damage in the joint, the maximum predicted moment was never reached.
