Experimental Assessment of Columns with Short Lap Splices Subjected to Cyclic Loads

PEER Report 2003/04
Pacific Earthquake Engineering Research Center
College of Engineering
University of California, Berkeley

April 2003

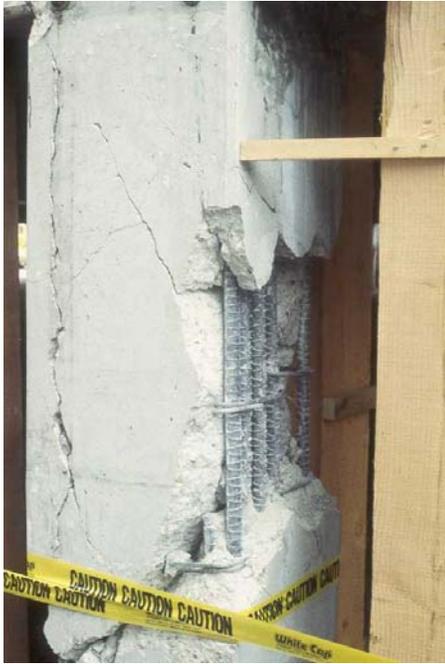
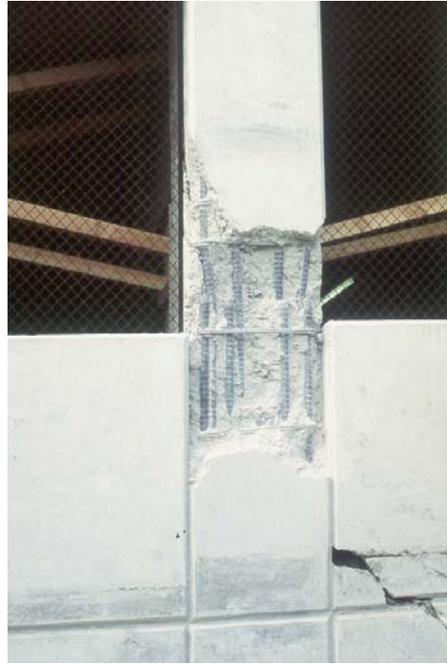
Fig. 1.1 - Splice Damage: Northridge Earthquake

(a) One-Story Parking Structure

(b) 8-Story Parking Structure

Following the Northridge earthquake, shear and splice failures in reinforced concrete columns were commonly observed in older buildings and in building columns designed as nonparticipating elements. Splice damage at the base of an exterior column in a one-story parking structure is shown in Figure 1.1(a) (Sherman Oaks, near the 101/405 interchange). The column is approximately 450 mm square with $20d_b$ lap splices. Cross sections of the interior columns of this structure had been significantly increased to provide longer seat lengths for the precast floor girders; however, no apparent changes had been made to the exterior columns. Damage to the column indicated that slip had occurred along the splice, with spalling of concrete, which is fairly common for splice failures. Diagonal cracks in some of the exterior columns indicated that the shear capacities of these columns might have been compromised. The shear distress in some columns (and the lack of significant observed damage in the splice region) indicates a range of behavior for columns with presumably similar details.

Damage to columns of an eight-story parking structure located across the street (Ventura Boulevard) from the structure shown in Figure 1.1(a) is shown in Figure 1.1(b). The structure was designed using the 1982 UBC, and built in the mid-1980s. Although the columns in this structure had been designed with the lap splice near the mid-height of the column, “nonstructural” reinforced concrete exterior panels were cast directly against the columns, creating a captive column. The maximum moment for the captive column was shifted to the splice region, possibly leading to the observed damage. Splice damage was limited in this structure due to the extensive use of shear walls, which limited the lateral drift imposed on the columns.

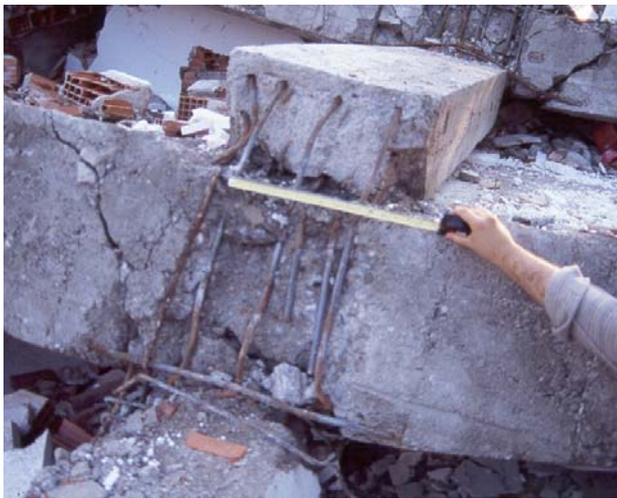
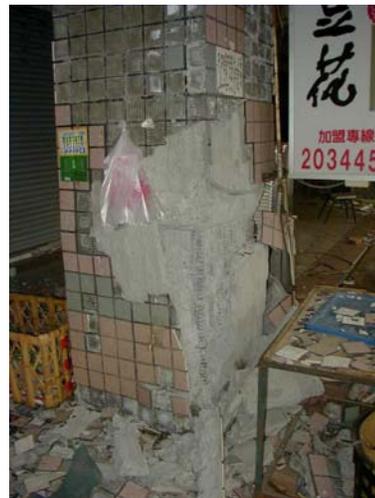
Figure 1.2 - Anchorage and Splice Damage

(a) Connection region— Gölcük, Turkey

(b) 12-Story Building— Nantou

anchored with short hooks into the top of the column in the story below. The failure surface between the column and the floor slab indicates that the interior column longitudinal bars were inadequately anchored, and pulled out, most likely at relatively low load levels, allowing the column to rotate freely. Lateral loads imposed on the columns under this condition lead to higher axial compression in the column (because the axial load for lateral and gravity loads are additive). The axial compression, when coupled with the column rotation caused by reinforcement slip, could lead to premature buckling of the exterior column longitudinal reinforcement passing through the joint.

Damage in the splice region was observed in a 12-story building in Nantou (Fig. 1.2(b)), Taiwan; however, the use of shear walls was a significant factor in limiting the damage to the columns. Damage also was observed at some of the exterior beam-column connections in a three-story building near Nantou, Taiwan. Failure at the exterior connection regions for this building may have been initiated by slip along the interior column splice bars, leading to significant rotation of the column. Under the column rotation, large compression would be exerted at the column edge, potentially leading to the peeling away of the concrete in the joint region.

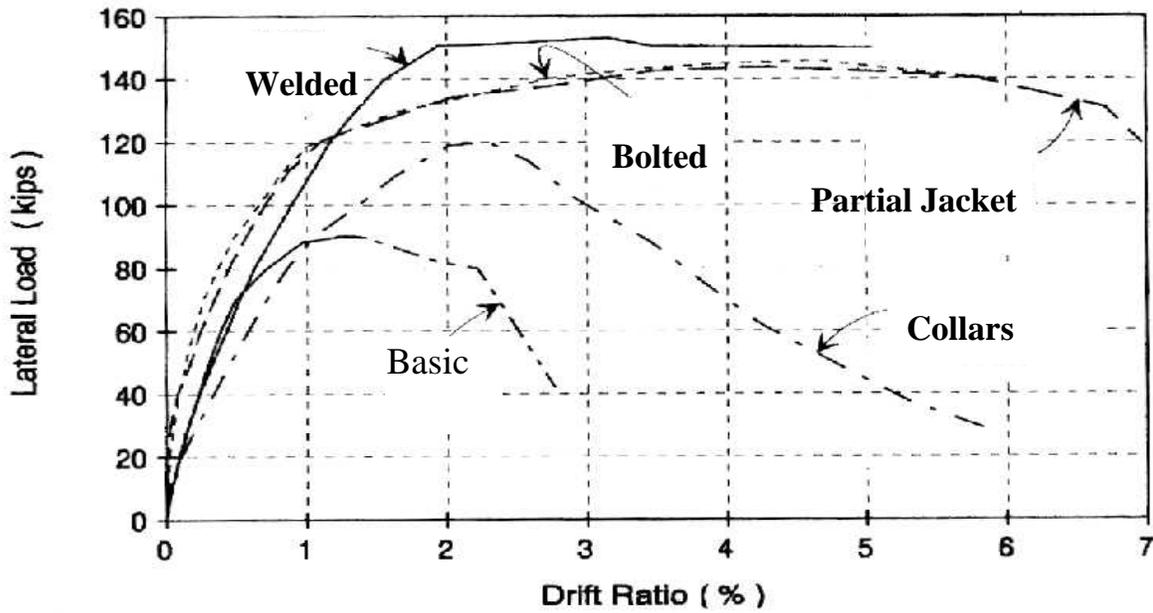
Figure 1.3 - Comparison of Test Results (Aboutaha et al., 1996)

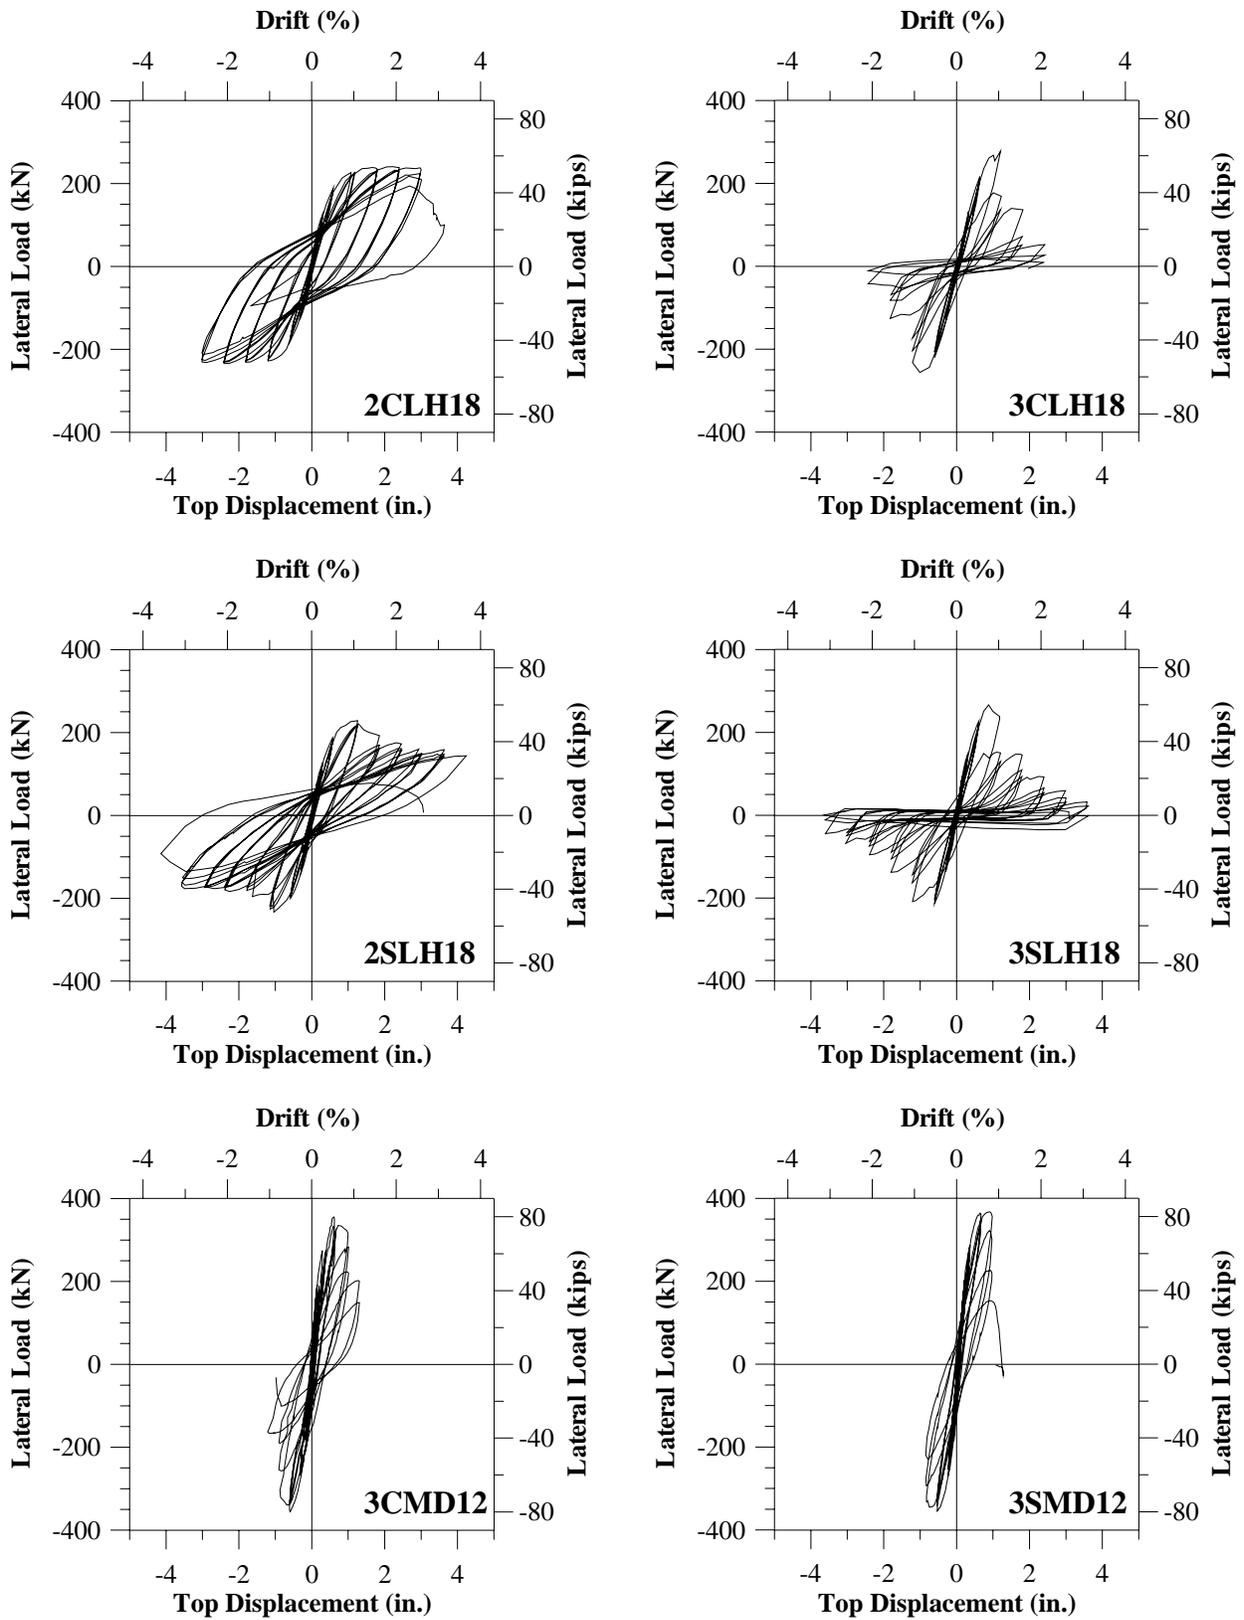
Figure 1.9 - Lateral Load-Top Displacement Relations (Lynn et al., 1996)

Lateral load, top displacement response of specimens tested by Lynn are shown in Figure 1.9. All specimens exhibited lateral strength degradation due to shear failure. Specimens with low axial load and steel ratio (2CLH18 and 2SLH18) showed fairly ductile response (displacement ductility of 4.2 and 3.5, respectively) compared with other specimens. Although the yield stress was reached in the spliced bars, cracks along the lap splice led to strength degradation and eventually shear failure (just above the splice) in the specimens with low axial stress (2SLH18 and 3SLH18). For the specimens with high axial stress, abrupt shear failures were observed for columns with and without the lap splices, shortly after reaching the bar yield stress in tension; therefore, the splice did not substantially influence the observed behavior.

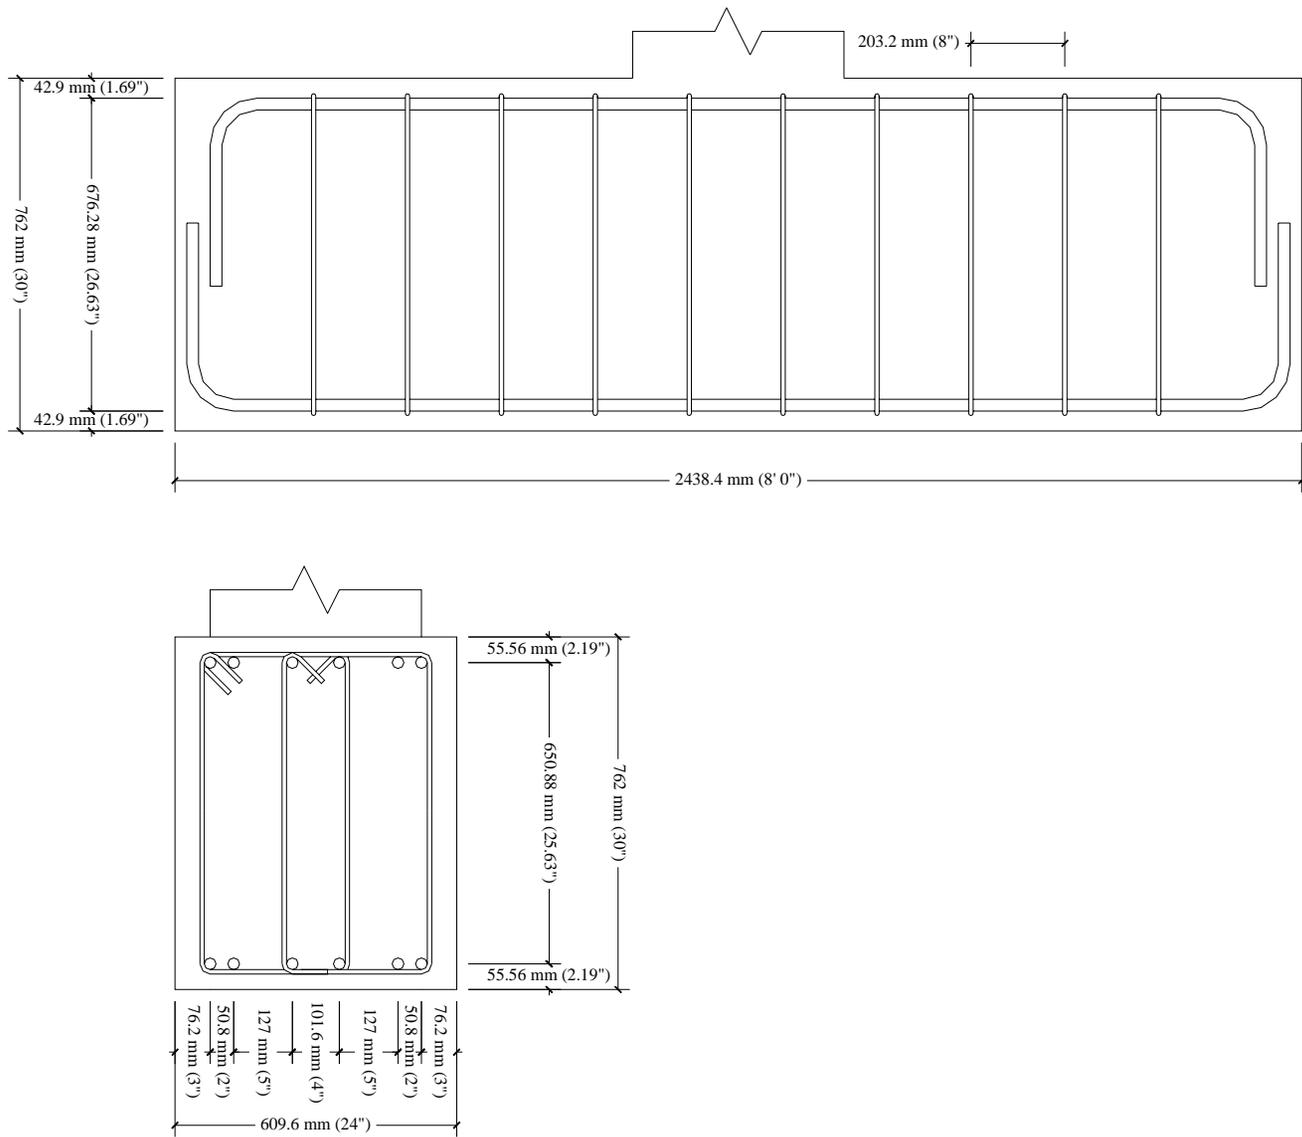
Figure 2.5 - Pedestal Reinforcement Details

Reinforcement cages for the foundation blocks (or pedestals) were fabricated first. Column pedestals are reinforced with 6 - #8 ($d_b = 1.0$ in.; 25.4 mm) top and bottom longitudinal reinforcing bars. Shear reinforcement consists of a #3 hoop and two #3 ties ($d_b = 0.375$ in.; 9.53 mm) spaced at 203.2 mm (8 in.) on center. Pedestal reinforcement details are shown in Figure 2.5. Reinforcement used was provided by C&M Steel, located in Fontana, California. Finished pedestal cages were placed in the forms using a crane.

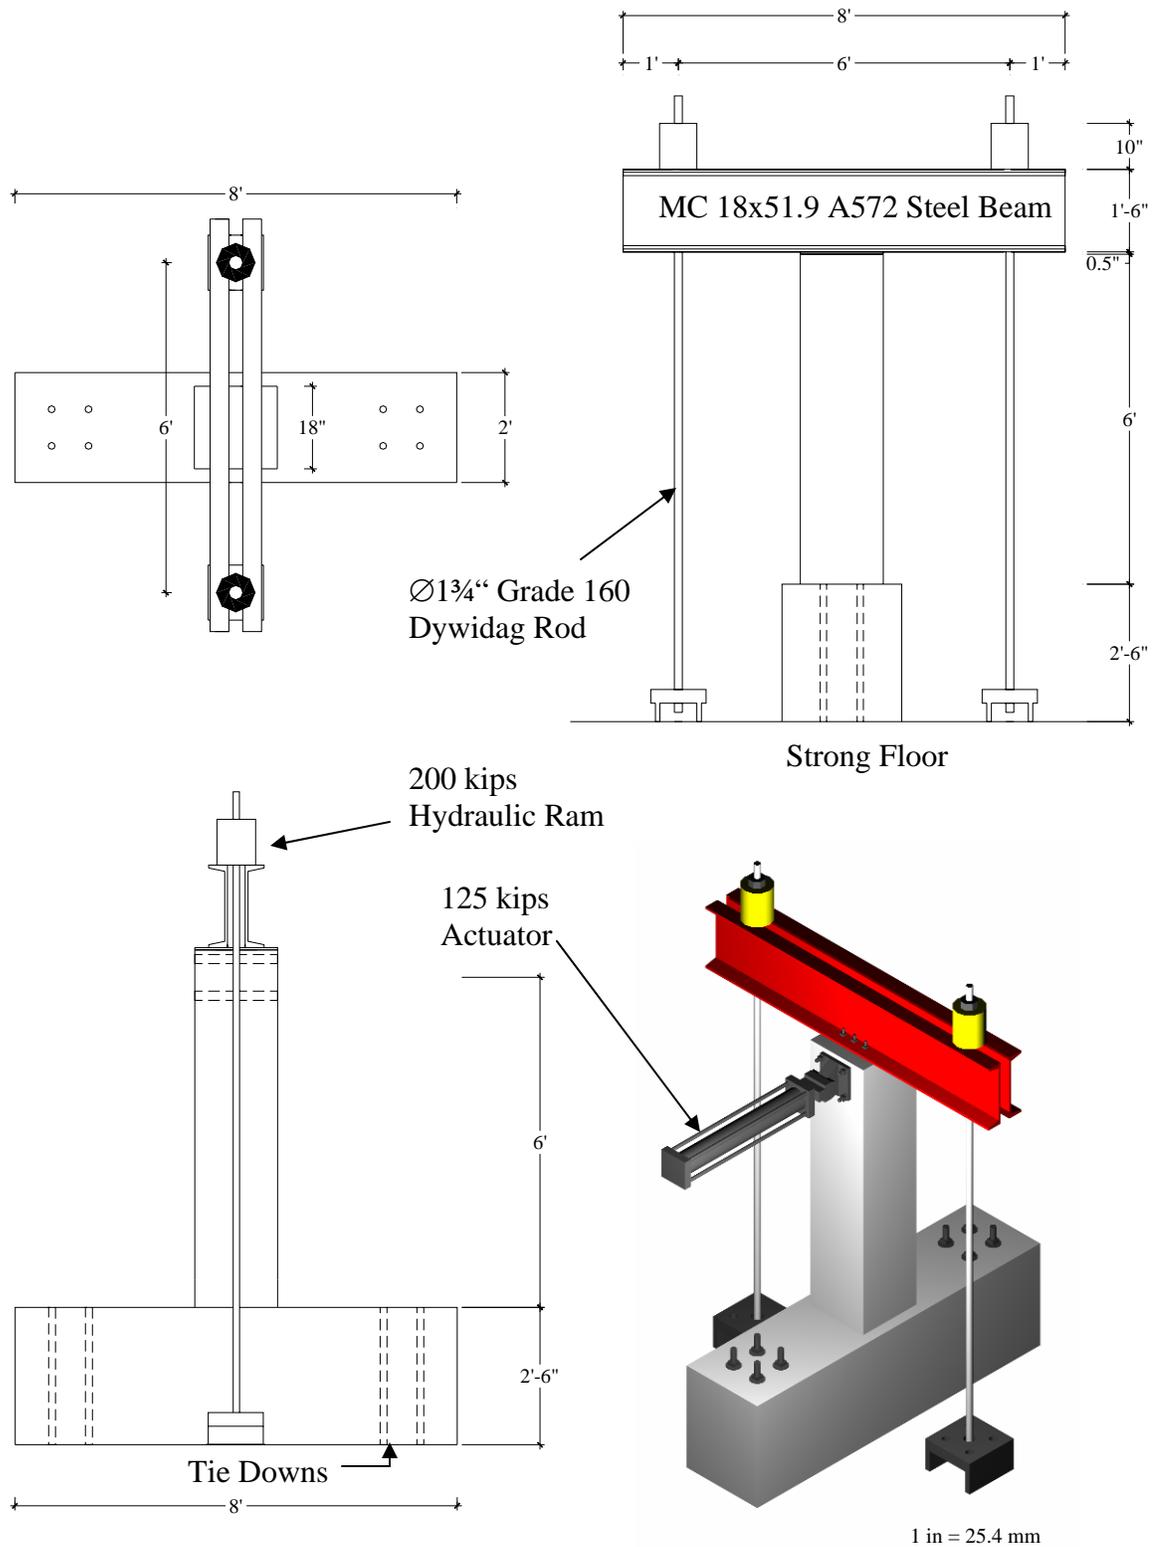
Figure 2.12 - Test Setup

Six reinforced concrete column specimens with pre-1960s construction details are tested. The test specimens consist of a cantilever column with a foundation block attached to a strong floor (Fig. 2.1). The specimens represent a building column from column mid-height between floors to the column-joint interface for an interior column. The column cross section is 18 in. (457 mm) square with 8 - #8 ($d_b = 1.0$ in.; 25.4 mm) longitudinal reinforcing bars and #3 ($d_b = 0.375$ in.; 9.53 mm) ties @ 12 in. (304.8 mm) spacing with 90° hooks. The column cross-section and reinforcement details are the same as in the UC Berkeley test program (Lynn et al., 1996). The column height is selected to ensure that the shear strength of the columns (using ACI 318-99 Eq. 11-4 and 11-15) are sufficient to develop the lateral load required to reach the nominal moment capacity at the base of each column, where a lap splice is located. A lap splice length of $20d_b$ is used based on the requirements for compression splices in older buildings.

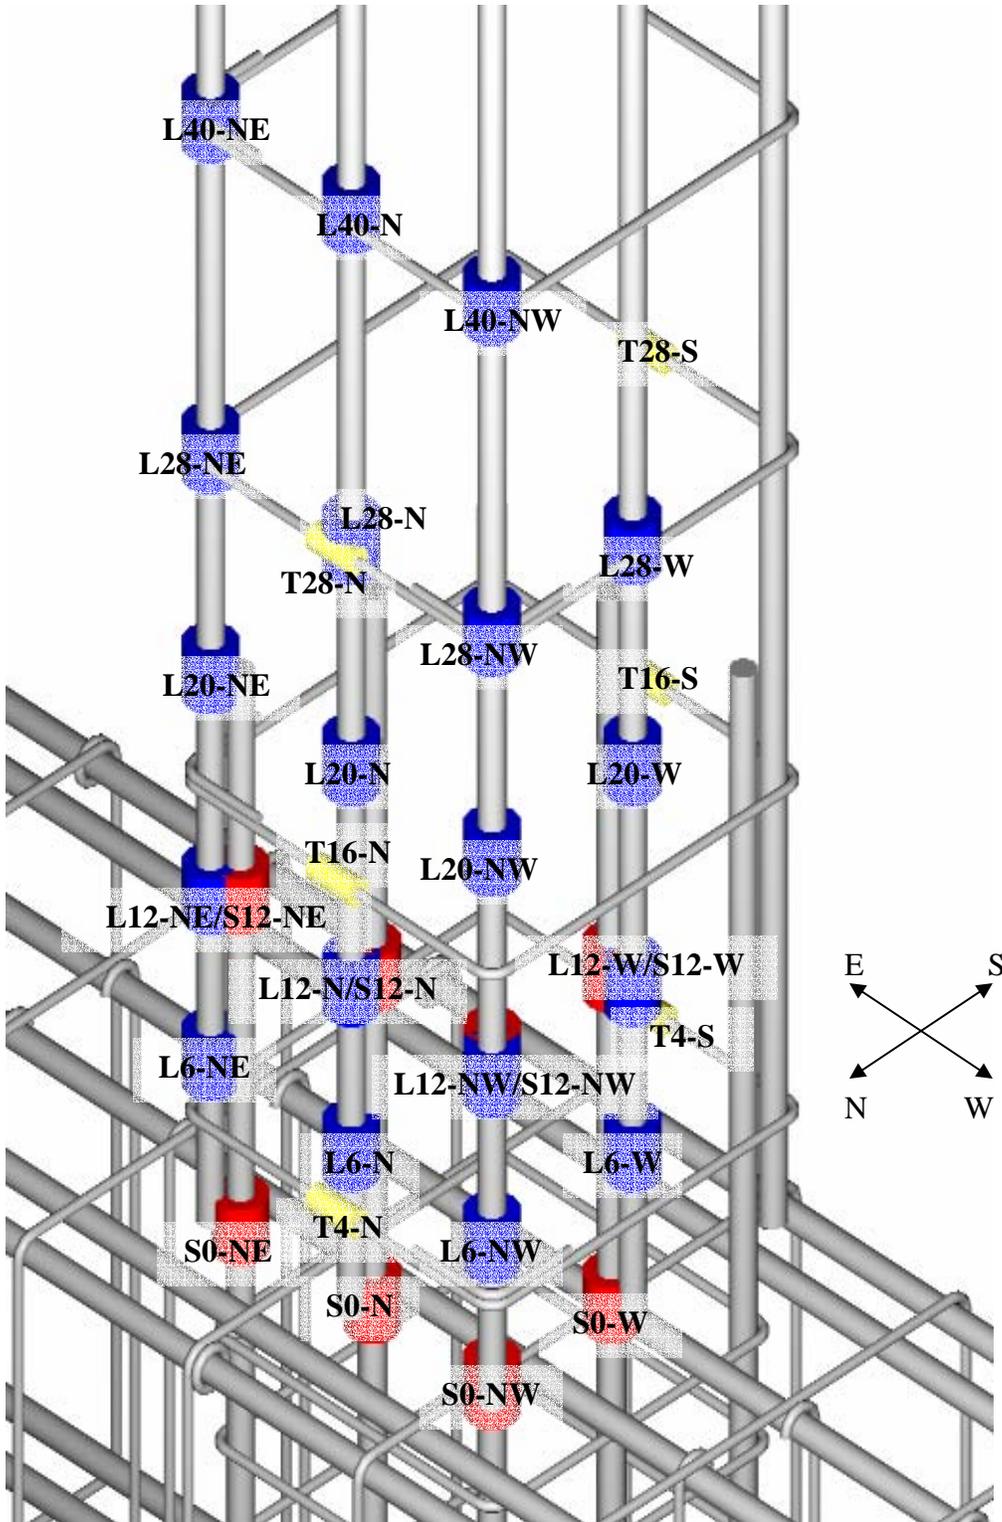
Figure 2.17 - Strain Gauge Labeling Scheme

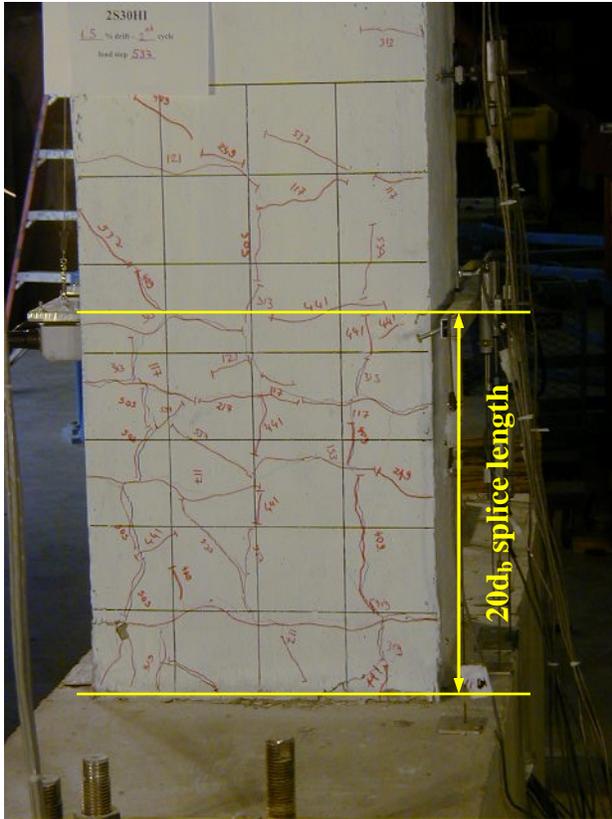
Figure 3.1 - Longitudinal Cracks Indicating Bond Deterioration (S20HI at 1.5% Drift) (Left)

Specimen S20HI is a companion to specimen S20MI, but with higher shear demand (with decreased column height from 1823 mm to 1676 mm). At the sixth step of the first cycle to 0.25% lateral drift ratio (DPN 103), the first flexural cracks were observed. This coincided with a change in initial stiffness of the lateral force-displacement plot, which was monitored on a computer screen during the experiment. At 0.50% lateral drift ratio, flexural cracks became abundant on the tension column face up to a height of 685 mm above the pedestal (41% of the column height). Crack widths were very small (<1.5 mm). Longitudinal cracking along the splice length was first observed during the cycle to 0.75% lateral drift (DPN 313). After three cycles of 1.5% lateral drift were completed, longitudinal cracks propagated along the column to as much as 660 mm above the pedestal level. Crack widths were limited, generally less than 1.5 mm. Concrete crushing also was observed at this drift level (DPN 537), and concrete cover spalling occurred as drift levels were increased. At 3.0% lateral drift, the corner reinforcement bars were visible. At 7.0% lateral drift, all concrete cover over the bottom 400 mm of the column had spalled off. Shear cracks were observed on the north and south faces of the column starting at a drift level of 0.5% (DPN 201). Some minor cracking also was observed on the north side of the pedestal at this drift level. At 0.75% lateral drift, additional shear cracks were observed (DPN 297), generally located between one-quarter and one-half column depths away from the column base (114 mm to 229 mm). Although observed shear cracking was more significant than that observed for the first three specimens (S10MI, S20MI, and S30MI), longitudinal cracking was dominant indicating that bond deterioration caused lateral strength degradation.

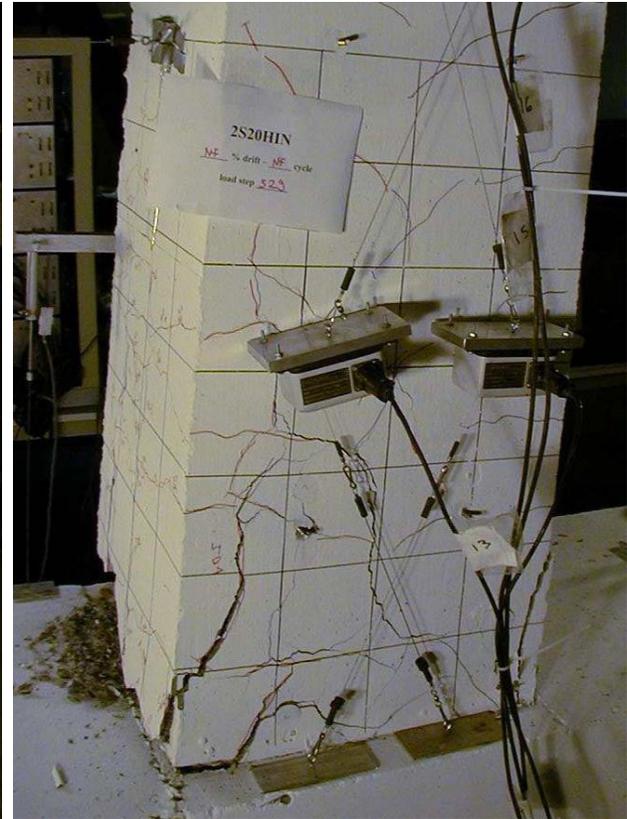
Figure 3.2 - Longitudinal and Shear Cracking (S20HIN at 5.8% Drift) (Right)

S20HIN was the only specimen tested with the near-fault displacement history (Fig. 2.30). Initial lateral displacement cycles were identical with the standard displacement history (Fig. 2.29), except for the absence of the cycles to 0.75% lateral drift. Response of the specimen was similar to that for the other specimens. Initial flexural cracks were observed during the first cycle of 0.50% lateral drift (DPN 105 and 121 on the east and west faces of the specimen, respectively). Longitudinal cracking started during the first cycle to 1.0% lateral drift (DPN 297 and 312). At 1.0% lateral drift, 53% of the column height (890 mm) displayed flexural cracks. Longitudinal cracks along the splice length first appeared over a length of 100 mm at the bottom of the column. After completion of the second cycle to 1.0% lateral drift, longitudinal cracks had propagated along the entire splice length ($20d_b$). When 4.0% lateral drift was reached, longitudinal crack propagation had ceased and crack widths were as wide as 4 mm. For higher

drift ratios, the crack at the column-pedestal interface increased substantially due to the slip of longitudinal bars relative to the starter bars anchored within the pedestal. Concrete spalling started around 4.0% lateral drift, but it was not significant compared to the other specimens, mainly due to the lack of a cyclic displacement history.

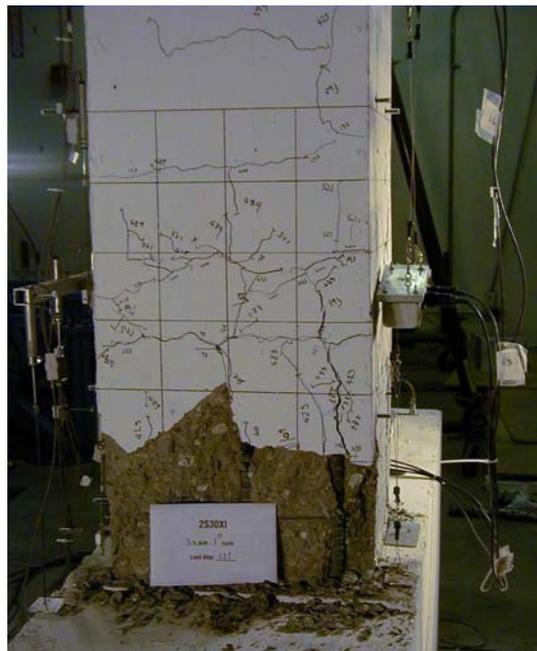
Figure 3.3 - Concrete Spalling (S30XI at 3% Drift)

The test program concluded with testing of specimen S30XI. Initial flexural cracks were observed on the west and east face of the column during the second cycle to 0.25% lateral drift (DPN 137) and during the first cycle to 0.50% lateral drift (DPN 216), respectively. Flexural cracking propagated along the column height as the applied lateral drift level was increased. After the application of three cycles of 0.50% lateral drift (DPN 289), flexural cracks were observed over the bottom 0.7 meters of the column (45% of the column height). Longitudinal cracking initiated during the first cycle of 0.75% lateral drift at data point numbers 297 and 313 on the west and east faces of the column, respectively. Observed longitudinal cracks were less prominent than for other specimens, and occurred only over the bottom 100 mm of the column on the north-west and north-east corners of the specimen. These cracks propagated up the column to a height of 686 mm (45% of the column height) when the lateral drift reached 2.0% (DPN 585). Concrete crushing was first observed at 1.5% lateral drift, and followed by spalling of concrete during the first cycle to 2.0% drift. Specimen S30XI was subjected to the highest shear demand of the columns tested; consequently wider shear cracks were observed. However, the extent of longitudinal cracking along the splice suggests that lateral strength loss was due to bond deterioration.

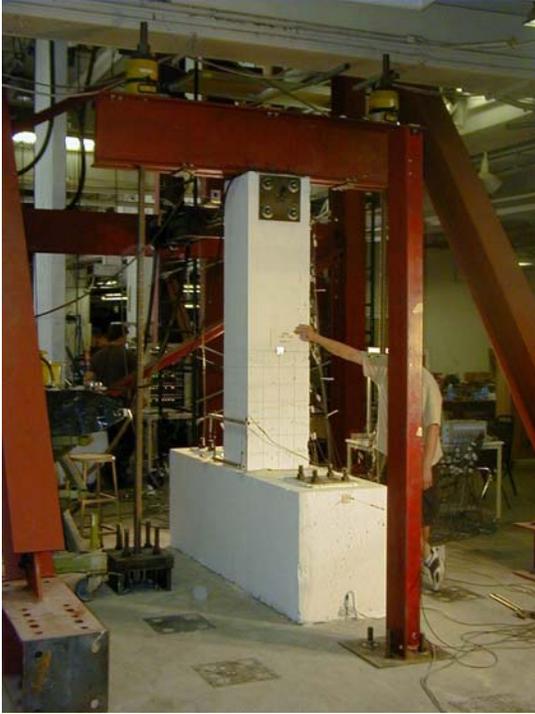
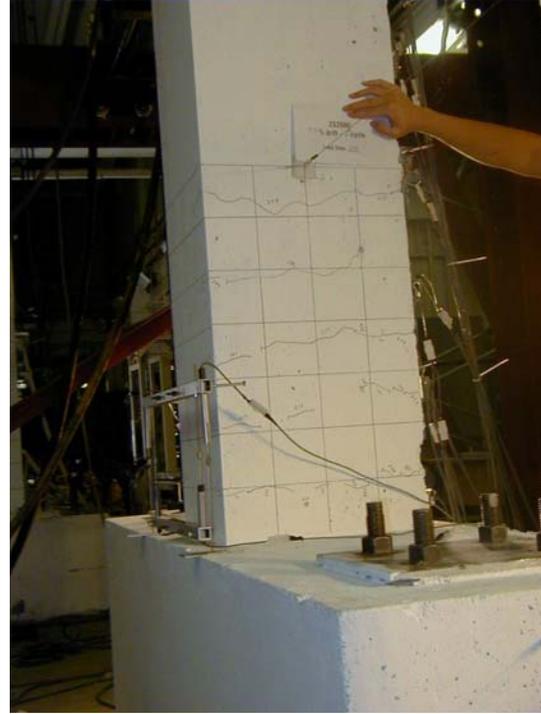
Figure 3.4 -Specimen S20MI at 0.50% Lateral Drift

S20MI was the second specimen tested. Flexural cracking on the column face started as early as the first cycle of 0.25% lateral drift ratio (DPN 105). When the lateral drift ratio reached to 0.75%, cracks were observed from the pedestal-column interface to a height of 864 mm above the pedestal (47% of the column height). Similar to specimen S10MI, longitudinal cracks observed during the first cycles to a peak drift level of 0.75% (DPN 297 pushing east, DPN 313 pulling west) occurred between the column-pedestal interface at the NW and NE corners of the column and the first flexural crack above the pedestal (approximately 100 mm). During the first cycle of 1.0% drift level, sudden and substantial crack propagation along the splice length (to a

total length of 508 mm) was observed at NE corner of the column (DPN 409). Lateral strength degradation initiated during the first cycle to 1.0% drift ratio (DPN 409) for the negative (east) direction and during the first cycle of 1.5% drift ratio (DPN 489) on the positive (west) direction. At 1.0% lateral drift, when lateral strength degradation initiated, longitudinal cracks were observed only at the south-west and north-east corners of the specimen. Cracks were narrow and had lengths of 114 mm on the east face and 514 mm on the west face. After completion of three cycles of 1.5% lateral drift, longitudinal cracks were present on west and east column faces along the lap-splice length. Bond deterioration was evident for all the longitudinal bars located on these two faces of the column. Initial hairline shear (diagonal) cracks were observed during the first cycle of 0.75% drift level (DPN 313). Additional shear cracks formed during the first cycle to 1.5% lateral drift ratio (DPN 487); however, after lateral strength degradation initiated, no new diagonal cracks were observed. Concrete crushing and spalling also were observed adjacent to the column-pedestal interface during the cycle to 1.5% lateral drift ratio (DPN 489). After the first cycle of 3.0% lateral drift was completed, all concrete cover on the east and west faces had spalled off over the bottom 127 mm of the column, and the longitudinal bars located at the south-west corner of the column were clearly visible. Pictures of Specimen S20MI from 0.5% to 7% drift ratio are presented in Figures 3.4 through 3.10. These pictures efficiently summarize the damage progress during testing.

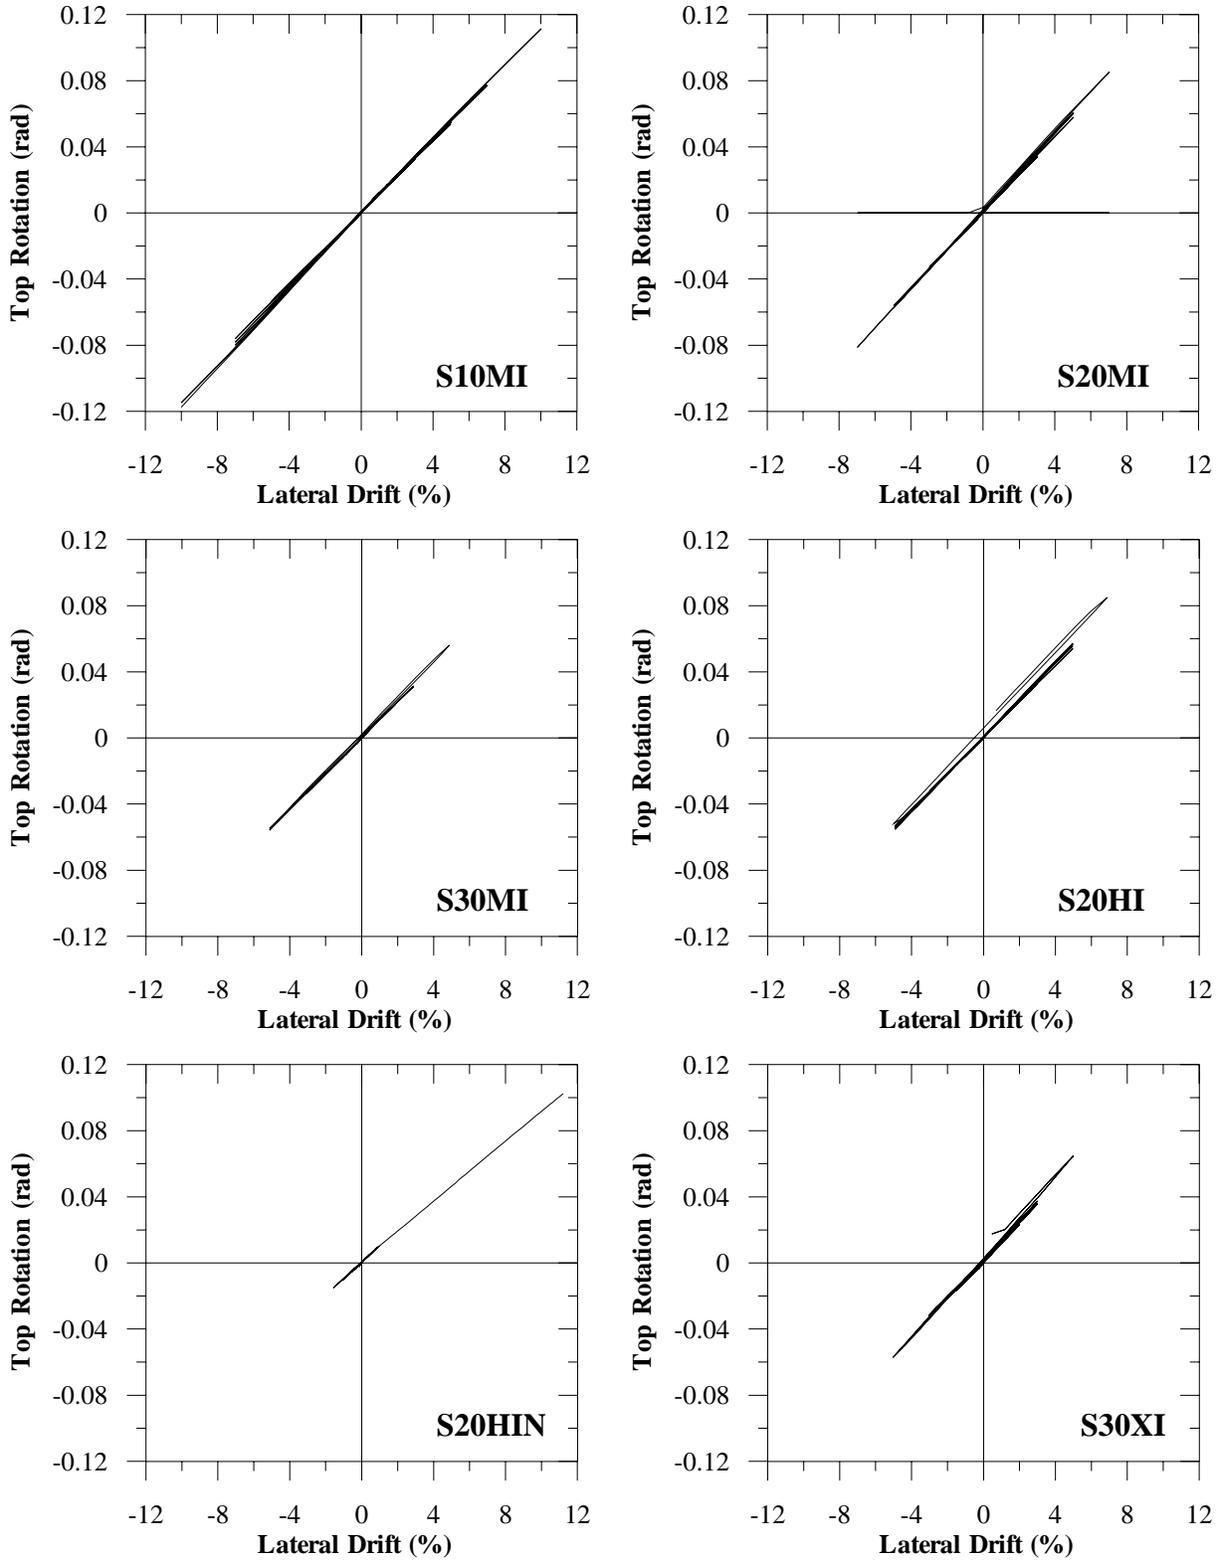
Figure 3.12 - Lateral Drift-Top Rotation

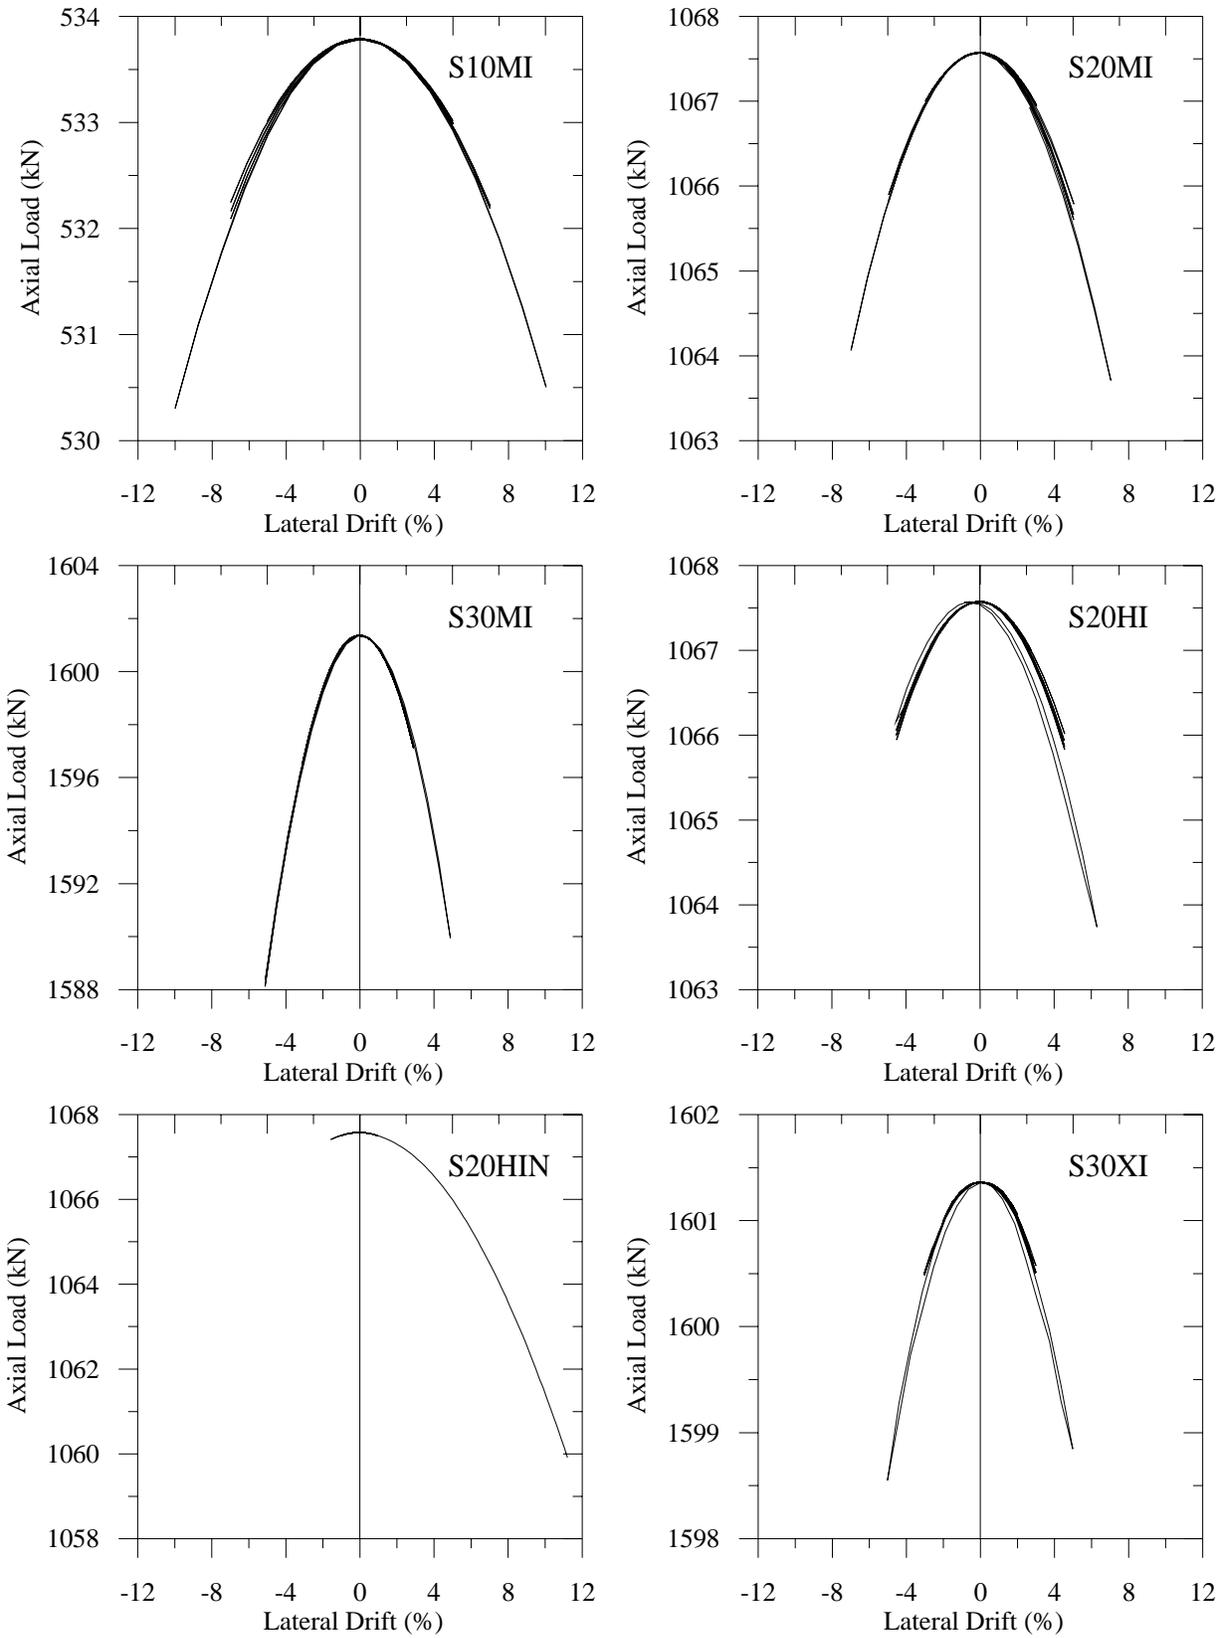
Figure 3.13 - Lateral Drift-Axial Load

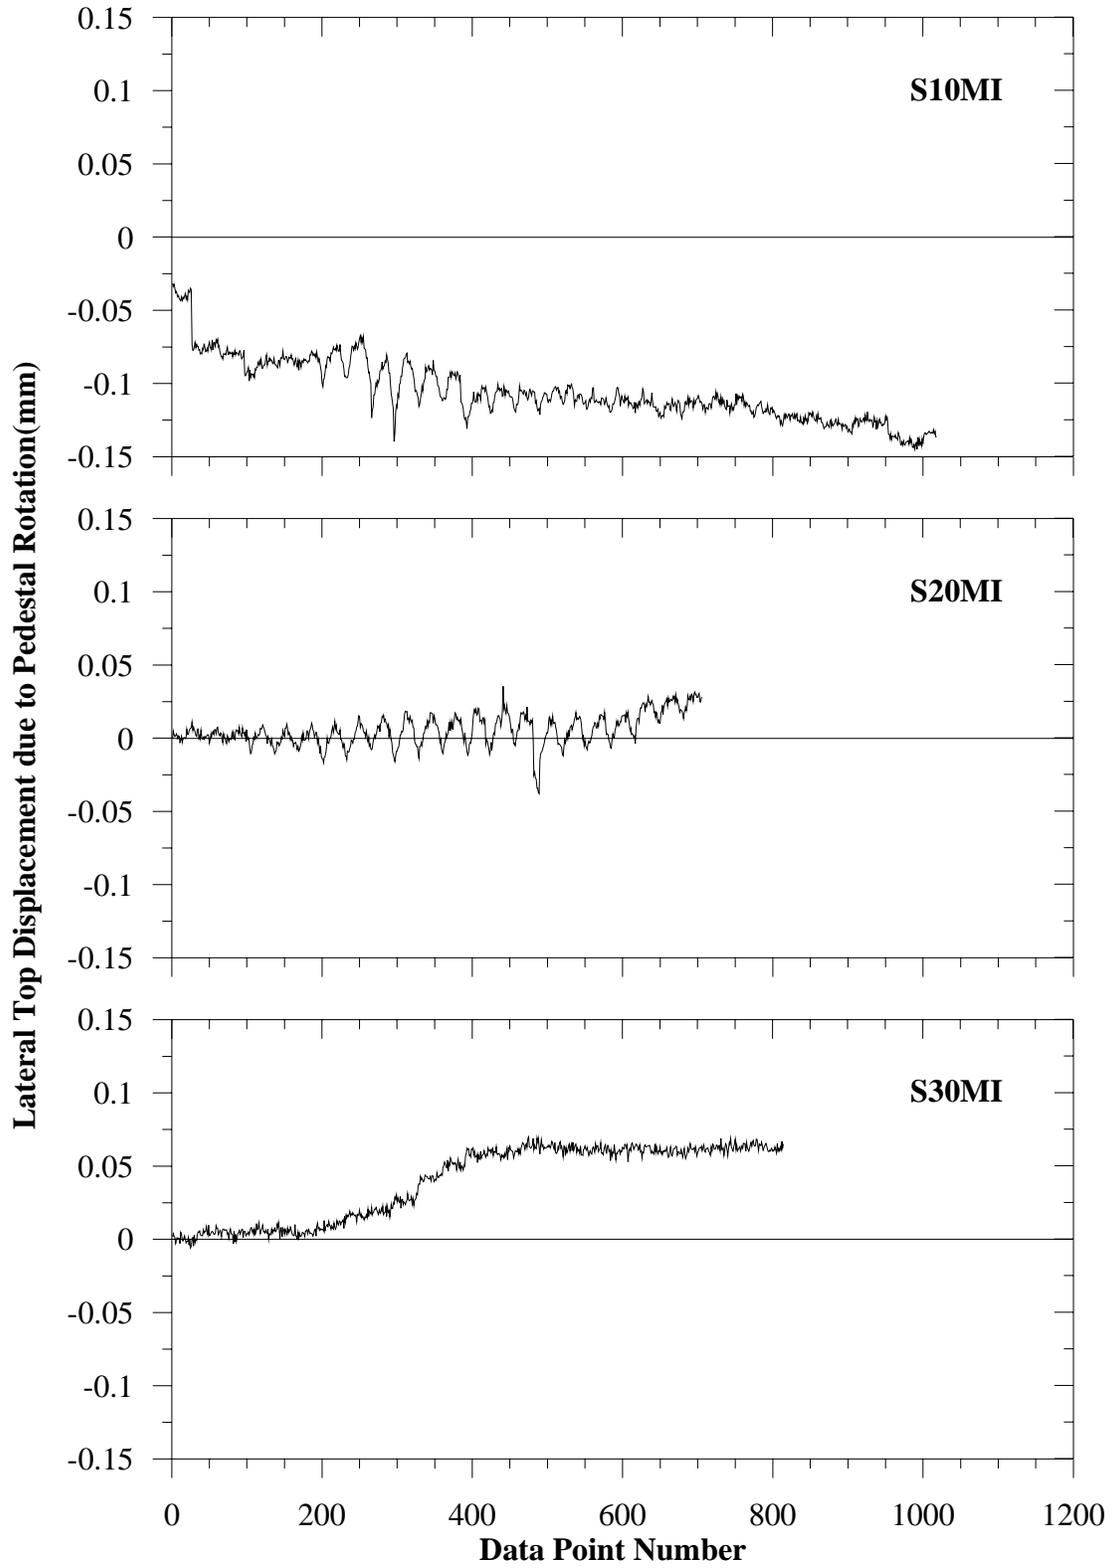
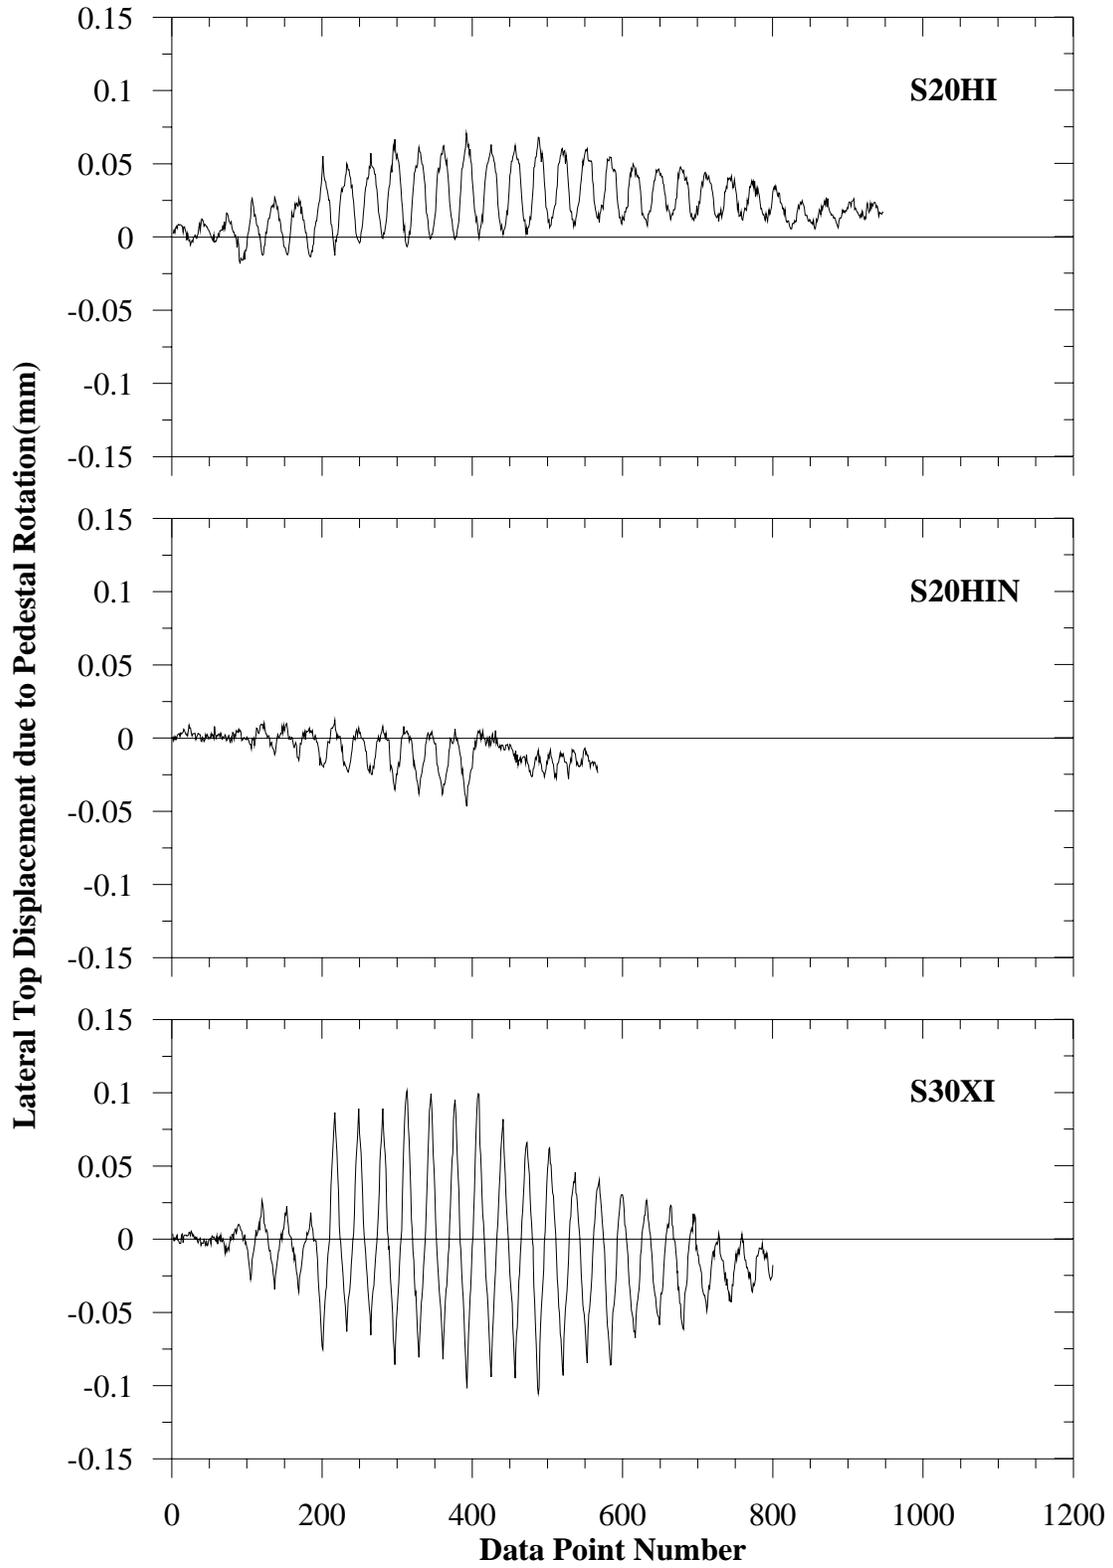
Figure 3.20- Top Displacement due to Pedestal Rotation

Figure 3.21 - Top Displacement due to Pedestal Rotation
