Experimental Assessment of Columns with Short Lap Splices Subjected to Cyclic Loads

PEER Report 2003/04
Pacific Earthquake Engineering Research Center
College of Engineering
University of California, Berkeley

April 2003

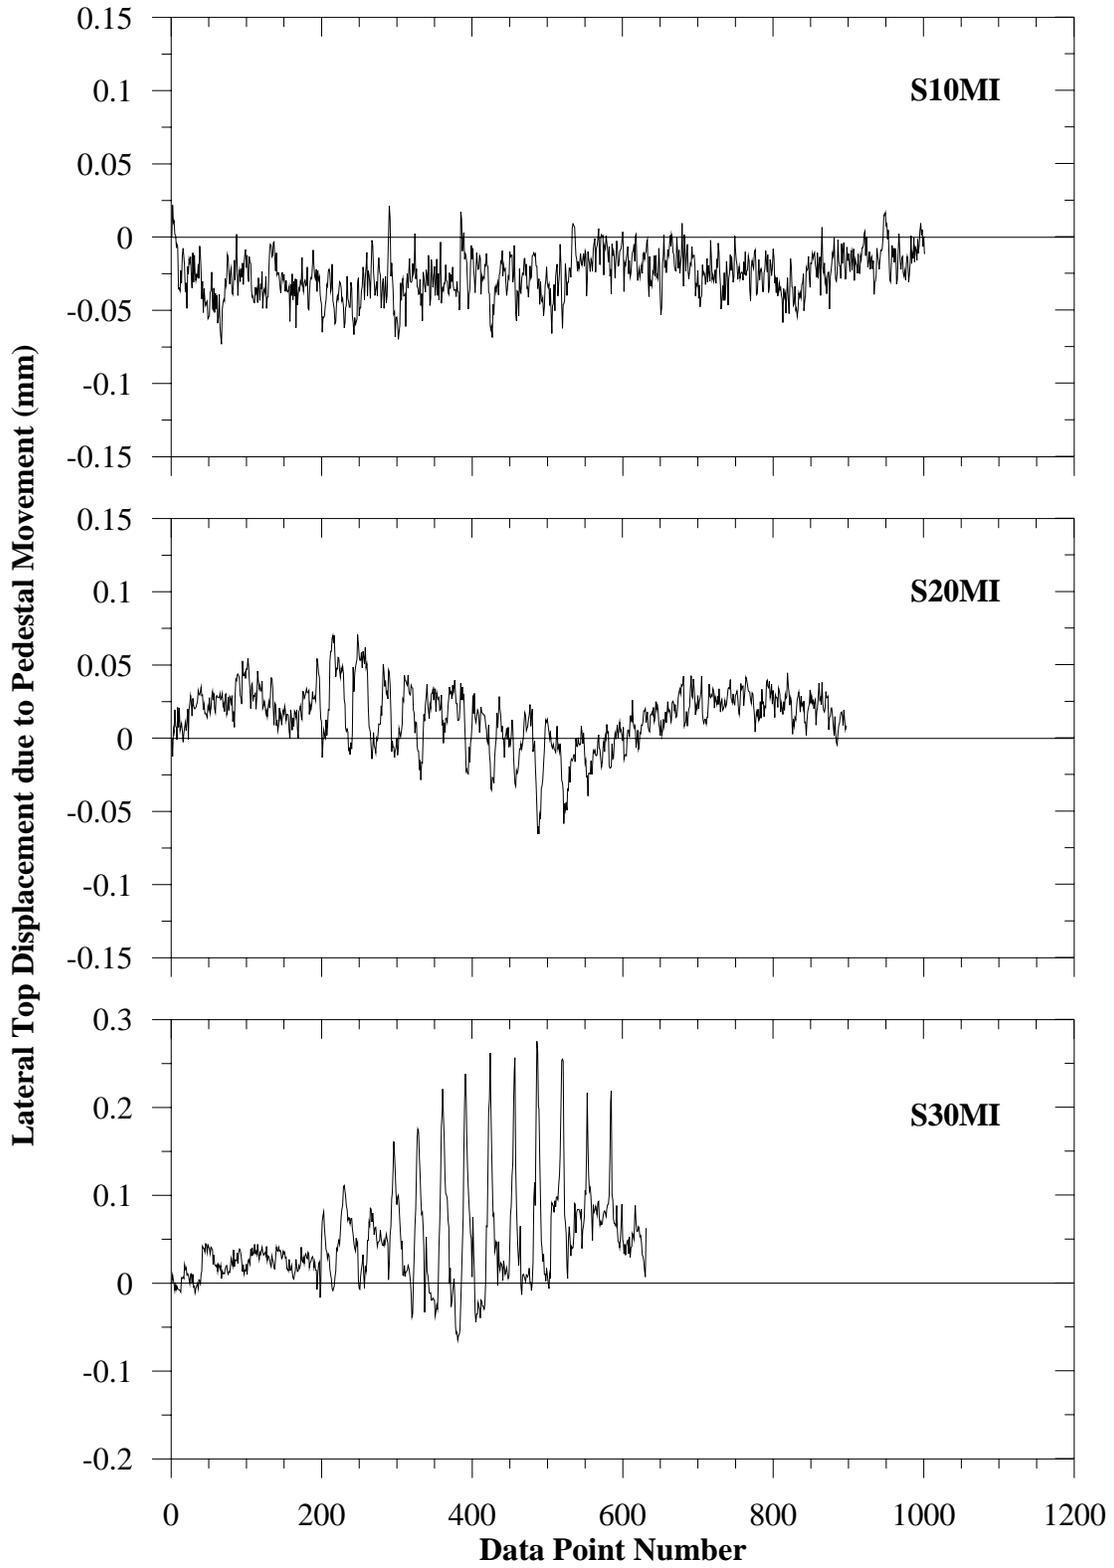
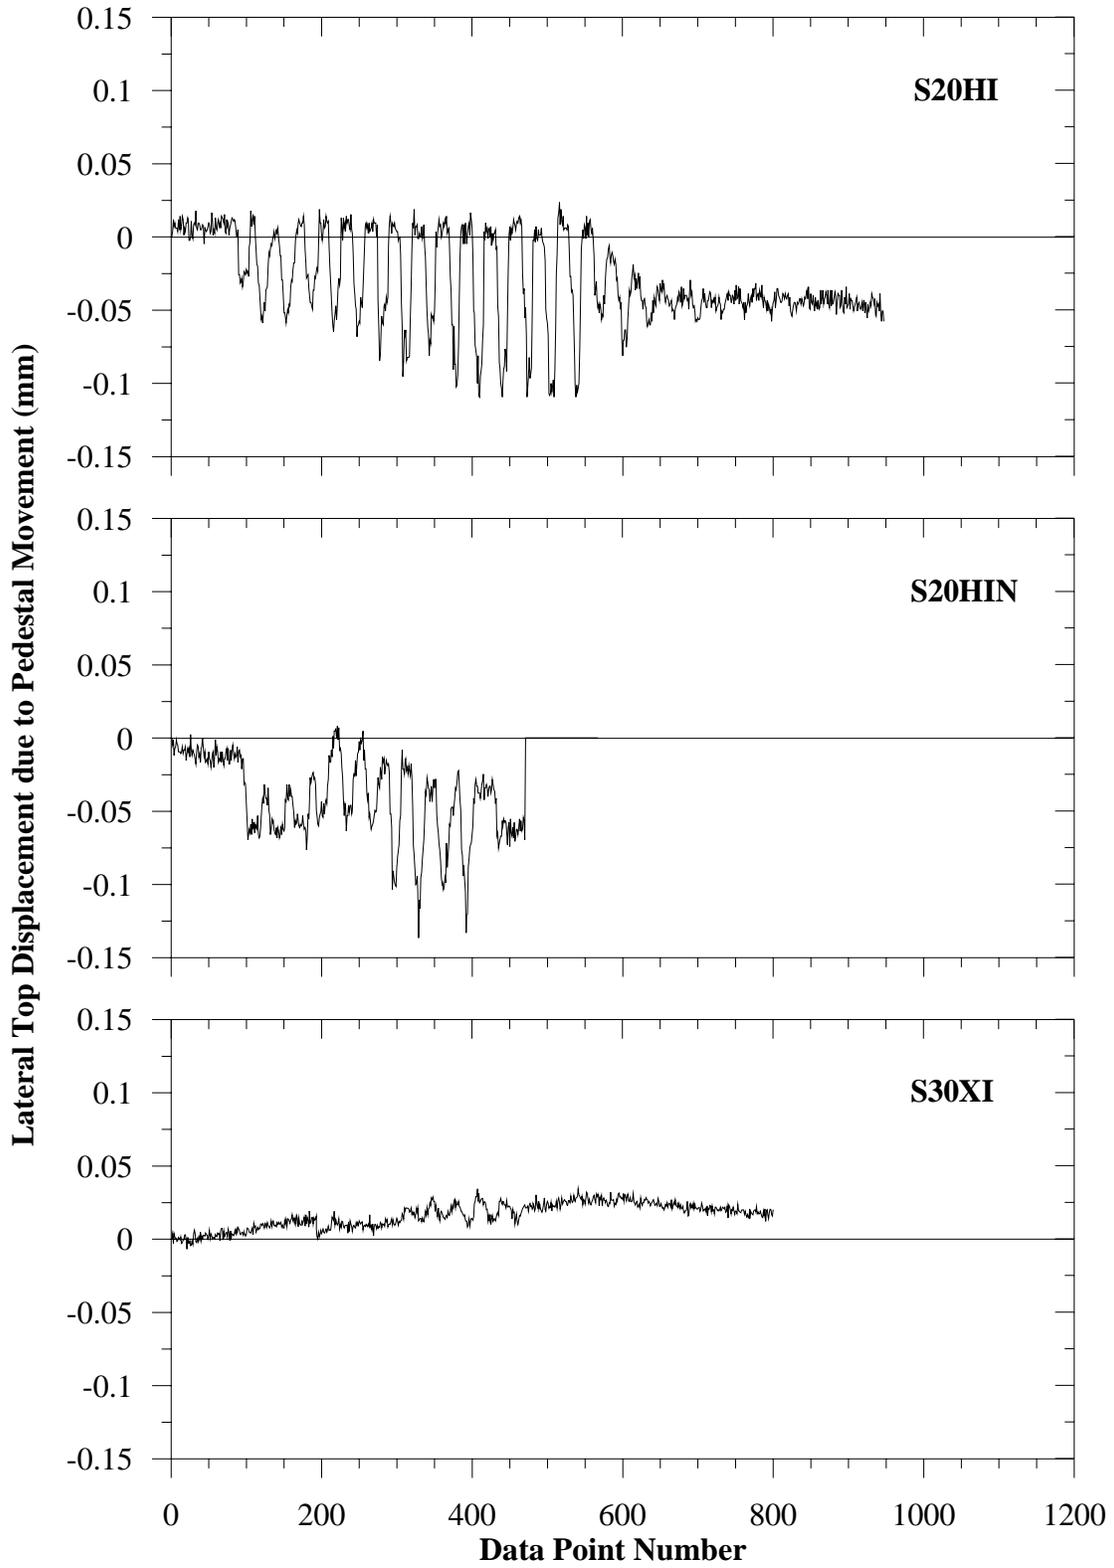
Figure 3.22 - Top Displacement due to Pedestal Movement

Figure 3.23 - Top Displacement due to Pedestal Movement

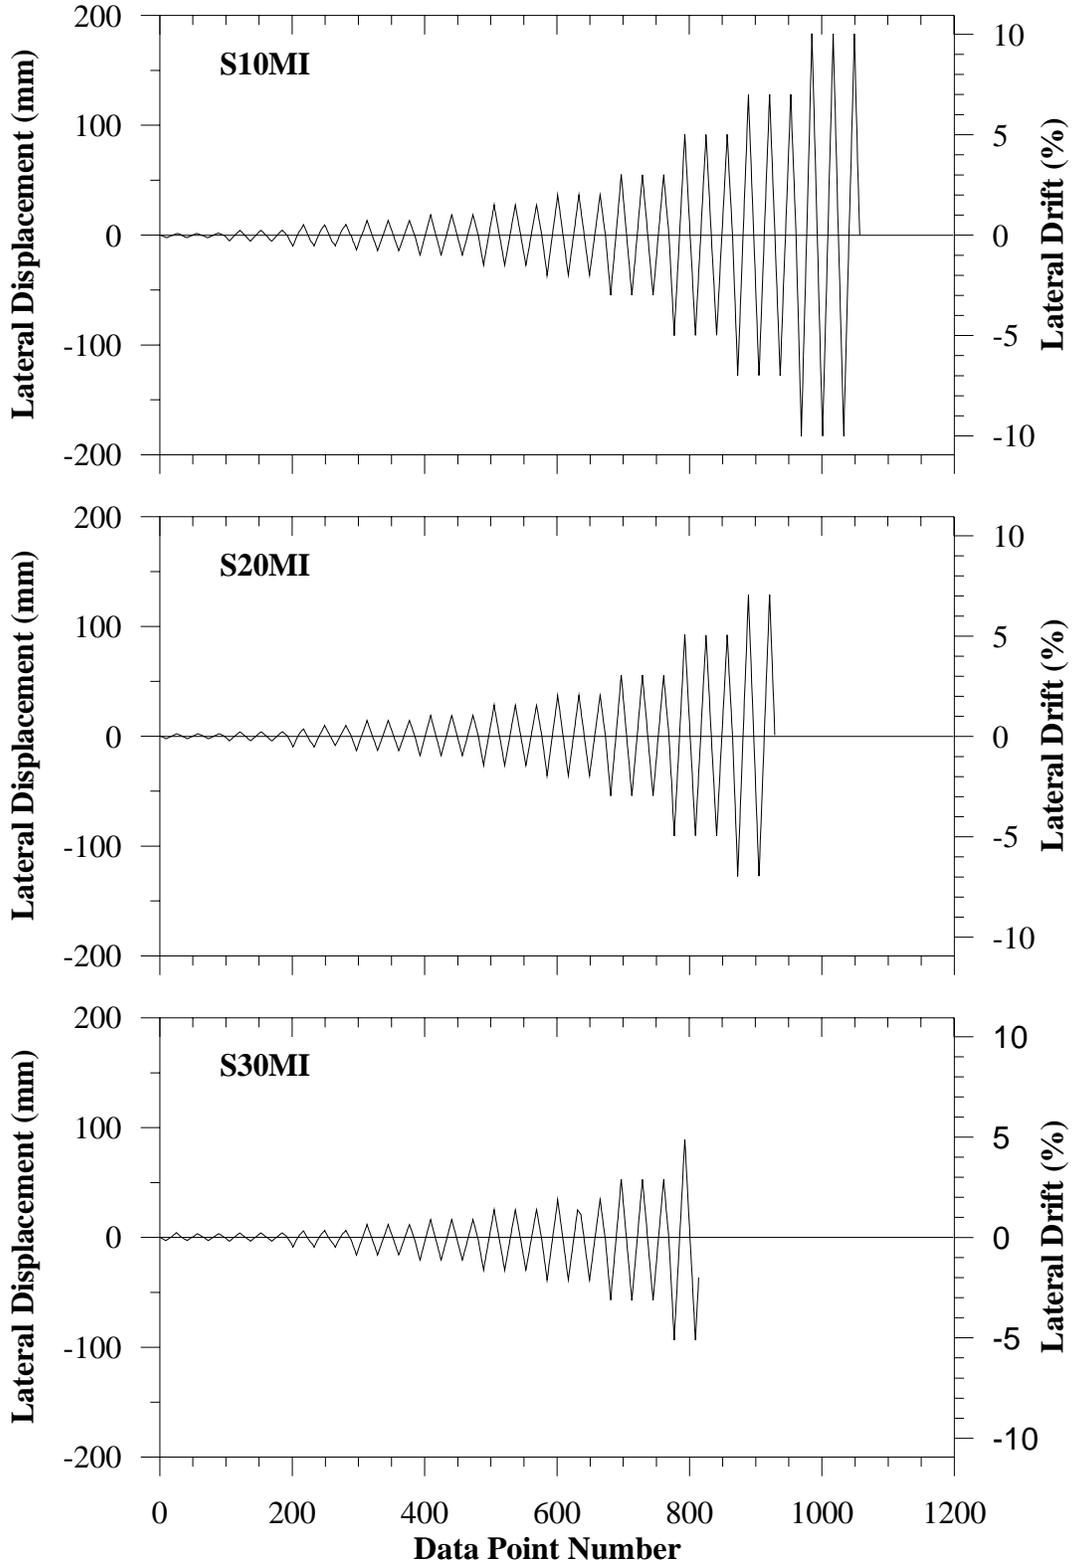
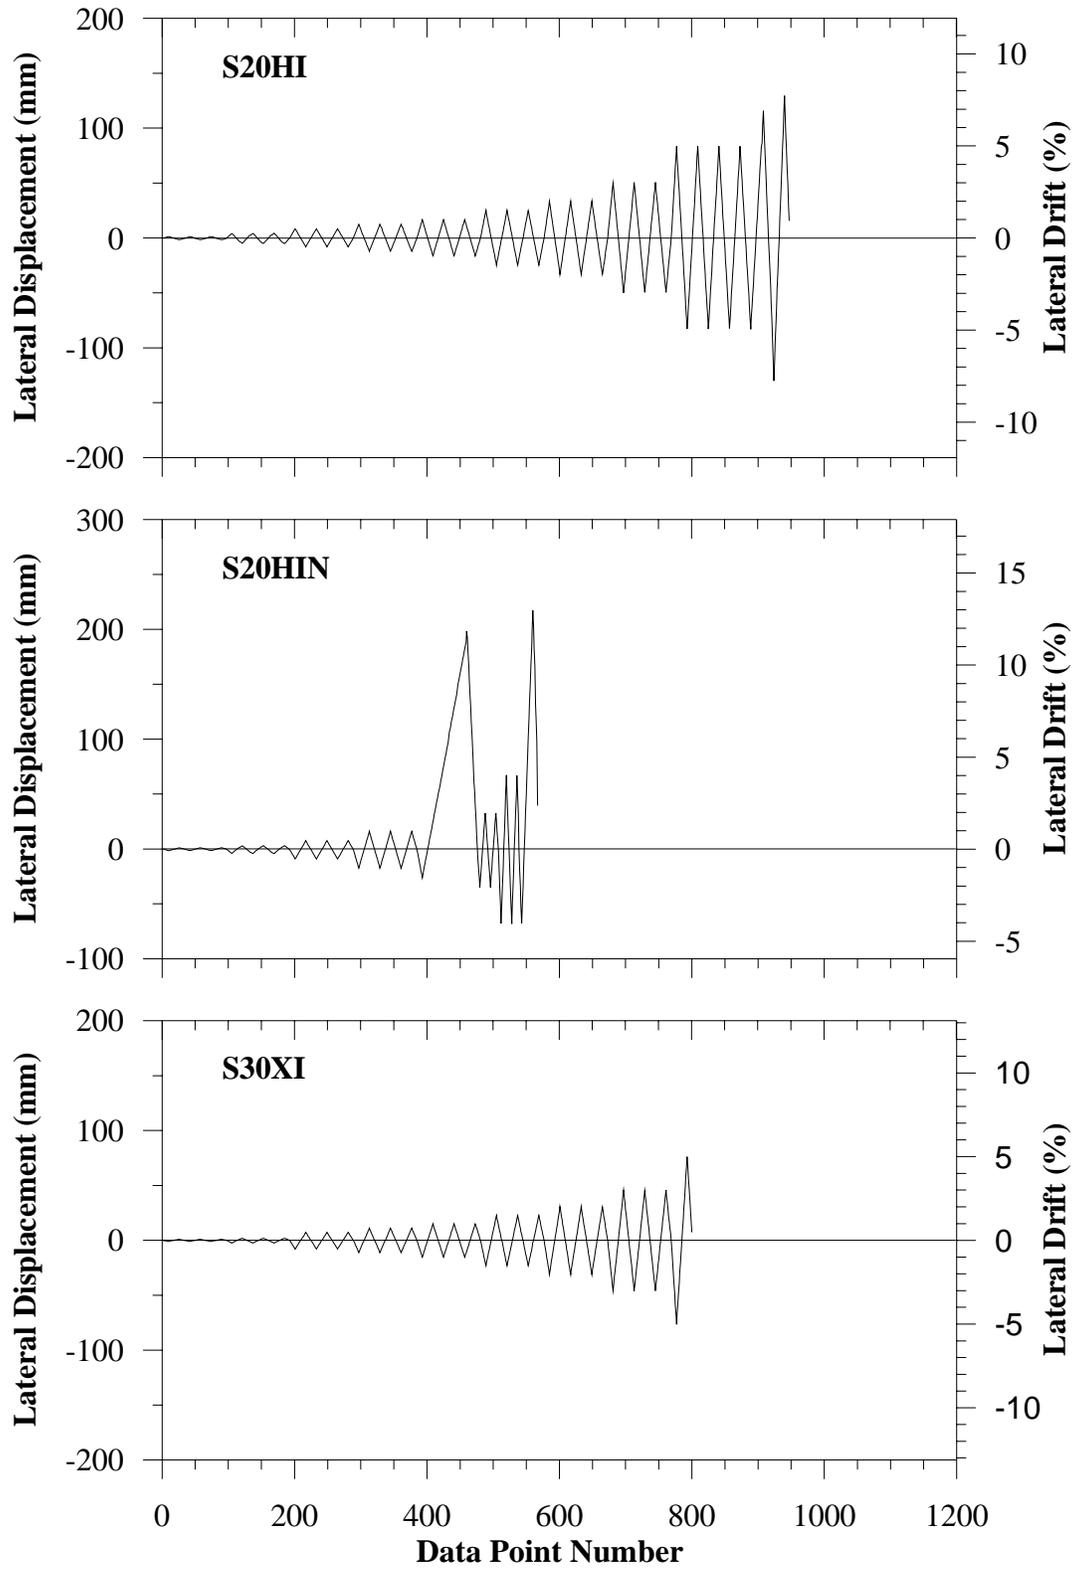
Figure 3.24 - Modified Lateral Displacement Histories

Figure 3.25 - Modified Lateral Displacement Histories

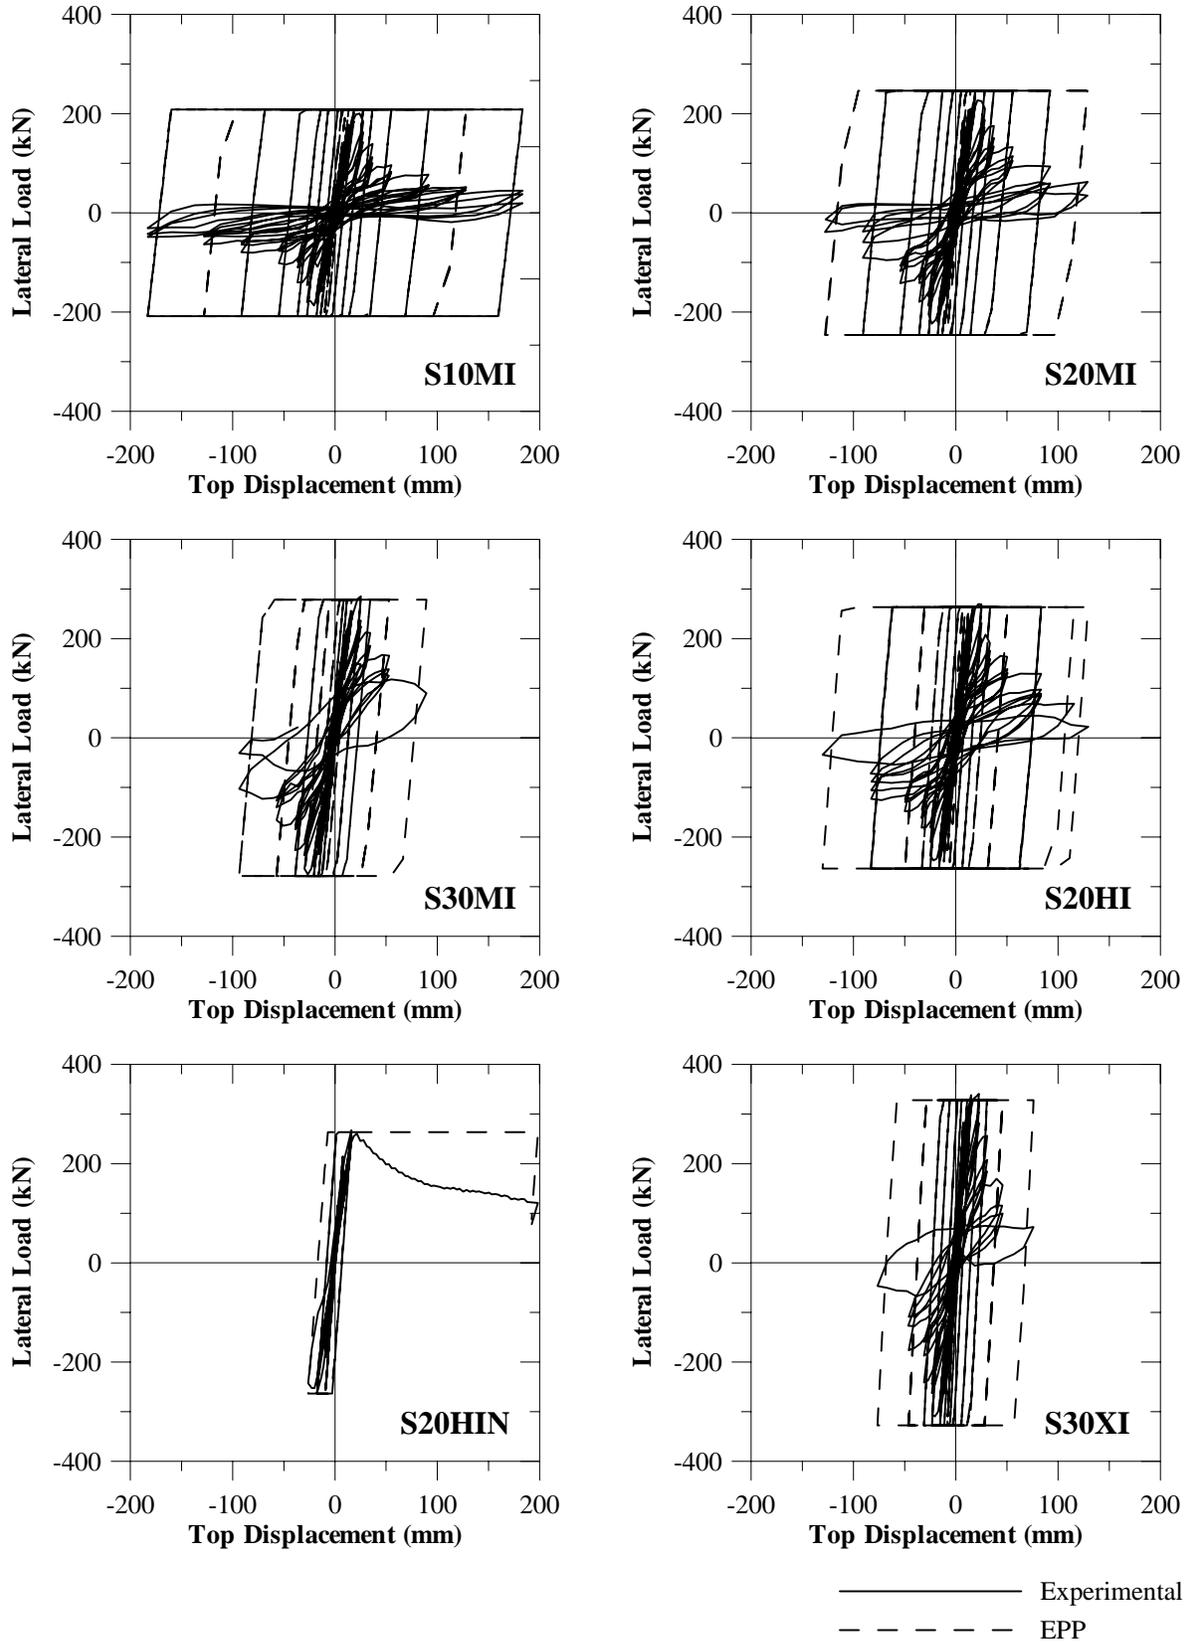
Figure 3.41 - Actual and Elastic-Perfectly-Plastic Load-Displacement Responses

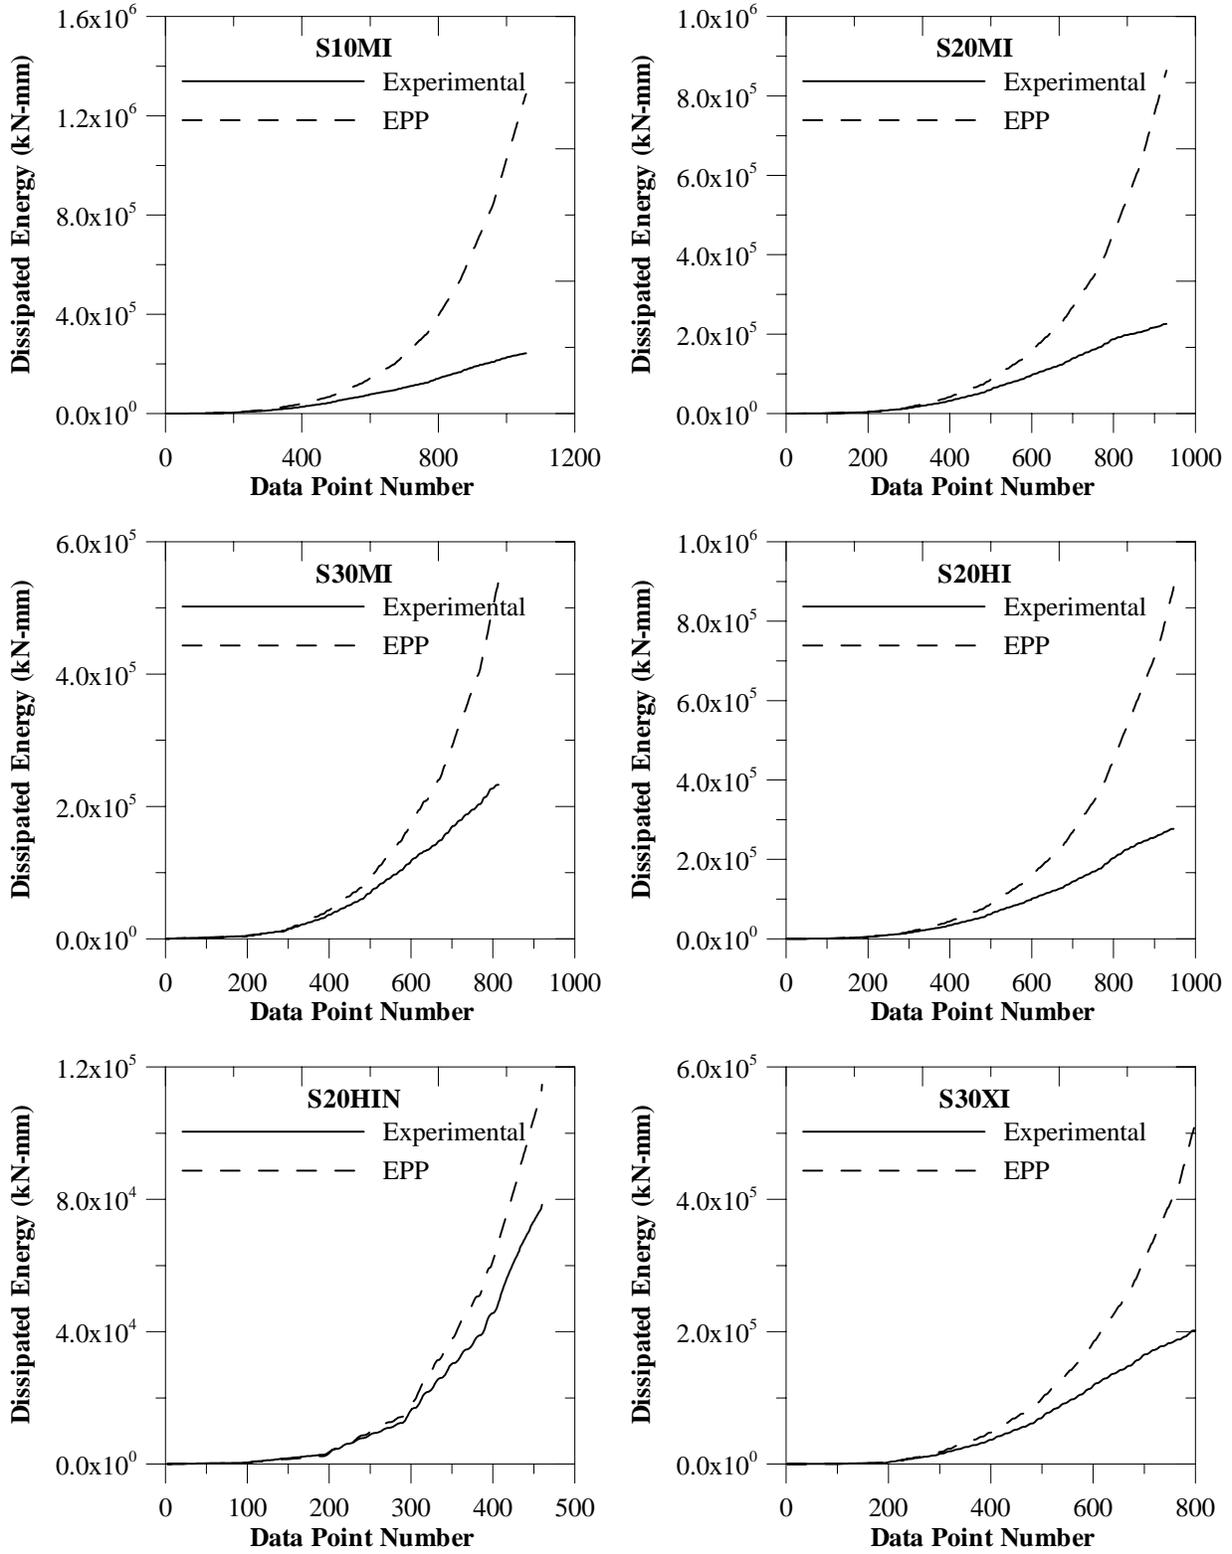
Figure 3.42- Total Energy Dissipated by Actual and EPP Columns

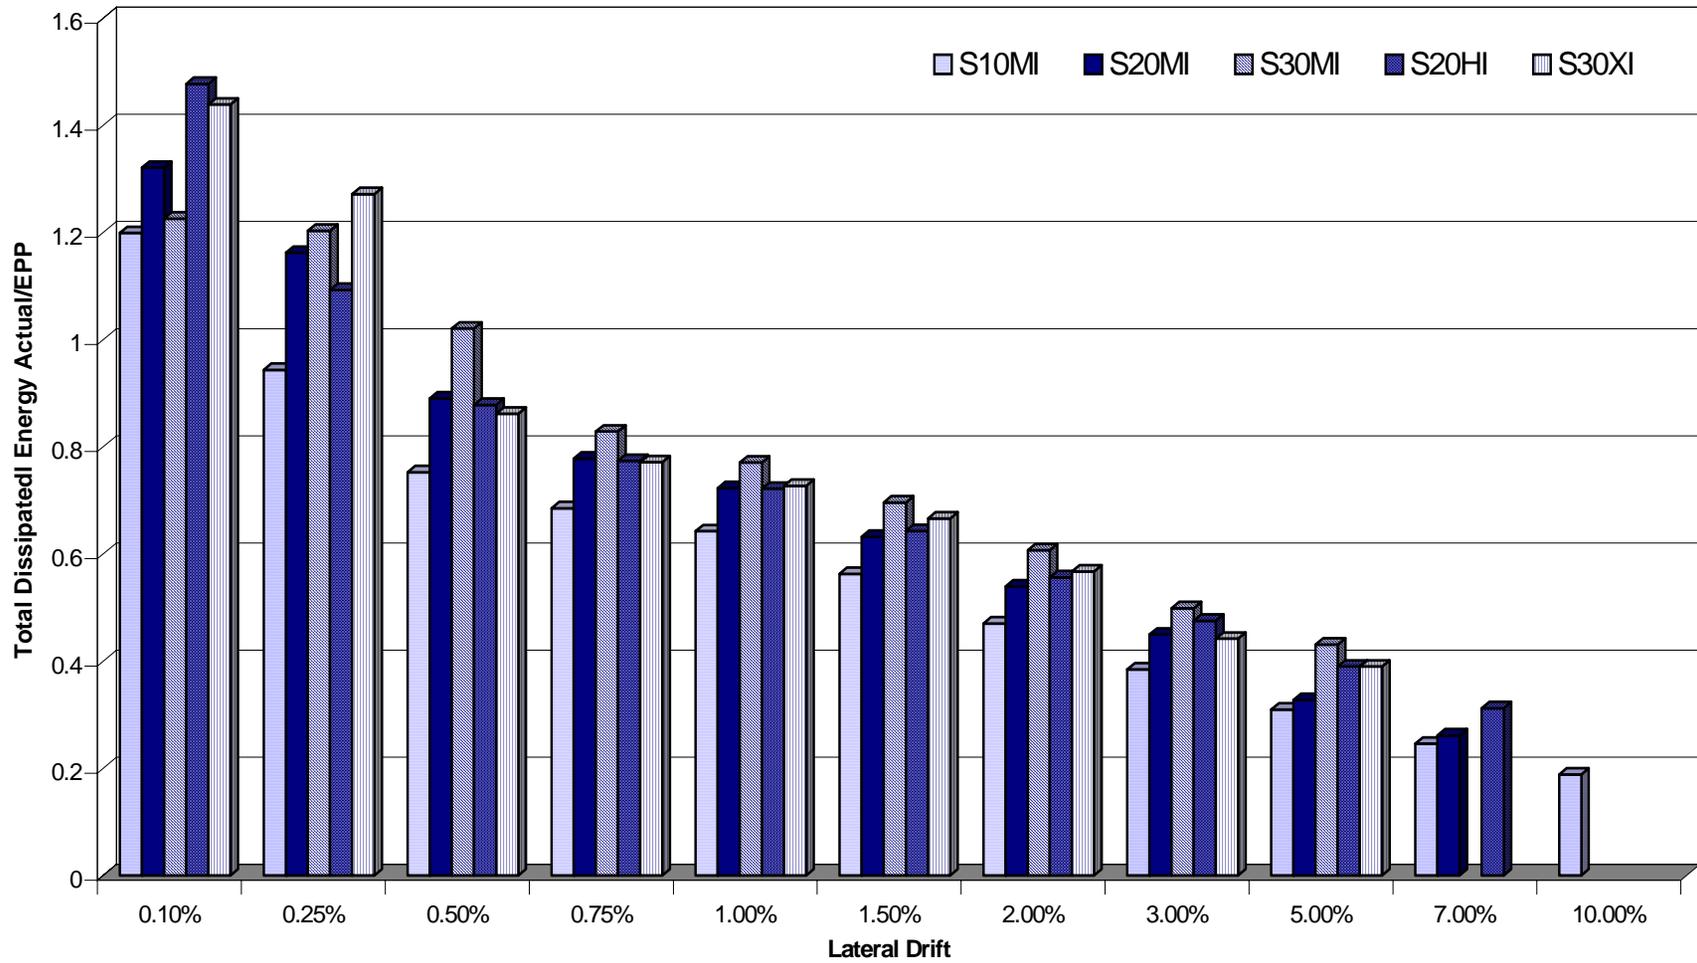
Figure 3.43 - Normalized Energy Dissipation

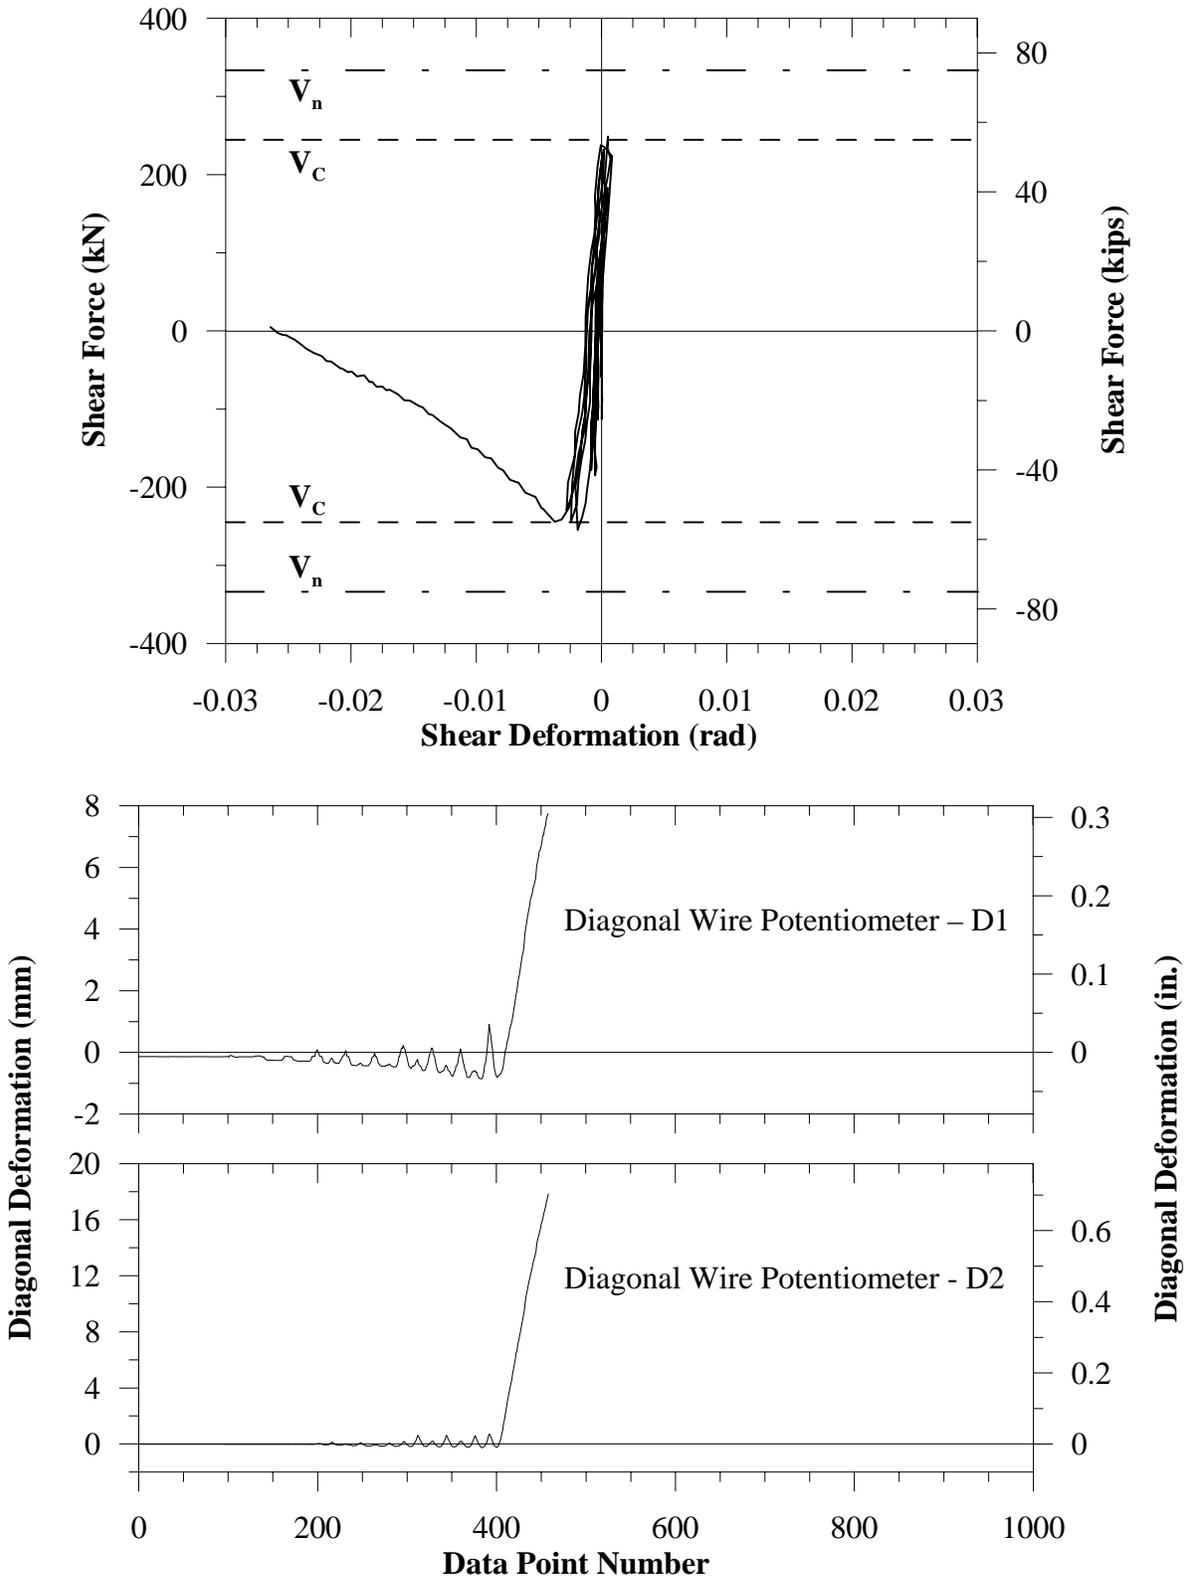
Figure 3.102 - S20HIN Shear Deformation along Splice Length ($20d_b$)

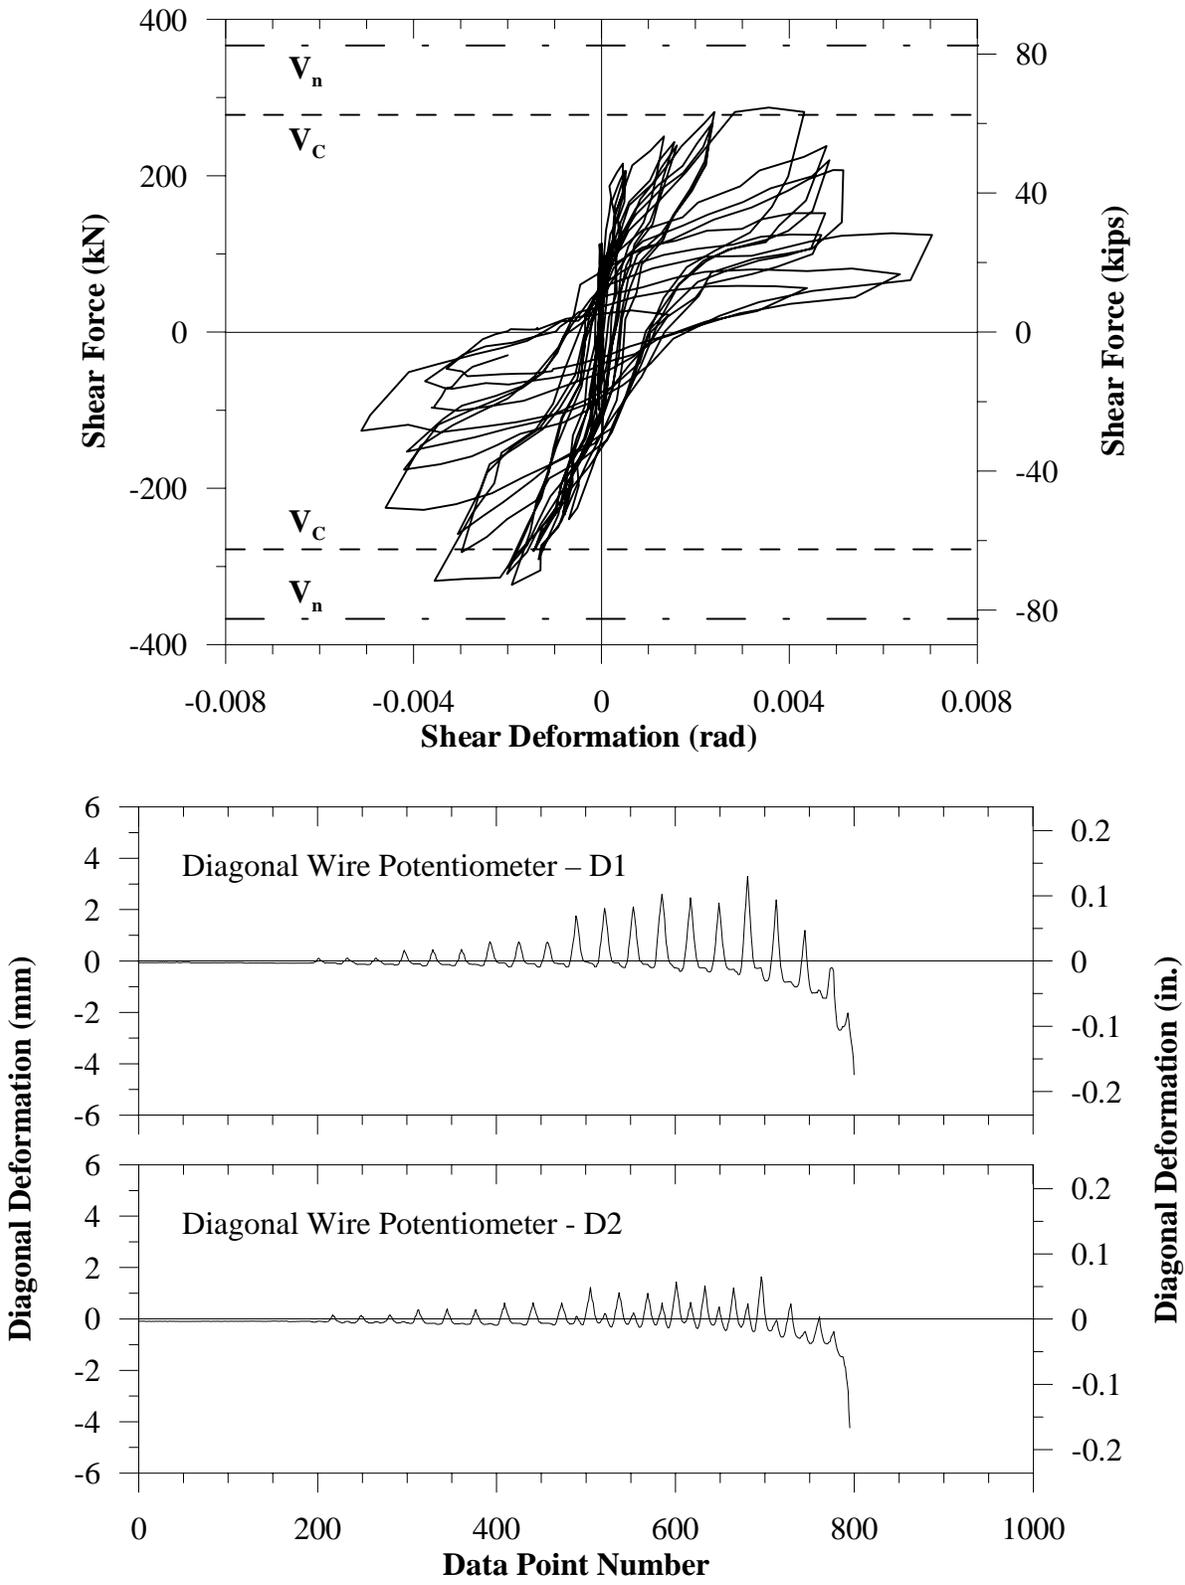
Figure 3.103 - S30XI Shear Deformation along Splice Length ($20d_b$)
