**SEISMIC PERFORMANCE OF CONCRETE  
SPECIAL BOUNDARY ELEMENT**

Ariel Creagh, Cristian Acevedo, Jack Moehle, Wael Hassan, and Ahmet Can Tanyeri  
Home Institution: The University of Texas at Austin  
REU Site: University of California Berkeley

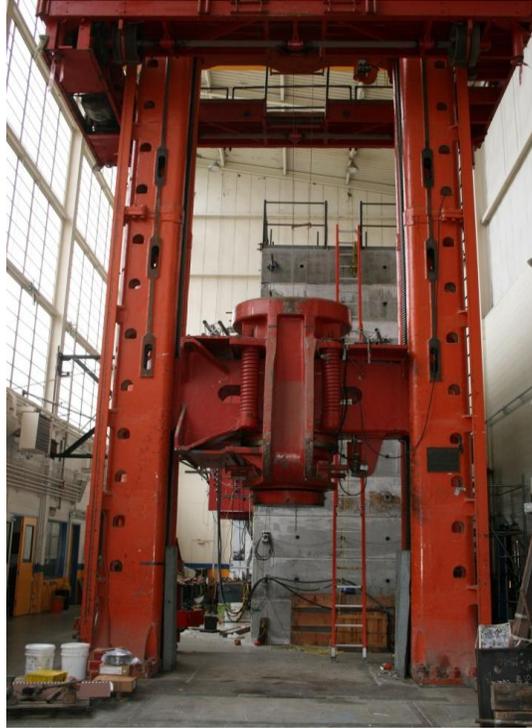
**Figure 6: 4,000 kip capacity compression machine**

The compression test was performed by the “Big Press” in the NEES@Berkeley laboratory shown in Figure 6. Loading capacity is 4,000 kips with best control maintained in tests less than 10 minutes in duration.

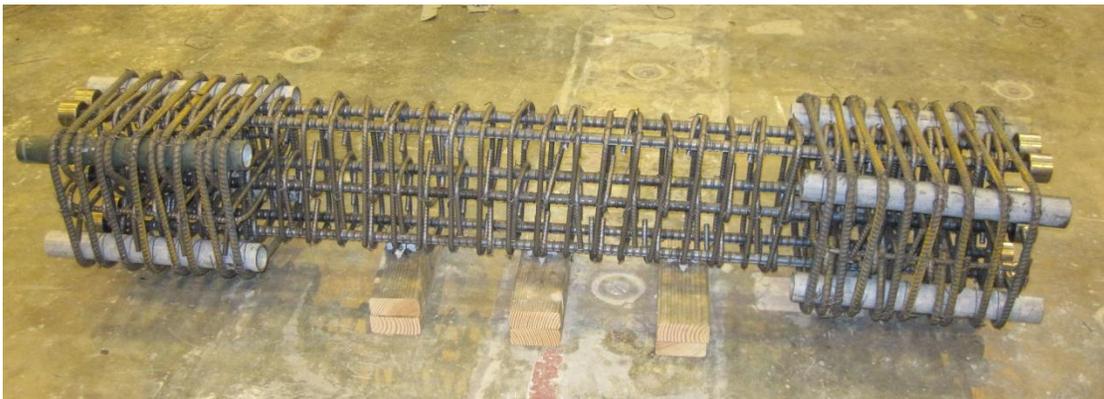
**Figure 7: Reinforcement cage**

Figure 7 shows one of two identical reinforcement cages constructed of No. 6 longitudinal bars and No. 3 transverse bars.

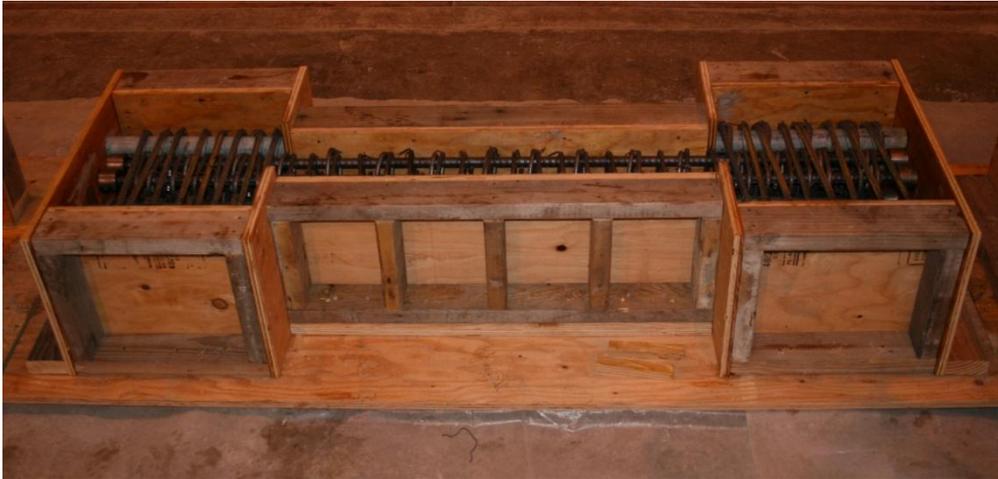
**Figure 8: Concrete formwork**

Formwork as seen in Figure 8 was constructed by nailing sections together and then assembling units with screws. One was made for each specimen. All the 2x4's were recycled from previous experiments at the NEES lab.

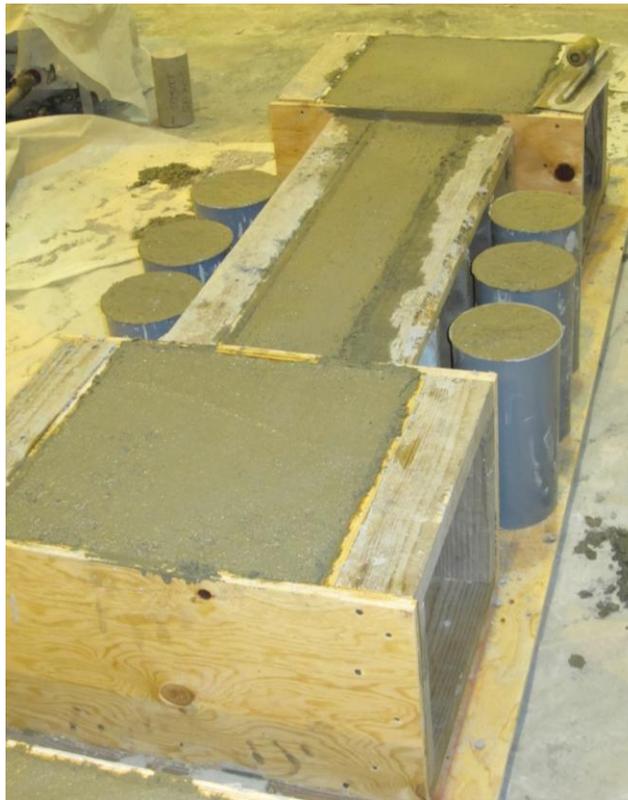
**Figure 9: Finished concrete**

Concrete was poured and finished off. Six cylinders per specimen were cast so that compression tests could be done to determine strength before experimentation. The specimens cured by covering with plastic and wet burlap for 25 days. Figure 9 shows the finished concrete.

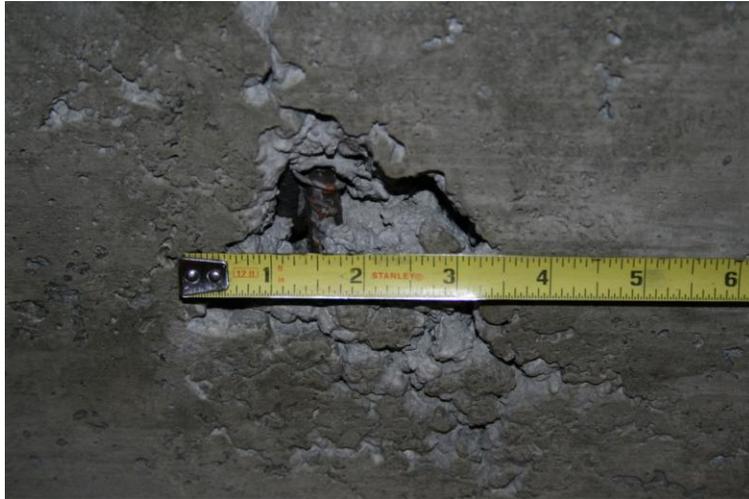
**Figure 10: Honey-combing found in Specimen 1**

After formwork removal, honey-combing was found on the right side of Specimen 1 about 3 ½” in diameter. The hole was grouted before testing, and appeared to show no significant effect on the results. Figure 10 shows the most severe honey-combing before grouting.

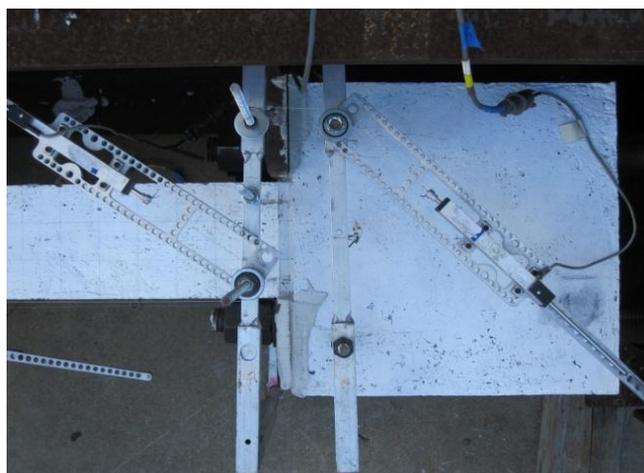
**Figure 11: Aerial view of Novatechnik transducers used in tension test**

Longitudinal displacements created as the specimen was tensioned were measured by Novatechnik transducers attached to brackets placed on the top and bottom of each specimen as shown in Figure 11 and 12. Two to measure the strain of the 36” boundary element and two at each loading head to monitor the displacement between the tension head-boundary element interface, so that slippage could be monitored. The transducers were connected to the data acquisition system so that the displacements could be recorded as well as available during the test to determine when 4% strain was achieved.

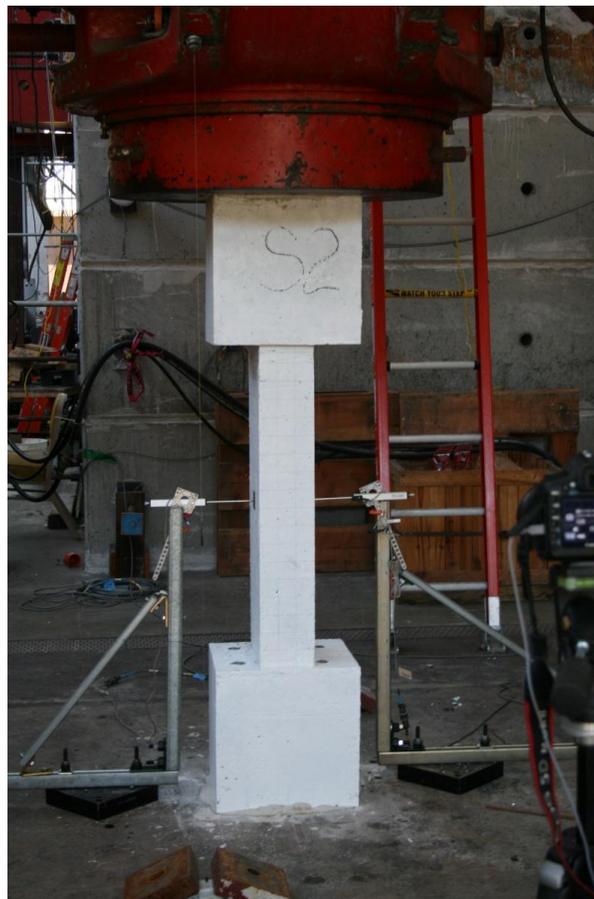
**Figure 15: Compression test set up**

The concrete specimens were grouted in place on the top and bottom in order to ensure an even distribution of force and alignment so that the force was purely axial. Loading began steadily at a rate of 1 kip per second until failure. This can be seen in Figure 15.

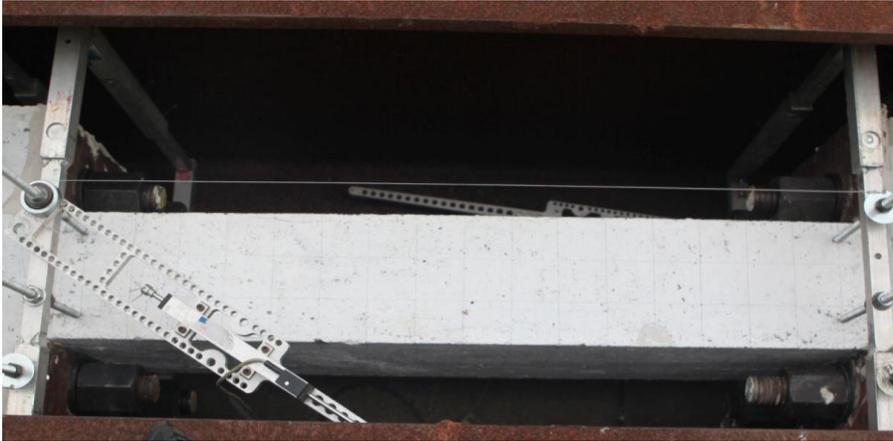
**Figure 16: Specimen 1 before tension test**

The following pictures demonstrate intermediate results from the tension portion of the experiment. Large cracking developed to  $\frac{1}{4}$ " in some cases, and at the very least, hairline cracking could be seen in the plane of each transverse reinforcing hoop. Figure 16 shows the specimen before testing and Figure 17 displays the specimen after the test was performed and the hydraulic jack was unloaded.

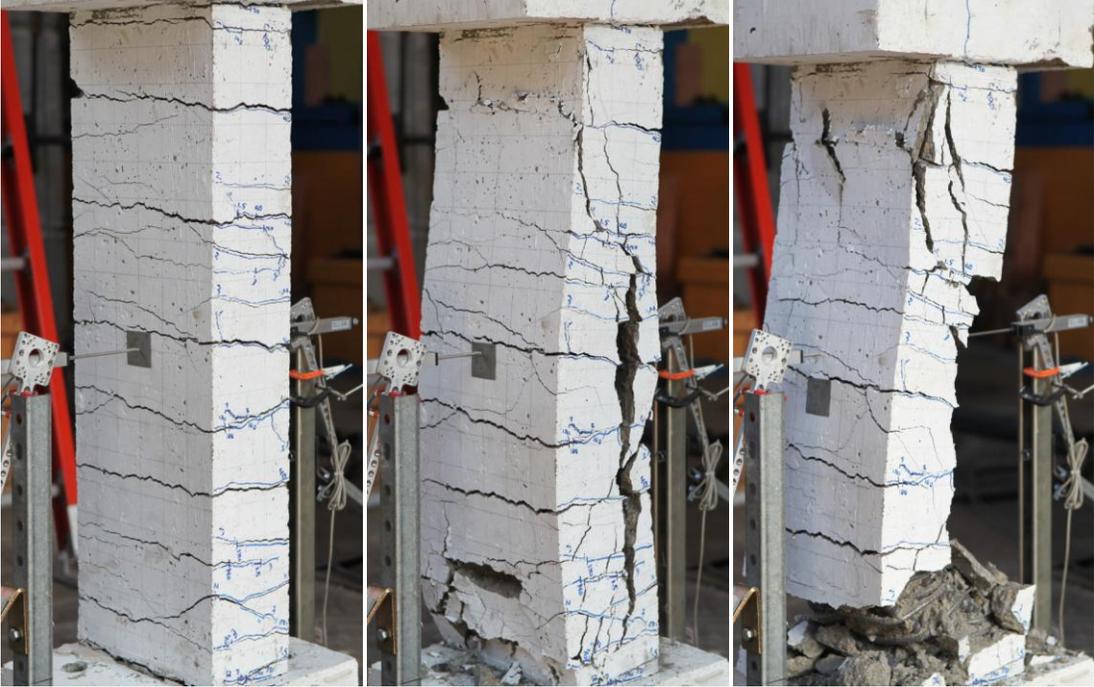
**Figure 18: Specimen 1 compression test results**

Figures 18 and 19 show a before, middle, and after picture to explain the sequencing of failure. The initial condition of the pre-tensioned specimen consisted of relaxed strain due to unloading without crack closure. As loading began, the concrete cracked up the middle of the cross-section and global buckling was seen immediately. A ductile curve shaped developed before completely giving way. Loading capacity topped at 170 kips.

Because the tension test took the longitudinal reinforcement past the point of yielding, residual strain was seen in the bars. This prevented closure of the concrete cracks developed during the tension test. Therefore, as loading increased in compression, a critical condition was created at each crack where it was susceptible to instability because the force was being resisted by only the longitudinal bars. As they began to give way to the left, the rotation caused the concrete to meet on the right side of the specimen. This crushed the concrete under the concentrated force, and all strength was lost.

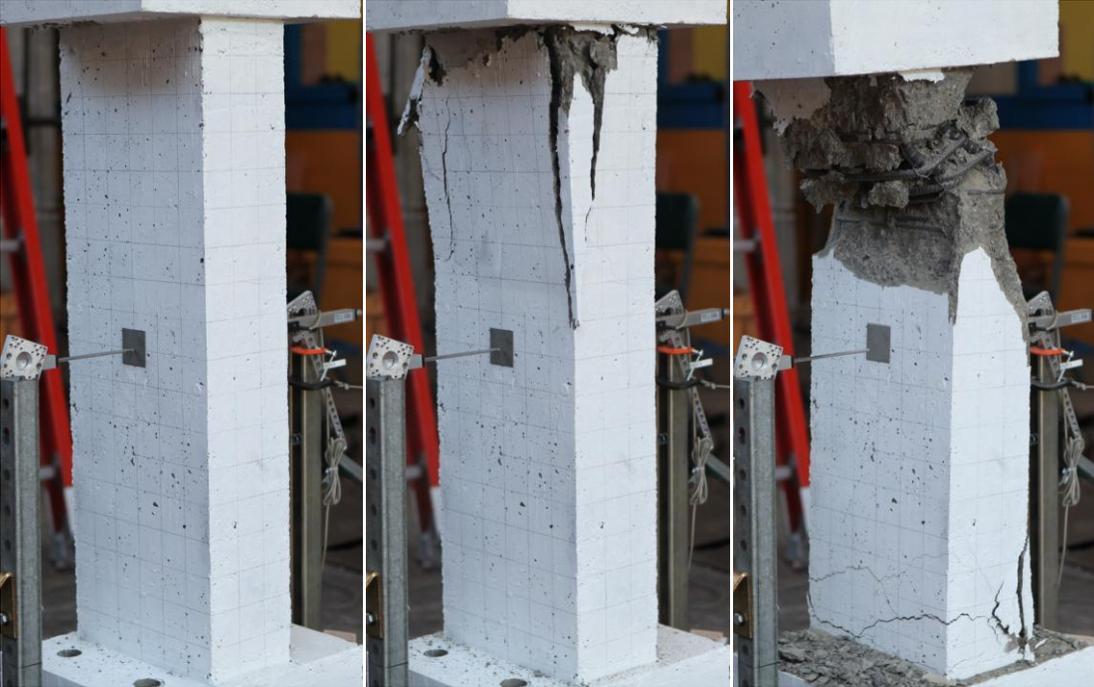
**Figure 19: Specimen 2 compression test results**

Comparatively, specimen 2 saw different results. The failure demonstrated brittle response. As the concrete spalled near the top of the boundary element, global buckling occurred

instantaneously. All strength was lost immediately. However, specimen maintained loading until 600 kips.

Specimen 2 results were surprising because ductile response was anticipated because of the high ratio of transverse reinforcement to longitudinal. Instead, an explosive spalling of the concrete occurred and resulted in immediate loss of loading capacity. This could be attributed to small concrete cover or too thin of a minimum cross-sectional dimension.
