## INTRODUCTION

February 2010, a magnitude 8.8 earthquake struck South Central Chile. Of the reinforced concrete structures, 50 were severely damaged, 4 of which were partially or totally collapsed. Chilean concrete design uses shear walls as the main lateral force resisting system, and they were a critical part in the failure of these buildings. However, the failure mechanism stumped engineers. One proposed theory suggested that because of commonly used T-shaped shear walls, the boundary elements of the web section were subject to both tension and compression with reversals of the ground motion. The intention of this research was to provide evidence of the effect tensioning a boundary element has on buckling failure.

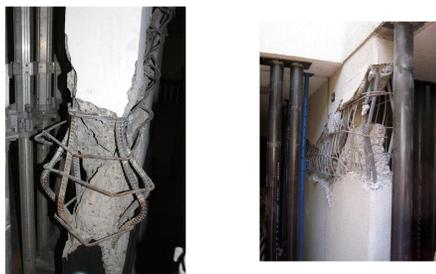
Figure 1 & 2: Failure of shear walls after Chilean earthquake

- Chile uses American building codes
- A few differences exist and codes are loosely enforced
- Damage seen in shear walls without boundary elements
- Shear walls detailed according to ACI 318-08 Section 21.9.6.4 appeared to have no damage

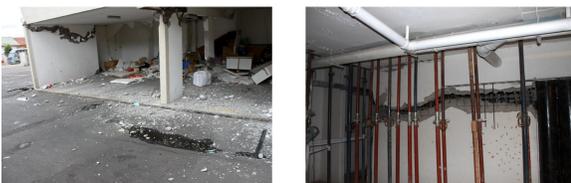
Figure 3 & 4: Typical damage seen in shear walls after February earthquake

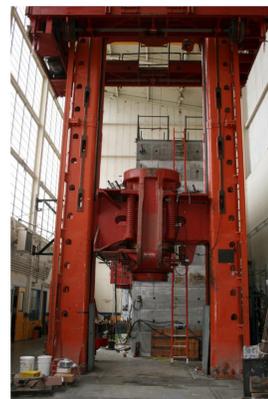
Figure 8: "Big Press" 4,000 kip capacity compression machine

- Loading rate at roughly 1.0 kip/s until total failure

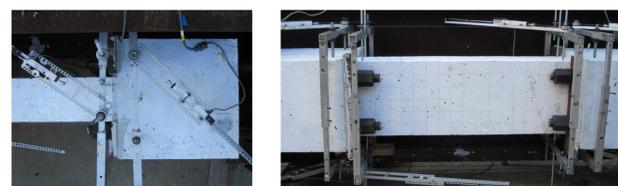
Figure 10, 11, & 12: Instrumentation to measure displacements

- Spring loaded Novotechniks connected to removable brackets
- Wire potentiometers

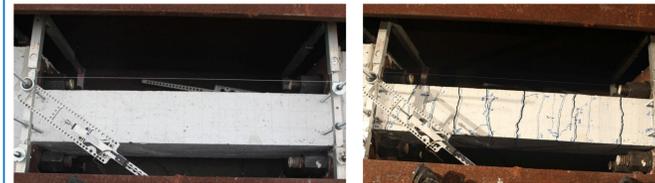
### S1 TENSION

- Development of cracks present in the planes of transverse reinforcement due to stress concentrations and decreased clear cover
- Tension loading plateaus at a yield strength of approximately 183 kips, 20 kips larger than the anticipated yield strength of the rebar, can be attributed to strain hardening

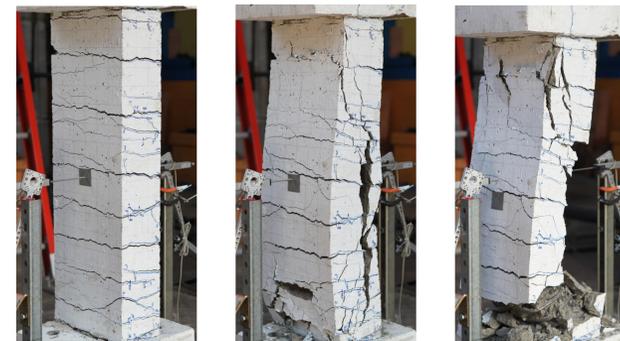
### S1 COMPRESSION

- After pre-tensioning, all the compressive load was carried by the elongated rebar
- Buckling of the yielded rebar within the cracks caused uneven contact of the separated concrete, crushing the concrete on the right side
- Instability allowed global buckling of the cross section at 170 kips

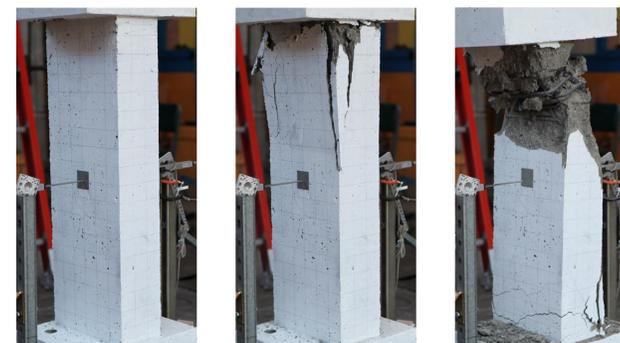
### S2 COMPRESSION

- Virgin column placed in pure compression took loading until 600 kips
- Explosive spalling of the concrete and global buckling developed in a short amount of time
- Unable to declare the failure ductile as anticipated

A special boundary element subjected to tension prior to compression can only tolerate less than a third of the load capacity of a virgin boundary element. Although a more ductile failure was seen in the pre tensioned case, this drastic decrease in compression capacity is alarming. Continued analysis will take place with emphasis on Euler buckling and critical buckling load. With the following information, further research is needed: investigation under what conditions boundary elements are vulnerable to extreme tension, most probable strains likely to develop, and performance under multi-cycle loading.
