**SEISMIC VULNERABILITY OF NON-SPECIAL BOUNDARY ELEMENT
OF SHEAR WALL UNDER AXIAL FORCE REVERSALS**

Cristian E. Acevedo, Florida International University
Research Partner: Ariel Creagh
REU Site: University of California, Berkeley
Research Advisor: Professor Jack P. Moehle
Graduate Advisors: Wael Hassan, PhD Candidate,
Ahmet Can Tanyeri

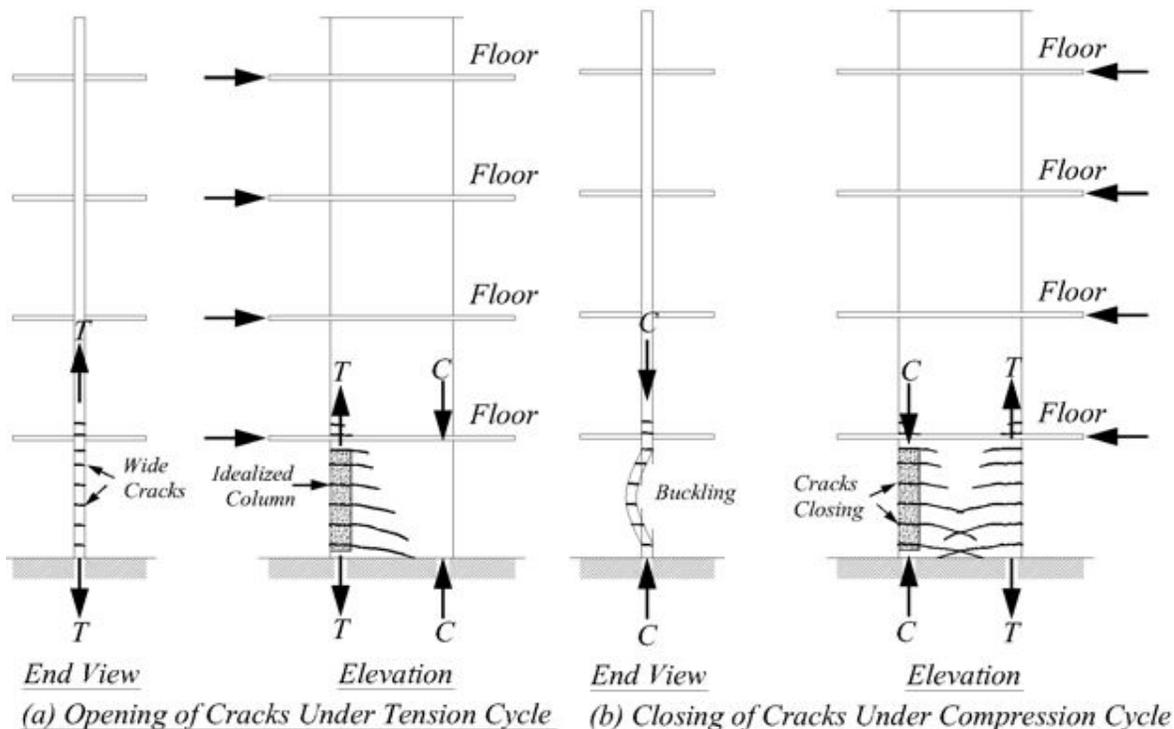
Figure 1.1: Earthquake lateral loads inducing axial forces on wall end-region: (a) cracks open under tension; (b) cracks close when load is reversed in compression (Chai and Elayer, 1999)

Taking a closer look at Figure 1.1, it can be seen that crack development and closure appears as a result of tension and compression loadings, respectively. In addition, experiments with columns containing special boundary elements show that the cracks follow the same spacing as the transverse reinforcement (Chai and Elayer, 1999). Nonetheless, these experiments did not address whether buckling of the column is attributed to compression alone or tension then compression; but rather focused on estimating the maximum tensile strain after reversed cyclic loadings.

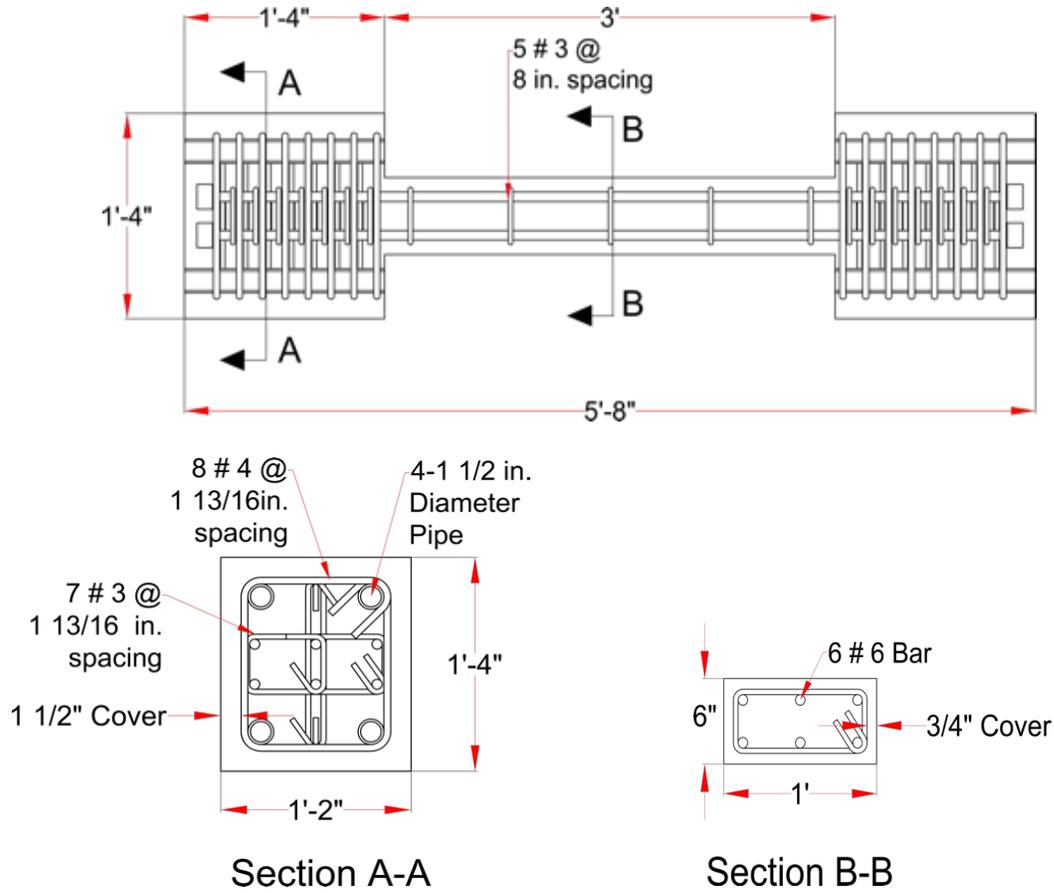
Figure 2.1: Specimen dimension and detailing

The two specimens were built according to ACI 318-08 Section 21.9.6.5 for non-special boundary elements (NSBE). The dimensions were six inches thick by 12 inches deep by 36 inches high. The thickness chosen represented the actual thickness of a wall, while the depth and the height represented a section of the wall carefully chosen to prevent any slenderness problem when testing. The tension part of the test was the controlling factor in the overall design of the specimens. In order to pull one of the specimens in tension, special heavily reinforced concrete heads were designed to withstand the splitting forces (Refer to Section 2.4.2.1 for more details).

The steel reinforcement consisted of #6 longitudinal headed bars, #3 transverse reinforcement along the longitudinal bars, and #4 transverse reinforcement and #3 cross ties for the heads. Figure 2.1 shows the specimen dimensions and detailing.

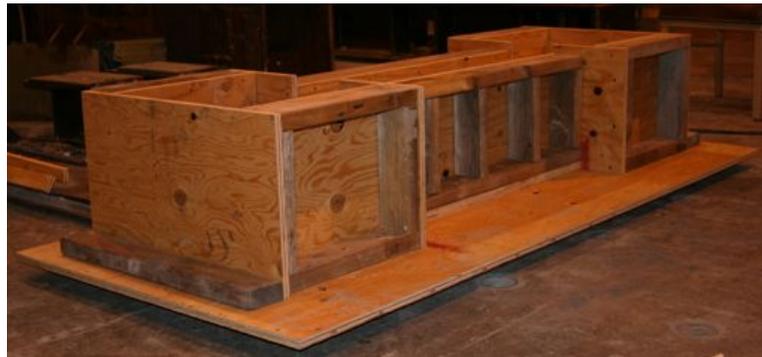
Figure 2.2: Concrete formwork

The construction process began with the concrete formwork, followed by the reinforcement cage, ending with the concrete pouring and curing. The concrete formwork was built using two by four lumber and plywood sheets. The entire construction sequence is shown in Figures 2.1 – 2.6. The whole construction process took approximately seven weeks.

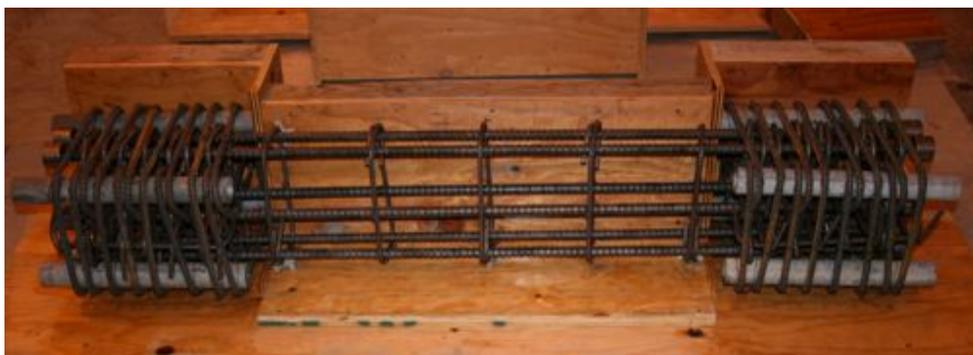
Figure 2.3: Reinforcement cage

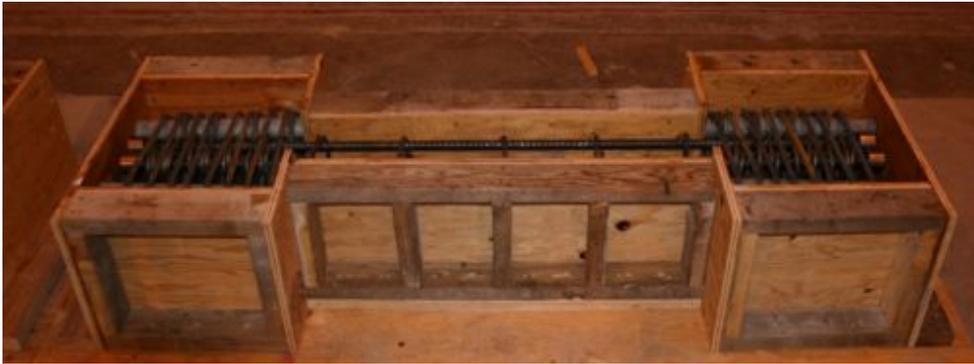
Figure 2.4: Reinforcement cage in concrete formwork

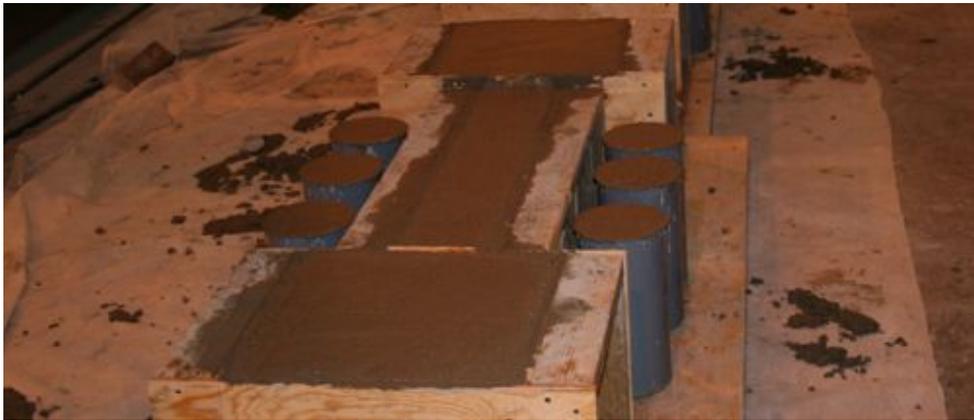
Figure 2.5: Concrete pouring

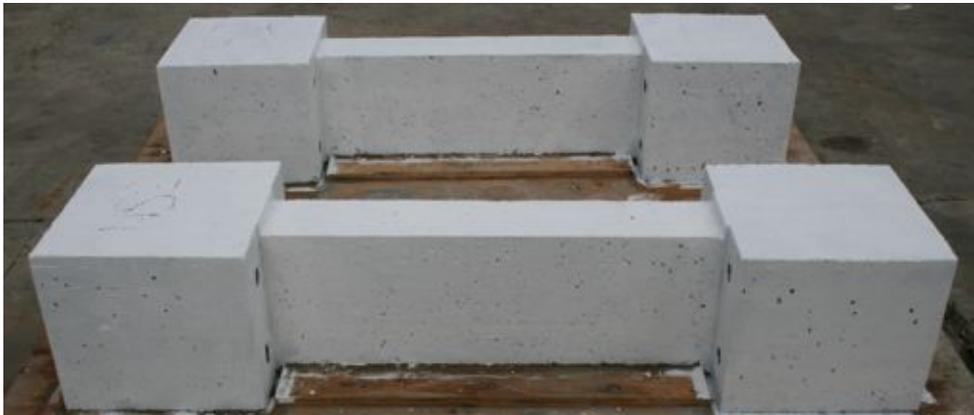
Figure 2.6: Final product

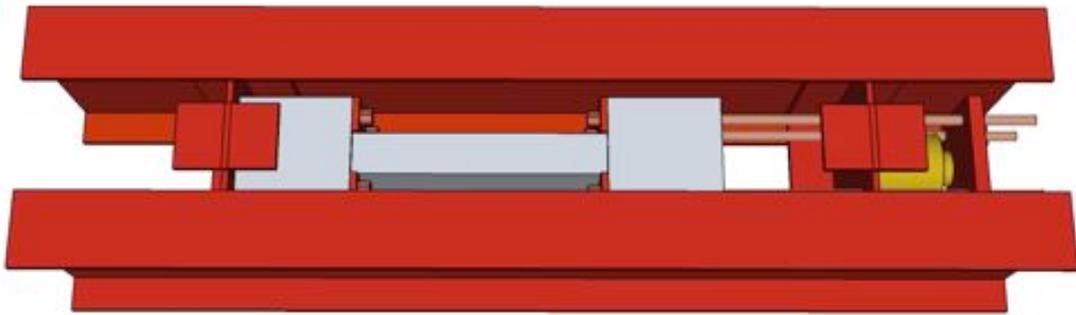
Figure 2.7: Tension setup schematic

The tension test was carried out to attain a four percent strain on the specimen. This value was chosen to reduce the contribution of the concrete when subjecting the specimen to compression. A special setup was constructed using a 300 kip hydraulic jack and W-Shape beams. Figure 2.7 shows a schematic of the setup.

The heads of the specimen were attached to the setup using eight $1\frac{1}{4}$ in. diameter William Rods (131 kips per rod). In the system, the jack pushed in between two plates to pull the rods and in turn the specimen in tension. The loading rate was done in 20 kip increments until the yielding of the specimen was reached. At this point, the increments were based on the strain, i.e., one and a half percent strain followed by two percent strain and so on until the four percent strain was reached. Crack development was measured and marked at the end of each load increment. One of the main concerns of this test was the compressive force acting on the concrete heads caused by the action-reaction of the headed rebar and the rods. For this reason, the heads were overly reinforced to resist splitting forces.

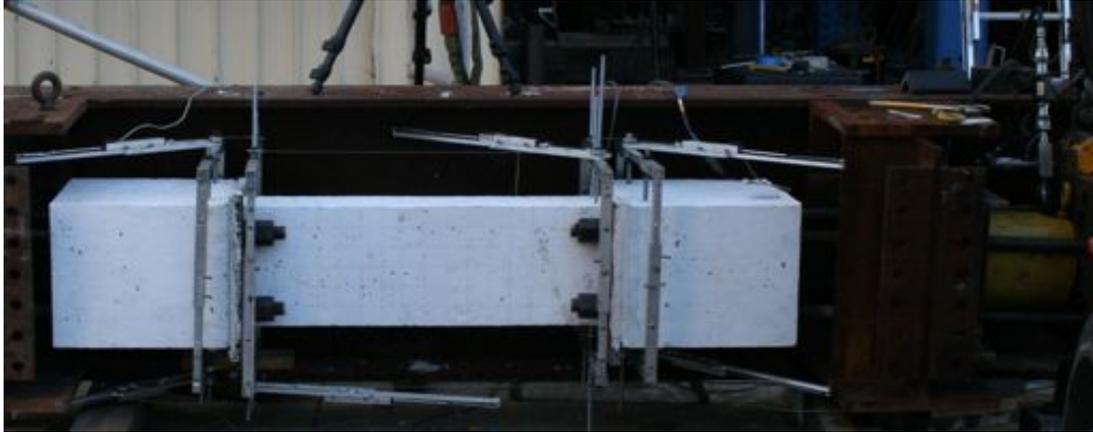
Figure 2.8: Tension setup

A total of six Novotechnik displacement transducers were used to measure the displacement of the specimen. Two of them measured the strain of the specimen, while the other four monitored any slippage between the concrete heads and the specimen. The transducers were attached to the specimen using special frames (see Figure 2.8). A pressure cell was also used to monitor the force being applied by the jack.

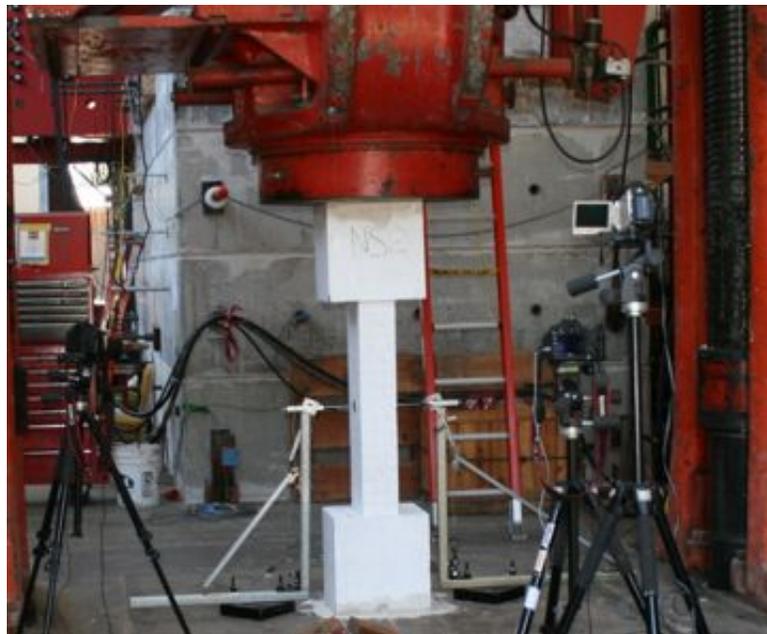
Figure 2.9: Compression setup.

The compression test was done using a Universal Testing Machine (UTM). The specimens were fixed in place using a special grout to reduce eccentricity (see Figure 2.9). The load rate was approximately one kip per second until failure.

Two Novotechnik displacement transducers were used to measure lateral deflection at the center of the specimen as seen above. In addition, two wire potentiometers were used to measure the

axial displacement. The wire potentiometers were attached to the UTM instead of the specimen to prevent spalling concrete interference in the readings. A built-in load cell in the UTM measured the load.

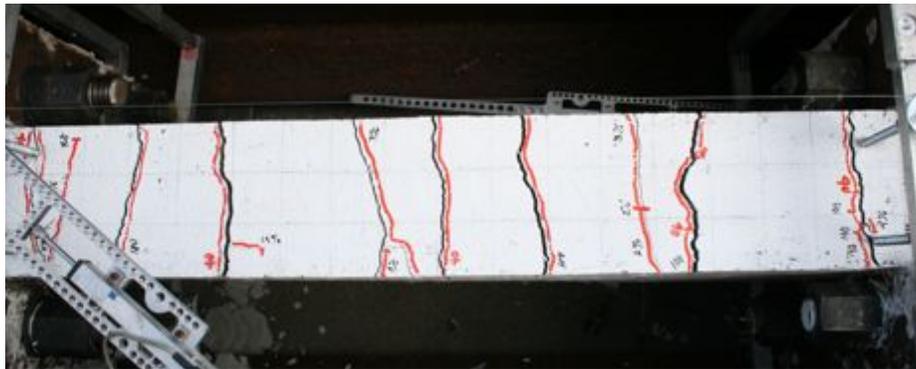
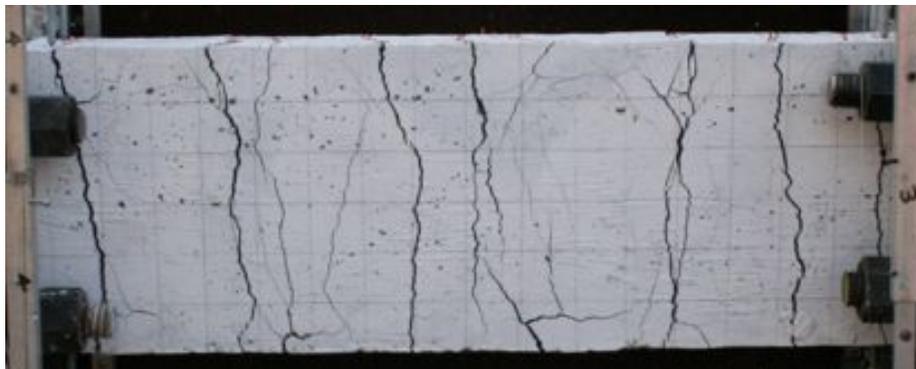
Figure 3.1: NSBE1 after tension test: (a) Plan view; (b) Side view

The tension test was successfully completed. Figures 3.1-2 show NSBE1 after being pulled to four percent strain.

During the test, cracks began to develop along the same spacing as the transverse reinforcement. When four percent strain was reached, more cracks began to appear in between the eight-inch spacing of the transverse reinforcement. The largest cracks measured on the specimen after four percent strain was approximately 0.21 inches. These cracks occurred at 1/3 from the top and bottom of the specimen.

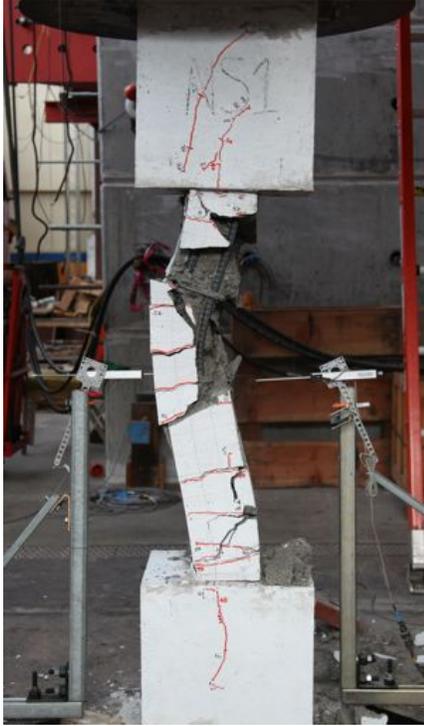
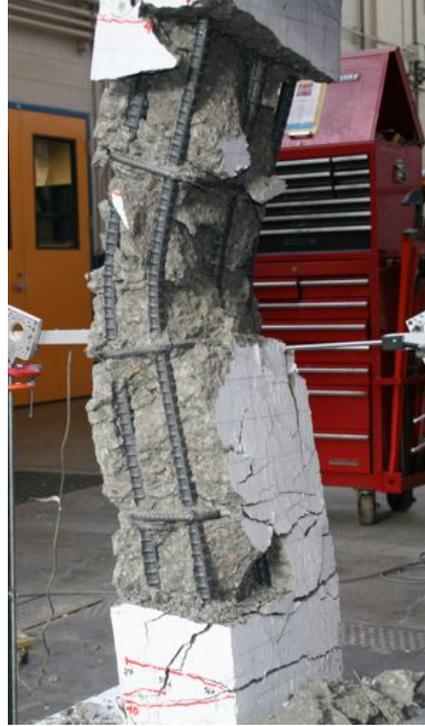
Figure 3.2: NSBE1 after compression

The figures below show the two specimens after the compression test was completed. Figures 3.2-3 show NSBE1 and NSBE2, respectively.

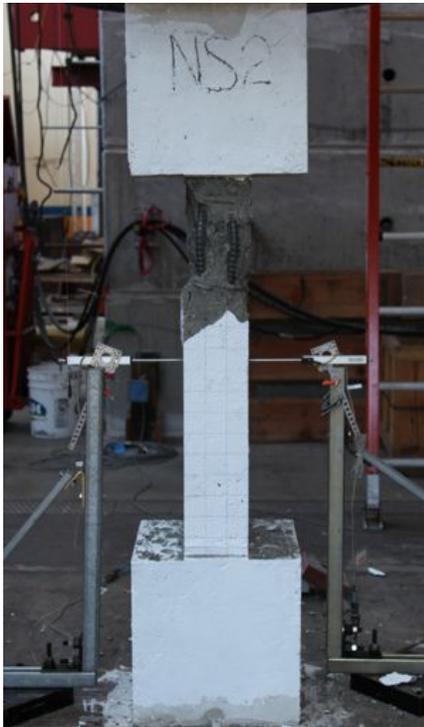
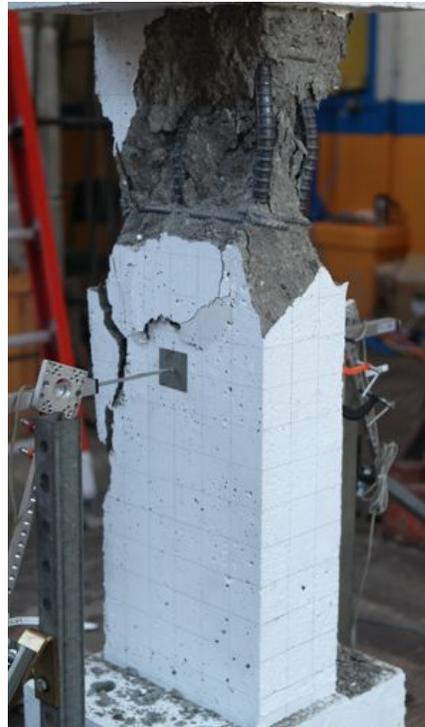
Figure 3.3: NSBE2 after compression

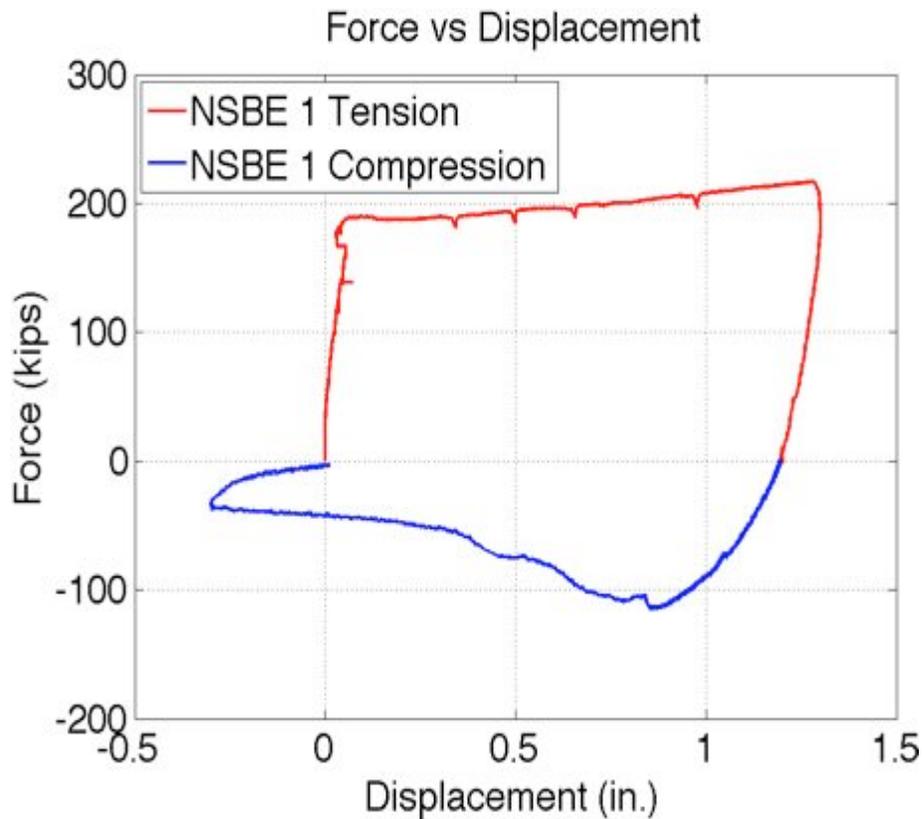
The compression test provided interesting results regarding the behavior of NSBE. Figure 4.1 shows the graphical representation of NSB1 after tension and compression. The graph shows the strain relaxing after the tension force was removed.

Figure 4.1: NSBE1 graph after tension and compression

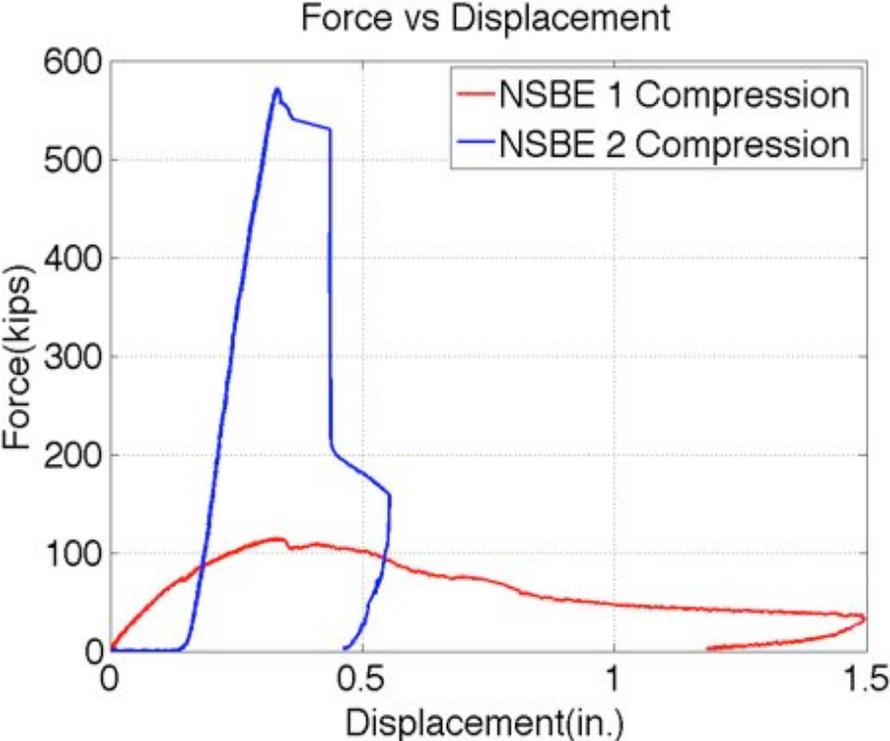
Pre-tensioning the specimen drastically reduced its compressive strength. The compressive strength of NSBE2 was outstanding in comparison to NSBE1. The maximum load that the two specimens were subjected to, were 115 kips for NSBE1 and 572 kips for NSBE2. It can clearly be seen that NSBE2 is five times stronger than NSBE1. Figure 4.2 provides a better representation of this strength difference.

Figure 4.2: NSBE1 vs. NSBE2

From the results, the low performance exhibited by NSBE1 is quite alarming. Comparing the experimental value of 115 kips to the conservative value of approximately 270 kips (provided by Eq.3 from ACI Code 10.3.6.2) it can be seen that the ACI Code reduction factors do not account for pre-tensioning conditions.

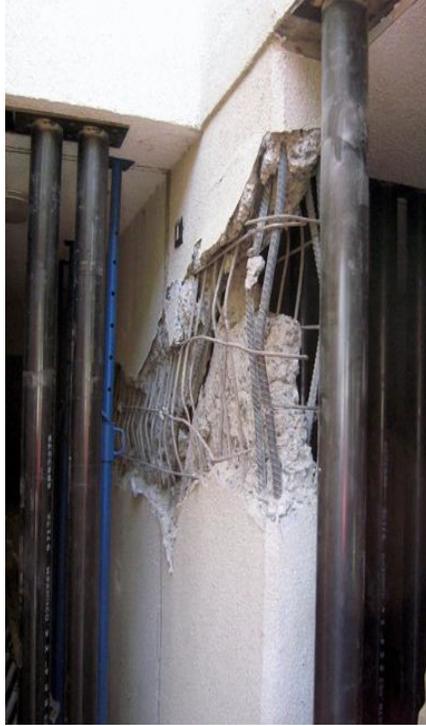
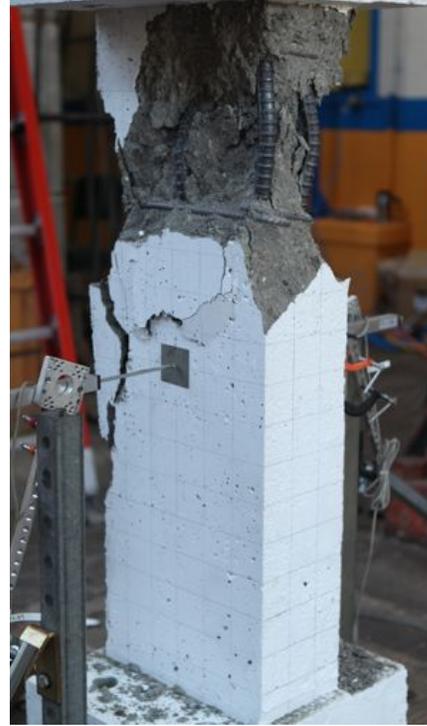
The non-ductile behavior shown by NSBE2 (see Figure 4.3) resembles the failure seen in the buildings in Chile, i.e., localized buckling and spalling. Comparing the two images further, it can be seen that the spalling slants downward from the top of the wall.

Figure 4.3: Comparison: (a) Chilean shear wall; (b) NSBE2
