NEW TECHNIQUES FOR EARTHQUAKE RECONNAISSANCE

Victoria Servin¹

¹ TAP/Jack Kent Cooke Foundation Summer Research Fellow, University of California, Berkeley & Chabot College, Hayward, CA, U.S.A.

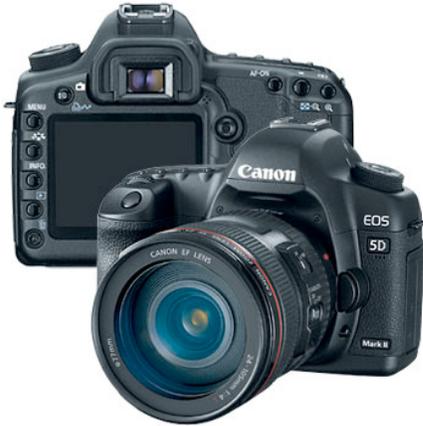
Fig. 3 Canon EOS 5D Mark II.

Canon EOS 5D Mark II. The Canon EOS 5D Mark II, Fig. 3, is a digital, single lens camera that has 21.1 megapixel full-frame CMOS sensor with DIGIC 4 image processor, a ISO range of 100-6400, and contains EOS technologies such as auto lighting optimizer and peripheral illumination correction. This camera model produced high-definition photographs and when paired with a fisheye lens, it captured high quality qualitative data in fewer shots. The Fisheye lens, Fig. 4, gave approximately thirty percent overlap with the photos; this gave sixty degrees of a view angle. This degree of view resulted in twenty-six photographs being needed to capture a full three-hundred and sixty degree, dome view. In order to yield quality photographs using the fisheye lens, the nodal point of the Canon camera with the fisheye lens had to be calculated.

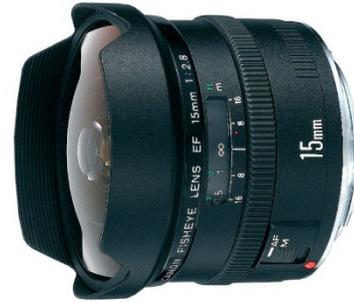
Fig. 4 Fisheye lens for Canon EOS 5D Mark II.

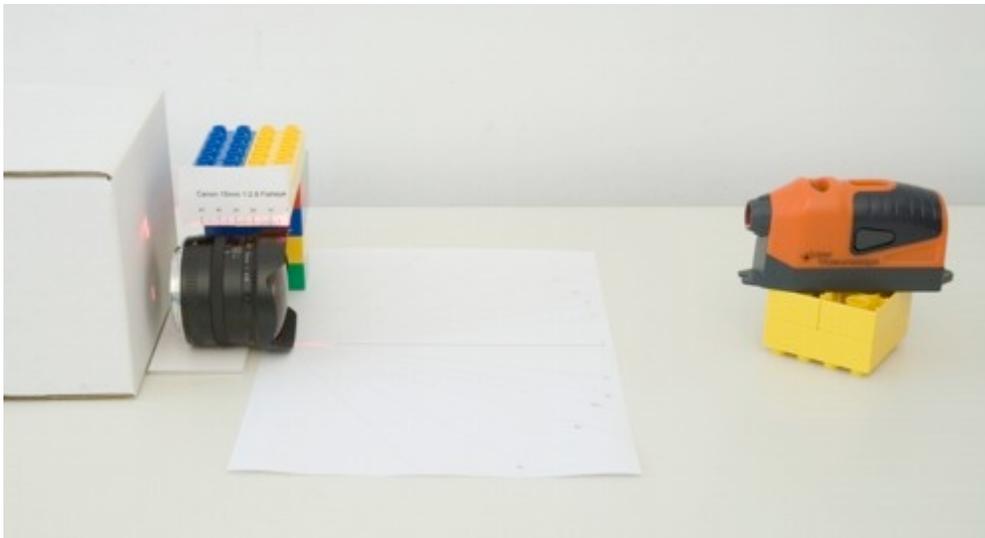
Fig. 3 Set-up for calculating nodal points on cameras (*source: Thomas Schwenger*).

Nodal-point calculation. To calculate the nodal point for the Canon camera, a laser pen, a template with angles marked on to adjust the laser beam, and a ruler were used. The nodal point for this camera was calculated by detaching the lens from the camera and creating a set-up similar to Fig. 3. To calibrate the set-up, the center line of the lens was aligned with the center line of the template. The center line of the scale was then aligned with the center line of the lens and the 0mm mark was aligned with the lens' front. The laser beam was projected along the center line through the lens. The beam at the zero degree line on the template was in line with the beam that was projected on top of the lens and the laser beam went through the lens. The level was then moved from the zero degree mark to the thirty degree mark because of the camera's sixty degree view and the desired thirty percent overlap. The level was adjusted until the laser beam showed behind the lens. The nodal point for the fisheye lens was calculated to be 19mm. Once the nodal point had been determined, the camera was then mounted onto the Manfrotto bracket (Fig. 4) and tripod (Fig. 5) to meet the 19mm difference from the lens and center of the tripod.

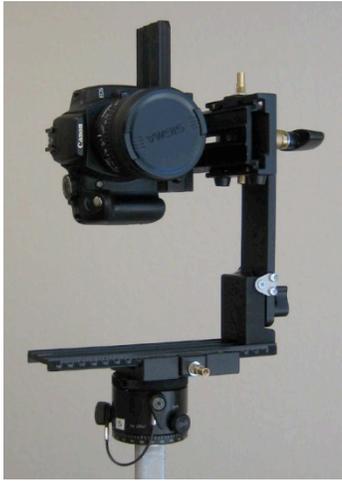
Fig. 4 Manfrotto bracket for camera.

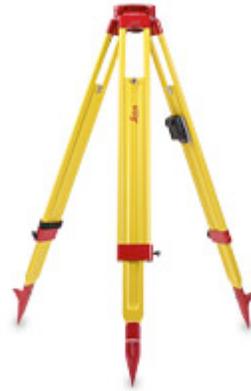
Fig. 5 Tripod for camera.

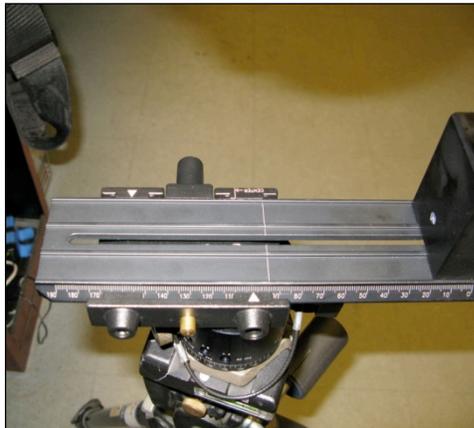
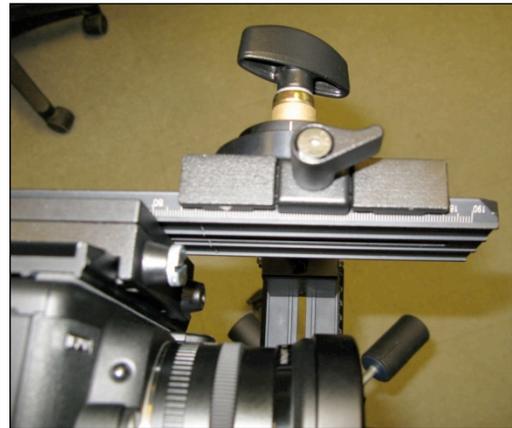
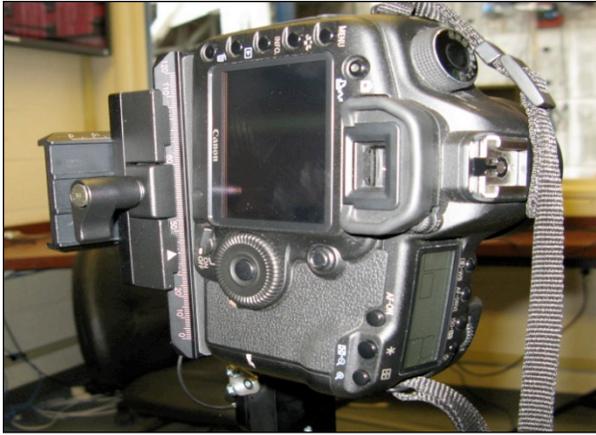
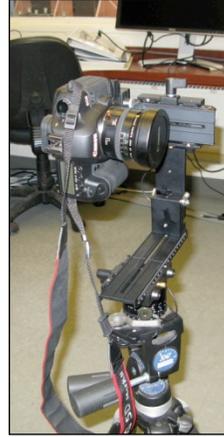
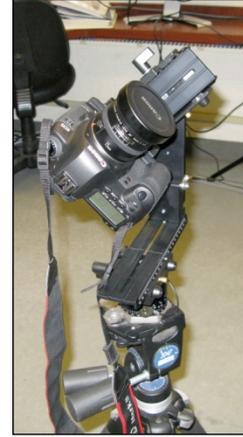
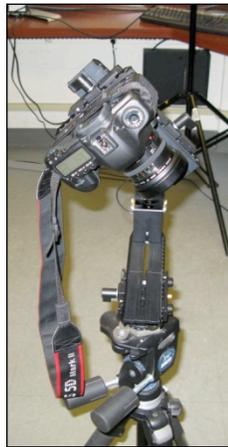
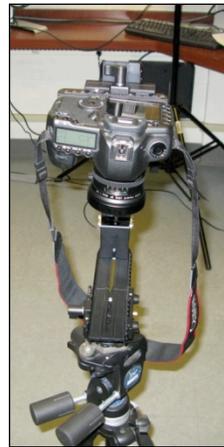
Tripod set-up. To meet the 19mm nodal point of the fisheye lens with the Canon EOS 5D Mark II, the bracket was set-up as shown Fig. 2. In Fig. 3, the lower level of the bracket, the white arrow was placed on 102cm (The solid white line did not meet with the line that says, “Center”). For the second level of the bracket, the white arrow was on 106cm like in Fig. 3 (The clamp’s edges were on 90cm and 180cm). For the third level, the white arrow was on 39cm and the clamp’s edges were on 24cm and 108cm (Fig. 4).

This set-up was designed to collect a total of twenty-six photographs, a photo taken at every 45°. Eight pictures at the horizontal level, 0° (Fig. 5). Eight pictures at a tilted upward stance, at 45° (Fig. 6). One picture at 0°, pointed upwards (Fig. 2). Eight pictures, at a tilted downward stance, at 45° (Fig. 8). One picture pointed downward at 0° (Fig. 9).

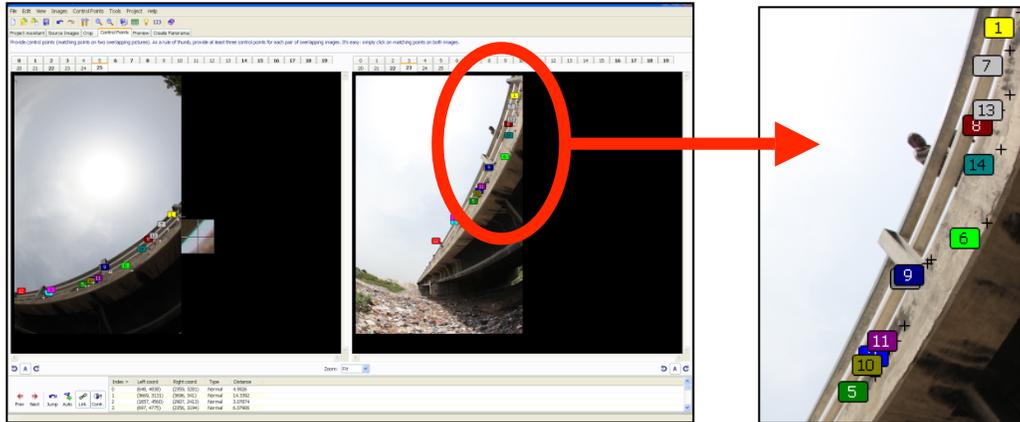
Fig. 10 Screen shot of photo stitching in PTGui software and zoomed-in section of control points.

The photos from the Canon camera were uploaded onto a computer and then onto the PTGui software. Control points were created to stitch the images together (Fig. 10). Control points are common points between two photos where the software aligns the two images into one. The stitched image was then warped to create the spherical panorama. The warping of the image results in a full dome-view of the area. The panorama was converted from a .jpeg file into a .mov file, where one can rotate, zoom-in, and see the photographs as a full three-hundred and sixty degree video.

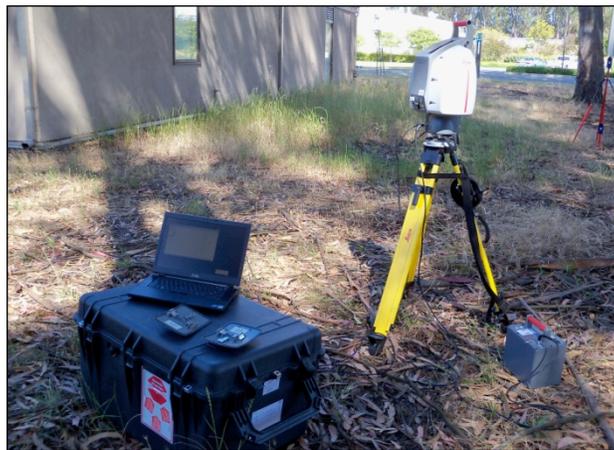
Fig. 11 Set-up of Leica ScanStation 2

Leica Scan Station 2. The Leica Scan Station 2 is a topographic surveying tool with 50,000 pts/sec maximum instantaneous scan speed. Each scanner position will generate a number of points in space called point clouds. A number of point clouds from different scanner positions around an object can be stitched together by means of reference points called targets. The fully stitched point cloud called registration represents the complete 3D image of the object in space.

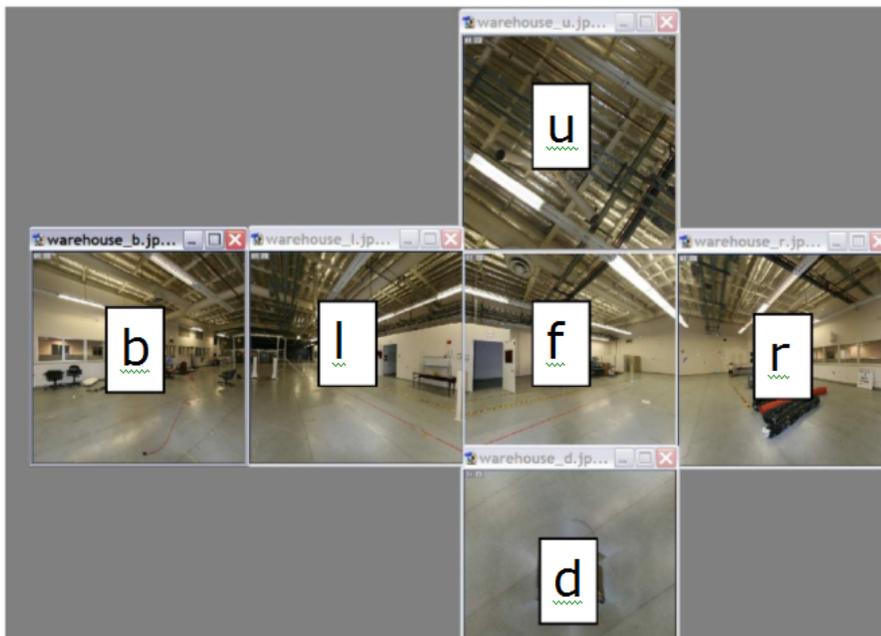
Fig. 12 Screen shot of a Cube Map (source: Leica Geosystems).

The spherical image created from technique I was converted into a Cube Map. The Spherical image was divided into six images: a top, bottom, front, back, left, and right view (Fig. 12). Once the Cube Map was created, it was imported onto Cyclone. In order to match the Cube Map and laser scan, three pairs of matching control points had to be created. For a detailed, step-by-step instructional guide, please see Manual for External Camera Workflow.

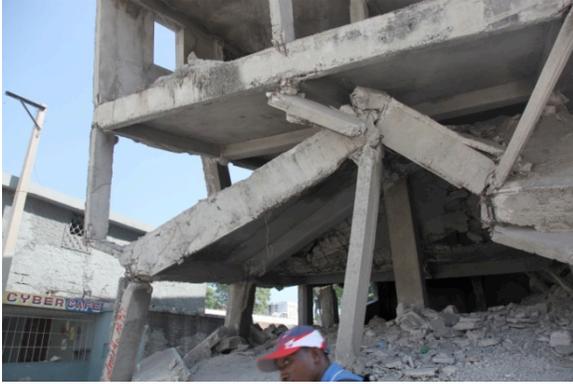
Fig. 13 Damaged first-level of a building in Haiti.

The images, panoramas, and videos have been stored at the Pacific Earthquake Engineering Research (PEER) Center, where future researchers can use the data to investigate damaged structures from the Haiti earthquake. A total of 1,031 high-definition photographs were taken in Haiti (Figs. 13-18). Of those 1,031 photographs, five spherical images and panoramas were able to be created from technique I (Fig. 19). However, the qualities of three panoramas were hindered because people were in some pictures and not in others, so when the images were stitched together, the resultant panorama was inconsistent. The resultant images, of those three panoramas, contained blurred connections between photos (Fig. 20).

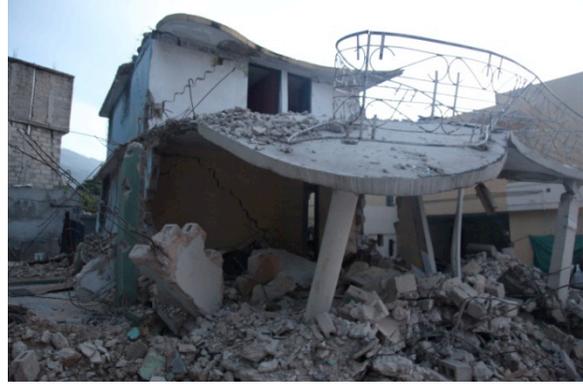
Fig. 14 Damaged house in Haiti.

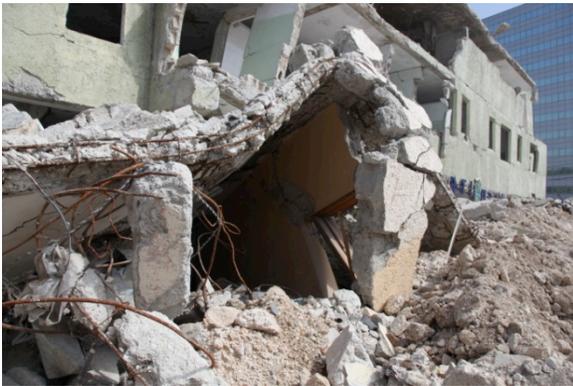
Fig. 15 Collapsed building in Haiti.

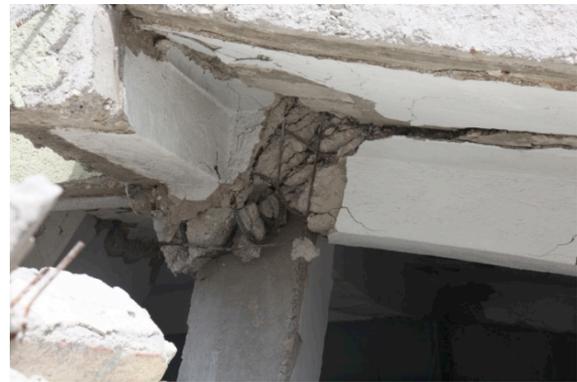
Fig. 16 Close-up of collapsed building.

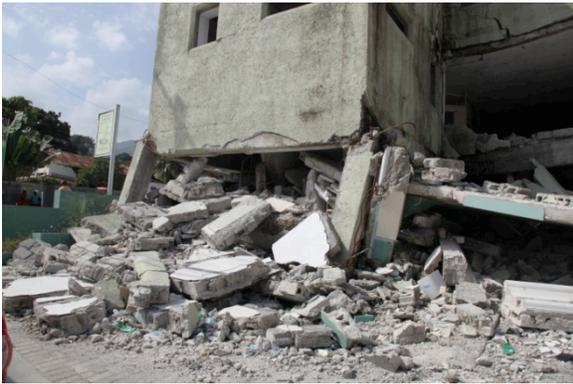
Fig. 17 Collapsed building in Haiti.

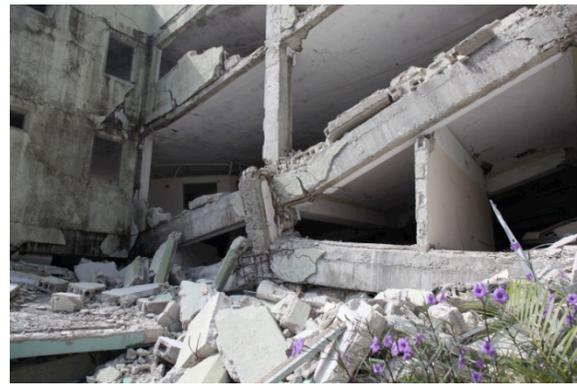
Fig. 18 Damaged Parking Lot in Haiti.

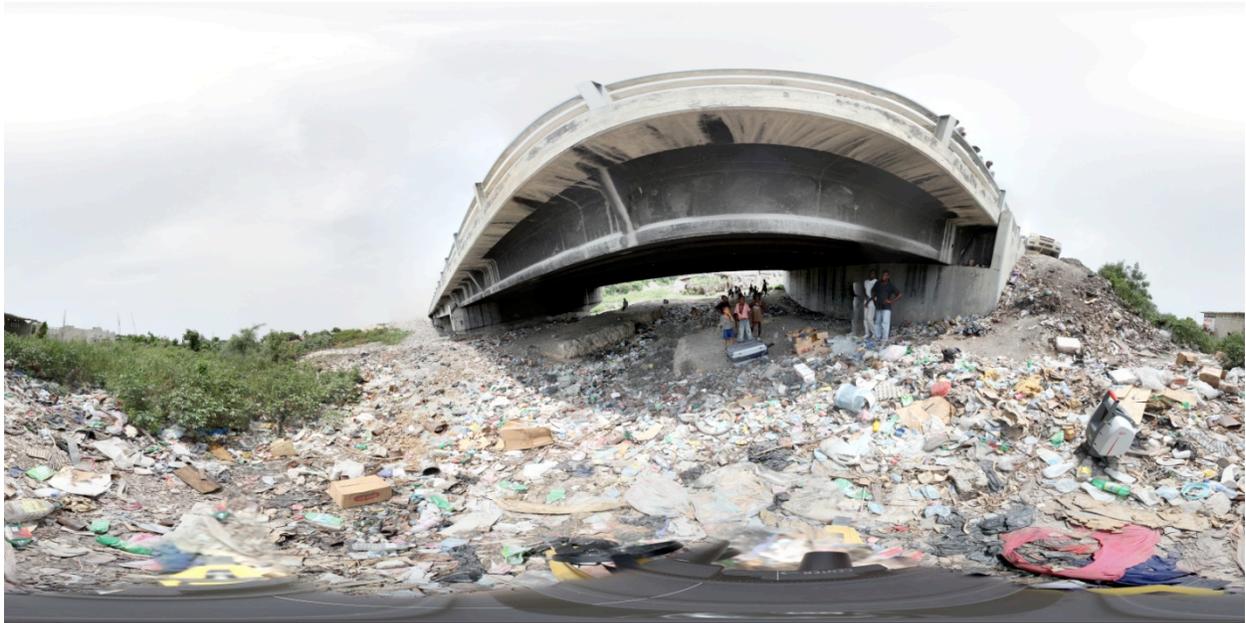
Fig. 19 Three-hundred and sixty spherical panorama of bridge.

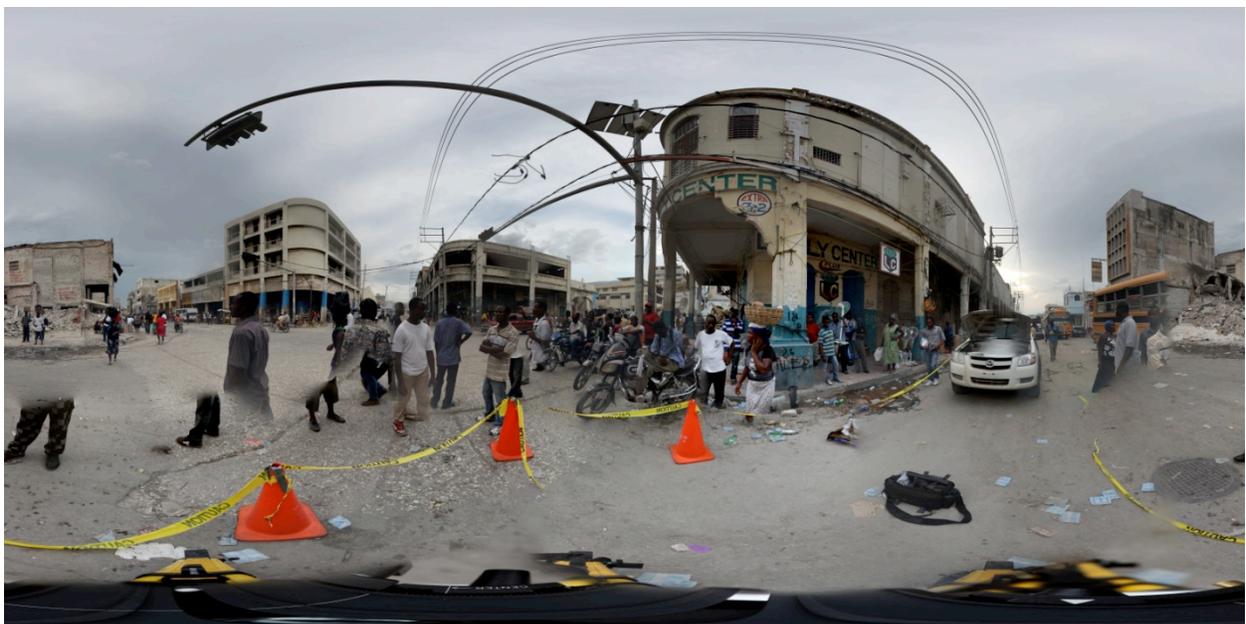
Fig. 20 Three-hundred and sixty spherical panorama of an intersection in Haiti.

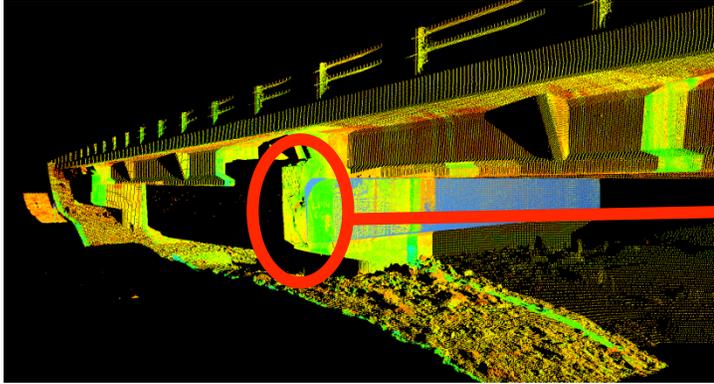
Fig. 21 Laser scan of bridge in Cyclone.

Technique I's images of Haiti serve as raw data of the catastrophe that struck Haiti. Detailed images were acquired and a full three-hundred and sixty degree view of the affected areas was obtained. Technique II, however, produced accurate laser scans and could also be zoomed in on (Figs. 21 and 22). Technique II also allowed for cross sections to be made and cracks to be measured (Figs. 23 and 24).

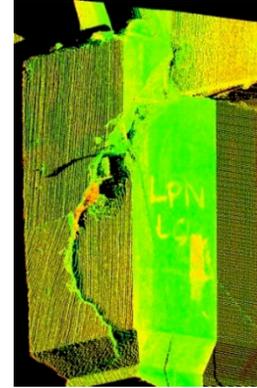
Fig. 22 Close-up of Bridge pier.

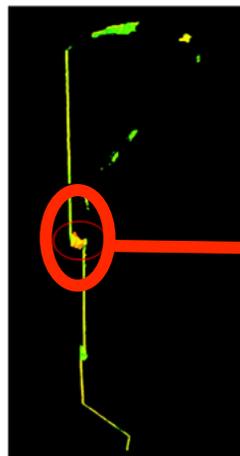
Fig. 23 Cross section of fig. 19.

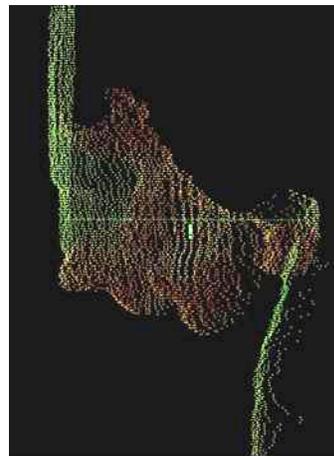
Fig. 24 Zoom-in of fig. 20.

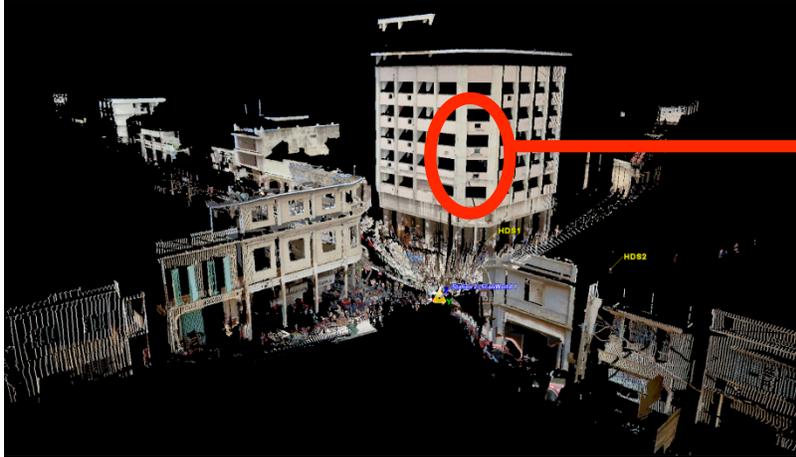
Fig. 25 Superimposed image of Asscotia Hotel in Haiti.

The combination of the high resolution photographs and Leica laser both mathematically and visually reflect the damaged state of the buildings. Through this technique, cracks can be seen realistically and measured (Fig. 25). The blend of technique I and II shows a better display than the laser scan and unlike the Canon camera, it allows for calculations to be made. The images can be zoomed in and measurements can be displayed.

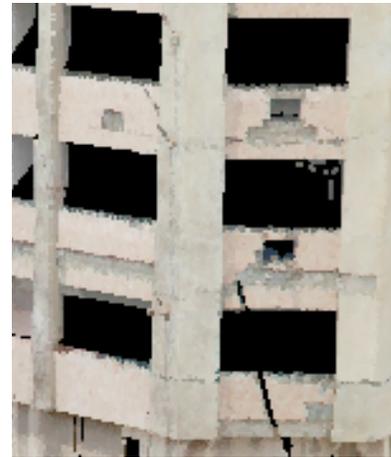
Fig. 26 Close-up of Fig. 25

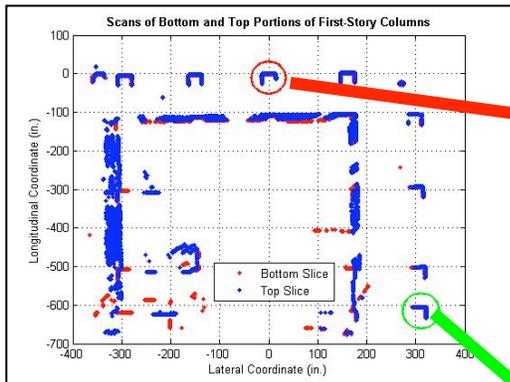
Laser scan cross sections of the Asscotia Hotel were loaded onto MATLAB, where the coordinates of the hotel were graphed to produce Fig. 27. Fig. 27 shows story drift between the top and bottom portions of the columns, beams, and walls. Fig. 27a and Fig. 27b shows the residual displacement from the top and bottom portions of the columns. In Fig. 27a and 27b, the blue dots represent the top portion of the columns and the red dots are representations of the bottom.

Fig. 27 Story drift shown in residual displacement graph produced by MATLAB.

In Fig. 27, the earthquake's effect on the Asscotia Hotel's structure can be seen. The gaps between the blue portions in Fig. 27 show where separation occurred between the material of the building. For example, between -400 and -300 longitudinal lines and -400 and -300 lateral lines, there is a portion missing. This means that part of the wall on the hotel is gone. The gap can be measured and the displacement can be measured for each column.

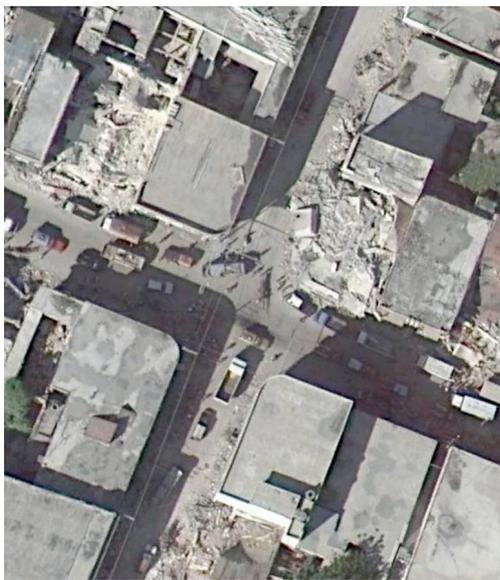
Fig. 28 Google Map's image of Mirand and Grand intersection in Haiti.

Technique III's advantages are clearly shown in comparison to satellite images (Figs. 28 and 29). The satellite's aerial view of the Mirand and Grand intersection does not show the extent of the earthquake's damage. Technique III, however, shows the horizontal view of the intersection; the viewpoint is of someone being in the center of the intersection. It gives details of the buildings because it is a composition of real-life shots from the high-definition images and laser scans.

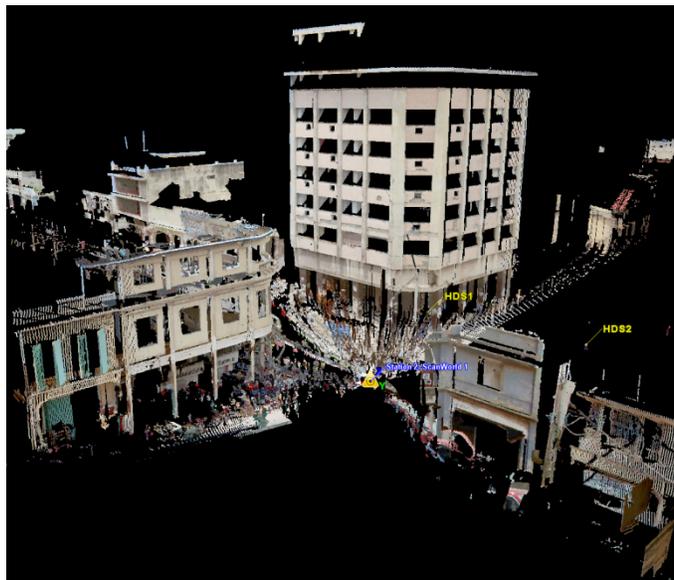
Fig. 29 Superimposed image on laser scan of Mirand and Grand intersection.
