New Techniques for Earthquake Reconnaissance

Author: Victoria Servin, Chabot College

SUMMARY

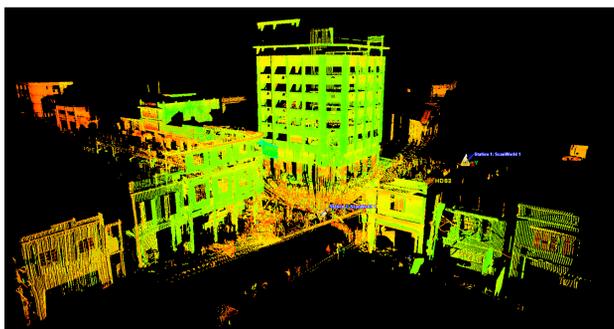
Fig. 1 Leica laser scanned image of the intersection of Mirand and Grand, Port-au-Prince, Haiti.

The high-definition photographs were superimposed upon the Leica Laser scanned images. Fig. 1 was the base image and Fig. 2 and 3 were then overlaid.

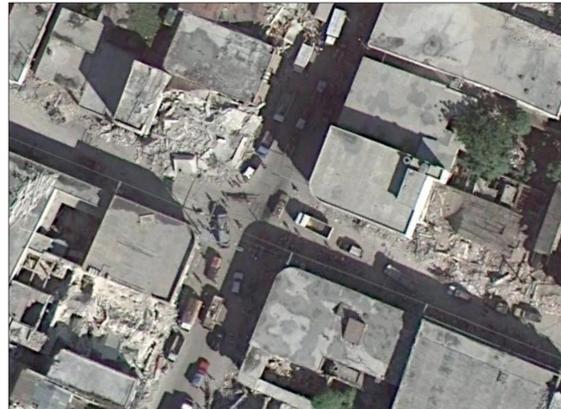
Fig. 7 Aerial view of Mirand and Grand intersection, Port-au-Prince, Haiti via Google Earth after earthquake.

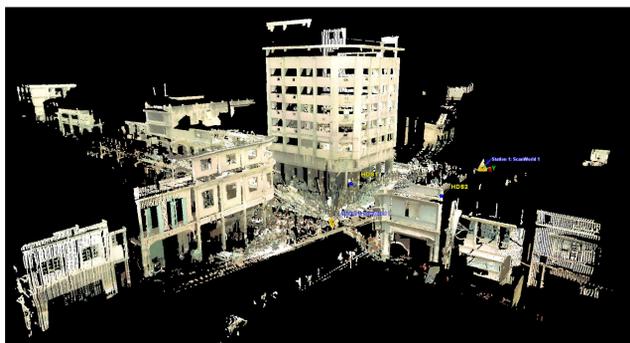
Fig. 6 Resultant image of high-definition photographs superimposed upon laser scan of Mirand and Grand intersection. This image demonstrates the advantage of having scanned and high-definition images to show earthquake damage as apposed to a satellite's aerial view.

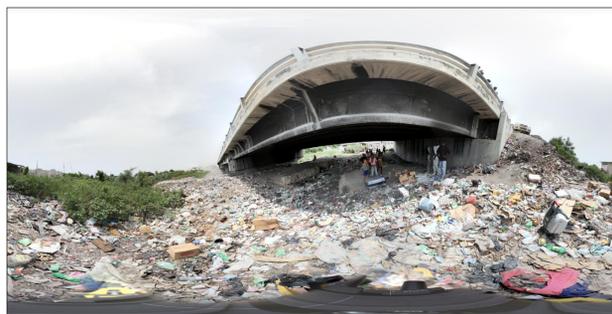
Fig. 8 Resultant three-hundred and sixty degree spherical panorama of bridge. Fisheye lens for high-definition camera was used.

Photographs such as Fig. 4 and 5 were stitched together through the creation of control points. The images were then aligned and warped to create a three-hundred and sixty degree spherical panorama.

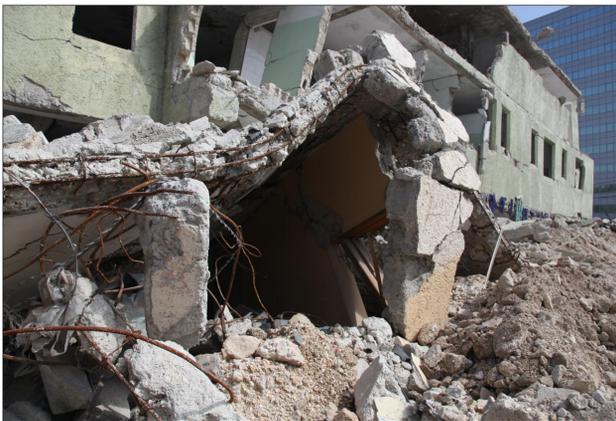
Fig. 10 High-resolution photograph of a collapsed building.
