# Northridge Earthquake + 25 years

## Accomplishments + Challenges Design + Retrofit of Buildings

John W. Wallace  
University of California, Los Angeles

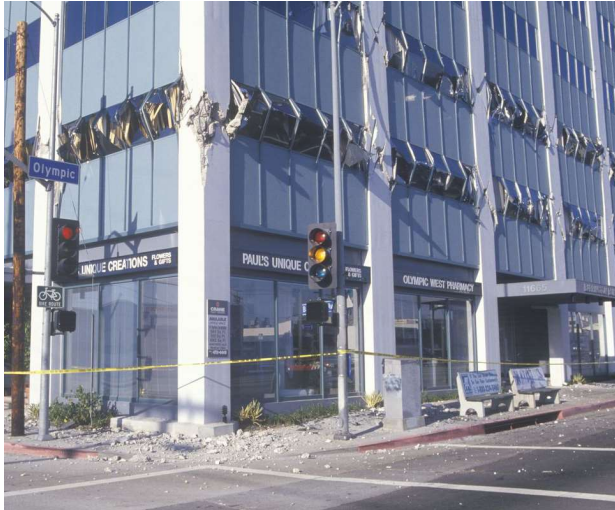
- Column Shear Failure

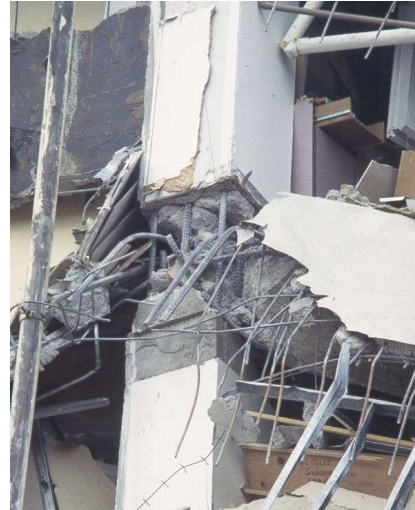
- Joint Failure

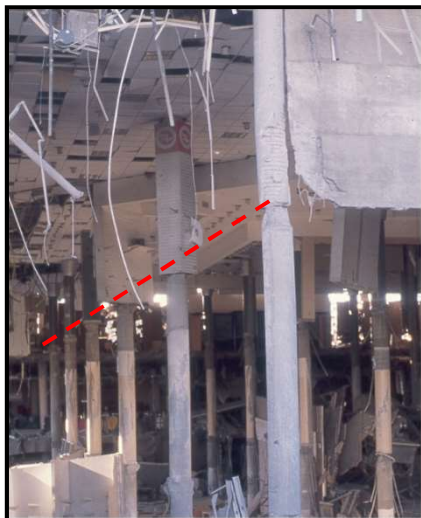
- Slab-column Punching shear

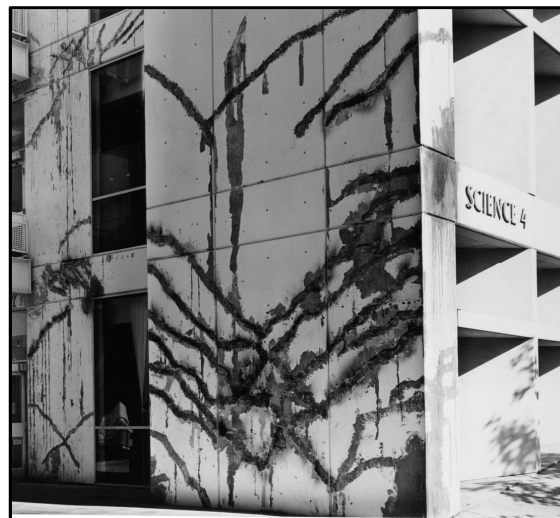
- Epoxy Injection

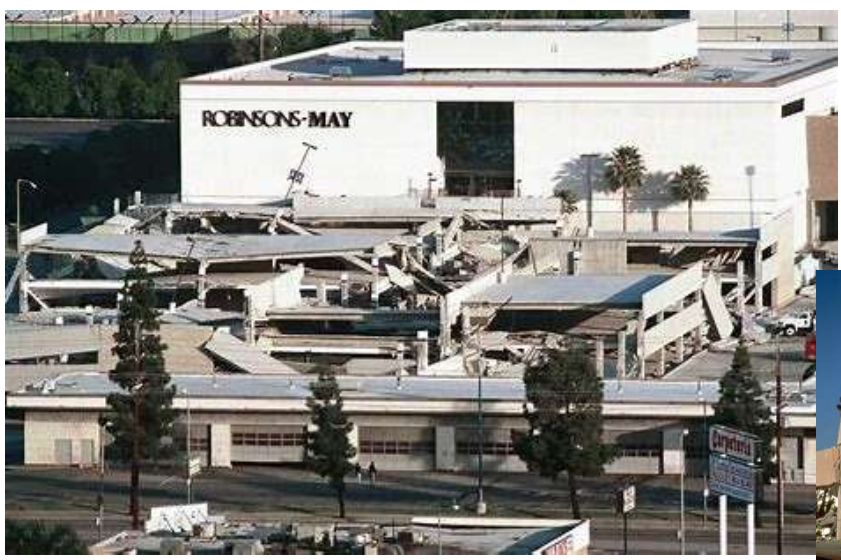
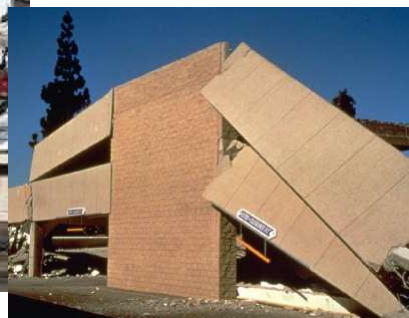
# Observations (2) - Diaphragms

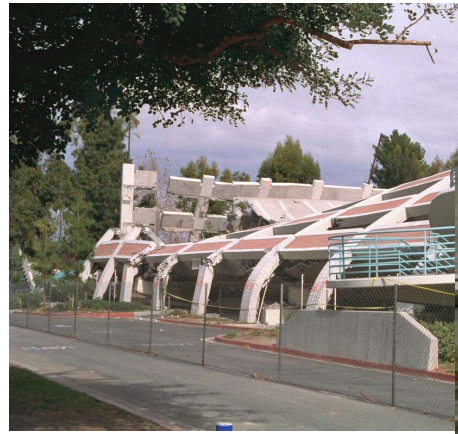
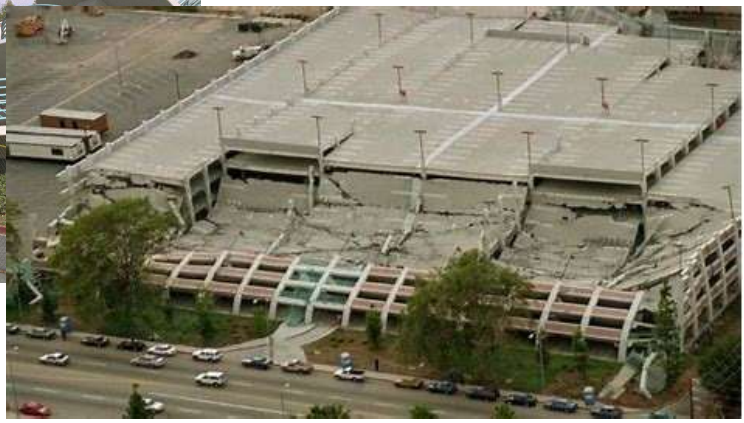
# Observations (3) - Gravity Systems

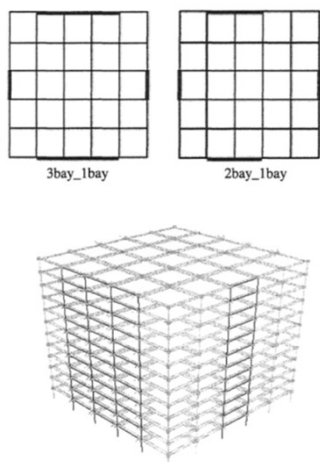
- Redundancy

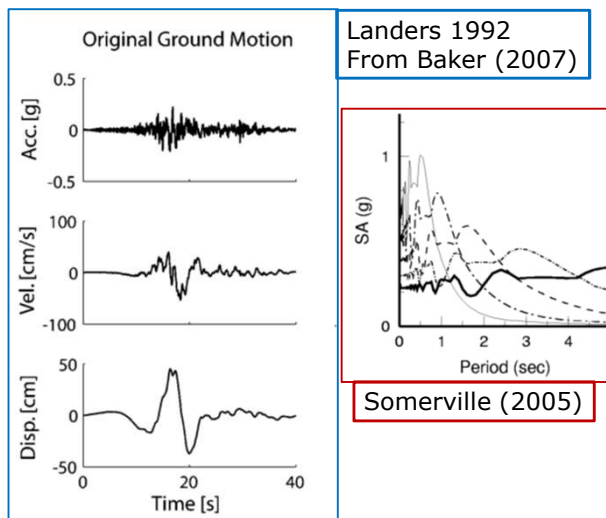
- Near fault ground motions

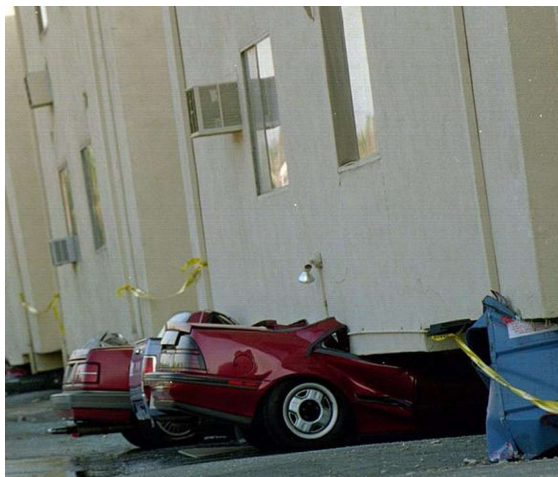
- Tuck-under parking

Damage from the 1994 Northridge quake is shown. (Credit: Boris Yaro / Los Angeles Times).

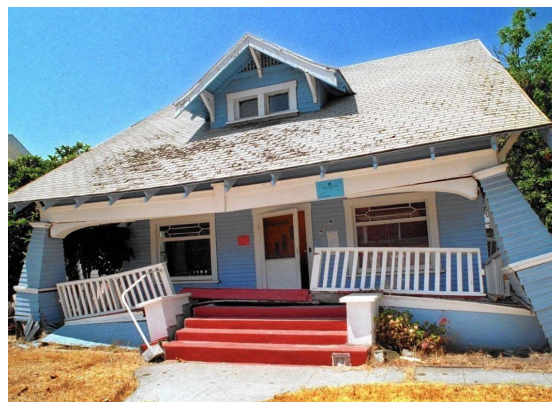
- Wood houses

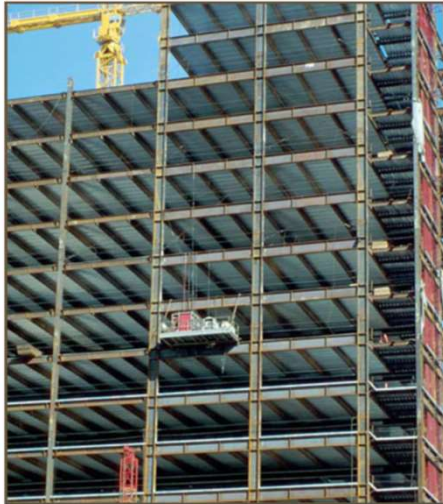
- Steel moment frames

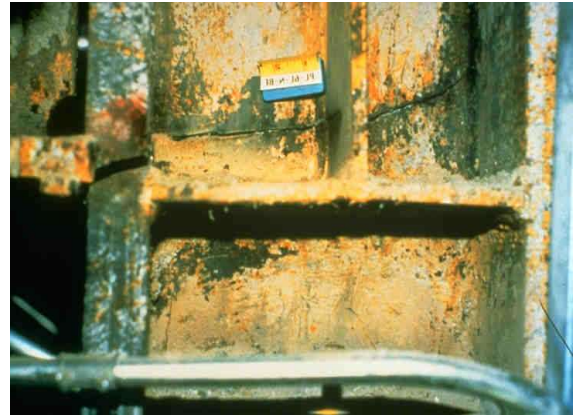
- Brittle fractures

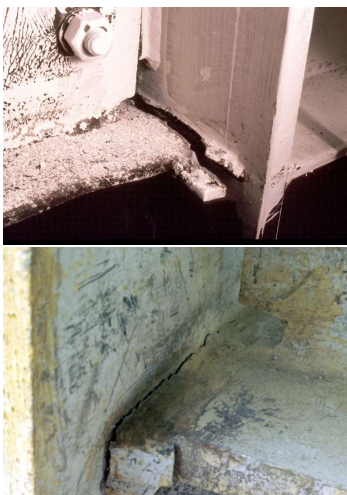
- Steel moment frames

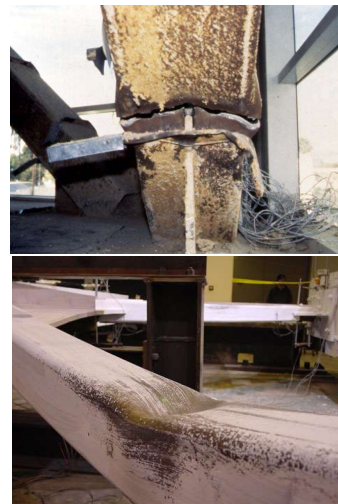
- Steel braced frames

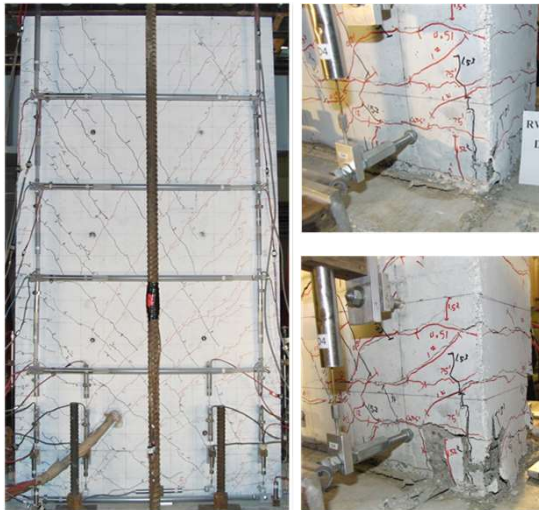
- Moderate damage

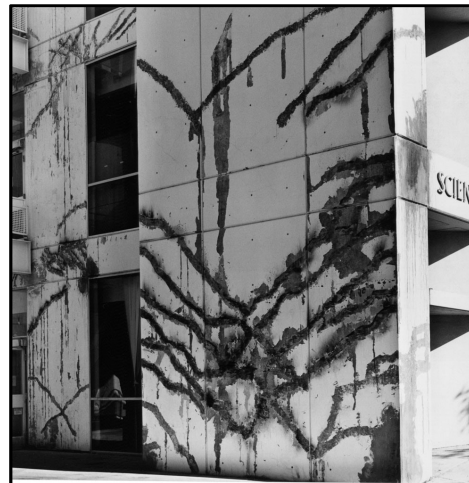
- Repair performance
