PACIFIC EARTHQUAKE ENGINEERING RESEARCH CENTER

Project Technical Summary

A Report for the “Quantifying the Performance of Retrofit of Cripple Walls and Sill Anchorage in Single- Family Wood-Frame Buildings” Project

PEER Report 2020/12

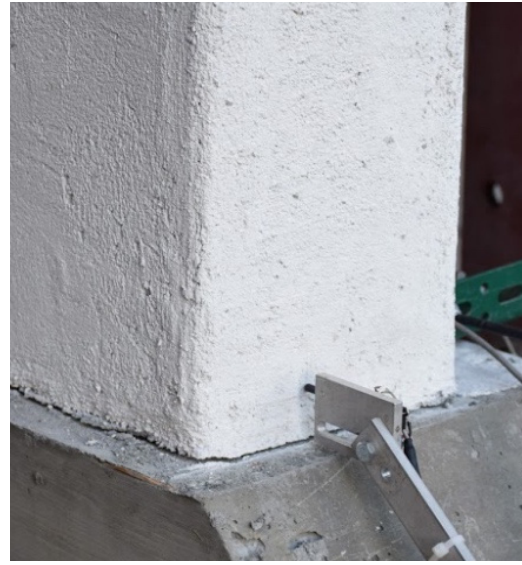
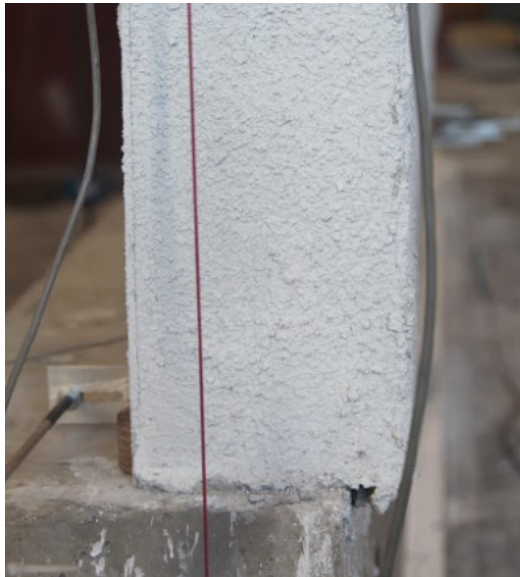
Figure 5.4 Photographs of the various bottom boundary conditions: (a) bottom of end of wall for bottom boundary condition “a”; (b) bottom of end of wall for bottom boundary condition “b”; (c) bottom of end of wall for bottom boundary condition “c”; and (d) bottom of end of wall for bottom boundary condition “d”.

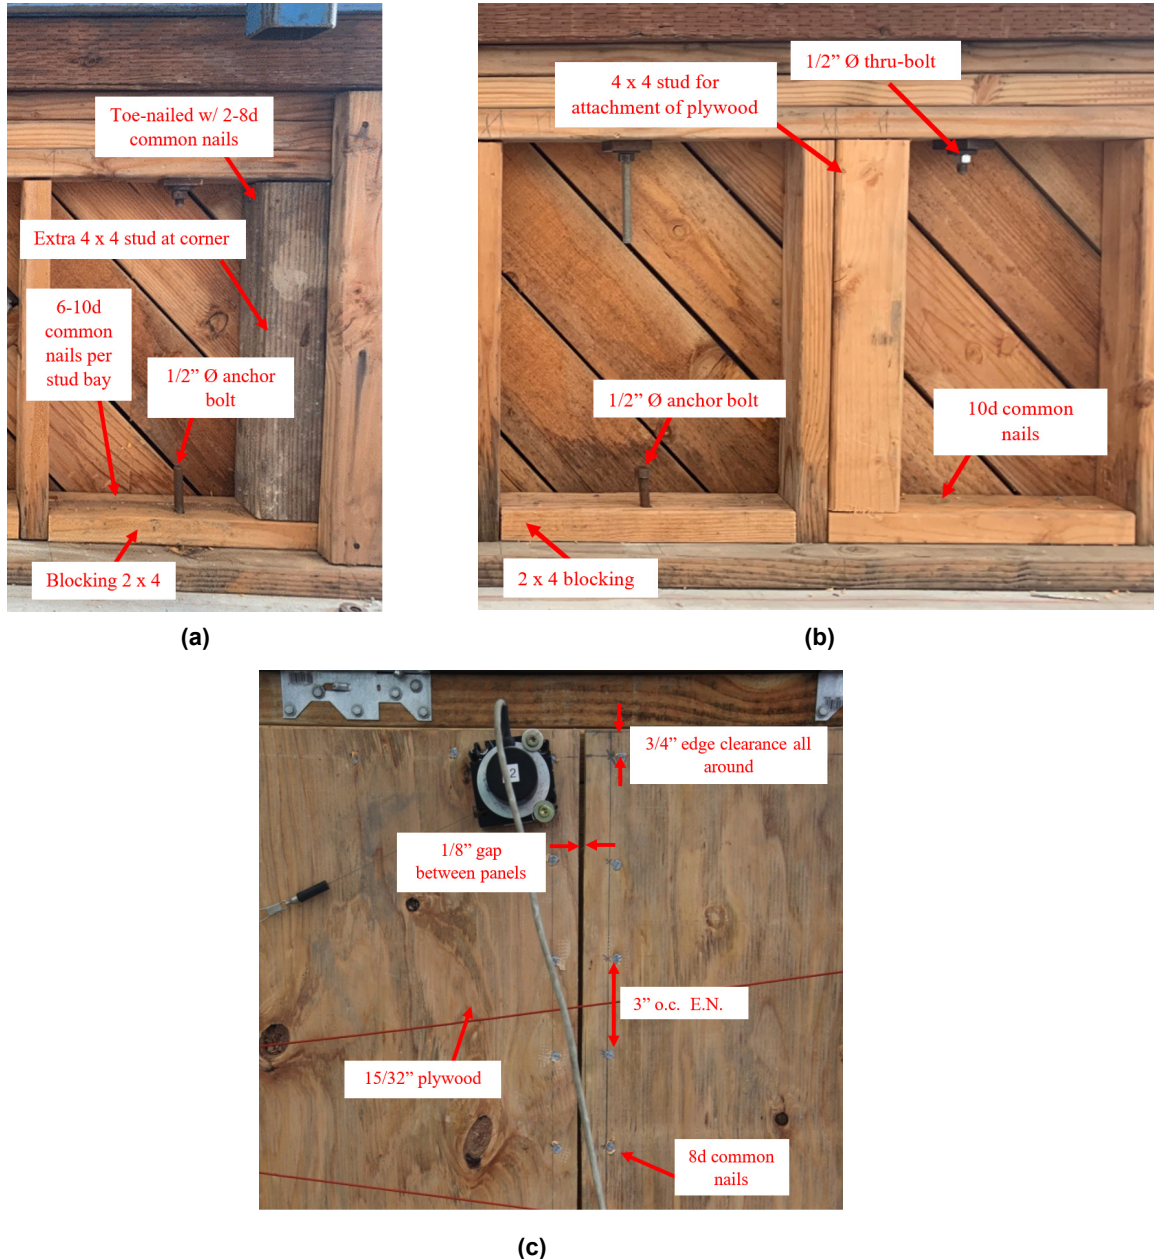
Figure 5.5 Photographs of the common retrofit application details: (a) interior corner retrofit detail; (b) interior retrofit detail; and (c) plywood attachment detail.

- Failure of the retrofitted, cripple wall was primarily attributed to sheathing nail head pull through and/or nail withdrawal along the edges of the plywood panels, especially along the top plate and sides. At the bottom of the plywood panels, nails withdrew from the framing as added blocking split at large displacements. Some tearing of the nails through the plywood panels (edge tear-out) was observed at the corners. Photographs of the retrofit details can be seen in Figure 5.5.

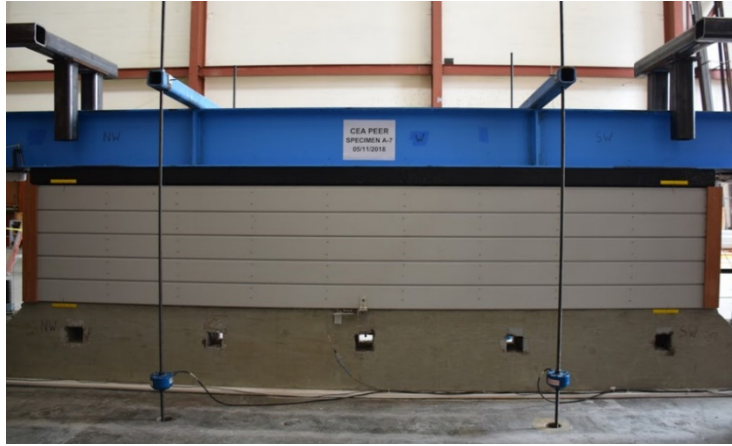
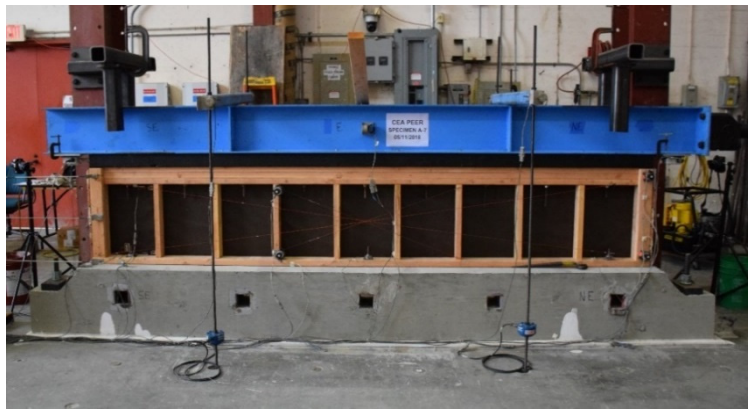
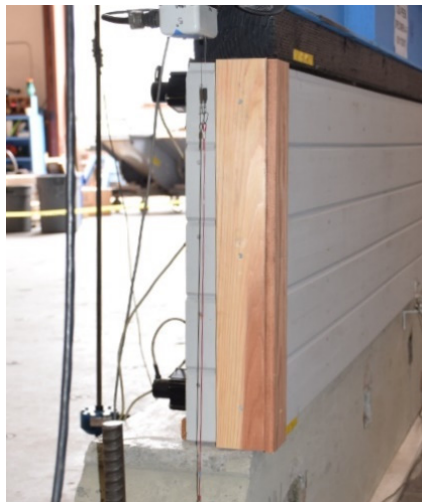
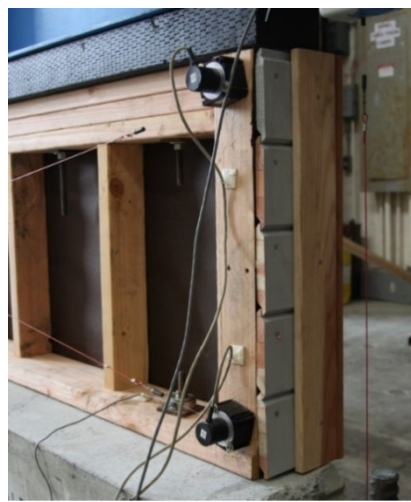
Figure 5.6 Specimen A-7: pre-test photographs for the existing 2-ft-tall cripple wall with horizontal siding exterior finish: (a) exterior elevation; (b) interior elevation; (c) north exterior corner; and (d) north interior corner [Schiller et al. 2020(b)].

- Horizontal siding also exhibited the largest drift capacity of any exterior finish, with little to no lateral strength degradation. The 2-ft-tall specimen dropped 25% of load from drift (4% drift ratio); strength was achieved by 12% drift. The 6-ft-tall specimen continued to gain strength until 12% drift; and

- The hysteretic response of cripple walls finished with horizontal siding was nominally symmetric. Photographs of the 2-ft-tall existing specimen with horizontal siding exterior finish are provided in Figure 5.6.

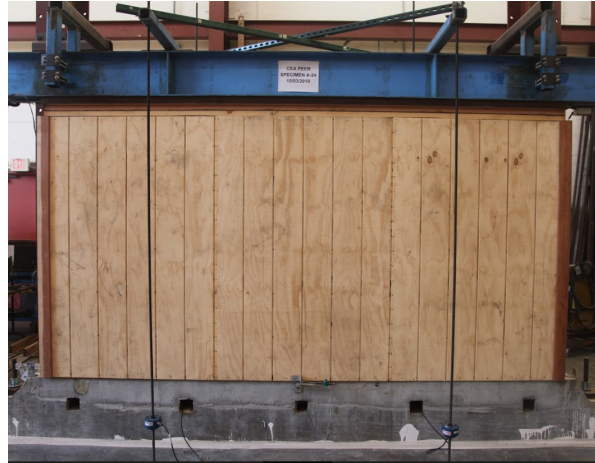
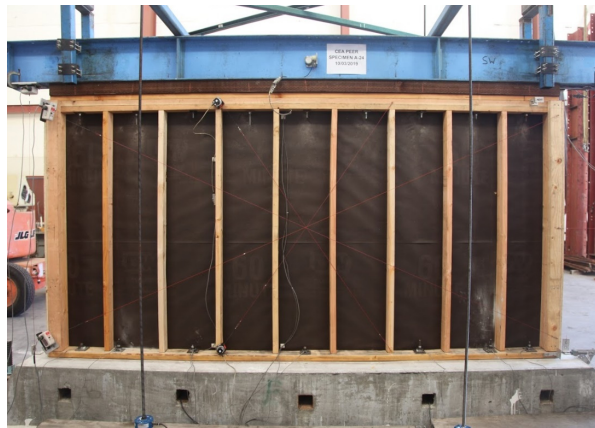
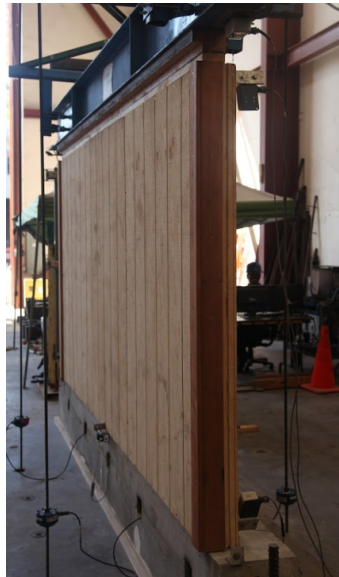
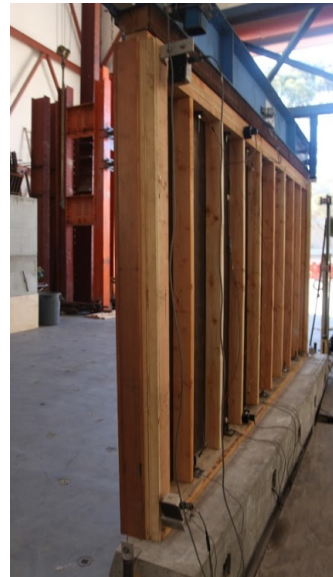
Figure 5.7 Specimen A-24: pre-test photograph for the retrofitted 6-ft-tall cripple wall with T1-11 wood structural panel exterior finish: (a) exterior elevation; (b) interior elevation; (c) north exterior corner; and (d) north interior corner [Schiller et al. 2020(b)].

- T1-11 finished cripple walls attained their strengths at relatively low drift amplitudes, i.e., these specimens were stiffer compared with other dry finished specimens. On average between push and pull for the 2-ft-tall specimen, 80% of the strength was achieved by 1.7% relative drift ratio, while strength was achieved at 4.7% relative drift ratio; however, this finish material did not do well in maintaining its strength post-peak. This was the result of fasteners losing attachment via tearing and pulling through along the edges of the panels; and

- The hysteretic response of cripple walls finished with T1-11 plywood panels were nominally symmetric. Photographs of the existing 6-ft-tall specimen with T1-11 wood structural panel exterior finish along with the hysteretic response of the specimen are provided in Figure 5.7 and Figure 5.8, respectively.

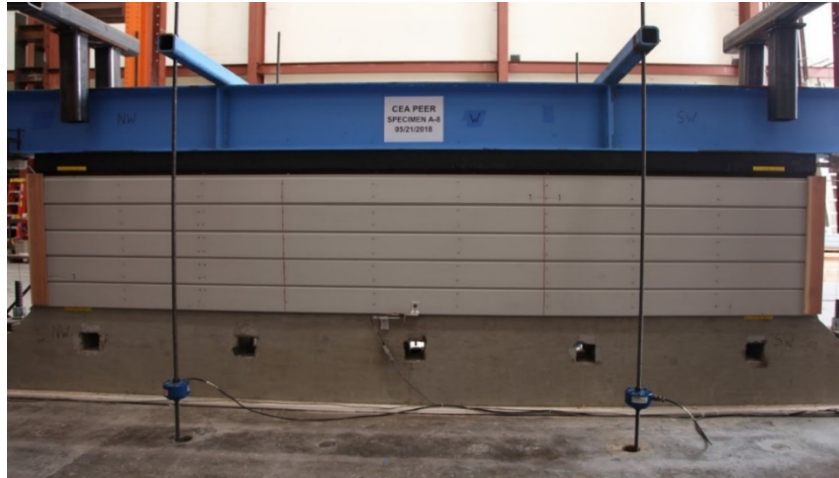
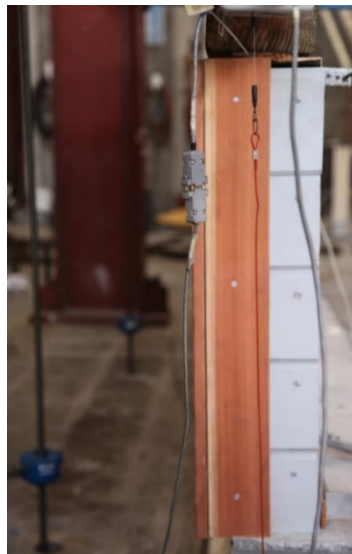
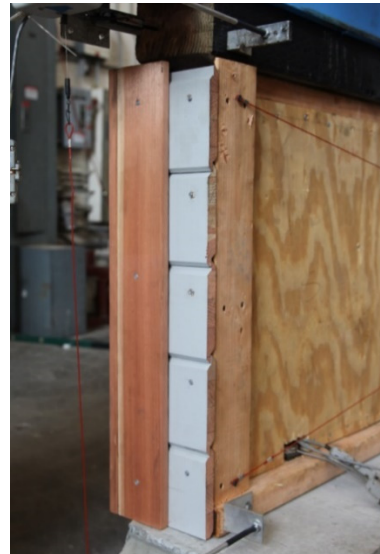
Figure 5.9 Specimen A-8: pre-test photographs for the retrofitted 2-ft-tall cripple wall with horizontal siding exterior finish: (a) exterior elevation; (b) interior elevation; (c) north exterior corner; and (d) north interior corner [Schiller et al. 2020(b)].

- For the retrofitted cripple walls with horizontal siding exterior finish, the drift at strength was reduced for the 6-ft-tall walls. The increased imposed displacement for 6-ft-tall walls (three times as high) caused the plywood to detach at a lower drift amplitude compared to the 2-ft-tall cripple wall. The same was the case for the T1-11 cripple walls, both the existing and retrofitted walls.

- Overall, loss of lateral load capacity occurred when the plywood panel detached from the framing. This occurred by either the nails tearing through the edges of the panels, the nails pulling through the panels, the nails pulling out of the framing, or the nails pulling the blocking off the sill plate. Each retrofitted cripple wall experienced all these phenomena, except the T1-11 cripple wall, which did not include any blocking.

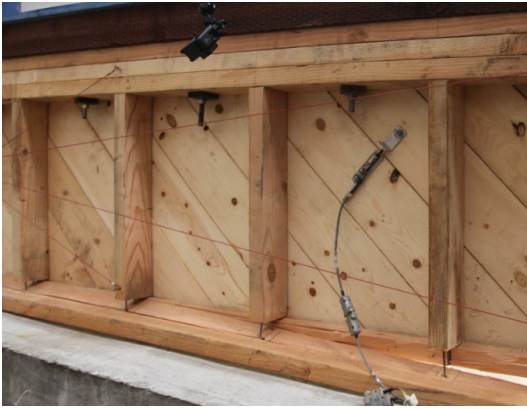
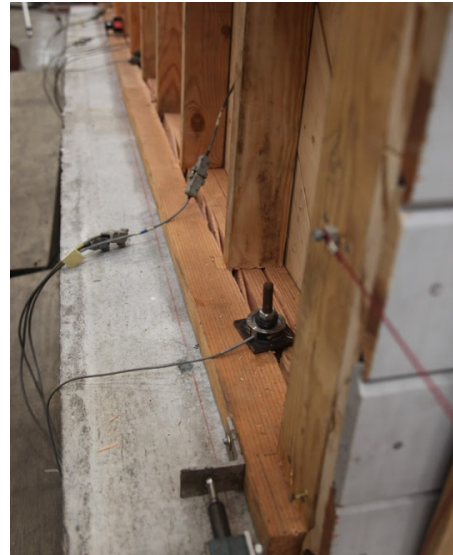
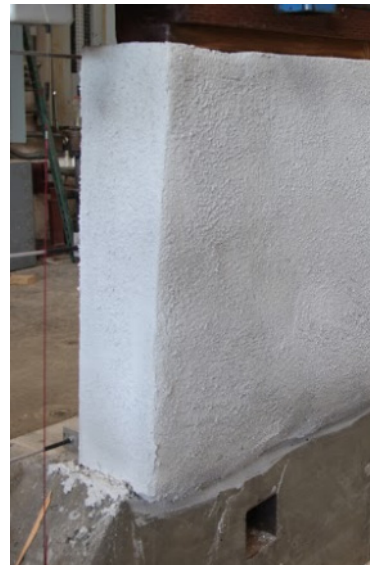
Figure 5.12 Specimen A-19: pre-test photographs of the retrofitted 2-ft-tall cripple wall with stucco over horizontal sheathing exterior finish and bottom boundary condition c: (a) exterior elevation; (b) interior elevation; (c) south interior corner; and (d) south exterior corner [Schiller et al. 2020c].

While the heavy vertical load cripple wall ended the test due to fractured anchor bolts, the light vertical load cripple wall test completion was associated with cross-grain splitting across the entire sill plate. This change in failure mode is due to the reduced vertical load decreasing the uplift resistance. Figure 5.11 shows images of the light vertically loaded cripple cross-grain cracking of the sill plate.

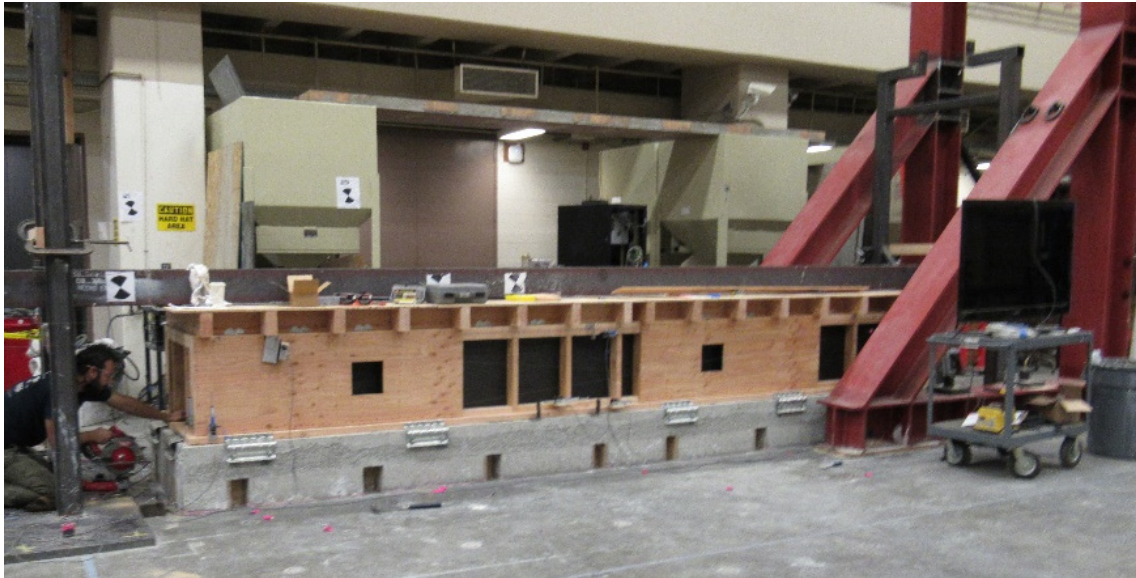
Figure 6.5 Specimen B-1 prior to start of testing.

retrofit be capable of developing the combined capacity of the finish materials and sheathing retrofit. Specimen B-1 served as one data point to confirm that this is achievable.

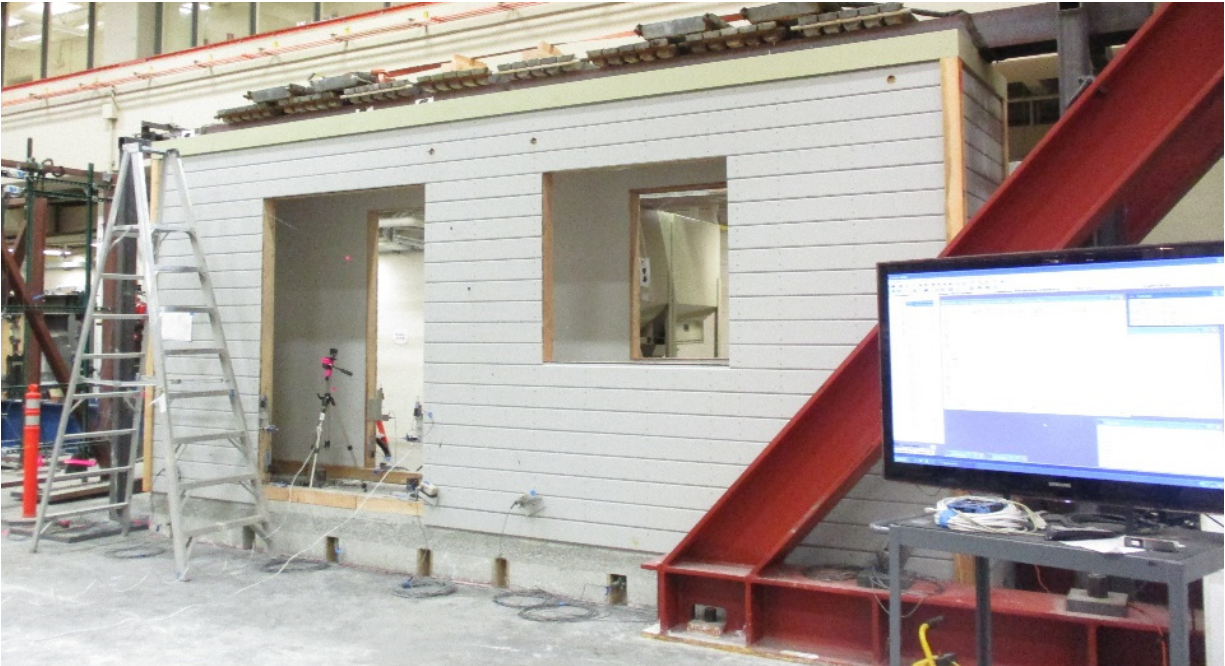
Figure 6.8 Specimen C-1 prior to start of testing.

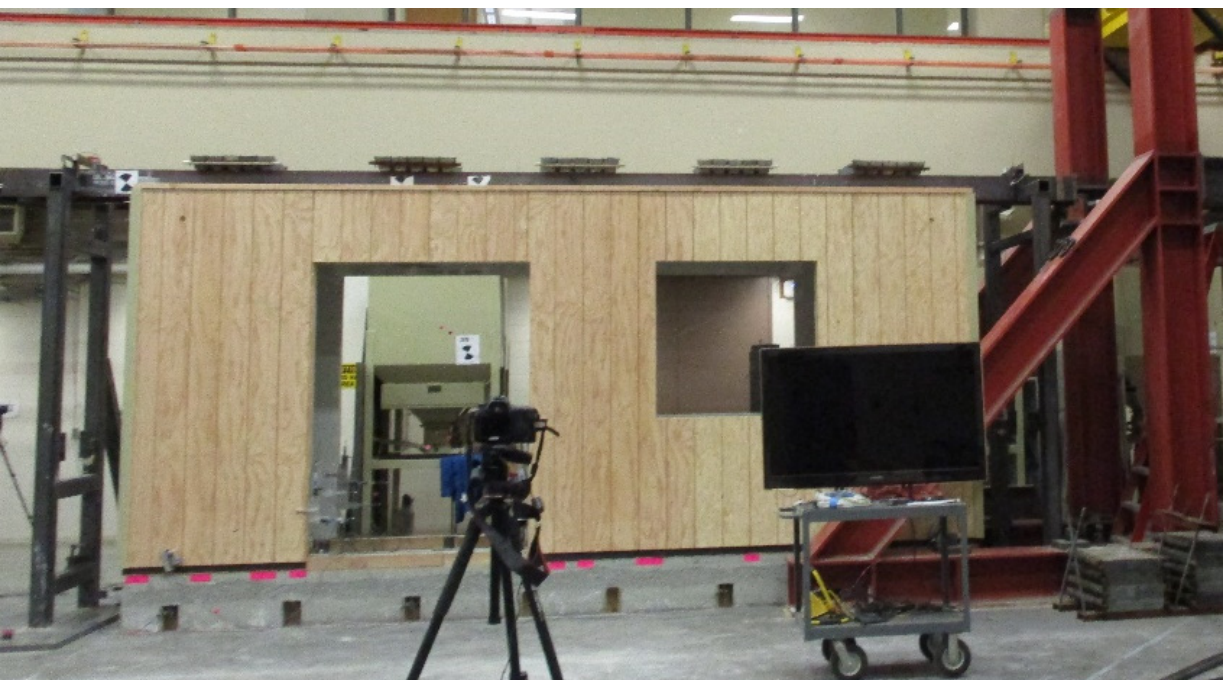
Figure 6.9 Specimen C-2 prior to start of testing.
