## **Performance Evaluation Database for Concrete Bridge Components and Systems under Simulated Seismic Loads**

**Yael D. Hose  
Frieder Seible**

PEER Report 1999/11  
Pacific Earthquake Engineering Research Center  
College of Engineering  
University of California, Berkeley

November 1999

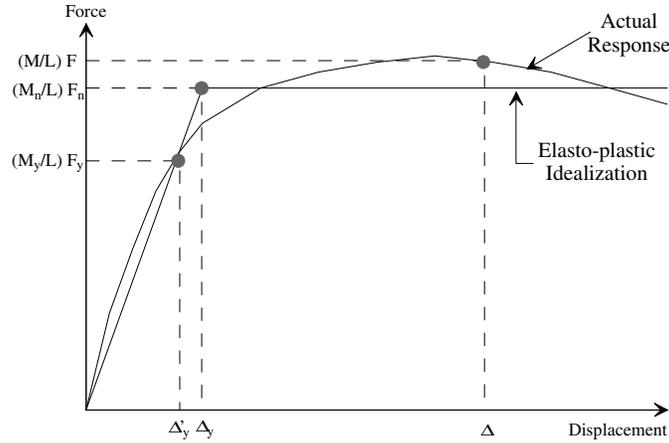
**Fig. 2.1. Bilinear approximation for displacement ductility parameter**

$$\mu_{\Delta} = \frac{\Delta}{\Delta_y} \quad (2.4)$$

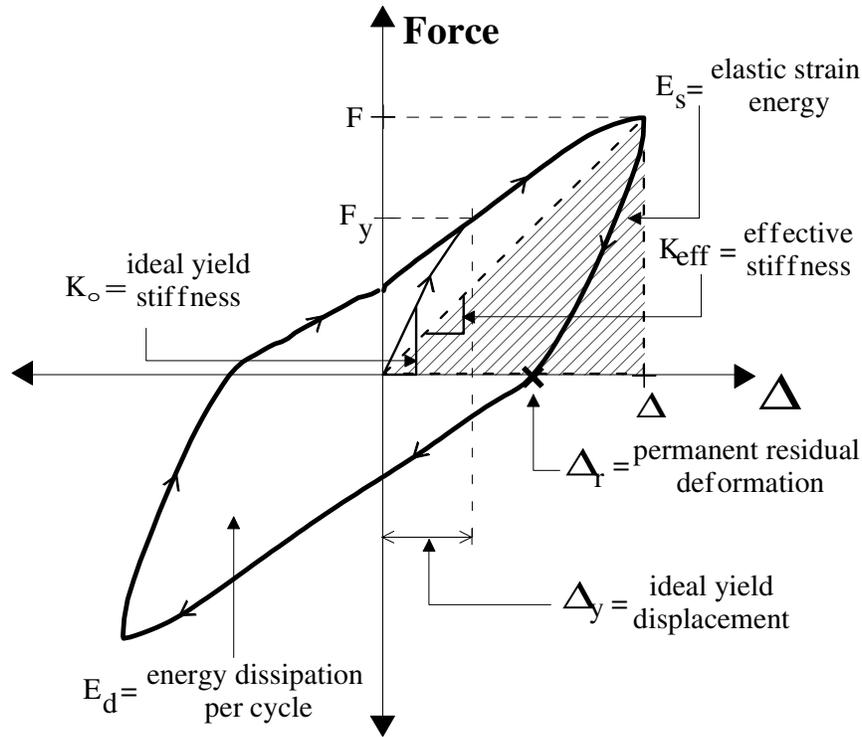
**Fig. 2.2. Residual deformation index (RDI), equivalent viscous damping ratio ( $\xi_{eq}$ ), and effective stiffness ( $K_{eff}$ ) for symmetric hysteresis loops**

The residual deformation index, **RDI**, is a function of the inelastic behavior of the structure and can be used as an index to estimate damage or reparability following a seismic event. A cyclically loaded inelastic structural component or system incurs a residual displacement that remains when the lateral load is removed. The RDI is a non-dimensional index that is obtained by dividing the permanent residual displacement observed at each performance level by the ideal yield displacement. This calculation is shown in Equation 2.5. Note that for nonlinear elastic structural response or low-level inelastic response, the RDI can be less than one. The parameters necessary for the calculation of the RDI for test units with symmetric hysteresis loops are depicted in Fig. 2.2.

The effective stiffness,  $K_{eff}$ , defines the slope of the equivalent linear elastic system represented by  $E_s$ , and is also depicted in Fig. 2.2. It is the ratio of the force at a given response level to the deformation at that level and is calculated by Equation 2.7. The initial stiffness at ideal yield,  $K_o$ , is calculated by Equation 2.8. For non-dimensional representation, the effective stiffness parameter in this document is normalized by the initial stiffness as shown in Equation 2.9. The equivalent viscous damping ratio and effective stiffness of an inelastic bridge system are important design parameters in some of the recent displacement-based bridge design methodologies and procedures (Kowalsky 1997).

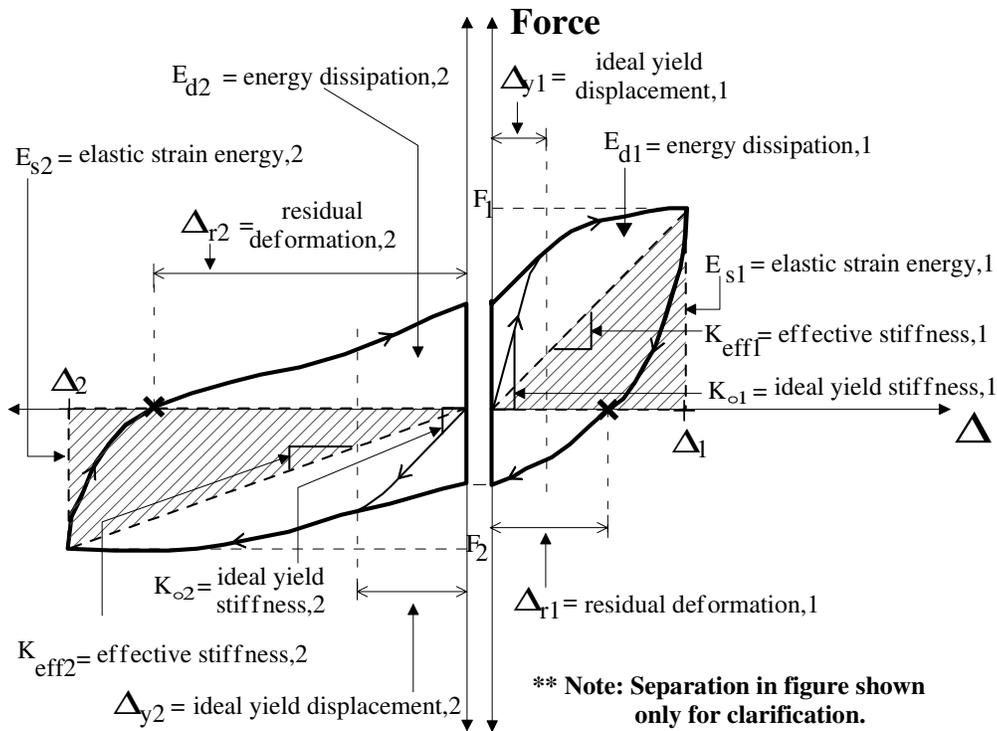
**Fig. 2.3. Residual deformation index (RDI), equivalent viscous damping ratio ( $\xi_{eq}$ ), and effective stiffness ( $K_{eff}$ ) for asymmetric hysteresis loops**

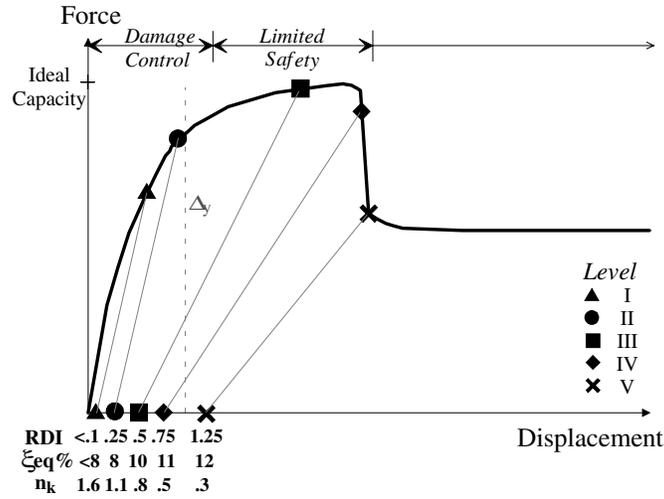
Fig. 4.1. Identification curve for *brittle* behavior mode.

Two performance ranges, similar to those defined in (FEMA 273 1997), are also labeled on the identification curves in Fig. 4.1 through Fig. 4.3. In order for a sufficient margin of safety to be maintained prior to potential failure, the performance ranges vary depending on what type of governing failure mode occurs in the structural member. For all three failure modes, the *Damage Control* range covers the elastic region, where the force resisting mechanisms of the bridge structures retain most of their pre-earthquake strength and stiffness. In the capacity assessment approach presented in this paper, Levels I and II define this elastic region. The risk of life-threatening injury from structural damage is low and only minor repairs are necessary. For *Brittle* structures shown in Fig. 4.1, the *Damage Control* performance range terminates between Levels II and III of the capacity assessment methodology. For the *Strength Degrading* mode shown in Fig. 4.2, the *Damage Control* performance range includes behavior defined by Level III. Level IV in *Brittle* and *Strength Degrading* structures usually indicates local failure with the onset of buckling, shear failure, or joint shear failure. For *Ductile* structures shown in Fig. 4.3, however, the damage and performance observed at Level IV is more stable, and thus is included in the *Damage Control* performance range. In all three behavior modes, moderate to significant damage is expected in the *Damage Control* range, but partial or total structural collapse is unlikely. Injuries may occur during the earthquake, but the overall risk of life-threatening injury as a result of structural damage is low. It is within this *Damage Control* range that future performance-based design procedures need to be concentrated to minimize repair time, cost, and operation interruption. The second performance range, *Limited Safety*, represents behavior and damage states at large deformations. This range covers Levels III-V in the capacity assessment for *Brittle* structures, Levels IV and V for *Strength Degrading* structures, and Level V for *Ductile* structures. A significant risk of life and economic loss may result if design or assessment procedures that reach performance within this *Limited Safety* range are employed (FEMA 273) 1997). From the preliminary curves it is recognized that the locations

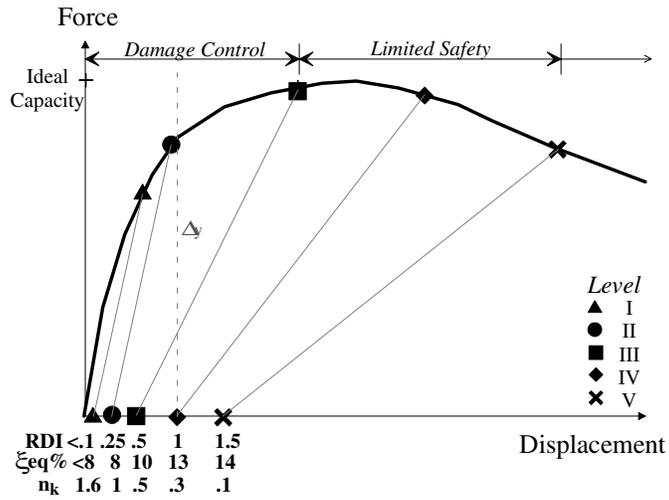
Fig. 4.2. Identification curve for *strength degrading* behavior mode.

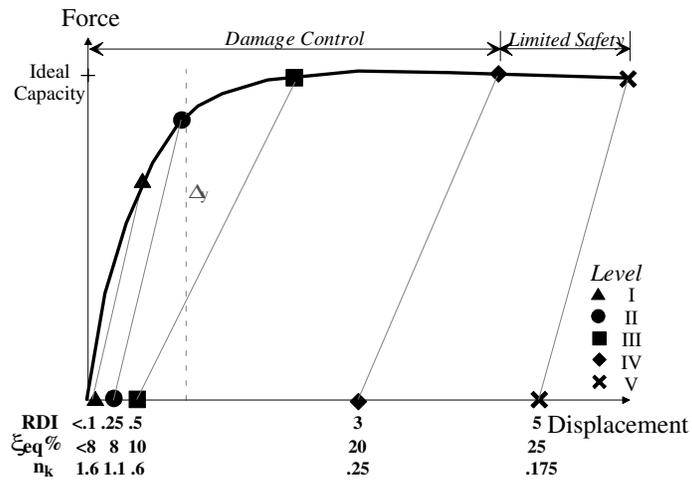
Fig. 4.3. Identification curve for *ductile* behavior mode.

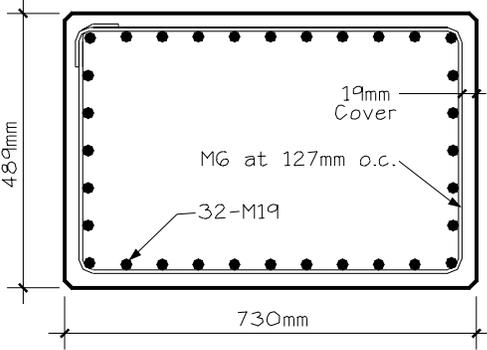
<b>Reinforcement Details:</b>

<b>Material Properties:</b>  <b>Longitudinal Steel:</b> $f_y = 317 \text{ MPa [46 ksi]}$ $f_u = 476 \text{ MPa [69 ksi]}$  <b>Transverse Steel:</b> $f_y = 276 \text{ MPa [40 ksi]}$ $f_u = 414 \text{ MPa [60 ksi]}$  <b>Concrete:</b> $f'_c = 33 \text{ MPa [4.8 ksi]}$
<b>Axial Load Ratio:</b>	<b>15%</b>

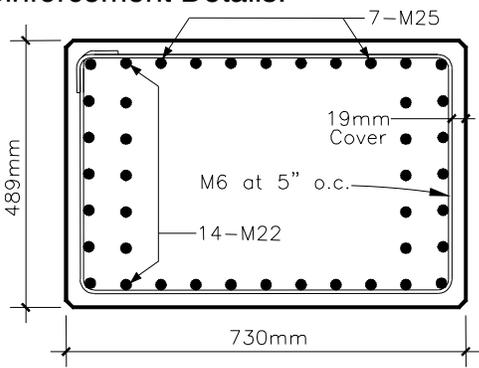
<b>Reinforcement Details:</b>

<b>Material Properties:</b>  <b>Longitudinal Steel:</b> $f_y = 317 \text{ MPa (46 ksi)}$ $f_u = 476 \text{ MPa (69 ksi)}$  <b>Transverse Steel:</b> $f_y = 276 \text{ MPa (40 ksi)}$ $f_u = 414 \text{ MPa (60 ksi)}$  <b>Concrete:</b> $f'_c = 33 \text{ MPa (4.8 ksi)}$
<b>Axial Load Ratio:</b>	<b>15%</b>

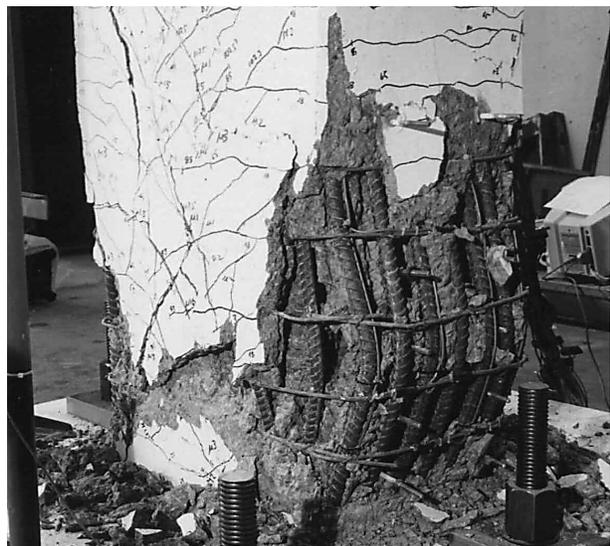
During the first cycle at ductility 4, which correlates to Level V and is shown in the final photograph, buckling of the longitudinal reinforcement occurred over a 635mm (25 inch) region extending from the top of the footing. During continued cycling, the longitudinal bar buckling caused the light transverse reinforcement ties to start opening up at the 90-degree corner laps. The lateral stiffness dramatically decreased and the capacity of the column dropped significantly. At this level, repair of the column is no longer recommended and complete replacement of the component is necessary.

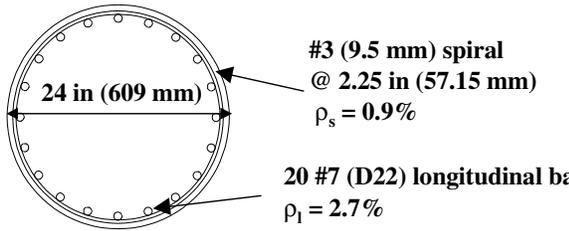
<b>Reinforcement Details:</b>

<b>Material Properties:</b> <b>Longitudinal Steel:</b> $f_y = 455 \text{ MPa [66 ksi]}$ $f_u = 745 \text{ MPa [108 ksi]}$ <b>Transverse Steel:</b> $f_y = 414 \text{ MPa [60 ksi]}$ $f_u = 683 \text{ MPa [99 ksi]}$ <b>Concrete:</b> $f'_c = 41.1 \text{ MPa [6.01 ksi]}$
<b>Axial Load Ratio:</b>	14.7%

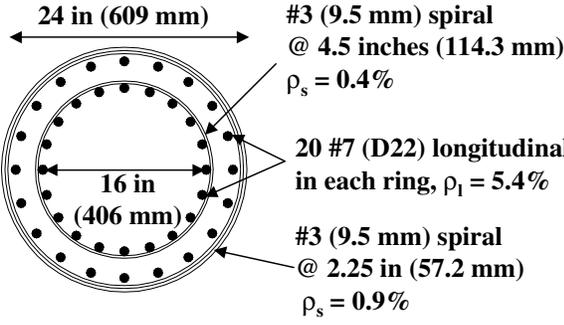
<b>Reinforcement Details:</b>

<b>Material Properties:</b> <b>Longitudinal Steel:</b> $f_y = 455 \text{ MPa [66 ksi]}$ $f_u = 745 \text{ MPa [108 ksi]}$ <b>Transverse Steel:</b> $f_y = 414 \text{ MPa [60 ksi]}$ $f_u = \text{NA}$ <b>Concrete:</b> $f'_c = 33.7 \text{ MPa [4.89 ksi]}$
<b>Axial Load Ratio:</b>	18%

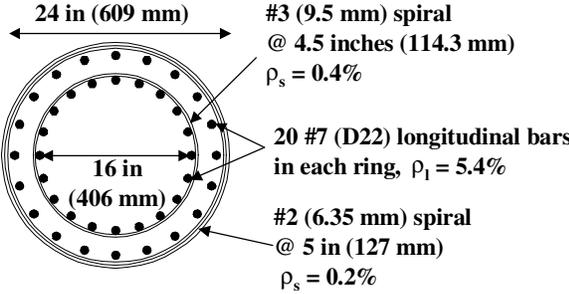
<b>Reinforcement Details:</b>

<b>Material Properties:</b>  <b>Longitudinal Steel:</b> $f_y = 467 \text{ MPa (68 ksi)}$ $f_u = 764 \text{ MPa (111 ksi)}$  <b>Transverse Steel:</b> $f_y = 414 \text{ MPa (60 ksi)}$ $f_u = 662 \text{ MPa (96 ksi)}$  <b>Concrete:</b> $f'_c = 36.3 \text{ MPa (5.26 ksi)}$
<b>Axial Load Ratio:</b>	<b>8.4%</b>

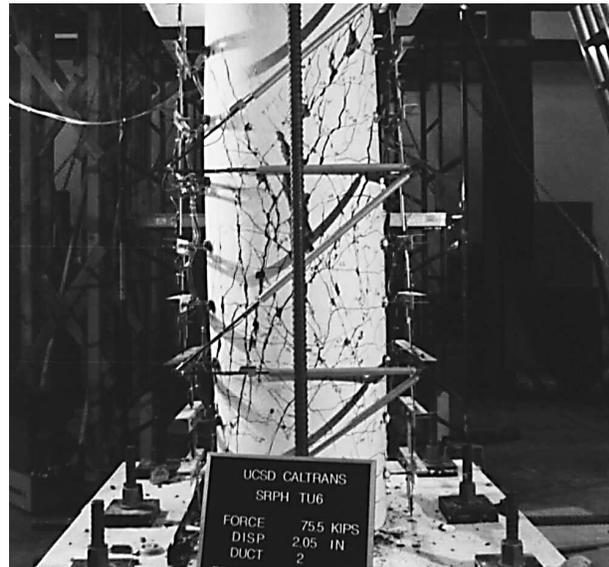
Level V

Continued cycling and further loading of the column to ductility 2 causes Performance Level V, STRENGTH DEGRADATION, to be reached as the concrete core is completely obliterated. During the second cycle at this level, the spiral fractured and a complete compression zone failure occurred to complete the test. The final photograph shows the damage of the column at this level, demonstrating that replacement of the component is necessary.

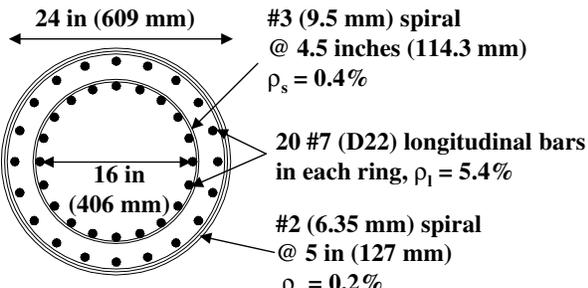
<b>Reinforcement Details:</b>

<b>Material Properties:</b> <b>Longitudinal Steel:</b> $f_y = 462 \text{ MPa (67 ksi)}$ $f_u = 745 \text{ MPa (108 ksi)}$ <b>Transverse Steel:</b> $f_y = 414 \text{ MPa (60 ksi)}$ $f_u = 662 \text{ MPa (96 ksi)}$ <b>Concrete:</b> $f'_c = 35.2 \text{ MPa (5.1 ksi)}$
<b>Axial Load Ratio:</b>	8.7%

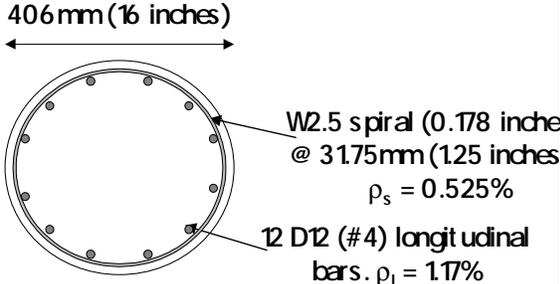
Reinforcement Details:

<p>406mm (16 inches)</p> <p>W2.5 spiral (0.178 inches) @ 31.75mm (1.25 inches) <math>\rho_s = 0.525\%</math></p> <p>12 D12 (#4) longitudinal bars. <math>\rho_l = 1.17\%</math></p>	<b>Material Properties:</b> Longitudinal Steel: $f_y = 455 \text{ MPa (66 ksi)}$ $f_u = 745 \text{ MPa (108 ksi)}$ Transverse Steel: $f_y = 590 \text{ MPa (85.5 ksi)}$ $f_u = 834.5 \text{ MPa (121 ksi)}$ Concrete: $f'_c = 34.5 \text{ MPa (5.0 ksi)}$	
Axial Load Ratio:	0

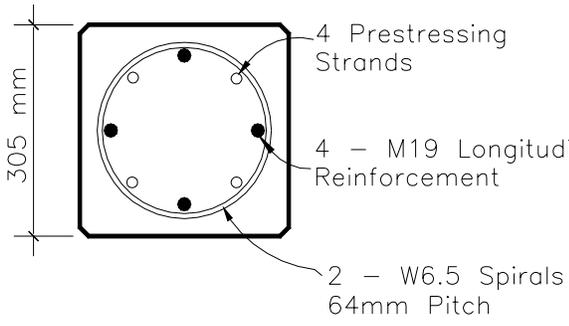
<b>Reinforcement Details:</b>		<b>Material Properties:</b>

<p>305 mm</p> <p>4 Prestressing Strands</p> <p>4 - M19 Longitudinal Reinforcement</p> <p>2 - W6.5 Spirals 64mm Pitch</p>		<p><b>Longitudinal Steel:</b></p> <p><math>f_y = 453 \text{ MPa [65.66 ksi]}</math></p> <p><math>f_u = 724 \text{ MPa [105.00 ksi]}</math></p> <p><b>Transverse Steel:</b></p> <p><math>f_y = 598 \text{ MPa [86.73 ksi]}</math></p> <p><math>f_u = 725 \text{ MPa [105.14 ksi]}</math></p>
<b>Axial Load Ratio:</b>	<b>T</b>	<b>-12%</b>
<b>(piles)</b>	<b>C</b>	<b>24%</b>
		<p><b>Concrete:</b></p> <p><math>f'_c = 55 \text{ MPa [7.98 ksi]}</math></p>

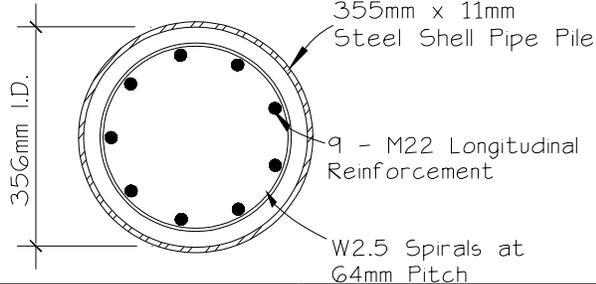
Test Unit Designation	Standard Caltrans Class 1780 Pile, STD3		
Test Unit Description	Unit <i>STD3</i> was a 7/12-scale model of the standard Caltrans composite steel shell reinforced concrete core Class 1780 Pile found in route I-880 5th and 6th Street Viaduct bent pile details. Scaling of the prototype pile resulted in a steel shell 11mm in thickness and an inside diameter of 356mm. The core was symmetrically reinforced with 9 M22 longitudinal bars for a reinforcement ratio of 3%, and a minimum concrete cover of 32mm. The transverse reinforcement ratio of 0.30% consisted of a W2.5 spiral at a 64mm pitch.		
Reinforcement Details:

Material Properties:	<p><b>Longitudinal Steel:</b>  <math>f_y = 465 \text{ MPa [67.44 ksi]}</math>  <math>f_u = 757 \text{ MPa [109.78 ksi]}</math></p> <p><b>Transverse Steel:</b>  <math>f_y = 599 \text{ MPa [86.87 ksi]}</math>  <math>f_u = 717 \text{ MPa [103.94 ksi]}</math></p> <p><b>Concrete:</b>  <math>f'_c = 45 \text{ MPa [6.53 ksi]}</math></p>

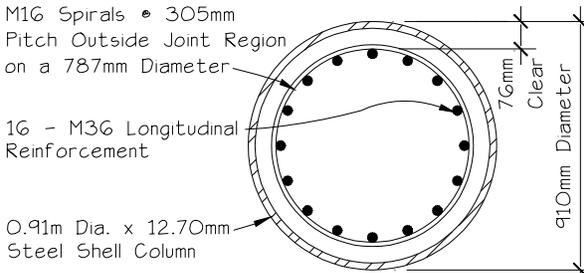
<b>Reinforcement Details:</b>

<p>M16 Spirals • 305mm Pitch Outside Joint Region on a 787mm Diameter</p> <p>16 - M36 Longitudinal Reinforcement</p> <p>0.91m Dia. x 12.70mm Steel Shell Column</p>		<b>Material Properties:</b> <b>Column:</b> Longitudinal Steel: M36 (#11) $f_y = 453 \text{ MPa [65.7 ksi]}$ $f_u = 724 \text{ MPa [105.0 ksi]}$ Transverse Steel: M16 (#5) $f_y = 598 \text{ MPa [86.7 ksi]}$ $f_u = 725 \text{ MPa [105.1 ksi]}$ <b>Cap Beam:</b> Longitudinal Steel: M29 (#9) $f_y = 455 \text{ MPa [66.0 ksi]}$ $f_u = 772 \text{ MPa [111.9 ksi]}$ Transverse Steel: M13 (#4) $f_y = 425 \text{ MPa [61.6 ksi]}$ $f_u = 716 \text{ MPa [103.8 ksi]}$ <b>Concrete:</b> Column: $f'_c = 55 \text{ MPa [7.98 ksi]}$ Cap Beam: $f'_c = 38 \text{ MPa [5.51 ksi]}$				
		<table border="1"> <tr> <td rowspan="2">Axial Load Ratio: (Columns)</td> <td>EC's</td> <td>3%</td> </tr> <tr> <td>IC</td> <td>5%</td> </tr> </table>		Axial Load Ratio: (Columns)	EC's	3%
Axial Load Ratio: (Columns)	EC's	3%				
	IC	5%

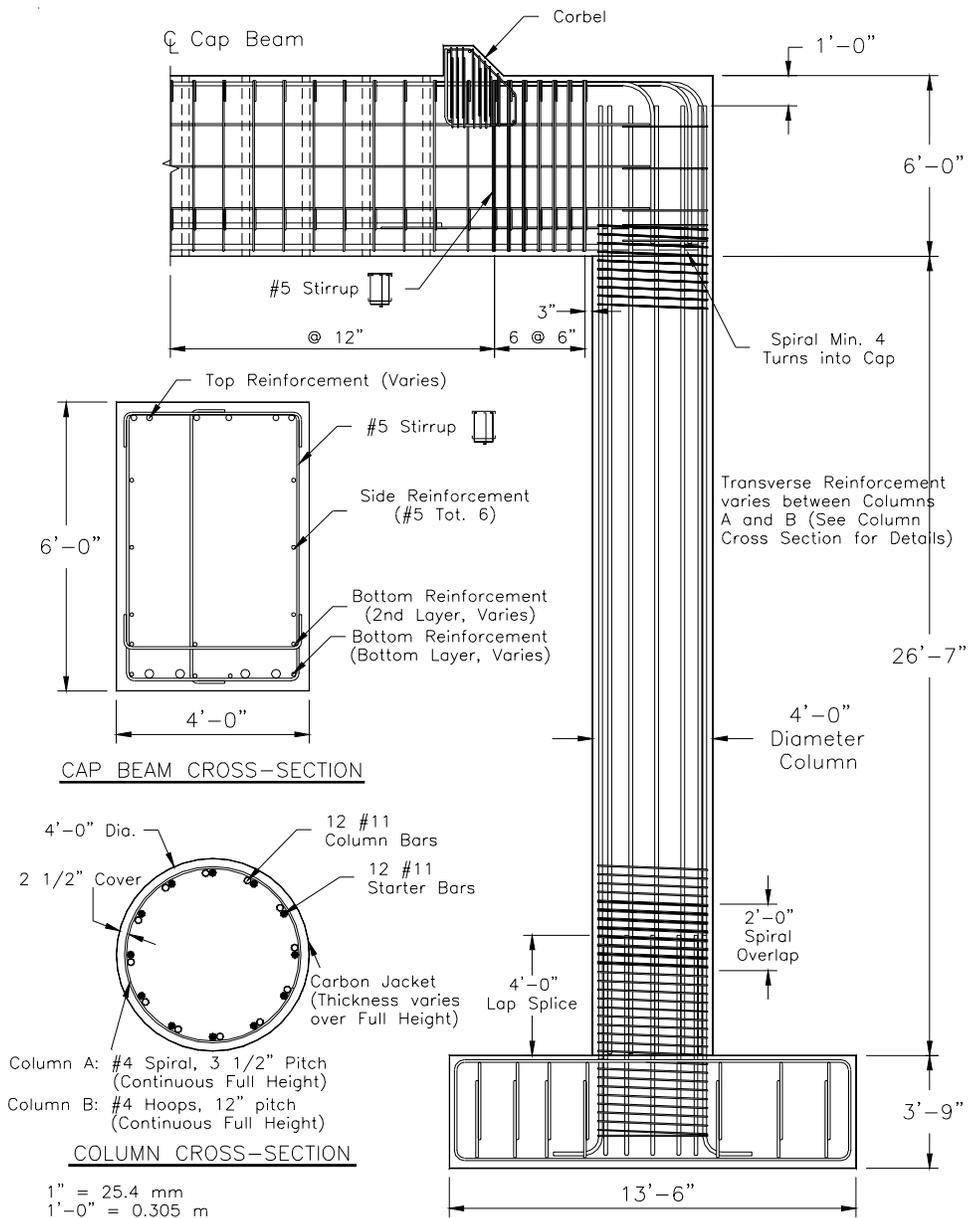
**Reinforcement Details:**

<b>Axial Load Ratio: (Columns)</b>	<b>T</b>	<b>3.5% to 0.3%</b>	<b>C</b>	<b>3.5% to 6.1%</b>
--	----------	---------------------	----------	---------------------

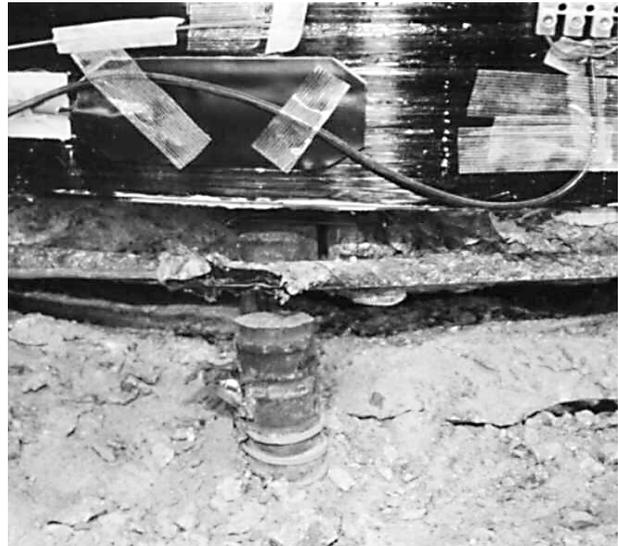
Level V in the PBEE assessment methodology initially occurred at ductility 10 when a starter bar ruptured during cycling. Additional starter bars ruptured as the test unit was displaced to ductility 13. Ten of the 24 starter bars ruptured (7 in column A and 3 in column B). Jacket cracks in column A opened as wide as 9.5mm (3/8 inch) while jacket cracks in B opened as much as 6.4mm (1/4 inch) exposing the column concrete surface. At this level, replacement of the structure is necessary.
