## Seismic Evaluation and Retrofit of 230-kV Porcelain Transformer Bushings

PEER Report 1999/14  
Pacific Earthquake Engineering Research Center  
College of Engineering  
University of California, Berkeley  
December 1999

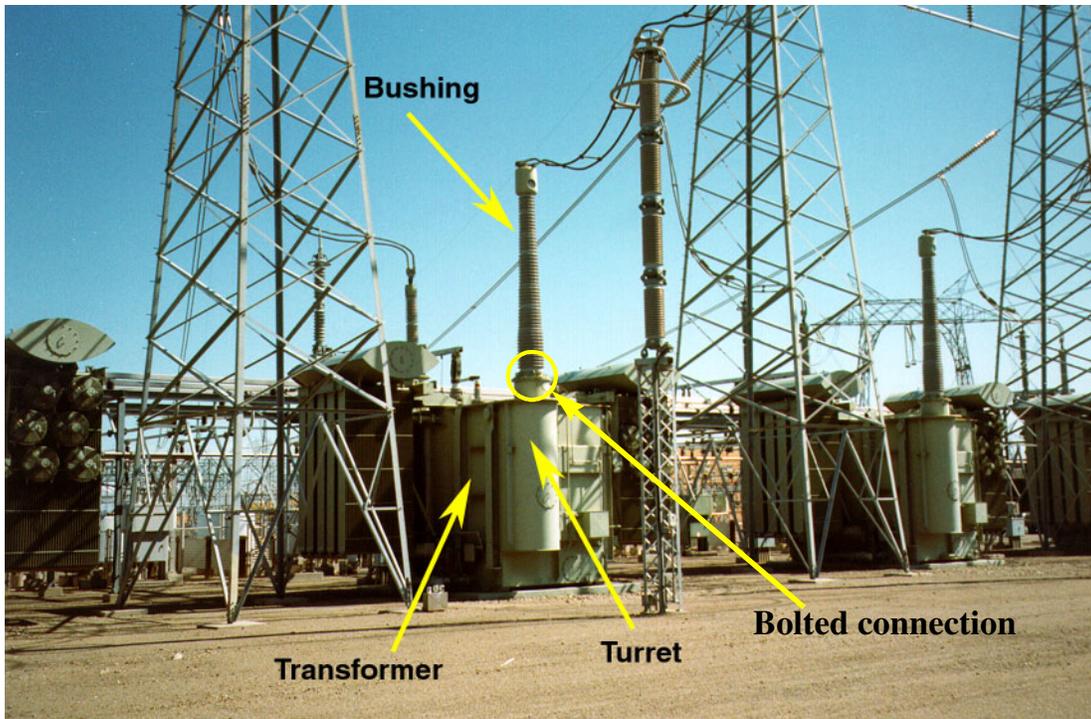
Figure 1-1 Bushing mounted on an oil-filled transformer

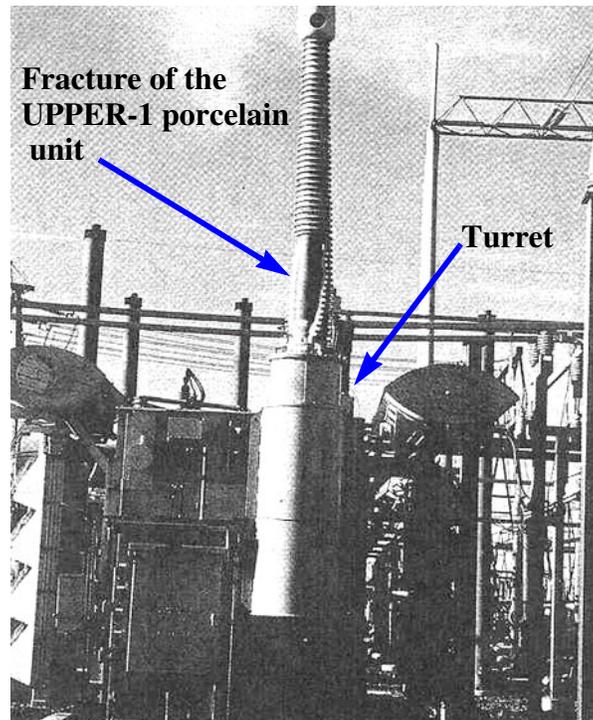
Figure 1-3 Fracture of an UPPEER-1 porcelain unit from severe earthquake shaking

Recent major earthquakes (Northridge, 1994; Kobe, 1995; Izmit, 1999; and Southern California, 1999) have demonstrated that porcelain transformer bushings, especially the high-voltage bushings rated at 196 kV and above, are susceptible to damage during severe ground shaking. For these bushings, it has been postulated that the inertia forces produce large shear forces and bending moments at the connection between the UPPER-1 porcelain unit and the bushing flange (termed the gasket connection herein, see Figure 1-2), and that these forces can cause failure. Four types of failure have been documented (Schiff, 1997): (a) oil leakage at the gasket connection, (b) slip of the UPPER-1 porcelain unit relative to the bushing flange, (c) gasket extrusion from the gasket connection, and (d) cracking of porcelain. Figure 1-3 shows a bushing with cracked porcelain mounted atop a turret (Schiff, 1997).

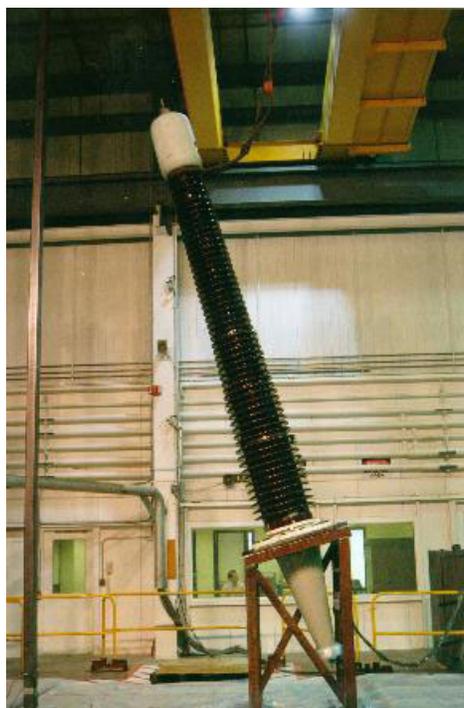
Figure 1-4 Seismic testing of a 500-kV bushing (Courtesy of CERL, Ill)

The bushing was mounted on a small braced frame (see Figure 1-4) and tested using input motions generated from random signal. The motions consisted of a set of narrow-banded input signals whose amplitudes at the prescribed center frequency were adjusted to equal the IEEE 693-1997 acceleration spectrum ordinates. A fundamental frequency of approximately 6 Hz and a damping ratio of between 2 to 3 percent of critical were reported. During the qualification test (matched to the 2-percent IEEE 693-1997 response spectrum with a PGA of 0.5g), the bushing sustained no damage. During the fragility tests, (matched to the 2-percent IEEE 693-1997 response spectrum with a PGA of 1.0g), the bushing leaked oil.

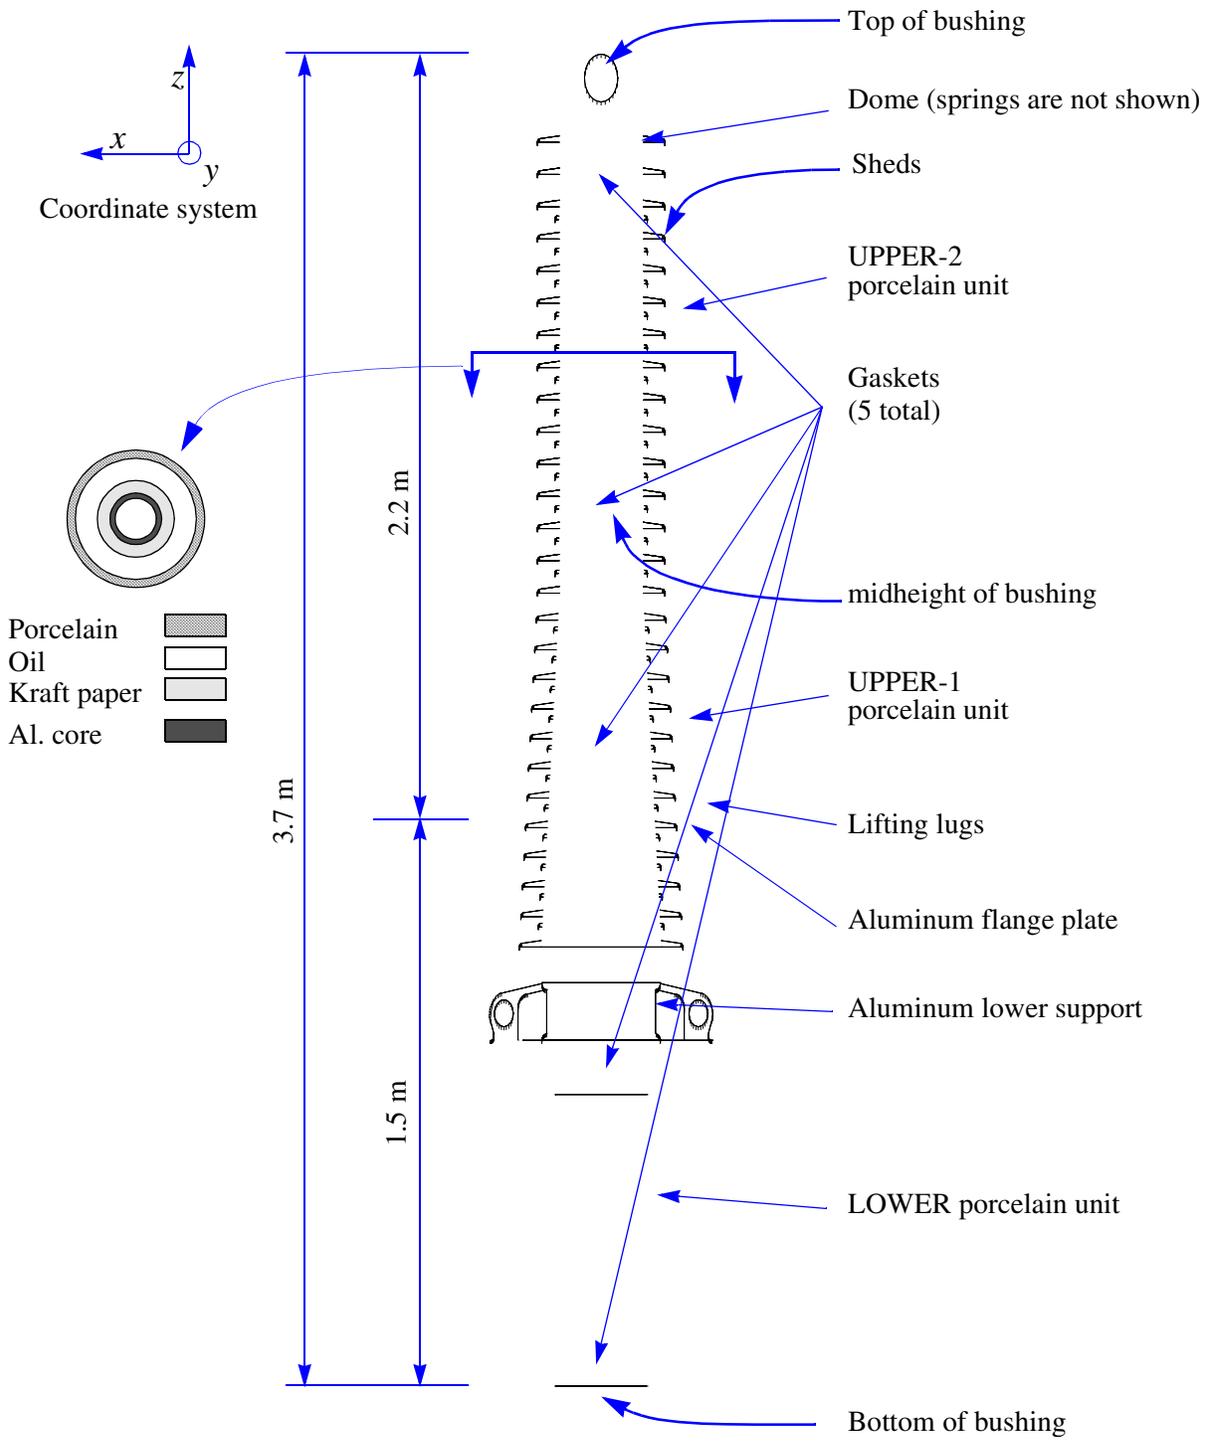
Figure 2-4 Longitudinal section and cross section through a 230-kV type-U bushing, manufactured by General Electric

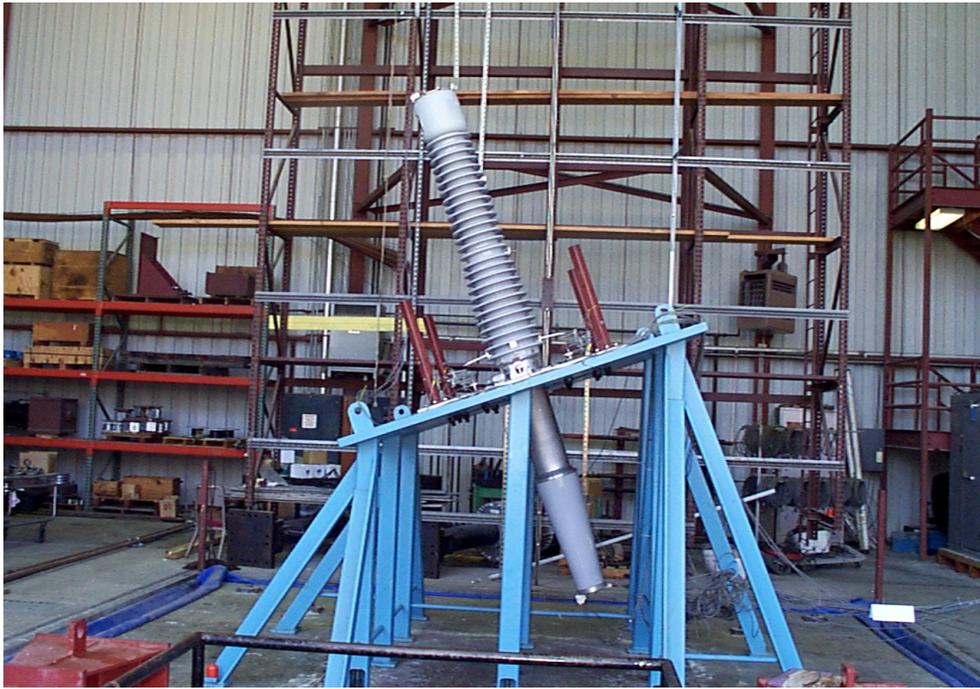
Figure 4-1 A rigidly mounted 230-kV bushing on the earthquake simulator

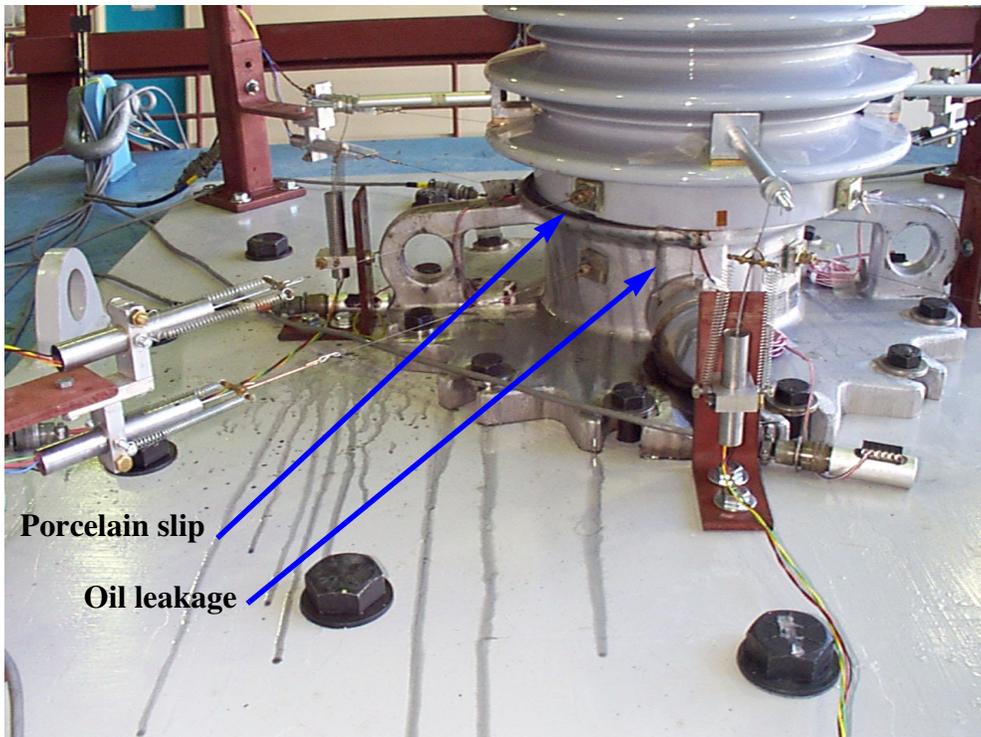
Figure 4-7 Bushing-2 after Test No 38 showing oil leakage and slip of porcelain

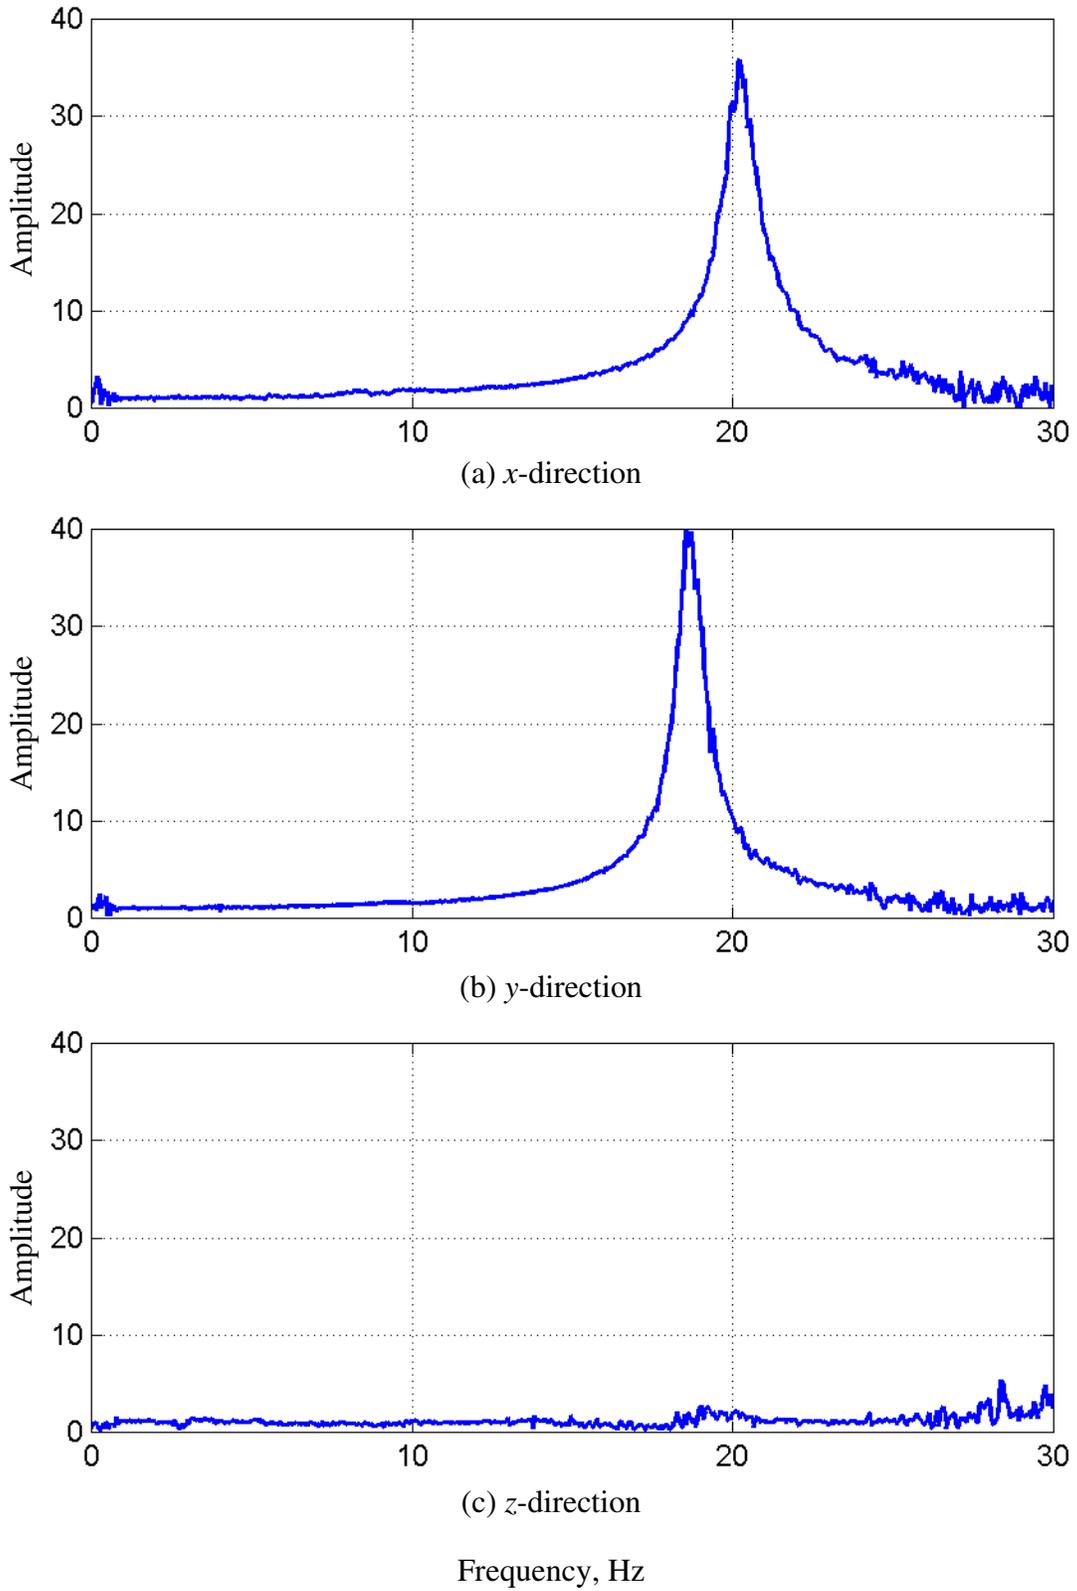
Figure 4-8 Transfer function amplitudes between the top of Bushing-1 and frame

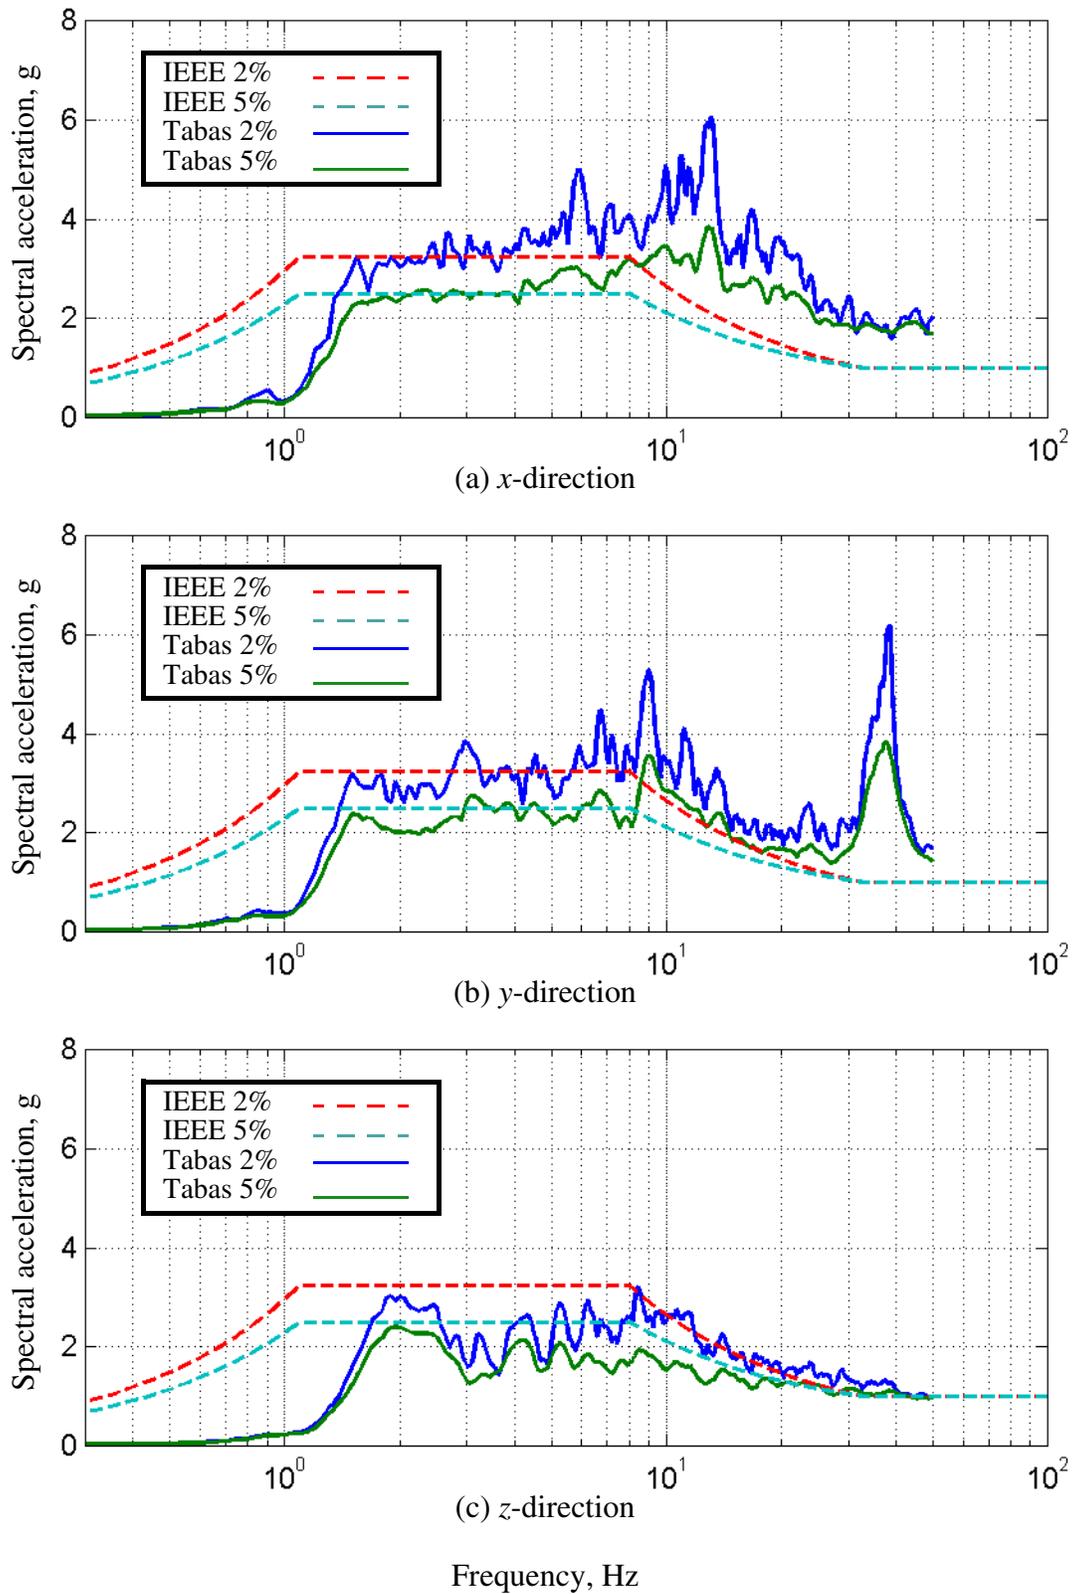
Figure 4-10 Response spectra for Bushing-1; Test No 12, target PGA=1.0g

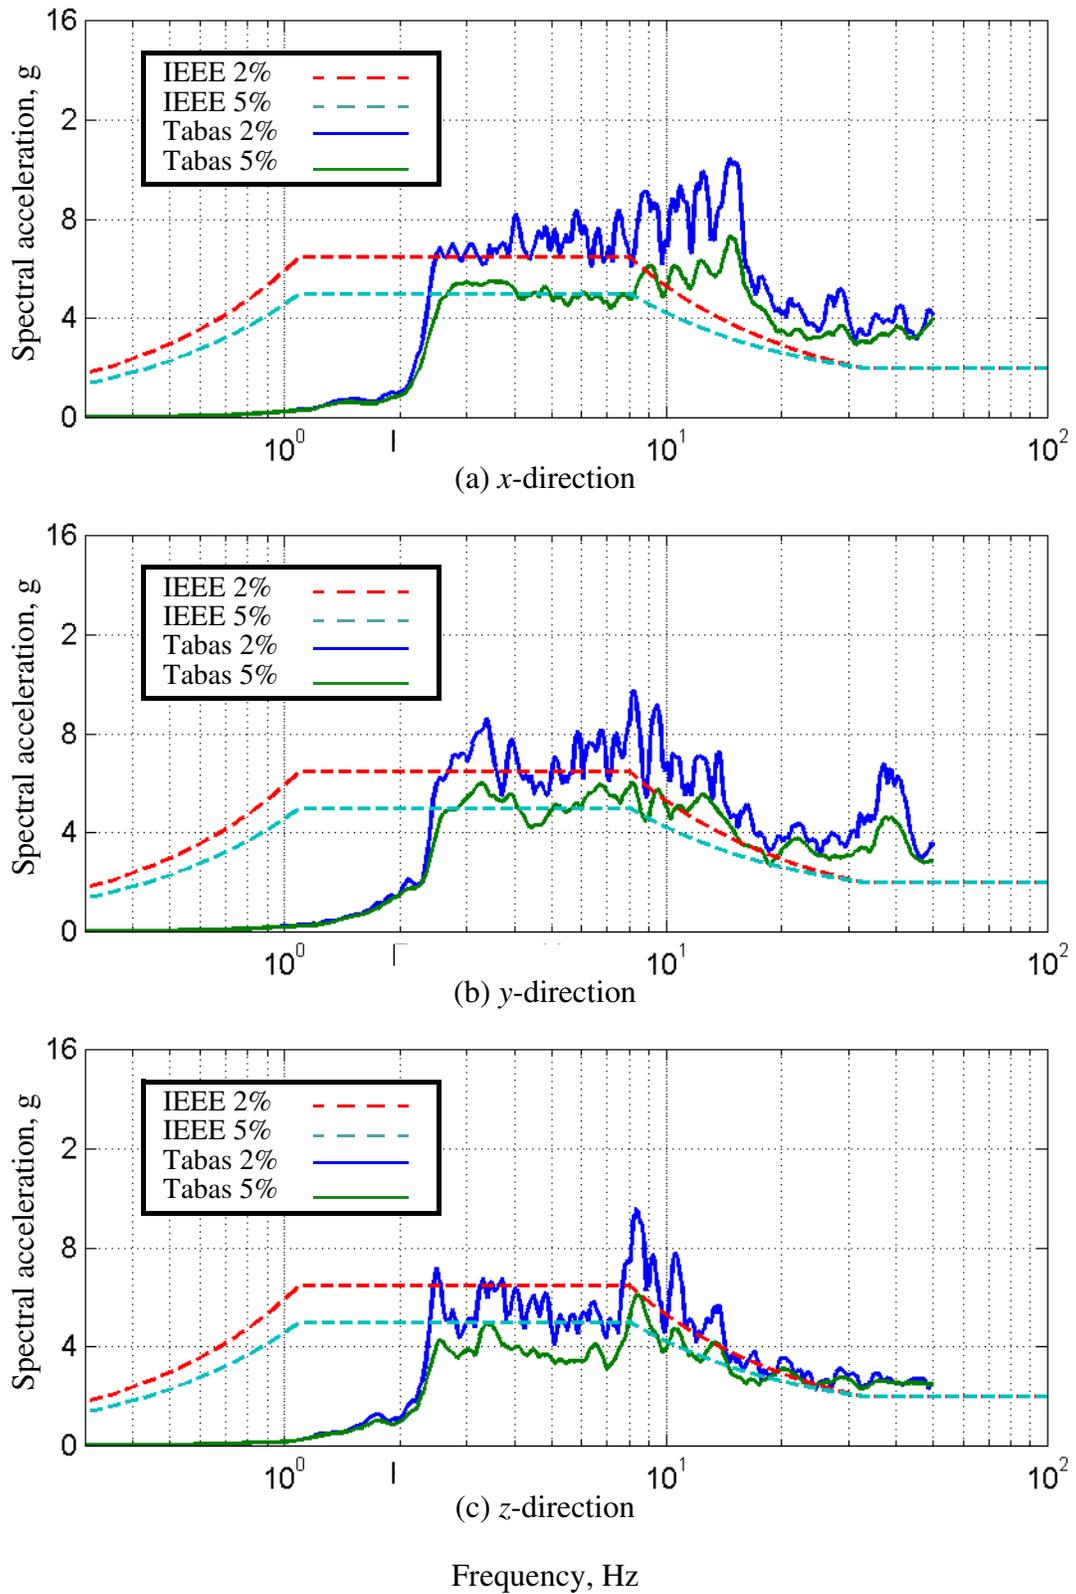
Figure 4-11 Response spectra for Bushing-1; Test No 17, target PGA=2.0g

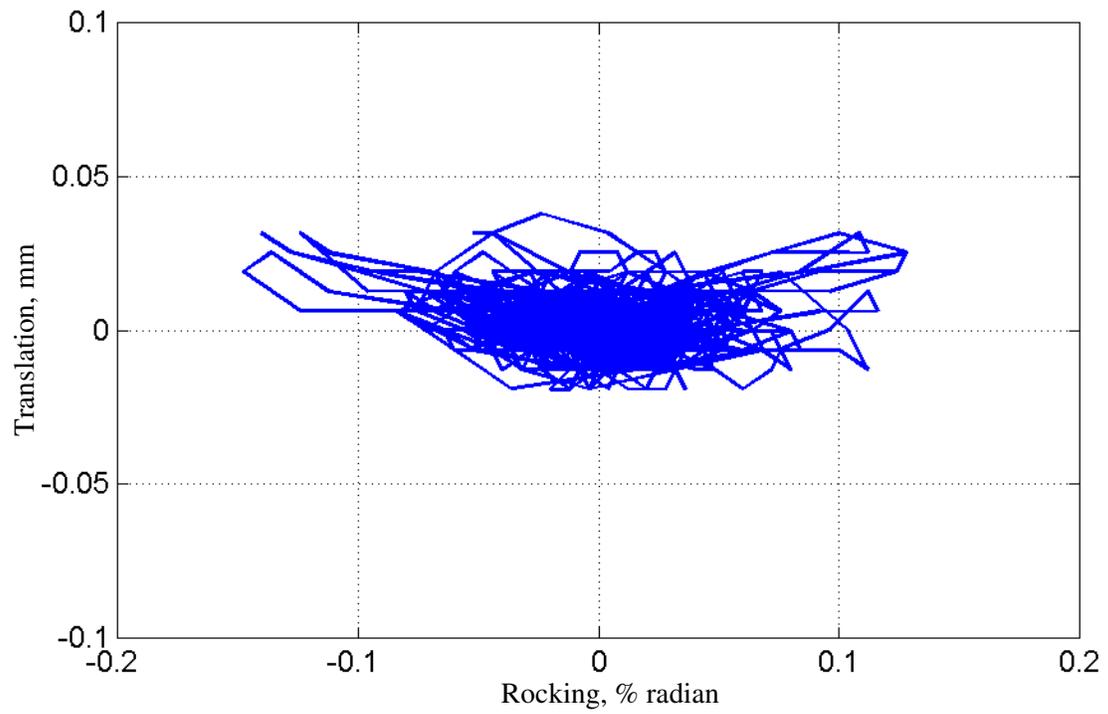
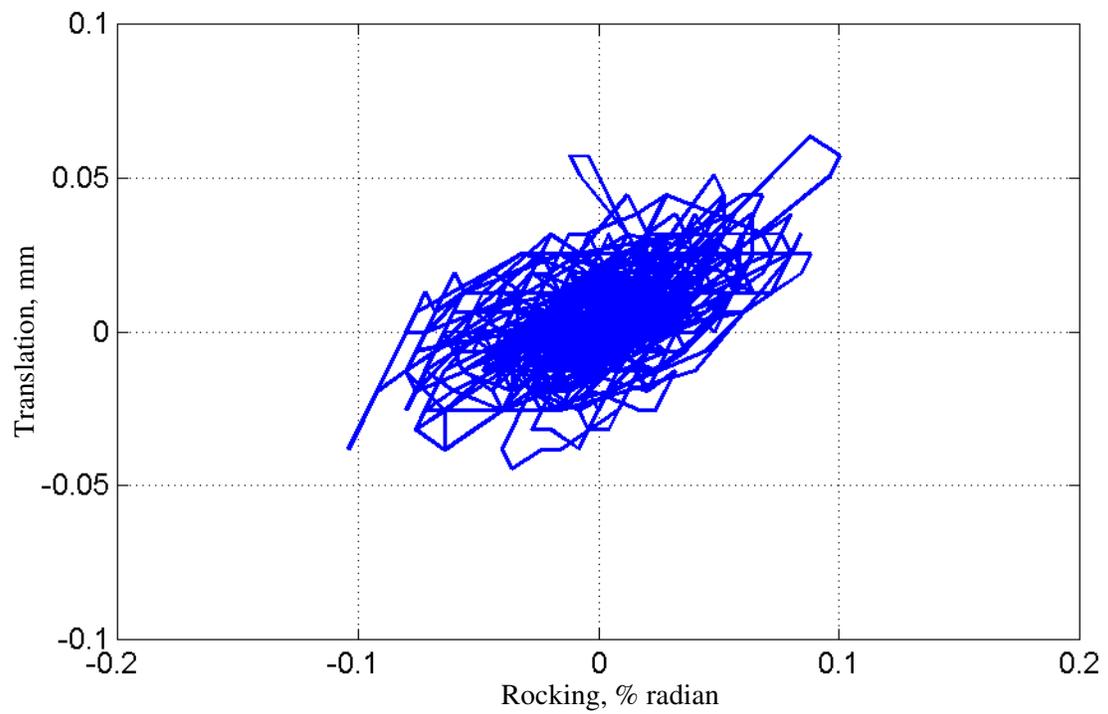
(a) About y- axis

(b) About x- axis

Figure 4-12 Vertical displacement versus rocking for Bushing-1; Test No 17, target PGA=2.0g

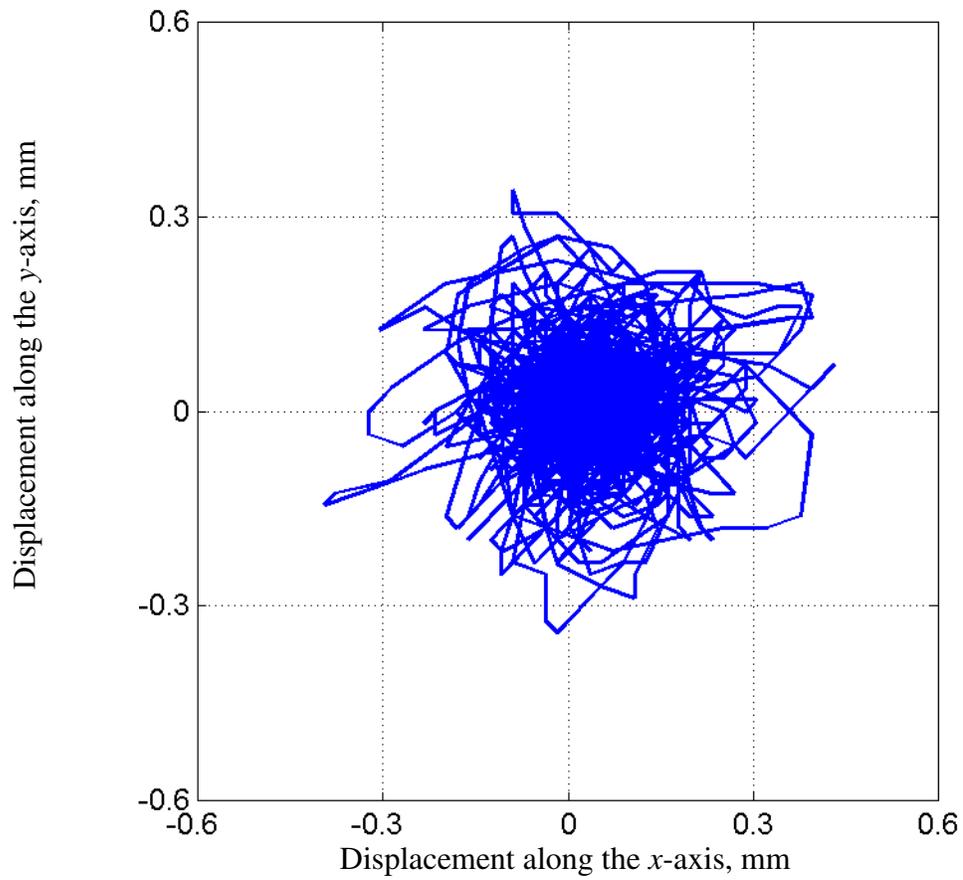
Figure 4-13 Orbit of motion for Bushing-1; Test No 17, target PGA=2.0g

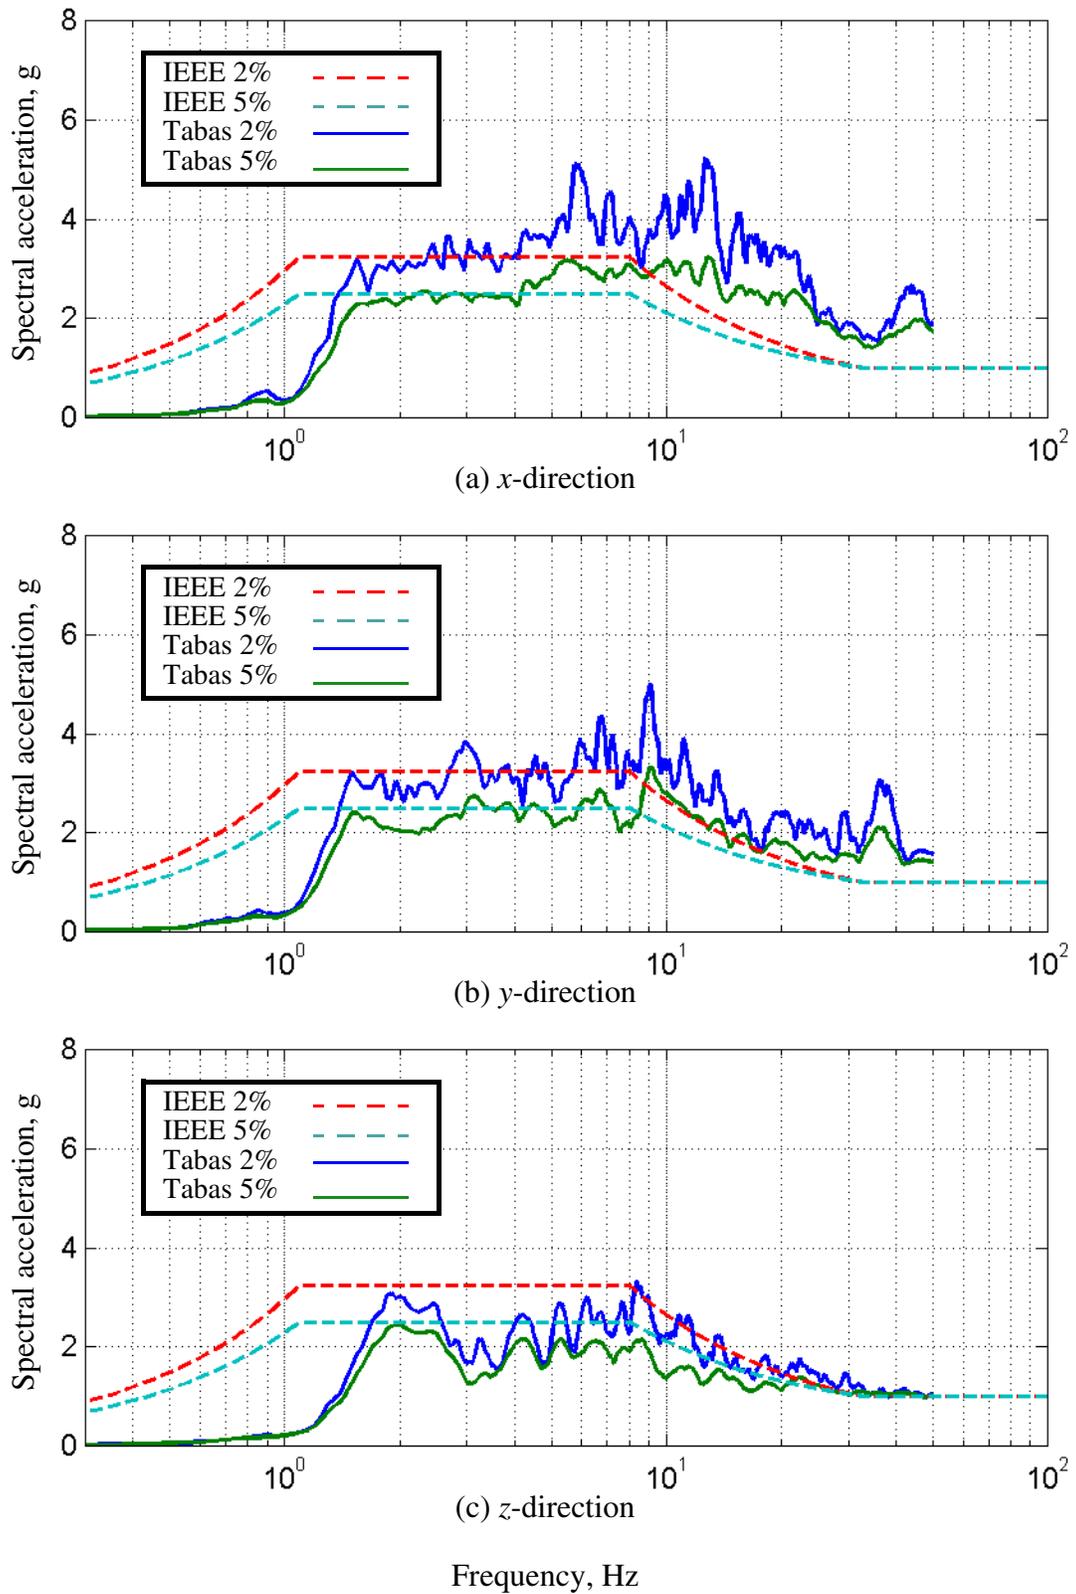
Figure 4-14 Response spectra for Bushing-2; Test No 19, target PGA=1.0g

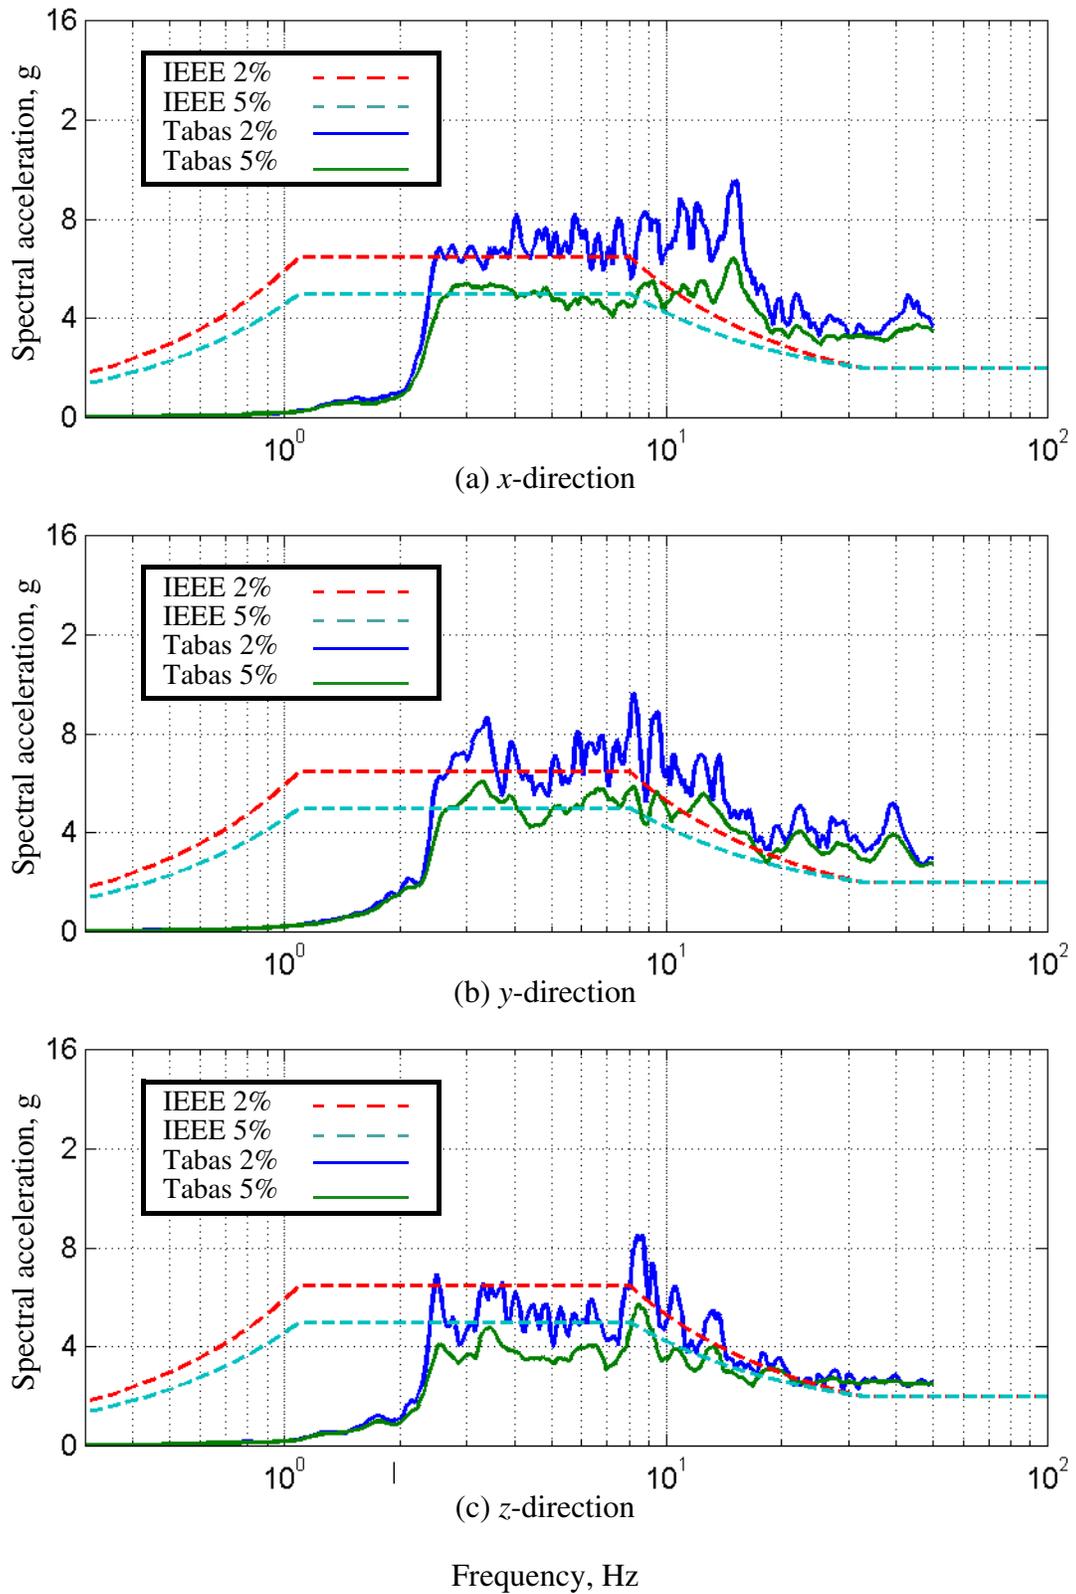
Figure 4-15 Response spectra for Bushing-2; Test No 24, target PGA=2.0g

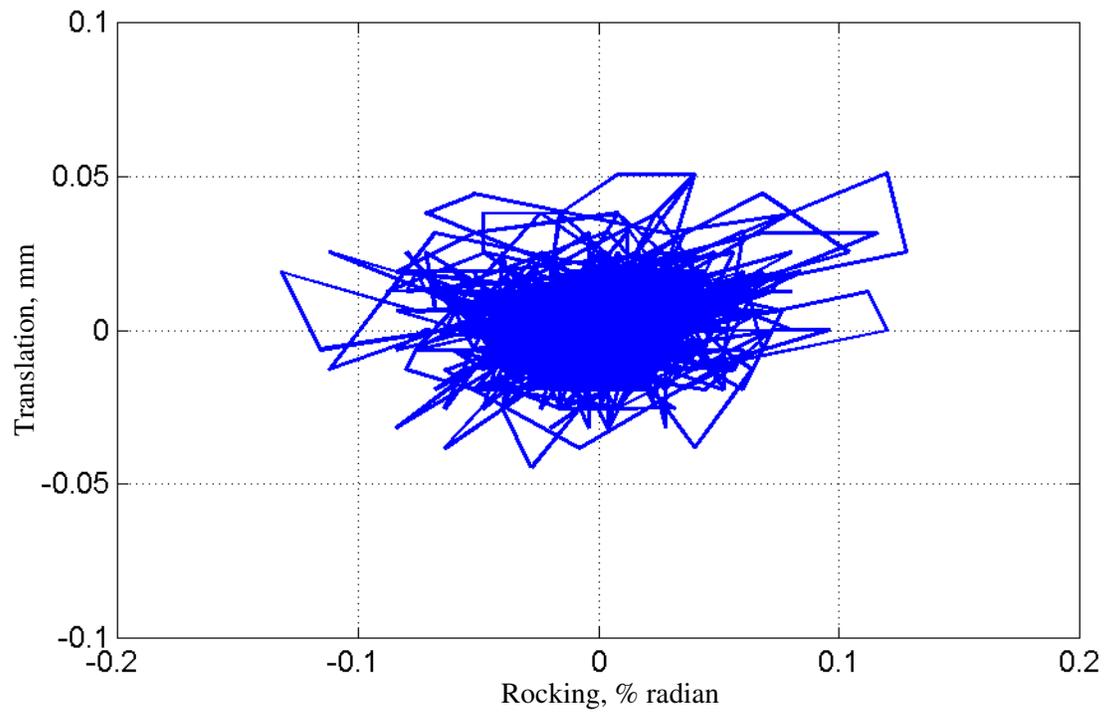
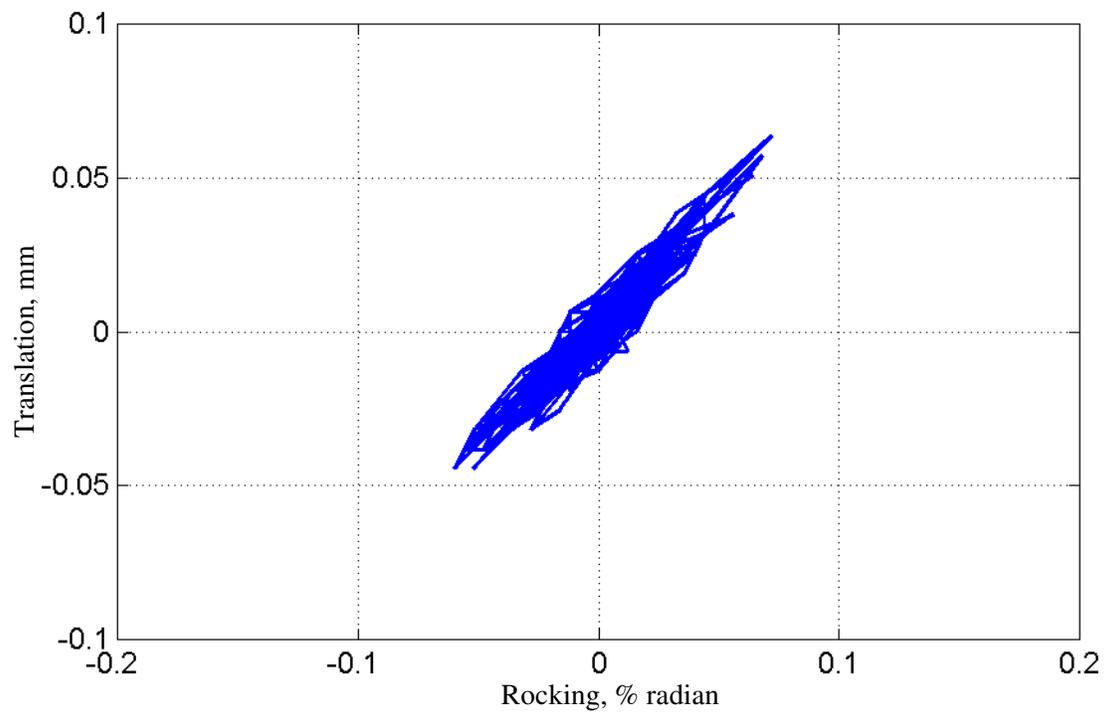
(a) About y- axis

(b) About x- axis

Figure 4-16 Vertical displacement versus rocking for Bushing-2; Test No 24, target PGA=2.0g

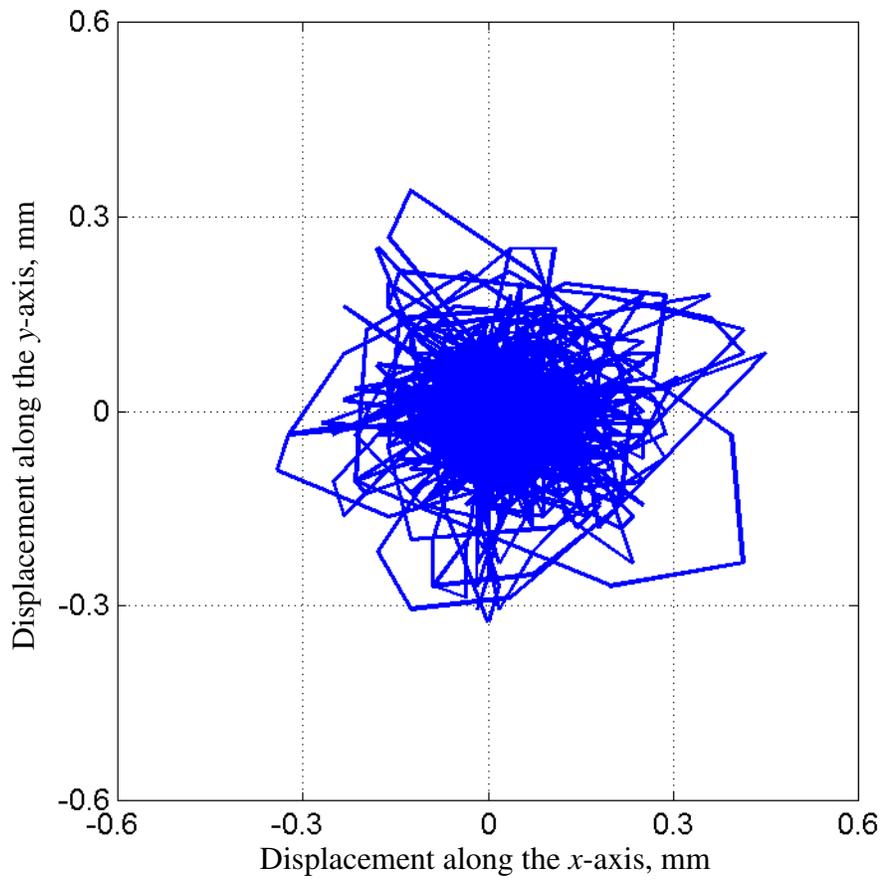
Figure 4-17 Orbit of motion for Bushing-1; Test No 24, target PGA=2.0g

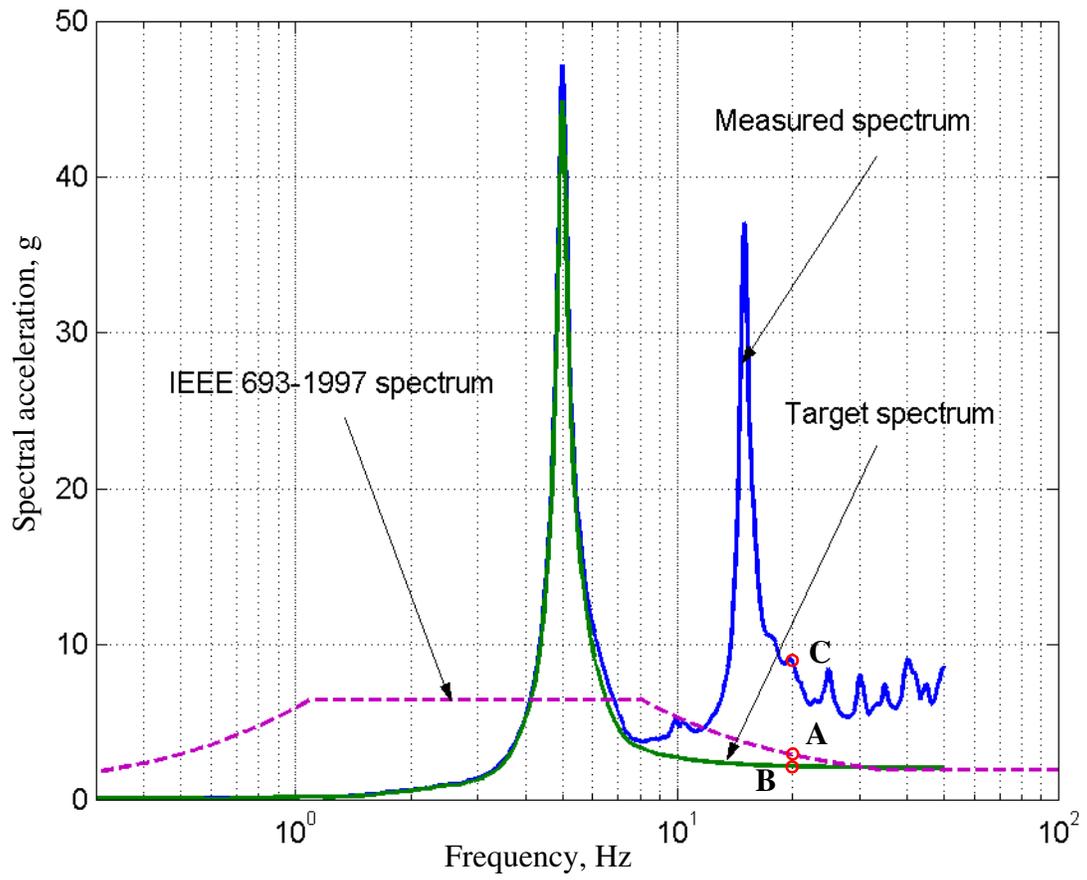
Figure 4-19 Response spectrum for high-amplitude harmonic tests

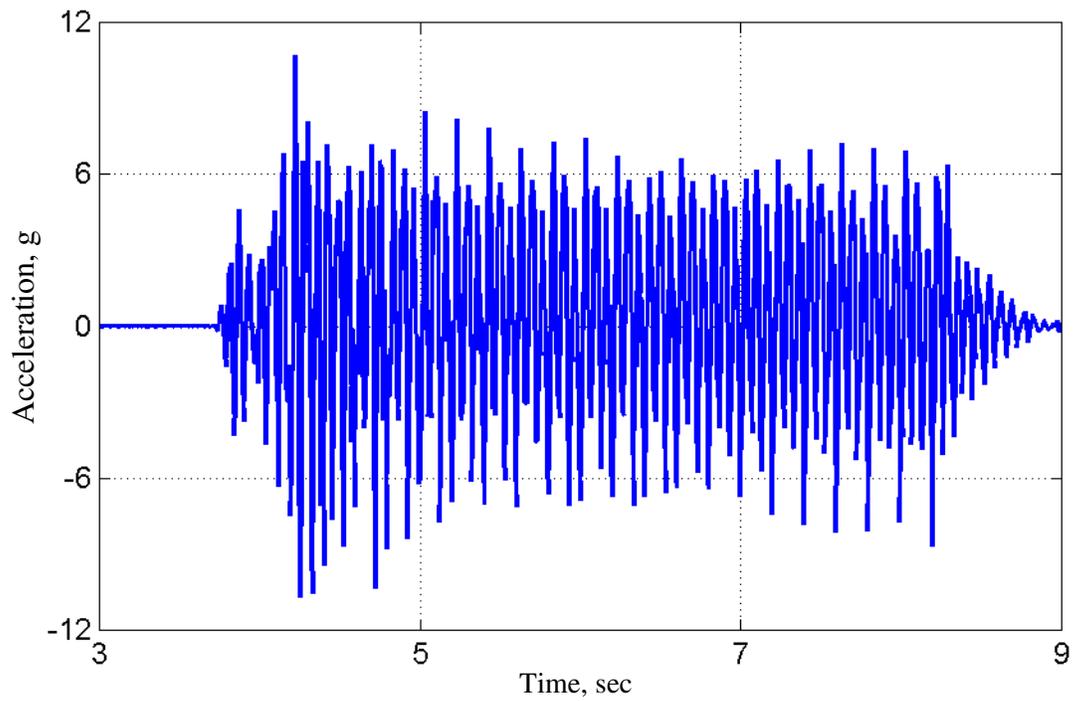
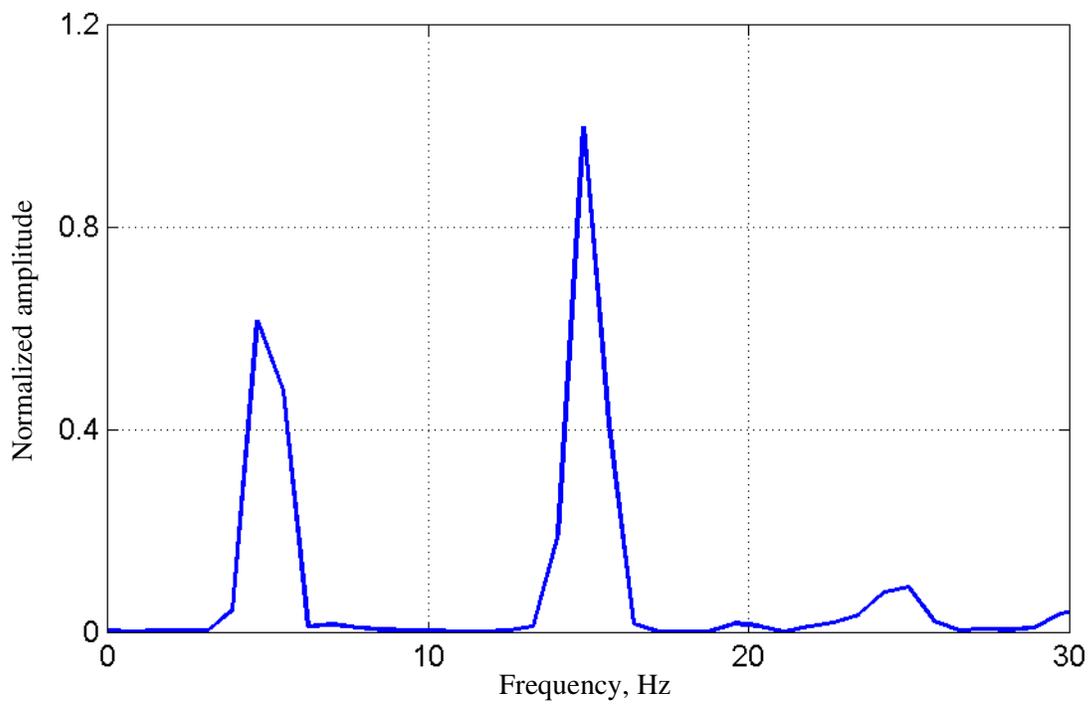
(a) History of the difference in acceleration between the top and bottom of bushing

(b) Power spectrum for the acceleration at the top of the bushing

Figure 4-20 Acceleration response of Bushing-2 without terminal, Test No 38

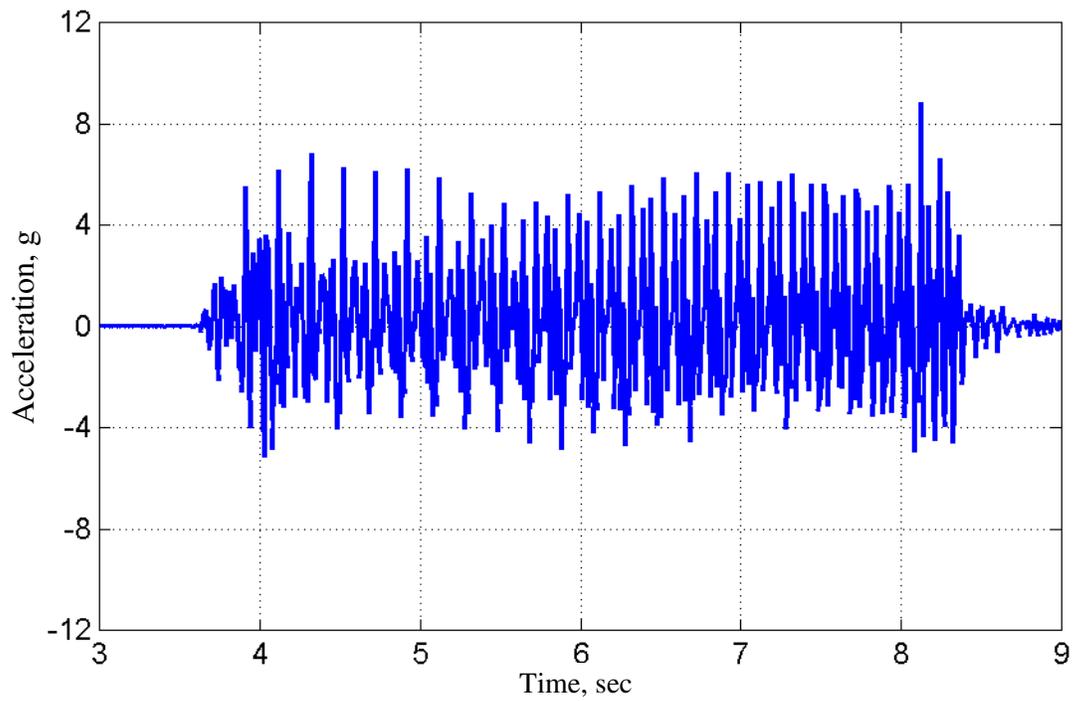
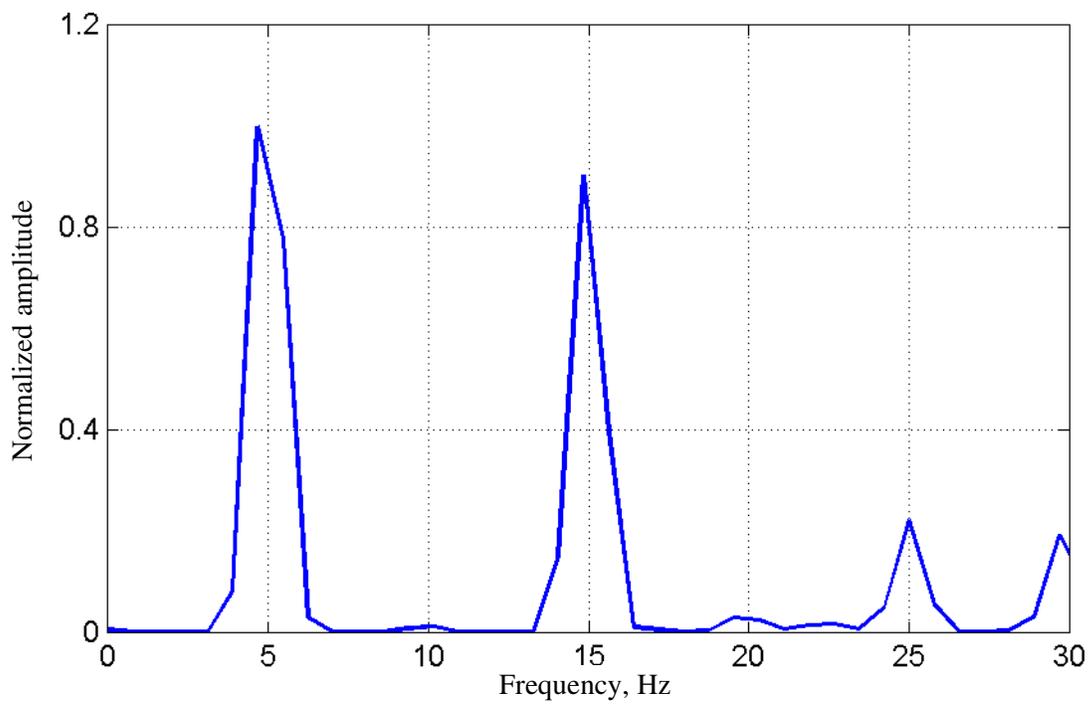
(a) History of the difference in acceleration between the top and bottom of bushing

(b) Power spectrum for the acceleration at the top of the bushing

Figure 4-21 Acceleration response of Bushing-2 with terminal, Test No 37
