## Seismic Evaluation and Retrofit of 230-kV Porcelain Transformer Bushings

PEER Report 1999/14  
Pacific Earthquake Engineering Research Center  
College of Engineering  
University of California, Berkeley  
December 1999

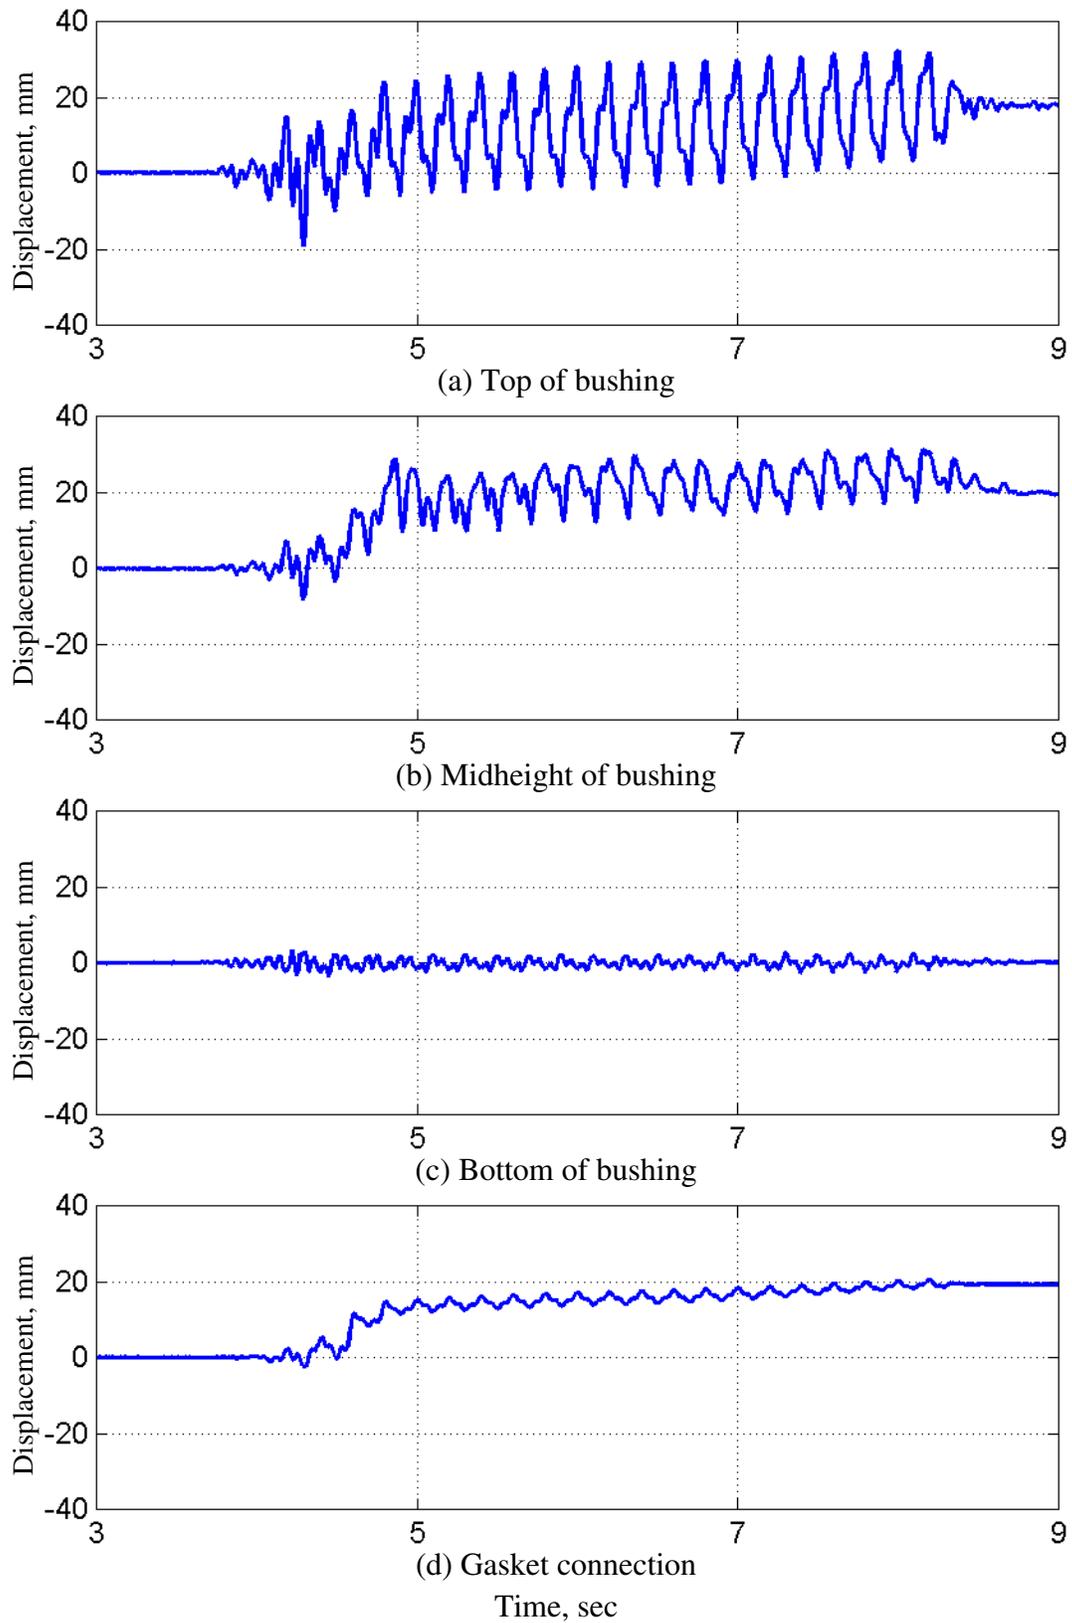
Figure 4-22 Displacement history of Bushing-2 relative to support frame, Test No 38

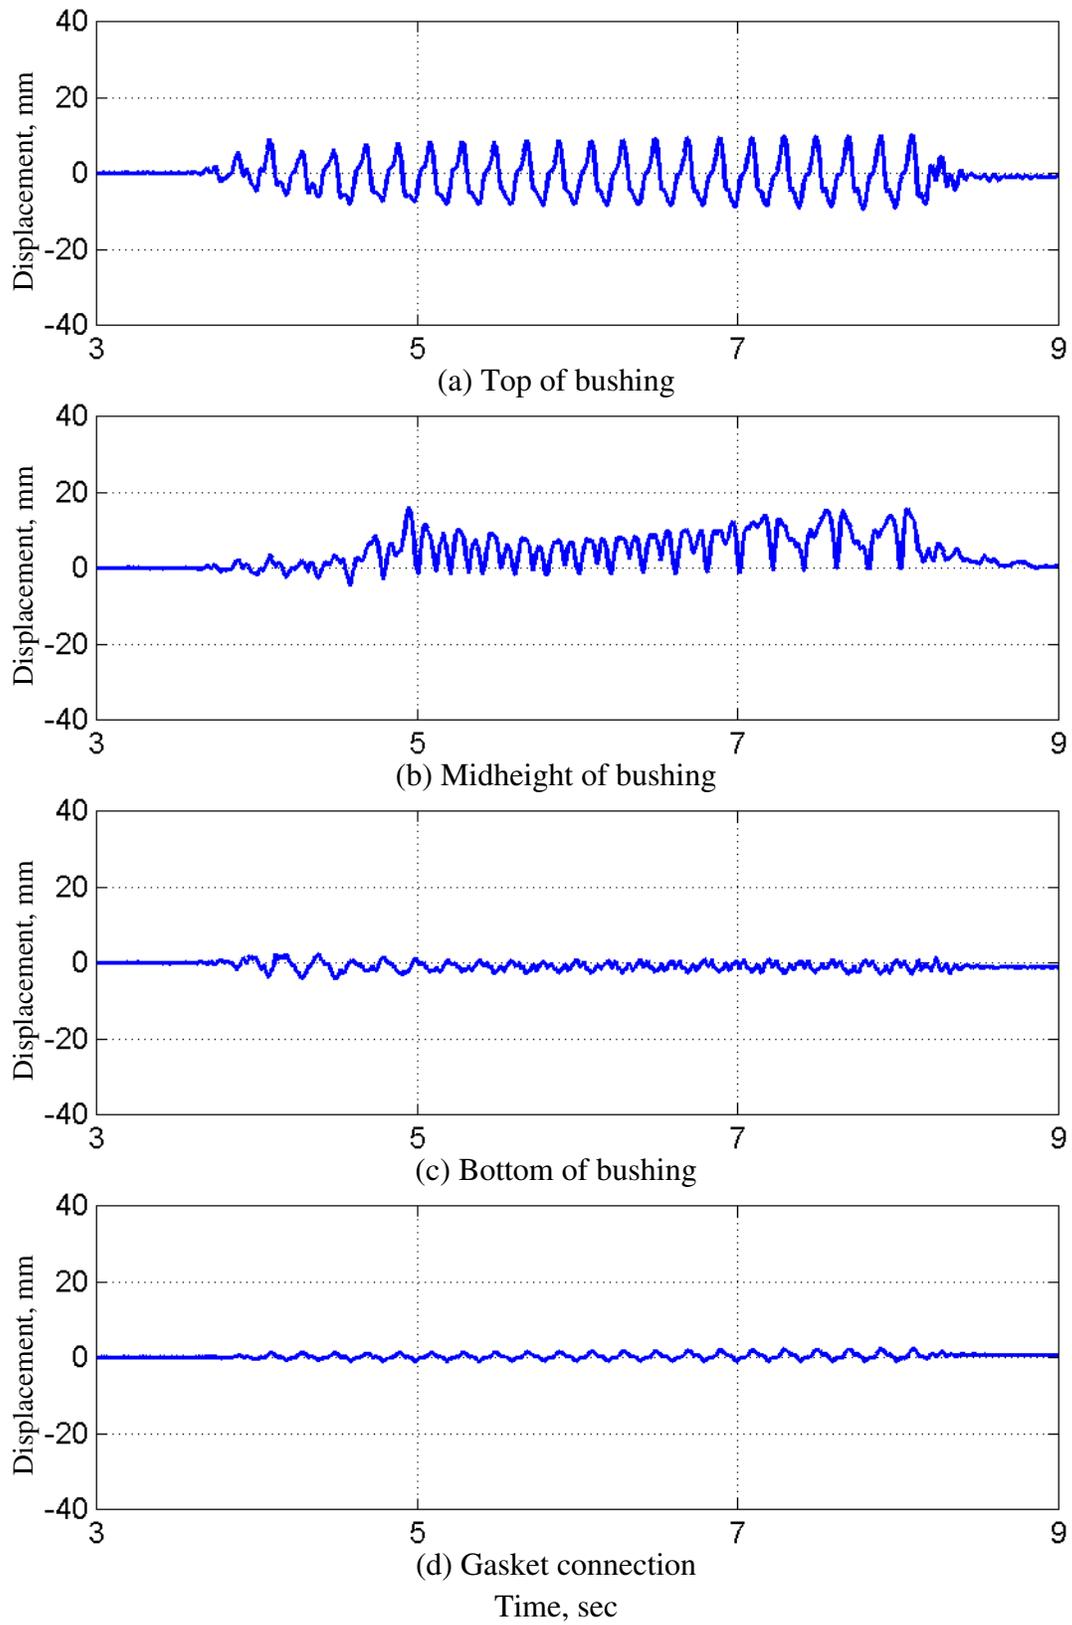
Figure 4-23 Displacement history of Bushing-2 relative to support frame, Test No 37

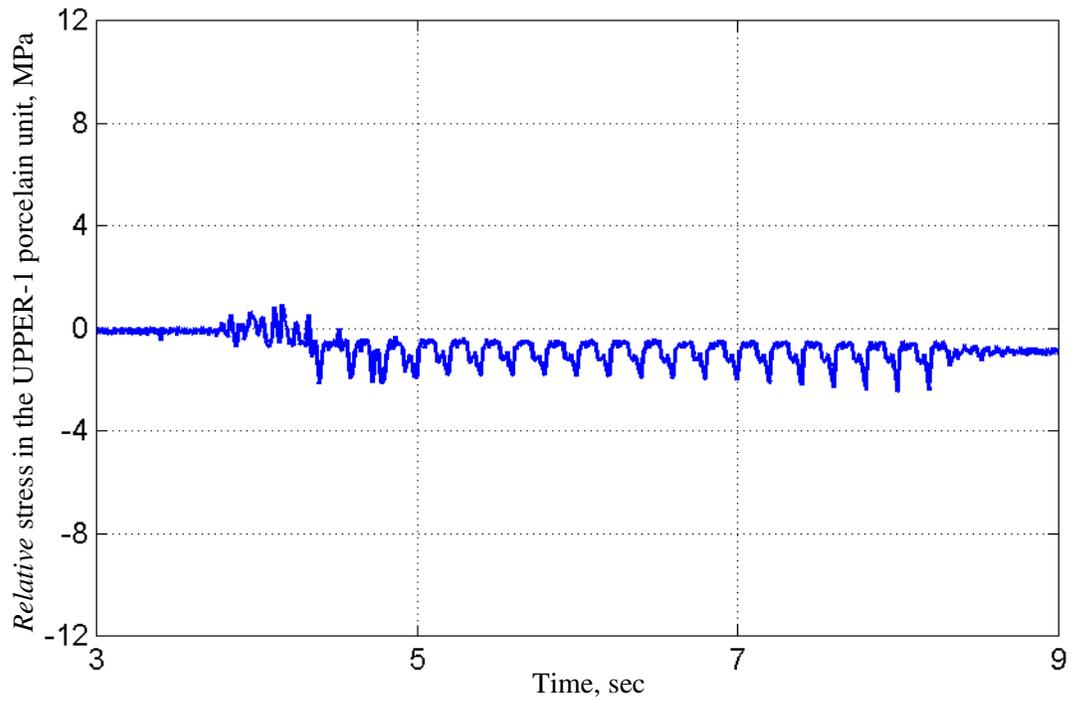
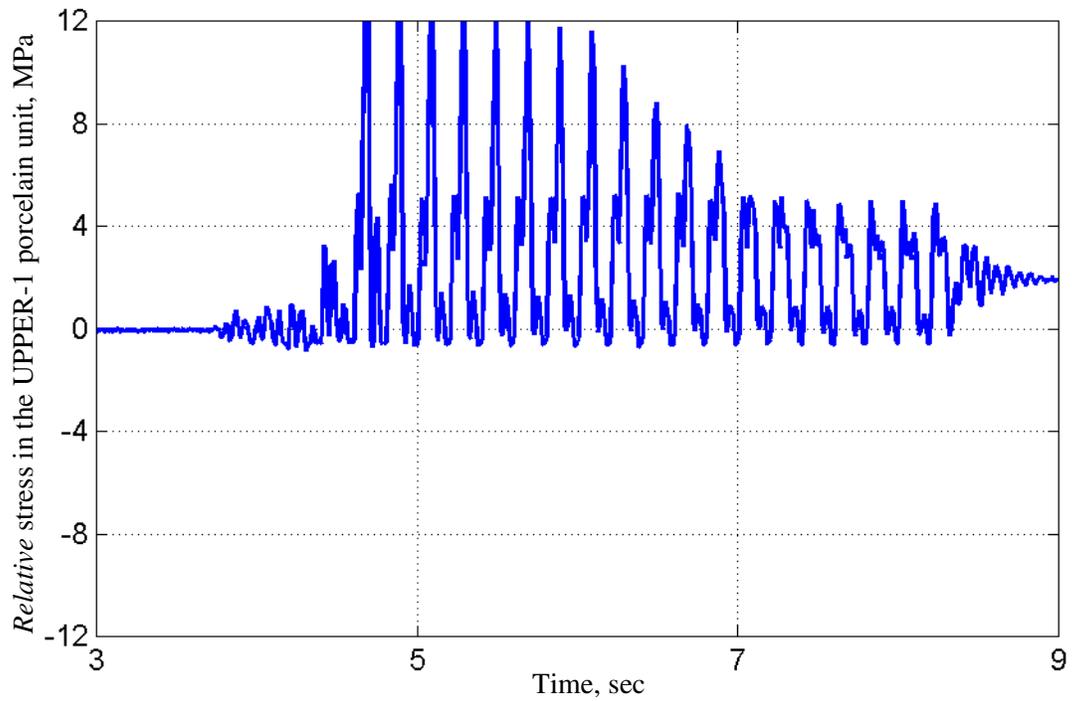
(a) Stress history of channel 39

(b) Stress history of channel 41

Figure 4-26 Stress history of the UPPER-1 porcelain unit, Test No 38

The zero-corrected stress histories for the UPPER-1 porcelain unit along the  $x$ -axis were studied by examining data from channels 39 and 41. The recorded strain data were converted to stress by multiplying the measured values by the porcelain modulus of elasticity (assumed to equal 97,000 MPa, see Chapter 2). The stress data for the test without the terminal are shown in Figure 4-26, and the stress data for the test with the terminal are shown in Figure 4-27. The stress histories shown in these figures are *relative* values and represent the change in porcelain stress during the earthquake simulator testing. In these figures, compressive stresses are designated as positive. To obtain the absolute stress in the UPPER-1 porcelain unit, the initial compressive post-tensioning stress of 0.9 ksi (6.2 MPa) has to be added to the values shown. As a result, data indicate no tensile stress in the UPPER-1 porcelain unit. During Test No 38 (test without the terminal), the relative stress values on the opposite sides of the UPPER-1 porcelain unit had opposite signs. On one side, there was additional compressive stress, whereas on the opposite side, some of the post-tensioning force was relieved. At the conclusion of the test, the residual stress in the UPPER-1 porcelain unit was positive on one side and negative on the other side. This observation is consistent with the differential residual vertical displacements discussed in the last paragraph. The strain gage data of Test No 37 (test with the terminal) show that the stress in the UPPER-1 porcelain unit was small — an observation consistent with the data presented in the last paragraph.

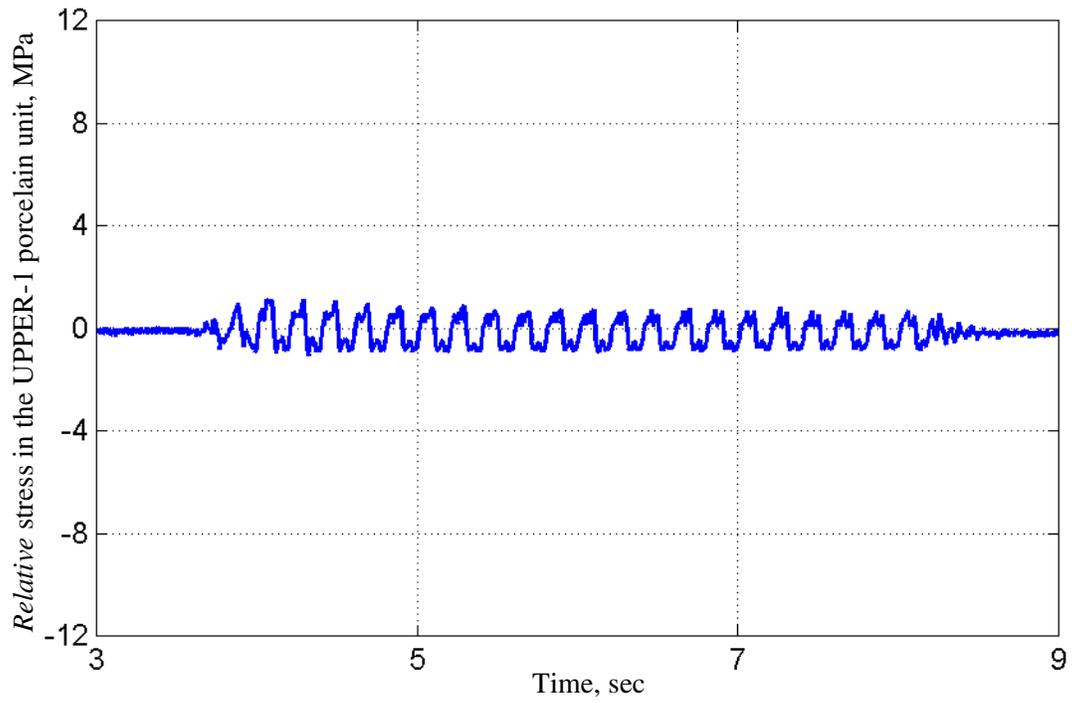
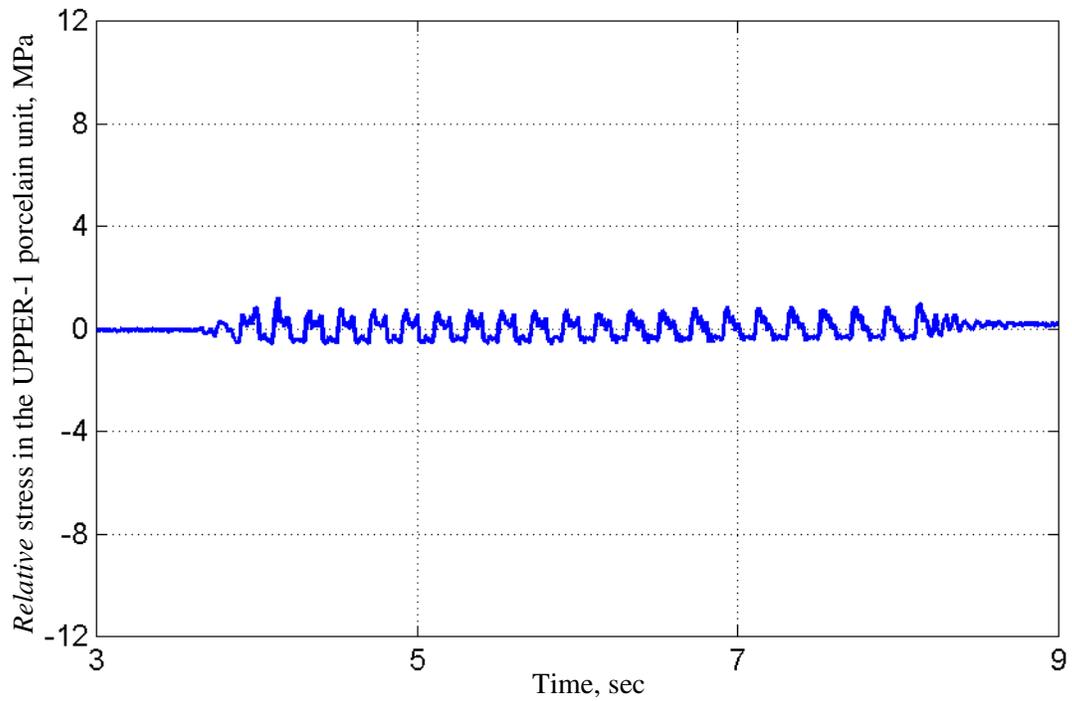
(a) Stress history of channel 39

(b) Stress history of channel 41

Figure 4-27 Stress history of the UPPER-1 porcelain unit, Test No 37

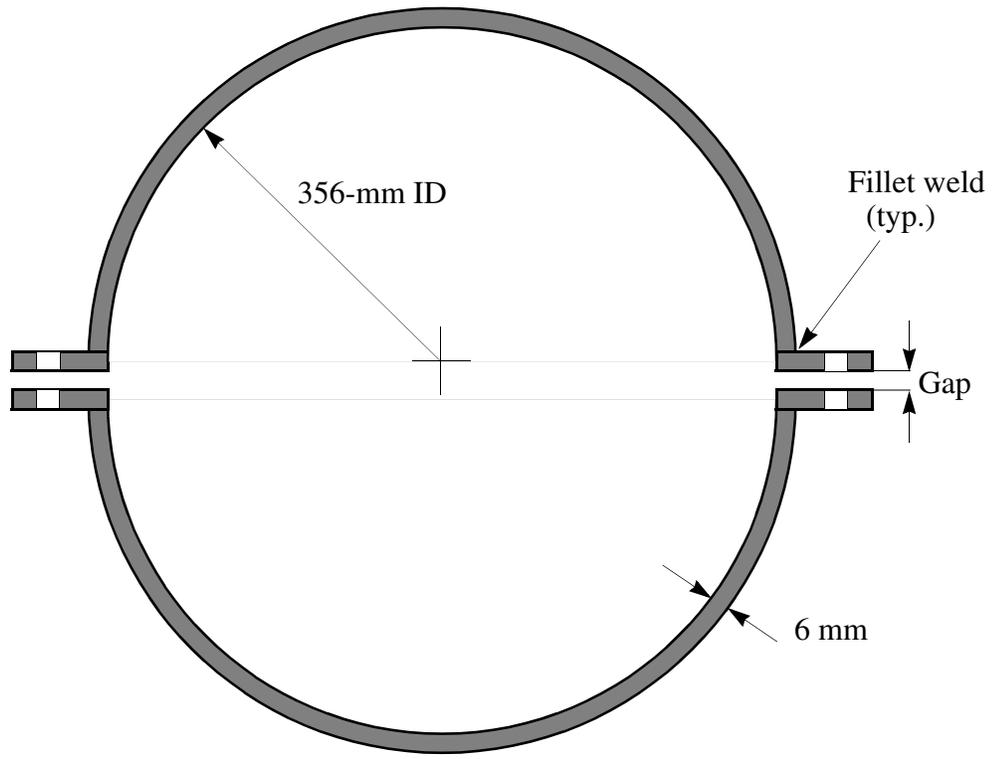
(a) Plan

(b) Elevation

Figure 5-1 Geometry of Ring-1

During the cyclic tests of Bushing-1, Ring-1 separated from the epoxy, rotated with respect to the bushing, and uplifted. Ring-1 improved the response of the 230-kV bushing only marginally. The detail was modified by Dr. Schiff and the utilities, and designated as Ring-2. The gap between the two semicircular rings was eliminated by reducing the gap between the porcelain and the ring from 5/8 in. (16 mm) to 3/8 in. (10 mm), and 1/2-in. (13-mm) thick steel angles were used to secure the ring to the bushing to prevent uplift of the ring.

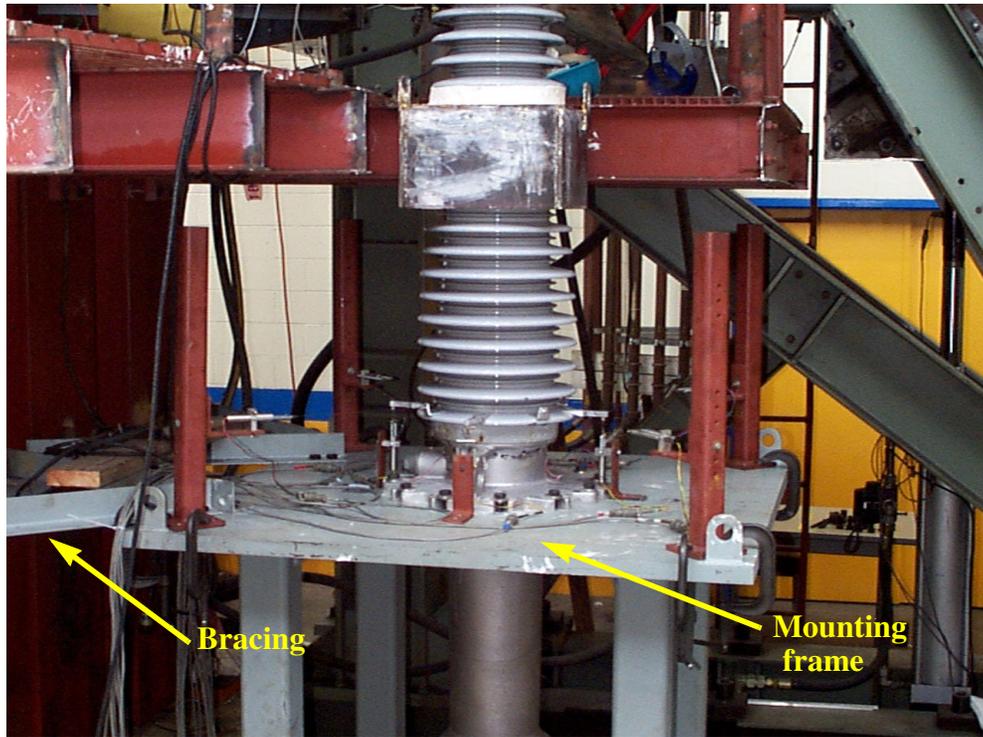
Figure 6-1 Bushing-1 and the mounting frame

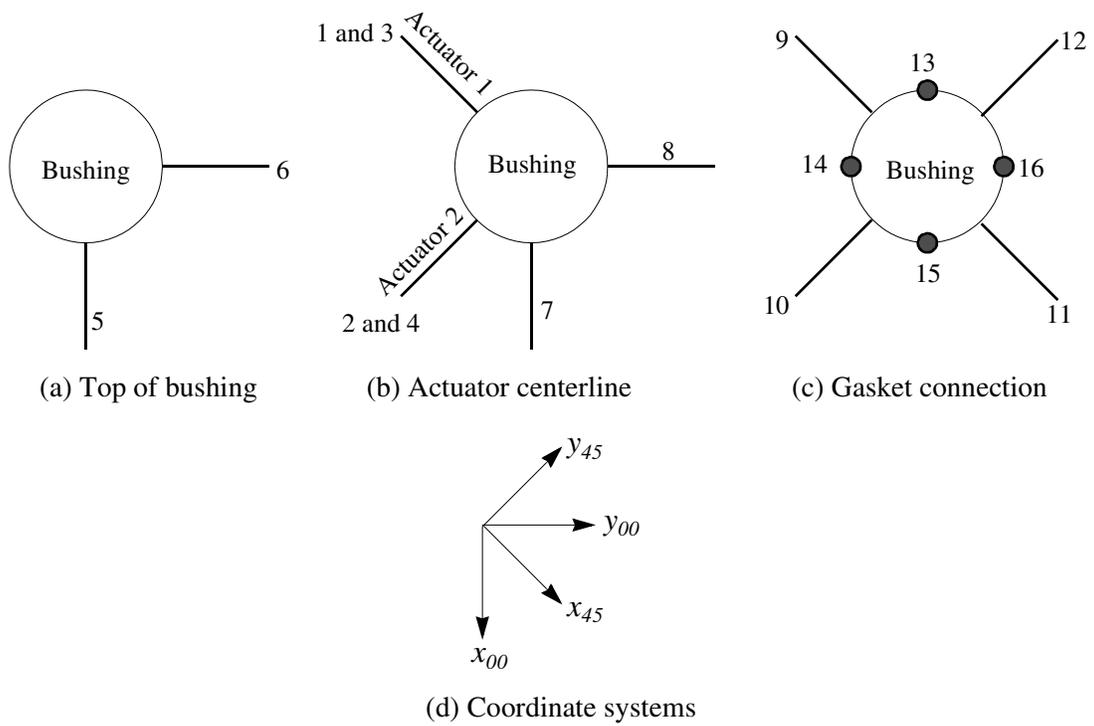
Figure 6-5 Instrumentation for static tests of Bushing-1

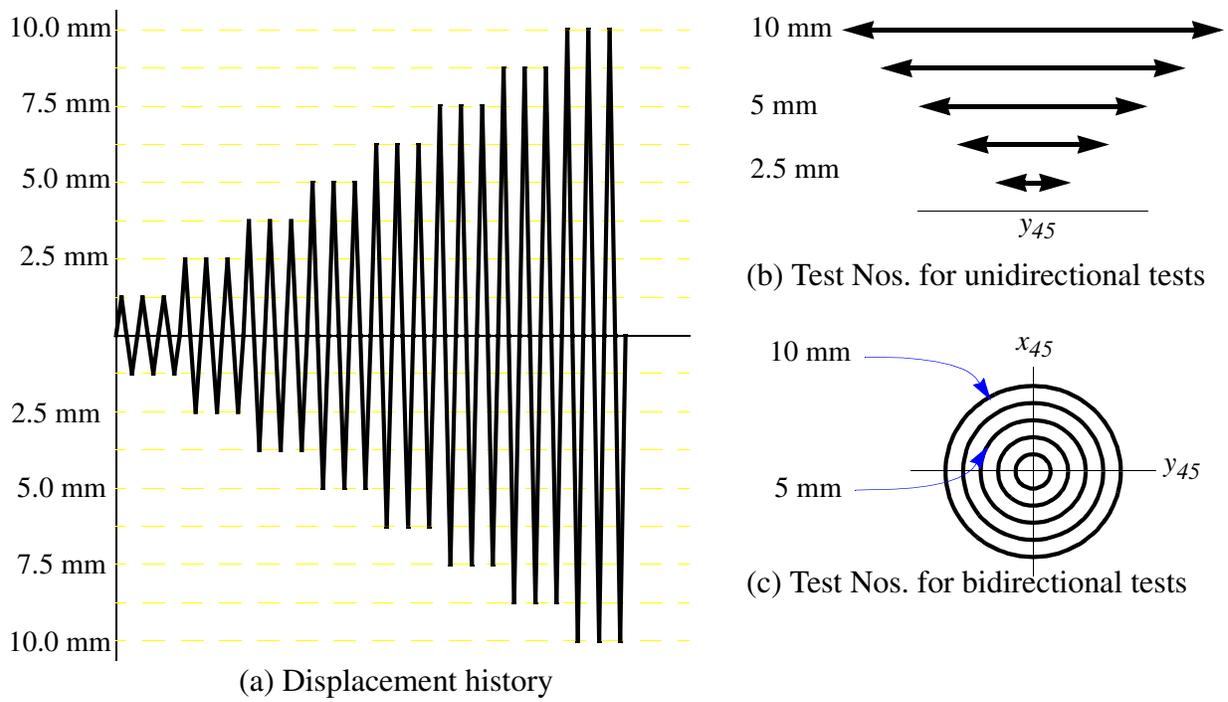
Figure 6-10 Displacement history for static cyclic tests

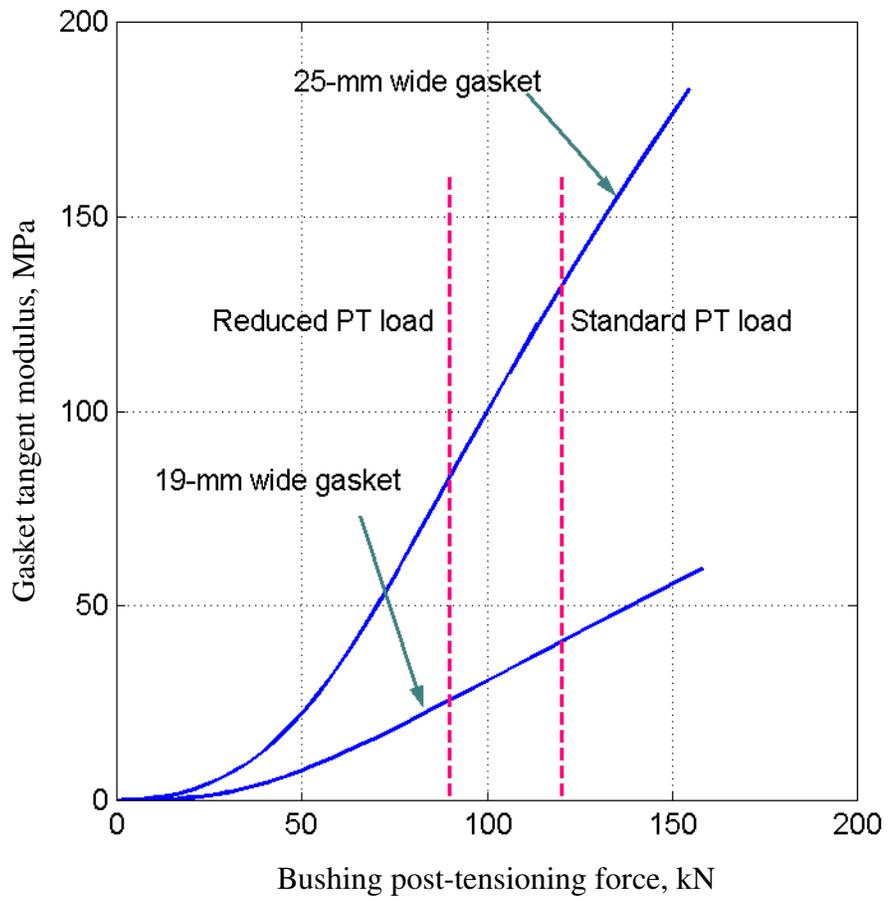
Figure 6-12 Effect of preload on the gasket stiffness

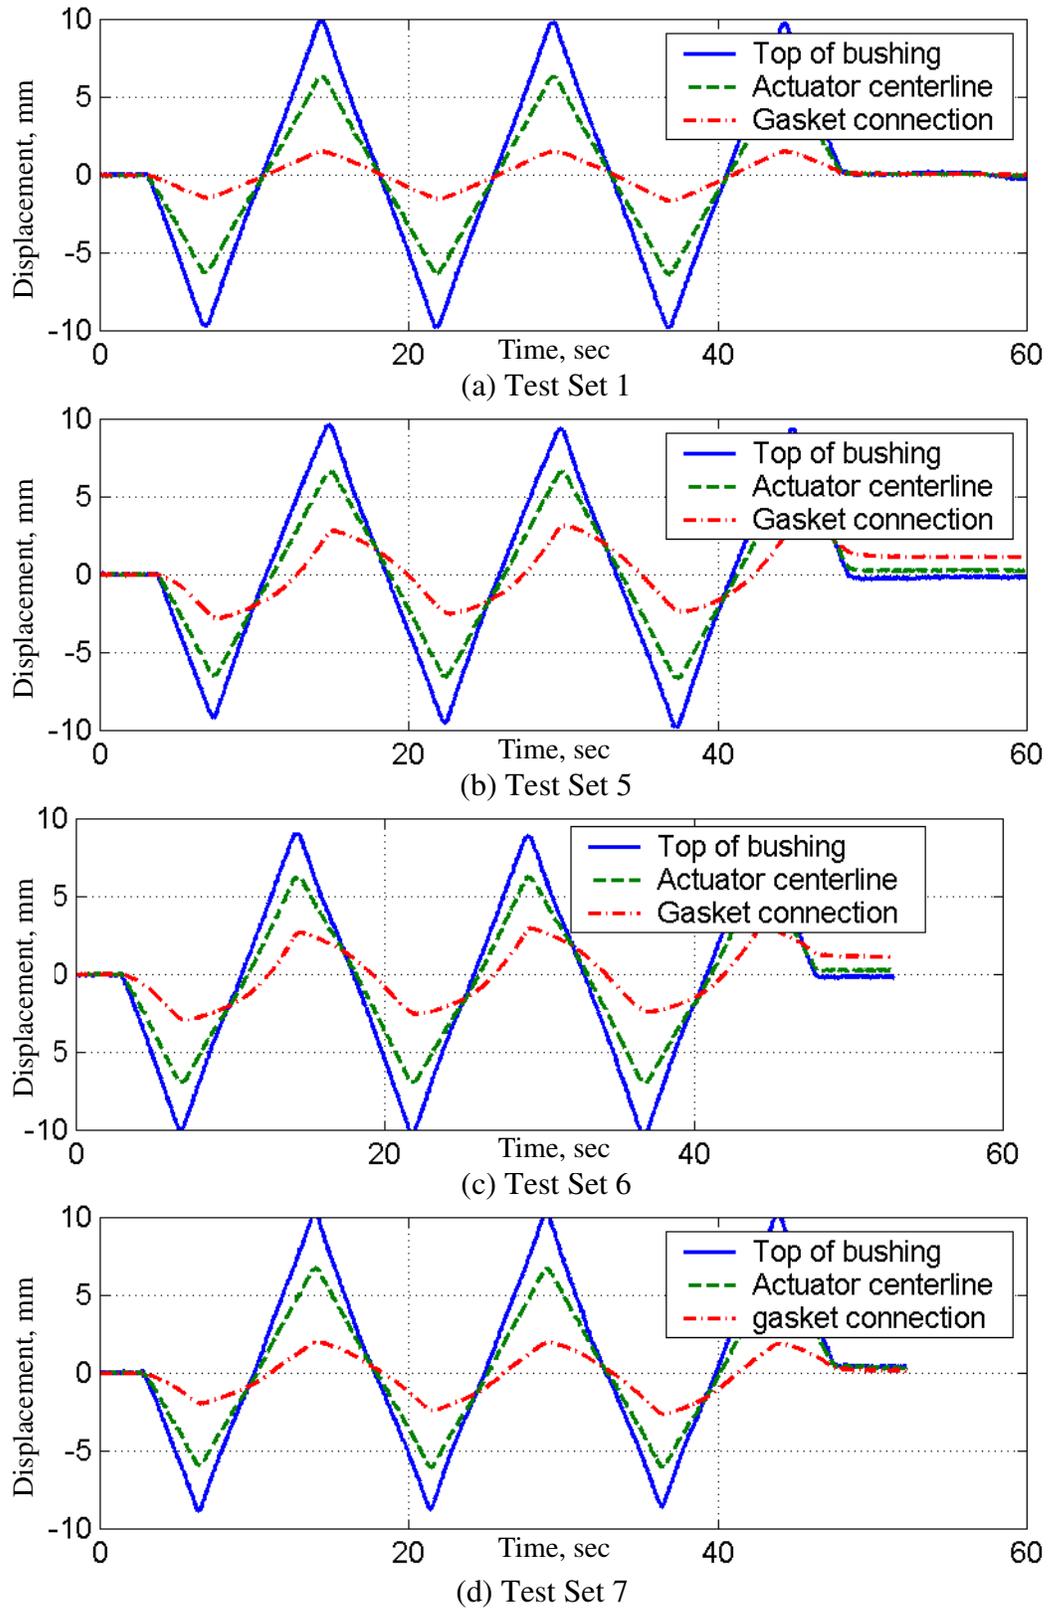
Figure 6-15 Displacement histories of Bushing-1 for Test Sets 1, 5, 6, and 7

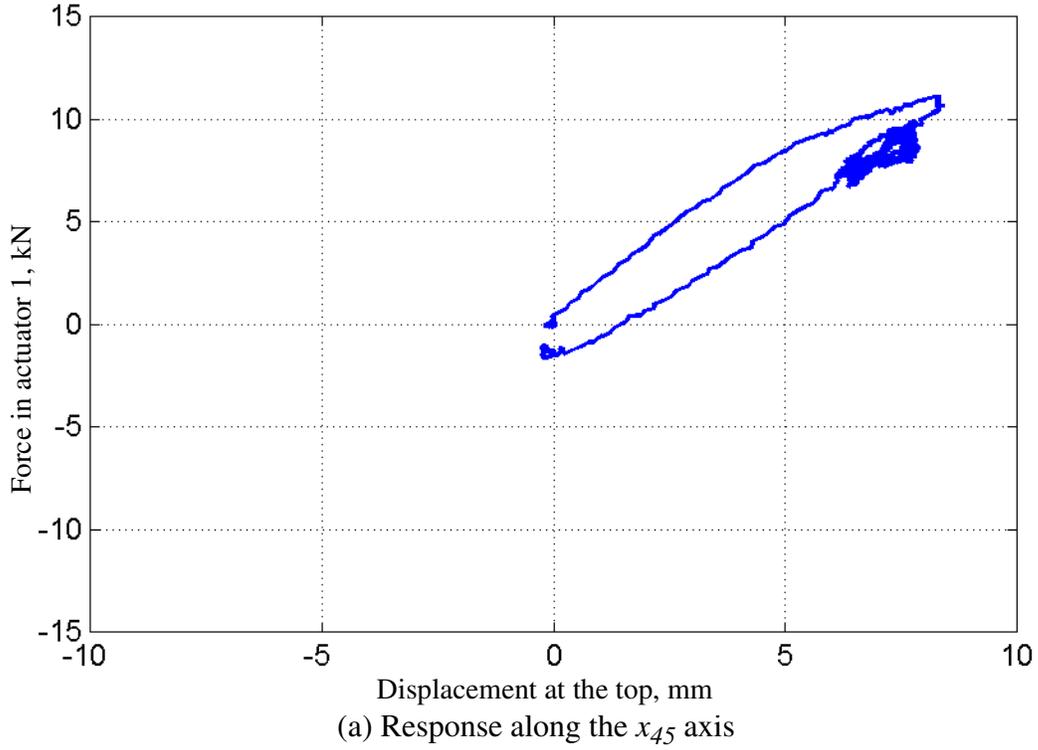
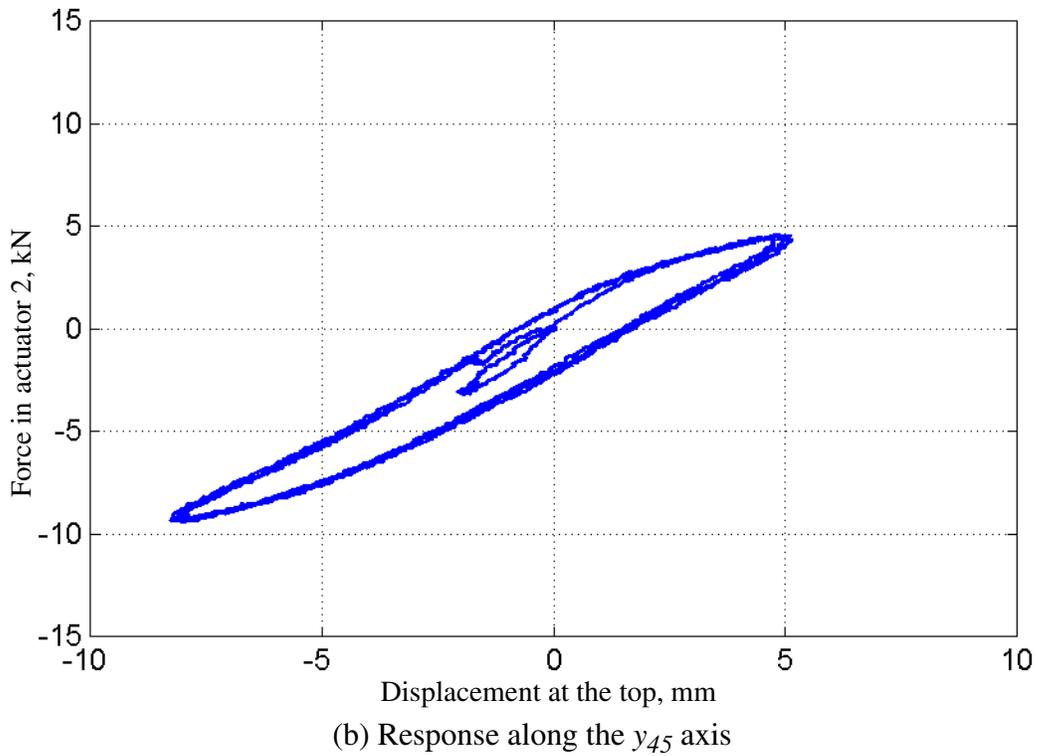
Figure 6-16 Force-displacement history for Bushing-1, Test No 4, Test Set 3

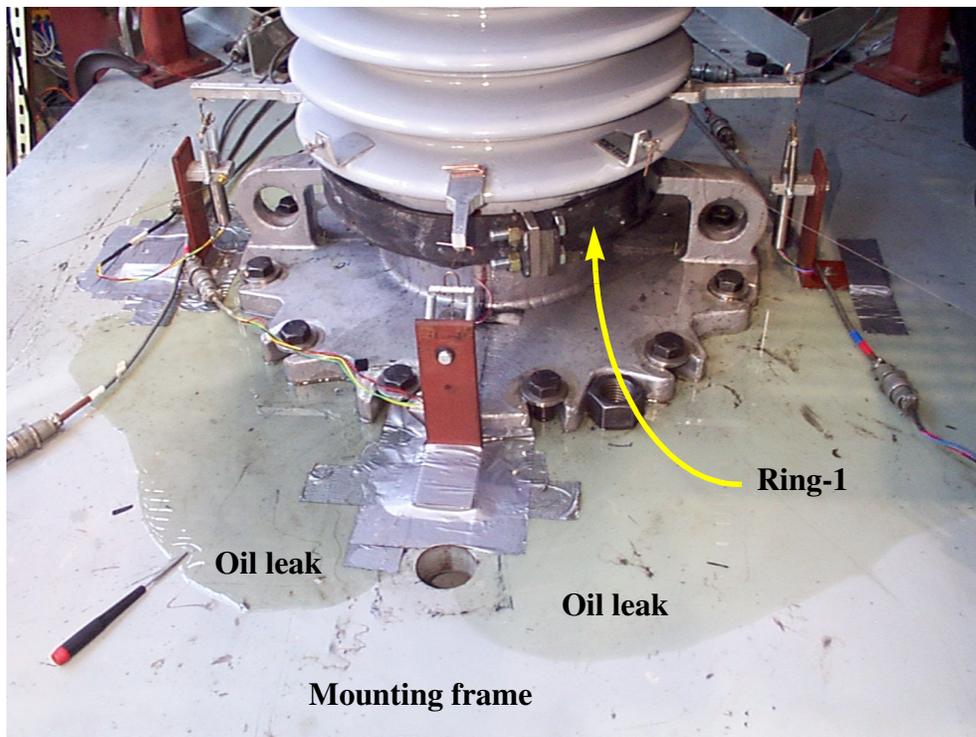
Figure 6-19 Oil leakage from the gasket connection following Test Set 12

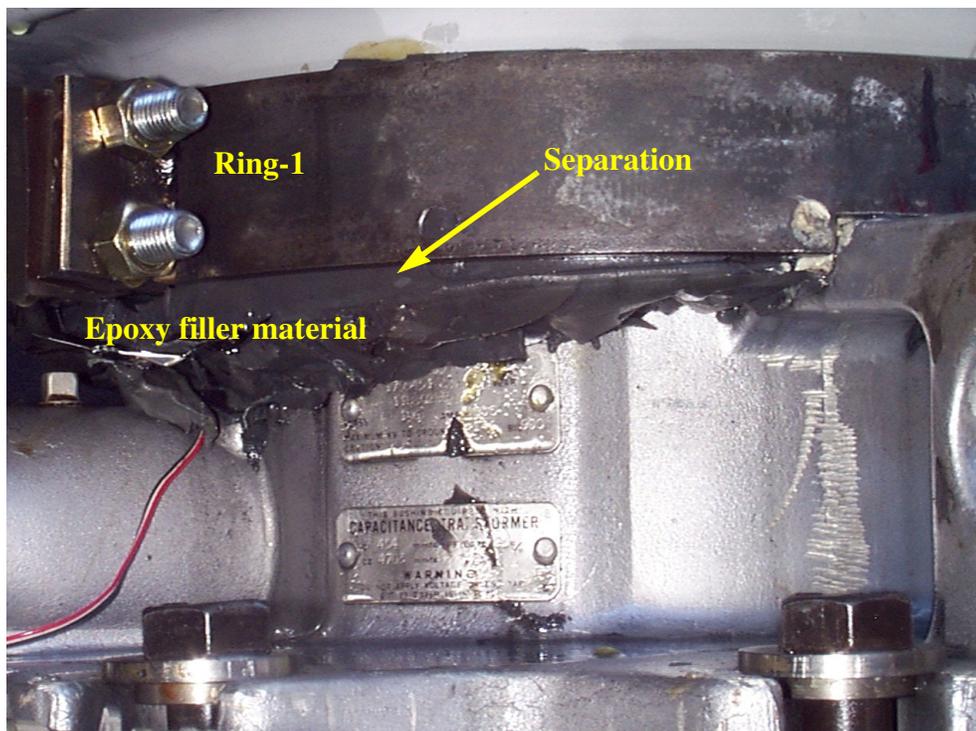
Figure 6-20 Separation of Ring-1 from the epoxy filler material, Test Set 13

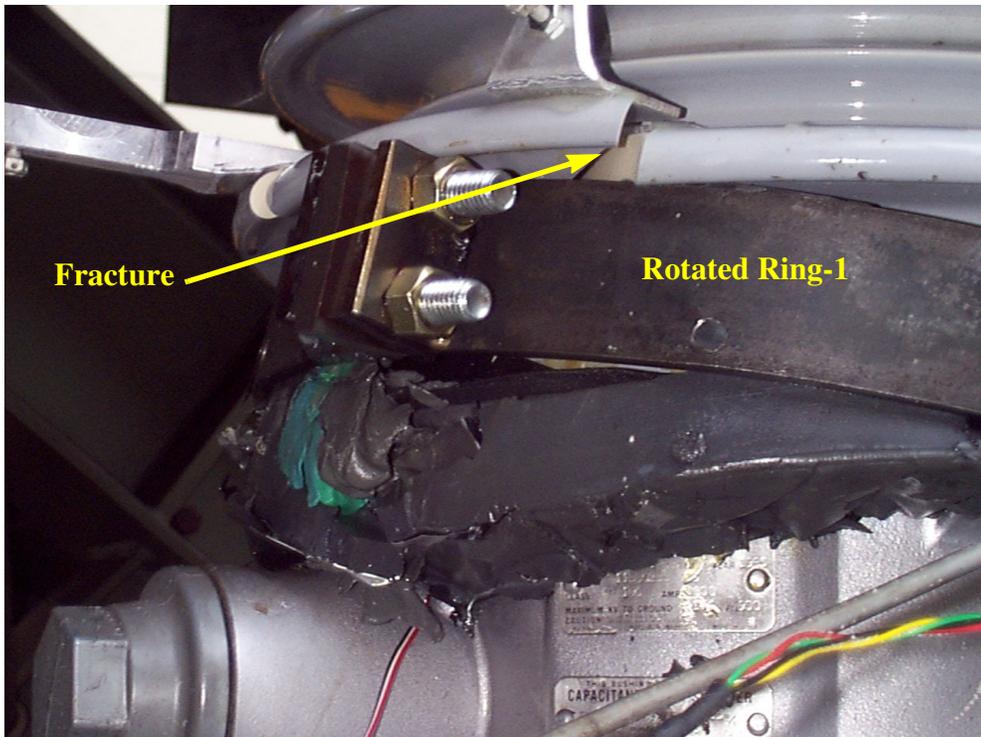
Figure 6-23 Fracture of the bottom shed of the UPPER-1 porcelain unit, Test Set 14

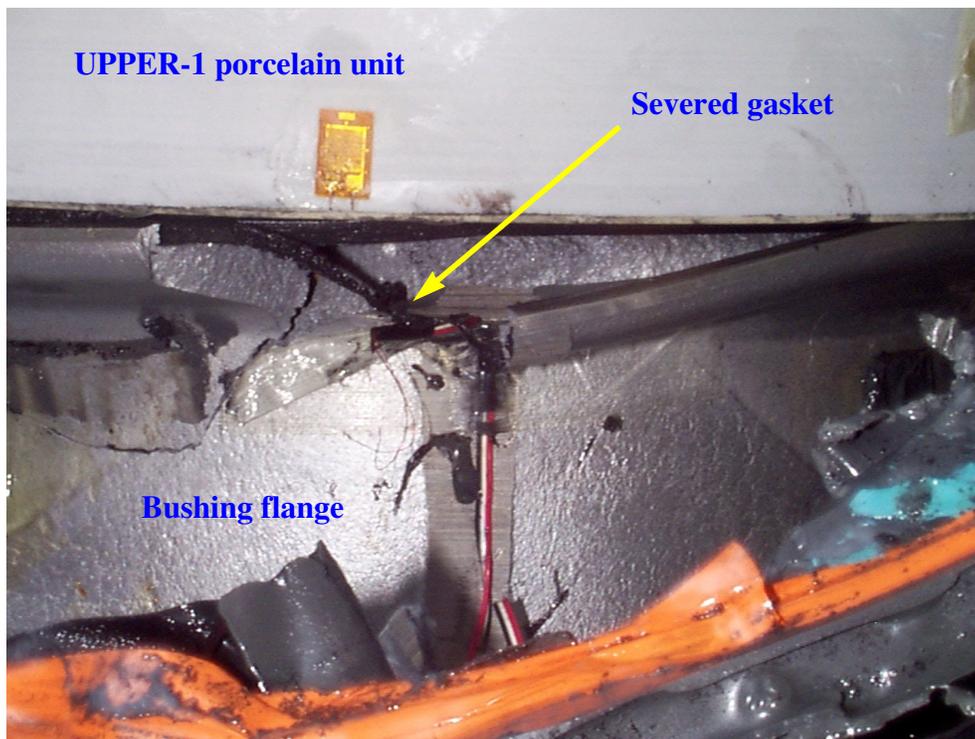
Figure 6-24 Torn portion of gasket at the gasket connection, Test Set 14

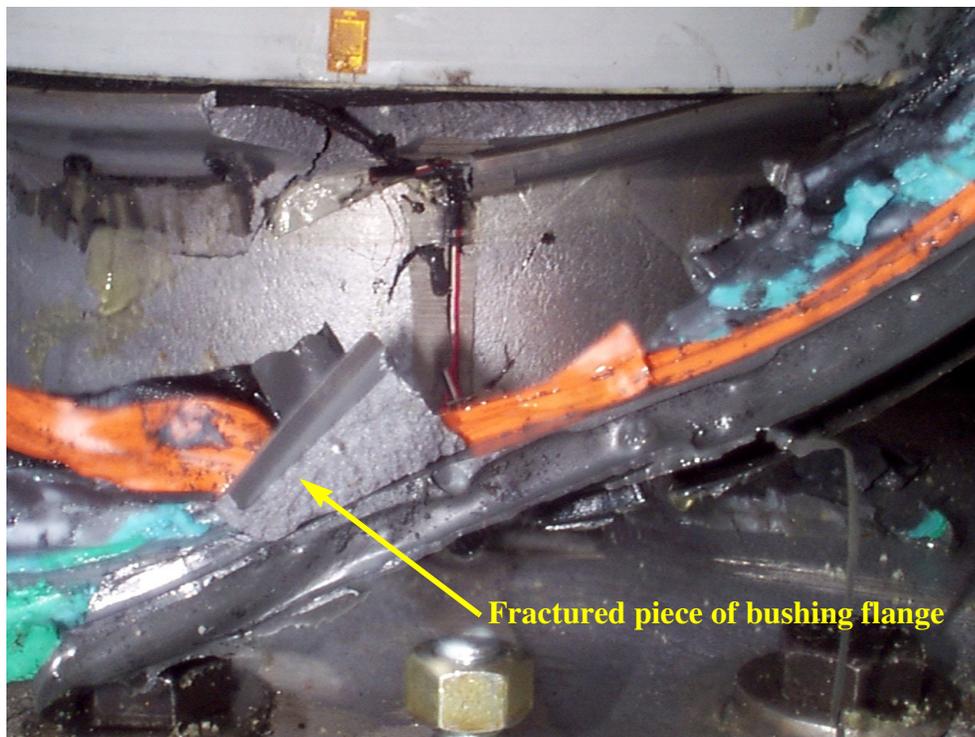
Figure 6-25 Fracture of cast aluminum flange following Test Set 14

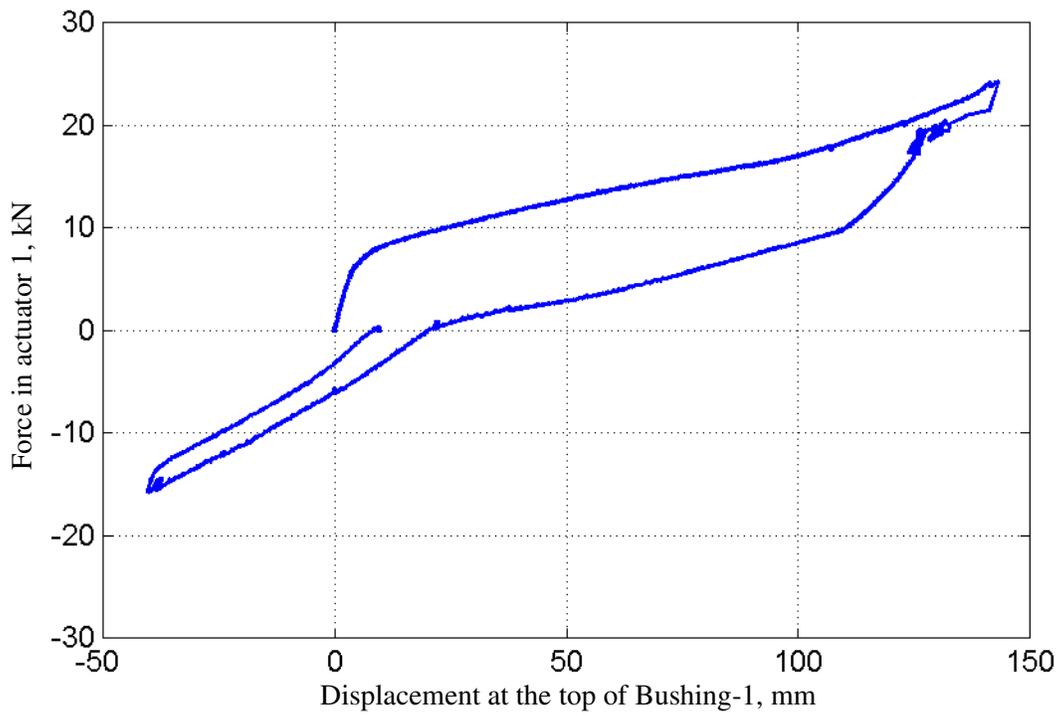
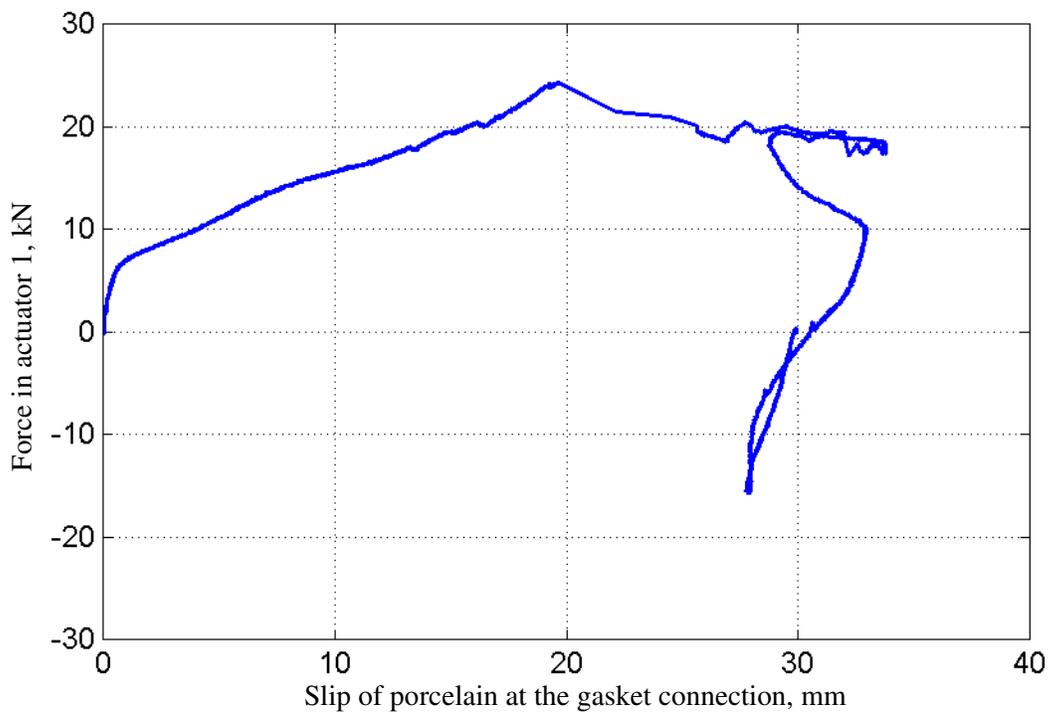
(a) Hysteretic response at the top of Bushing-1

(b) Hysteretic response at the gasket connection of Bushing-1

Figure 6-26 Response of Bushing-1 during the monotonic test (Test Set 14)

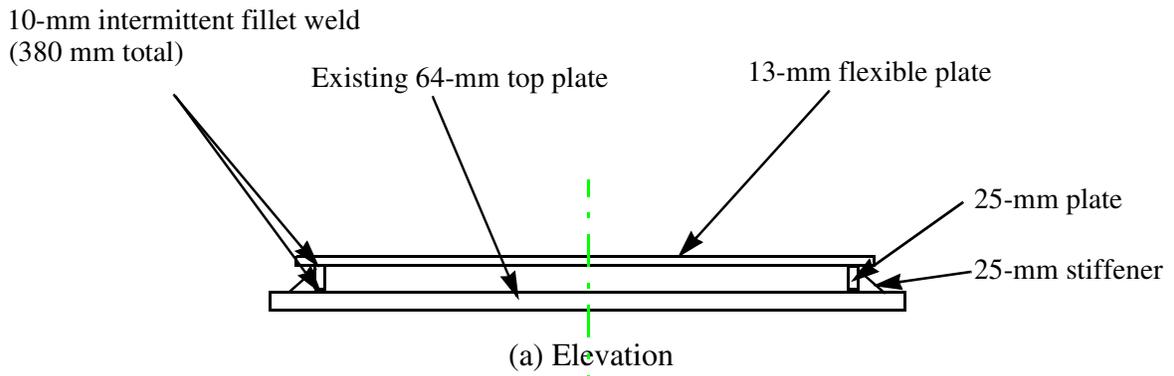
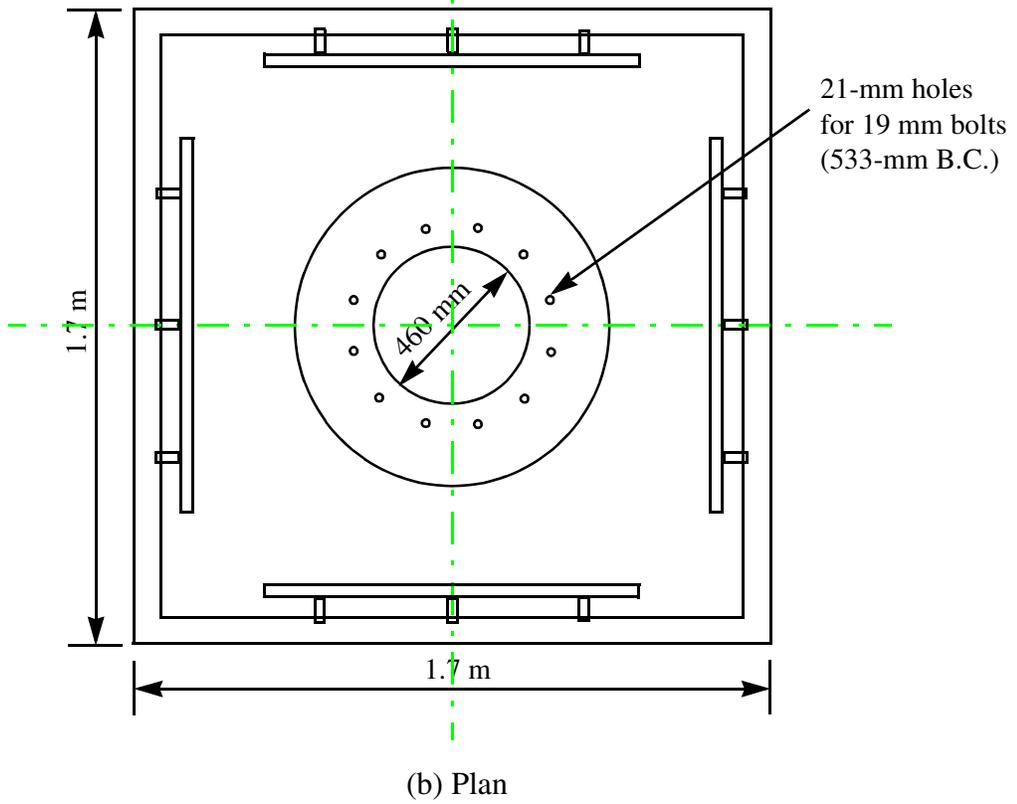
Figure 7-1 Details for flexible plate

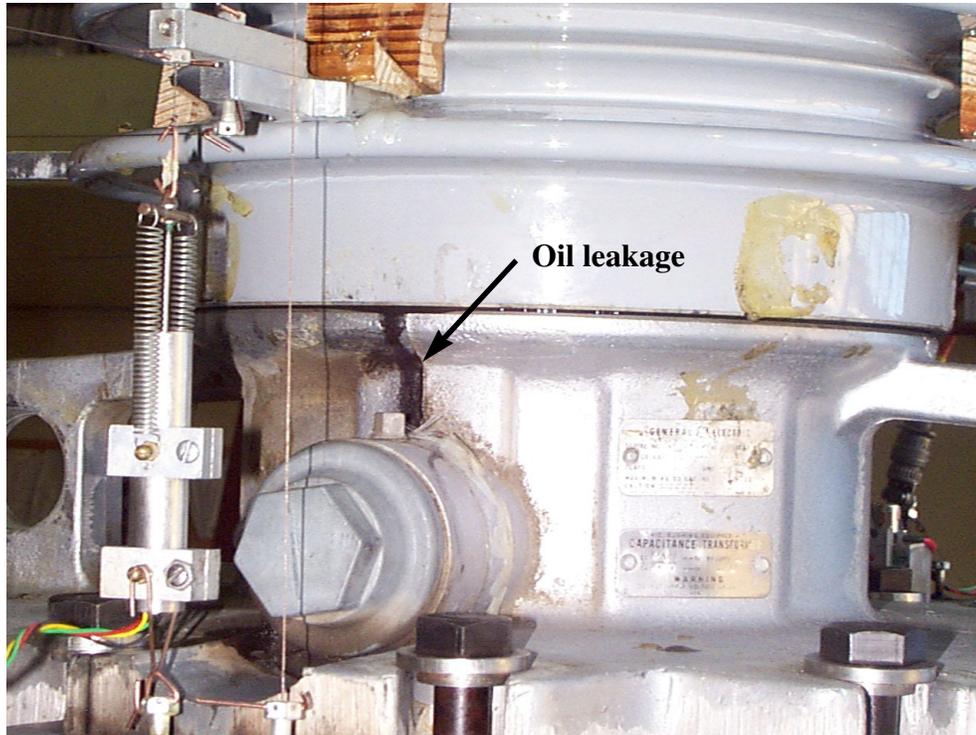
Figure 7-12 Bushing-2 after Test No 15 (target PGA=1.4g) showing oil leakage

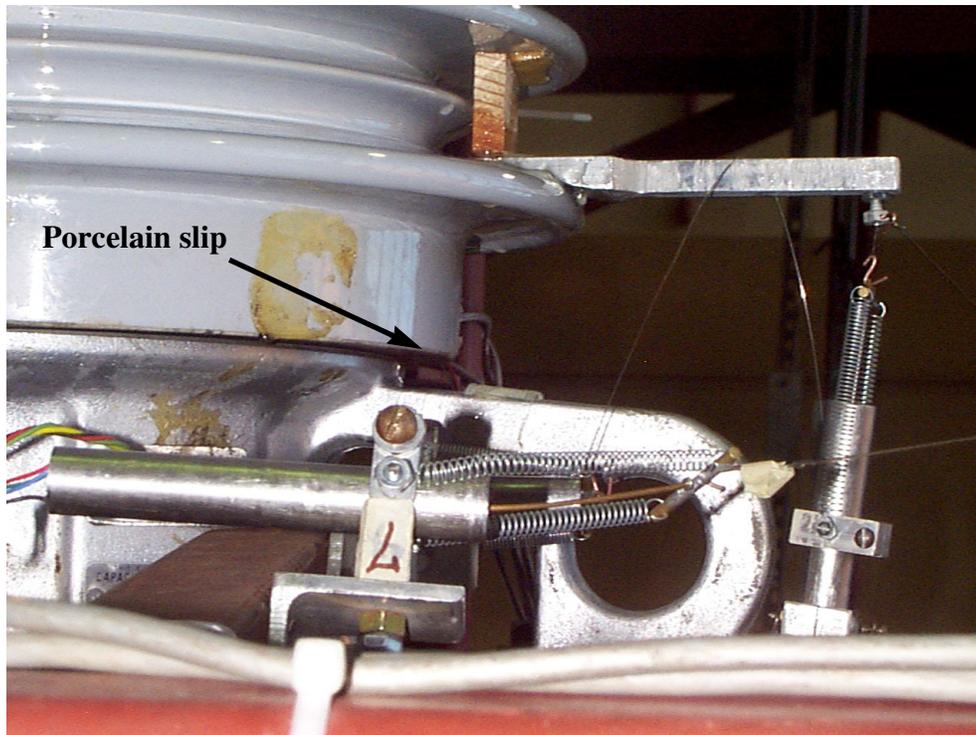
Figure 7-13 Bushing-2 after Test No 17 (target PGA=1.8g) showing slip of porcelain
