## Seismic Evaluation and Retrofit of 230-kV Porcelain Transformer Bushings

PEER Report 1999/14  
Pacific Earthquake Engineering Research Center  
College of Engineering  
University of California, Berkeley  
December 1999

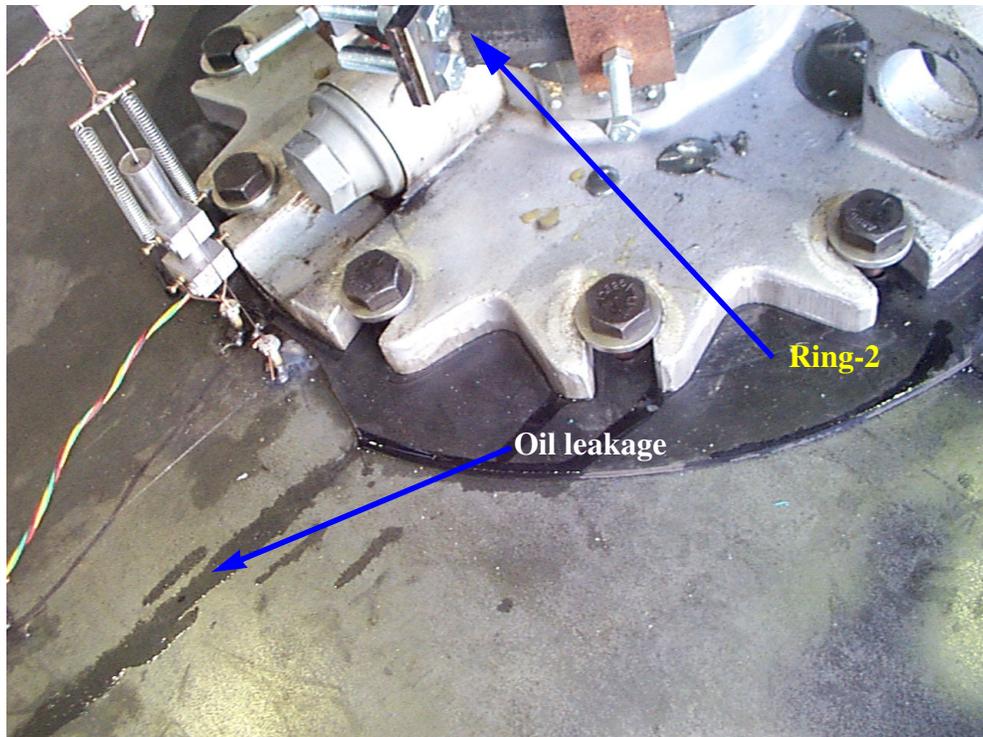
Figure 7-15 Retrofitted Bushing-2 after Test No 23 (target PGA=2.8g) showing oil leakage

For earthquake tests with target PGAs exceeding 2.4g, oil leaked from the ring-to-bushing connection. Although the ring retrofit detail delayed oil leakage, it was unable to prevent oil leakage for extreme shaking.

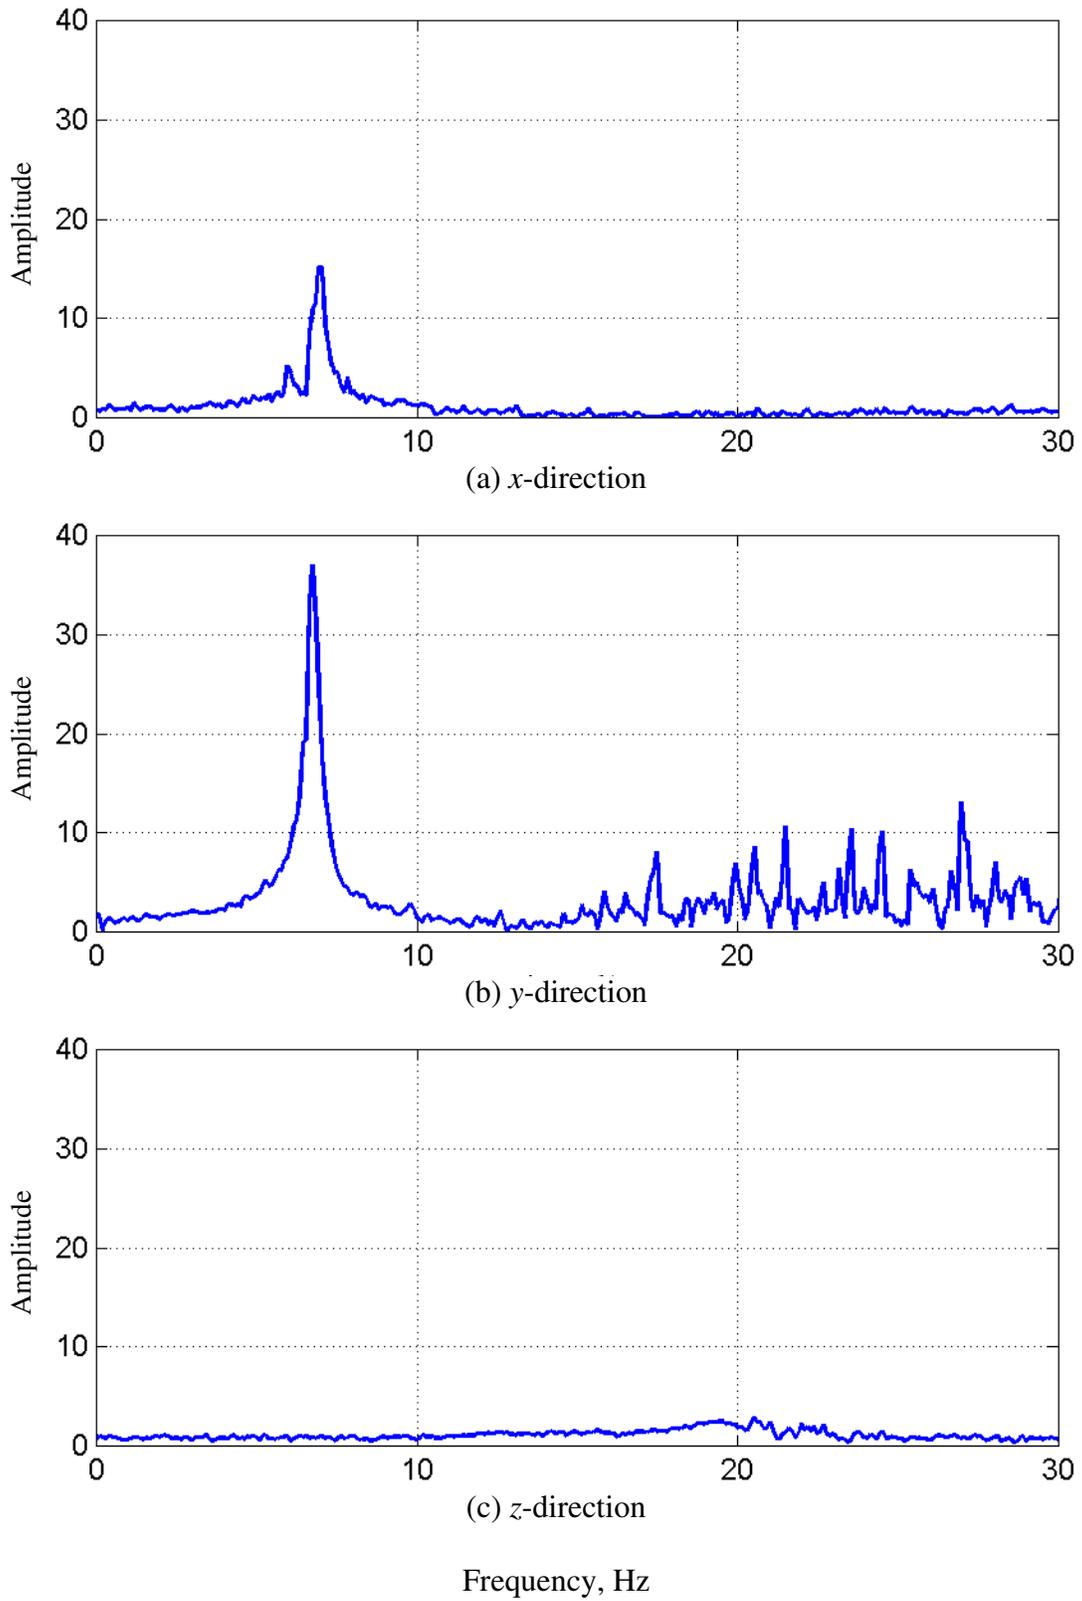
Figure 7-16 Transfer function amplitudes between the top of Bushing-2 and the flexible plate

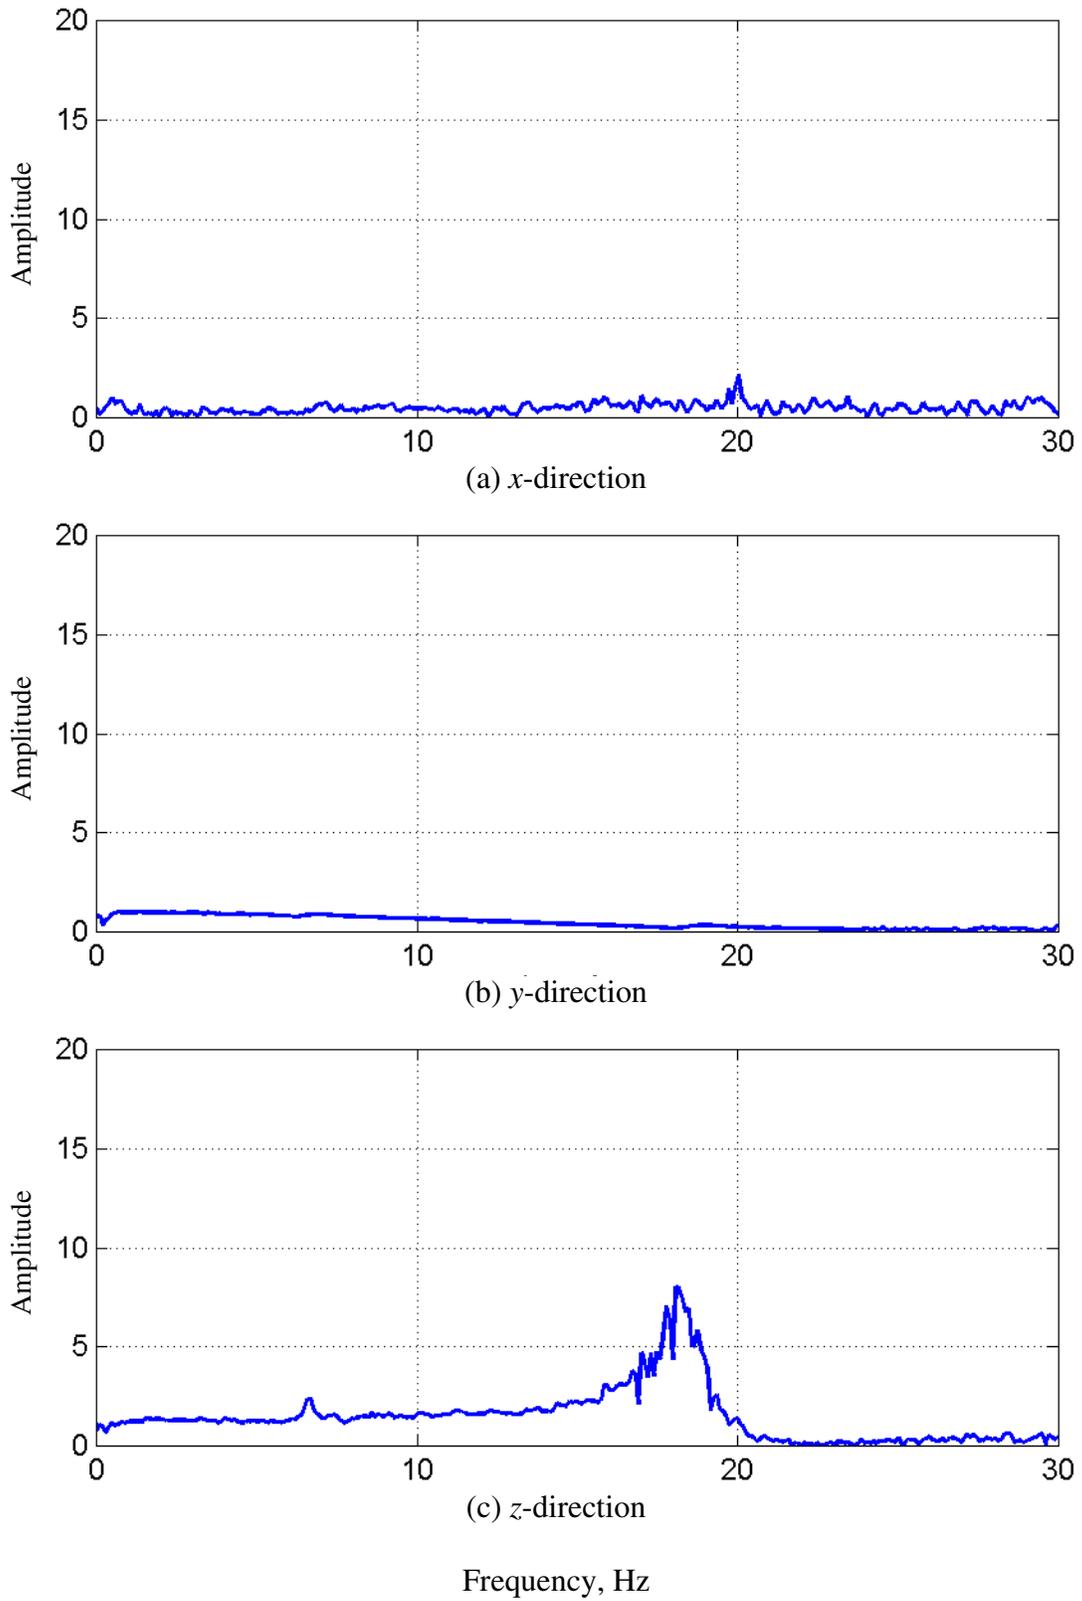
Figure 7-17 Transfer function amplitudes between the flexible plate and the rigid support

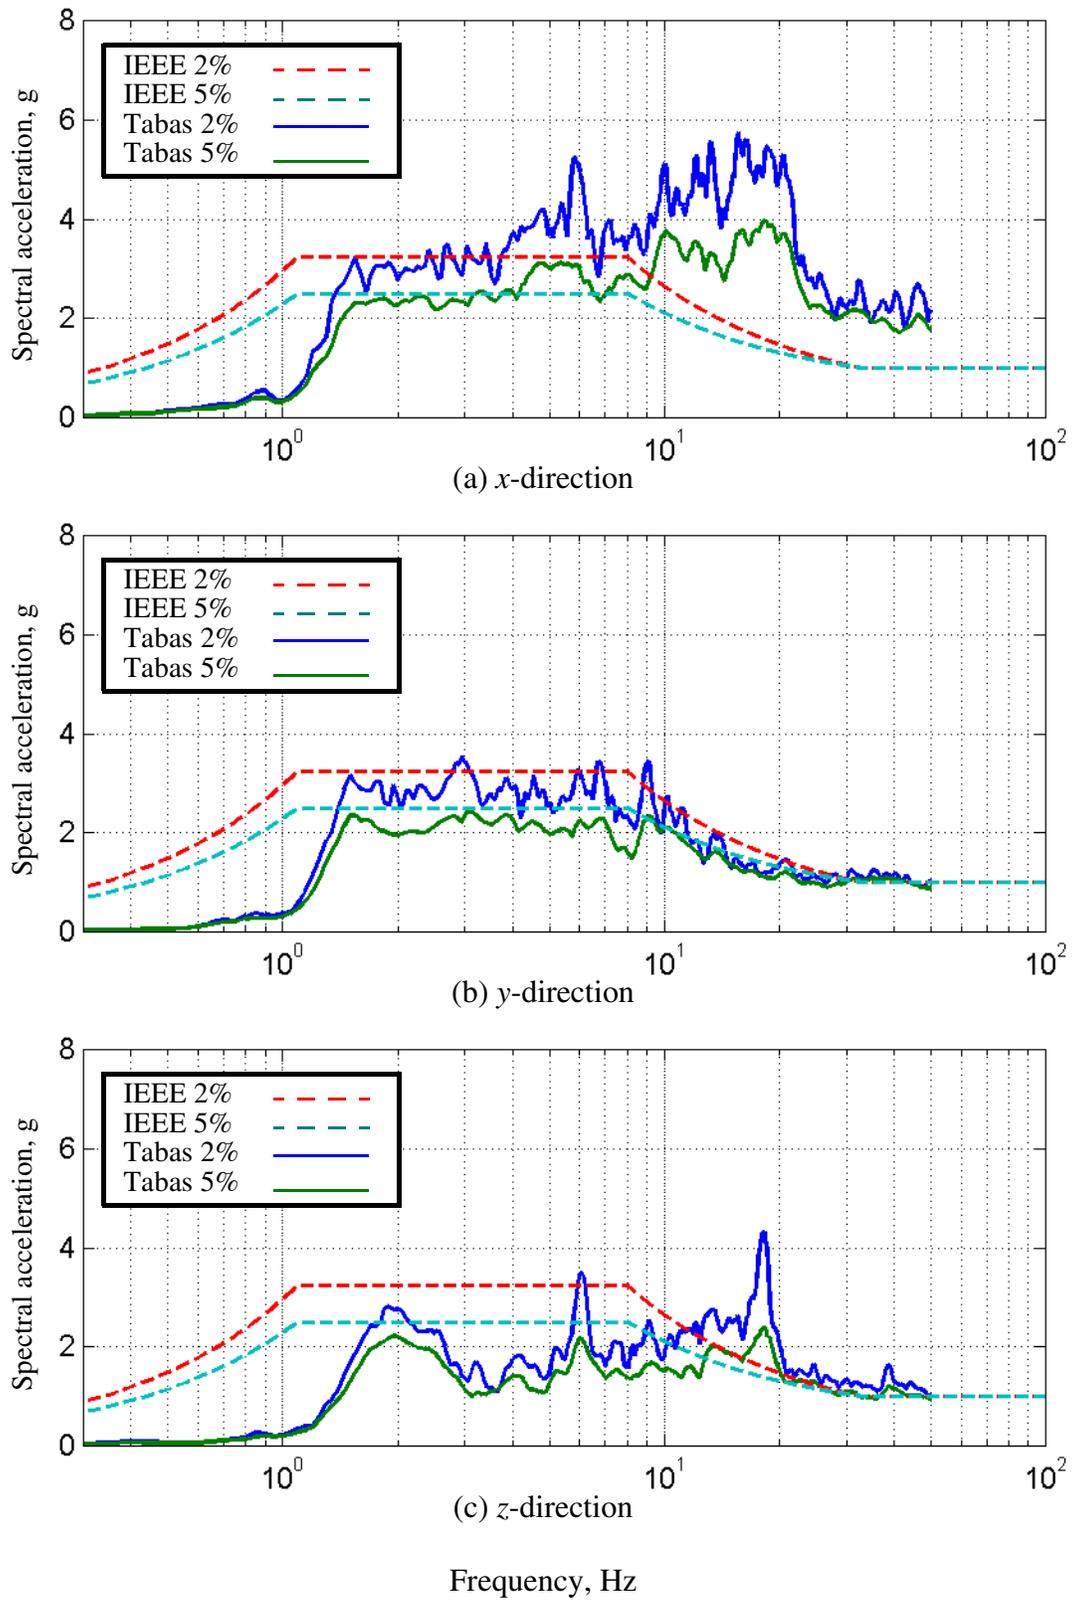
Figure 7-18 Response spectrum for Bushing-2 without Ring-2; Test No 13, Tabas-A, target PGA=1.0g

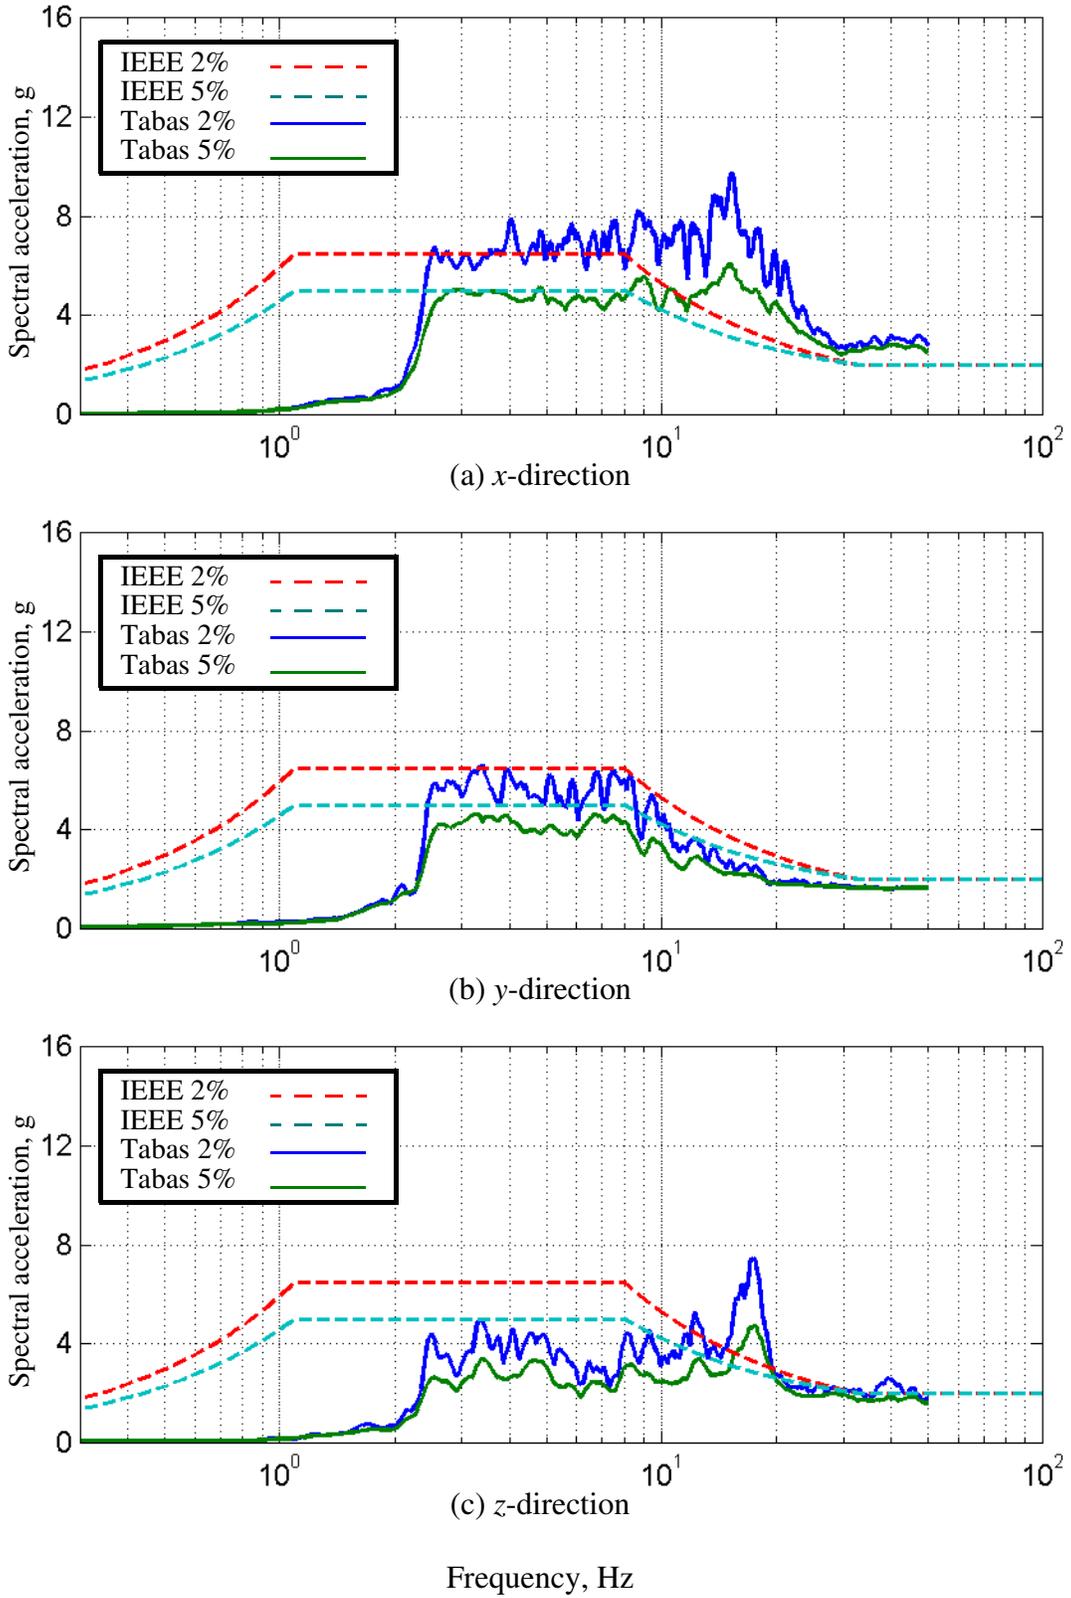
Figure 7-19 Response spectrum for Bushing-2 without Ring-2; Test No 18, Tabas-A, target PGA=2.0g

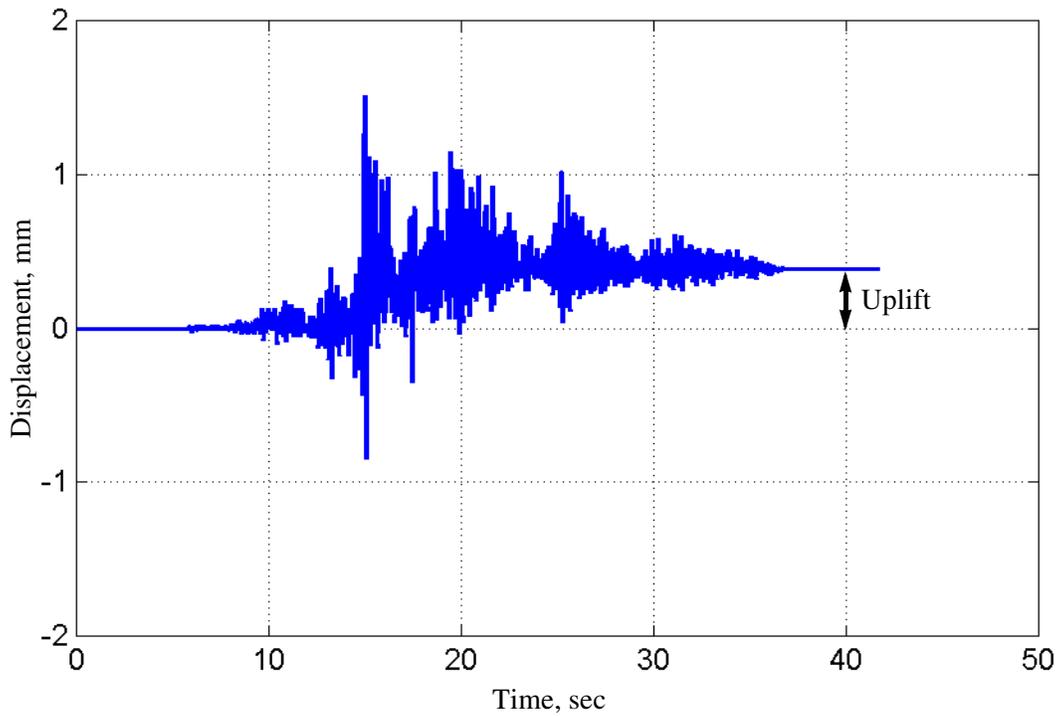
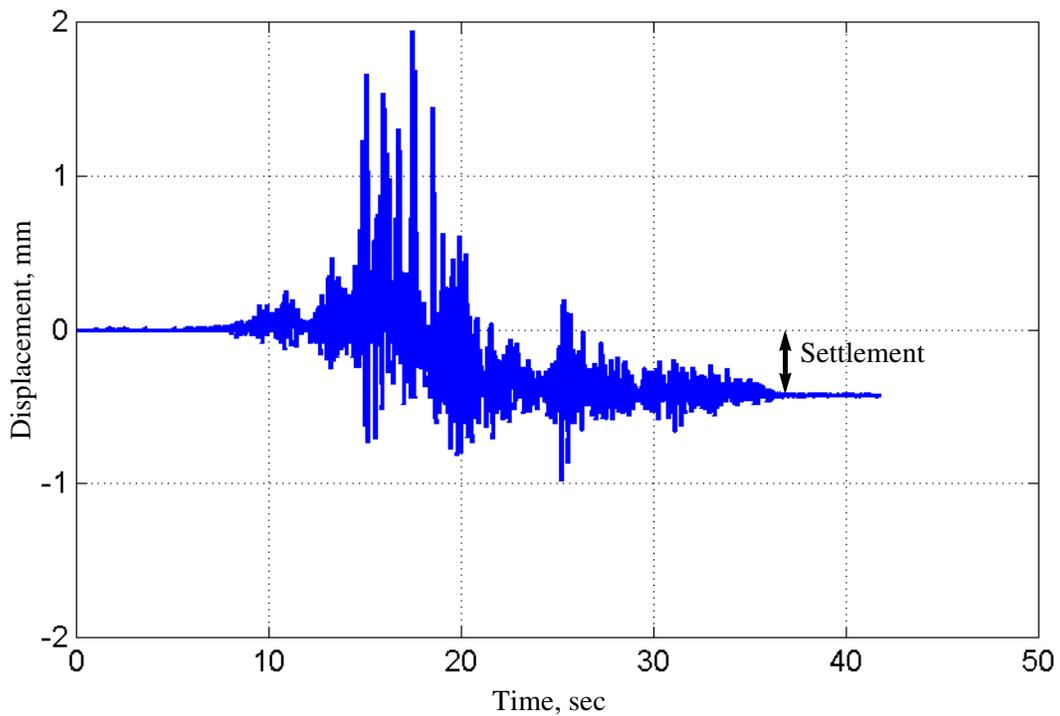
(a) Along y-axis (Channel 49)

(b) Along y-axis (channel 51)

Figure 7-20 Components of vertical motion for Bushing-2 without Ring-2; Test No 18, Tabas-B, target PGA=2.0g

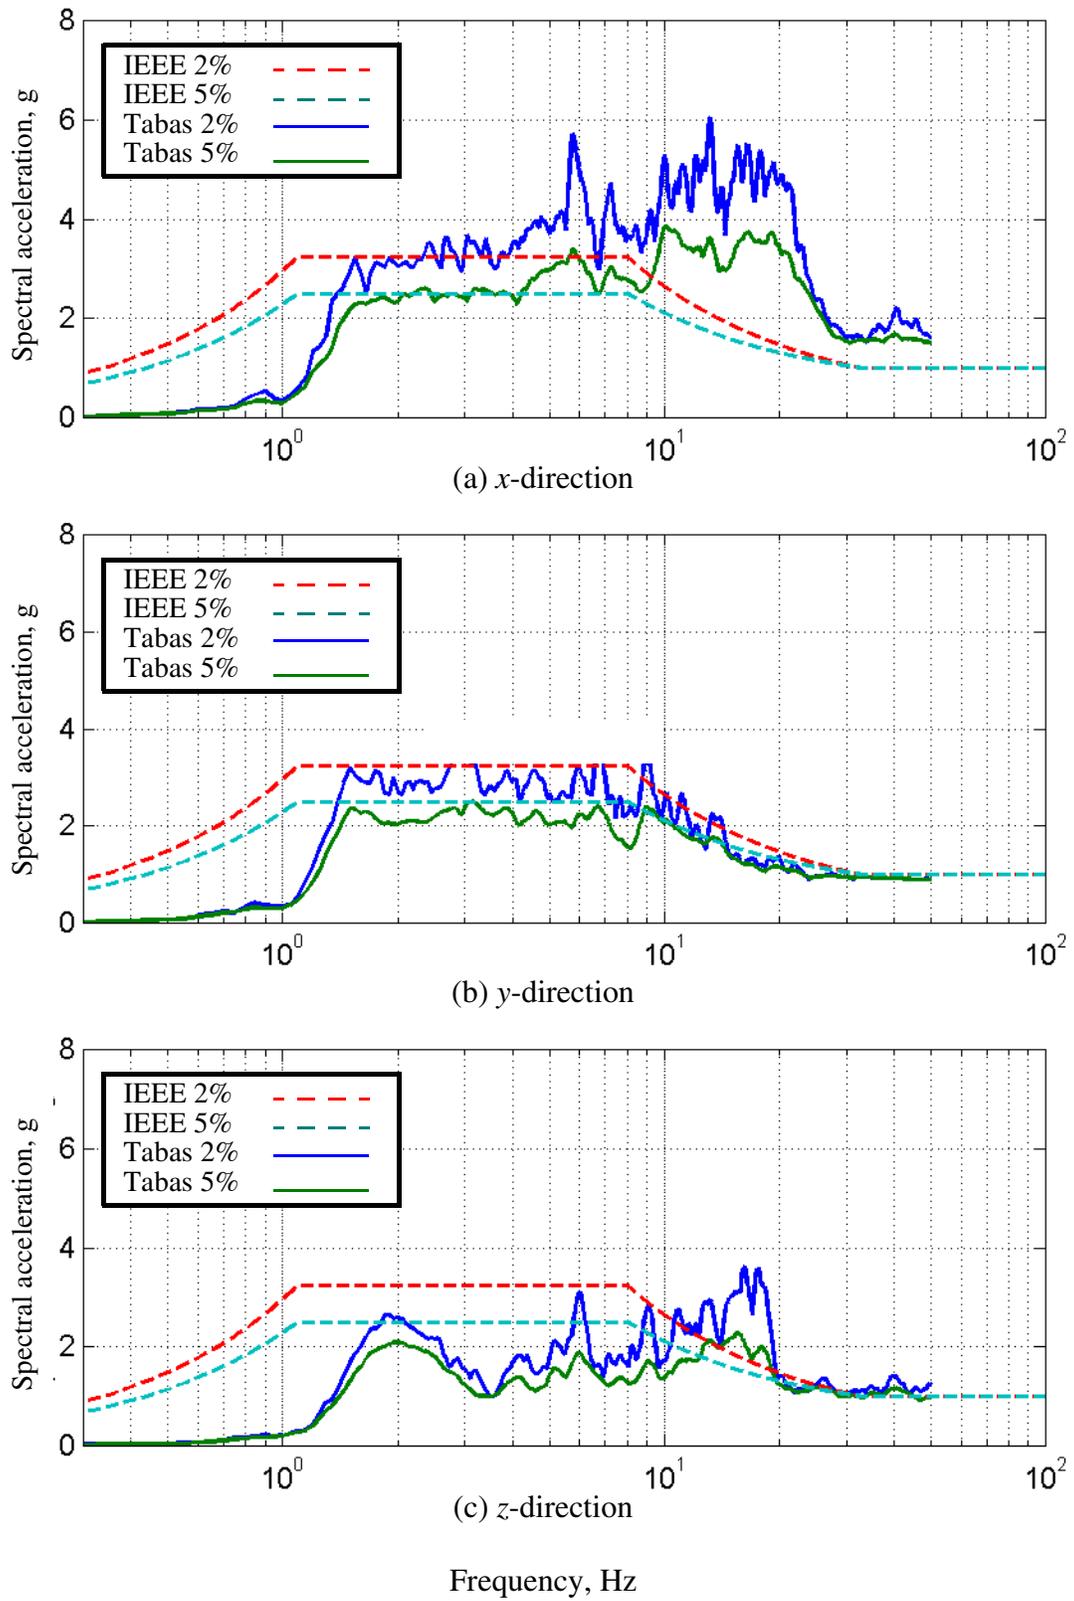
Figure 7-24 Response spectrum for Bushing-2 retrofitted with Ring-2; Test No 13, Tabas-A, target PGA=1.0g

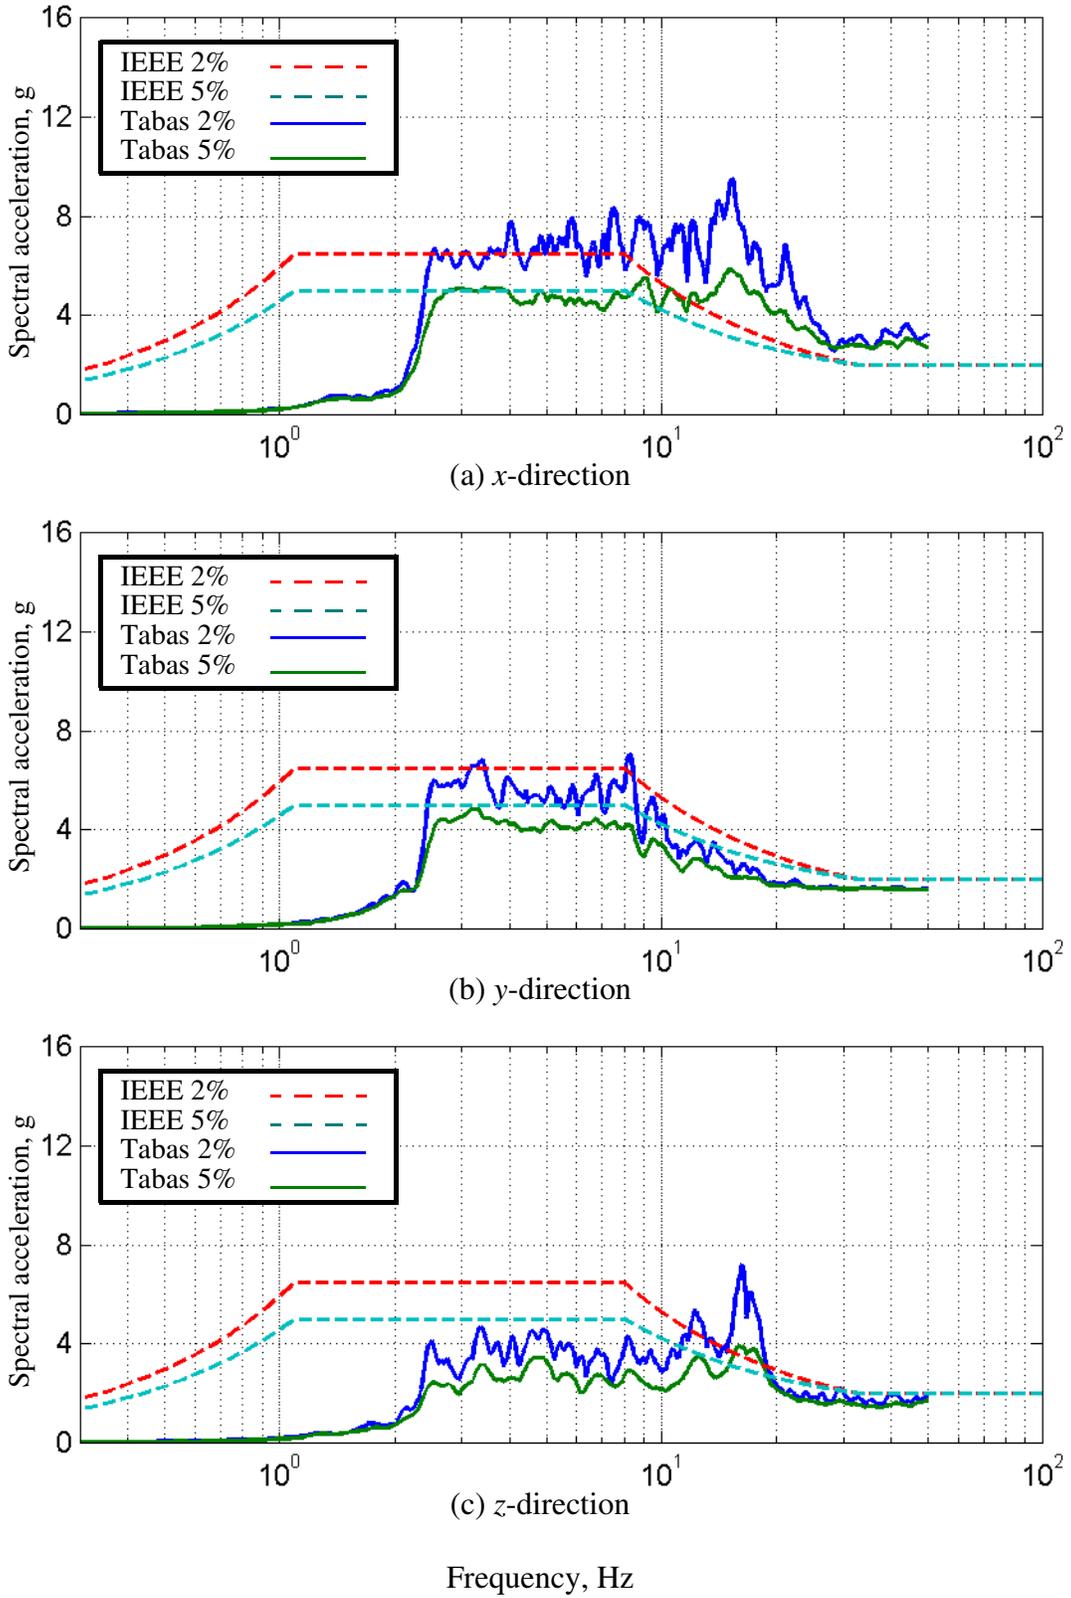
Figure 7-25 Response spectrum for Bushing-2 retrofitted with Ring-2; Test No 18, Tabas-B, target PGA=2.0g

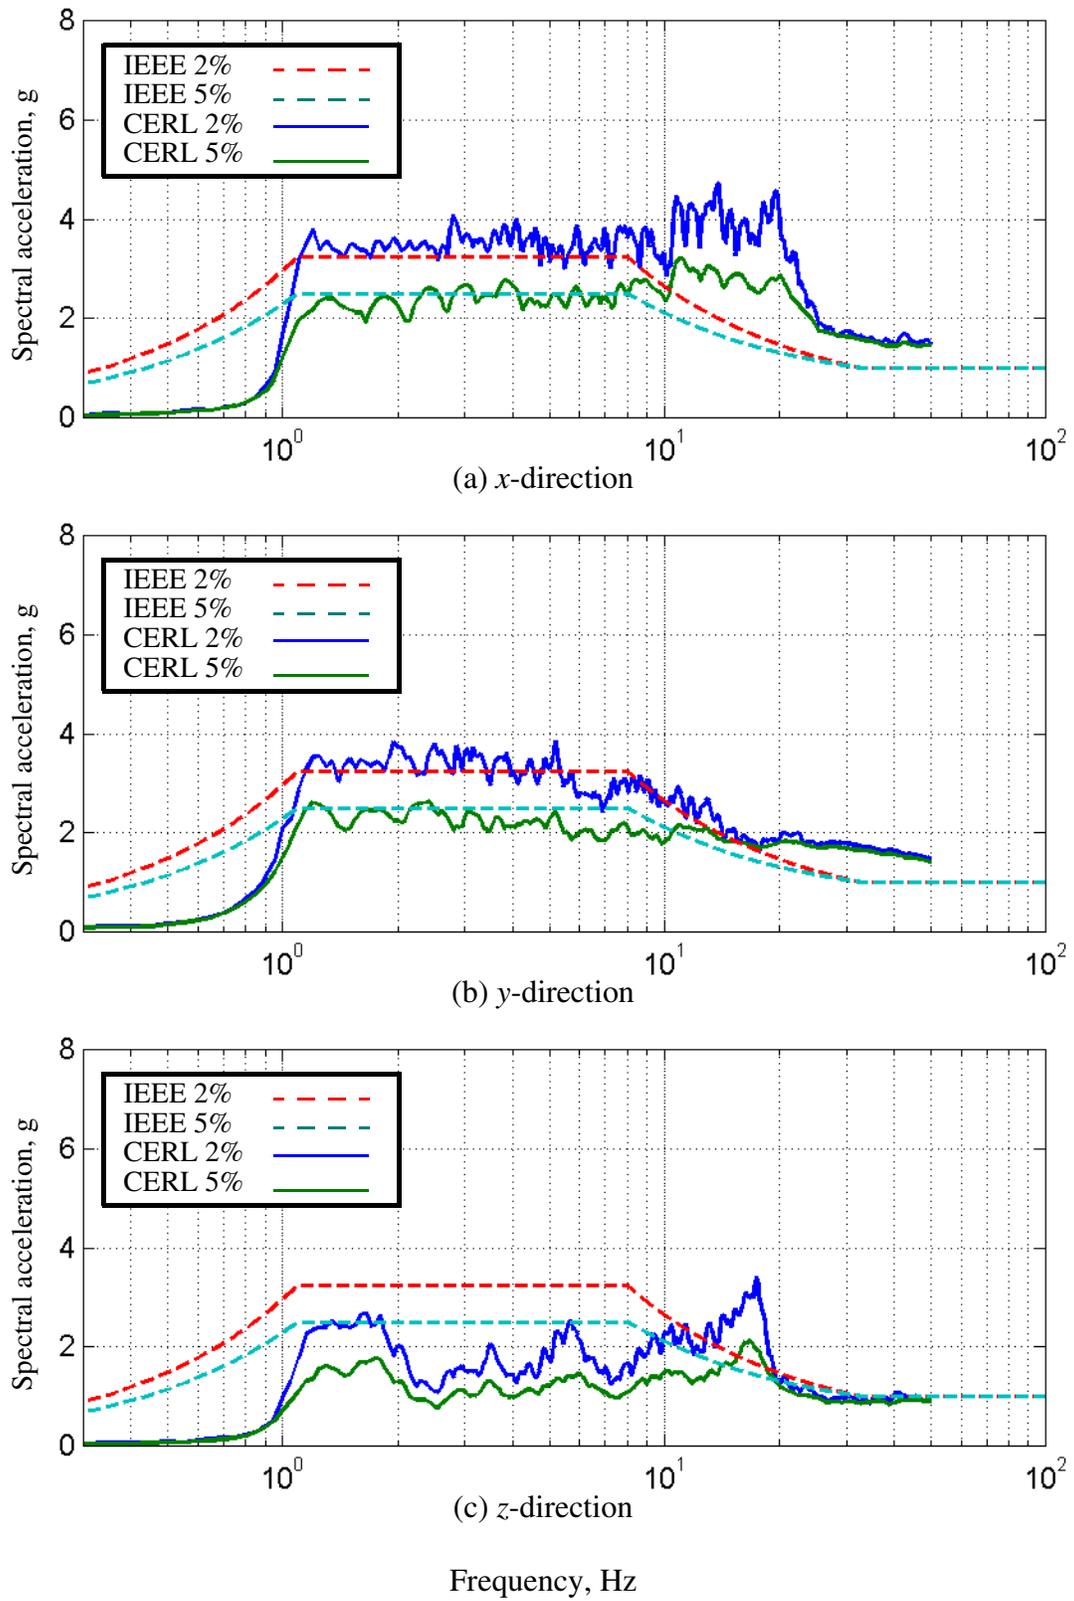
Figure 7-26 Response spectrum for Bushing-2 retrofitted with Ring-2; Test No 19, CERL, target PGA=1.0g

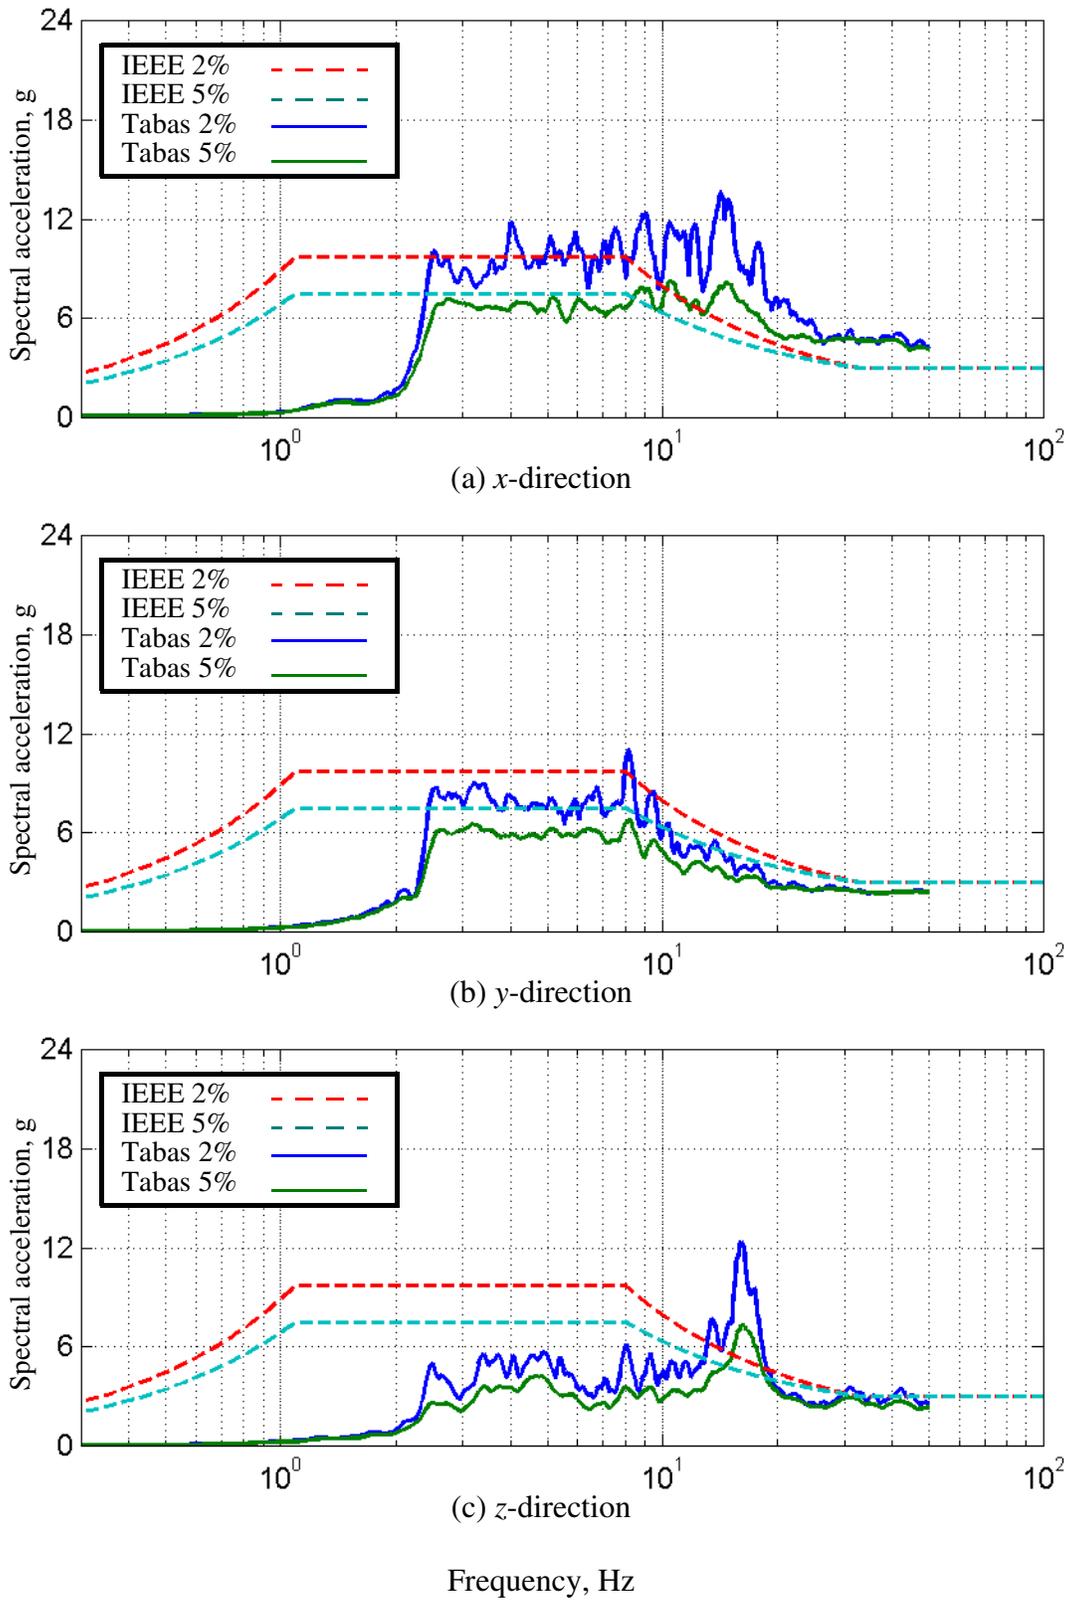
Figure 7-27 Response spectrum for Bushing-2 retrofitted with Ring-2; Test No 24, Tabas-B, target PGA=3.0g

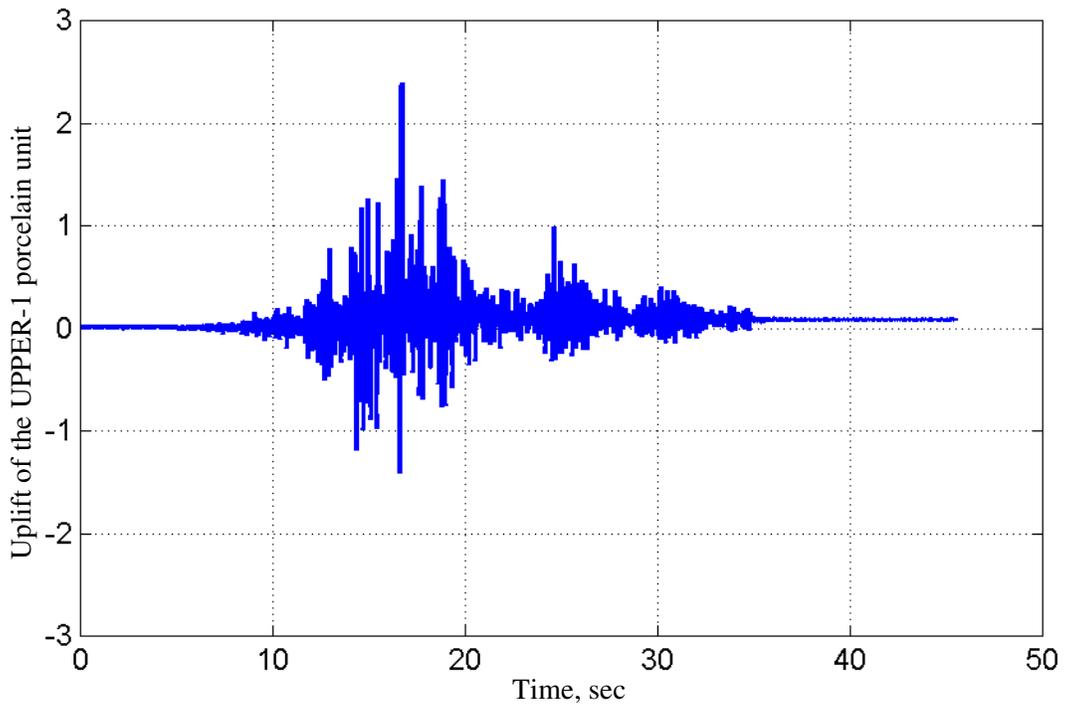
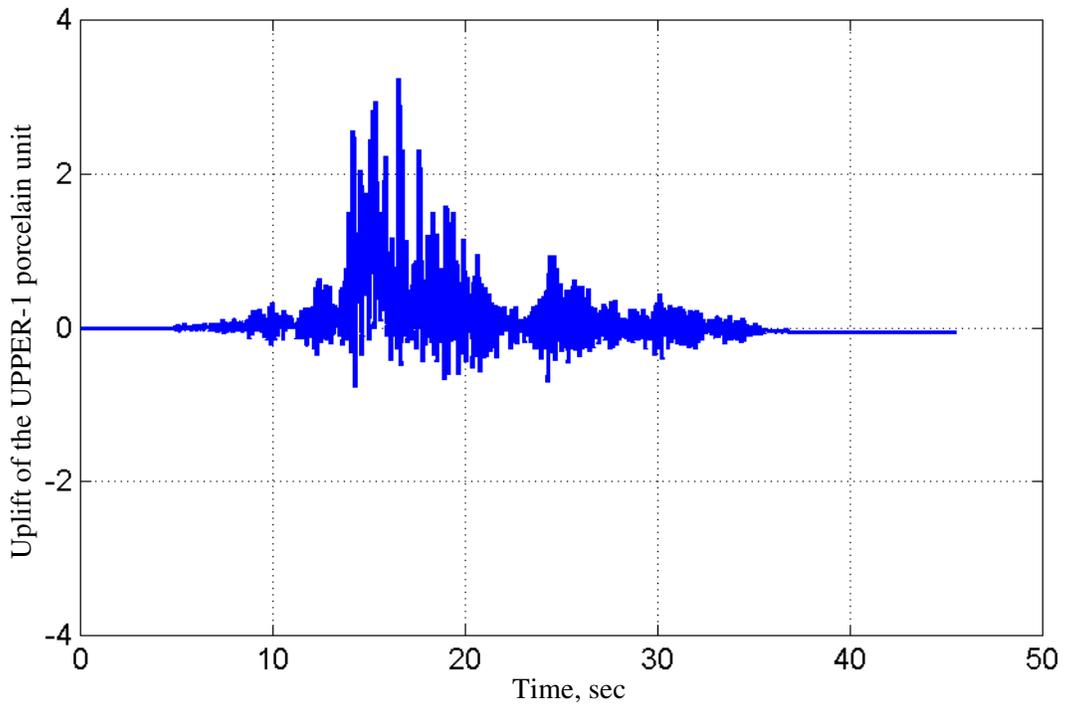
(a) *x*-direction

(b) *y*-direction

Figure 7-28 Components of vertical motion for Bushing-2 retrofitted with Ring-2; Test No 24, Tabas-B, target PGA=3.0g

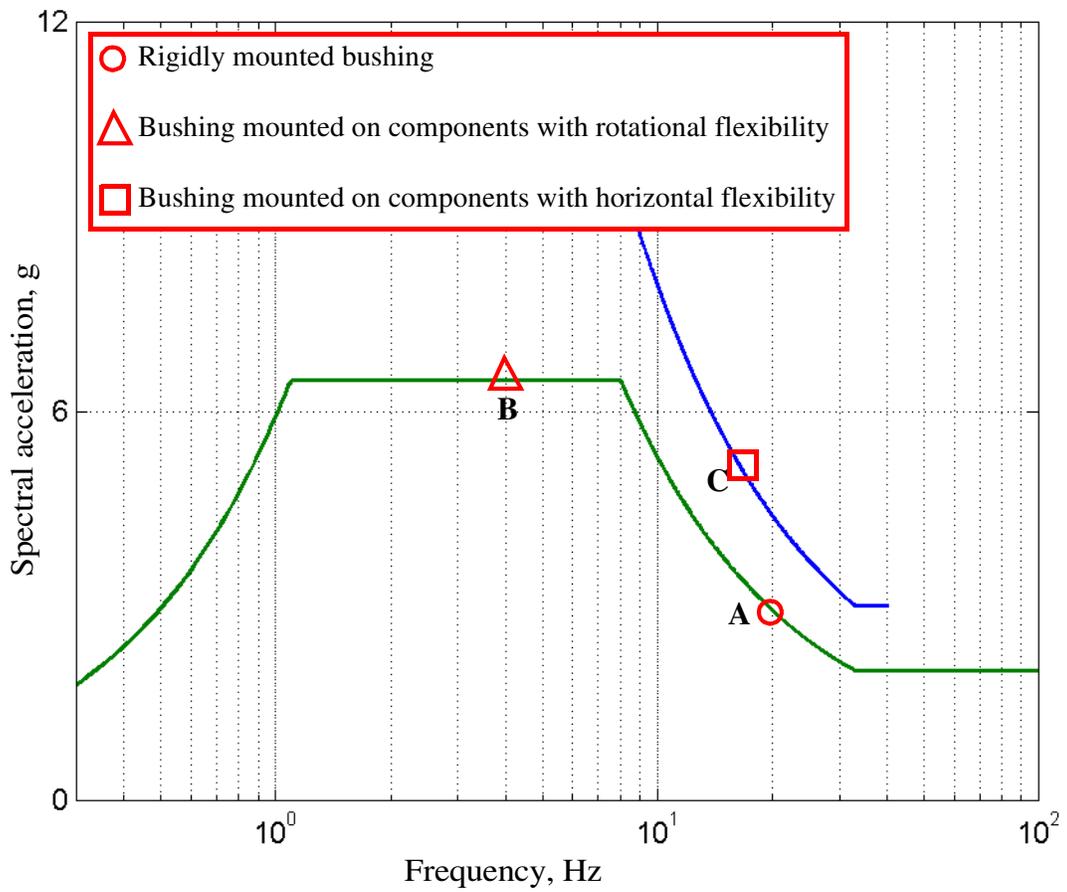
Figure 7-31 Effects of support flexibility on the spectral acceleration response of a bushing

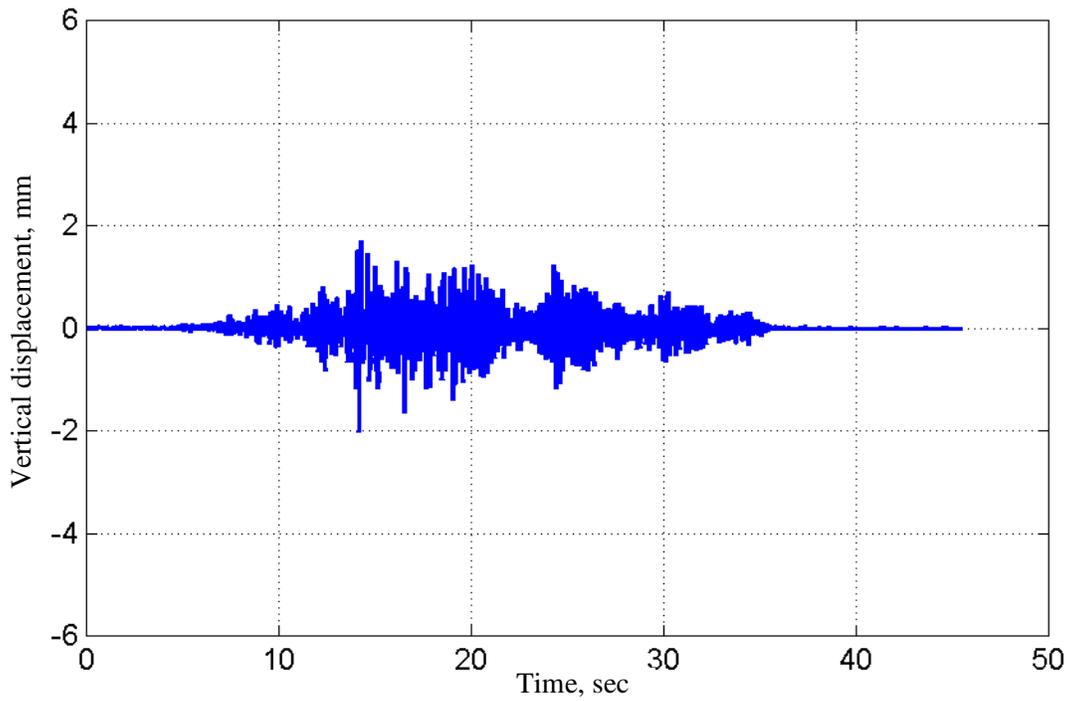
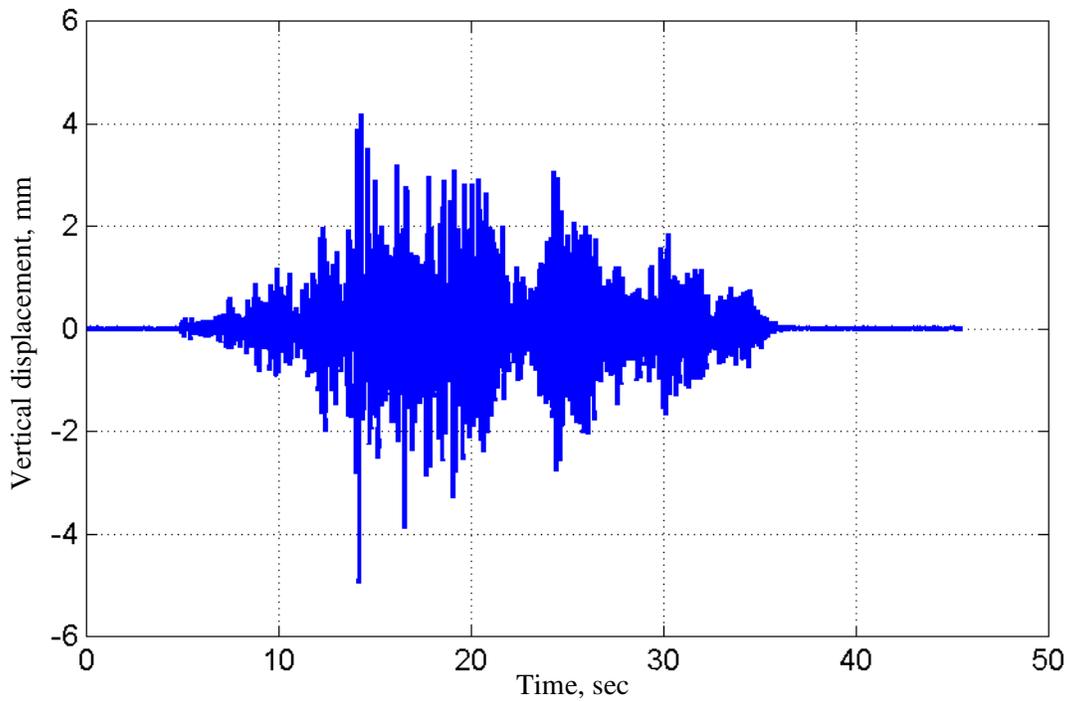
(a) At mid-circle of *flexible* plate (channel 60)

(b) At the bushing flange (channel 61)

Figure 7-32 Displacement response of flexible plate in  $z$ -direction; Test No 24, Tabas-B, target PGA=3.0g

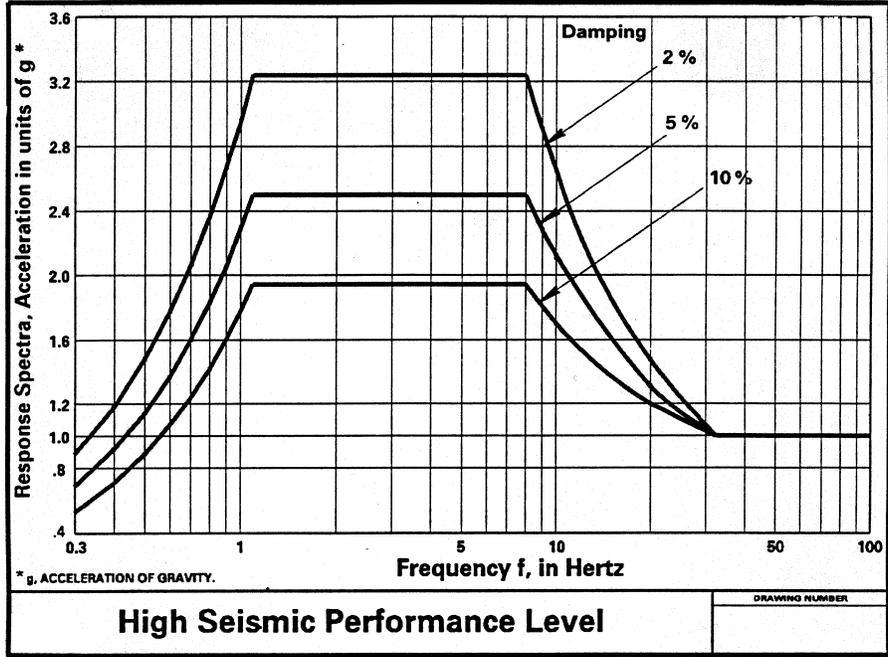
Figure A-1 Spectra for High Seismic Performance Level (IEEE, 1998)

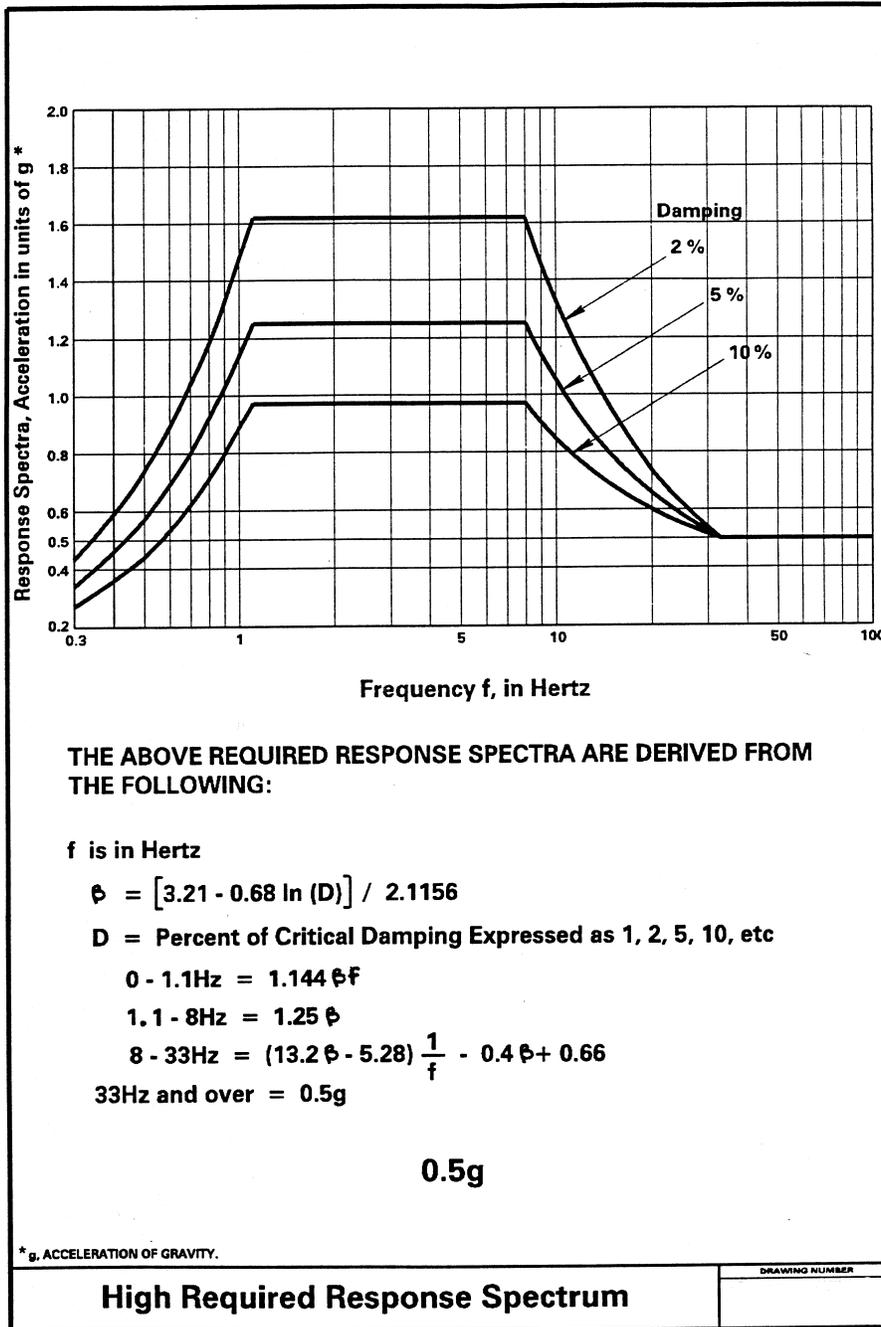
Figure A-3 Spectra for High Level Required Response Spectrum (IEEE, 1998)

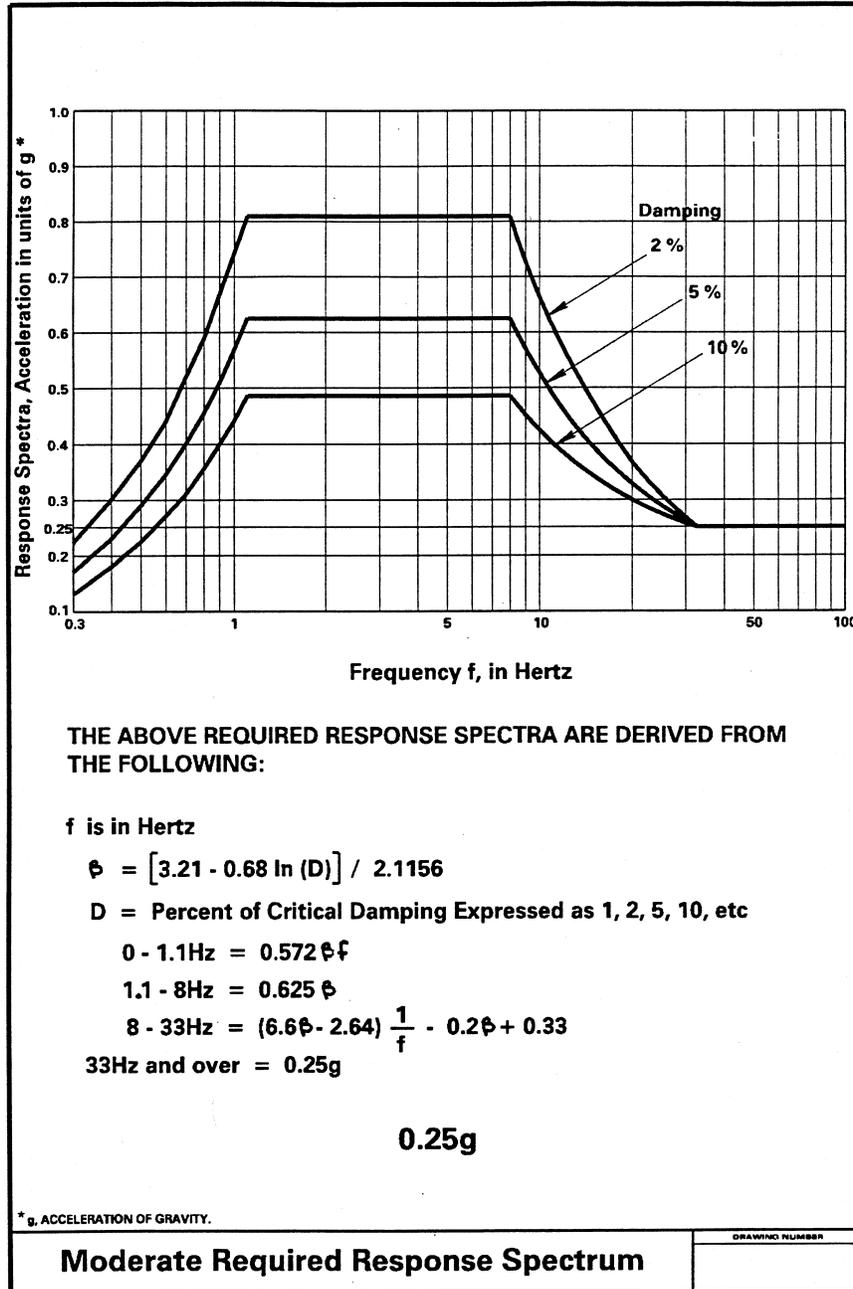
Figure A-4 Spectra for Moderate Level Required Response Spectrum (IEEE, 1998)
