## Seismic Evaluation and Retrofit of 230-kV Porcelain Transformer Bushings

PEER Report 1999/14  
Pacific Earthquake Engineering Research Center  
College of Engineering  
University of California, Berkeley  
December 1999

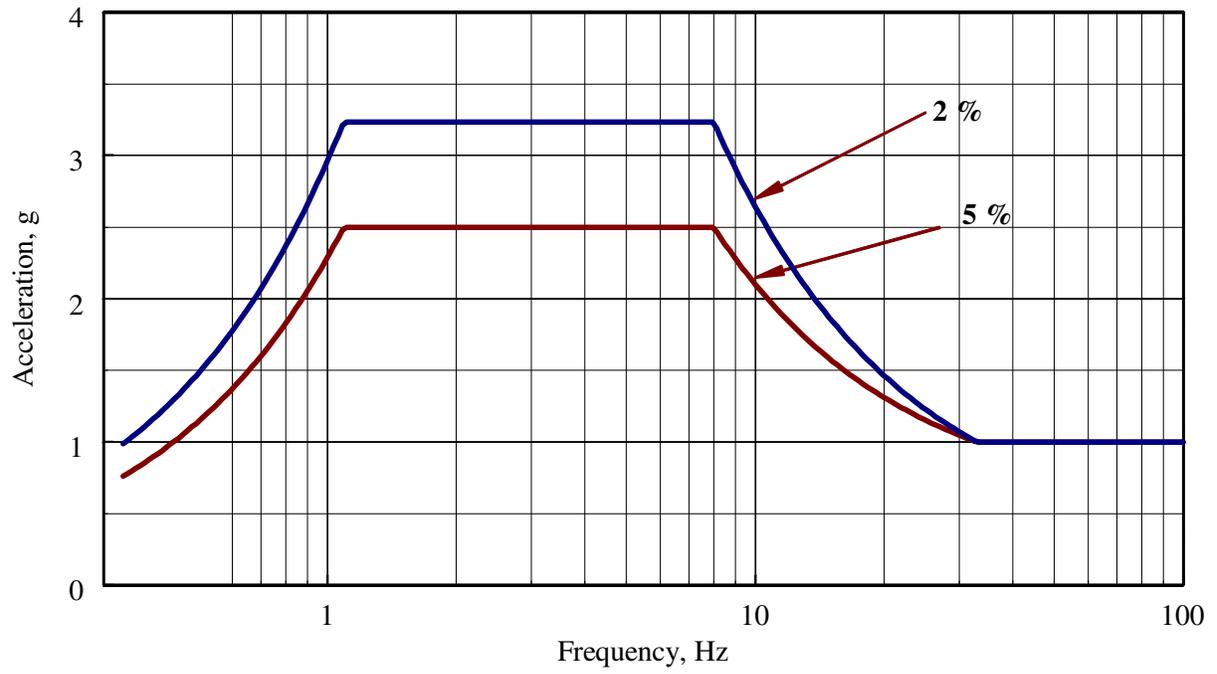
Figure A-5 Test Response Spectra for Moderate Level qualification of a transformer-mounted Bushing
