# Fiber Optic (+) Monitoring of Building Settlement and Bridge Degradation

Dr Matt DeJong (dejong@berkeley.edu)

# Outline – 4 projects

1. Tunneling-induced building settlement: Building scale  
(Bank Station - London, UK)
2. Tunneling-induced building settlement: City scale  
(Crossrail - London, UK)
3. Rail bridge diagnostics  
(CFM-5 Bridge – Yorkshire, UK)
4. Rail bridge degradation  
(Marsh Lane Viaduct – Leeds, UK)

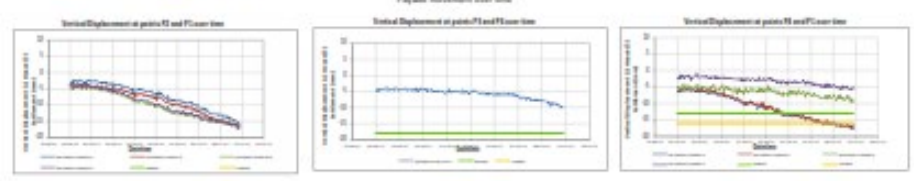
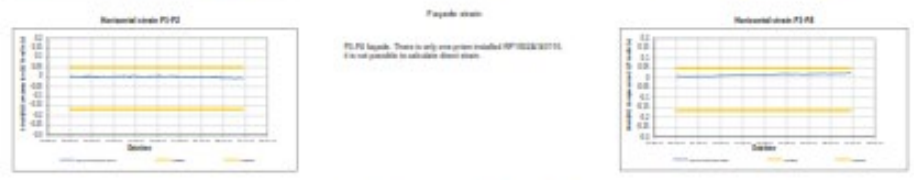
Monitoring results  
It should be noted that the predicted movements presented in the graphs below were obtained by these superposition of the movements resulting from modelling the pier tunnel and substructure. 3 BCS.

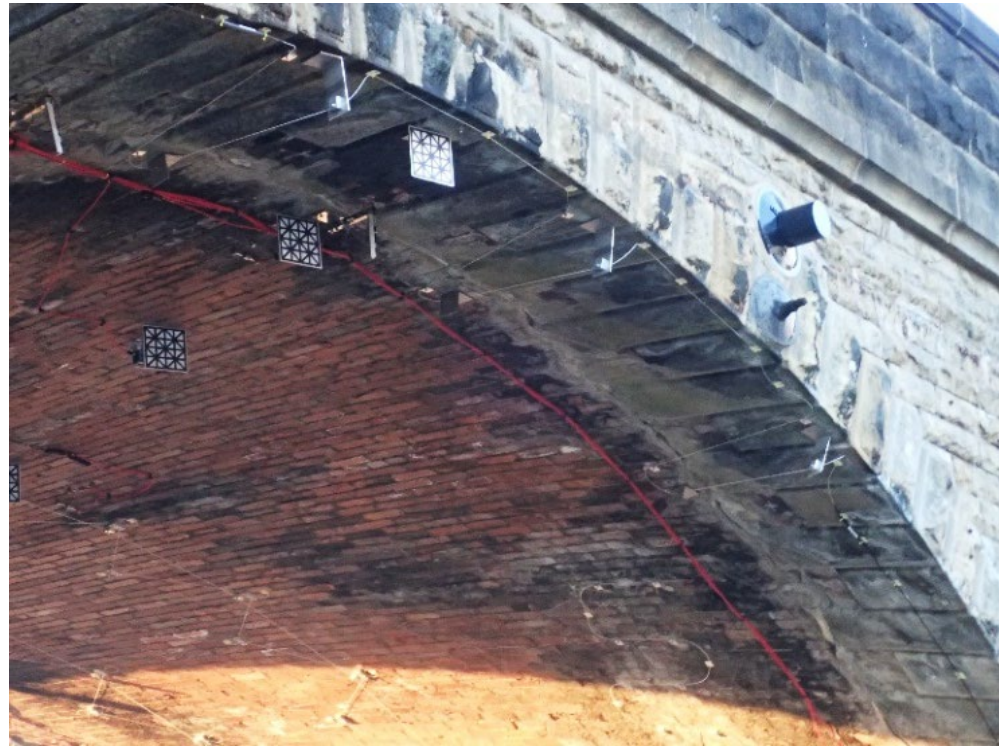
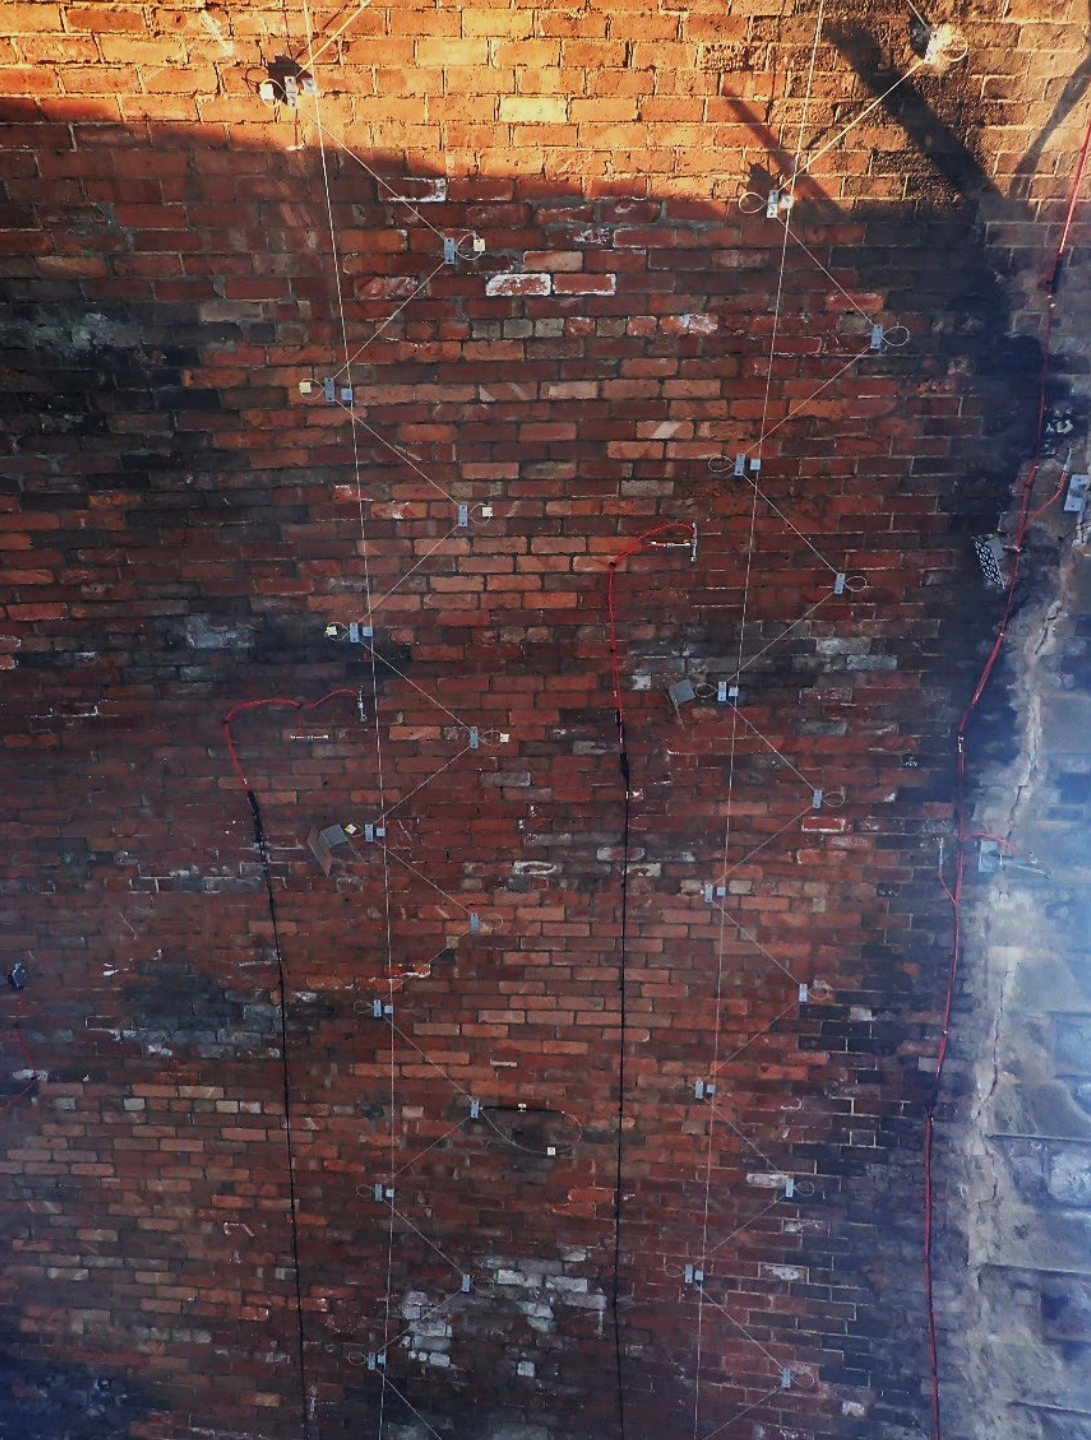
FBG pairs:

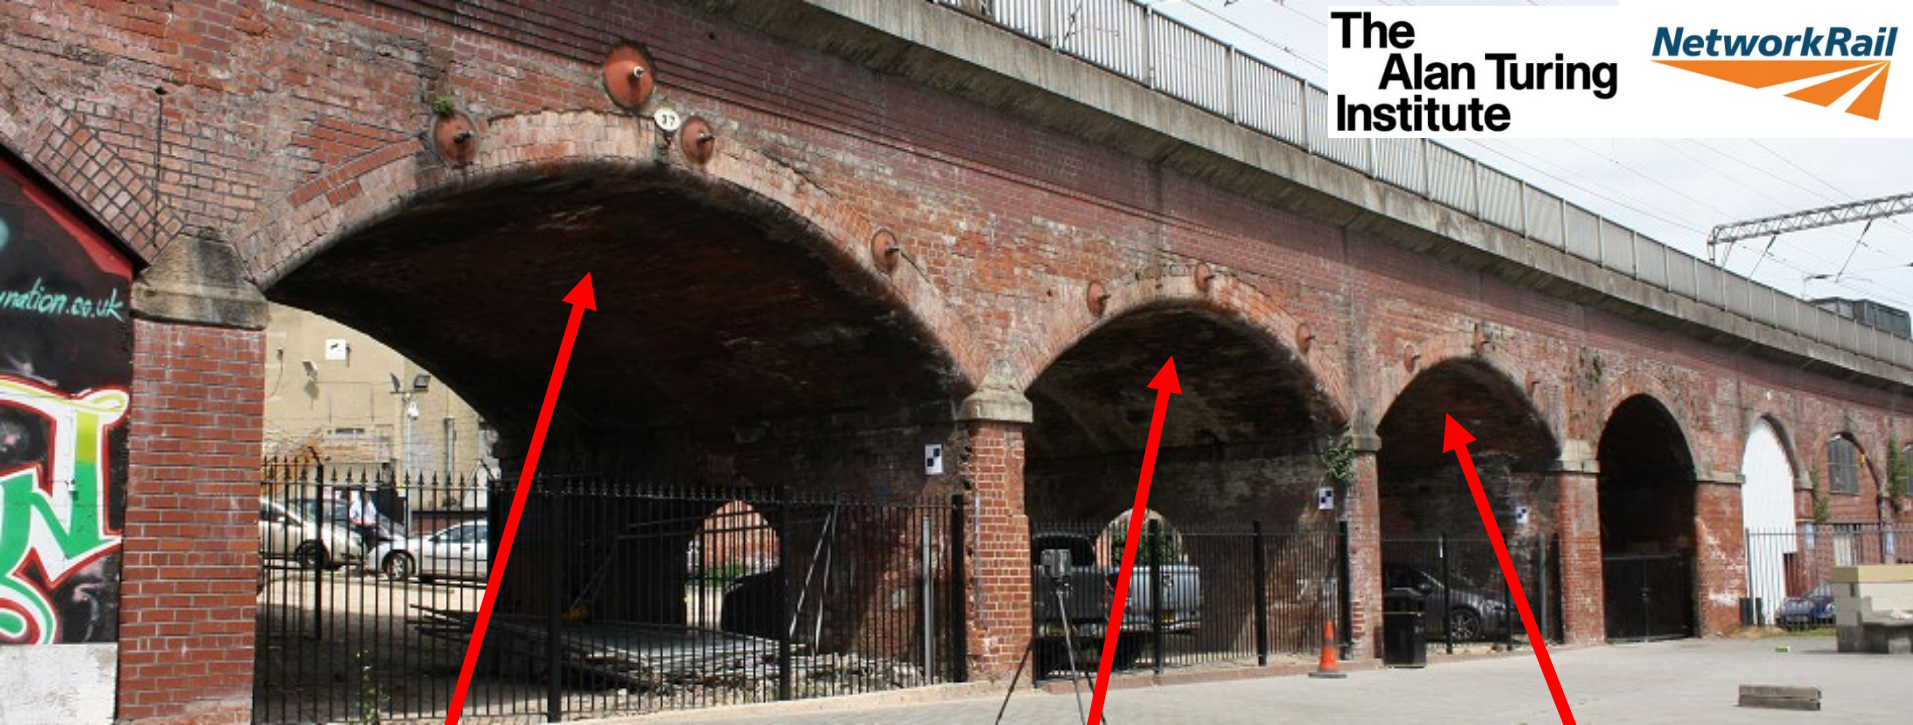
# Sensing Deployment

Fibre optic cables

Acoustic emission sensors

High-sensitivity accelerometers
