Ductility of RC Shear Wall Boundary Element in Compression

PEER Internship Program – Summer 2012

Undergraduate Intern: Dustin T Cook, CSU Chico
Intern Mentor: Duy To, UC Berkeley
Faculty Mentor: Dr. Jack Moehle
University of California Berkeley

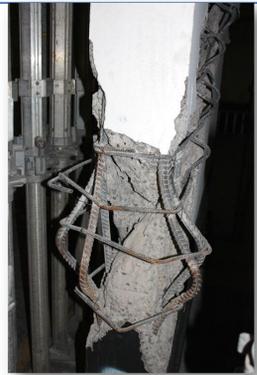
Shear wall boundary element of Chile 2010

On February 27, 2010 a massive 8.8 moment magnitude earthquake struck just off the Chilean coastline, ranking it the 5th most energetic earthquake in the world. Although many building performed exceedingly well in this earthquake, wide spread damage was found in reinforced concrete shear walls, particularly in their boundary elements. The damage that was seen in these shear walls was not caused by shear effects however. Instead concrete spalling and rebar buckling was seen in most of the shear walls, caused from large compressive forces in the boundary elements. These failures were most likely due to lack of transverse reinforcement and slenderness, commonly seen in Chilean shear walls. The examination of the effects and damages seen in this earthquake raise questions about shear wall design and construction here in the United States. This test looks into the ductility of shear wall boundary elements under compression, designed according to current Californian code, in order to evaluate the quality of current design.

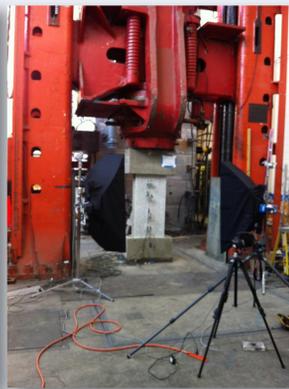
- 2 Specimens were constructed in Davis Hall and loaded in uniaxial compression till rupture at the Richmond Field Station in the 4 mil lb. capacity UTM.
- Each specimen was of the same dimensions but had different transverse reinforcement spacing of 3.96", according to current ACI code, and 2.61", a suggested requirement of future ACI code.

- Two other specimens of smaller dimensions were also constructed and tested in the same manner, these are being reported on by PEER intern, Andrew Lo.
- During construction, the large specimen with a 2.61" transverse spacing developed large cavities and honeycombs and was unable to be tested along with the others. This specimen will be reconstructed and tested at a later time.

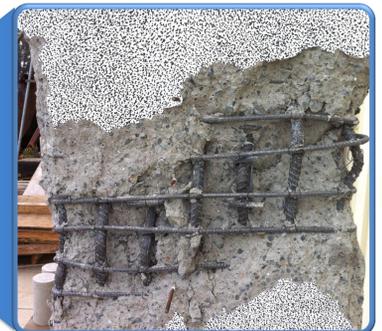
Rupture section of the specimen after testing.

Failure occurred do to concrete spalling in concentrated area, which led to a reduction in cross sectional area and increase of stress. This increased stress and lack of concrete cover led to yielding of the transverse reinforcement followed by buckling of the longitudinal reinforcement and finally failure of the whole specimen.
